# The Chanter's House Ottery St. Mary Devon

Results of Archaeological  
Monitoring and Evaluation, 2008

Report No.: 090924  
Date: 24.09.09  
Authors: G Gillard  
L Bray  
T Green  
B Morris

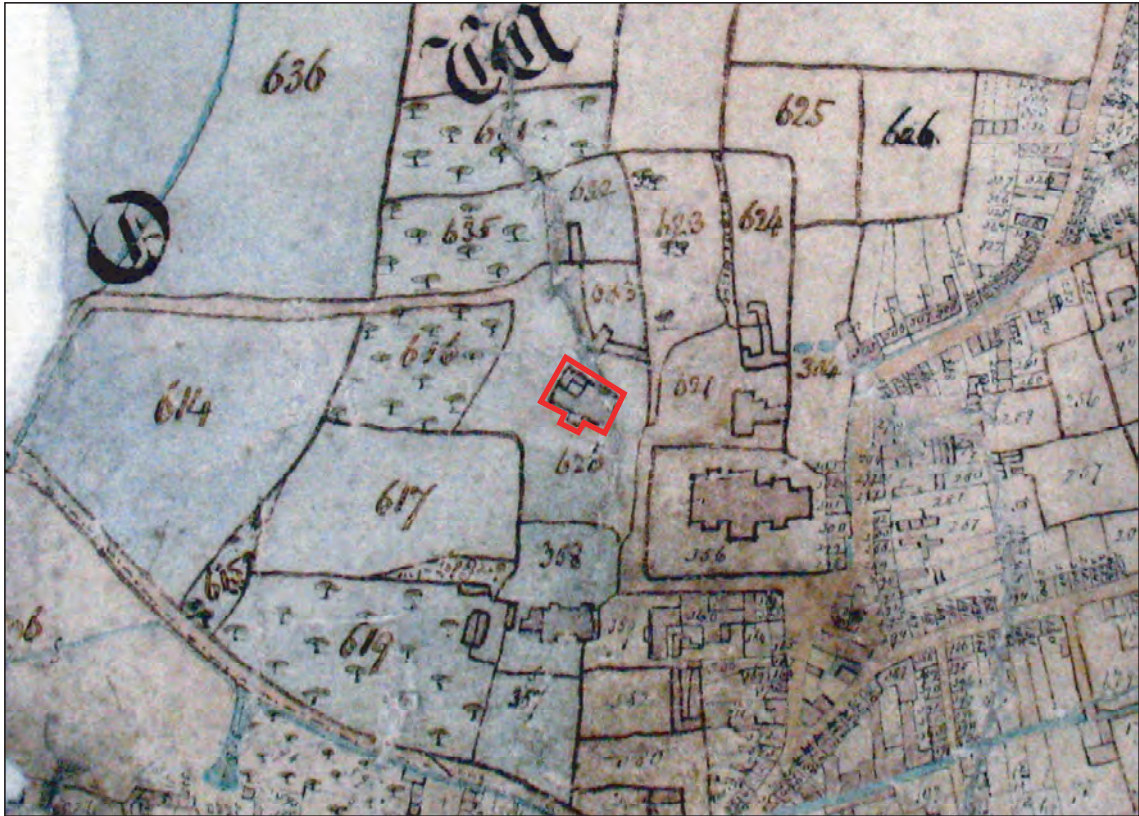
Fig. 3: Extract from the 1840 tithe map of Ottery St. Mary. The Chanter's House is shown in red (DRO).

features follow the line of a boundary present on the OS surveyor's draft map of 1806-7 and the tithe map of 1840 (see Fig. 3). The apportionment makes clear that this boundary divides the closes appertaining to Chanter's House (then Heath's Court) from the meadows to the west, subsequently interpreted as the boundary of the collegiate grounds (see Dalton 1917, 77). It is notable that this boundary is not present on the OS map of 1888 (see Fig. 4) but is reinstated in the same position by 1903 (see Fig. 5).

[501] was a ditch belonging to the historic boundary between meadows to the west and the closes of Chanter's House to the east (see Fig. 3). There is nothing to indicate this boundary was anything other than a shallow ditch, most probably with a hedge and bank, as there is no sign of a more substantial ditch or footings for a wall or stone-lined bank. This boundary was removed sometime between 1840 and 1888, the ditch being filled in if it had not already silted up. This was part of a programme of works that saw the small closes and meadows to the west of Chanter's House being replaced by formal gardens and parkland.

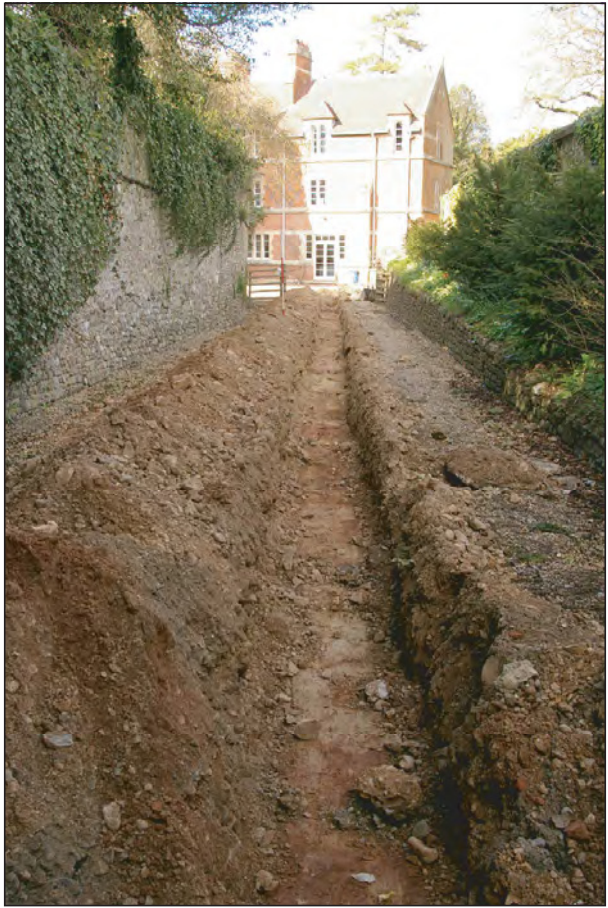
Plate 1: Trench 1, looking north along the drive to the Chanter's House. The wall of St Mary's Churchyard is on the right (2m scale).

The only feature of archaeological note in Trench 1 was the base of a brick wall, 0.2-0.3 m wide, trending east-west across it to the west of the steps leading to St. Mary's Church. It comprised a single course of brick with some stone set into a bed of mortar resting on the natural subsoil. It is probable this can be associated with the garden walls shown on 19<sup>th</sup> century maps (see Figs. 4 & 5).

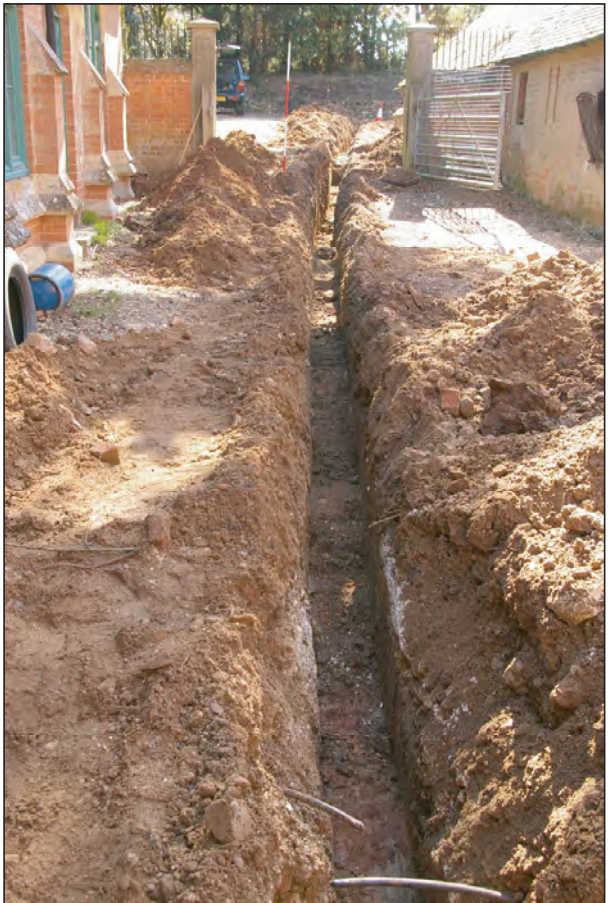
Plate 2: Trench 1, looking east across the courtyard at the rear of the Chanter's House (2m scale).

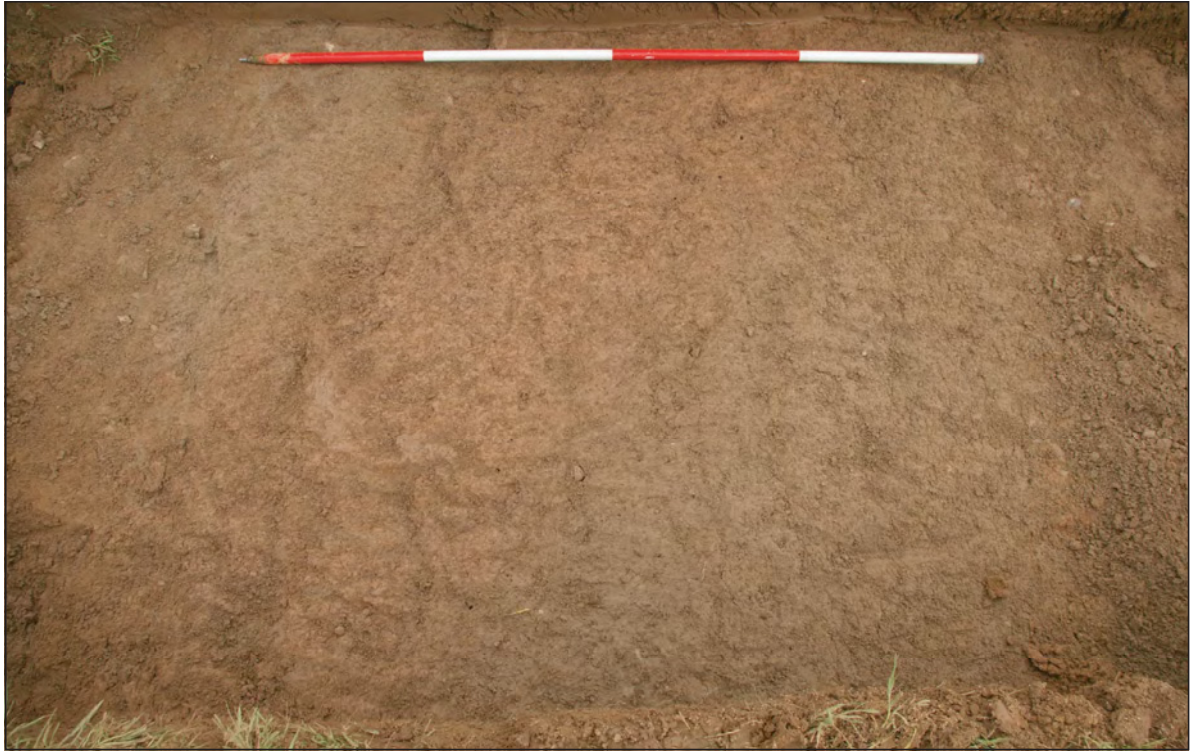
Plate 3: Trench 3, linear features [301] and [303] (2m scale).

Feature [301], the westernmost of the two, was up to 1m wide and proved to be only 0.1m deep with a flat bottom. This feature is likely to represent the truncated base of a ditch. It contained a single fill, context (302), a soft homogenous red-brown silty-clay that contained occasional pieces of flint or chert up to 80mm in size, and rare fragments of charcoal up to 10mm in size. (302) also contained several fragments of grey roof slate, including one near-complete example, and these were similar to those encountered during the excavation of Trenches 1 and 2 (see above). Also recovered were three pieces of green-glazed ceramic roof tile. Though these were broken and somewhat abraded and lacked diagnostic crests or slashing, it is probable these are of late or early post-medieval date, and may therefore be derived from one of the religious collegiate buildings associated with the Chanter's House.

Feature [303], the easternmost of the two, was similar in character to [301], consisting of a shallow ditch up to 1.35m wide by 0.12 m deep with a concave profile. Its fill, (304), was a soft homogenous reddish-grey silt containing rare inclusions of flint or chert up to 40mm in size, and very occasional flecks of charcoal.

Given the proximity of the two features and their common orientation, it is likely they represent the remnants of a field boundary, with a hedge or possibly a wall running between them.

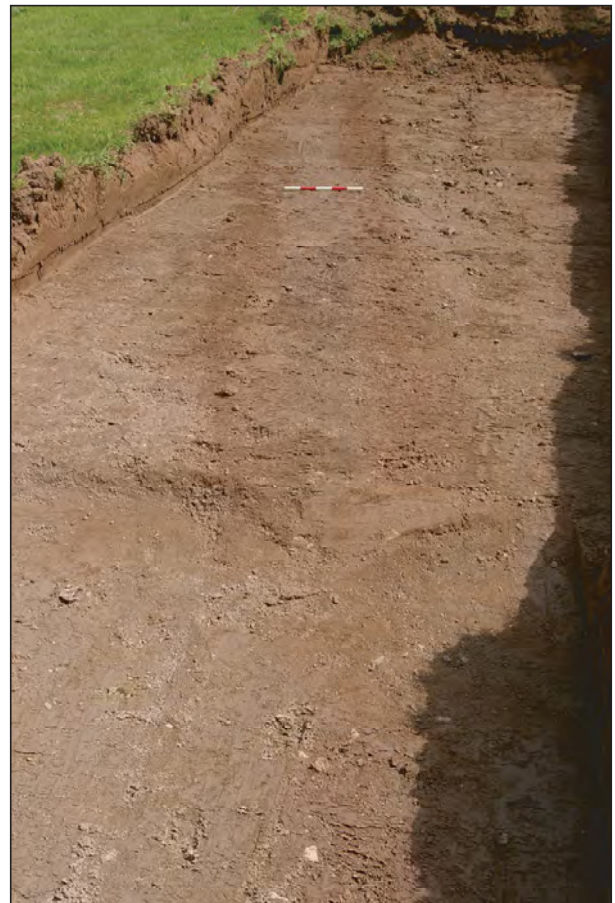
Plate 4: Topsoil strip between Trenches 3 and 4, showing linear feature [501]/[503] (2m scale).

At the southwestern end of the trench a linear feature [501] was observed. It ran diagonally across the trench from northeast to southwest. The observed length of [501] was 14m and it was 1.1m wide by up to 0.16m deep with a shallow, concave profile. It was filled by (502), a fairly soft, mid-brown slightly clayey silt that produced a single sherd of post-medieval glazed stoneware. The homogeneous, silty nature of this fill suggests that cut [501] had silted up naturally.

(502) was itself cut by linear gully [503], which ran down its centre. This was 0.35m wide, 0.07m deep with a shallow concave profile. It was filled with (504), a soft, light-grey silt in which a single sherd of 19<sup>th</sup> century pottery was found.

Linear [501]/[503] shared the same alignment as features [301] and [303] observed in evaluation Trench 3 a few metres to the southwest. It is probable that [501]/[503] represents a continuation of one of these features, with the absence of the second attributed to truncation – and both [301] and [303] were very shallow features.

[503] is a recut along the line of [501], and perhaps some trace of the older boundary was then still visible. It was along this line that pieces of iron post were found in the topsoil suggesting that the reinstated boundary took the form of metal fencing. The posts looked similar to those forming part of extant fencing to the southwest in a boundary running on the same line as [503]. [503] is probably a shallow drainage ditch but it is so slight that it may simply be a ditch worn by the passage of animals along the base of the fencing. The fence and ditch seem to have been lost by the mid 20<sup>th</sup> century.
