# AREA TO THE REAR OF 46 MARKET STREET APPLEDORE DEVON

Results of an Archaeological Desk-Based Assessment and Historic Building Recording

Report No.: 090312 Authors: T. Green

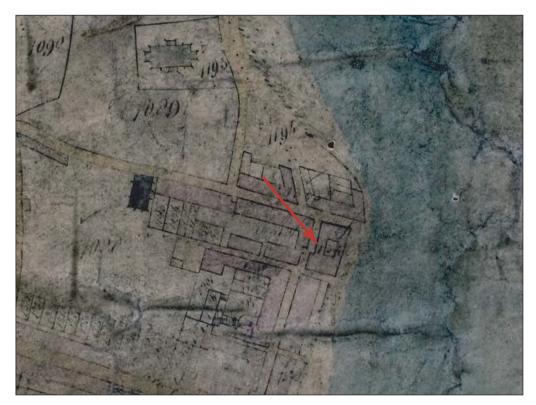
Fig. 2: Extract from the Northam tithe map, c.1840. The location of Number 46 Market Street is arrowed. (NDRO)

The earliest detailed plan of Appledore is found on the Northam tithe map of c.1840 (Fig. 2). This depicts a single block at the junction of Meeting Street and Market Street bounded to the south by what is now Vernon Street. The block bears a single (illegible) number and is therefore in a single ownership. The block appears to correspond to the group of houses depicted to the left of the bottom end of Meeting Street in the 1819 painting. The tithe map record seems to show buildings round a central open area which does not, on the face of it, correspond to the painting; however, it is possible that the apparent building(s) on the east side of the block was/were single storey and not visible to the painter. The map pre-dates by c.5 years the construction of the quay, so that the relationship of the buildings and their curtilage to the shoreline can be reasonably well judged.

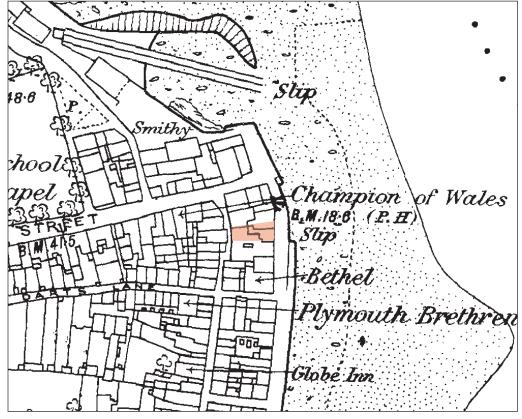
Fig. 3: Extract from the Ordnance Survey First Edition map at 1:2500, 1889 (Devonshire sheet 19.2). The location and extent of Number 46 Market Street is highlighted.

The Ordnance Survey First Edition 1:2500 map of 1889 (Fig. 3) provides more detail, showing boundaries within the single block depicted in c.1840. The location of Number 46 Market Street can be identified, since it lies at the narrowest point of Market Street, where the opposite property to the west invades the street line. It can be seen therefore that at this date it was part of a larger property with a long frontage on Market Street and extending eastwards to adjoin the Quay. The boundary between this property and that to the north divides an open area which must correspond in part to that shown in c.1840. By this date the part to the south of the boundary had been partly built over, this mid-19th century work including the now extant eastward extension of Number 46. In the centre of this enlarged single building the map records a small open area.

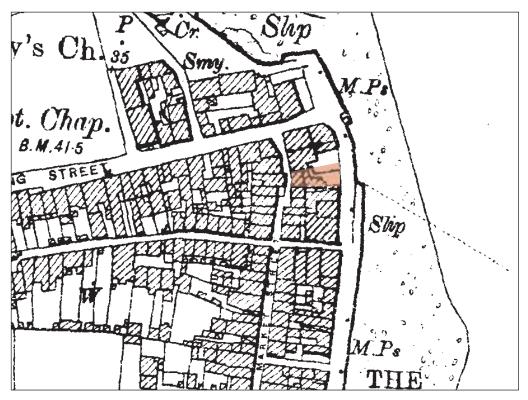
Fig. 4: Extract from the Ordnance Survey Second Edition map at 1:2500, 1905 (Devonshire sheet 19.2). The location and extent of Number 46 Market Street is highlighted.

Between 1889 and 1905 further change occurred. The Ordnance Survey Second Edition map of 1905 indicates further subdivision. In the intervening 16 years the part of the property fronting onto Market Street had been divided into three, the most northerly subdivision corresponding to what is now the Market Street end of Number 46. The eastward extension was now also divided from a newly created property to the south corresponding to what is now known as *Missioner's Cottage*.

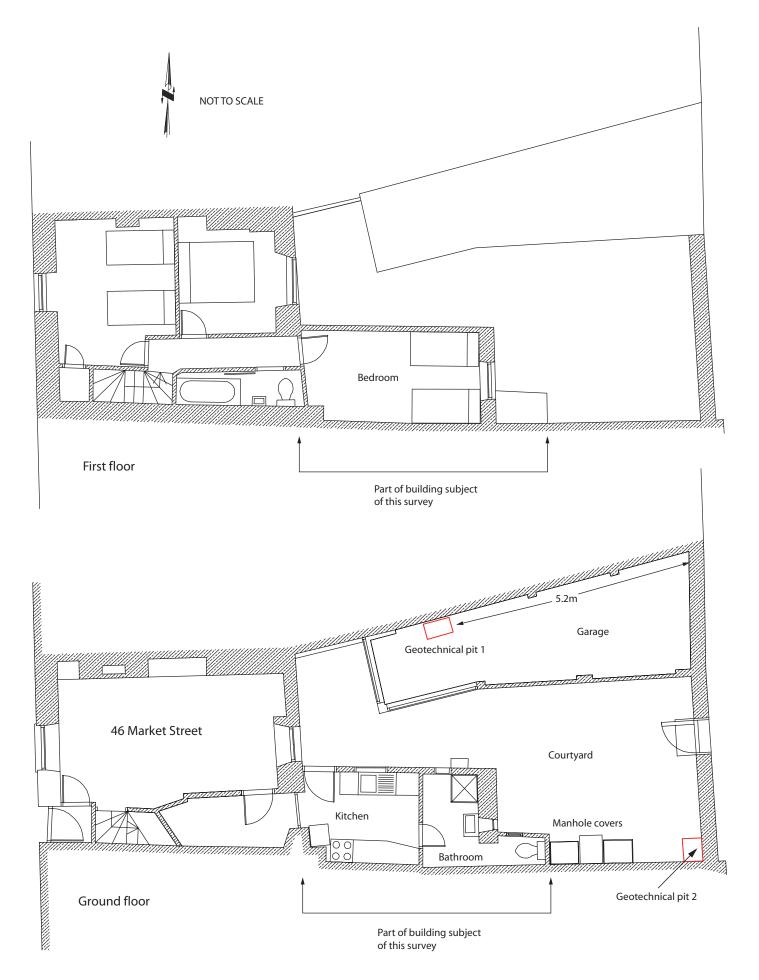
Fig. 5: Ground and first floor plans of 46, Market street, Appledore showing the part of the building subject to survey and position of the geotechnical pits. (Based on drawing supplied by Clive Jones Architects)

Two 1m square pits were hand-dug under archaeological observation (see Fig. 5)

Located in the garage against the boundary of the site, 5.2m from the north east corner. The revealed stratigraphy consisted of a 50mm deep layer of modern concrete, over 250mm of loose grey-brown silt-sand with common stone <200mm and modern brick. This overlay a depth of 200mm of cobbling with rounded and angular stone and some brick, covered by a thin layer of concrete and set within a matrix of very dark grey soft silt. Beneath this layer was 0-400mm of soft grey-brown sand-silt with common grit and stone and containing  $19^{th}/20^{th}$  century pottery. This was not present against the wall to the north and was up to 400mm thick to the south side of the pit. Below this and down to the full depth of the pit (1100mm) was yellow-brown sand with a little rounded stone.

Located in the south-east corner of the yard, this pit revealed 150mm of cobbles overlying 350mm of grey-brown sand-silt with fragments of modern brick, mortar and pottery, over a modern ceramic drain. It should be noted that the surface of the yard was around 400mm below that of garage and therefore the cobbles in the yard are likely to be the same as those found in Pit (1) 300mm below the surface.

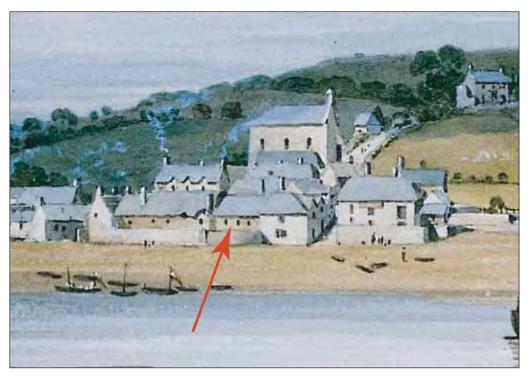
Plate 2: Extract from a watercolour by G.Shepherd, 1819 (original in the Ashmolean Museum, Oxford). This selection shows Meeting Street leading down to the foreshore with the recently (1816) constructed Independent Chapel half way up the hill on the left. The arrow indicates the approximate location of Number 46 Market Street. (From An Illustrated History of Appledore, page 31 - with the author's permission.)

It can be seen in the painting of 1819 (Plate 2) that at that date there were, at the junction of Meeting Street and the foreshore, two long buildings with a north-south axis (the more northerly having either a neighbour or an extension on its north-east). The evidence of the tithe map is that the buildings on the west side of the block at the junction of Market Street and Meeting Street had a north-south axis. The western side of the large property (comprising what is now Number 46 and its southern neighbour) recorded on the OS map of 1889 (Fig. 3) similarly has a north-south axis, suggesting the survival at this date of (one of ) the long building(s) shown in 1819 – though it is hard to tell exactly which, assuming that the painter's record was accurate. This was subsequently internally divided into three, as shown in 1905. The central division has since been removed and replaced by a courtyard, while the third (southern) division appears to have been extended westwards to meet the building line of Market Street to the south. Number 46 would thus appear to be the remainder of this early building. Consideration of certain internal details – wall thickness, the presence of what appears to be the remainder of a flagged through-passage, a roughly re-constructed gable end visible in the loft – suggests that the Market Street end of Number 46 is the remnant of a post-medieval dwelling quite possibly of the three-cell cross-passage type. The mid-19th century extension was built over a hitherto open yard which may originally have extended to the edge of the foreshore.

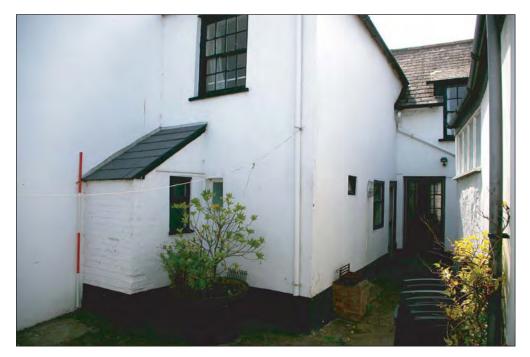
Plate 3: The extension to the rear of 46 Market Street Appledore viewed from the east.

The element of the building that is the subject of this report consists of a two storey extension to the rear (east) of 46 Market Street, probably constructed in the mid-19<sup>th</sup> century, consisting of a ground floor kitchen and bathroom and a first floor bedroom. The external walls are smooth rendered probably of stone construction with a slate roof hipped to the rear of the building. The lower part of the north elevation has a doorway to the west (adjacent to the rear of 46 Market Street) with a plain four panelled door and a modern two light window with the upper part louvered to the east. This window is likely to be a replacement for an earlier sash window as seen on the upper part of the east elevation. A further small window to the east would appear modern and acts as a vent for the bathroom. The upper part of this elevation has no openings. The east elevation has a modern small window in the lower part and an 8x8 light hornless sash window central in the upper part. Attached to the south of this elevation is a small single storey brick privy with a slate roof, the former external doorway of which has now been blocked and converted to a window. This room is now accessed from inside the building.

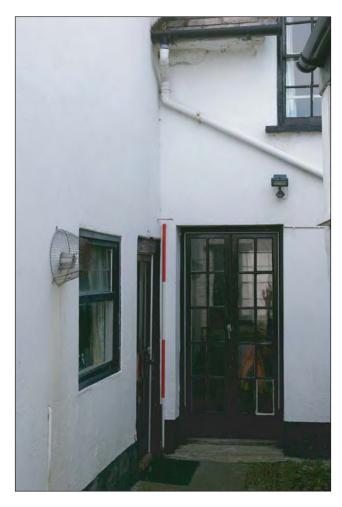
Plate 4: The rear doorways to the main range and the extension.

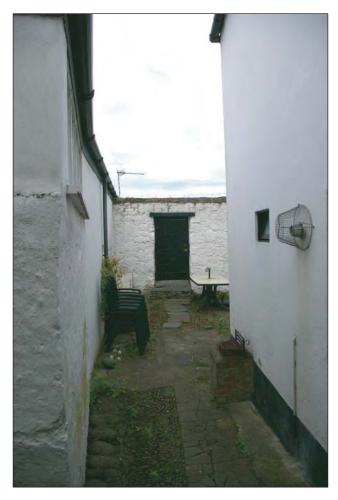
Plate 5: The passageway between the extension and the garage viewed from the west showing the rear gateway to Appledore Quay.

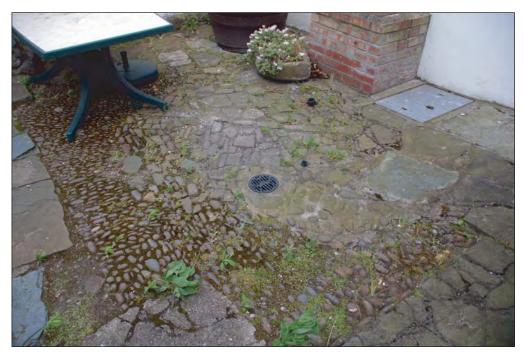
Plate 6: The cobbled surface of the courtyard to the rear of the extension viewed from the north west.

The yard to the rear of 46 Market Street is paved variously with a rectangular sandstone paving, beach pebble and angular sandstone cobbles. Much of the surface has been disturbed by the laying of modern drainage.
