**THE CHASE
HARLYN BAY
ST MERRYN
CORNWALL**

Heritage Assessment

South West Archaeology Ltd. report no. 201211

Work undertaken by SWARCH for
A Private Client (The Client)

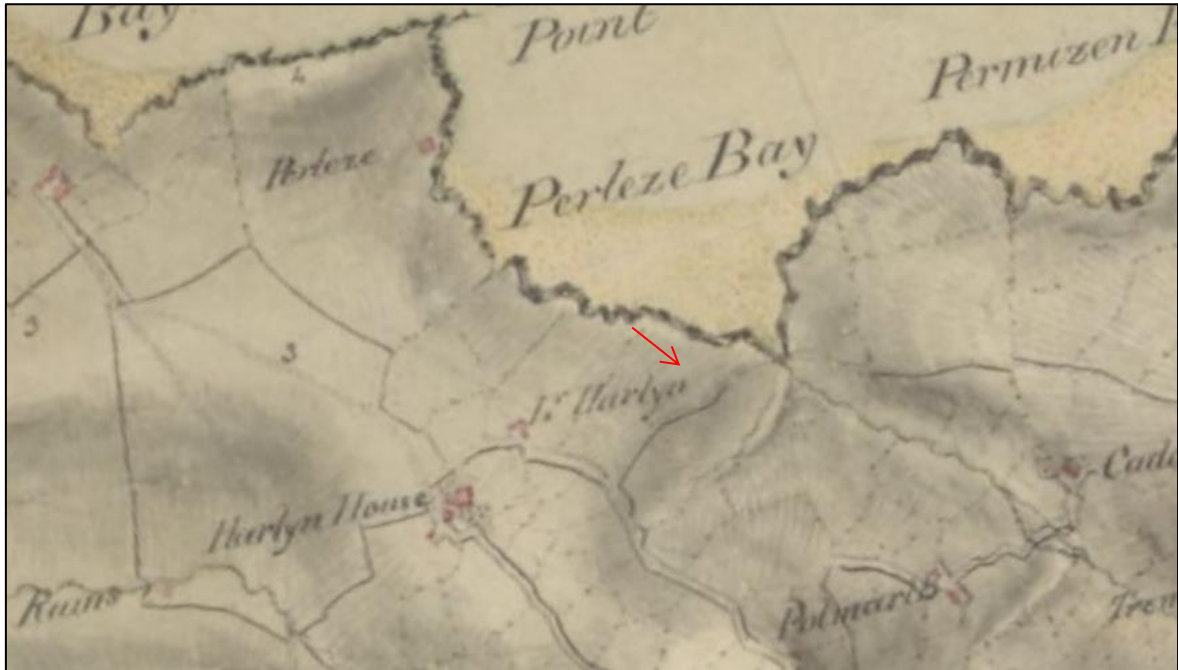
FIGURE 2: EXTRACT FROM THE 1808 SURVEYORS DRAFT MAP (BL). THE APPROXIMATE SITE LOCATION IS INDICATED

The surveyors draft map for Padstow (Figure 2) shows little development at Harlyn in the early 19th century, the properties shown are away from the coast. The main residence appears to be Harlyn House. Harlyn Bay is named Perleze Bay at this date. No development can be seen in the location of the proposed site.

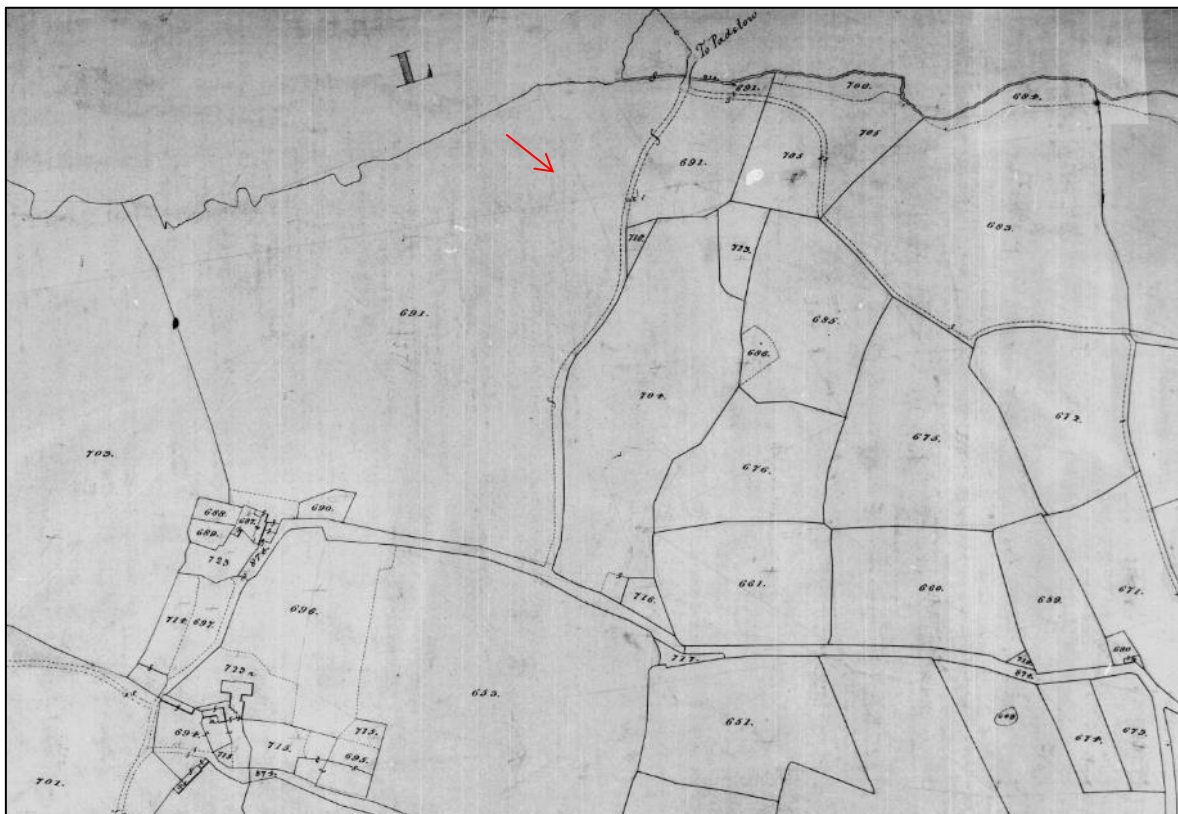
FIGURE 3: EXTRACT FROM THE 1841 TITHE MAP (TNA). THE APPROXIMATE SITE LOCATION IS INDICATED

The 1841 St Merryn tithe map (Figure 3) shows the site as part of a large open field belonging to John Henry Thomas Peter as part of Lower Harlyn and occupied by Henry Hawken. It is named Undertown and is recorded as under arable cultivation at the date of the tithe survey. The Padstow road evidently cuts through the north eastern part of the plot, which is shown with the same plot number. No development is evident in the area of the site, with the only properties limited to those shown on the earlier surveyors draft map.

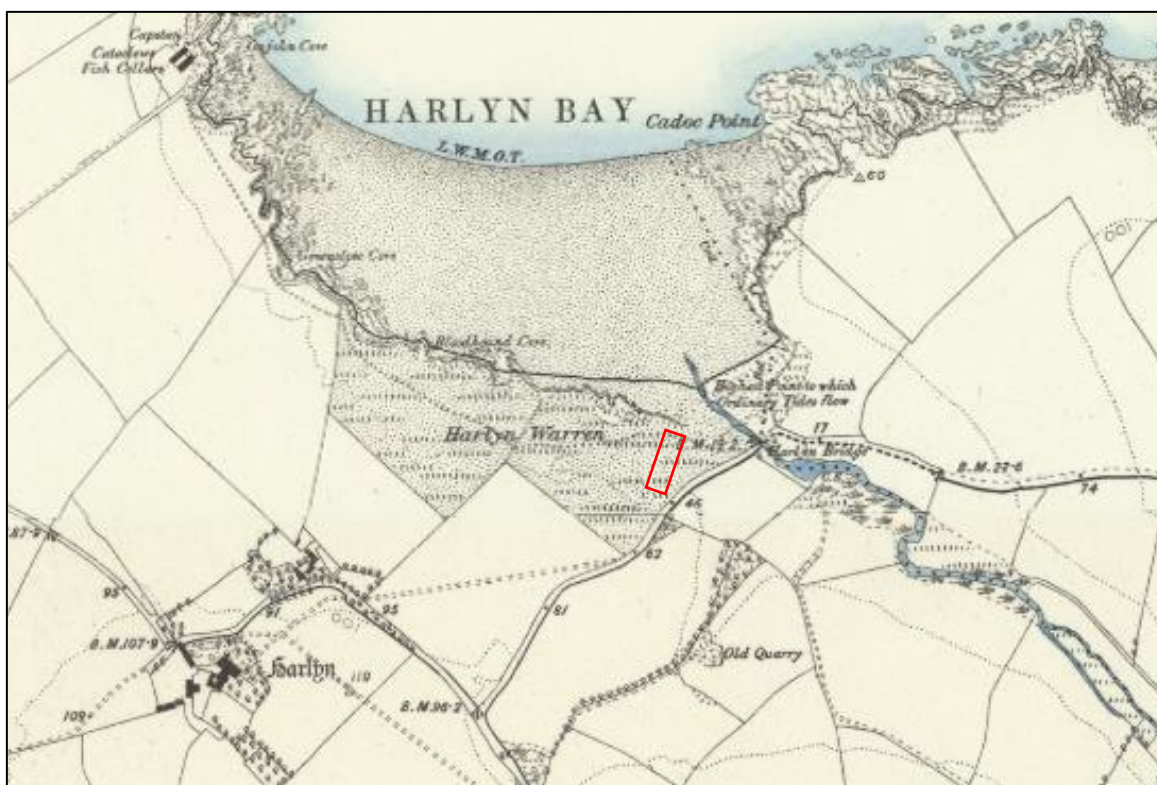
FIGURE 4: EXTRACT FROM THE 1880 FIRST EDITION 6" OS MAP. THE APPROXIMATE SITE LOCATION IS INDICATED

The Ordnance Survey First Edition map (Figure 4) shows the site as part of Harlyn Warren, clearly no longer under arable cultivation by this date. The main settlement of Harlyn is still located around Harlyn House. Harlyn Bay is named on this map.

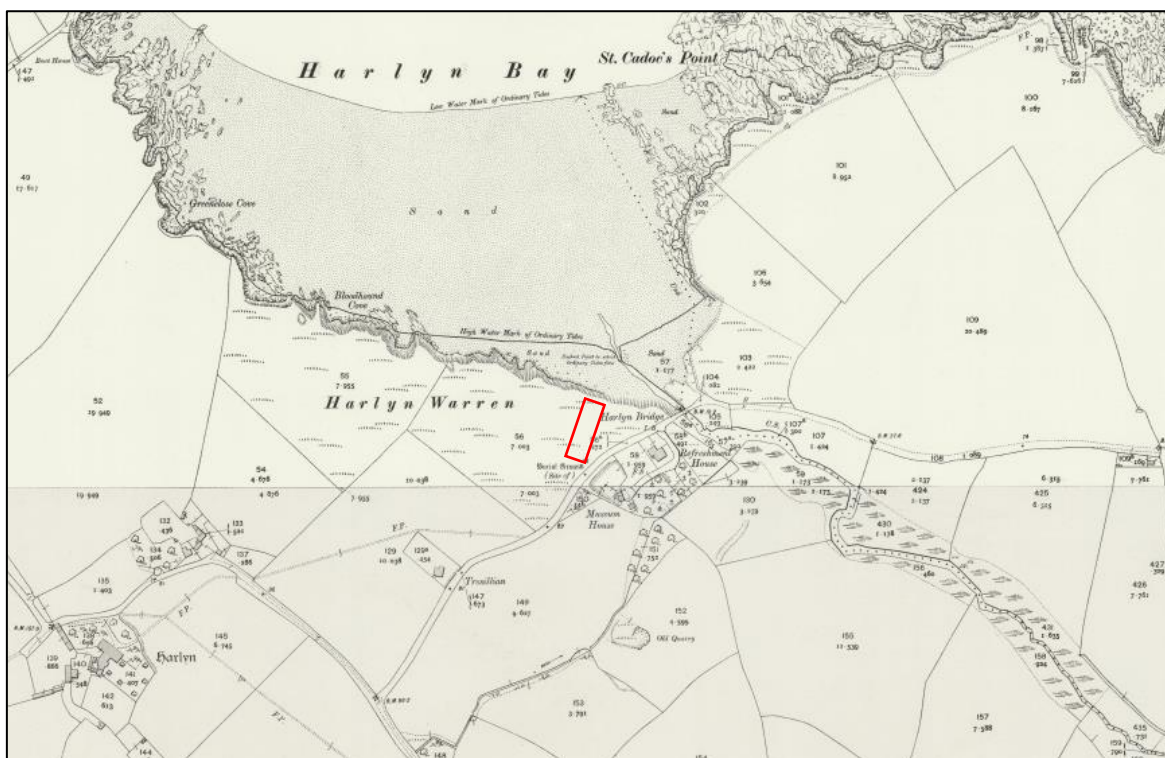
FIGURE 5: EXTRACT FROM THE 1905 SECOND EDITION 25" OS MAP. THE APPROXIMATE SITE LOCATION IS INDICATED.

The Ordnance Survey Second Edition (Figure 5) post-dates the discovery of the Iron Age cemetery in Harlyn and shows this as an earthwork. A museum building and refreshment house are both labelled along with a single property named Tresillian, between Harlyn House and the emerging coastal settlement of Harlyn. The proposed development site is still a part of Harlyn Warren at this date.

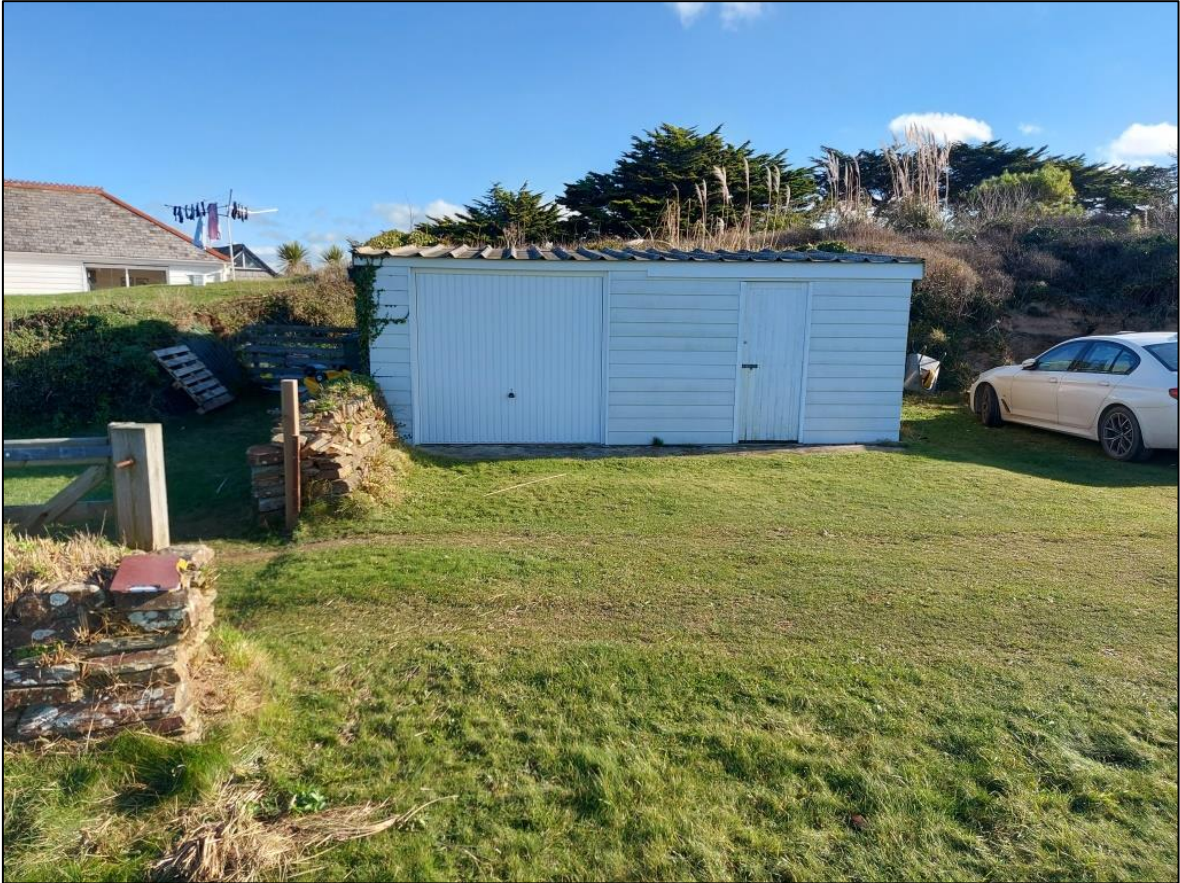
The site was visited on 12th November 2020, in sunny, dry conditions. The proposal site is currently occupied by a modern garage with adjacent parking area, it is otherwise laid to neatly mown grass (see Figure 8). To the east of the garage, and between it and a swimming pool for the property is a c.2-2.5 high bank of sand. To the north of the site is a modern stone wall with timber gate accessing the garden of The Chase. To the south is a modern oil tank (Figure 9).

FIGURE 8: EXISTING GARAGE, WITH THE CHASE BEHIND, VIEWED FROM THE WEST.

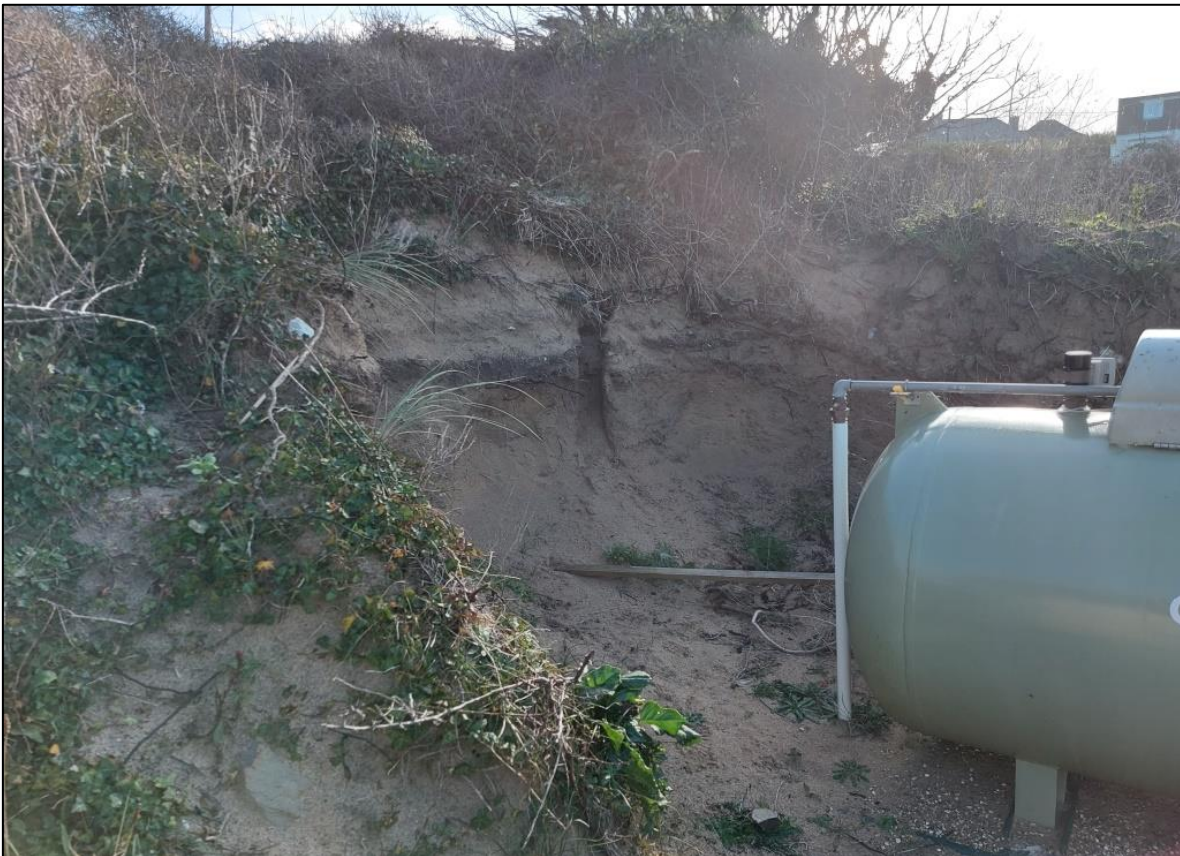
FIGURE 9: ADJACENT OIL TANK, TERRACED INTO THE SAND BANK AT THE BACK (EAST) OF THE EXISTING GARAGE. VIEWED FROM THE NORTH WEST.

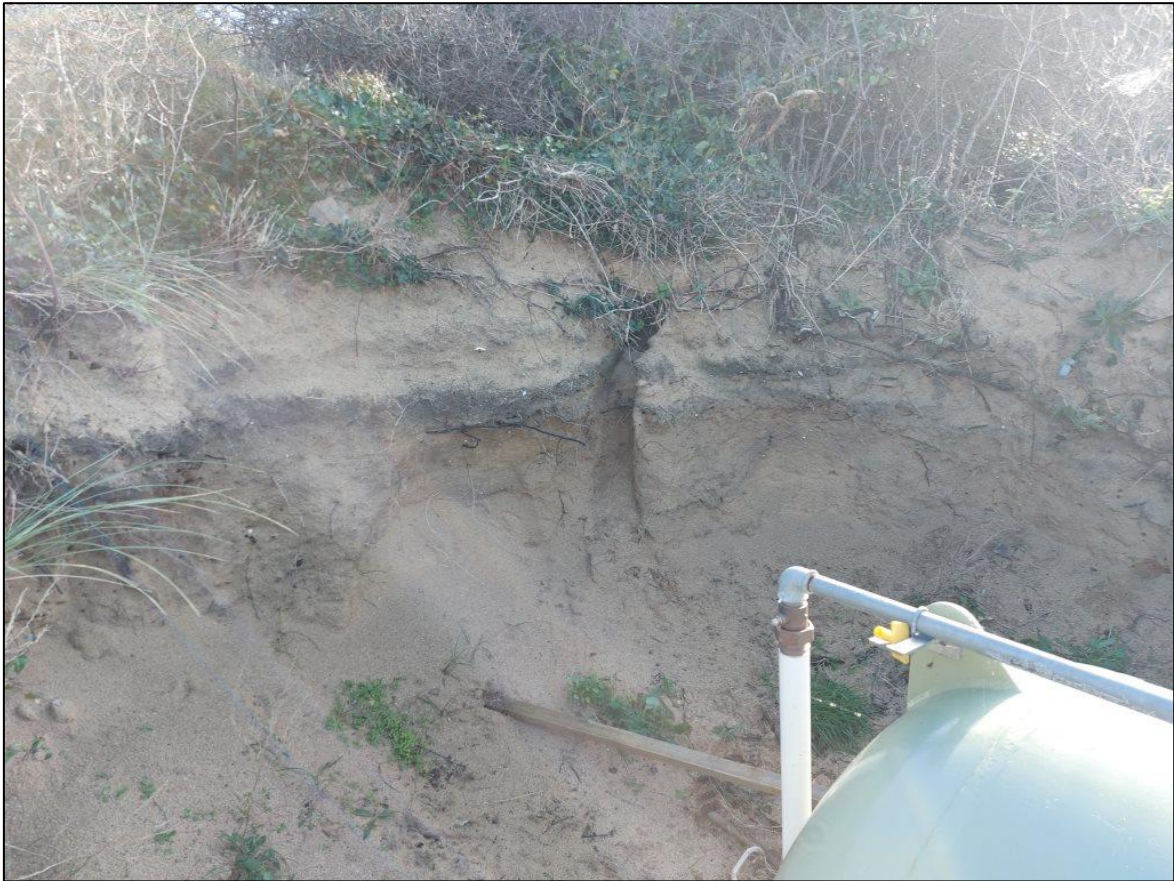
The site is broadly level and has been terraced into the sand dunes, although the bank to east has seemingly been fractionally built up (by c.0.5m) and exaggerated presumably during the construction of The Chase or swimming pool during the 20th century. The sand bank demonstrates a clear buried stabilisation layer (see Figure 10), which was visible in the area that has been recently re-cut for a new oil tank. The site is approximately 1m higher than the public road to the east, whilst the private access drive is located to the south. The private drive overlies the mains sewer and was subject to an archaeological watching brief during its construction in the 1990s.

FIGURE 10: DETAIL SHOT OF THE STABILISATION LAYER ASSUMED TO BE (C.1960S) GROUND SURFACE, VIEWED FROM THE NORTH-WEST.

Given the proximity of Bronze Age and Iron Age activity there remains archaeological potential despite the modern landscaping, and it is anticipated that an archaeological condition, to allow for archaeological monitoring and recording of works will be required.
