# HOOPER'S BRIDGE MILL-HOUSE

Heritage Statement & Impact Assessment

South West Archaeology Ltd. report no. 210604

By E. Wapshott  
Report Issued: 6<sup>th</sup> June 2021  
Report Finalised: 17<sup>th</sup> June 2021

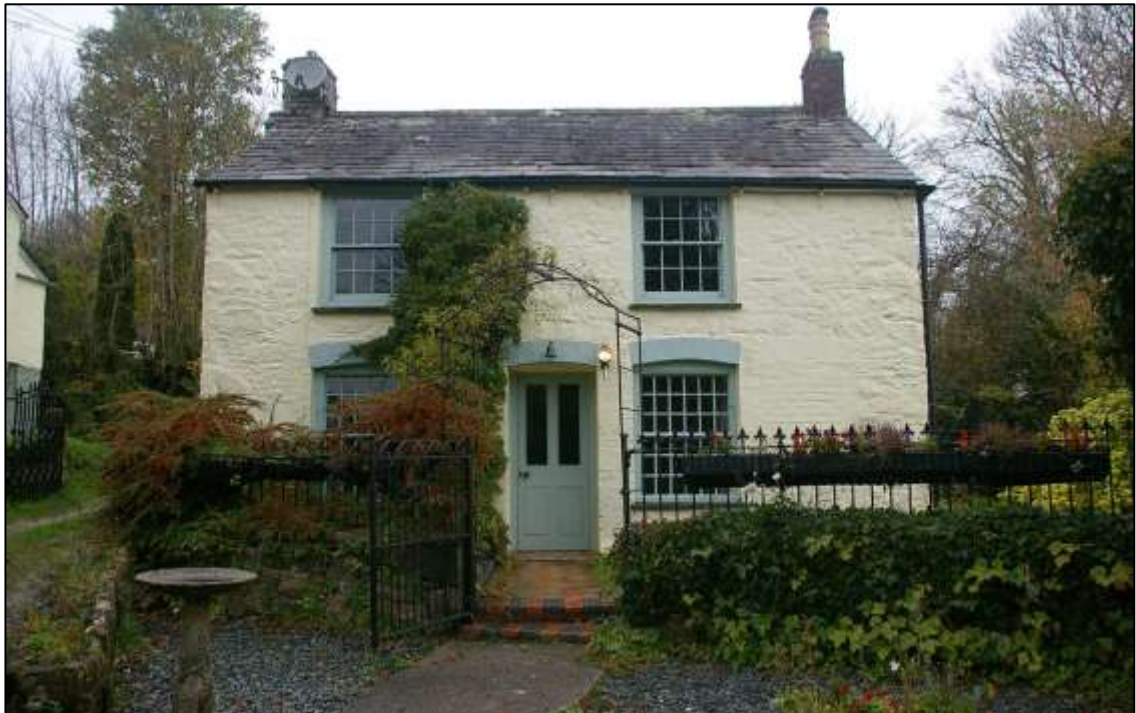
*Cover plate: The Mill-House; from the east-south-east.*

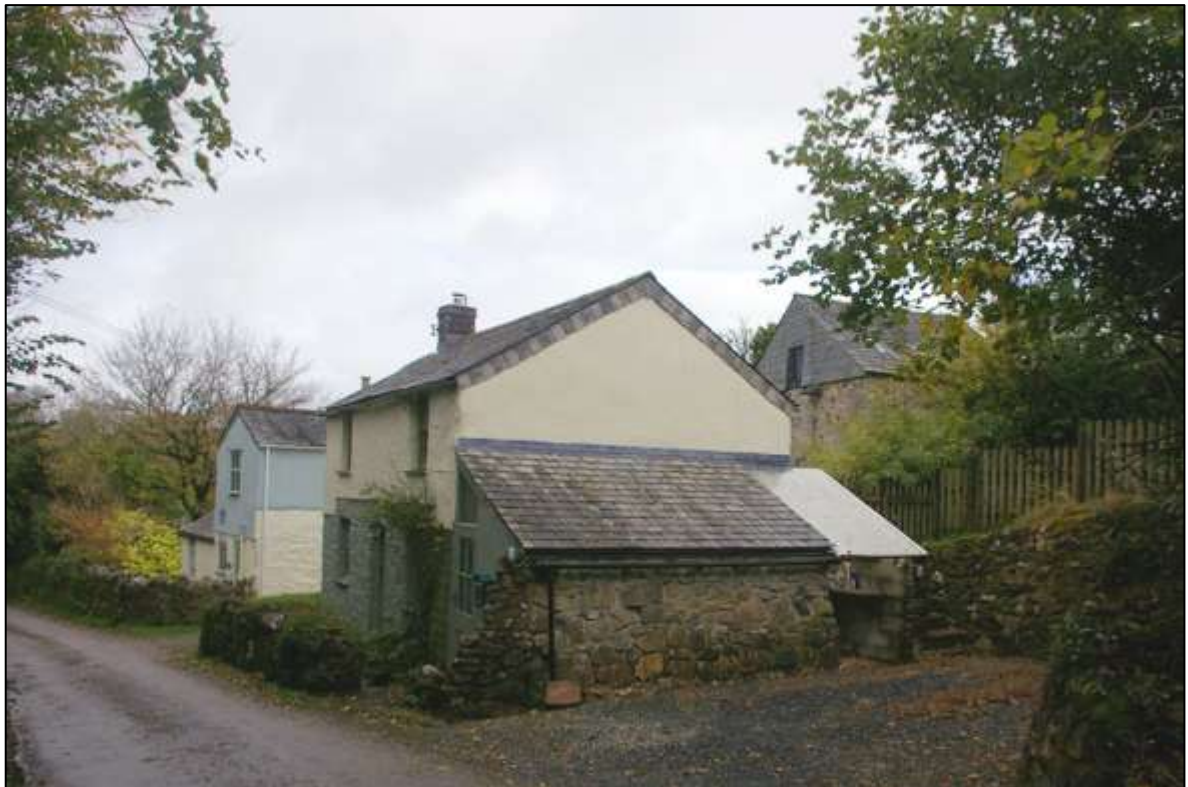
FIGURE 5: THE SITE AT HOOPER'S BRIDGE MILL; THE MILLER'S COTTAGE, THE MILL HOUSE AND WATERMILL BEHIND; FROM THE WEST-NORTH-WEST.

Hooper's Bridge (formerly Bodwannick) Mill is located c.2.5 miles west of Bodmin, and 1 mile north-west of the village of Lanivet. It sits on the steep east-facing slopes of a river valley, above a historic stone bridge, Hooper's Bridge, which is also an 18<sup>th</sup> century structure and is Grade II Listed. The site is bounded on its north side by the steep-sided narrow parish lane; both the Miller's cottage and Mill-House face onto this lane, a track between accessing the watermill and further ruined structures behind to the south-east and to the east. The site is bordered by steep pasture fields to the west and south along the valley bottom with woodland to the south-west and east across the valley. The Miller's cottage is in separate ownership, as is the separate barn and mill outbuilding to the north-east in the valley bottom.

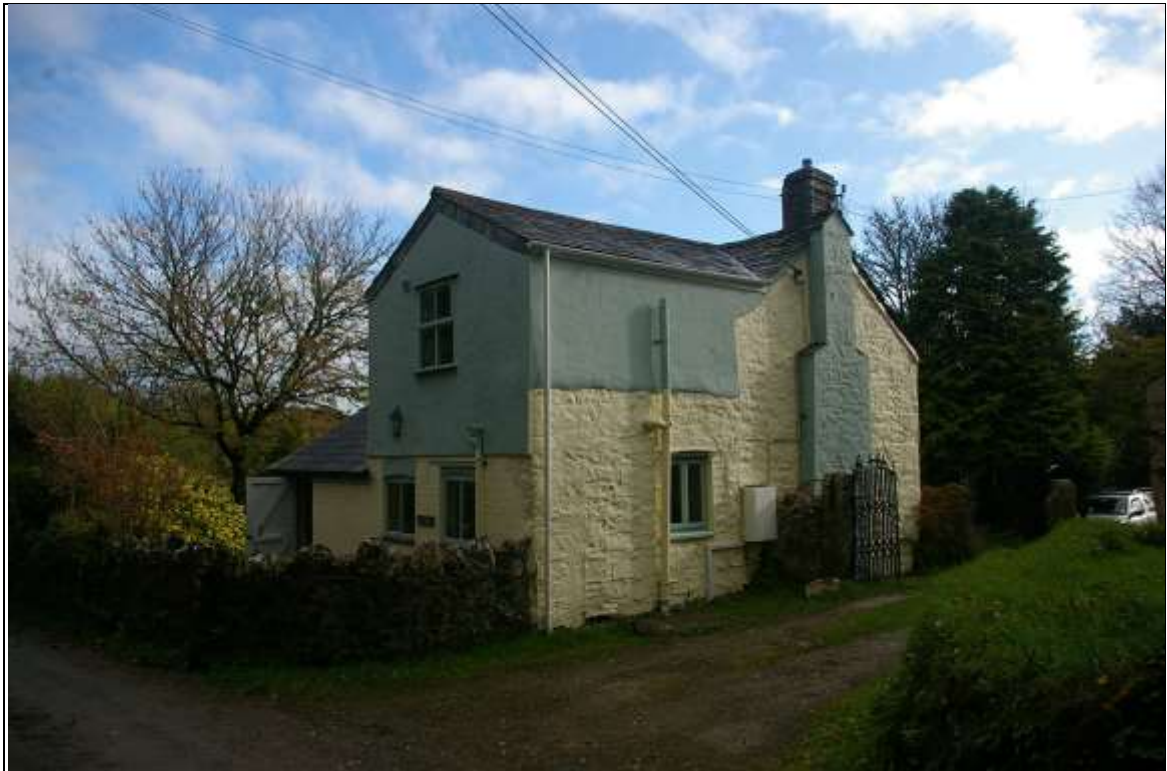
FIGURE 6: THE WEST GABLE AND REAR ELEVATION OF THE HOUSE, AS IT FACES THE ROAD; FROM THE WEST.

The west gable end is blind; it has a boxy tapered projecting flue stack, with squat square shaft. An inline stack with modern rebuilt brick shaft occupies the east gable, which is also blind, abutted by the single storey lean-to. The east wall of the brick lean-to on the north-east corner of the house has a tall narrow window set at half height which lights the stairs.

To the north-west rear is a two-storey gabled extension, with smooth rendered upper walls and slated eaves, the lower walls of painted exposed stone, with a clear build line up against the wall of the house. This extension has irregular fenestrations, a large first floor window in the 'north' gable, two low windows on the ground floor, one of which with a brick segmental arch may be a blocked doorway as it appears to have been blocked and altered on the exterior face. There is also a small window which looks west out onto the drive with chunky timber lintel. To north-east a steep cat-slide roof covers a low lean-to single storey extension; this is built of painted brick, with a modern ledged and braced plan door on the north-east corner.

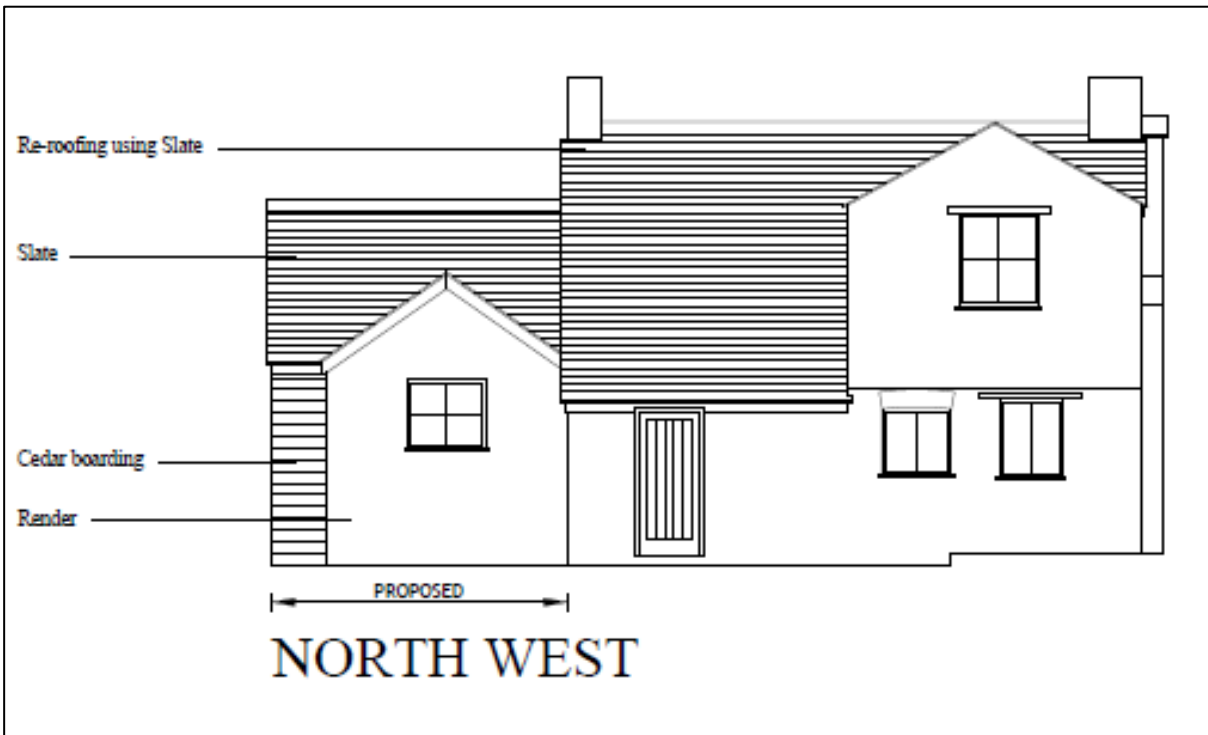
THE PROPOSED DRAWINGS OF THE NORTH ELEVATION; AS SUPPLIED BY AGENT.

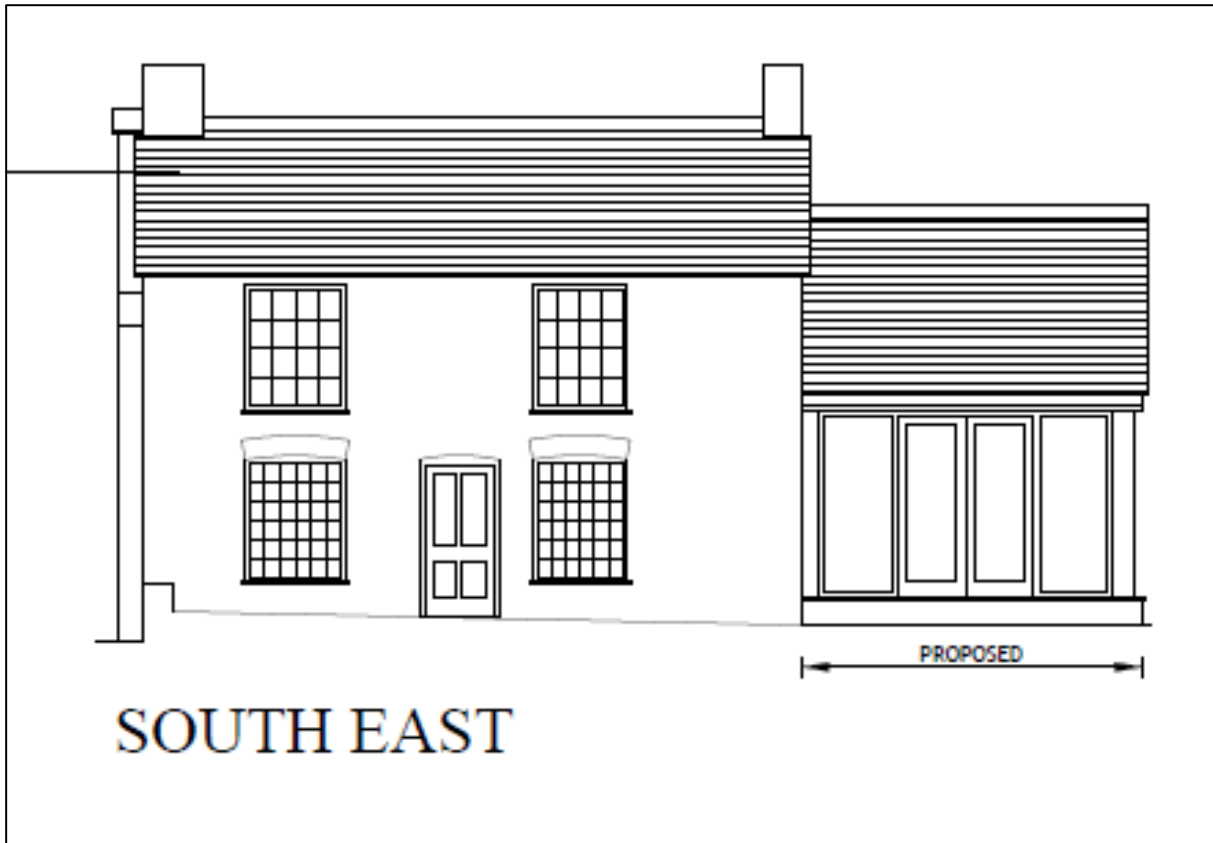
THE PROPOSED DRAWINGS OF THE EAST GABLE OF THE PROPOSED EXTENSION; AS SUPPLIED BY AGENT.

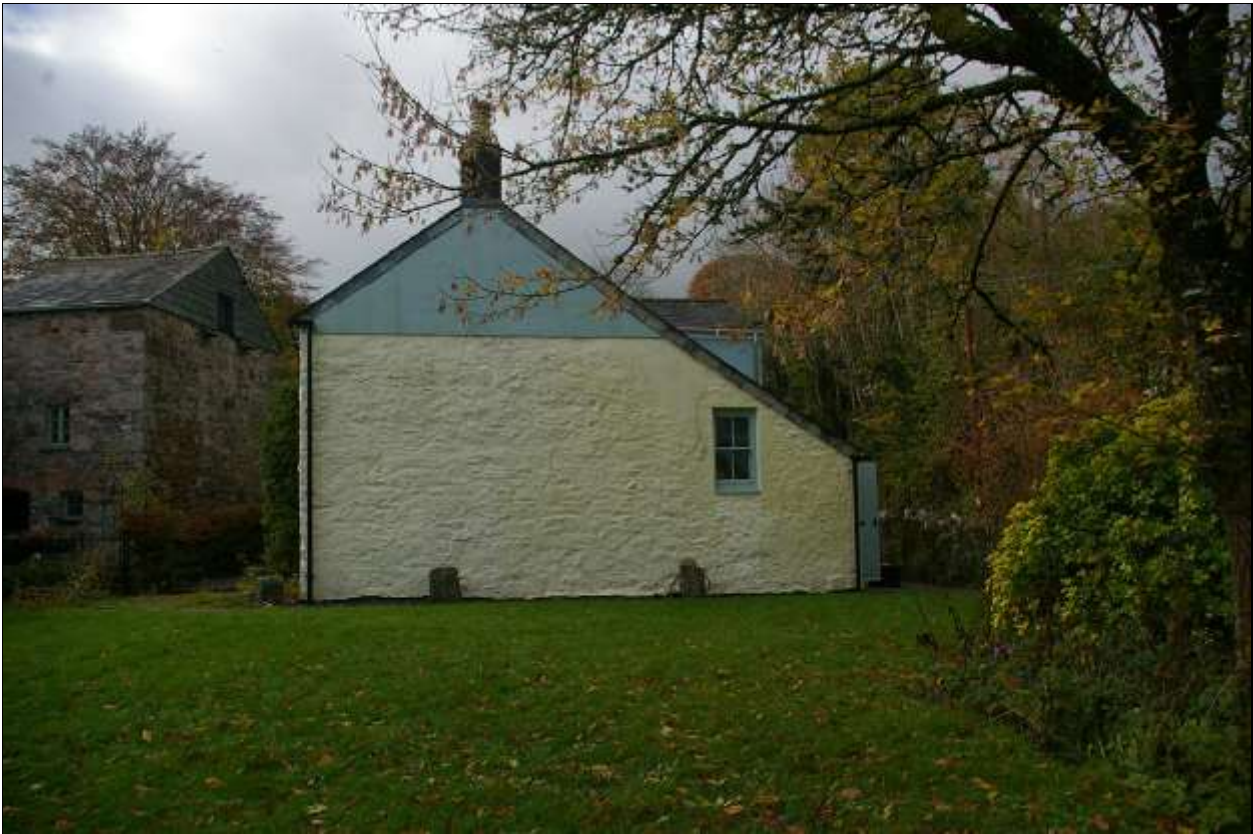
1. THE EAST ELEVATION OF THE MILL HOUSE; FROM THE EAST.

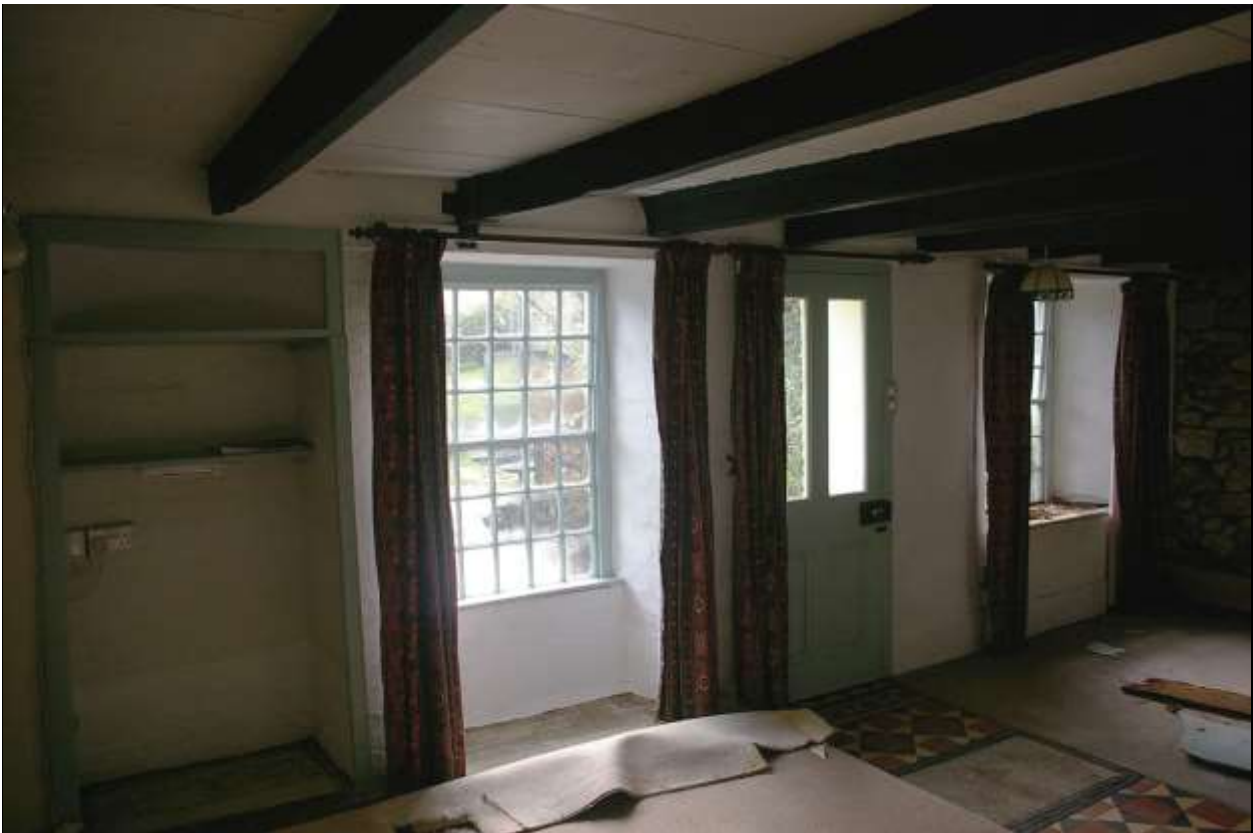
2. THE MAIN GROUND FLOOR SPACE IN THE MILL HOUSE, FORMERLY TWO ATTACHED COTTAGES; FROM THE NORTH-EAST.

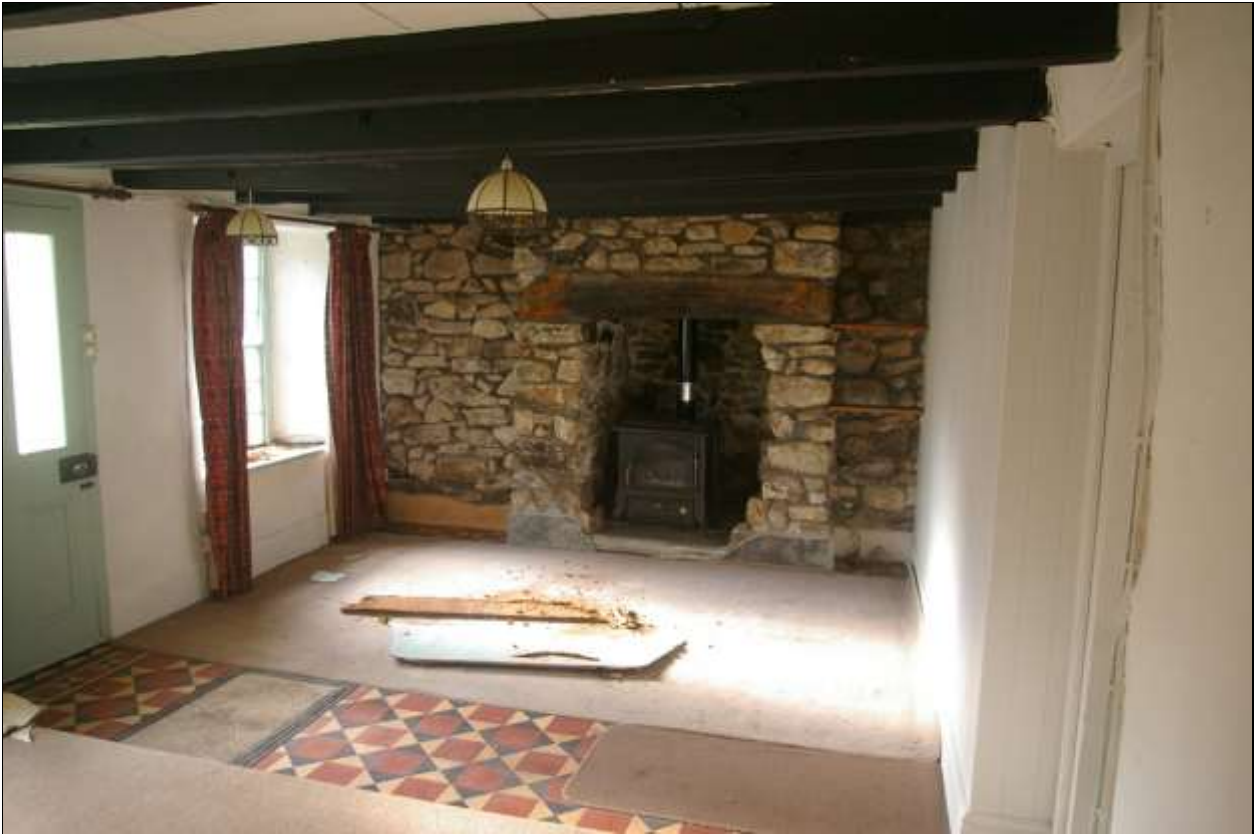
3. THE MAIN GROUND FLOOR SPACE IN THE MILL HOUSE, OPENED UP FROM TWO SEPARATE ROOMS; FROM THE EAST-NORTH-EAST.

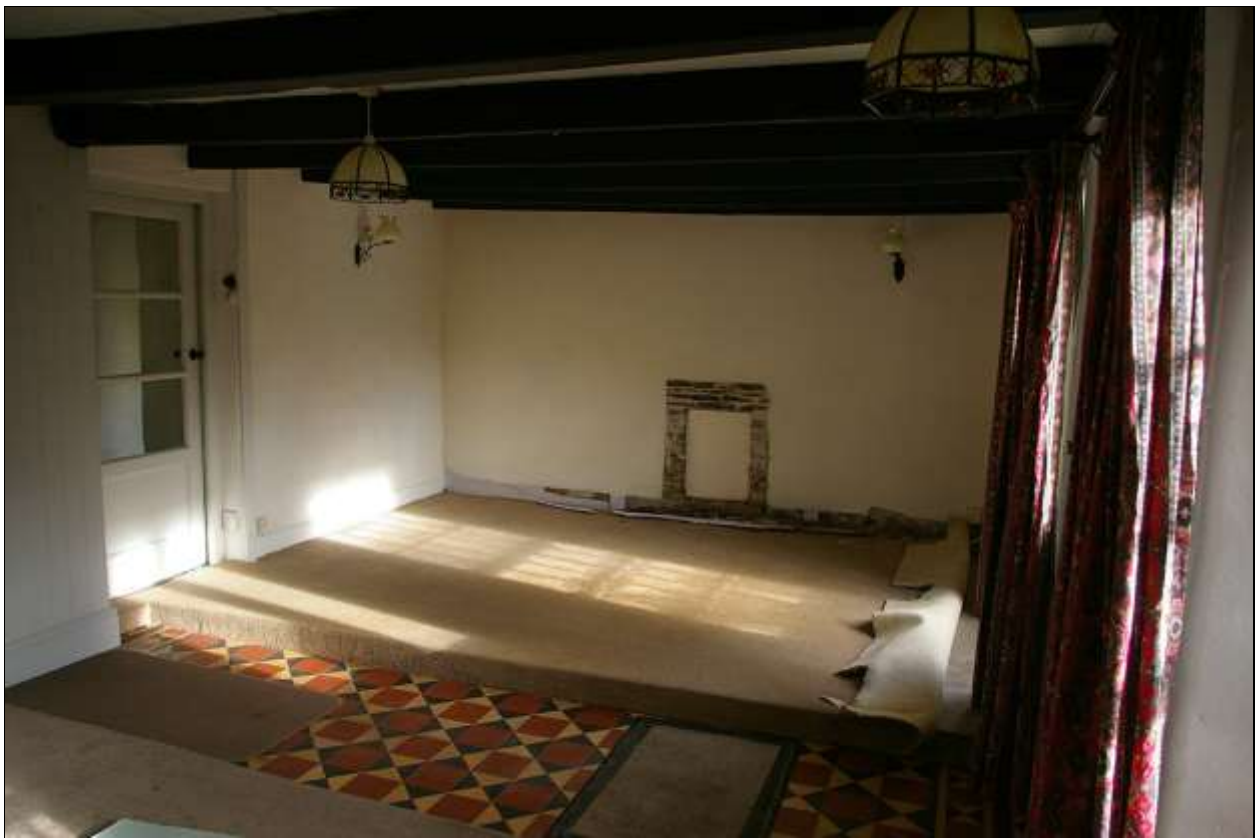
4. THE EAST GABLE OF THE MILL HOUSE WITH INLINE BLOCKED FIREPLACE; FROM THE WEST-SOUTH-WEST.

High. This is one of the surprising conservation values for this building. The house is full of changes in wall thickness, blocked and brick-up doorways and adapted elements. This is unusual in such a small size single phase constructional building, but reflects the complex narrative of the site. The building will undoubtedly contain further evidential value, such as the blocked fireplace in the east gable.

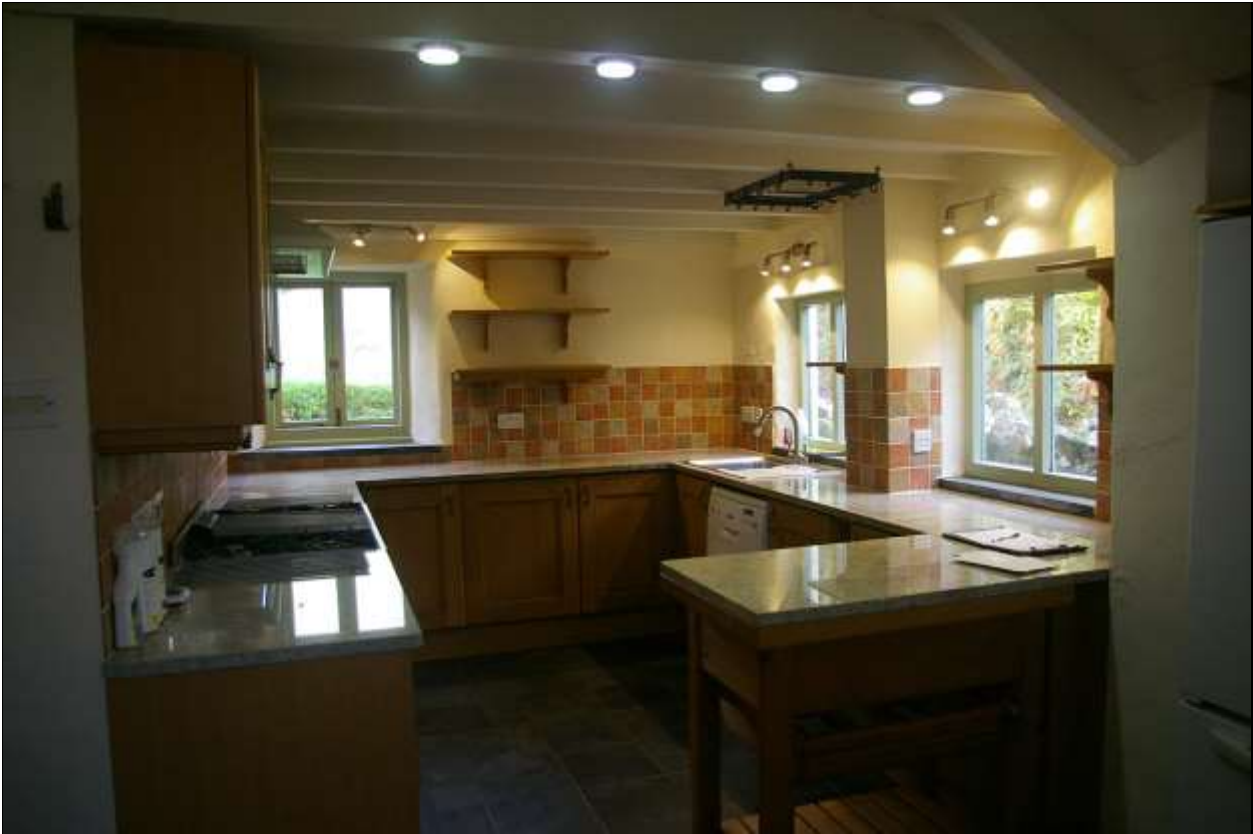
5. THE KITCHEN WITHIN A 19<sup>TH</sup> CENTURY EXTENSION ON THE BACK OF THE MILL HOUSE; FROM THE EAST-SOUTH-EAST.

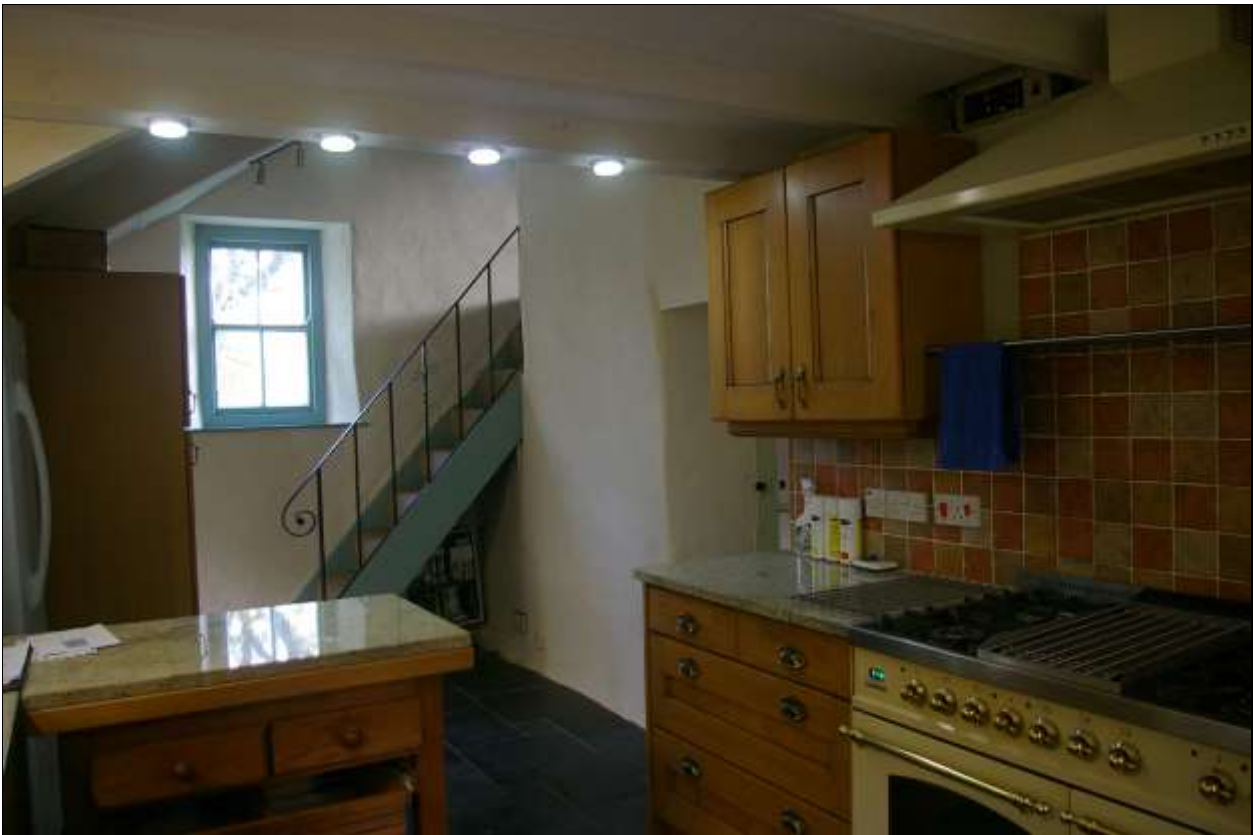
6. THE KITCHEN, WITHIN A 19<sup>TH</sup> CENTURY EXTENSION AND ANOTHER ADJACENT LEAN-TO OUT-SHUT, KNOCKED TOGETHER TO MAKE A MODERN SPACE; FROM THE NORTH-WEST.

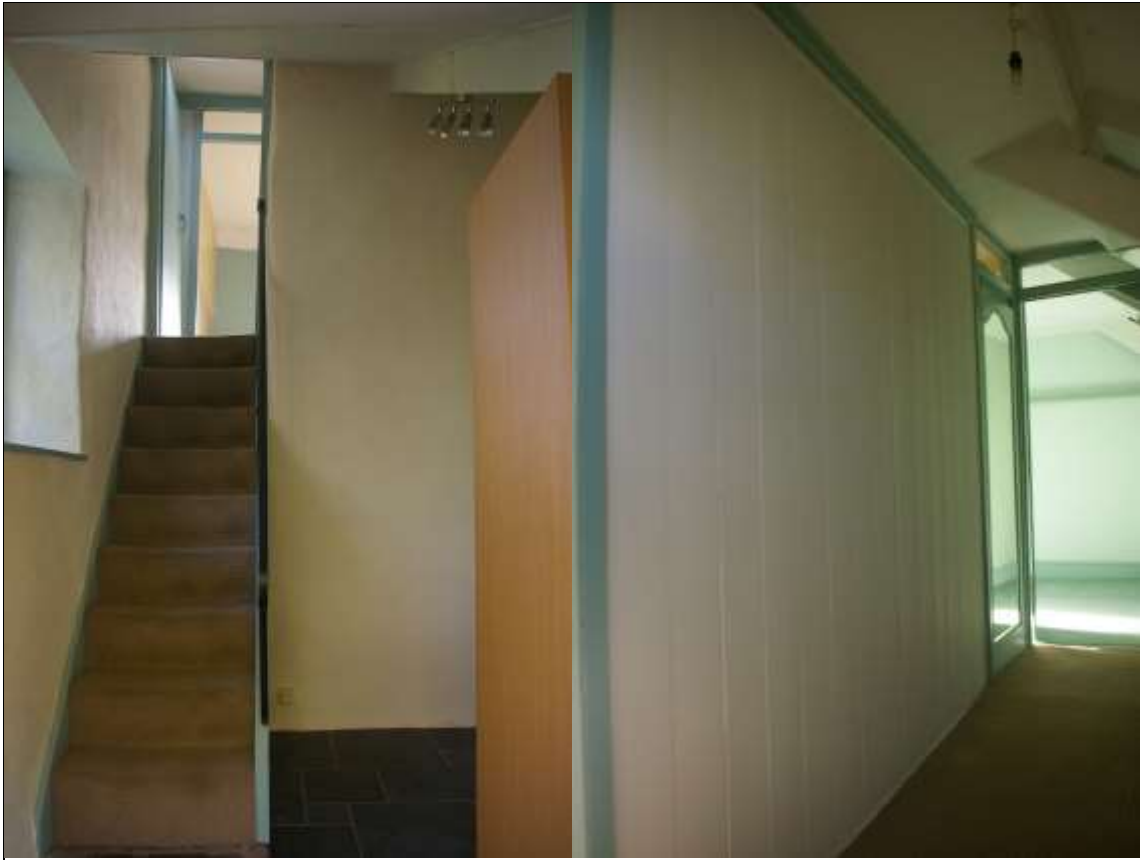
7. LEFT: THE STAIRS FORCED THROUGH THE REAR WALL OF THE MILL HOUSE; FROM THE NORTH.

8. RIGHT; VIEW ALONG THE PARTITIONED CORRIDOR IN THE MILL HOUSE, FORMING TWO BEDROOMS; FROM THE EAST-NORTH-EAST.

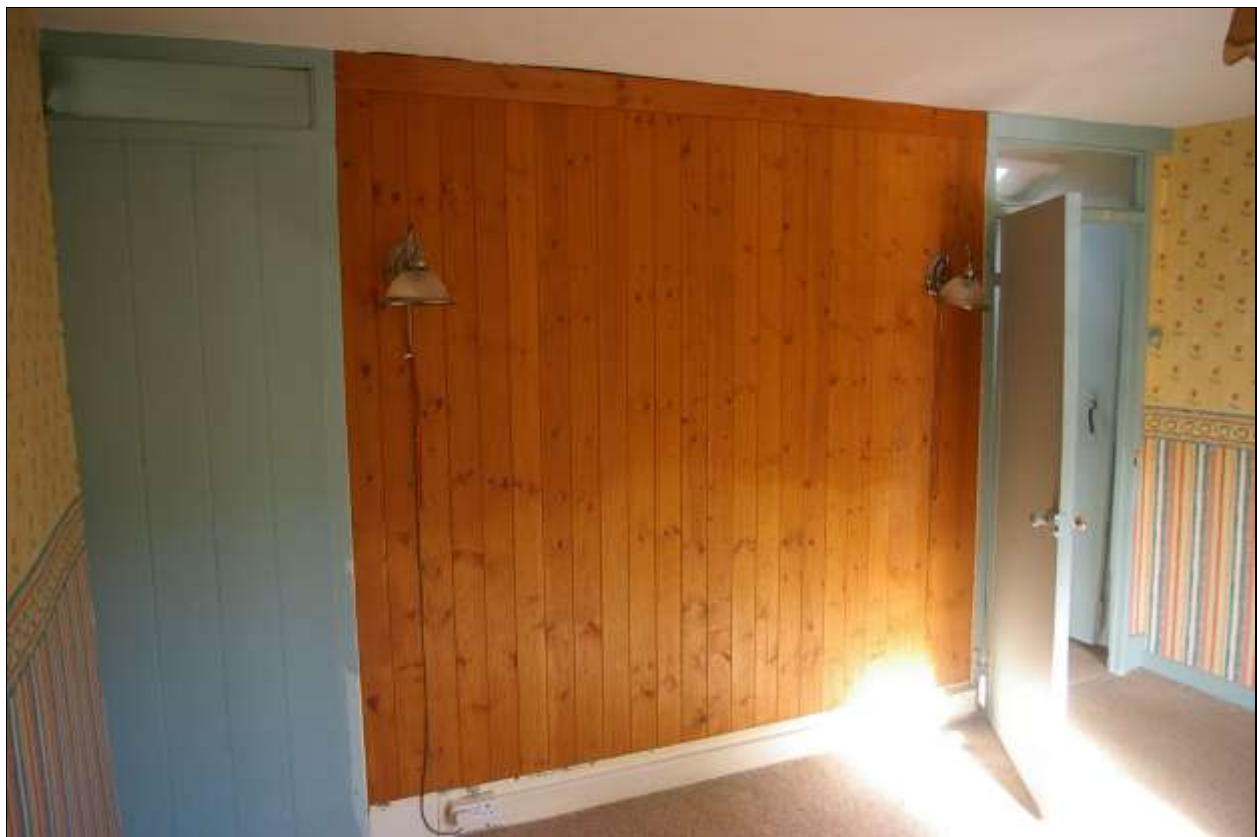
9. THE EASTERN BEDROOM, SHOWING REMOVAL OF A DIVIDING PARTITION WALL; FROM THE SOUTH-WEST.

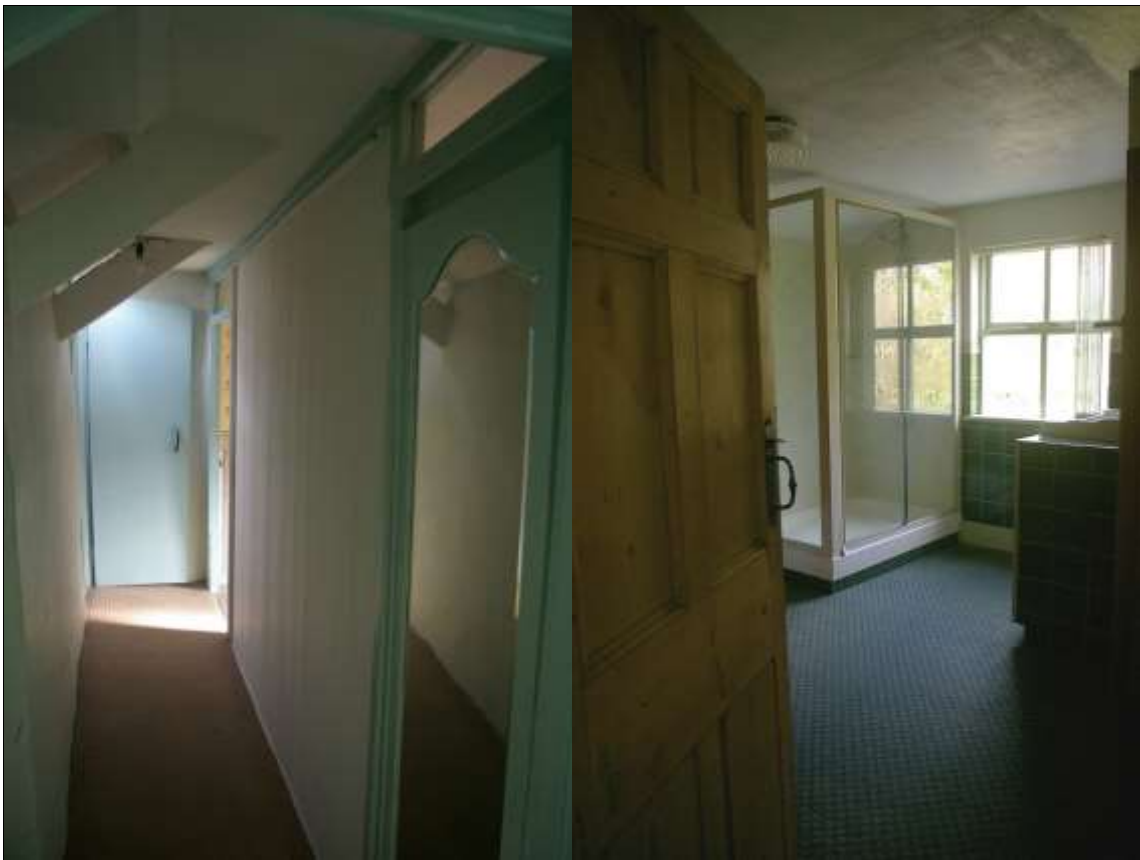
11. LEFT: THE PARTITIONED CORRIDOR; FROM THE WEST-NORTH-WEST.

12. RIGHT: THE BATHROOM IN THE 19<sup>TH</sup> CENTURY EXTENSION; FROM THE SOUTH-EAST.

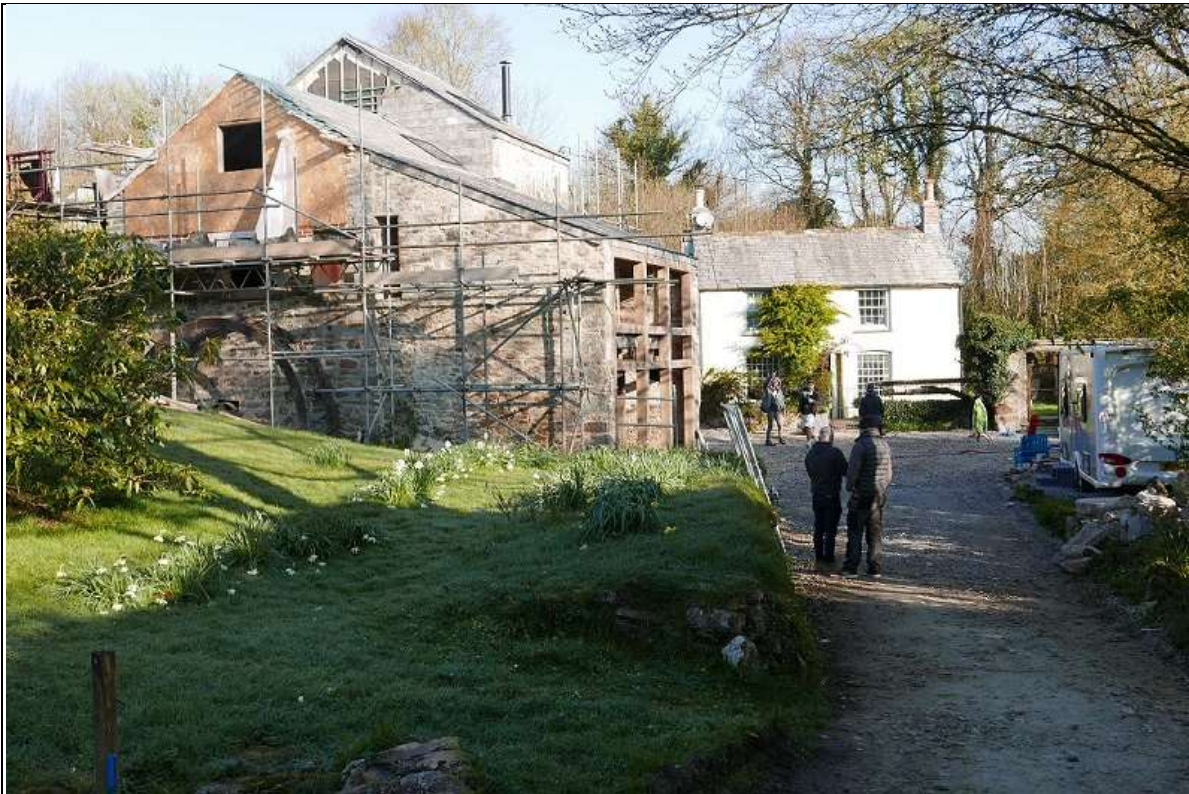
13. 2021 PHOTO OF THE WATERMILL BUILDING UNDER RENOVATION, WITH THE HOUSE BEHIND; FROM THE

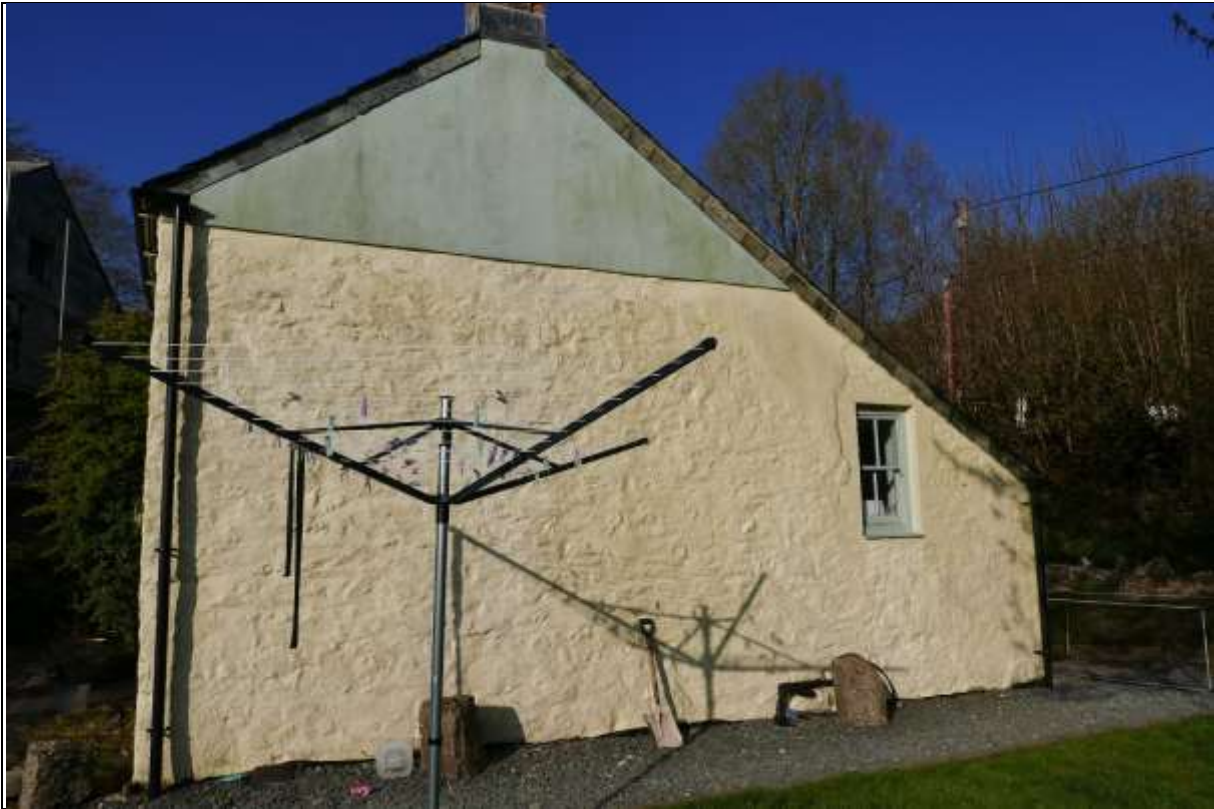
15. THE ..... ELEVATION, WHICH WILL BE ABUTTED BY THE EXTENSION, WITH A DOOR FORCED THORUGH TO CONNECT; FROM THE

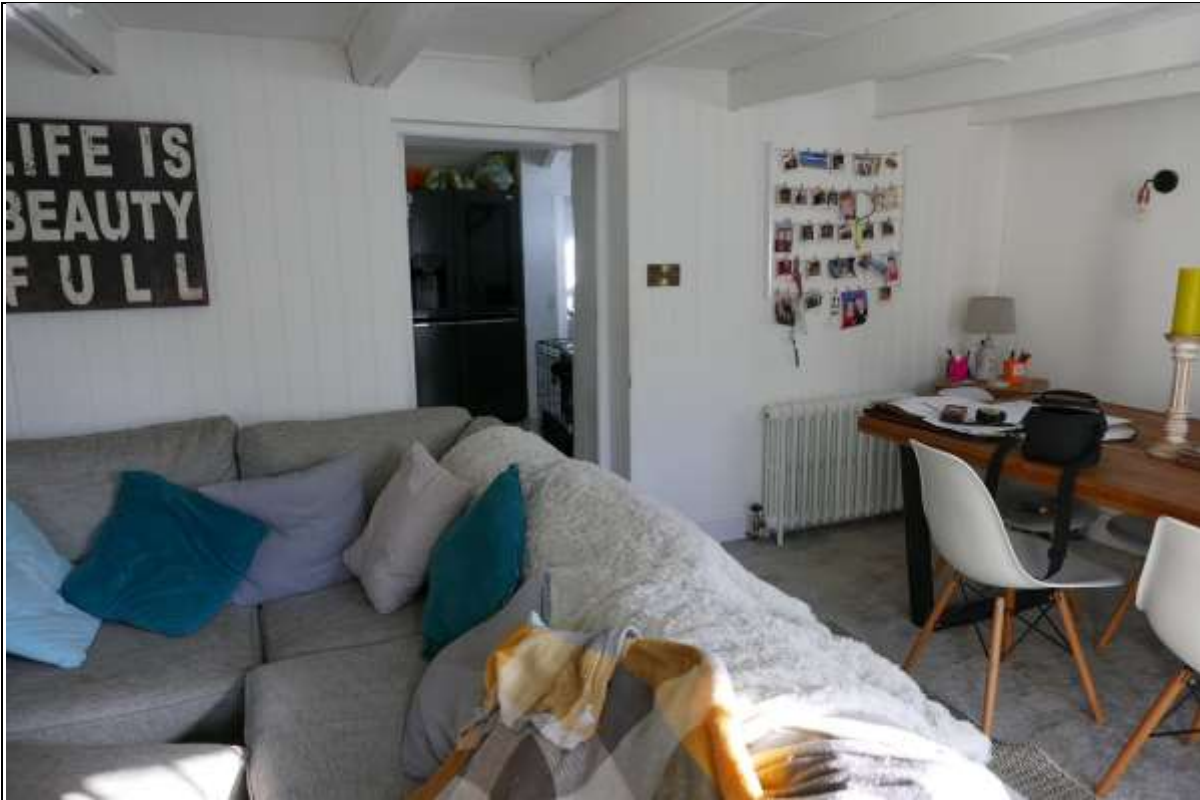
17. THE REAR WALL OF THE MAIN ROOM IN THE MILL-HOUSE, WITH BEADED PLANK BOARDING; FROM THE

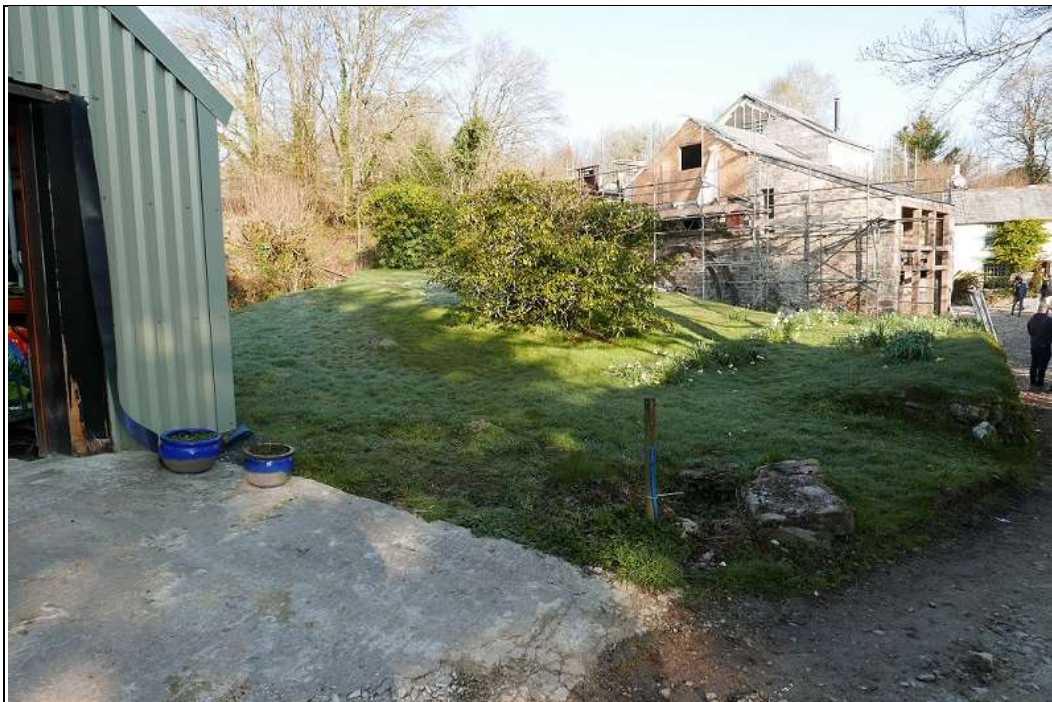
20. THE MILL BUILDING UNDER RENOVATION AND THE CURRENT AGRICULTURAL SHED; FROM THE SOUTH-EAST.

The existing shed is to be demolished and replaced with a purpose-built structure in the same location and on the same footprint. Since this effectively replaces like-for-like the impact on the watermill and house will be *negligible*. Overall the current garage is in a fairly prominent position but since the site has always had a mixed working agricultural and residential character a modern agricultural character shed is not out of place. The visual of the site as a whole could be improved if a darker green colourway could be sought for the cladding allowing the structure to blend in more effectively on the slope.

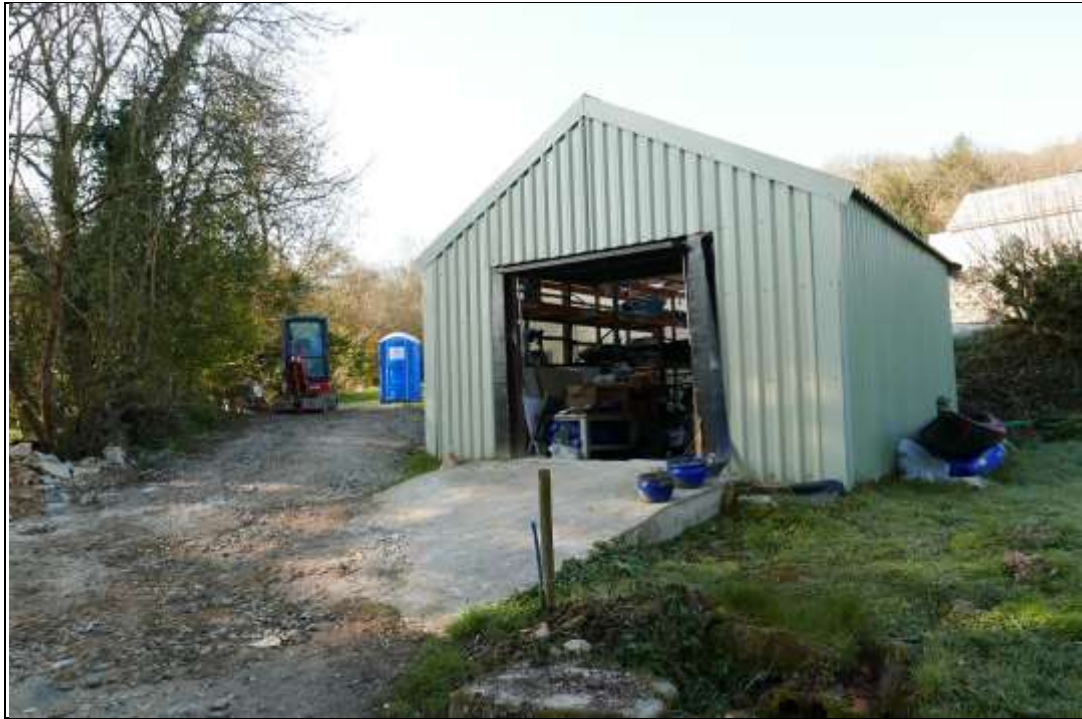
21. THE CURRENT SHED; FROM THE NORTH.

Like-for-like replacement of an existing workshop/garage with a similar agricultural building is felt to be negligible overall and the impact could in fact be improved with a darker colourway on the cladding.
