THE BARNs
CARWYTHENACK FARM
GWEEK
CORNWALL

Results of a Heritage Assessment

South West Archaeology Ltd. report no. 210702

By E. Wapshott
Report Version: FINAL
Draft Issued: 2nd July 2021
Report Finalised: 9th February 2022

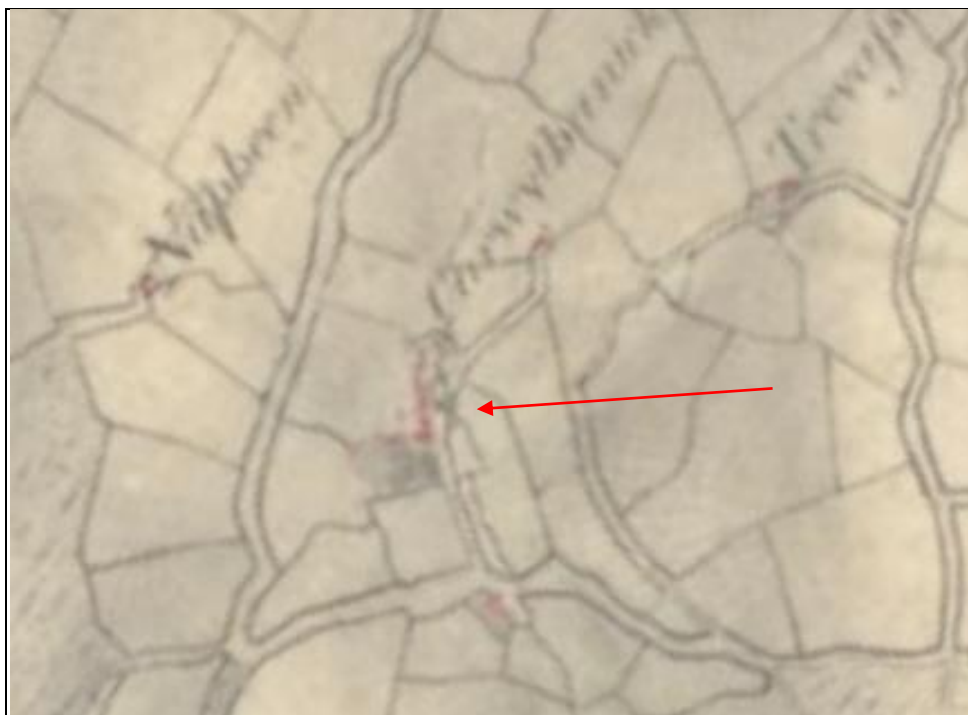
FIGURE 4: 1811 SURVEYORS DRAFT, APPEARS TO SHOW A COMPLEX GARDEN LANDSCAPE AND THE MANSION AND SEVERAL PARALLEL AND PERPENDICULAR BLOCKS, APPROACHED VIA THE LONG SOUTH DRIVEWAY, WITH THE LODGE TO THE BOTTOM; (BRITISH LIBRARY; 2021).

The Robert Dawson 1811 surveyor's draft, prepared for the tithe mapping and OS mapping and records the site at Carwythenack. The map is not particularly detailed but the main house is marked and a short block behind, all coloured red for occupied buildings and then a series of lineally arranged but detached buildings run behind it, on the same footprint of the barns today, but clearly not a continuous range. The farmhouse is also clearly present to the north. The pond is clear and the field boundaries look very similar but a drive appears to approach from the south, with a lodge; the gardens appear to be very formal with some unusual enclosure shapes and smudged details, indicating layout, it looks like there may be features in the field which retains the gates and it is clear the gates are more of an eye-catcher feature to the garden, as there is no entrance on this side.

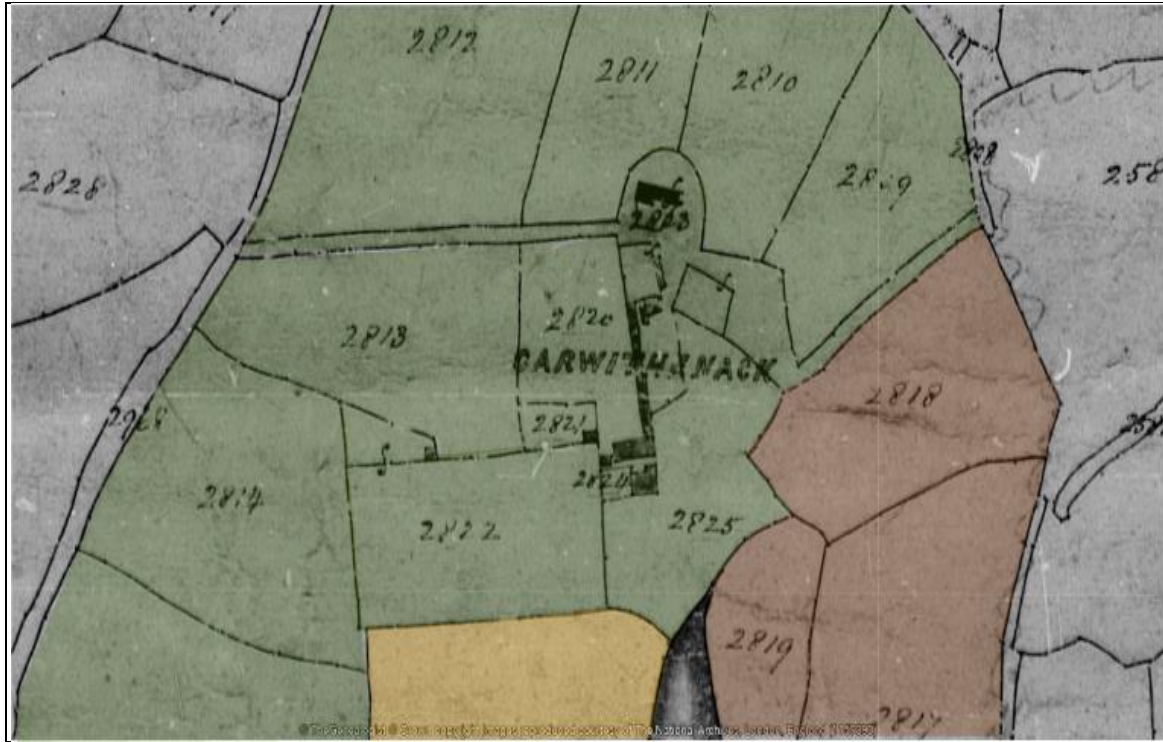
FIGURE 5: ANNOTATED EXTRACT OF THE TITHE MAP, SHOWING THE OWNERSHIP ACROSS THE SITE; TO BE READ IN CONJUNCTION WITH THE APPORTIONMENT TABLE (TNA; 2021).

Plot 2820 is not defined as having a function and we can assume it is merely a 'yard'. 2821 is marked as *garden*; 2822 is marked as *back garden*; 2823 is marked as '*houses and lane*'; 2824 is marked as '*mansion and offices*'. The land is split into Carway Thenack and Lower Carway Thenack, with ownership held by Caroline Mary Hill, whose estate is being managed by two trustees, Rectors, Rev. Edward Trevennen and Rev. William Veale. We can clearly see that the barn range is already present on this map in almost the same form we see it today, indicating that the barns are 18th century and all of the later phasing is early 19th century and predates the later

1830s or early 1840s surveying of the tithe. Barn ranges 3 and 4 are the only ones which seem markedly different as they are not attached and barn range 4 has a small projection on the south-west corner.

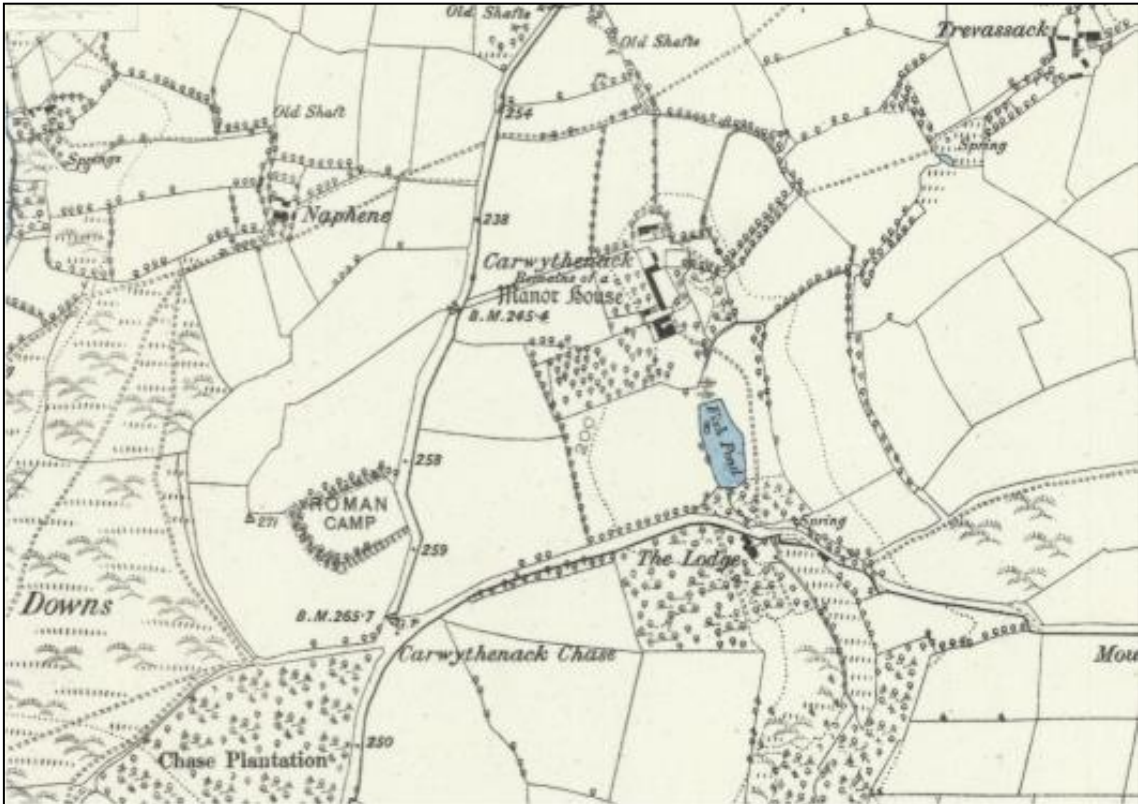
FIGURE 6: 1ST EDITION OS MAP, PUBLISHED 1888 (NLS; 2021).

By the 1st Edition 6-inch OS map, surveyed in 1877, published in 1888 far more detail is given on the planting of the estate and the relationships of the wider landscape. The buildings primarily look the same, apart from the rectangular range behind the ‘mansion’, barn range 1, which appears to have been truncated, with a gap between the building and the long linear range. To the far end the barn range 3 has now been built onto and linked to barn range 4. We can also see the houses marked on the 1842 map and owned by Richard Rowe below the pond is marked here a ‘Lodge’ and a dotted line appears to mark a carriage drive up to the mansion. A definitive line of trees encloses the rectangular field and garden to the west, where the gate piers still stand, marking the difference between leisure grounds and farmland. The mansion house has acquired an L-shaped range of service buildings within the walled garden next to the house and in the yard behind, a wall now built between the manor and the former ‘offices’. It may be that this is the point barn range 1 becomes part of the farmyard complex, no longer domestic. Boundaries and lines within the yard area seem to have been formalised and it may be that the mansion is now very much separate from the rest of the holding.

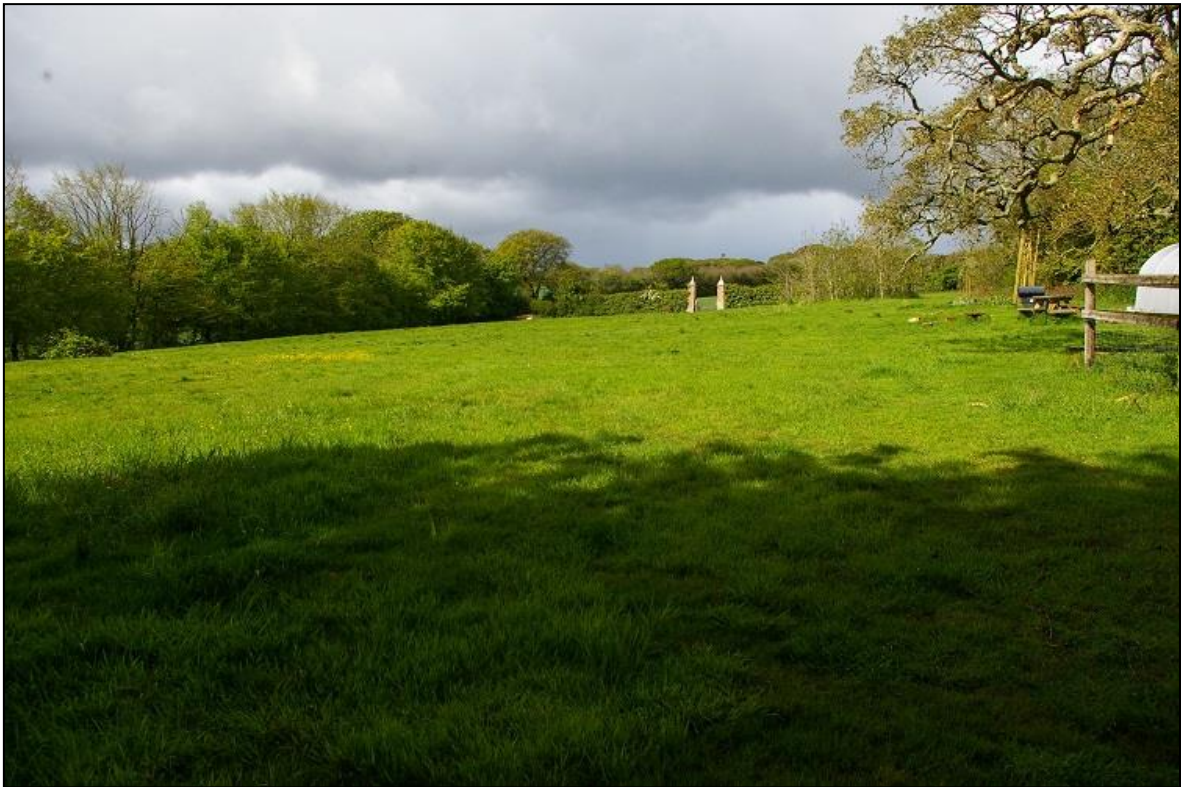
FIGURE 11: THE FORMAL GARDENS, NOW A FIELD, WITH GATE PIERS, HEDGE, VETERAN TREE AND CLEAR LINEAR EARTHWORKS, INDICATING HISTORIC GARDEN STRUCTURES OR LAYOUT; FROM THE NORTH-EAST.

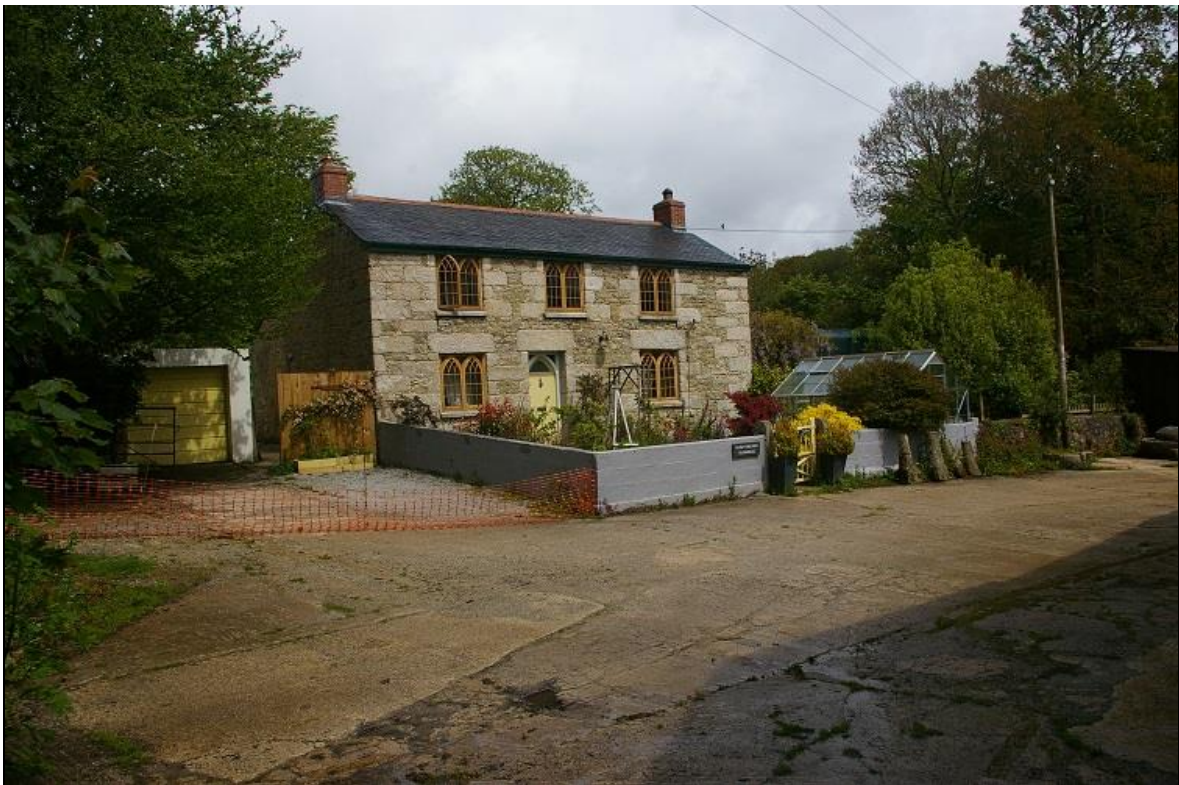
The farmhouse is of vernacular killas with faced and dressed massive granite dressings to the openings and corners. It is of pleasing Gothic style, with decorative windows but is noticeably asymmetrical and this may be due to the building being remodeled from a different structure; it is enclosed within a walled cottage garden. Behind the farmhouse are small paddocks and a garden, curvilinear field boundaries fan out behind the farmhouse with really heavy mature tree planting; this field pattern is noted on all historic maps, even the surveyors draft and frames an ovoid

FIGURE 12: THE FARMHOUSE AT CARWYTHENACK; FROM THE WEST-SOUTH-WEST.

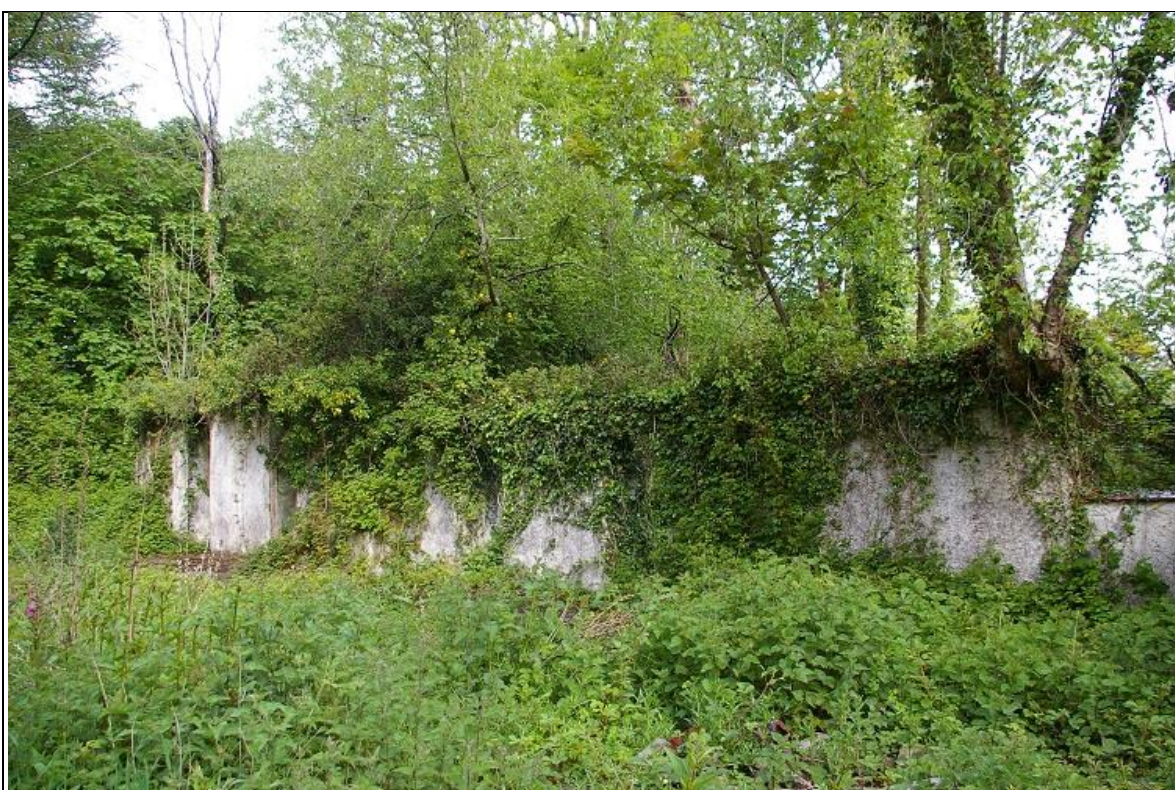
Barn range 1 is of single storey height, to the south-west of the site. It is linear in form, on a rough east-west alignment, now of roofless ruined condition. It is formed of two historic gabled attached buildings, with a modern section of infill between it and Barn range 2 to the east, at a perpendicular angle. To the south this building faces onto the former 'domestic offices' courtyard behind the 18th century mansion house, the ground surface is of damaged quartz cobbling, with a raised concrete platform along the front of the building and a concrete block water trough; to the north it faces onto the yard, the ground level of which has been significantly raised. The modern wall coverings of cement render obscure vital details about this range which directly served the manor house and further recording after proper clearance and stripping of the render, of at least the interiors, would be able to inform on the mansion-house site.

BR1 – Building B; of lower height, probably also once three bays in length, of more obvious vernacular build, rendered externally its walls are thicker and more irregular in profile. This has two low doorways to the front wall, with roughly dressed granite lintels and dressed granite visible to the reveals in places, there is a blocked window and door in the rear wall and the gable to the west belongs to BR1A. This building also contains animal pens which are uncomfortable with the rear openings, for example closing against the window opening, so again are a secondary use of this space. Concrete block walls form two pens and a thick end wall to the east has been partly truncated and capped in cement, leaving the space open to Building C. The walls are internally rendered obscuring further details.

FIGURE 13: BARN RANGE 1; BUILDING A IN THE BACKGROUND, BUILDING B IN THE FOREGROUND, WITH TALL GABLE BETWEEN; FROM THE SOUTH-EAST.

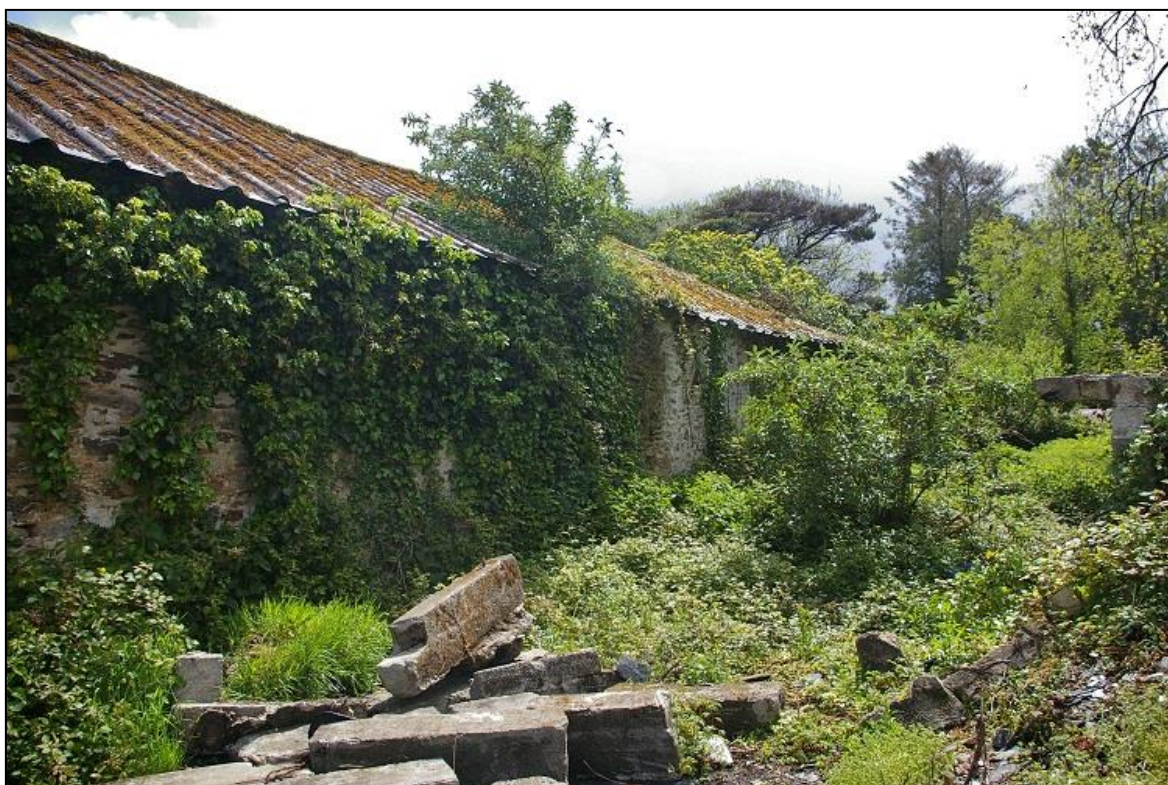
east elevation the building is failing, with a significant lean; this is due to the knocking out of windows to form doorways and the forcing/enlarging of openings above, which has weakened the build. This east wall includes important details which indicate this had a domestic-service origin rather than originally being a barn, as all of the openings along the ground floor show evidence of being windows, there are no original doorways and several windows above are enlarged into loading doors. It is attached to barn range 3 on the north end. The rear wall of Barn range 2 and Barn range 3 seems to incorporate fragments of battered walling, which may relate to other walled gardens linked to the 18th century mansion or even earlier structures associated with the medieval manor complex. Behind this barn it faces onto the former second yard space, the ground levels of which have been significantly raised. This range also includes three pieces of visible recycled stone, in its walls, believed to be from the medieval manor complex.

FIGURE 14: THE REAR WALL OF BARN RANGES 2 & 3, SHOWING COMPLEX PHASING EVIDENCE SUCH AS RAISES AT THE EAVES AND BLOCKED AND FORCED OPENINGS AND THE EXTENSION AND TRUNCATION OF EARLIER WALLS; FROM THE NORTH-WEST.

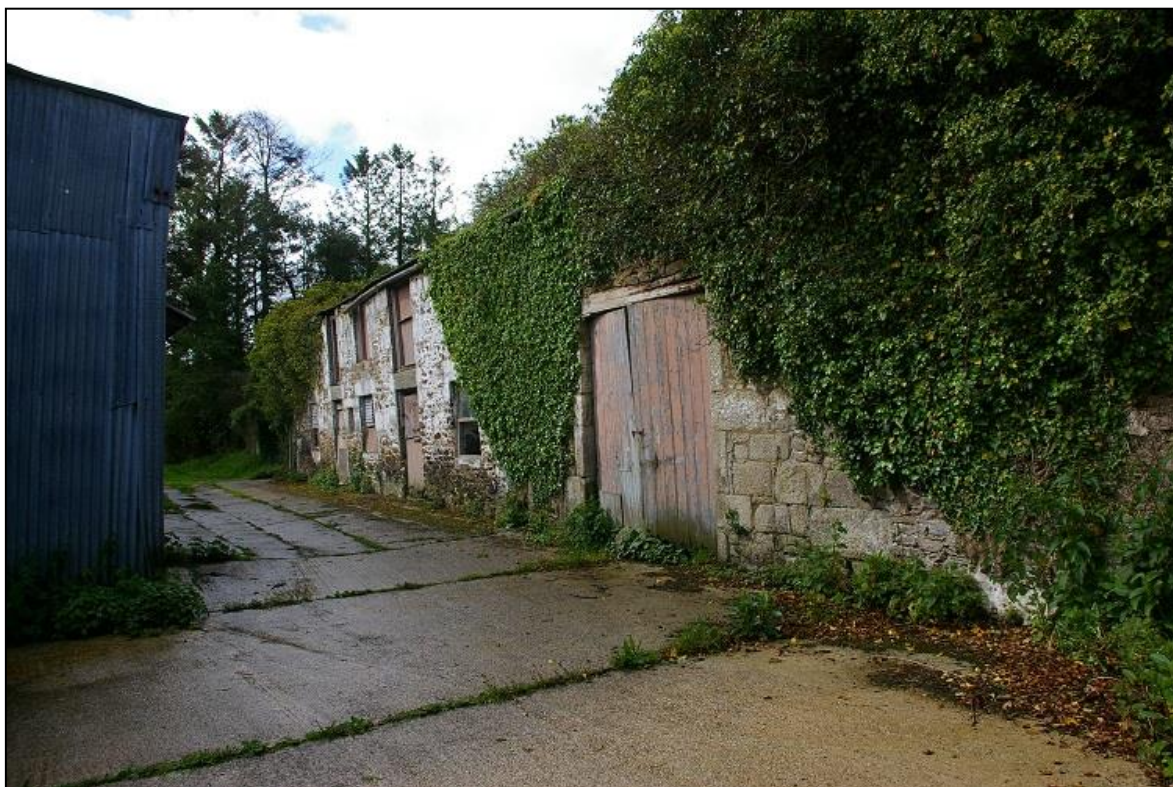
BR2 – Building C; is a short two bays width, a two storey section of infill, built between separate barns, Br2B and Br3. It has a rubble-built front wall, with a large section of recycled dressed granite square ashlar blocks and a double height, off-centre trap or cart door, with heavy pine lintel and painted plank doors on heavy hinges. The front wall, on its inner face contains at least two blocks of recycled stone with coiled or scroll carving, damaged sections of ‘rams-head’ carving, another piece of which is seen in the ramp of barn range 4. Access is provided via two forced doorway to Br2B and Br3 to the west side. There is a small slit vent to the west wall, which clearly shows evidence of a raise, being battered and of far heavier more vernacular build to the ground floor.

FIGURE 15: BARN RANGE 2, THE EAST FRONT, BUILDING C IN THE FOREGROUND AND BUILDING B TO THE CENTRE, BUILDING A IN THE BACKGROUND; FROM THE NORTH-EAST.

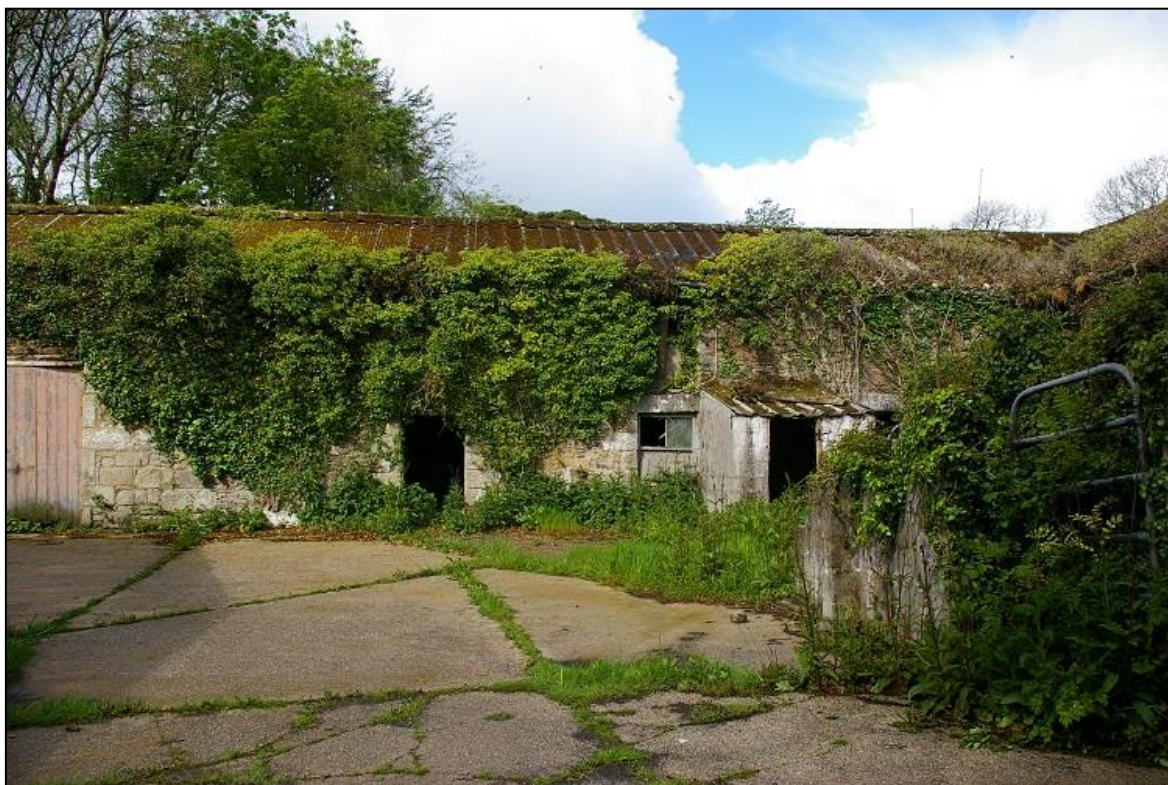
Internally this building is set up very much like Br2B, it has modern concrete pens to the east, with a feed channel to the west, served by a door in the north wall, with thick frame and plank stable door and another forced door to the south from Br2C. The loft floor structure here is heavier than in Br2B, with large wide elm boards and replacement pine boards, most of the floorboards are missing. To the north end the build changes becoming much looser and rubbly, there is a massive pine beam, bracing the former end of the barn and a timber frame with plank boarding has been installed above, there is hatch with a rotten timber ladder and a framework for a timber hopper within the loft. The barn is open to barn range 4 at this end.

FIGURE 16: BARN RANGE 3; FROM THE EAST.

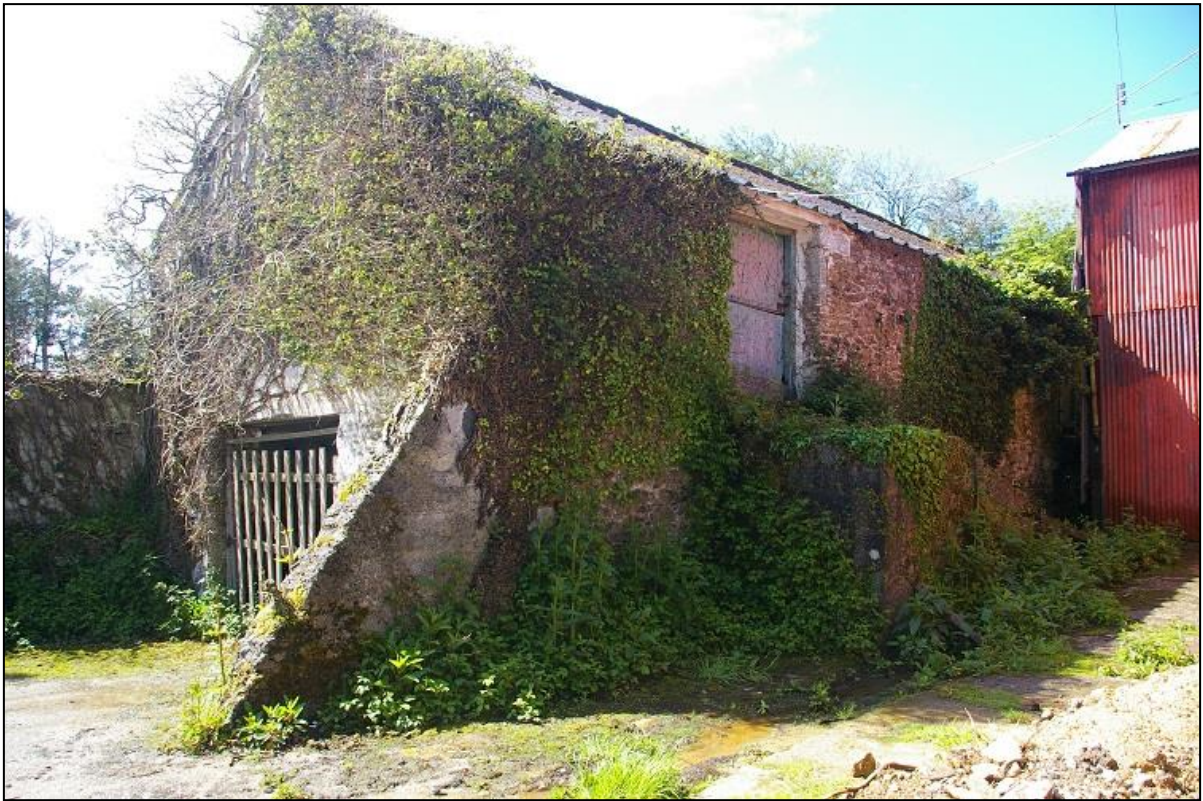
this range, there is a further loading door on the north wall, on the build line, which accesses the loft, now blocked by the modern corrugated barn.

FIGURE 17: BARN RANGE 4, WITH CONCRETE BLOCK BUTTRESSES AND RAMP TO LOFT; FROM THE NORTH-EAST.

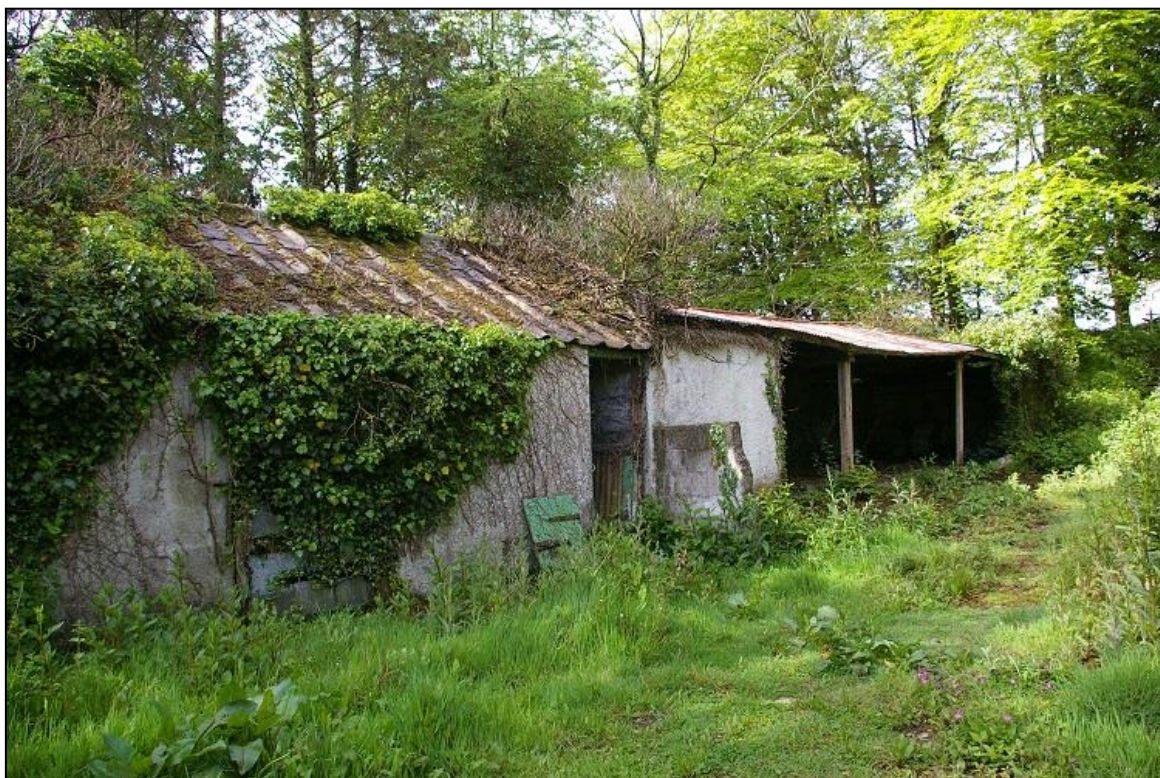
FIGURE 18: BARN RANGE 5; BUILDING A, OPEN FRONTED IN THE BACKGROUND, BUILDING B IN THE FOREGROUND; FROM THE NORTH-EAST.

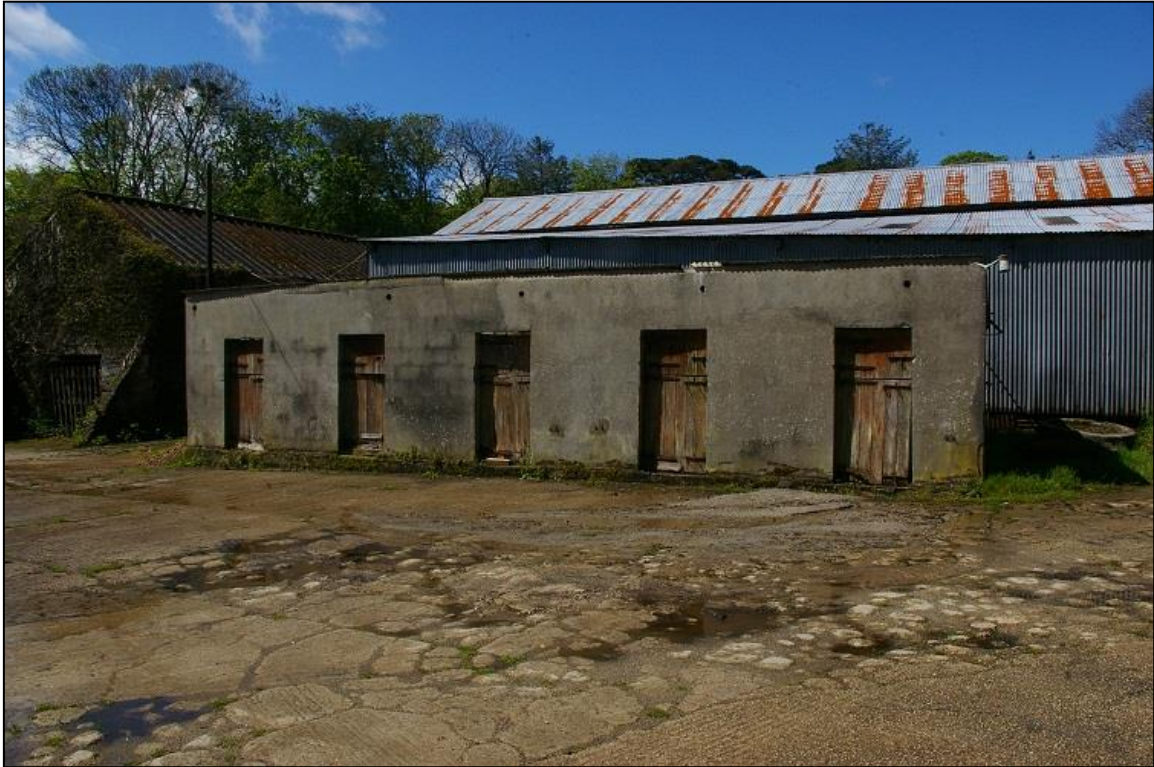
FIGURE 19: THE STABLES, BARN RANGE 6; FROM THE NORTH-EAST.

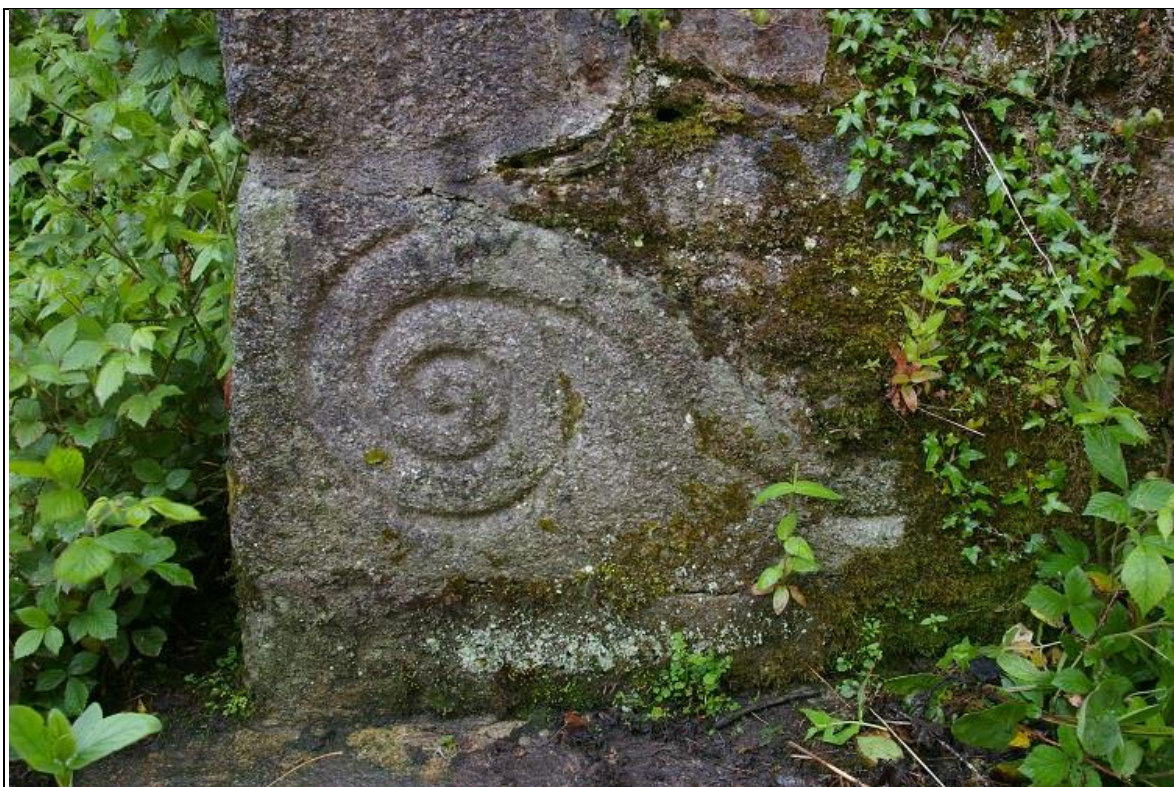
Barn range 4 also contains a large block of carved stone, a sizeable rams-head carving used on the corner of the granary slope/ramp serving the loft. This has been much altered and certainly there is the potential to remove all of the concrete structures from the south front and if necessary replace, extending the footprint, if desired. It is flexible internally for change, with few fittings surviving.

FIGURE 20: A DRESSED, CARVED GRANITE –STONE, REUSED IN THE RAMP SERVING THE LOFT OF BARN RANGE 4; FROM THE NORTH.

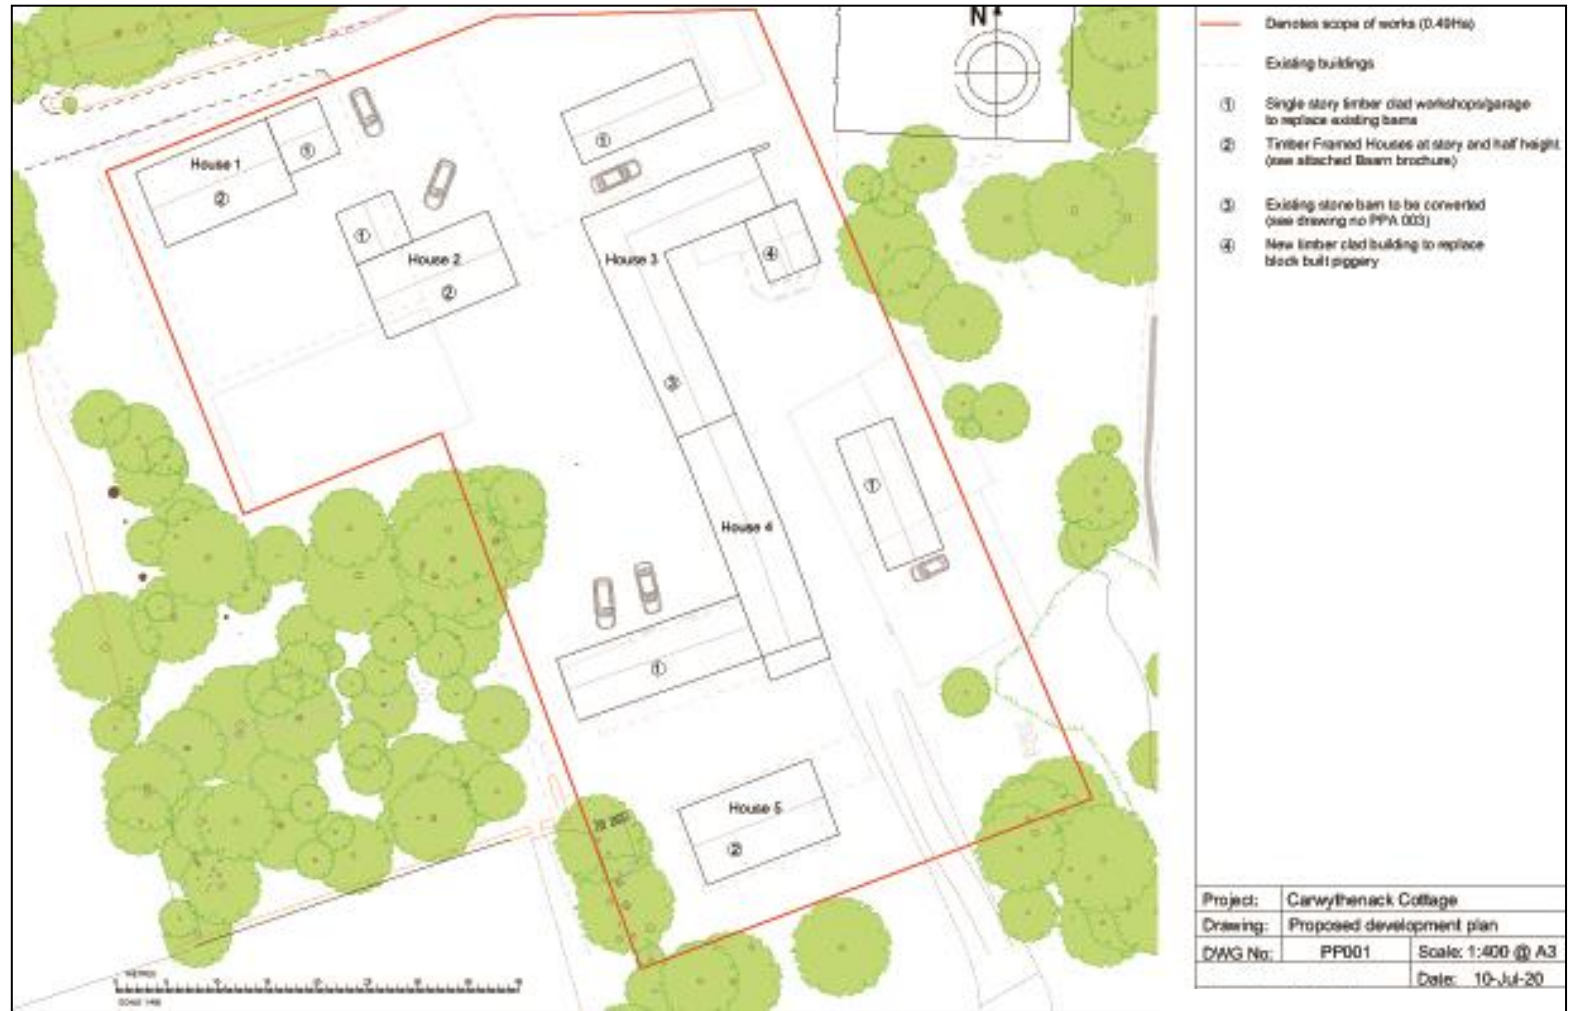
FIGURE 22: PROPOSALS FOR THE SITE AT CARWYTHENACK FARM (AS SUPPLIED BY CLIENT).

- **The modern barns and pole barns are to be demolished, some will be replaced with timber workshop; the agricultural sheds to the north-west are to be replaced by two timber modern houses.**

Removing the poor quality 20th century buildings, many of which are significantly dilapidated and opening the yard areas back up is considered a benefit of the proposals. Where areas of quartz paving, cobbling and historic yard surfaces can be seen, i.e. between barn ranges 1 and 5 and east of barn range 2, it is strongly advised that this is retained and made a feature of. Across the site it is appropriate for ground works to be monitored due to the high archaeological potential and ancient origins of the manor. Reconnecting the historic barns with their wider setting will have a positive impact and allow the historic range to once again be the focus of the site, visually and spatially.

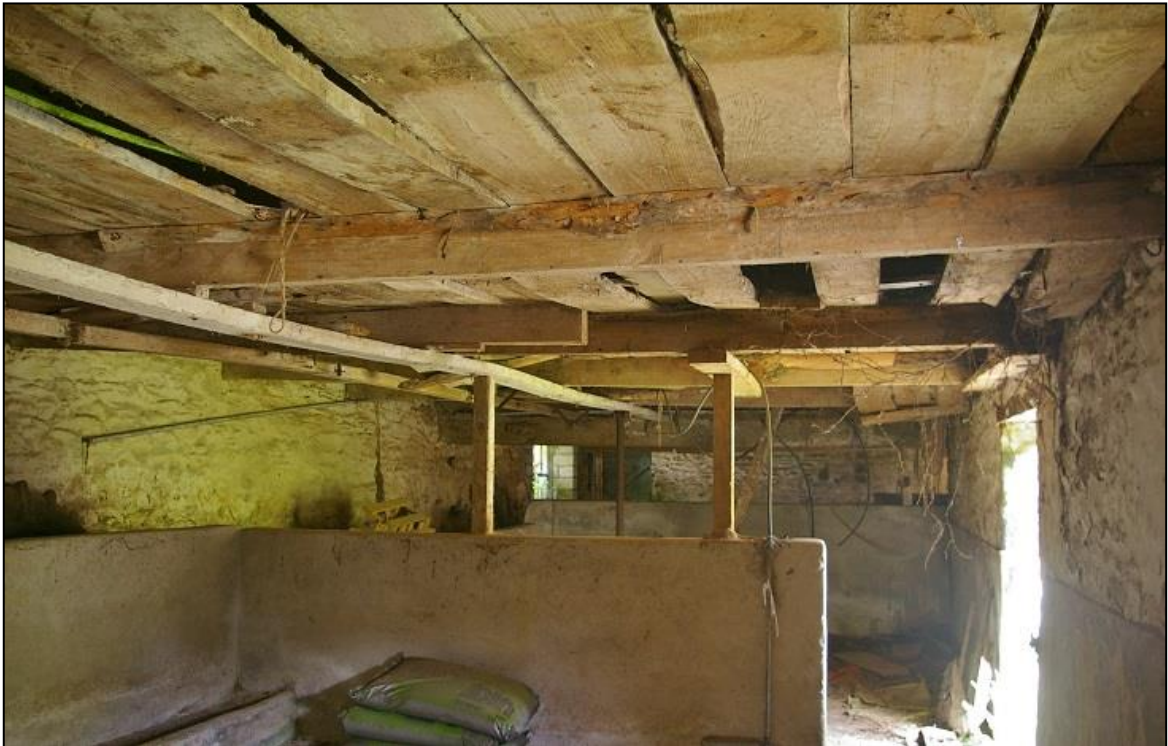
FIGURE 23: THE INTERIOR OF BARN RANGE 3; FROM THE SOUTH-SOUTH-EAST.

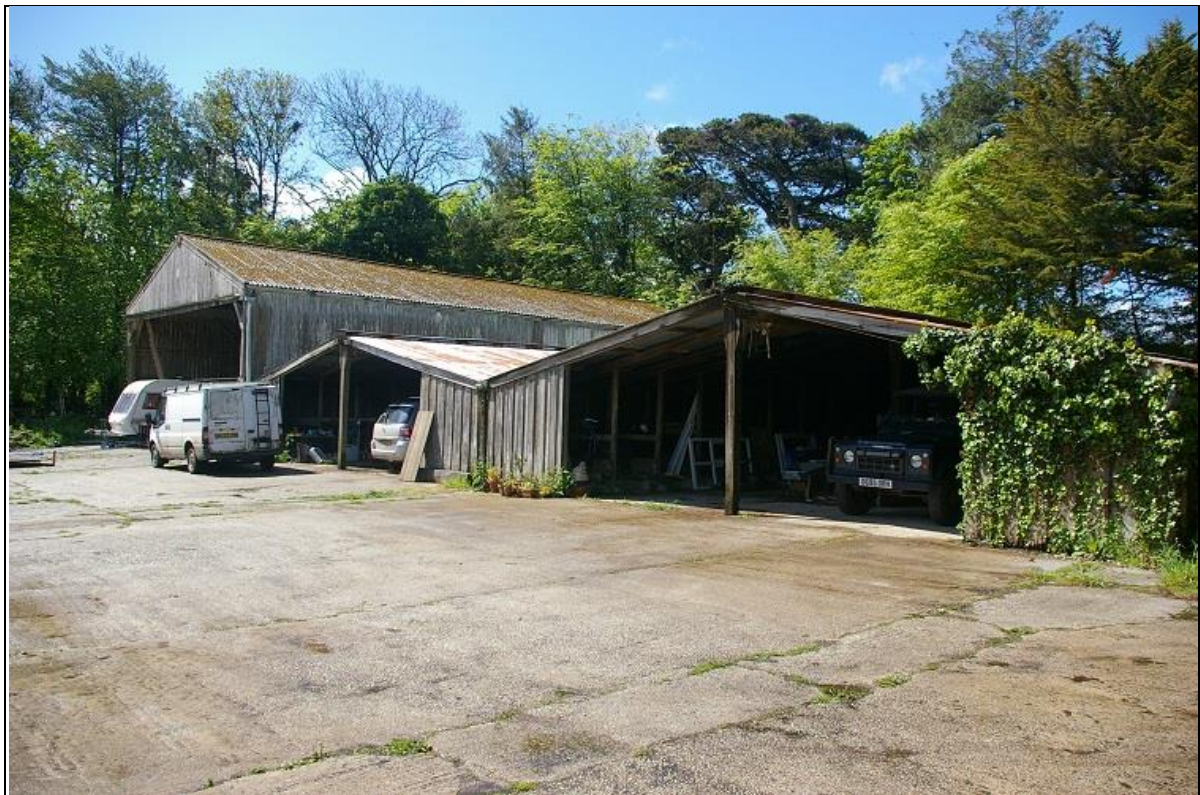
2. THE MODERN AGRICULTURAL SHEDS TO THE WEST AND NORTH-WEST OF THE HISTORIC BARNs; FROM THE NORTH-EAST.

To the north-west of the historic barns, north and east there are modern concrete and timber sheds, open span agricultural buildings, a more enclosed corrugated shed and metal framed pole barns with corrugated cladding. All of these structures date from the mid-late 20th century and are associated with the phase of concreted yard surfaces and some concrete block additions to the historic barns. They contribute at present to the abandoned rural farming character of the site but are visually dominant over the historic buildings and are in relatively poor condition. Although the scale of the buildings is quite significant they are not expected to have disturbed the ground beneath them to any real extent, as they are all largely frame-construction; there is potential for archaeological evidence to survive beneath the concrete slab footprint of these buildings. A good quartz, slate pebble and granite cobbled yard is seen to partially survive beneath the concrete in the yard to the east of Barn range 2, adjacent to the pole barns. It is believed the ground surface has been considerably built up in the yard with the agricultural sheds behind barn ranges 1-3; this concreted area however as 'garden and yards' may seal more interesting occupational deposits.

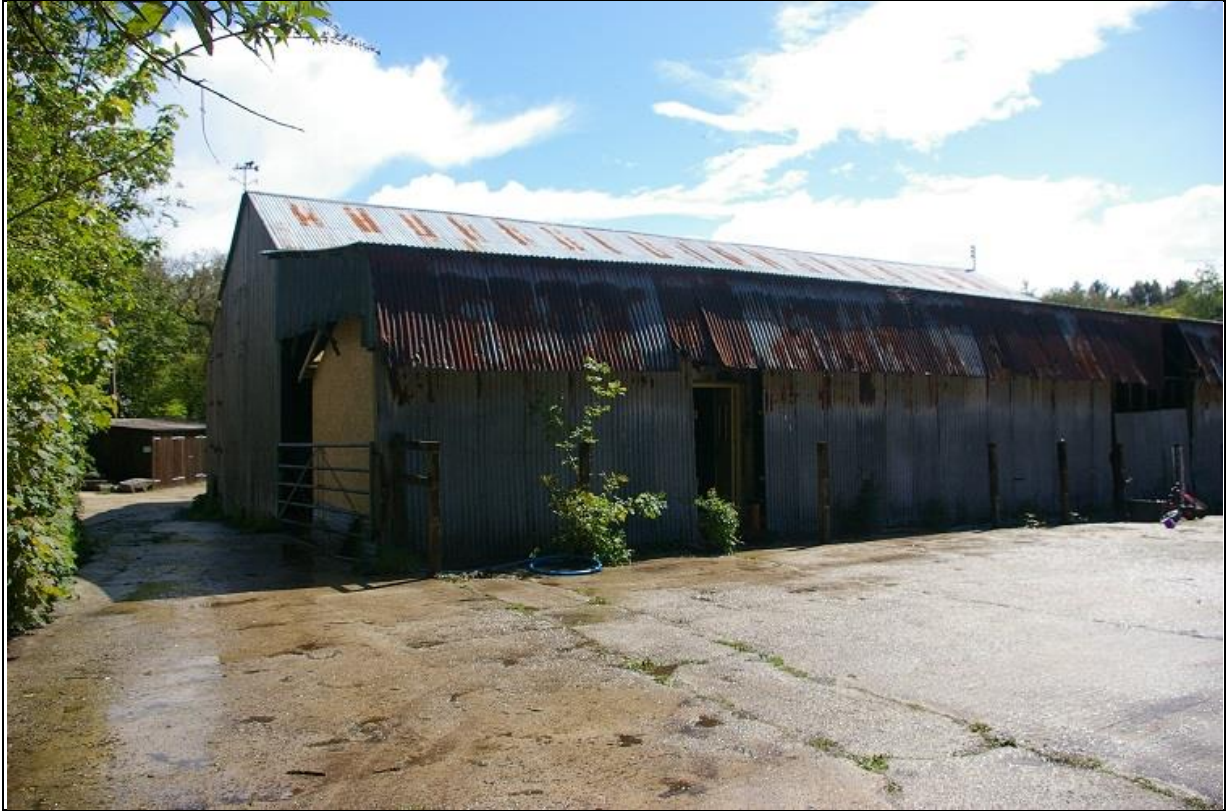
3. THE LARGE CORRUGATED BARN TO THE NORTH OF THE HISTORIC BARNs, WHICH SOMEWHAT CLUSTERS THE FARMHOUSE; FROM THE WEST-NORTH-WEST.

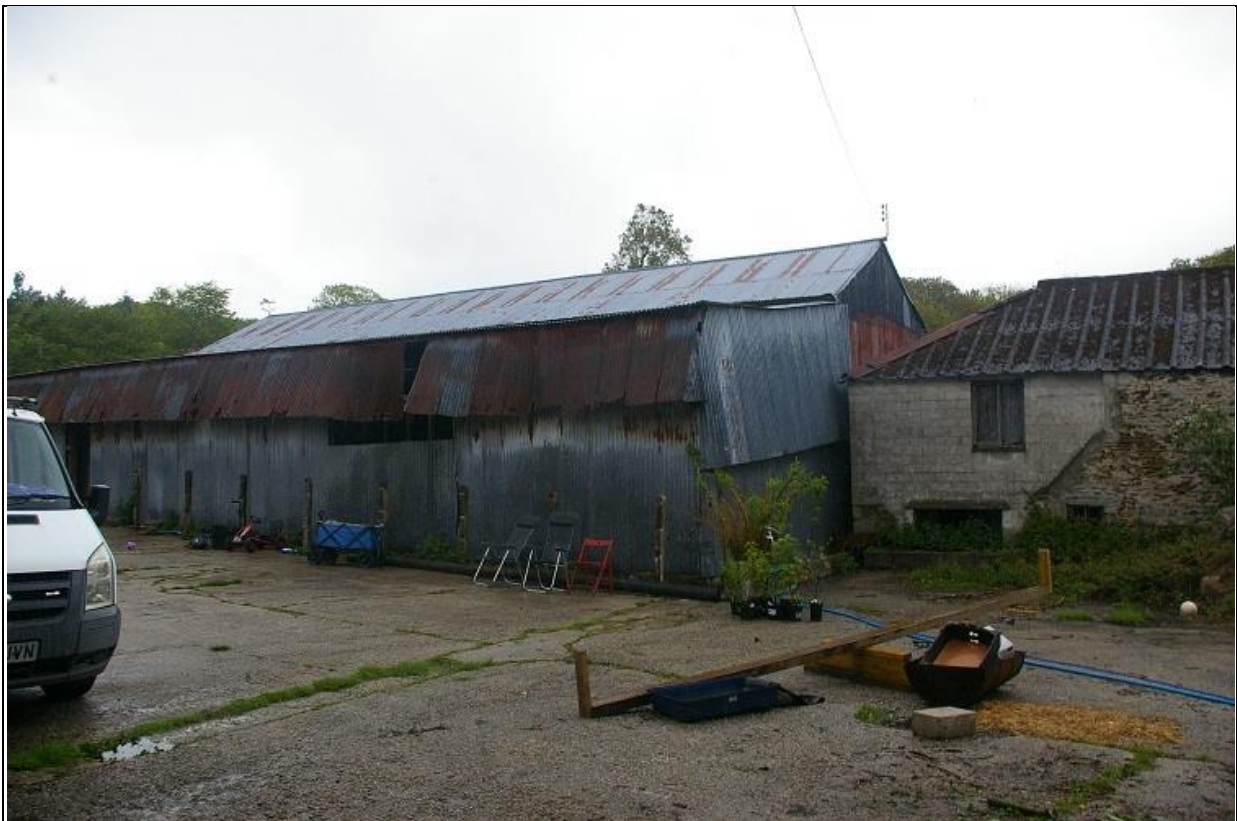
4. THE LARGE CORRUGATED BARN IS BUILT VERY CLOSE TO THE HISTORIC BARN RANGES 3 & 4, CLUSTERING AND VISUALLY DOMINATING THE HISTORIC BUILDINGS; FROM THE SOUTH-WEST.

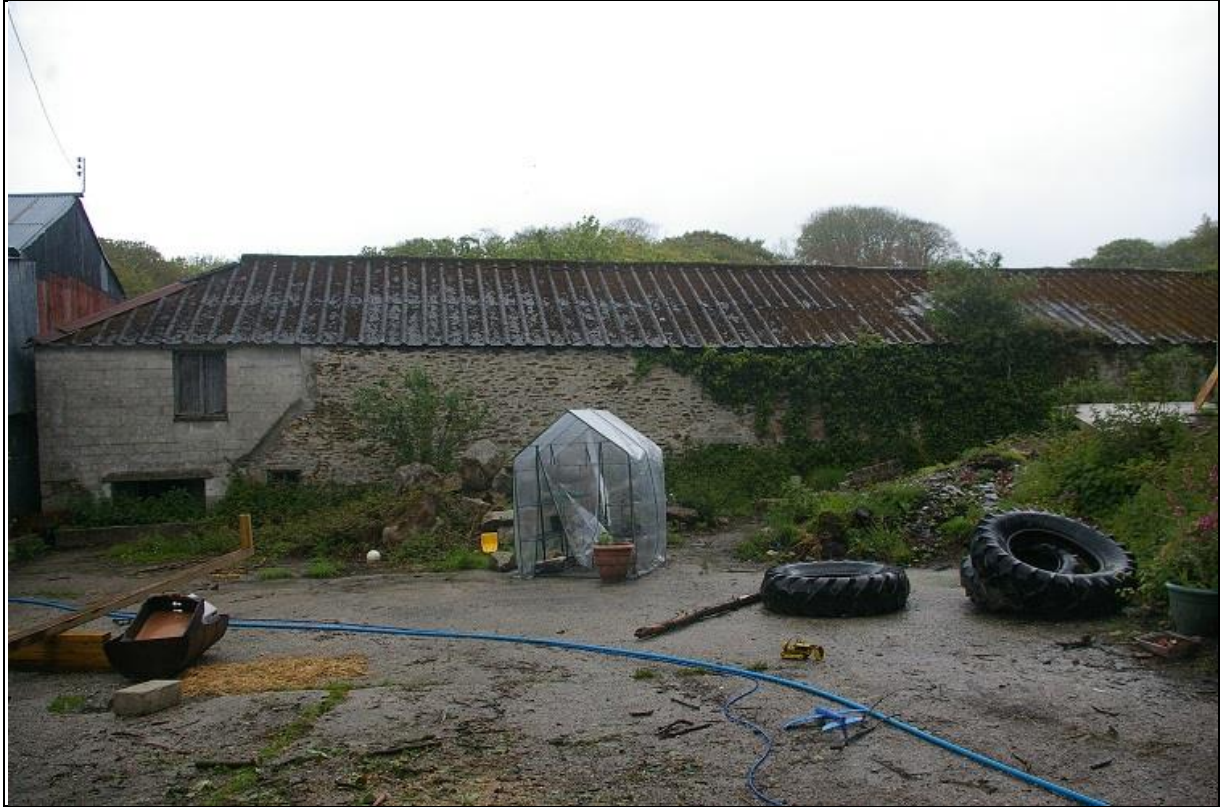
5. THE REAR WALL OF BARN RANGE 3, WHERE IT IS LINKED TO BARN RANGE 4, THE CORNER HAVING TO BE REBUILT AGAIN IN BLOCK WORK; FROM THE WEST.

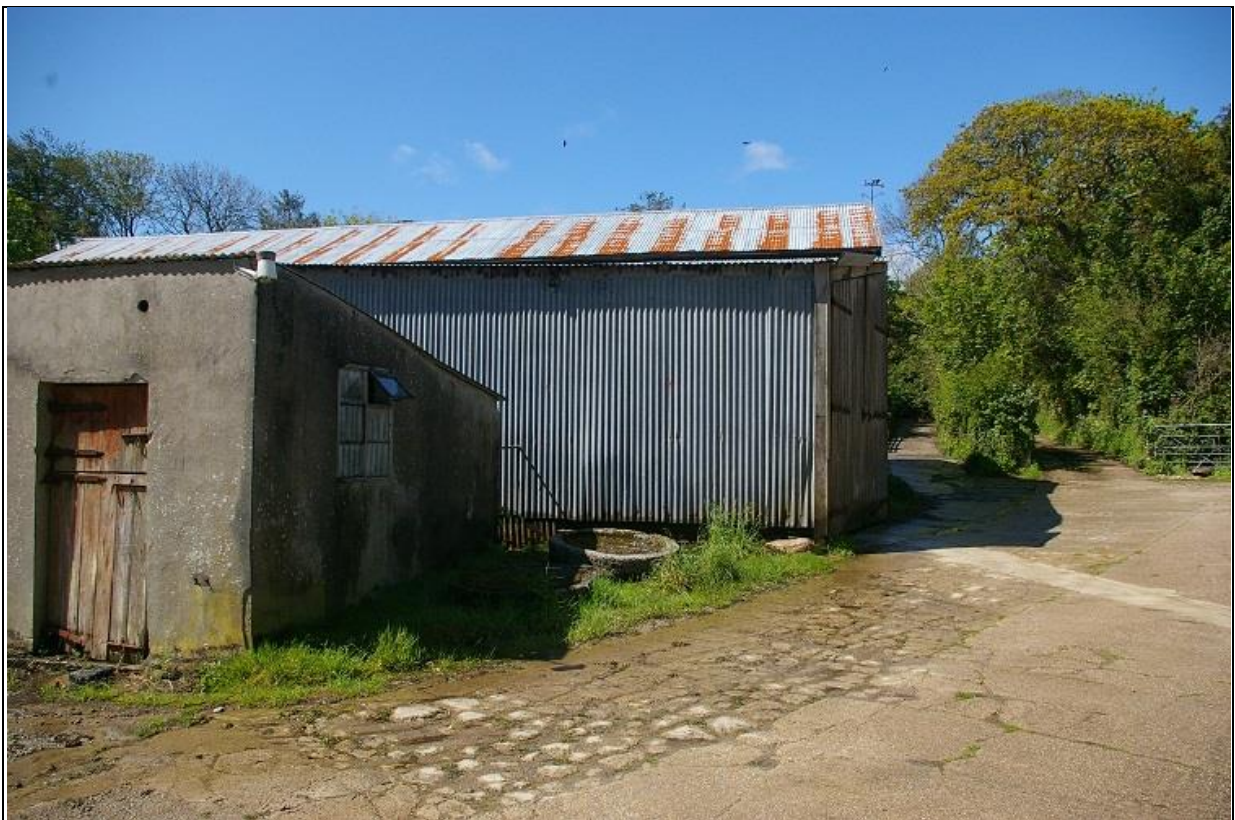
6. BARN RANGE 6 IS TO THE EAST OF THE CORRUGATED BARN, VIEW SHOWING ITS NORTH WALL; FROM THE EAST.
