THE BARNs
CARWYTHENACK FARM
GWEEK
CORNWALL

Results of a Heritage Assessment

South West Archaeology Ltd. report no. 210702

By E. Wapshott
Report Version: FINAL
Draft Issued: 2nd July 2021
Report Finalised: 9th February 2022

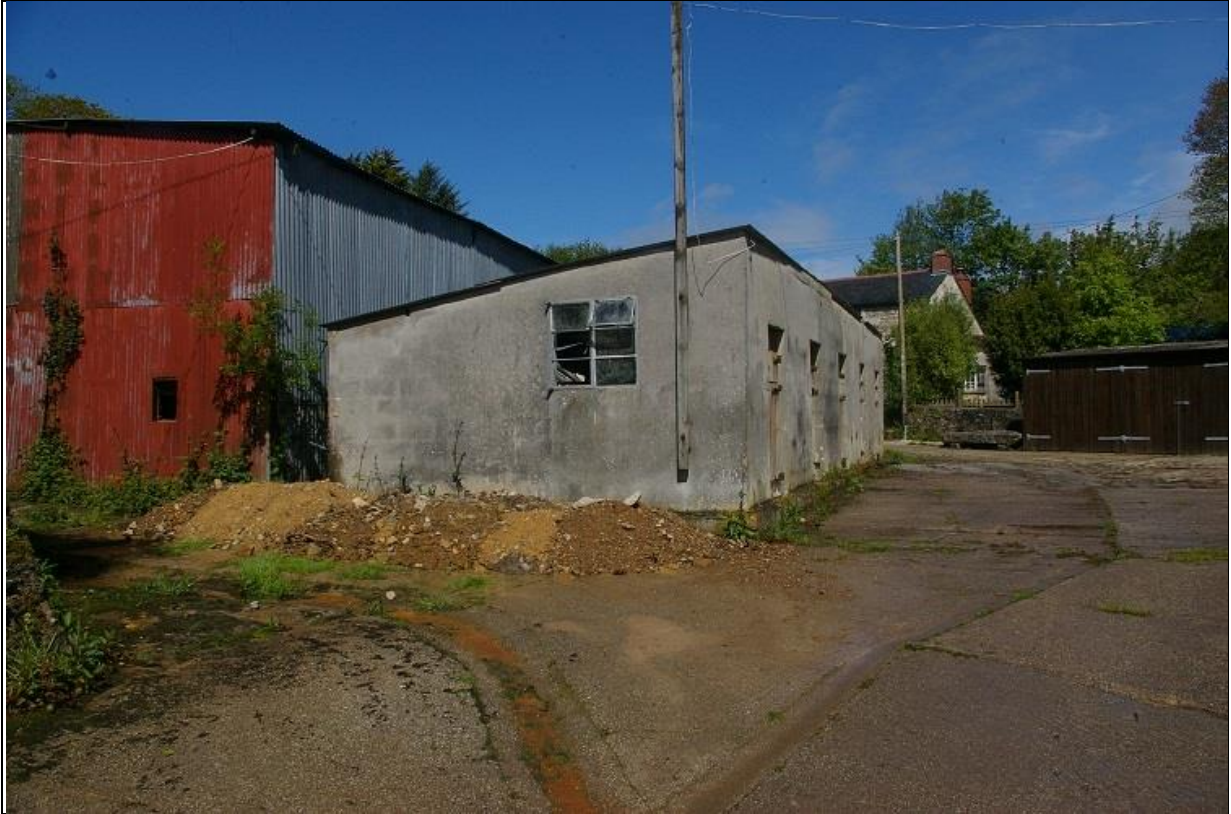
7. THE SOUTH END OF BARN RANGE 6, WITH THE FARMHOUSE IN THE BACKGROUND; FORM THE SOUTH-EAST.

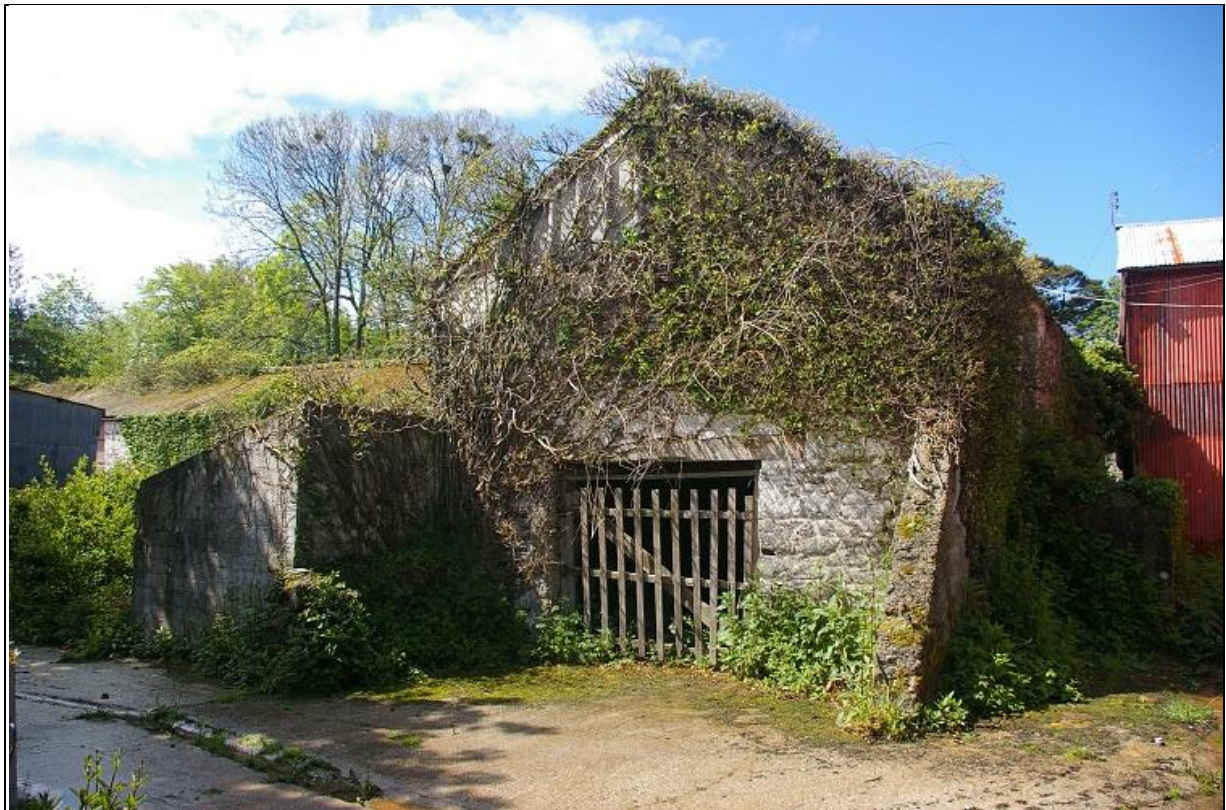
8. BARN RANGE 4, THE EAST GABLE AND CONCRETE BLOCK BUTTRESS, WITH CONCRETE BLOCK PIGSTIES TO THE SOUTH; FROM THE EAST-NORTH-EAST.

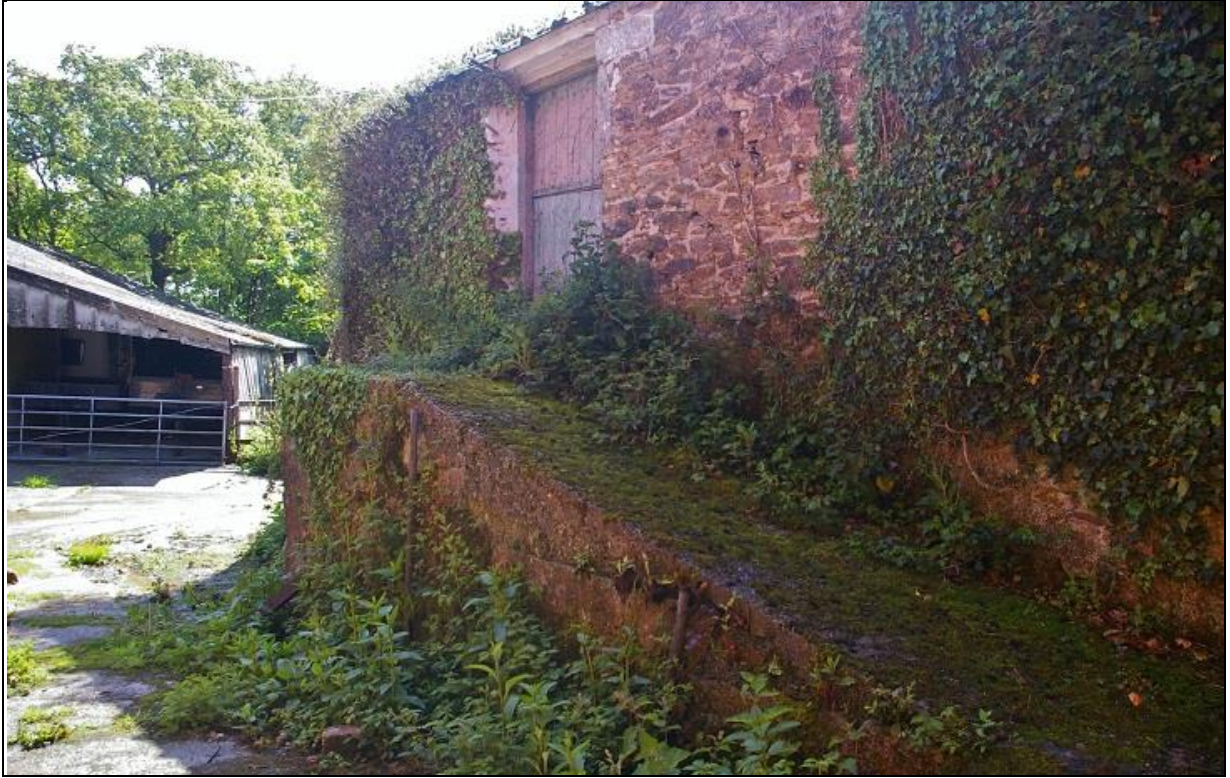
9. THE NORTH ELEVATION OF BARN RANGE 4, AT THE EAST END, WITH THE DOOR TO THE LOFT, FORCED INTO THE WALL, SERVED BY A RAMP BUILT OF RUBBLE STONE; FROM THE NORTH-WEST.

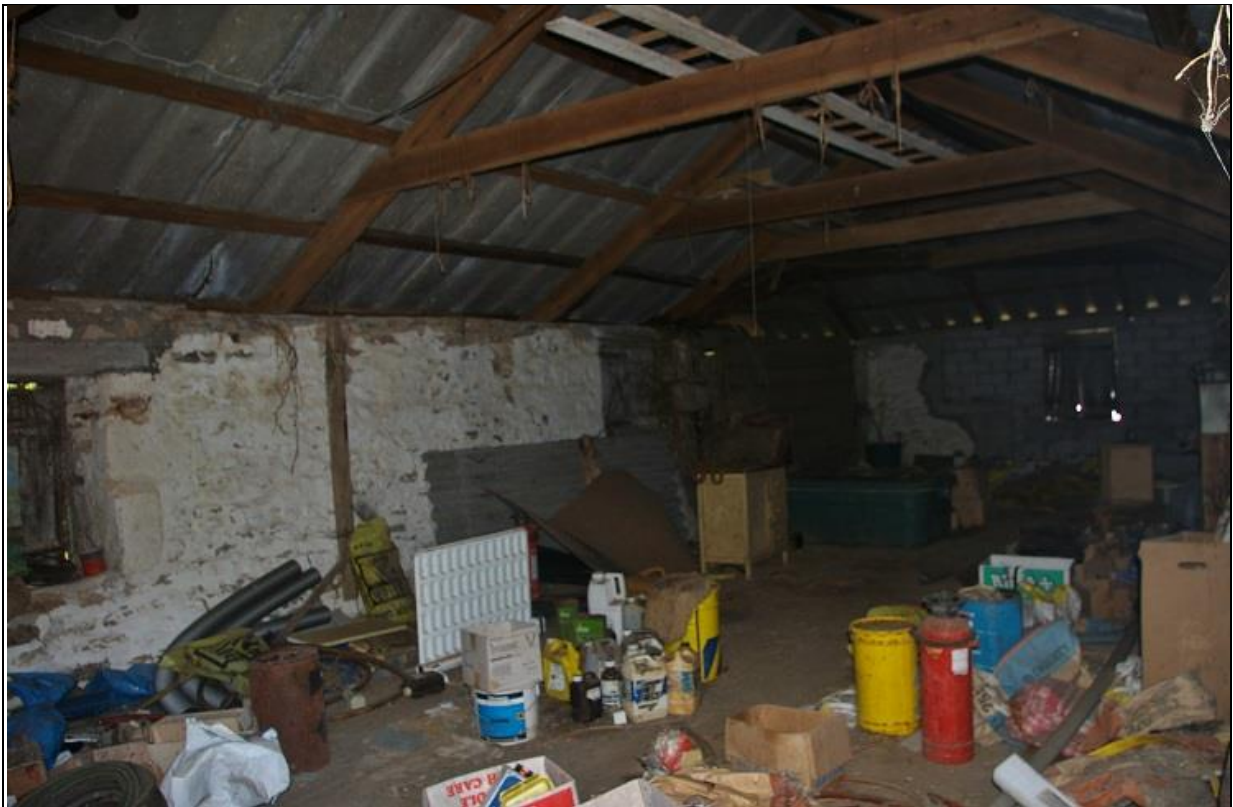
10. THE LOFT IN BARN RANGE 4, AS ACCESSED VIA THE RAMP; THE BUILD LINE CAN BE SEEN IN THE WALLS, WHERE THE BARN WAS EXTENDED TO MEET BARN RANGE 3 TO THE WEST; FROM THE NORTH-EAST.

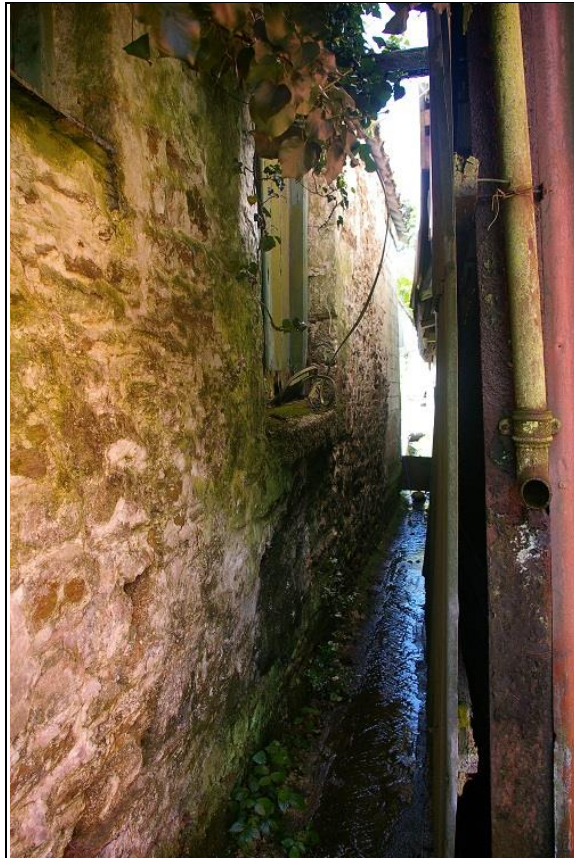
11. THE REST OF THE NORTH ELEVATION OF BARN RANGE 4 IS BLOCKED BY THE CORRUGATED BARN, SHOWING A CLEAR BUILD LINE WITHIN THE STONework, WHERE THE BARN WAS EXTENDED TO MEET BARN RANGE 3; FROM THE EAST.

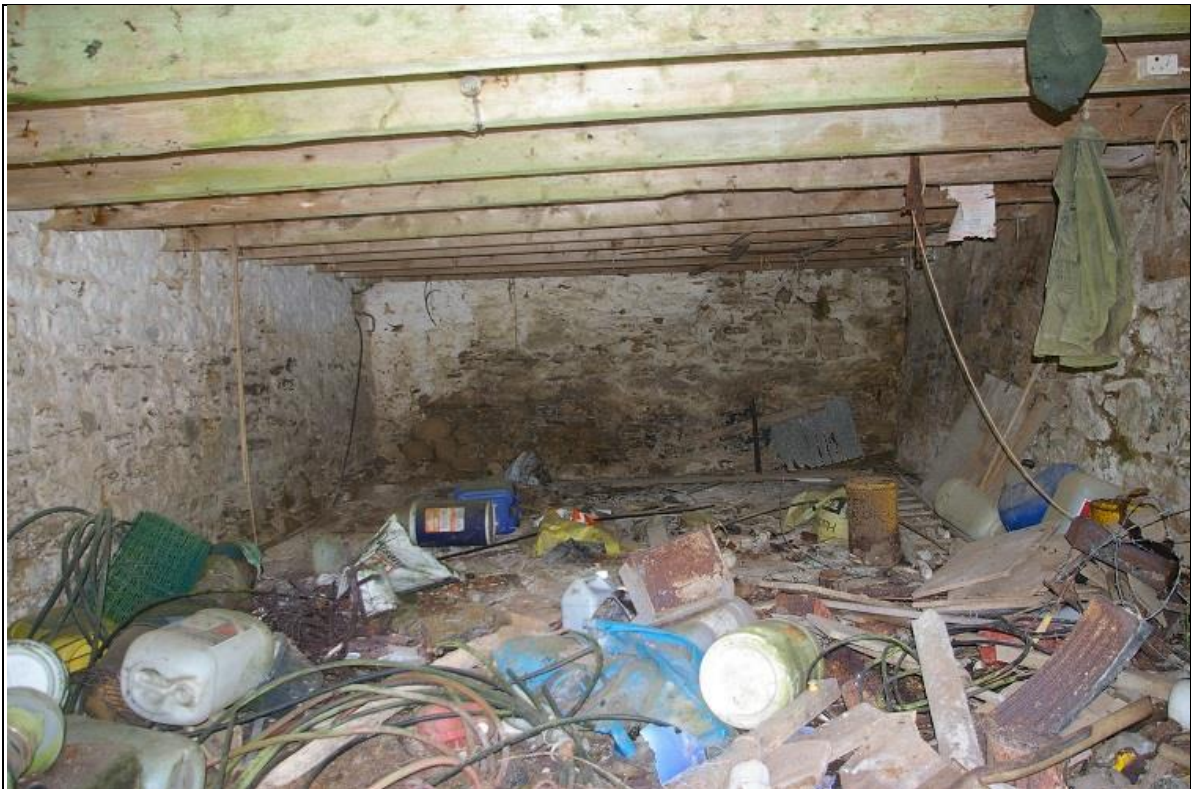
12. THE INTERIOR OF THE GROUND FLOOR OF BARN RANGE 4, BUILDING B, OPEN TO THE EAST GABLE, SHOWING BATTERED WALLS TO THE EAST END AND AGAIN A CHANGE OF BUILD; FROM THE EAST.

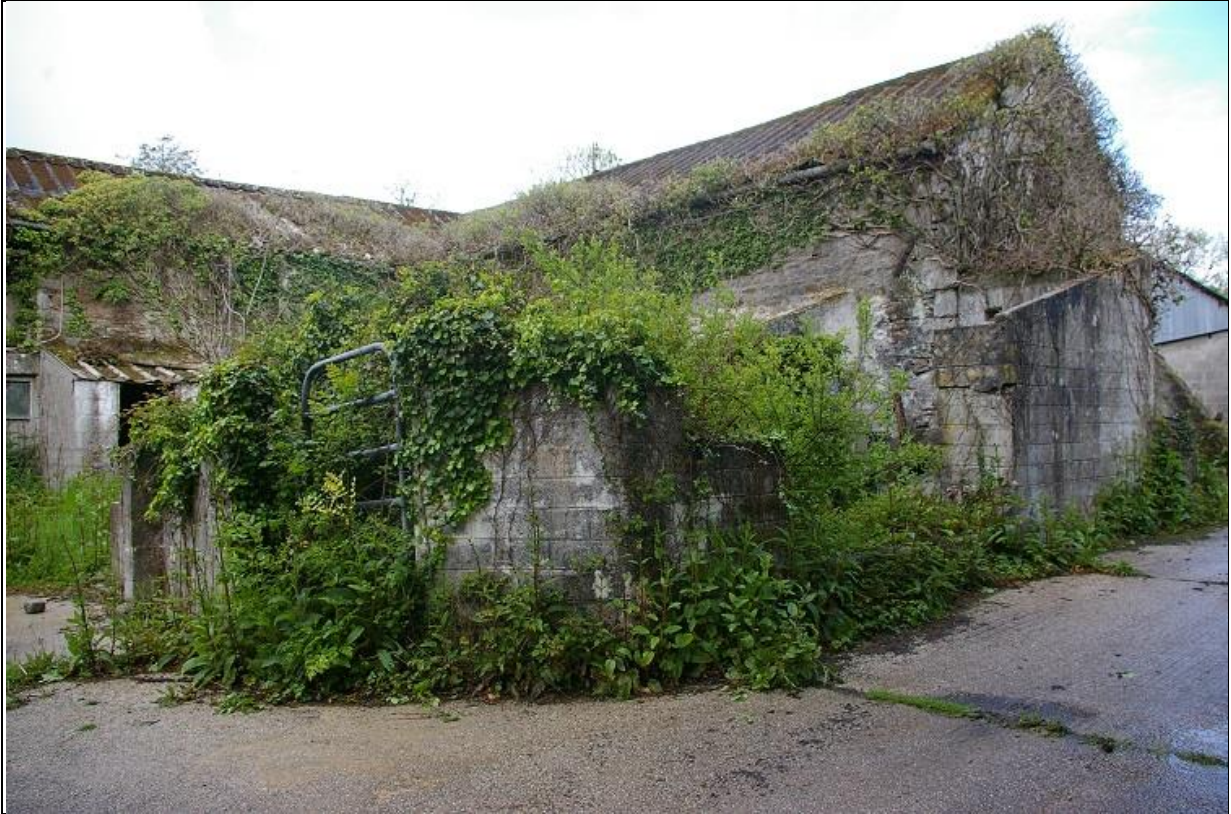
13. THE SOUTH FRONT OF BARN RANGE 4 WITH RUINED CONCRETE BLOCK BUILDINGS ATTACHED; FROM THE SOUTH-EAST.

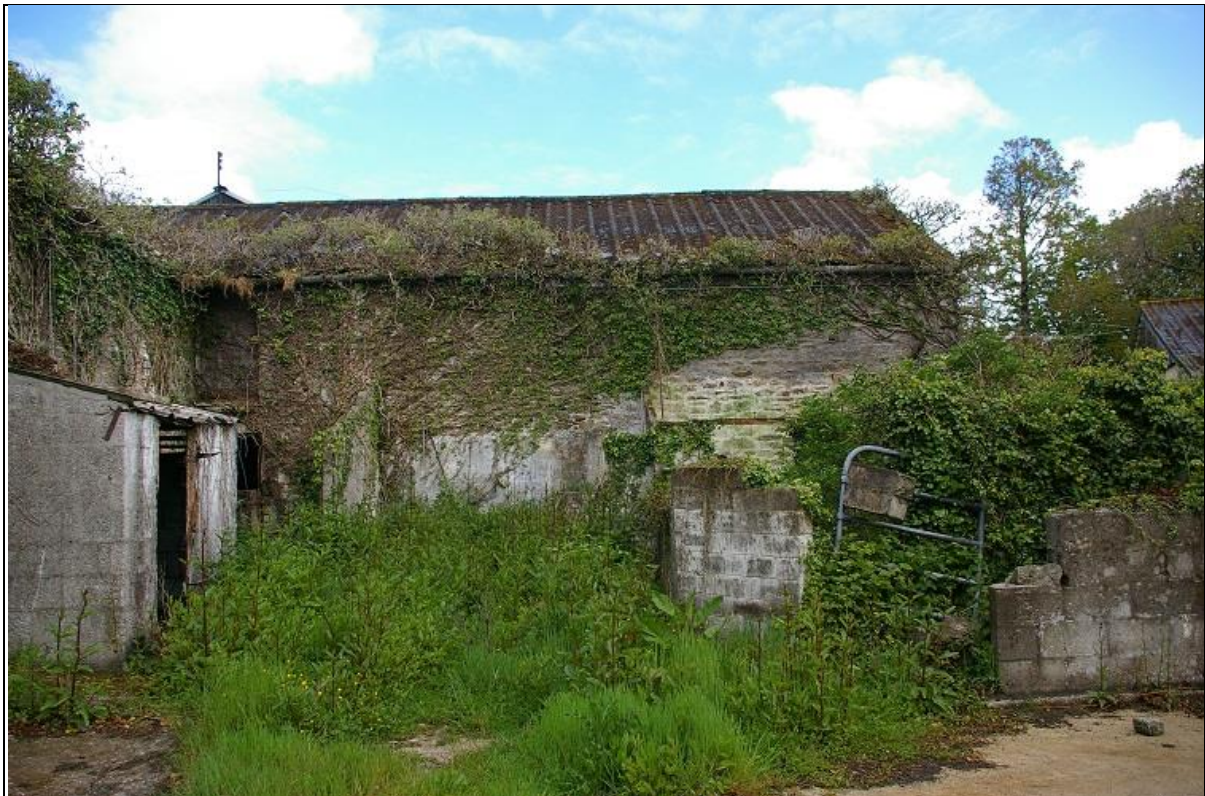
14. THE SOUTH ELEVATION OF BARN RANGE 4, SHOWING THE PROJECTING STUB WALL OF THE FORMER PROJECTION SHOWN ON THE HISTORIC MAPPING; FROM THE SOUTH.

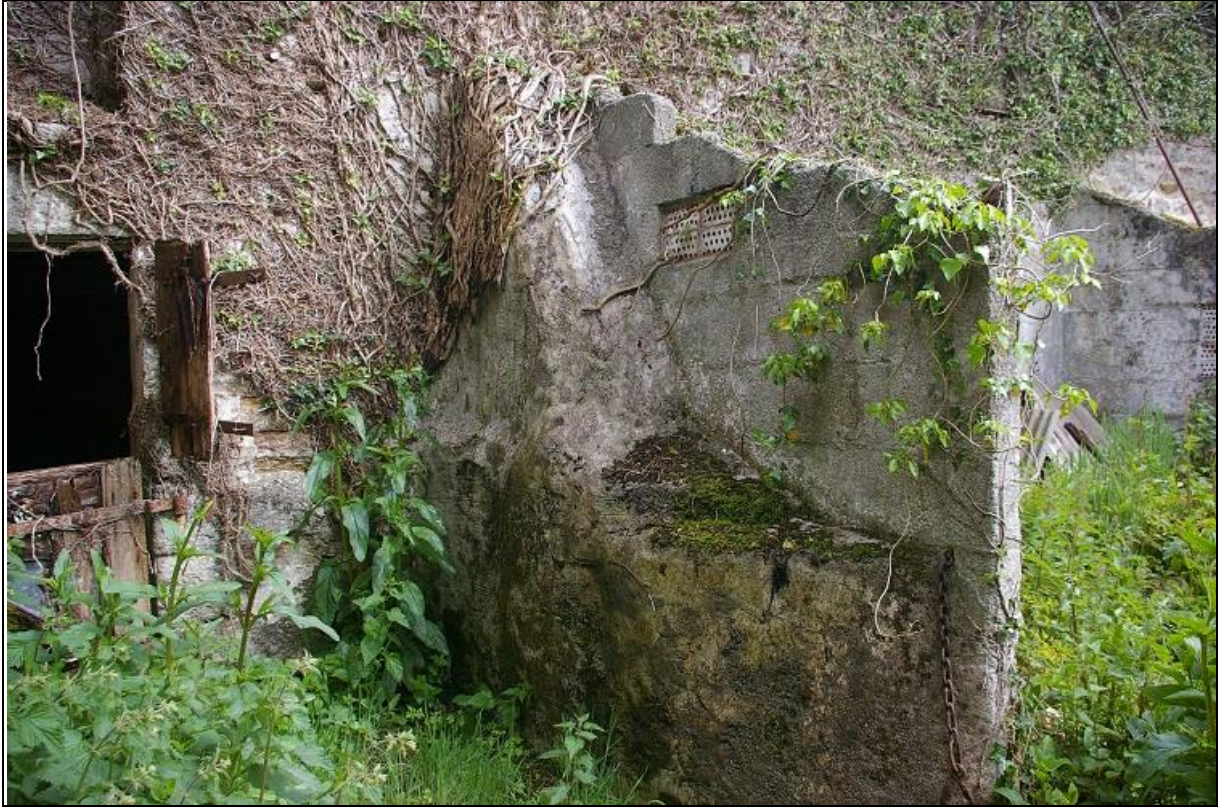
15. PROJECTING WALL STUB ON THE FRONT OF BARN RANGE 4; FROM THE SOUTH-WEST.

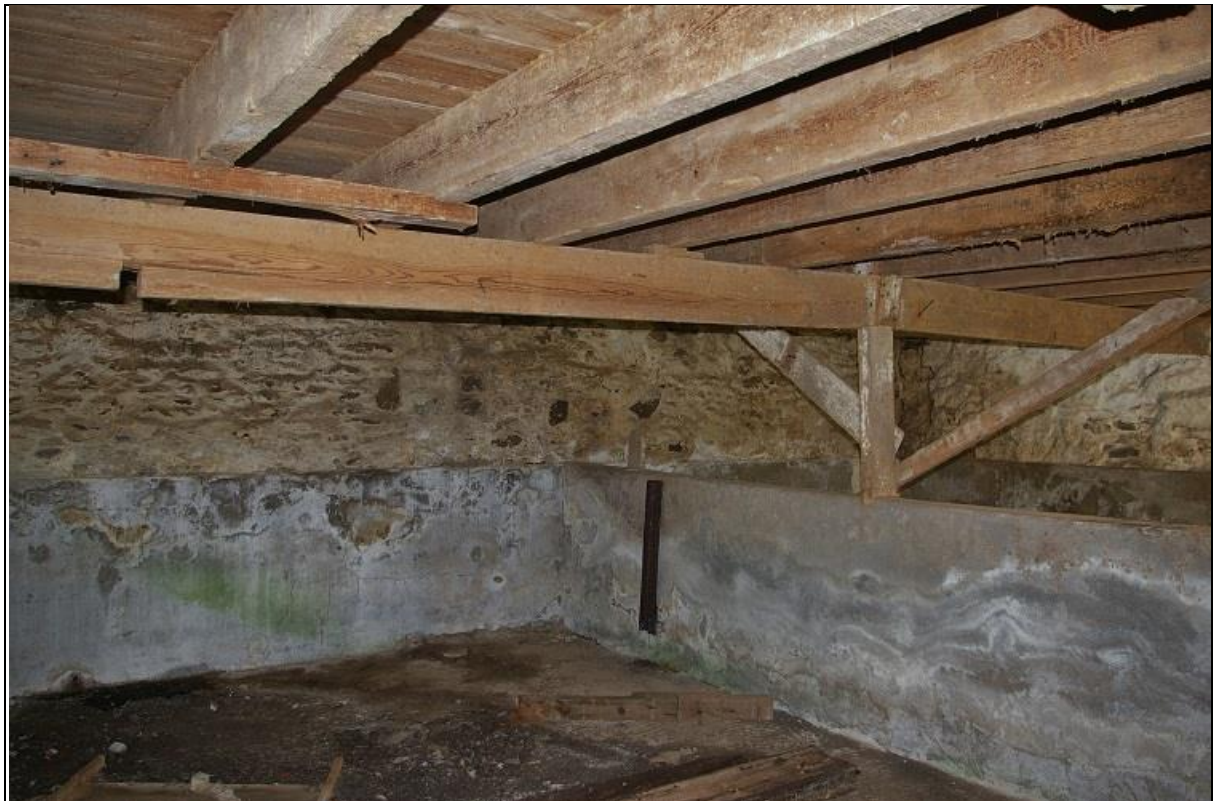
16. BARN RANGE 4, BUILDING A, SHOWING TWO CONCRETE PENS, SHOWING BUILD LINE IN THE REAR WALL WHERE IT WAS EXTENDED OUT TO MEET BARN RANGE 3; FROM THE SOUTH-WEST.

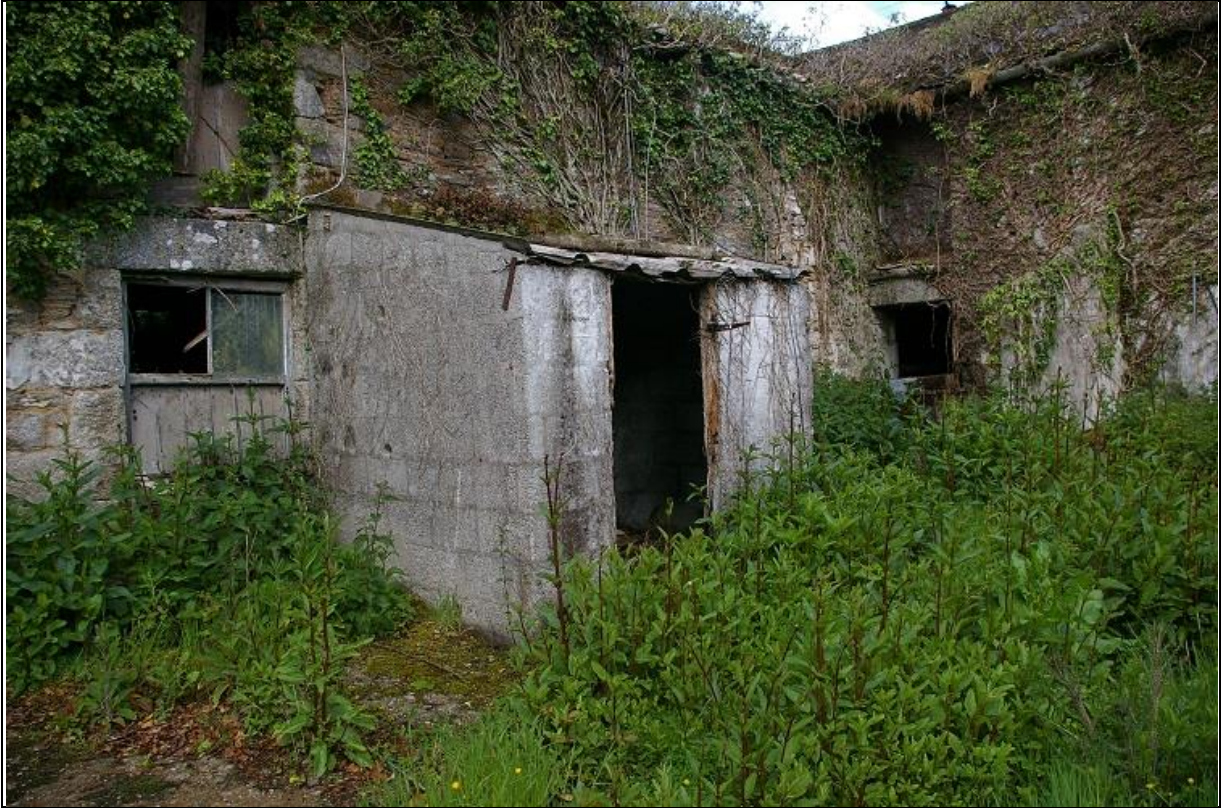
17. THE EAST FRONT OF BARN RANGE 3, WITH SMALL CONCRETE BLOCK GENERATOR SHED; FROM THE SOUTH-EAST.

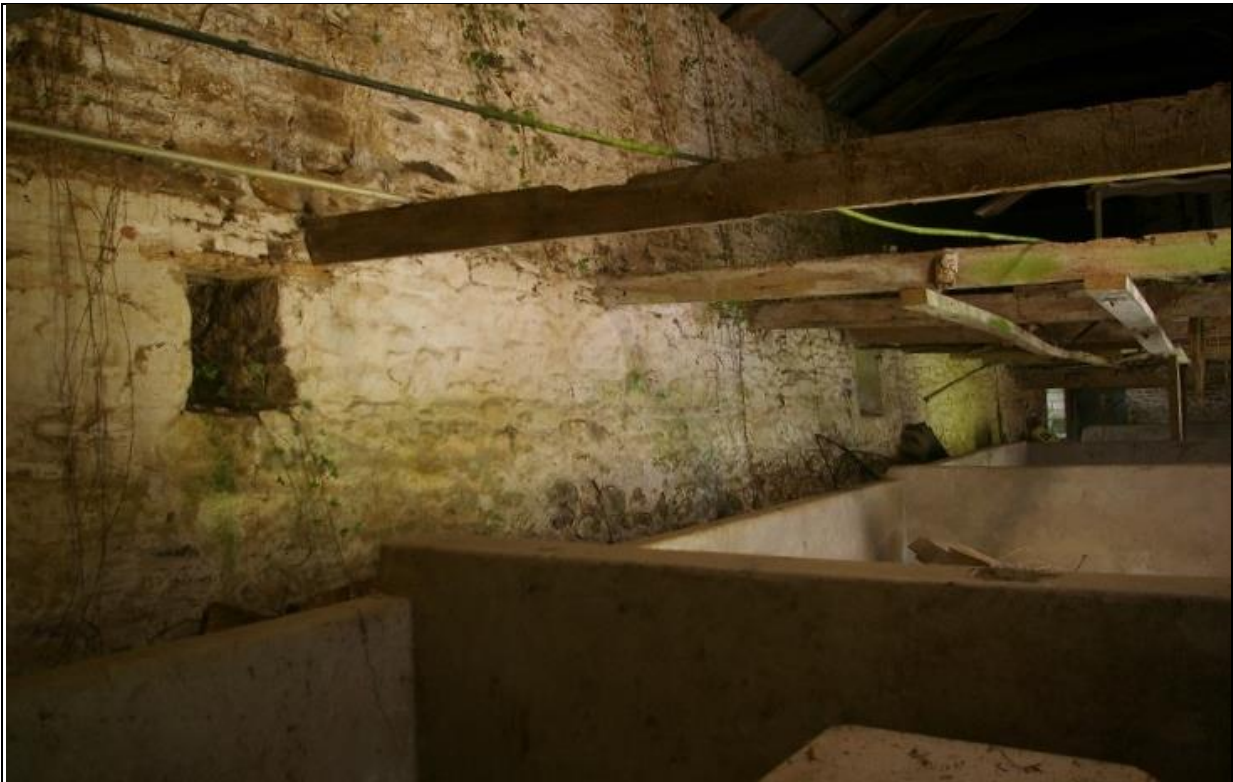
18. THE BACK WALL OF BARN RANGE 3, SHOWING DIFFERENT BATTERED BUILD TO THE LOWER PART OF THE WALL, WITH MODERN CONCRETE PENS; FROM THE SOUTH-EAST.

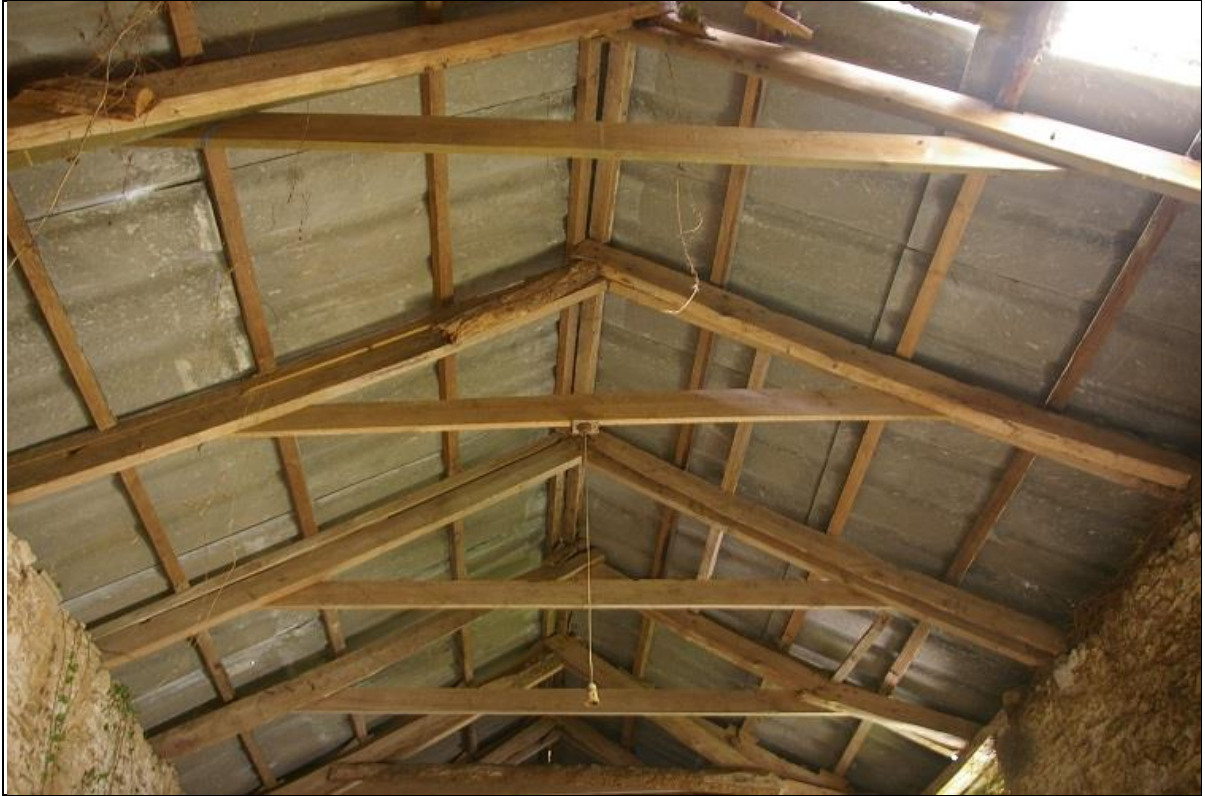
19. THE ROOF OVER BARN RANGE 3, THE ELM TRUSSES HAVE LARGELY FAILED, REPLACED WITH 20TH CENTURY PINE AND CORRUGATED SHEETING; FROM THE SOUTH.

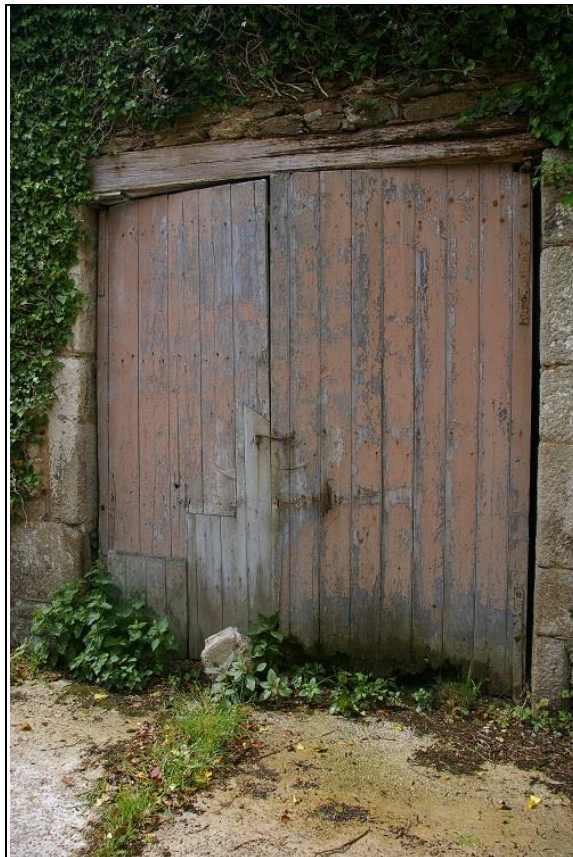
20. THE LARGE PLANK BOARDED DOORS TO BUILDING C, BARN RANGE 2; FROM THE NORTH-EAST.

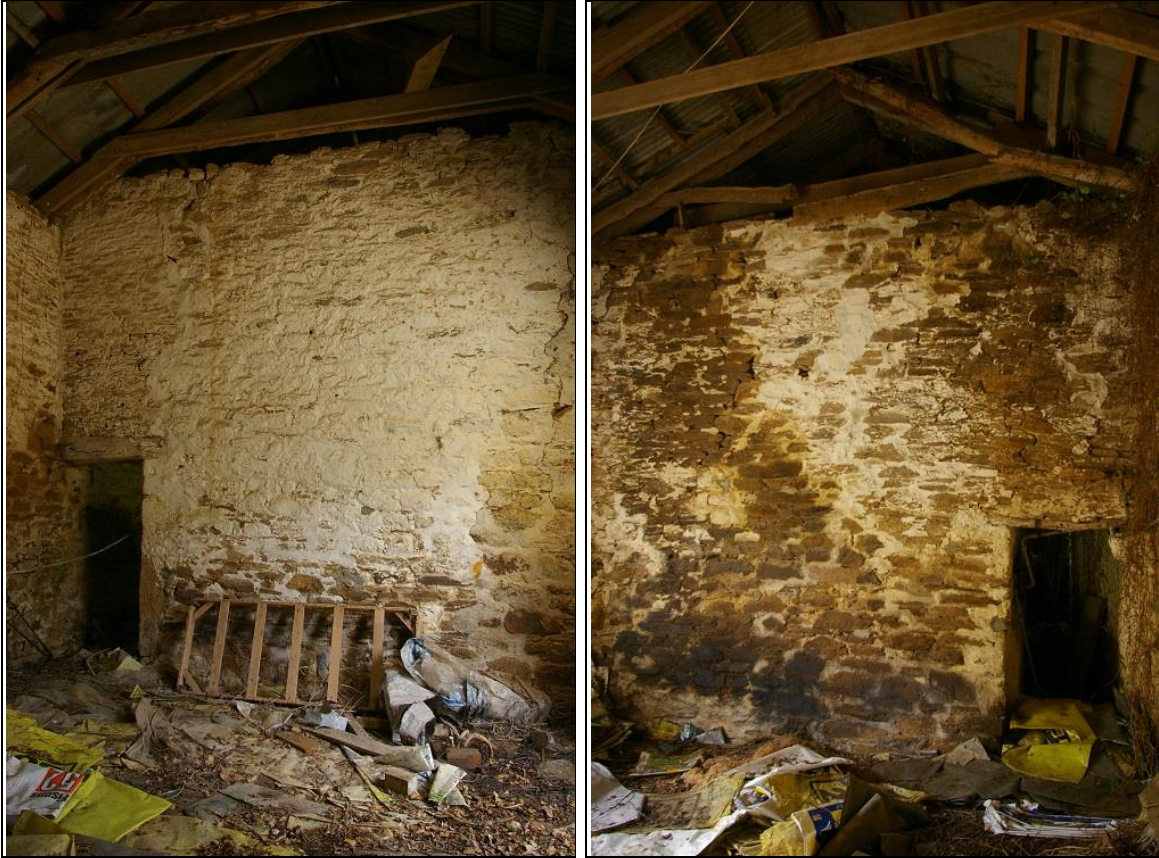
21. A – THE END WALL OF BARN RANGE 3, WITHIN THE INFILL SECTION BUILDING C, BARN RANGE 2. B – THE END WALL OF BARN RANGE 2, FROM WITHIN BUILDING C, WHICH IS INFILL.

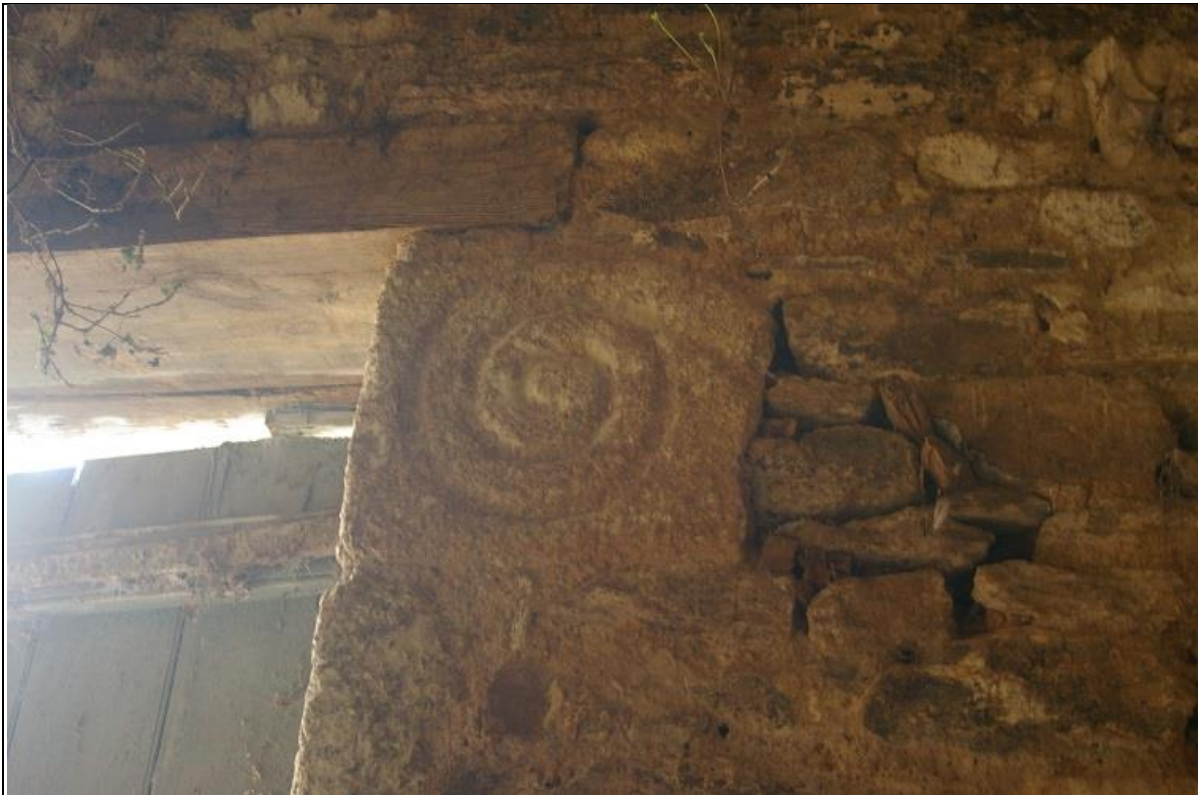
22. ONE OF THE OTHER REUSED CARVED STONES IN THE WALL OF THE INFILL BARN, BUILDING C, BARN RANGE 2; FROM THE WEST.

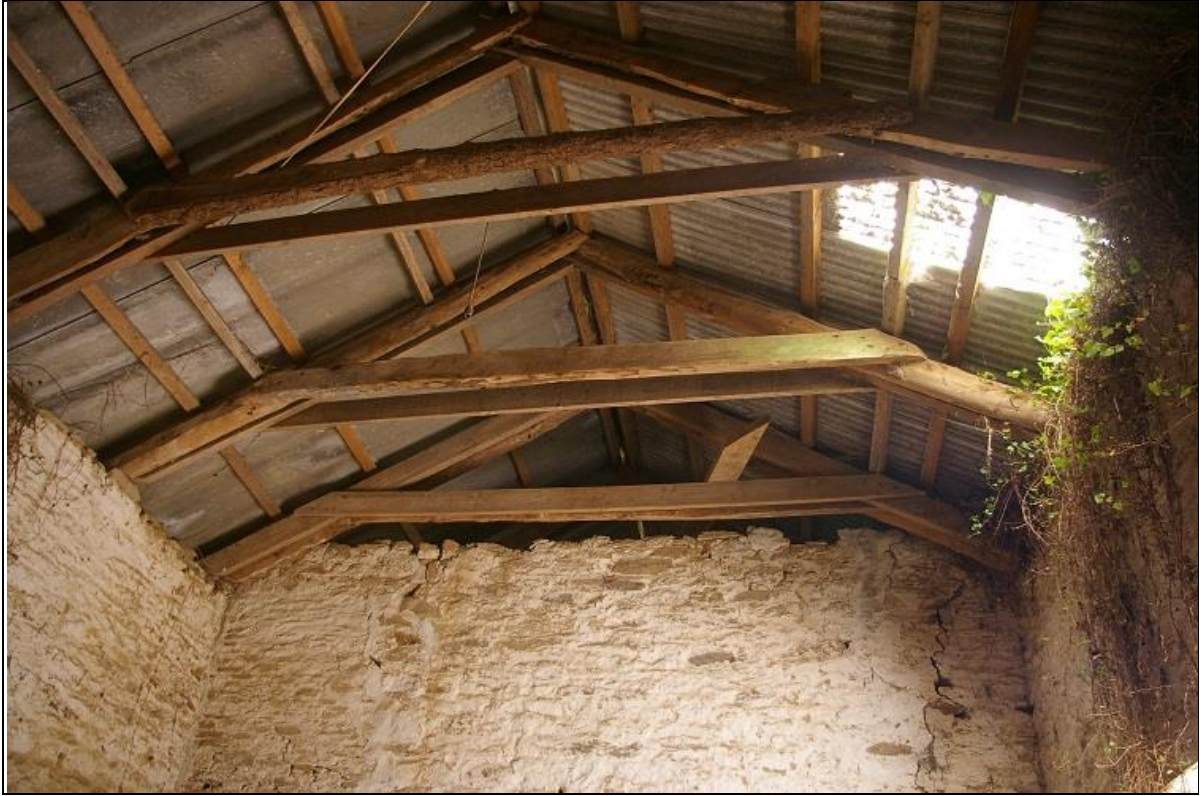
23. THE ROUGH EMBARKED TRUSSES OVER INFILL STRUCTURE BUILDING C, OF BARN RANGE 2, CLEARLY OF A POORER QUALITY THAN SOME OF THE OTHER 18TH CENTURY BUILDINGS; FROM THE SOUTH-EAST.

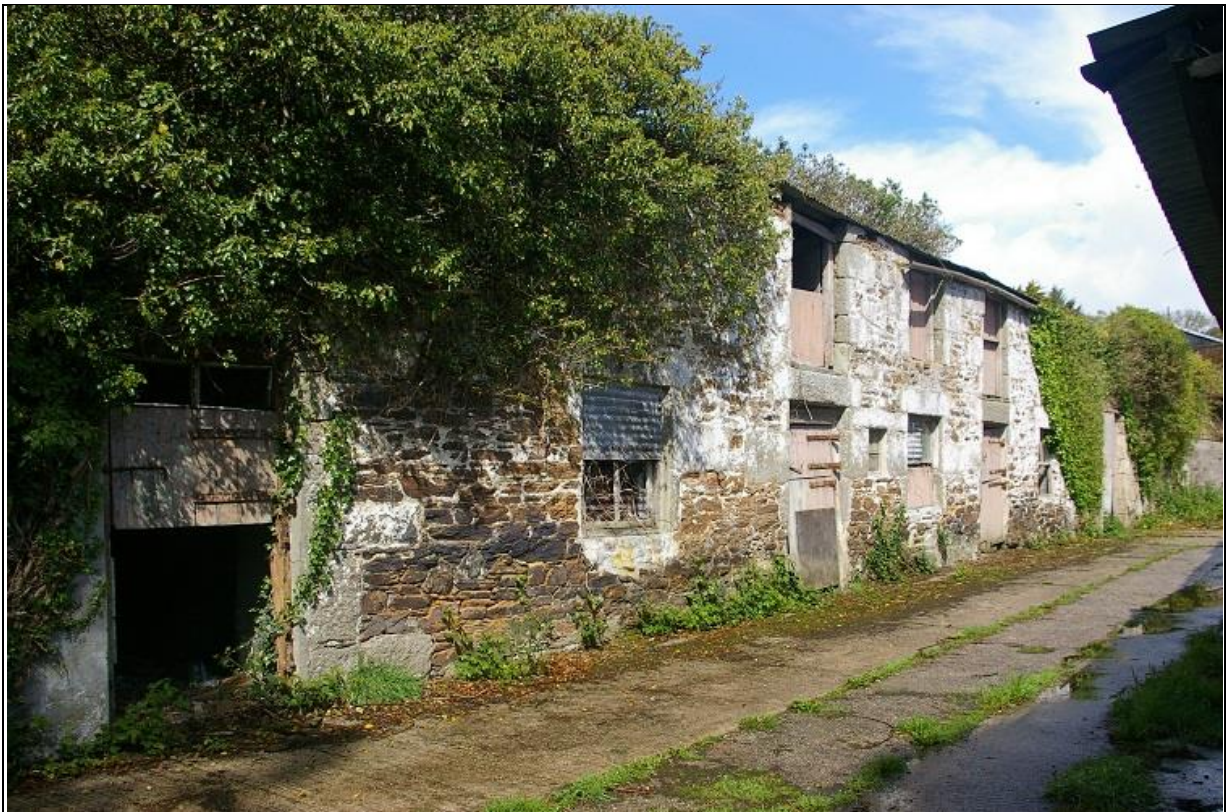
28. BARN RANGE 2, BUILDING B, THE LONG BARN TO THE CENTRE, BUILDING A TO THE FOREGROUND; FROM THE SOUTH-EAST.

Barn range 2 is of two storey height forming the west side of the main east farmyard, a long linear range on a north-south alignment; formed of three attached buildings, a lean-to, a barn and a cart store. The building is still roofed with corrugated concrete fibre sheeting panels but is damaged in places and sections of the loft floor have failed due to water ingress, so the loft was not accessed. The building faces east, having a 'presentation' front and there is an associated quartz and granite cobbled yard surface along the front, partly covered by modern concrete. At the south end of the

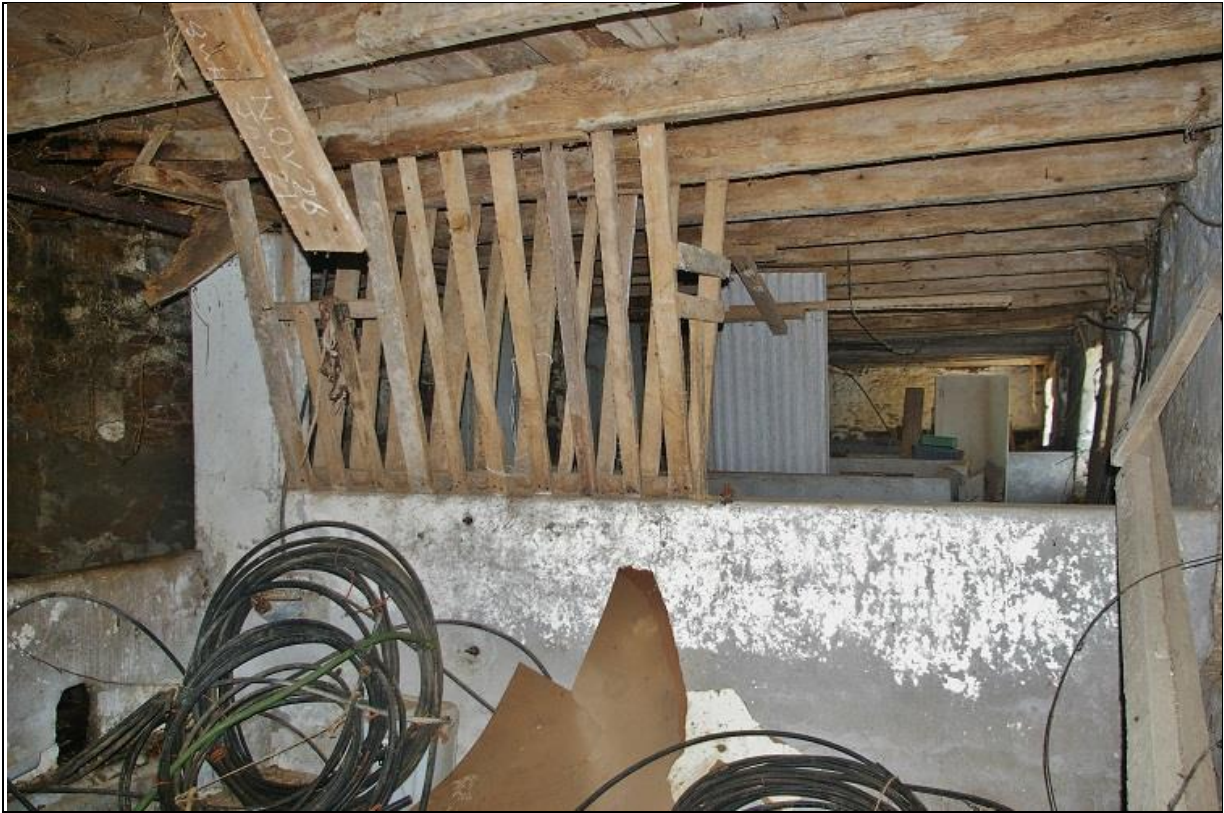
29. THE GROUND FLOOR INTERIOR OF BARN RANGE 2, BUILDING B, WITH MODERN CONCRETE PENS BREAKING UP THE SPACE; FROM THE SOUTH-EAST.

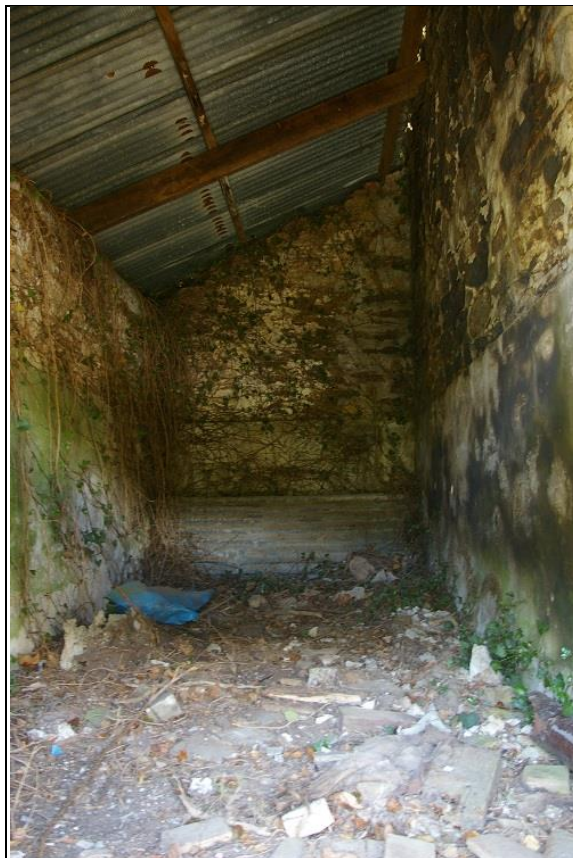
30. THE INTERIOR OF BUILDING A, BARN RANGE 2, A LEANTO BUILT ON THE END OF BUILDING B; FROM THE EAST.

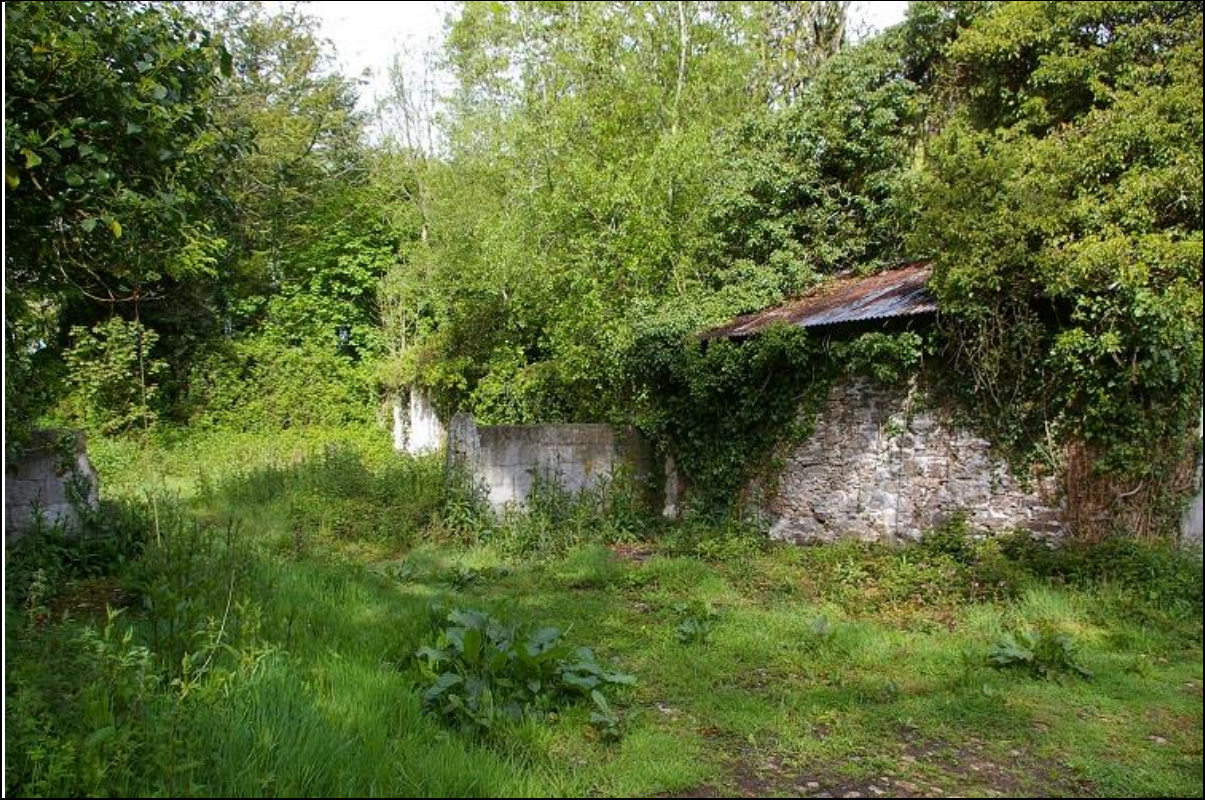
31. BUILDING A, BARN RANGE 2, WITH CONCRETE BLOCK WALL ENCLOSING THE FORMER MANSION HOUSE REAR COURTYARD; FROM THE SOUTH-EAST.

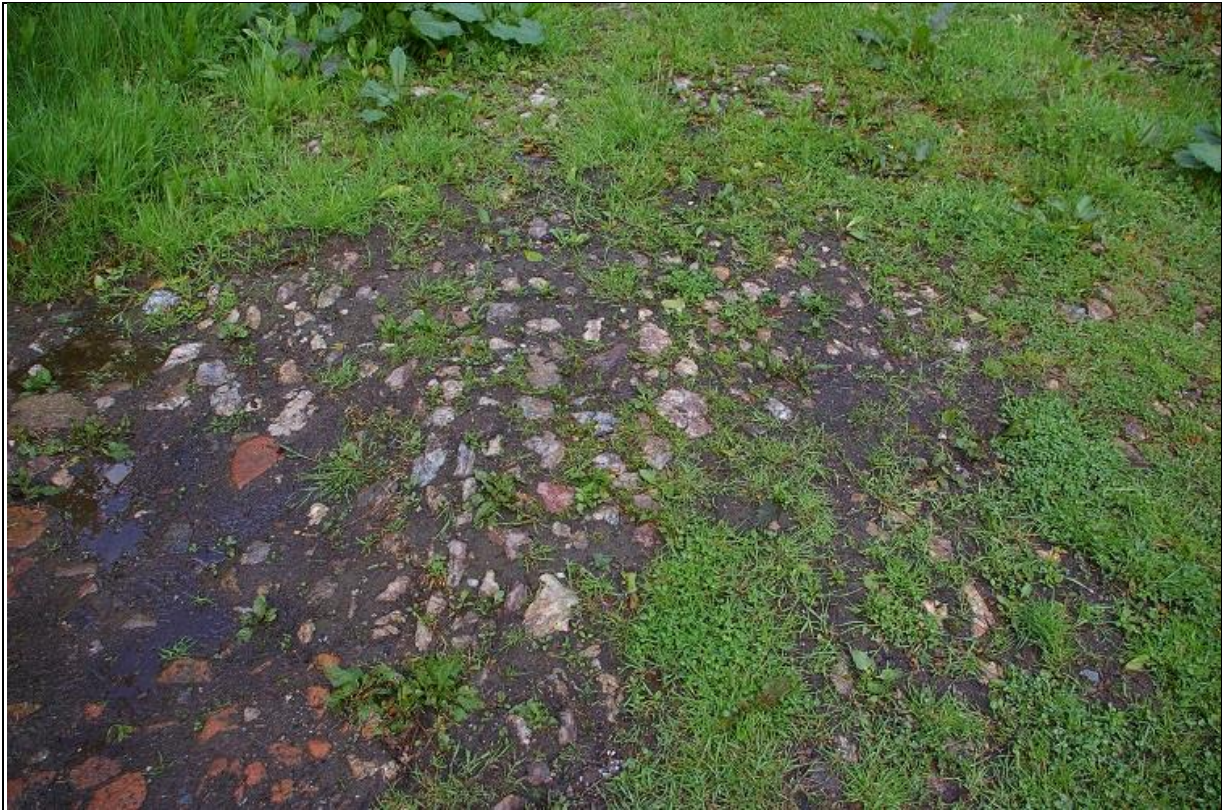
34. THE QUARTZ AND COBBLED YARD SURFACES SEEN IN THE EAST YARD AND SOUTH YARD.

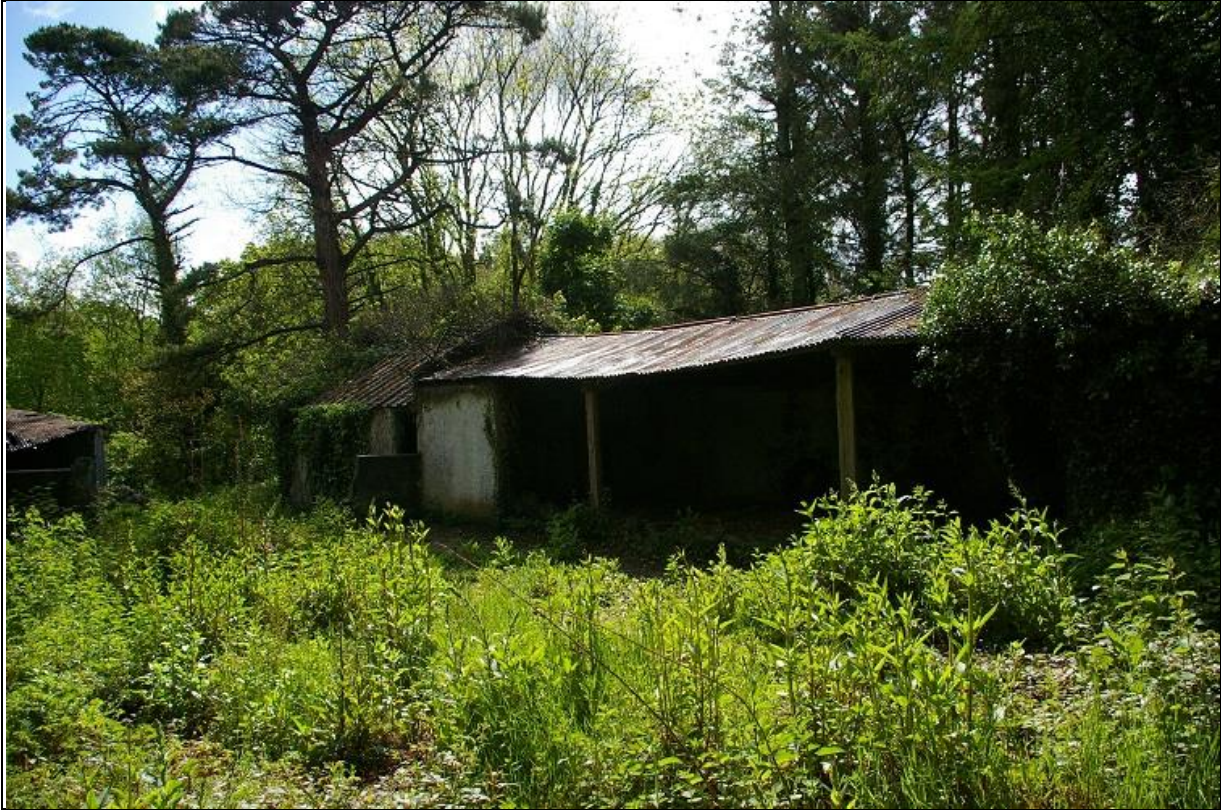
35. BARN RANGE 5, OPEN FRONTED LINHAY AND ANIMAL HOUSING, ON THE LINE OF THE VICTORIAN SERVICE BUILDINGS; FROM THE NORTH-WEST.

Behind the single storey barn range which is referred to in this report as barn range 5, low walls appear to indicate pig pens, or a range with small rooms, however other low walls and ruinous features looked to be visible above the dense foliage. This building sits on the line of the 19th century service outbuildings which are first documented on the 1880s mapping. The location of the actual manor house is just outside of the ownership boundary of the site but this area is of *High* archaeological potential and sensitive to development; careful clearance of the area is recommended first, as further assessment may need to be made on the impact and archaeological features associated with the lost mansion may be found.

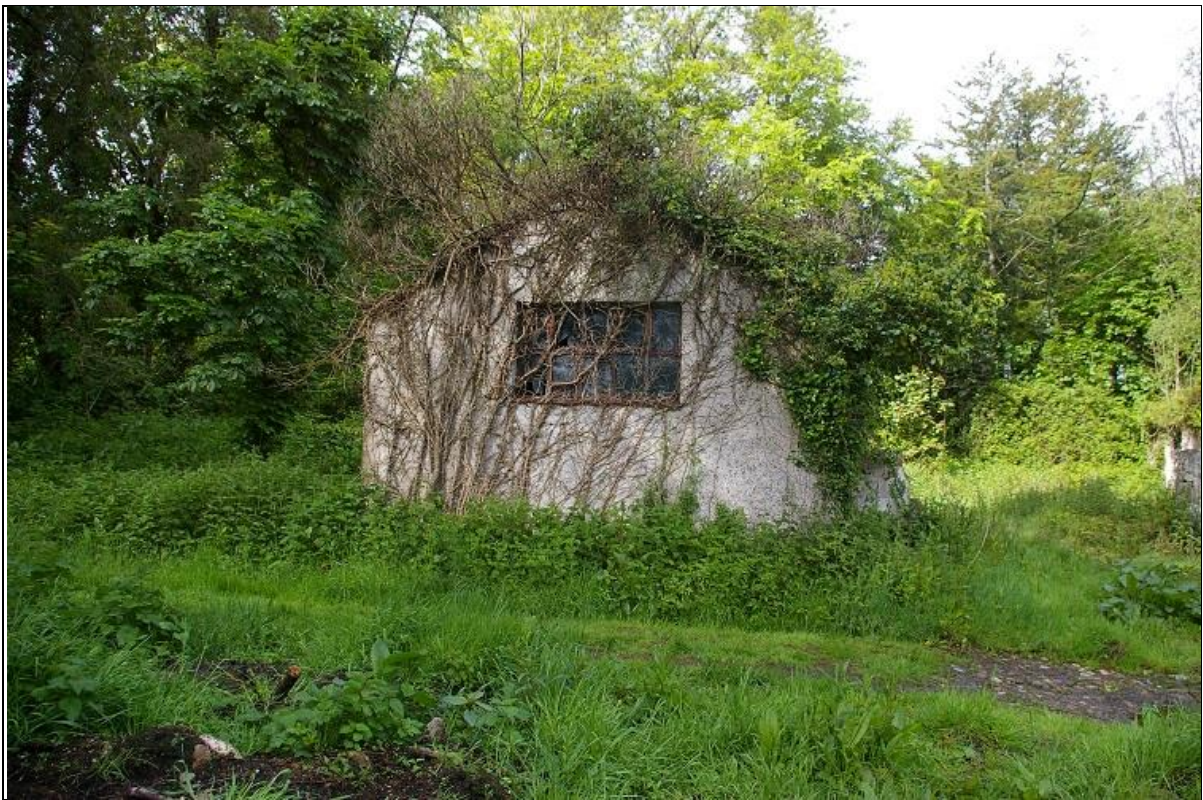
36. THE EAST END OF BUILDING RANGE 5, BUILDING B—AN ANIMAL HOUSE; FROM THE EAST.
