THE BARNs
CARWYTHENACK FARM
GWEEK
CORNWALL

Results of a Heritage Assessment

South West Archaeology Ltd. report no. 210702

By E. Wapshott
Report Version: FINAL
Draft Issued: 2nd July 2021
Report Finalised: 9th February 2022

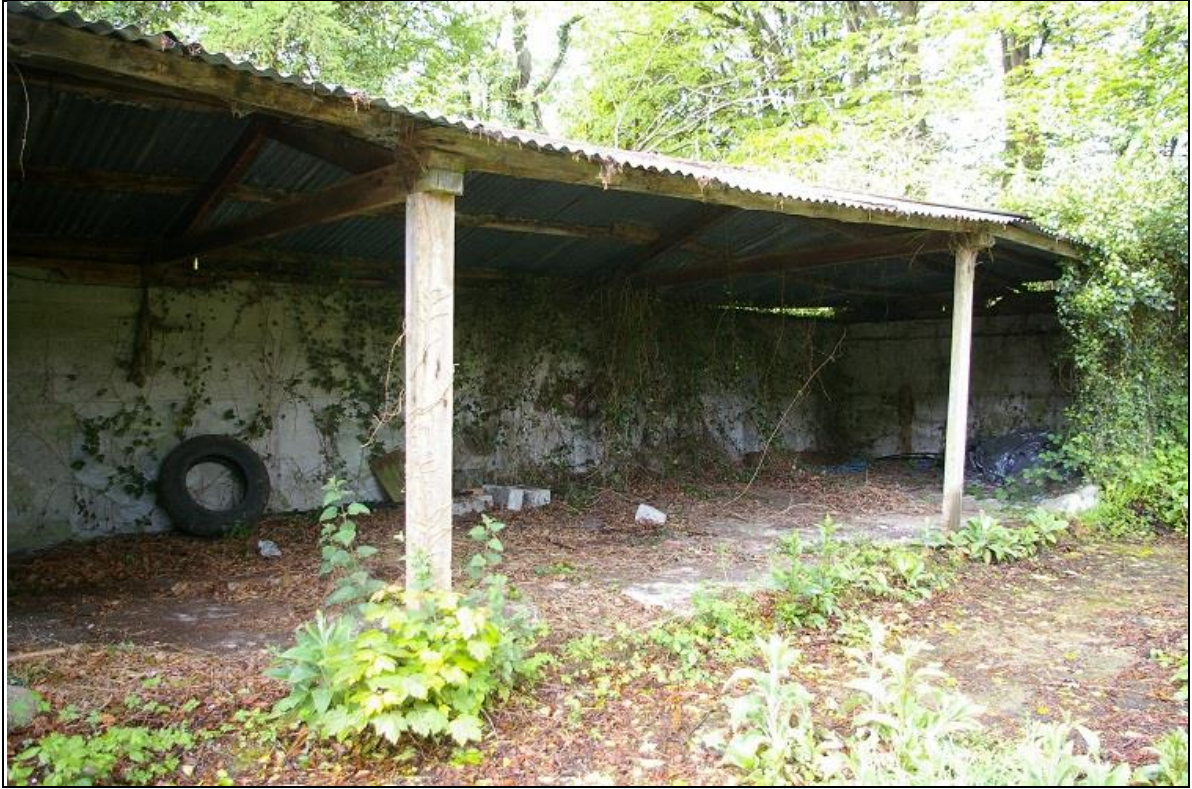
37. THE INTERIOR OF BUILDING A, BARN RANGE 5; FROM THE NORTH-EAST.

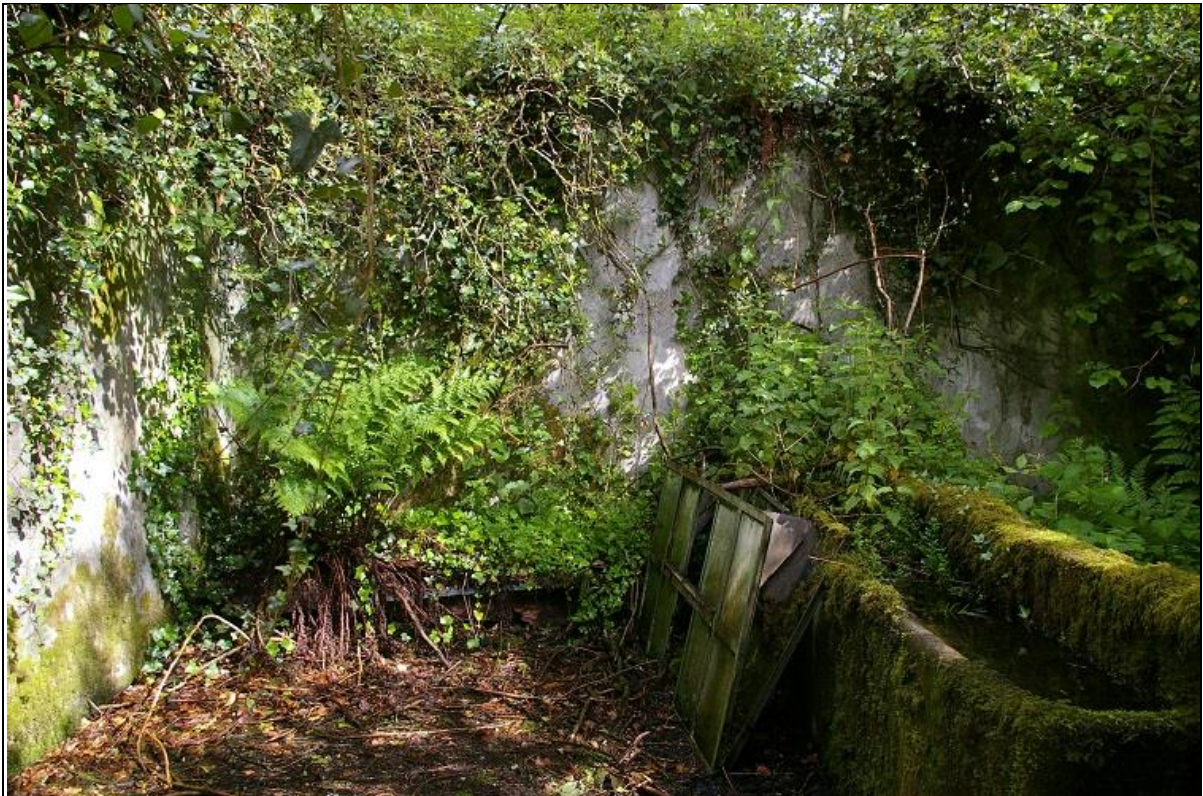
38. THE INTERIOR OF BUILDING A, BARN RANGE 1; FROM THE SOUTH.

Barn range 1 is of single storey height, to the south-west of the site. It is linear in form, on a rough east-west alignment, now of roofless ruined condition. It is formed of two historic gabled attached buildings, with a modern section of infill between it and Barn range 2 to the east, at a perpendicular angle. To the south this building faces onto the former 'domestic offices' courtyard behind the 18th century mansion house, the ground surface is of damaged quartz cobbling, with a raised concrete platform along the front of the building and a concrete block water trough; to the north it faces onto the yard, the ground level of which has been significantly raised. The modern wall coverings of cement render obscure vital details about this range which directly served the manor house and further recording after proper clearance and stripping of the render, of at least the interiors, would be able to inform on the mansion-house site.

party wall and there are metal and concrete feeder troughs to the north wall. All internal walls are cement rendered, with the east west and north walls appearing to be blind. The granite lintels used over the doorways have pintle holes indicating they have been recycled here, there is evidence of facing and rustication so these may have been recycled from either previous of the lost high-status houses.

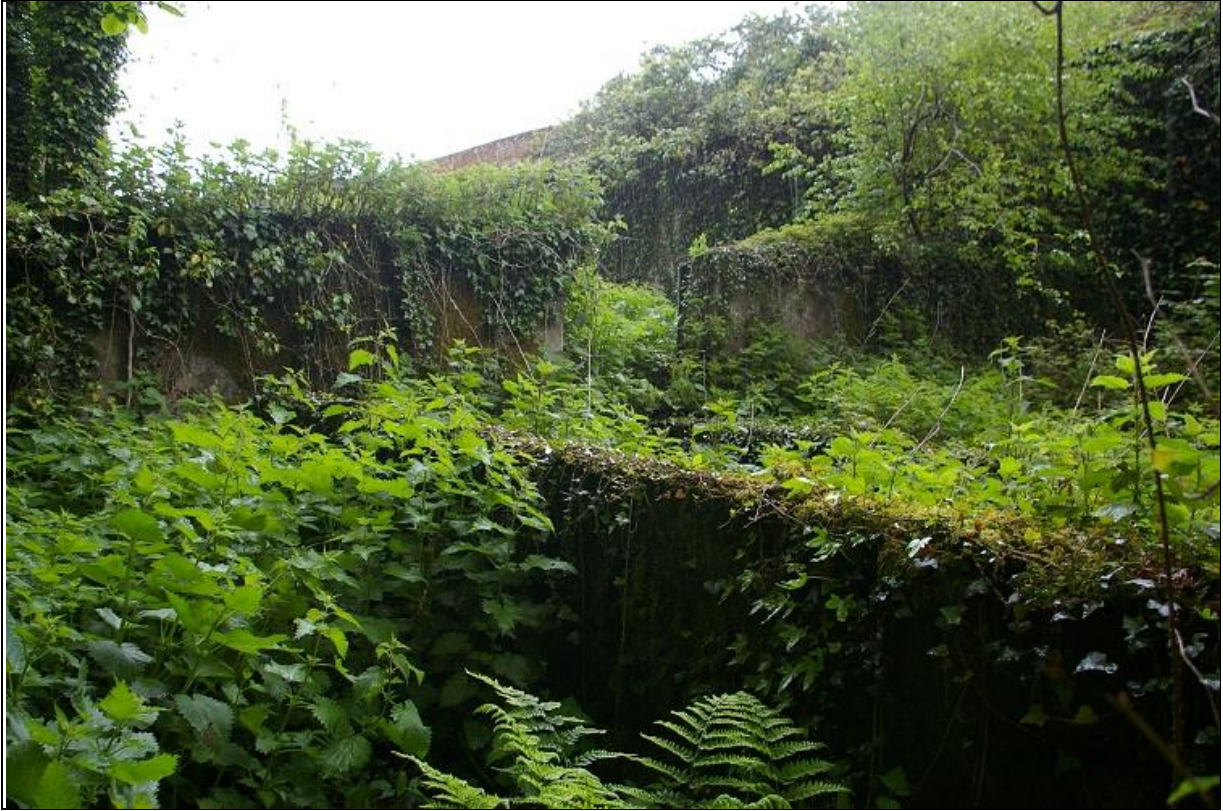
39. THE OVERGROWN INTERIOR OF BUILDING B BARN RANGE 1, SHOWING BLOCKED WINDOWS AND DOORS TO THE FORMER REAR YARD AND MODERN ANIMAL PENS; FROM THE SOUTH-WEST.

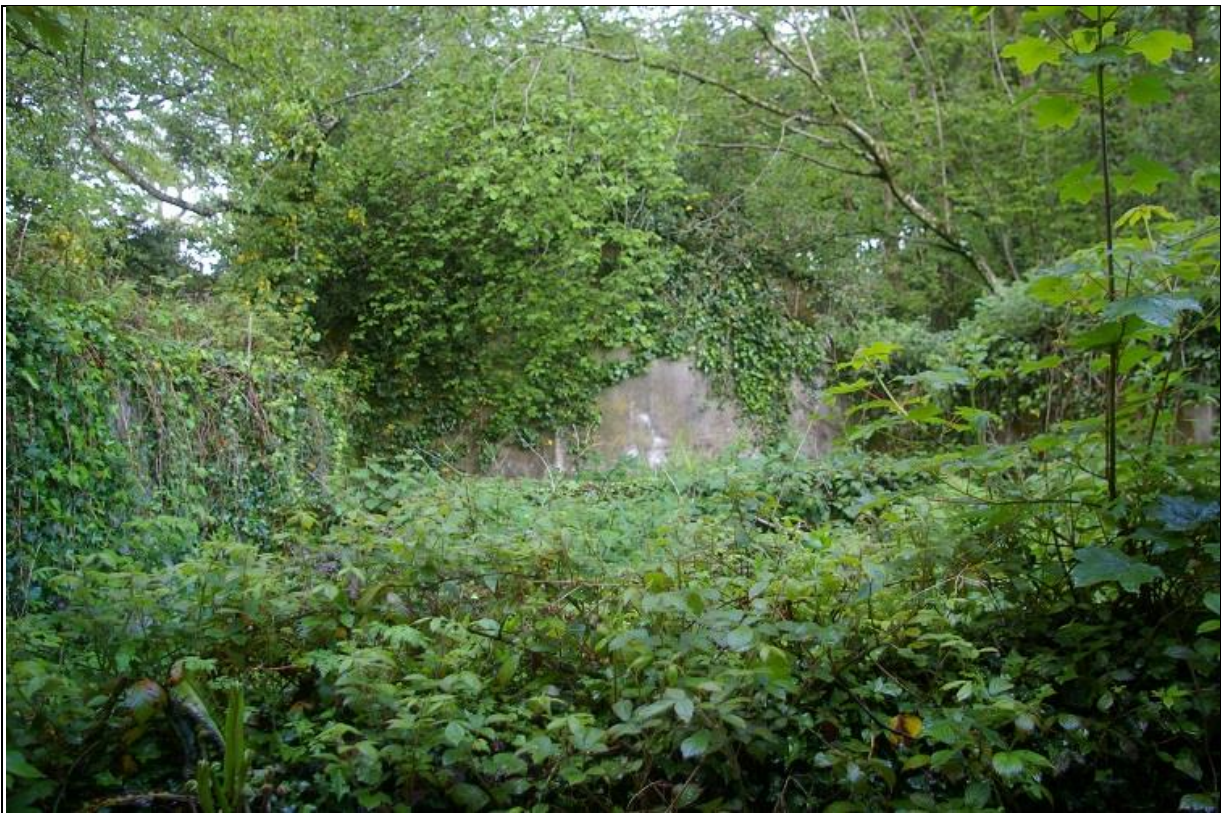
40. LOOKING THROUGH BUILDING B, BARN RANGE 1 TO THE RAISED GABLE BETWEEN TO BUILDING A; FROM THE EAST.

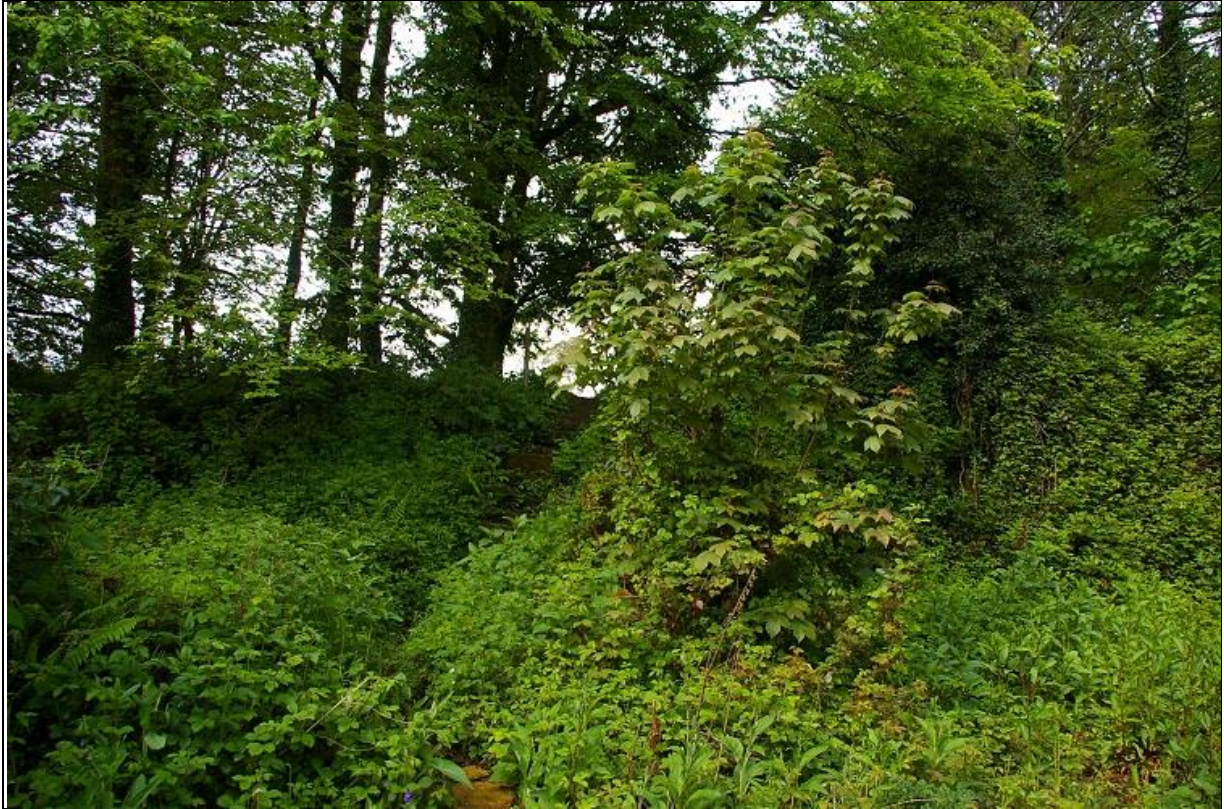
41. STEPS UP TO THE FORMAL GARDEN, WITH OVERGROWN HEDGEROW TREES ON A STONE-FACED BANK, ALSO SHOWING THE WALL AND FORMER POTTING SHED OR POSSIBLY EVEN GARDEN STRUCTURE OF THE KITCHEN GARDEN TO THE RIGHT HAND SIDE; FROM THE EAST.

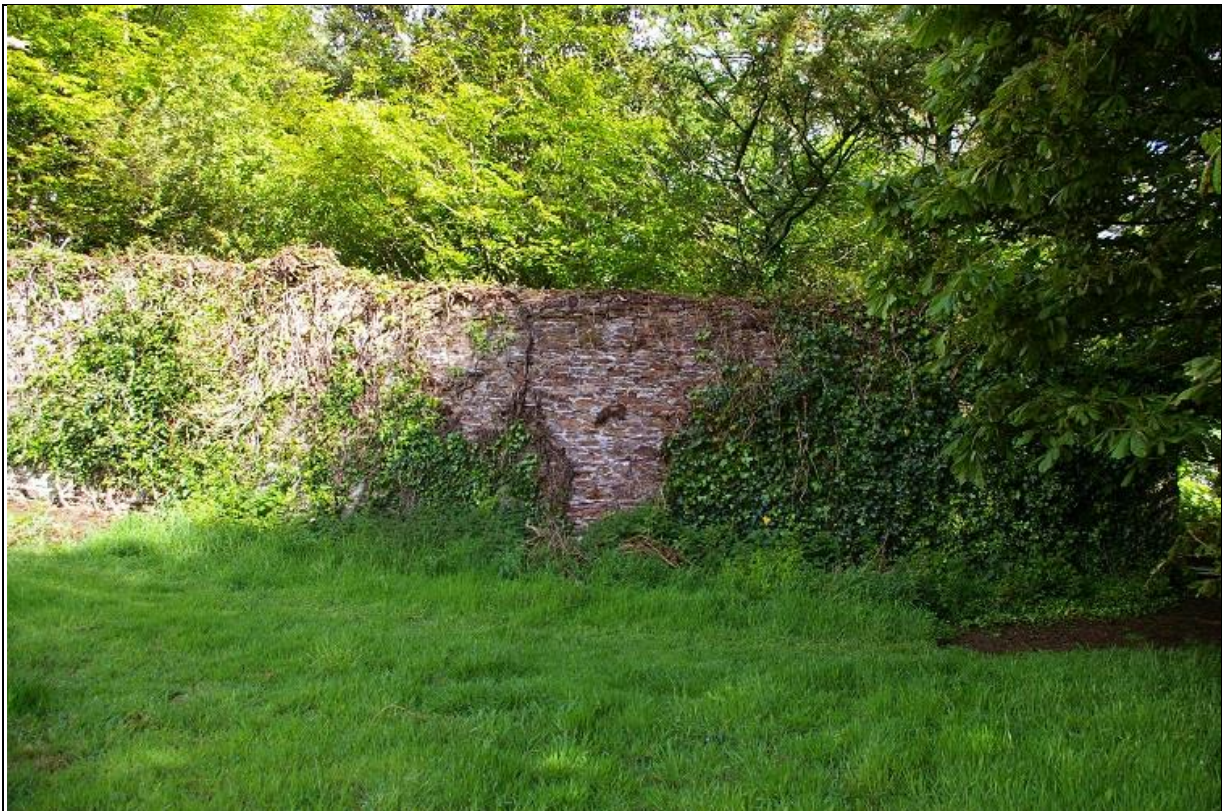
42. THE LISTED FORMER GARDEN WALLS; WEST OF THE BARNs; FROM THE SOUTH.
