TREWITHEN ESTATE REGISTERED PARK AND GARDEN PROBUS CORNWALL

Archaeological and Historic Landscape Survey

South West Archaeology Ltd. Report no.210524

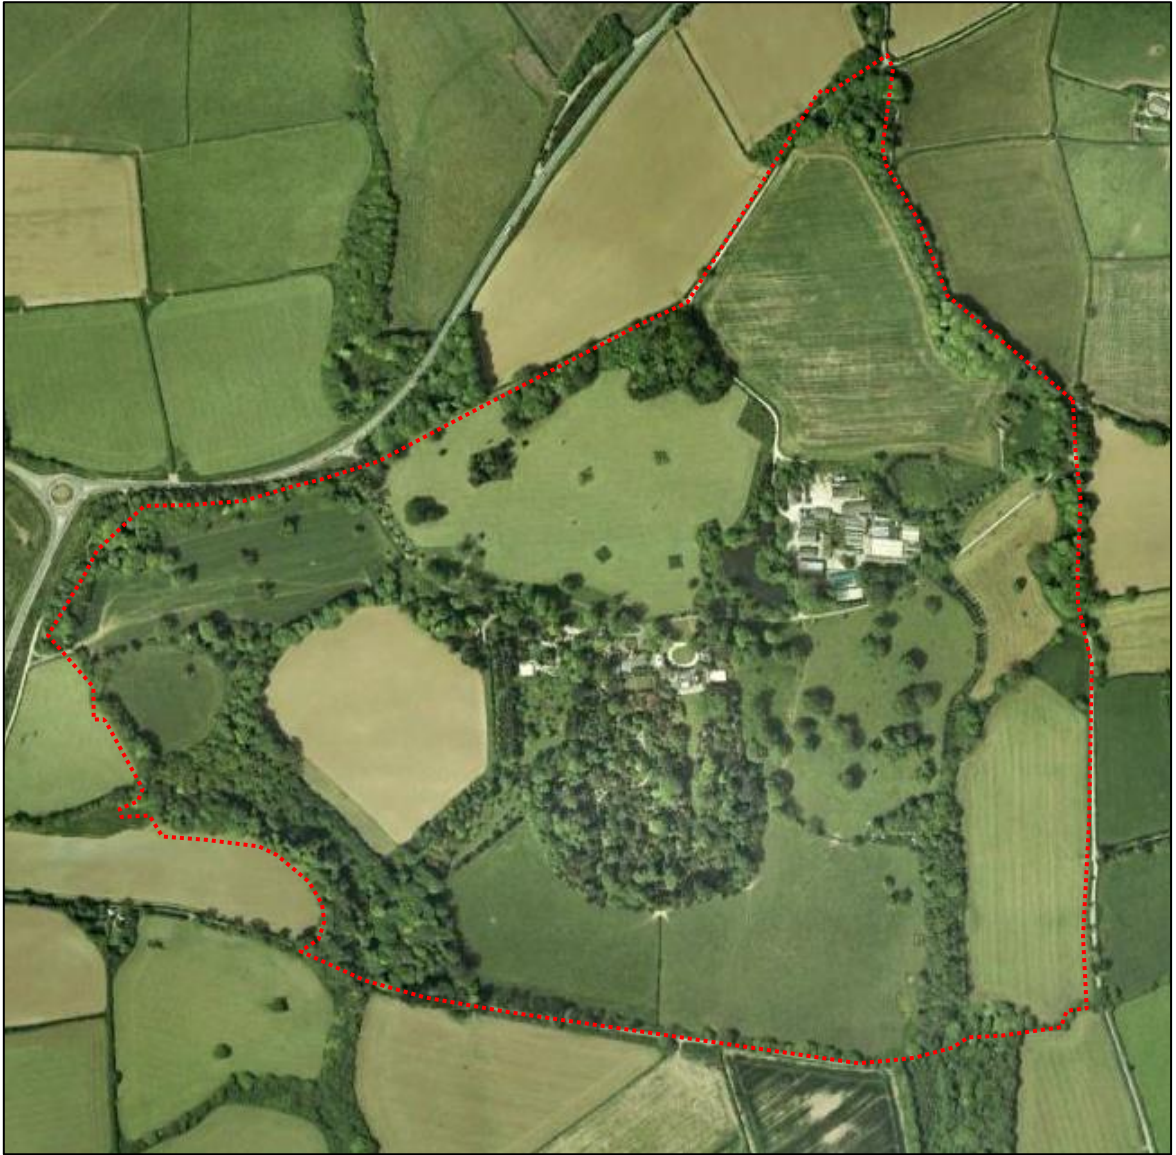
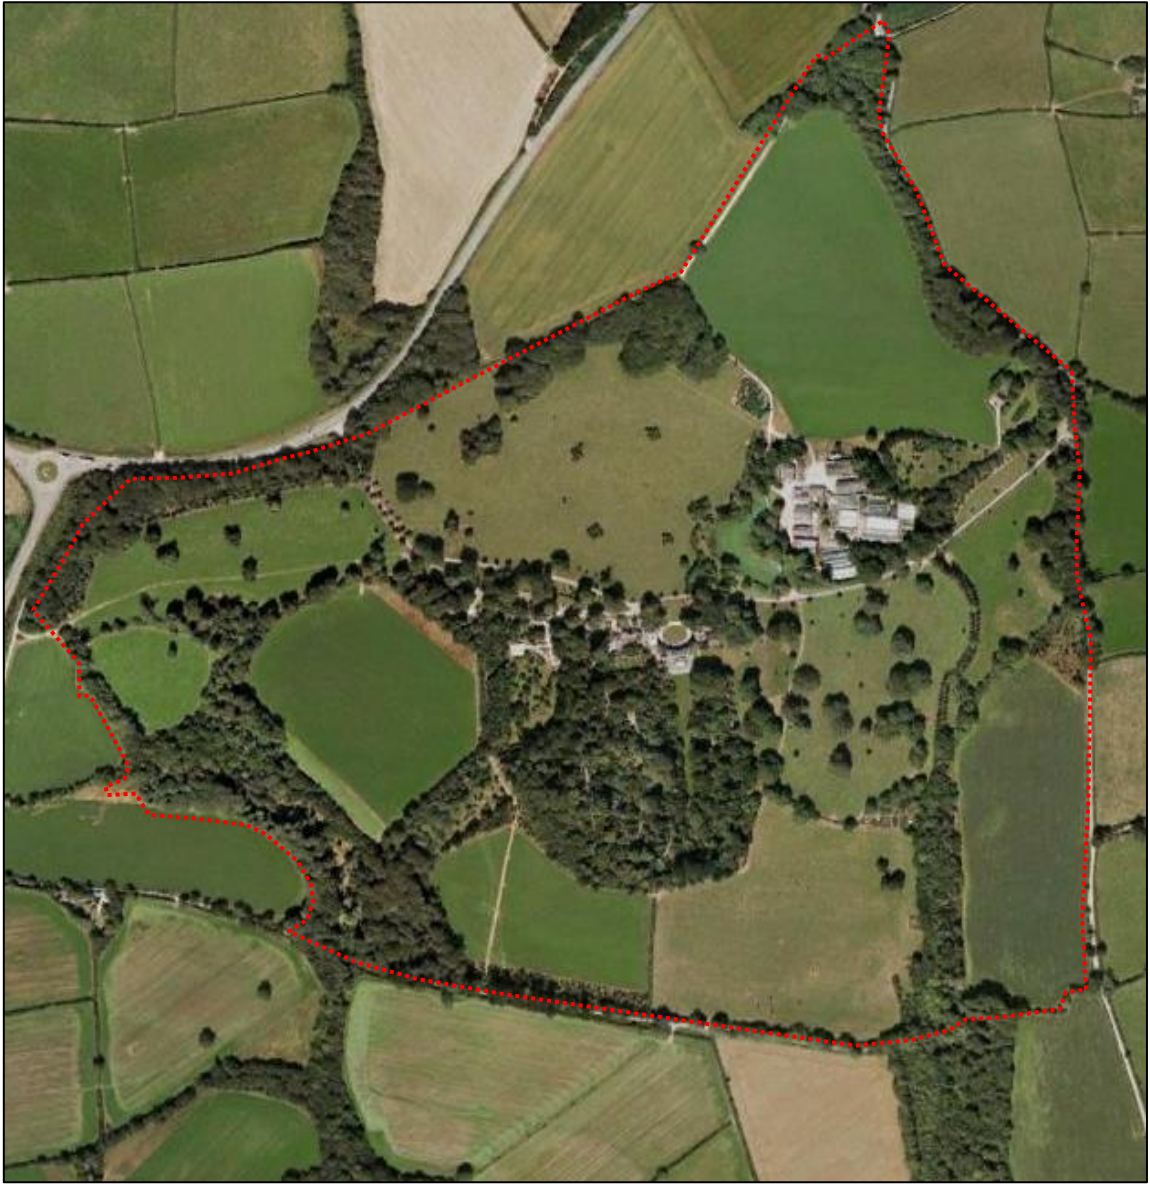
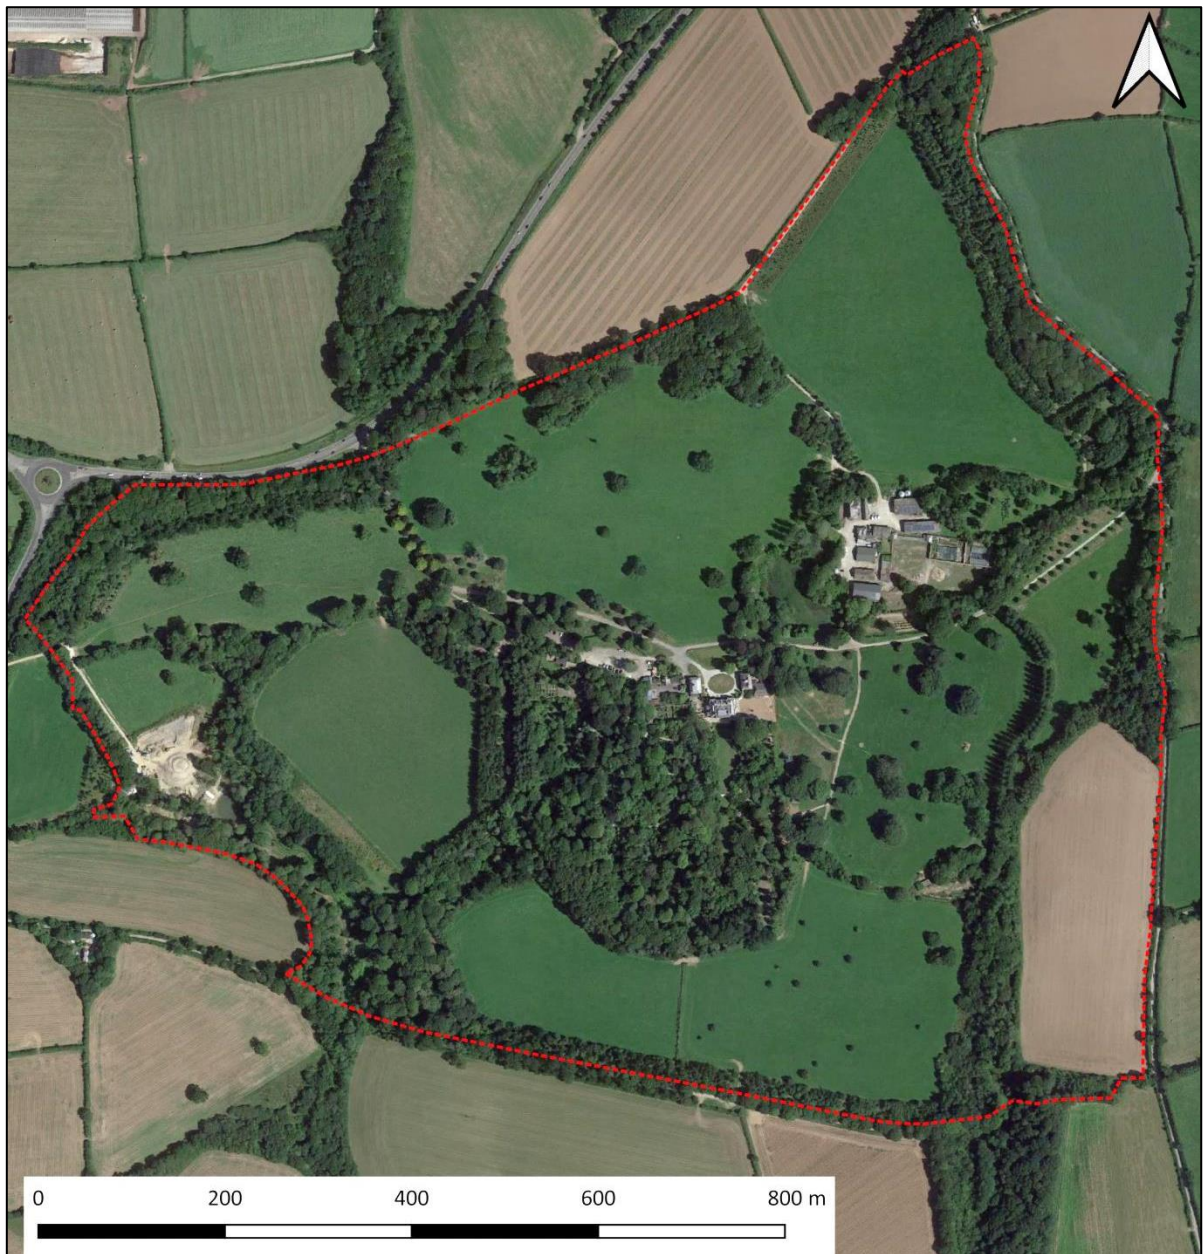
Aerial photography of the survey area (Figures 19-21) is limited in its identification of archaeological features due to the large amount of woodland cover. Imagery of the enclosed fields shows that some of this area has been ploughed within the recent past. Modern ploughing, if intensive/deep is likely to have removed any archaeological features with the possible exception of substantial earthworks. The aerial photograph from 2001 shows numerous trackways across the north western field (Menagwidden) within the parkland. The 2005 photograph appears to show two strips with vegetation removed/different vegetation, one on the north east and the other on the south west of the field named Great Downs at the Tithe survey. A line of disturbed ground running south from this is evident, perhaps indicating the insertion of a pipeline or drain.

FIGURE 19: 2001 AERIAL PHOTOGRAPH WITH THE SURVEY AREA OUTLINED IN RED. © 2021 INFOTERRA LTD AND BLUESKY.

FIGURE 20: 2005 AERIAL PHOTOGRAPH WITH THE SURVEY AREA OUTLINED IN RED. © 2021 GETMAPPING PLC

FIGURE 21: MODERN AERIAL PHOTOGRAPH WITH THE SURVEY AREA OUTLINED IN RED. © GOOGLE 2021

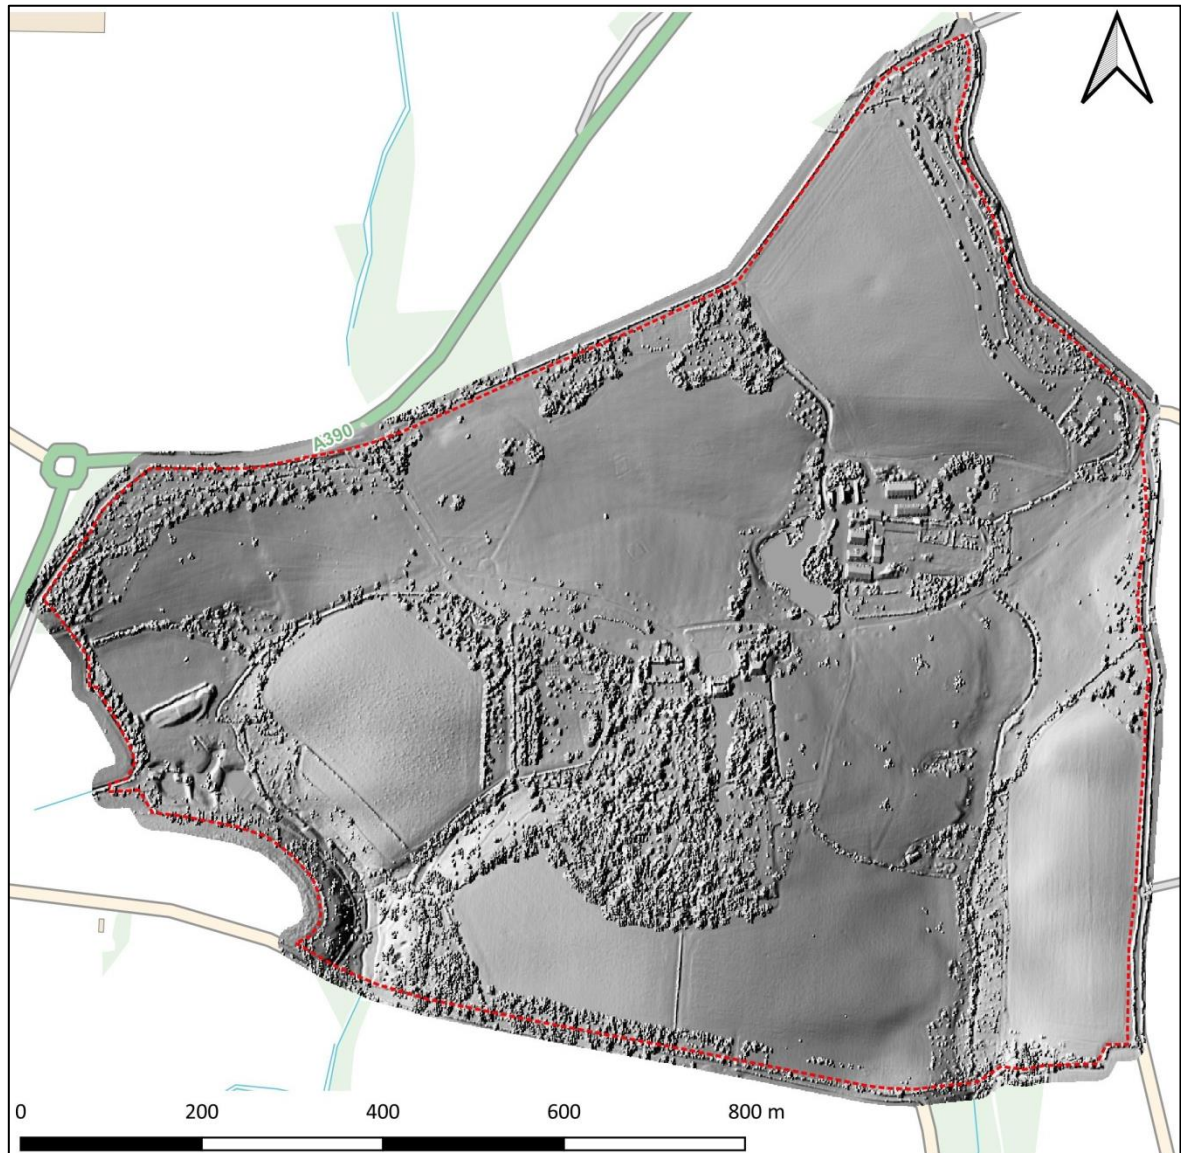
Figure 22 shows LiDAR data of the survey area with the vegetation cover apparent. Figure 23 shows the survey area with the vegetation cover digitally 'removed'.

FIGURE 22: 2019 COMPOSITE 1M DSM LIDAR DATA PROCESSED WITH RVT 2.2.1 MULTIHILLSHADE D315_H35_Z2 AND QGIS 3.14. © ENVIRONMENT AGENCY COPYRIGHT AND/OR DATABASE RIGHT 2015. ALL RIGHTS RESERVED. © CROWN COPYRIGHT AND DATABASE RIGHTS 2021.

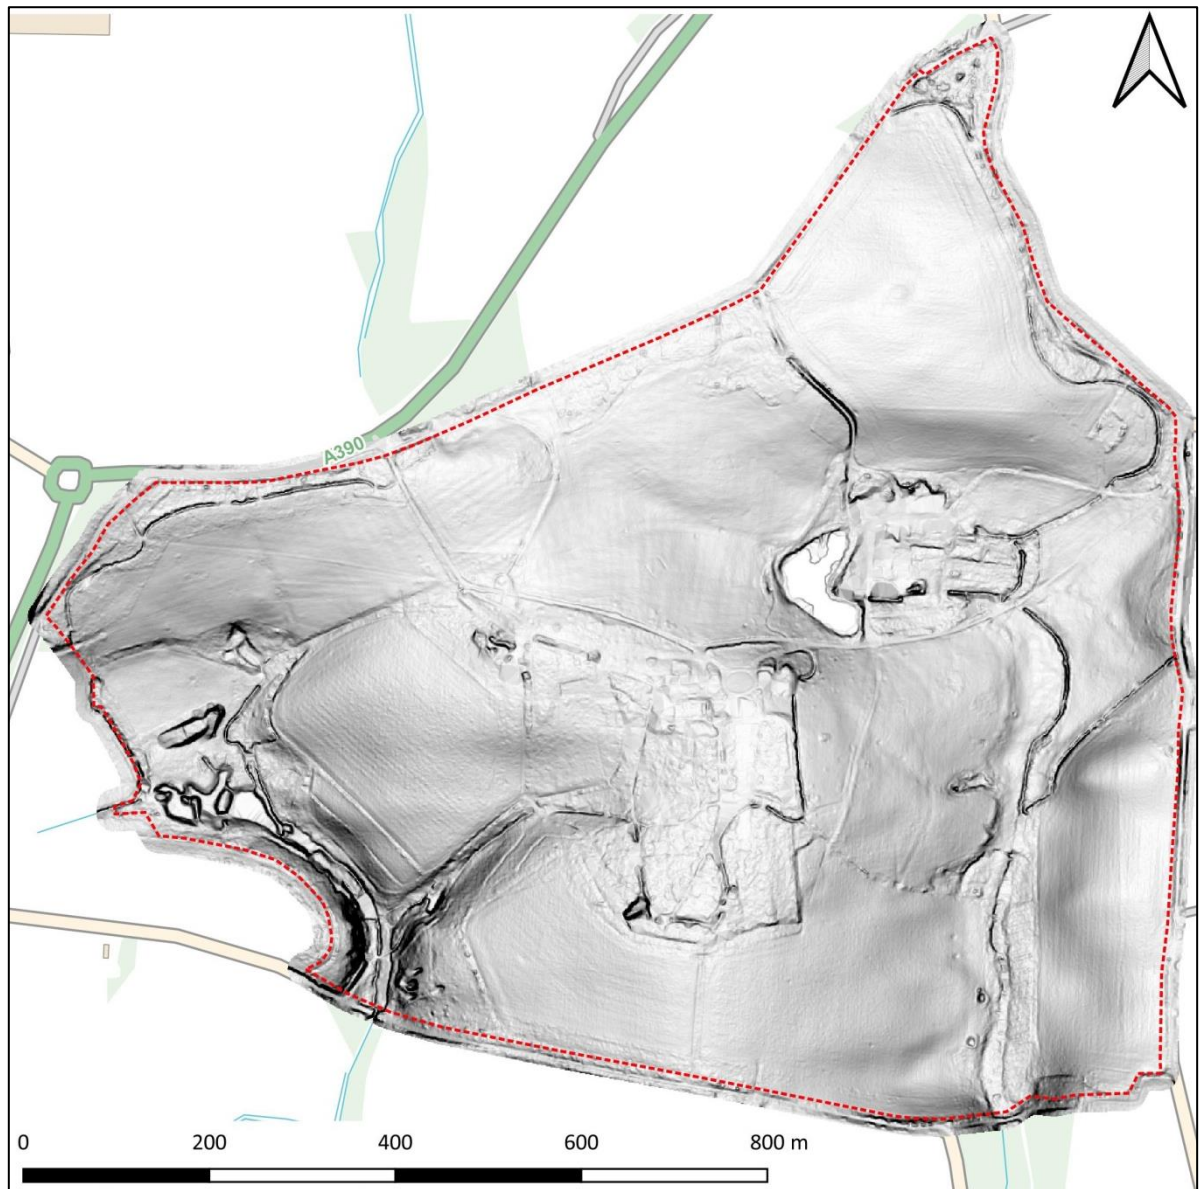
Figure 24 shows LiDAR data of the survey area with the vegetation cover apparent. Figure 25 shows the survey area with the vegetation cover digitally 'removed'

FIGURE 25: 2019 COMPOSITE 1M DTM LIDAR DATA PROCESSED WITH QGIS 3.14 SLOPE Z2. © ENVIRONMENT AGENCY COPYRIGHT AND/OR DATABASE RIGHT 2015. ALL RIGHTS RESERVED. © CROWN COPYRIGHT AND DATABASE RIGHTS 2021.

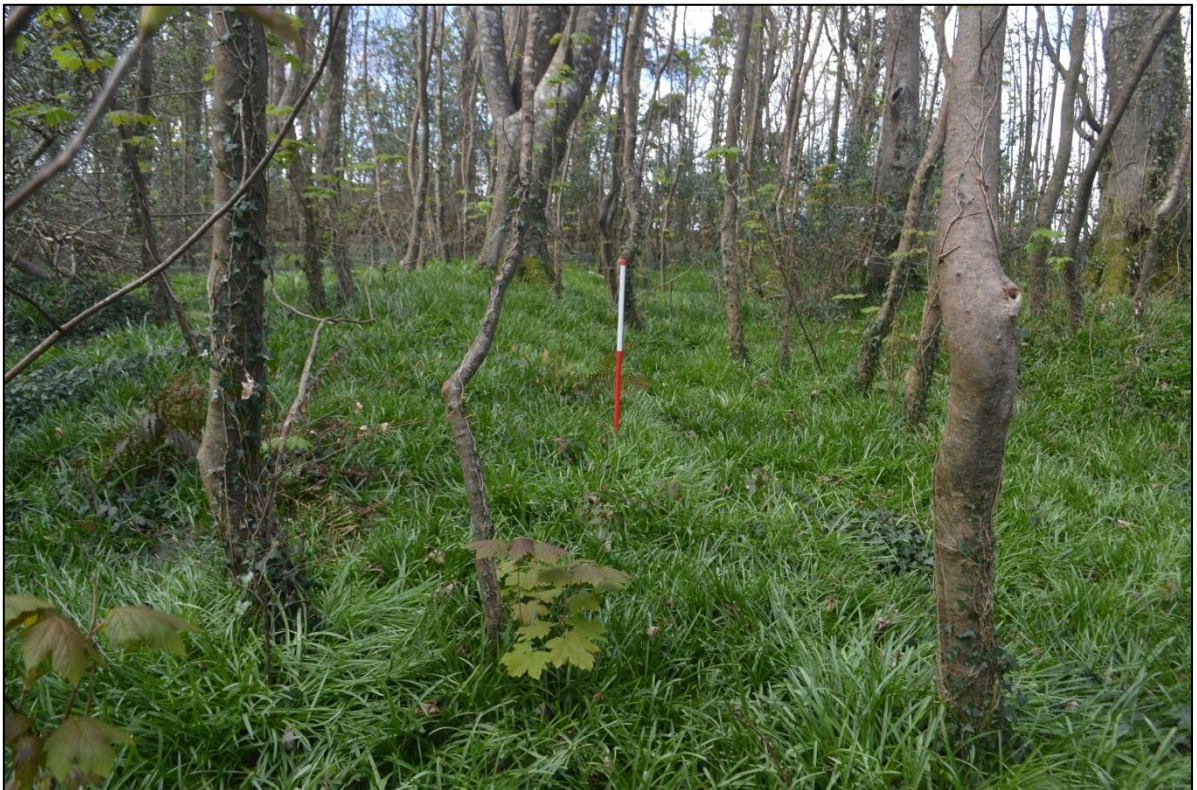
A gully c. 2m wide x 1m deep with slight bank on the western side is located in the north western corner of woodland in Menagwidden. The dense ground vegetation in this area of the woodland makes determining its precise form difficult but it may be part of a disused entrance into the adjacent field.

FIGURE 27: BANK AND GULLEY IN THE NORTH WEST OF MENAGWIDDEN; FROM THE SOUTH

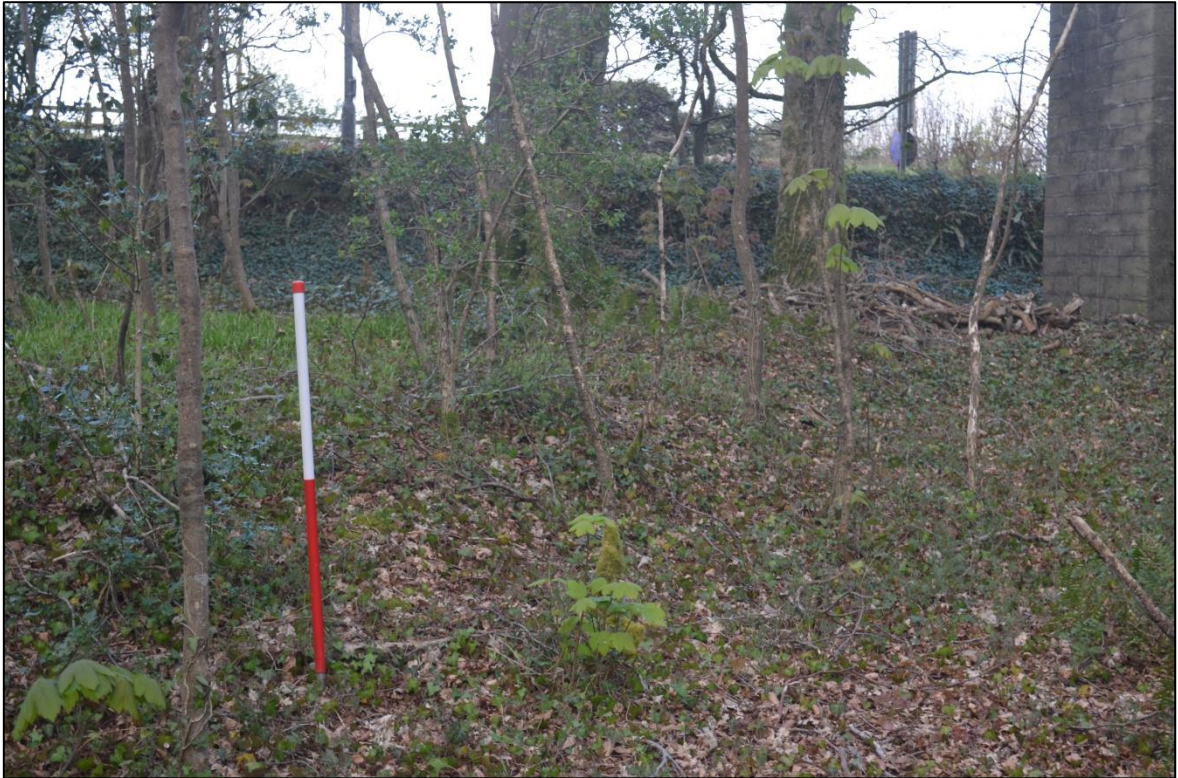
2. Slight scarp possibly representing a historic boundary or pathway

A slight scarp is visible to the south west of a number of block built pillars in woodland in the north west of Menagwidden. It runs south west diagonally from the pillars toward the pathway through the woodland. This feature may be related to the use or construction of the block built pillars just to the north.

FIGURE 28: SLIGHT SCARP POSSIBLY REPRESENTING A HISTORIC BOUNDARY OR PATHWAY EVIDENT TO THE SOUTH WEST OF A NUMBER OF BLOCK BUILT PILLARS IN A WOODED AREA OF MENAGWIDDEN, CLOSE TO THE A390. FROM THE SOUTH

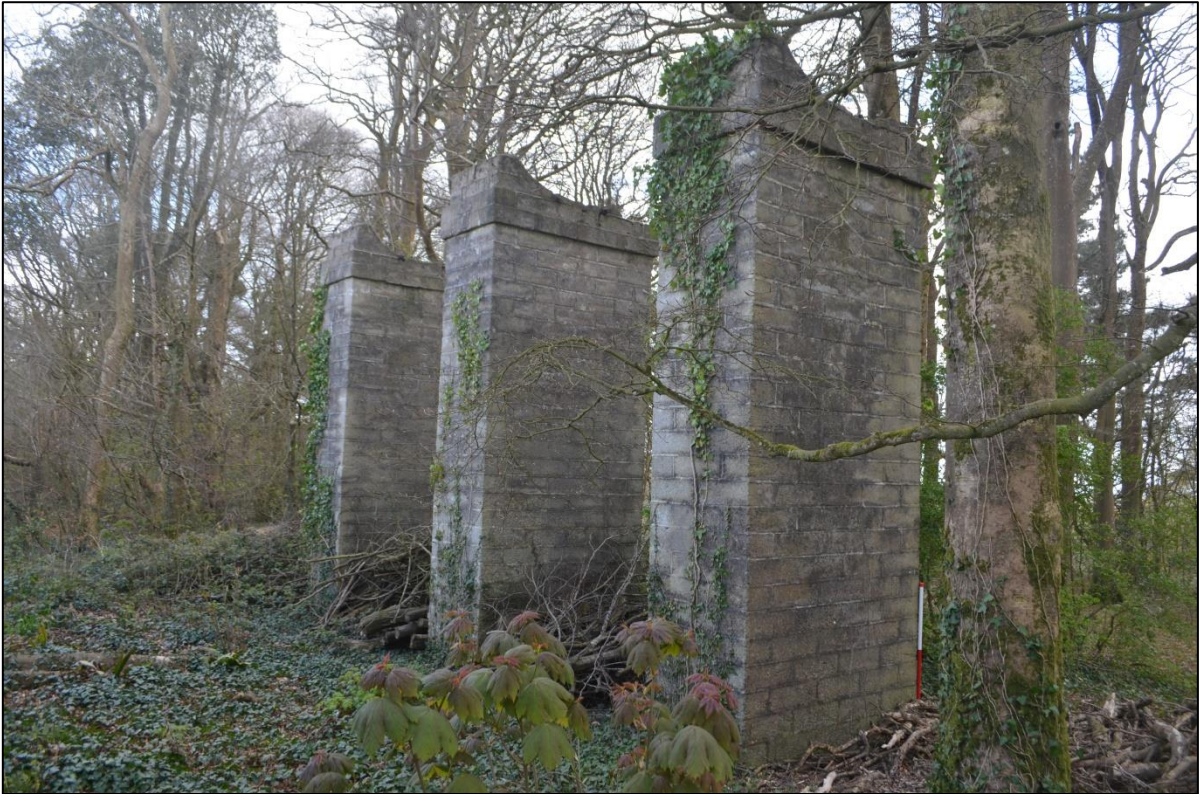
Three pillars constructed of mortared blocks were identified in woodland along the northern boundary of Menagwidden adjacent to the A390. The pillars are c. 2m x 1m x 5m tall with c.2m between each pillar. They are oriented north-south. Each pillar has a semi-circular curved top, which appears to be broken, with evidence of iron fixings protruding from the top. The Estate Manager confirmed that these were constructed to hold a water tank fed from a pump house located within the woods which has since been removed. No clear evidence for this pump house was identified during the walkover which suggests it was either totally removed or any slight traces of its location are hidden by ground vegetation. It is believed the tank was removed c.1970s when the estate was connected to mains water supply.

FIGURE 29: THREE MORTARED BLOCK PILLARS CONSTRUCTED IN WOODLAND IN THE NORTH WEST OF MENAGWIDDEN; FROM THE SOUTH EAST

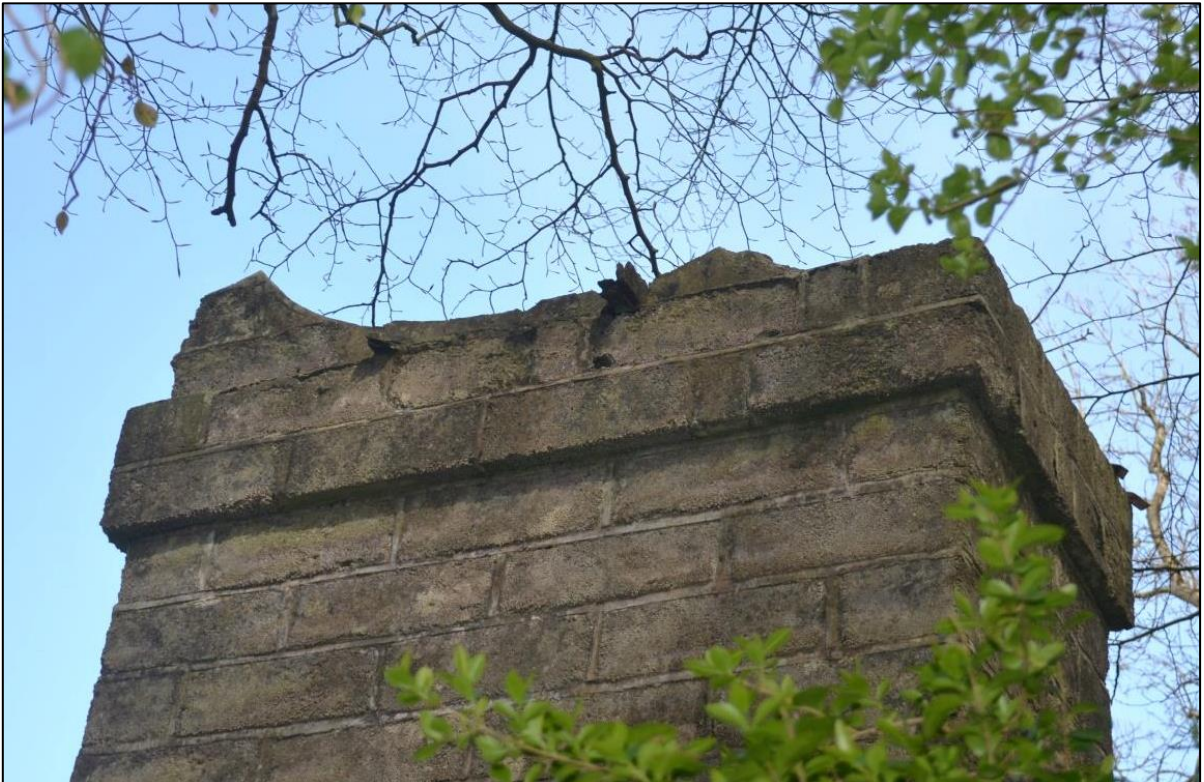
FIGURE 30: DETAIL OF THE SEMI-CIRCULAR TOP TO ONE OF THE PILLARS, NOW BROKEN, WITH EVIDENCE OF IRON FIXINGS. FROM THE SOUTH WEST

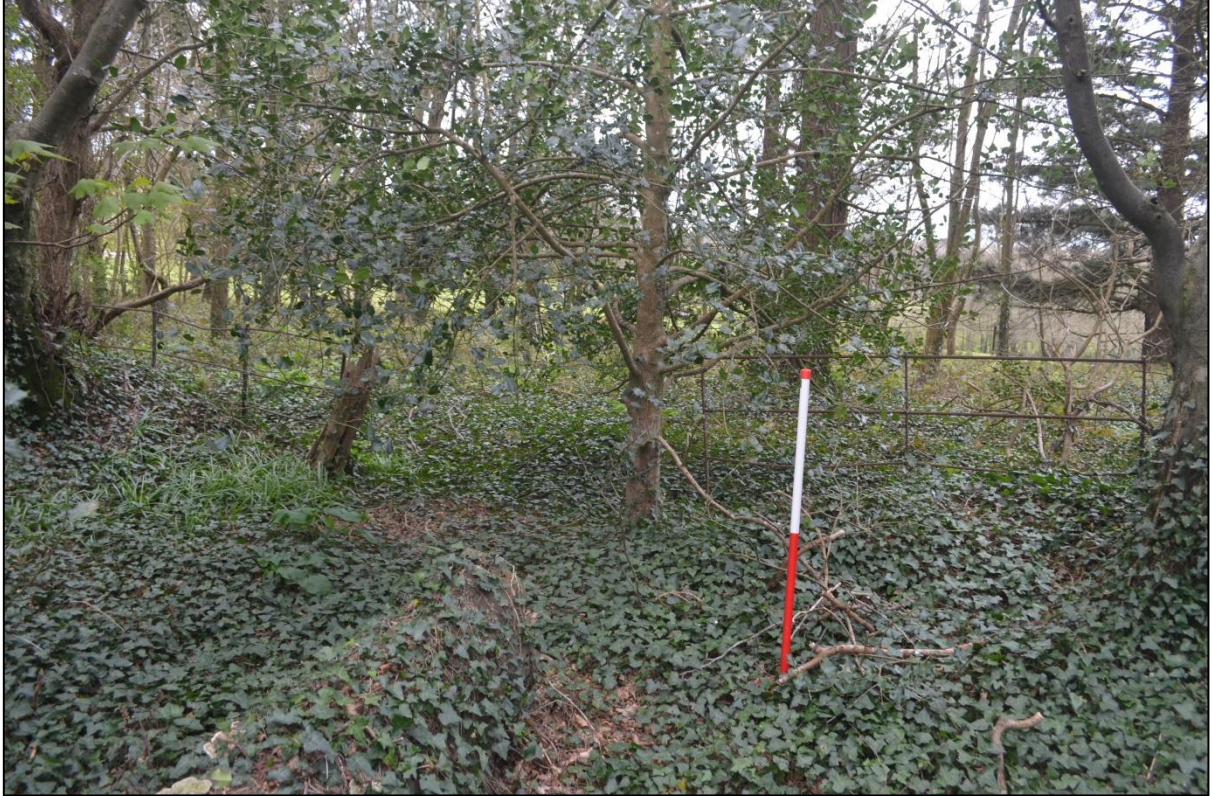
A gap in the ha-ha/corn ditch boundary in this area is either a deliberate construction or has been filled in this area. The boundary lies within woodland in the north western area of Menagwidden. Iron estate fence panels were visible on both sides of the infilled area, suggesting a possible former gateway.

FIGURE 31: A BREAK IN THE HA-HA/CORN DITCH BOUNDARY IS MARKED EITHER SIDE BY IRON ESTATE FENCE PANELS SUGGESTING A POSSIBLE FORMER GATEWAY. FROM THE NORTH

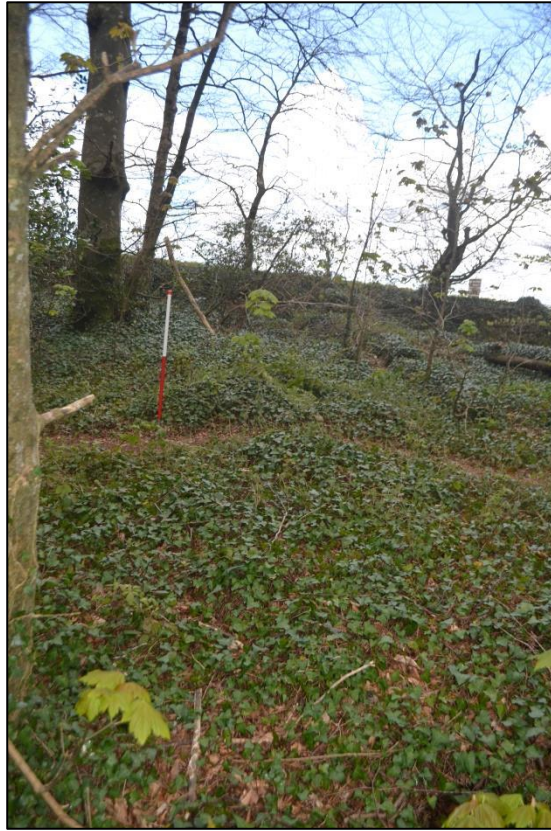
5. Possible former field boundary in woodland in the north west of Menagwidden

A slight linear was evident running north-south through woodland close to the northern boundary of the Registered Park and Garden in the north western area of Menagwidden. No boundaries are shown on historic maps in this location.

FIGURE 32: A SLIGHT LINEAR WAS OBSERVED RUNNING NORTH-SOUTH IN WOODLAND CLOSE TO THE NORTHERN BOUNDARY OF THE REGISTERED PARK AND GARDEN AT TREWITHEN. FROM THE SOUTH

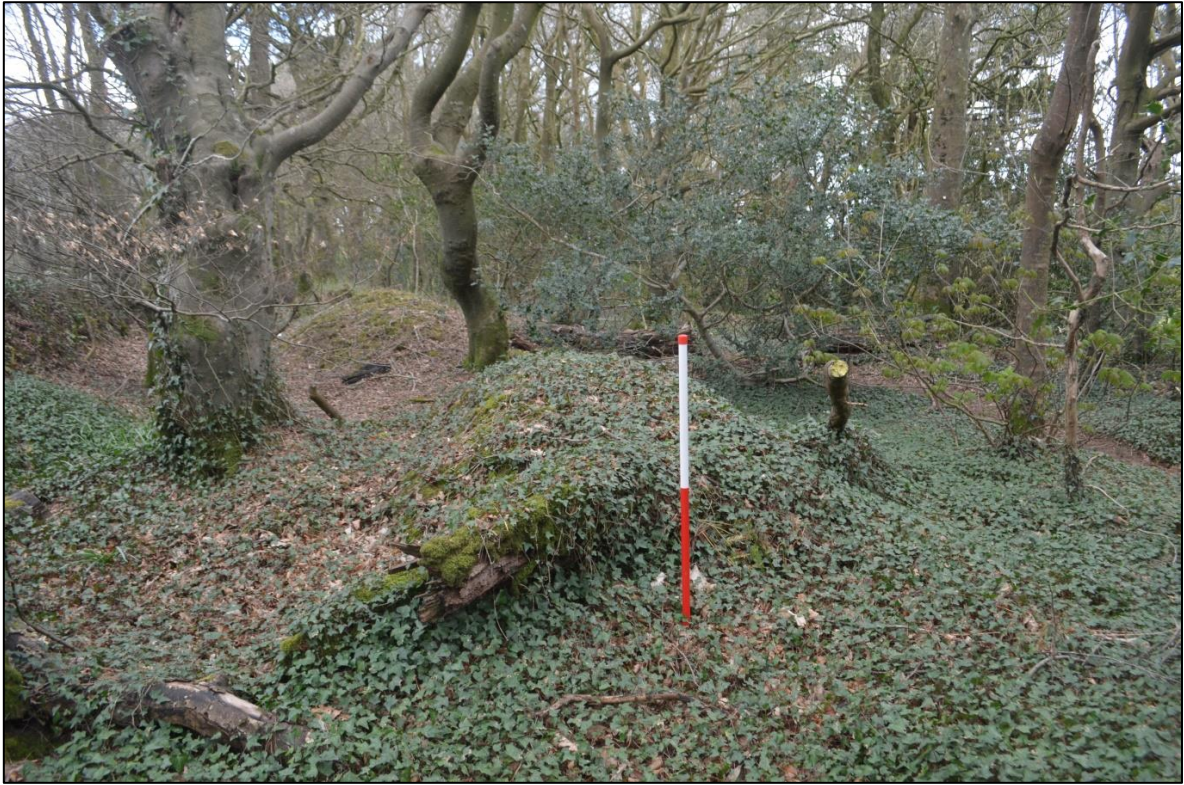
Two mounds or short sections of bank were noted to the south of the boundary which forms the northern extent of the Trewithen Registered Park and Garden. One measures approx. 1m x 3m x 2m and a more circular mound measures c. 3m in diameter. An animal burrow was noted on the south side of this mound. It is unclear whether these are of archaeological origin or could be the result of extensive historic animal burrowing.

FIGURE 33: TWO SECTIONS OF BANK OR MOUNDS IN WOODLAND IN THE NORTH OF MENAGWIDDEN. FROM THE WEST

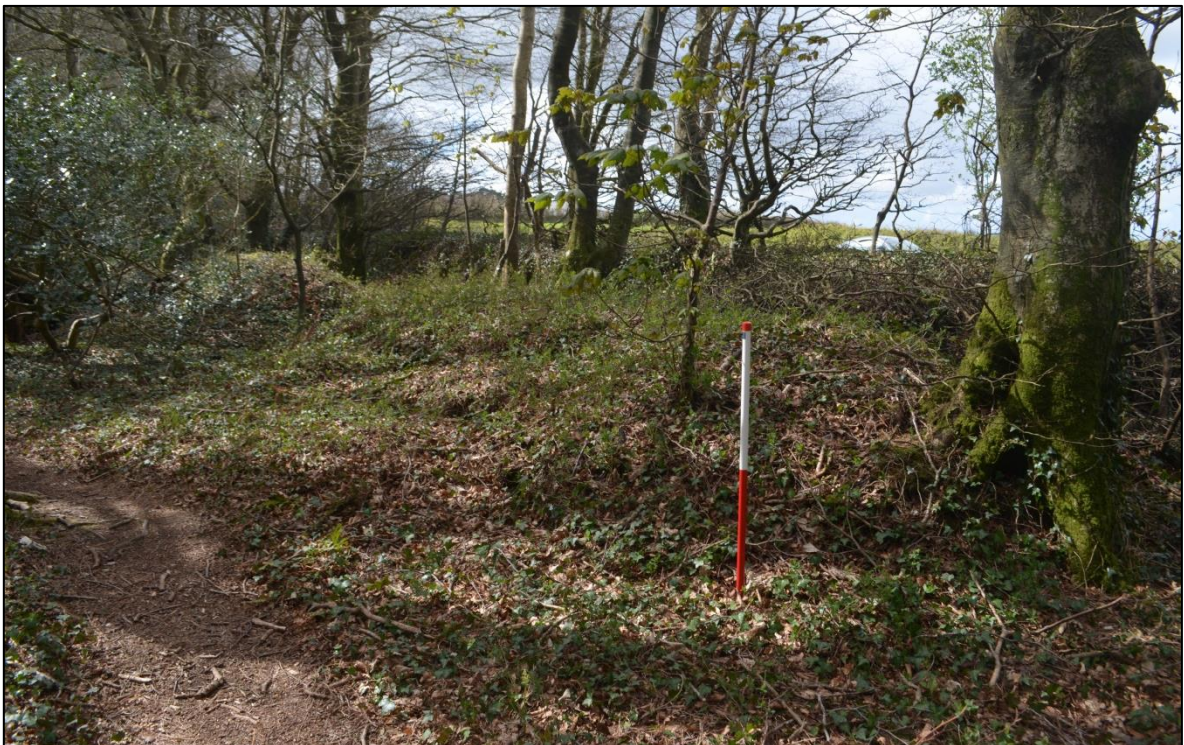
Two short sections of possible bank or mounds located south of Registered Park and Garden boundary in the north of Menagwidden. Approximately 1m high x 6m long x 2m wide. These could potentially be the result of extensive historic animal burrowing.

FIGURE 34: TWO SHORT SECTIONS OF MOUND OR BANK IN THE NORTH OF MENAGWIDDEN. FROM THE SOUTH EAST

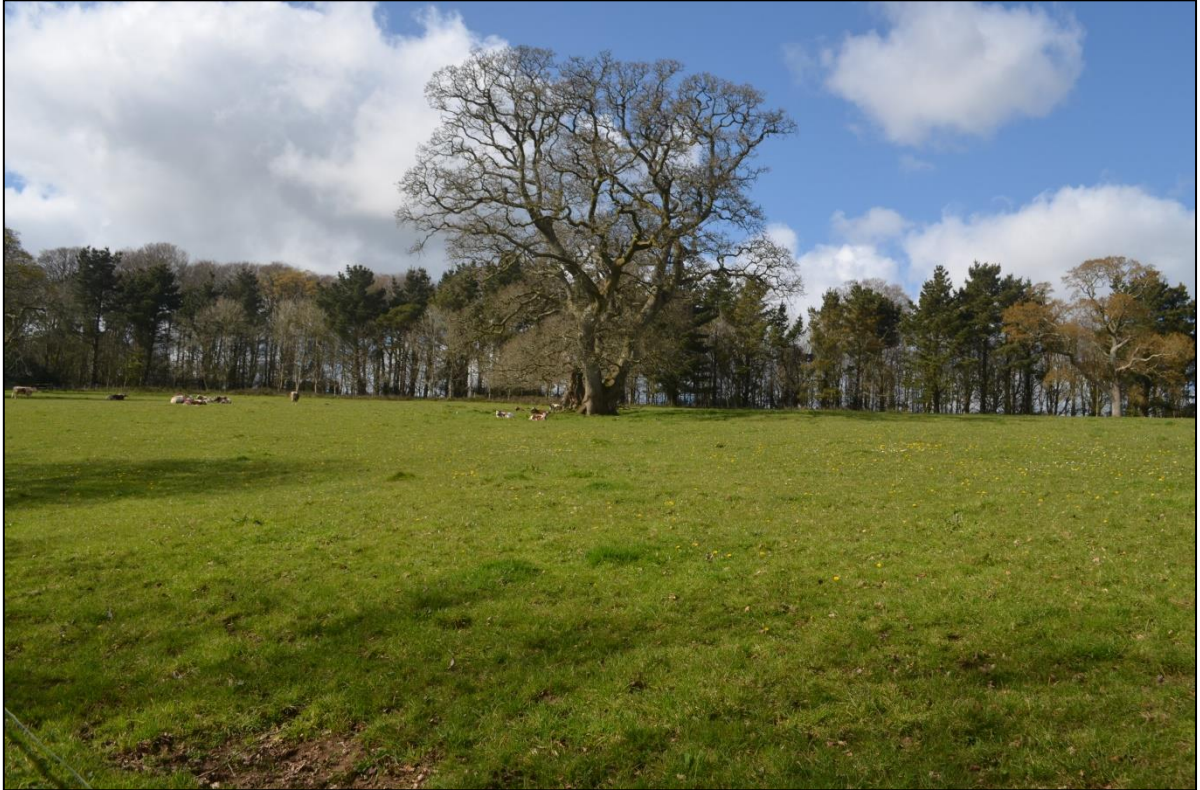
There was no clear earthwork evidence observed during walkover survey to indicate this boundary with any certainty although very slight level change was noted in this area of field. A number of trees which appear to be of reasonable age were observed on the likely line of this boundary.

FIGURE 35: VERY SLIGHT CHANGE IN LEVEL ACROSS FIELD INDICATED BY THE LINE OF TREES IN THE CENTRE OF THE PHOTOGRAPH MAY INDICATE THE HISTORIC BOUNDARY WHICH APPEARS TO BE VISIBLE ON LIDAR IMAGERY; FROM THE SOUTH

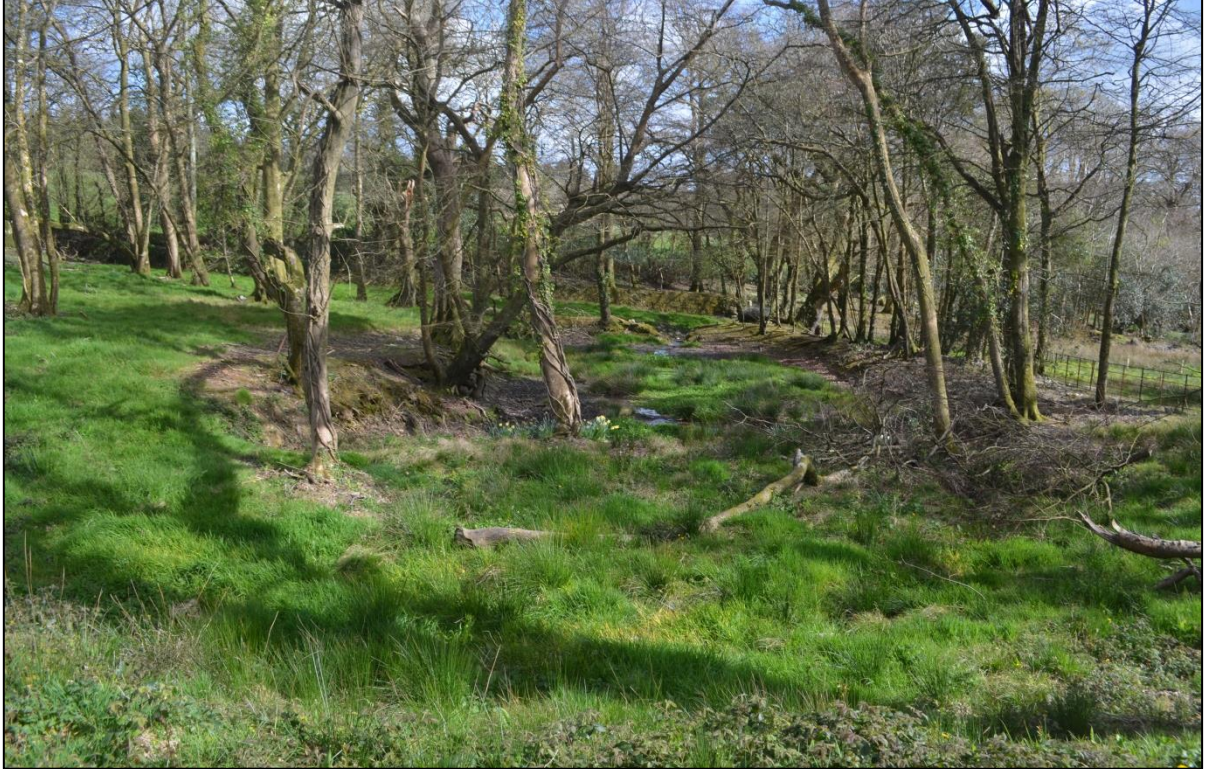
A historic pond is shown in this location on historic mapping. It is depicted as a rectangle in 1841 but remodelled at its north western end into a more oval form by 1879. It is possible that a small pond is shown just to the south east of the extant pond on the 1747 estate plan. By the early 20th century the pond appears to have separated back into a more rectangular pond and a separate squarish feature depicted more as marshy ground than water filled, with a spring labelled at the north eastern end. The form of the pond is still visible on the ground and appears to be wet/muddy in bottom but it is not holding water.

FIGURE 36: THE SURVIVING ELEMENTS OF THE HISTORIC POND. FROM THE NORTH

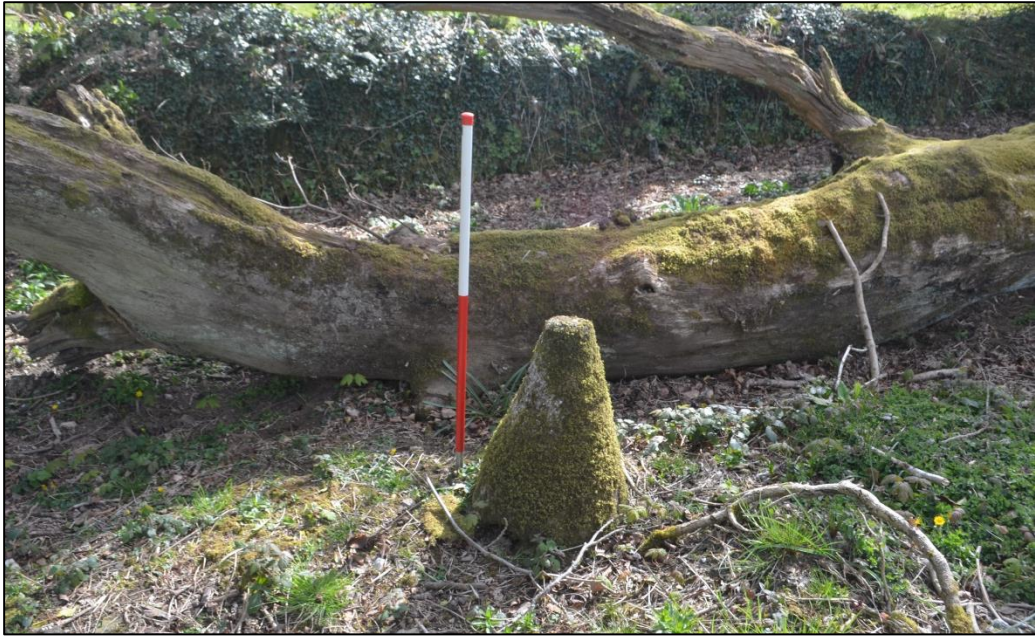
11. Cone shaped stone east of a historic pond

A moss covered cone shaped piece of stone c.0.5m high is located to the east of a historic pond in the northern area of the Eagle Ponds Valley. It may be part of a staddle stone and would appear not to be in situ although it is not clear why it is in this location.

FIGURE 37: MOSS COVERED STONE CONE. FROM THE EAST

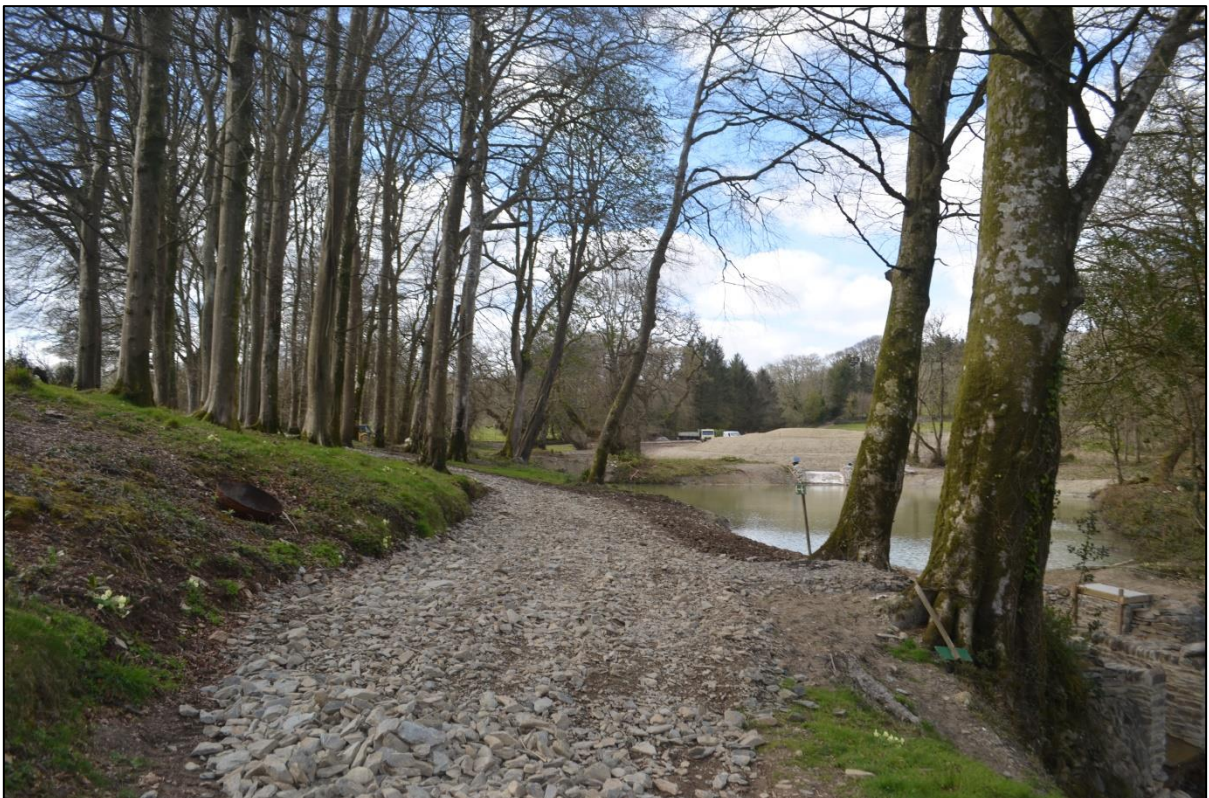
12. Historic Ponds in Eagle Ponds Valley

A series of ponds are shown in this location on estate plans from 1824. Their form appears to have evolved between 1841 and 1879. Renovation works are currently ongoing in this area and walkover survey was not carried out due to the large amount of plant movement and groundworks taking place. The survival of historic features in this area is therefore unknown.

FIGURE 38: RENOVATION WORKS TAKING PLACE IN THE WEST OF THE EAGLE PONDS VALLEY. FROM THE EAST

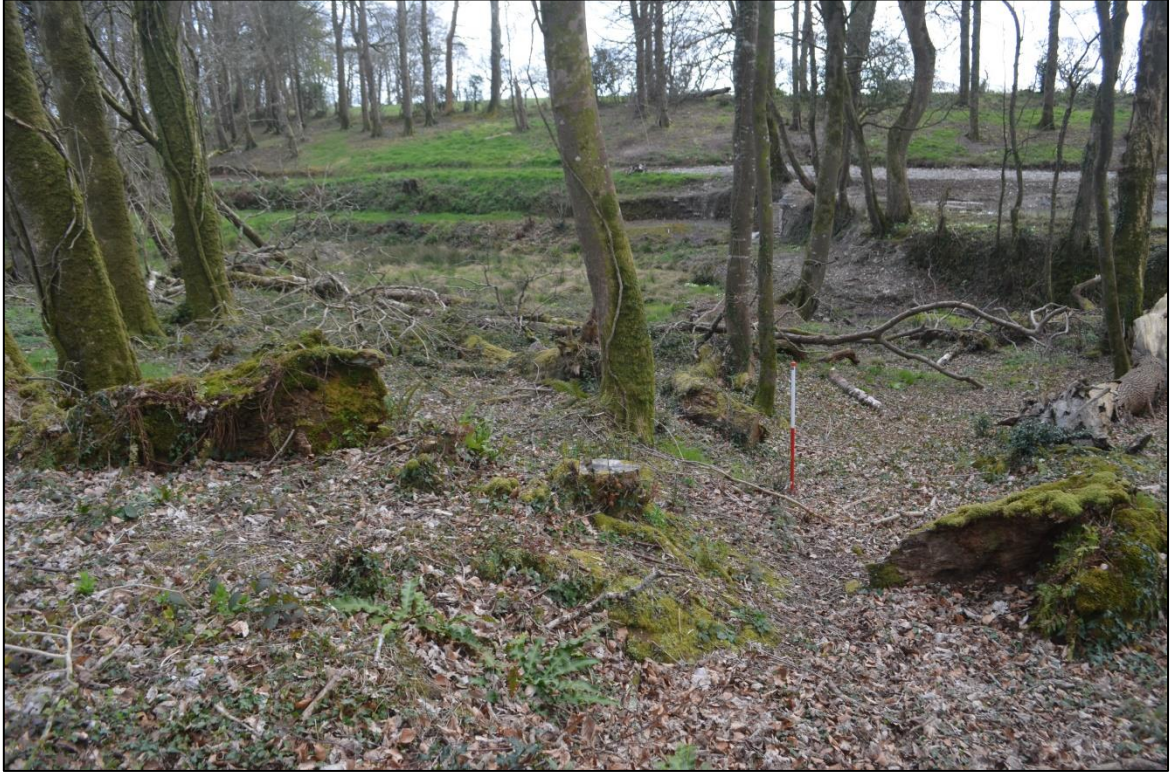
13. Earthwork bank

Historic boundary surviving as a low tree topped earthwork oriented approximately north-south. May correspond with a boundary shown on the 1747 estate map. A boundary appears in this location on the Second Edition Ordnance Survey map.

FIGURE 39: EARTHWORK BANK TO THE EAST OF THE PONDS RESTORATION AREA. FROM THE NORTH

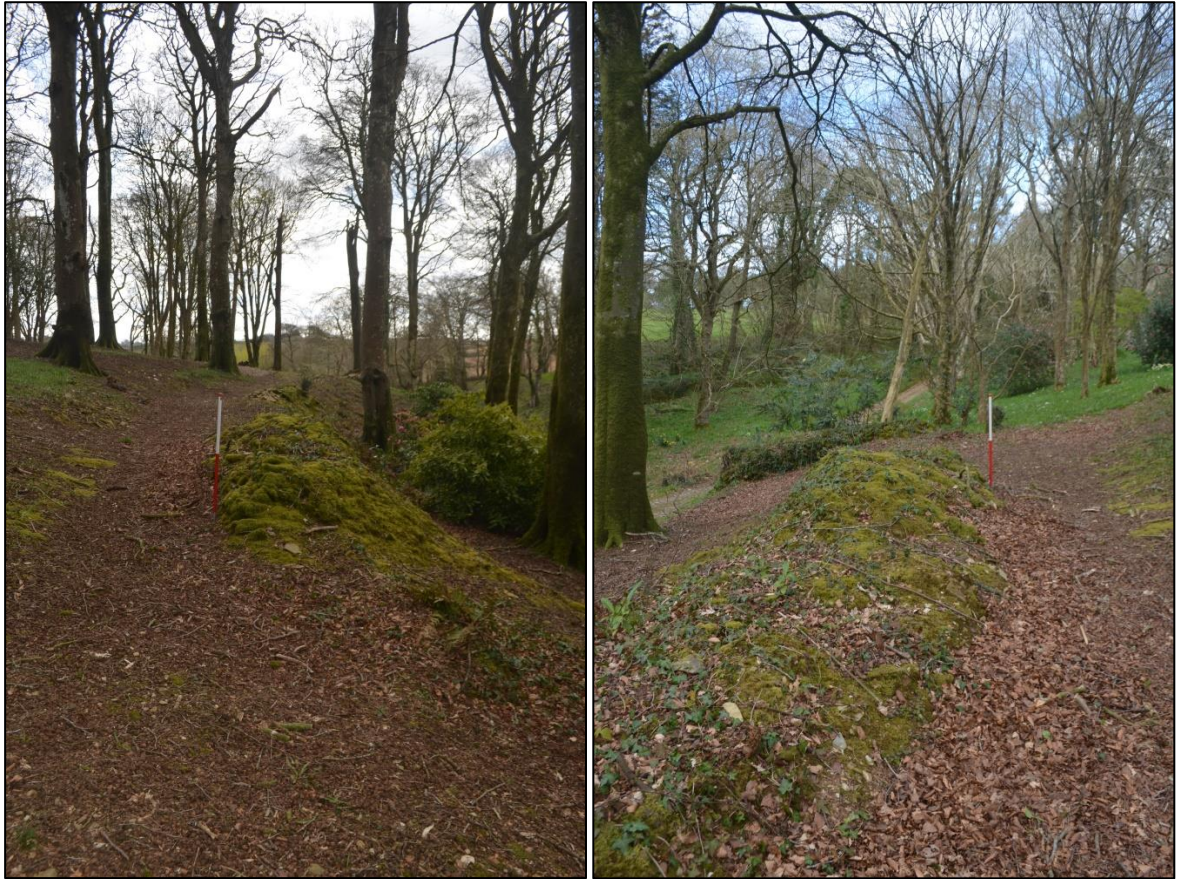
14. Relict boundary

Two short sections of possible relict stone and earth boundary which appear to correspond to a boundary shown on the 1747 estate map are located in the eastern area of the Eagle Ponds Valley. The boundary lies just to the south west of an avenue of trees which formed the southern drive into Trewithen shown on this map.

FIGURE 40 (L): SOUTH WESTERN SECTION OF RELICT BOUNDARY. FROM THE NORTH EAST
FIGURE 41 (R): NORTH EASTERN SECTION OF RELICT BOUNDARY. FROM THE SOUTH WEST

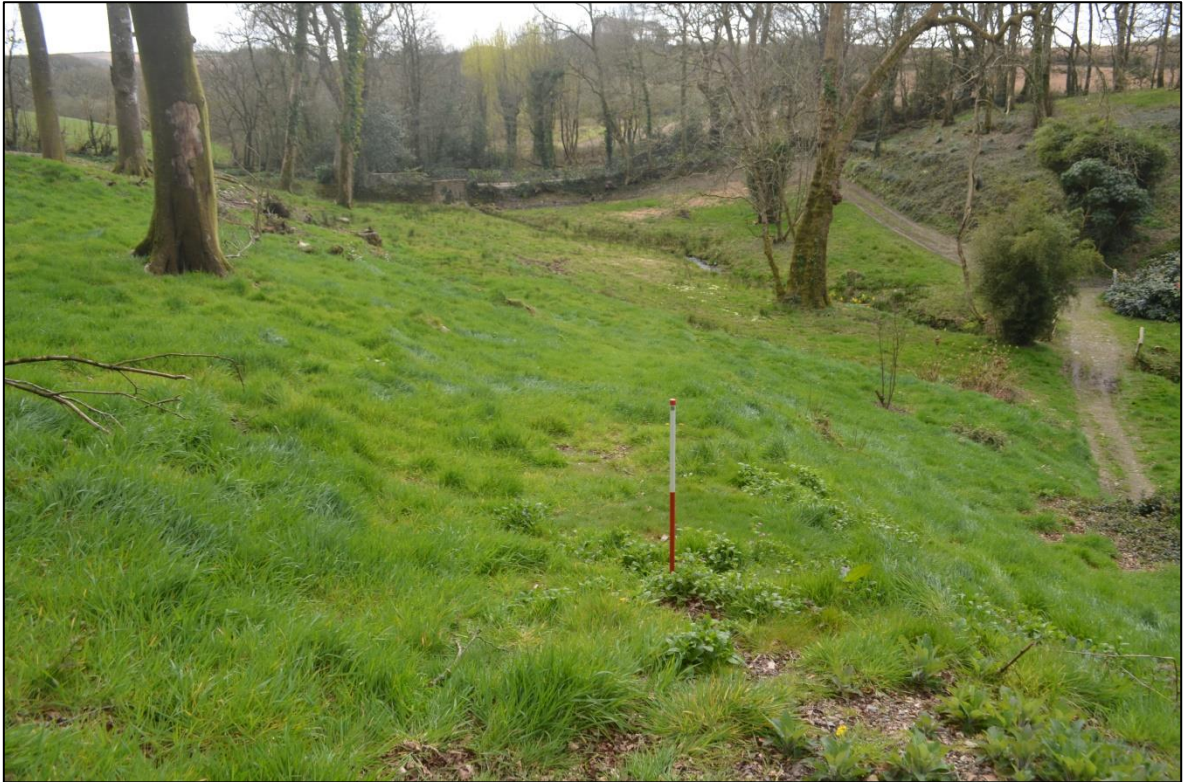
15. Historic Path

A possible historic pathway was recorded through a section of woodland in the Eagle Ponds Valley, to the east of the present pathway. It appears to follow the line of a boundary shown on the 1747 estate plan, to the east of an avenue of trees lining the southern entrance into the estate.

FIGURE 42: SECTION OF POSSIBLE HISTORIC PATH OR BOUNDARY; FROM THE NORTH EAST
