TREWITHEN ESTATE REGISTERED PARK AND GARDEN PROBUS CORNWALL

Archaeological and Historic Landscape Survey

South West Archaeology Ltd. Report no.210524

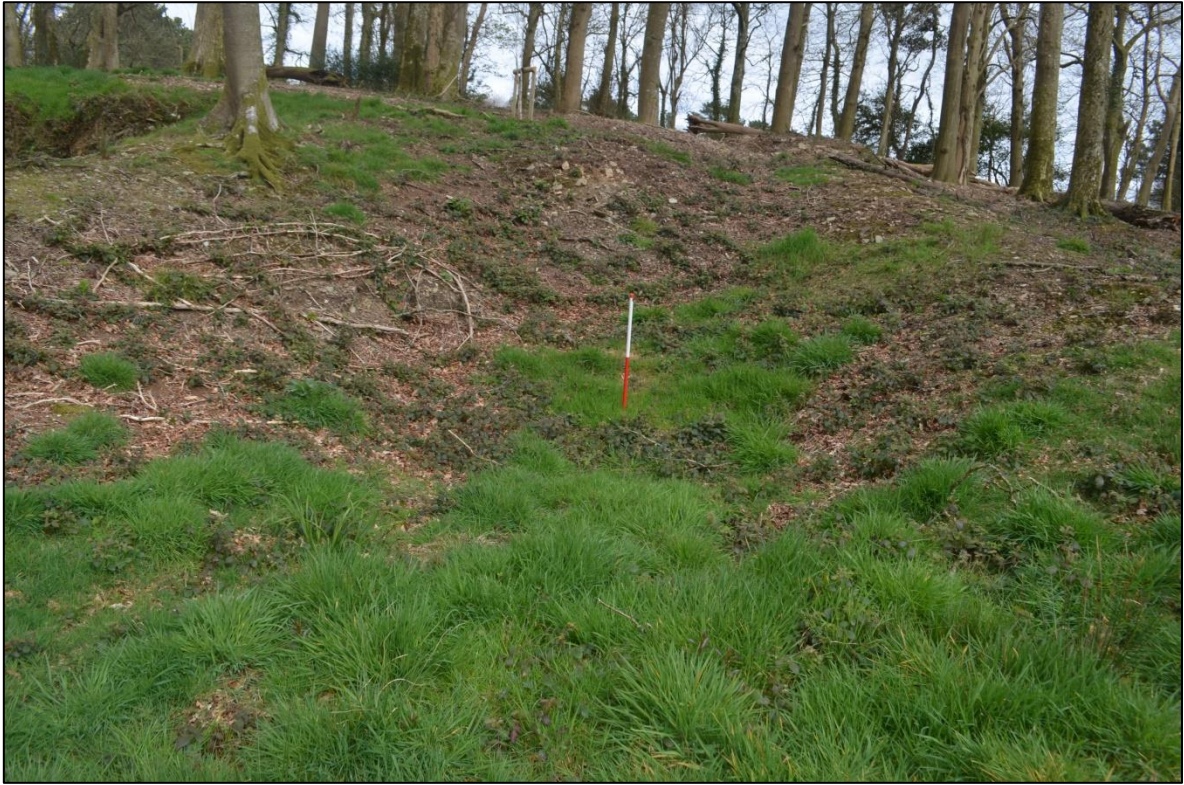
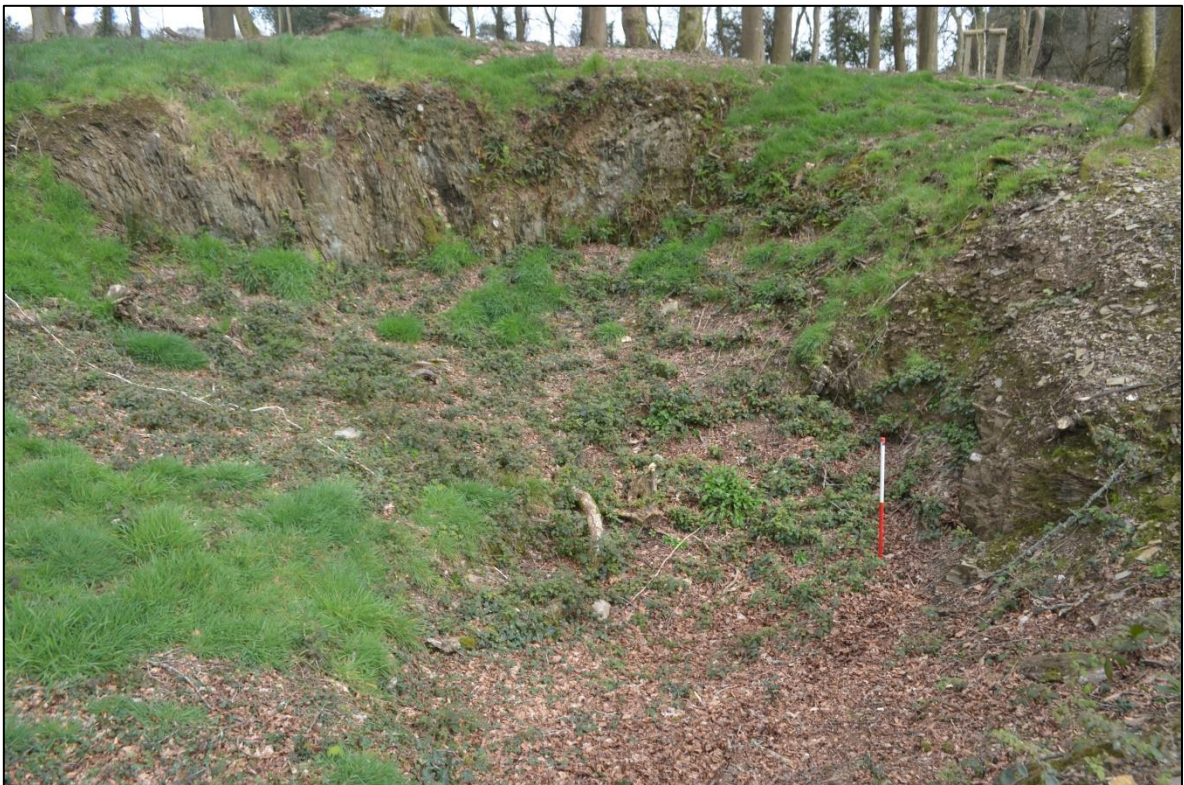
16. Historic Quarries

Two seemingly historic quarries are located to the north of a historic boundary shown on Ordnance Survey First Edition mapping. An old quarry is also marked in this location on this map. One is much deeper (>4m in depth) than the other. Significant recent groundworks appear to have taken place in this location which may have removed any further evidence of the historic quarrying activity in this area.

FIGURE 43: PROBABLE HISTORIC QUARRYING IN THE SOUTH EAST OF THE EAGLE PONDS VALLEY. FROM THE SOUTH

FIGURE 44: HISTORIC QUARRYING, LIKELY TO BE THAT RECORDED ON THE ORDNANCE SURVEY FIRST EDITION MAP AS 'OLD QUARRY'. FROM THE SOUTH

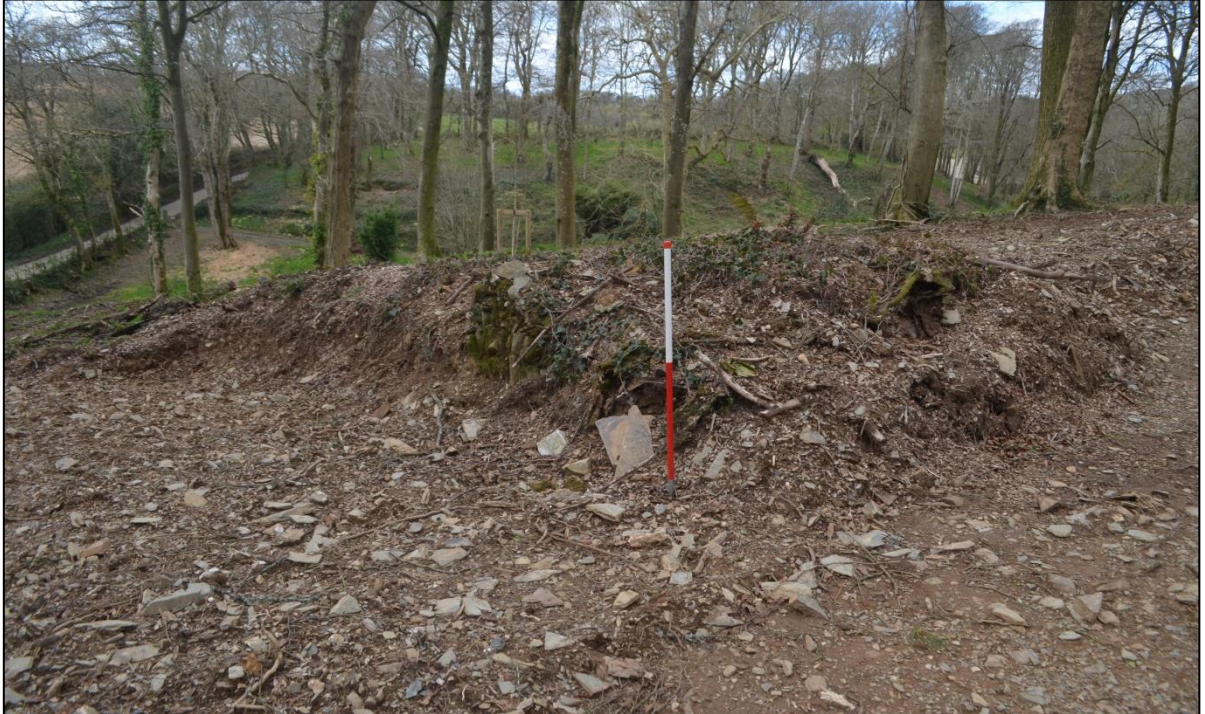
17. Historic Boundary

A fragment of a boundary shown on the Ordnance Survey First Edition map survives to the east of the historic quarrying activity in the south eastern area of the Eagle Ponds Valley. The boundary appears to have been recently truncated by modern forestry and/or quarrying activity.

FIGURE 45: HISTORIC BOUNDARY SHOWN ON ORDNANCE SURVEY FIRST EDITION MAPPING, THE BOUNDARY APPEARS TO HAVE BEEN TRUNCATED BY RECENT GROUNDWORKS WITHIN THIS AREA. FROM THE EAST.

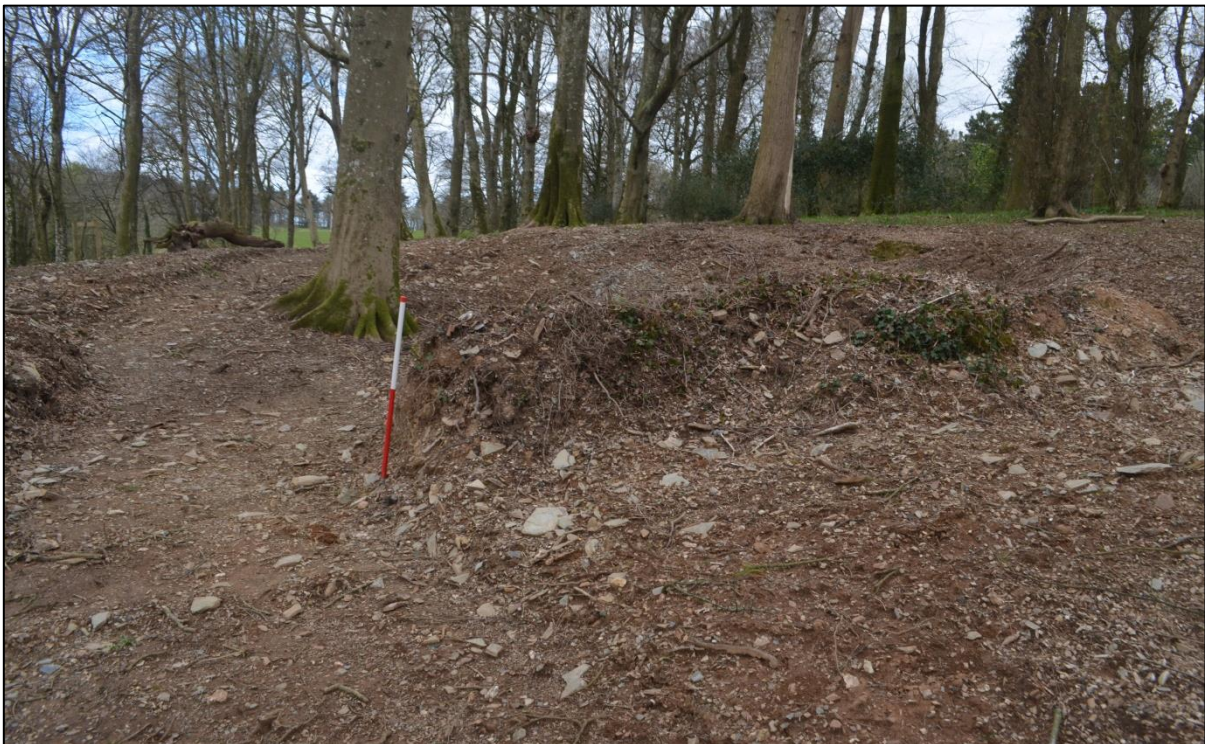
FIGURE 46: BREACHED SECTION OF A BOUNDARY SHOWN ON FIRST EDITION ORDNANCE SURVEY MAP WITH PATH CREATED THROUGH. FROM THE EAST

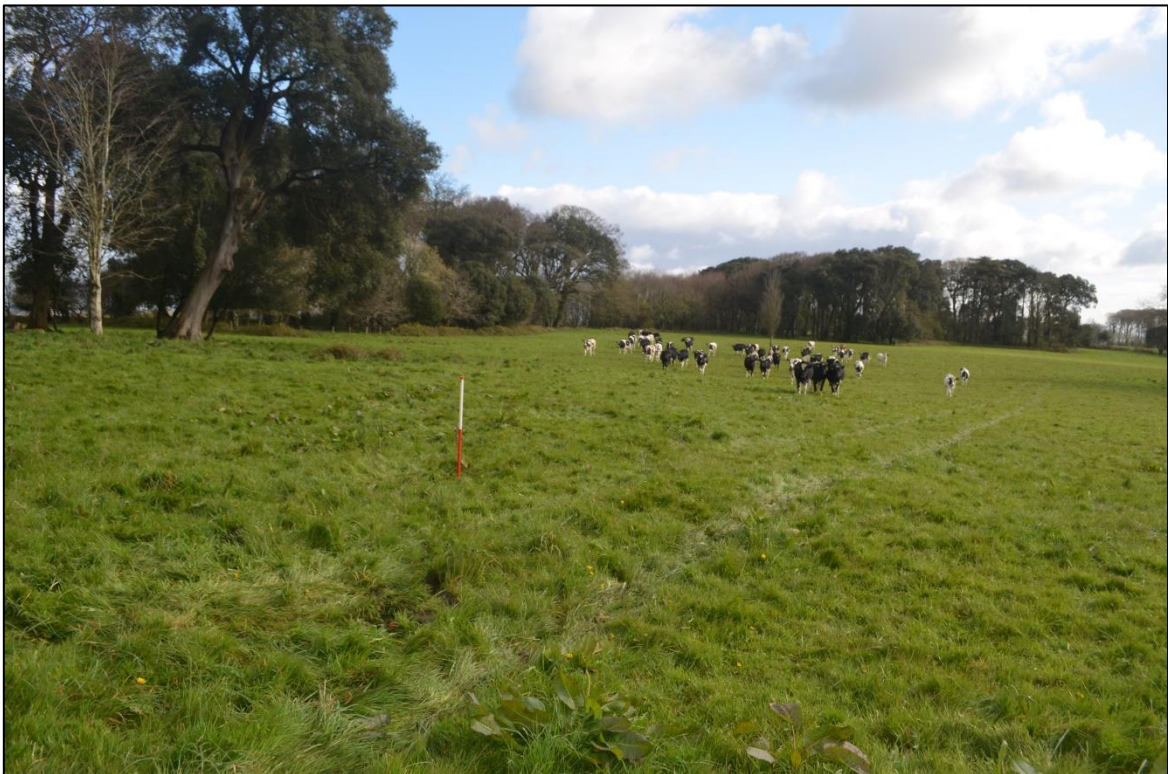
19. Boundary shown on 1841 map SW 9110 4776

A slight raised earthwork bank approximately 2m wide is visible in the location of a boundary first shown on the 1841 estate map. The boundary is oriented approximately north east-south west and curves to the north east at its northern end, close to a number of trees.

FIGURE 47: SLIGHT EARTHWORK BOUNDARY ON THE LINE OF A BOUNDARY FIRST SHOWN ON THE 1841 ESTATE MAP. FROM THE SOUTH WEST

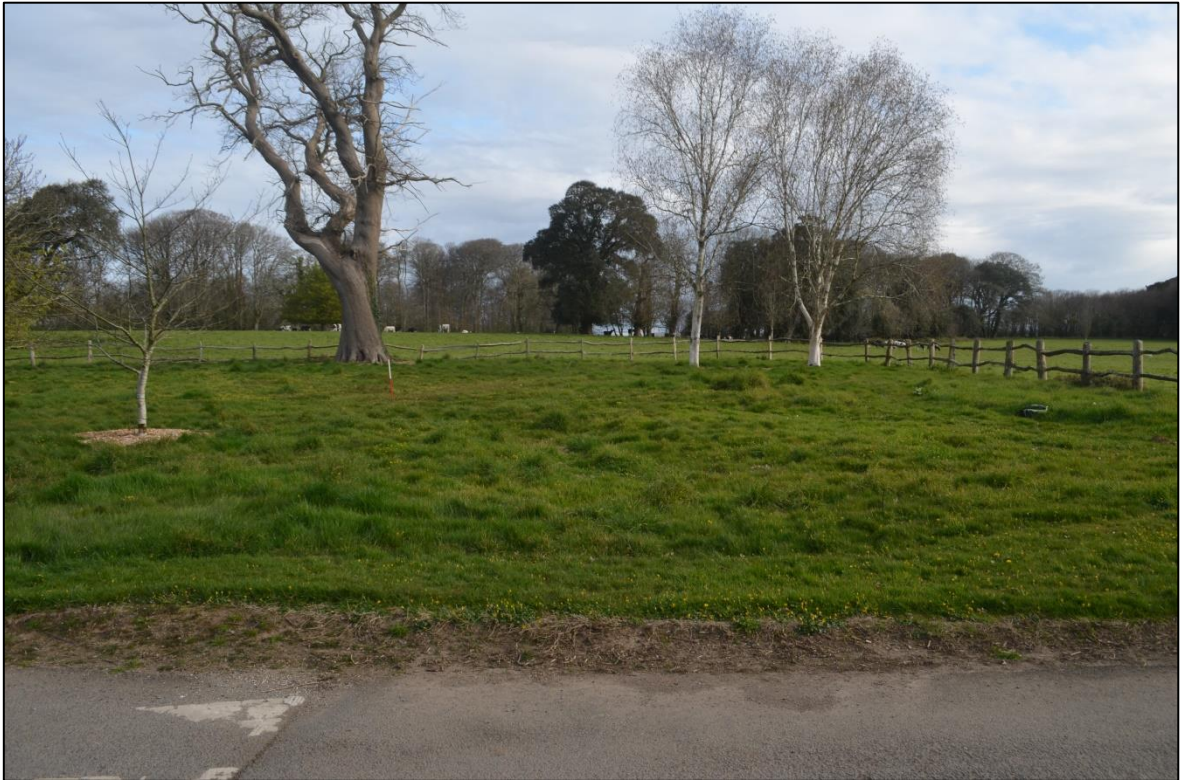
20. Slight curved hollow

A slight almost semi-circular curving earthwork hollow visible in the location of a curved boundary around a plantation shown on the 1841 estate map.

FIGURE 48: SLIGHT CURVING HOLLOW IN LOCATION OF BOUNDARY SHOWN ON 1841 PLAN. THE RANGING POLE MARKS THE NORTH EASTERN EXTENT OF THE CURVE WHICH IS VISIBLE AS A RAISED AREA OF GROUND IN THE FOREGROUND OF THE PHOTO. FROM THE SOUTH WEST

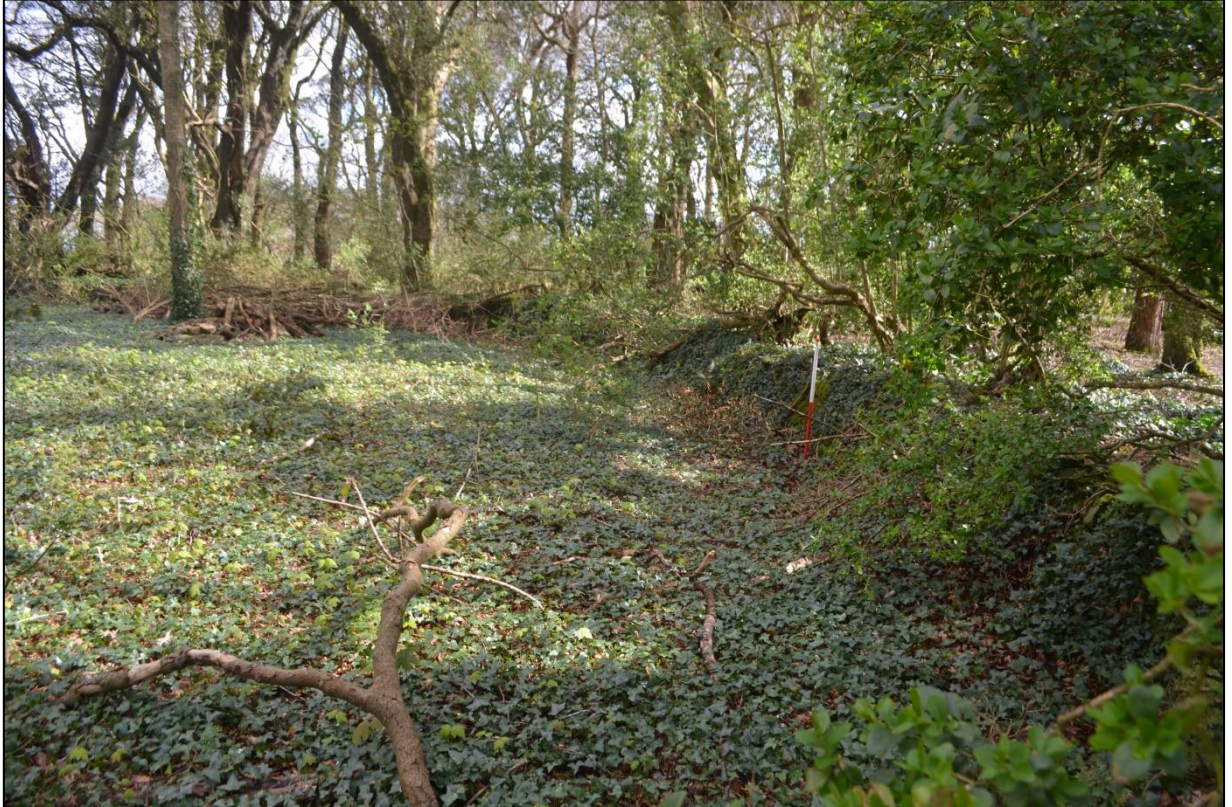
21. Section of boundary

A curving section of boundary corresponding with a boundary shown on Ordnance Survey First Edition mapping was recorded in an area of woodland in the northern part of The Park. The boundary appeared to be a Cornish Hedge Bank although it was covered with vegetation and trees.

FIGURE 49: FRAGMENT OF BOUNDARY CURVING NORTH AT 90 DEGREES; FROM THE WEST

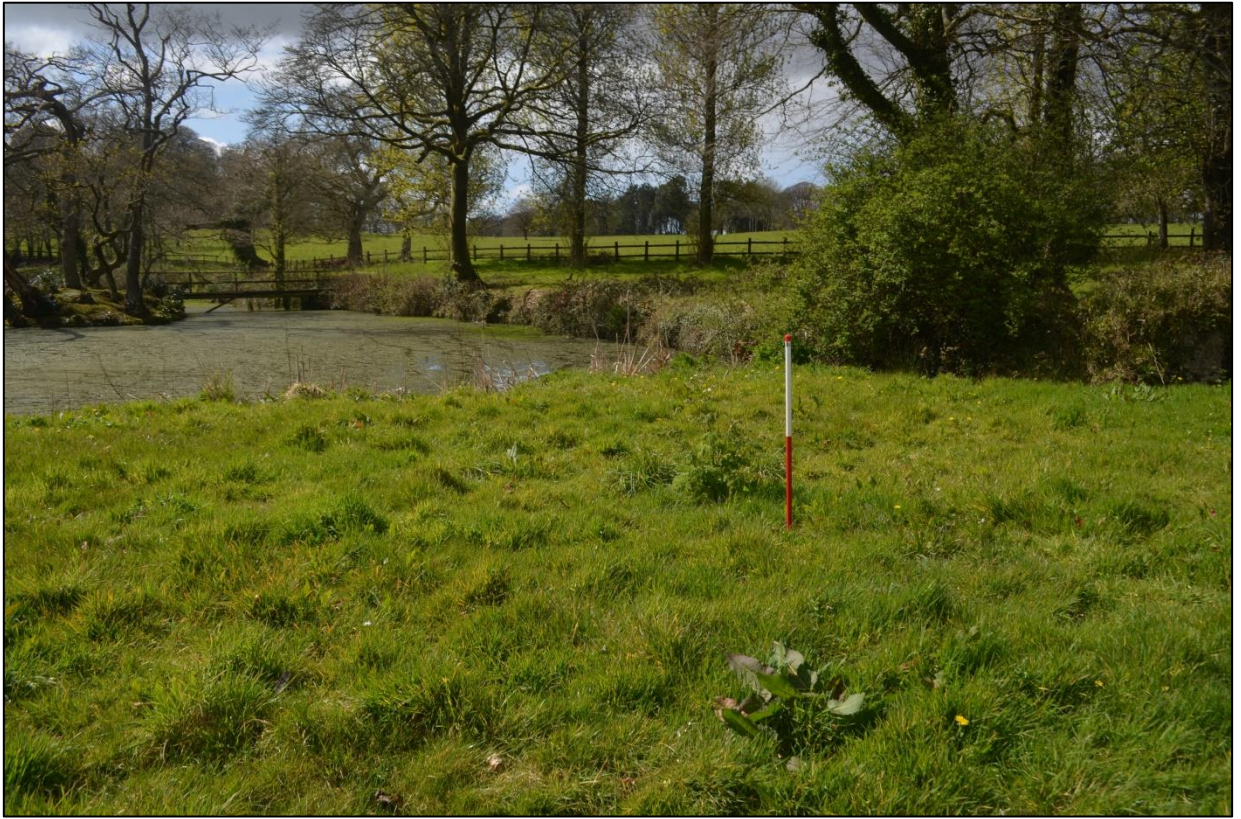
A square shaped depression was observed to the east of the lake at Trewithen Farm. The hollow measured approximately 2m x 2m. Its date and function are unknown.

FIGURE 50: SLIGHT SQUARE SHAPED DEPRESSION TO THE EAST OF THE LAKE AT TREWITHEN FARM; FROM THE EAST

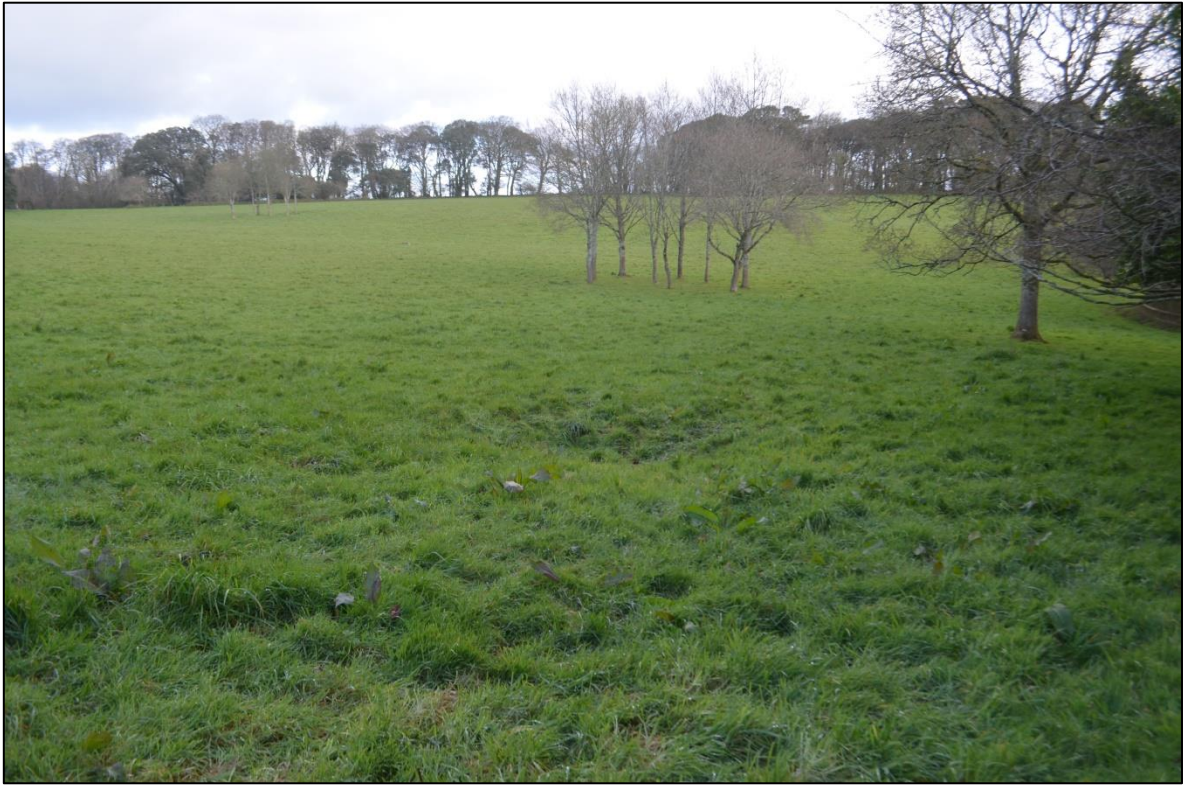
SW 9131 4759

A circular hollow is visible close to the fence line in the south east corner of The Park. The hollow measures c.2m in diameter and is c.0.5m deep. Its date and function are uncertain.

FIGURE 51: CIRCULAR HOLLOW IN SOUTH EAST CORNER OF THE PARK. FROM THE SOUTH

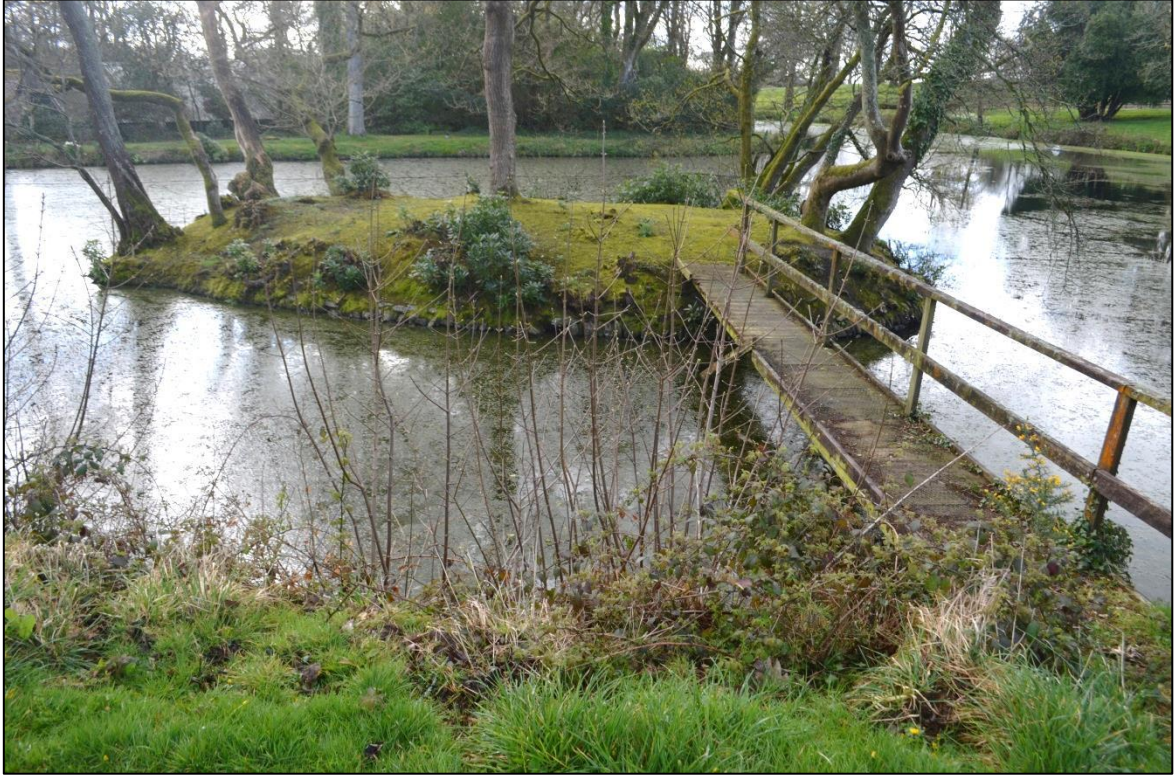
A man-made island with a built stone faced edge is located at the northern end of the lake which lies to the west of Trewithen Farm. The island appears to be accessed by a wooden bridge which is in poor condition.

FIGURE 52: MAN-MADE ISLAND ON THE LAKE TO THE WEST OF TREWITHEN FARM. FROM THE NORTH

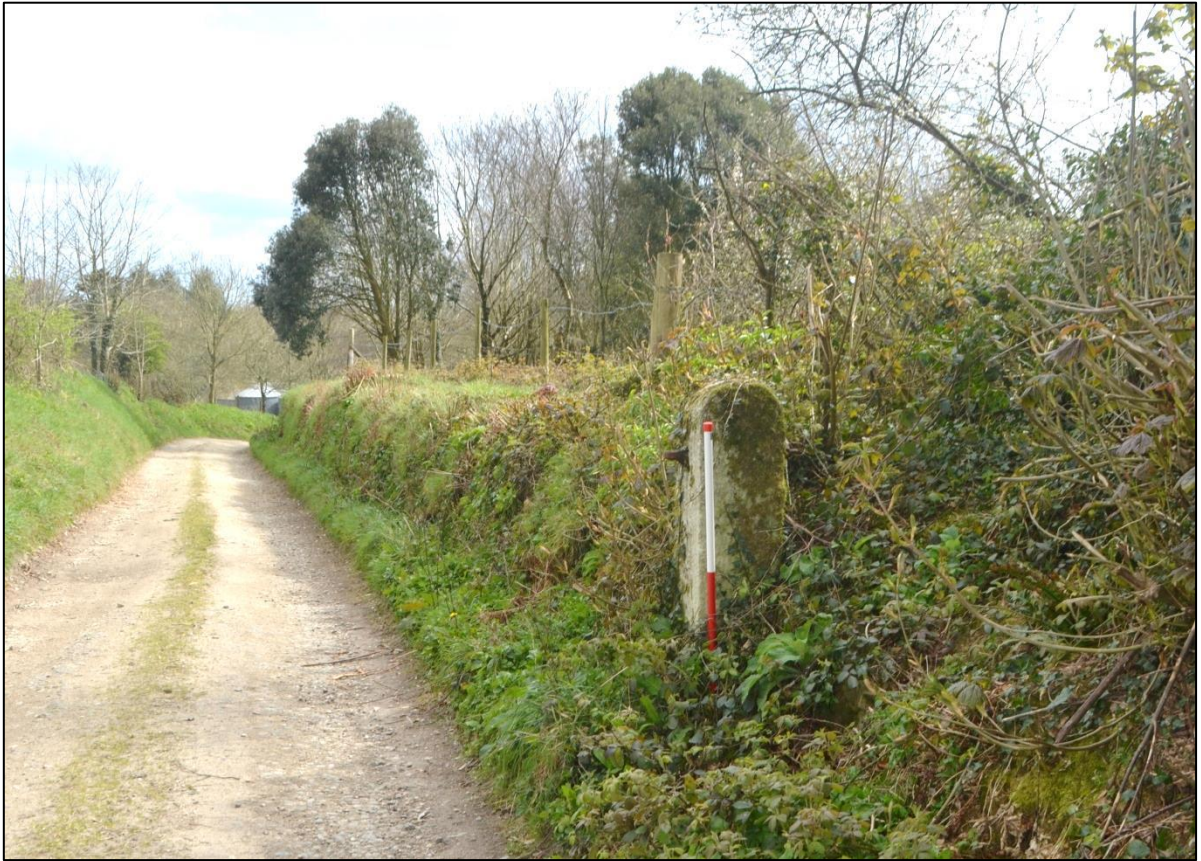
SW 9140 4784

A single curved topped granite gatepost is located on the western side of the drive down to Trewithen Farm. There is evidence for an iron gate fixing but the gate is no longer extant.

FIGURE 53: SINGLE GATEPOST ON WESTERN SIDE OF DRIVE INTO TREWITHEM FARM. FROM THE NORTH WEST.

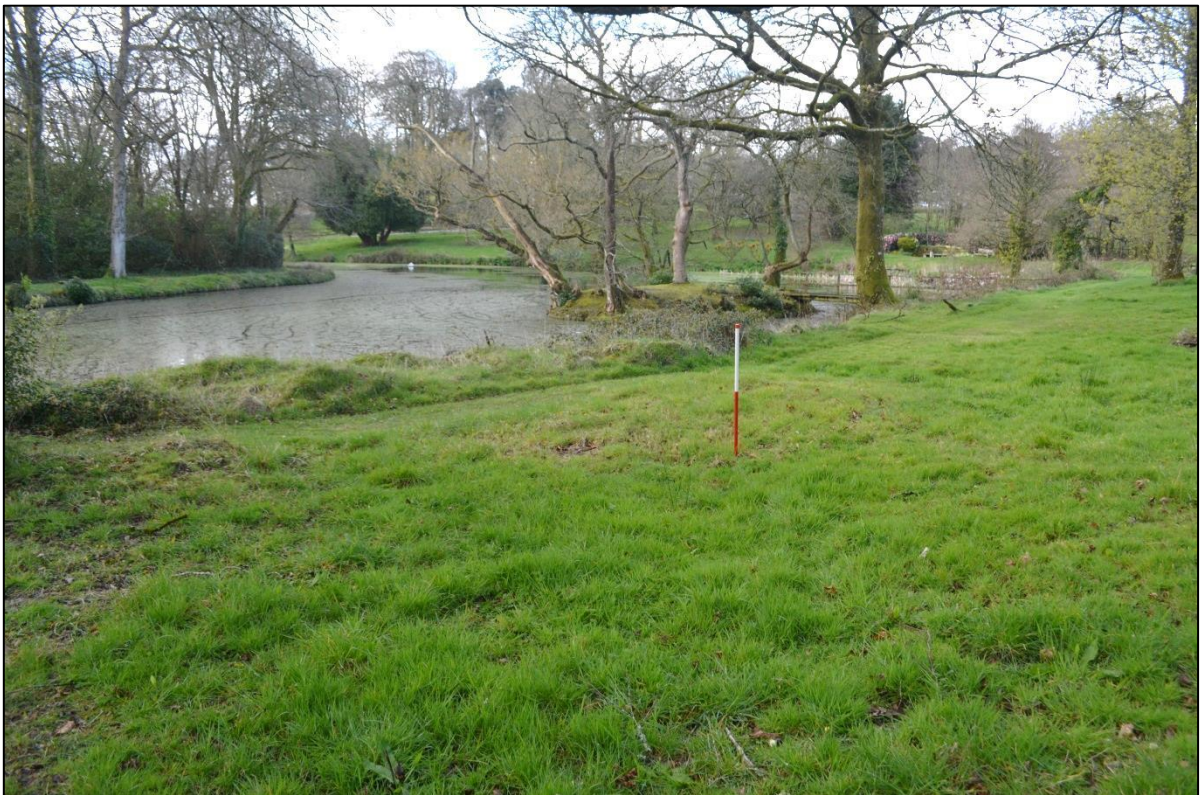
29. Slight circular mound at northern end of lake to the west of Trewithen Farm

A slight, approximately circular mound c.2.5m in diameter is located at the northern end of the lake to the west of Trewithen Farm. Its date and function are uncertain.

FIGURE 54: SLIGHT CIRCULAR MOUND LOCATED AT THE NORTHERN END OF THE LAKE TO THE WEST OF TREWITHEN FARM. FROM THE NORTH EAST

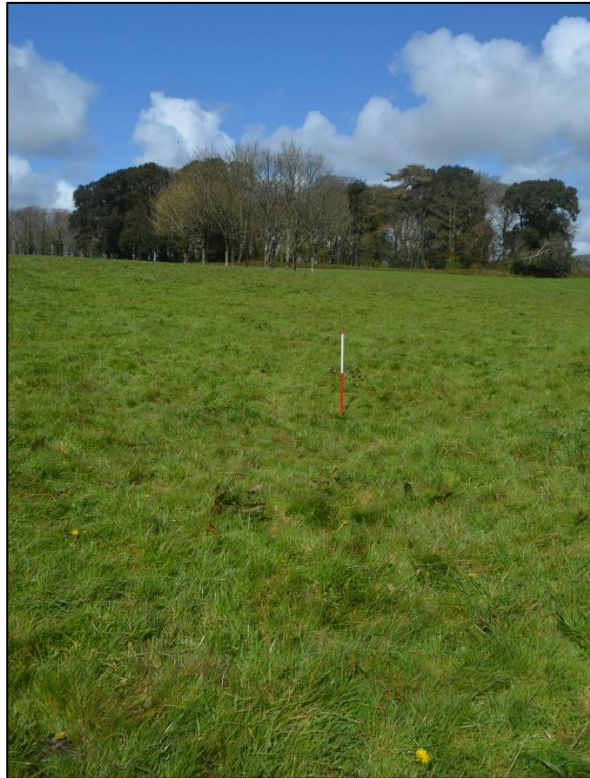
30. Slight depression at the eastern side of The Park

A slight curved depression on the eastern side of The Park may be a historic tree throw.

FIGURE 55: SLIGHT CURVED DEPRESSION, POSSIBLY A HISTORIC TREE THROW. FROM THE SOUTH

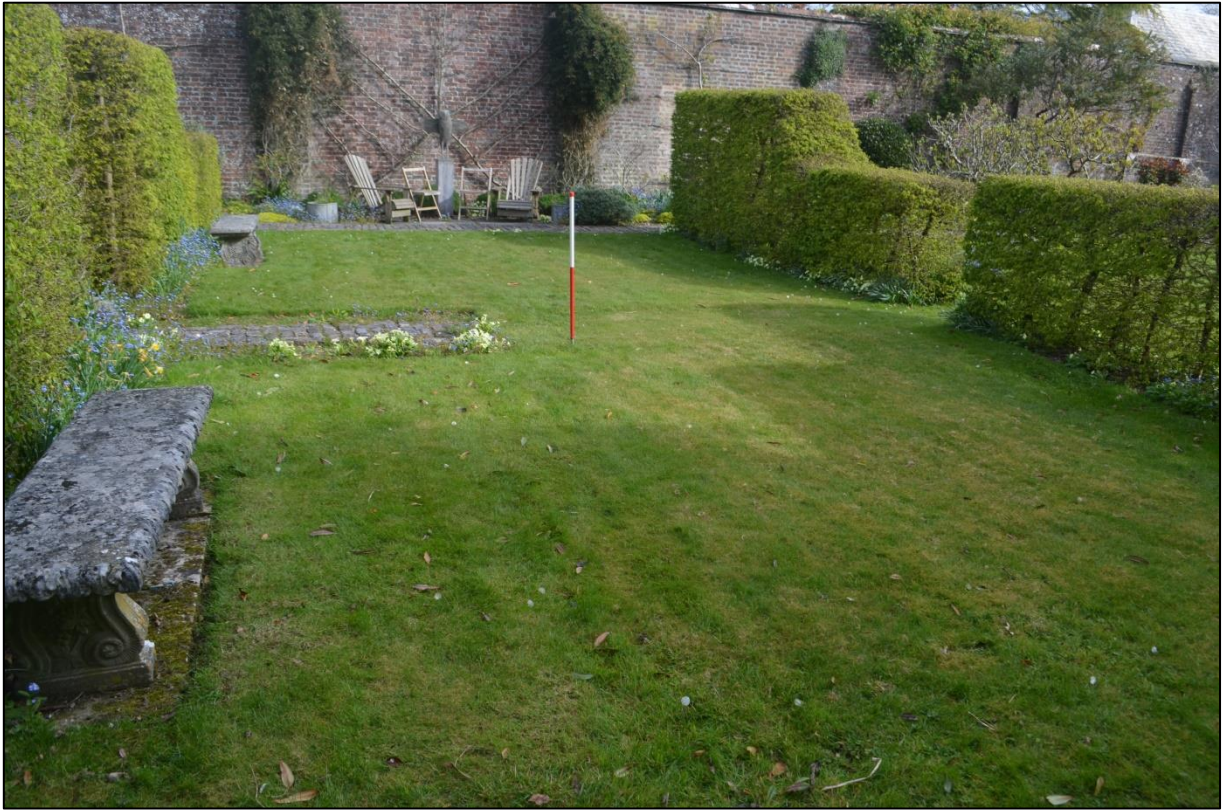
SW 9125 4750

Depressions and undulations within the grassed sections of the walled gardens suggest paths or planting beds may formally have been located in these areas.

FIGURE 56: SLIGHT DEPRESSIONS AND UNDULATIONS WITHIN THE GRASSED AREA OF THE WALLED GARDEN HINT AT EARLIER PATHS OR BEDS. FROM THE SOUTH

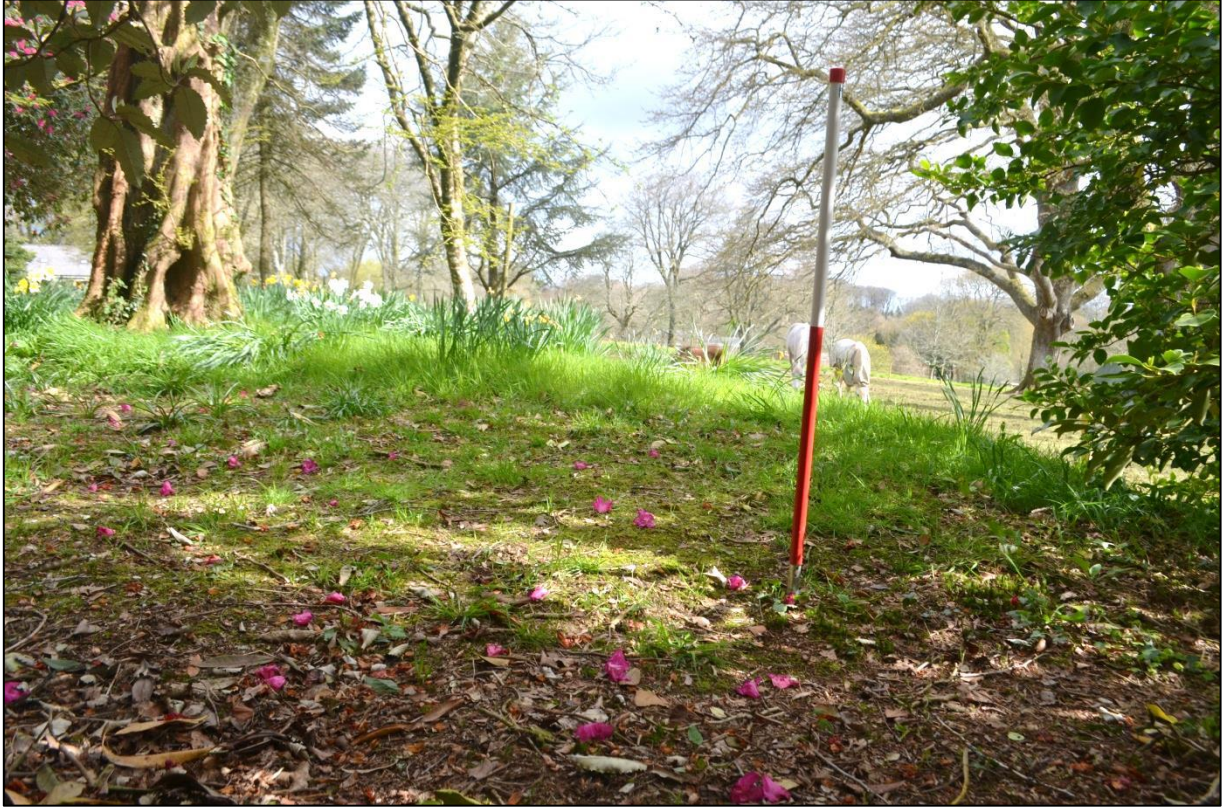
A slight depression was noted in the location of square feature/right angle turn in the boundary of the gardens shown on the 1747 estate plan. A tree was also growing in this area so it was not possible to determine whether any evidence for a feature located at this point survives.

FIGURE 57: SLIGHT DEPRESSION NOTED AT THE POINT WHERE THE BOUNDARY SHOWN ON THE 1747 ESTATE PLAN TURNS 90 DEGREES TO THE WEST. FROM THE SOUTH WEST

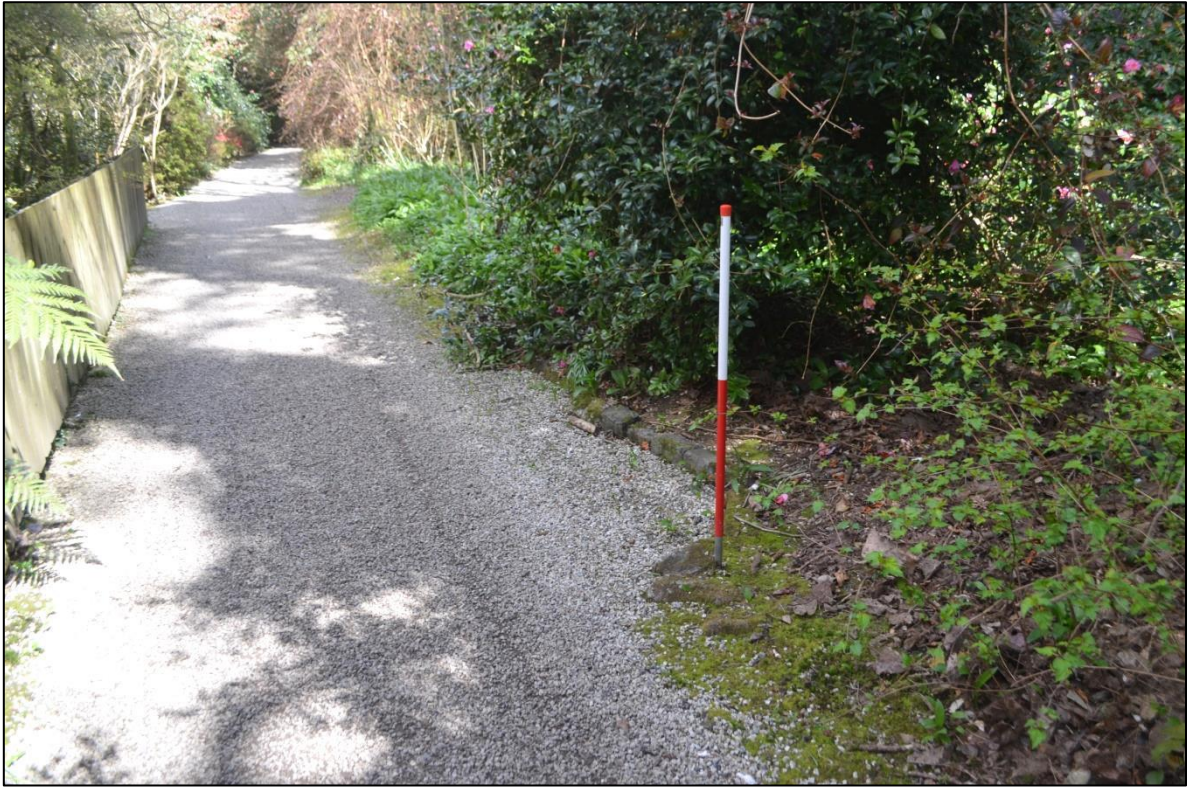
A short section of single block stone edging in flattened U shape was noted to the eastern side of the pathway in area with no other stone edging. It is notable as it appears to be in a similar shape to the path shown on the 1747 estate map although seems to be located further south along the path than that indicated on the 1747 map.

FIGURE 58: CURVED AREA OF PATH EDGING IN A FORM SIMILAR TO THAT SHOWN ON THE 1747 ESTATE MAP ALTHOUGH IT APPEARS TO BE IN A SLIGHTLY DIFFERENT LOCATION ALONG THE PATH. FROM THE SOUTH

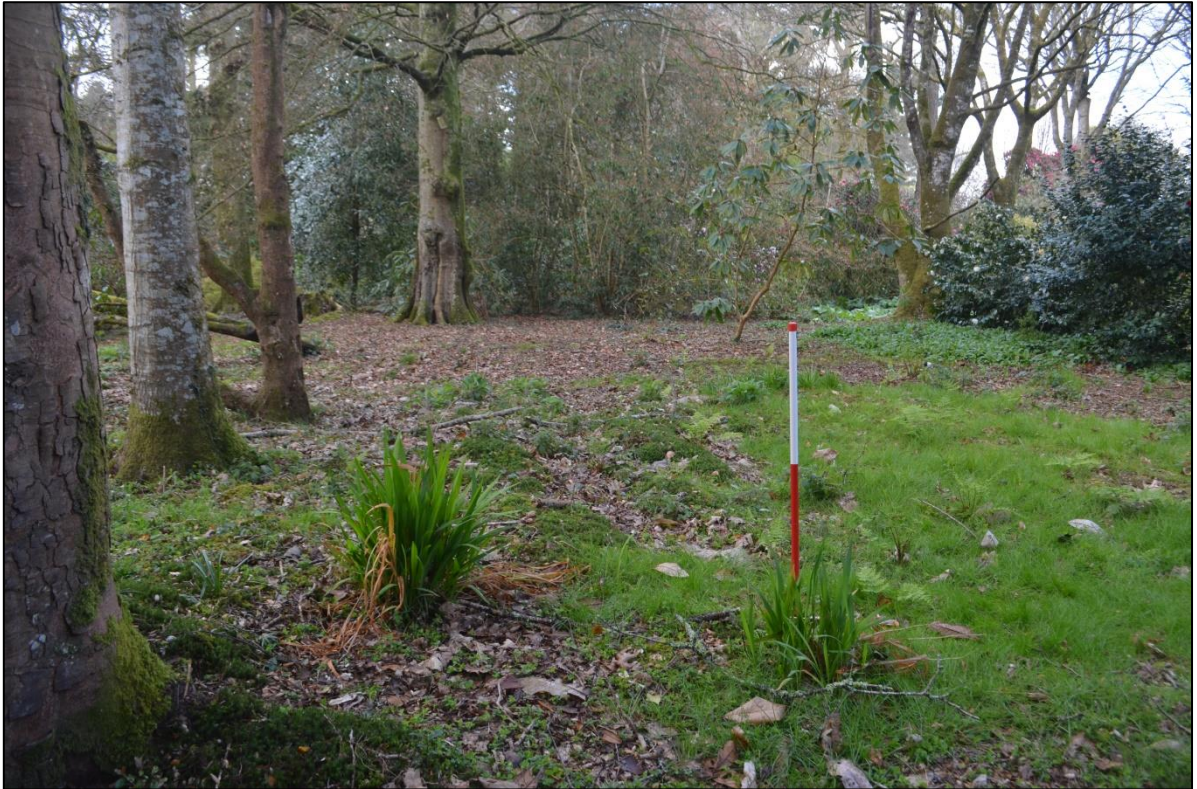
35. Area of slight earthworks possibly representing paths and features on historic maps
SW 9123 4745

An area of slight earthworks located in a clearing within the woodland gardens (in an area now known as Skilton Bay) possibly representing the survival of fragments of path arrangements shown on the 1747 and 1841 estate maps. Two slight rectangular shaped hollows could be remnants of a feature shown on the 1747 estate map consisting of a circular arrangement with a feature located in the centre, four rectangular projections at each of the cardinal points and a path leading into it from the south.

FIGURE 59: SLIGHT EARTHWORKS IN THE AREA OF A SERIES OF PATHS AND FEATURES SHOWN ON HISTORIC MAPS. FROM THE SOUTH

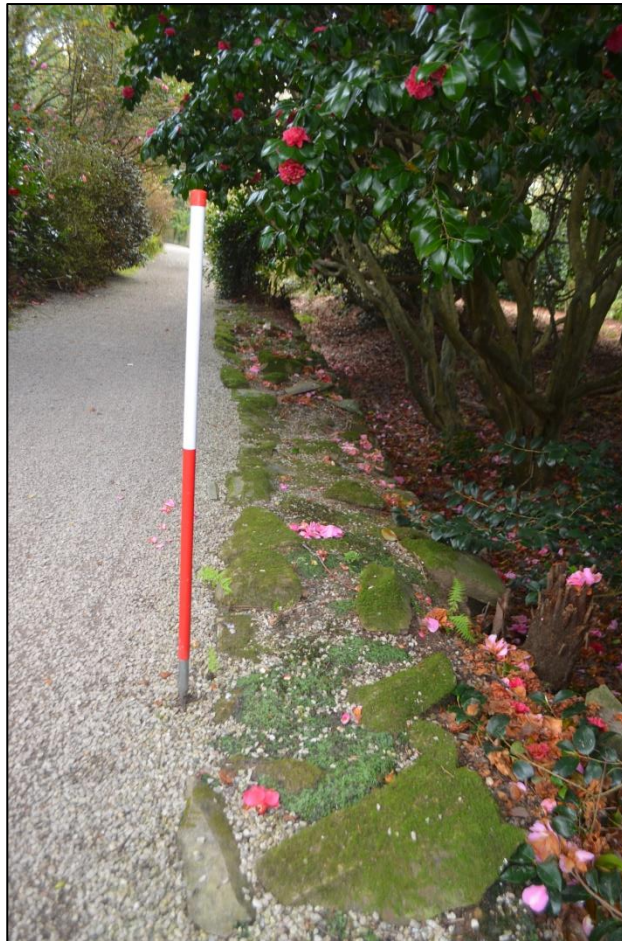
36. Exposed stone at the top of Ha-ha

A small section exposed stone at the top of a ha-ha on the line of a boundary shown on the 1747 estate map is visible in the south eastern area of the pleasure grounds. It provides the eastern edge of the path and gives evidence for the construction of the ha-ha.

FIGURE 60: EXPOSED STONE SECTION AT THE TOP OF A HA-HA IN THE SOUTH EAST OF THE PLEASURE GARDENS. FROM THE NORTH

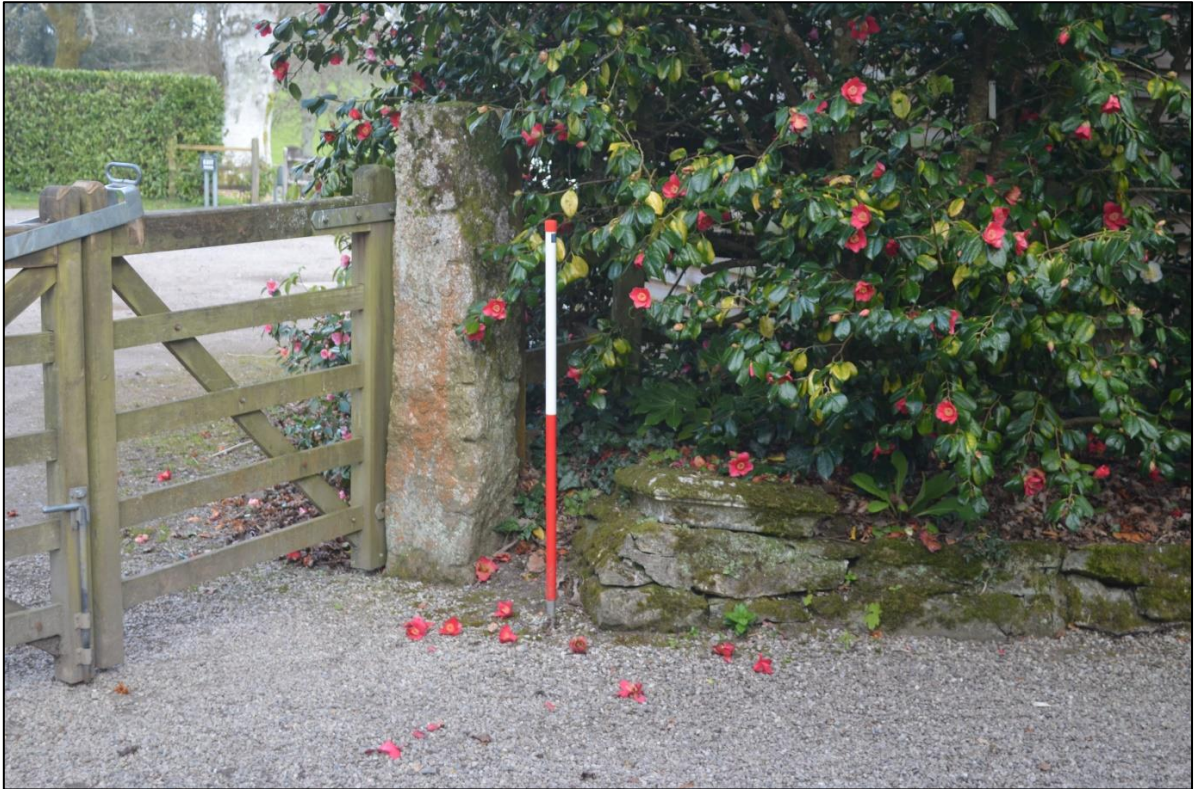
37. A granite gate post and a stone capping for a pillar at the eastern end of the car park
SW 9121 4754

A granite gate post holds a wooden gate into Trewithen Gardens at the eastern end of the car park. A square pointed capping stone for a pillar or post, evidently not in situ, is positioned on a wall just to the east of the gate post.

FIGURE 61: STONE GATE POST AND SQUARE CAPPING STONE (JUST TO THE RIGHT OF THE RANGING POLE) RESTING ON A LOW WALL AT AN ENTRANCE INTO TREWITHTEN GARDENS. FROM THE SOUTH

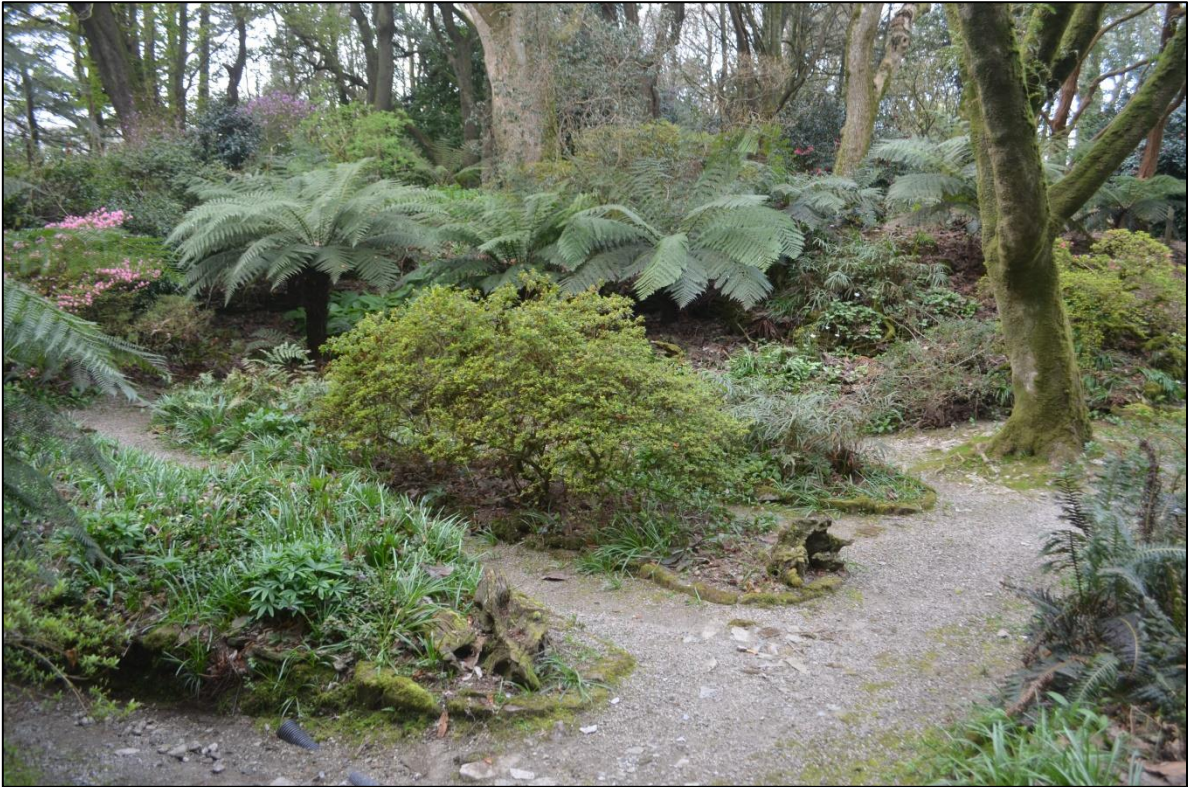
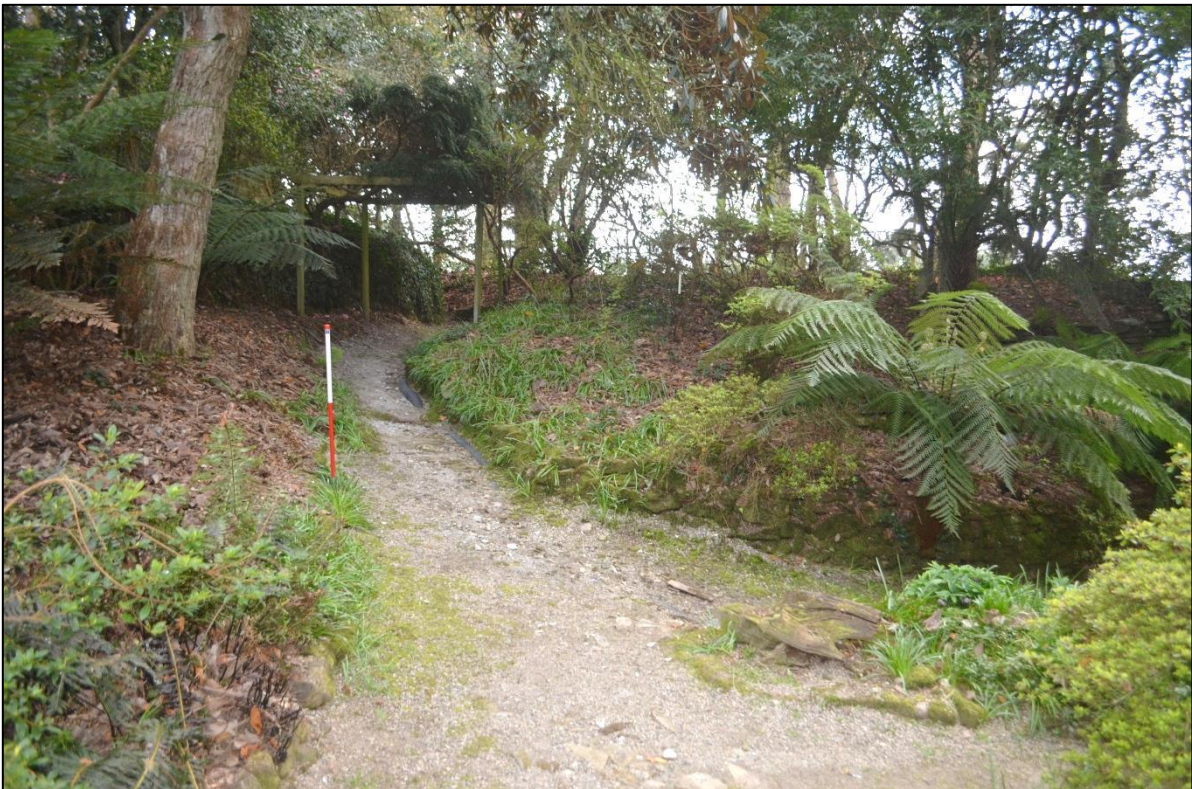
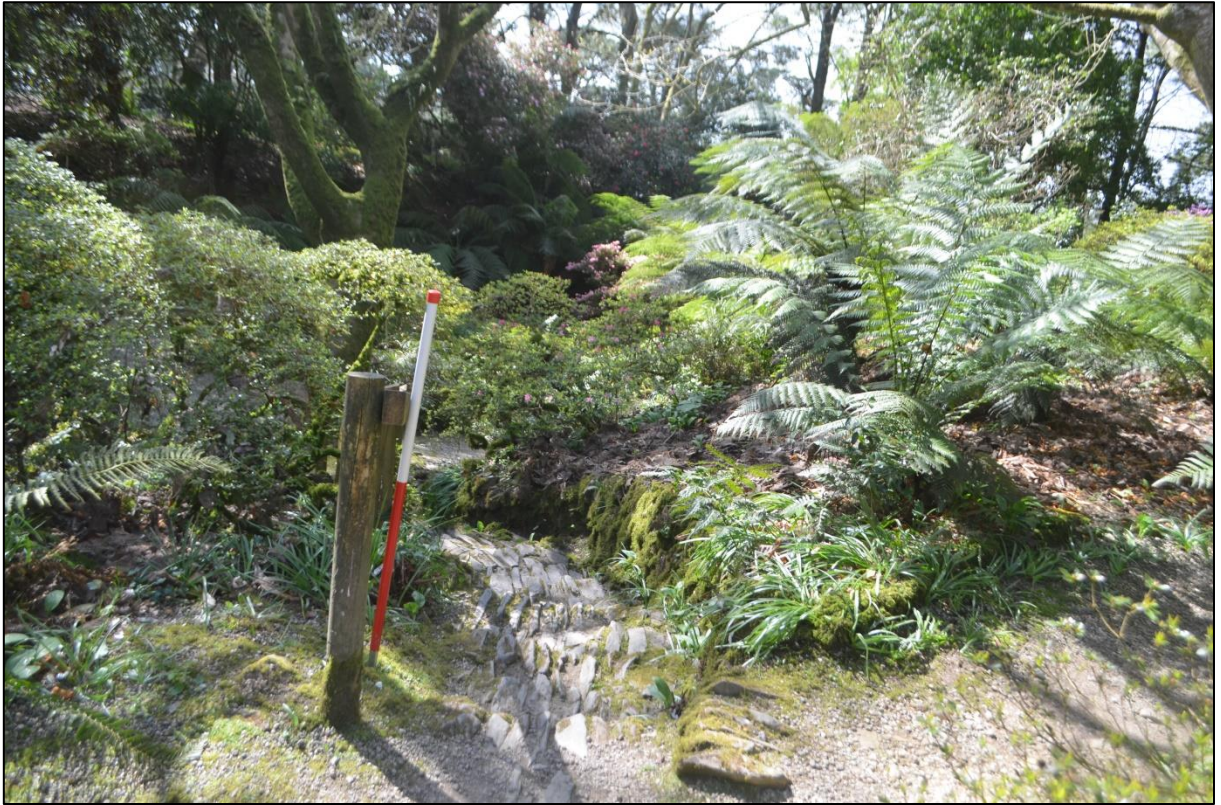
38. An old quarry shown on 1841 estate map now a fernery named the cock pit.

A former Quarry shown on the 1841 estate map is now a fernery created in the early 20th century named the cock pit. An interpretation sign within the gardens states that the quarry was terraced to make an amphitheatre used for cock fighting. A sunken rock garden was planted in the early 20th century by George Johnstone. The cock pit is accessed from the south via the base of the ha-ha shown on the 1747 estate map. This boundary creates the western side of the cock pit which is accessed from the north by a series of steps.

FIGURE 62: VIEW DOWN INTO THE COCK PIT. FROM THE SOUTH

FIGURE 63: VIEW FROM THE COCK PIT TO THE SOUTH. THE EDGE OF THE HA-HA/BOUNDARY SHOWN ON THE 1747 ESTATE PLAN CAN JUST BE SEEN ABOVE THE RANGING POLE IN THIS PHOTO.

FIGURE 64: STEPS LEADING DOWN INTO THE NORTHERN SIDE OF THE COCK PIT. FROM THE NORTH
