TREWITHEN ESTATE REGISTERED PARK AND GARDEN PROBUS CORNWALL

Archaeological and Historic Landscape Survey

South West Archaeology Ltd. Report no.210524

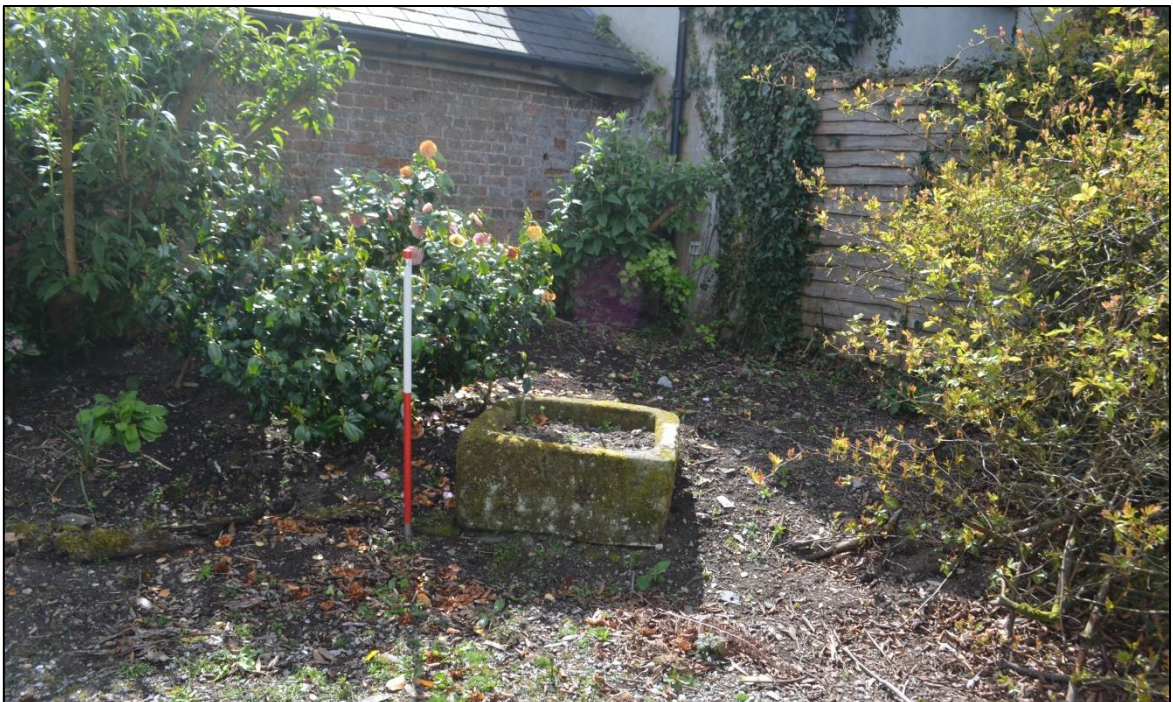
39. Stone trough

A stone trough is sited near the eastern end of Trewithen House. This may be the feature recorded in the CSHER as a medieval cross base previously used to wash beer bottles at the Crown Inn, St Ewe, although the location is slightly different to that given in the CSHER. This feature would however have served that function but appears to resemble a stone trough rather than a medieval cross base.

FIGURE 65: STONE TROUGH TO THE NORTH WEST OF TREWITHEH HOUSE. FROM THE NORTH

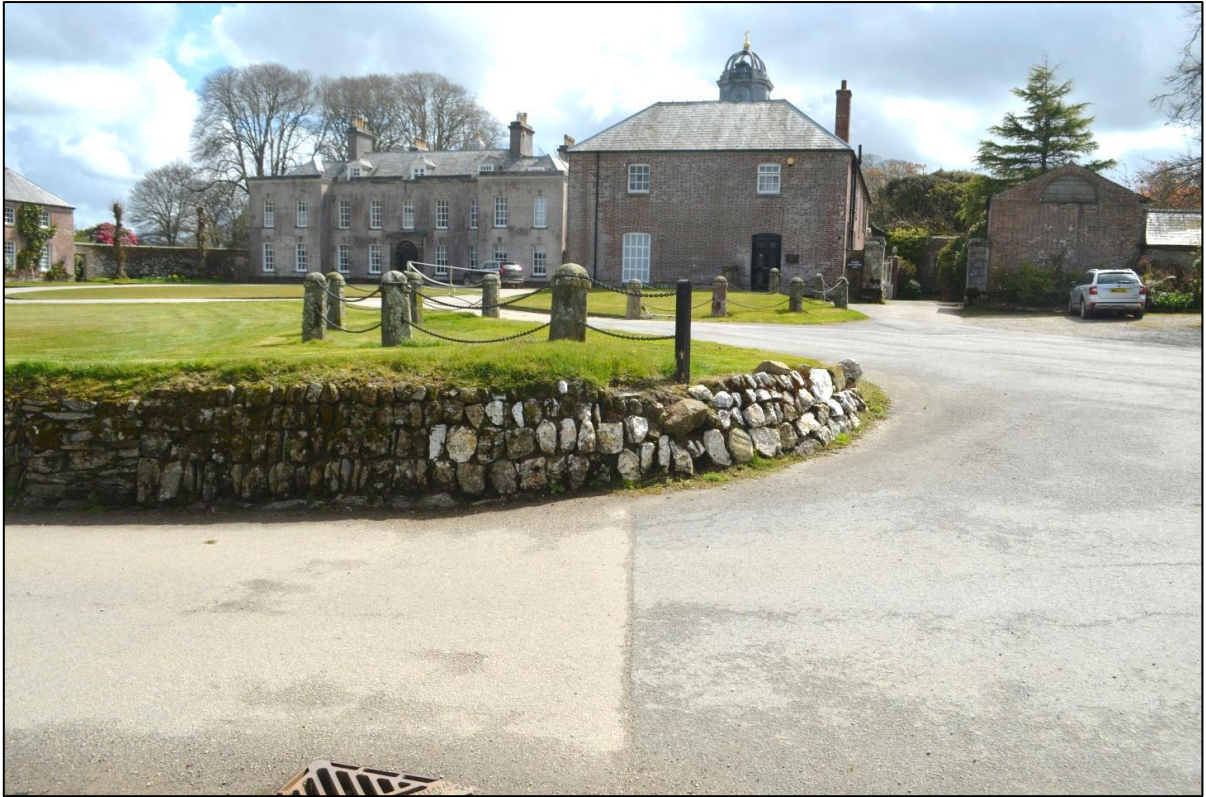
40. A series of low stone posts linked with chains in the location of a curving boundary shown on Ordnance Survey First Edition map

The boundary consists of a series of low stone posts linked with a painted metal chain.

FIGURE 66: SERIES OF POSTS LINKED WITH CHAIN SHOWN IN THE LOCATION OF A CURVED BOUNDARY DEPICTED ON ORDNANCE SURVEY FIRST EDITION MAPPING. FROM THE NORTH

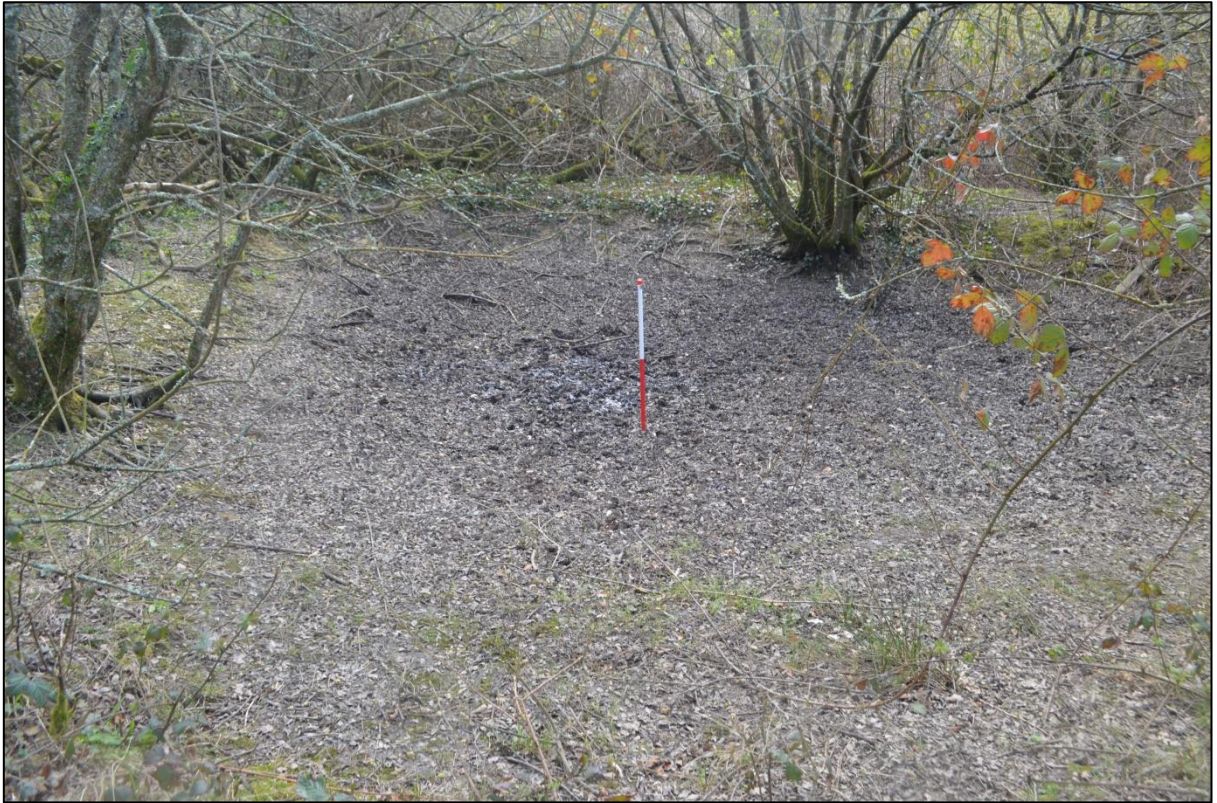
SW 9155 4715

A circular feature identified through LiDAR analysis is a circular hollow c. 6m in diameter. The current Ordnance Survey mastermap shows a pond in this location but no ponds are shown on historic mapping. Although muddy at the base the hollow did not appear to be holding water and was located to the west of the watercourse which flows through this field.

FIGURE 67: CIRCULAR DEPRESSION SHOWN AS A POND ON MODERN MAPPING. FROM THE WEST

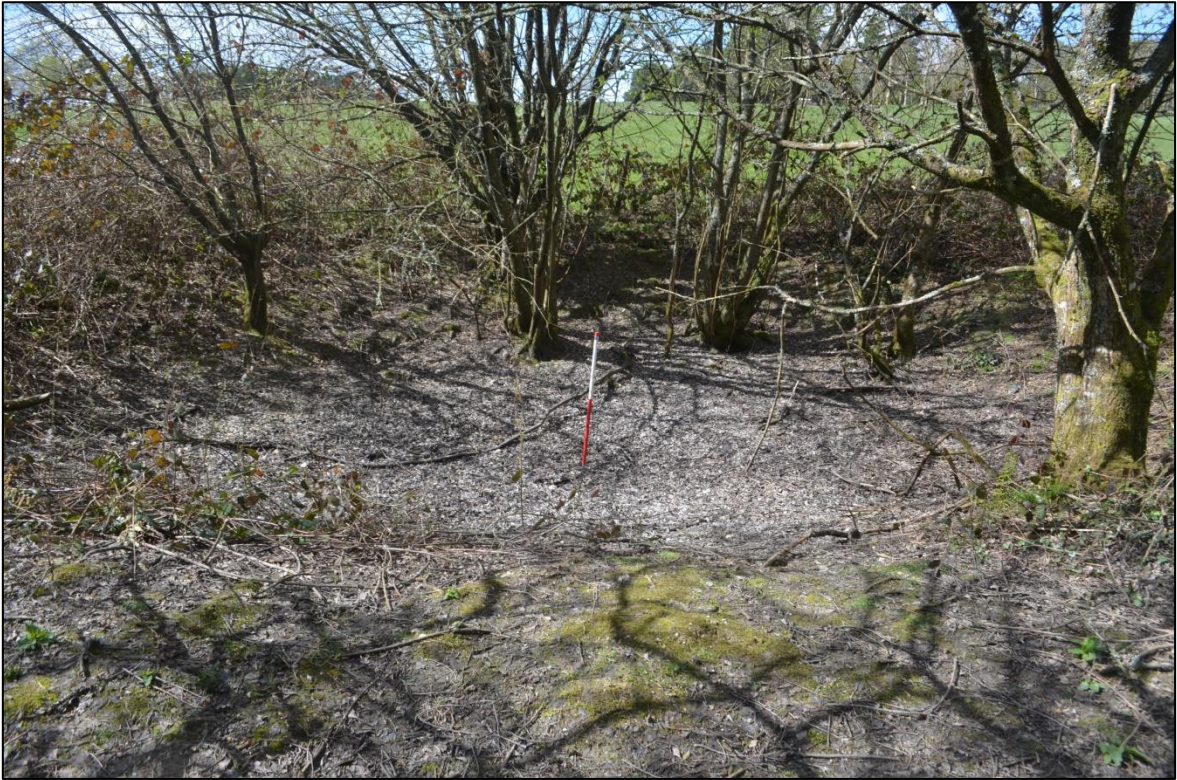
42. Possible pond

An oval feature identified through LiDAR analysis is a hollow c. 10m x 6m. The current Ordnance Survey mastermap shows a pond in this location but no ponds are shown on historic mapping. Although muddy at the base the hollow did not appear to be holding water and was located to the west of the watercourse which flows through this field. Possible spoil from the creation of the pond was thrown around the eastern side to create a curved bank on this side.

FIGURE 68: OVAL DEPRESSION SHOWN AS A POND ON MODERN MAPPING. FROM THE WEST

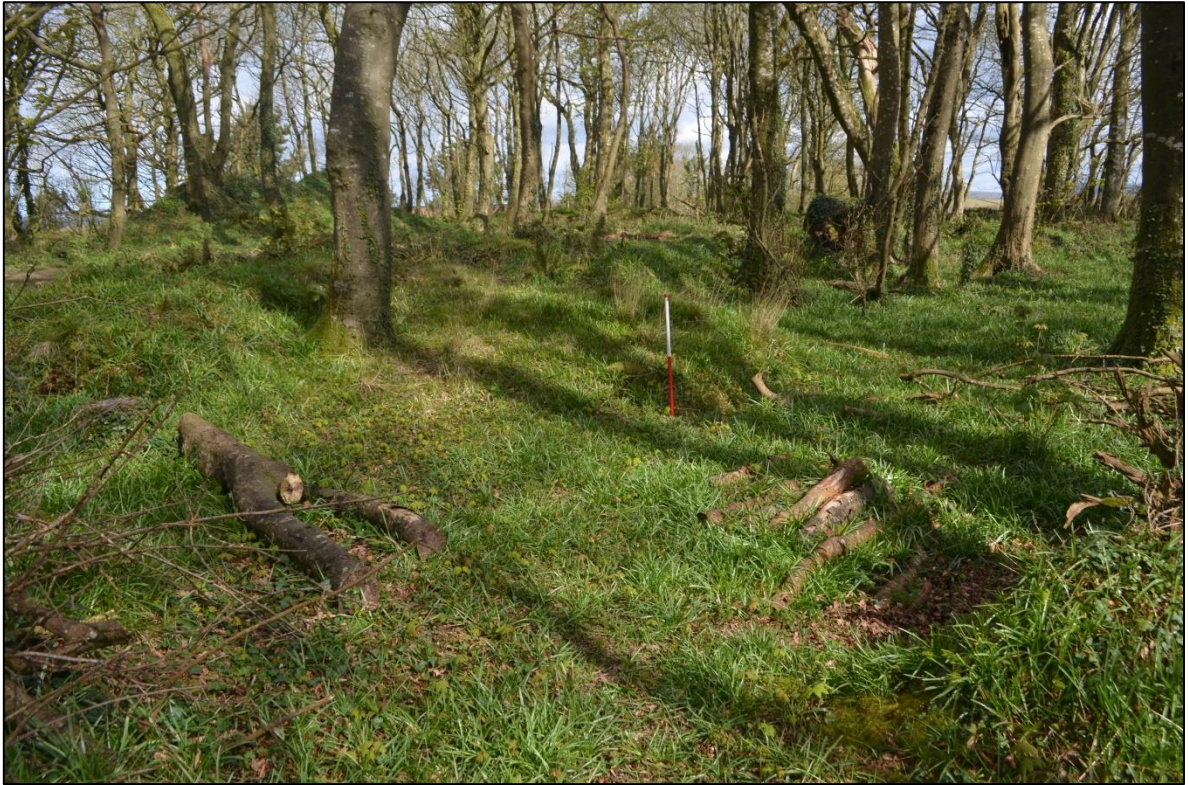
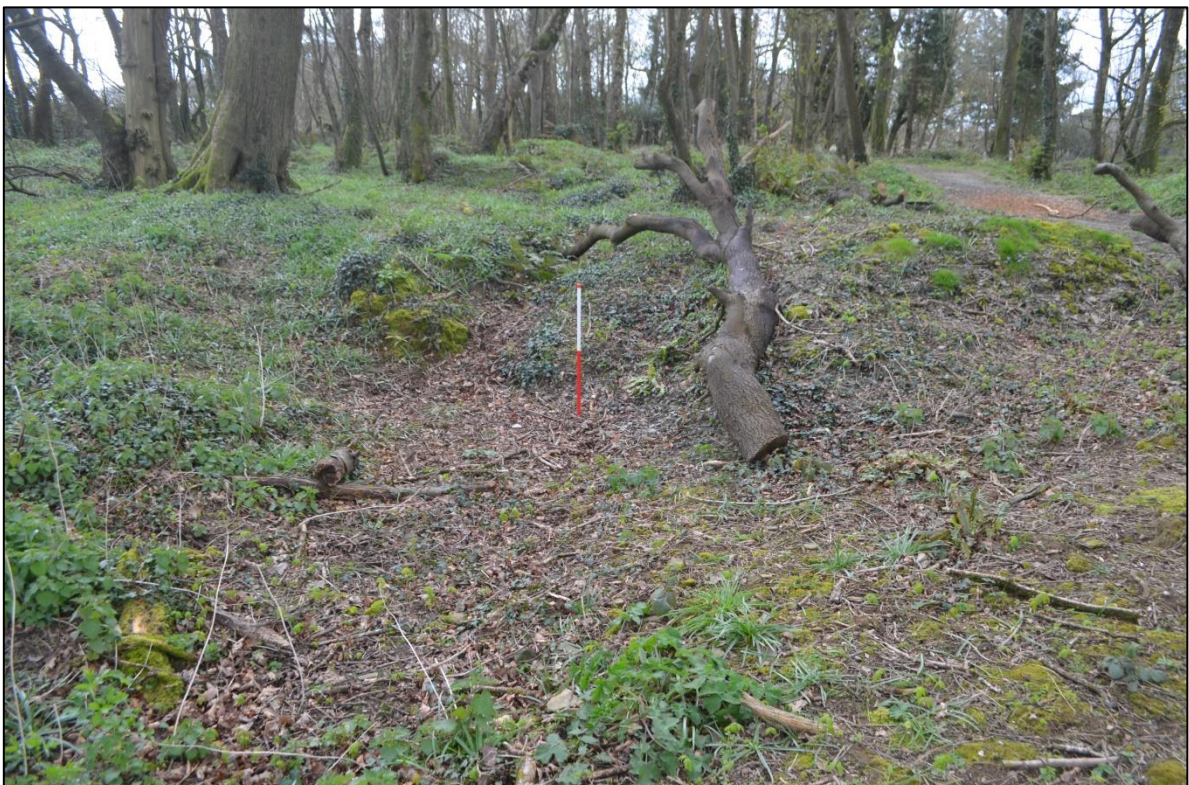
SW 9155 4818

Walkover survey showed extensive historic ground disturbance in this area. Three areas are indicated by hachures on the Ordnance Survey First Edition map. The 1824 St Aubyn plan shows a pond, a spiral mount and a smaller feature within this area although they are not shown on the 1841 plan. It is possible that if they were constructed as shown on the 1824 plan that they were relict by 1841 and therefore not of interest to the tithe survey (which the 1841 map appears to be based on) as that area had become 'plantation' so were therefore not depicted. This may explain their depiction in 1824 and 1879 but not 1841.

FIGURE 69: EARTHWORKS IN THE NORTH EAST OF HALLS CLOSE. THE MOUNT CAN BE SEEN IN THE BACKGROUND ON THE LEFT HAND SIDE OF THE PHOTOGRAPH. FROM THE SOUTH WEST

FIGURE 70: EARTHWORKS IN THE NORTH EAST OF HALLS CLOSE. FROM THE NORTH EAST

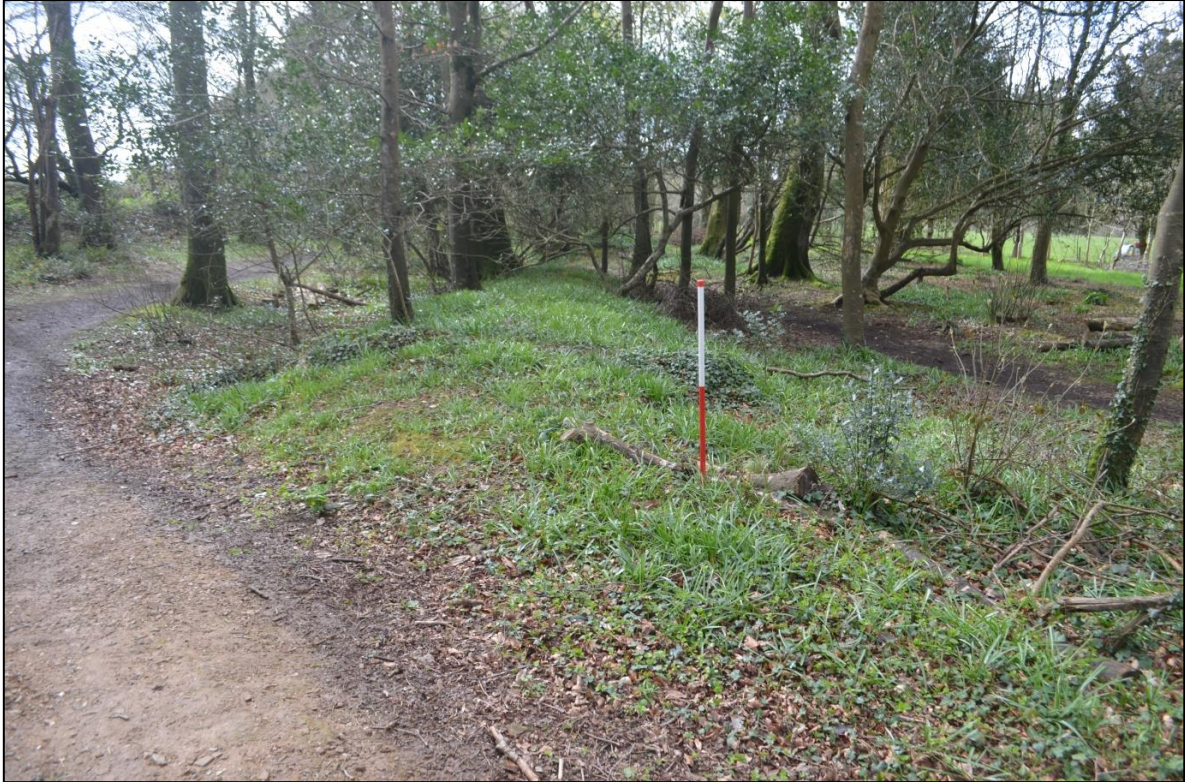
44. Section of boundary shown on First Edition Ordnance Survey map
SW 9155 4815

A short section of boundary first shown on the Ordnance Survey First Edition map is visible in woodland in the north east of Halls Close. The earthwork bank survives to a low height.

FIGURE 71: SECTION OF LOW EARTHWORK BANK IN LOCATION OF A BOUNDARY FIRST SHOWN ON THE 1879 ORDNANCE SURVEY MAP. FROM THE NORTH

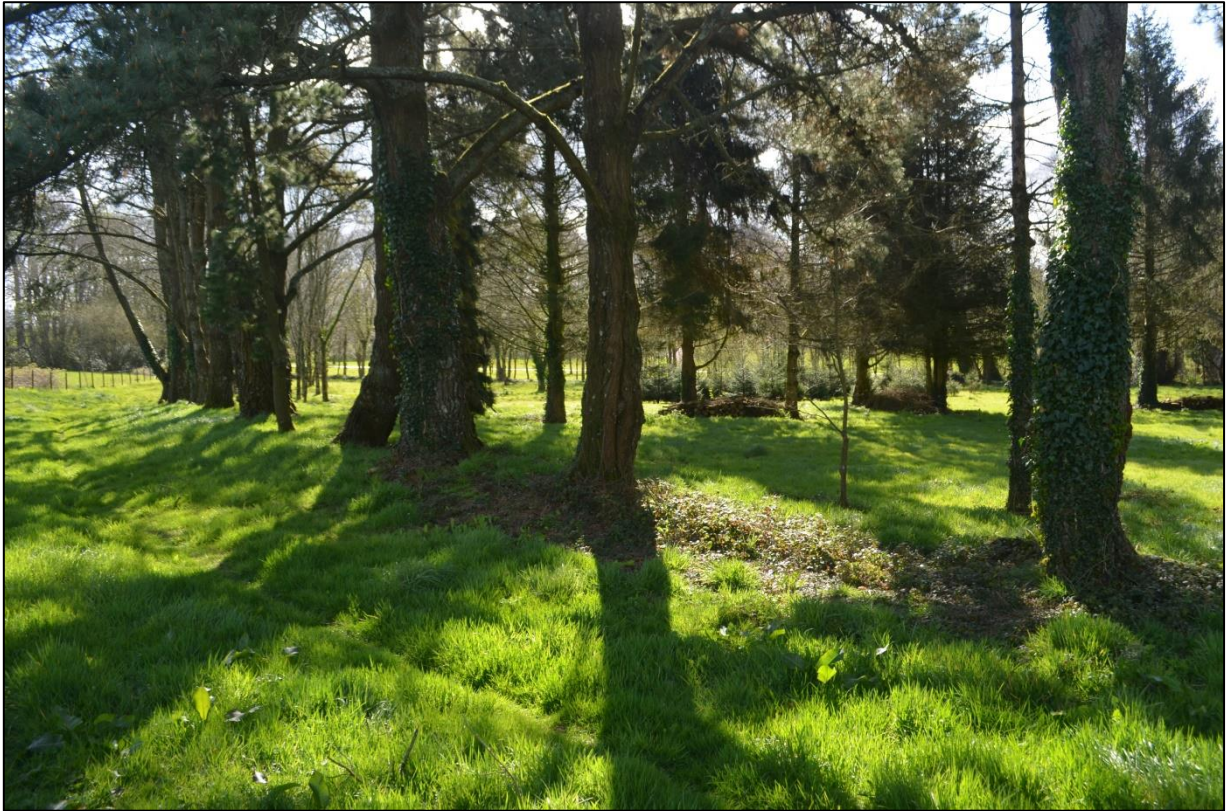
A line of trees was noted planted along a slight bank at the boundary between a field and plantation in the north eastern area of Home Farm.

FIGURE 72: SLIGHT BANK WITH LINE OF TREES PLANTED, TO THE NORTH EAST OF THE HOME FAR. FROM THE NORTH

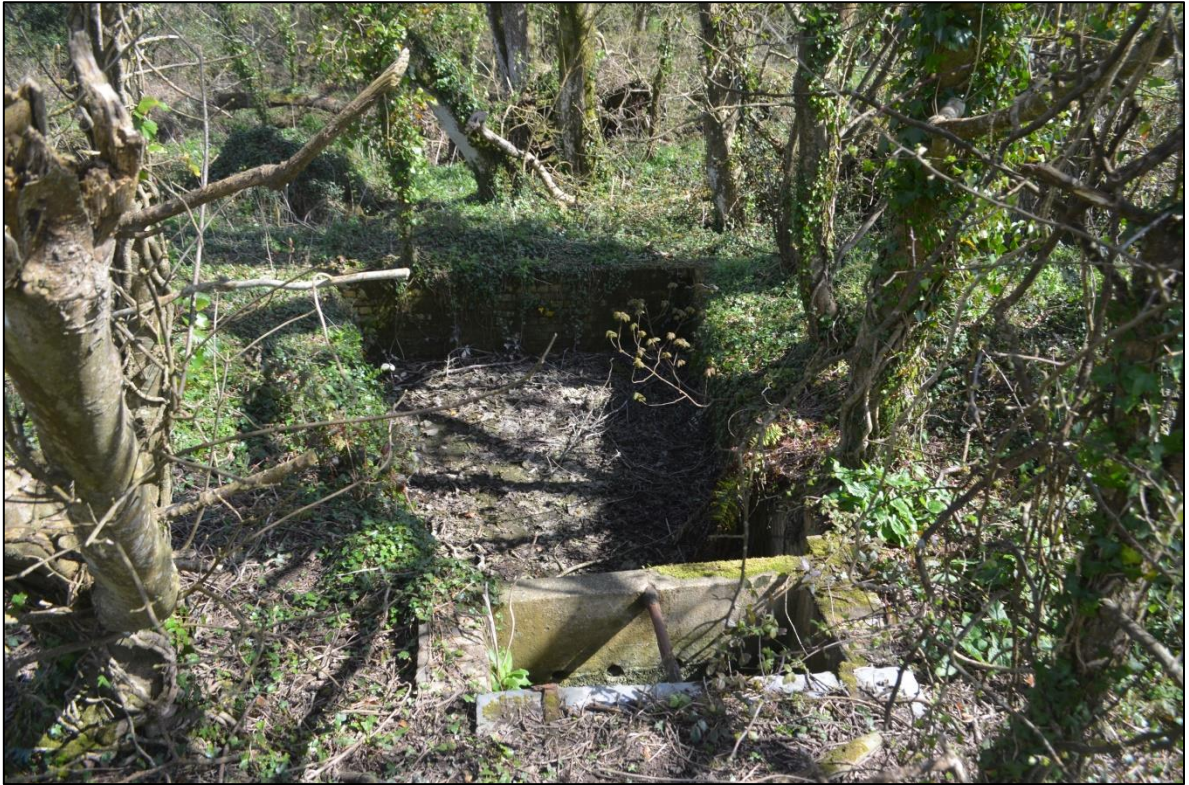
SW 9155 4743

A rectangular hollow or depression visible on LiDAR imagery within Undertown is a brick lined pond or tank c.10m x 5m. It appeared to be empty and had a concrete element at its western end suggesting this feature is of modern date but unknown function. It is in area of the field which has been fenced and a number of trees are growing around it.

FIGURE 73: BRICK POND OR TANK LOCATED IN UNDERTOWN. FROM THE WEST

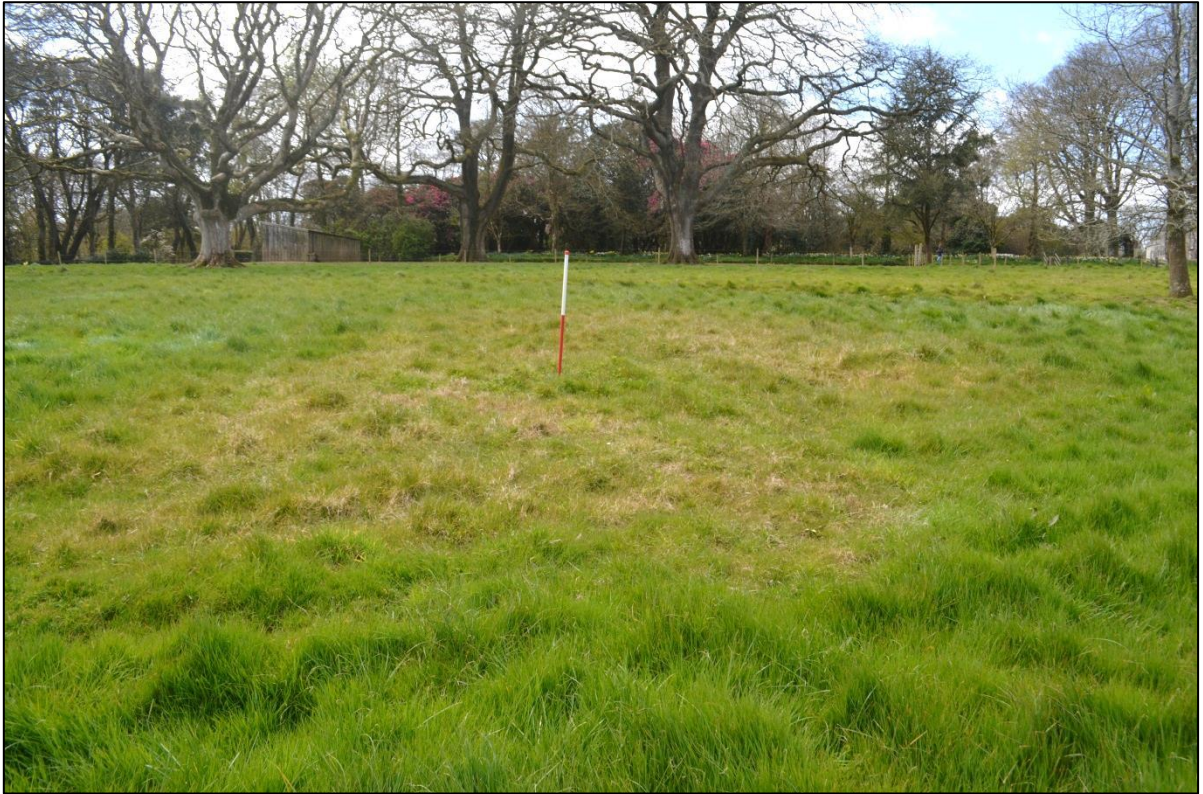
49. Mound

A slight ring shaped mound with a small dip in centre is located on the western side of Undertown. The mound is approximately 7m diameter. A 'crop mark' has been created in the grass growing on the mound which is poorer and yellowed in comparison to the dark green grass which surrounds it. This suggests a significant quantity of stone is located just below the surface of the mound. There is a possible gap in the ring on the northern side. The date and function of this mound is unclear although its location, just to the east of a modern trackway through the field suggests it could be a modern dump of rubble.

FIGURE 74: MOUND LOCATED ON THE WESTERN SIDE OF UNDERTOWN. DIFFERENTIAL GRASS GROWTH IS NOTICEABLE ON THE MOUND WITH A POSSIBLE GAP IN THE 'RING' ON THE RIGHT SIDE OF THE RANGING POLE

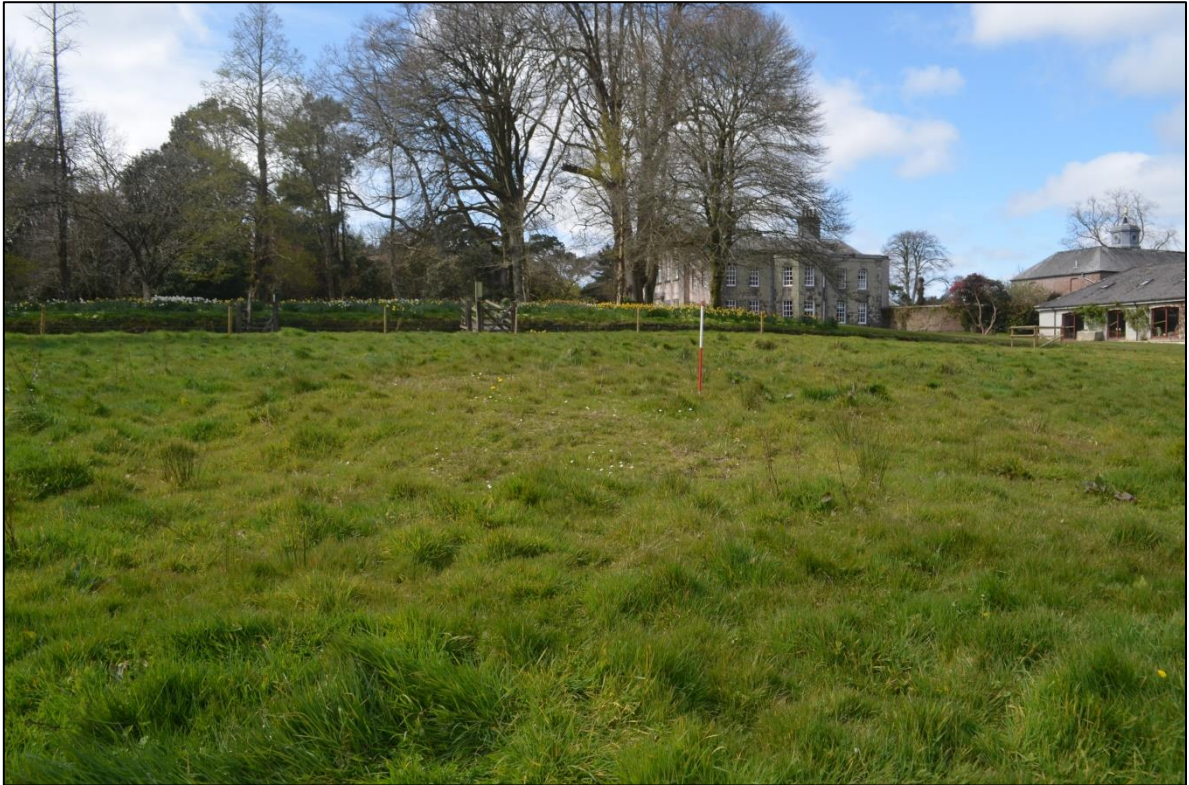
50. Mound

An approximately circular slight mound c.10m diameter is located to the western side of Undertown, close to the Ha-ha which forms the eastern extent of Trewithen Gardens. The mound is slightly pointed towards its eastern side. There does not appear to be any apparent built form and it may be a tree mound.

FIGURE 75: APPROXIMATELY CIRCULAR SLIGHT MOUND LOCATED ON THE SOUTH EAST OF TREWITHEN HOUSE; FROM THE EAST.

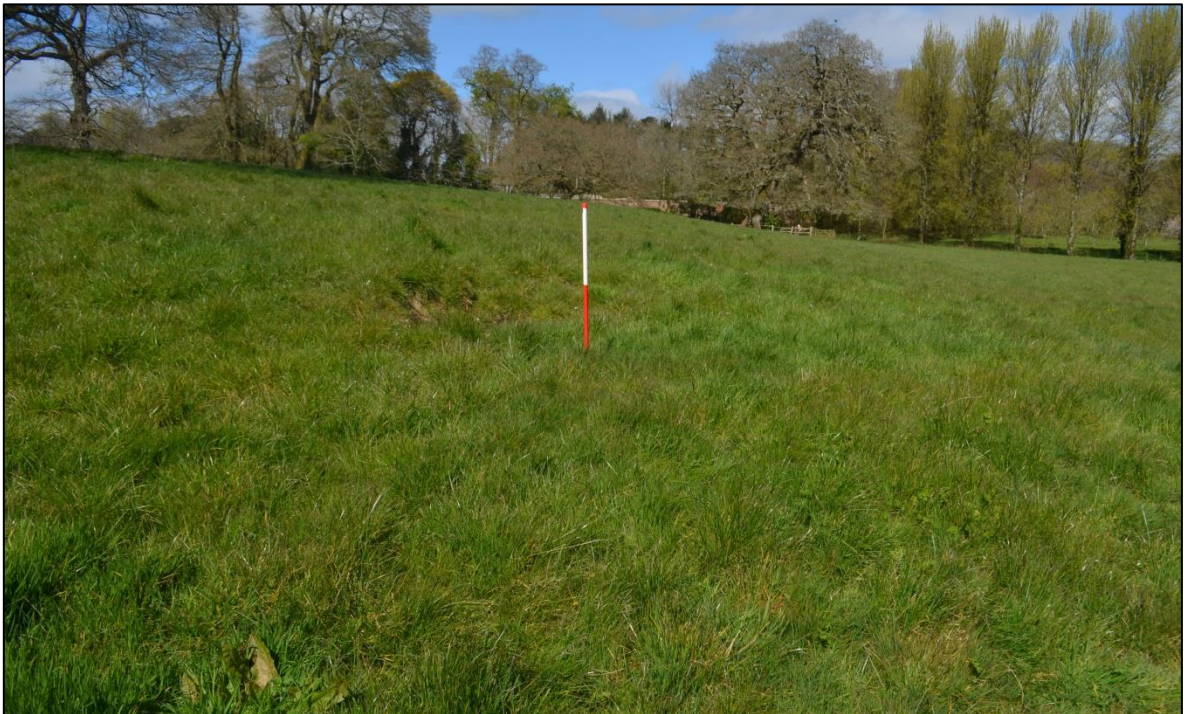
51. Possible hollow or depression visible on LiDAR imagery

A hollow or depression visible on LiDAR imagery within Undertown is possibly a historic tree throw. It comprises a circular hollow approximately 2.5m diameter. It is straighter on north side and appears to be in line with other historic trees.

FIGURE 76: POSSIBLE HISTORIC TREE THROW NEAR TO THE WATERCOURSE IN UNDERTOWN; FROM THE SOUTH EAST

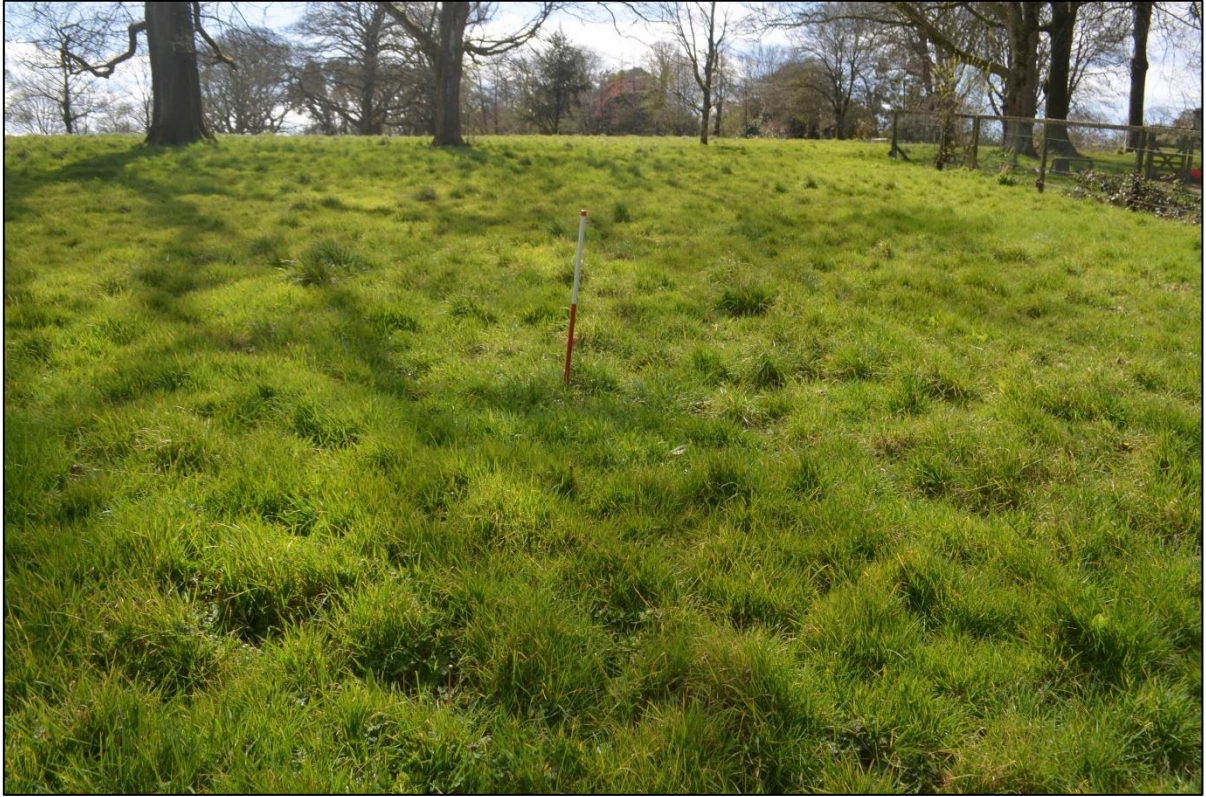
52. Possible hollow or depression visible on LiDAR imagery

A hollow or depression visible on LiDAR imagery within the northern area of Undertown is possibly a historic tree throw. It comprises a circular hollow approximately 3.5m in diameter.

FIGURE 77: POSSIBLE HISTORIC TREE THROW CLOSE TO THE NORTHERN EDGE OF UNDERTOWN; FROM THE NORTH EAST.

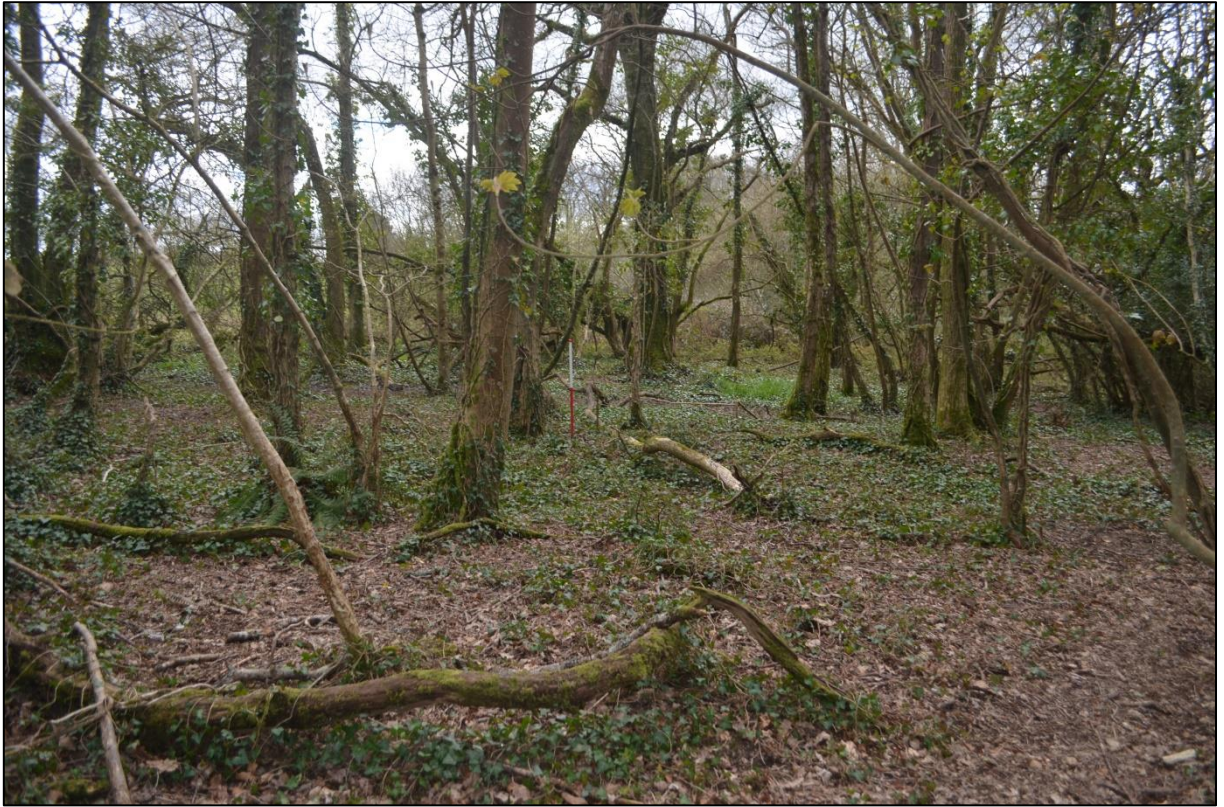
SW 9161 4719

A narrow strip of east –west oriented ridges are visible on LiDAR imagery within a wooded area on the western side of Tredinham Fields. This area appears to have been planted with trees between 1879 and 1905. Slight ridges are visible in this area with approximately 6m between centres of ridge tops. These appear likely to relate to tree planting in this area rather than historic ploughing.

FIGURE 78: SLIGHT RIDGES VISIBLE IN THE WOODLAND TO THE WEST OF TREDINHAM FIELDS. FROM THE NORTH

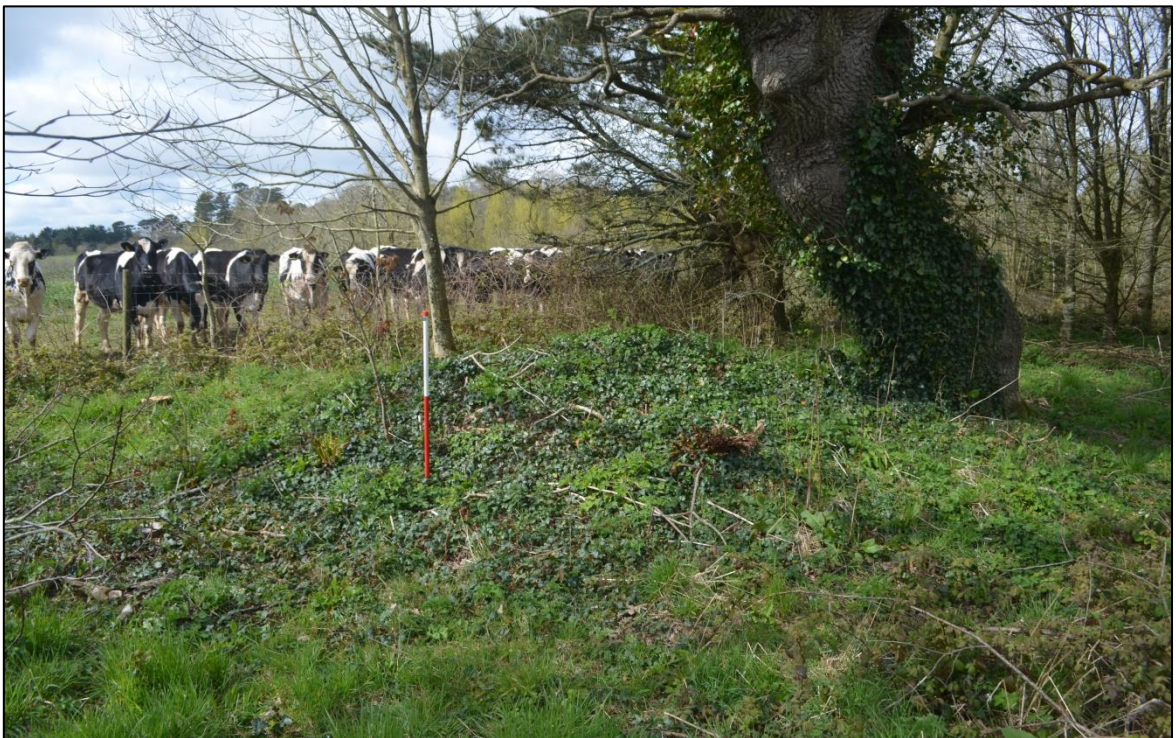
A vegetation covered oval shaped stone rubble and earth mound c. 5m x 3m x 1m was noted in a wooded area at the north of Tredinham Fields. The date and function of this mound are unknown. It is possible it could represent historic animal burrowing.

FIGURE 79: OVAL SHAPED MOUND IN THE NORTH OF TREDINHAM FIELDS. FROM THE NORTH WEST.

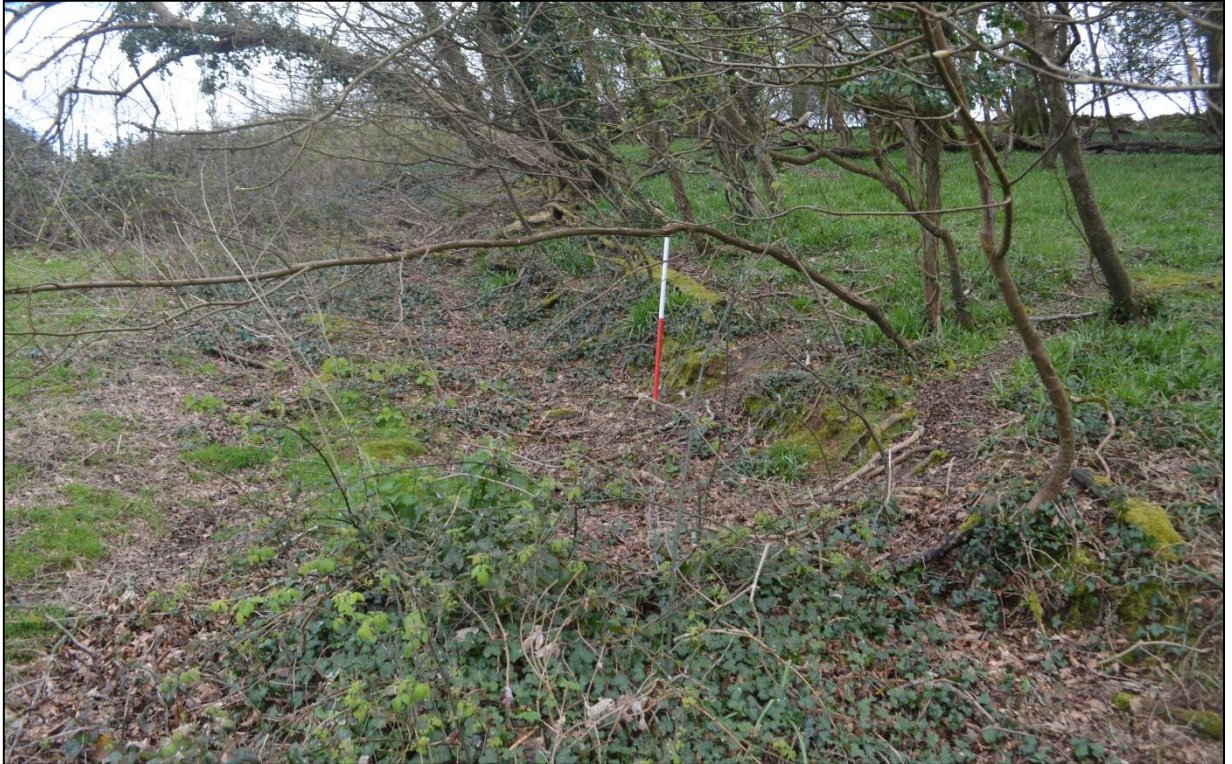
SW 9168 4711

A slight linear earthwork suggests a possible historic boundary feature which does not appear to be shown on any available historic maps, located in a wooded area at the south of Tredinham Fields.

FIGURE 80: POSSIBLE HISTORIC BOUNDARY FEATURE IN THE SOUTH OF TREDINHAM FIELDS. FROM THE WEST

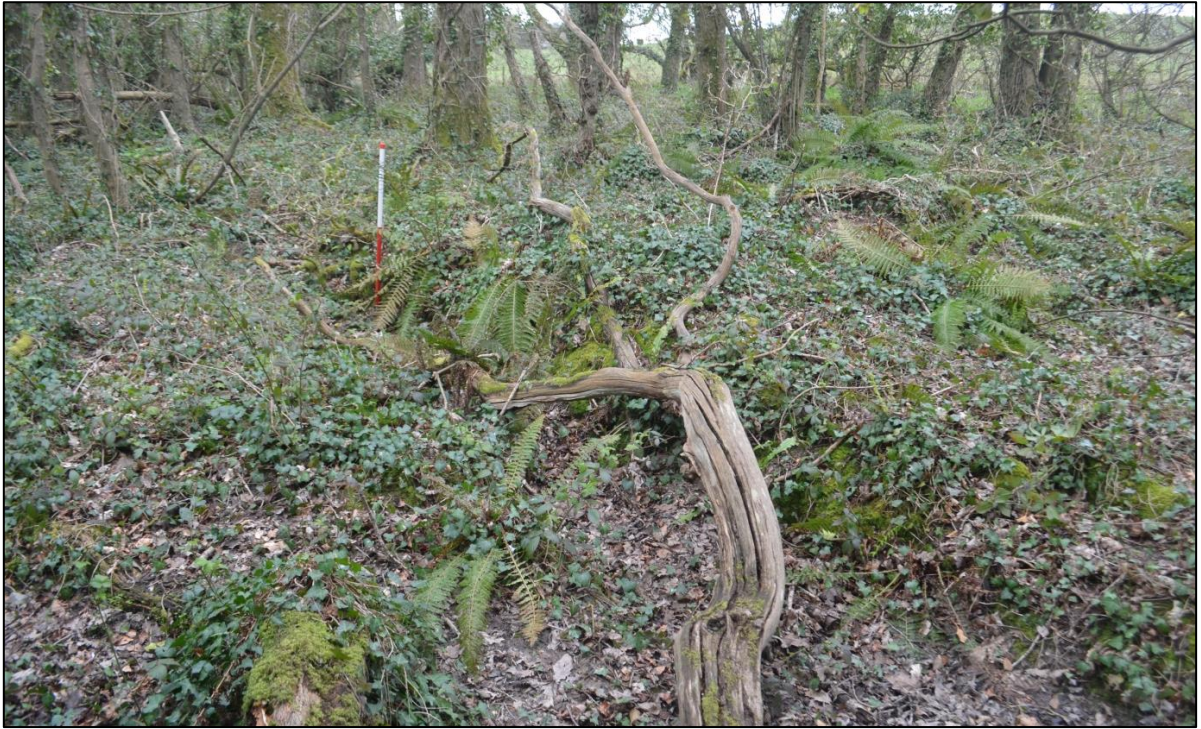
56. Linear cut feature

A linear cut feature c. 5m x 1m x 0.5m is located in a wooded area on the western side of Tredinham Fields. It is oriented diagonally across the slope, running toward the watercourse. It does not appear to have an obvious function; it may be a drain although it appears to begin in the middle of the sloping ground. It is covered with fallen branches and ground vegetation.

FIGURE 81: SLIGHT LINEAR CUT FEATURE IN WOODLAND ON THE WESTERN SIDE OF TREDINHAM FIELDS. FROM THE WEST.

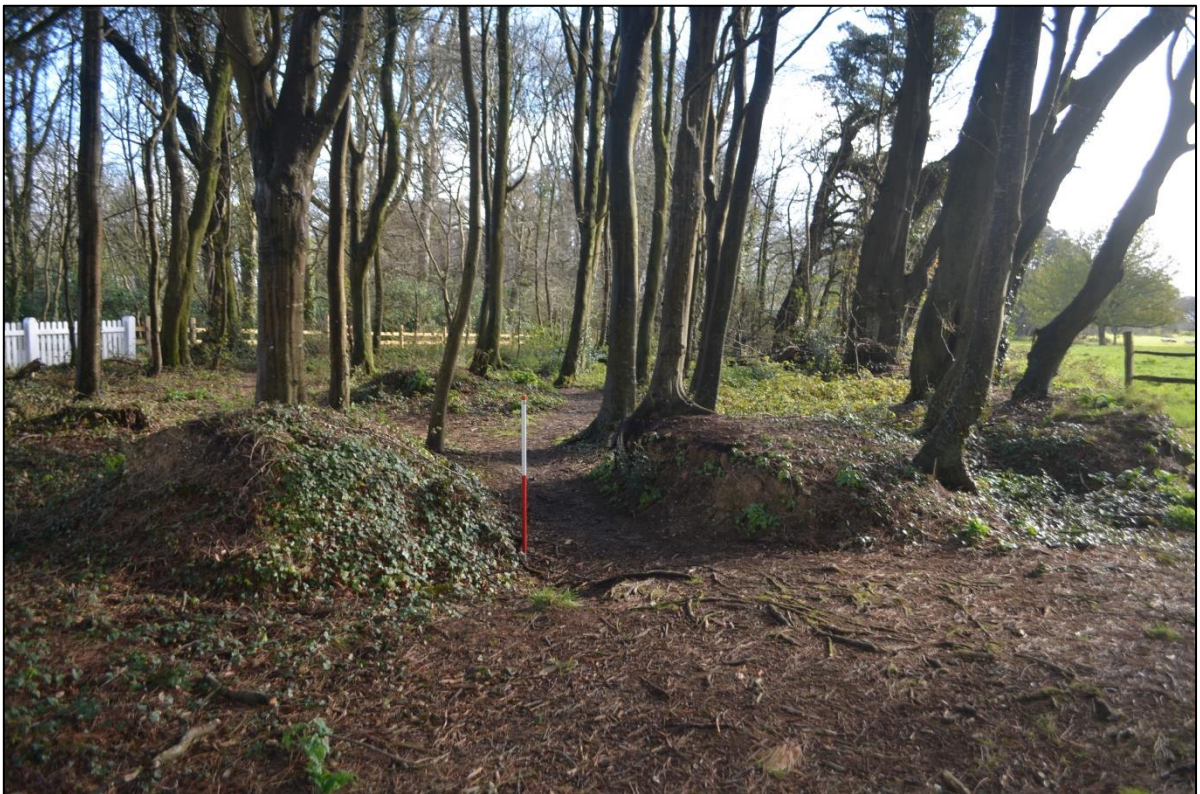
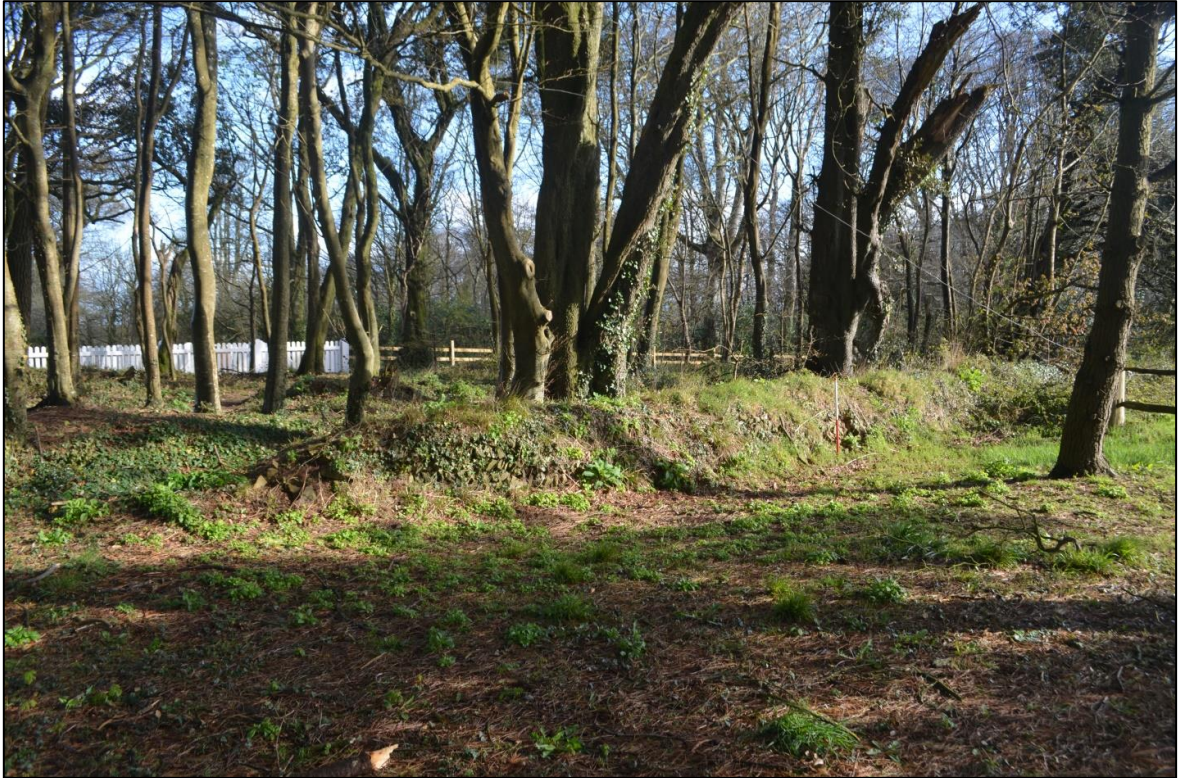
Boundary 1	
Type	Cornish Hedge Bank
Date	Unknown
Condition	Acceptable
Description	Cornish hedge bank >1m in height. Western end appears to be more of an earth bank.
Notes	Western end appears eroded/cut through by a trackway through the small woodland which this boundary encloses.

FIGURE 86: WESTERN END OF BOUNDARY CUT BY A TRACKWAY THROUGH THE SMALL WOODLAND WHICH IT ENCLOSES. FROM THE SOUTH.

FIGURE 87: BOUNDARY VIEWED FROM THE SOUTH

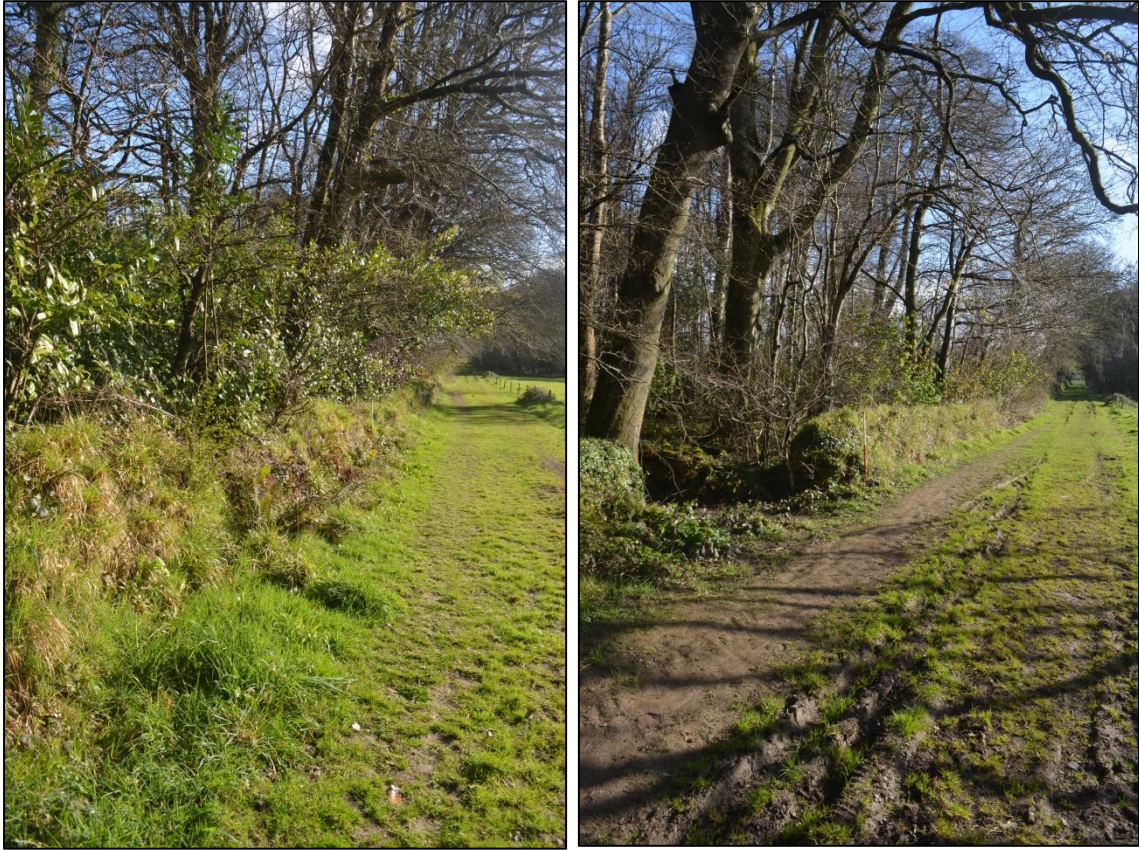
Boundary 2	
Type	Cornish Hedge Bank
Date	Before 1879
Condition	Acceptable
Description	Stone and earth bank topped in places by a hedge. Generally covered in vegetation.
Notes	Some areas of erosion visible, possibly caused by animal activity.

FIGURE 88: (L) BOUNDARY 2, VIEWED FROM THE SOUTH. FIGURE 89 (R): BOUNDARY 2 FROM SOUTH SHOWING BREAK IN BANK.

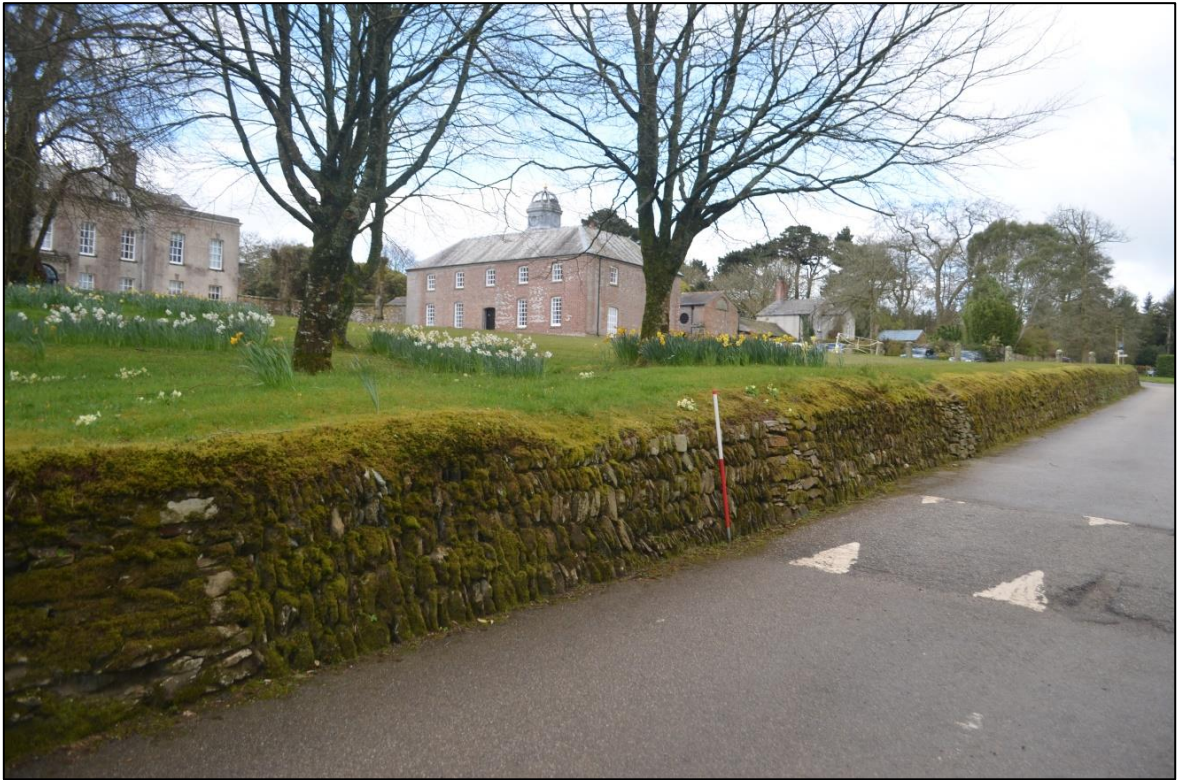
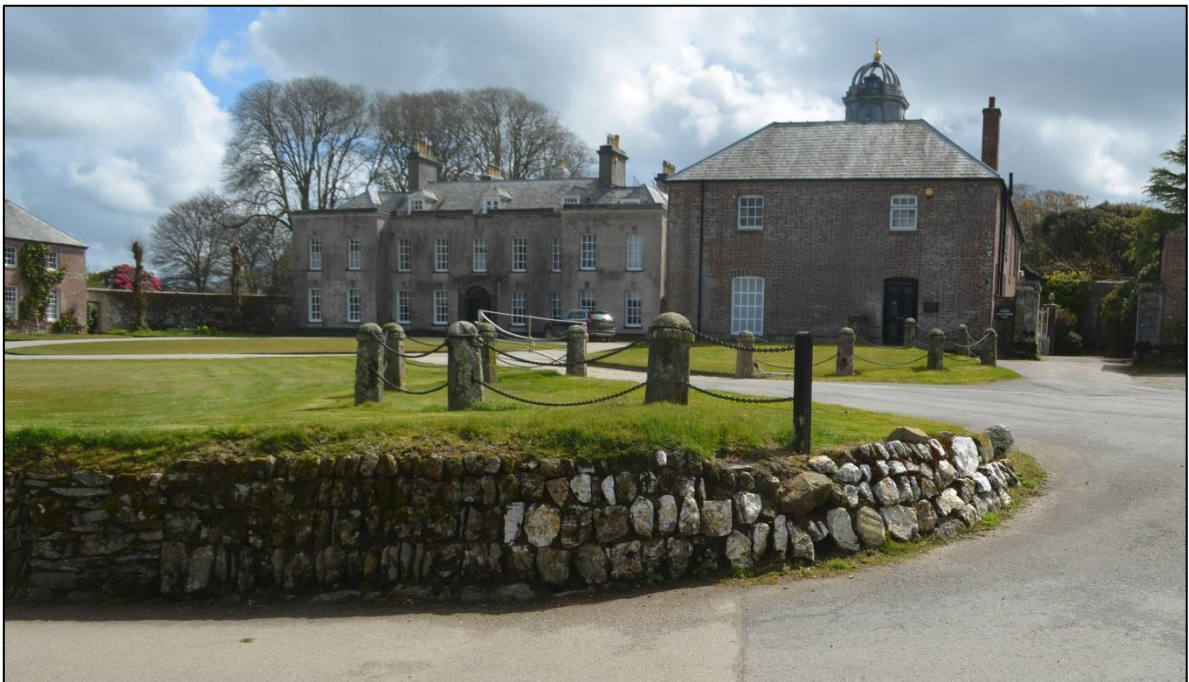
Boundary 3	
Type	Ha-ha
Date	Before 1841
Condition	Good
Description	Stone faced ha-ha to the north of Trewithen House on the south side of the access drive
Notes	Quartz blocks used by entrance to house.

FIGURE 90: HA-HA TO THE NORTH OF TREWITHEH HOUSE. FROM THE NORTH EAST.

FIGURE 91: CURVED END OF HA-HA IN FRONT OF TREWITHEH HOUSE CONSTRUCTED OF QUARTZ BLOCKS. FROM THE NORTH.
