TREWITHEN ESTATE REGISTERED PARK AND GARDEN PROBUS CORNWALL

Archaeological and Historic Landscape Survey

South West Archaeology Ltd. Report no.210524

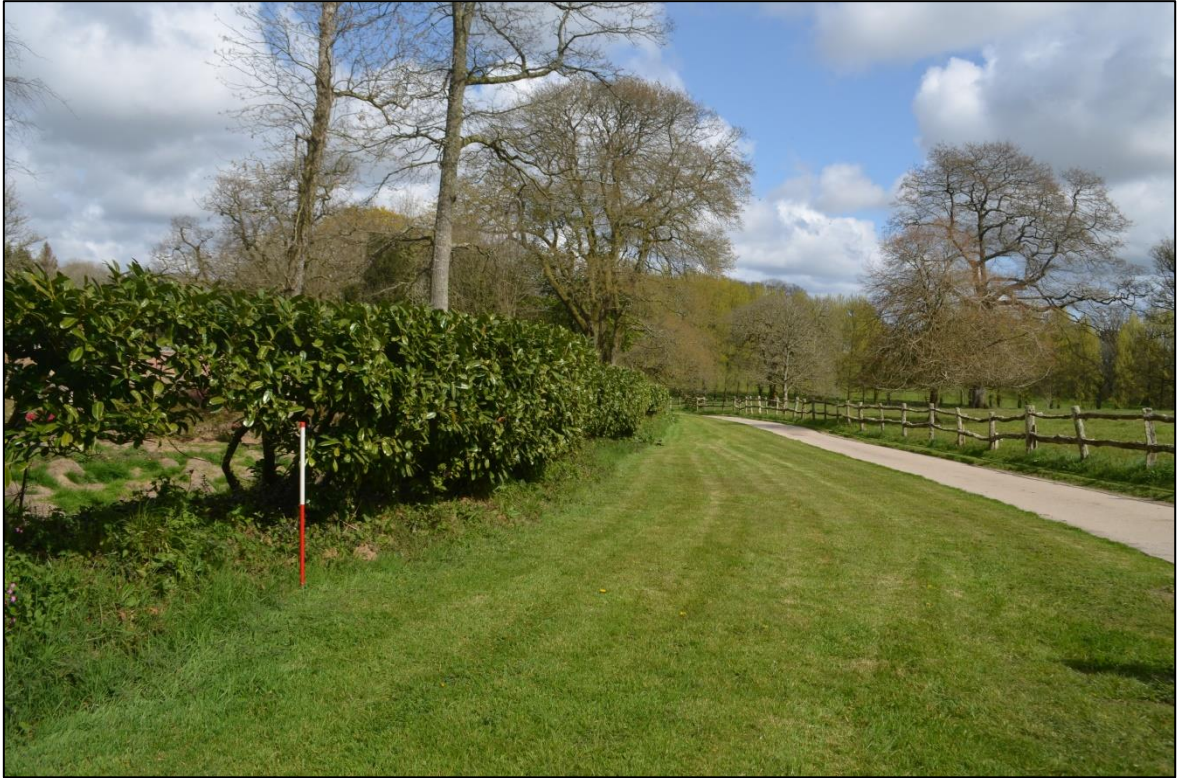
Boundary 4	
Type	Cornish Hedge Bank
Date	Before 1841
Condition	Acceptable
Description	Very slight Cornish Hedge bank topped with laurel hedge

FIGURE 92: SLIGHT CORNISH HEDGE BANK TOPPED WITH LAUREL. FROM THE WEST.

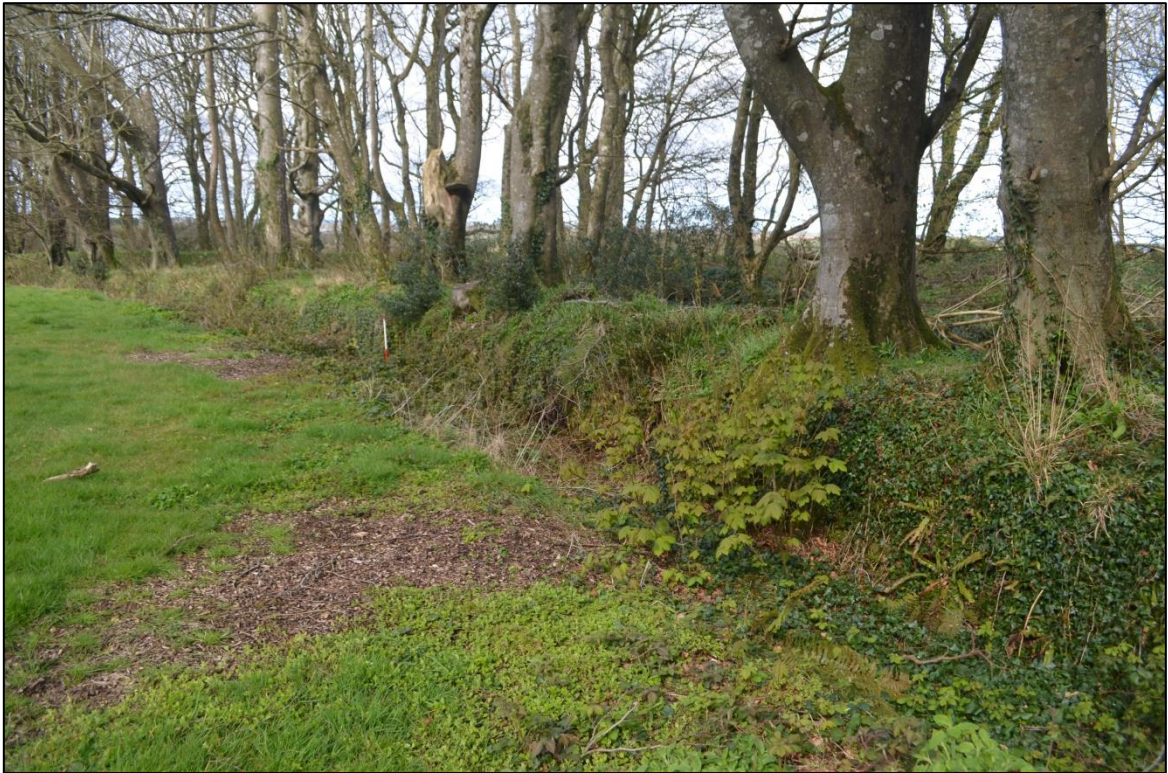
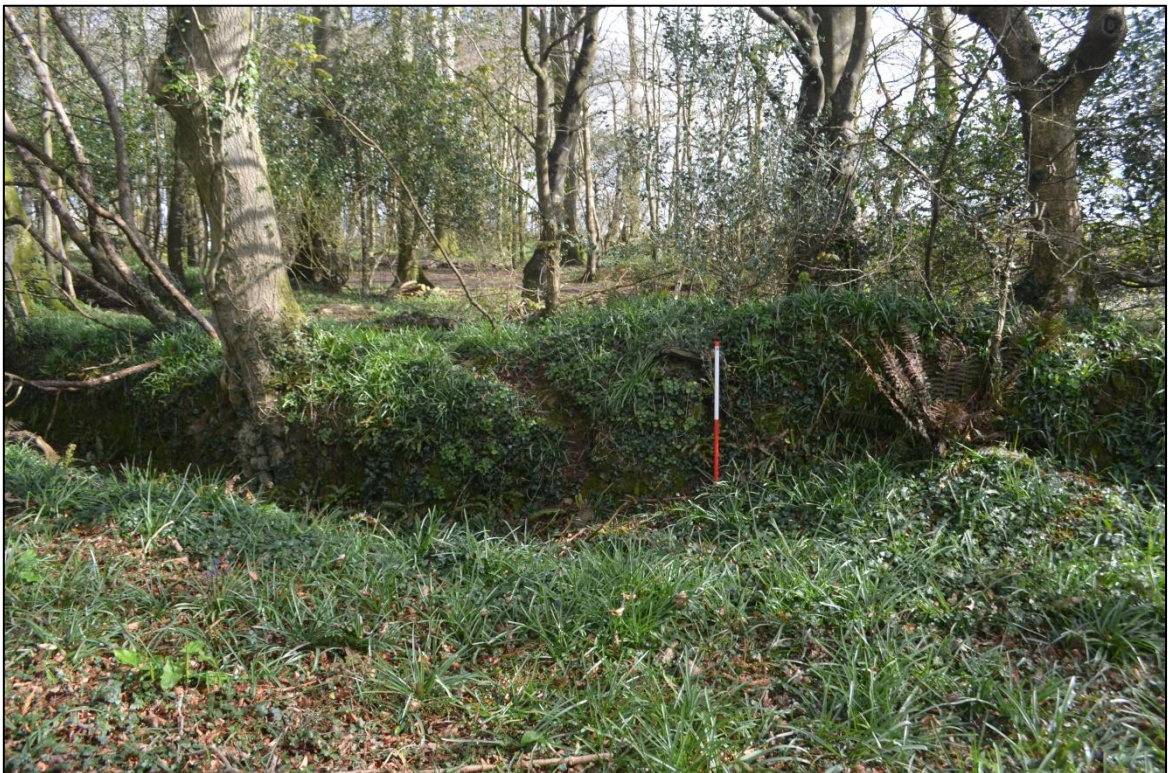
Boundary 5	
Type	Ha-ha/Corn ditch and Cornish Hedge Bank
Date	Before 1841
Condition	Good
Description	Although characterised as a Cornish Hedge Bank this boundary changes in form along its length. It appears more like a Ha-ha at its northern end, with a ditch on its south side. It loses the ditch and rises higher with the ground level along east side of the Registered Park and Garden. Tree topped in places.
Notes	As the boundary straightens along the eastern boundary of the Registered Park and Garden it appears to rise up slightly and loses the ditch noticeable in the northern section. It is possible that this boundary was formed in this way to facilitate views out from a walk or ride which passes close to it back towards Trewithen House. A pond and spiral mount are shown just to the north of this boundary on the 1824 St Aubyn plan.

FIGURE 93: NORTHERN END OF BOUNDARY 5 WHICH RESEMBLES A HA-HA OR CORN DITCH IN FORM. FROM THE SOUTH EAST.

FIGURE 94: CHANGE IN FORM AND LEVEL OF BOUNDARY 5 AS IT STRAIGHTENS ALONG ITS EASTERN SIDE. FROM THE WEST.

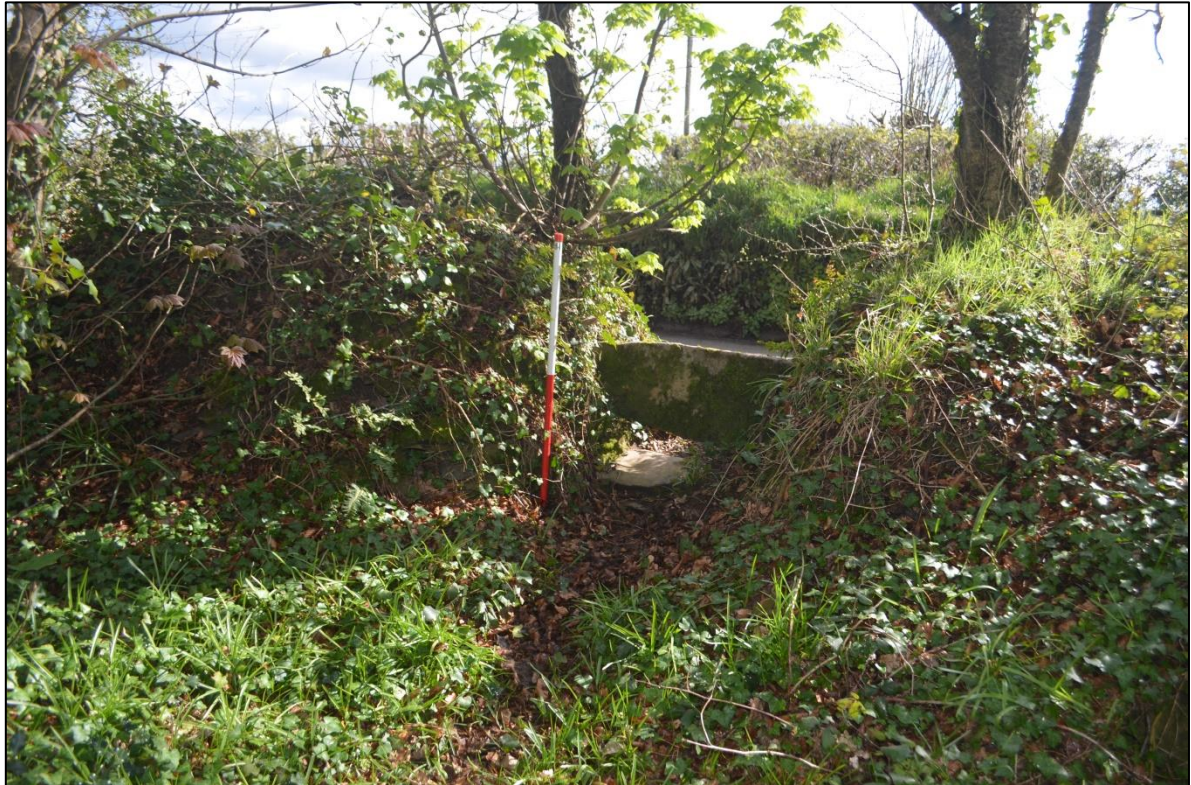
Boundary 6	
Type	Cornish Hedge Bank
Date	Before 1879
Condition	Acceptable
Description	Cornish Hedge Bank topped with a hedge. Forms the eastern boundary of the Registered Park and Garden and runs alongside a local road. A stone stile was noted allowing access from the road.
Notes	Some erosion/slumping of the bank has occurred in places.

FIGURE 95: STONE STILE IN BOUNDARY 6; FROM THE SOUTH WEST.

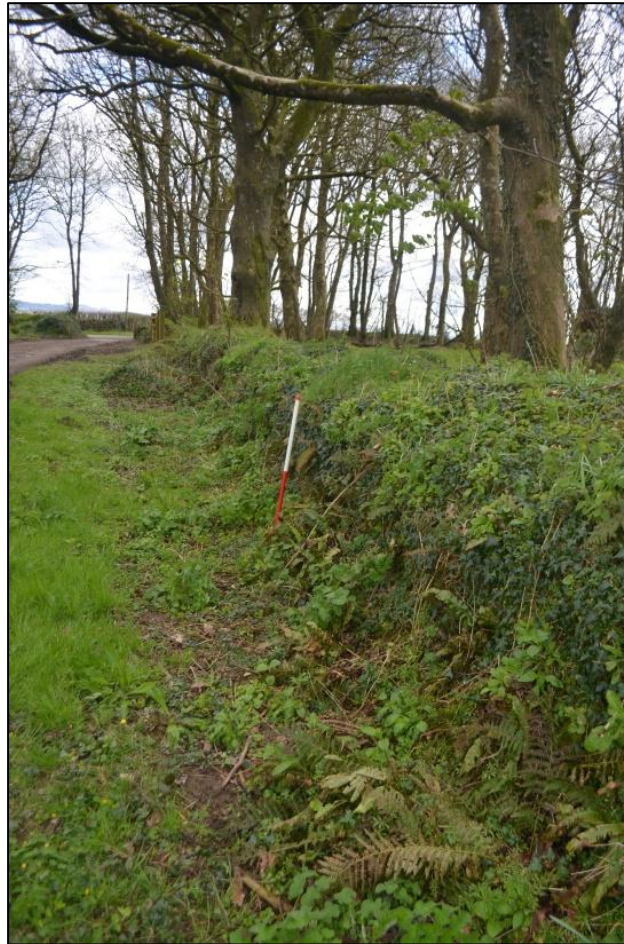
Boundary 7	
Type	Cornish Hedge Bank
Date	Before 1879
Condition	Acceptable
Description	Cornish Hedge Bank topped with a hedge.
Notes	Some erosion of the bank has occurred in places.

FIGURE 96: BOUNDARY 7 FROM THE WEST.

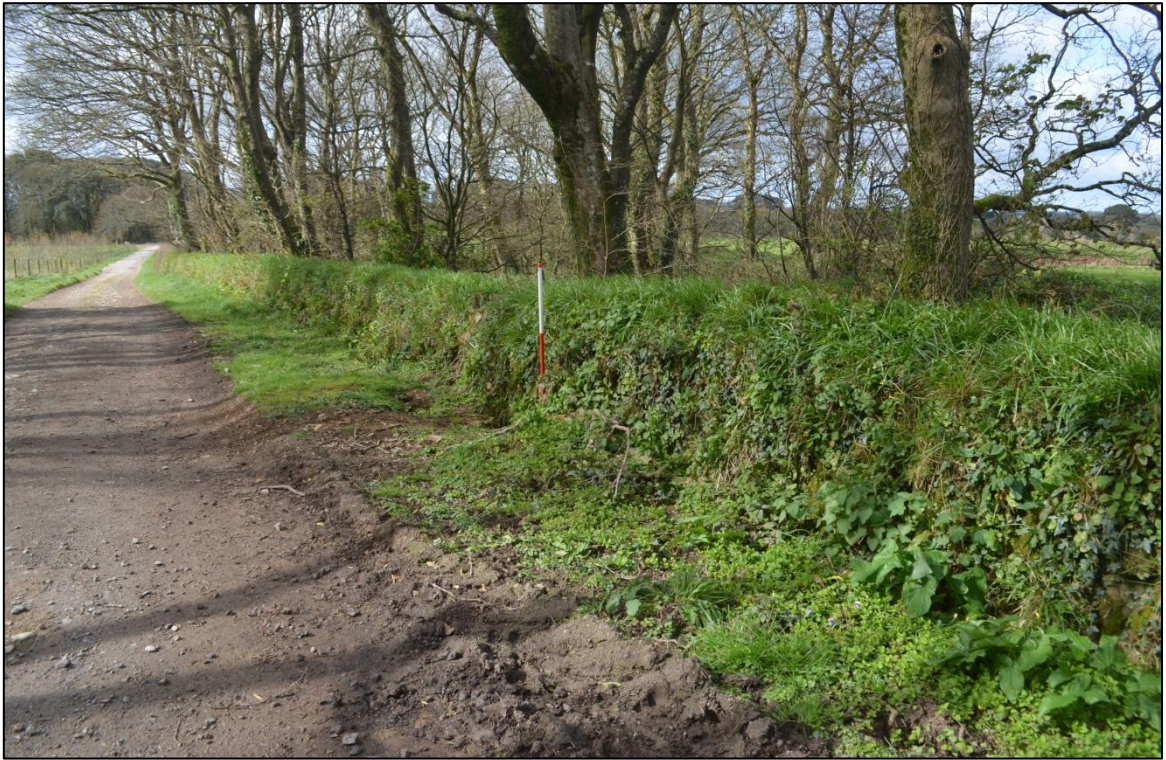
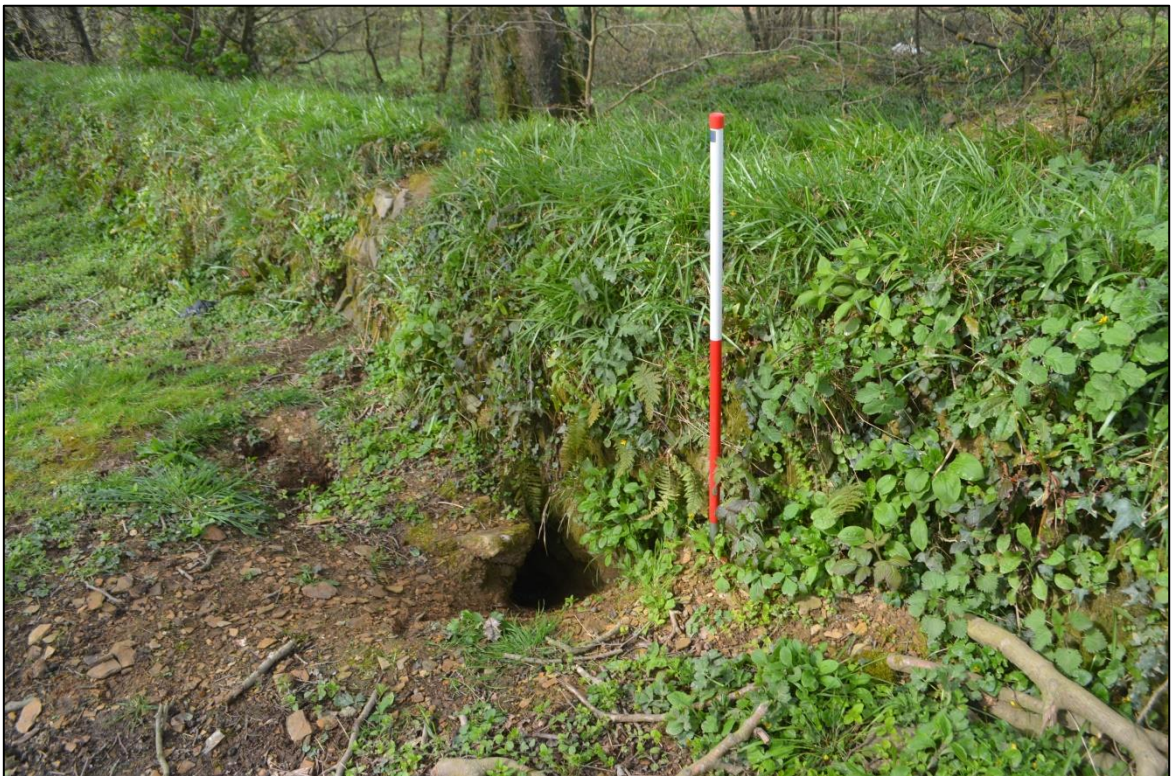
Boundary 8	
Type	Cornish Hedge Bank
Date	Before 1879
Condition	Acceptable
Description	Cornish Hedge Bank with some evidence of animal burrowing below.
Notes	Some evidence of animal burrowing below the bank was observed.

FIGURE 97: BOUNDARY 8 VIEWED FROM THE EAST.

FIGURE 98: EVIDENCE OF ANIMAL BURROWING UNDER BOUNDARY 8. FROM THE SOUTH EAST.

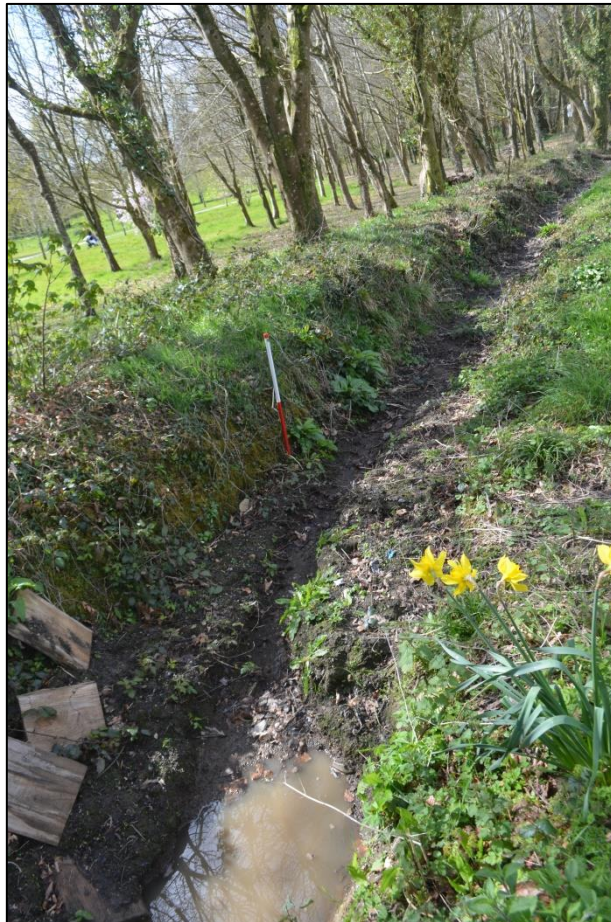
Boundary 9	
Type	Cornish Hedge Bank
Date	Before 1841
Condition	Acceptable
Description	Cornish Hedge Bank with some trees on top. To the east of Trewithen Farm. Vegetation covered.
Notes	The bank is covered with vegetation and fallen trees in some places so it is difficult to discern its condition. A section of mortared stone wall has been added at the eastern end where the bank meets the drive to Kennelgate Bungalow.

FIGURE 99: BOUNDARY 9 VIEWED FROM THE NORTH EAST

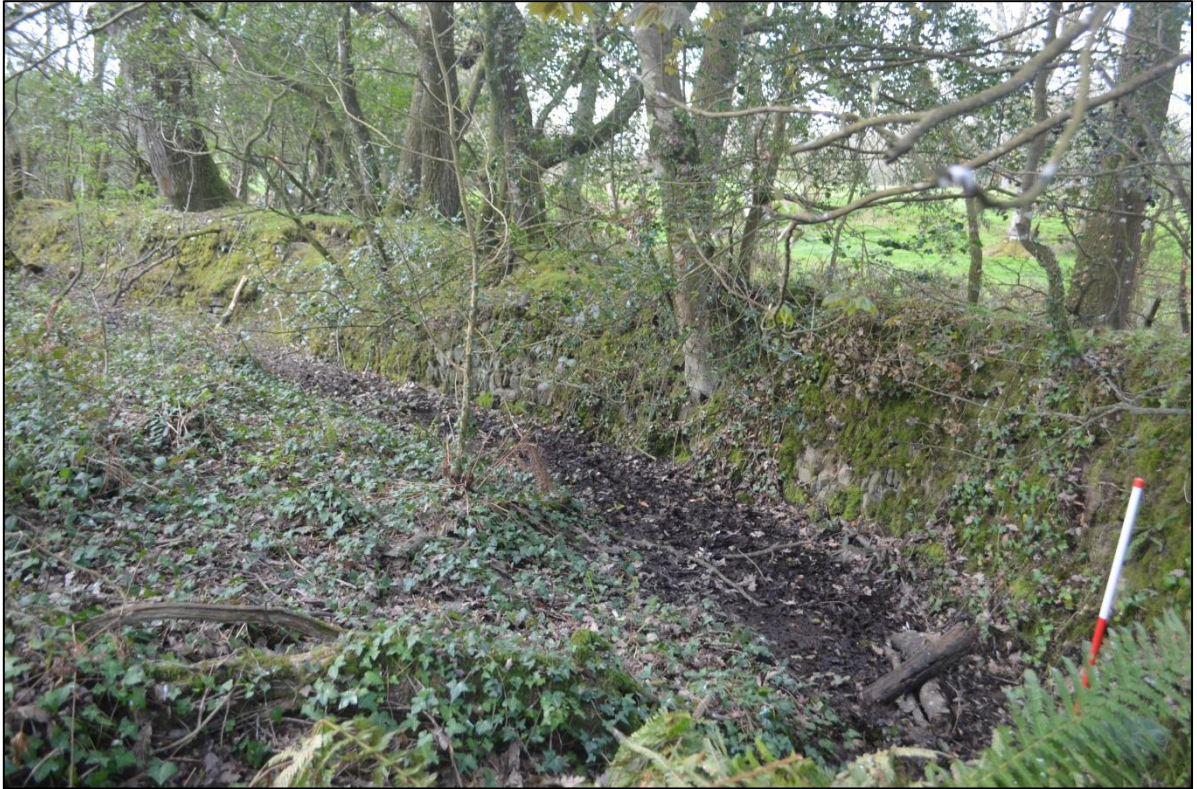
Boundary 10	
Type	Cornish Hedge Bank
Date	Before 1841
Condition	Poor
Description	Cornish Hedge Bank varying in height between c.1.2m and almost ground level where collapsed.
Notes	Recent felling of trees at eastern end of boundary. Bank almost disappears in places but is relatively high in others. Areas of collapse/erosion observed.

FIGURE 100: BOUNDARY 10 FROM THE NORTH.

- A monitoring and repair schedule should be considered for the historic boundaries across the estate. These are in need of regular monitoring and maintenance to prevent decay and/or loss of these features.

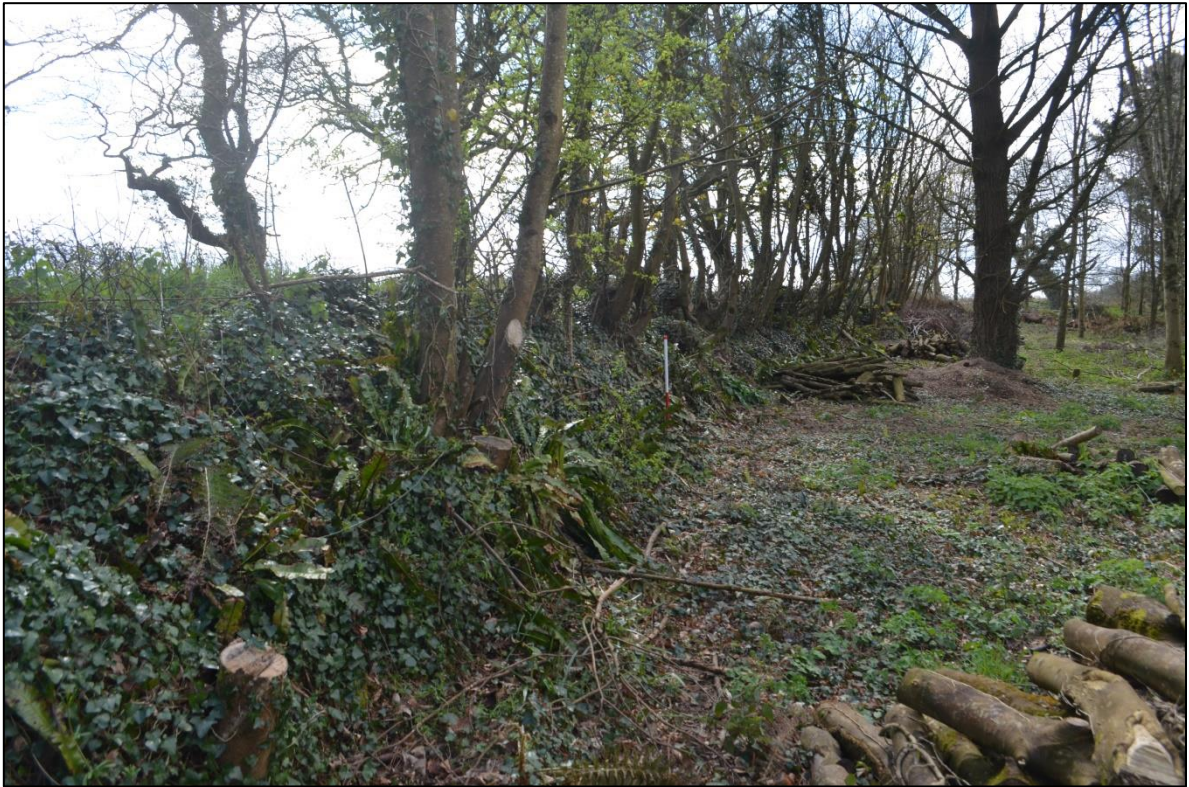
FIGURE 101: BOUNDARY 11 FROM THE NORTH.

Boundary 11	
Type	Cornish Hedge Bank
Date	Before 1747
Condition	Acceptable
Description	Cornish Hedge Bank, tree topped along much of its length. Forms part of the eastern boundary of the Registered Park and Garden, running alongside a local road.
Notes	A recent breach in the bank was observed at the far southern end which appears to permit access through.

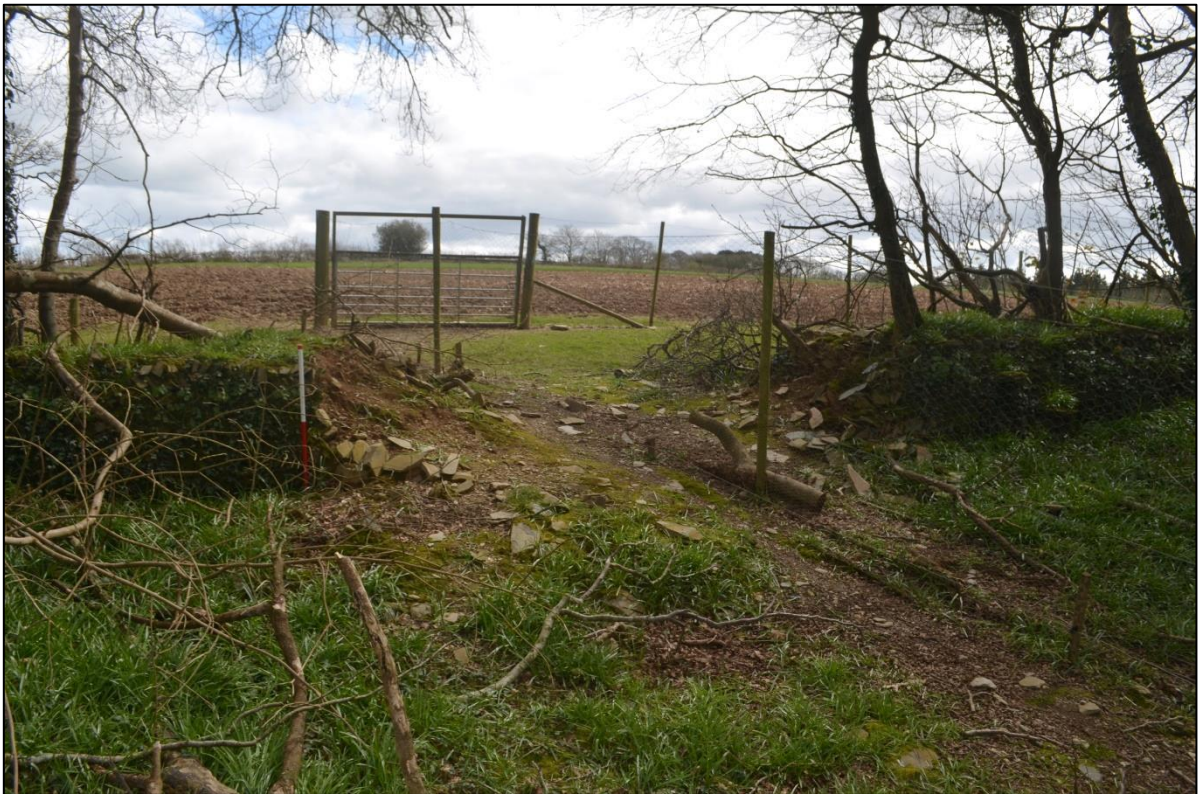
FIGURE 102: RECENT BREACH IN BOUNDARY 11 AT ITS SOUTHERN END.

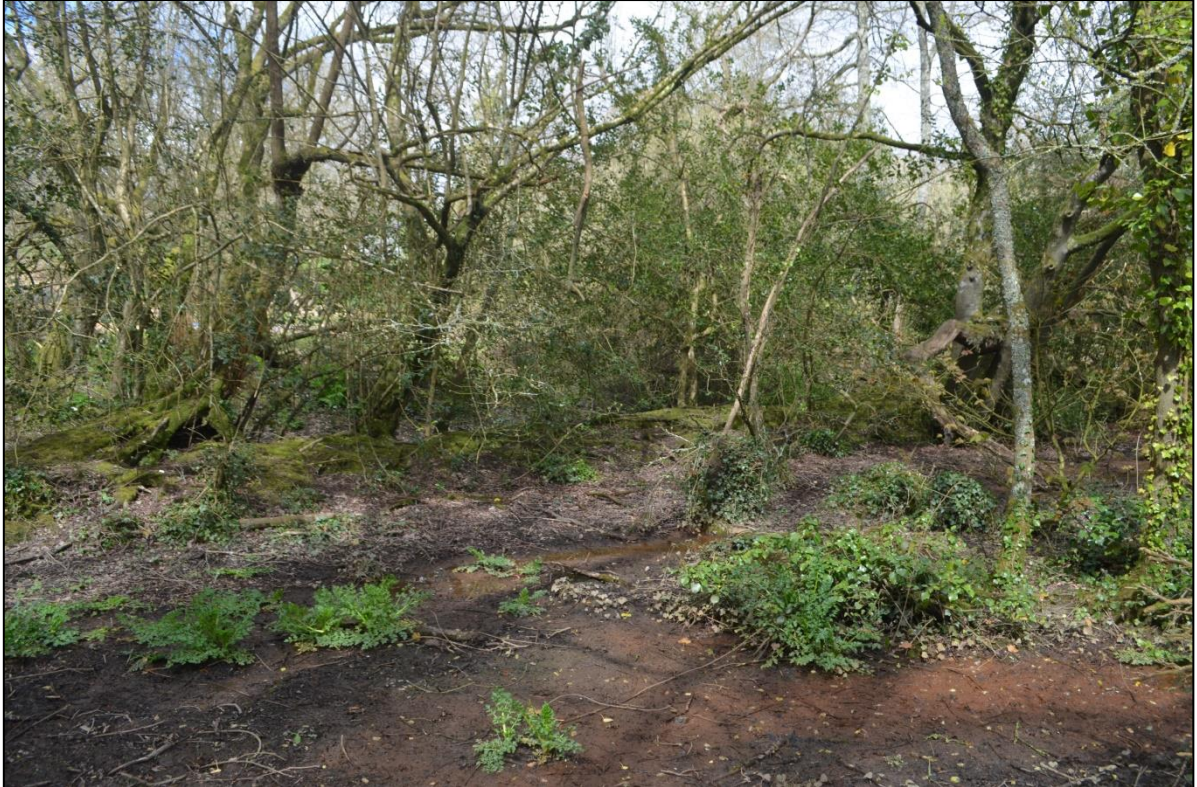
Boundary 12	
Type	Cornish Hedge Bank
Date	Before 1747
Condition	Poor
Description	Low Cornish Hedge Bank topped with trees
Notes	Low eroded bank.

FIGURE 103: BOUNDARY 12 VIEWED FROM THE SOUTH WEST

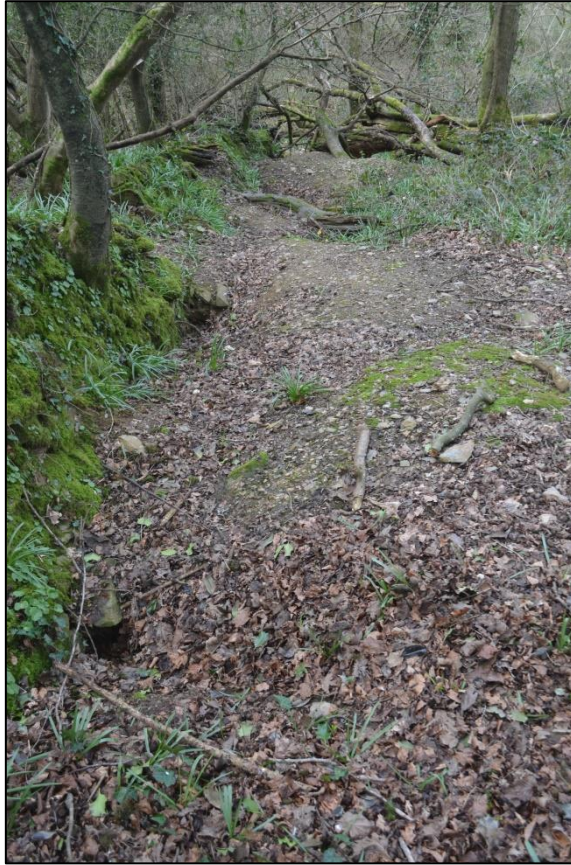
Boundary 13	
Type	Cornish Hedge Bank
Date	Before 1747
Condition	Acceptable
Description	Cornish Hedge Bank with some trees
Notes	Animal burrowing under western end.

FIGURE 104: WESTERN END OF BOUNDARY 13 WITH EVIDENCE OF ANIMAL BURROWING. FROM THE EAST.

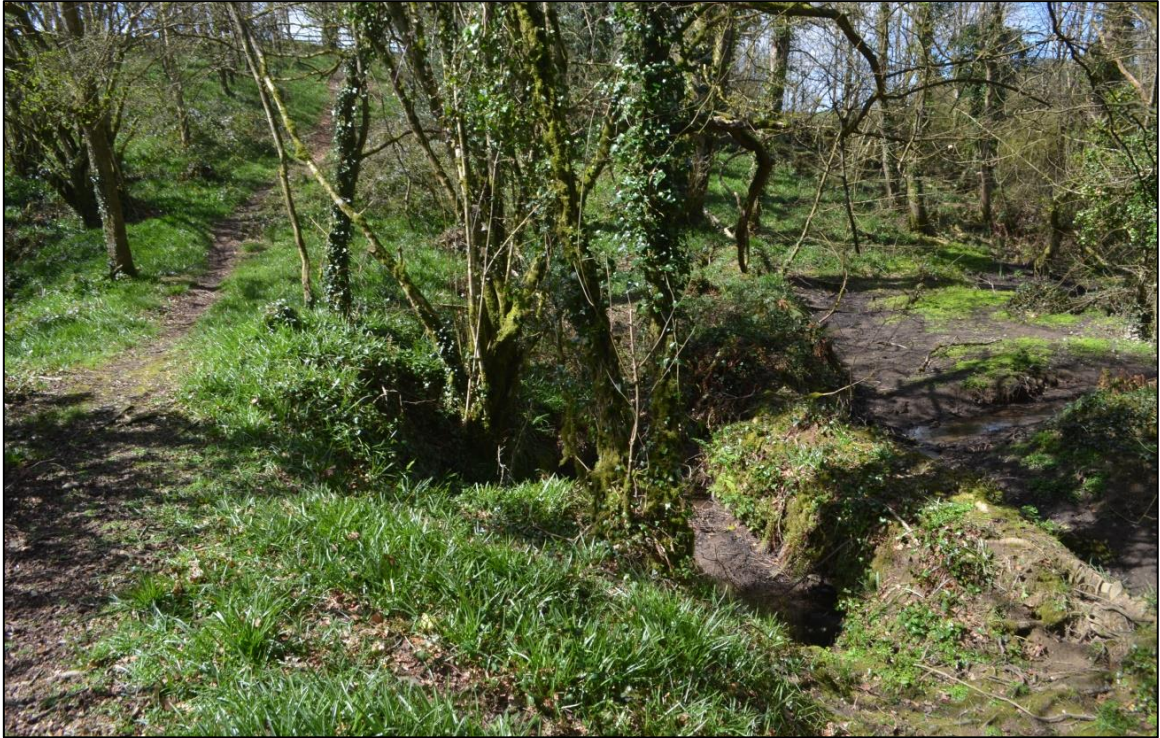
Boundary 14	
Type	Cornish Hedge Bank
Date	Before 1747
Condition	Acceptable
Description	Cornish Hedge Bank forming part of southern boundary of the RPG
Notes	Boundary Crosses stream. Gaps/erosion in places.

FIGURE 105: BOUNDARY 14 CROSSING STREAM. FROM THE EAST.

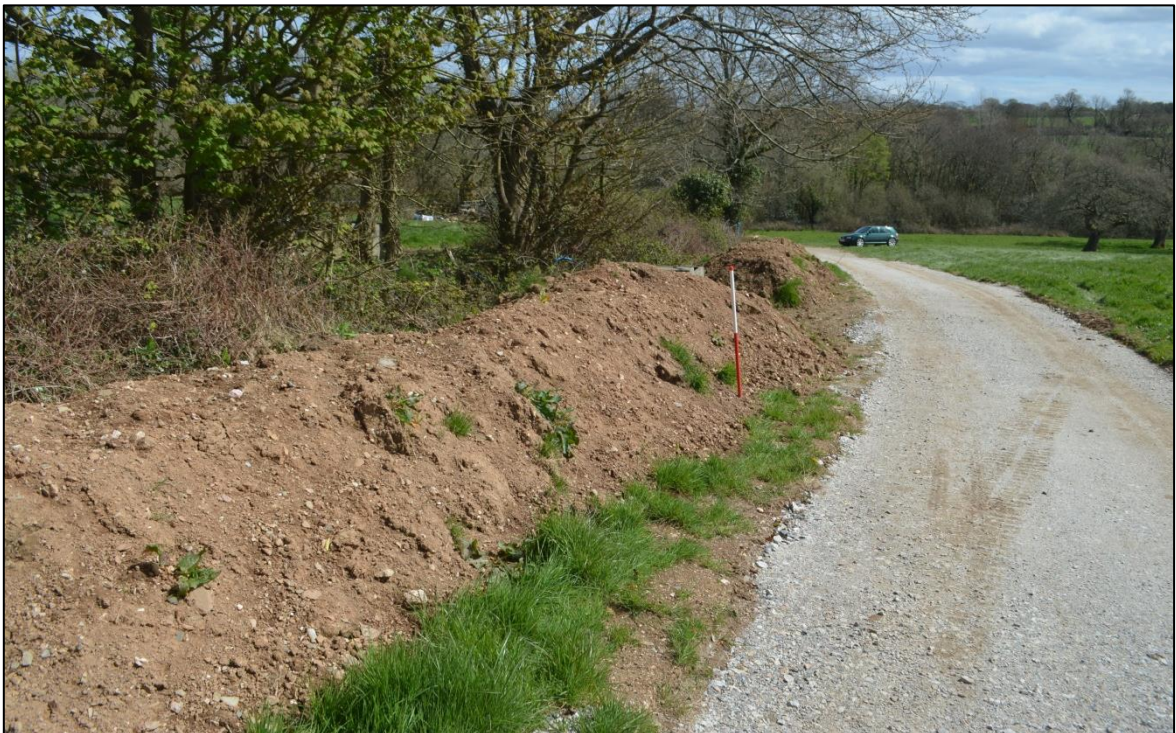
Boundary 15	
Type	Cornish Hedge Bank
Date	Before 1841
Condition	Acceptable
Description	Cornish Hedge Bank topped with trees
Notes	Difficult to assess as largely hidden behind bank of earth created by redevelopment of a historic barn.

FIGURE 106: BOUNDARY 15 IS LOCATED TO THE LEFT OF THE BANK OF SOIL. FROM THE NORTH.

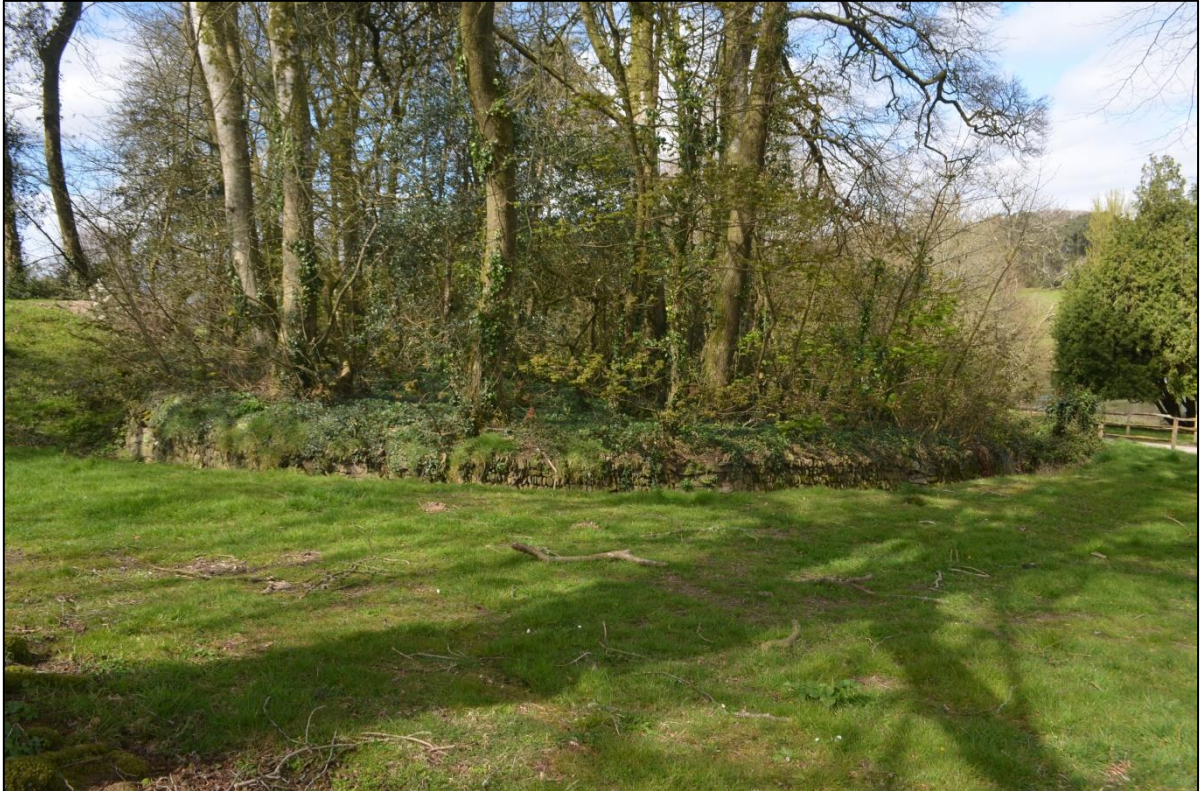
Boundary 16	
Type	Ha-ha
Date	Before 1841
Condition	Good
Description	Curved bank resembling a Ha-ha with a ditch on the outer side. Trees are growing inside the circular enclosure.
Notes	A ditch was observed on the outside of the curved stone faced bank.

FIGURE 107: CURVED HA-HA VIEWED FROM THE SOUTH EAST.

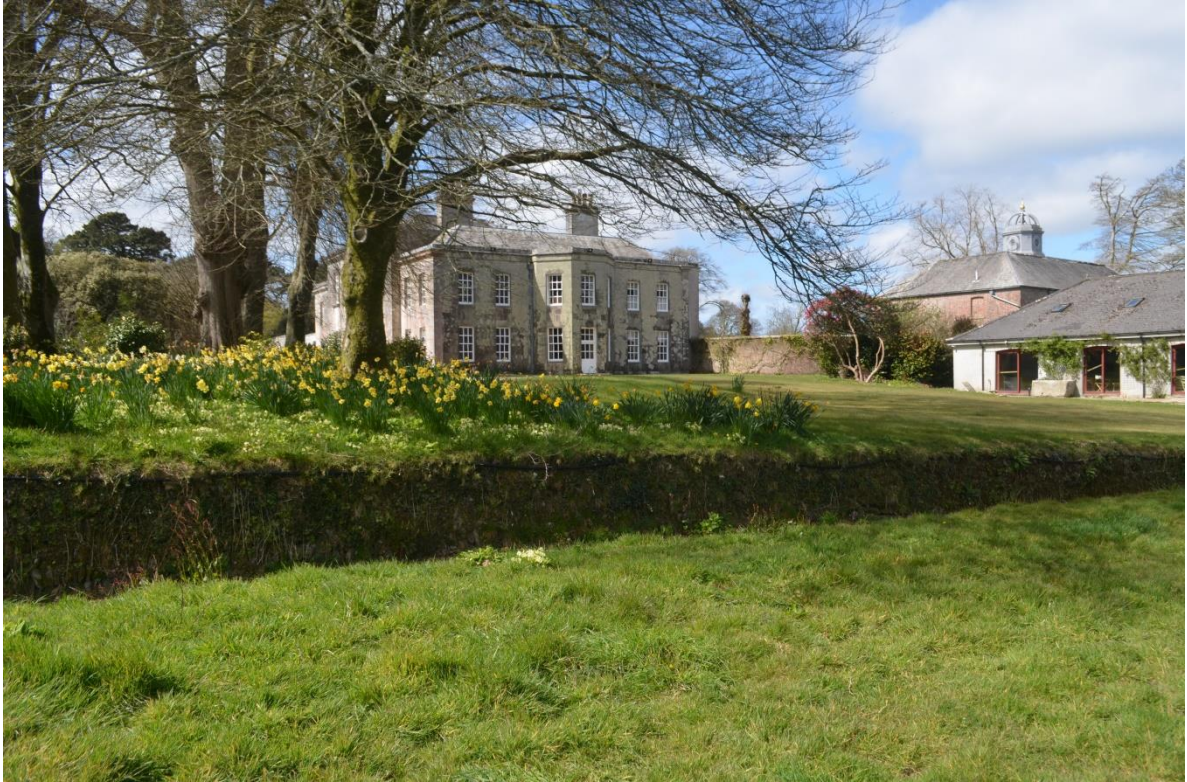
Boundary 17	
Type	Ha-ha
Date	Before 1747
Condition	Good
Description	A stone faced Ha-ha on the eastern side of Trewithen House. A ditch is observable on the eastern side.
Notes	It is possible the northern end may have been truncated when the present structure housing a swimming pool was added. There is a change in form at far southern end – Ha-ha is lower and more collapsing. This appears to be after the section which steps out to the east as shown in the 1747 estate plan, where the Ha-ha has been extended after 1747 but probably prior to 1841.

FIGURE 108: THE HA-HA TO THE EAST OF TREWITHEM HOUSE. FROM THE EAST.

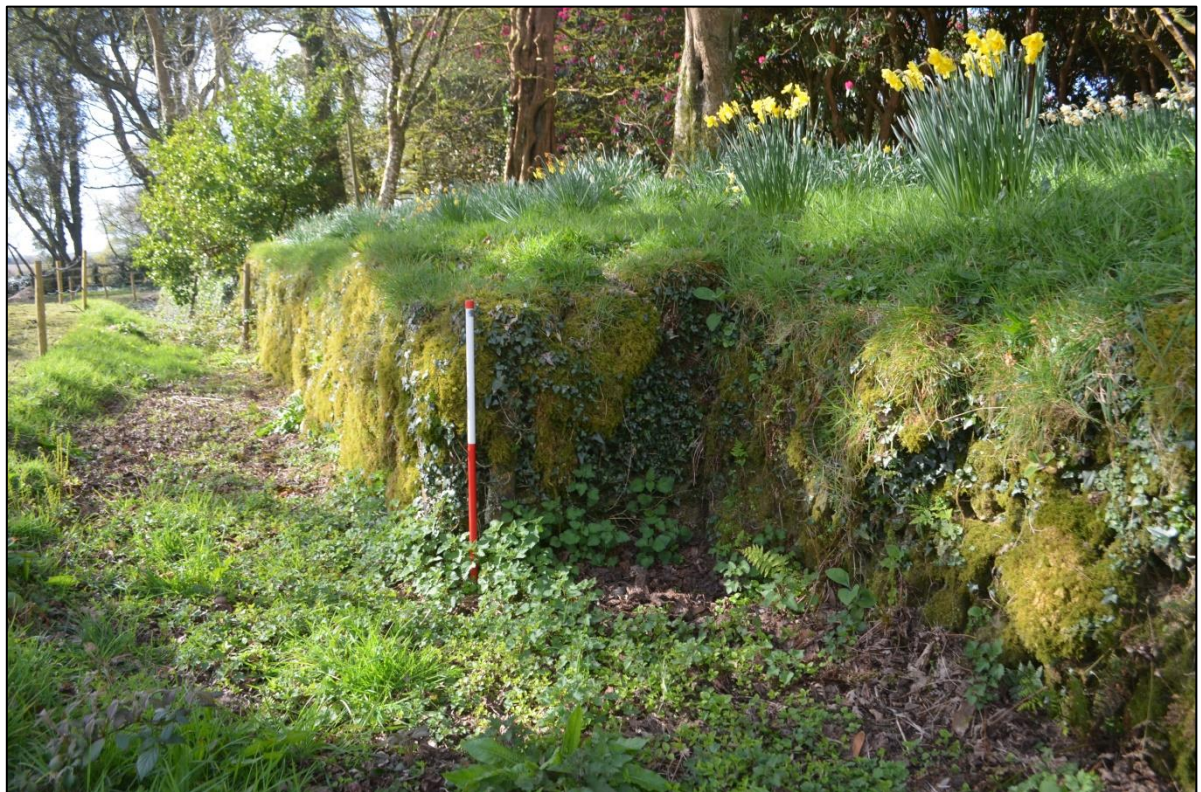
FIGURE 109: THE HA-HA STEPS OUT TO THE EAST TO THE SOUTH OF THE HOUSE, AS SHOWN ON THE 1747 ESTATE PLAN.

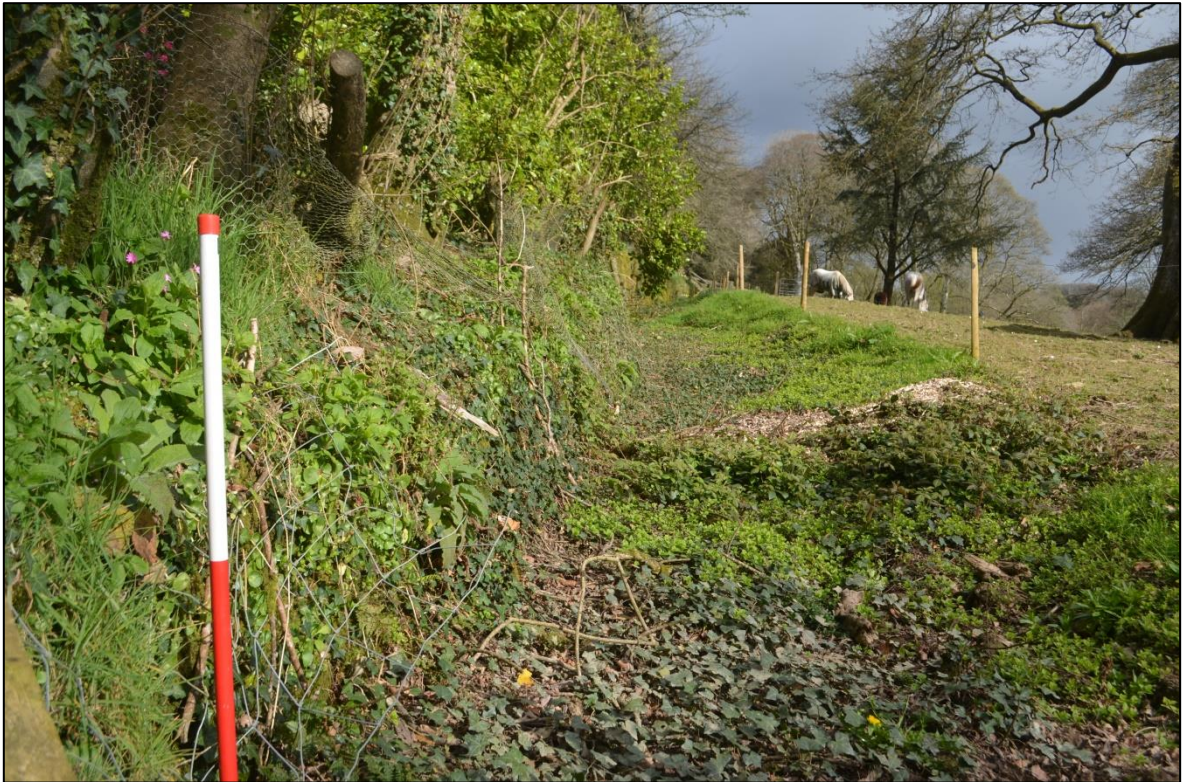
FIGURE 110: A CHANGE IN BUILD FORM AND QUALITY IS DISCERNIBLE AT THE SOUTHERN END OF THE HA-HA WHERE IT APPEARS TO HAVE BEEN EXTENDED AFTER 1747 BUT PROBABLY BEFORE 1841.

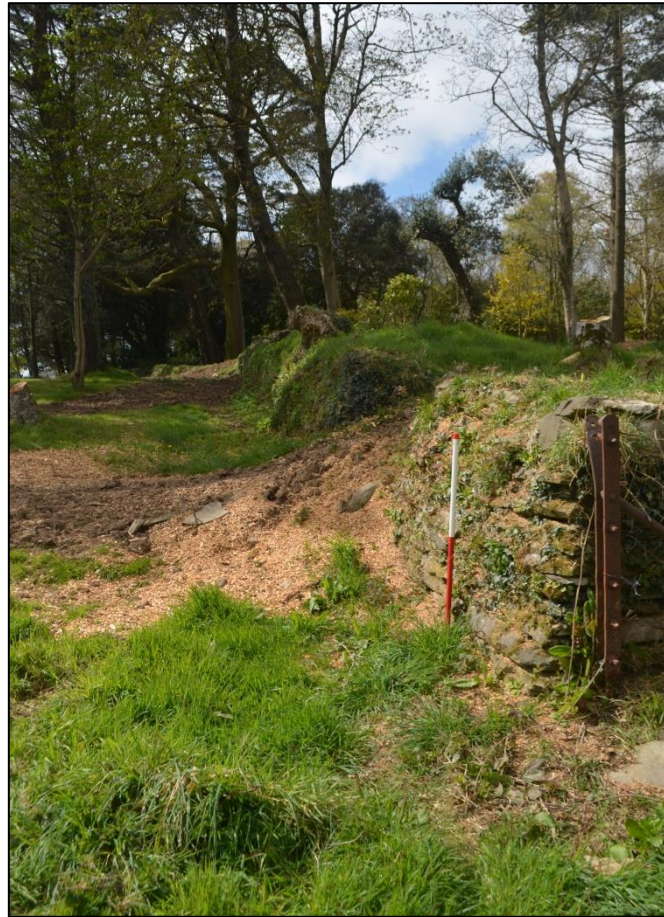
FIGURE 111: THE FAR EASTERN SECTION OF THIS BOUNDARY RESEMBLES A HA-HA IN FORM AND MAY BE A FRAGMENT OF THE 1747 GARDEN BOUNDARY; IT HAS BEEN BREACHED IN A NUMBER OF PLACES TO ALLOW PLANT TO ACCESS THE GARDEN. FROM THE SOUTH EAST.

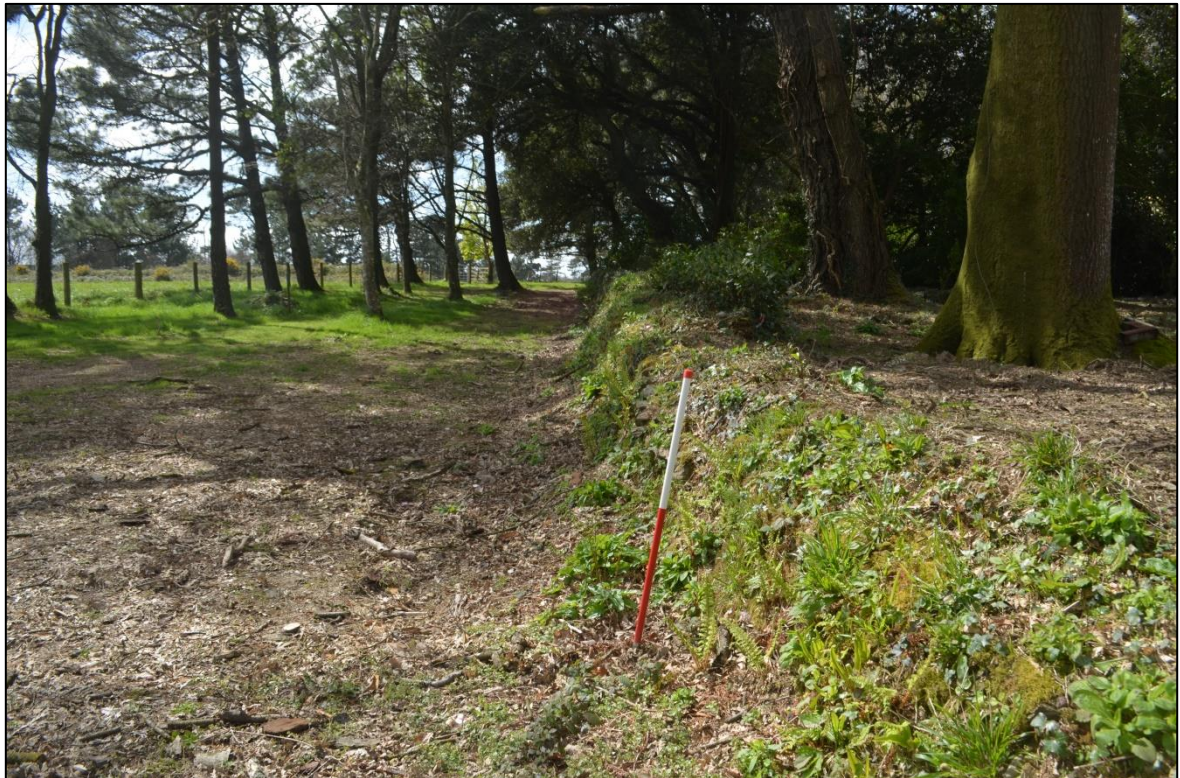
Boundary 18	
Type	Cornish Hedge Bank
Date	Before 1841 (possible 1747 fragment)
Condition	Poor
Description	Although recorded as a Cornish Hedge Bank this feature appears in places more similar to a Ha-ha in form although this may in part be a result of erosion.
Notes	The location of this feature would suggest a ha-ha is possible though maybe unnecessary as the gardens to north, between it and Trewithen House appear to be wooded by 1841 so views outward are unlikely to be necessary . It has been breached in a number of places to create access into the gardens. There is some evidence of iron estate fencing. It is possible that the far eastern section may date to 1747 where it would have formed the south eastern corner of the formal garden and this may explain the resemblance of this section to a ha-ha.

FIGURE 112: THE BOUNDARY CONTINUES TO THE WEST, BECOMING MORE OF A CORNISH HEDGE BANK IN FORM. FROM THE EAST.

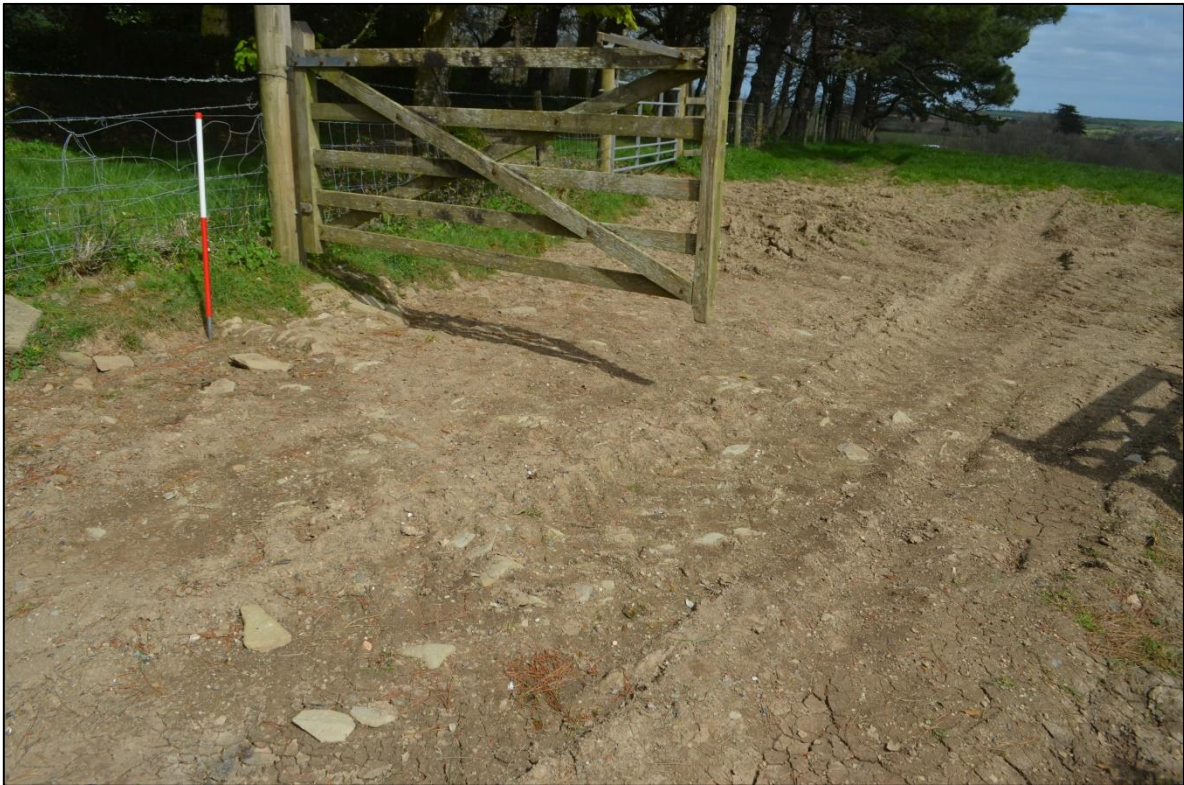
FIGURE 113: NORTHERN SECTION OF THE BOUNDARY WHERE THE FOOTINGS OF THE CORNISH HEDGE BANK CAN STILL BE DISCERNED UNDER THE LINE OF THE GATEWAY. FROM THE SOUTH WEST.

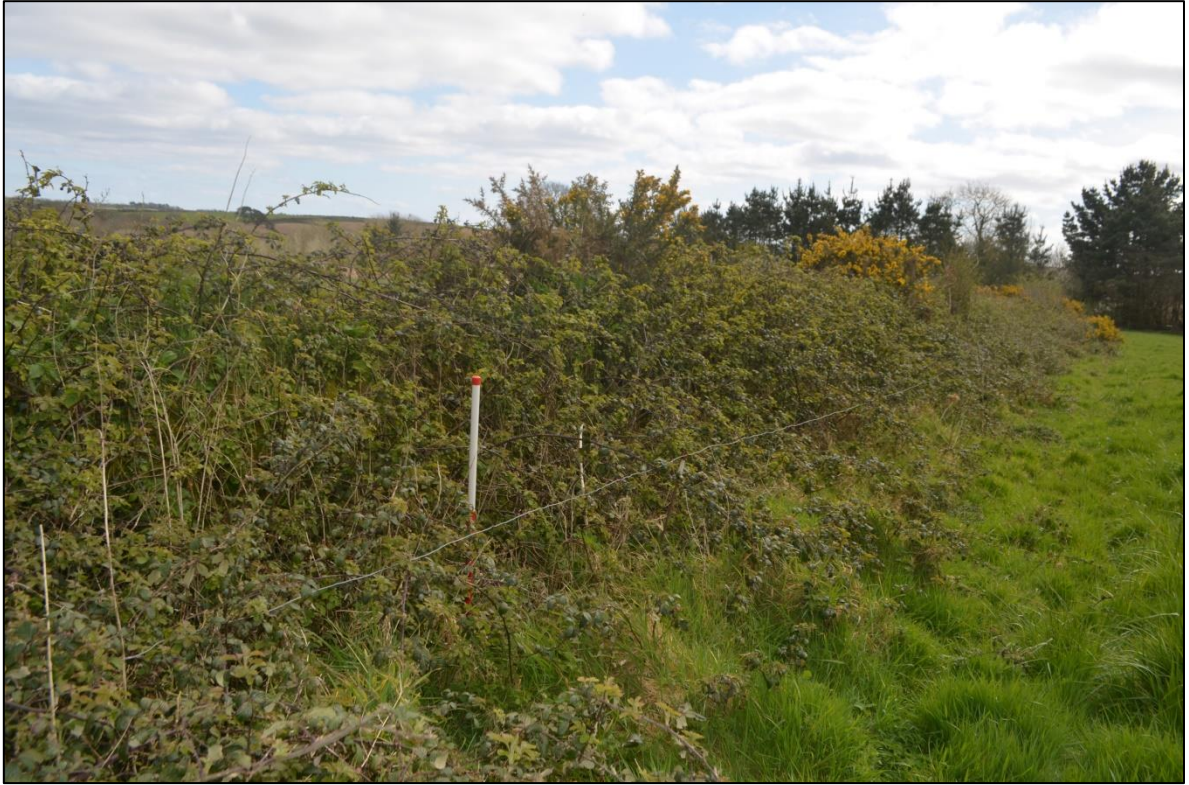
Boundary 19	
Type	Cornish Hedge Bank
Date	Before 1841
Condition	Acceptable
Description	Cornish Hedge Bank. Evidently breached at northern end to create gateway. Difficult to discern due to vegetation, particularly brambles.
Notes	Stone footings of the removed northern section of bank still visible in gateway. Area at southern end not covered in vegetation shows evidence of horizontal and vertical stone construction.

FIGURE 114: CENTRAL SECTION OF THE BOUNDARY, VERY OVERGROWN. FROM THE NORTH.

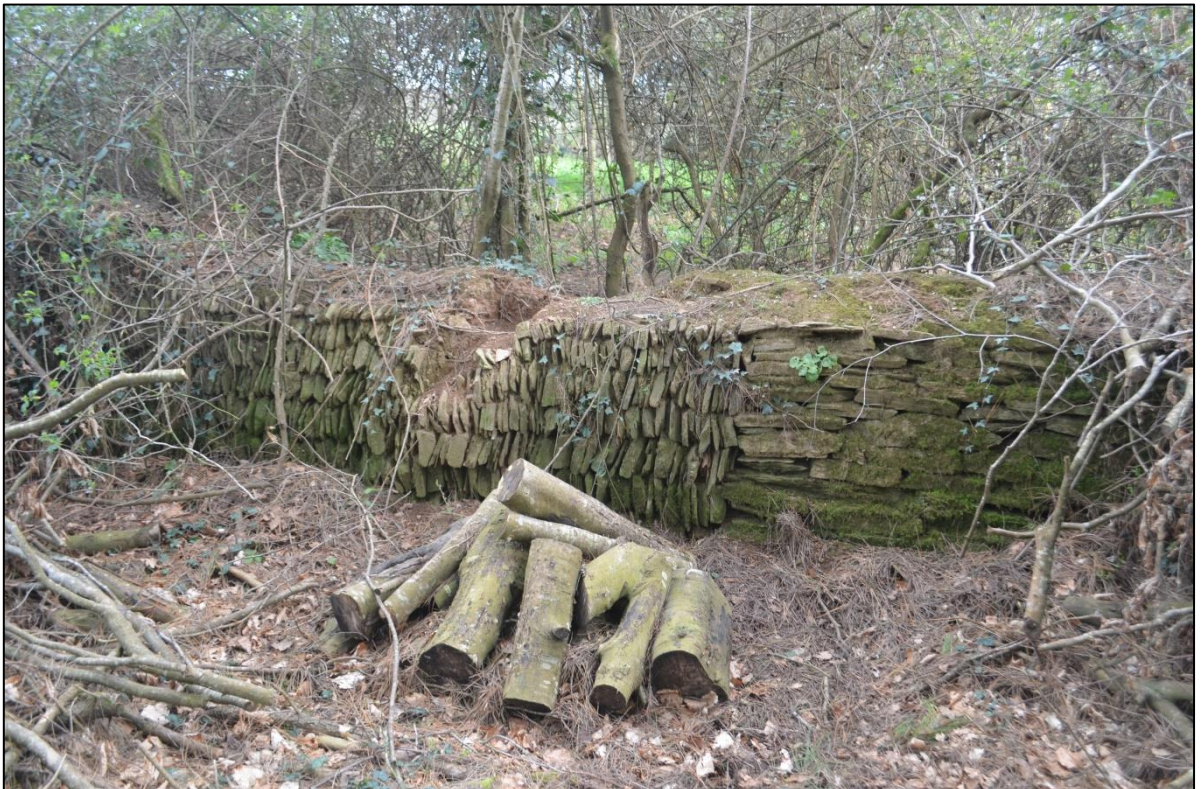
FIGURE 115: SOUTHERN SECTION OF THE BOUNDARY WITH THE STONWORK EVIDENT AND A SMALL AREA OF COLLAPSE. FROM THE WEST.
