TREWITHEN ESTATE REGISTERED PARK AND GARDEN PROBUS CORNWALL

Archaeological and Historic Landscape Survey

South West Archaeology Ltd. Report no.210524

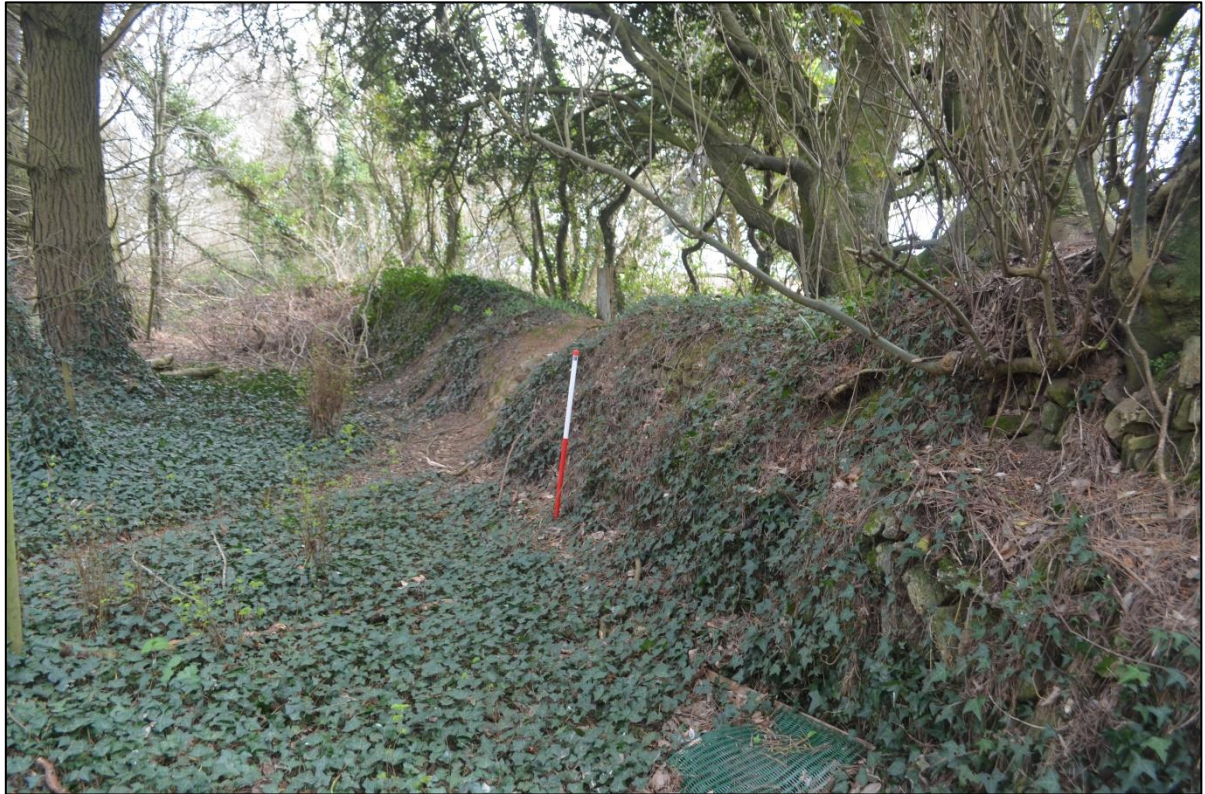
Boundary 20	
Type	Cornish Hedge Bank
Date	Before 1747
Condition	Acceptable
Description	Cornish Hedge Bank generally covered in vegetation. Forms part of the southern boundary of the Registered Park and Garden.
Notes	The condition of the bank is generally poorer at the western end where more erosion/collapse appears to have occurred.

FIGURE 116: BOUNDARY 20 VIEWED FROM THE NORTH.

- A monitoring and repair schedule should be considered for the historic boundaries across the estate. These are in need of regular monitoring and maintenance to prevent decay and/or loss of these features.

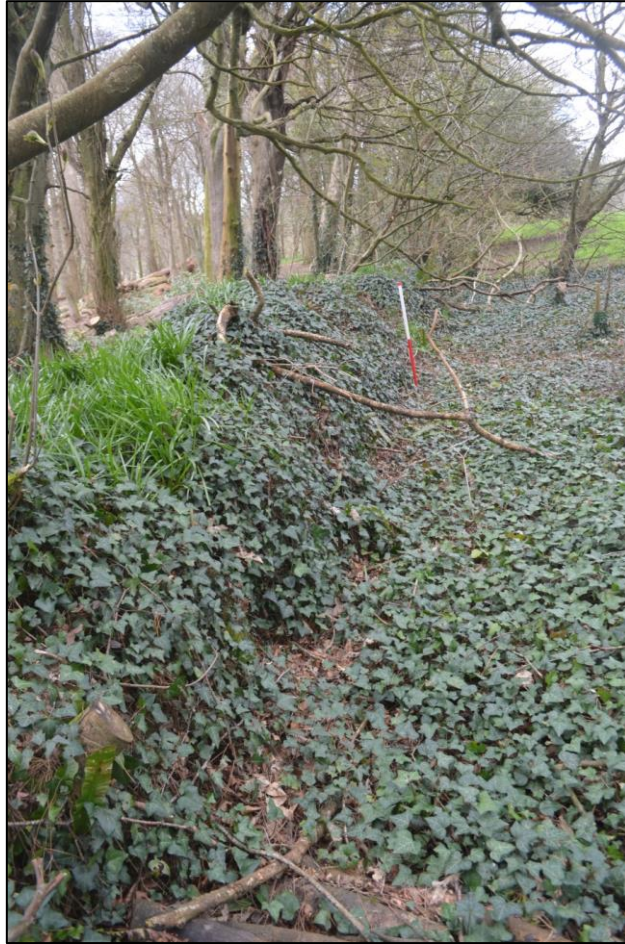
Boundary 21	
Type	Cornish Hedge Bank
Date	Before 1747
Condition	Acceptable
Description	Cornish Hedge Bank largely covered in vegetation
Notes	Some areas of collapse but difficult to assess due to ivy coverage.

FIGURE 117: BOUNDARY 21 VIEWED FROM THE EAST.

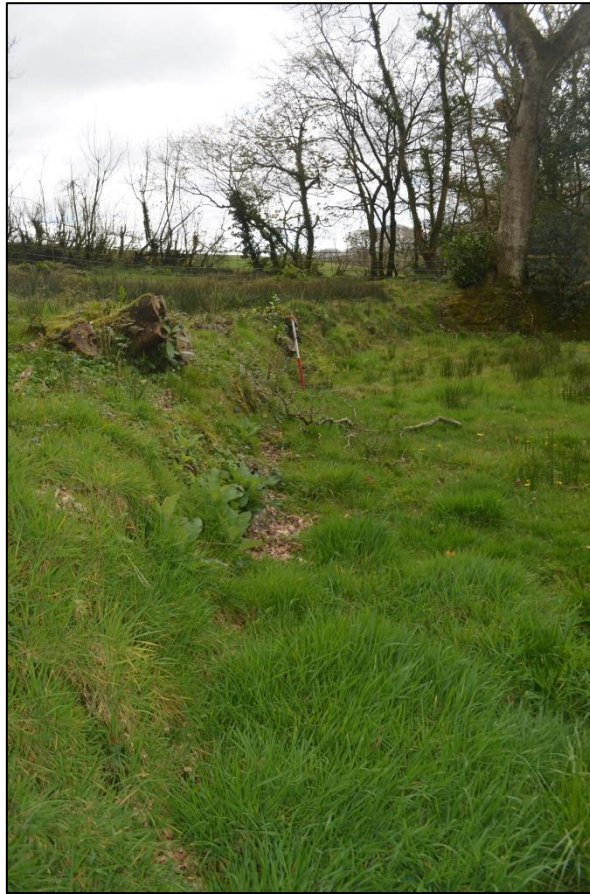
Boundary 22	
Type	Ha-ha/Corn ditch
Date	Before 1747
Condition	Acceptable
Description	Stone faced possible ha-ha or corn ditch, overgrown with vegetation in places
Notes	This feature may have formed eastern side of pond shown on the 1747 estate plan to the east of the southern entrance into the estate. A gap has been created to allow path to pass through. Some small areas of collapse were observed.

FIGURE 118: BOUNDARY 22 VIEWED FROM THE NORTH

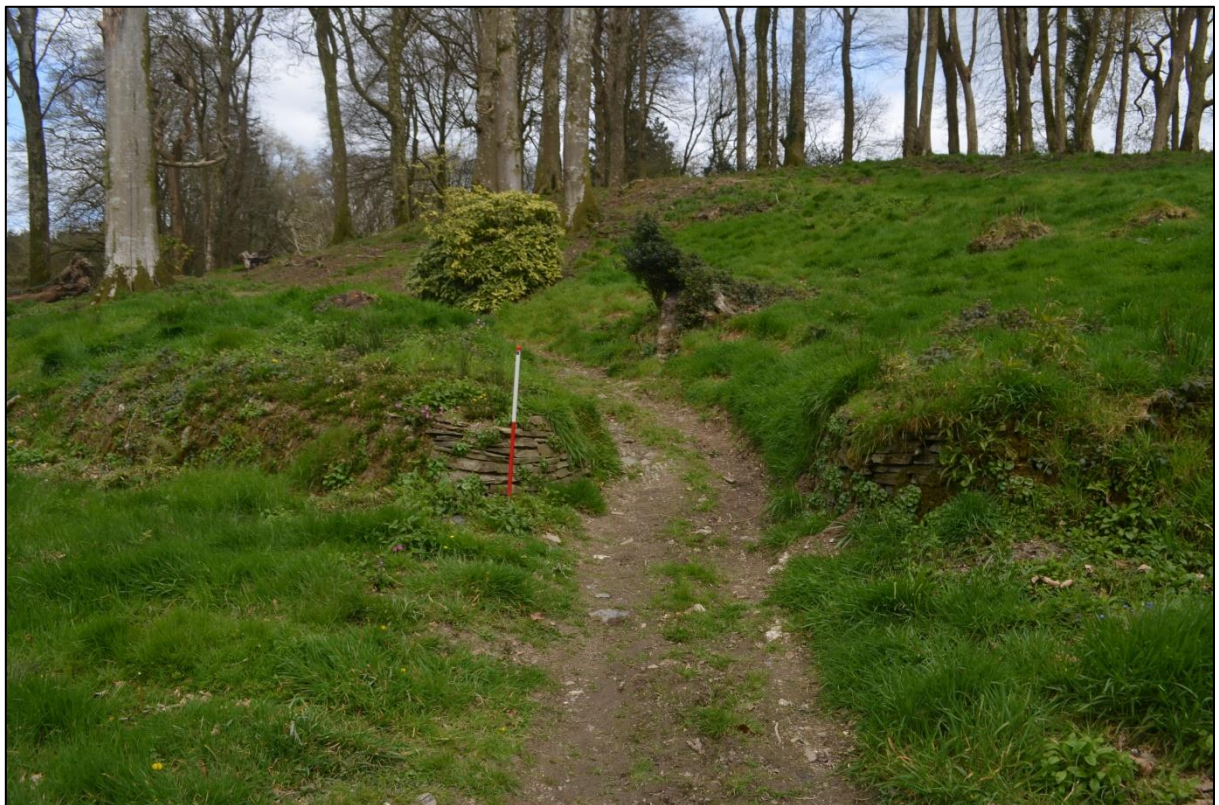
FIGURE 119: A GAP HAS BEEN CREATED IN THE BOUNDARY TO ALLOW THE PATH TO PASS THROUGH. FROM THE WEST.

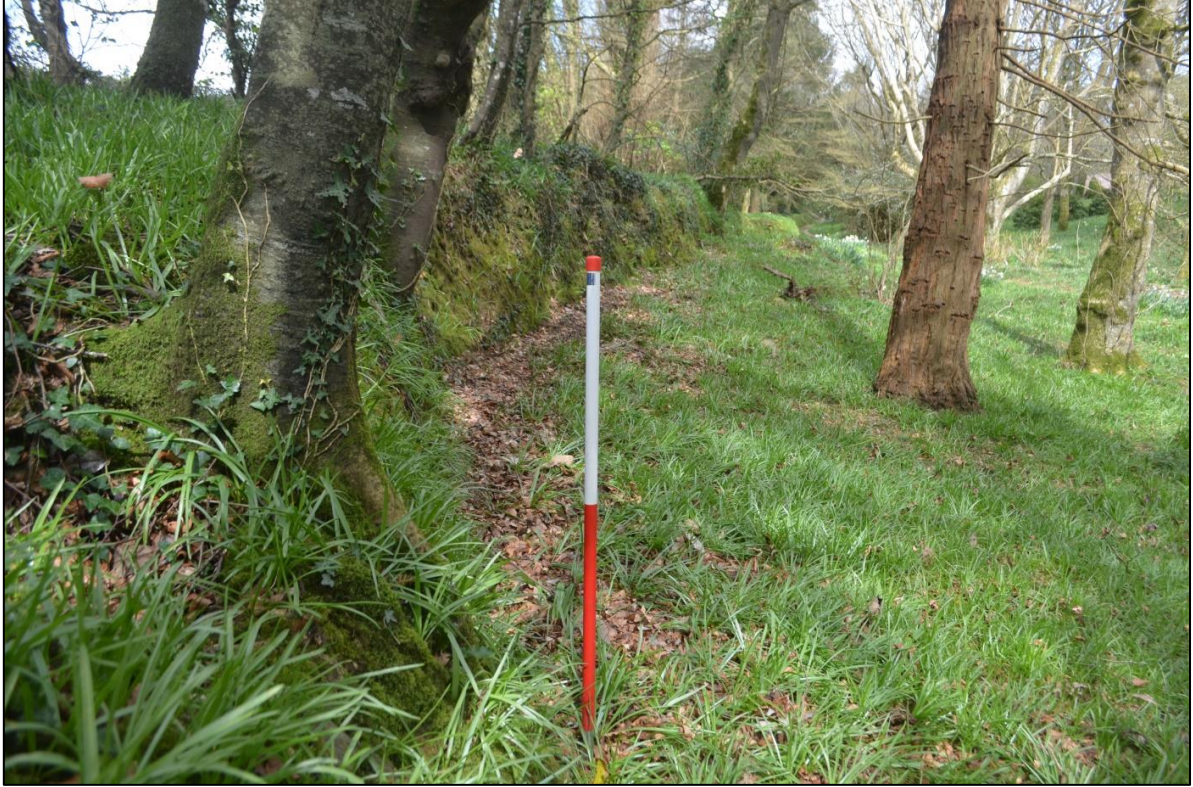
Boundary 23	
Type	Cornish Hedge Bank
Date	Before 1747
Condition	Acceptable
Description	Cornish Hedge Bank covered with vegetation. Bank appears to continue at its western end to become the north/western side of a pond shown on the 1st Ed OS map.

FIGURE 120: BOUNDARY 23 FROM THE SOUTH WEST.

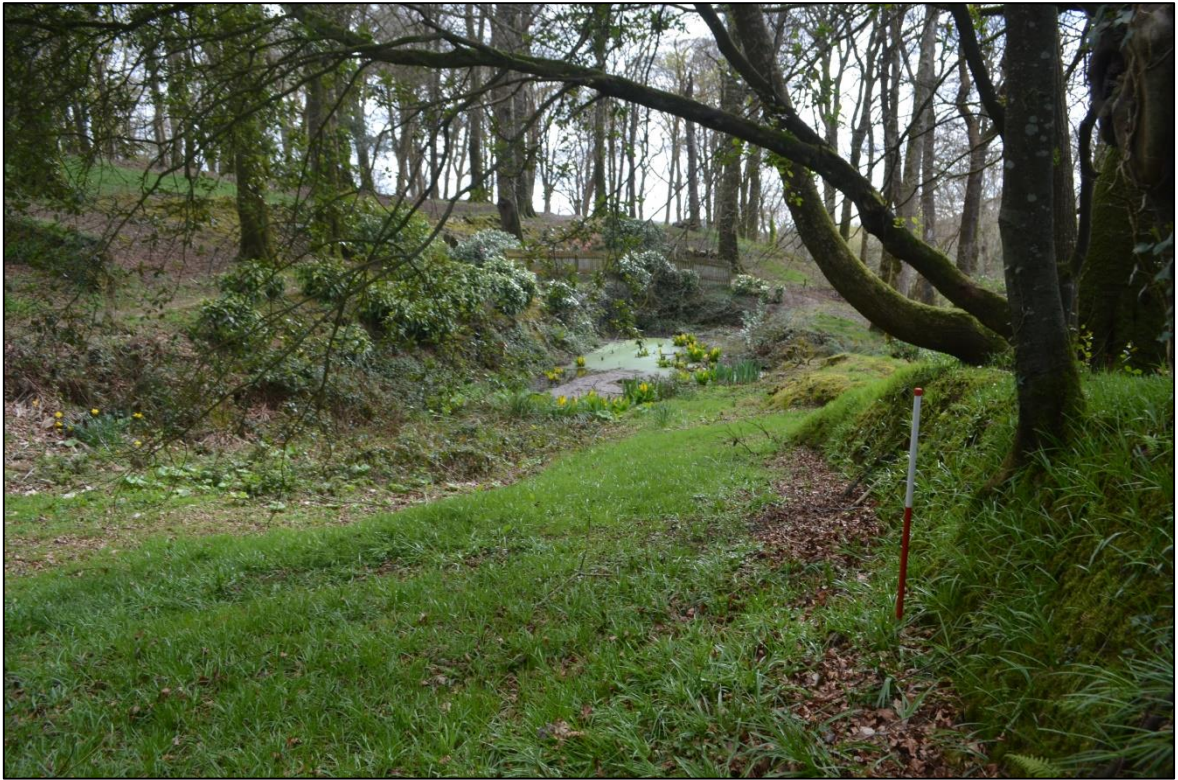
FIGURE 121: THE BOUNDARY CONTINUES TO THE SOUTH WEST WHERE IT APPEARS TO BECOME THE NORTHERN EDGE OF A POND. FROM THE NORTH EAST.

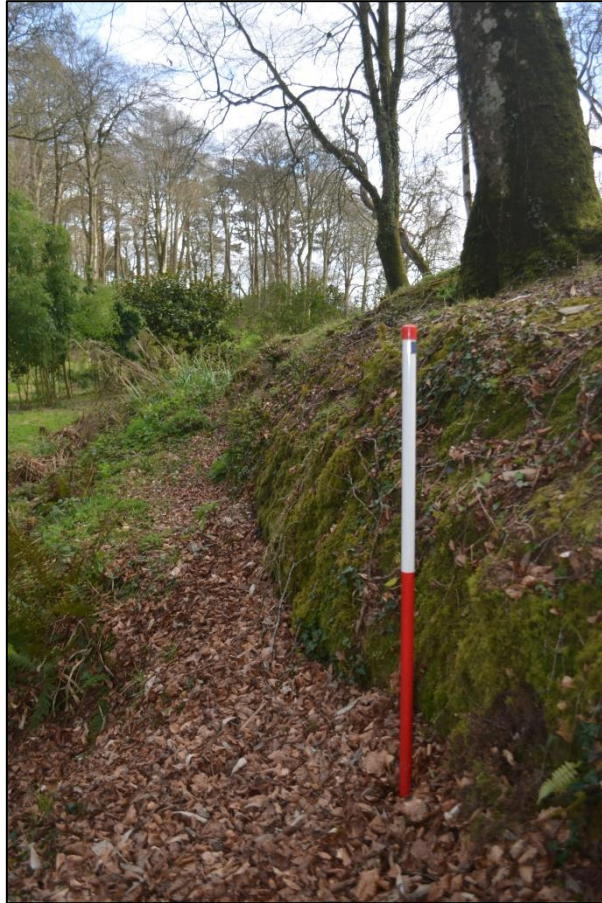
Boundary 24	
Type	Ha-ha/Corn ditch
Date	Before 1841
Condition	Poor
Description	Vegetation covered vertical cut feature forming eastern side of the pathway through the woodland towards the ponds shown on maps from 1841
Notes	Vegetation coverage makes condition and form difficult to assess. Some areas of collapse observed.

FIGURE 122: BOUNDARY 24 VIEWED FROM THE NORTH.

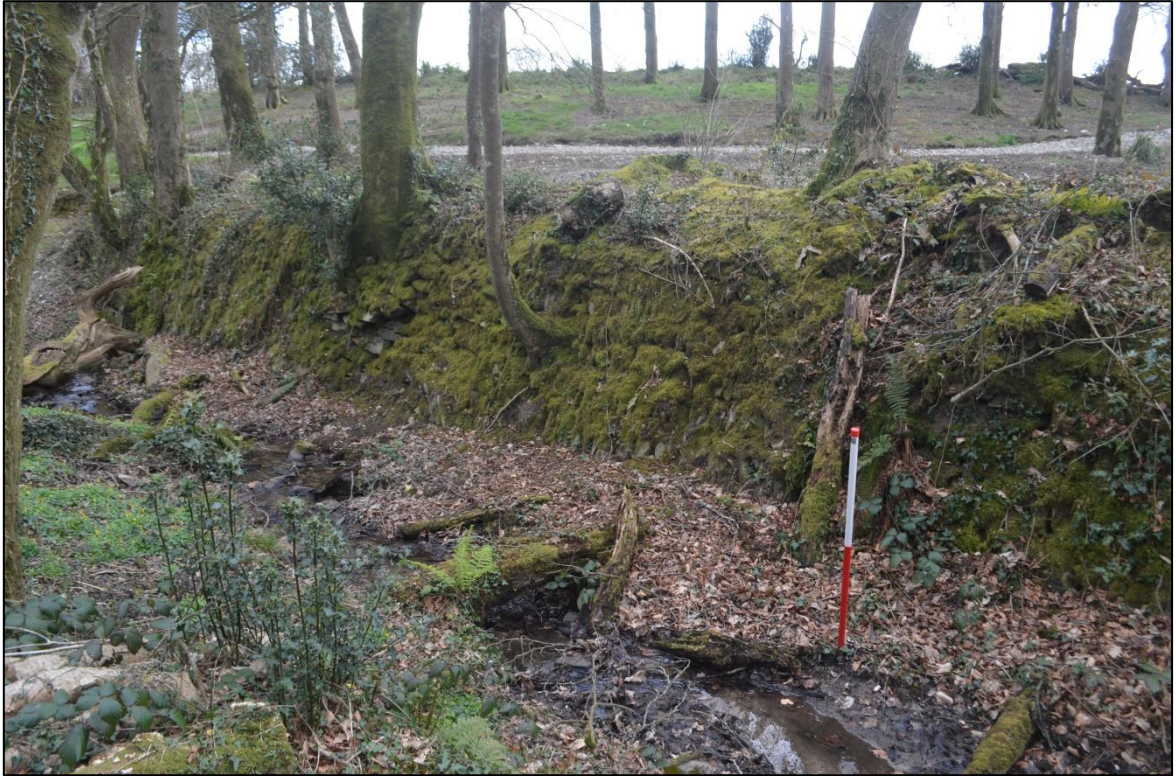
Boundary 25	
Type	Cornish Hedge Bank
Date	Before 1747
Condition	Acceptable
Description	Cornish Hedge Bank covered with moss
Notes	Ditch on eastern side

FIGURE 123: BOUNDARY 25 FROM THE NORTH EAST.

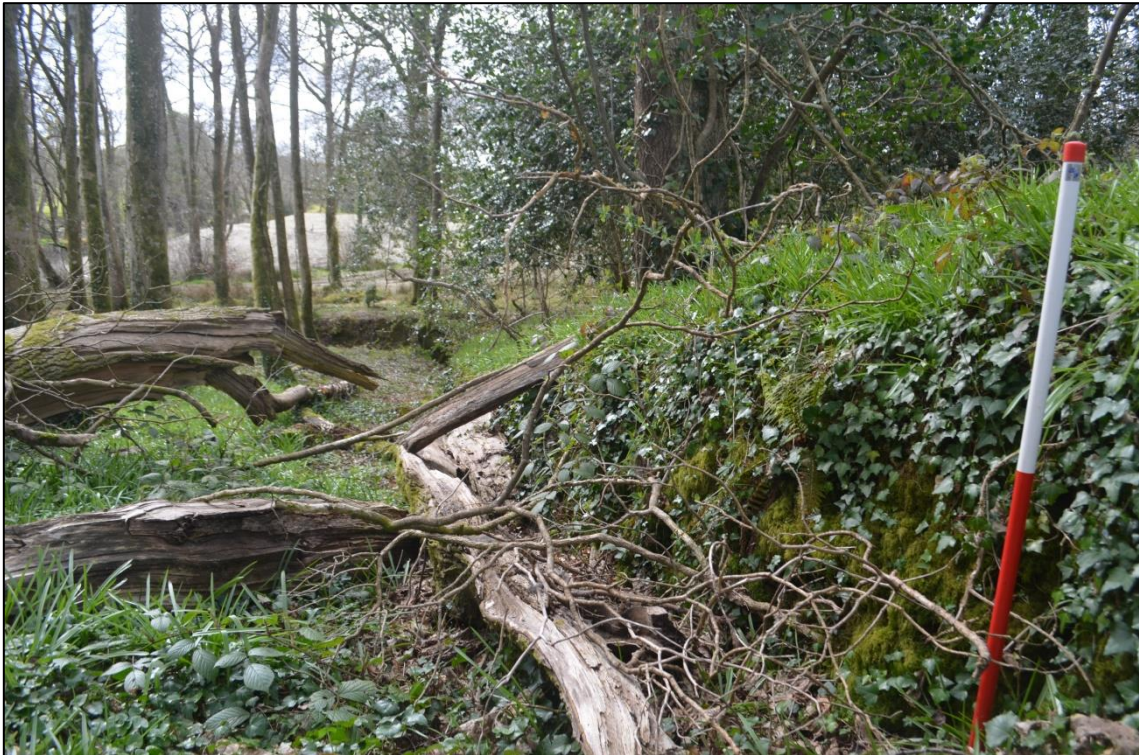
Boundary 26	
Type	Ha-ha/Corn Ditch
Date	Before 1841
Condition	Acceptable
Description	Stone faced ha-ha
Notes	Moss covered

FIGURE 124: BOUNDARY 26 VIEWED FROM THE EAST

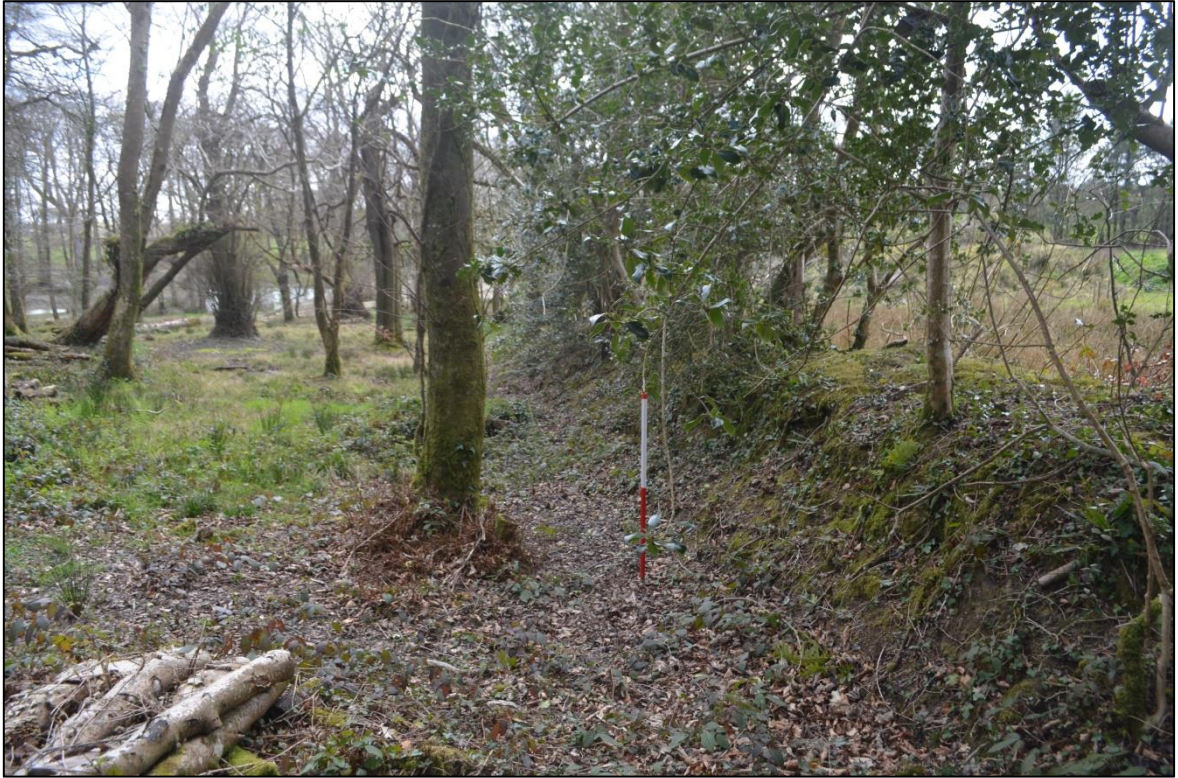
Boundary 27	
Type	Cornish Hedge Bank
Date	Before 1841
Condition	Poor
Description	Cornish Hedge Bank forming part of the western boundary of the RPG. Topped with trees/hedge
Notes	Appears to have lost much of its stone facing in places, covered in moss and vegetation.

FIGURE 125: BOUNDARY 27 VIEWED FROM THE NORTH

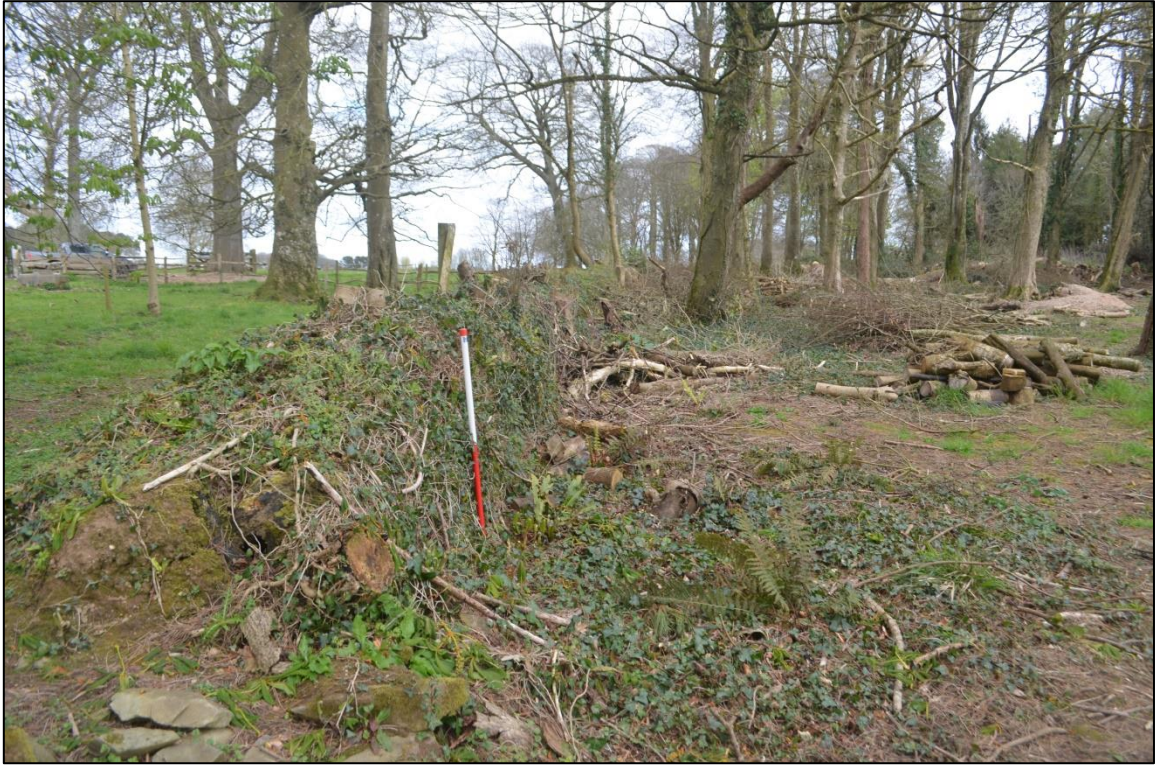
Boundary 28	
Type	Cornish Hedge Bank
Date	Before 1841
Condition	Acceptable
Description	Cornish Hedge Bank
Notes	Evidence that trees on and around the bank have been recently felled. This boundary may incorporate parts of a boundary shown on the 1747 map

FIGURE 126: BOUNDARY 28 VIEWED FROM THE SOUTH WEST

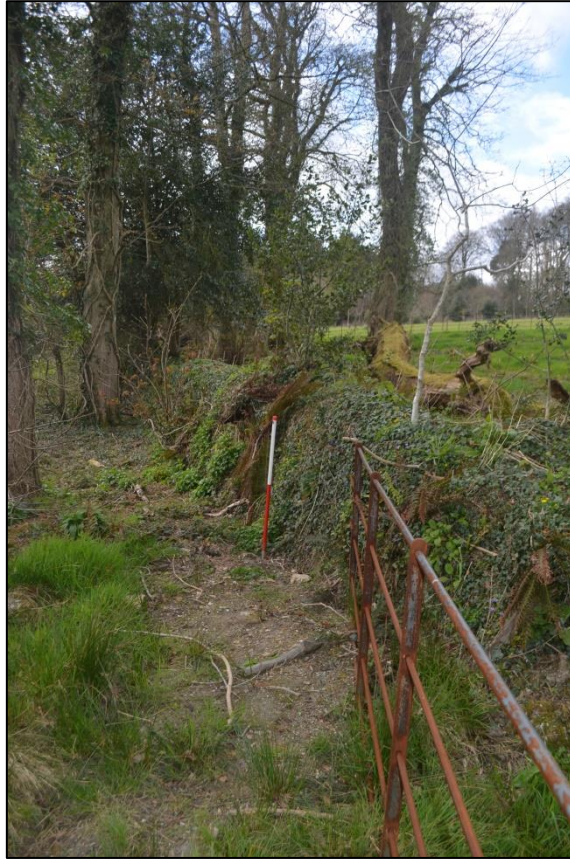
Boundary 29	
Type	Cornish Hedge Bank
Date	Before 1841
Condition	Acceptable
Description	Largely Cornish Hedge Bank with a small section of Iron Estate Fencing near the location of a historic pond.

FIGURE 127: BOUNDARY 29 VIEWED FROM THE SOUTH EAST

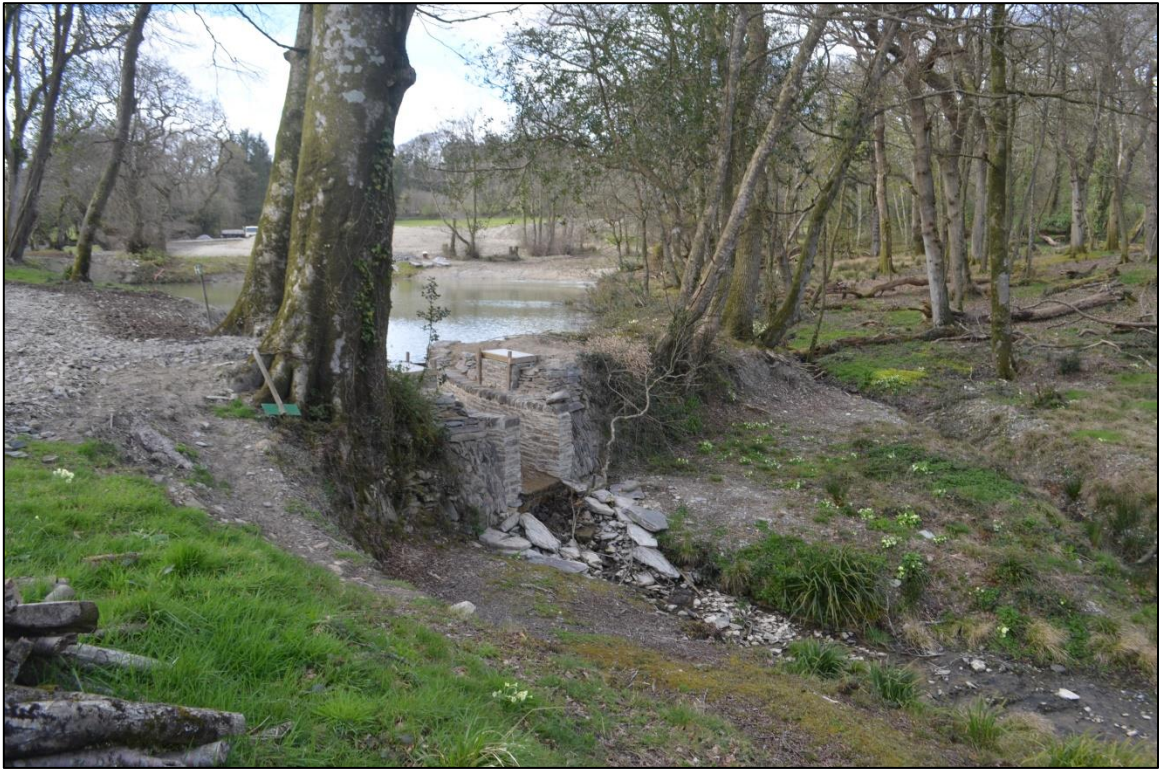
Boundary 30	
Type	Cornish Hedge Bank
Date	Before 1879
Condition	Acceptable
Description	Cornish Hedge Bank with stone built sluice gate inserted at southern end as part of pond restoration project
Notes	Erosion of bank in places. Forms western edge of the historic ponds

FIGURE 128: BOUNDARY 30 VIEWED FROM THE SOUTH

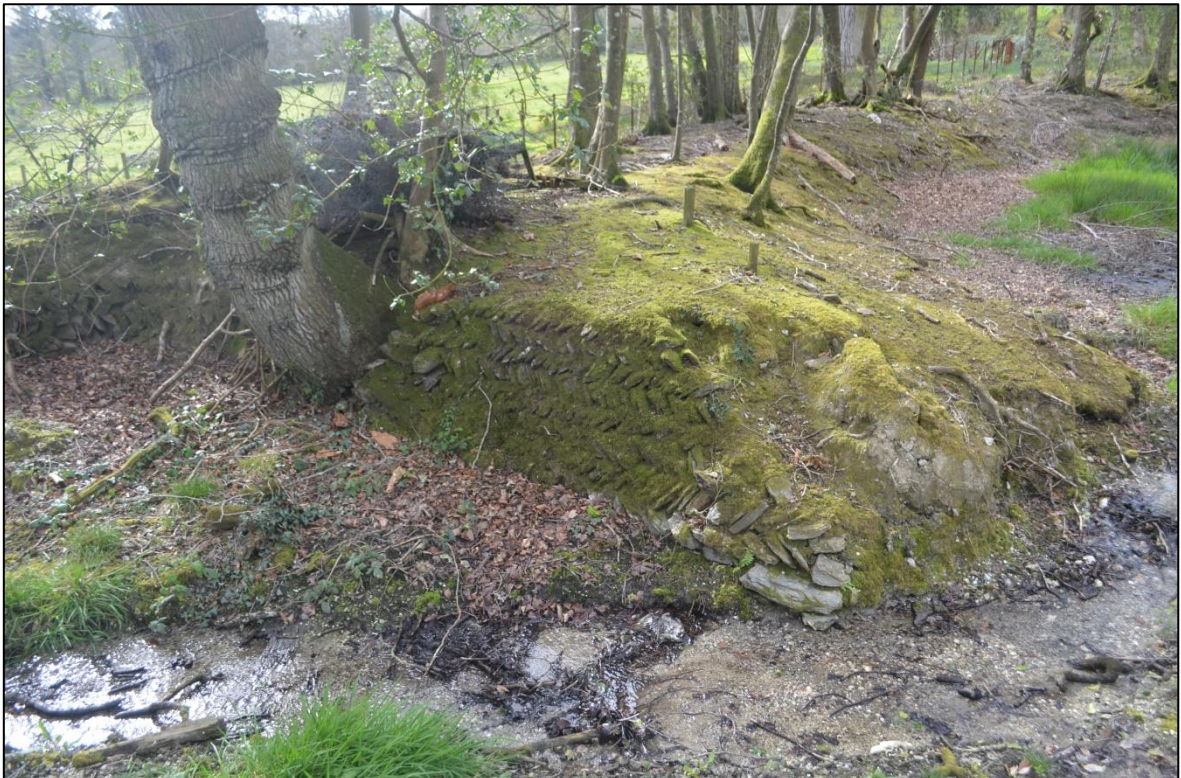
Boundary 31	
Type	Cornish Hedge Bank
Date	Before 1747
Condition	Acceptable
Description	Short section of stone faced bank, in location of pond shown on 1747 map
Notes	Herringbone pattern in small section of stone faced bank

FIGURE 129: BOUNDARY 31, VIEWED FROM THE SOUTH EAST

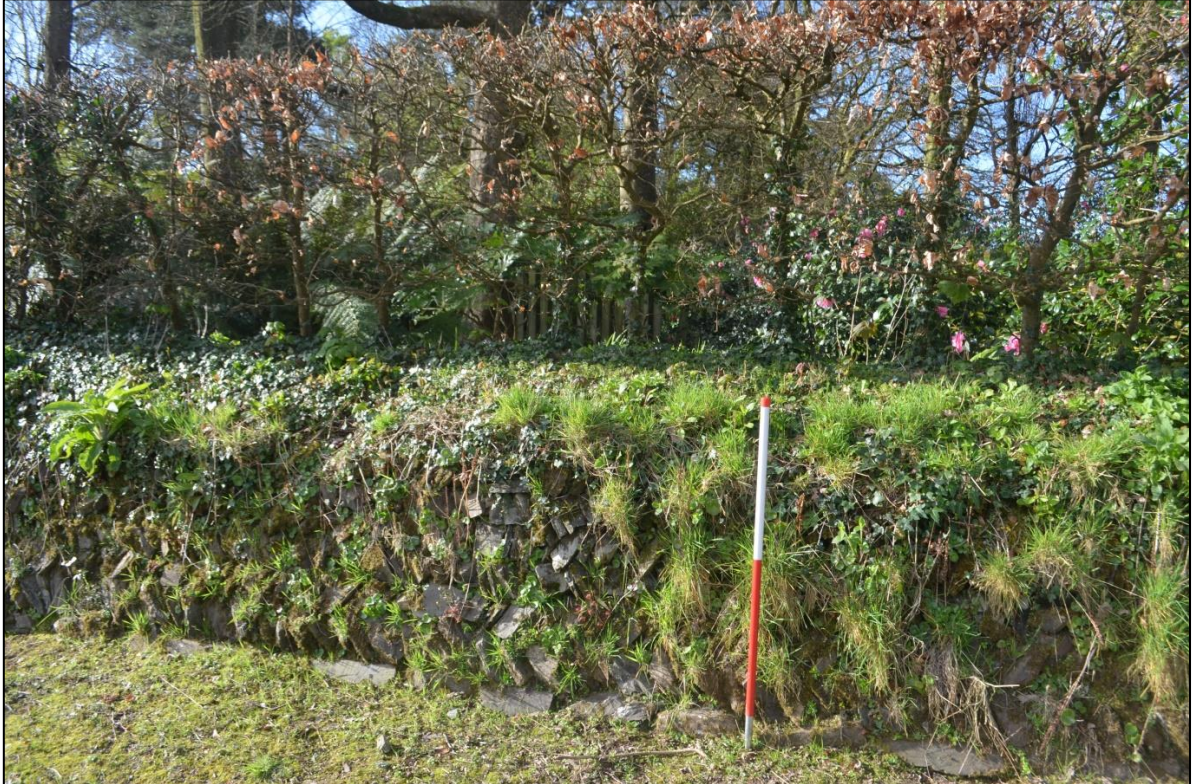
Boundary 32	
Type	Cornish Hedge Bank
Date	Before 1841
Condition	Good
Description	Cornish Hedge Bank topped by relatively recent beech hedge. Forms southern boundary of car park. Herringbone pattern to stone bank construction

FIGURE 130: BOUNDARY 32 VIEWED FROM THE NORTH

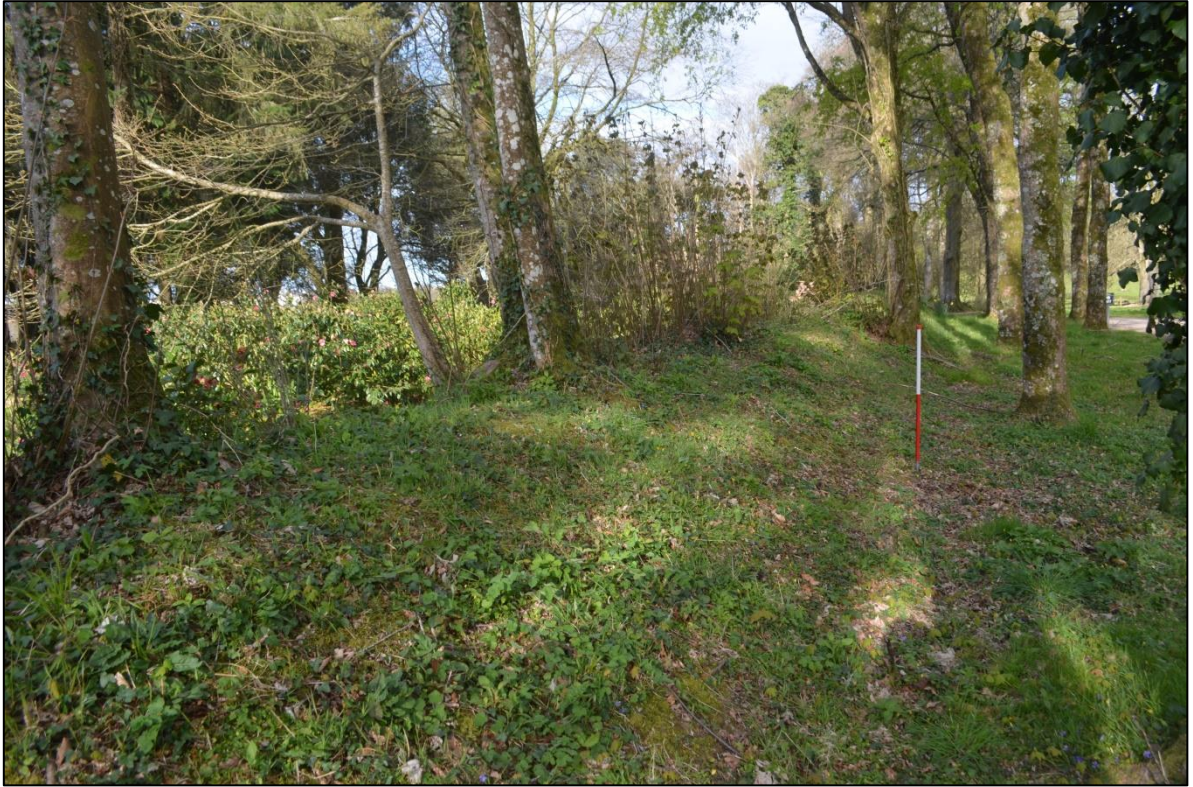
Boundary 34	
Type	Bank
Date	Before 1747
Condition	Acceptable
Description	Earth Bank which appears quite slumped. Doesn't appear to contain built stone element. c.1.5m high x 2m wide at base. Some trees on top.

FIGURE 131: BOUNDARY 34 VIEWED FROM THE NORTH EAST

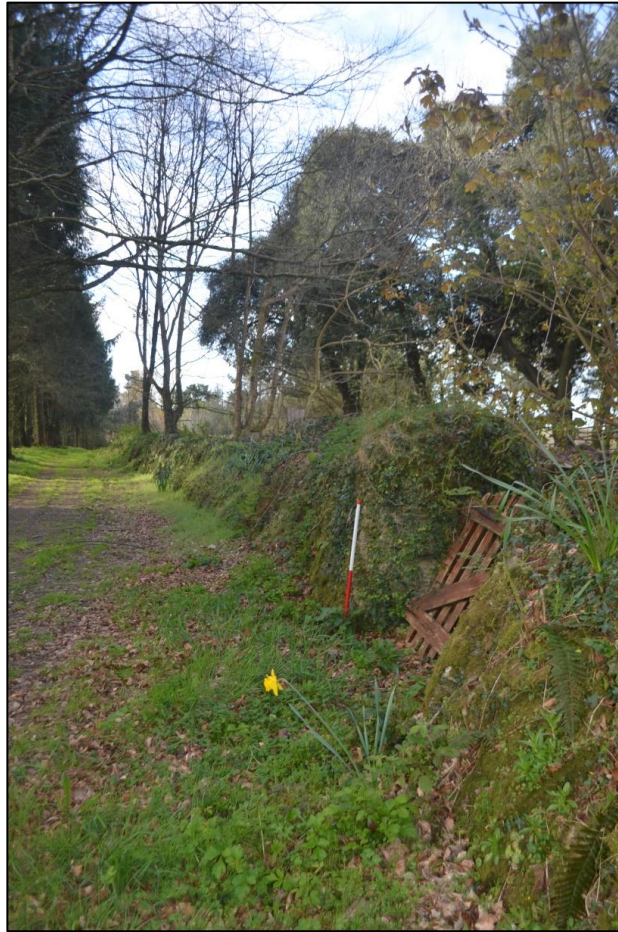
Boundary 35	
Type	Cornish Hedge Bank
Date	Before 1747
Condition	Poor
Description	Cornish Hedge Bank with a number of gaps made for access through into the adjacent field.
Notes	Bank appears to be slumping in a number of places.

FIGURE 132: BOUNDARY 35 VIEWED FROM THE NORTH EAST

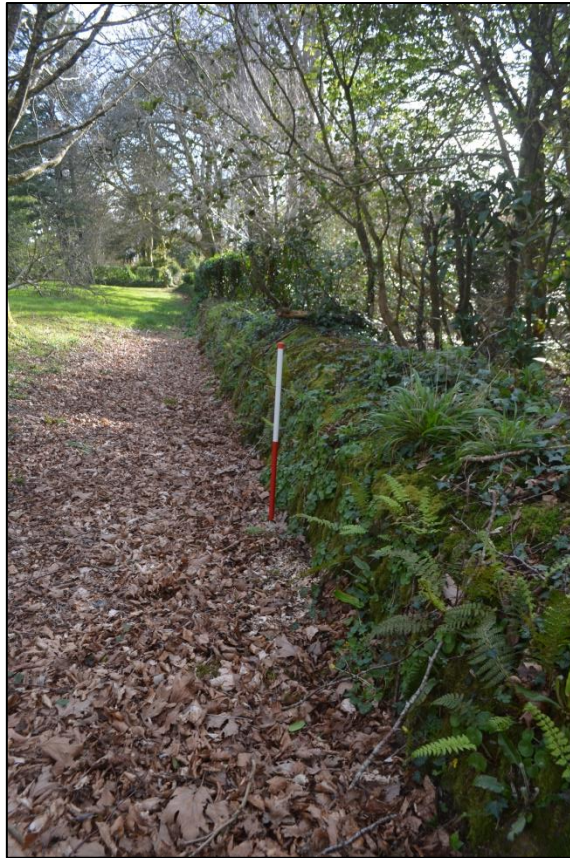
Boundary 36	
Type	Cornish Hedge Bank
Date	Before 1841
Condition	Poor
Description	Cornish Hedge Bank no more than 1m in height. Appears in a declining condition.

FIGURE 133: BOUNDARY 36 VIEWED FROM THE NORTH WEST

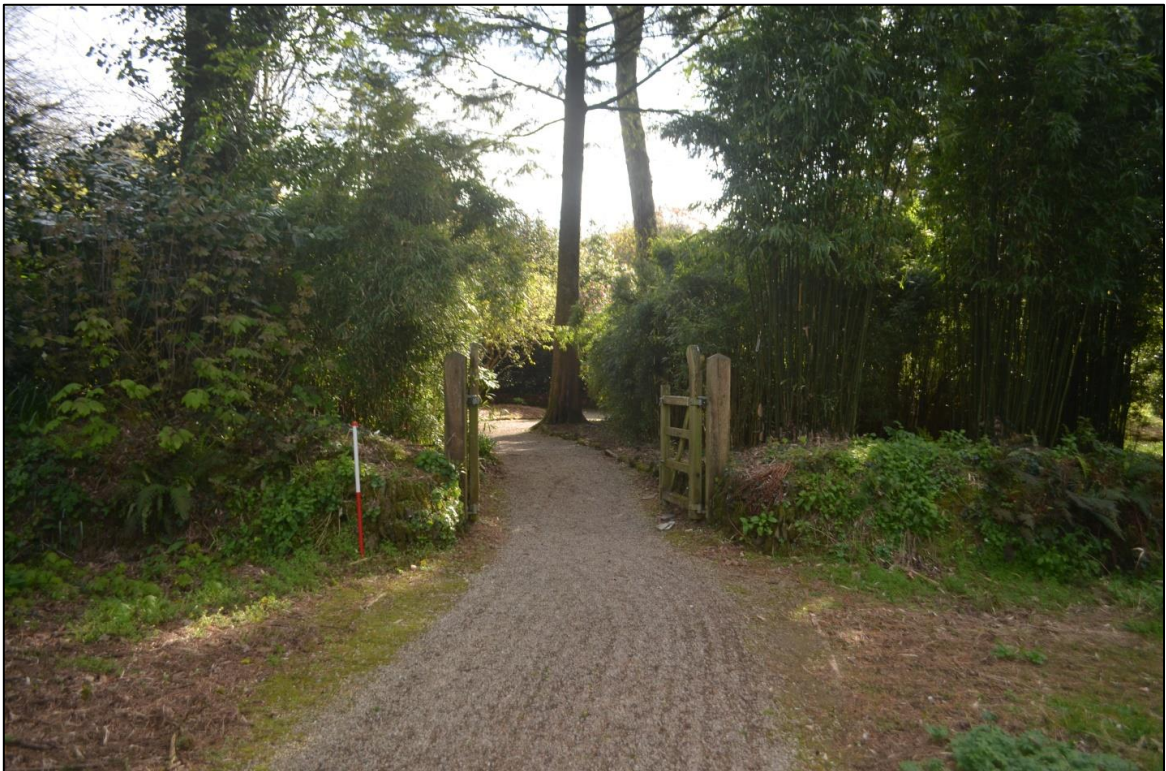
FIGURE 134: GATEWAY THROUGH BOUNDARY 36 LEADING INTO TREWITHEEN GARDENS. FROM THE WEST

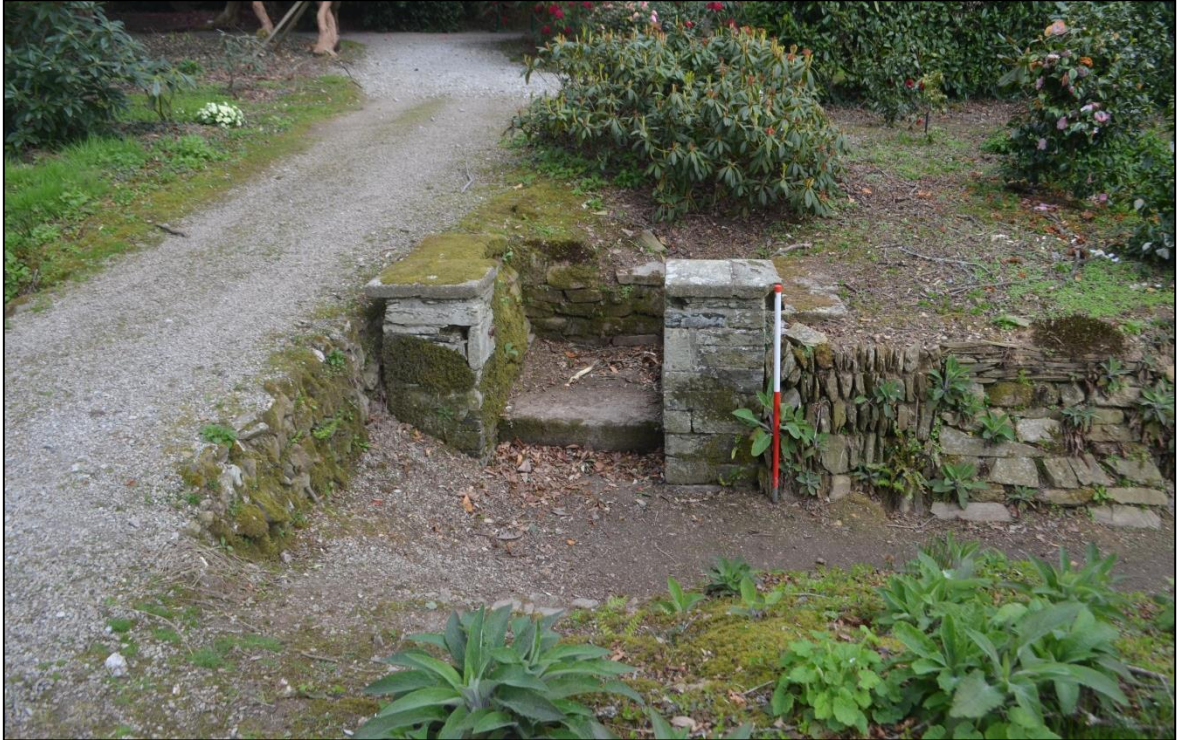
Boundary 37	
Type	Ha-ha
Date	Before 1879
Condition	Acceptable
Description	A ha-ha shown on OS 1st Edition map. Small stone steps down southern side and stone gate piers and stone steps up northern side. Evidence of metal gate fixings.
Notes	Two paths cross the Ha-ha, interrupting the boundary.

FIGURE 135: SET OF STONE STEPS PROVIDING ACCESS WITH EVIDENCE OF METAL GATE FIXINGS. FROM THE SOUTH

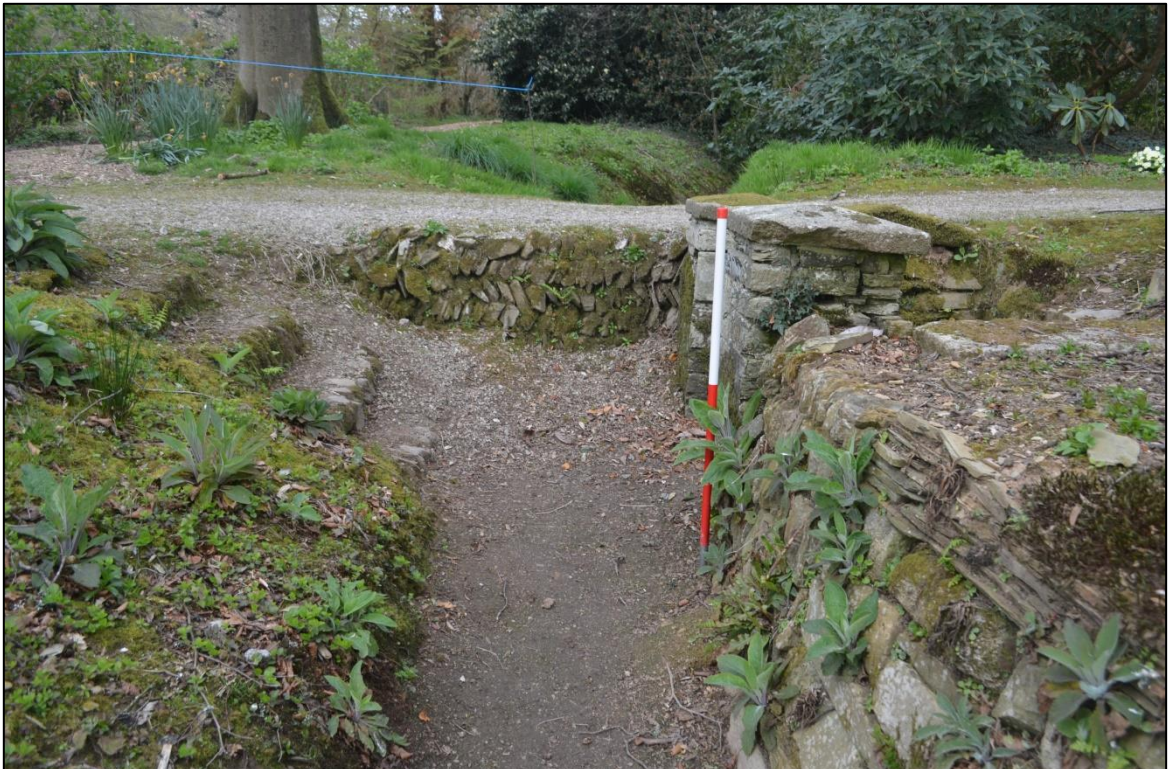
FIGURE 136: THE HA-HA CONTINUES TO THE WEST ON THE ADJACENT SIDE OF THE PATH. FROM THE EAST

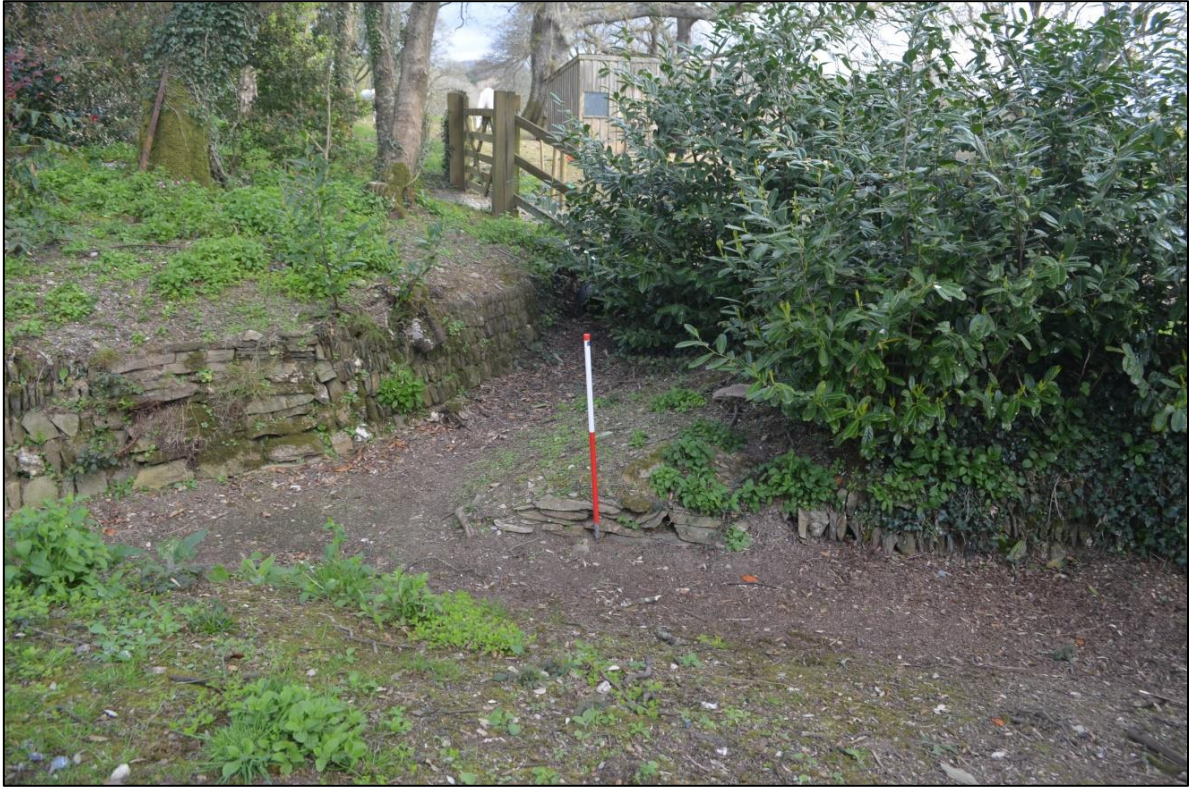
FIGURE 137: THE HA-HA BOUNDARY APPEARS TO DIVIDE AT ITS EASTERN END. FROM THE SOUTH

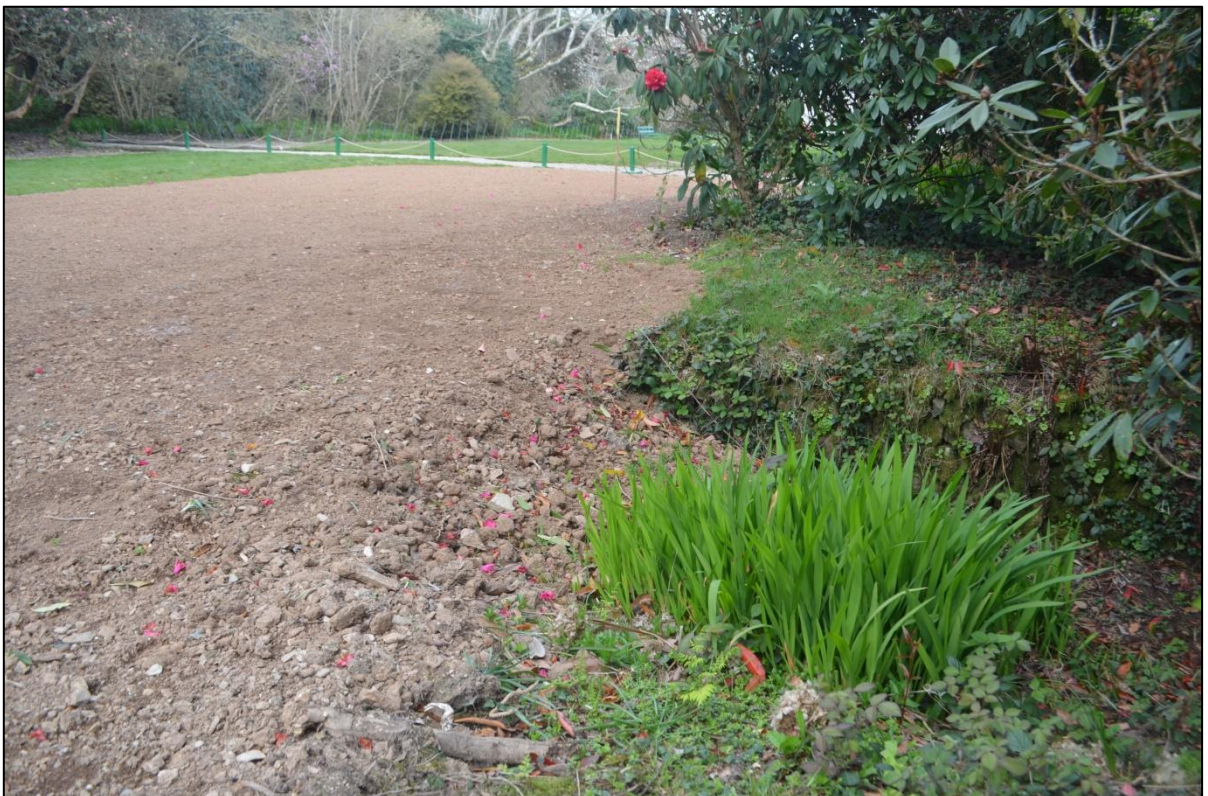
FIGURE 138: THE HA-HA APPEARS TO BE INTERRUPTED BY THE LAWN RUNNING SOUTH OF THE HOUSE, BEFORE COMMENCING AGAIN TO THE SOUTH WEST. IT WAS NOT POSSIBLE TO VISUALLY DETERMINE WHETHER THIS WAS A CONSTRUCTED END OR HAS BEEN INFILLED.

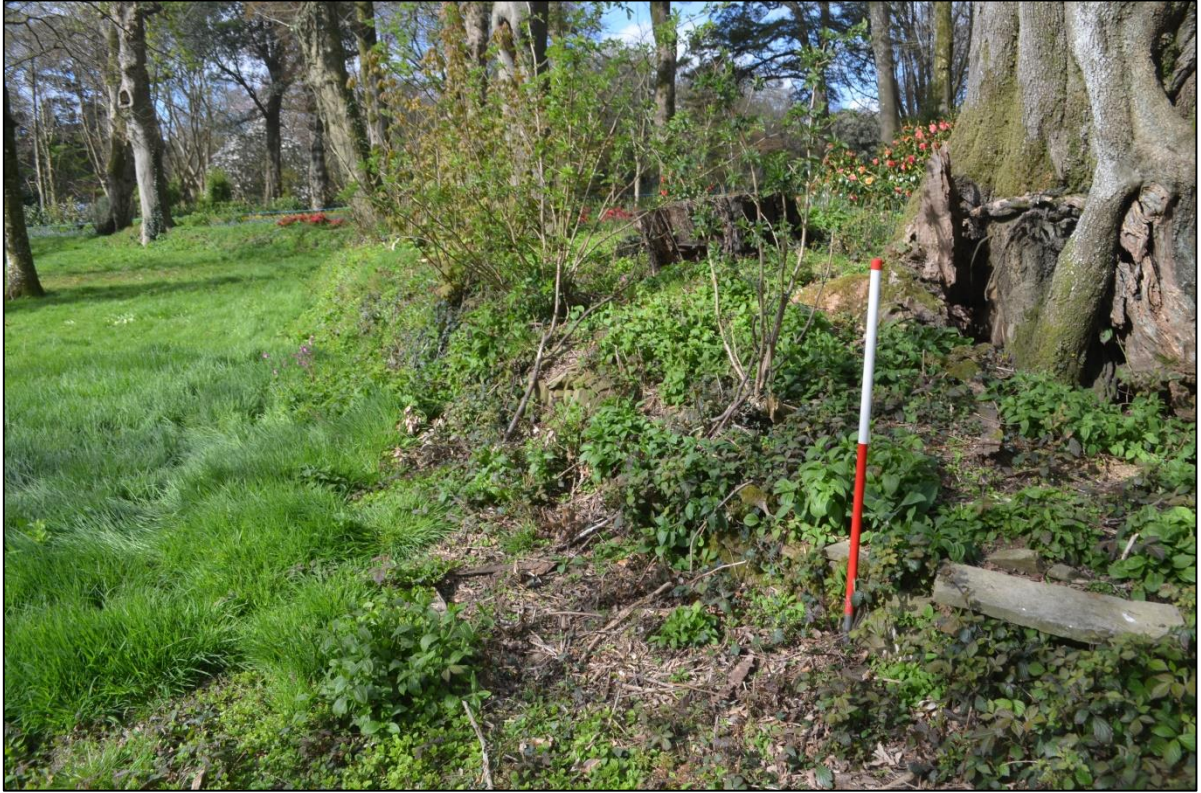
Boundary 38	
Type	Cornish Hedge Bank
Date	Before 1841
Condition	Poor
Description	Cornish Hedge Bank with evidence of horizontal and herringbone pattern stonework although most is obscured by vegetation.
Notes	Boundary ends or is truncated by a path

FIGURE 139: BOUNDARY 38 VIEWED FROM THE SOUTH EAST

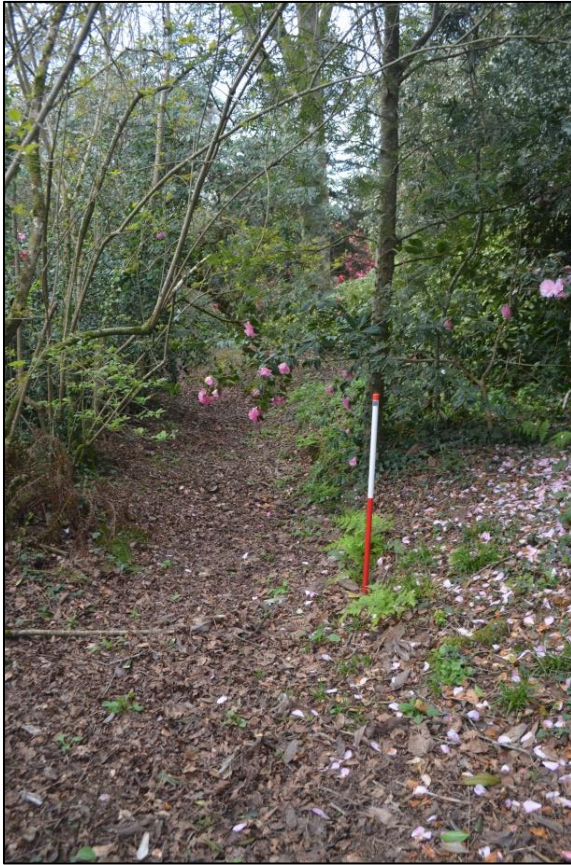
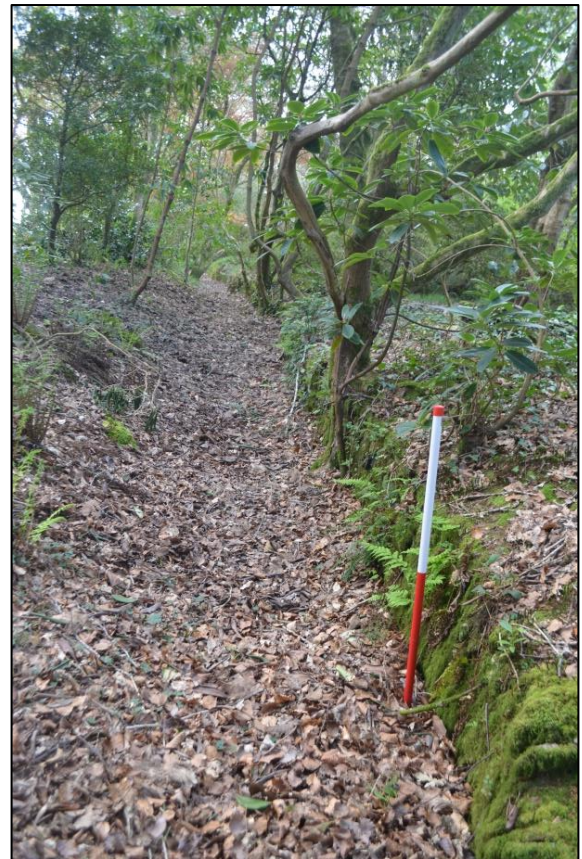
Boundary 39	
Type	Ha-ha
Date	Before 1879
Condition	Acceptable
Description	Appears to be part of a ha-ha although the northern section has been largely filled with earth
Notes	Appears contiguous with ha-ha to east although path crossing between them prevents their function as a ha-ha. The path is not shown on historic OS maps. The north east section appears to have been partially filled in.

FIGURE 140 (L): THE NORTH EASTERN SECTION OF BOUNDARY 38 APPEARS TO HAVE BEEN LARGELY INFILLED. FROM THE WEST
FIGURE 141 (R): THE BOUNDARY BECOMES MORE EVIDENT AS IT STRETCHES OUT TO THE SOUTH. FROM THE NORTH WEST
