TREWITHEN ESTATE REGISTERED PARK AND GARDEN PROBUS CORNWALL

Archaeological and Historic Landscape Survey

South West Archaeology Ltd. Report no.210524

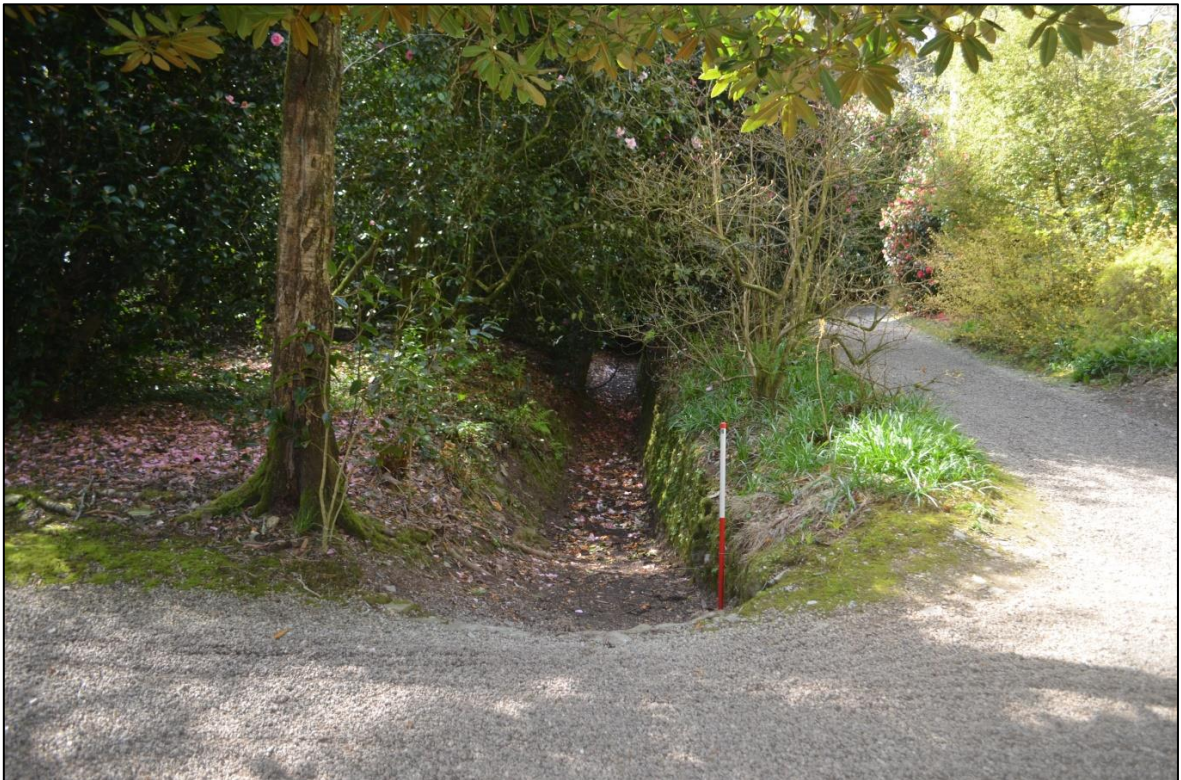
FIGURE 142: A PATH CROSSES THE HA-HA TOWARDS ITS SOUTHERN END. FROM THE NORTH

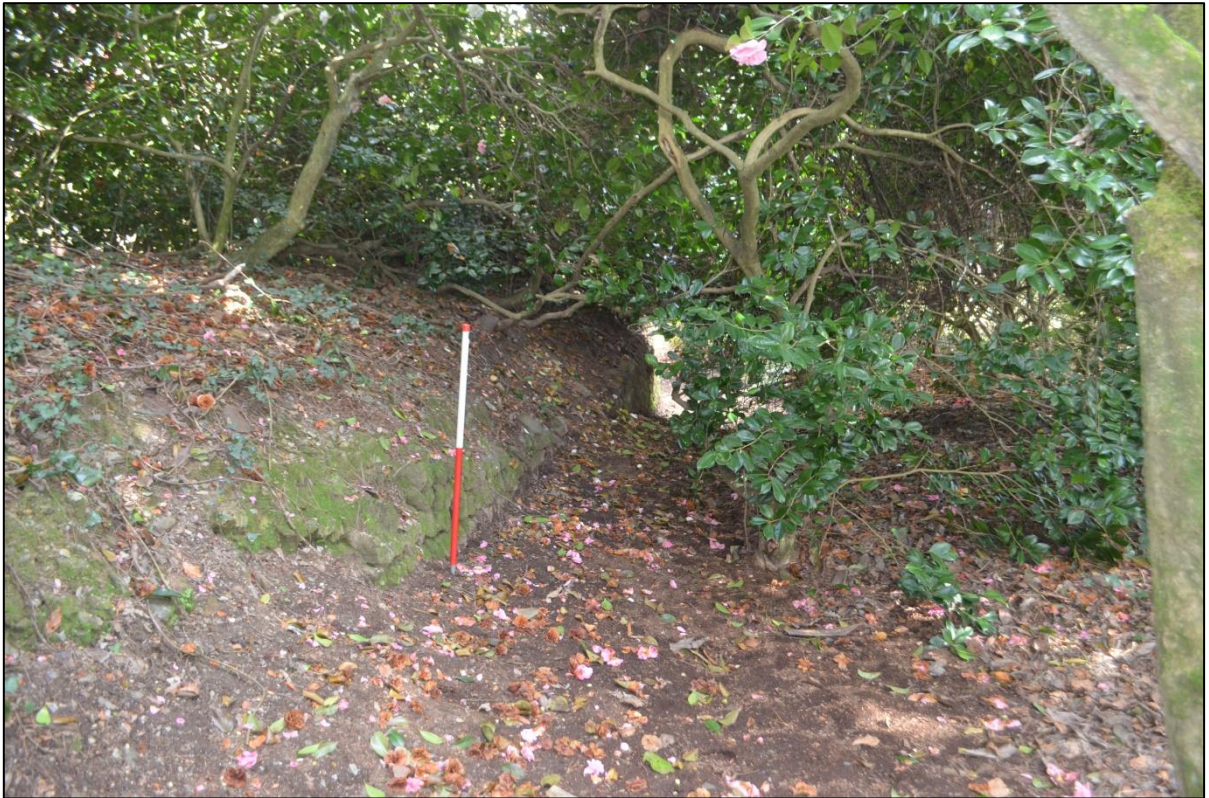
FIGURE 143: THE HA-HA FADES OUT AT ITS SOUTHERN EXTENT. FROM THE SOUTH

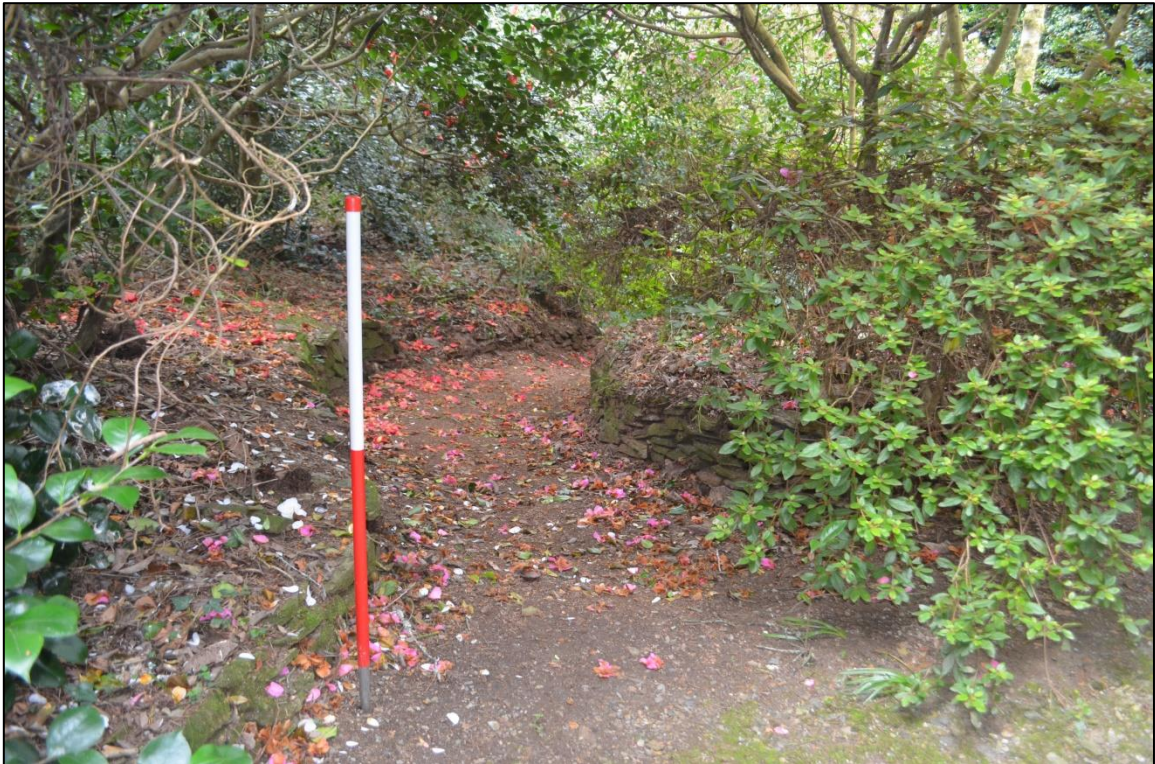
FIGURE 144: WESTERN END OF HA-HA WHICH APPEARS TO HAVE BEEN MODIFIED TO FORM A CURVED ENTRANCE. FROM THE EAST

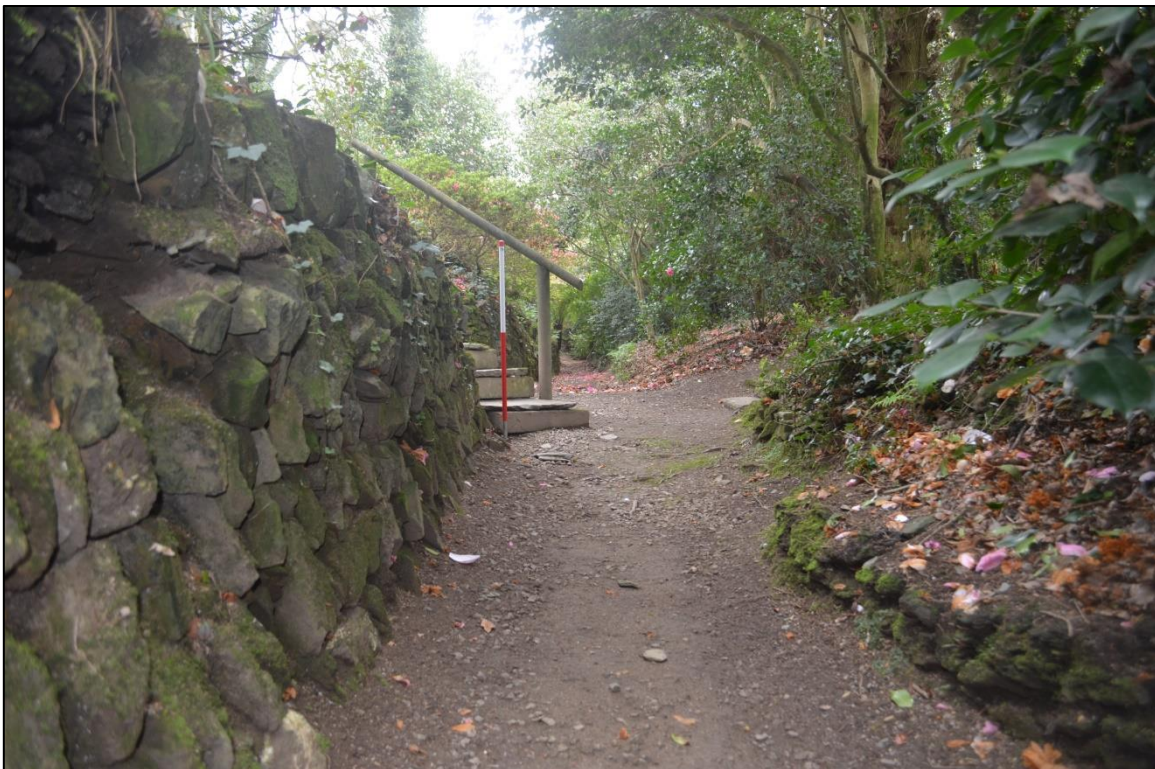
Boundary 40	
Type	Ha-ha
Date	Before 1747
Condition	Good
Description	A ha-ha extends from east to west alongside a pathway, curving around and continuing to the north. It follows the form of a boundary shown on the 1747 plan. Steps have been constructed down the northern side in two places.
Notes	The eastern end appears to have been remodelled with two short lengths of path meeting and joining together before following the form of the 1747 boundary. Blocks of quartz are incorporated into the stone wall with more quartz noted in the circular part.

FIGURE 145: STEPS HAVE BEEN INSERTED INTO THE VERTICAL FACE OF THE HA-HA TO PERMIT ACCESS. FROM THE WEST

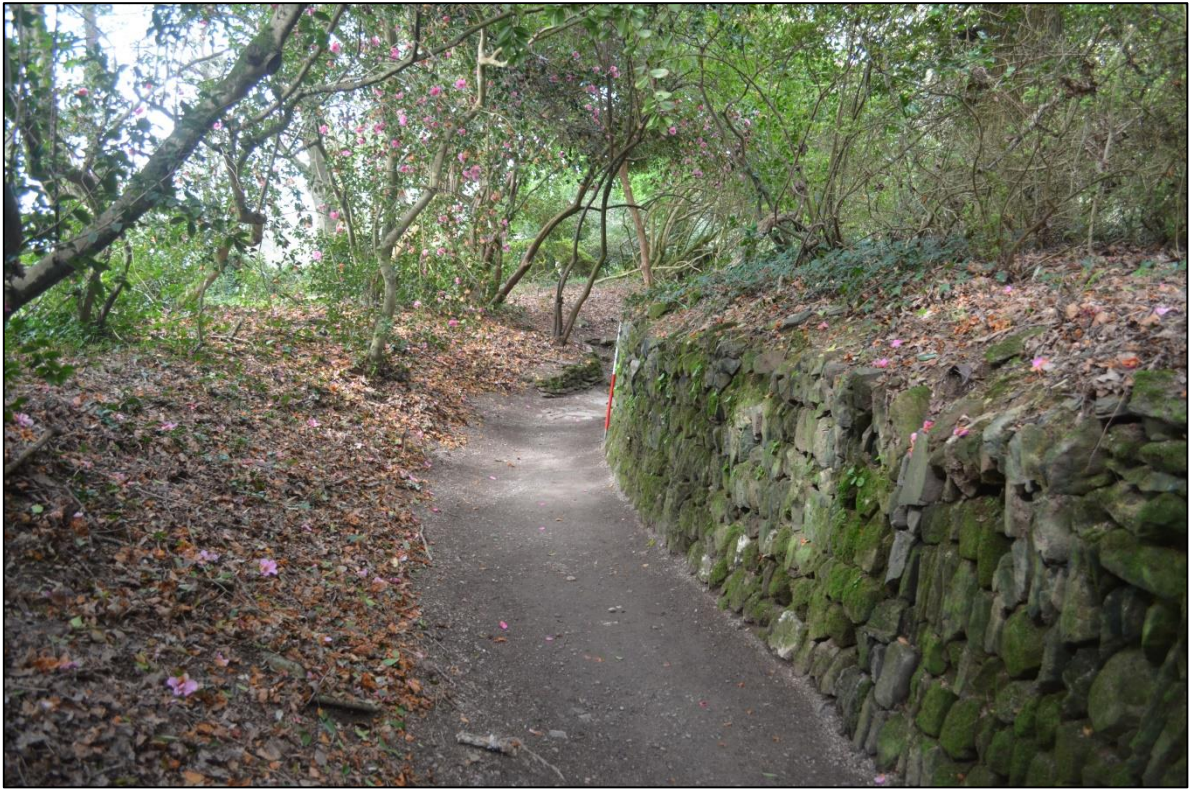
FIGURE 146: THE HA-HA CURVES AROUND AT ITS WESTERN END, THIS ALIGNS WITH THE BOUNDARY SHOWN ON THE 1747 PLAN.
FROM THE EAST

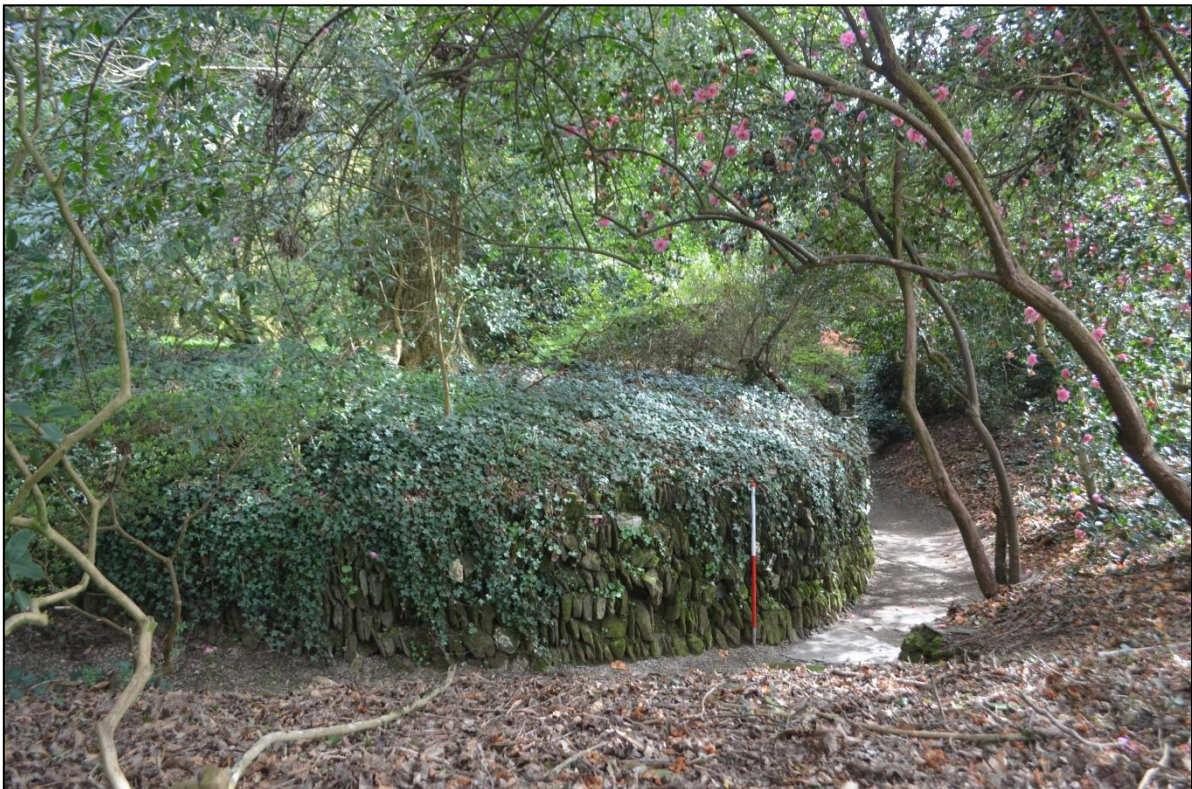
FIGURE 147: THE HA-HA CAN BE SEEN TO CURVE 90 DEGREES BEFORE CONTINUING NORTH. FROM THE WEST

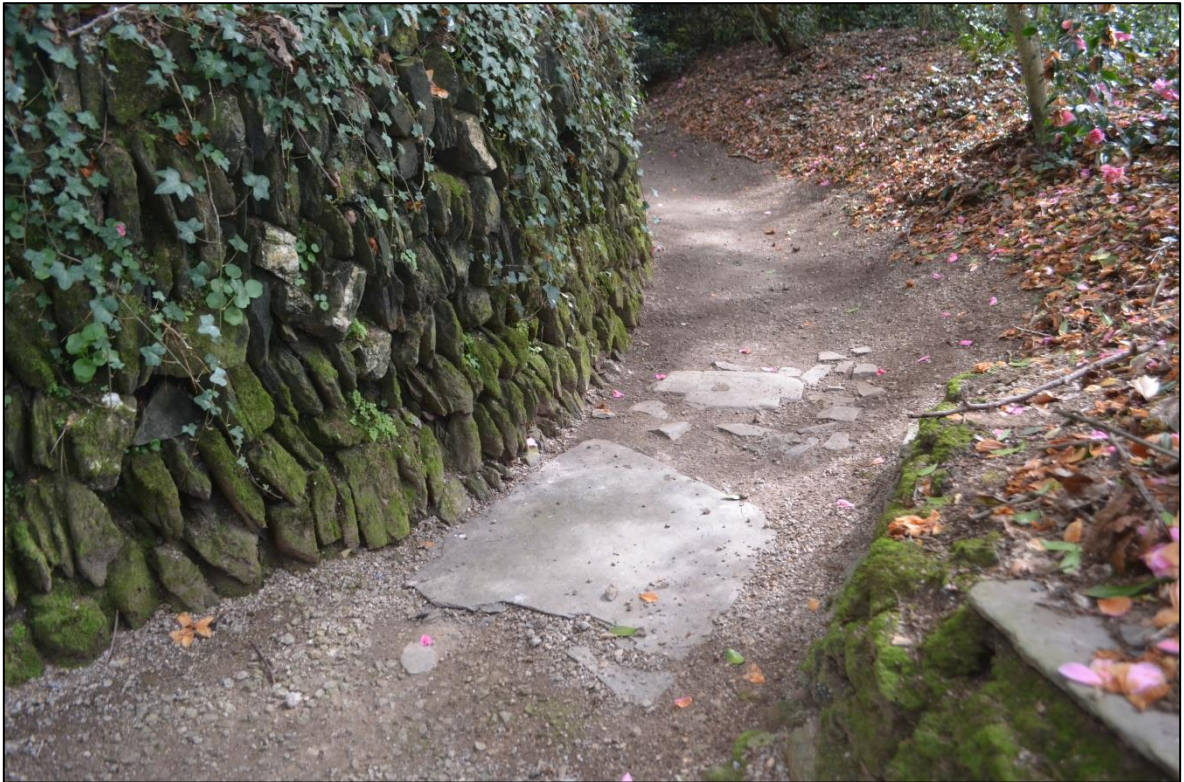
FIGURE 148: ONE LARGE AND ONE SMALLER FLAG STONE APPEAR TO HAVE BEEN LAID AT THE POINT WHERE STEPS DESCEND DOWN INTO THE CURVED SECTION OF THE HA-HA. FROM THE WEST

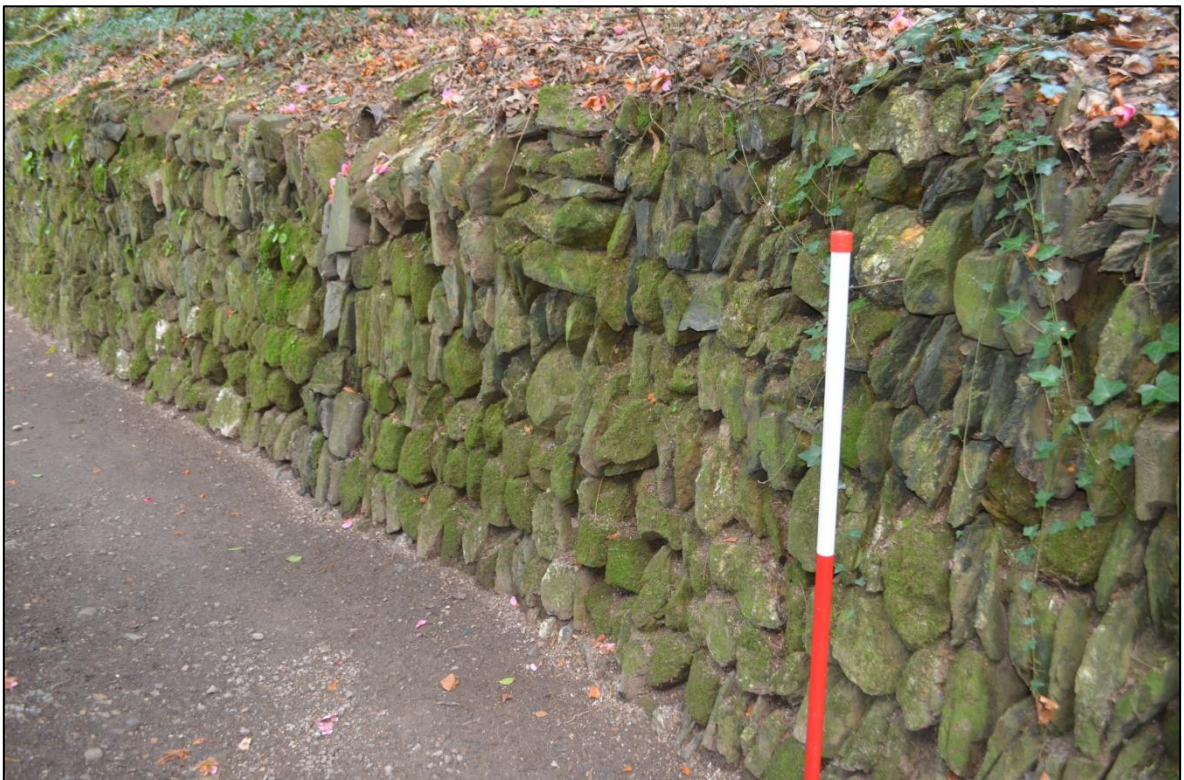
FIGURE 149: THE BUILD FORM OF THE CURVED SECTION OF THE HA-HA APPEARS TO BE CONTIGUOUS WITH THE STRAIGHT SECTION ALTHOUGH IT SEEMS LIKELY THAT REPAIRS HAVE BEEN MADE TO THE UPPER SECTIONS OF THE WALL.

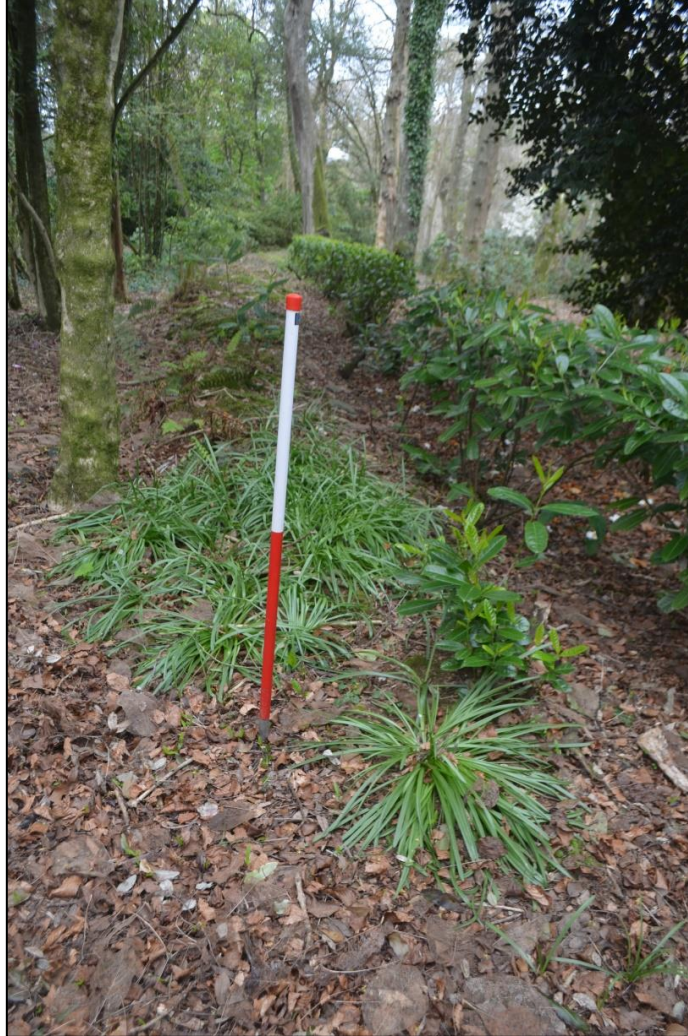
Boundary 41	
Type	Cornish Hedge Bank
Date	Before 1841
Condition	Poor
Description	Cornish Hedge Bank surviving only at a low level. Terminates near to the cock pit
Notes	Eroding in places, bank at a low level.

FIGURE 150: LOW SURVIVING BOUNDARY. FROM THE NORTH

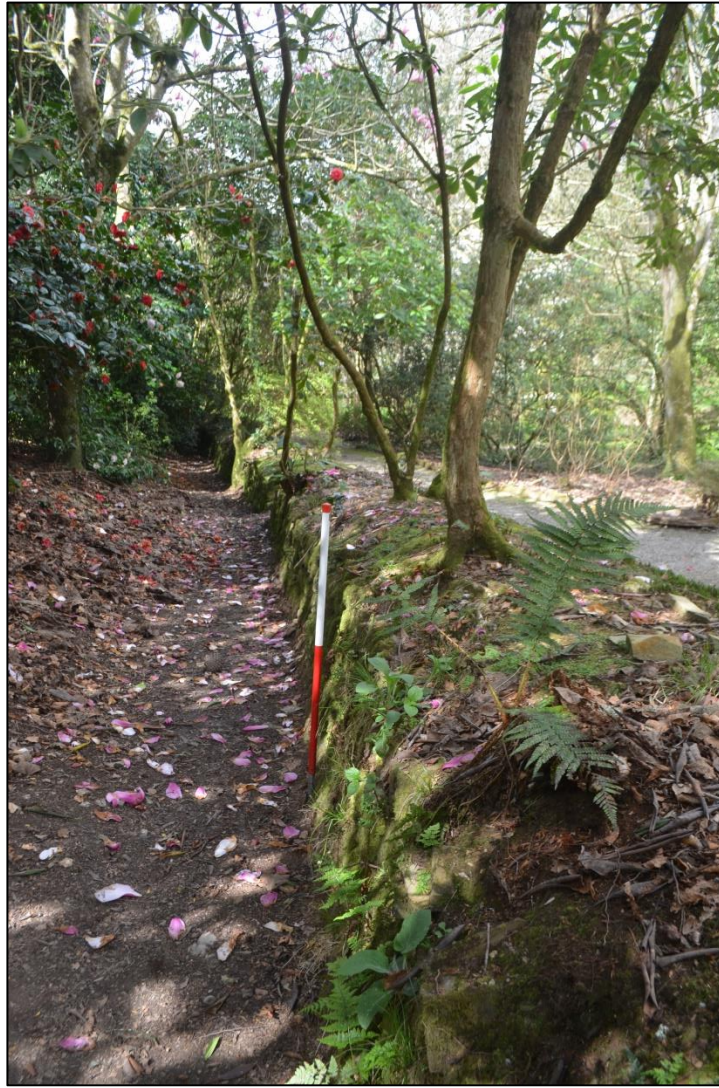
FIGURE 151: BOUNDARY 42. FROM THE EAST

Boundary 42	
Type	Cornish Hedge Bank
Date	Before 1841
Condition	Good
Description	Cornish Hedge Bank alongside pathway

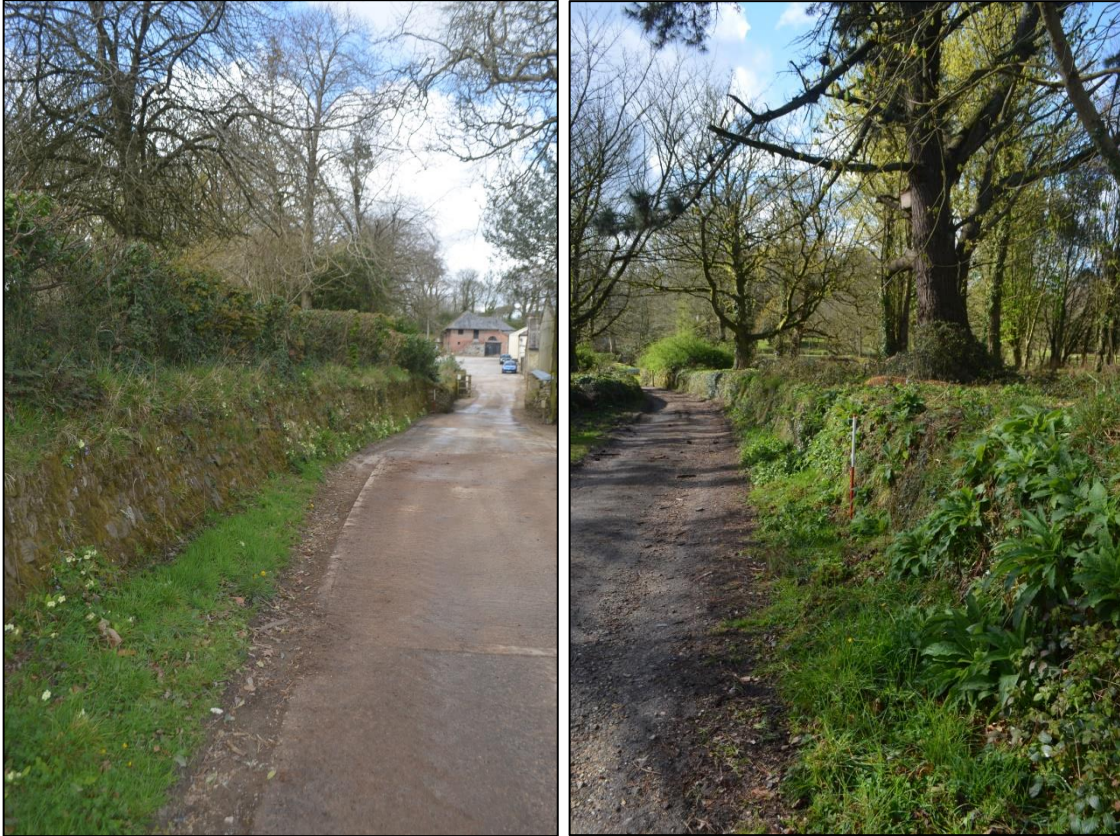
Boundary 43	
Type	Cornish Hedge Bank
Date	Before 1841/1879
Condition	Acceptable
Description	Cornish hedge bank to the south of Trewithen Farm largely covered in vegetation.
Notes	Some small areas of erosion but condition appears reasonably stable. Poorer condition near building. c.2m tall in places. Horizontal and vertical construction

FIGURE 152 (L): BOUNDARY 43 TO THE SOUTH OF TREWITHEM FARM. FROM THE SOUTH

FIGURE 153 (R): BOUNDARY 43 NORTH OF TREWITHEM FARM. FROM THE NORTH

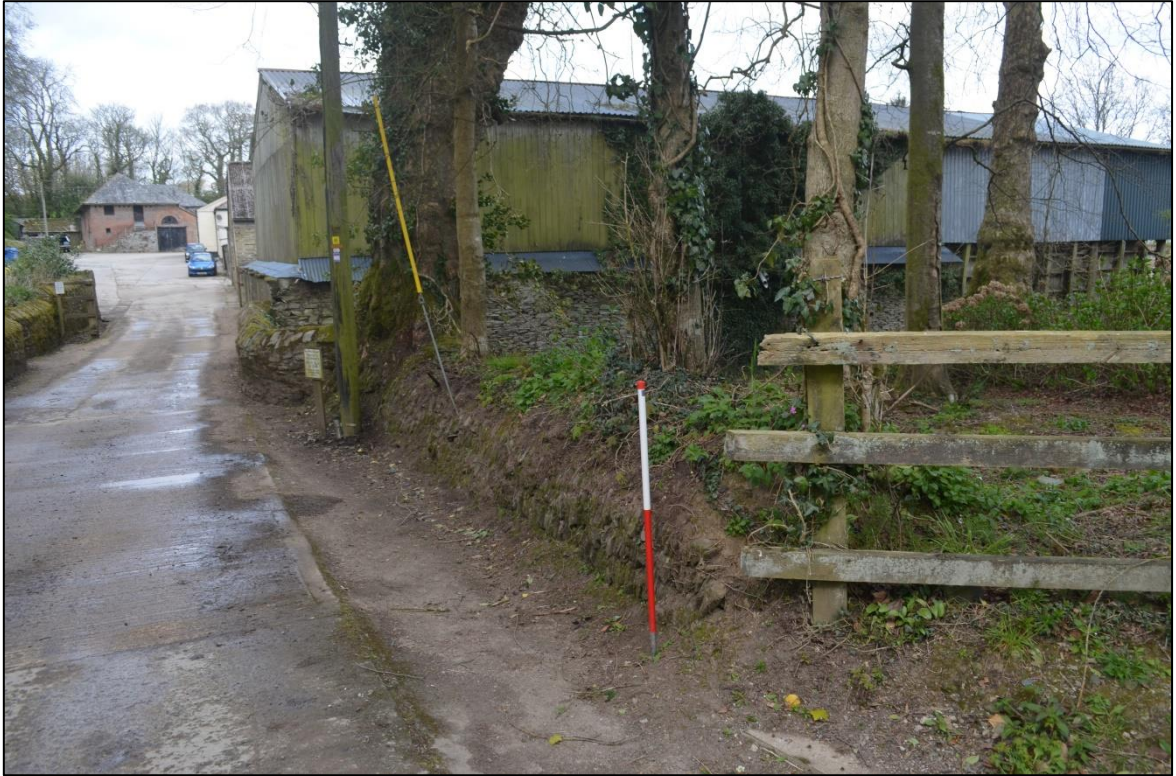
Boundary 44	
Type	Cornish Hedge Bank
Date	Before 1747
Condition	Acceptable
Description	Low Cornish Hedge Bank c.0.7m
Notes	Evidence of gradual erosion.

FIGURE 154: BOUNDARY 44 FROM THE SOUTH

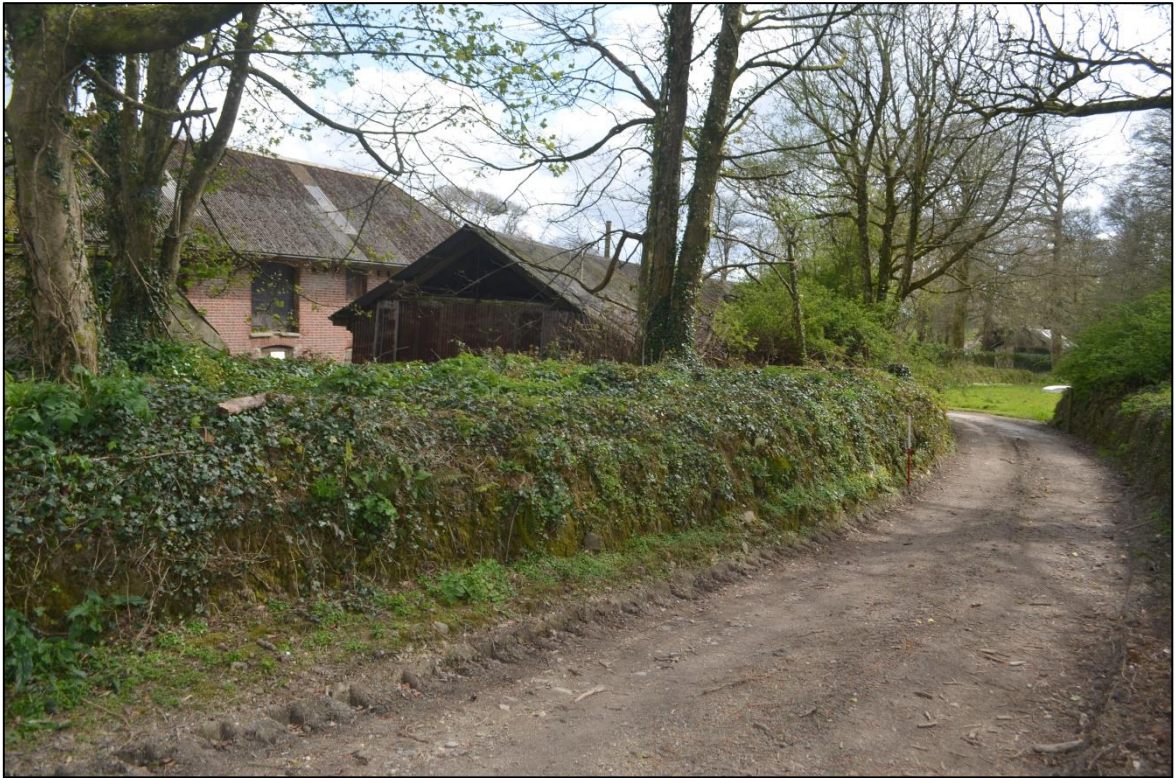
Boundary 45	
Type	Cornish Hedge Bank
Date	Before 1841
Condition	Poor
Description	Small length of Cornish Hedge Bank defining the north western corner of Trewithen Farm
Notes	Covered with vegetation.

FIGURE 155: BOUNDARY 45 FROM THE NORTH

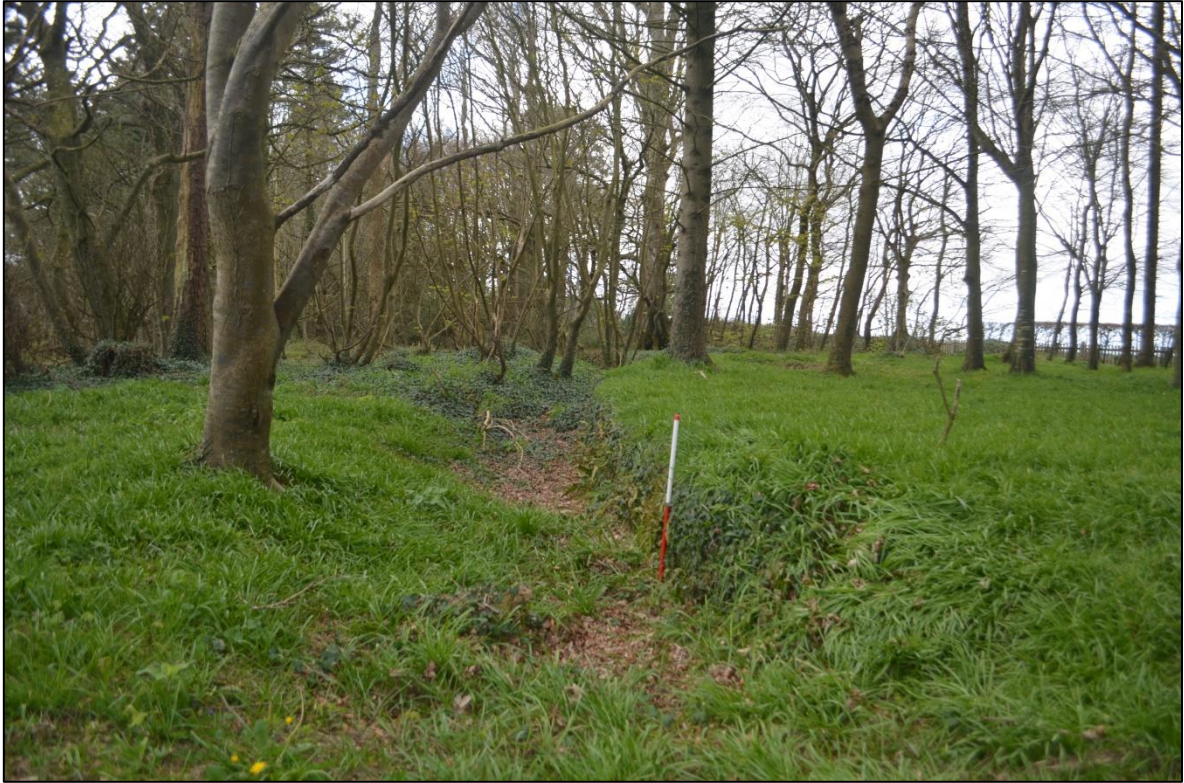
Boundary 46	
Type	Ha-ha/Corn ditch
Date	Before 1841
Condition	Acceptable
Description	A ha-ha running approximately parallel to the boundary of the RPG on the north western side. Correlates with a boundary shown on 1824 St Aubyn plan but not shown exactly on 1841 plan. Evident on 1st Ed OS.
Notes	Located in woodland, generally overgrown. Boundary line appears to continue east toward the access into the estate but ha-ha is not extant. A slight mound is visible on top of stone face in the western part of the woodland suggesting the possibility it may have been a Cornish Hedge Bank, in places at least. Aerial photographs from 2000 suggest that the woodland to the south of this boundary was planted in the late 1990s/early 2000 and therefore this boundary marked the line between arable field and the plantation. It is therefore possible this boundary was constructed to facilitate views back to Trewithen House from a walk or ride along the southern edge of this plantation shown on the 1824 St Aubyn plan.

FIGURE 156: BOUNDARY 46 FROM THE EAST

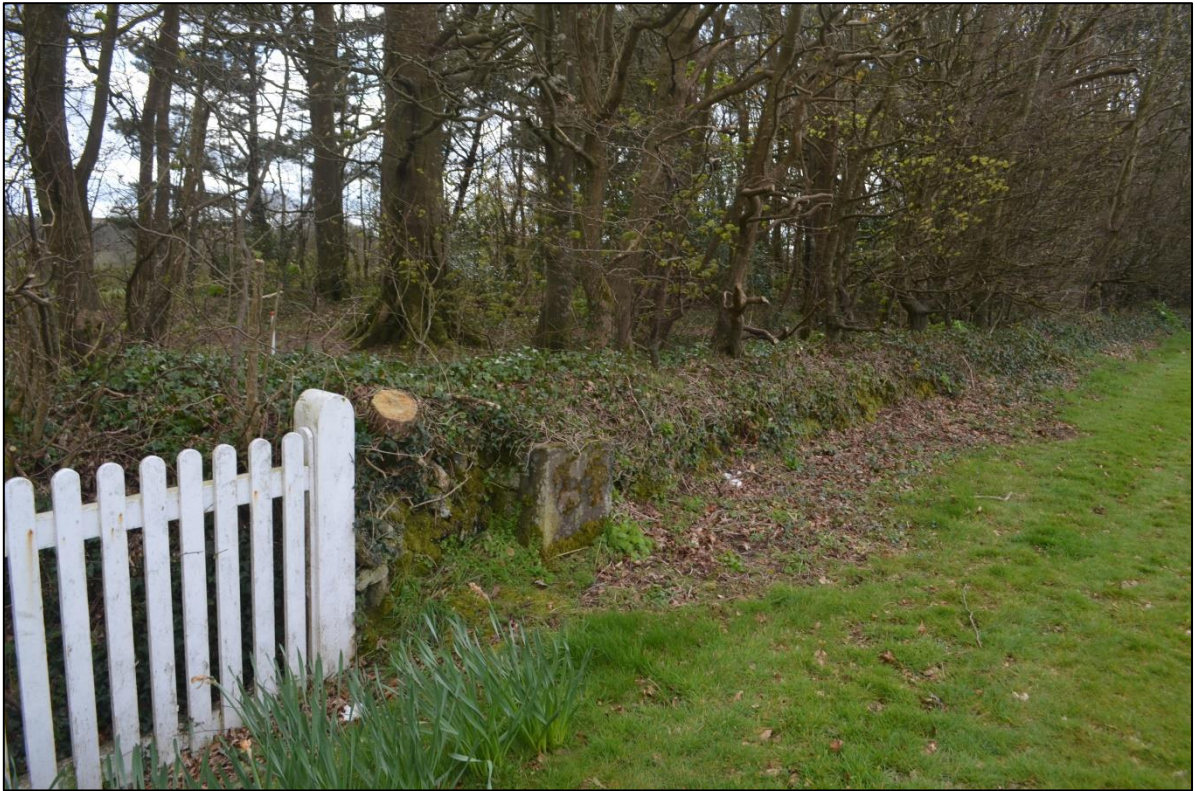
Boundary 47	
Type	Cornish Hedge Bank
Date	Before 1841
Condition	Acceptable
Description	Boundary at the north western corner of the RPG. Appears to have been a Cornish Hedge Bank although eroded and very low on the northern side. Southern side appears very sloping in places.

FIGURE 157: BOUNDARY 47 VIEWED FROM THE A390 (NORTH)

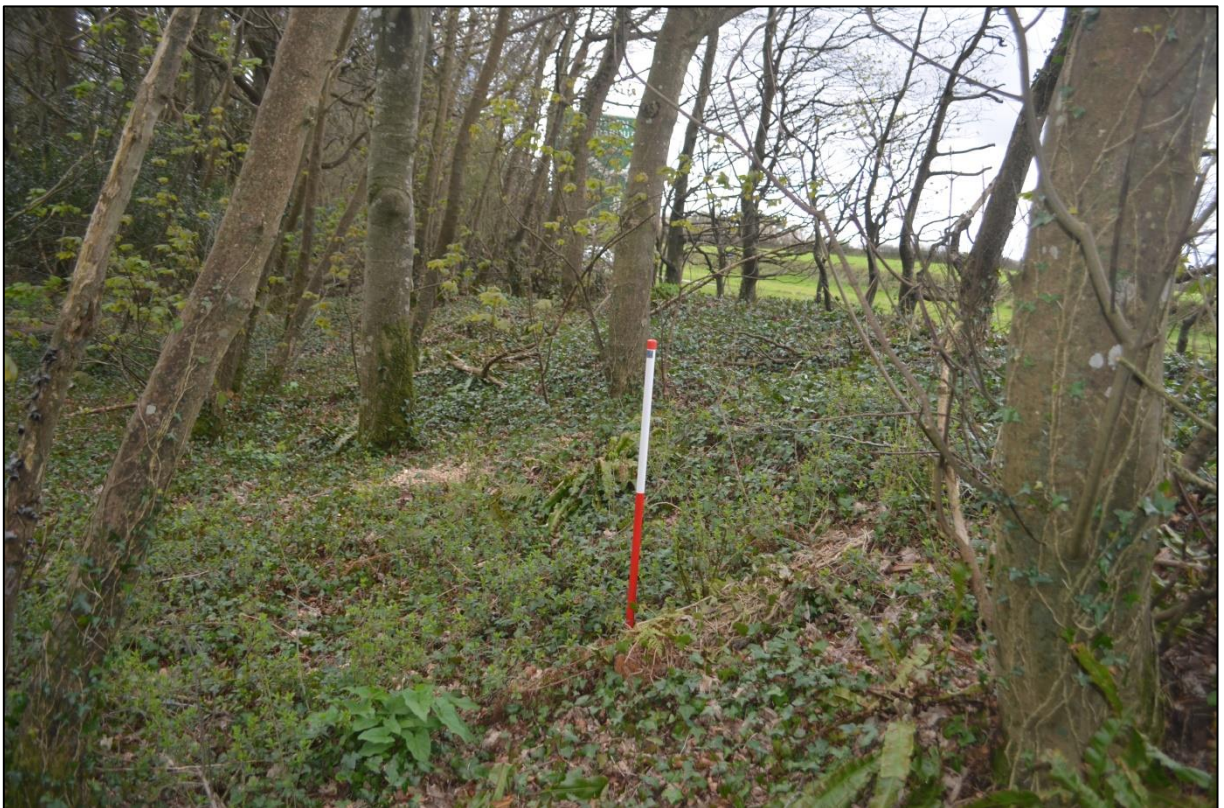
FIGURE 158: BOUNDARY 47 FROM THE SOUTH SHOWING SLOPING SECTION OF BANK.
