Mountjoy, Colan, Cornwall – Archaeological Statement v.3

South West Archaeology Ltd. 11.12.2020 B Morris OASIS Ref: southwes1-426523 Centroid Grid Ref: SW 86400 60707

Project Background

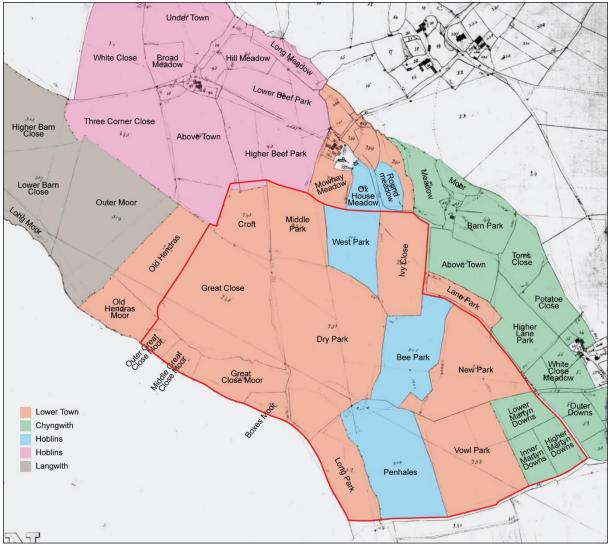
FIGURE 2: GRAPHIC DERIVED FROM THE COLAN TITHE MAP AND APPORTIONMENT OF C.1840 (PRO), SHOWING THE FIELD NAMES AND UNITS OF LANDHOLDING.

The mid-19th century tenurial landscape also retains echoes of the medieval layout of the site. It was divided between four tenements and two landowners: William Mallet Hoblyn and a collective (William and Henry Benny, Richard Taunton and Eliza Mackey). The Hoblyn family acquired the Colan Barton estate in the 17th century, by sale from the Blewetts and the last Earl of Radnor. The Barton was originally held by a family of the same name, passing in moieties through marriage to the Blewetts and the Trefusis family in c.1500 (Lysons 1814). The four tenements were: Lower Town; Chyngwith; Hoblins (presumably from Hoblyn); and Mellionack Wartha. The intermingled distribution of Lower Town and Hoblins, and the fact that Lower Town was owned by three different families, points to a complex pattern of landholding ultimately derived from the intermingled parcels of a medieval strip field system. The field names themselves are mostly prosaic and straightforward; the exceptions are Round Meadow and Old Hendras. Round Meadow could be taken to indicate the presence of an enclosure of Late Prehistoric or Romano-British date (as recorded on the HER: MCO7857), and a stone spindle whorl has been recovered from the field (MCO920). No earthworks are reported here. Hendra (hen+tre) is Cornish for 'winter farmstead/home farm' and would strongly indicate either a medieval or earlier settlement site in or near this field. It is worth noting there is a Scheduled enclosure on the hill spur c.0.8km to the north-north-east (MCO950/8224) in a similar topographical location.

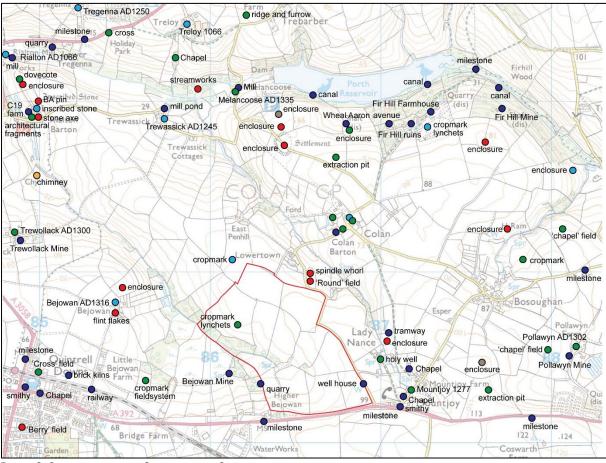
FIGURE 3: SITES LISTED ON THE CORNWALL AND SCILLY HISTORIC ENVIRONMENT RECORD.

There are relatively few recorded archaeological features within the site, restricted to the cropmarks of probable medieval lynchets on the upper slopes of Field 9 (MCO32846) and a lost field boundary (MCOMCO32847). There is a tiny stone-built structure on the roadside near Mountjoy (Field 4) described on the HER as a well house (MCO57027); formerly a two-storey structure, this has been cut down and fitted with a mono-pitch roof. The west wall is pierced by three openings: two doors flanking a small central window. The three openings have pointed segmental stone arches that would suggest an association with house Mellionec Vean ('Lowertown Barn'). Internally there are alcoves in the north and south walls just inside the doors, evidence for floor joists, and a blocked first floor opening in the south wall; the well is not immediately obvious. At the south-west corner of the site a quarry is noted (MCO26012), with Bejowan Mine (MCO11826) just to the west. This would suggest mining-related features could be present on this part of the site.

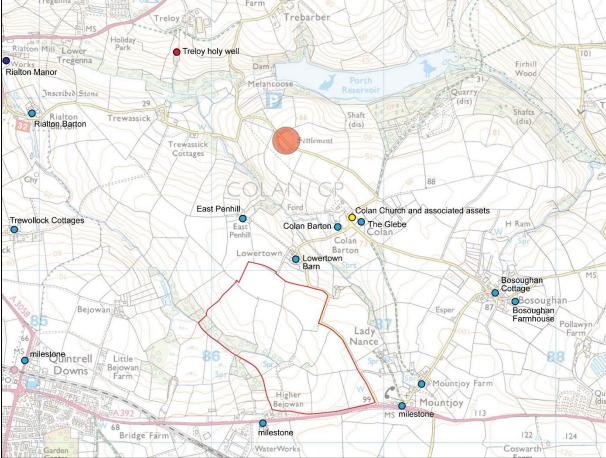
FIGURE 4: DISTRIBUTION OF DESIGNATED HERITAGE ASSETS (SOURCE: HISTORIC ENGLAND).

There 46 designated heritage assets within 2km of the site boundary: five Scheduled Monuments (Tregenna wayside cross; wayside cross and cross base in Colan churchyard; Melancoose round; and Treloy holy well); one Grade I Listed building (Church of St. Colanus); three Grade II* Listed buildings (Rialton Manor; Courtyard walls at Rialton; holy well at Rialton); and the rest being Grade II Listed structures. Of this group, some are located at some distance and there is intervening screening, from the terrain (e.g. Rialton manor GII*), built environment (e.g. Manuels Farmhouse GII) or both. The total also includes nine milestones. At this preliminary stage it is considered an appreciable effect could be experienced at: the barn at Lowertown (GII); Penhill Farmhouse (GII); Colan Barton (GII); the Church of St Colanus (GI); the Glebe at Colan (GII); and Melancoose Round (SAM). This is due to proximity, line of sight, and the impact arising from the effect a development could have on the approach to the assets. Accordingly, site visits were made to all of these assets to asset the potential for harm, with the exception of Penhill Farmhouse, which is not visible from the public road and is accessed via a private track. It should be noted that all the Listed buildings and the Scheduled round are located at a distance and immediate settings would not be affected – it is distance views and contextual views that are considered here.

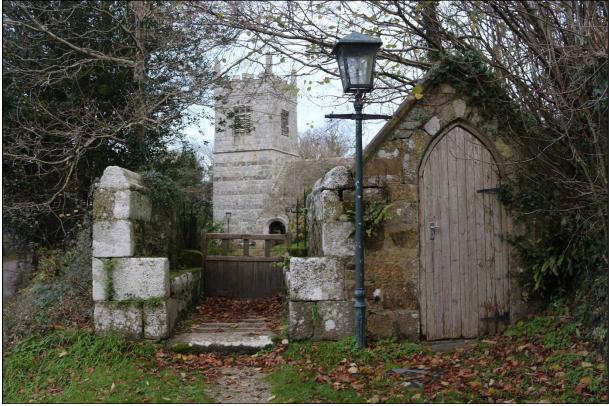
1. THE SOUTH GATE OF THE CHURCHYARD; VIEWED FROM THE SOUTH. THE BIER HOUSE COULD ALSO BE THE WORK OF WILLIAM WHITE.

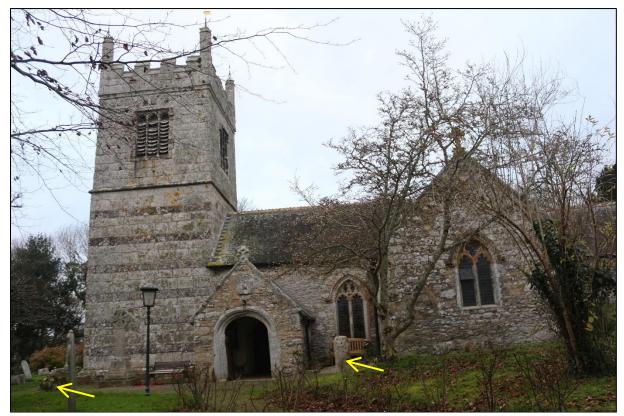
2. THE CHURCH OF ST COLANUS; VIEWED FROM THE SOUTH. THE SCHEDULED CROSS AND CROSS BASE ARE INDICATED.

A small and attractively composed church with a low, two-stage tower with pinnacles. Located on a facing slope, the road around the churchyard is raised up above the level of Colan Barton providing something of a viewing platform. However, on this side of the church the field boundaries sport mature trees and views from the body of the church are extremely limited; views from behind and over the church from the cemetery behind are not possible. Limited views would, however, be possible in winter from the south entrance/coffin rest to Field 11. Impact: negligible.

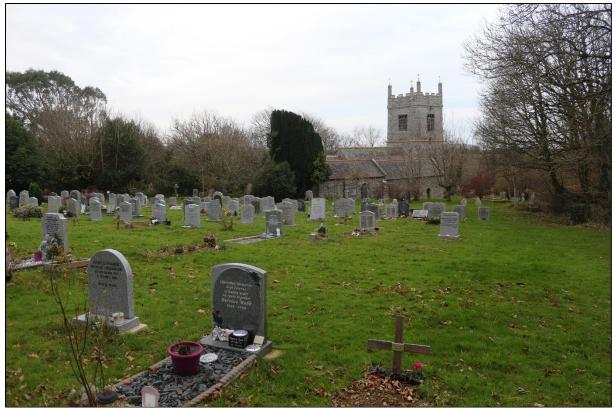
3. THE CHURCH FROM THE CEMETERY; VIEWED FROM THE NORTH-EAST. VIEWS THROUGH TO THE SITE ARE EFFECTIVELY SCREENED.

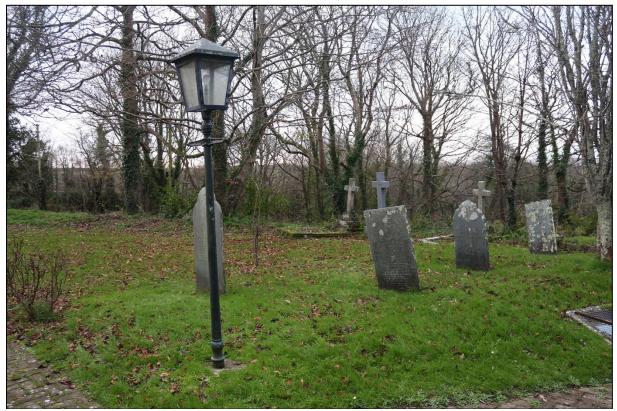
6. THE VIEW FROM THE CHURCH PORCH, LOOKING TOWARDS THE SITE; VIEWED FROM THE NORTH-EAST.

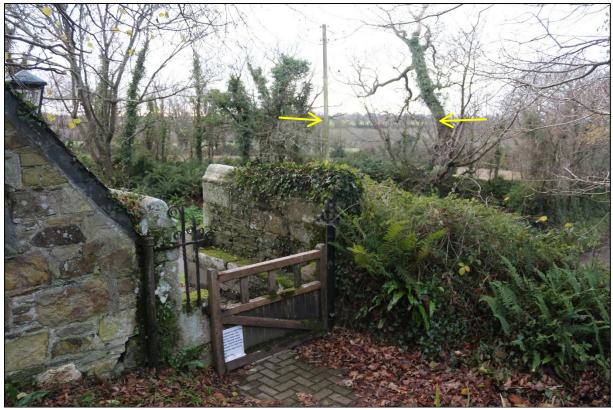
7. The south gate of the churchyard, looking out to the site. Field 11 is just visible (indicated); Viewed from the North-East.

- Field 11 appears to be most readily visible from Colan Church, so excluding this field from the development could be considered. Otherwise, additional screening along the hedgeline or use as public open space would be appropriate.

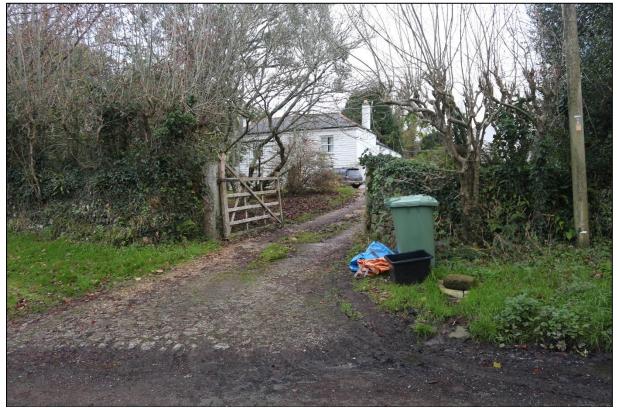
$\mathbf{8}.$ The Glebe; viewed from the WSW.

An attractive rectory building set back from the road to the east of the church. The slate-hung and whitewashed façade is fairly low, but it is considered likely that limited views across the trees and shrubs in the front garden from the upstairs windows would be possible to Field 11. Impact: negligible.

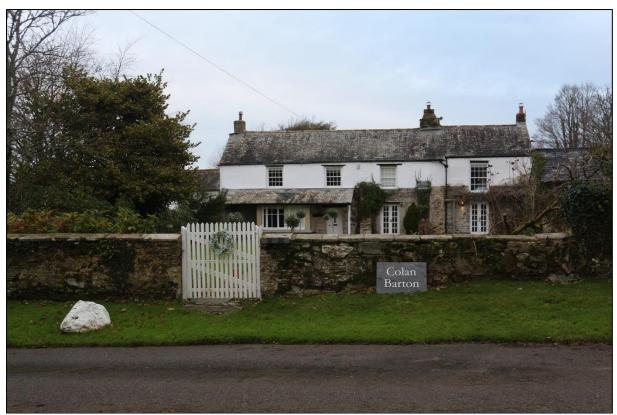
A larger former farmhouse (Listed as 17th century but probably with a medieval core), renovated and converted for use as a holiday let, diminishing its intrinsic value. The surroundings are neatly kept but the principal façade faces south-east to the lane and again, the trees along the sunken lane provide comprehensive screening. Views to the lower part of Field 11 would be possible in winter

9. COLAN BARTON; VIEWED FROM THE SOUTH-EAST.

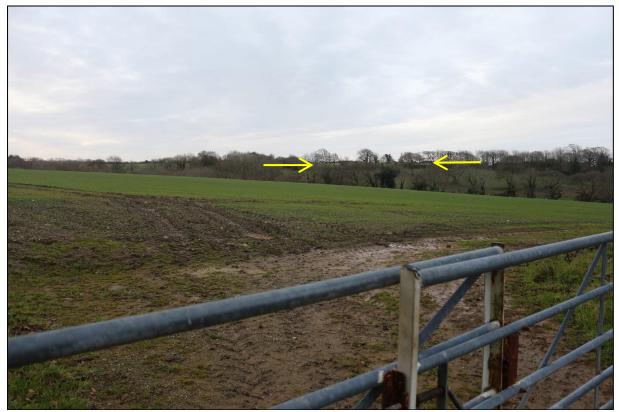
from the field gateway opposite the house. Views across the farmhouse from higher ground to the east are not possible due to the trees around its curtilage. Impact: negligible.

10. THE VIEW FROM THE GATES OPPOSITE COLAN BARTON. FIELD 11 IS JUST VISIBLE (INDICATED). VIEWED FROM THE NORTH.

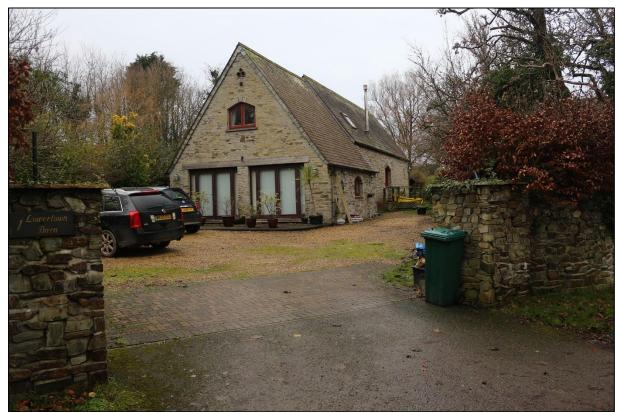
12. THE CONVERTED BARN AT LOWERTOWN, IN A SIMILAR STYLE TO THE LISTED HOUSE; VIEWED FROM THE EAST.

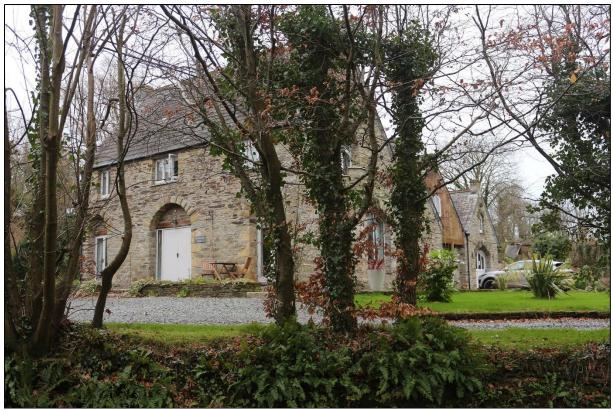
The Listed structure here (*Mellionec Vean*) is deeply curious. The Listing states it forms part of a range of *barns* in a Gothic style. Its form and architectural elaboration are decidedly atypical for an agricultural building but is mirrored by other buildings on the Hoblyn estate (e.g. Whitewater Farm at Talskiddy (Berry 2018), and probably the wellhouse in Field 4). It is the work of noted Gothic Revival architect William White, designed and built c.1875 for the Hoblyn family of Fir Hill. It may have been adapted from a farm building, but this structure was a dwelling from the outset. The association with White, together with the loss of Fir Hill and his other work for the Hoblyns, enhances the importance of this building. The other oddity about Lowertown is the fact that the older farmhouse – with a massive and clearly 17th century gable and lateral stacks – is not Listed despite the fact it is probably medieval in origin. Both buildings are set back into the slope, fully screened from the site by the terrain, with additional screening from trees around the curtilage. Neither building is visible in views from across the valley. Impact: negligible.

13. THE LISTED 'BARN' AT LOWERTOWN (*Mellionec Vean*), A GOTHIC REVIVAL HOUSE BY WILLIAM WHITE; VIEWED FROM THE NORTH-EAST.

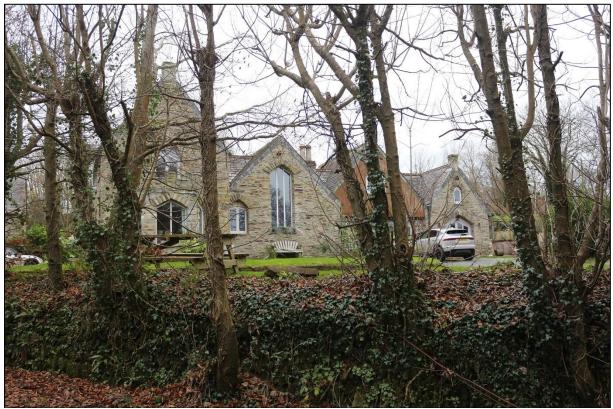
14. THE LISTED 'BARN' AT LOWERTOWN (MELLIONEC VEAN); VIEWED FROM THE NORTH.

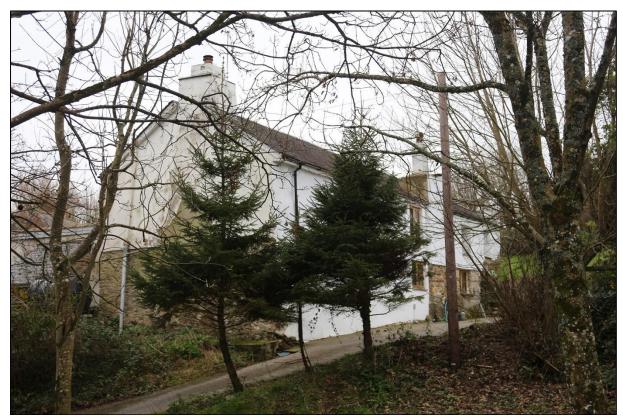
16. THE UNLISTED FARMHOUSE AT LOWERTOWN; NOTED THE MASSIVE GABLE AND LATERAL STACKS; VIEWED FROM THE NORTH.

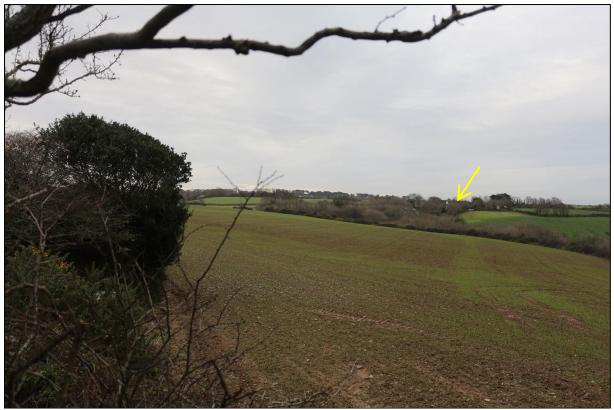
The round is bisected by a public lane and only the western half of the earthwork survives. The interior is overgrown with scrub, on the edge of a large arable field. It no longer presents as a dramatic earthwork but the surviving part faces towards the site. Views from the monument to Field 10 may be possible, but there is screening from hedgebanks. Impact: negligible.

17. THE SITE VIEWED FROM MELANCOOSE ROUND (ON THE LEFT); PENHILL FARM IS INDICATED. VIEWED FROM THE NORTH.

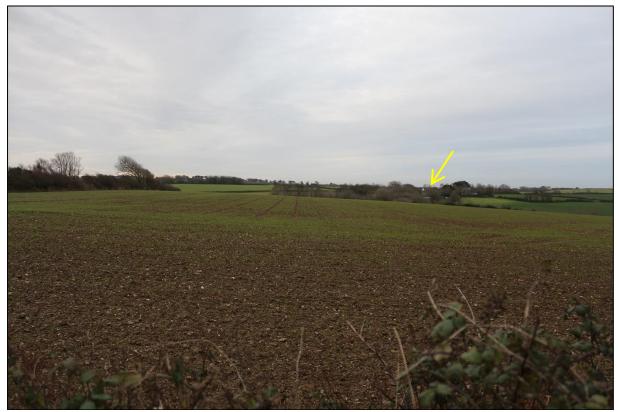
Penhill was not accessible but is (just) visible in distant views. Its curtilage is also surrounded by trees and views back to the site are unlikely to be possible, and in contextual views it is largely concealed. One of the surviving farm buildings (converted?) sports a long roof with high narrow gables and thus may also be the work of William White. Impact: negligible.

18. The site (extreme left, behind the hedge) viewed from east of Melancoose Round; Penhill Farm is indicated. Viewed from the north.

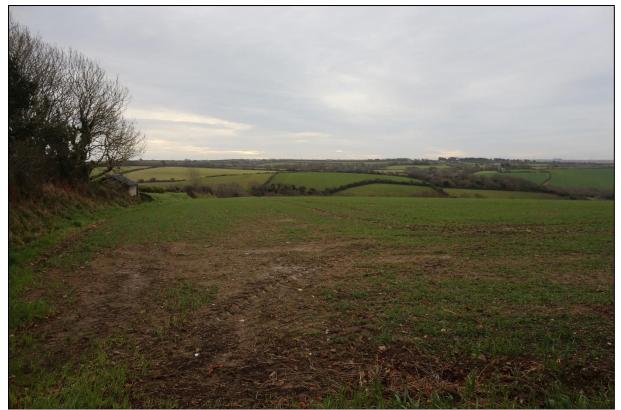
19. The site viewed from Trebarber Farm above Porth Reservoir. Note the way most of the site is screened by the intervening hill spur. Viewed from the north.

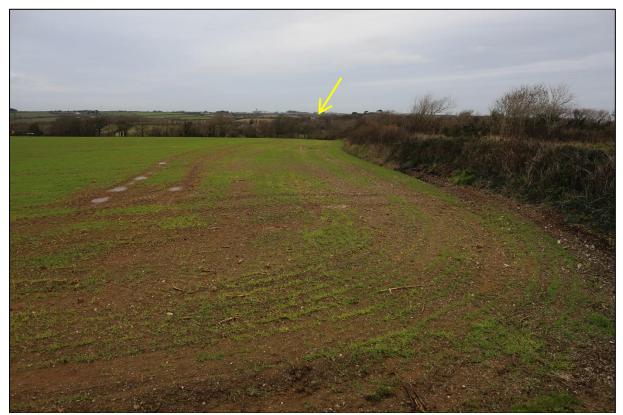
20. THE VIEW BACK TO THE CHURCH OF ST COLANUS (INDICATED) FROM THE SOUTH CORNER OF FIELD 11; VIEWED FROM THE SOUTH.

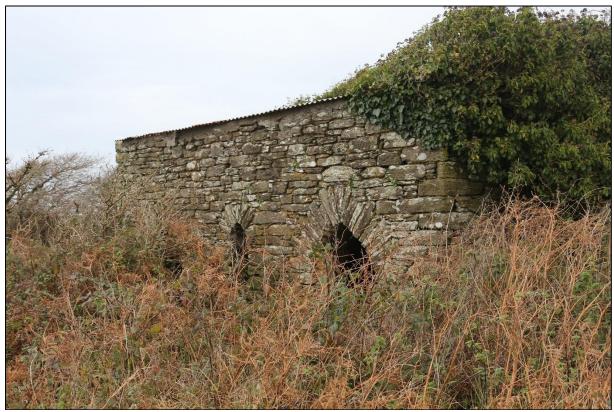
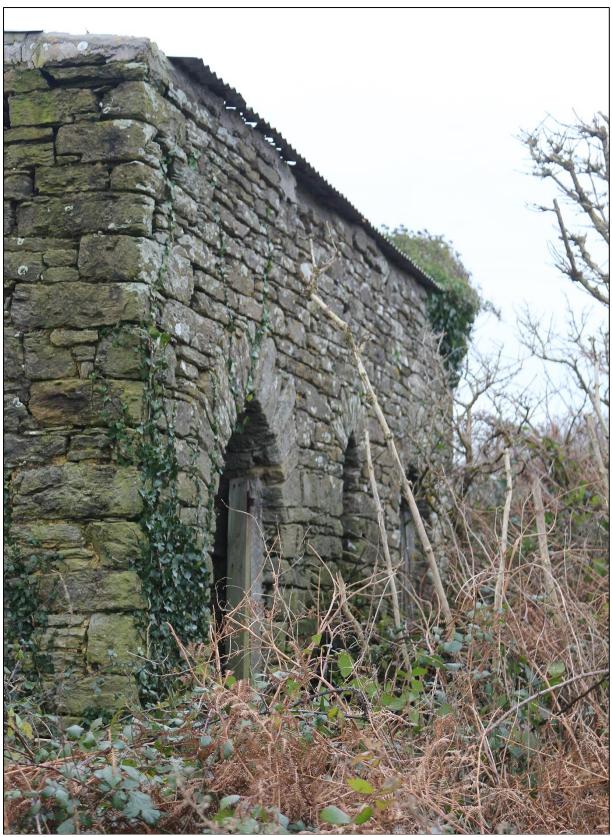
26. The 'wellhouse' on the edge of Field 4; viewed from the south.

$27.\,\mbox{The}\ '\mbox{wellhouse'}\ \mbox{on the edge of Field}\ 4;$ viewed from the North.
