LAND AT CAERHAYS BARTON
ST. MICHAEL CAERHAYS
ST. AUSTELL
CORNWALL

Results of an Archaeological Evaluation

South West Archaeology Ltd. report no. 210806

By P. Webb
Report Version: FINAL
Draft Issued: 09th August 2021
Report Finalised: 27th August 2021

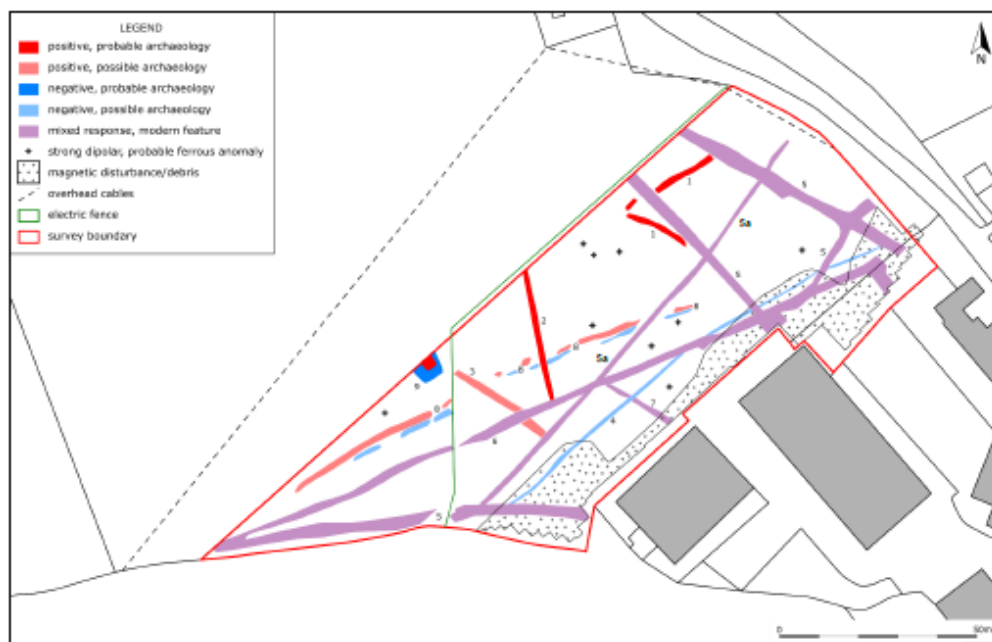
FIGURE 6: INTERPRETATION OF THE GEOPHYSICS RESULTS.

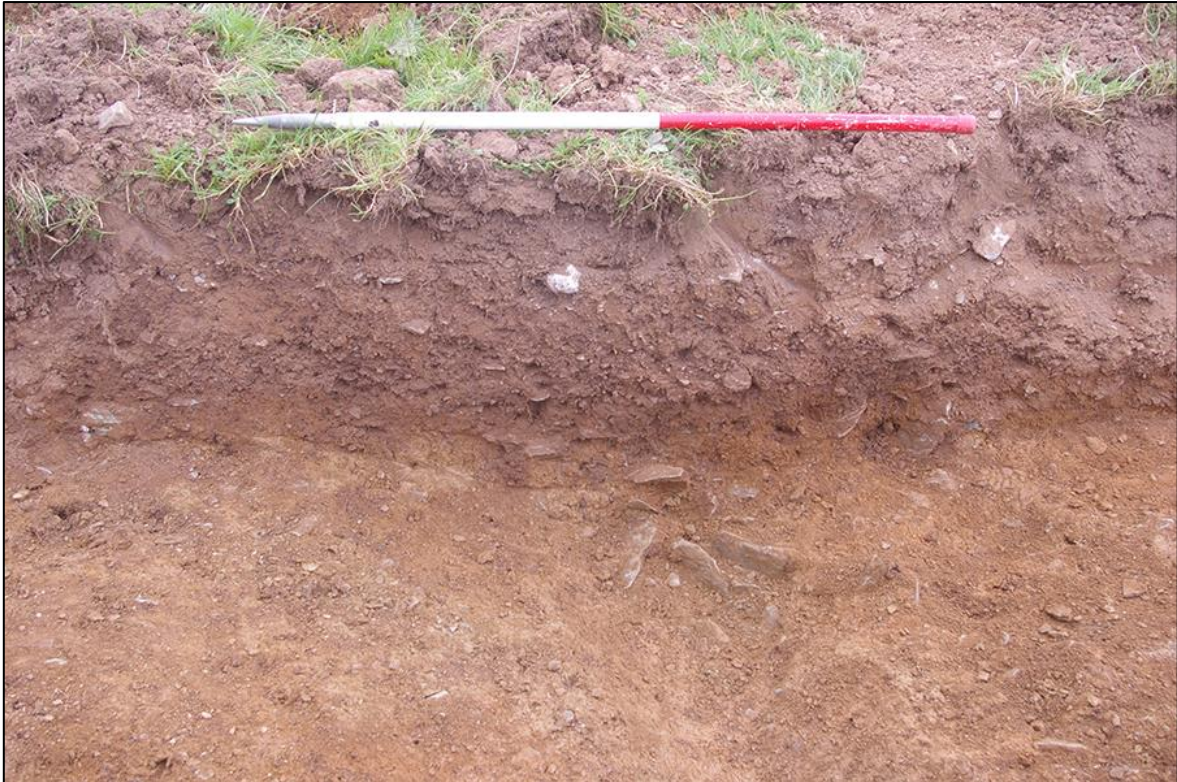
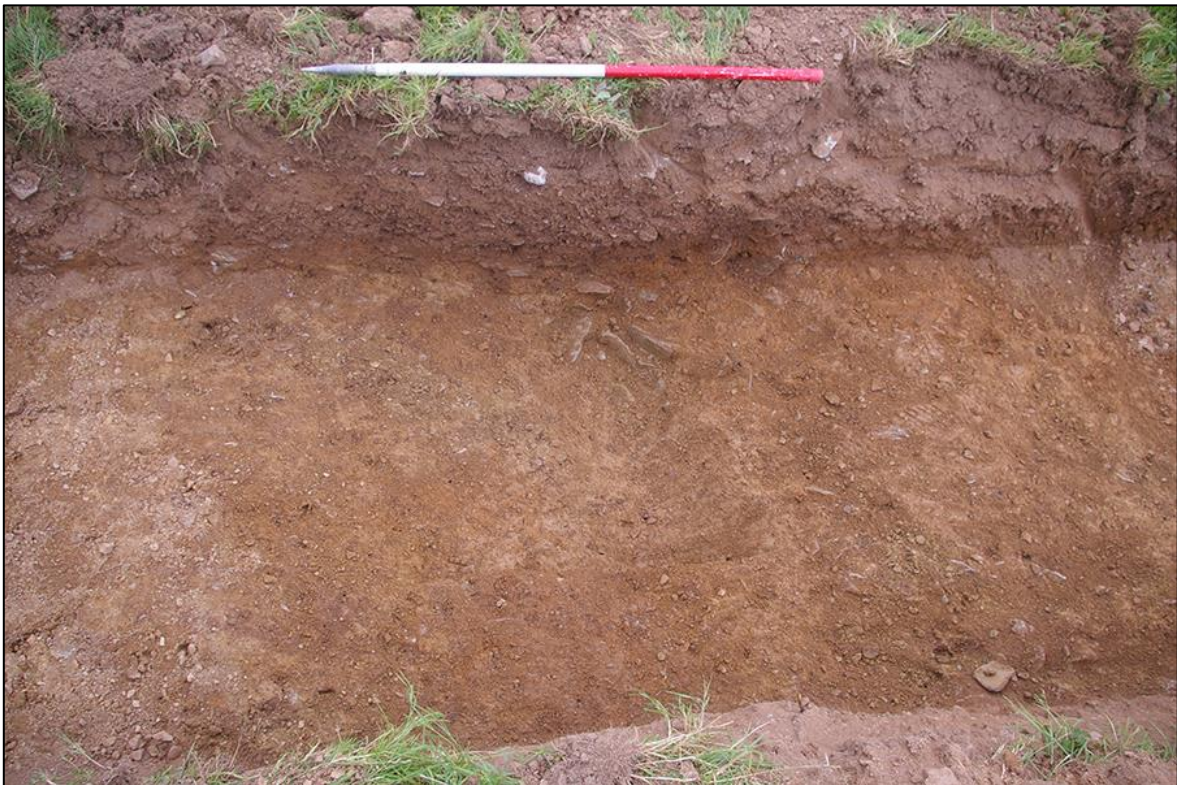
1. DITCH [105], NORTH-EAST FACING TRENCH SECTION; VIEWED FROM THE NORTH-EAST (1M SCALE).

2. DITCH [105], POST-EXCAVATION; VIEWED FROM THE NORTH-EAST (1M SCALE).

A total of three features (Figure 3), all ditches were identified within the trench. Ditch [105] was located towards the southern end of the trench, corresponding approximately with the possible drainage feature identified by the geophysical survey. It was orientated approximately north-east to south-west, measuring 0.75m wide and 0.16m deep with moderate sloping sides, gradual break of slope and concave base. It contained a single fill: (106), mid-dark brown friable silt with sub-angular stone inclusions. No finds were recovered from this feature.

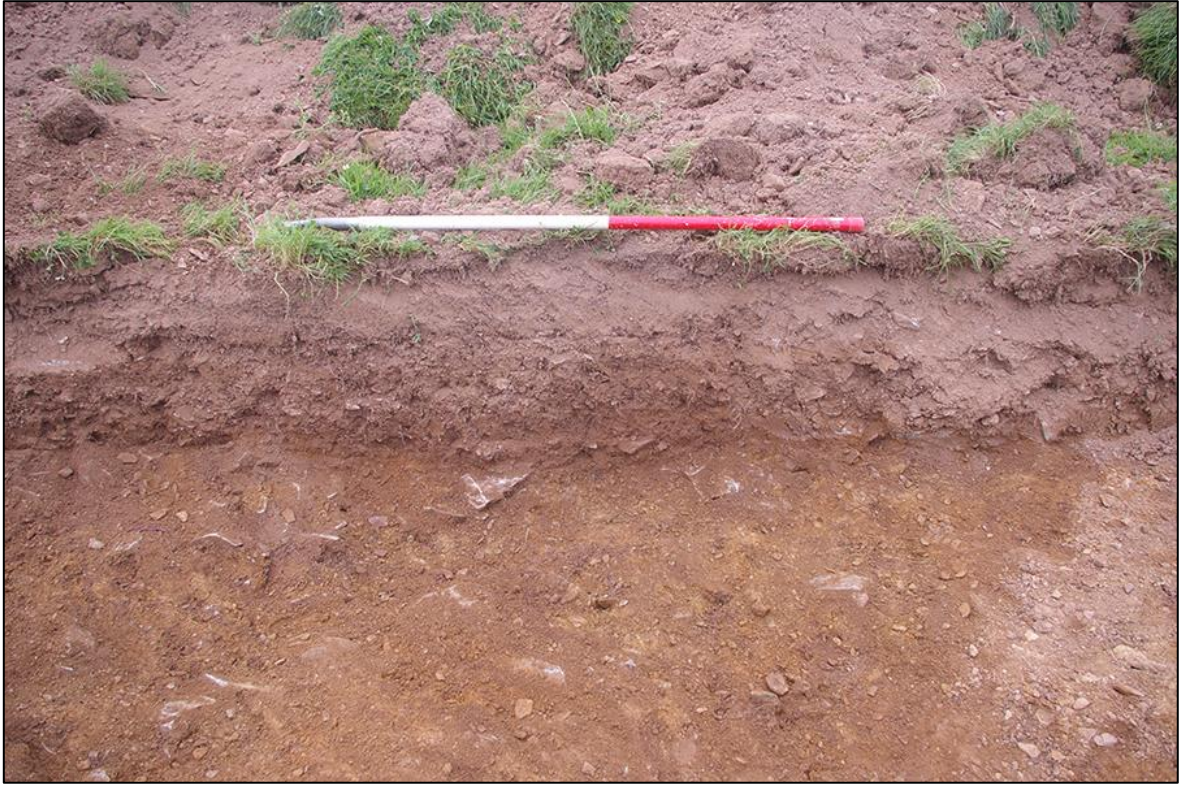
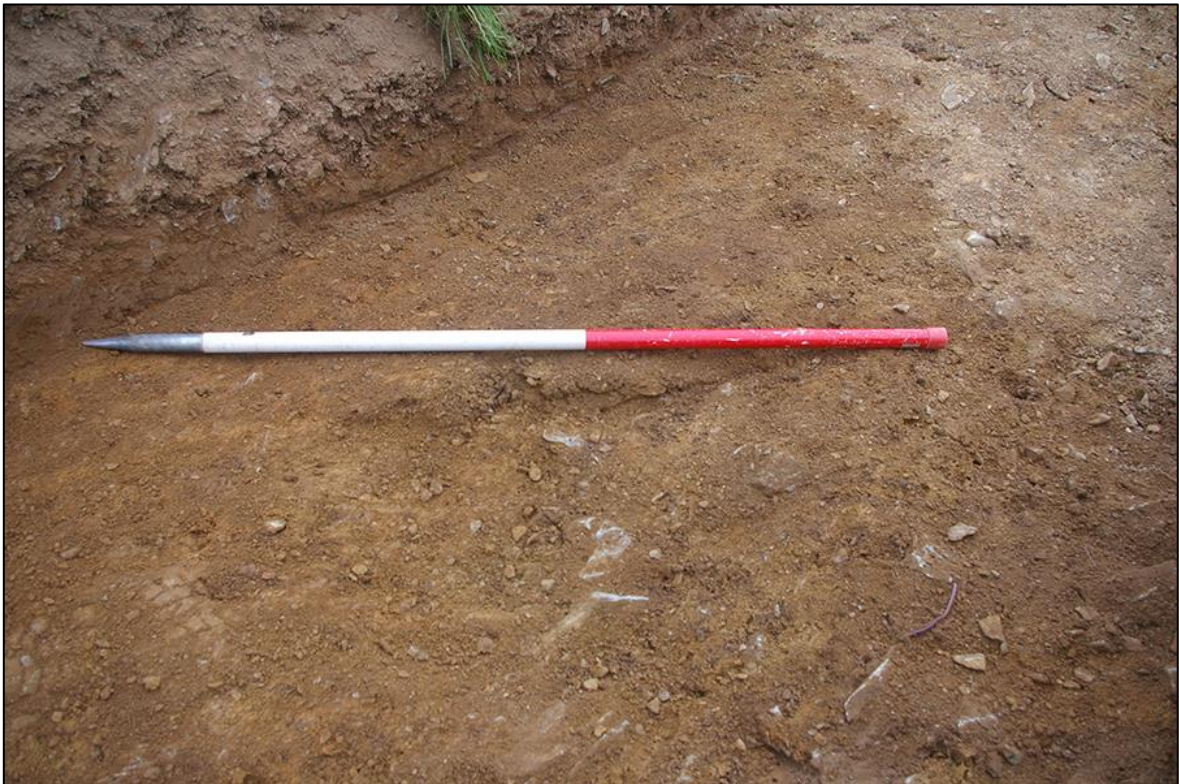
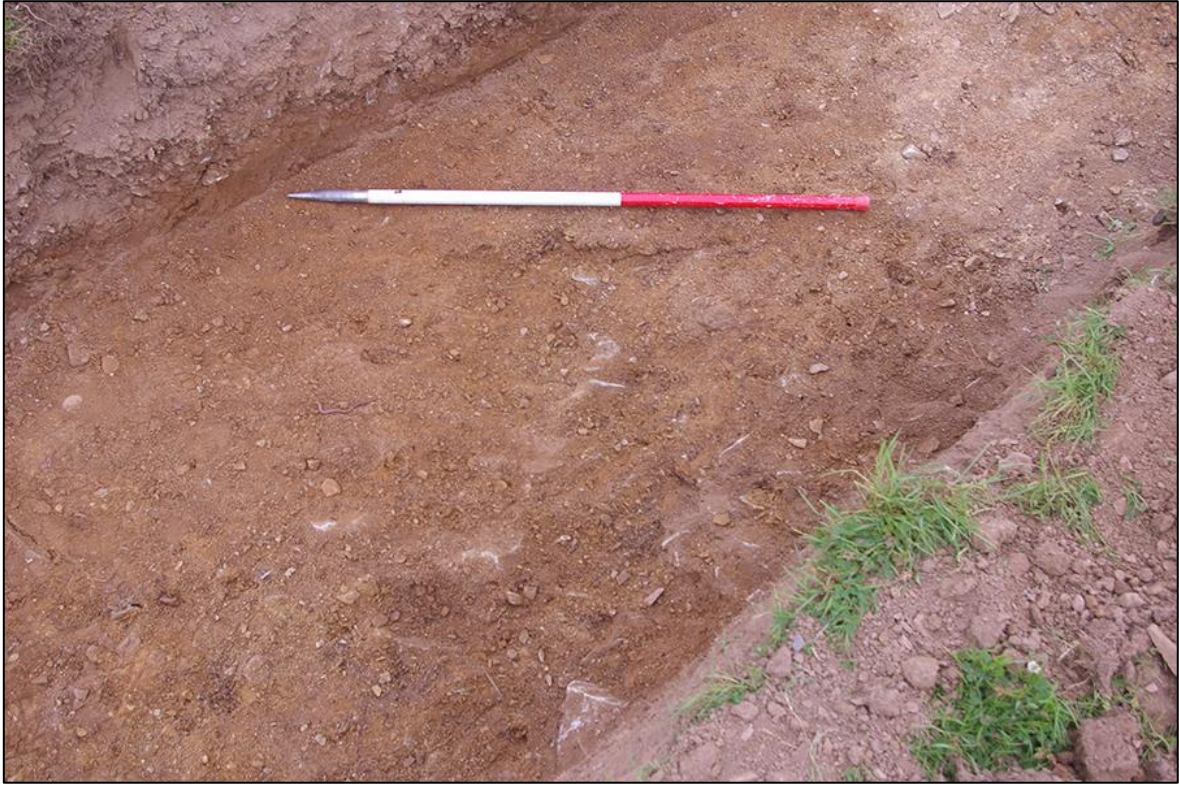
3. DITCH [107], NORTH-EAST FACING TRENCH SECTION; VIEWED FROM THE NORTH-EAST (1M SCALE).

4. DITCH [107], WEST FACING SECTION; VIEWED FROM THE WEST (1M SCALE).

5. DITCH [107], POST-EXCAVATION; VIEWED FROM THE WEST (1M SCALE).

Ditch [107] was located towards the northern end of the trench, corresponding approximately with the southern of the two possible ditch features identified by the geophysical survey. It was orientated approximately west-north-west to east-south-east, measuring 0.60m wide and 0.06m deep with shallow sloping sides, gradual break of slope and concave base. It contained a single fill: (108), dark brown friable silt. No finds were recovered from this feature.

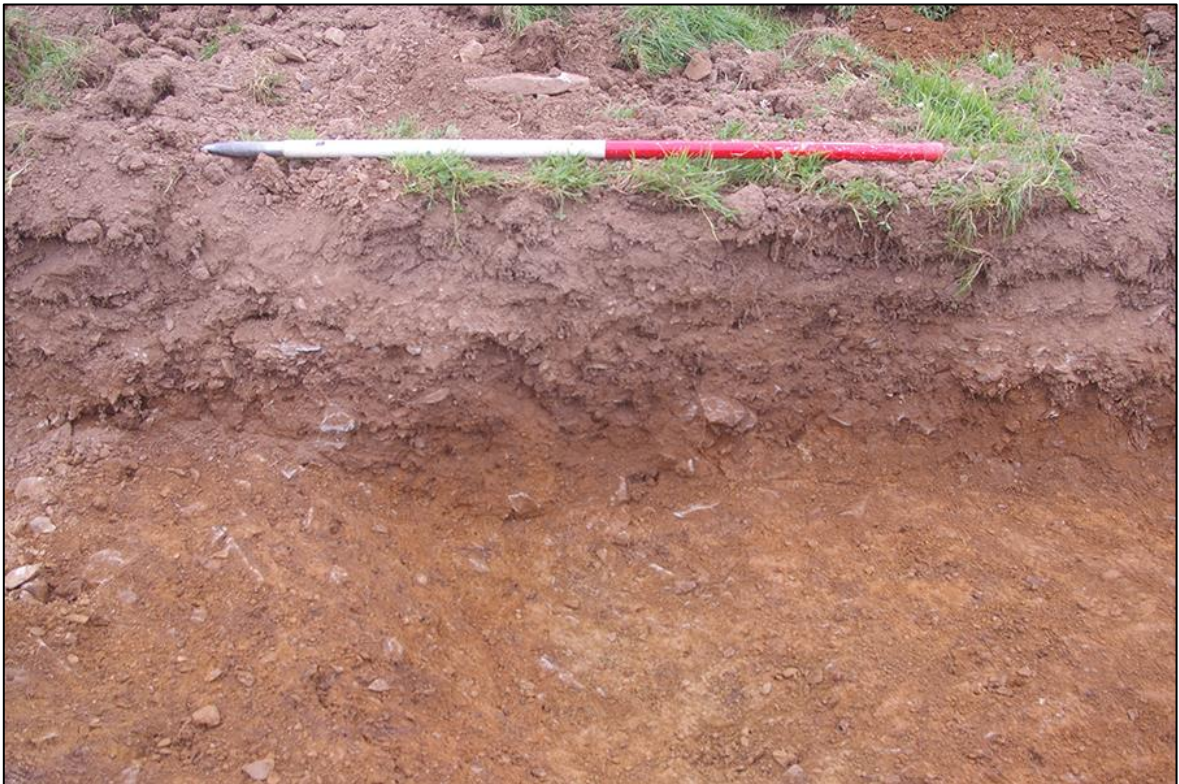
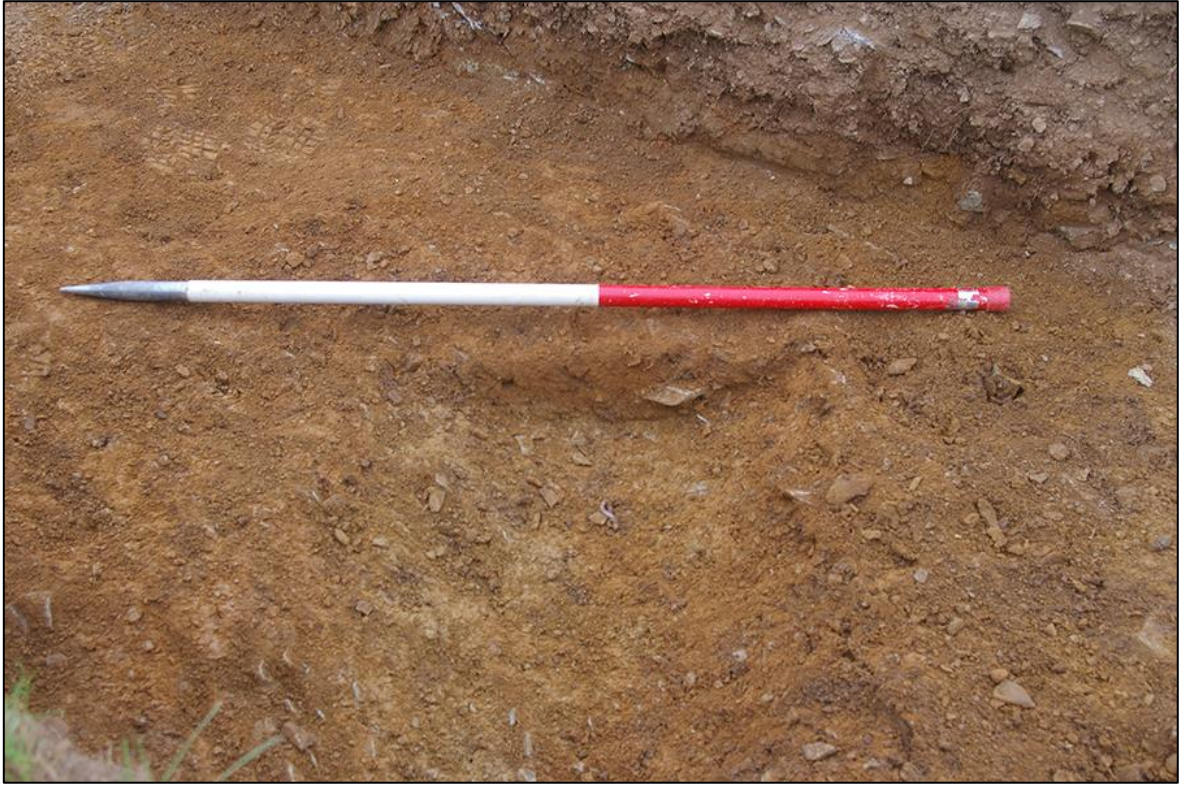
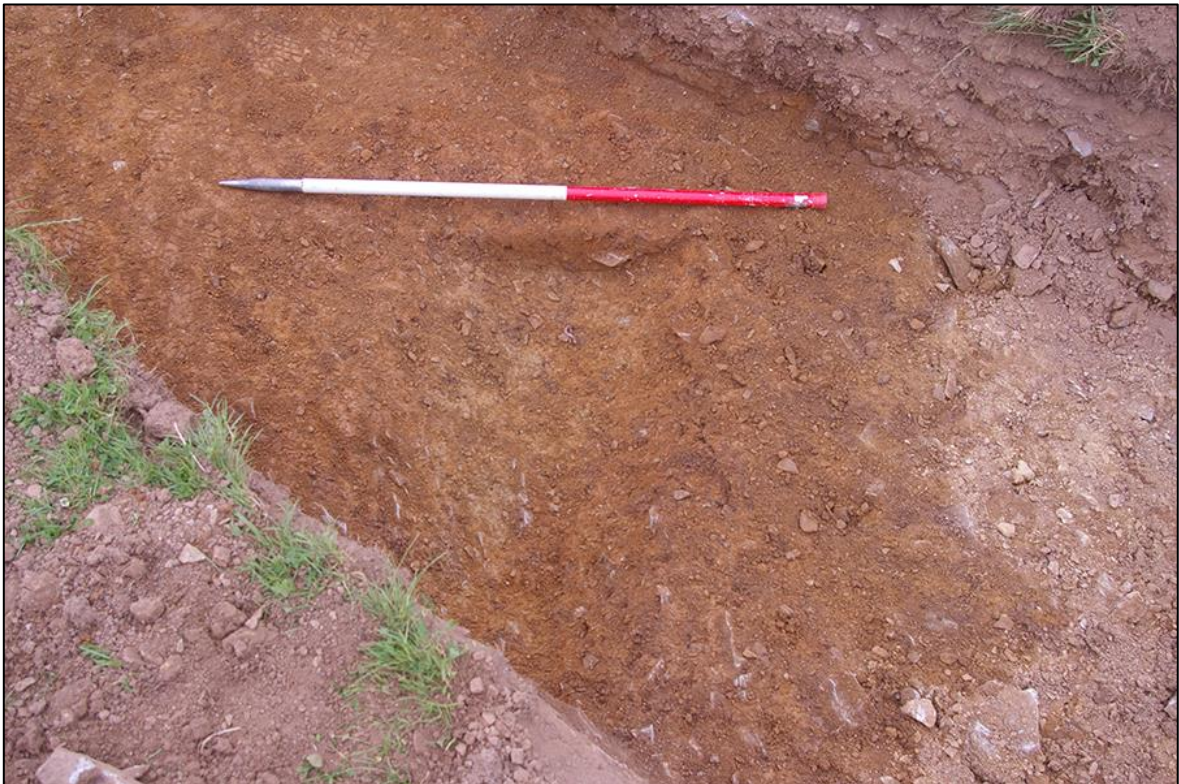
6. DITCH [109], NORTH-EAST FACING TRENCH SECTION; VIEWED FROM THE NORTH-EAST (1M SCALE).

7. DITCH [109], SOUTH-WEST FACING SECTION; VIEWED FROM THE SOUTH-WEST (1M SCALE).

8. DITCH [109], POST-EXCAVATION; VIEWED FROM THE SOUTH-WEST (1M SCALE).

Ditch [109] was located to the north of ditch [107], corresponding approximately with the northern of the two possible ditch features identified by the geophysical survey. It was orientated approximately north-east to south-west, measuring 0.56m wide and 0.13m deep with moderate

sloping sides, gradual break of slope and slightly concave base. It contained a single fill: (110), mid slightly orange-brown friable-soft silt-clay. No finds were recovered from this feature.

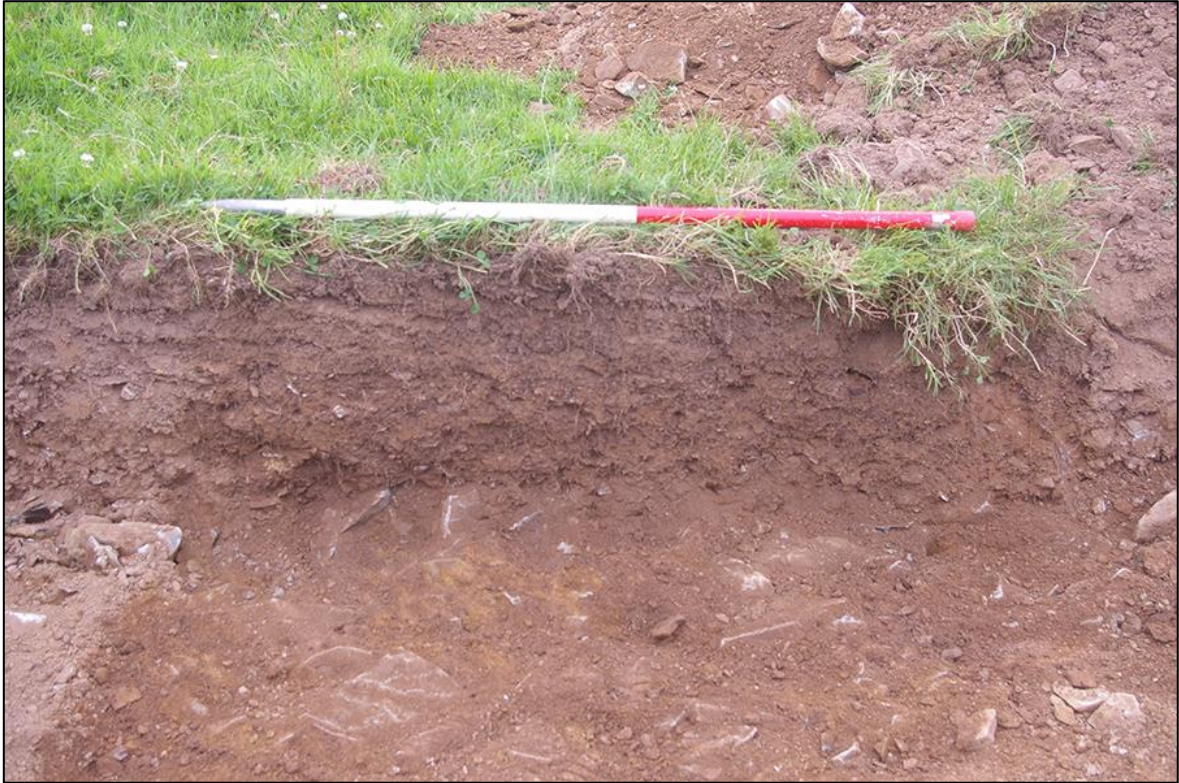
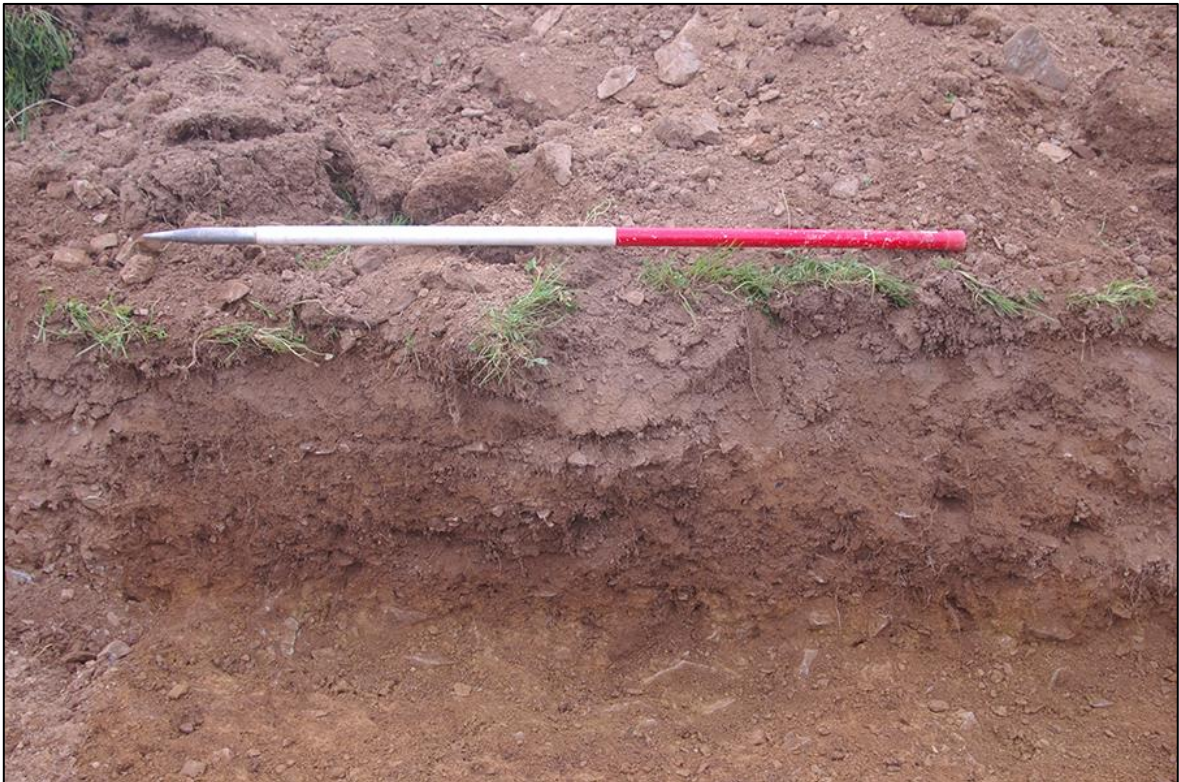
11. TRENCH 02, REPRESENTATIVE SOUTH-EAST FACING TRENCH SECTION, SOUTH-WEST END; VIEWED FROM THE SOUTH-EAST (1M SCALE).

12. TRENCH 02, REPRESENTATIVE SOUTH-EAST FACING TRENCH SECTION, NORTH-EAST END; VIEWED FROM THE SOUTH-EAST (1M SCALE).

Trench 02 was located across the middle of the development site and was positioned to target a blank area on the geophysical survey. It measured 25.85m long on an approximate north-east to south-west alignment. The topsoils were 0.30-0.35m thick; upper subsoil 0.05-0.15m thick; and lower subsoil up to 0.05m thick. Finds recovered from this trench included post-medieval pottery from the active topsoil.

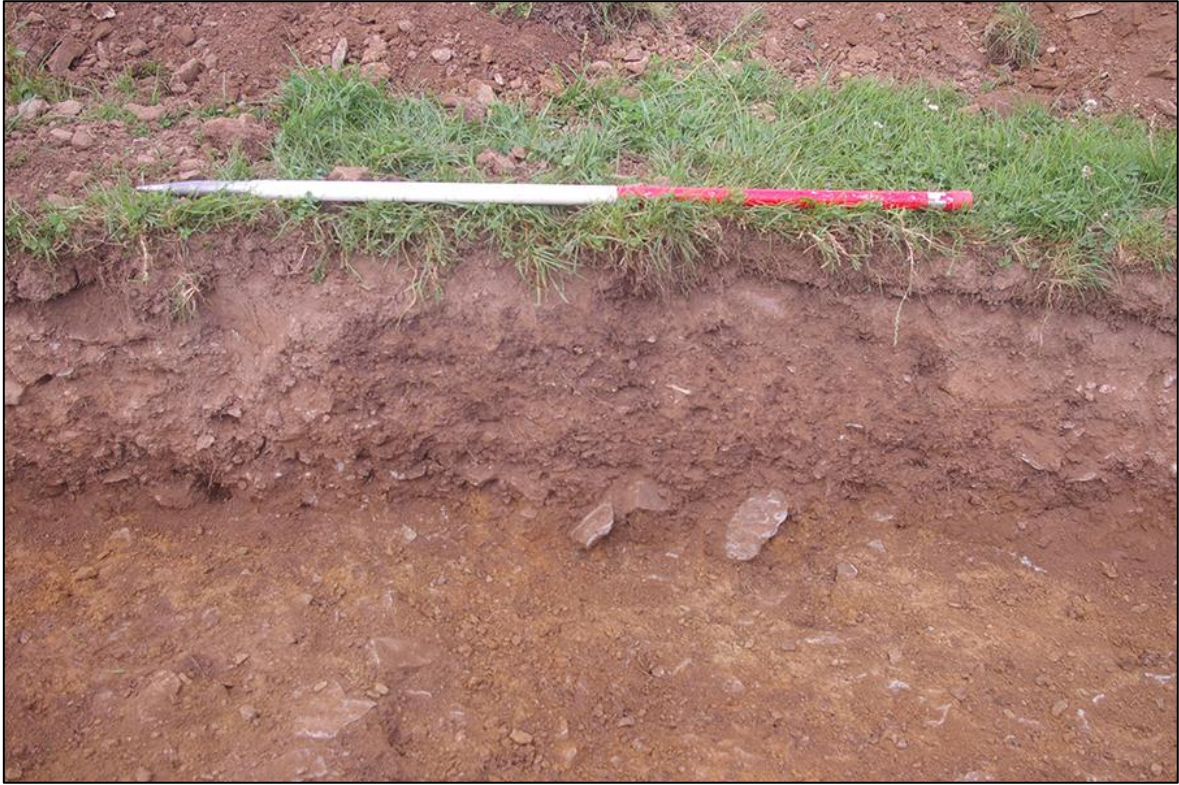
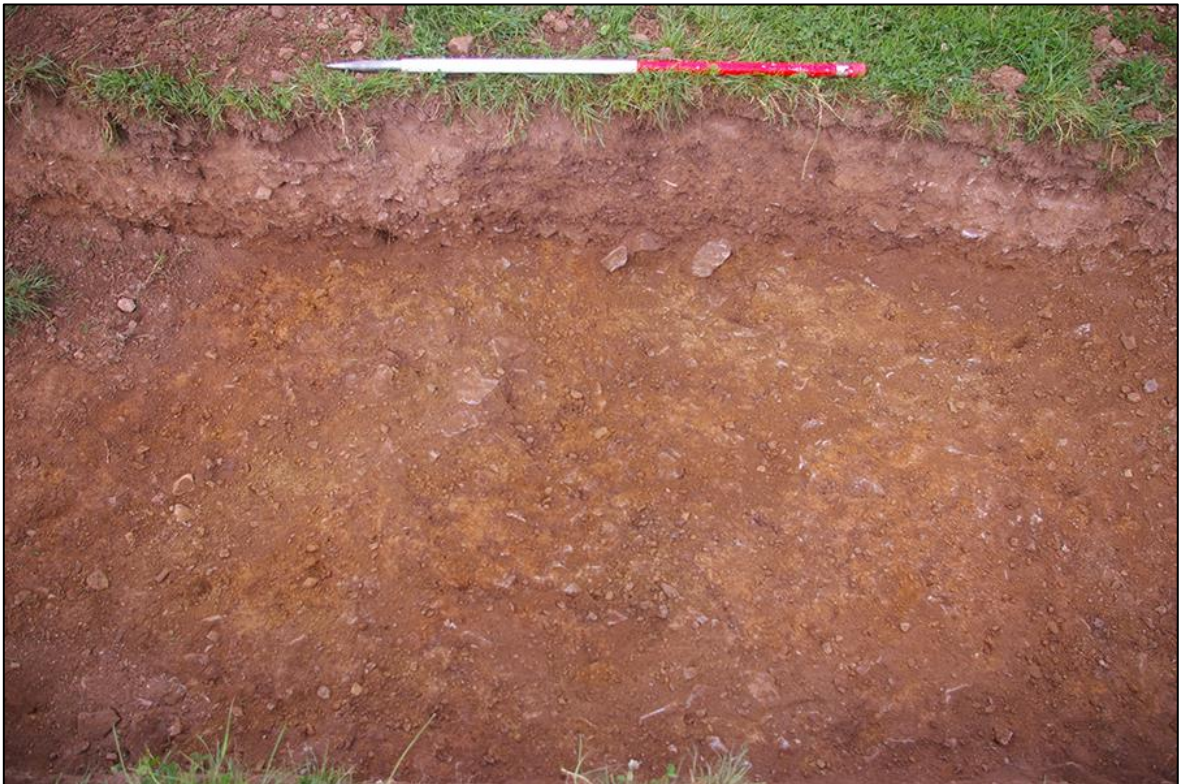
15. DITCH [305], NORTH-EAST FACING TRENCH SECTION; VIEWED FROM THE NORTH-EAST (1M SCALE).

16. DITCH [305], POST-EXCAVATION; VIEWED FROM THE NORTH-EAST (1M SCALE).

A total of two features (Figure 4), both ditches, were identified within the trench. Ditch [305] was located towards the southern end of the trench just to the south of a ditch and possible bank anomaly identified by the geophysical survey. It was orientated approximately north-east to south-west, measuring 0.65-0.70m wide and 0.10m deep with moderate sloping sides, gradual break of slope and very slightly concave base. It contained a single fill: (306), dark brown friable silt. No finds were recovered from this feature.

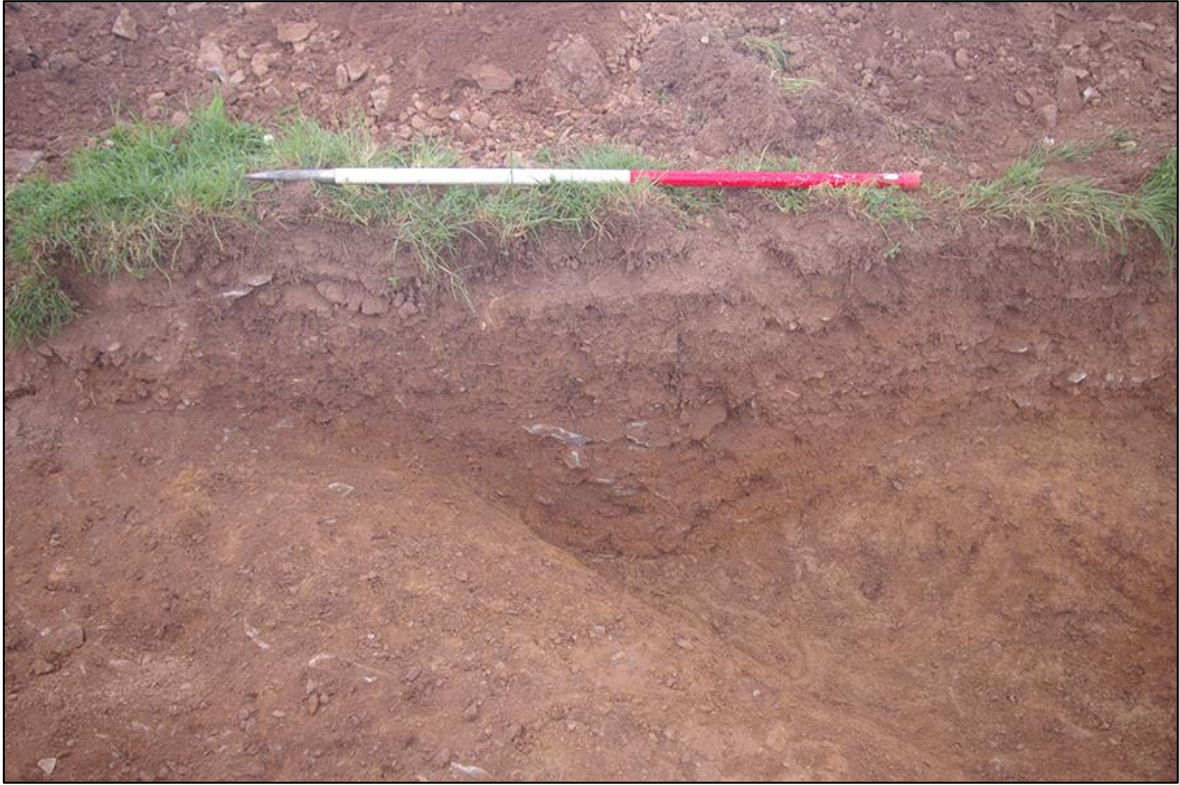
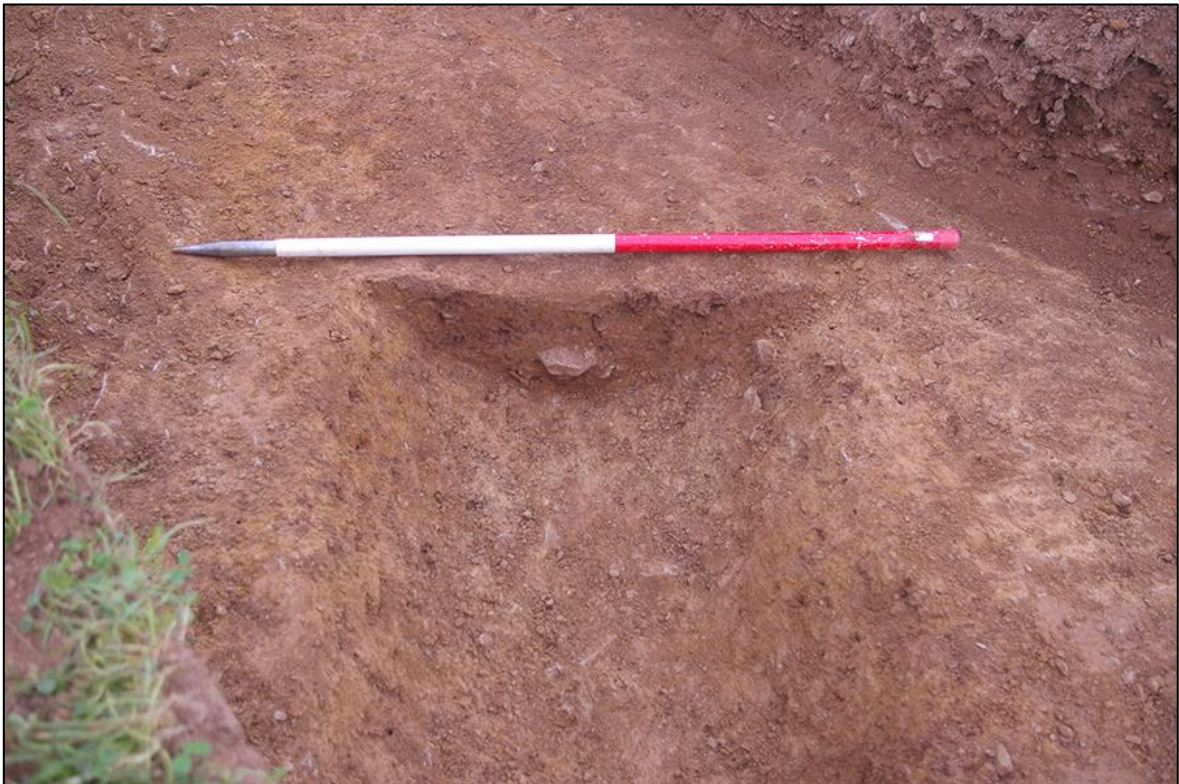
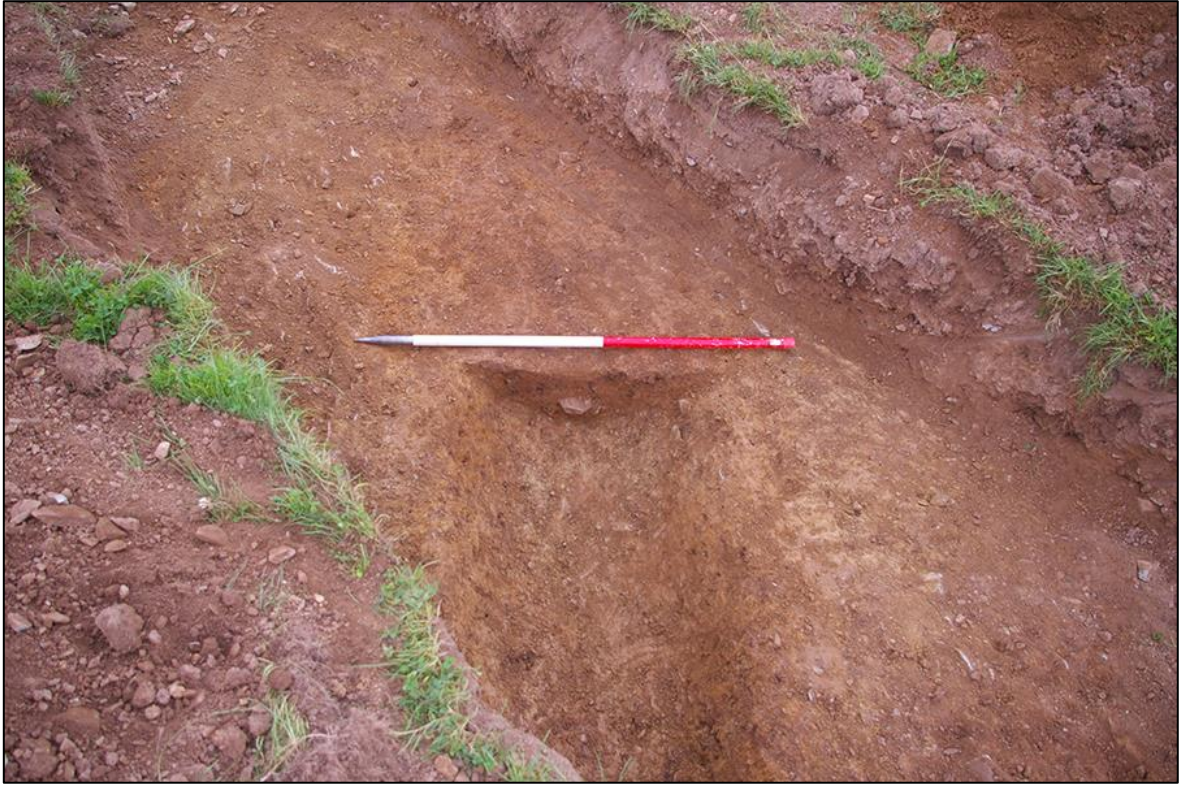
17. DITCH [307], NORTH-EAST FACING TRENCH SECTION; VIEWED FROM THE NORTH-EAST (1M SCALE).

18. DITCH [307], SOUTH FACING SECTION; VIEWED FROM THE SOUTH (1M SCALE).

19. DITCH [307], POST-EXCAVATION; VIEWED FROM THE SOUTH (1M SCALE).

Ditch [307] was located to the north of ditch [305], corresponding with the position of a linear ditch anomaly identified by the geophysical survey. It was orientated approximately north to south, measuring 0.70m wide and 0.28m deep with moderate sloping sides, gradual break of slope and concave base. It contained two fills: (308) and (309), dark orange-brown friable-soft silt-clays. No finds were recovered from this feature.

All of the ditches are undated, though are likely to reflect episodes of agricultural activity and drainage. The alignment of ditch [307] is broadly congruent with that of elements of the existing field-system and likely forms part of the post-medieval enclosure of the medieval field layout. The parallel and perpendicular alignment of ditches [107], [109] and [405] suggests that they are all associated with each other within the same field-system (ditches [107] and [109] forming the corner of an enclosure/field), and whilst following a slightly different alignment to ditch [307], still respect other elements of the existing field layout, and may form part of the earlier field layout.

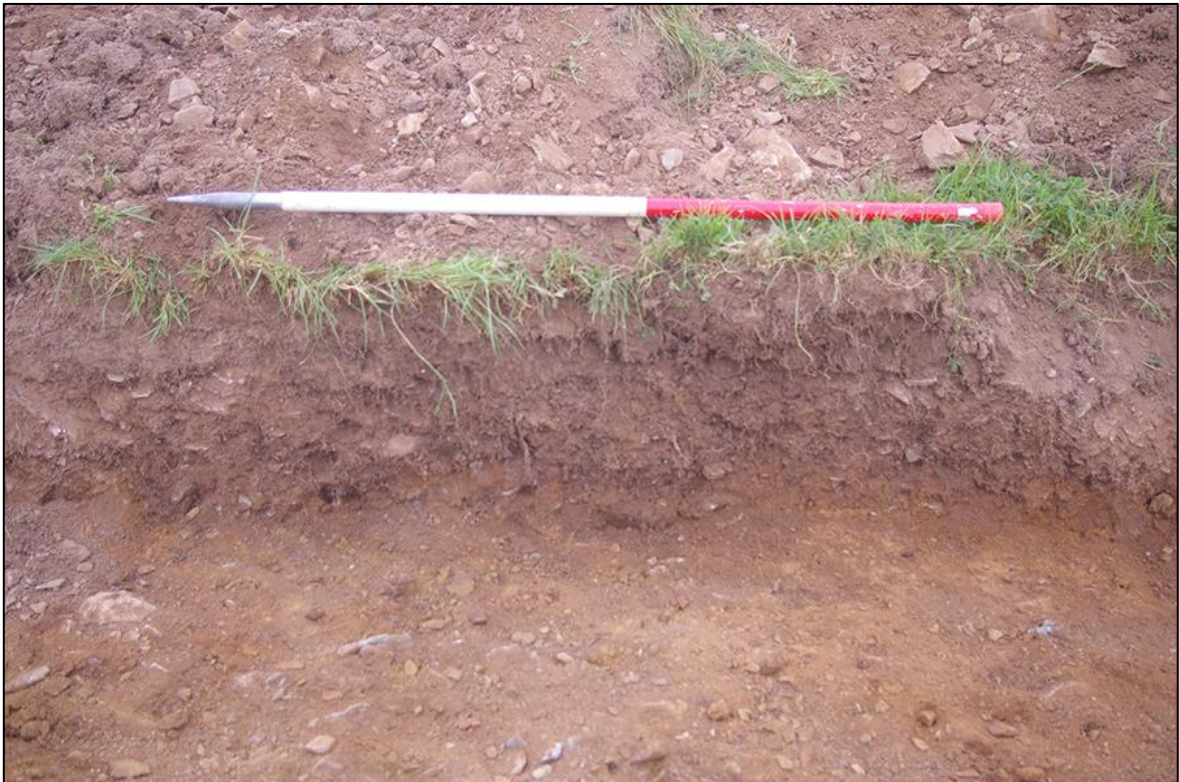
20. TRENCH 03, REPRESENTATIVE NORTH-EAST FACING TRENCH SECTION, NORTH END; VIEWED FROM THE NORTH-EAST (1M SCALE).

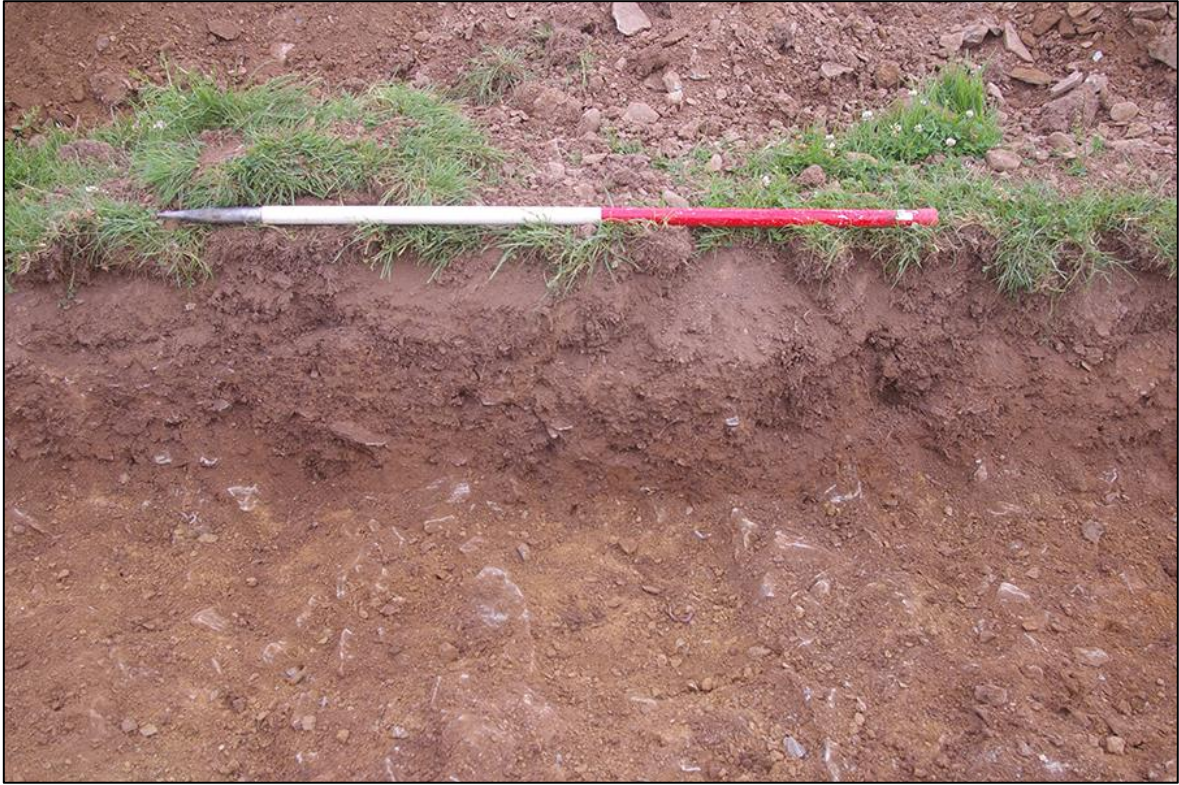
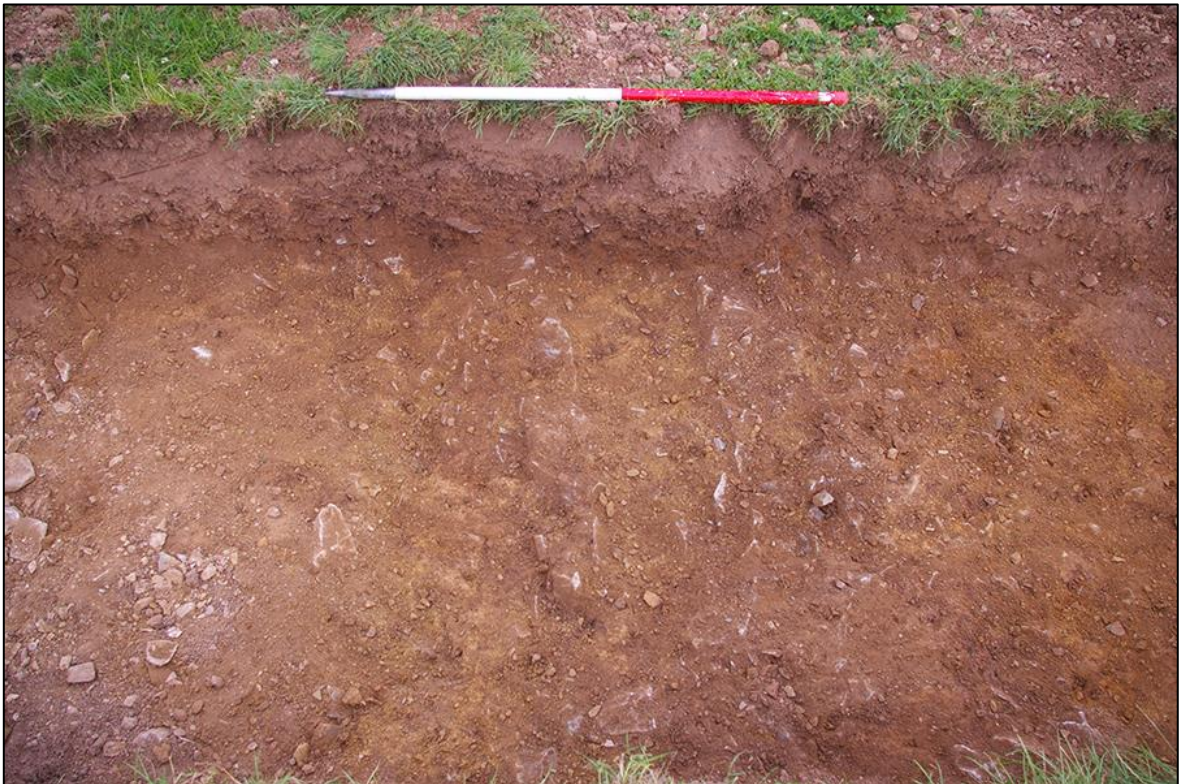
23. DITCH [405], SOUTH-EAST FACING TRENCH SECTION; VIEWED FROM THE SOUTH-EAST (1M SCALE).

24. DITCH [405], POST-EXCAVATION; VIEWED FROM THE SOUTH-EAST (1M SCALE).

A single ditch (Figure 4) was identified within the trench. Ditch [405] was located towards the centre of the trench, corresponding with the position of a linear ditch anomaly identified by the geophysical survey. It was orientated approximately north-west to south-east, measuring 1.05m wide and 0.10m deep with moderate sloping sides, gradual break of slope and broadly flat base. It contained a single fill: (406), dark brown friable silt. No finds were recovered from this feature.

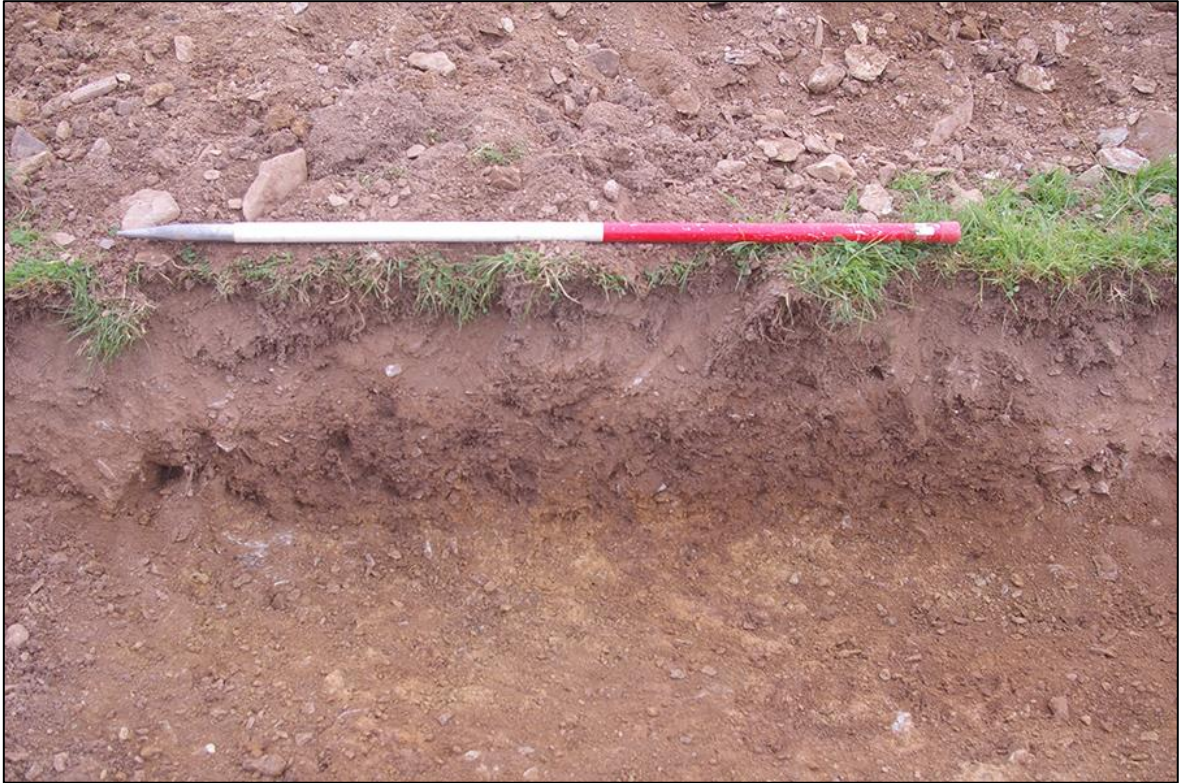
25. TRENCH 04, REPRESENTATIVE SOUTH-EAST FACING TRENCH SECTION, SOUTH-WEST END; VIEWED FROM THE SOUTH-EAST (1M SCALE).
