PITT FARM BROADHEMPSTON DEVON

Results of a Desk-Based Assessment,
Historic Building Recording & Archaeological Watching Brief

Report No.: 110329
Date: 29/03/2011
Authors: C. Humphreys
S. Walls
T. Green

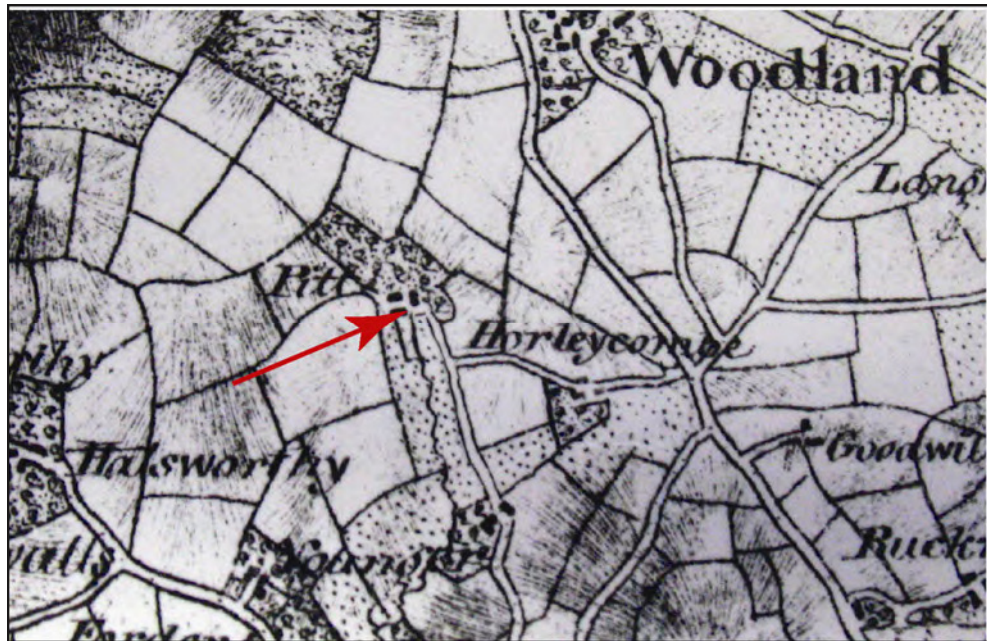
Figure 3: Extract from the Ordnance Survey's draft map of 1805 (WCSL).

The earliest cartographic representation of Pitt Farm is the Ordnance Survey draft map of 1805 (Figure 3) which shows three buildings at the head of a stream and an orchard to the north of these buildings.

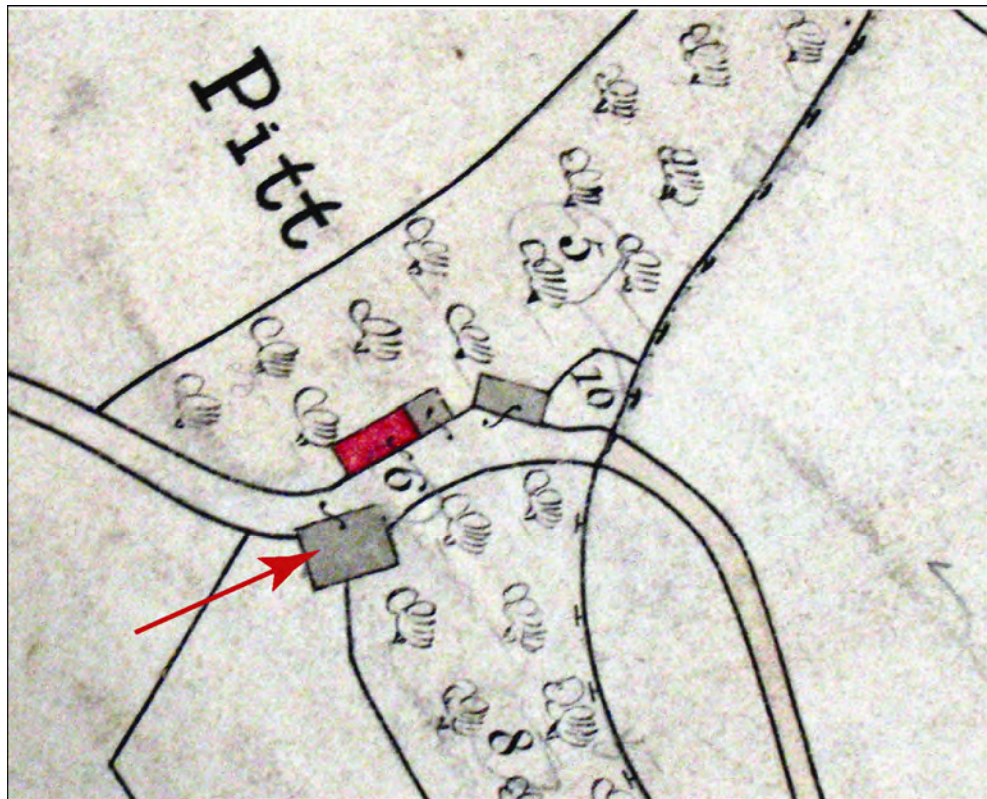
It is the tithe map of 1841 (Figure 4) which provides the earliest detailed record of the layout of Pitt Farm. Number 6 on the map is interpreted in the tithe apportionment (1841) as 'House and Court'. Number 10 is a garden, and numbers 5 and 8 are orchards. The farm house, identified by its red/pink coloration, is shown to have a barn or stable – in grey – attached at its east end. There are two other outbuildings, but it is the building to the south of the farmhouse which is located in the approximate position of the barn under investigation. (Note the exact location and proportions of this outbuilding to the south of the dwelling and compare with that seen in Figure 5).

Figure 4: Extract from the Broadhempston tithe map of 1841. The location of the barn is arrowed (DRO).

The barn set for conversion shares its location with a large outbuilding which was present in the early 19th century (Figure 4). In the later 19th century a smaller building was recorded in this location (Figure 5). This may have been a reduced version of the original or may have been a new build. The footprint of this building has remained apparently unchanged since the later 19th century.

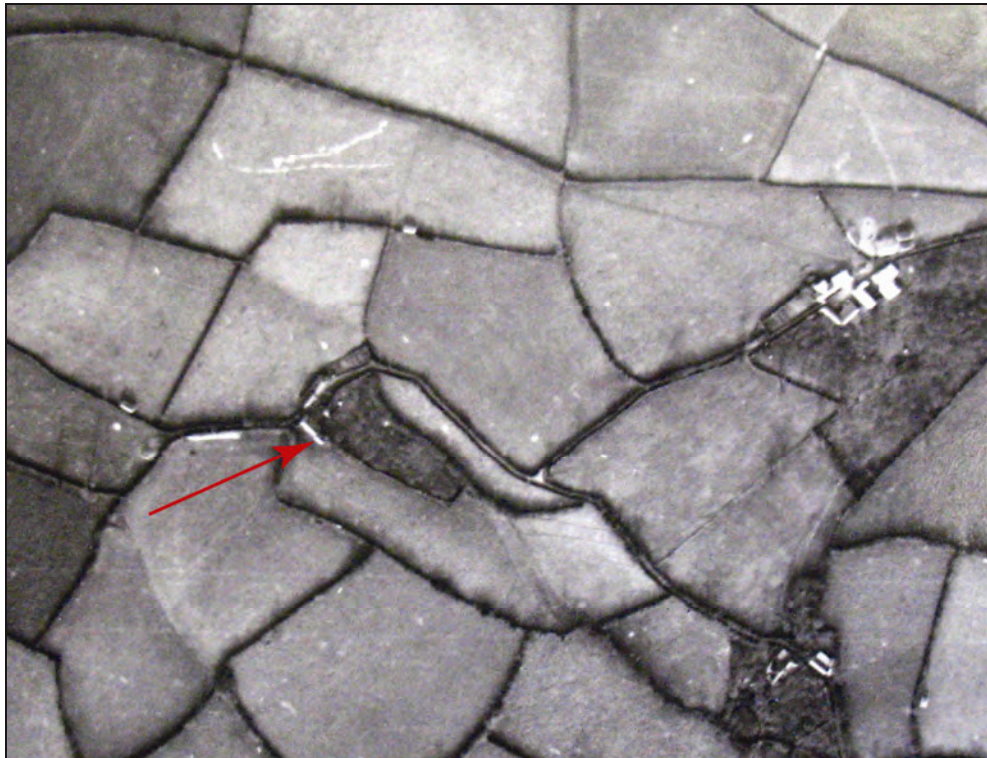
In the absence of any further cartographic record until the late-20th century, the 1946 photograph (Figure 7) provides some indication of the mid-20th century layout. The barn is clearly still in place, but the building opposite it seems to have been reduced. An aerial photograph of 1989 (Figure 8) provides evidence of development during the later 20th century including a rectangular building opposite and parallel to the barn. Since 1989 this building has been removed.

Figure 7: Aerial photograph of 1946. The location of the present building is arrowed (DCHES).

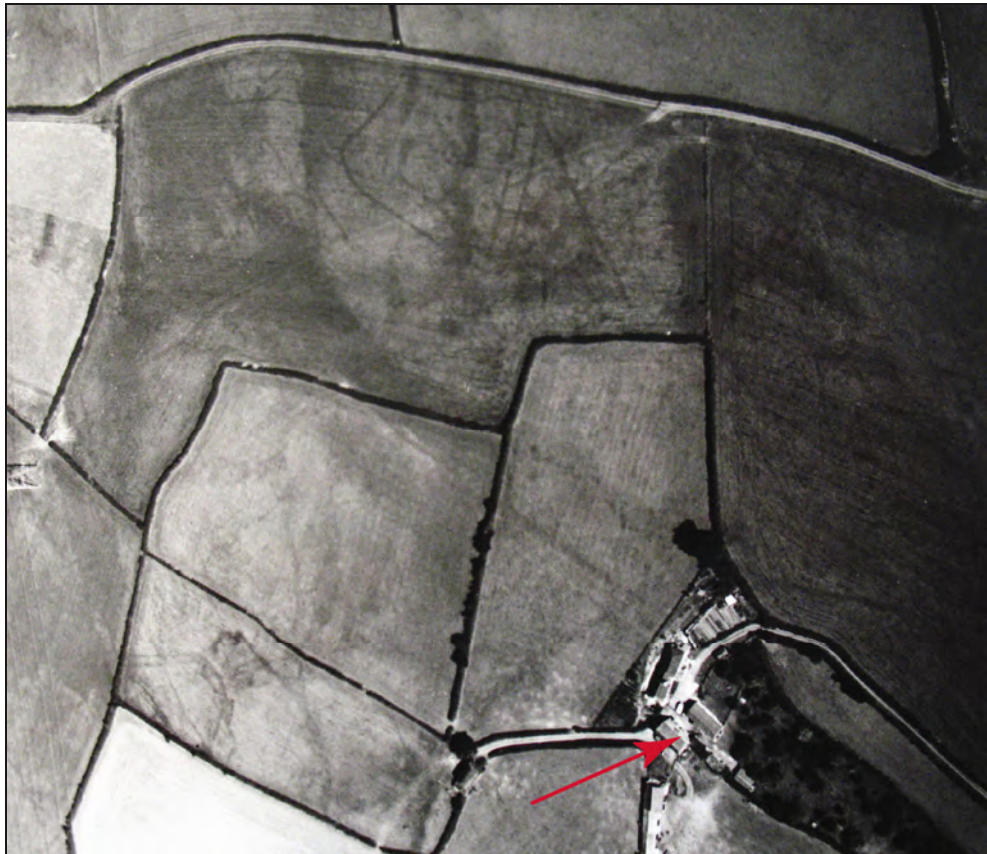
The aerial photograph of 1989 (Figure 8) also hints at the existence of a possibly double-ditched enclosure of unknown date to the north-west of Pitt Farm, which can be seen as a crop mark (see also Appendix 3). The same photograph appears to record other crop-marks to the west of Pitt Farm which may also indicate a further ditched enclosure. This latter is apparently not noted in the Devon HER and may be illusory.

Figure 8: Aerial photograph of 1989. The location of the present building is arrowed. Crop marks are visible top centre and lower left (DCHES).

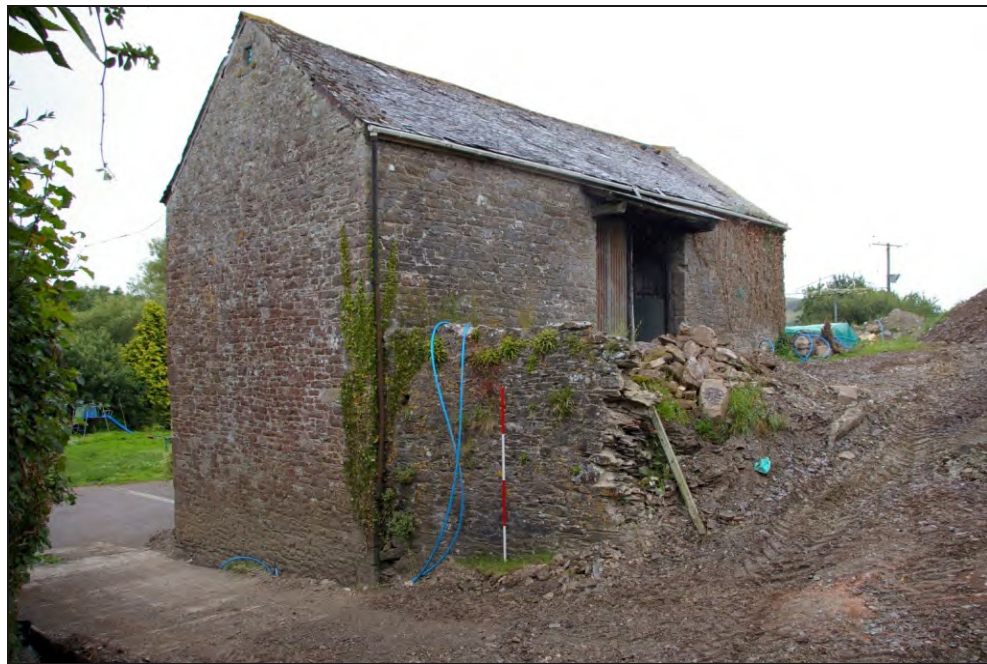
A mid 19th century two storey bank barn of single phase build set on a north-west to south-east orientation and cut into a slope rising to the west (Figure 9). The barn consists of a ground floor shippon and a first floor threshing floor and storage, accessed from the rear (upslope) of the building. Constructed of roughly coursed rubble stone (various shales, some sandstone and some granite) with larger squared quoins to all openings and corners and rounded quoins on the north-east corner. All stonework with lime mortar bonding. A slate roof, the building gabled at both ends, with the pitch on a north-west to south-east orientation.

A two storey elevation to the east with three openings on the ground floor each with stone segmental arches, straight roughly chamfered timber lintels and double doors. The centre and most northerly openings have modern ledged and braced doors with modern fittings set in modern frames. The opening to the south is partially blocked by an interior division that subdivides the ground floor with a concrete block work wall. This forms a small animal compartment with a concrete feeder at the south end. The door to this section is a modern, stable type door.

Figure 9: North and west elevations viewed from the west (2m scale).

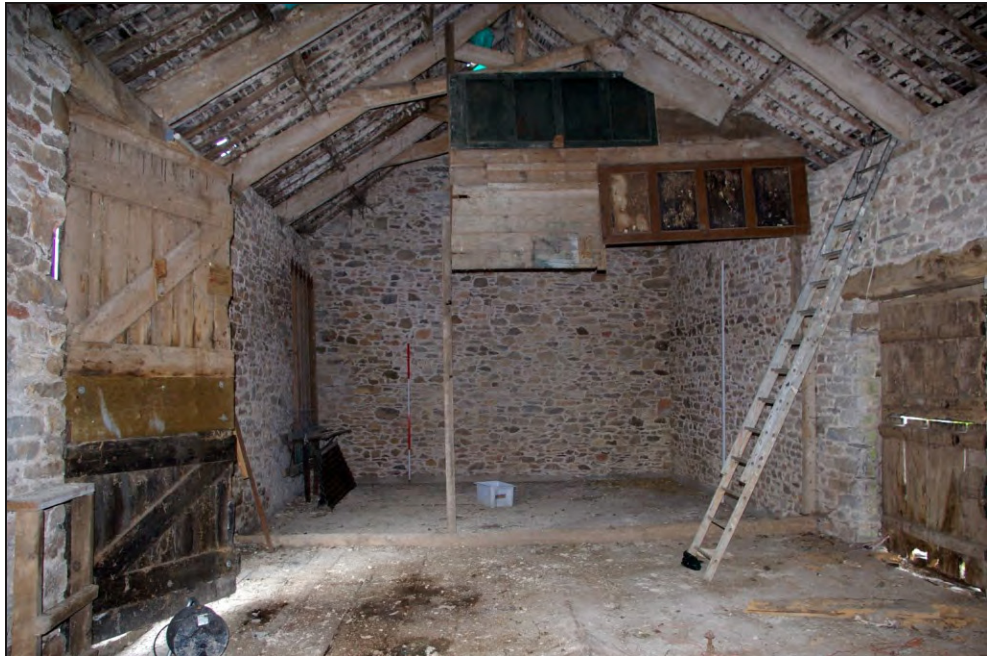
First floor is fully open to the roof of six bays (Figure 10).

The floor boards in the central area forming the threshing floor are pit sawn, running north to south and of random width. The floor is defined by a raised wooden kerb bolted to the beams below; to the north this feature is complete to the south only the bolts remain.

The floor structure to the north of the threshing floor is comparatively modern with 4 x 2 inch joists and 6 inch pine boards, that to the south has 4 x 3 inch joists and random width pine boards.

There are a pair of openings to east and west of the threshing floor; that to the west has a pair of full height ledged and braced doors with that to the south in two sections. The pair are set in pegged frames and hung on square-ended strap hinges. The doors close to a central removable wooden post (replacement) with a wooden sliding fastener. The smaller ledged draft door to the east is set in a splayed opening. The stable type door has each leaf fitted to a pegged frame with one square-ended and one spear-ended strap hinge. The door fame is held in place near the top by spikes into wooden blocks (elm) that are set in to the wall. There are roughly chamfered wooden lintels above both doors.

Figure 10: Interior of the first floor viewed from the south-east (2m scale).

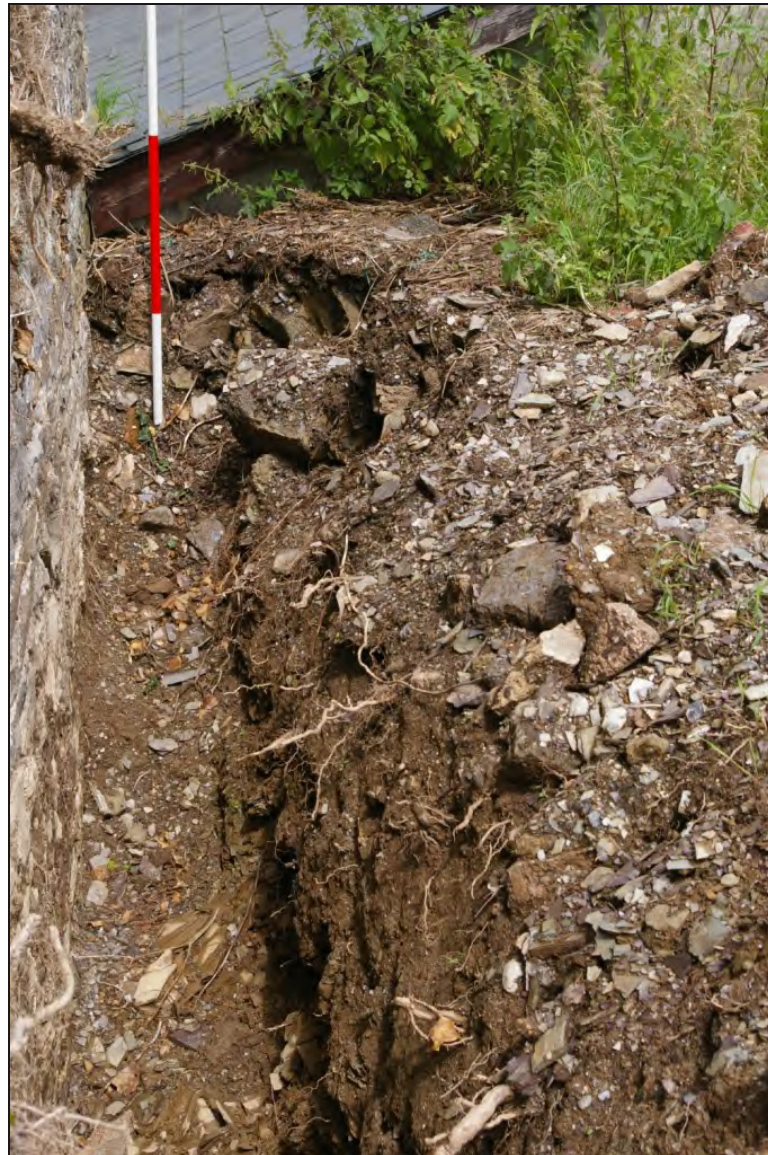
A watching brief was conducted during the excavation of service trenches along the lengths of the northern and western sides of the barn (Figure 13). These revealed that the material which surrounded the barn on these sides comprised a series of re-deposited layers of shillet and sub-soil. No archaeological features were apparent, nor were any finds recovered.

Figure 13: Shot from the south-east along the service trench alongside the northern wall of the barn (2m scale).
