THE OLD CLERGY HOUSE

CORNWOOD

Historic Building Recording

South West Archaeology Ltd. report no. 220810

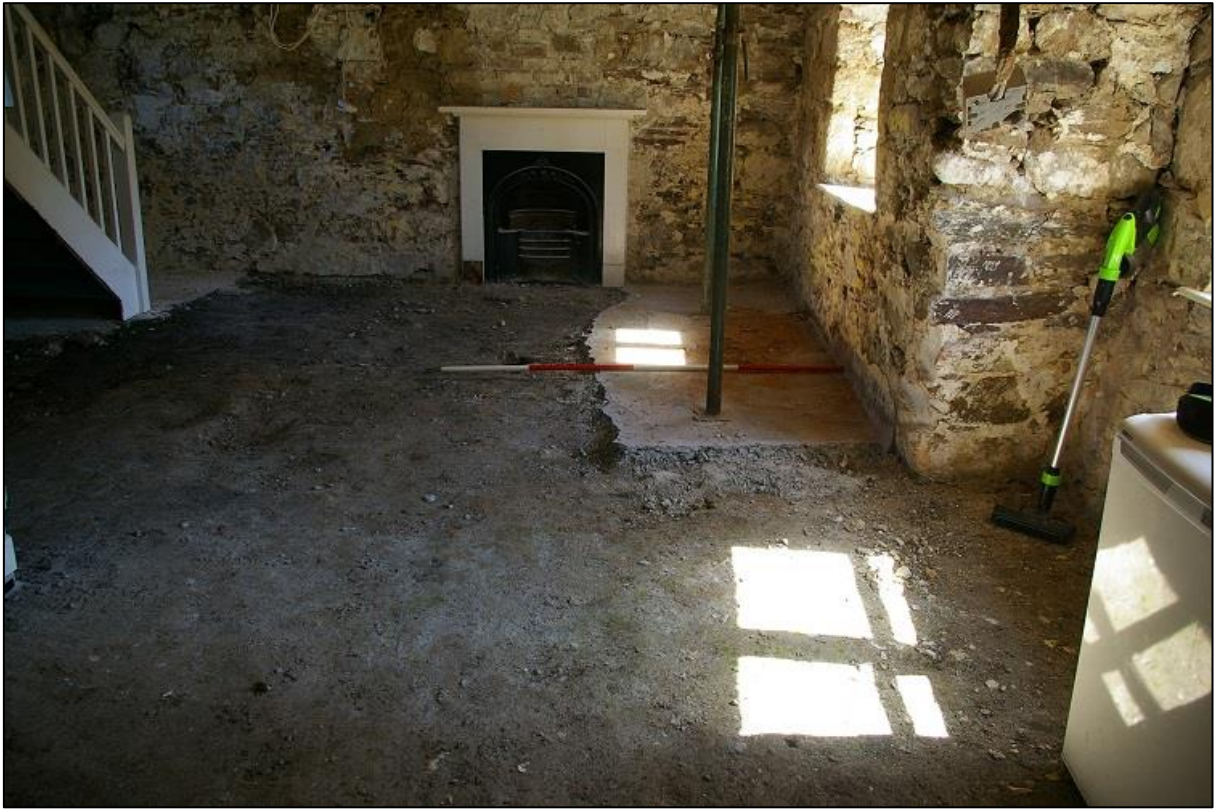
FIGURE 3: THE NORTH END OF THE ROOM, WITH PARTIAL CONCRETE FLOOR REMAINING AND POST MEDIEVAL FIREPLACE, LIKELY POST 1800; FROM THE SOUTH-SOUTH-EAST (2M SCALE).

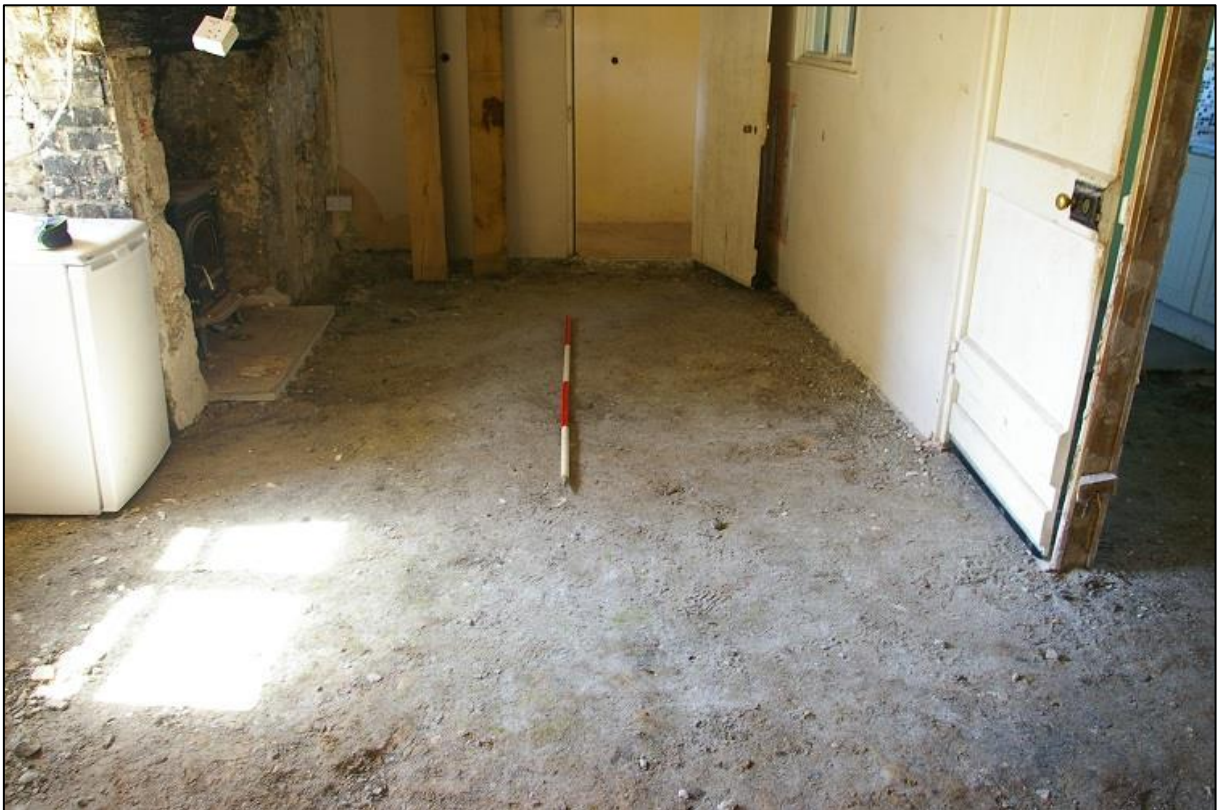
FIGURE 4: THE SOUTH END OF THE ROOM, WITH LATERAL STACK TO THE FRONT WALL AND MODERN PARTITION WALL FORMING THE KITCHEN; FROM THE NORTH-NORTH-WEST (2M SCALE).

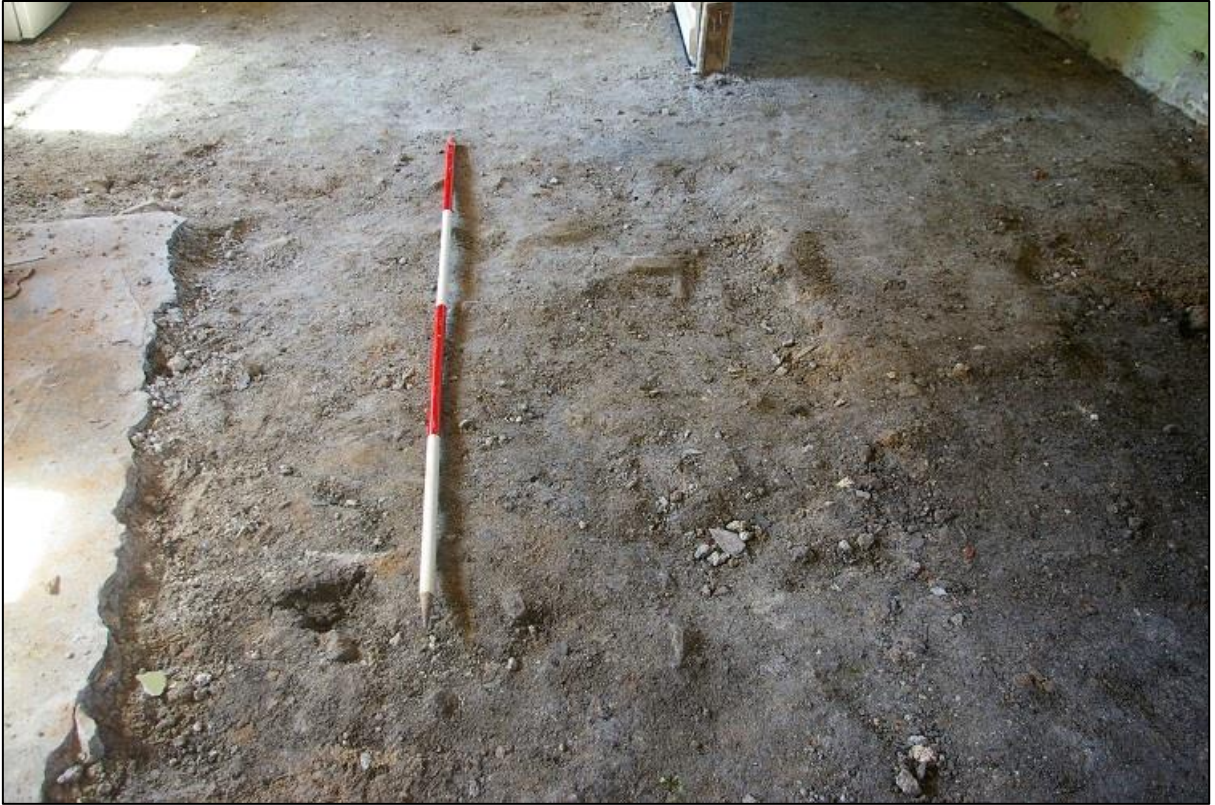
FIGURE 5: DETAILED VIEW OF THE SUB-RECTANGULAR SUNKEN AREA OF FLOOR, WITH THE MAJORITY OF THE SURVIVING COBBLES LEFT IN SITU; FROM THE NORTH-NORTH-WEST (2M SCALE).

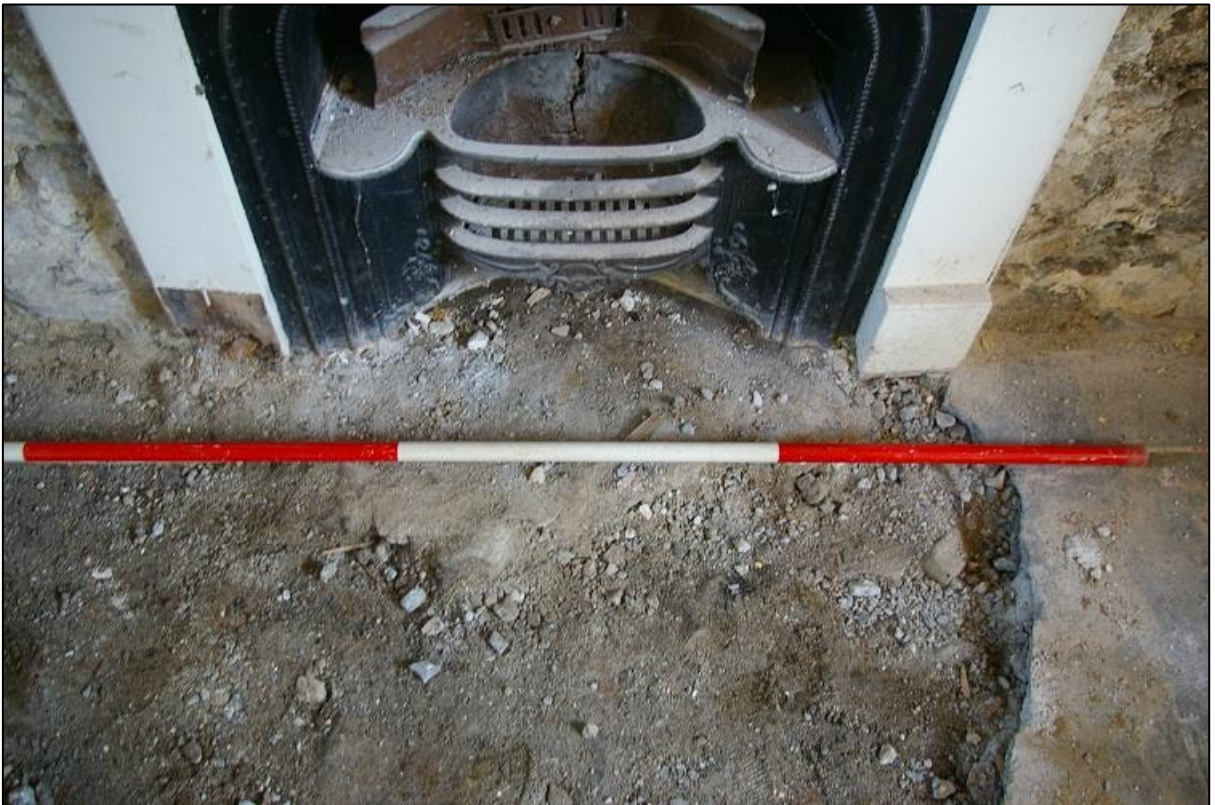
FIGURE 6: PATCH OF COBBLES IN FRONT OF BOX HEARTH, PARTIALLY OBSCURED BY LOWER LAYERS OF CEMENT FLOOR; FROM THE SOUTH (2M SCALE).

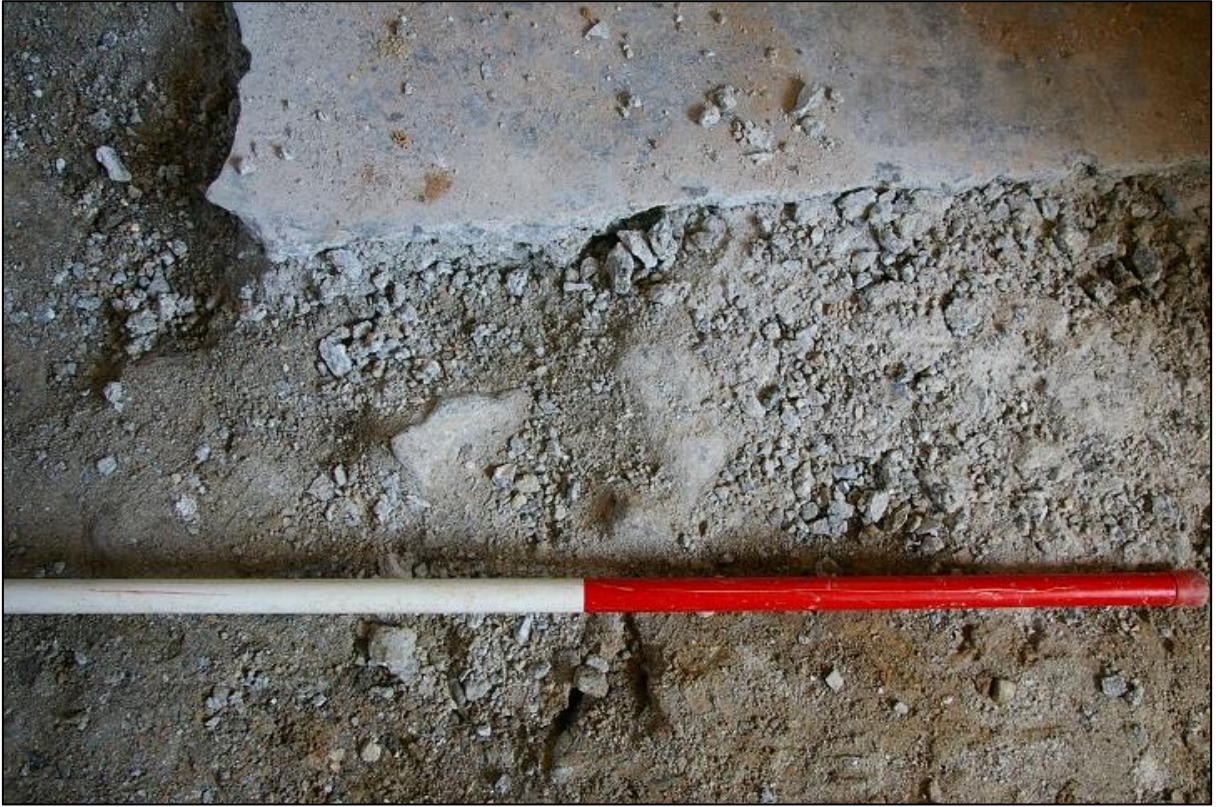
FIGURE 7: PAIR OF LARGER, IRREGULARLY SHAPED SLATESTONE COBBLES NEAR THE RETAINED CONCRETE SLAB, TO THE EAST OF THE ROOM; FROM THE SOUTH (2M SCALE).

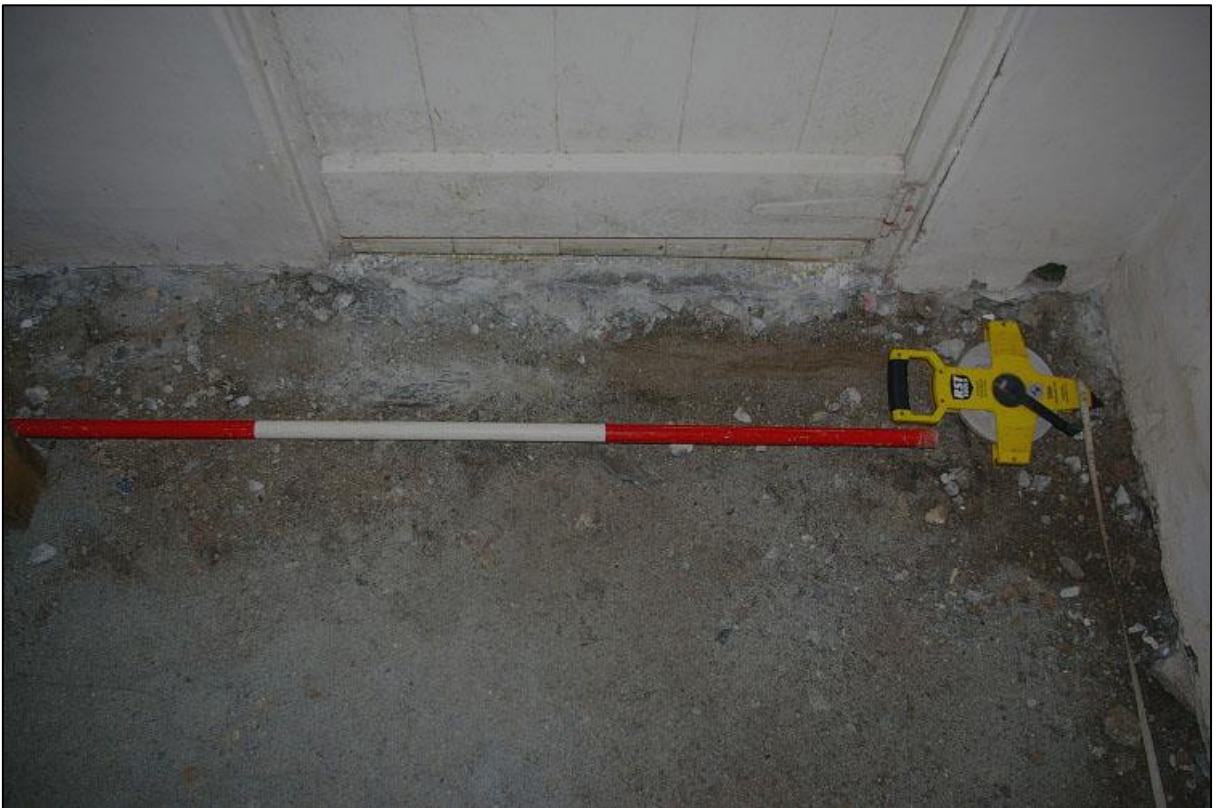
FIGURE 8: BROWN LIMECRETE FLOOR AND A FEW SPLIT SLATE LINEAR COBBLES IN THE DOORWAY TO THE HALL, ALONGSIDE THE PLANK PARTITION, AS WELL AS THE CONCRETE FLOOR IN THE HALLWAY VISIBLE ABOVE; FROM THE NORTH (2M SCALE).

A number of neat, lineally arranged split cobbles can be seen to line the south wall of the room, seemingly parallel to and respecting a plank boarded partition covered by plasterboard, forming a hallway serving the front door of former No.2. These appear to be associated with a second historic floor surface, above them; a hard polished surface, of pale brown colour, which could be a section of limecrete, which emerges within the doorway; this can be seen to be topped by a modern concrete floor, within the adjacent hallway space.

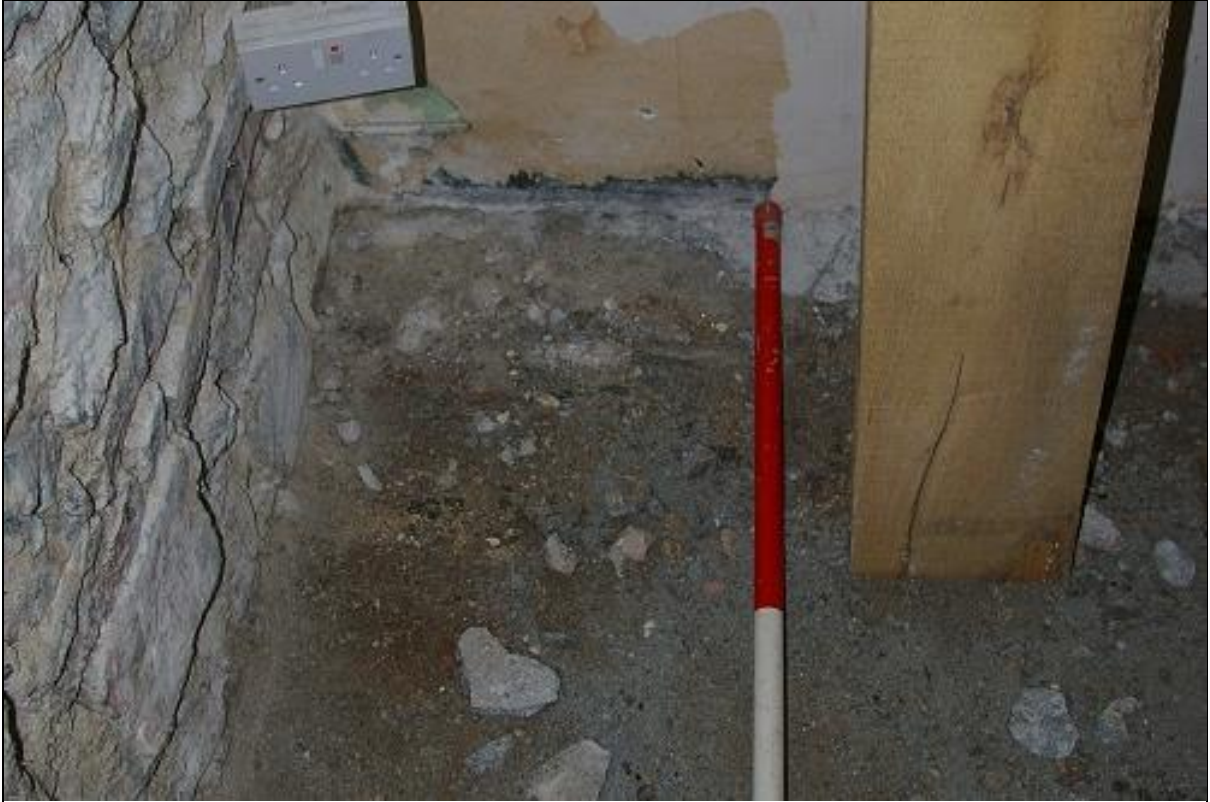
FIGURE 9: NARROW, LINEAR, SPLIT SLATE COBBLES PARALLEL WITH THE PLANK PARTITION WHICH FORMS THE HALLWAY TO THE SOUTH END OF FORMER COTTAGE NO.2; FROM THE NORTH (2M SCALE).

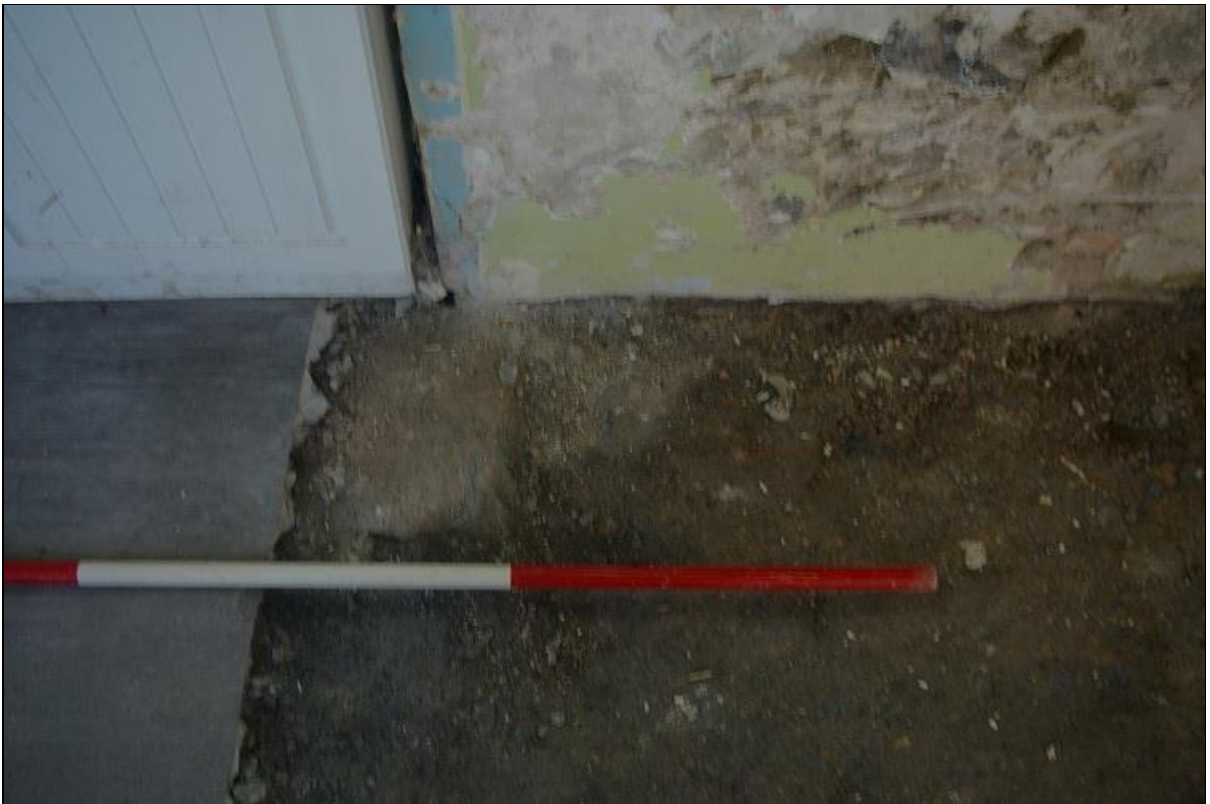
FIGURE 10: THE FLAT, LARGE STONE, SEEN AGAINST THE WALL IN THE KITCHEN AREA, ON THE EDGE OF THE LIFTED CONCRETE FLOOR; FROM THE EAST (2M SCALE).

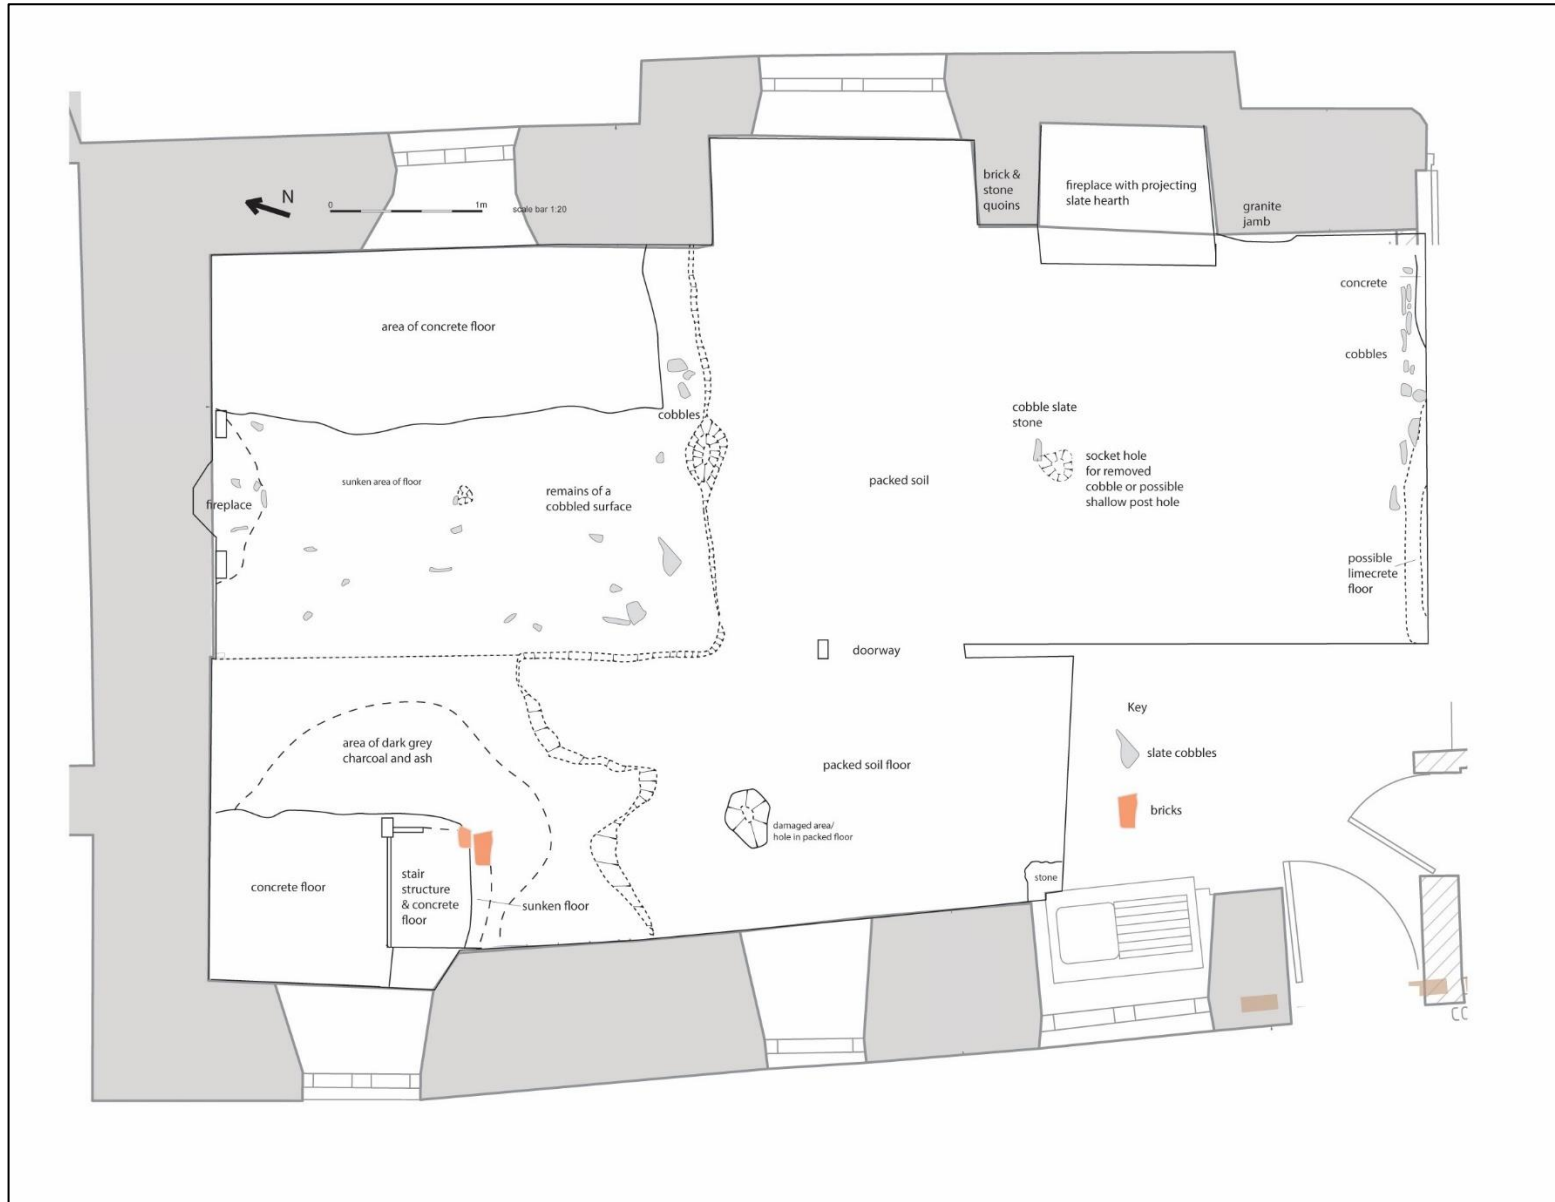
FIGURE 11: ANNOTATED PLAN OF THE FLOOR, IN FORMER NO.2, THE OLD CLERGY HOUSE, OVERLAID ON THE ARCHITECTS PLANS (AS SUPPLIED BY CLIENT), SHOWING THE LOCATIONS OF THE REMAINING COBBLES.

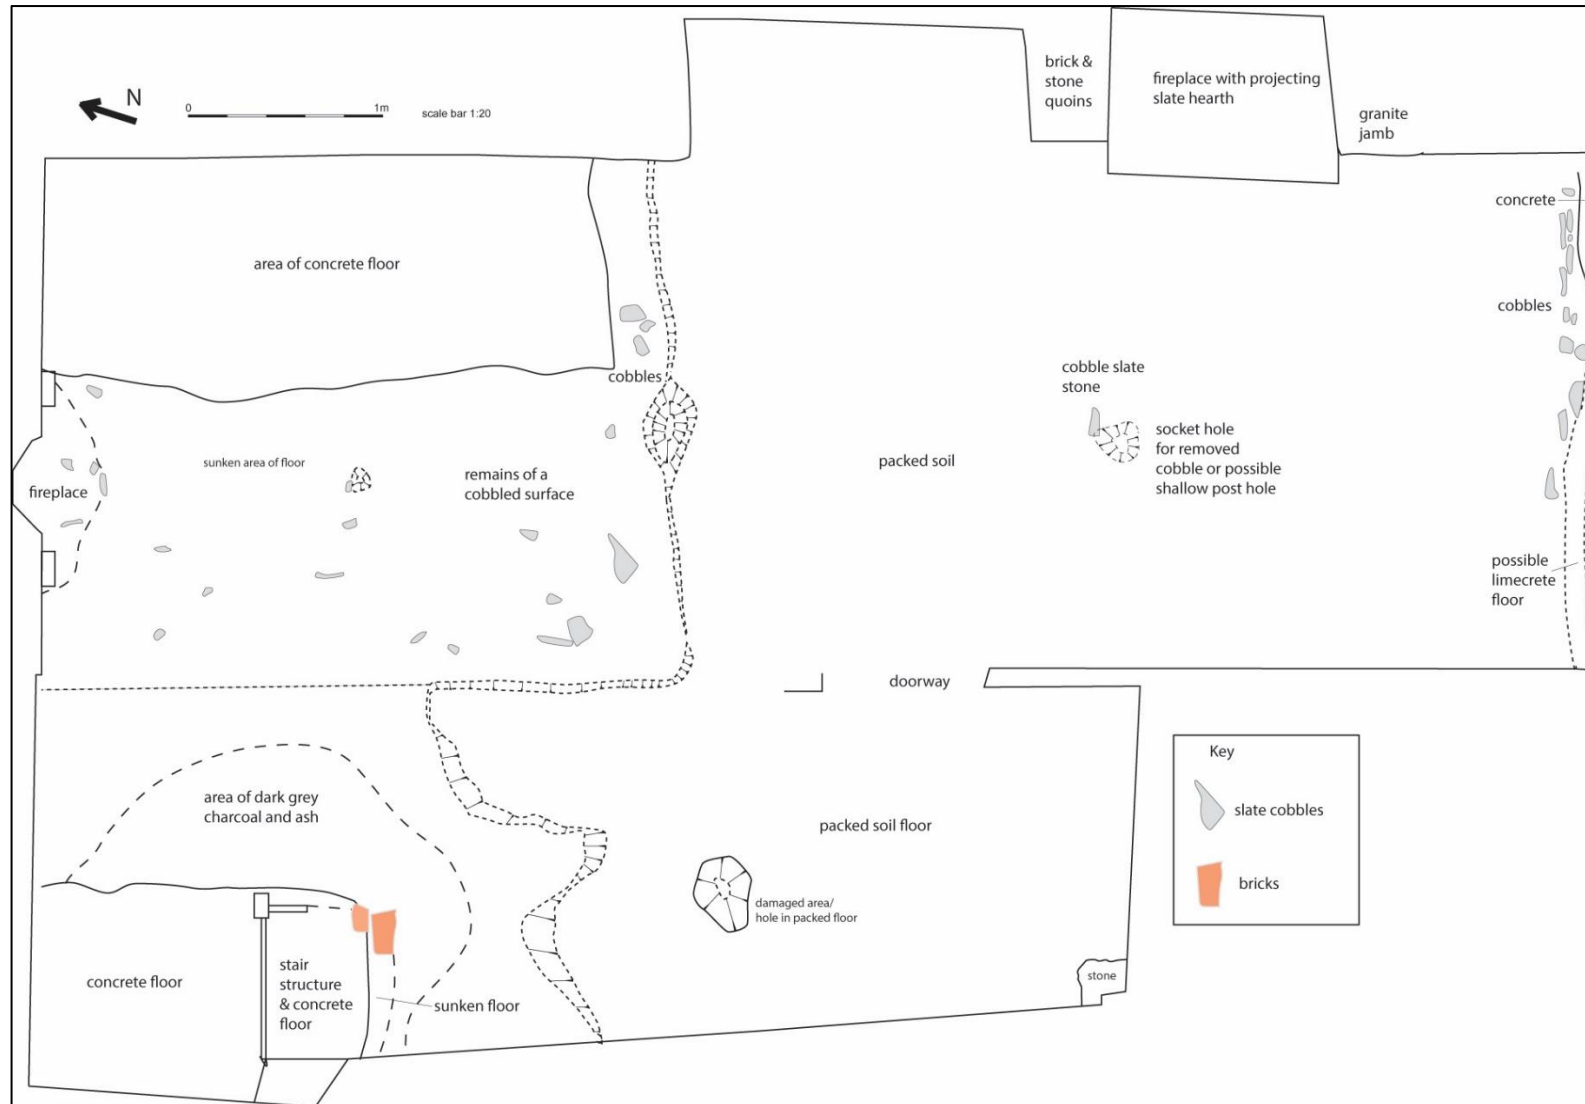
FIGURE 12: DIGITAL ILLUSTRATION OF SCALED PLAN OF THE EXPOSED FORMER COBBLED FLOOR SURFACE, AS RECORDED.

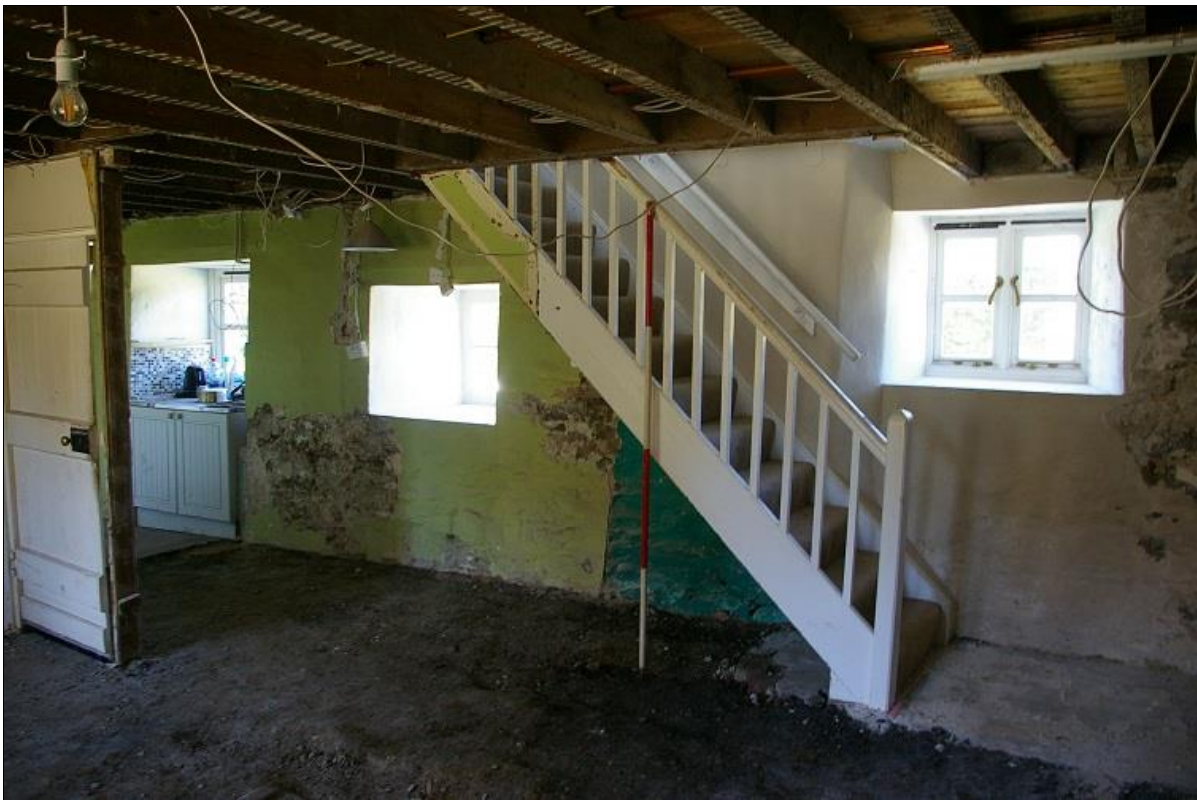
2. THE REAR WALL OF THE COTTAGES, WITH MODERN STAIRCASE TO THE FIRST FLOOR; FROM THE EAST-NORTH-EAST, WITH 2M SCALE.

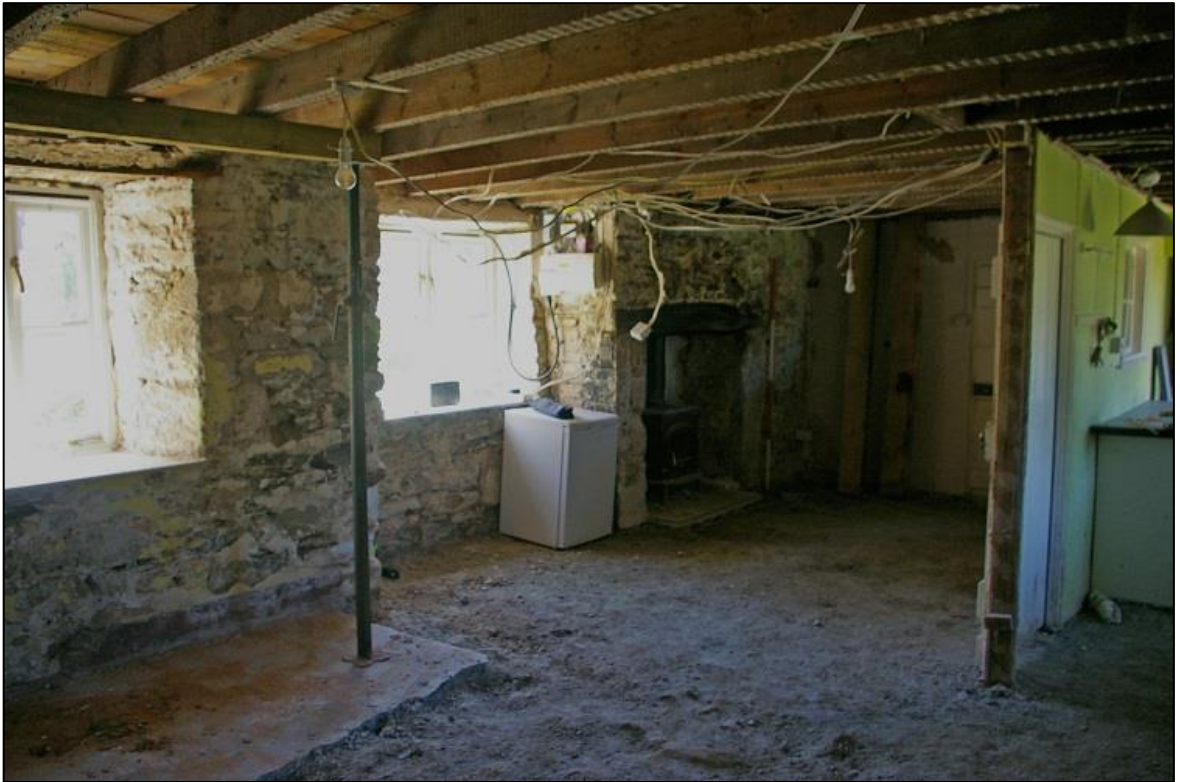
3. THE FRONT WALL OF THE COTTAGE, FORMERLY KNOWN AS NO.2, WITH LATERAL STACK (2M SCALE); FROM THE NORTH-WEST.

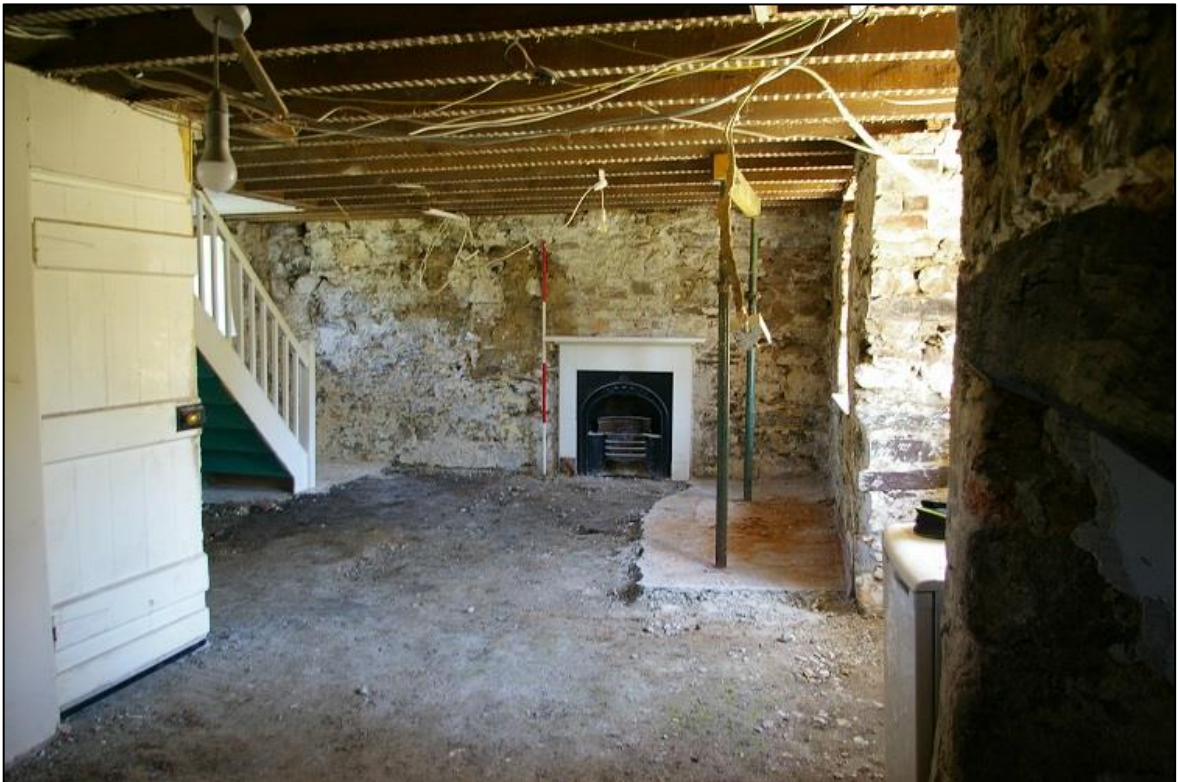
4. THE EXTENDED NORTH GABLE, WITH BOX HEARTH, WITH RAISED BASKET GRATE (2M SCALE); FROM THE SOUTH-EAST.

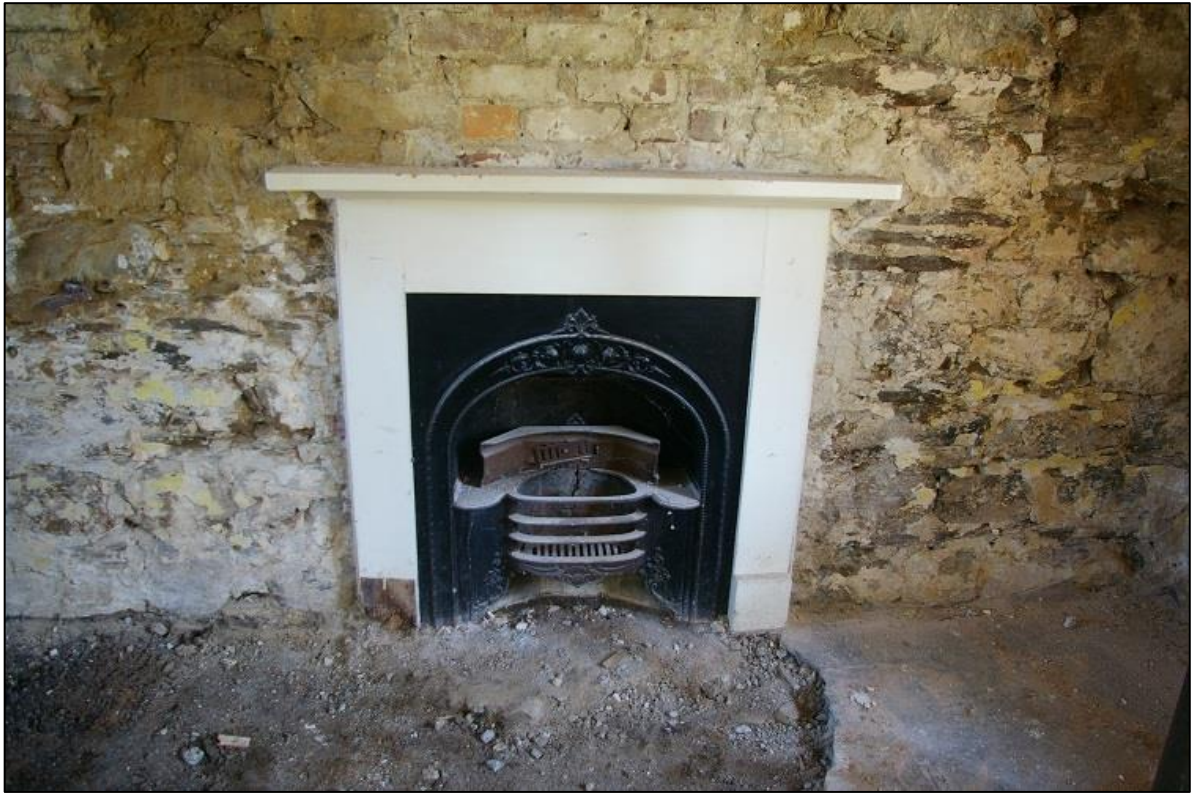
5. THE 19TH CENTURY BOX HEARTH, WITH INSET BASKET GRATE TO THE NORTH END OF THE ROOM, THE POTENTIAL BLOCKED WINDOW CAN BE SEEN ABOVE AND TO THE RIGHT-HAND SIDE, WITH STRAIGHT JOINT AND SLATE LINTEL; FROM THE SOUTH.

The exposed stone of the walls indicates there is further evidential value in the building with some complex structural phasing observed; the north gable appears to have been replaced and extended and there may be a blocked window opening to the right hand side of the box hearth, where a long slate slab appears to form a lintel and there is at least one build line/set of reveals; the other side is disrupted by the later post medieval hearth. The hearth itself exhibits brickwork patching of the flue above the fireplace and all of the windows on the east front wall have evidence for the removal and raising of their lintels, again with brick patching to the reveals, suggestive of a 19th century change here. Interestingly there is also a clear build line between the Hall-bay outer wall and much disruption and rebuild around the projection, suggesting that this structure was much altered in a post medieval phase of work and this projection may have contained an earlier stair, adjacent to the stack.

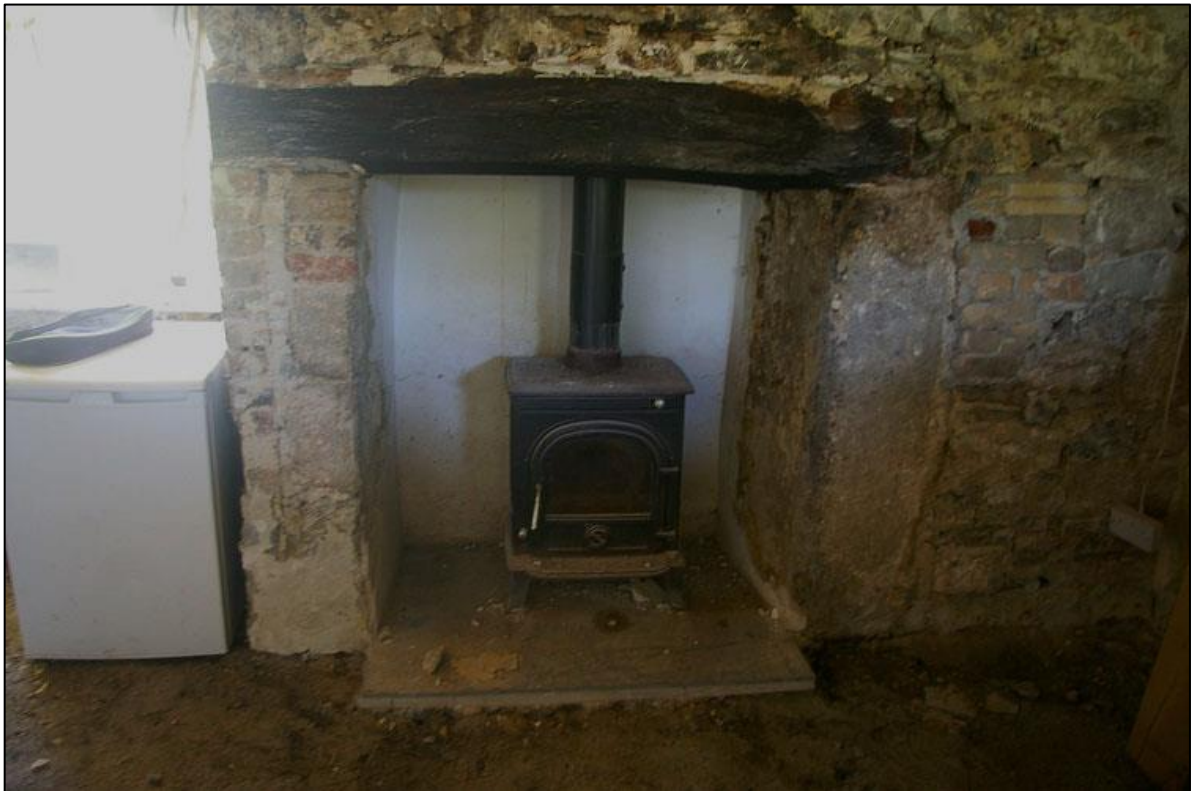
6. LATERAL STACK WITH CHARRED BRESSUMMER BEAM AND UPRIGHT GRANITE SET TO RIGHT HAND SIDE, THE LEFT JAMB REBUILT WITH BLOCKS AND BRICKWORK, FORESHORTENING THE HEARTH; FROM THE WEST.

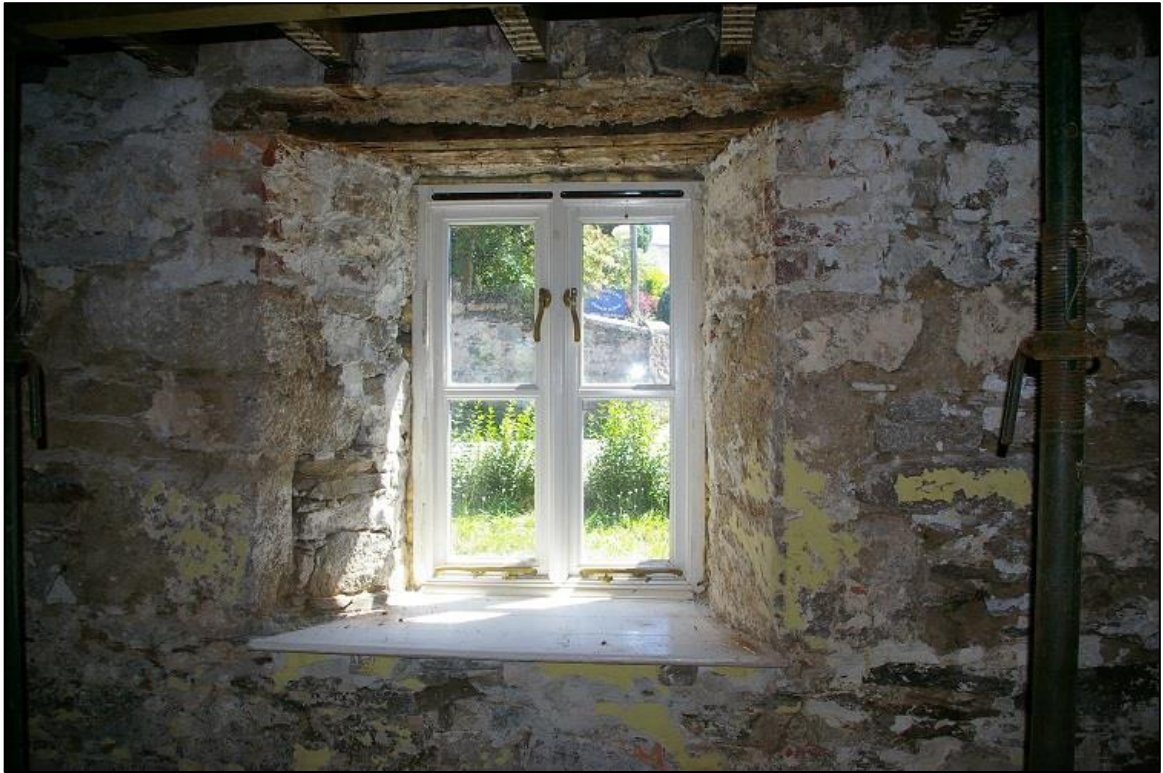
7. EXAMPLE OF ONE OF THE WINDOWS IN THE FRONT WALL, SHOWING GOOD VERNACULAR GRANITE QUOINS TO THE ORIGINAL BOXY OPENING, WITH LINTELS RAISED ABOVE, INFILLED WITH BRICK BENEATH NARROW TIMBER LINTELS; FROM THE WEST.
