LAND AT CAERHAYS BARTON ST MICHAEL CAERHAYS CORNWALL

Results of a Geophysical Survey

South West Archaeology Ltd. report no. 210610

By P. Webb
Report Version: FINAL01
Issued: June 10th 2021

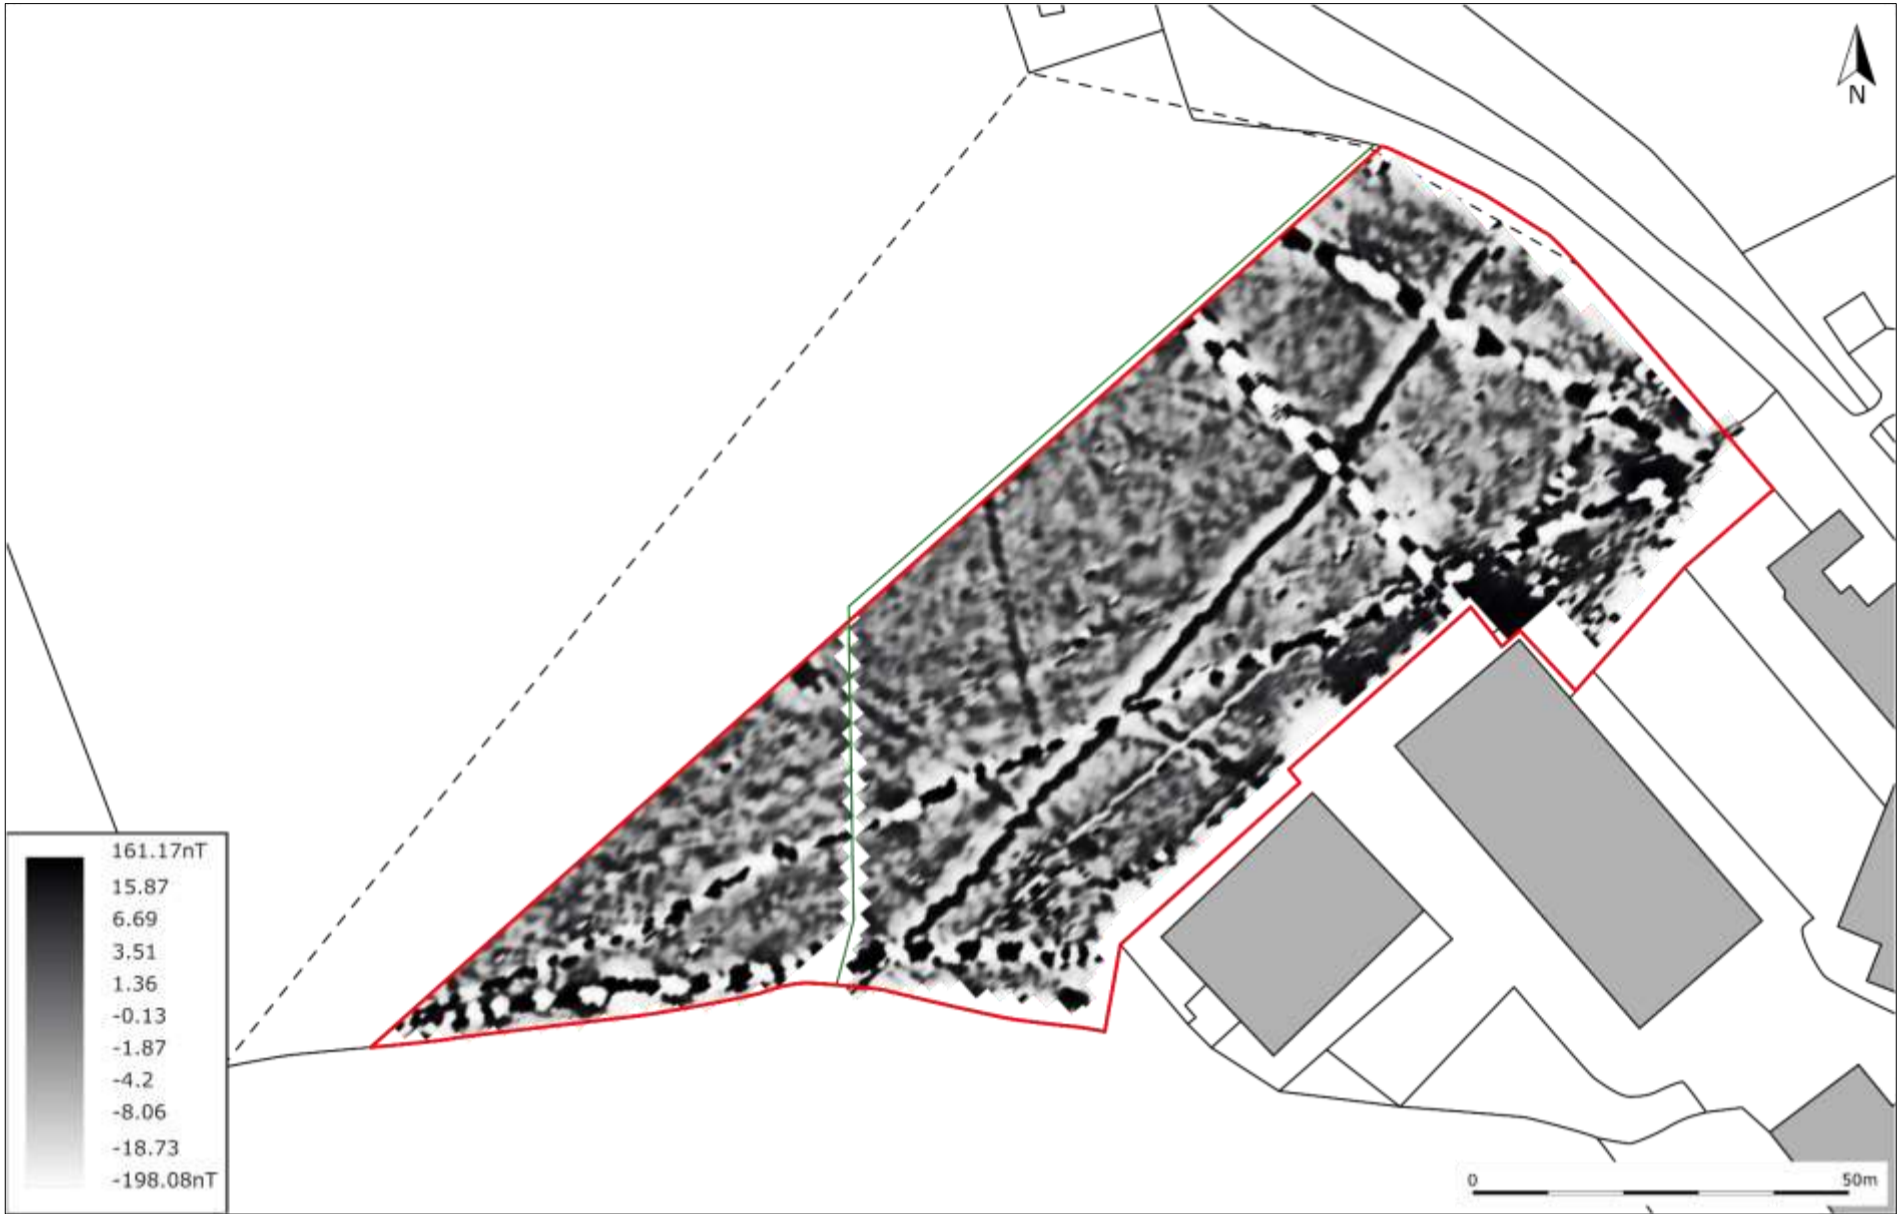
FIGURE 2: SHADE PLOT OF THE GRADIOMETER SURVEY DATA; BAND WEIGHT EQUALIZED, GRADIATED SHADING.

Table 1 with the accompanying Figures 2 and 3 show the analyses and interpretation of the geophysical survey data.

The weak responses of some of the anomalies indicates that the majority are only likely to survive to a shallow depth. The background geological variation across the site was between +/-5nT.

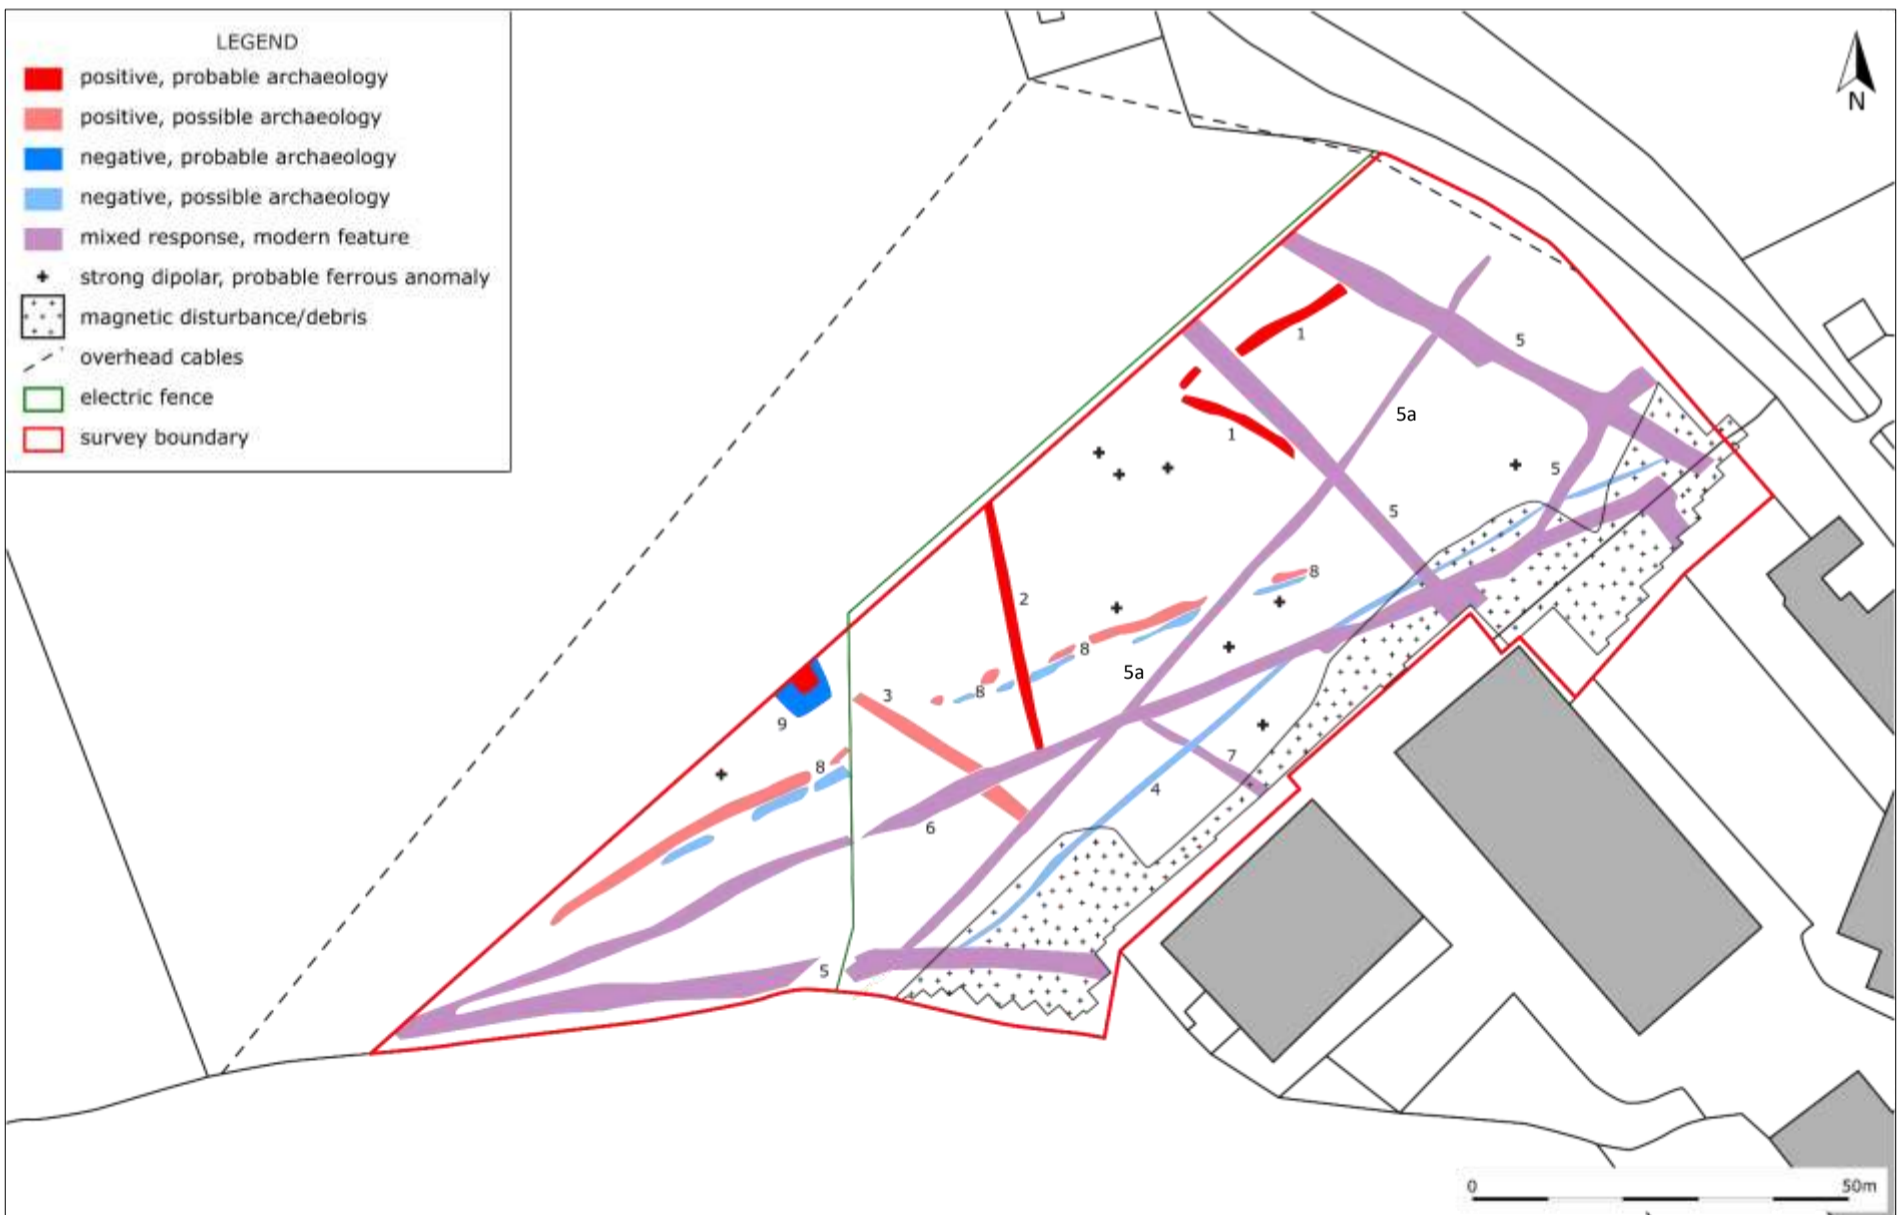
FIGURE 3: F1, INTERPRETATION OF THE GRADIOMETER SURVEY DATA.

Anomaly Group 1 consists of two weak positive (+3.42nT to +14.02nT) linear responses indicative of cut and infilled features such as ditches. They are orientated approximately north-east to south-west and north-west to south-east along the lines of the existing fieldsystem and may belong to an earlier phase.

Anomaly Group 2 consists of a moderate positive (+4.71nT to +24.63nT) linear response indicative of a cut and infilled feature such as a ditch. It is orientated approximately north to south. Whilst broadly along the lines of the existing fieldsystem, it does appear to be slightly off-set and may form part of a different earlier field layout.

Anomaly Group 3 consists of a weak positive (+4.98nT to +15.81nT) linear response indicative of a cut and infilled feature such as a ditch. It is aligned approximately north-west to south-east, along the lines of the existing field system, parallel to elements of Group 1, and is likely to form part of the same phase of fieldsystem.

Anomaly Group 4 consists of a moderate negative (-32.44nT to -5.51nT) linear response indicative of a ceramic or stone feature such as a drain. It is orientated approximately north-east to south-west.

Anomaly Groups 5 and 7 consist of very strong bipolar (-198.08nT to -4.41nT and +6.47nT to +135.44nT) linear responses indicative of buried modern services. They are aligned between approximately east to west and north-west to south-east. (Note that one of these (5a) appears to line up with the cropmarks of a field boundary approaching from the south-west. It is unclear whether this indicates the cropmark is of a relatively recent feature, or if a Prehistoric feature has generated a very strong magnetic response).

Anomaly Group 6 consists of a very strong positive (+6.47nT to +101.52nT) with associated negative (-110.98nT to -4.56nT) linear response indicative of a buried modern service. It is aligned approximately north-east to south-west.

Anomaly Group 8 consists of a moderate positive (+3.95nT to +25.61nT) with associated negative (-16.32nT to -3.48nT) linear response indicative of a cut and infilled feature such as a ditch with associated compacted/banked material. It is aligned approximately north-east to south-west, along the lines of the existing fieldsystem and may form part of an earlier phase.

Anomaly Group 9 consists of a moderate dipolar (-18.77nT to -3.06nT and +10.36nT to +35.99nT) discrete ovoid response indicative of a cut and infilled feature such as a pit. Its position at the end of a linear feature may suggest that the two form part of a modern service such as a drain.

Modern disturbance, dipolar anomalies and magnetic disturbance are also located across the field, particularly around the site boundaries. This is likely due to the presence of ferrous objects and other metallic debris and the metallic components of fence lines and field boundaries.

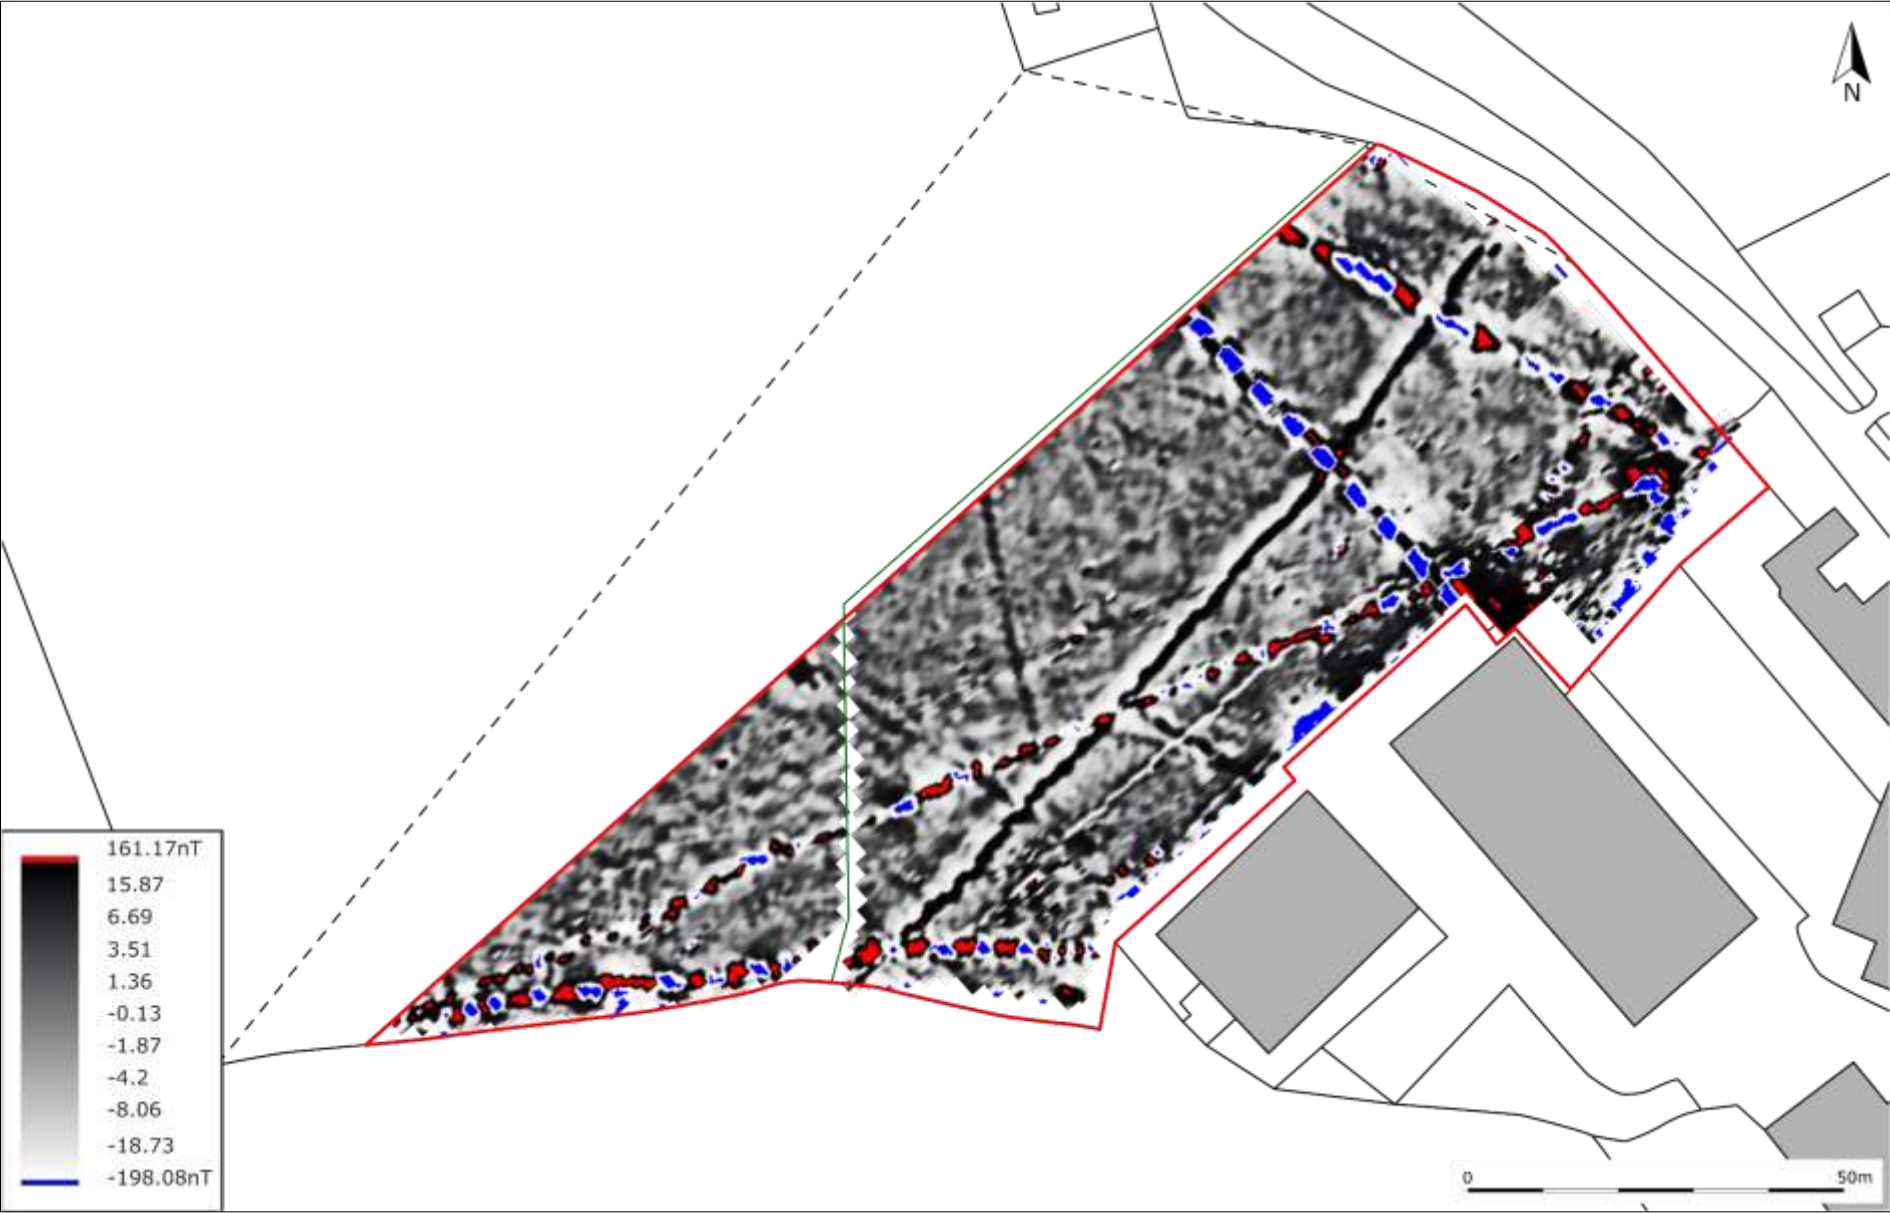
2. F1, RED-GREY-BLUE SHADE PLOT OF THE GRADIOMETER SURVEY DATA; BAND WEIGHT EQUALISED; GRADIATED SHADING.

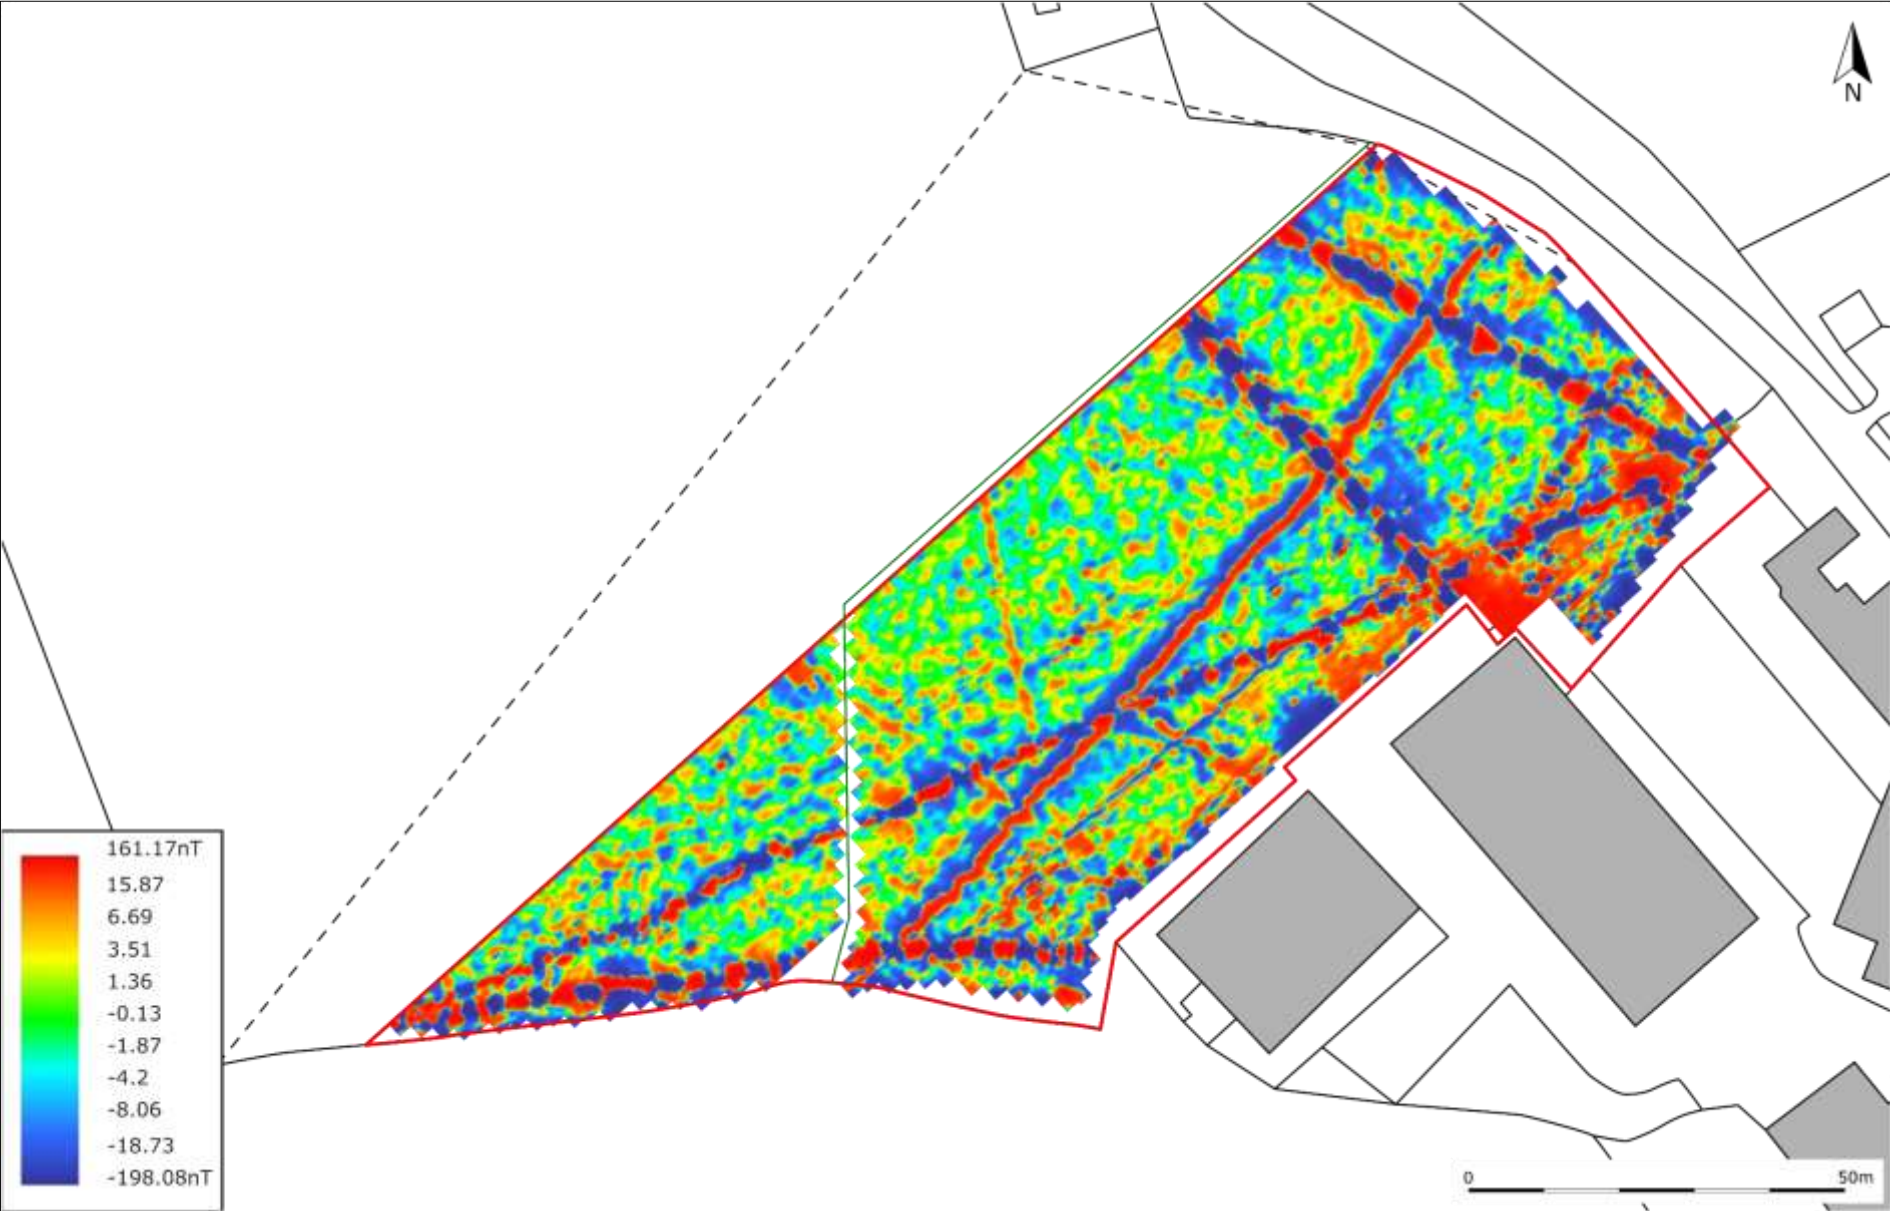
3. F1, RED-GREEN-BLUE2 SHADE PLOT OF THE GRADIOMETER SURVEY DATA; BAND WEIGHT EQUALISED; GRADIATED SHADING.

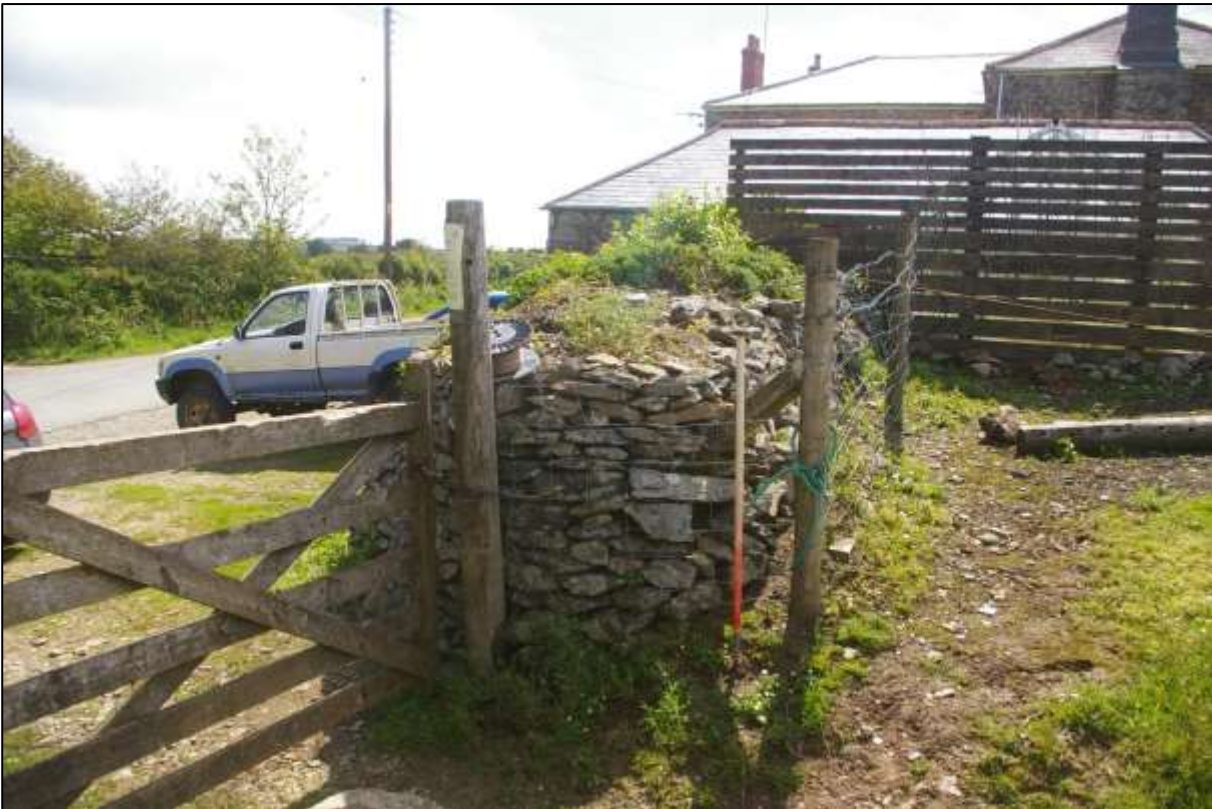
1. DETAIL OF THE NORTH-EASTERN STONE-FACED BOUNDARY; VIEWED FROM THE NORTH-WEST (1M SCALE).

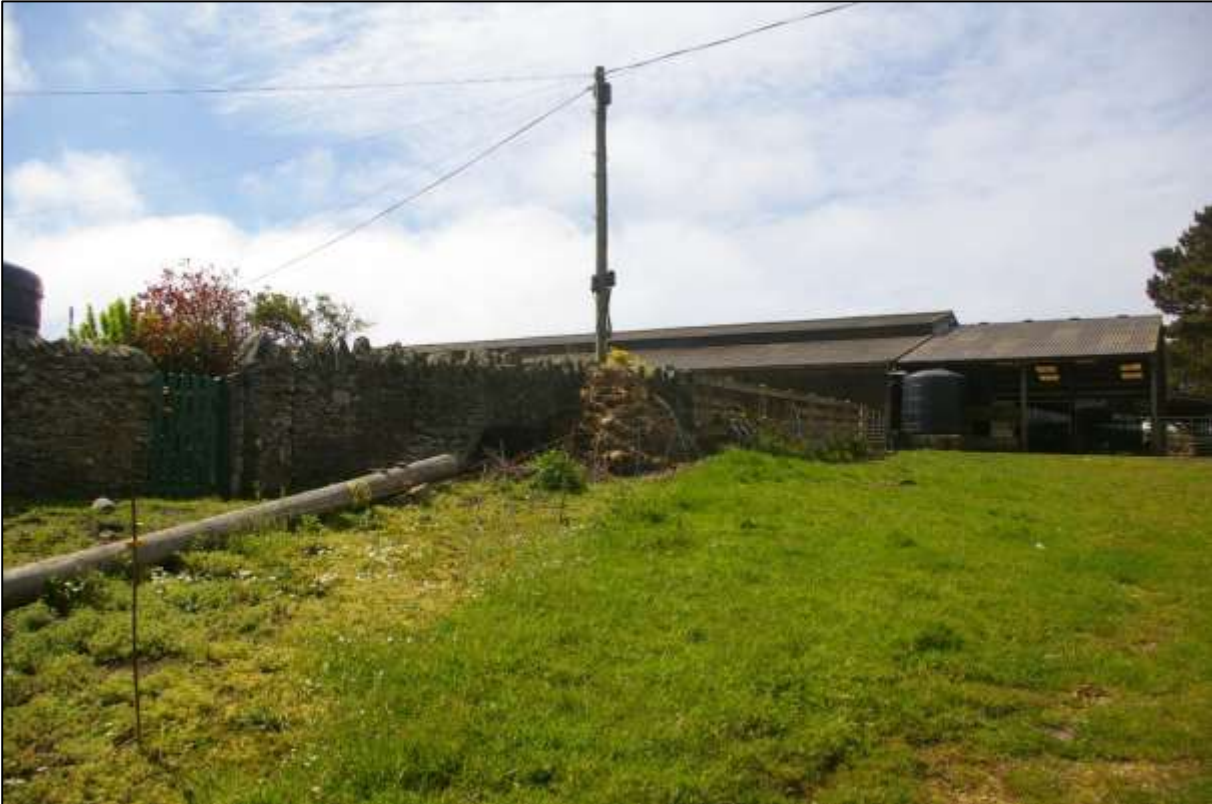
2. DETAIL OF THE SOUTH-EASTERN SITE BOUNDARY, SHOWING THE OLD TELEGRAPH POLES; VIEWED FROM THE NORTH-WEST (NO SCALE).

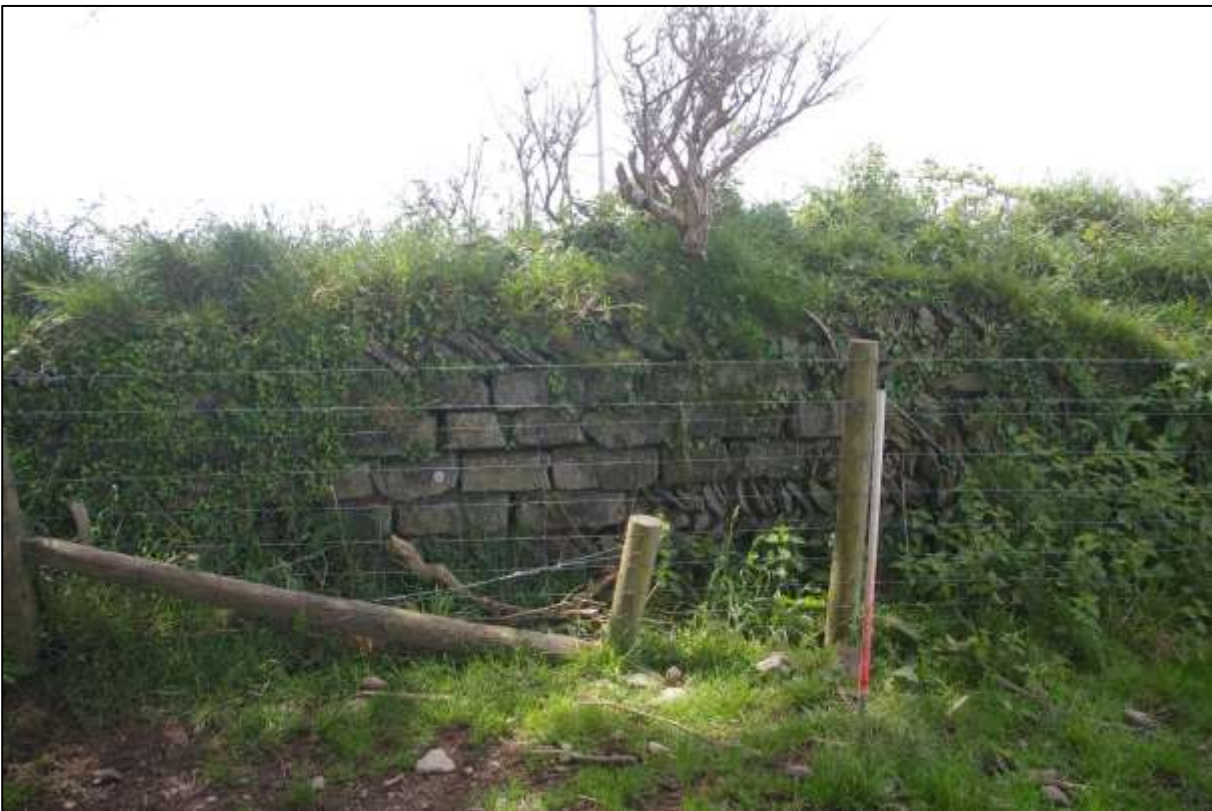
6. DETAIL OF MODERN REPAIRS TO THE SOUTHERN BOUNDARY; VIEWED FROM THE NORTH (1M SCALE).
