THE CIDER BARN
DENT HOUSE
DODDISCOMBSLEIGH
DEVON

Results of a Desk-Based Assessment
and
Historic Building Recording

Report No.: 090212
Authors: T. Green
C. Humphreys
R. Waterhouse

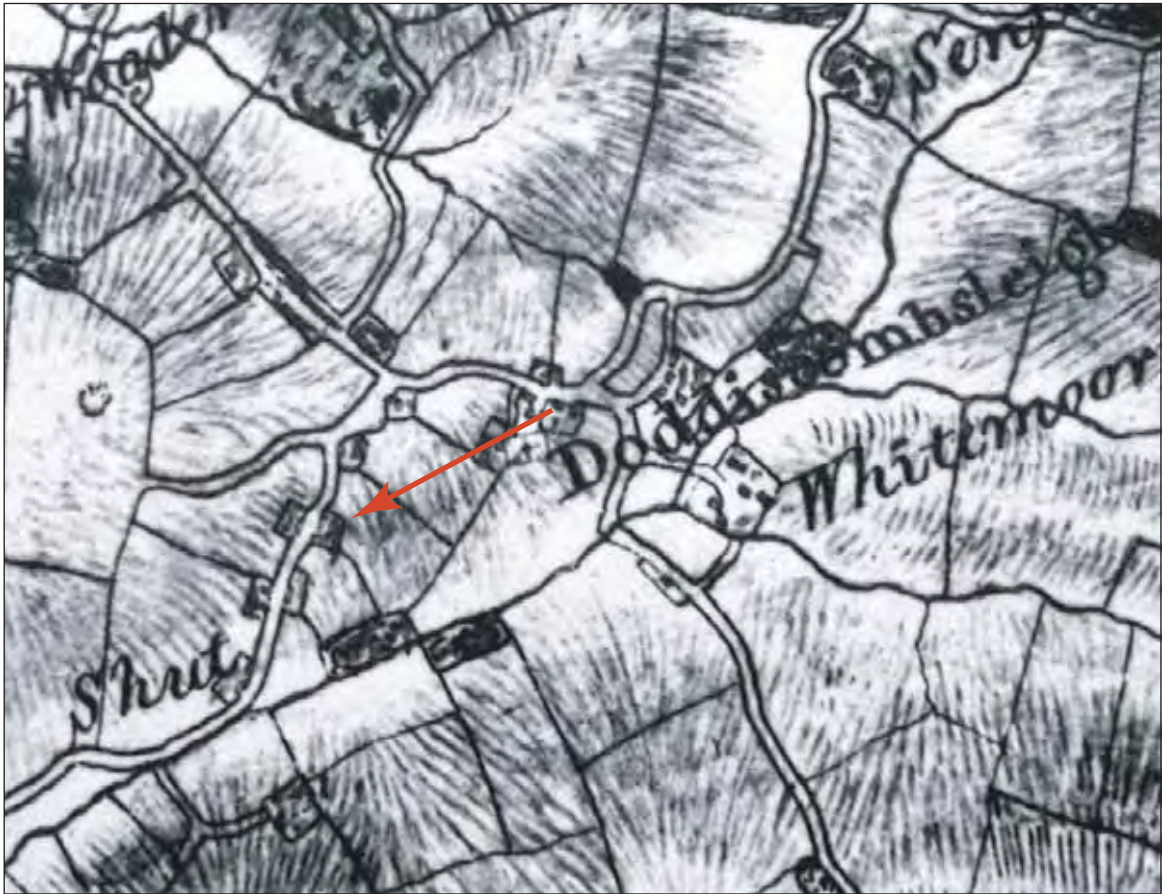
Fig. 2: Extract from the Ordnance Survey surveyor's draft number 37, 1803-4. The location of Dent House is arrowed. (WCSL)

The location of Dent House is identifiable on the Ordnance Survey surveyor's draft map of 1803-4 (Fig. 2), but no reliable detail can be recognised. The earliest clear cartographic record of Dent House and its outbuildings is found in the Doddiscombsleigh tithe map of c.1840 (Fig.3). On this map the house is named and represented by an L-shaped plan to the south of which were a long building on an east-west axis adjoining on the east a similarly proportioned building lying north-south. The small enclosure to the south of this group is numbered 520 on the tithe map and identified in the tithe apportionment as 'Garden'. The larger piece of ground to the east, number 519, is 'Meadow'. The area to the north, 518, is 'Orchard'.

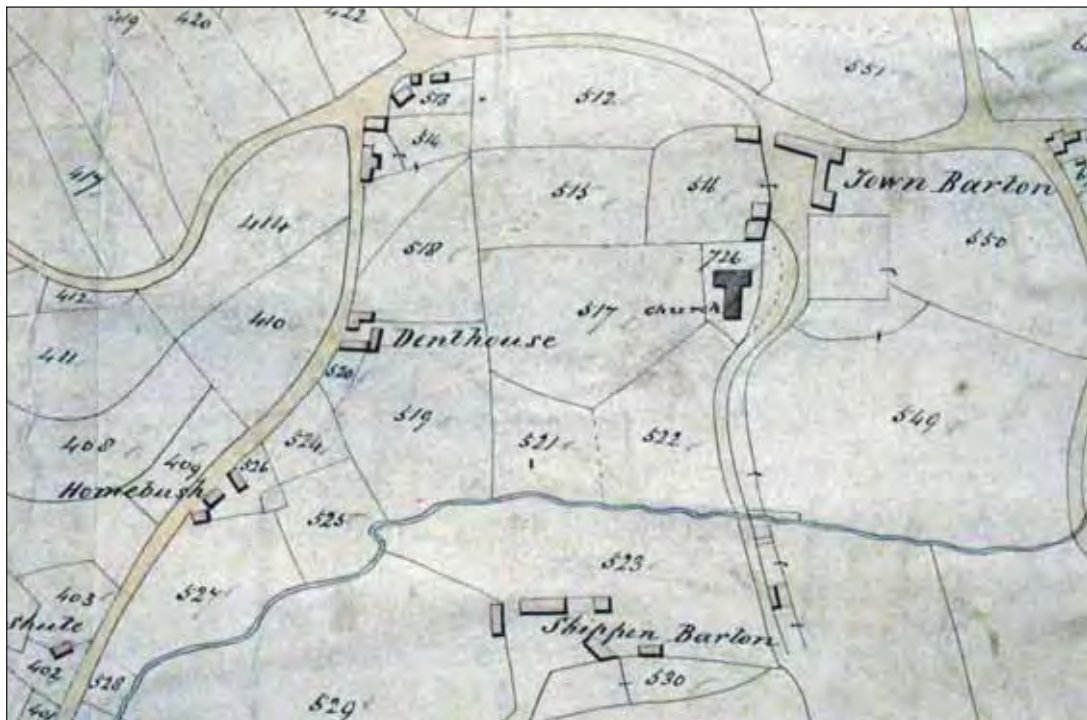
Fig. 3a: Extract from the Doddiscombsleigh tithe map, c.1840 showing Dent House in its local context. (DRO)

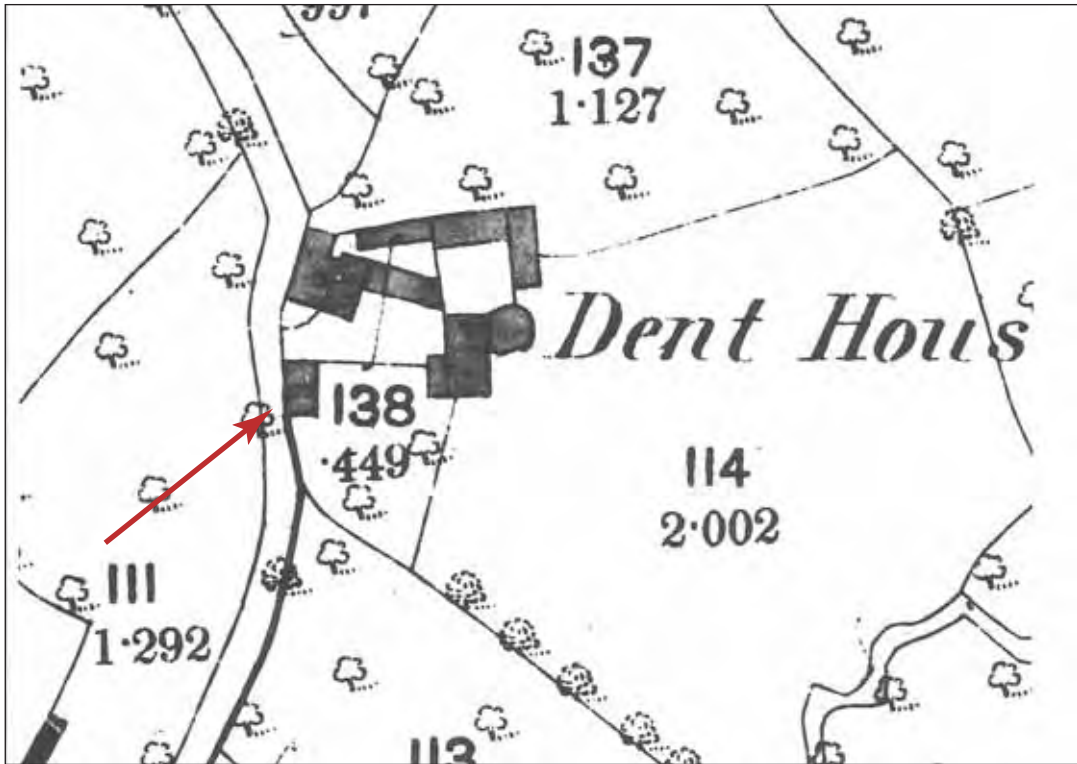
The Ordnance Survey First Edition map at 1:2500 surveyed in 1886 and published in 1888 (Fig. 4) shows the lay-out of the buildings in the later 19th century. Comparison of the maps of c.1840 and 1888 indicates considerable change during the middle years of the century. While the dwelling house seems to have escaped relatively unscathed, the outbuildings had clearly undergone considerable modification. To the north and east of the dwelling house was now an extensive L-shaped range of buildings, while to the south the long east-west building had been removed and the building adjoining it on the east had either been retained with the addition of a round engine house on its east side or had been completely replaced. This would appear to have been a threshing barn. Standing beside the road in the north-west corner of the former 'garden' (520 on the tithe map) was now a rectangular building on a north-south axis. This would appear to be the now existing cider barn.

Fig. 4: Enlarged extract from the Ordnance Survey First Edition map at 1:2500, surveyed 1886, published 1888, Devonshire sheet 91.7. The cider barn is arrowed. (WCSL)

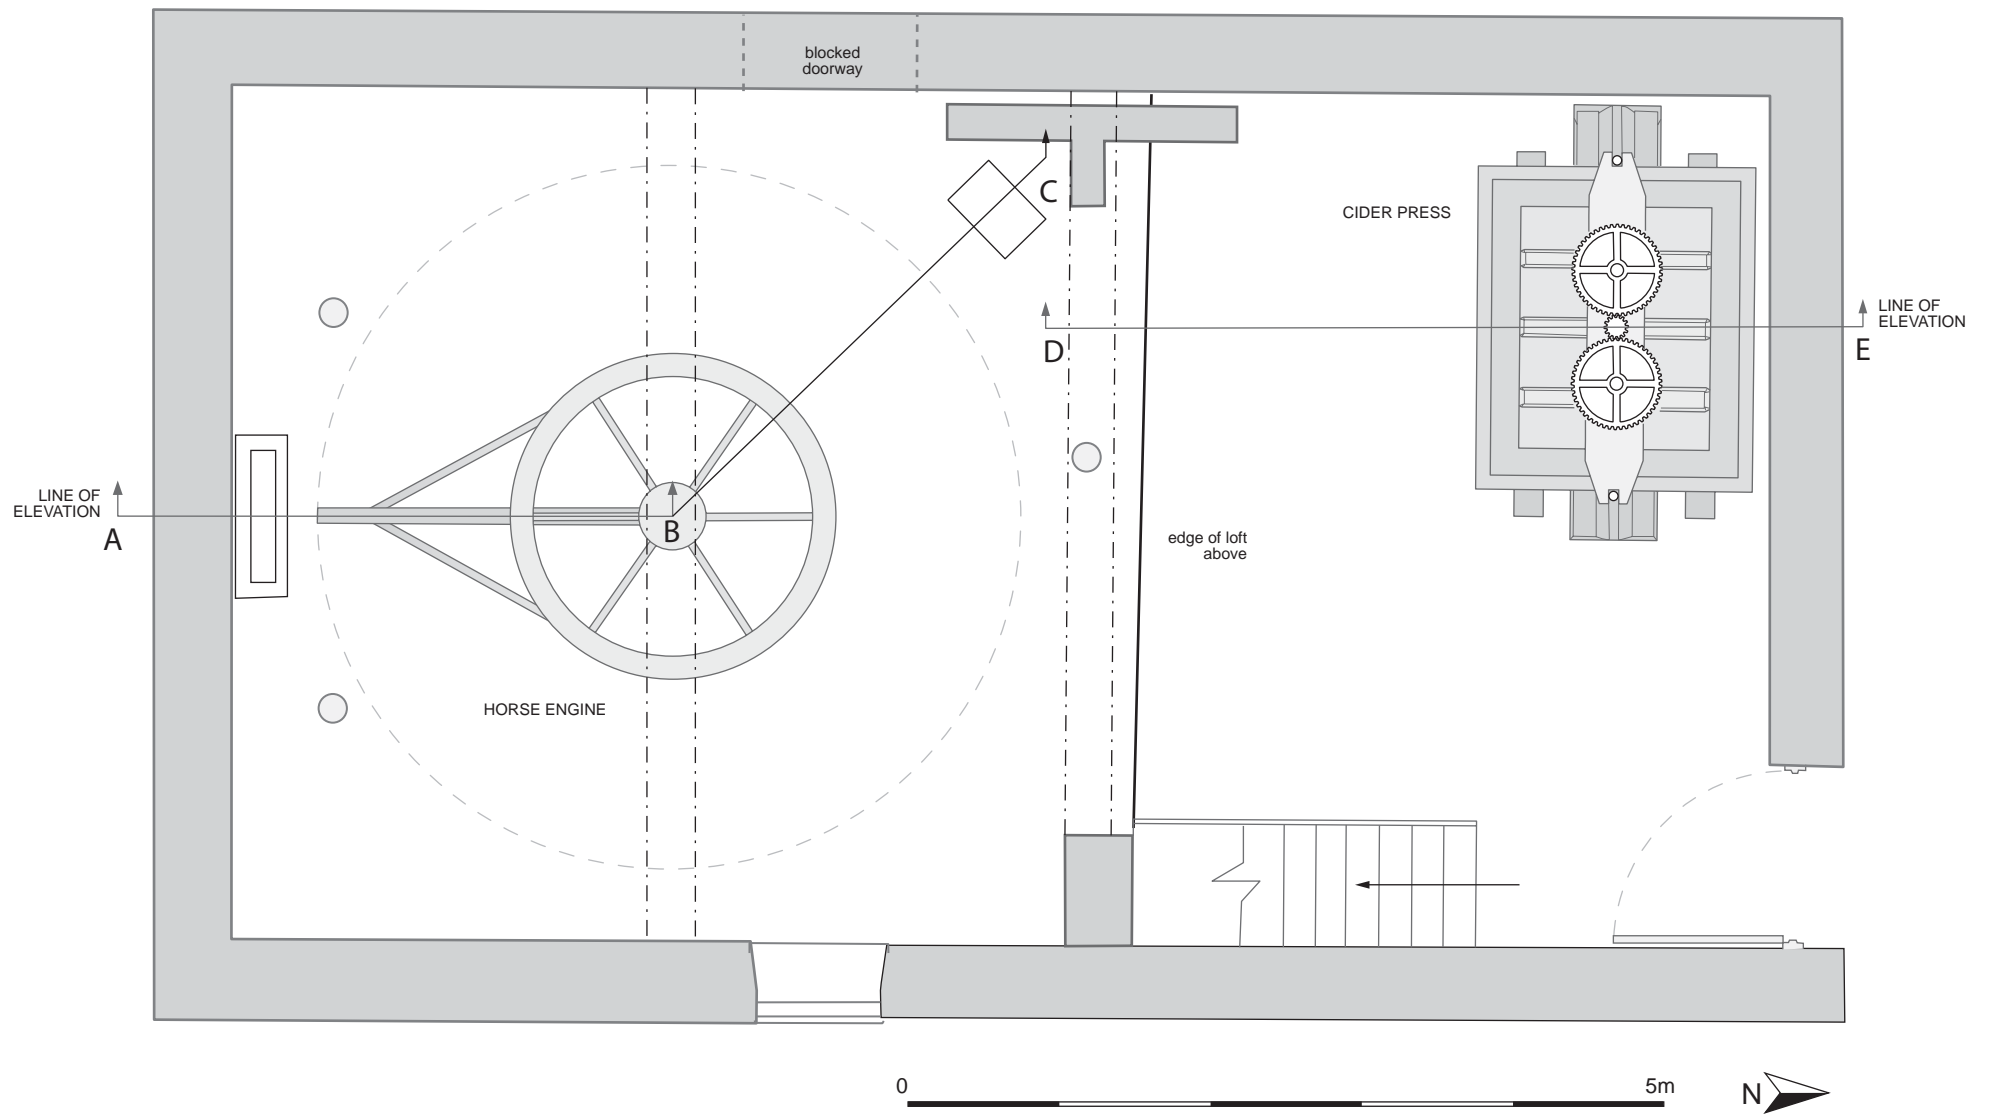
Fig. 6: Cider Barn, ground floor plan.

Internally, the eastern half of the building has a first floor, supported on two large transverse beams with axial joists with their ends set in the walls and supported on planks constructed into the wall faces. The western half has no upper floor, although a high window in the north wall suggests that it was partially floored originally. The edge of the first floor to the open part is protected by a simple timber fence, angled outwards with two close-set elm boards to retain loose apples. A recycled domestic straight run staircase of the later 19th century rises to first floor level against the north wall.

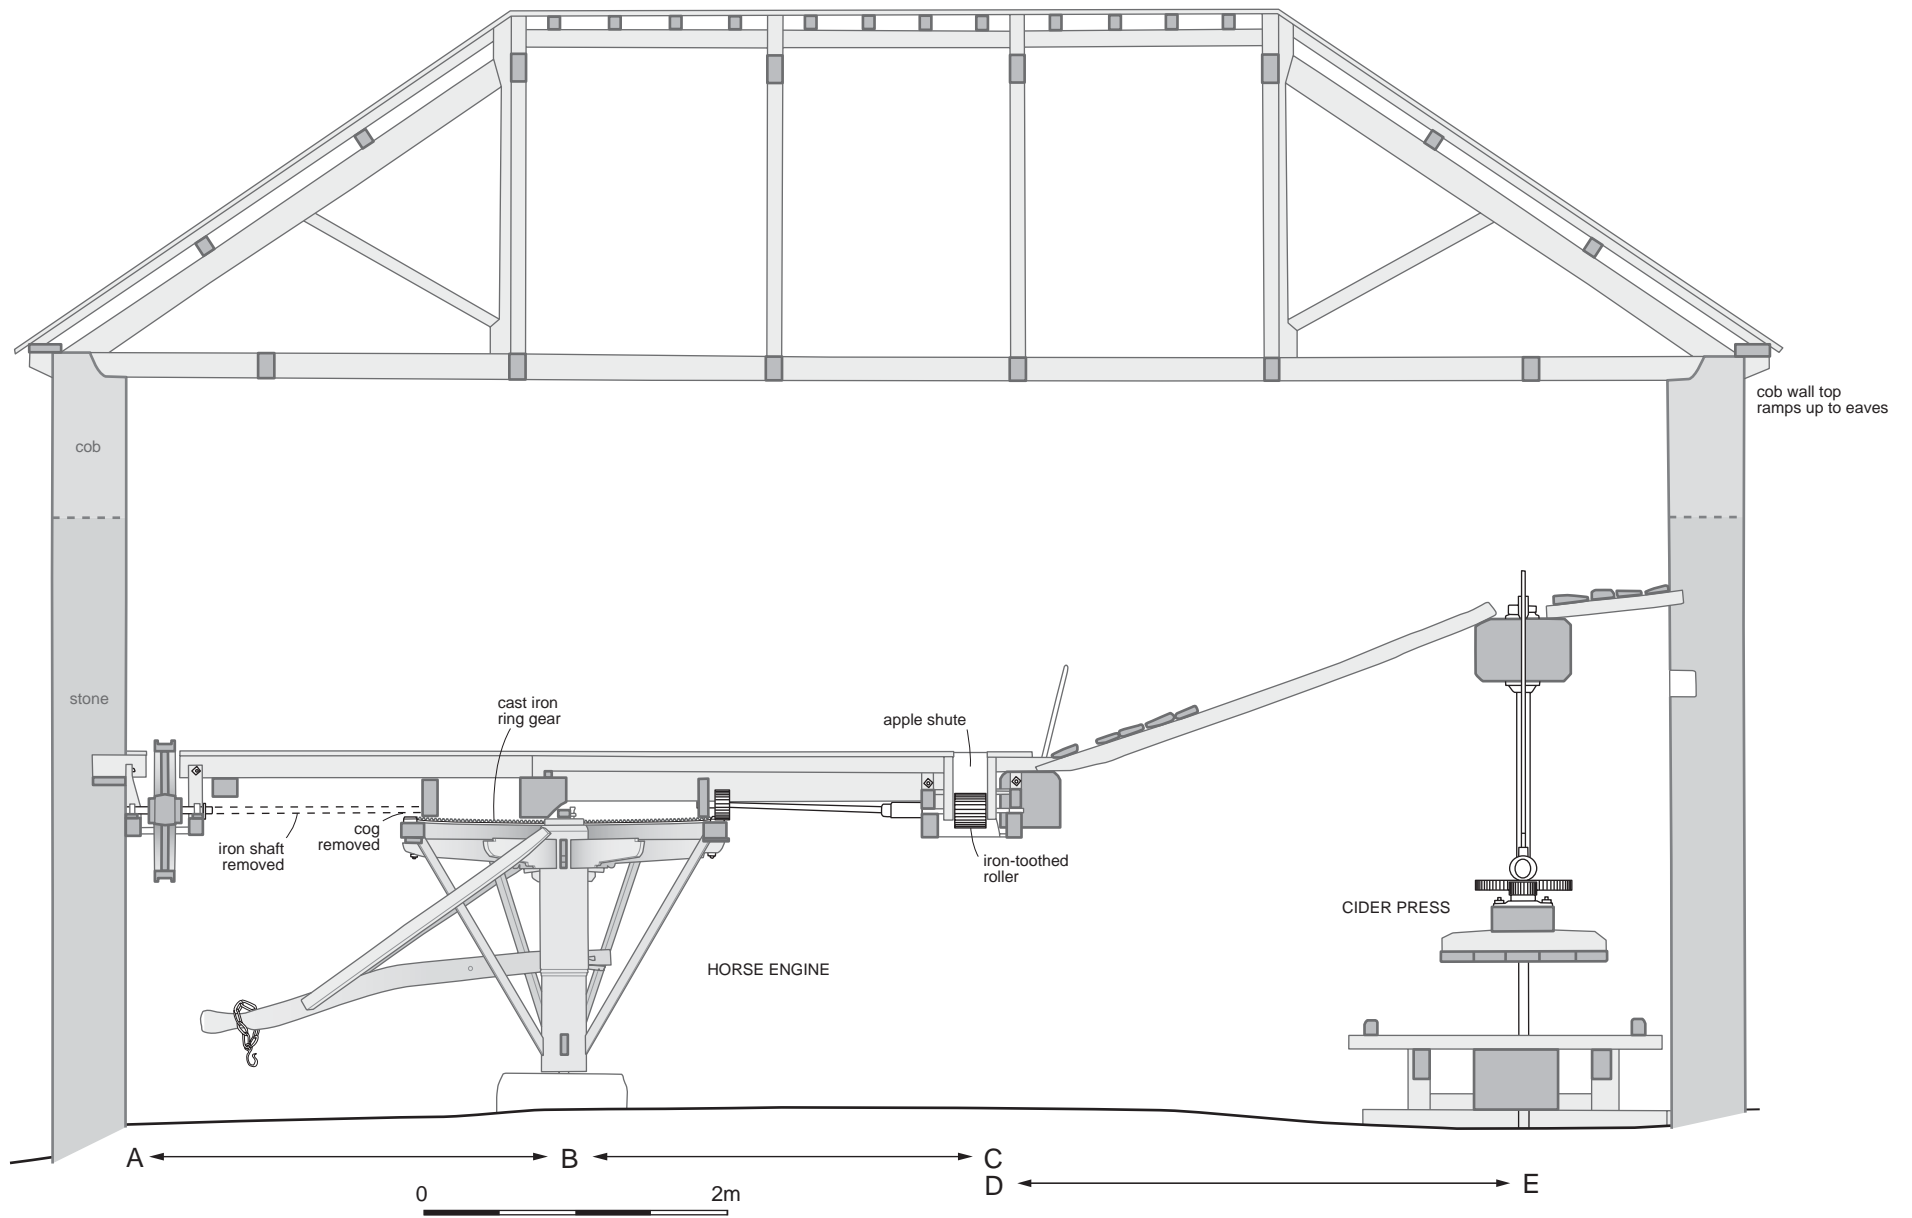
Fig. 8: Cider Barn, east-facing [AB] and north east-facing [BC] elevation of horse-engine and east-facing [DE] elevation of cider press. See Fig. 6 for location of elevations.

The horse engine is based on a heavy lathe-turned vertical post, with iron-bound ends holding wrought iron pintles; the lower sitting in a probable bronze bearing, led into a large granite block with the upper held in a cast iron bearing housing, bolted to the west side of the ceiling beam. The upper, larger diameter part of the post is morticed to take six radiating spokes, which were adjusted for height by wedges. The inner ends of these are deeper, with heavy beads to sloping soffits with radiused ends.

A timber ring of several segments, morticed & bolted together, was originally nailed, but is now through-bolted to the top of each arm at its extremity. A cast iron ring gear in segments is through-bolted to the upper face of the timber ring.

A mortice through the lower part of the main post takes a roundwood tiller, whose tenon is wedged in place. This tiller has a shaped end with a short length of chain to which the pony that provided the motive power would have been tethered. The tiller projects beyond the diameter of the ring gear and has drooped significantly, necessitating the addition of two later suspension bracers, nailed roughly to the underside of the timber ring.

There is a south-western square drive shaft of wrought iron with wallower gear taking power from the ring gear in a vertical cast iron screw-adjusted slide, mounted in an oak trimmer between the joists. This drives a gear train in the eastern side of a timber crusher case, bolted to the underside of the ceiling joists, against the eastern face of the central ceiling beam.

The crusher case is rectangular, being composed of four axial struts with morticed transverse cross-members, gripping several bronze bearings in cast iron housings. Two toothed cast iron interlocking crusher rolls sit within this frame, below a short plank-lined vertical chute from the floor above. The soffits of the frame have wrought iron loops, formerly attaching the boards to direct the falling pulp to the collecting bin below (not now present).

The eastern square drive shaft of wrought iron has had the wallower removed where it would have engaged with ring gear. The other end has a timber constructed belt drive wheel, partly projecting through a hole in the upper floor, with a central turned hub and shaped spokes. The shaft is supported by three bearings on wooden frames suspended from joists, with two flanking the belt wheel, the other above the ring gear.

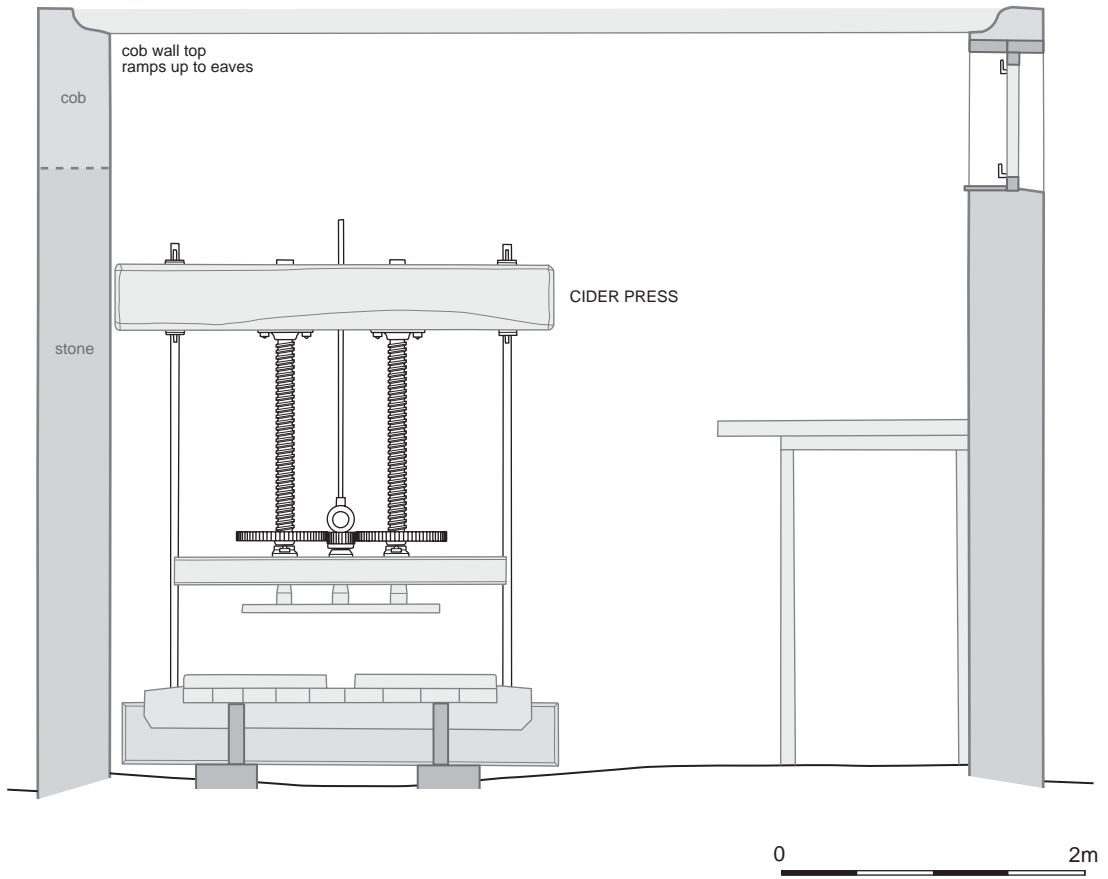
Fig. 9: Cider Barn, south-facing elevation of cider press.

The tall, twin-screw cider press is set against the west wall, rising into the upper floor level, with a rough access ramp on bracer timbers fixed between the head-beam and the western extremity of the first floor structure an short bracer timbers nailed to the top of the head-beam and set into the wall to the west.

A rectangular frame, formed with two large horizontal beams, is linked by square wrought iron posts which pass through holes in the beams. Slots in the posts take the tapered cotter-pins; these are located immediately above the bottom beam and both above and below the top beam. Large square washers fit between the cotter-pins and the timbers.

The bottom beam is supported on two transverse sleeper beams, which support the press deck via four short posts, set away from the beam with short spacers at their feet. Two axial joists are notched into the tops of these posts. The press deck is square, formed of thick transverse boards with a raised lip nailed to the upper surface around the edge. This projects forward in the middle at the front to form a narrow spout. A depression in the earth floor here would have housed a cut-down barrel to collect the juice.

The press board consists of five axial planks, nailed to three transverse joists which in turn are bolted to the soffit of a stout oak cross-beam which slides between the two vertical iron posts.

The screw mechanism consists of a pair of vertical wrought iron continuously threaded bolts with square-cut threads, which pass through the upper beam and work in threaded cast iron rings, bolted to its soffit. These bolts are fixed into globe-shaped housings in the upper face of the cross-beam. The base of each bolt has a cast iron gear wheel fitted to it, which mesh with a small-diameter cog set between them.

This cog is fitted to a slim vertical shaft of round section which sits in a bearing on the upper face of the cross-beam and passes up through the upper beam of the press frame. The upper end of this rod is square, presumably to be turned on occasion with a spanner. Just above the cog is fixed a cast iron globular barring point, with two large holes passing through it. A long bar could be set in this and the rod twisted, thus turning both of the twin screws simultaneously. This would result in the press deck applying even pressure onto the stacked pulp, interleaved with straw layers, known as the 'mock'.

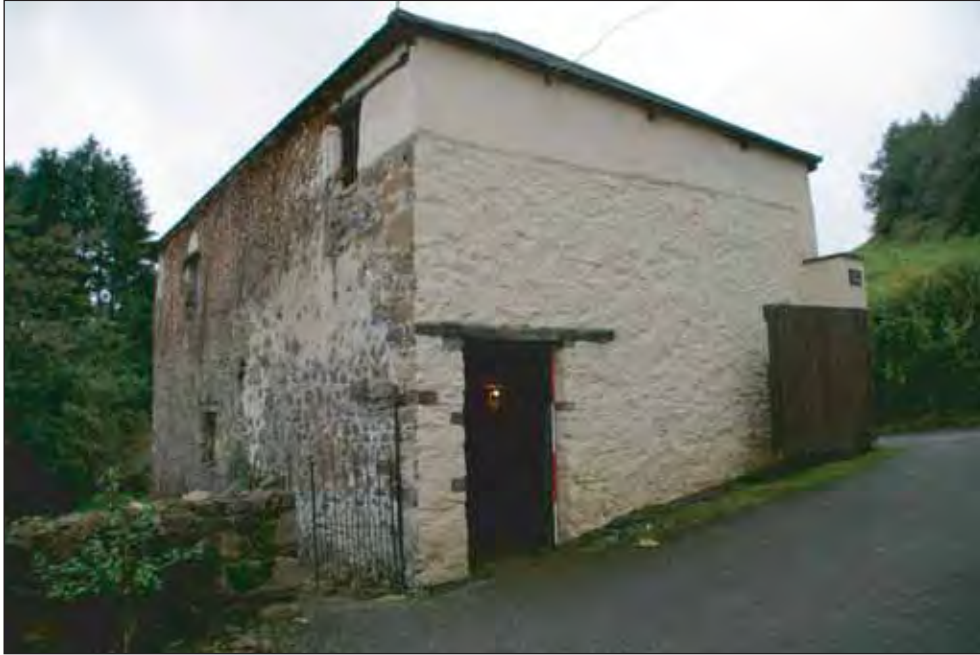
Plate 1. The Cider Barn viewed from the north east.

An apparently purpose-built rectangular structure of two storeys in mortared rubble with the final metre of walling in cob (plate 1). The rear wall partly incorporates an earlier cob wall with stone footings, which continue alongside the road to the east. The roof is of ridged slate with fully hipped ends on tiebeam & kingpost trusses (plate 2).

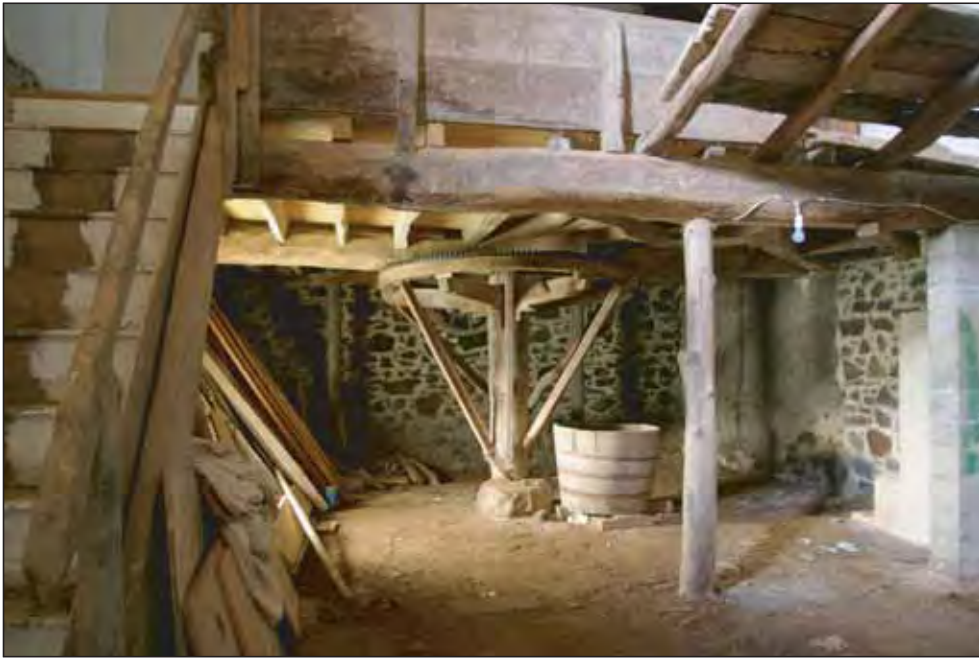
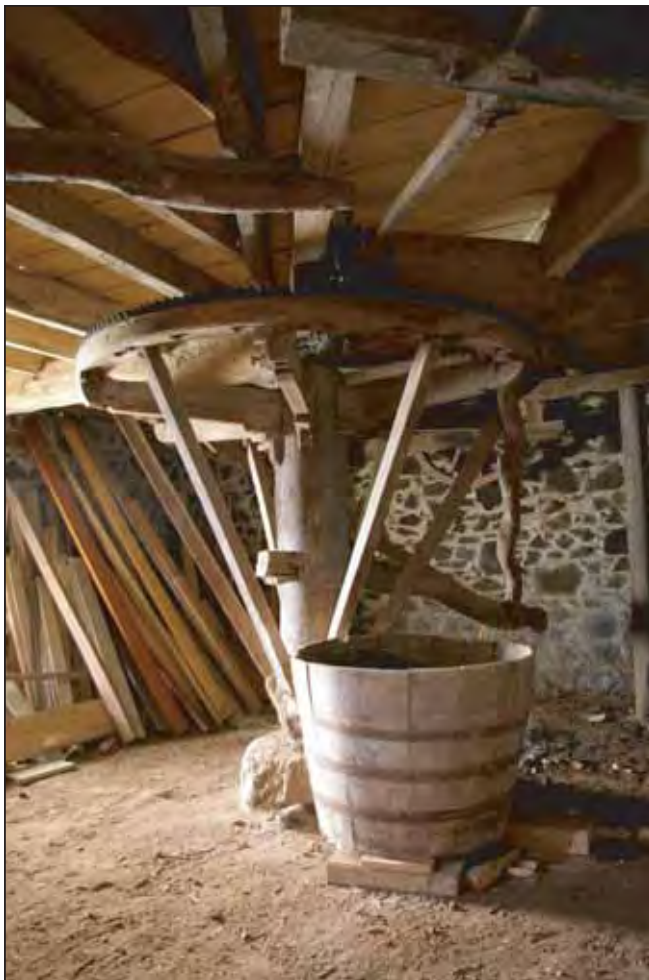
Located in the ground floor area at the eastern end, with a horse engine under the eastern of two beams, driving a horizontal shaft extending south-west to the roller-crusher fixed against the south end of the western beam. There is a second shaft to the east that drove a pulley against the east wall with the operating machinery on the first floor (no longer in existence). The horse engine, apple crusher and two shafts appear primary with building, although parts of the horse engine construction constitute later repairs.

Plate 3: The interior of the Cider Barn viewed from the north, after clearance of debris.

Plate 4. The interior of the Cider Barn viewed from the north west.

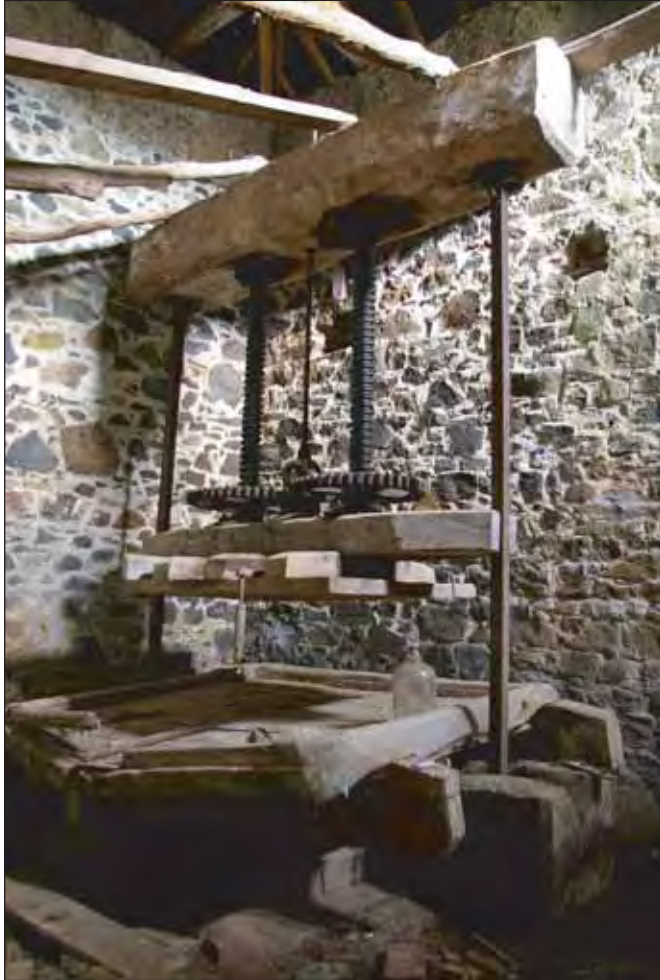
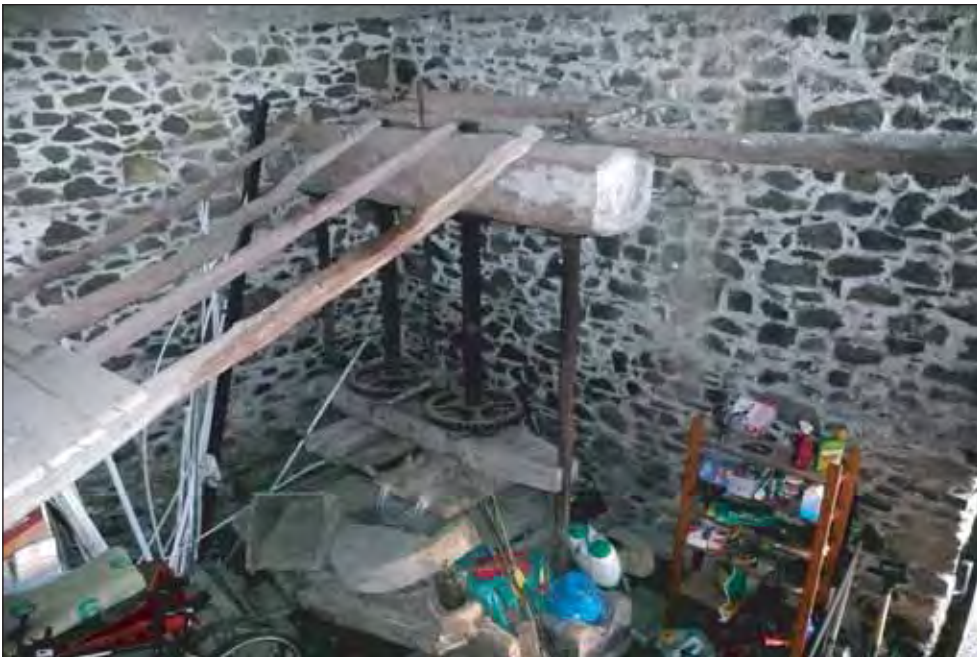
This appears to be a secondary press, possibly taller than the original. A horizontal timber near floor level against the south wall seems to have supported an earlier deck, while two pockets in the west wall appear to have contained short timber ties by which the top beam or timber uprights of an earlier press were attached to the wall. This method of fixing a press has been observed elsewhere in Devon. The angled timbers bracing the present press between the first floor structure and the end wall appear to be contemporary with it and not original.

Plate 5. The cider press viewed from the south east.

Plate 6. The cider press viewed from the first floor.
