**11 BELGRAVIA STREET  
PENZANCE  
CORNWALL**

Heritage Impact Assessment – Proposed Window Replacement

South West Archaeology Ltd. report no. 220131

## Results of a heritage assessment on proposed window replacements

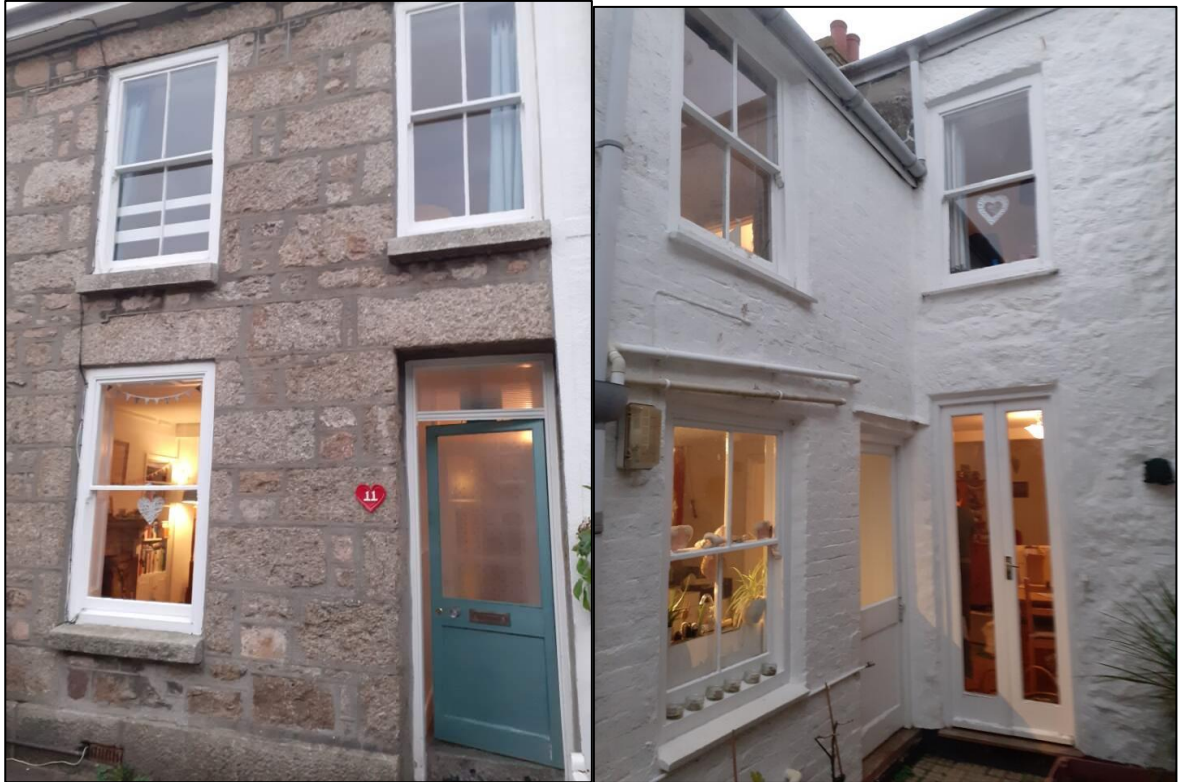
The proposals are to replace the wooden sash windows of the property with UPVC double-glazed sash windows on the front of the property and standard double glazed casement windows at the rear of the property. There are three windows at the front and three windows at the rear.

FIGURE 4 (LEFT): THE WINDOWS AT THE FRONT OF THE PROPERTY.

FIGURE 5 (RIGHT): THE WINDOWS AT THE REAR OF THE PROPERTY.

The windows to the front of the No.11 facing into the street, need to be replaced in a style as was once intended for the wider planned development, and should retain the two-over-two sash style windows. Any changes to the rear windows of No.11 will have no effect upon the wider conservation area and are not of major concern in terms of their impact.
