THE DELL/HAPPY VALLEY AND SURROUNDING PARKLAND SALTRAM DEVON

Archaeological and Historic Landscape Survey

South West Archaeology Ltd. report no. 210317

By F. Balmond, MCifA
Report Version: FINAL
Draft Issued: 17th March 2021
Report Finalised: 28th April 2021

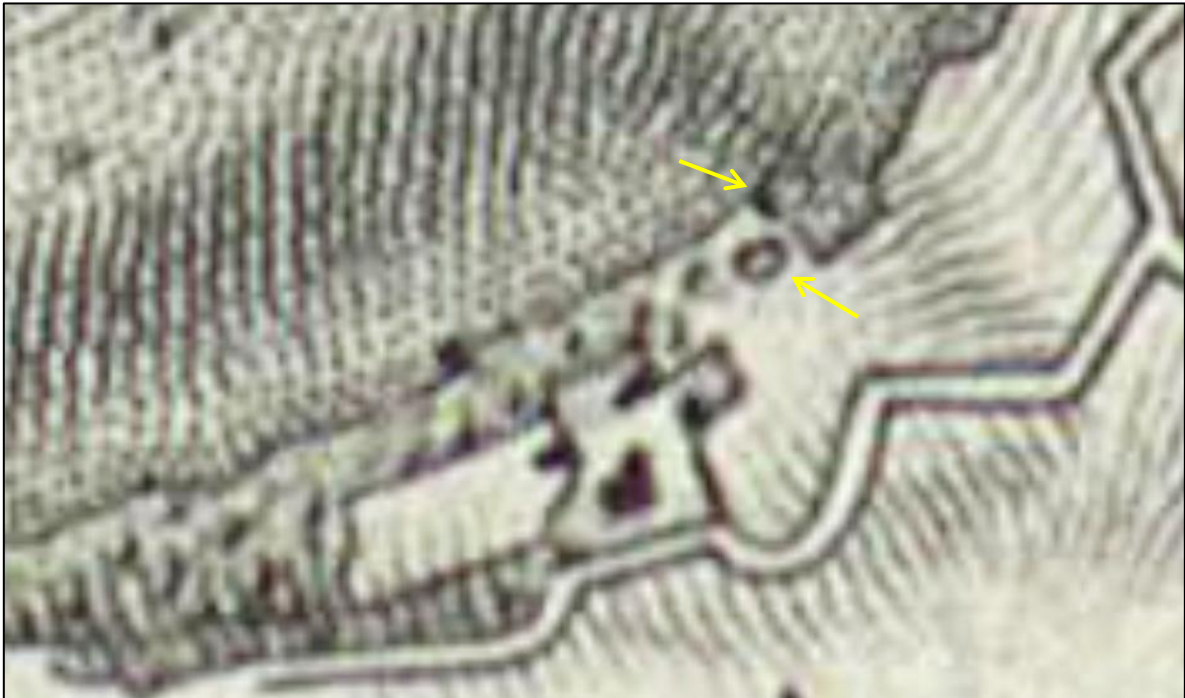
A revised published version of the 1809 Ordnance Survey map shown below (Figure 10) does appear to be less heavily shaded and also suggests the presence of features in the positions indicated above.

FIGURE 10: PUBLISHED VERSION OF THE 1809 ORDNANCE SURVEY MAP, PUBLISHED C.1830 (SUPPLIED BY NICHOLAS PEARSON ASSOCIATES). TWO POSSIBLE FEATURES WITHIN THE DELL ARE INDICATED.

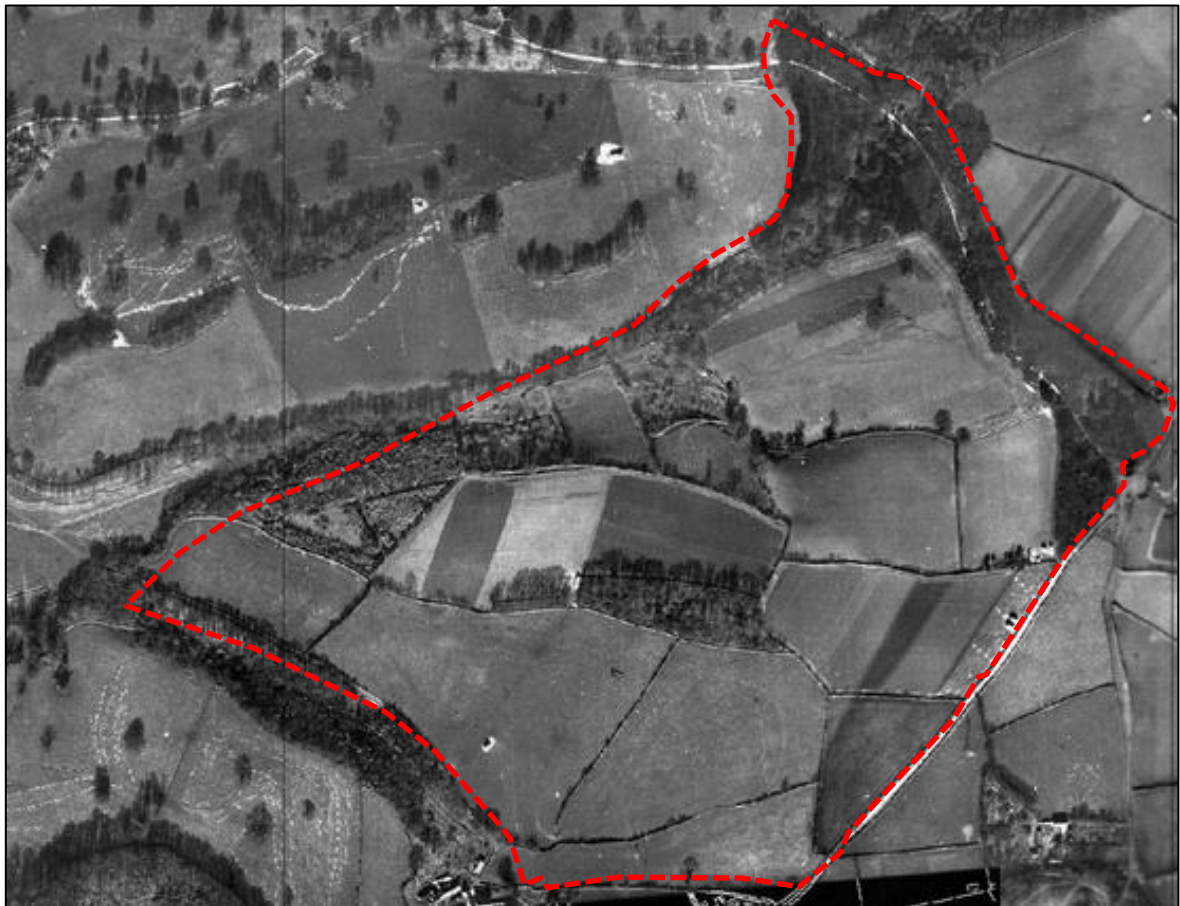
camp was apparently used to accommodate Italian POWs at the end of the war (Teasdale 2017 3:23). Aerial photographs from c.1946 (Figure 18) show some details of the survey area in the immediate post war period. Although the tree cover makes it difficult to determine features with certainty, small areas of white suggest recent possible ground disturbance in places within the woodland of The Dell and to the north of the South Drive. Two short linear features are just visible to the west of Barn Park Clump although it is unclear whether these are related to military or agricultural uses. A possible structure is shown close to the boundary line with South Drive in Barn Park and further possible buildings or structures are evident close to the southern boundary of Barn Park with New Park and along the eastern boundary of New Park; the function of these structures is difficult to discern but could either be military or agricultural. Another possible structure is evident in Great Down, close to Wixenford and a further possible building or structure is evident between the Wixenford Brake Plantations.

A pathway through the triangular part of Sellar Acres Plantation to a gateway into Sellar Acres appears to have been created between 1933 and 1946. At Bickham, lynchets or terraces are visible in the southern half of Lower Meadow. The farmhouse appears to have been almost totally removed by this date, although the its location can just be determined; the wall enclosing its garden or yard can still be seen along with the small square structure in the north western corner. Bickham Barn appears to be roofed in the 1946 aerial photograph.

FIGURE 18: c.1946 AERIAL PHOTOGRAPH SHOWING THE SURVEY AREA INDICATED IN RED (NT).

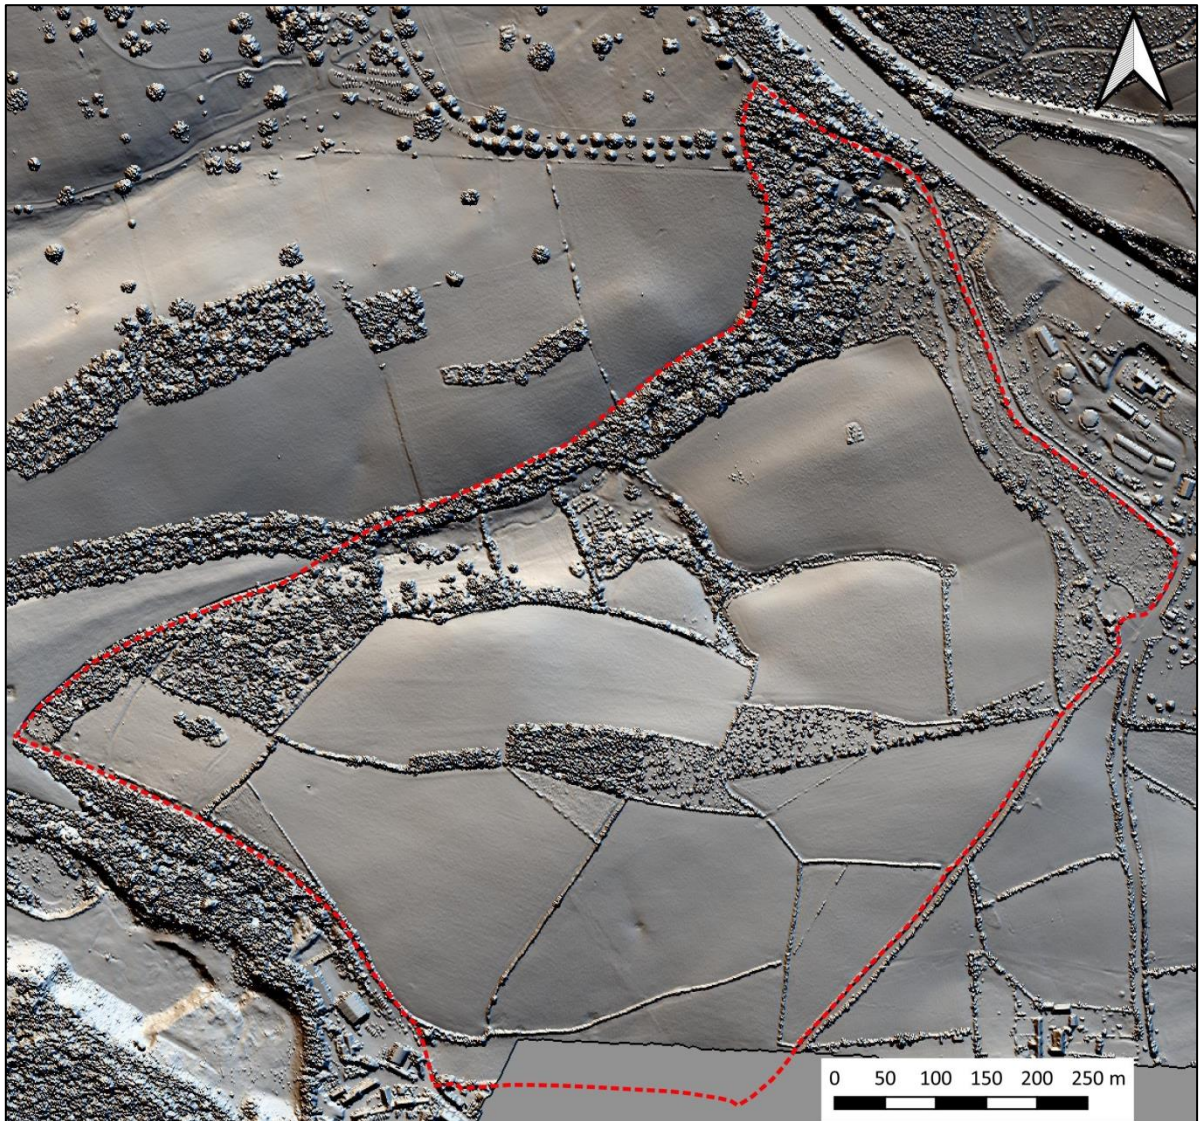
Figure 23 shows LiDAR data of the survey area from 2018 with the vegetation cover apparent. Figure 24 shows data from 2010 to provide full coverage of the survey area with the vegetation cover digitally 'removed'.

FIGURE 23: 2018 1M DSM LIDAR DATA PROCESSED WITH RVT 2.2.1 MULTIHILLSHADE D32_H35_Z2 AND QGIS 3.14. © ENVIRONMENT AGENCY COPYRIGHT AND/OR DATABASE RIGHT 2015. ALL RIGHTS RESERVED.

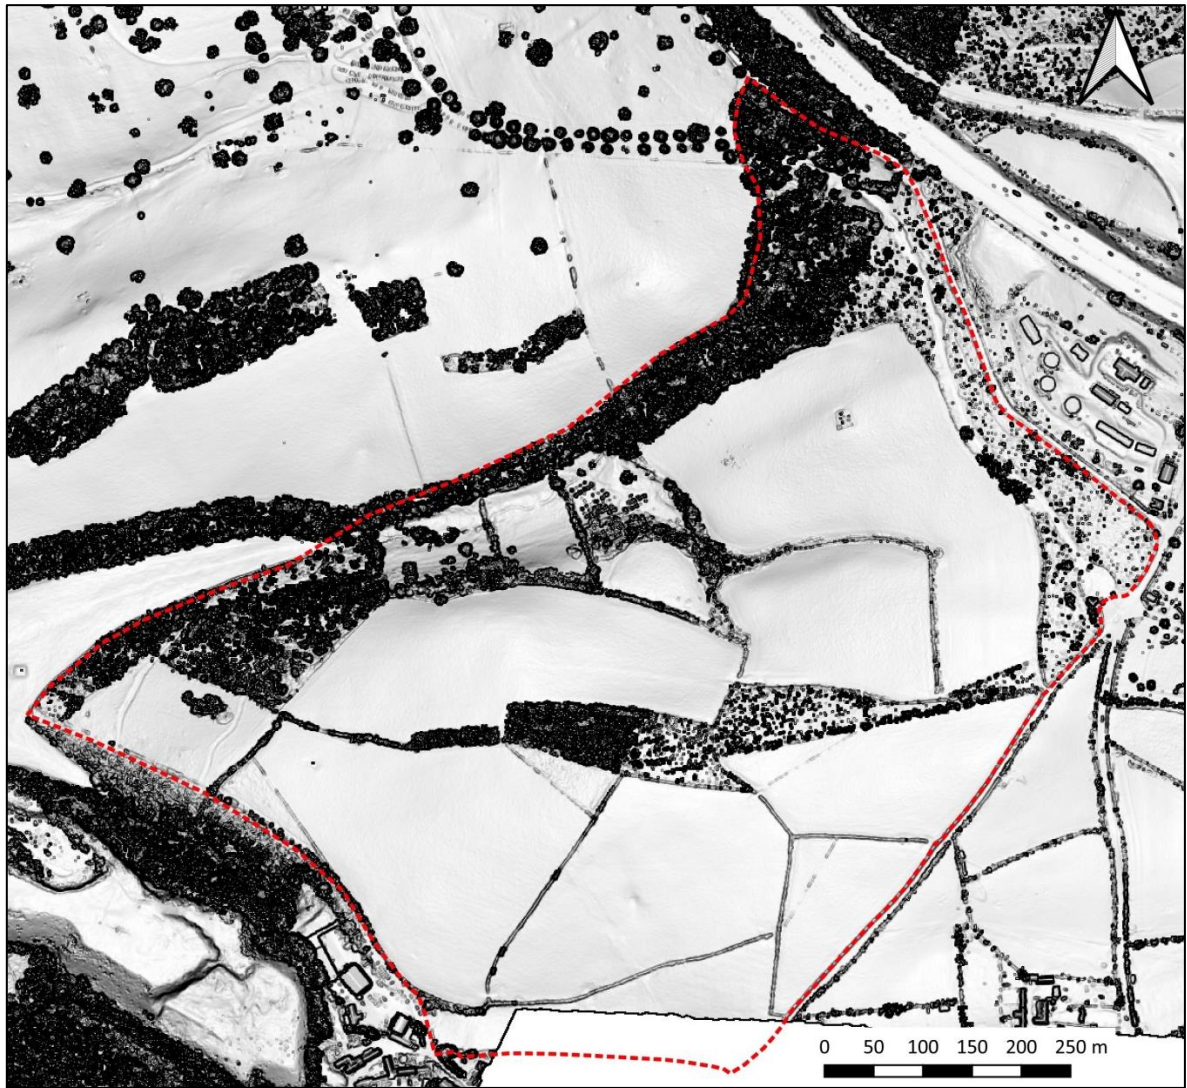
Figure 25 shows LiDAR data of the survey area from 2018 with the vegetation cover apparent. Figure 26 shows data from 2010 to provide full coverage of the survey area with the vegetation cover digitally 'removed'

FIGURE 25: 2018 1M DSM LIDAR DATA PROCESSED WITH QGIS 3.14 SLOPE Z1. © ENVIRONMENT AGENCY COPYRIGHT AND/OR DATABASE RIGHT 2015. ALL RIGHTS RESERVED.

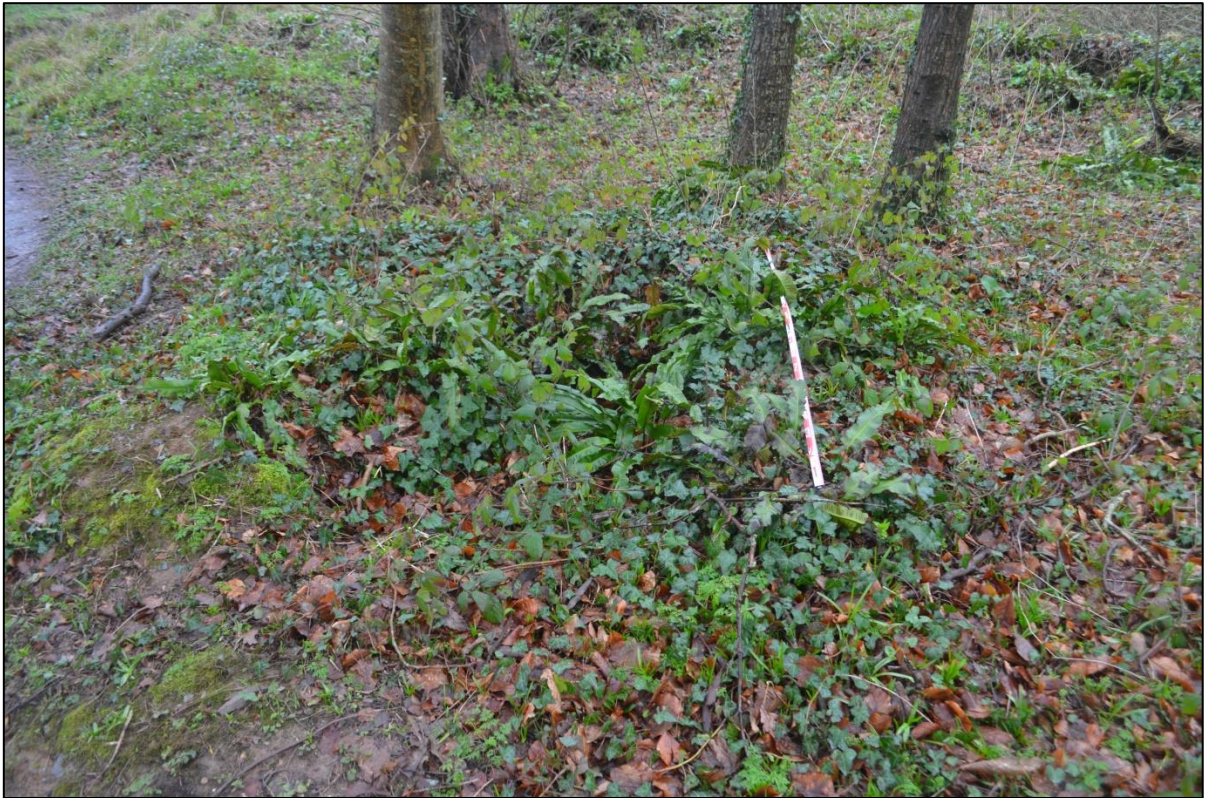
A square earth bank feature c.2m x 2m x 0.5m deep is located just to the north of the narrow footpath that enters The Dell from the local access road which bounds The Dell on its north eastern side. It may have a possible entrance on its southern side although this may be caused by erosion of the bank. This feature may relate to military use of the estate during World War Two.

FIGURE 28: SQUARE FEATURE ALONGSIDE FOOTPATH IN NORTH EASTERN CORNER OF THE DELL; FROM THE SOUTH

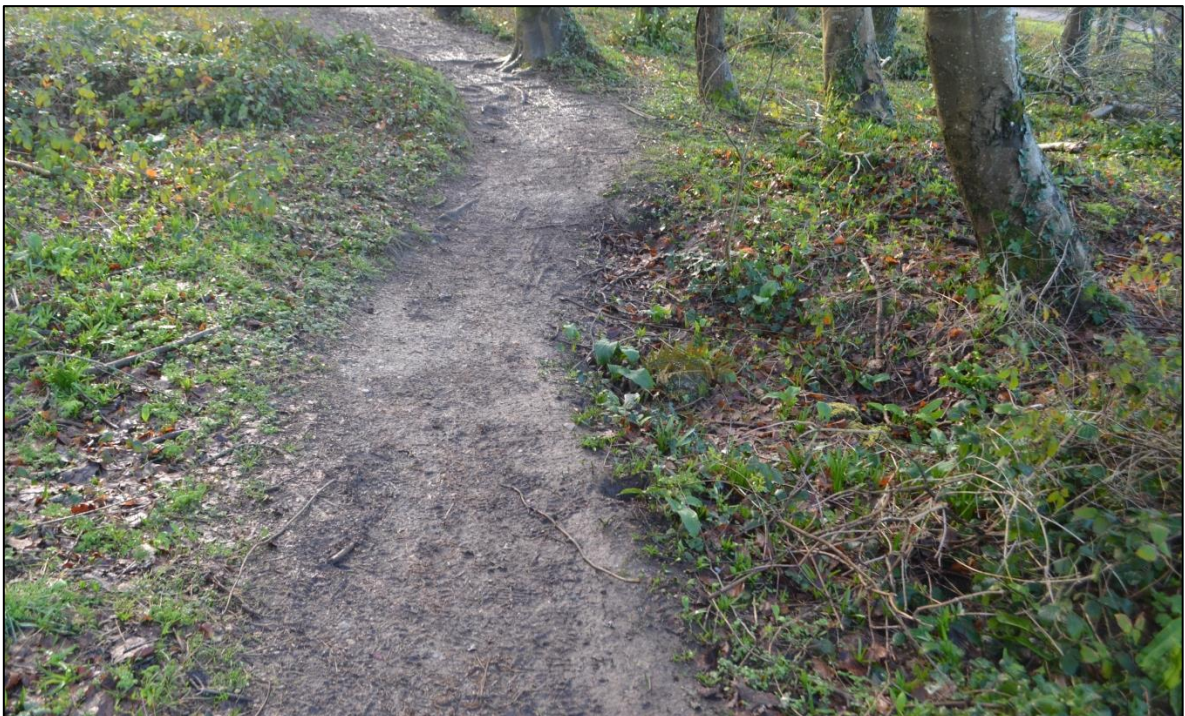
An approximately rectangular feature c. 2m x 1m appears to be partially cut by the narrow footpath that enters The Dell from the local access road which bounds The Dell on its north eastern side. A piece of concrete was observed on one side of this feature. This feature could relate to military use of the estate during World War Two.

FIGURE 29: SLIGHT RECTANGULAR FEATURE CUT BY PATH VISIBLE ON THE RIGHT HAND SIDE OF THE IMAGE; FROM THE NORTH WEST.

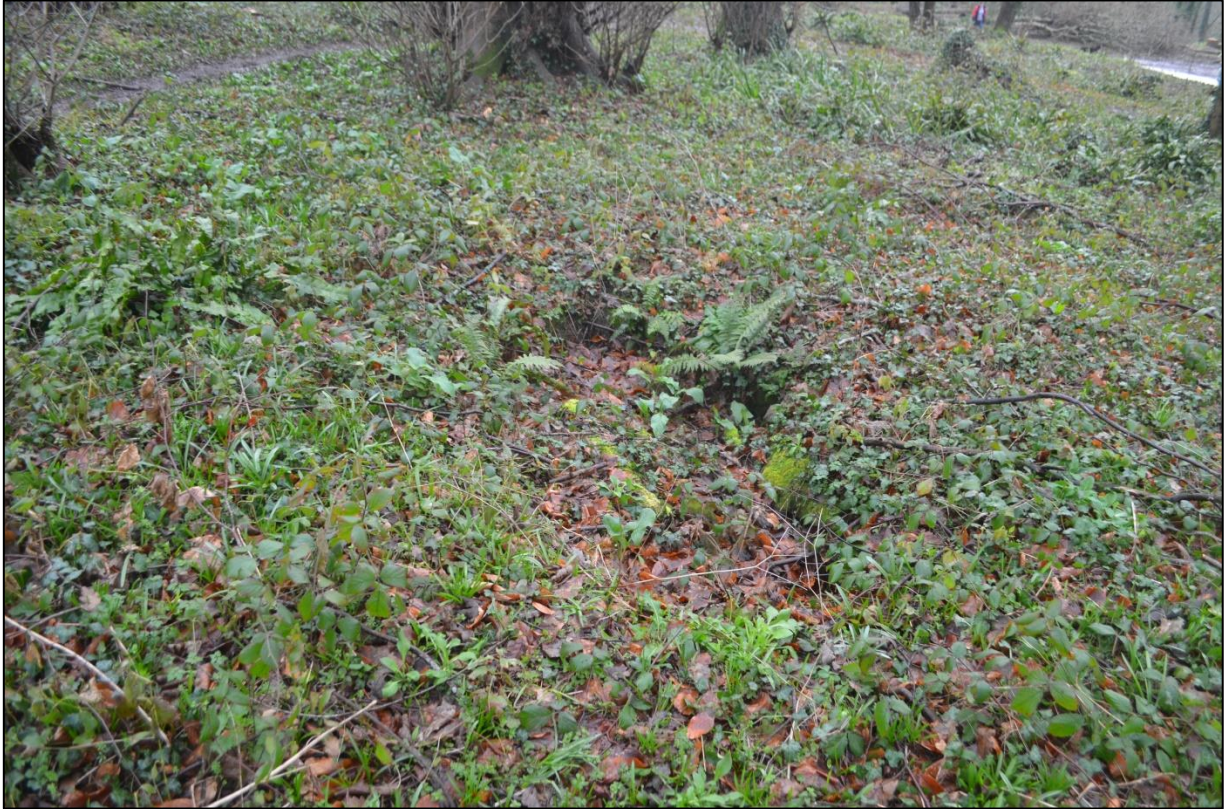
SX 5259 5539

A rectangular cut feature c. 1.5m x 1m is located close to the northern edge of The Dell near the narrow footpath that enters The Dell from the local access road which bounds The Dell on its north eastern side. This feature could relate to military use of the estate during World War Two.

FIGURE 30: SLIGHT RECTANGULAR FEATURE CUT NEAR FOOTPATH, VIEWED FROM THE WEST.

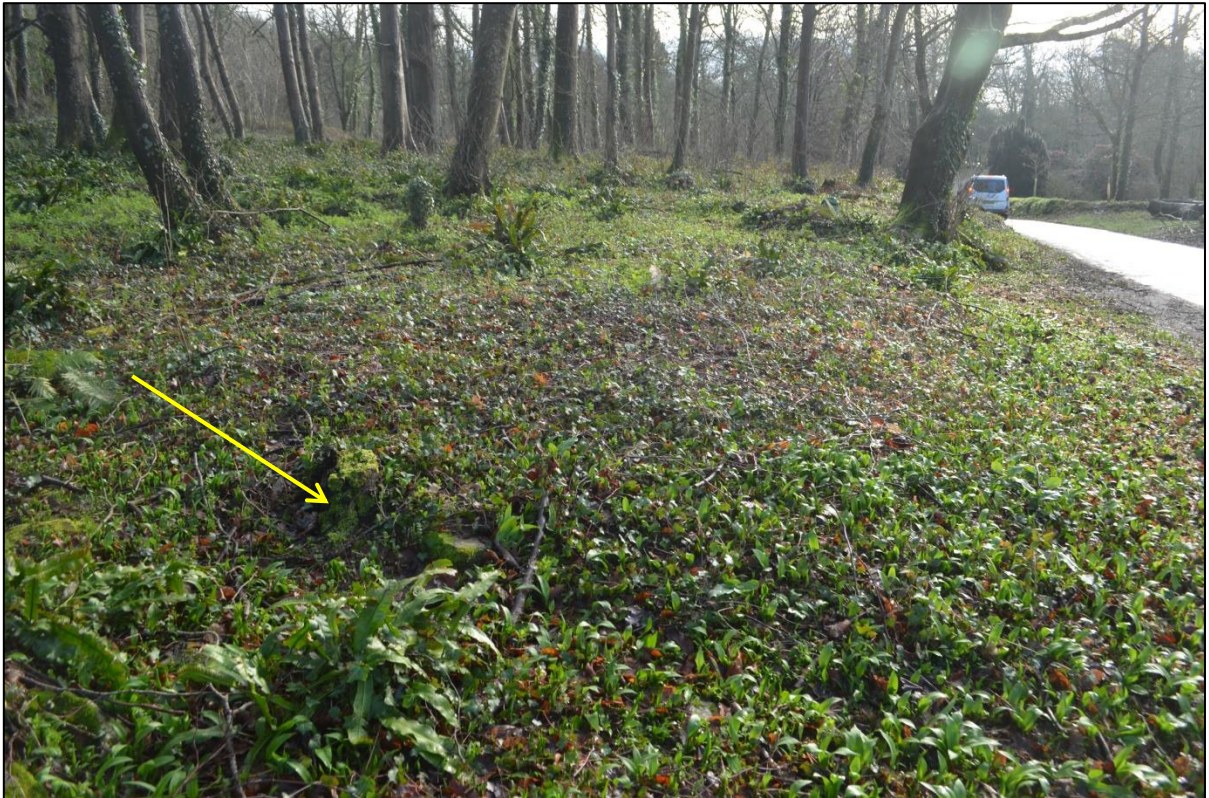
A possible rectilinear feature c.7m x 3m is located on the north side of the South Drive opposite a footpath into The Dell. The feature is approximately rectangular in shape with no obvious built form discernible however brick, stone and lumps of concrete were observed on its surface. The vegetation cover of this area meant that no further features could be determined. It could be created as a result of widening of the driveway or possibly creating a lay-by (although this area is not presently a lay-by) and material may have been dumped in this area. This feature could relate to military use of the estate during World War Two.

FIGURE 31: SLIGHT RECTILINEAR SHAPED FEATURE ALONGSIDE THE SOUTH DRIVE. THE ARROW INDICATES AN AREA OF BRICK AND CONCRETE.

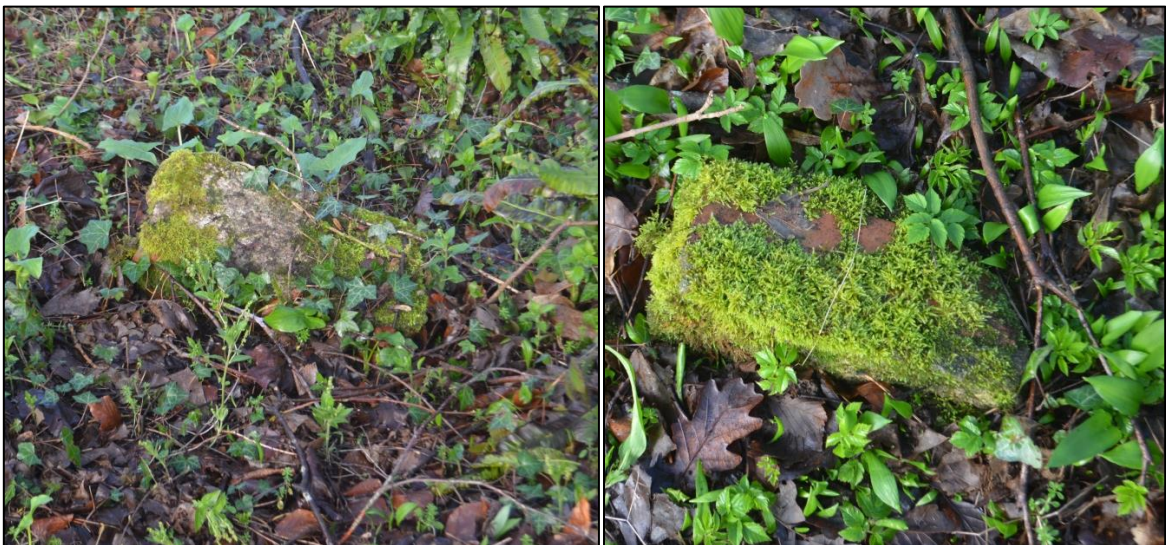
A second approximately square feature c.2m x 2m is located adjacent to the feature discussed above on the north side of the South Drive opposite a footpath into The Dell. The feature has no obvious built form discernible however blocks of concrete and brick were observed on its surface. The vegetation cover of this area meant that no further features could be determined. It could be created as a result of widening of the driveway or possibly creating a lay-by (although this area is not presently a lay-by) and material may have been dumped in this area. This feature could relate to military use of the estate during World War Two.

FIGURE 32: BLOCKS OF CONCRETE AND BRICK WERE OBSERVED AMONG THE VEGETATION ON THE SURFACE OF THE TWO POSSIBLE FEATURES OPPOSITE THE PATH INTO THE DELL.

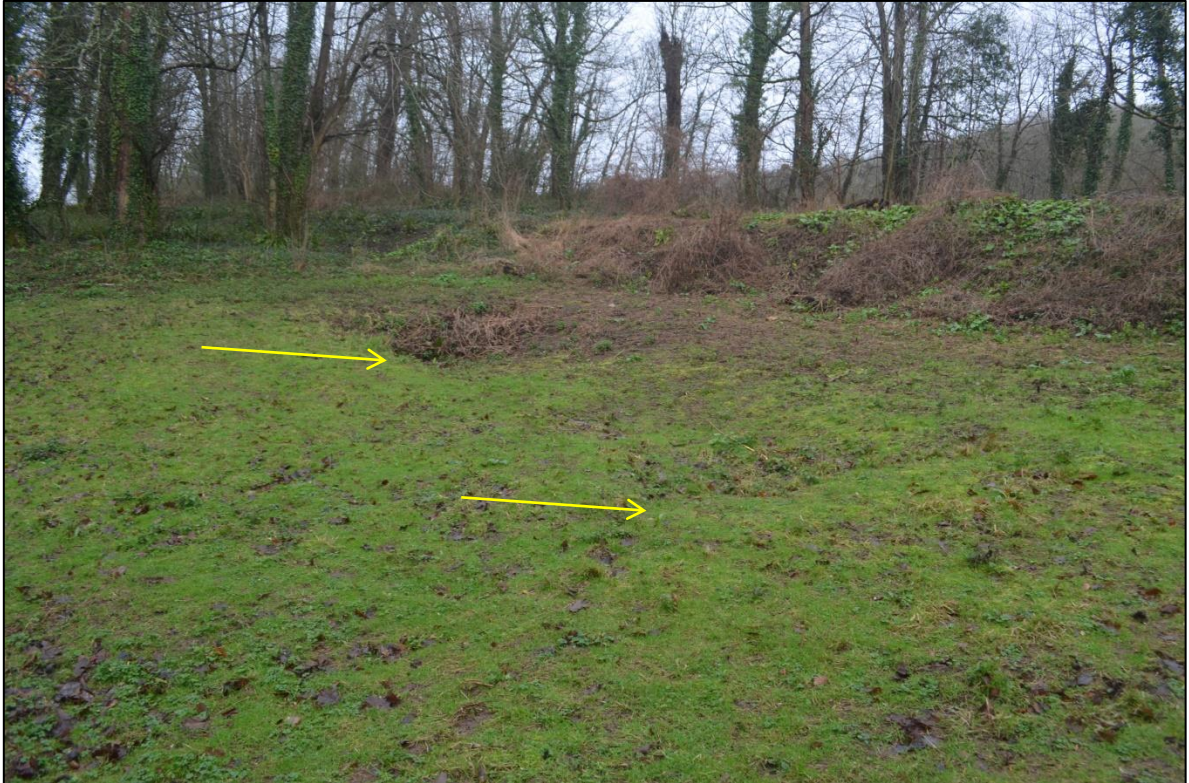
Two rectangular features were observed cut into the slope to the north of the south drive. Features can just be distinguished on LiDAR Imagery in this area. The western rectangular cut feature measures c.3m x2m x0.5m deep at the north eastern end while the eastern feature measures c.3m x 2m x 0.2m. These features could relate to military use of the estate during World War Two.

FIGURE 33: TWO RECTANGULAR CUT PLATFORMS TO THE NORTH OF THE SOUTH DRIVE. INDICATED BY ARROWS. FROM THE EAST

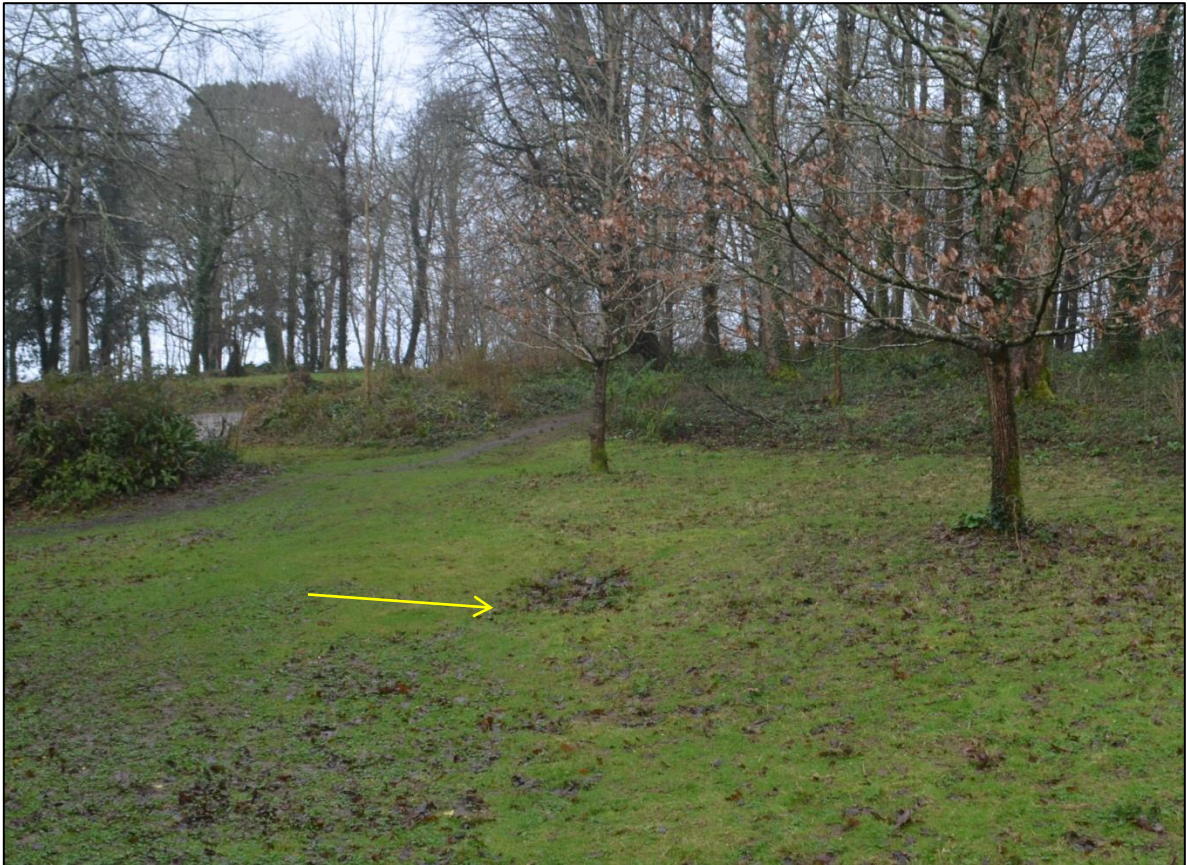
A further rectangular feature was observed cut into the slope to the north of the south drive, to the south of the features recorded above. The feature measures c.2m x1m x0.2m deep at the north eastern end. This feature could relate to military use of the estate during World War Two.

FIGURE 34: POSSIBLE RECTANGULAR CUT PLATFORM TO THE NORTH OF THE SOUTH DRIVE. INDICATED BY ARROW. FROM THE EAST

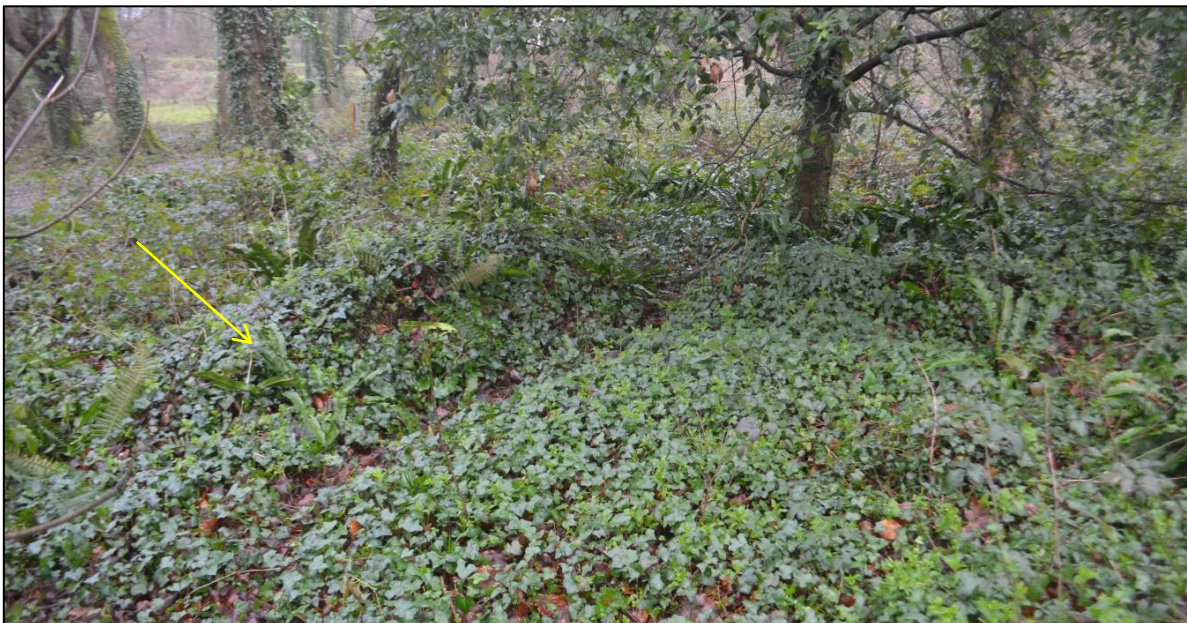
SX 5274 5525

A low section of bank c. 2m x 0.5m x 0.5m high was identified with a slight hollow to its east. This feature lies in an area of felled trees and other dense vegetation so identification on any further features was not possible.

FIGURE 35: SHORT SECTION OF EARTH BANK WITH SLIGHT HOLLOW TO THE EAST. THE FEATURE WHICH APPEARS TO BE A RETURN OF THE BANK AT A RIGHT ANGLE ON THE RIGHT HAND SIDE OF THE IMAGE IS AN IVY COVERED FALLEN TREE; FROM THE NORTH EAST.

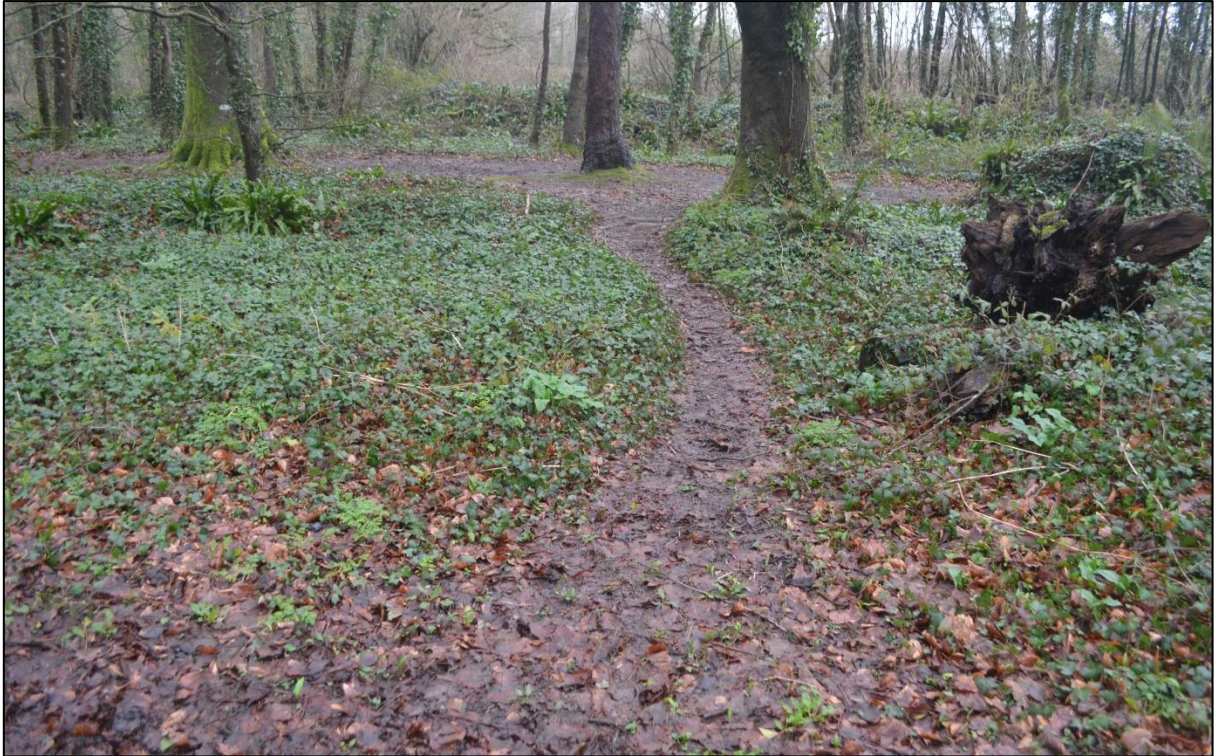
9. Two possible platform areas cut into slope to the north of South Drive

Two platform like areas are located either side of a path from the woodland onto the South Drive. They appear to be cut into slope and have a short area of bank above but may be one feature cut into two by the narrow pathway through. The western area measures c.3-4m x 3-4m x 0.5m while the eastern area is c.3m x 2m x 0.5m. They are covered with ivy and other vegetation.

FIGURE 36: TWO PLATFORM LIKE AREAS TO THE NORTH OF THE SOUTH DIVE, BISECTED BY A PATH. FROM THE SOUTH

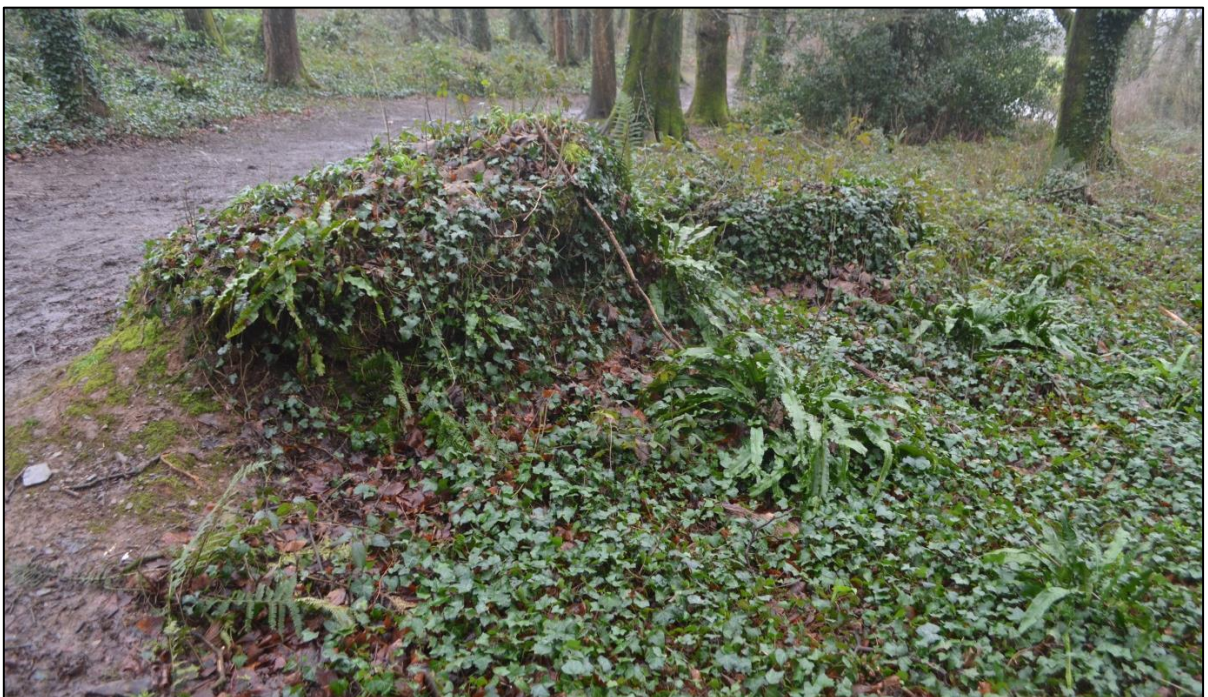
FIGURE 37: A SHORT SECTION OF BANK AT THE POINT AT WHICH THE PATH TOWARDS THE SOUTH DRIVE CUTS DOWN TO THE SOUTH FROM THE PATH THROUGH THE WOODLAND.

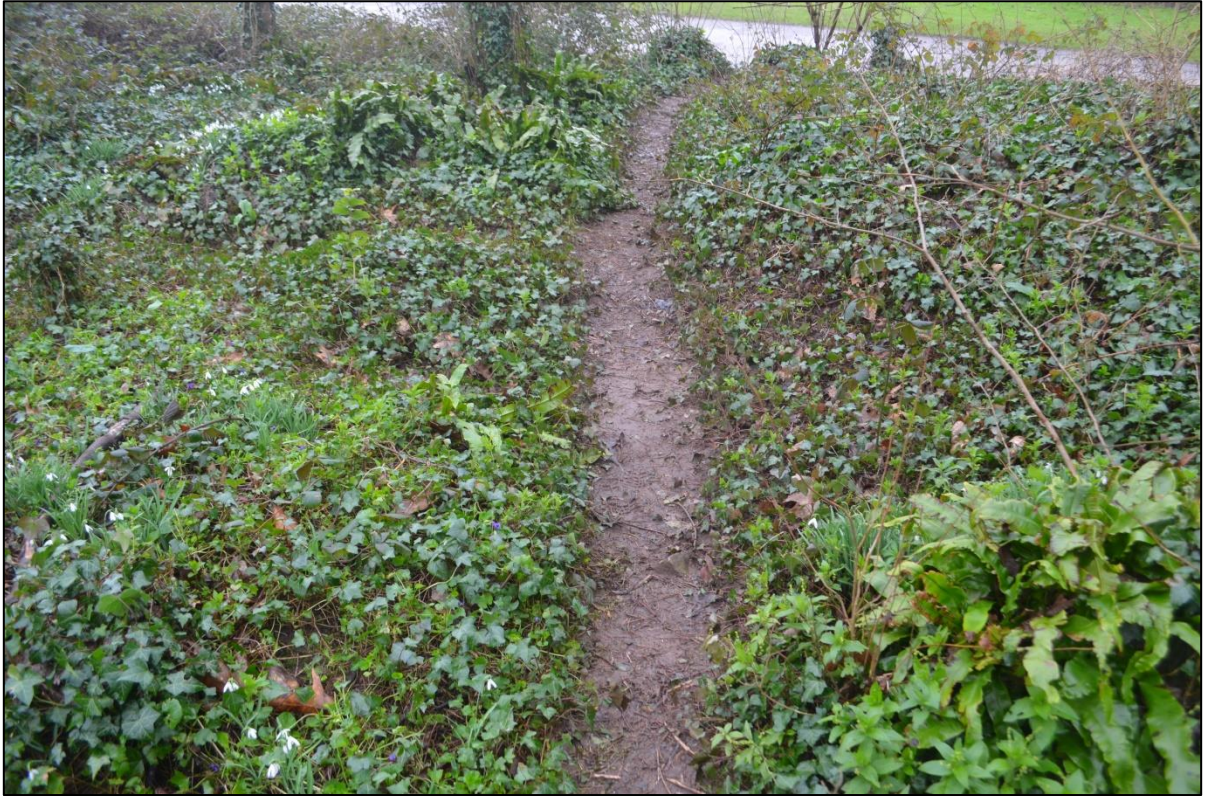
10. Slight rectilinear depression cut through by path

An approximately rectangular shaped slight depression oriented north-south is cut through by a path running east west to join the road at South Drive. The depression is c. 3m x 1.5m and the path clearly drops down into it and back upwards on the other side.

FIGURE 38: SLIGHT RECTILINEAR DEPRESSION BISECTED BY PATHWAY; FROM THE NORTH WEST

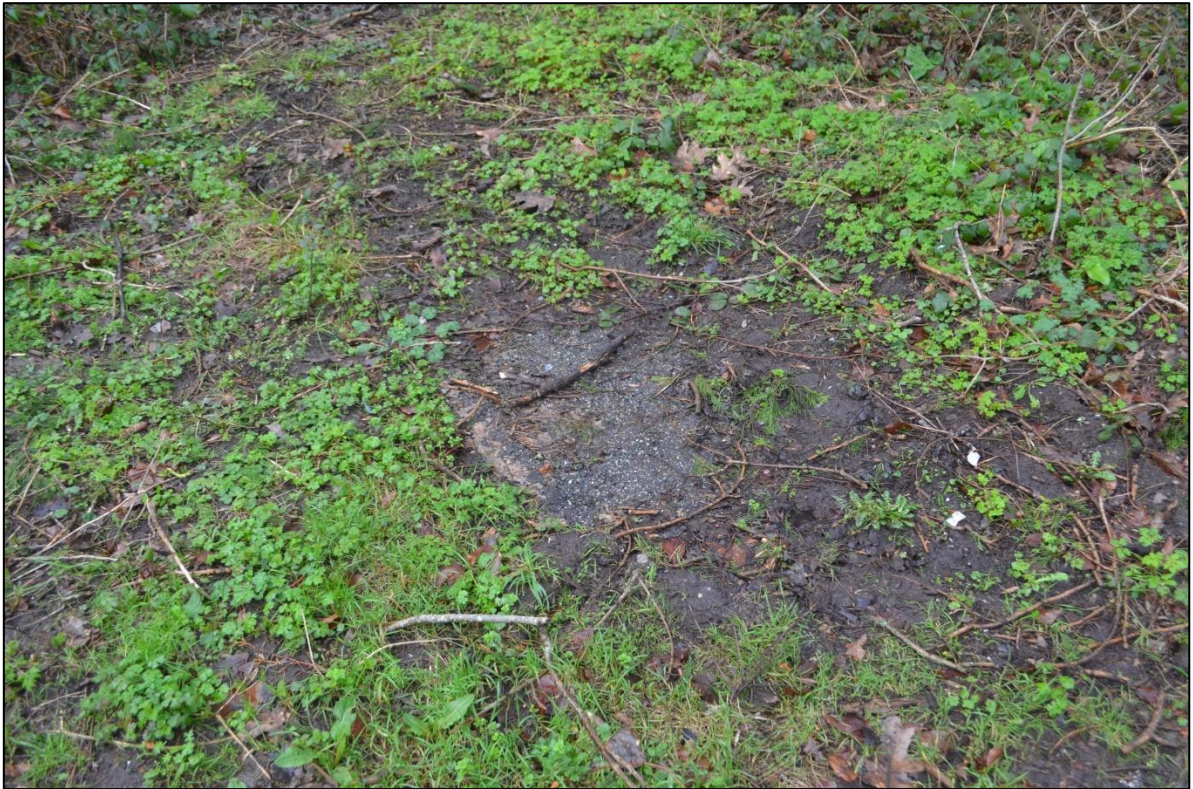
11. Short section of concrete road and concrete platform

A short section of tarmac covered concrete road terminating in a concrete platform is located just to the north north west of Stag Lodge. The road is now entirely covered with vegetation. The platform appears to have previously had a brick structure built on it as a small number of red bricks are still visible set into the edges of the platform. The platform measures c. 3m x 5m. Teasdale (2017) notes that pig houses were previously located to the west of Stag Lodge but does not state where exactly or at what date. This feature lies almost north of Stag Lodge, with access of South Drive so while it could have been pig houses it may also relate to military use of the estate during World War Two.

FIGURE 39: TARMAC COVERED CONCRETE ROADWAY NOW ALMOST ENTIRELY COVERED WITH VEGETATION, LEADING OFF SOUTH DRIVE; FROM THE NORTH.

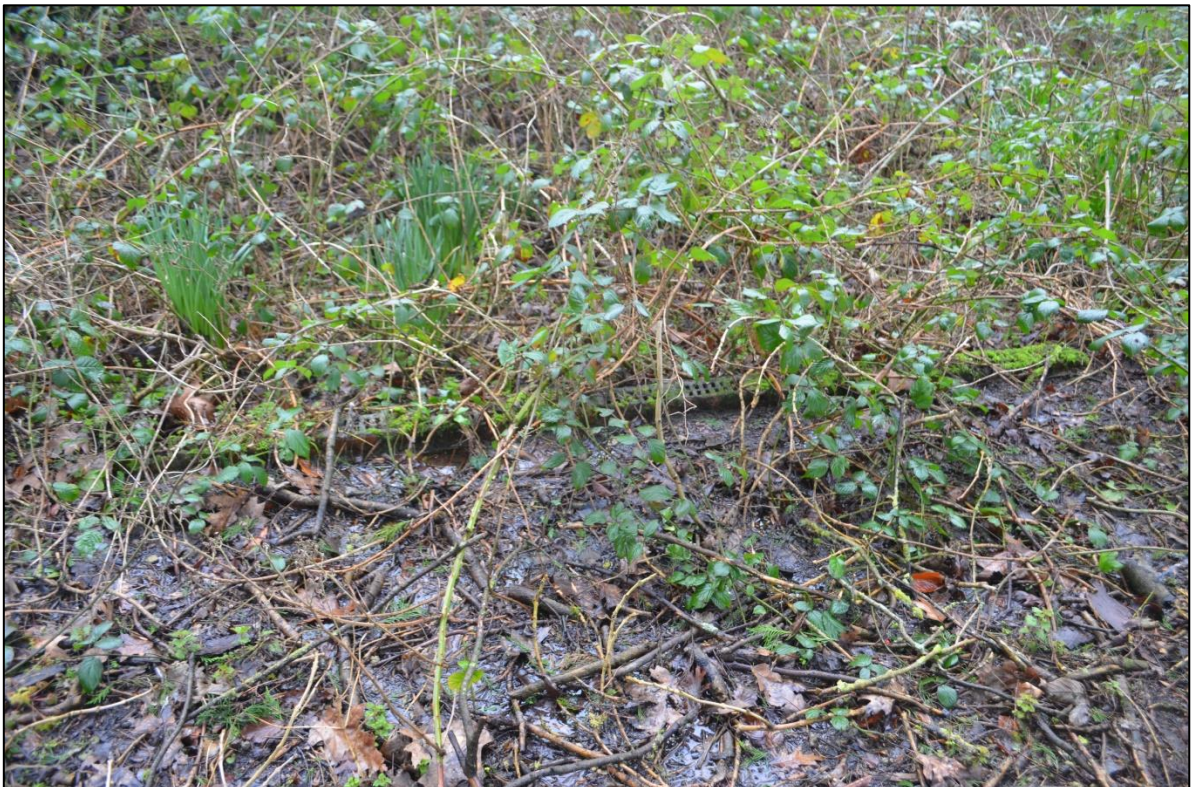
FIGURE 40: CONCRETE PLATFORM WITH 1 BRICK HIGH SURVIVING EDGING IN SOME AREAS; FROM THE EAST

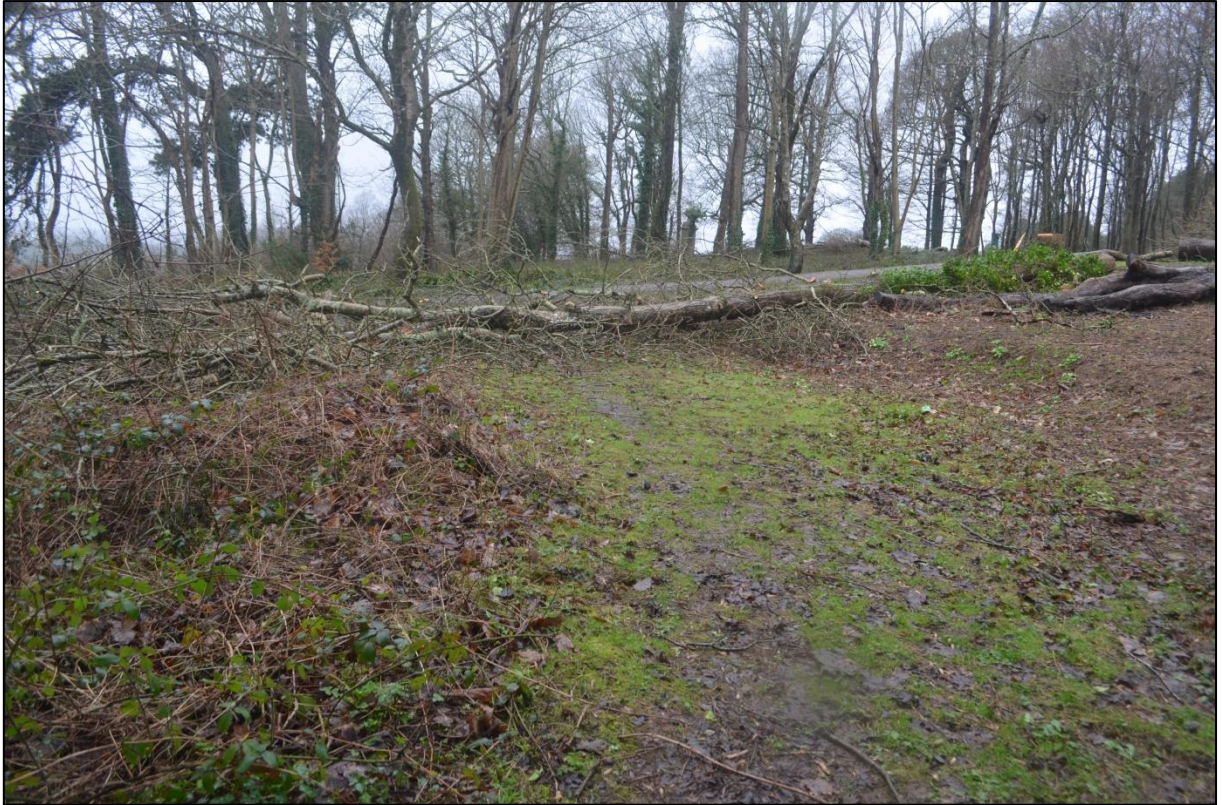
A curved flat platform area c. 6m in diameter appears to have been cut into the slope close to the north western side of The Dell. It is partially covered in fallen/cut timber. This feature is reminiscent of charcoal burning platforms however it is located close to what appears to be a pathway used to access The Dell and may be a more recent feature, possibly associated with woodland/estate management.

FIGURE 41: POSSIBLE CURVED PLATFORM WITH FELLED TIMBER ON EASTERN END; FROM THE SOUTH WEST.

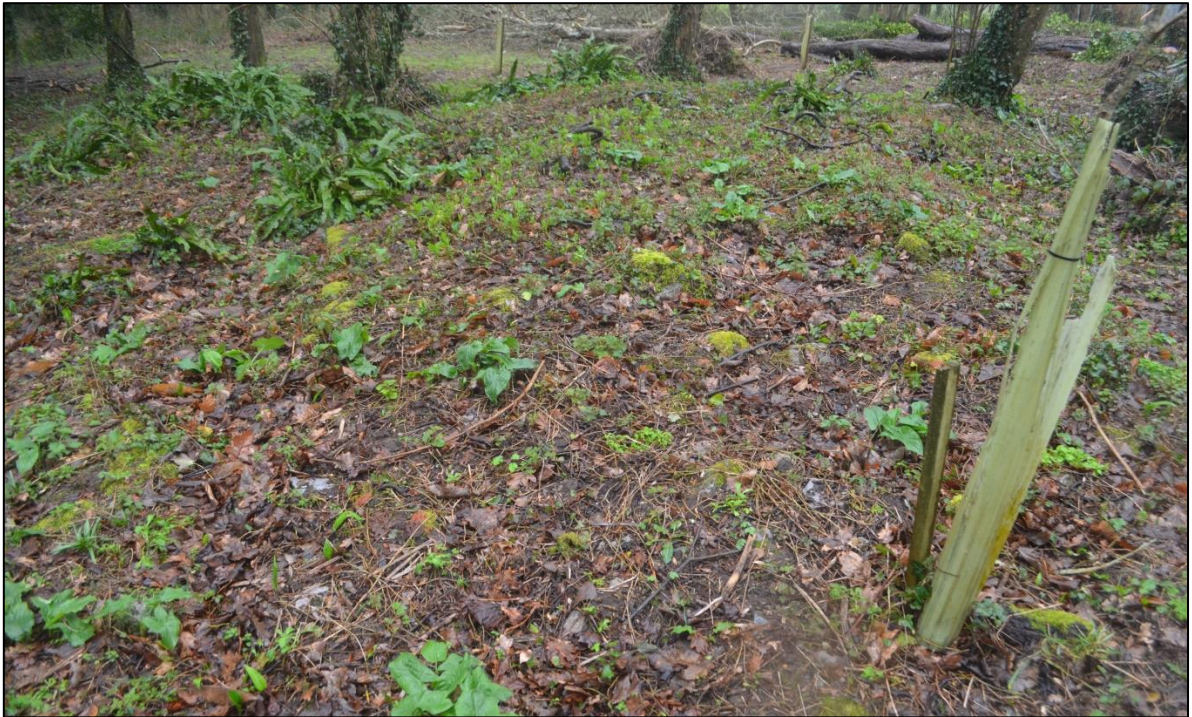
SX 5262 5532

An approximately rectangular area at the between the South Drive and two pathways into The Dell appears to be covered with a rough spread of stone and occasional brick. There appears to be no built form but this could be a dump of material.

FIGURE 42: APPROXIMATELY RECTANGULAR AREA OF STONE WITH OCCASIONAL BRICK; FROM THE NORTH

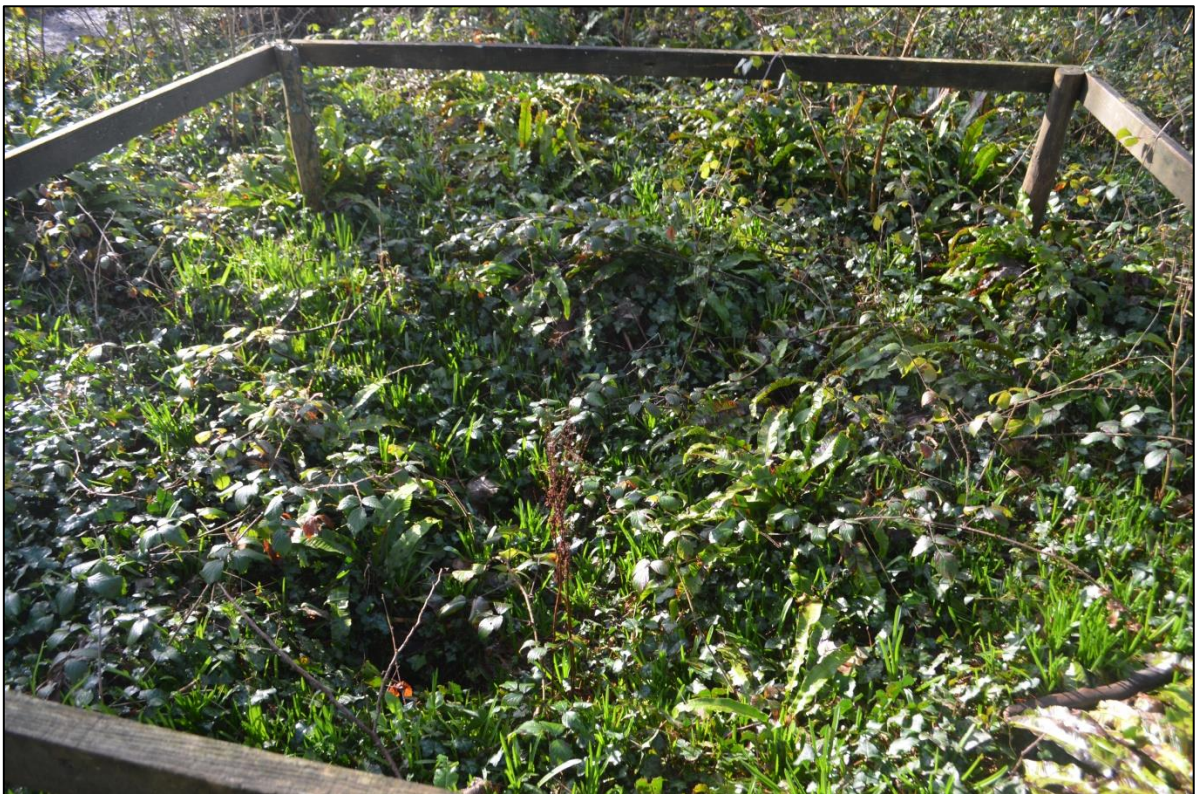
14. Fenced off cut feature in The Dell

An approximately 1.5m square cut feature c.0.2m deep located along the western boundary of The Dell. It has been fenced off with a modern timber post and rail fence. There is possible animal burrowing activity in the north east corner of the feature.

FIGURE 43: FENCED OFF CUT FEATURE CLOSE TO THE WESTERN BOUNDARY OF THE DELL; FROM THE NORTH.

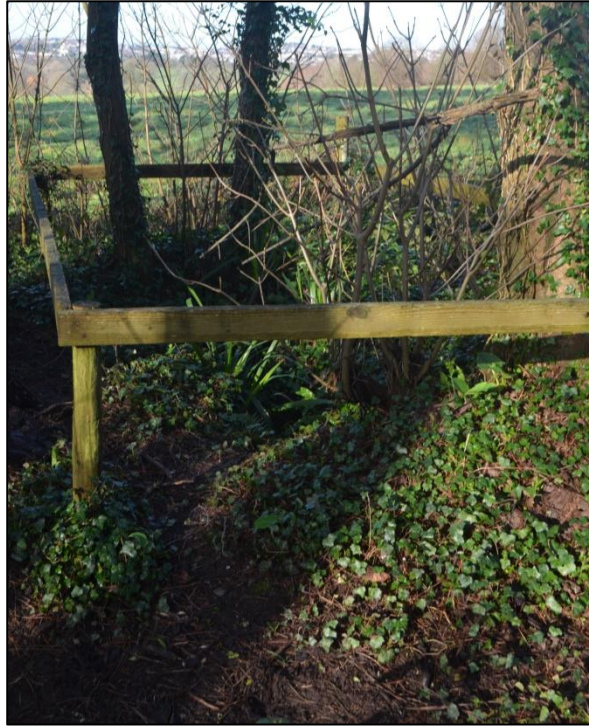
15. Fenced off cut feature in The Dell

A rectangular cut feature c.2.5m x 0.7m x c.0.5m deep located along the western boundary of The Dell. It has been fenced off with a modern timber post and rail fence. These fenced off features may relate to military use of the estate during World War Two and may be the 'foxholes or dug-outs' referred to by Teasdale (2017).

FIGURE 44: FENCED OFF CUT FEATURE ALONG WESTERN BOUNDARY OF THE DELL; FROM THE EAST
