THE DELL/HAPPY VALLEY AND SURROUNDING PARKLAND SALTRAM DEVON

Archaeological and Historic Landscape Survey

South West Archaeology Ltd. report no. 210317

By F. Balmond, MCifA
Report Version: FINAL
Draft Issued: 17th March 2021
Report Finalised: 28th April 2021

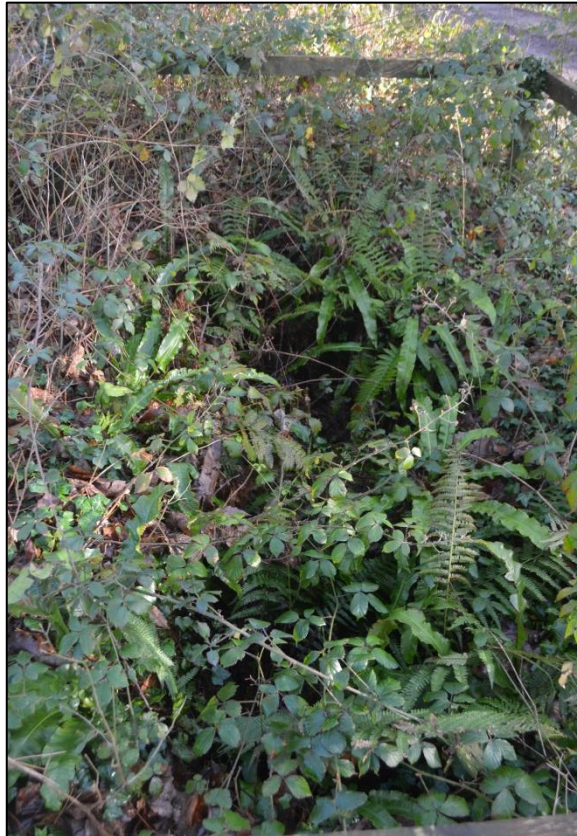
16. Fenced off cut feature in The Dell

A rectangular cut feature c.5m x 2m is located to the west of the main path through The Dell. It has been fenced off with a modern timber post and rail fence. It is covered with dense vegetation, mainly brambles which prohibit a clear view of the feature however it appears deeper at its south eastern end. These fenced off features may relate to military use of the estate during World War Two and may be the 'foxholes or dug-outs' referred to by Teasdale (2017).

FIGURE 45: FENCED OFF CUT FEATURE TO THE WEST OF THE MAIN PATH THROUGH THE DELL; FROM THE SOUTH

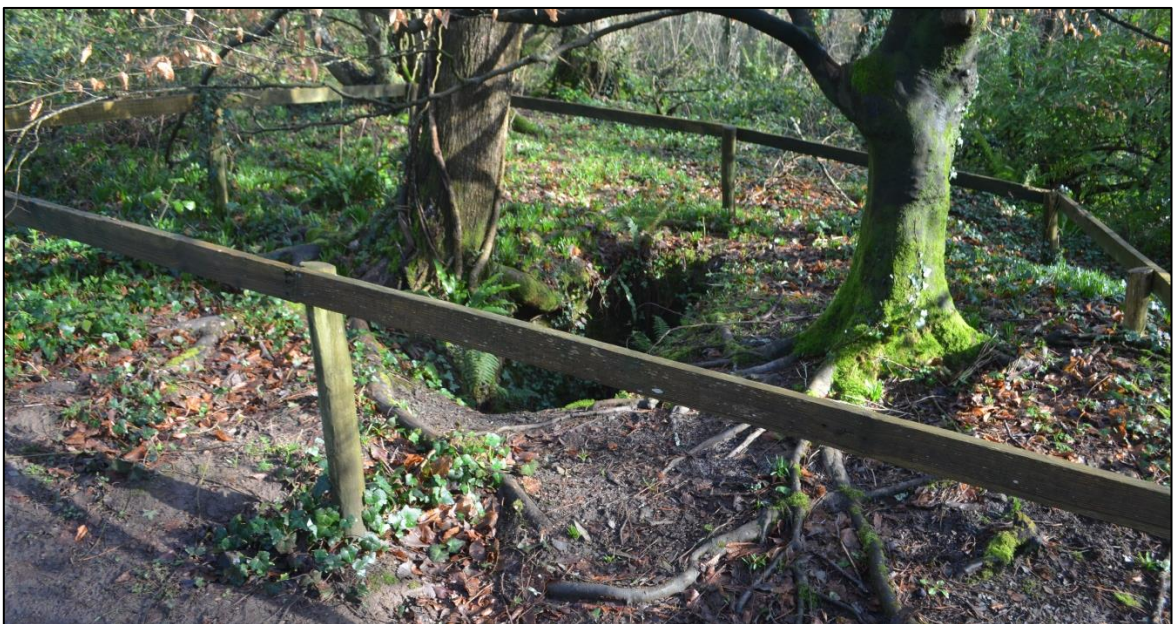
17. Fenced off cut feature in The Dell

A steep sided rectangular cut feature c.2.5m x 1m x 1.5m deep is located close to the convergence of two pathways through The Dell. It has been fenced off with a modern timber post and rail fence. It is located between two trees with mounds of soil located to the south of the cut feature. These fenced off features may relate to military use of the estate during World War Two and may be the 'foxholes or dug-outs' referred to by Teasdale (2017).

FIGURE 46: STEEP SIDED CUT FEATURE LOCATED BETWEEN TWO TREES IN THE DELL; FROM THE SOUTH.

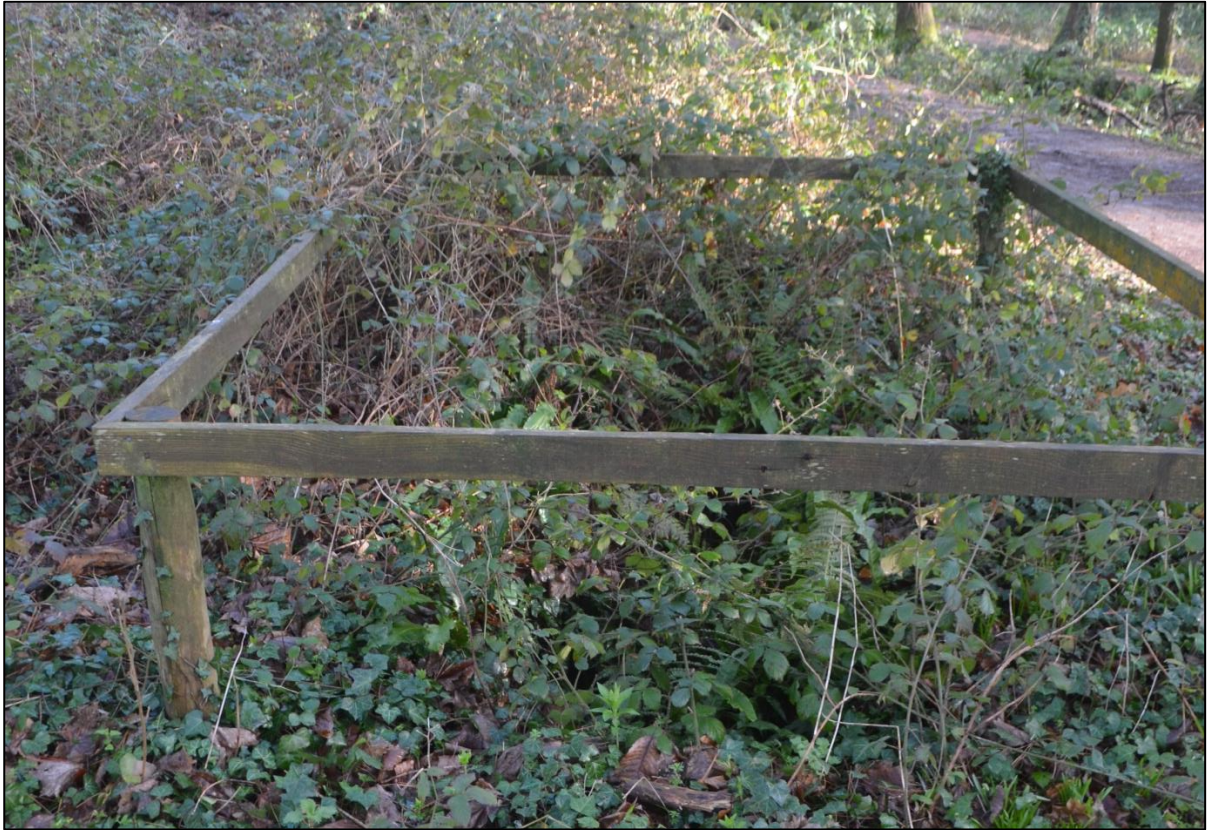
18. Fenced off cut feature in The Dell

A rectangular cut feature c.3m x 1m x 1m deep is located to the west of a pathway through The Dell. It has been fenced off with a modern timber post and rail fence. These fenced off features may relate to military use of the estate during World War Two and may be the 'foxholes or dug-outs' referred to by Teasdale (2017).

FIGURE 47: FENCED OFF CUT FEATURE TO THE WEST OF THE PATH THROUGH THE DELL; FROM THE SOUTH EAST

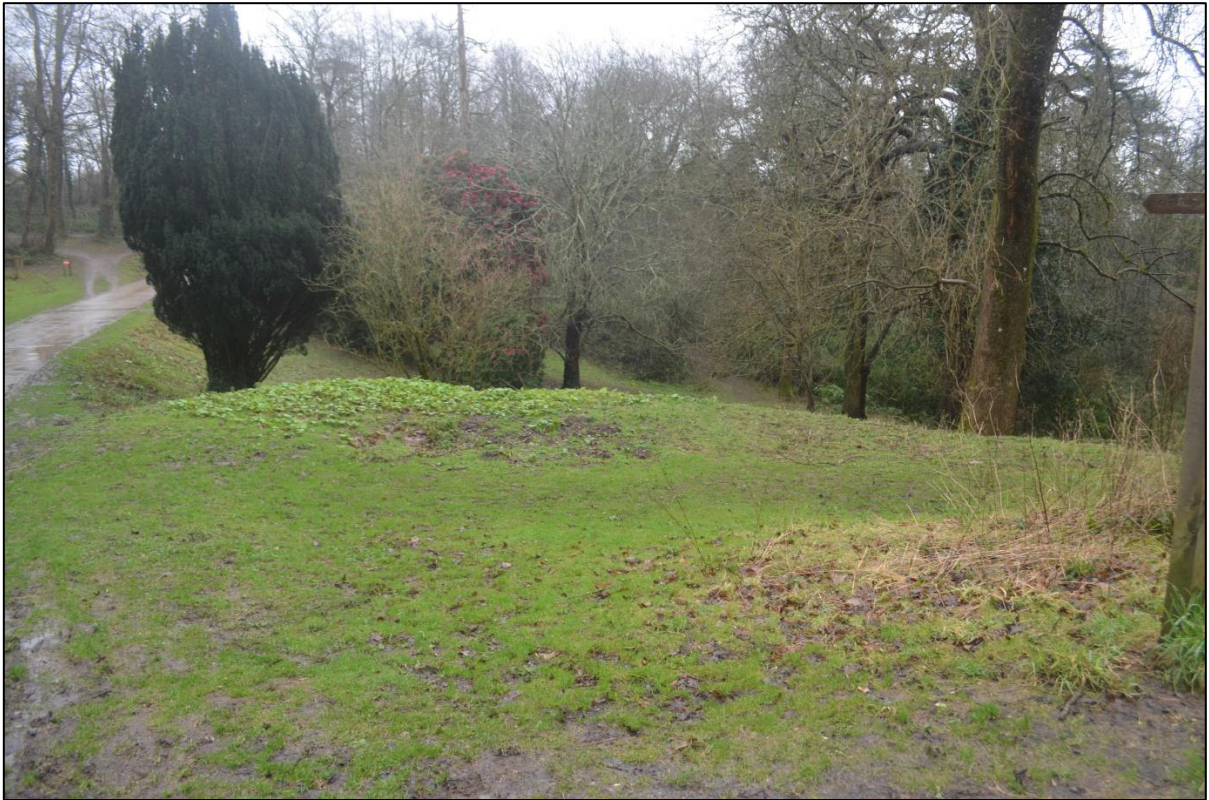
19. Possible curved platform south of South Drive at the head of The Dell.

A curved flat area appears to have been created at the head of The Dell, looking down the valley, just off the South Drive. It is unclear whether this dates to the creation of the valley garden or is a more modern feature.

FIGURE 48: POSSIBLE CURVED PLATFORM AT THE HEAD OF THE DELL; FROM THE WEST

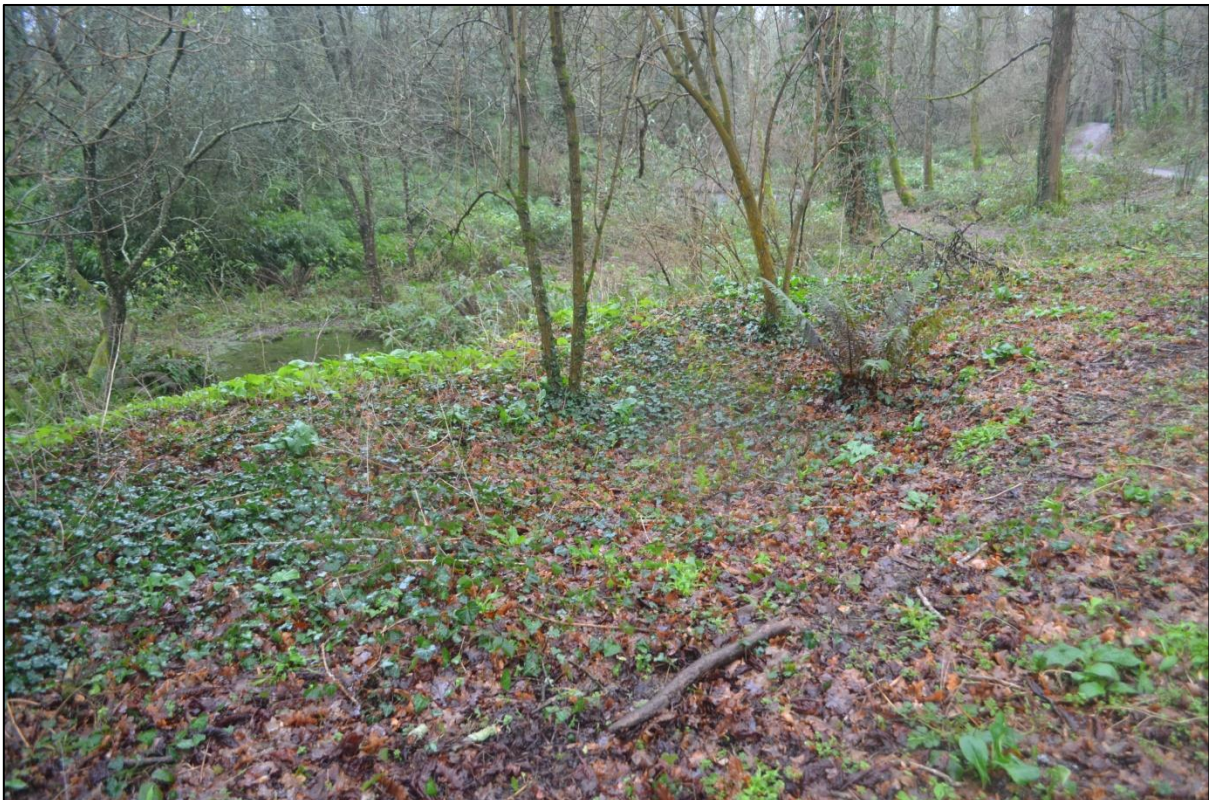
A slight platform c. 2m x 1.5m appears to have been created in the slope in the side of the valley, with views looking down to the ponds below and further down the valley.

FIGURE 49: PLATFORM OVERLOOKING THE PONDS AT THE TOP OF THE DELL WITH VIEWS DOWN THE VALLEY; FROM THE NORTH

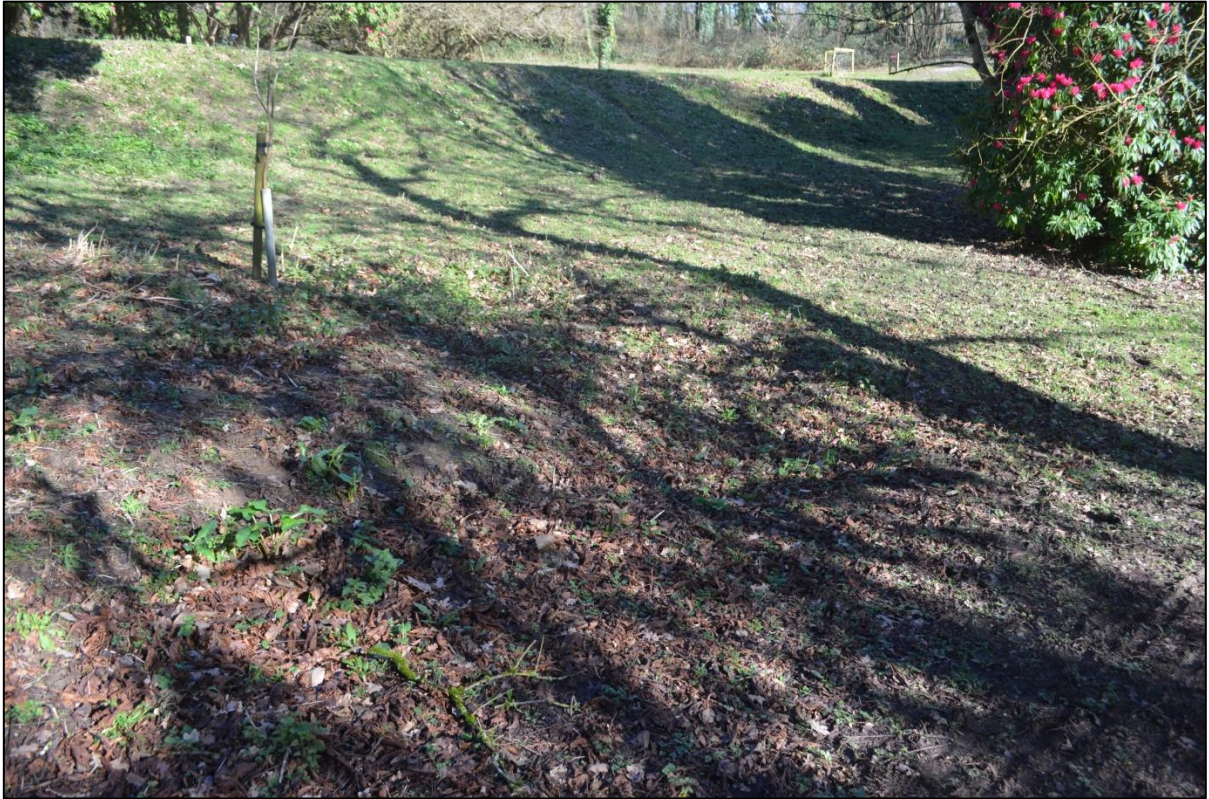
SX 5269 5528

A slight platform c. 1.5m x 4m appears to have been created in the slope in the head of the valley, with views looking down to the ponds below and further down the valley.

FIGURE 50: POSSIBLE PLATFORM AT THE HEAD OF THE DELL WITH VIEWS DOWN THE VALLEY; FROM THE WEST

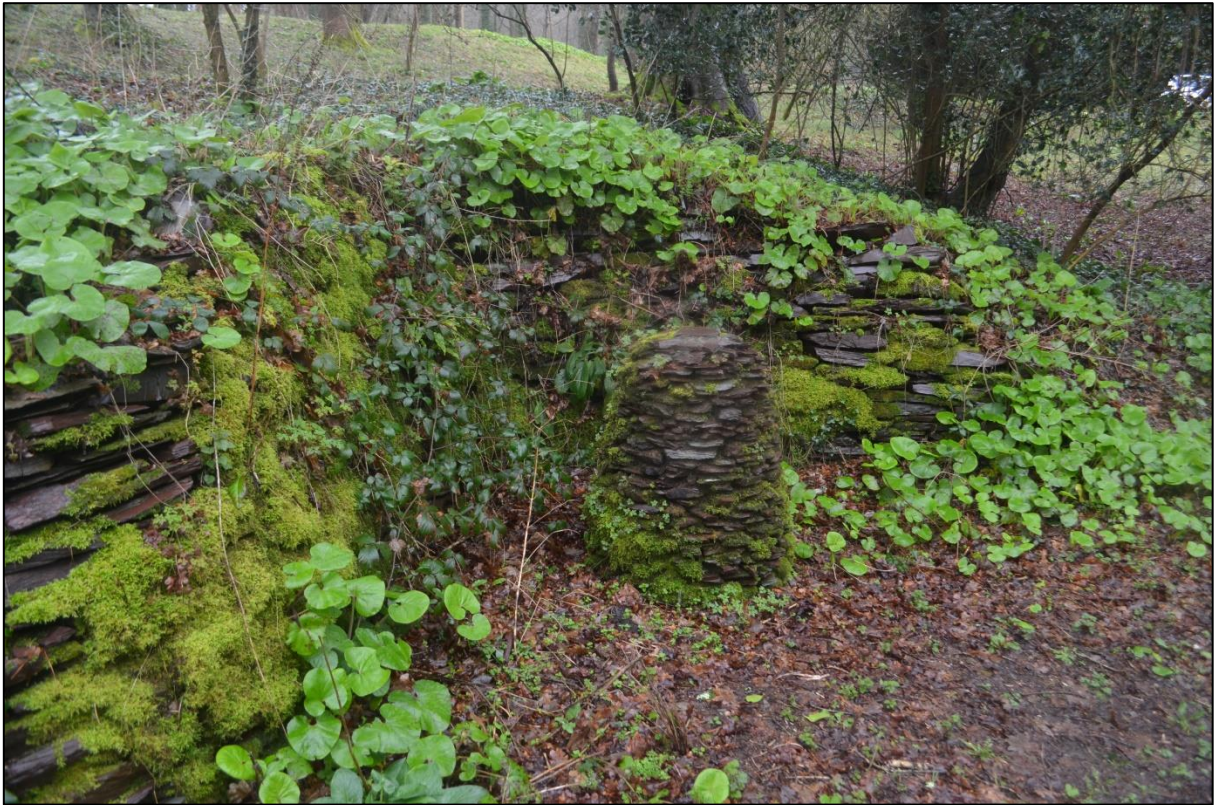
A curved stone wall is built into the side of the valley close to the head of The Dell. A circular stone built feature or plinth is located within it. The stone work appears to be in good condition and this feature does not appear to be shown on Ordnance Survey maps. It is therefore possible that this is a modern construction, perhaps dating from the early 2000s when it is recorded that the National Trust undertook unspecified works to the ponds at The Dell (Teasdale 2017), or it could be an older feature which has been restored. It is unclear whether the circular plinth in the centre is intended to be a base for something or is the feature in its own right.

FIGURE 51: CURVED CIRCULAR STONE WALL WITH STONE BUILT FEATURE IN THE CENTRE; FROM THE SOUTH

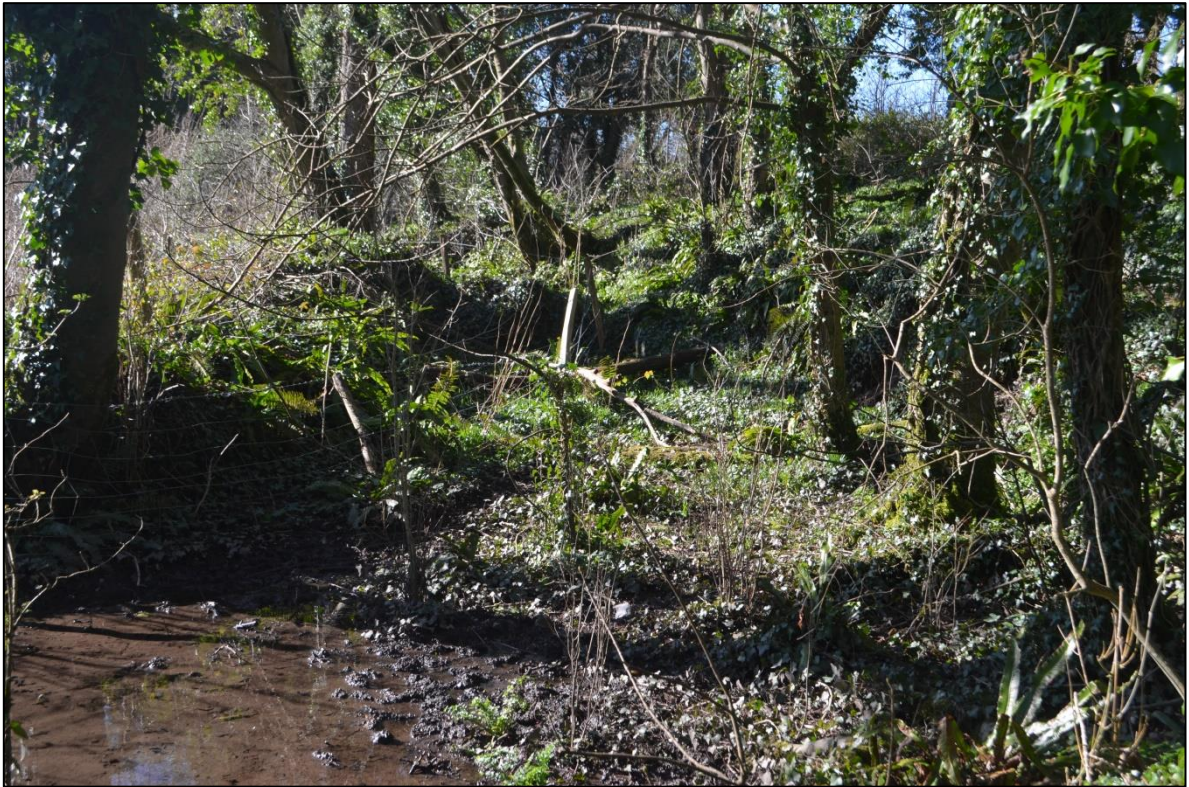
A U shaped section of stone faced boundary bank shown on Ordnance Survey First Edition mapping as part of the historic extent of Bickham farmstead is extant but covered in vegetation on the eastern side of the stream at the bottom of The Dell.

FIGURE 52: U SHAPED SECTION OF BOUNDARY EAST OF BICKHAM SHOWN ON HISTORIC MAPPING; FROM THE NORTH

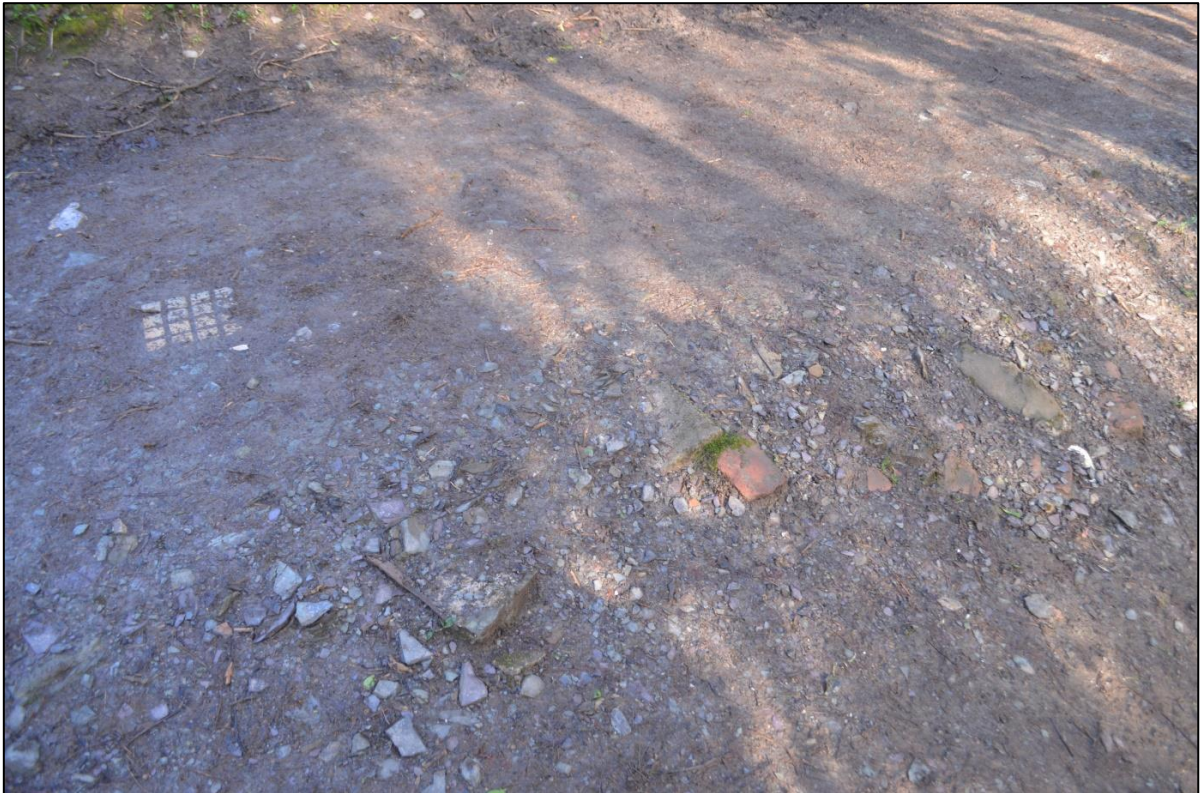
25. Path repairs along the main path through The Dell

Presumed path repairs along the section of path through The Dell opposite Bickham farmstead appear to have utilised some materials which stand out against the vernacular (compacted earth path). There include a cast concrete floor tile, roof tiles and a section of brick and concrete used in path edging. It is assumed that these materials have been added since the National Trust ownership of this part of the estate as part of a path repair as it only occurs in this area however it is unclear if there is a reason for this.

FIGURE 53: RANDOM CAST CONCRETE FLOOR TILE AND BRICKS ERODING FROM PATH EDGING.

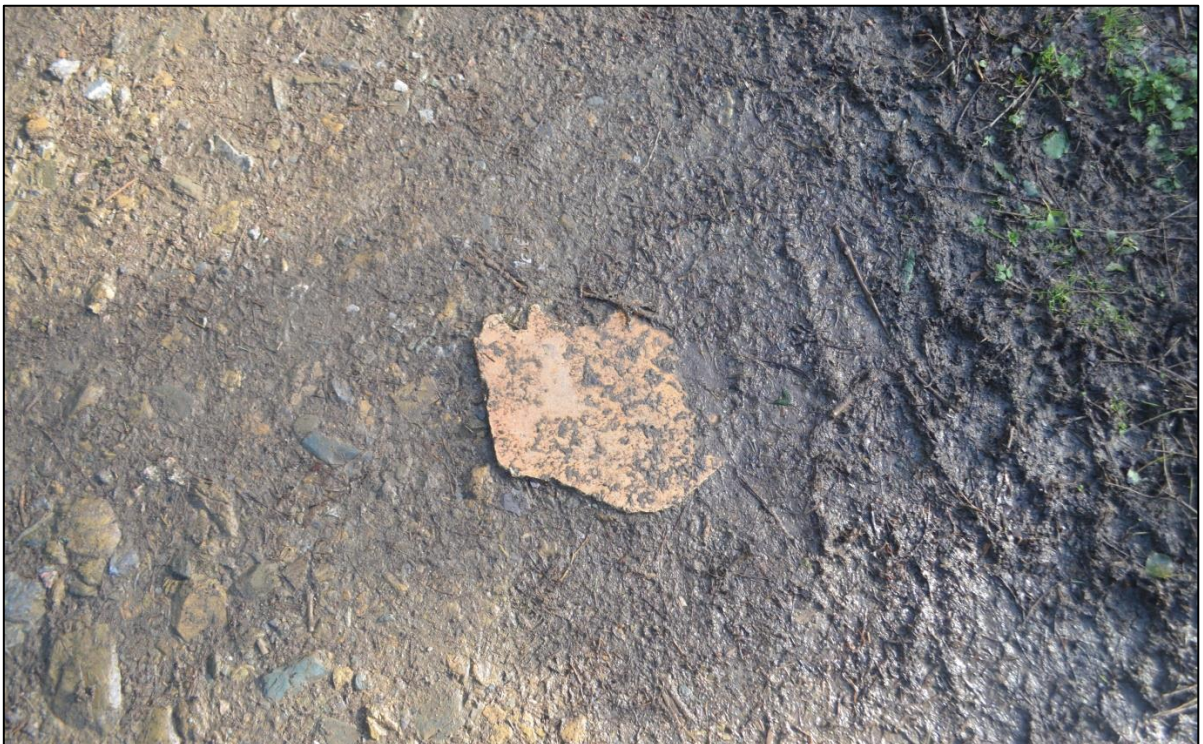
FIGURE 54: OCCASIONAL ROOF TILES APPEAR TO HAVE BEEN BUILT INTO THE PATH SURFACE

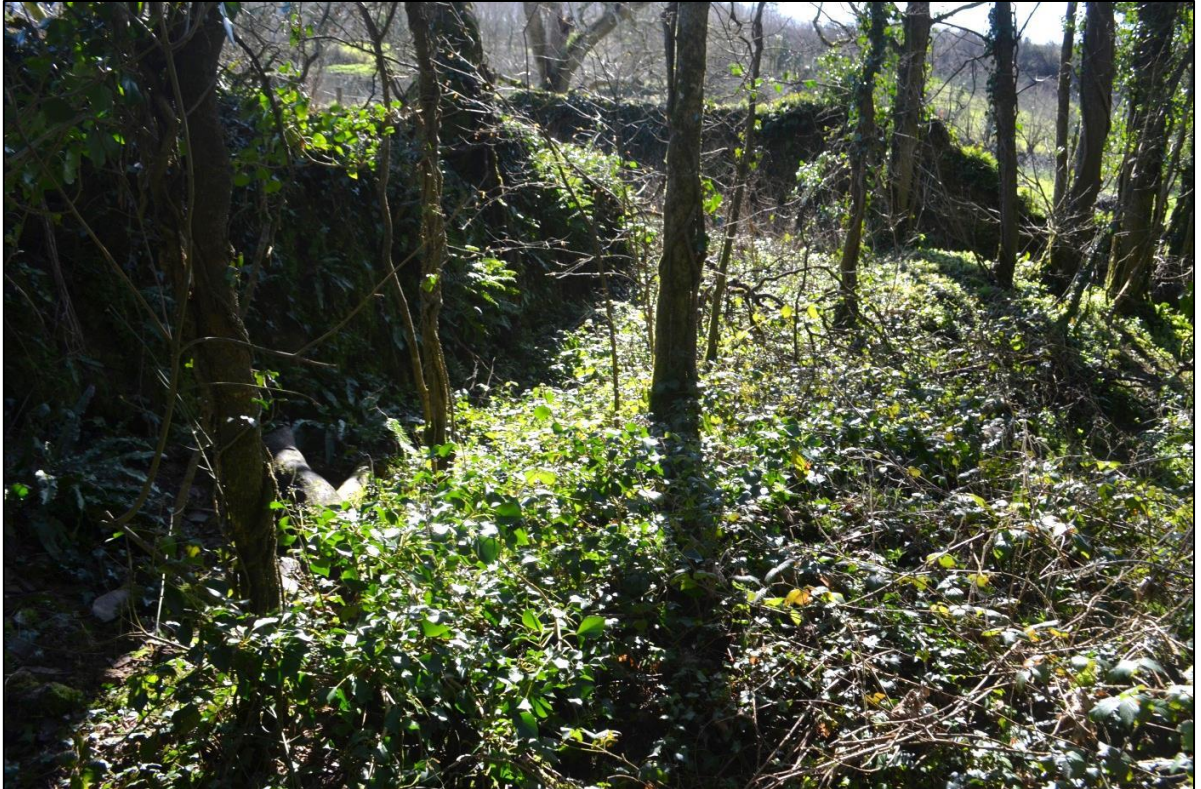
Three possible sections of surviving boundary to the north of Bickham appear to align with boundaries marking the northern area of the farmstead on the Ordnance Survey First Edition map. These walls were no longer marked by the 1933 Ordnance Survey map.

FIGURE 55: REMAINS OF TWO PARALLEL BOUNDARIES, THE ONE ON THE RIGHT ONLY VERY SLIGHT, SHOWN ON OS 1ST EDITION MAP; FROM THE NORTH.

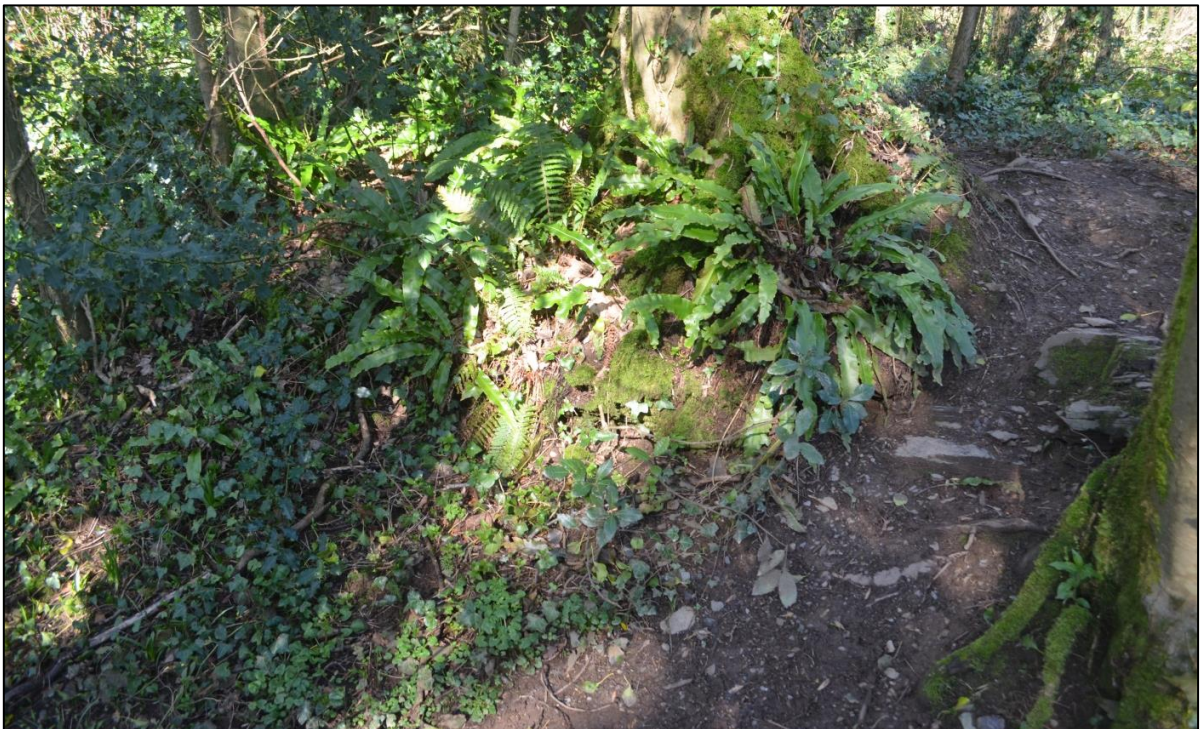
FIGURE 56: REMAINS OF BOUNDARY RUNNING EAST WEST TO THE STREAM AT THE BOTTOM OF THE DELL, SHOWN ON OS 1ST EDITION; FROM THE SOUTH.

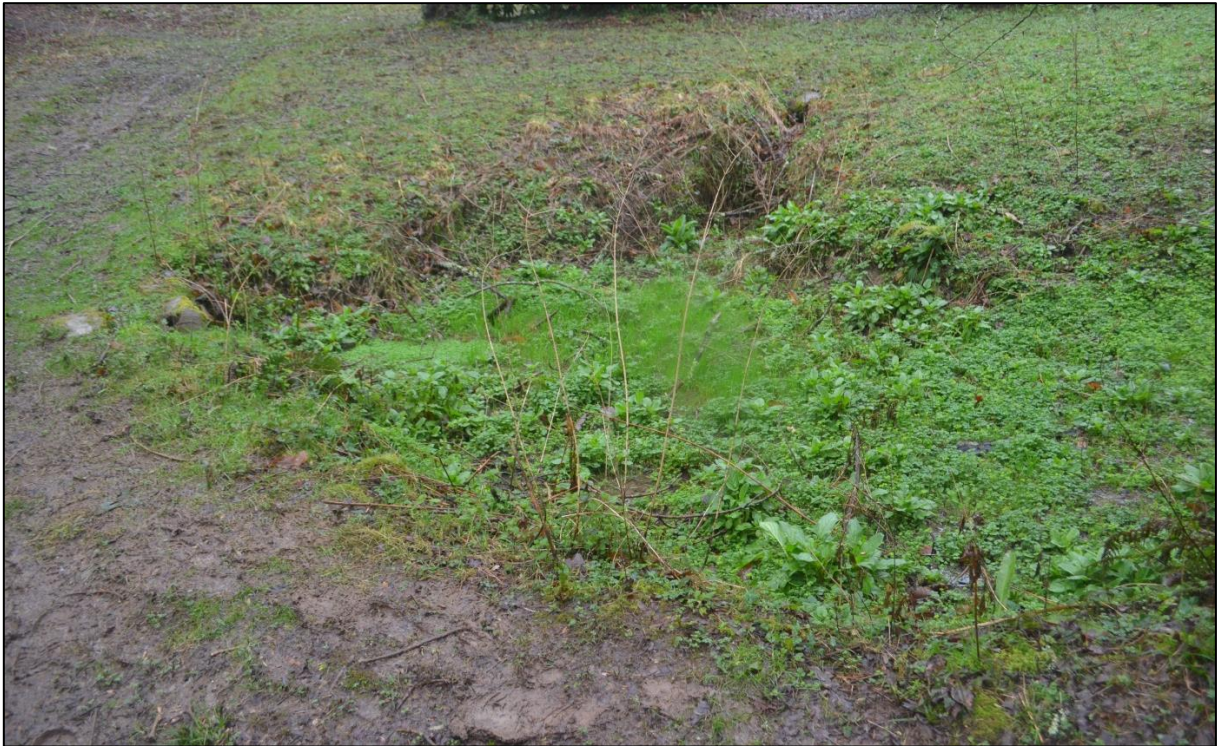
An approximately rectangular pond appearing to hold water located to the east of the other ponds in the chain. It appears to be cut in to the valley slope on its north western side but the north eastern side is jagged and has possibly collapsed slightly. Water appears to flow between pond 5 and pond 4 under a path which contains the only apparent built element of this pond.

FIGURE 58: POND 5; FROM THE SOUTH

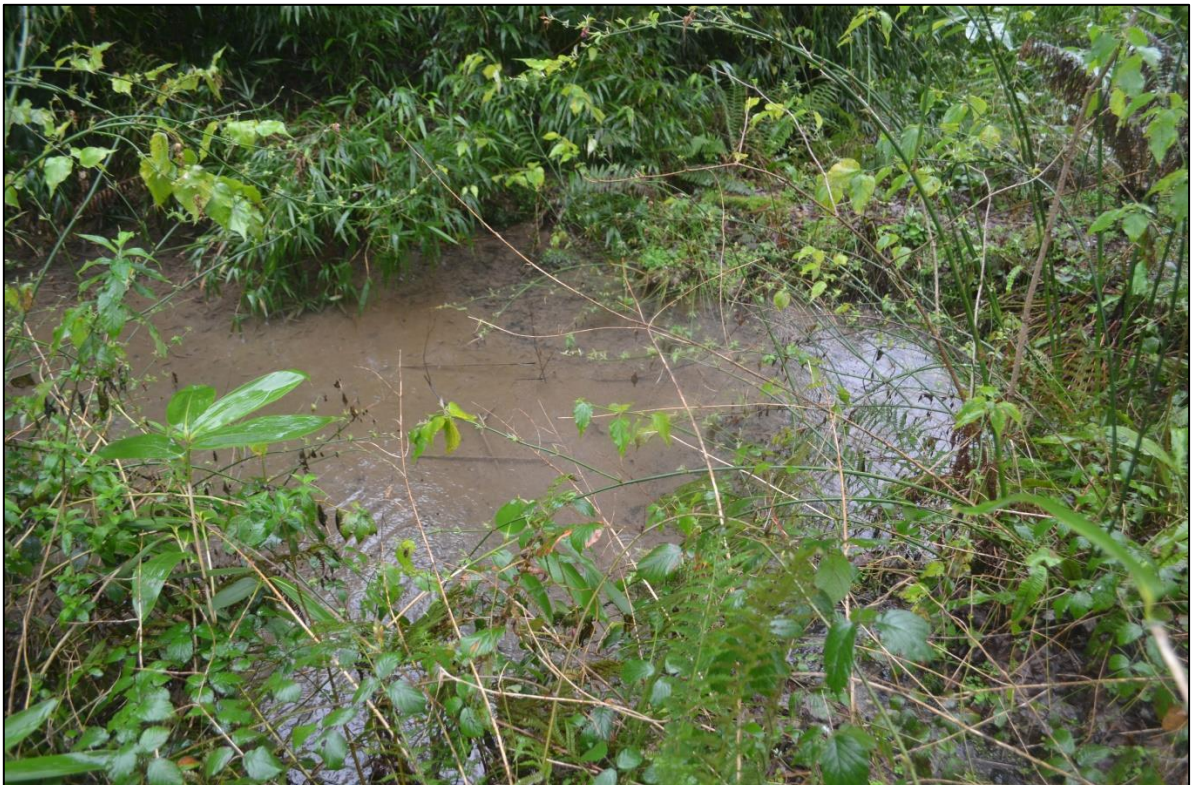
An approximately circular pond, holding water and located to the south west of pond 5. It is surrounded by dense vegetation so its exact form is difficult to discern although it does not appear to have any built structure. Water appears to flow into pond 4 from a channel from pond 3 and from pond 5. It then appears to flow south down a channel towards pond 2.

FIGURE 59: POND 4; FROM THE EAST

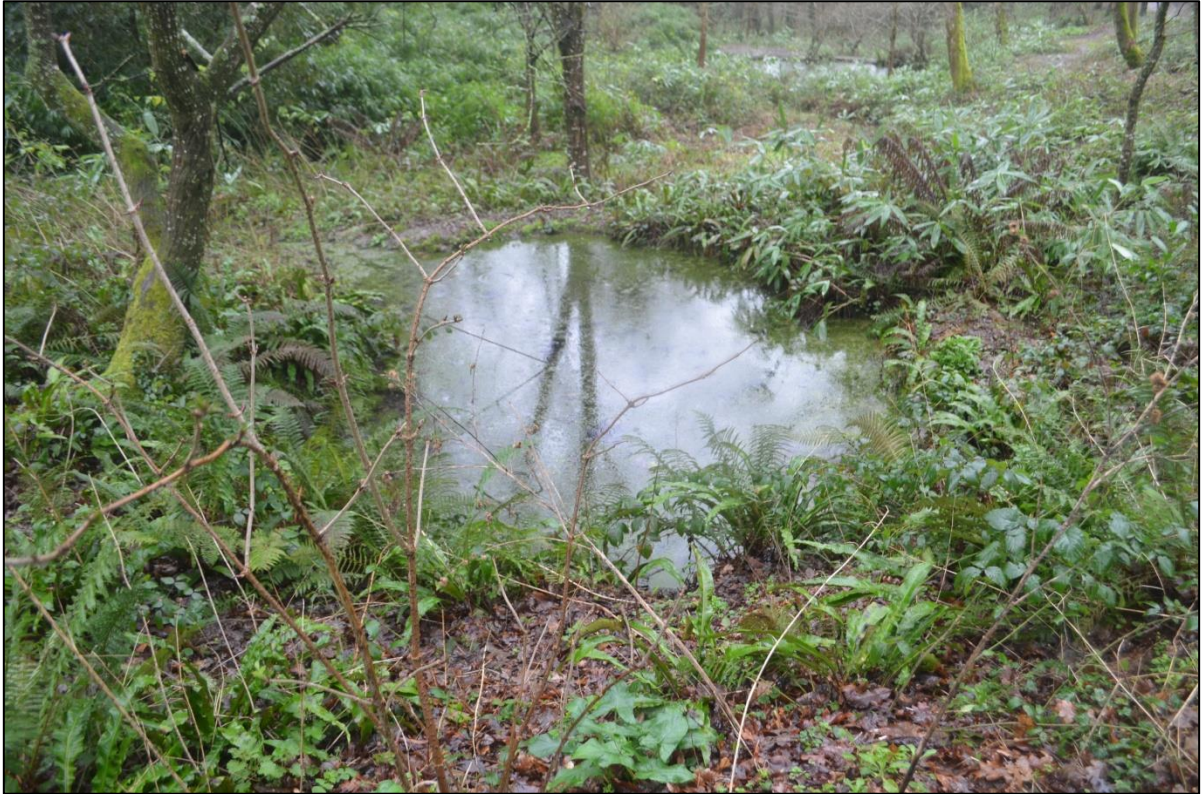
An approximately oval shaped pond, holding water and located to the north east of pond 4. It is surrounded by vegetation so its exact form is difficult to discern although it does not appear to have any built structure. Water appears to flow between pond 3 and 4 in a short channel and from pond 3 southwards through a channel towards pond 2.

FIGURE 60: POND 3; FROM THE WEST

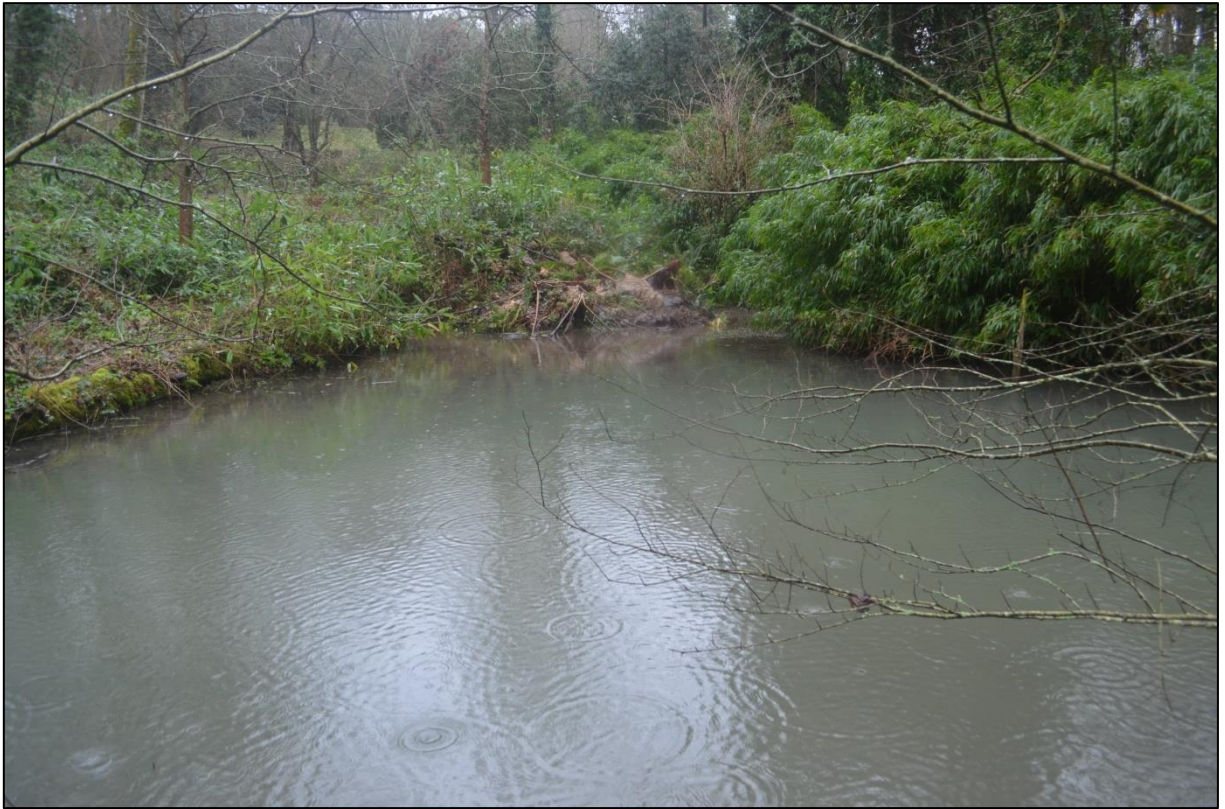
Pond 2 is a much larger pond located downstream of ponds 3-5. It is surrounded by vegetation so its exact form is difficult to discern although it does not appear to have any built structure. It is filled with water which appears to be quite deep. A largely earth dam/bridge is located across the southern end of the pond. Water flows out of a stone built channel through the dam and cascades over a projecting piece of slate before continuing downstream towards pond 1. A modern tourist statue labelled 'Lourdes' had been placed in the outfall from pond 2, observed on the second site visit but not the first, suggesting the significance of this site to visitors.

FIGURE 61: POND 2; FROM THE SOUTH

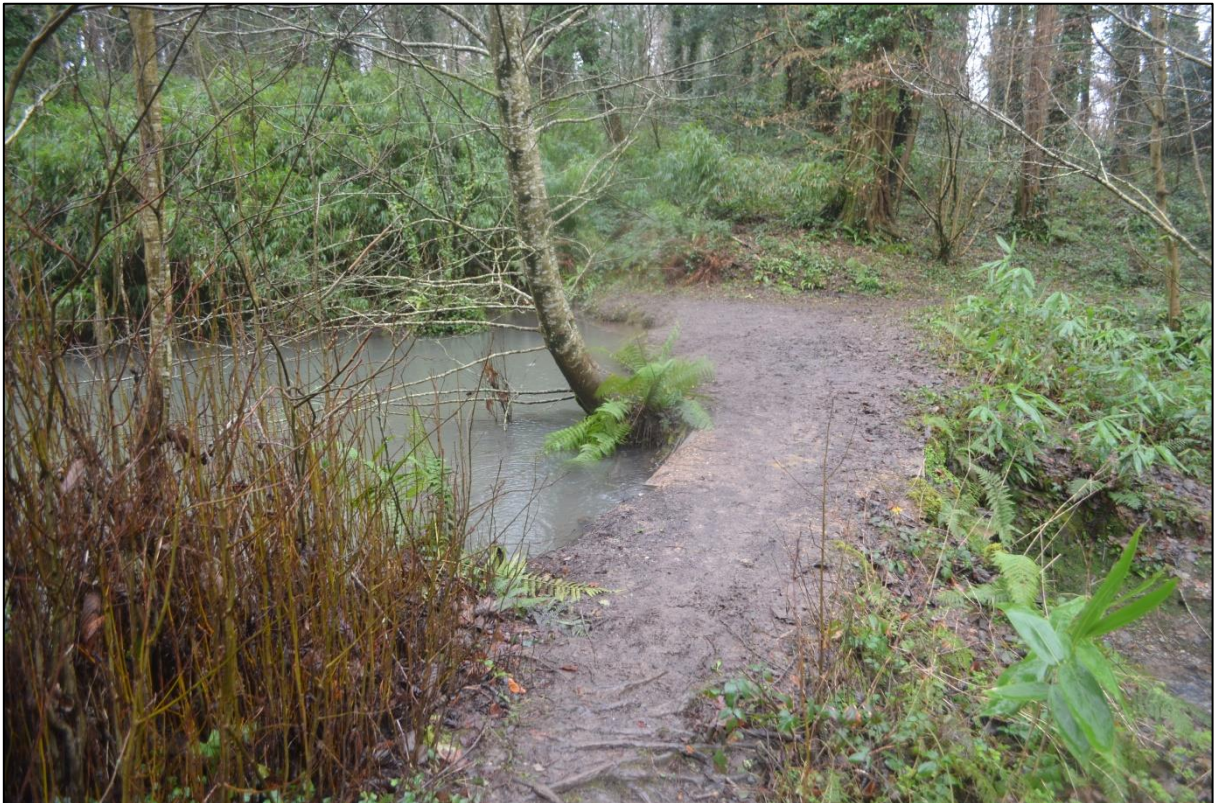
FIGURE 62: DAM/BRIDGE AT THE SOUTHERN END OF POND 2; FROM THE WEST

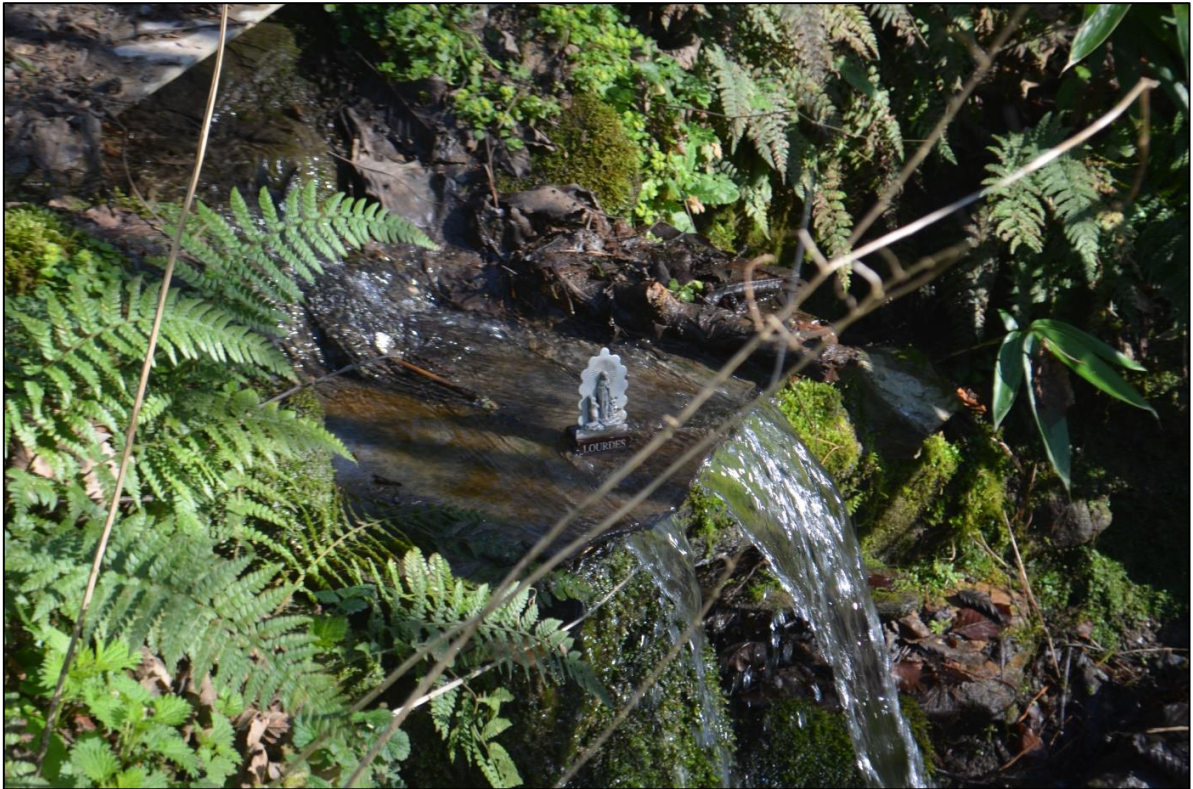
FIGURE 63: MODERN TOURIST STATUE FROM LOURDES PLACED IN THE OUTFALL OF POND 2.

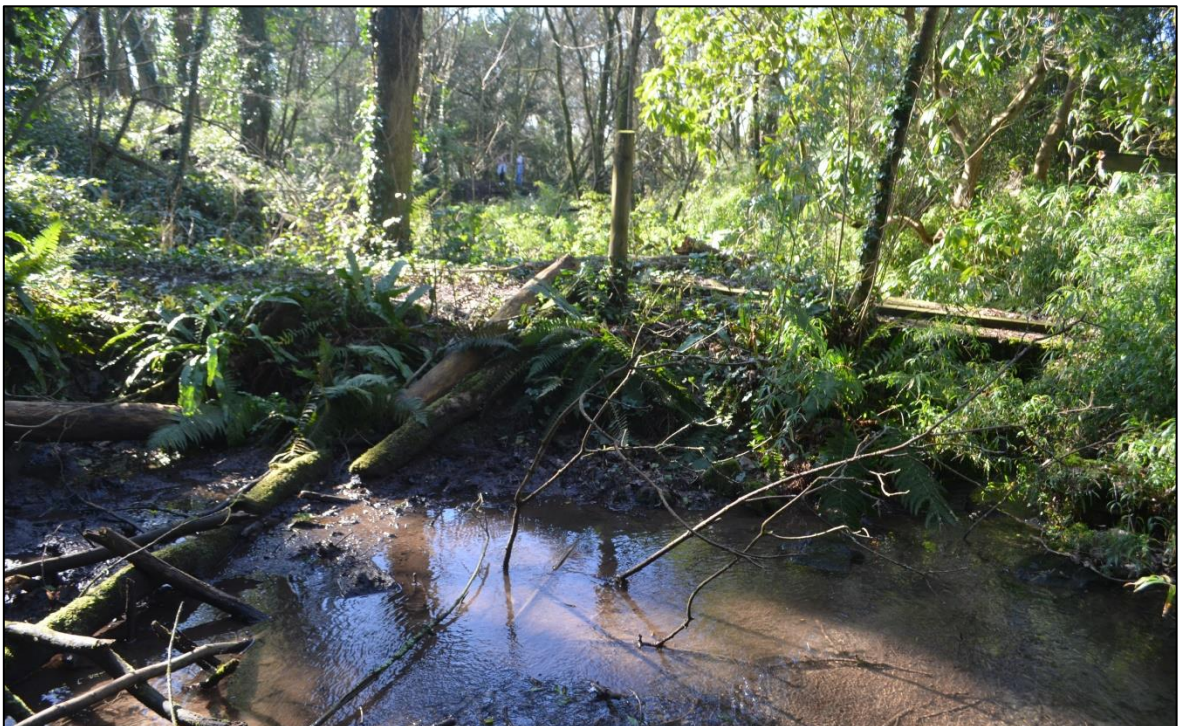
A wooden bridge and part of a bank are located at the northern end of pond 1. The wooden bridge is evidently a modern replacement but is aligned with a section of bank which is shown on the Ordnance Survey First Edition map as the northern edge of pond 1.

FIGURE 64: WOODEN BRIDGE ALIGNED WITH THE NORTHERN END OF POND 1 AS SHOWN ON THE OS 1ST EDITION MAP; FROM THE SOUTH.

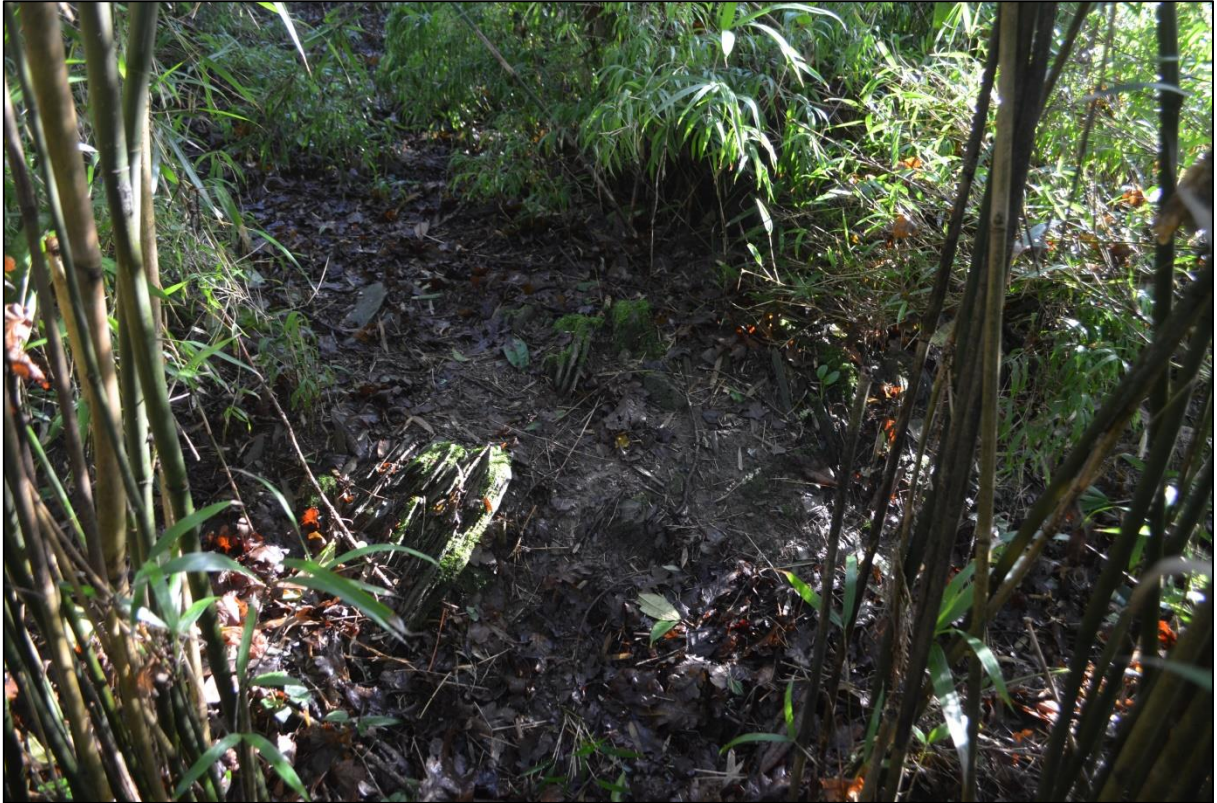
A small section of possible wall is located within a thicket of bamboo on the western side of pond 1. It consists of a slight bank seemingly with a number of stones set on edge running along its length. It appears to align with an area of wall or boundary shown on the Ordnance Survey First Edition map.

FIGURE 65: POSSIBLE SECTION OF BANK OR WALL LOCATED TO THE WEST OF POND 1; FROM THE SOUTH

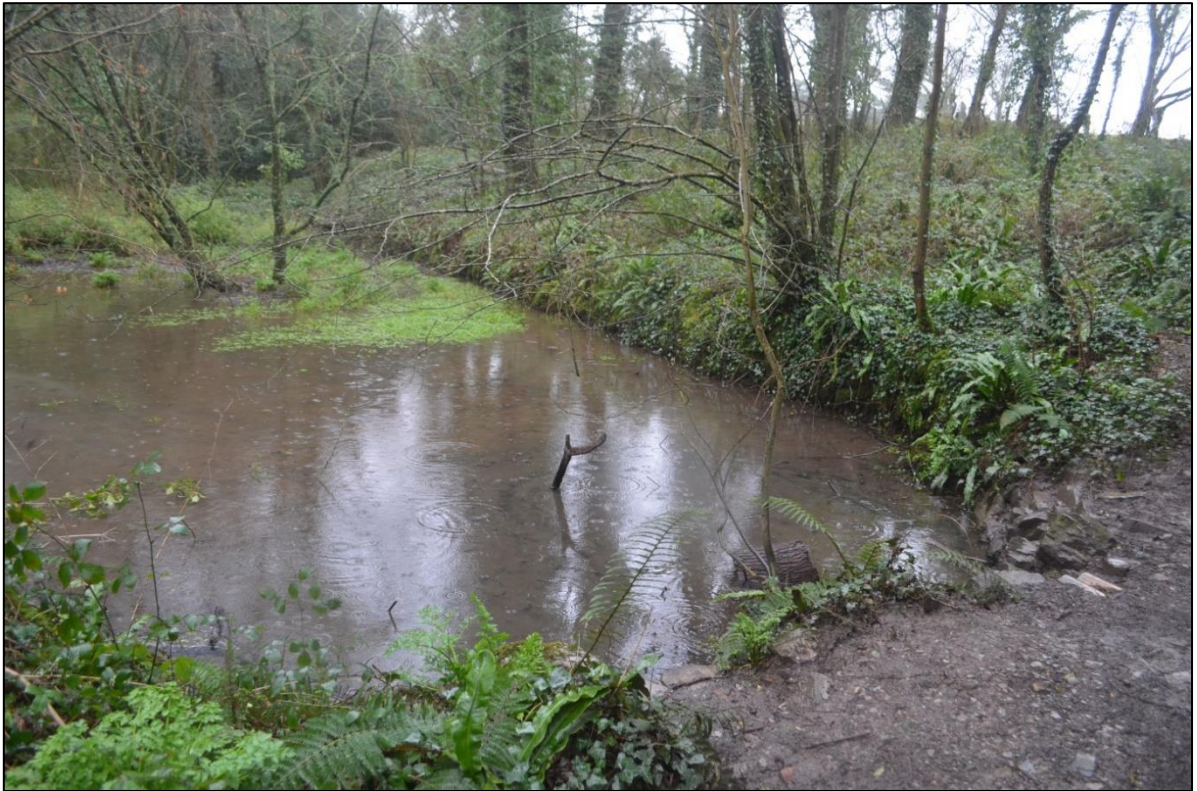
Pond 1 is a large pond, the most southerly of the chain of ponds and the only one which appears likely to predate the Victorian valley garden located in The Dell/Happy Valley. Only the eastern side of the pond appears to consist of a stone built wall, with the remaining sections seeming to have no built form. The built wall on the eastern side starts at SX 5258 5513. A stone and earth dam at the southern end of the pond has a stone built channel to allow the water to continue south along the stream channel, through the fields of Bickham farmstead. The pond has either been shortened or holds less water than when originally constructed as instead of being the roughly rectangular shape shown on the Ordnance Survey First Edition map it curves in on its western side creating a funnel shape before curving outwards again to the point where it is crossed by the wooden bridge discussed above which marks its original northern edge.

FIGURE 66: POND 1; FROM THE SOUTH.

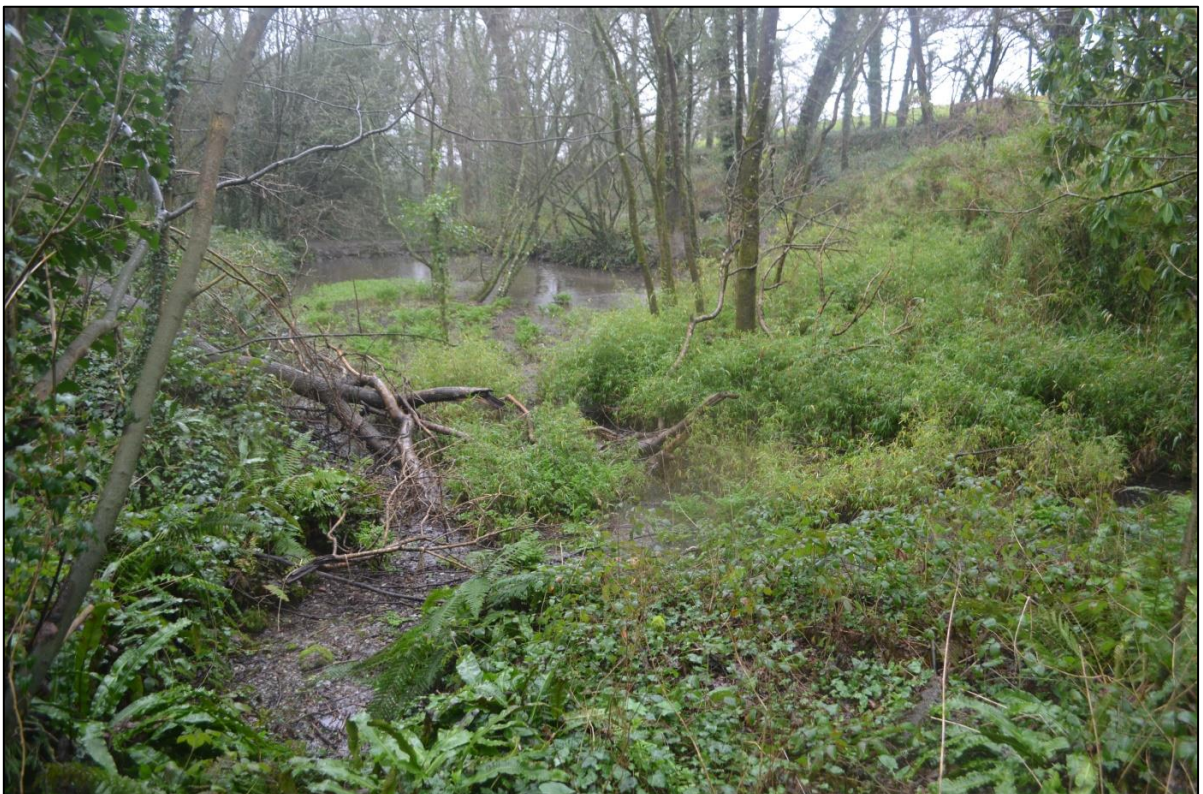
FIGURE 67: LOOKING DOWN THE HISTORIC EXTENT OF POND 1 AS SHOWN ON THE OS 1ST EDITION MAP FROM THE NORTH. THE POND HOLDS WATER IN ITS SOUTHERN AREA BUT APPEARS TO HAVE EITHER BEEN REDUCED IN SIZE OR HOLD LESS WATER THAN PREVIOUSLY DUE TO THE VEGETATION GROWTH IN THE NORTHERN AREA OF THE POND.
