THE DELL/HAPPY VALLEY AND SURROUNDING PARKLAND SALTRAM DEVON

Archaeological and Historic Landscape Survey

South West Archaeology Ltd. report no. 210317

By F. Balmond, MCifA
Report Version: FINAL
Draft Issued: 17th March 2021
Report Finalised: 28th April 2021

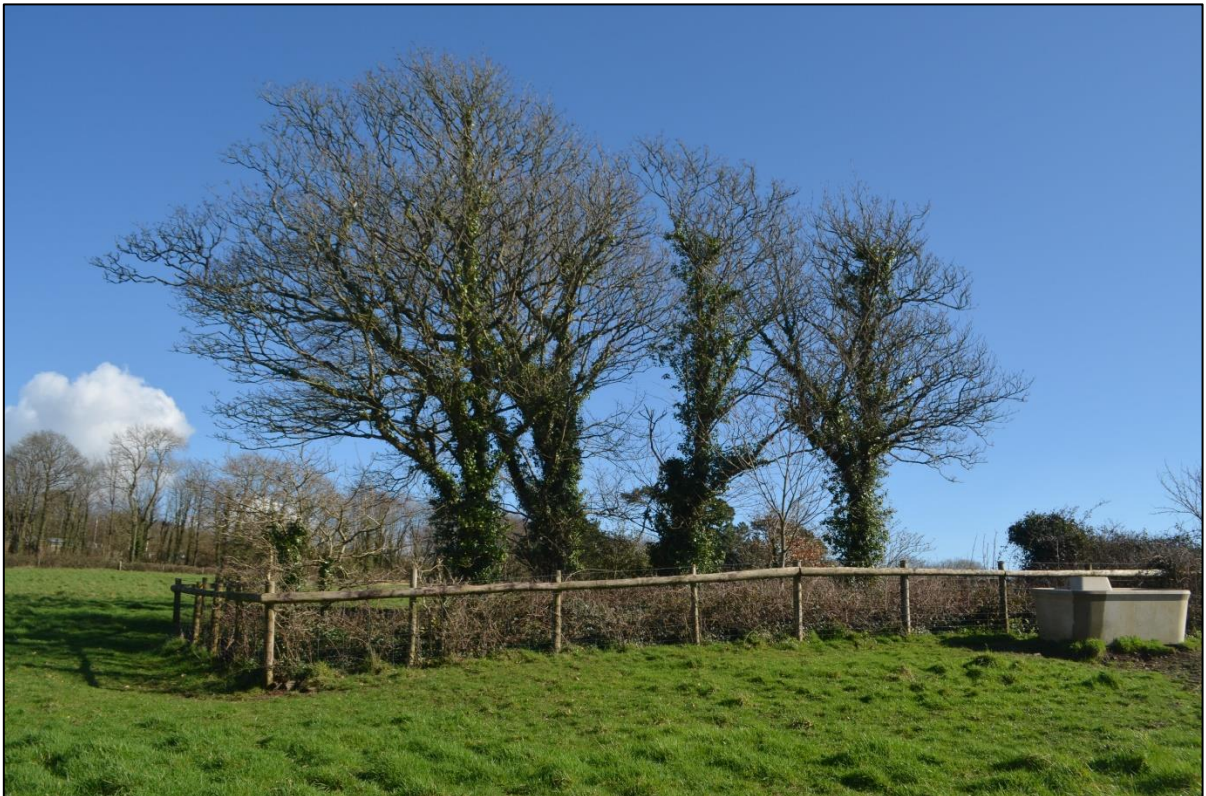
Bickham clump consists of a tree mound probably planted between the Parkers acquisition of Bickham farmstead in the early 19th century and the mid-19th century. It is fenced with modern timber and mesh fencing topped with barbed wire. Large modern concrete drinking troughs have been placed against the east and west sides of the fenced rectangle.

FIGURE 68: PHOTOGRAPH OF BICKHAM CLUMP, FROM THE WEST.

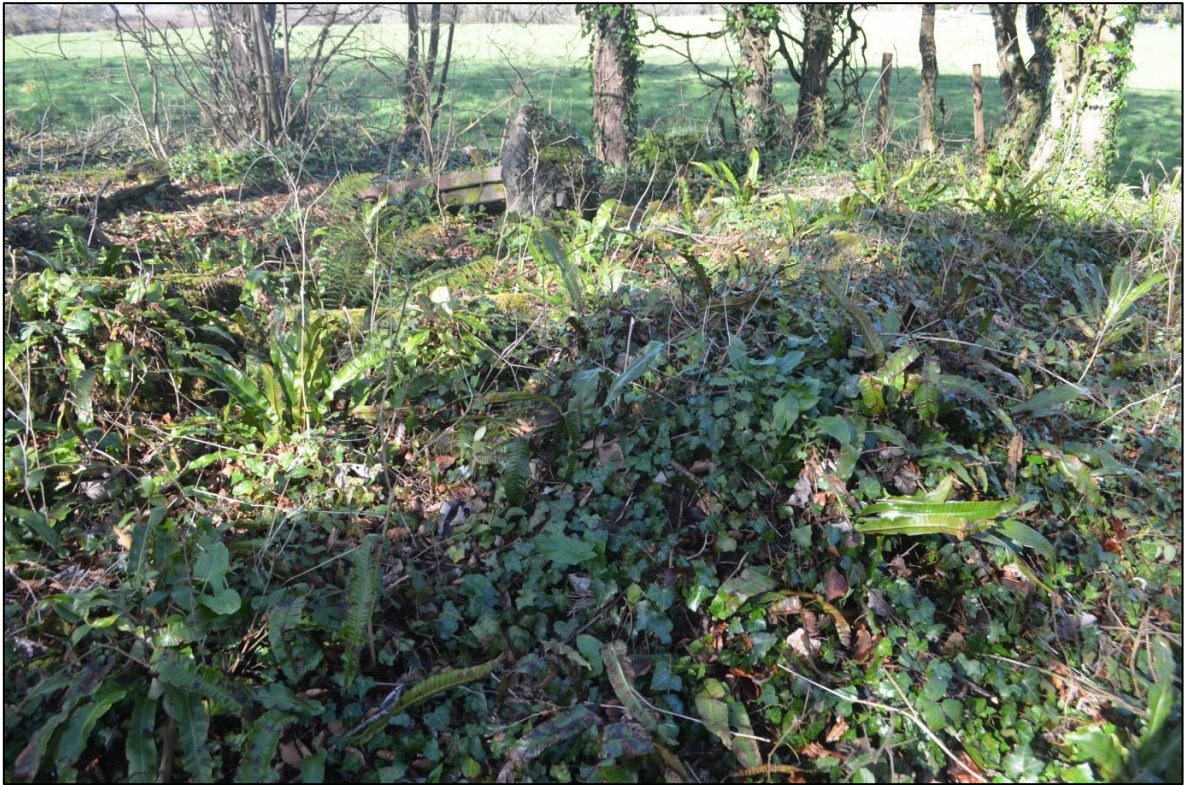
This area is very overgrown and covered with fallen deadwood so the exact dimensions of the features are difficult to determine. A section of bank c.5m x 1m x 0.7m high is located in the woodland to the south west of Stag Lodge. The bank appears to contain some concrete blocks. A metal post embedded in a substantial piece of concrete lies on its side on the western side of the bank. It is unclear what this feature represents however it appears in the approximate location of possible features or structures visible on 1946 aerial photographs. It is possible it may relate to the military use of the estate during World War Two.

FIGURE 69: SECTION OF BANK OR STRUCTURE LOCATED IN WOODLANDS TO SOUTH-WEST OF STAG LODGE. FROM THE SOUTH-EAST.

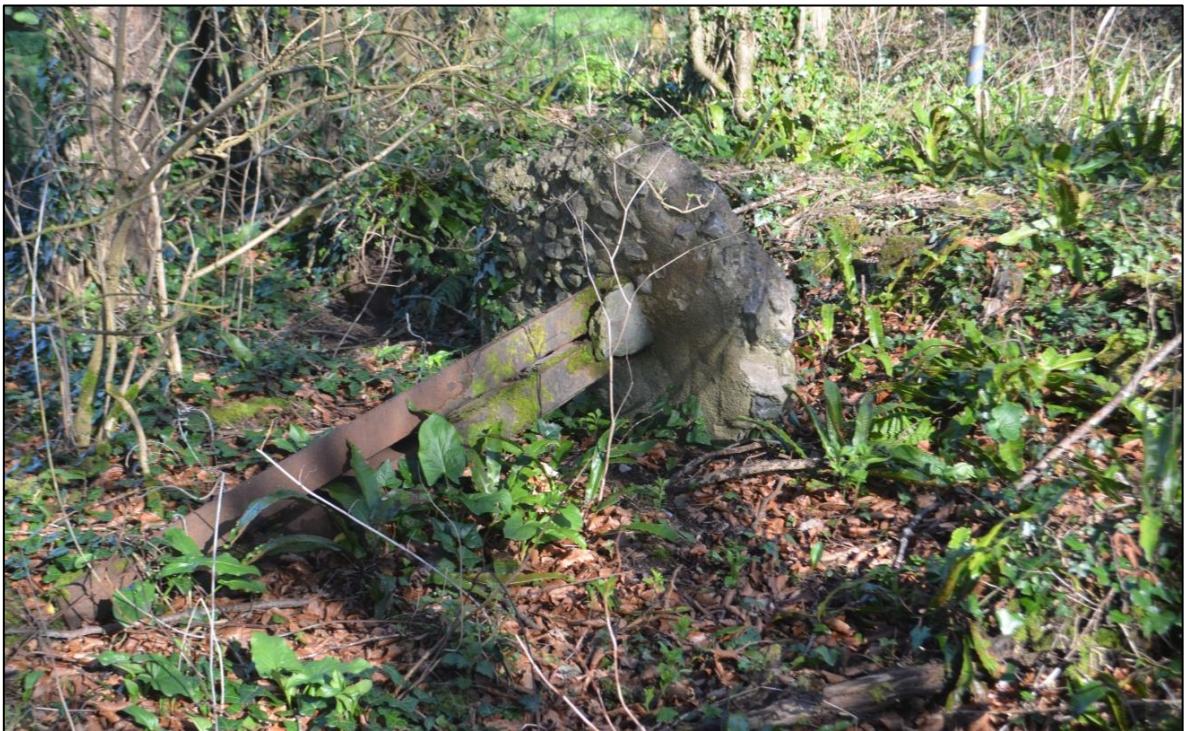
FIGURE 70: DETAIL OF METAL AND CONCRETE POST LOCATED TO THE WEST OF THE BANK FEATURE, FROM THE SOUTH WEST.

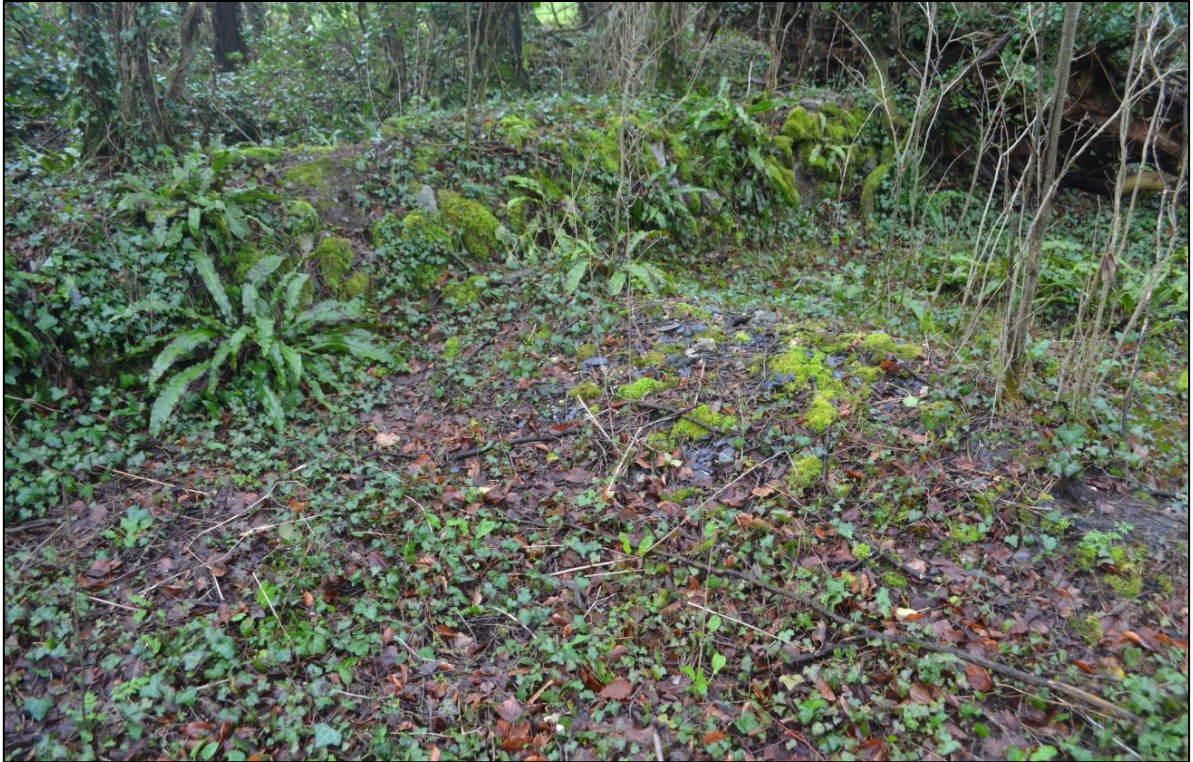
The meeting of a number of field boundaries in this area has created a thin strip of enclosed ground, possibly relating to an enclosed small strip of plantation shown on historic Ordnance Survey maps. A short low section of a possible former boundary is also evident in this area, aligned approximately north-south and constructed of stone.

FIGURE 71: SHORT SECTION OF POSSIBLE STONE BOUNDARY ABUTTING A STONE FACED BOUNDARY BANK ALONG THE SOUTHERN BOUNDARY OF BARN PARK.

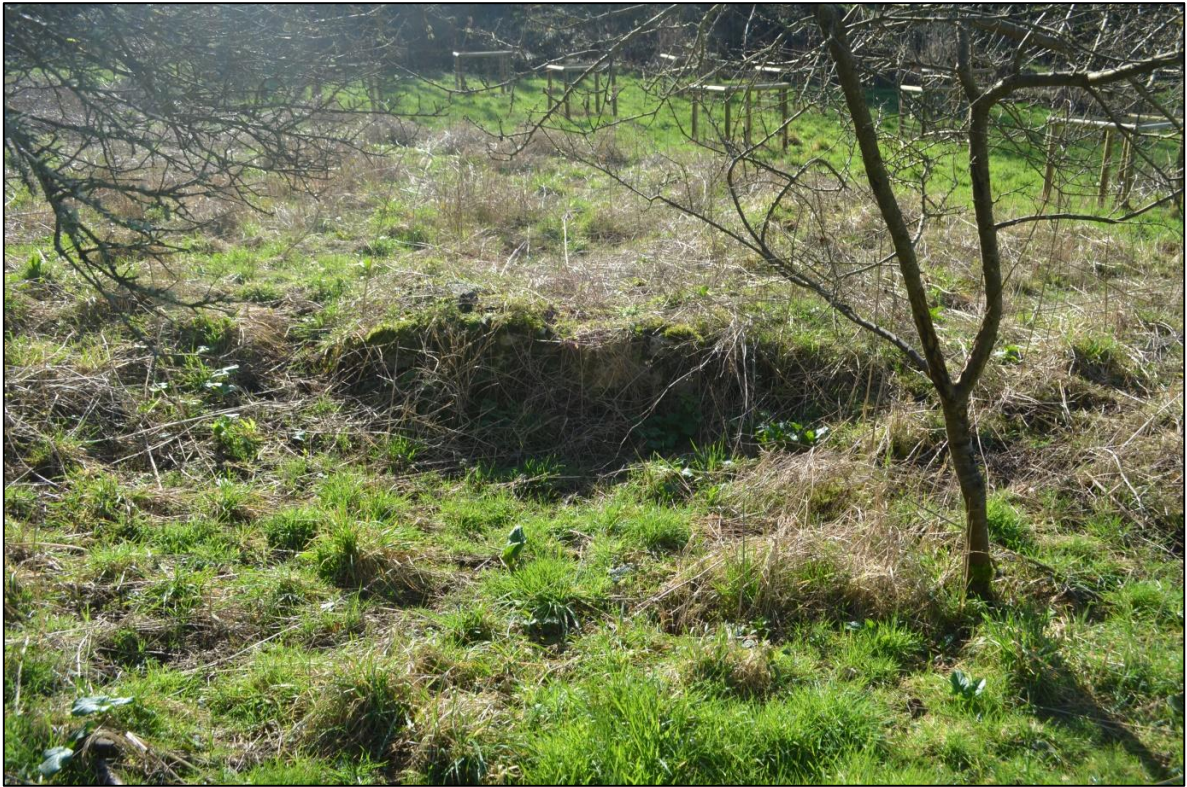
The site of a building, thought to be Bickham Farmhouse is just evident as an earthwork with a small area of low stone wall surviving in this location. Historic mapping suggests the building had an enclosure on the south east side, with a small square structure which originally abutted the building surviving after the farmhouse itself had apparently been demolished. The enclosure is apparent as a rectilinear shape which sits higher than the surrounding ground on its south western side.

FIGURE 72: SMALL SECTION OF SURVIVING STONE WALLING IN THE LOCATION OF BICKHAM FARMHOUSE. FROM THE NORTH.

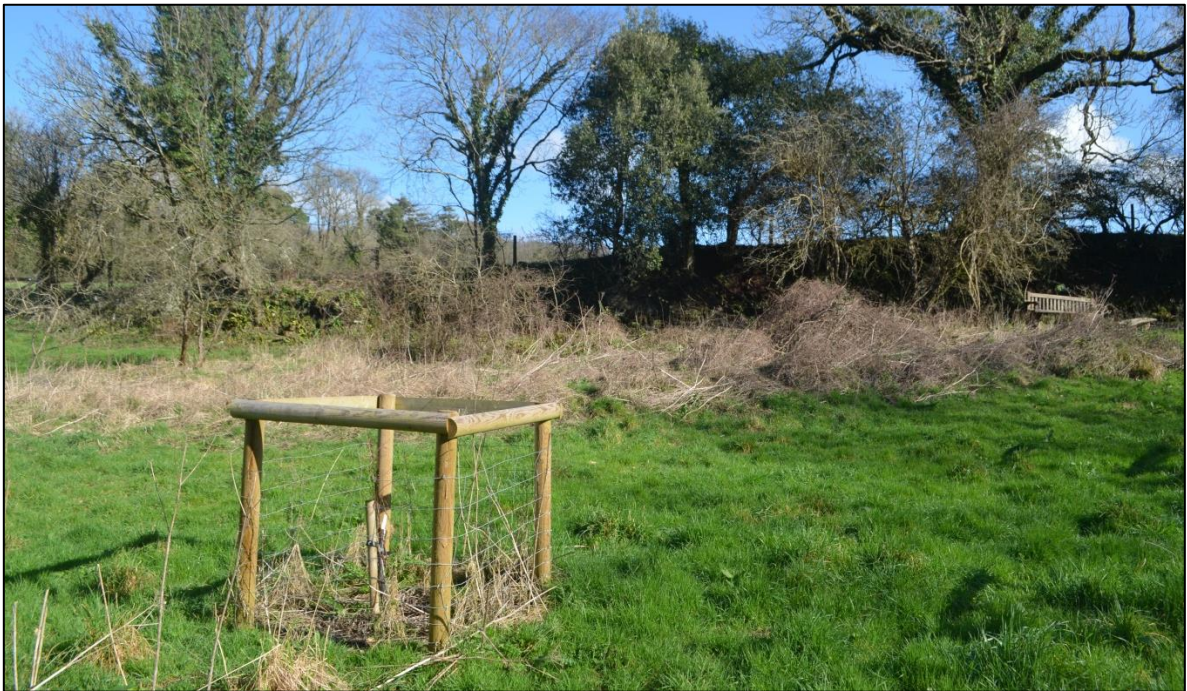
FIGURE 73: THE ENCLOSURE WHICH SURROUNDED THE SOUTH EAST SIDE OF BICKHAM FARMHOUSE; FROM THE SOUTH.

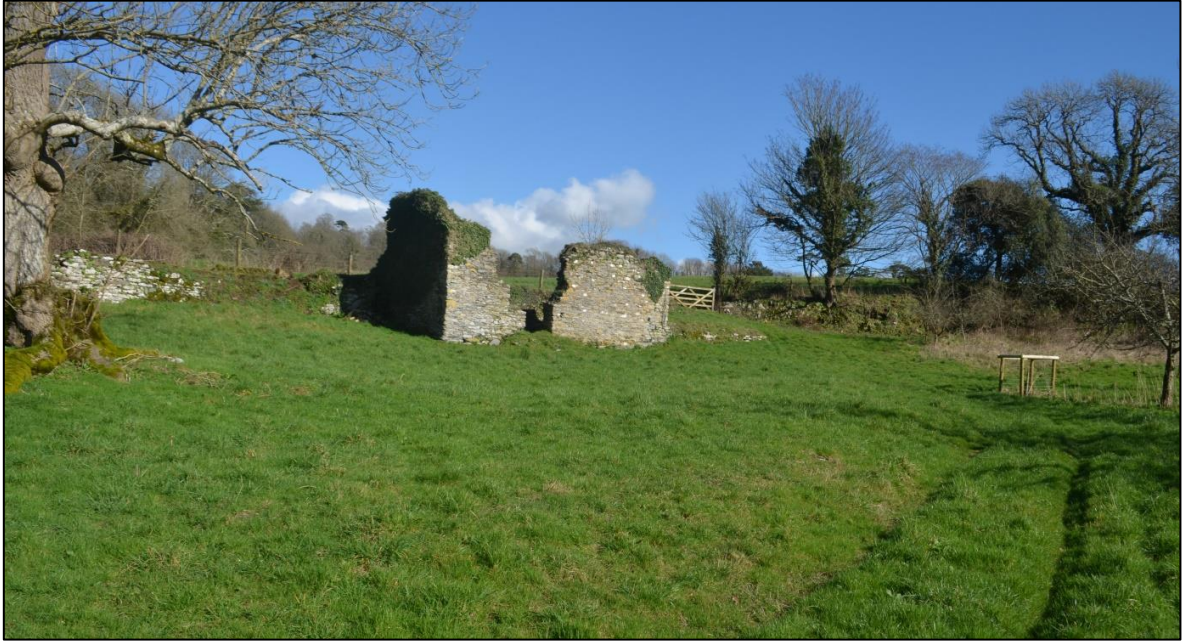
A part of Bickham Barn is still standing although historic mapping shows that the eastern end has been truncated. A new access appears to have been formed at first floor level on this elevation with a raised platform indicating the area which the building previously occupied. The barn is built into a bank on its rear (northern) elevation. The barn is currently roofless and in very poor condition with the front (south) elevation appearing to part company from the western gable

FIGURE 74: THE SETTING OF BICKHAM BARN SHOWING THE EXTENT OF THE SURVIVING FABRIC; FROM THE SOUTH WEST.

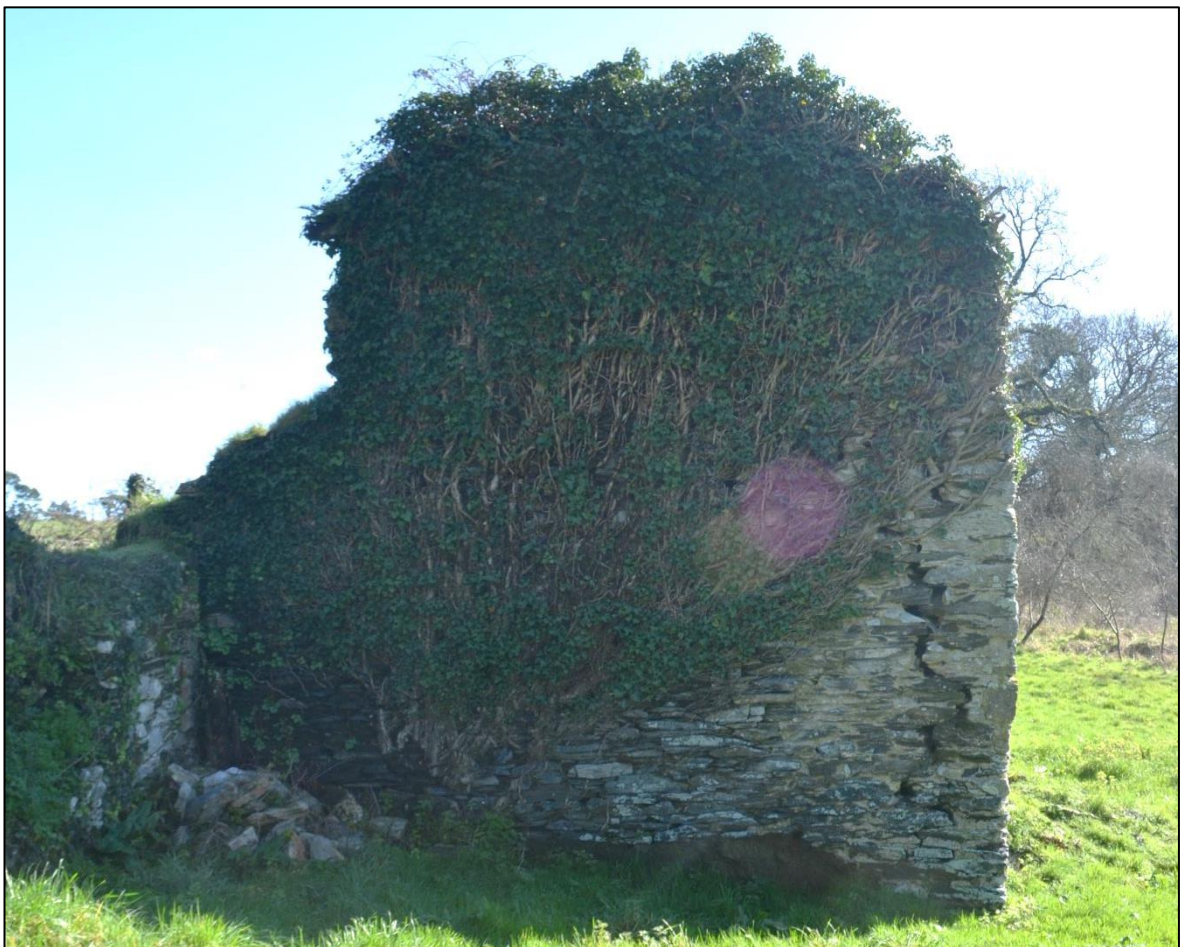
FIGURE 75: BICKHAM BARN SHOWING THE FRONT (SOUTH) ELEVATION PARTING FROM THE WESTERN ELEVATION.

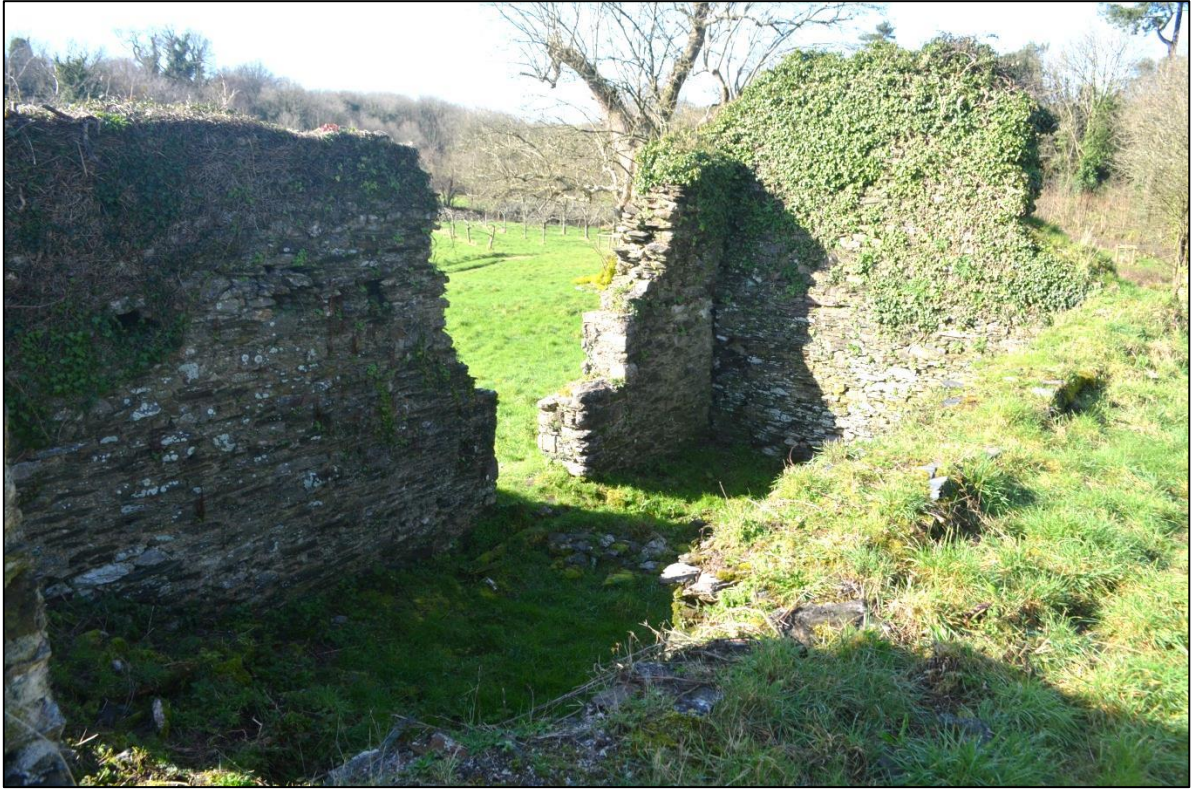
FIGURE 76: THE INSIDE OF BICKHAM BARN; FROM THE NORTH EAST

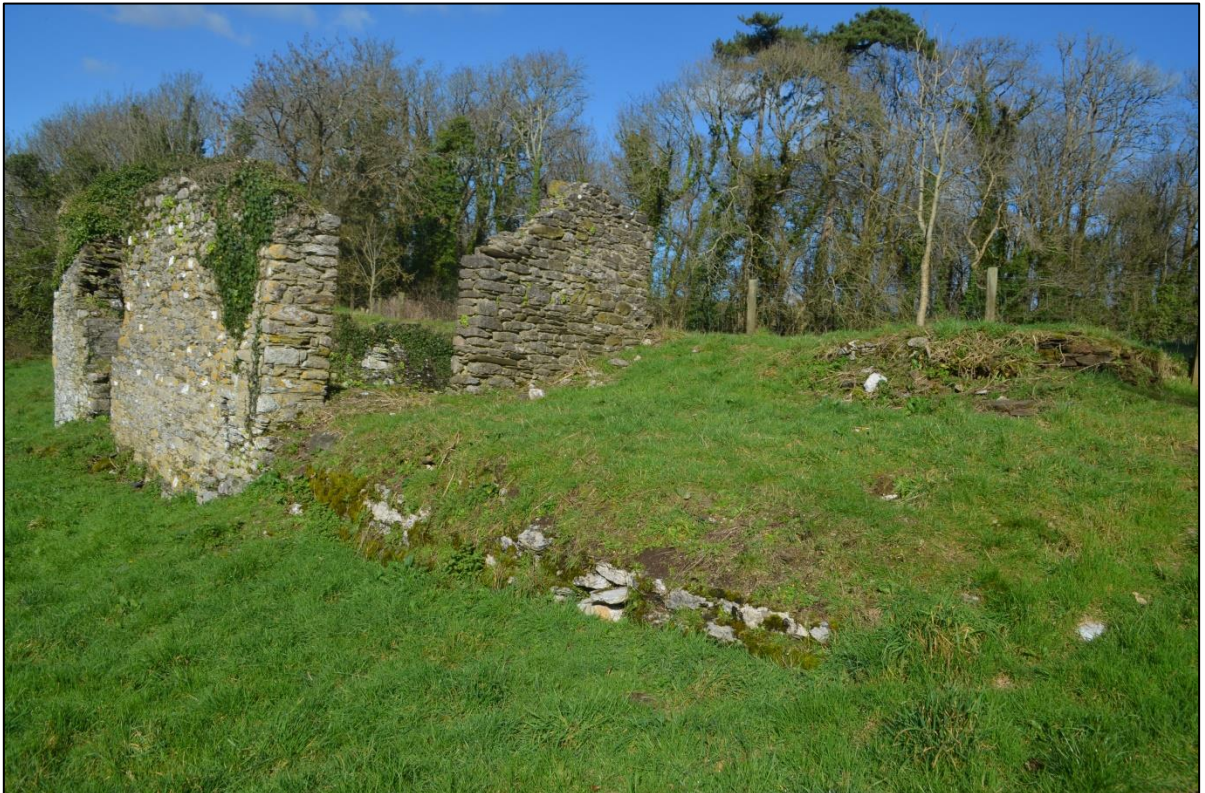
FIGURE 77: THE TRUNCATED EASTERN END OF BICKHAM BARN SHOWING THE CONTINUING STONEMWORK OF THE FORMER EXTENT OF THE STRUCTURE, FROM THE SOUTH-EAST.

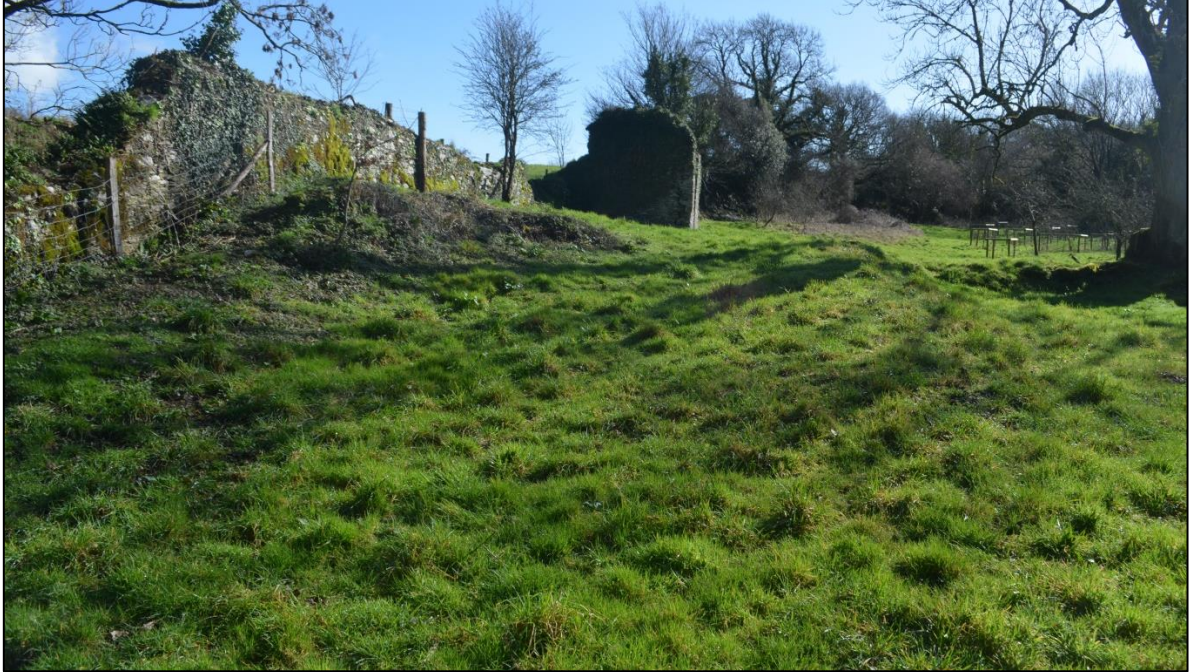
Part of a boundary at Bickham farmstead shown on the Ordnance Survey First Edition map survives as a low earthwork. The boundary extends south from the surviving stone faced boundary wall and has a tree growing upon it.

FIGURE 78: BOUNDARY SHOWN ON 1ST EDITION OS MAP SURVIVES AS A LOW EARTHWORK TOPPED WITH A TREE.

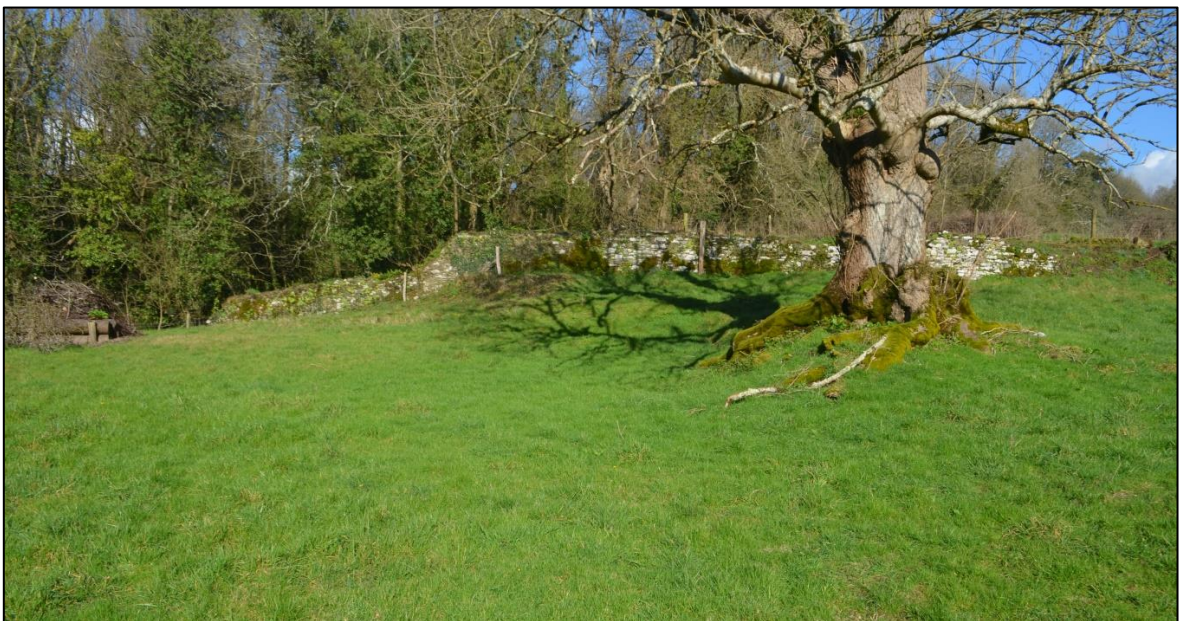
Part of a boundary at Bickham farmstead shown on the Ordnance Survey First Edition map survives as a low earthwork. The boundary extends east west parallel with the surviving stone faced boundary wall and intersects at a right angle with the boundary discussed above.

FIGURE 79: BOUNDARY SHOWN ON 1ST EDITION OS MAP SURVIVES AS A LOW EARTHWORK PARALLEL WITH THE STONE FACED BOUNDARY BANK.

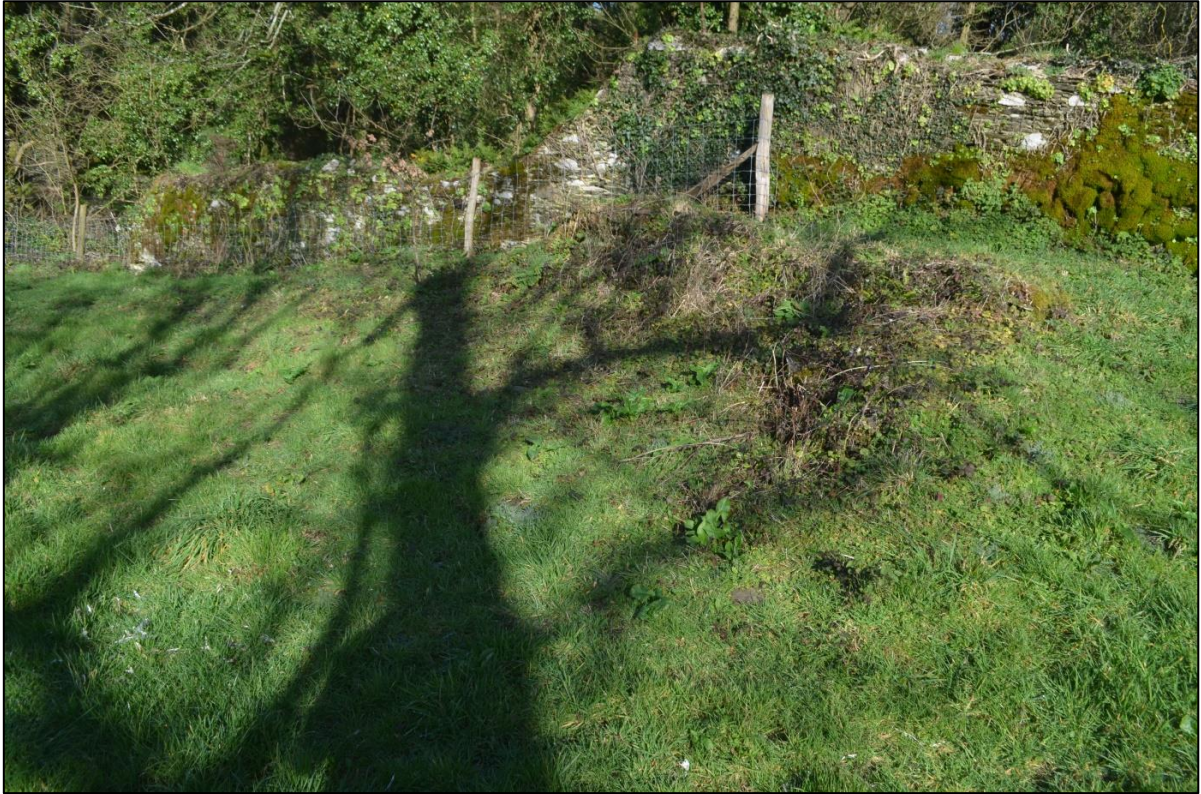
Part of a boundary at Bickham farmstead shown on the Ordnance Survey First Edition map survives as a short low earthwork with visible stone work construction in places . It appears to turn a right angle to the west at its northern end, adjacent to or intersecting with the standing stone faced boundary bank.

FIGURE 80: PROBABLE PART OF A BOUNDARY SHOWN ON THE OS 1ST EDITION MAP WITH SMALL AREAS OF STONE CONSTRUCTION JUST VISIBLE.

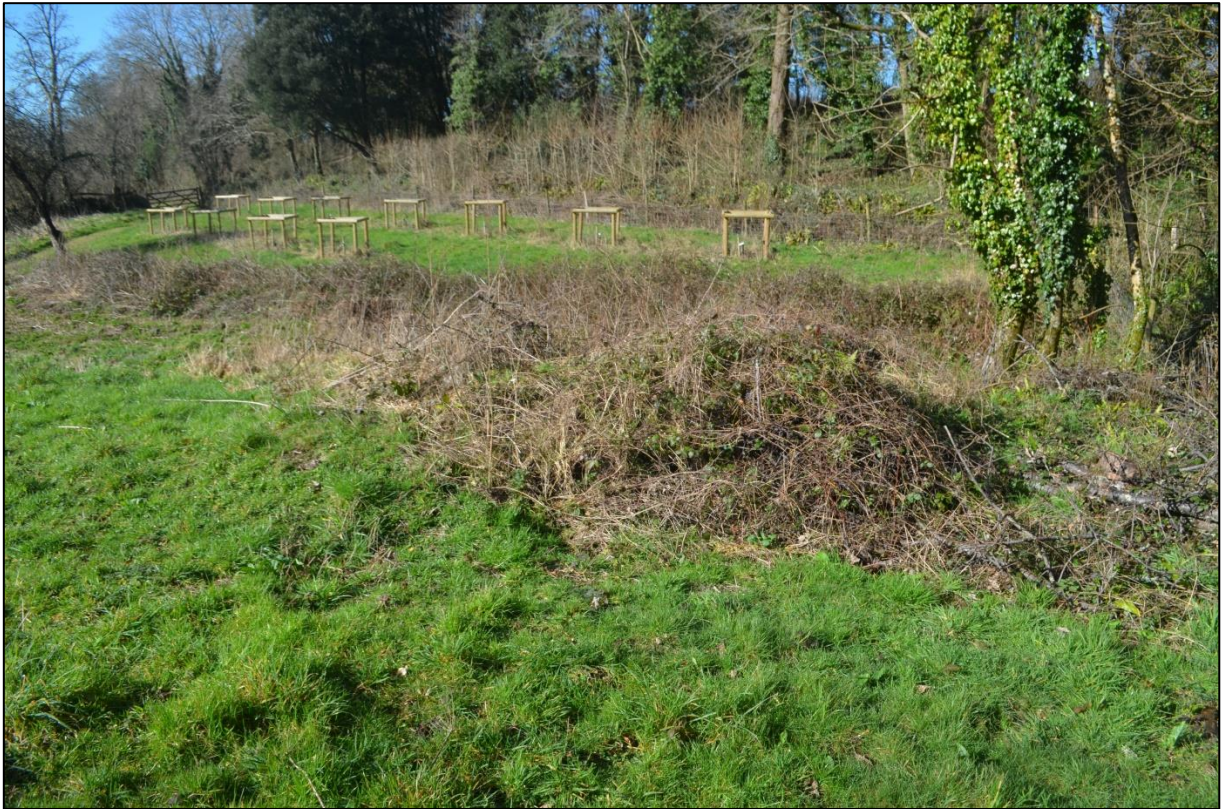
A vegetation covered mound c.2m in diameter containing visible stone is located in the north western area of Higher Orchard. It is unclear whether a structure is shown in this location on the Ordnance Survey First Edition map or whether it is a function of the vegetation shading however it appears to be the meeting point of a number of boundaries shown on that map. There is no structure shown on subsequent historic mapping.

FIGURE 81: VEGETATION COVERED MOUND IN THE NORTH WESTERN AREA OF HIGHER ORCHARD; FROM THE EAST.

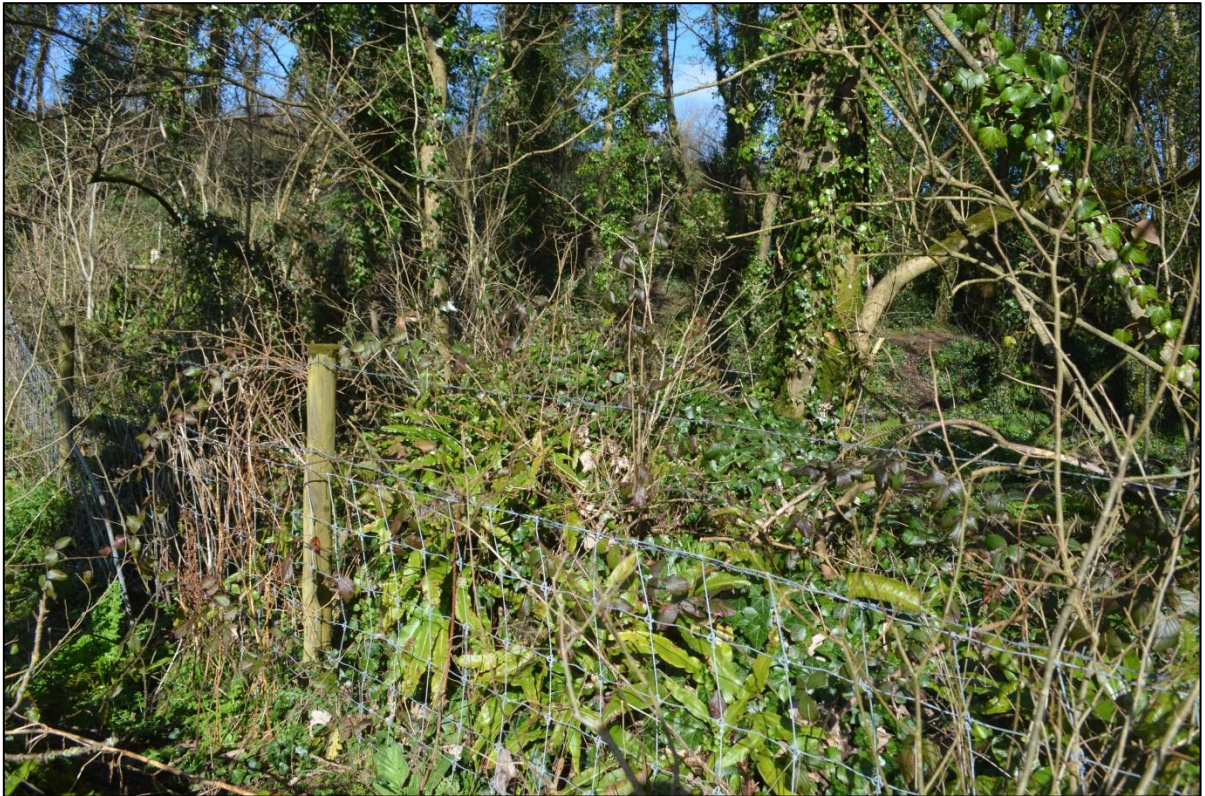
A small, vegetation covered mound c.1.5m diameter is located along the boundary between Higher Orchard and The Dell, close to the stream which runs through the valley. It is possible this represents the former extension of the stone boundary wall down to the stream.

FIGURE 82: SMALL MOUND LOCATED ALONGSIDE THE BOUNDARY BETWEEN HIGHER ORCHARD AND THE DELL.

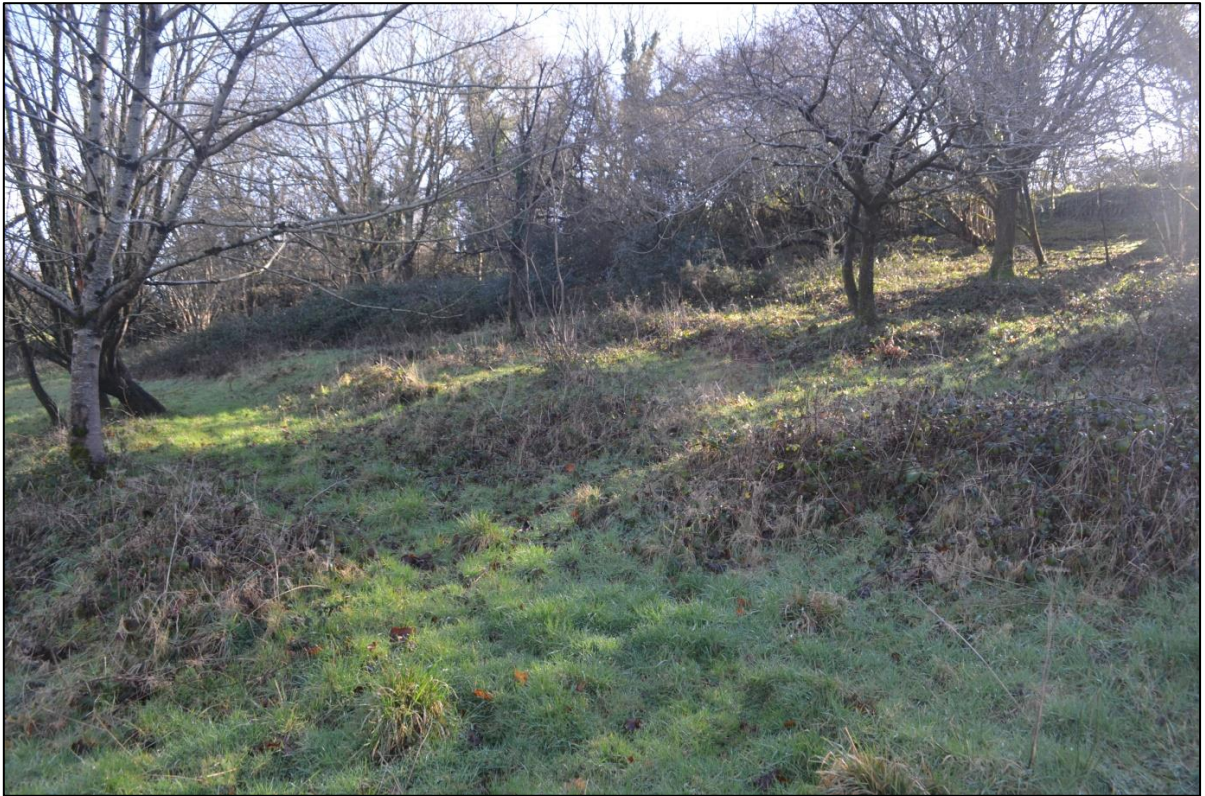
Slight terraces c.2-3m wide are visible on slopes at the south eastern end of Lower Orchard. This terracing is evident on 1946 aerial photographs and appears to have run the entire length of the southern half of Lower Orchard at this date. The trees growing along these terraces appear to be aligned with each other in the down slope direction. The terraces are slight but emphasised by scrub growth on their downslope sides.

FIGURE 83: TERRACING IN LOWER ORCHARD, PARTICULARLY VISIBLE AT THE SOUTH EASTERN END. FROM THE WEST.

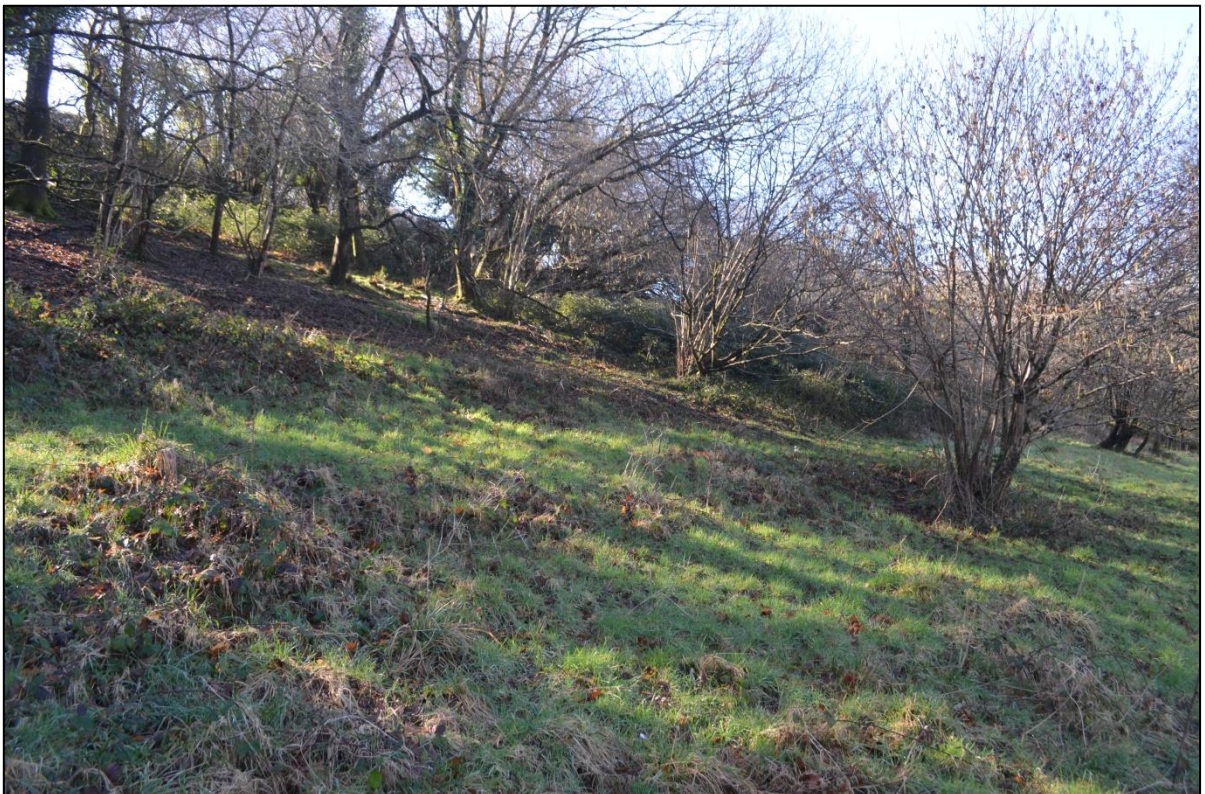
FIGURE 84: TERRACING IN LOWER ORCHARD, PARTICULARLY VISIBLE AT THE SOUTH EASTERN END. FROM THE EAST.

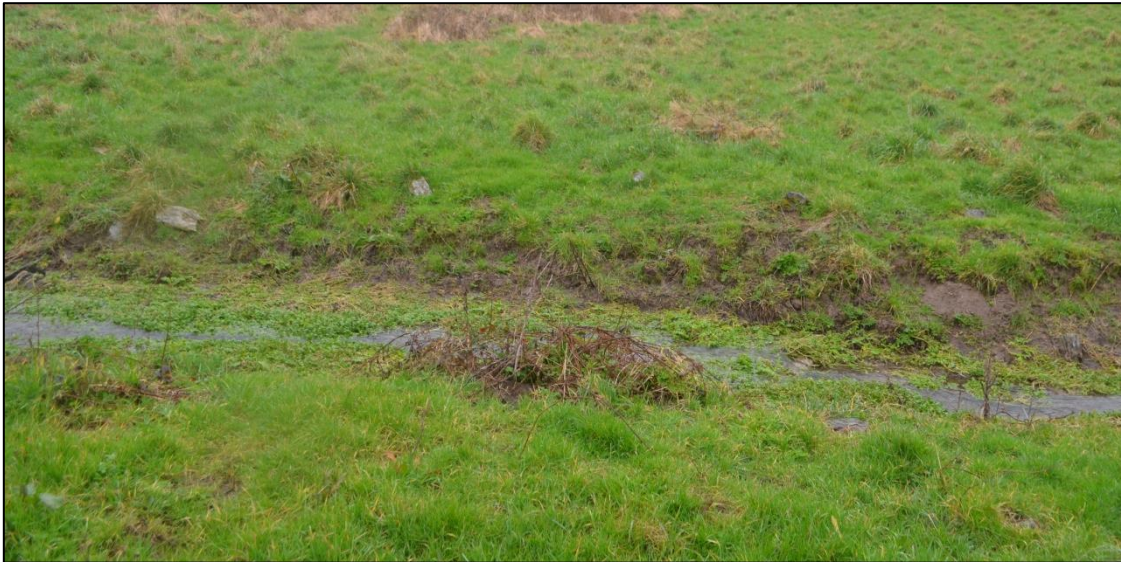
A number of stones appear to have been exposed alongside the stream in Lower Orchard; one has a circle painted on it. The stones appear to be spaced at relatively regular intervals however it is unclear whether this is natural or archaeological; it may be a feature of erosion from livestock accessing the watercourse although it does not appear to have occurred in the adjacent field.

FIGURE 86: LINE OF EXPOSED STONES ON THE SOUTHERN SIDE OF THE STREAM IN LOWER ORCHARD. FROM THE NORTH.

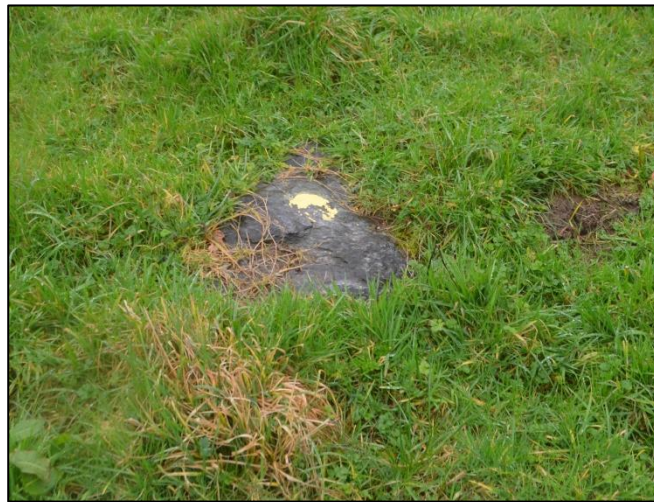
FIGURE 87: EXPOSED STONE ON THE NORTHERN SIDE OF THE STREAM WITH PAINTED CIRCLE. FROM THE NORTH.

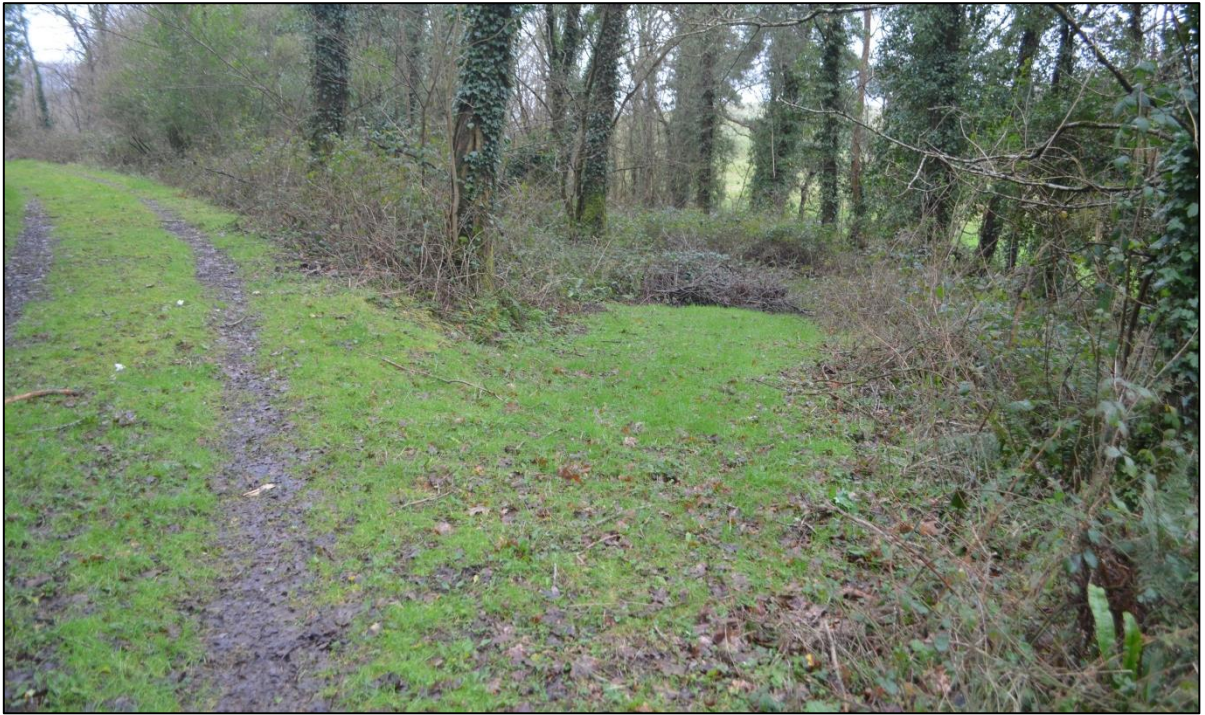
A short section of path leads off to the west from the path through Sellar Acres Plantation, terminating in dense vegetation close to the stream which runs along the northern boundary of the plantation. This appears to be part of the original pathway which ran at right angles through Sellar Acres, meeting in the centre. It is now very overgrown with brambles and a large tree limb appears to have either fallen or been left on it, further obscuring it.

FIGURE 88: PART OF THE PATHWAY THROUGH SELLAR ACRES, NOW TRUNCATED AND OVERGROWN. FROM THE EAST.

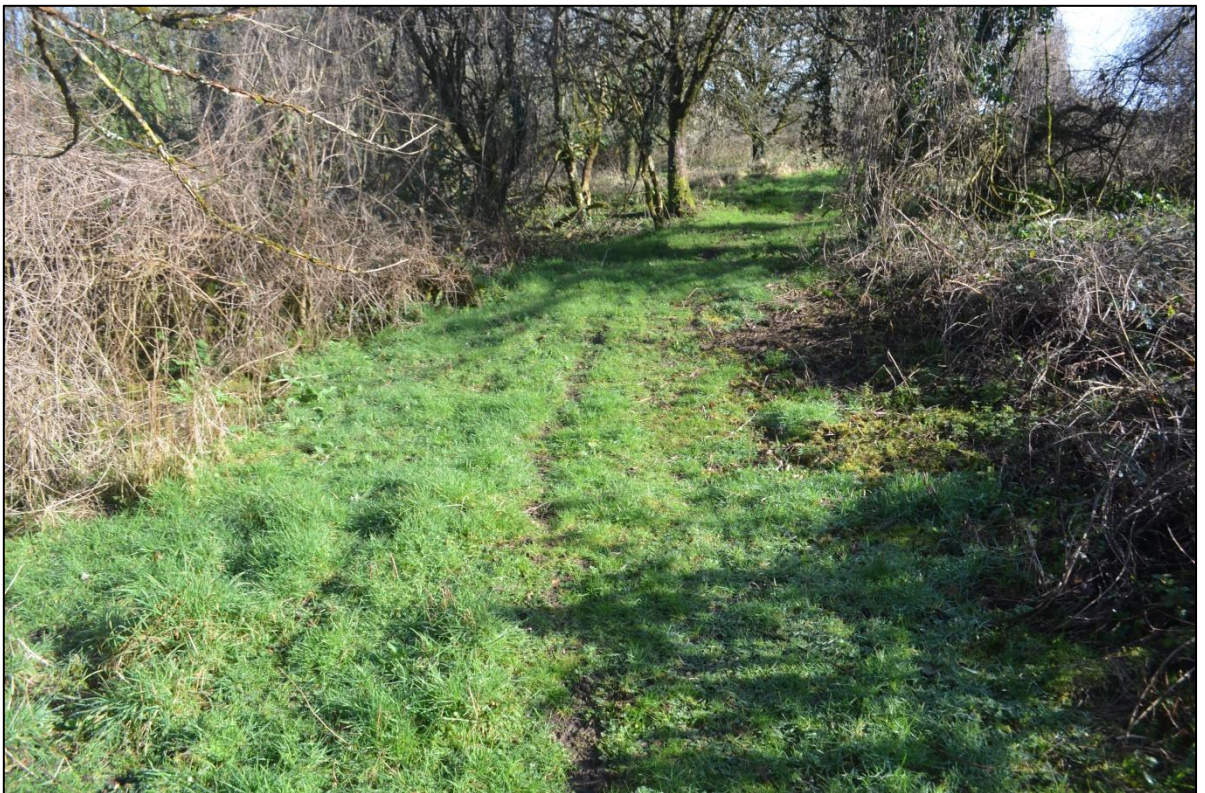
A short section of pathway leads to the top of the original extent of the Sellar Acres Plantation at a 45 degree angle to the original path which ran through the centre but has been truncated. This path does not appear on any Ordnance Survey mapping and appears to have been cut into the slope on one side but does not have any built form.

FIGURE 89: PATHWAY, POSSIBLY RELATIVELY MODERN LEADING UPHILL FROM THE ORIGINAL MARKED PATHWAY THROUGH SELLAR ACRES AT A 45 DEGREE ANGLE.

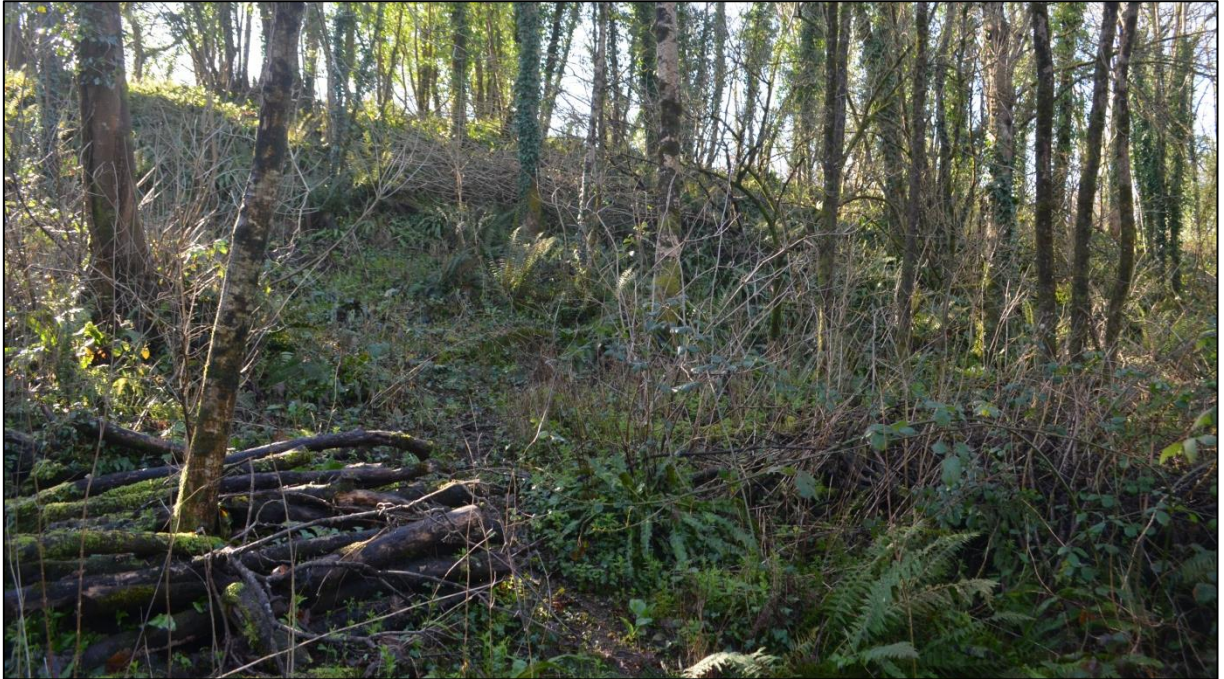
It is possible that the slopes in this area of Sellar Acres may have been subject to historic quarrying as ground appears to slope more steeply than the surrounding areas however as it is densely covered with brambles and scrub it is difficult to see the ground surface and it is therefore possible that this change in slope is geological or is the result of a landslip.

FIGURE 90: POSSIBLE QUARRYING AT THE EASTERN END OF SELLAR ACRES PLANTATION. FROM THE NORTH.

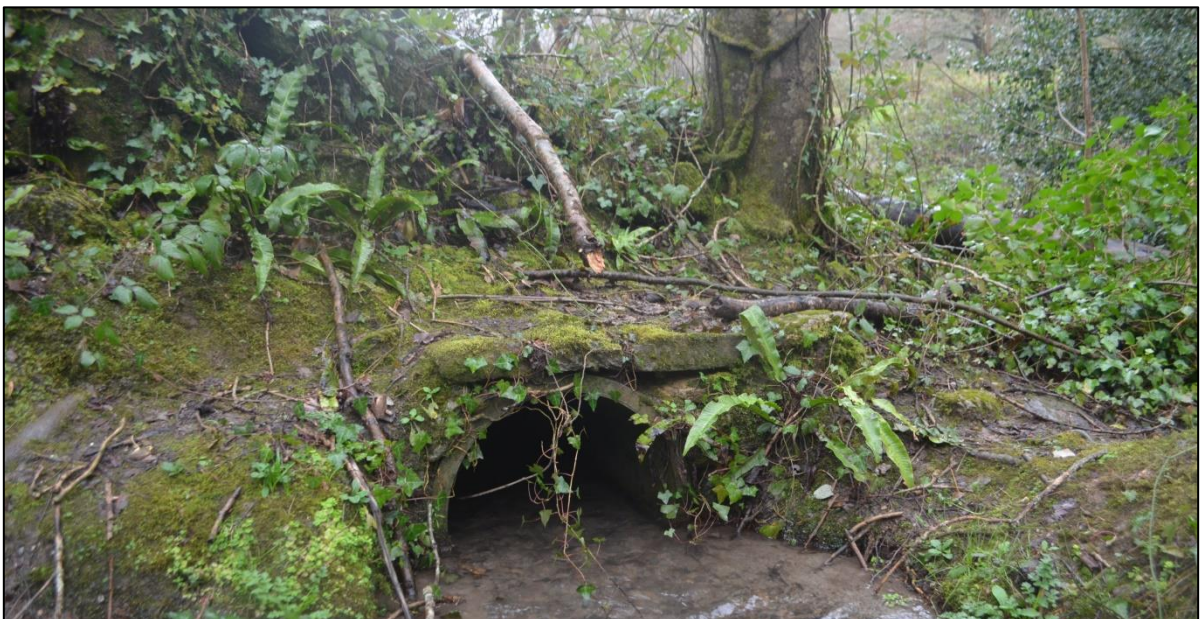
A stone faced boundary which crosses over the course of a stream appears to have a modern half pipe inserted to enable the stream to pass underneath. It is probable this dates to the change to the stream's to permit the development of the Chelston Meadows landfill site.

FIGURE 91: STONE FACED BOUNDARY BANK WITH HALF PIPE INSERTED TO ALLOW STREAM TO PASS UNDER. FROM THE WEST.
