THE DELL/HAPPY VALLEY AND SURROUNDING PARKLAND SALTRAM DEVON

Archaeological and Historic Landscape Survey

South West Archaeology Ltd. report no. 210317

By F. Balmond, MCifA
Report Version: FINAL
Draft Issued: 17th March 2021
Report Finalised: 28th April 2021

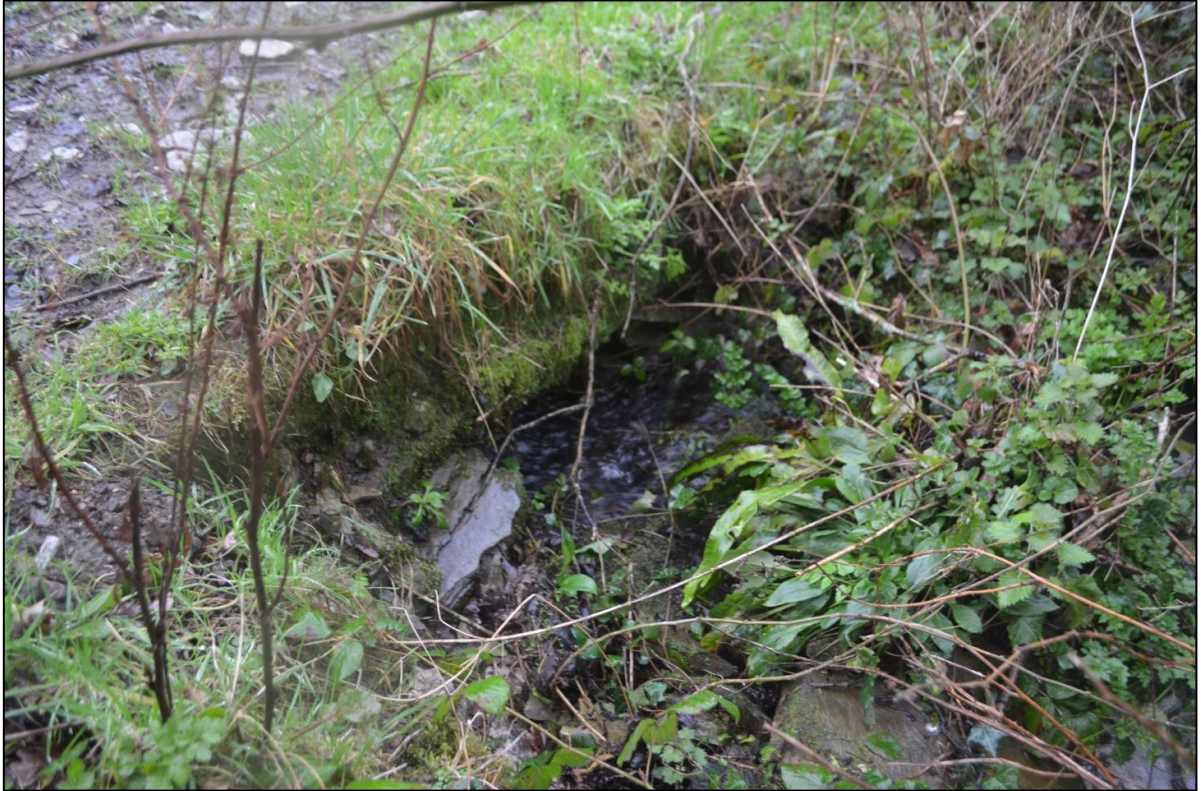
53. Stream culverted under boundary between Sellar Acres Plantation and Lower Orchard
SX 5218 5494

The historic course of the stream appears to take it underneath the boundary bank between Lower Orchard and Sellar Acres Plantation. The culvert appears to be of stone rubble construction and is covered with moss and vegetation.

FIGURE 92: THE HISTORIC COURSE OF THE STREAM TAKES IT THROUGH THE BOUNDARY BETWEEN SELLAR ACRES PLANTATION AND LOWER ORCHARD, FROM THE WEST.

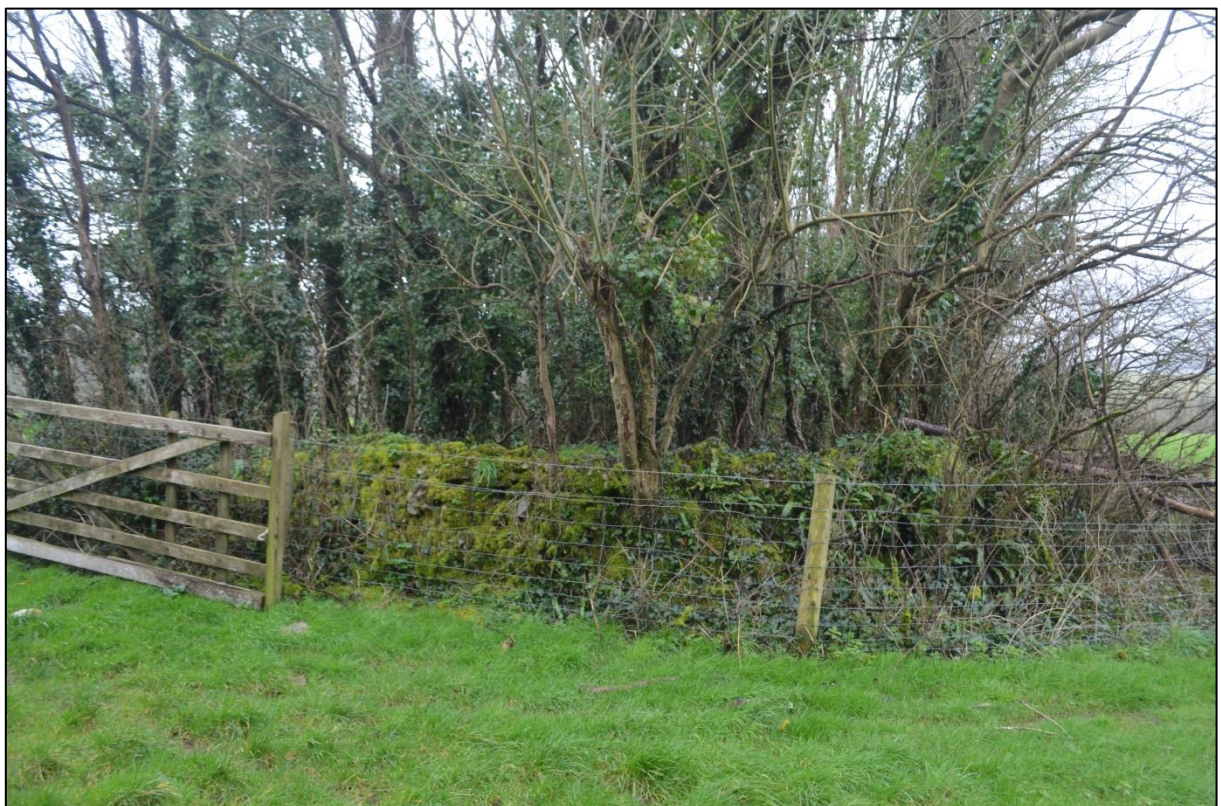
Wixenford Brake comprises two areas of woodland, a larger area to the east, shown on the 1784-6 Ordnance Survey map and a smaller area to the west, first shown on the Tithe map. Both are enclosed by substantial stone faced banks, in generally good condition. Modern timber and wire fences have additionally been added around Wixenford Brake to allow cattle grazing within the fields which surround the plantations. A wide access between Sellar Acres and Great Down separates the two areas of Wixenford Brake. Three possible archaeological features were identified in Wixenford Brake, all within the eastern section of the plantation.

FIGURE 93: STONE FACED BANK WITH MODERN FENCING ON THE EASTERN END OF THE WESTERN SECTION OF WIXENFORD BRAKE. FROM THE EAST.

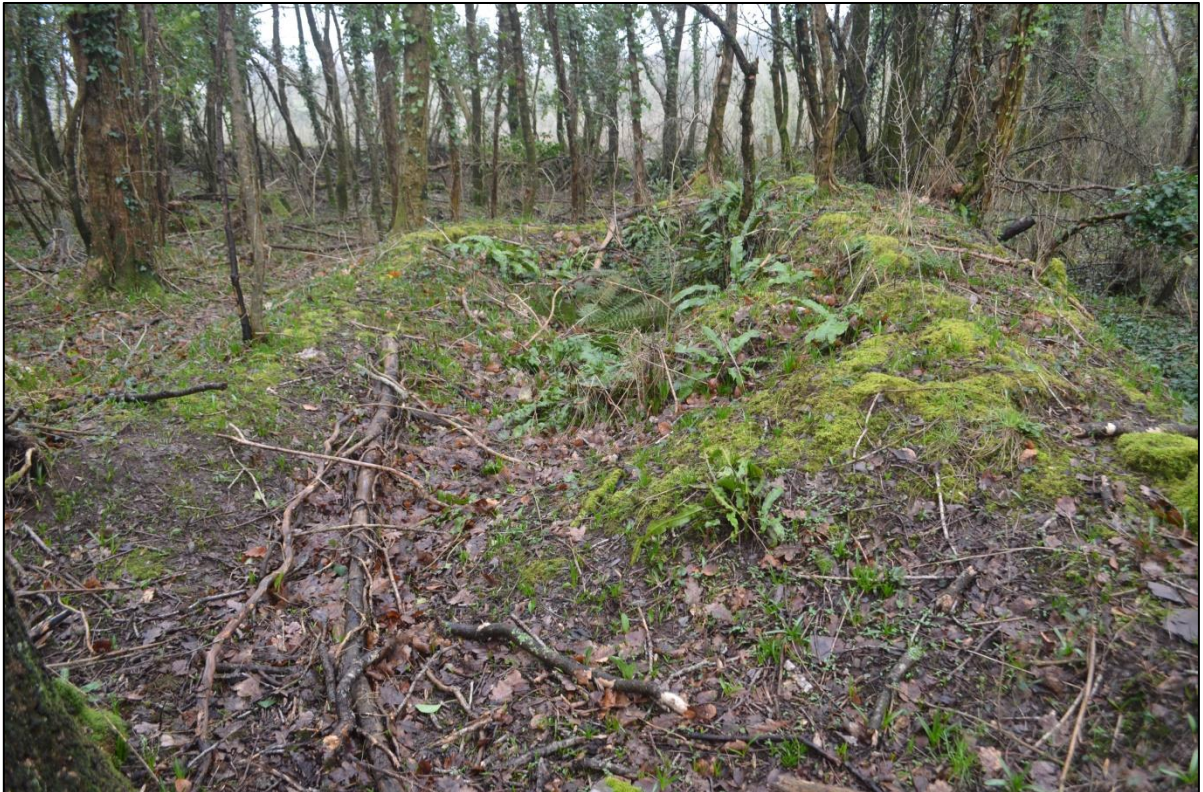
A possible rectangular structure abuts the western side of the stone faced bank at the eastern end of Wixenford Brake. It appears to consist of earth banks c.5m x 2.5m x 1m in height with a rectangular depression in the centre. It is unclear what this represents as there are no structures or buildings shown on historic mapping in this location.

FIGURE 94: POSSIBLE STRUCTURE AT EASTERN END OF WIXENFORD BRAKE; FROM THE SOUTH.

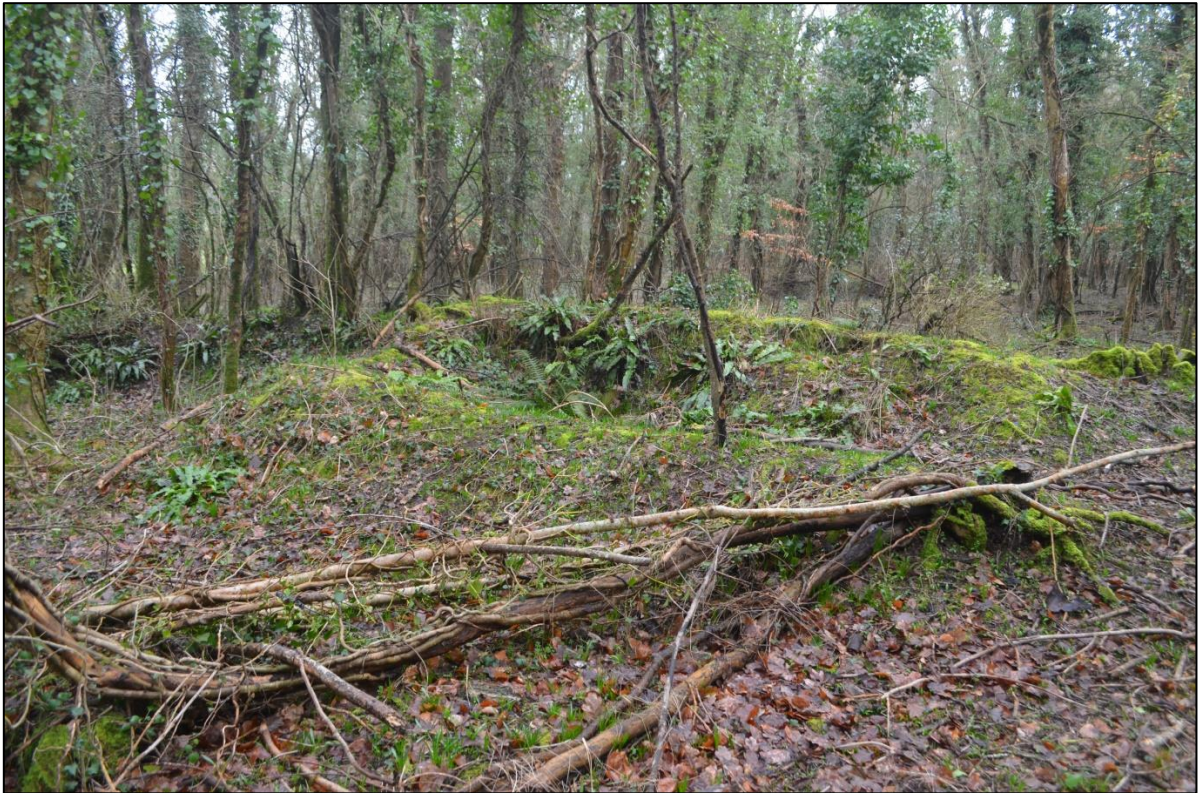
FIGURE 95: POSSIBLE STRUCTURE AT EASTERN END OF WIXENFORD BRAKE; FROM THE WEST.

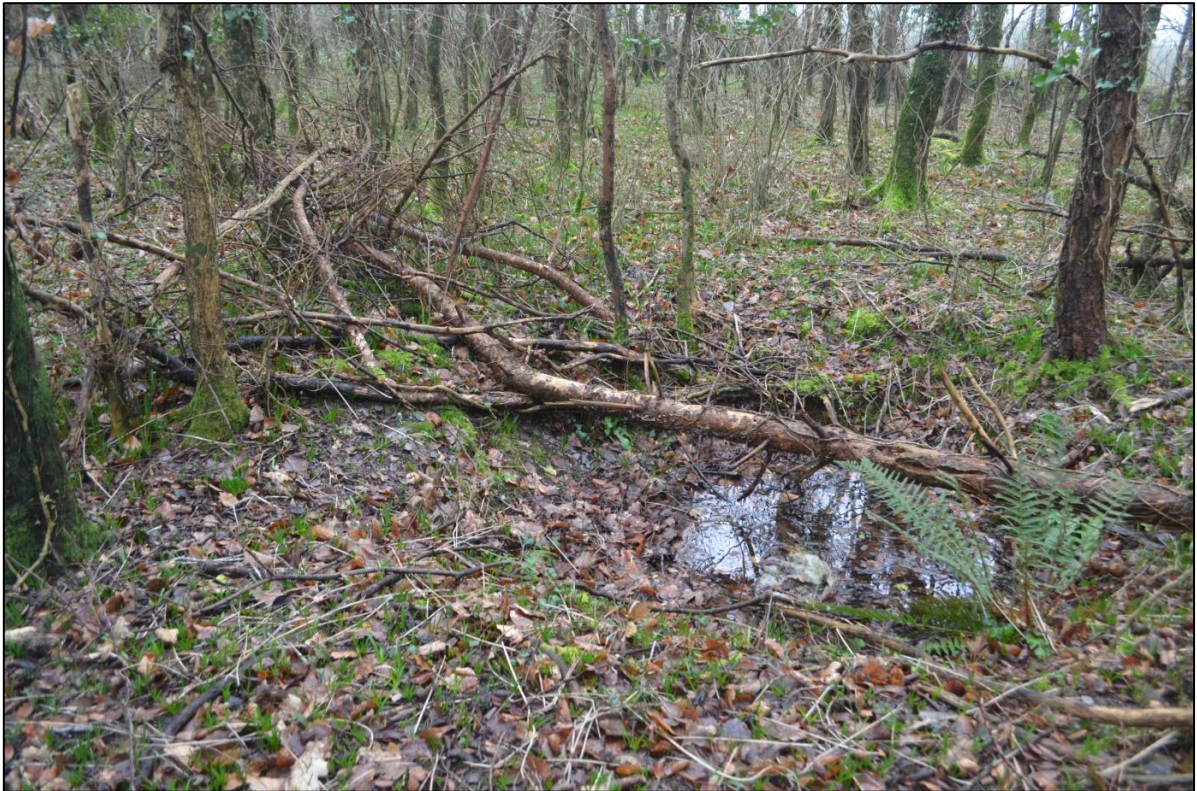
An approximately square depression c.2m square is located towards the eastern end of the eastern Wixenford Brake plantation. There appears to be a slight bank on the eastern side of the hollow, which itself is filled with water. It is possible that this feature could be natural in origin (e.g. eroded tree throw) however its seemingly square shape suggests it could be archaeological and of unknown date/function. 'Dug out' features relating to the US military occupation of the site during World War Two have been noted on the estate however although this feature appears potentially similar in form to a 'dug out/foxhole' it appears to be the only feature with this form within Wixenford Brake.

FIGURE 96: APPROXIMATELY SQUARE HOLLOW AT THE EASTERN END OF WIXENFORD BRAKE, WITH SLIGHT BANK ON THE EASTERN SIDE; FROM THE NORTH.

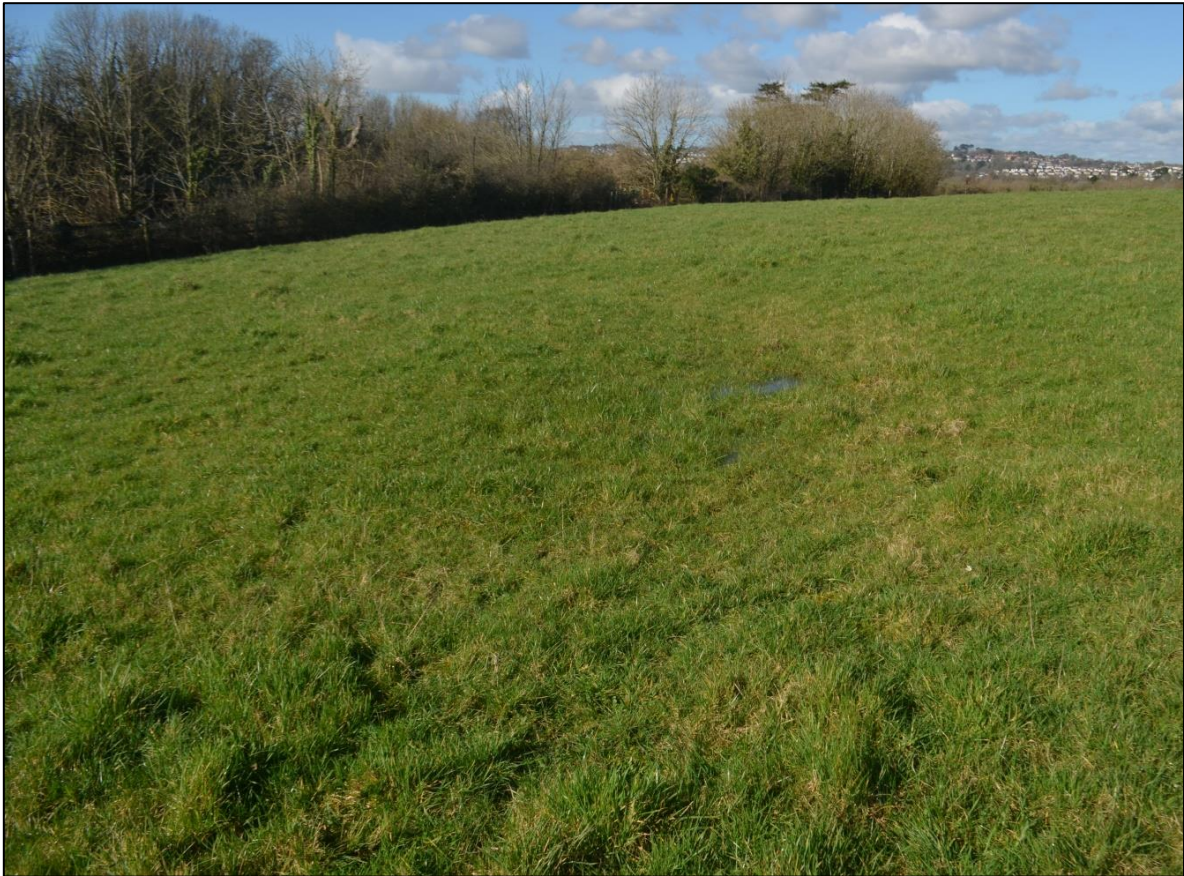
FIGURE 97: POSSIBLE RECTANGULAR SHAPED DEPRESSION IN SOUTHERN AREA OF GREAT DOWN. IT CAN JUST BE SEEN TO HOLD WATER IN THE CENTRE OF THE IMAGE; FROM THE SOUTH.

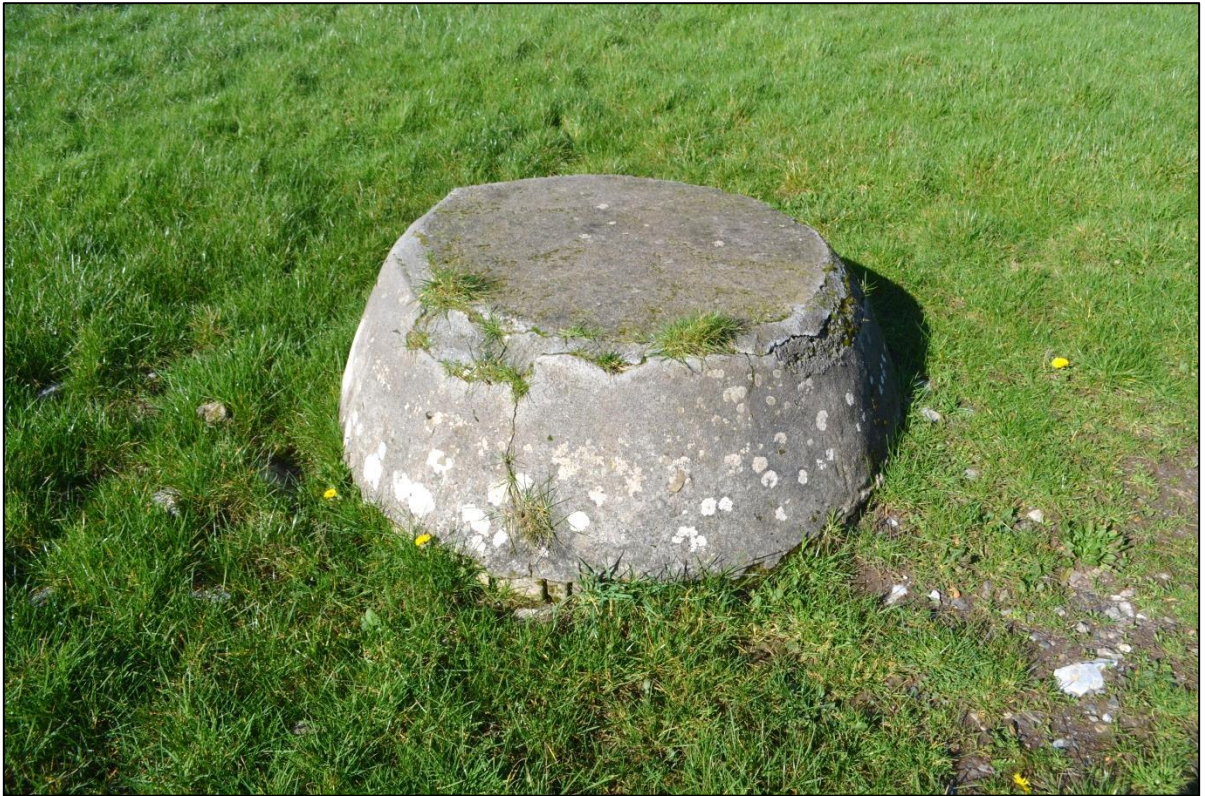
An approximately circular concrete covered feature was observed in the centre of Furze Down. This corresponds with a well-marked on the Ordnance Survey First Edition map and is therefore likely to be the capping of a well.

FIGURE 98: CONCRETE COVERED FEATURE, PRESUMED WELL CAPPING, IN FURZE DOWN

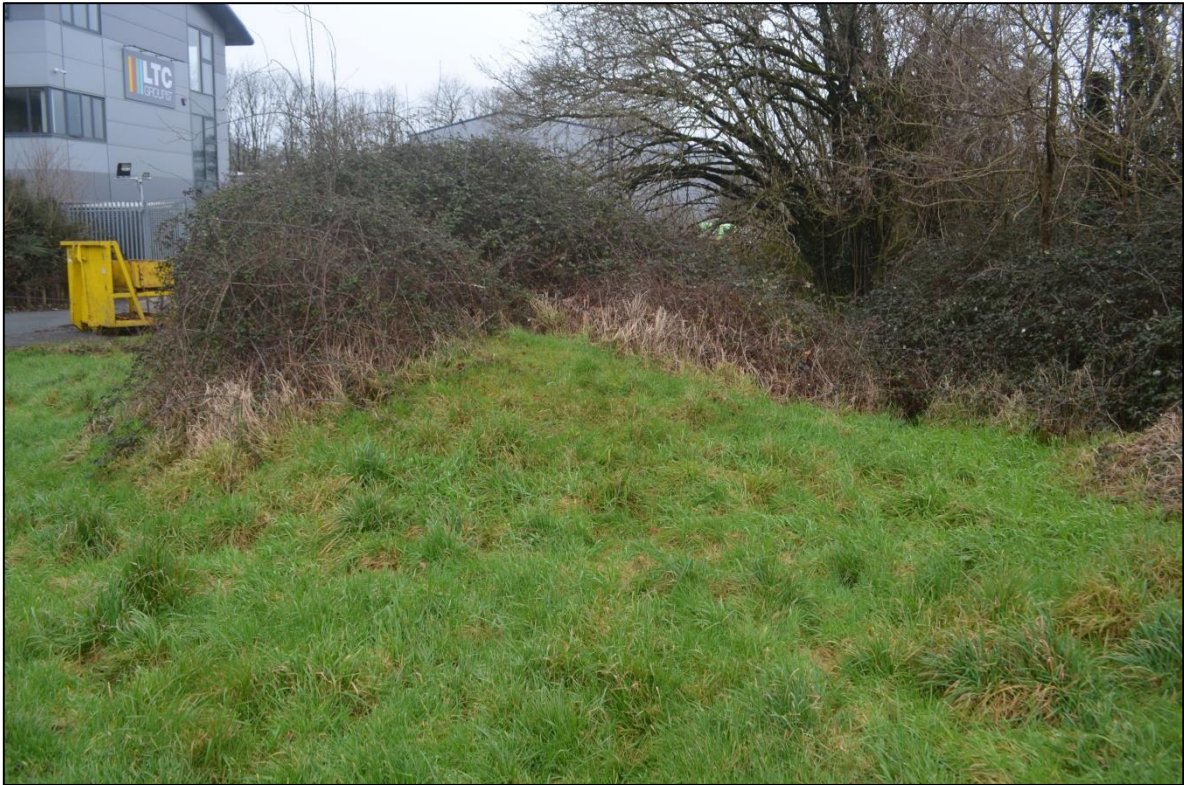
A large mound up to c.1.5m in height is located in the north western corner of Mowhay Meadow/Part Dean. It appears to contain stony material but is covered in a dense thicket of brambles so nothing further about its form could be determined. It is possible this mound represents a dump of material, possibly from Wixenford Farm or removal of boundaries in this area as no structure is shown in this location on historic mapping.

FIGURE 99: MOUND CONTAINING STONY MATERIAL, COVERED IN BRAMBLES, IN THE NORTH WEST OF MOWHAY MEADOW. FROM THE EAST.

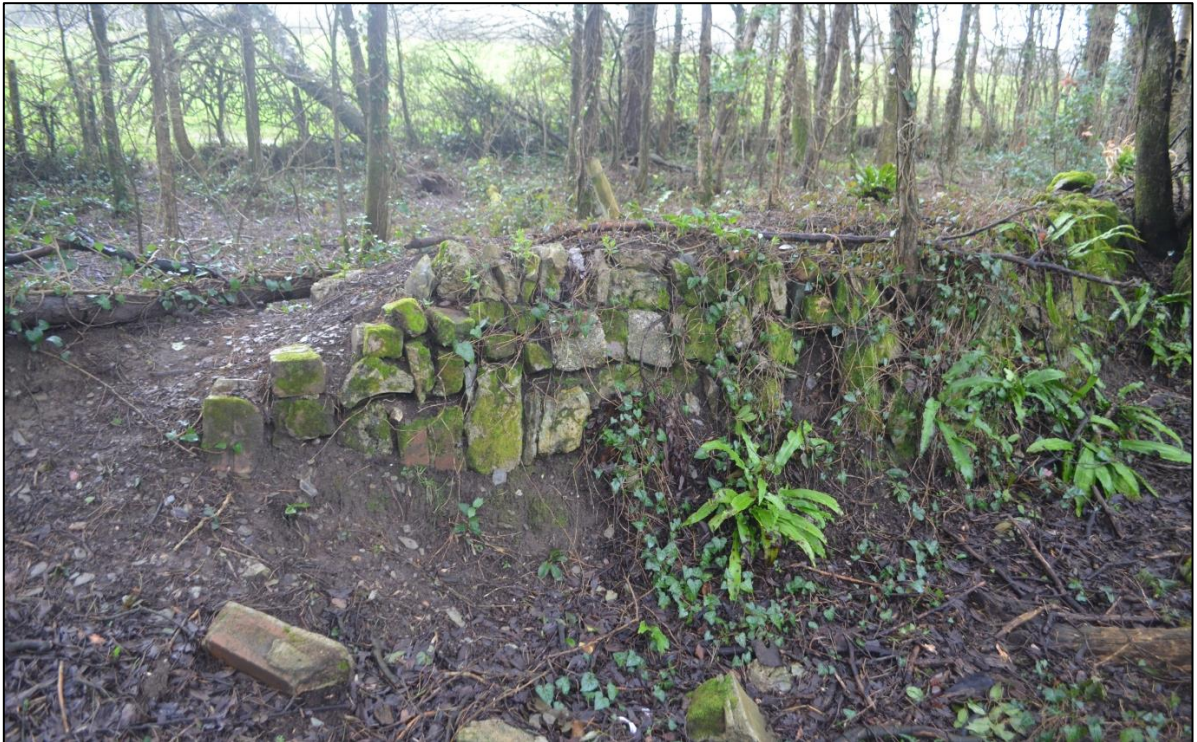
64. Presumed repairs to boundary bank

Presumed repairs to the stone faced boundary bank in this area appear to have utilised a range of non-traditional materials including brick and concrete, most of which appears to have failed and is collapsing.

FIGURE 100: BOUNDARY BANK ON NORTHERN EDGE OF NEW PARK, FROM THE NORTH.

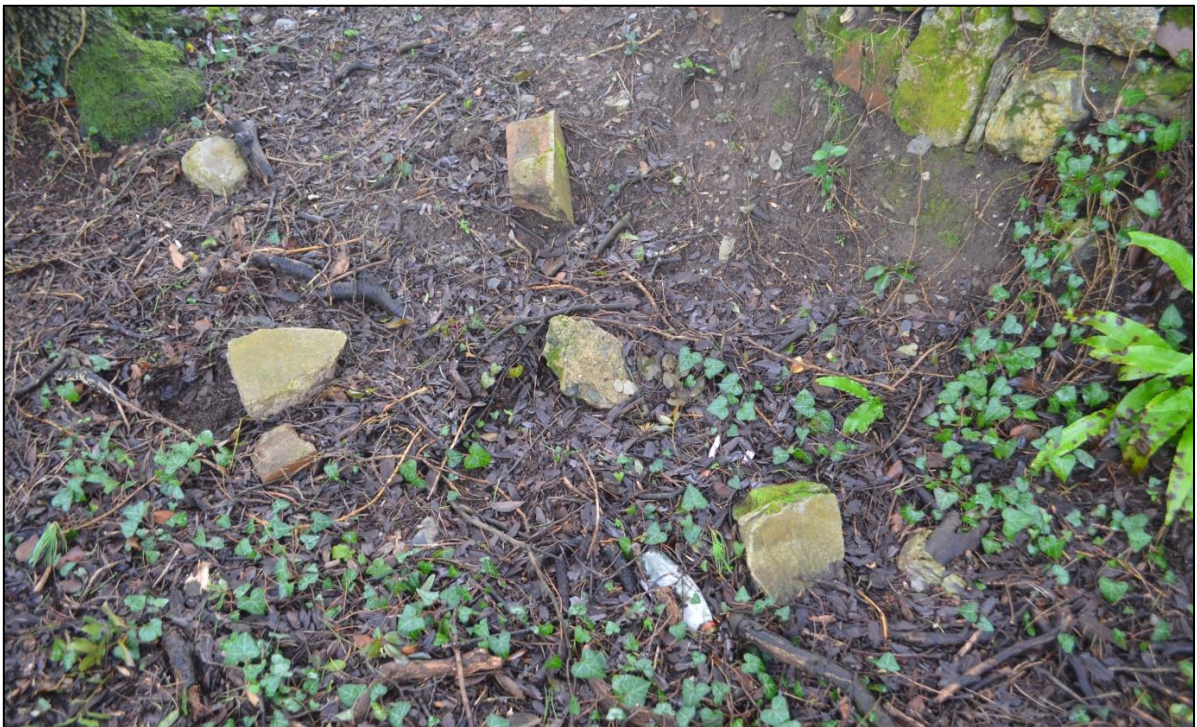
FIGURE 101: BOUNDARY BANK ON NORTHERN EDGE WITH MATERIALS FALLING OUT OF THE BOUNDARY, FROM THE NORTH.
