## Archaeological Test Pitting at Adworthy Brook, Witheridge, Devon

P. Webb, South West Archaeology Ltd., 07.04.22

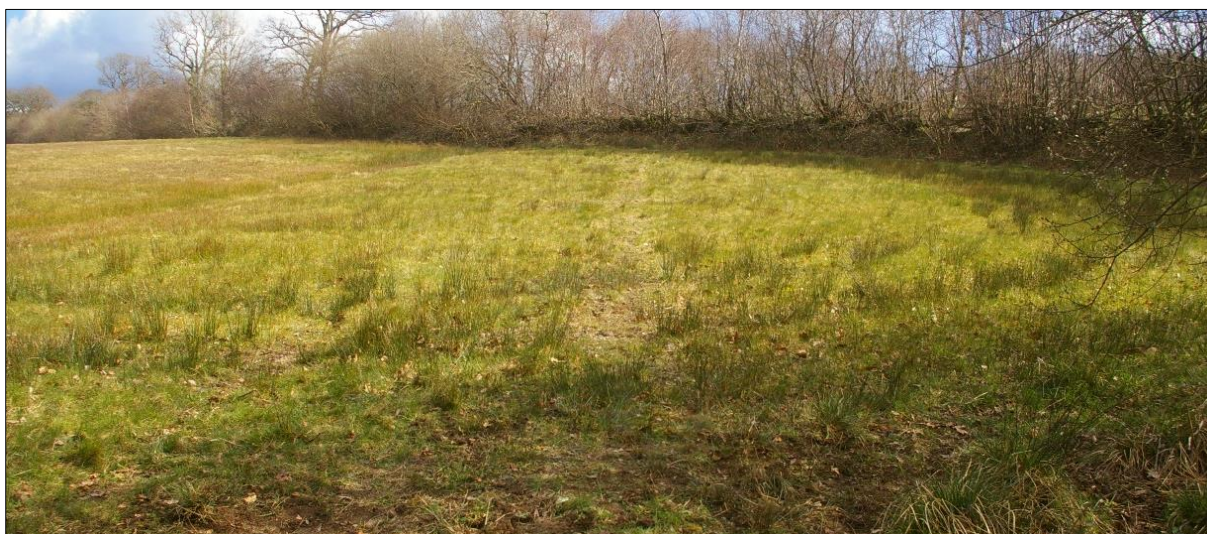
FIGURE 1: VIEW ALONG THE VISIBLE STRETCH OF THE WATER PIPE TRENCH; VIEWED FROM THE NORTH-WEST (NO SCALE).

The trench for the water pipe is a visible feature in the field. The western stretch from the gated entrance in the north-western corner of the field, up to the southern boundary, is readily identifiable as a slight linear parchmark in the grass. However, it was not clearly identifiable where it runs along the southern boundary. The three test pits were excavated where the line of the pipe trench was obvious, and to avoid unnecessary additional disturbance.

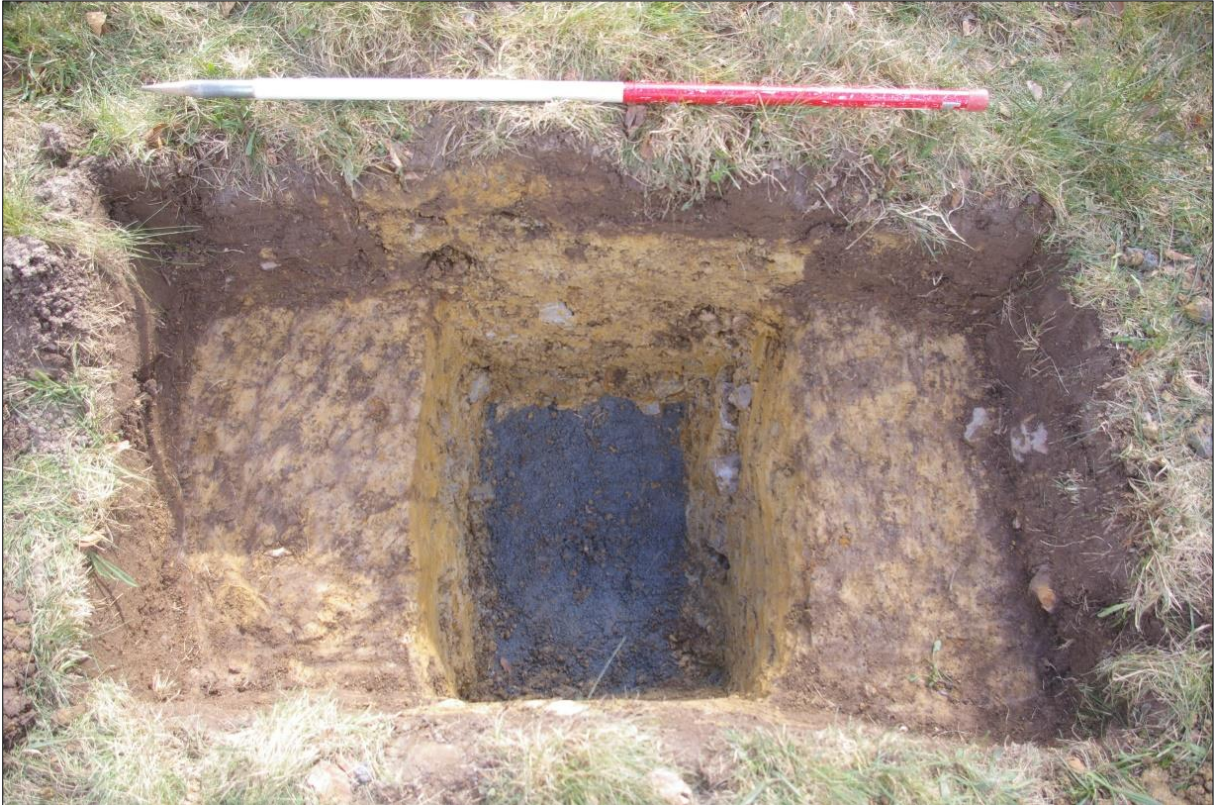
FIGURE 2: TEST-PIT 01, MID-EXCAVATION SHOWING AGGREGATE COVERING WATER PIPES; VIEWED FROM THE NORTH-WEST (1M SCALE).

The fills of the pipe trench were consistent across all three test-pits. They comprised (104/204/304) a replaced soft-friable mid slightly greyish-brown clay silt turf/topsoil 0.14-0.18m thick with occasional patches of re-deposited natural clay. Below this was (105/205/305), redeposited firm mid yellow clay natural c.0.65m thick with occasional sub-angular stone inclusions and lenses of topsoil. At its based was (106/206/306), a compact light grey and wet stony aggregate grit c.0.10m thick, which surrounded the two alkathene water pipes. No finds were recovered during the excavations.

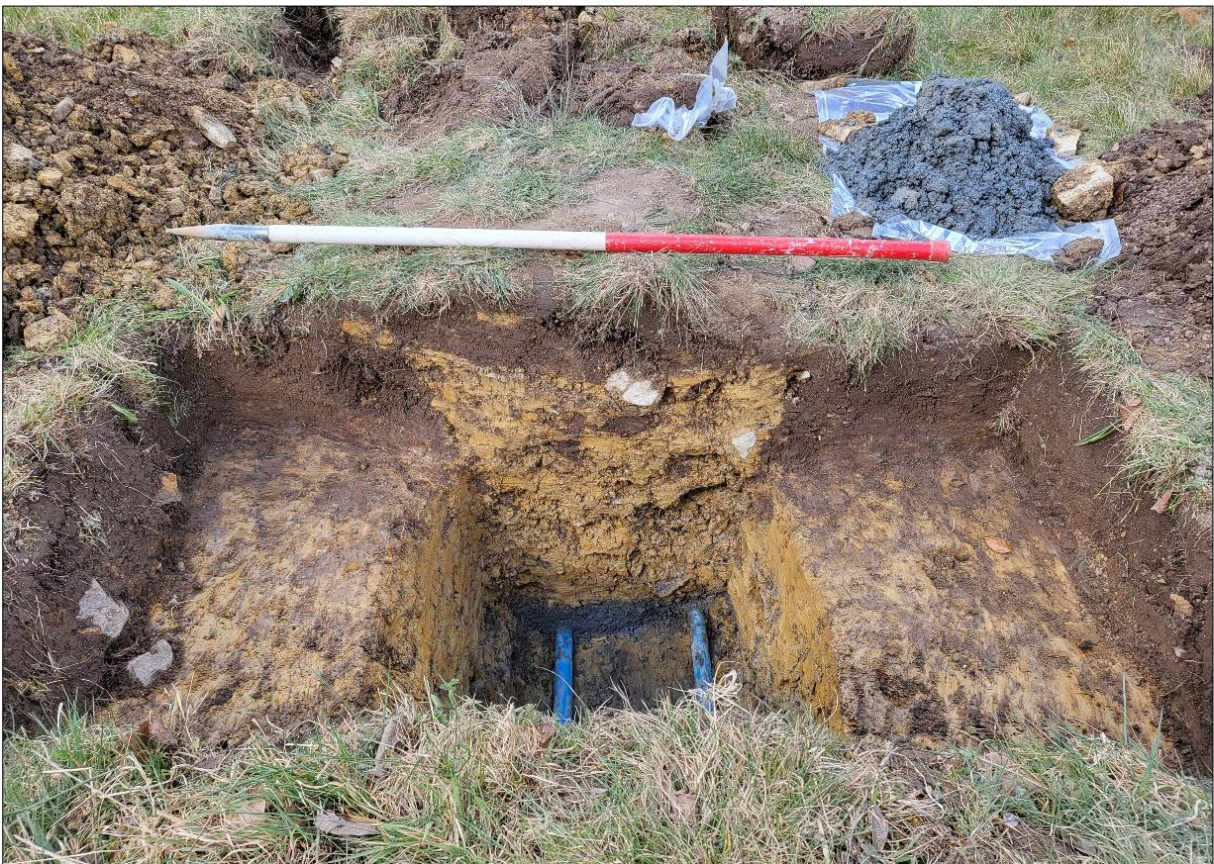
FIGURE 3: TEST-PIT 01, SOUTH-EAST FACING SECTION; VIEWED FROM THE SOUTH-EAST (1M SCALE).

The stratigraphy was consistent across the three test pits. The undisturbed stratigraphy consisted of three layers: a soft mid-to-dark slightly greyish-brown slightly silty clay-loam topsoil (100/200/300) 0.10-0.20m thick, which overlay a subsoil (101/201/301), a soft-friable mid greyish-brown clay-silt 0.10-0.06m thick, which sealed the natural (102/202/302), a firm mid yellow silt-clay.

The water pipe trench [103/203/303] ran north-west to south-east. It was between 0.4 and 1.05m wide and 0.75-0.8m deep. The base of the feature was 0.4-0.5m wide and the trench was therefore opened with a 400mm bucket. The top of the trench was much wider – between 0.8m and 1.05m – probably because the topsoil/subsoil was much less compact and thus liable to collapse, but perhaps also because the turf came away in sheets wider than the bucket.

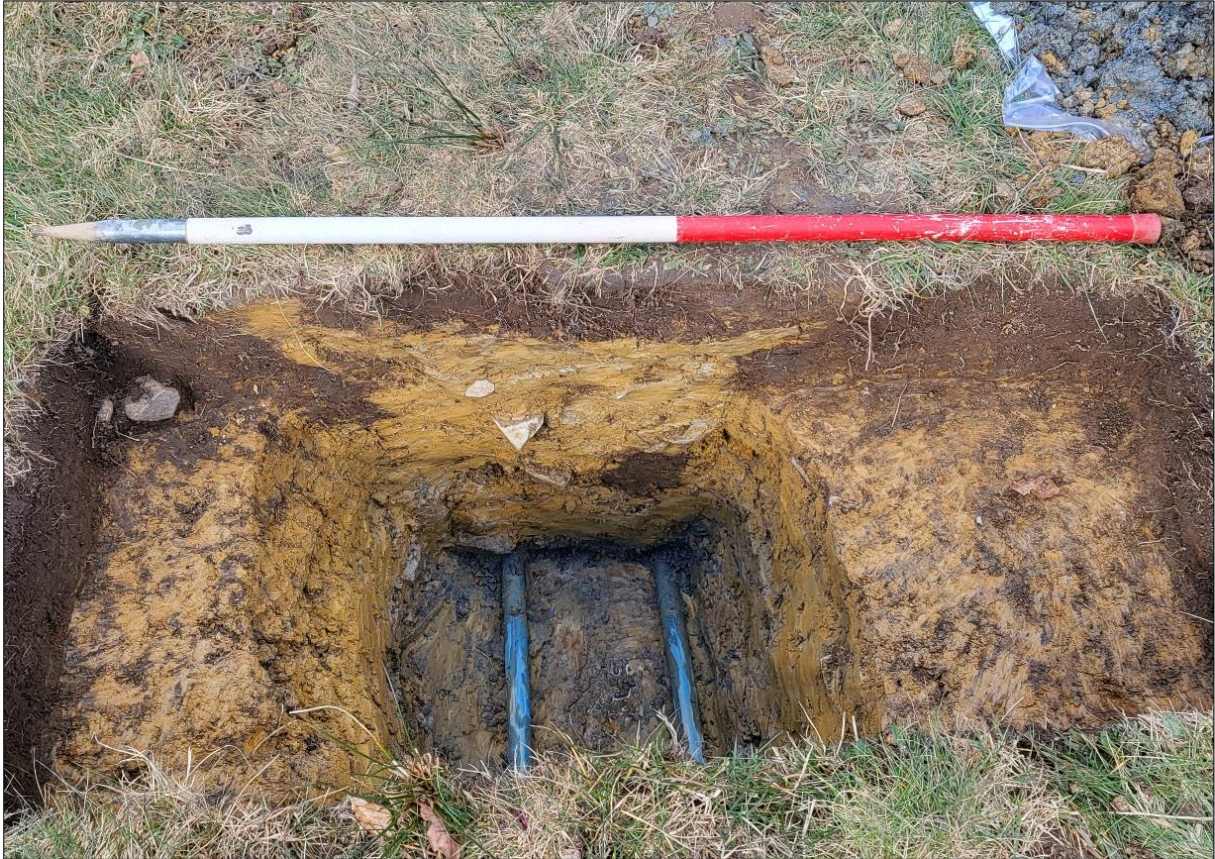
FIGURE 4: TEST-PIT 02, SOUTH-EAST FACING SECTION; VIEWED FROM THE SOUTH-EAST (1M SCALE).

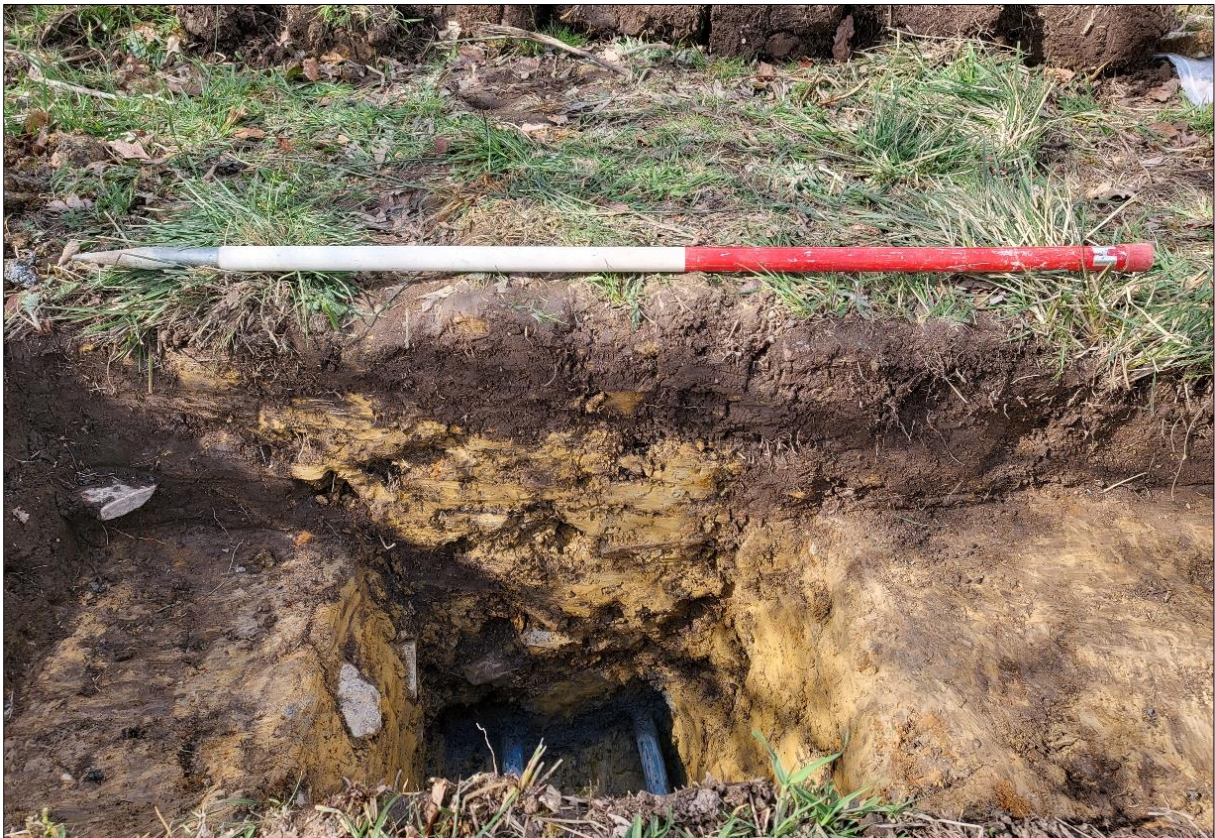
FIGURE 5: TEST-PIT 03, SOUTH-EAST FACING SECTION; VIEWED FROM THE SOUTH-EAST (1M SCALE).
