# CARVYNICK HOLIDAY PARK (NORTH FIELD)

Heritage Impact Assessment

South West Archaeology Ltd. report no. 220210

By N. Boyd and Dr. B. Morris, ACIfA  
Report Version: FINAL  
Draft Issued: 10<sup>th</sup> February 2022  
Report Finalised: 15<sup>th</sup> February 2022

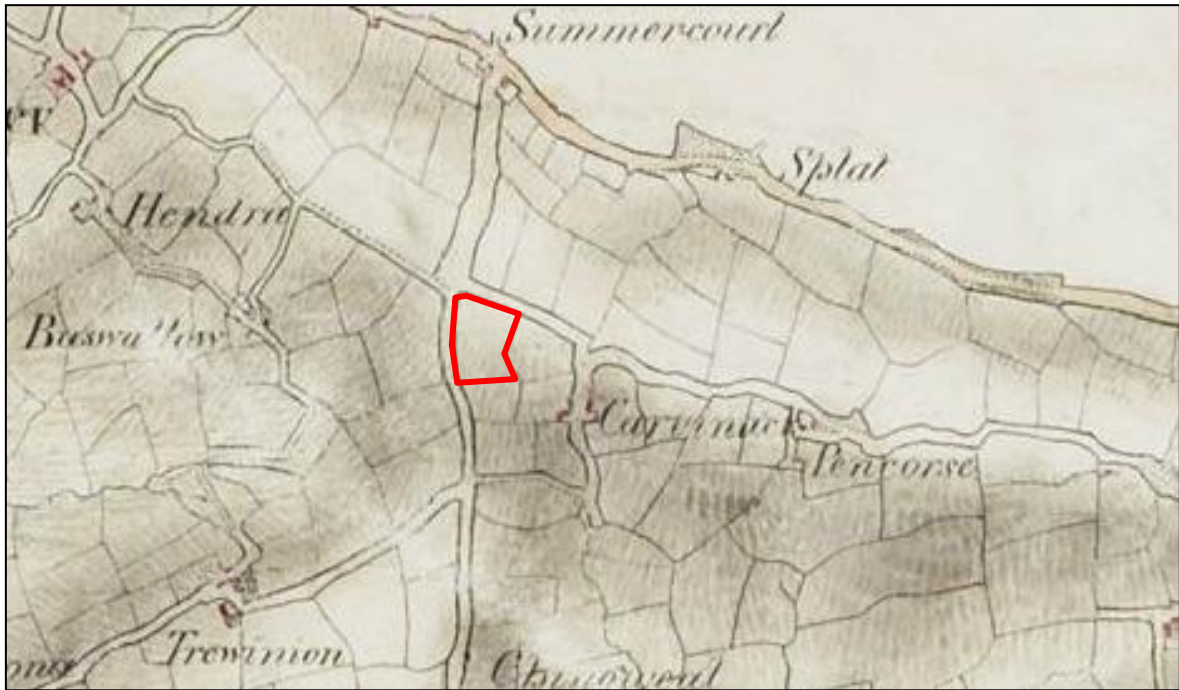
FIGURE 2: EXTRACT FROM THE 1810 OS SURVEYOR'S DRAFT MAP (BL); NORTH IS TO THE LEFT. THE APPROXIMATE LOCATION OF THE SITE IS INDICATED.

The earliest cartographic source available to this study is the 1810 Ordnance Survey (OS) surveyor's draft map. This shows the farmstead at Carvynick within a landscape of enclosed fields and minor settlements.

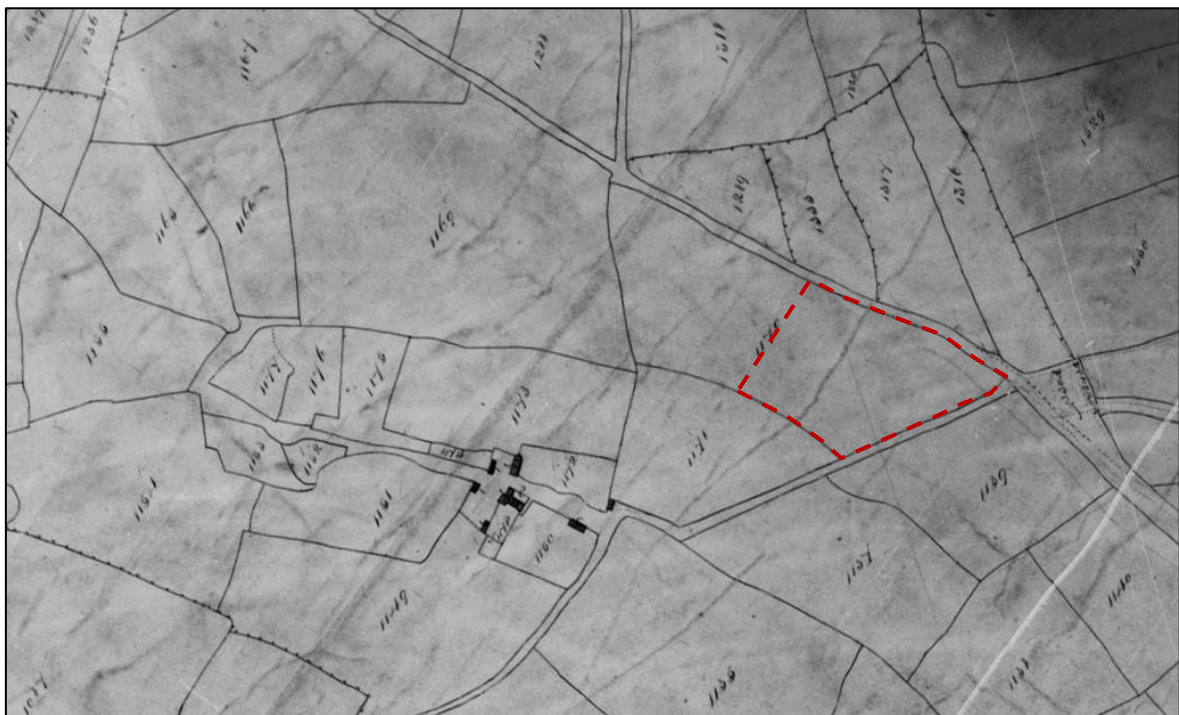
FIGURE 3: EXTRACT FROM THE 1840 ST ENODER TITHE MAP (TNA); THE SITE IS INDICATED.

The earliest accurate cartographic source available to this study is the 1840 St. Ender tithe map (Figure 3). This shows the farmhouse and a scattered range of outbuildings at Carvynick (south of the site). The 'North Field' is shown as it is today, here called *Higher Cooks Close* (plot no.1170), the name perhaps preserving the name of Thomas Cookes, a witness to several mid-17<sup>th</sup> century leases. The tithe apportionment records the land as part of *Carvinick Estate*, the extent of which is helpfully shown as a dotted line on the tithe map; this was a farm of 176a. The landowner was recorded as Joseph Pitts, Esq., and his land (not part of the farm, but listed under the estate) extended to the crossroads in Summercourt and included a terrace of cottages.

The farm is a long, narrow holding that extends from the base of the valley to the north-west to the higher ground on the edge of Summercourt. In general, the fields are fairly large and roughly sub-rectangular. There are hints that the larger central fields were enclosed from medieval strip fields, most obviously the dog-leg boundary with Pencorse to the south-west but also some of the gently-curving boundaries around the farmstead. More broadly, some of the field boundaries can be seen to define a broad sub-circular enclosure covering c.20ha, centred on the smaller fields to the west of the current farm and holiday park; this might imply the original settlement was located further from the road. It is of interest that the lane that approaches Carvynick from the south-west abruptly turns to the east next to the entrance before heading off to the north-east; this would originally have continued to the north and made a crossroads with the lane from Trewinnion (this route is still a public footpath).

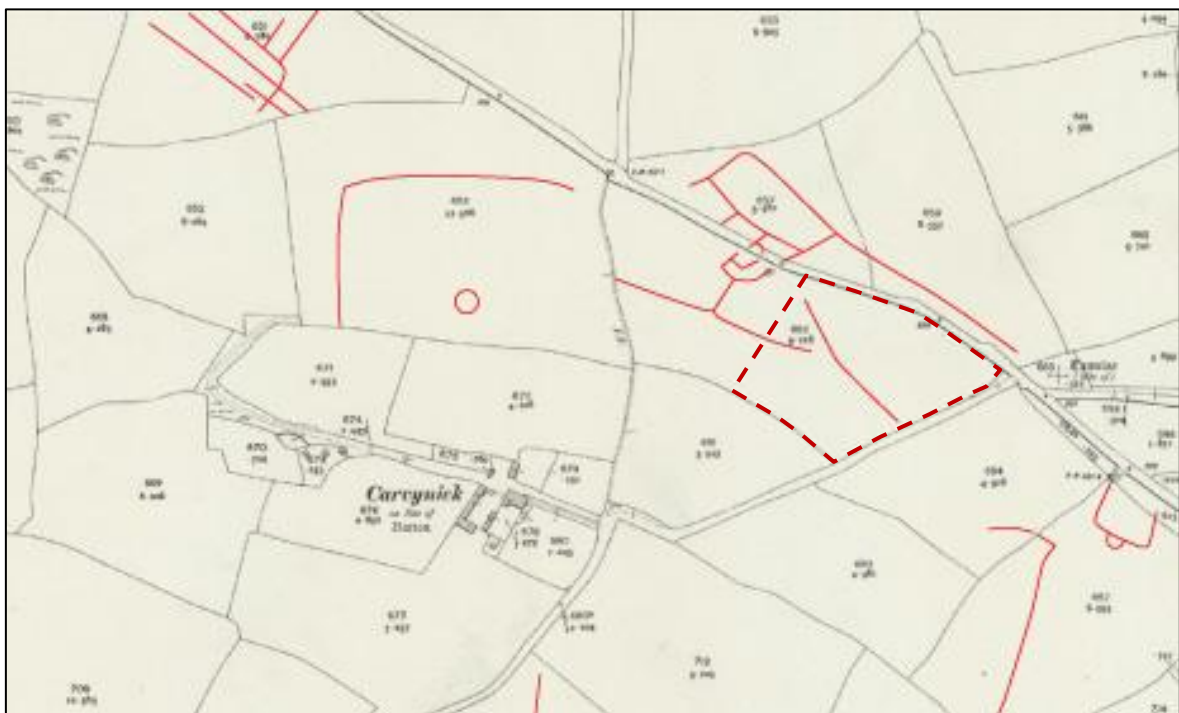
FIGURE 6: CROPMARKS AROUND CARVYNICK AS TRANSPosed BY THE NMP PROJECT (SOURCE CORNWALL AND SCILLY HER).

A review of recent (since 2000) commercially available aerial photography can trace the shift from golf course to holiday park but adds little to our understanding of the archaeological potential of the site. The most recent aerial photographs and Google Streetview indicate a track has been laid around the 'North Field' for tents. Cropmarks identified during the National Mapping Programme (NMP) (see Figure 6) show a series of relict field boundaries of probable Prehistoric date, as well as part of a sub-rectangular settlement enclosure to the north-western end of the 'North Field'.

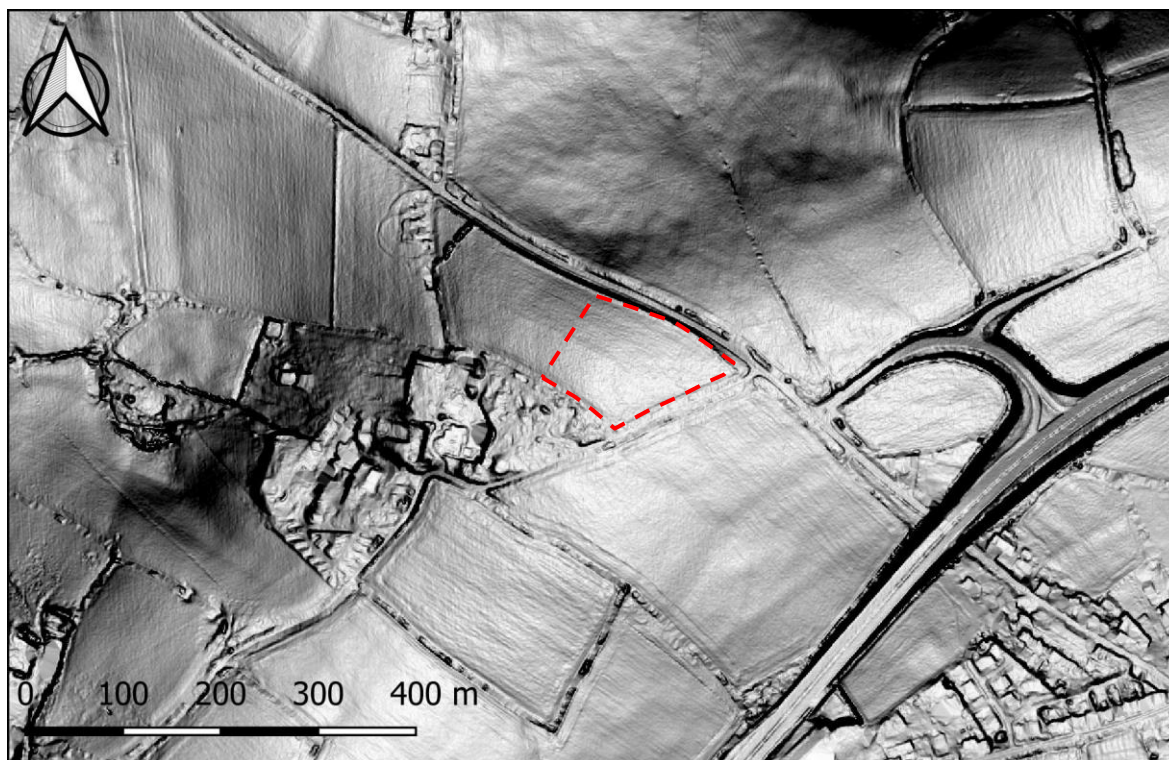
FIGURE 7: IMAGE DERIVED FROM ENVIRONMENT AGENCY LIDAR DATA (1M DTM, 2020) (PROCESSED WITH QGIS 3.16.11 SLOPE ANALYSIS, VERTICAL EXAGGERATION 3.0). CONTAINS DATA MADE AVAILABLE UNDER THE OPEN GOVERNMENT LICENCE V3.0.

Analysis of the 2020 1m DTM LiDAR data (Figure 7) indicates clear earthworks are absent from the 'North Field', but subtle earthworks are present elsewhere, particularly in the fields to the south, where the remains of historic field boundaries survive (and are visible as soil marks), as well as several long straight earthworks closer to the A30. North of the site and across the A3058 the ground appears very uneven, implying a shorter history of cultivation.

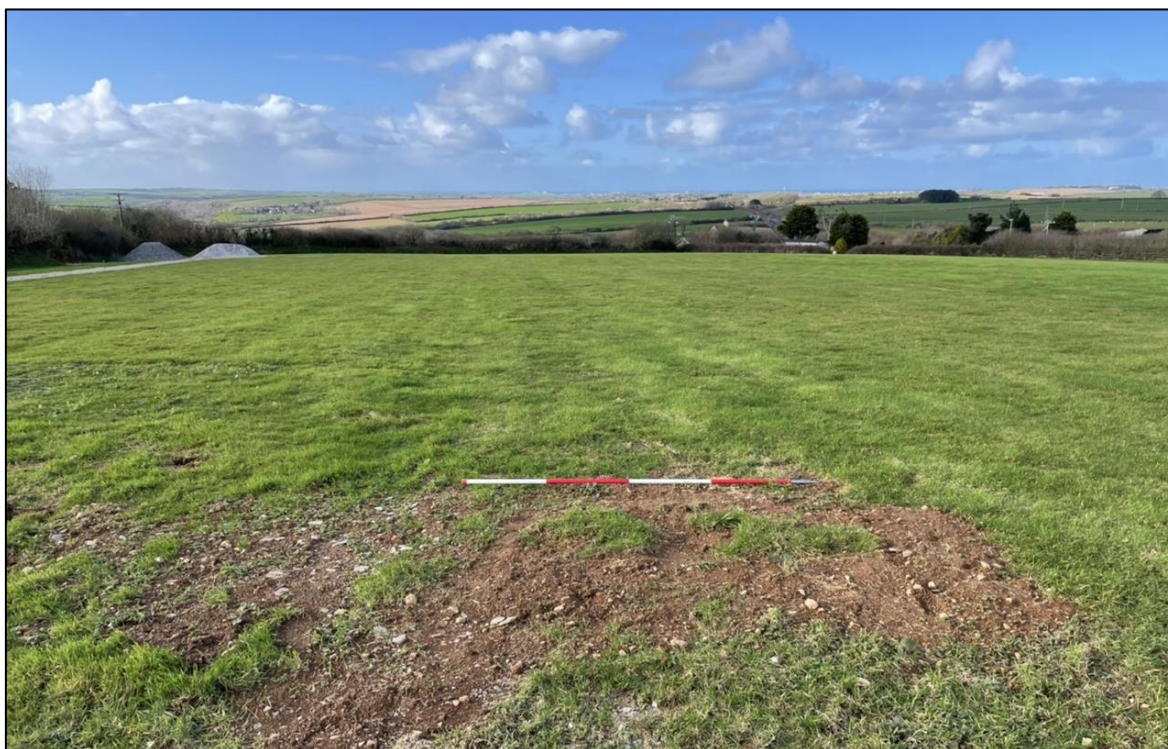
FIGURE 9: A VIEW ACROSS THE WESTERN HALF OF THE 'NORTH FIELD', WITH GEOTECHNICAL PIT IN THE FOREGROUND; VIEWED FROM THE SOUTH-EAST.

The field was inspected on the 10<sup>th</sup> of February by P. Bonvoisin. The weather was fine and mild. The site consists of part of a single sub-rectangular field with a long axis orientated south-east to north-west. The eastern half of the field is fairly level; the other half slopes gently to the west. The field is bounded to the south-east, south-west and west by Cornish hedgebanks topped with hedge shrubs; the boundary against the rest of the holiday park is deliberately taller to provide screening. The boundary to the north, against the A3058, is of more recent vintage: a wooden fence largely grown through by hedge shrubs. Access to the field is via a gateway onto the public lane in the south corner, and by two gateways in the western hedge. A recent breach has been made in the south-west hedge to facilitate access from the holiday park, and a metalled track has been installed which runs around the outside of the field, providing access to tent pitches. The field is laid to pasture and there are no visible earthworks, though several geotechnical pits were observed.

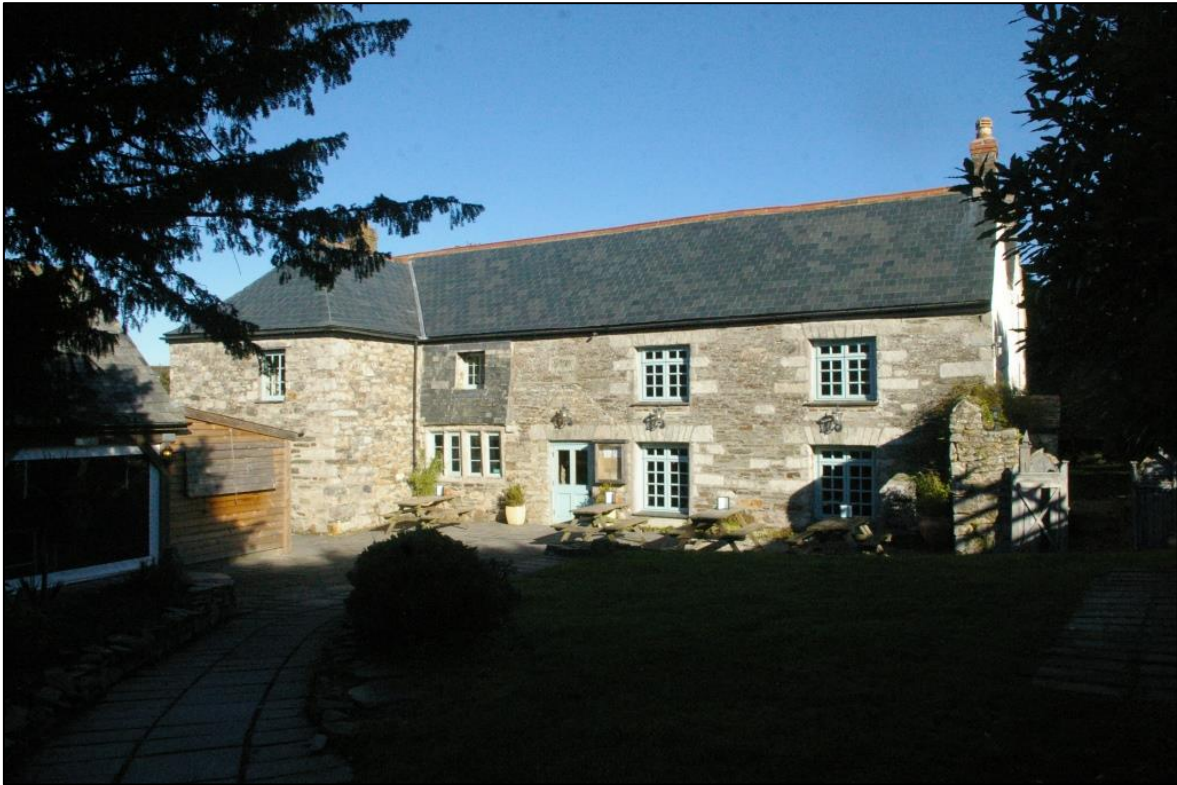
FIGURE 10: VIEW OF CARVYNICK HOUSE WITHIN ITS ENCLOSED PUB GARDEN SETTING. THE EXTREME SHADOWS EVIDENCE THE LOOMING HEDGES THAT ENCLOSE IT, SCREENING OUTWARD VIEWS; VIEWED FROM THE SOUTH (2018 PHOTO).

*Authenticity:* Low. Despite still visually presenting as historic, the farmhouse has been comprehensively reworked in the past and again in recent years. It is now presents as a 'historic country pub' that in no way reflecting its complex agricultural past. The interior is stripped out and intensively renovated presenting a pristine and fashionable rustic aesthetic, quite different to how it would have looked, even recently.

*Integrity:* High. Structurally the building is in good condition and upstanding, it exhibits its complex phasing well with several clear and visible constructional phasing all surviving. Internally it has been stripped out, including floors and ceilings but built features, such as fireplaces and stack, survive, as does one historic stone mullion window, a 19<sup>th</sup> century stair, and 19<sup>th</sup> century sashes to the rear, so it is not as devoid of historical integrity as first impressions suggest.

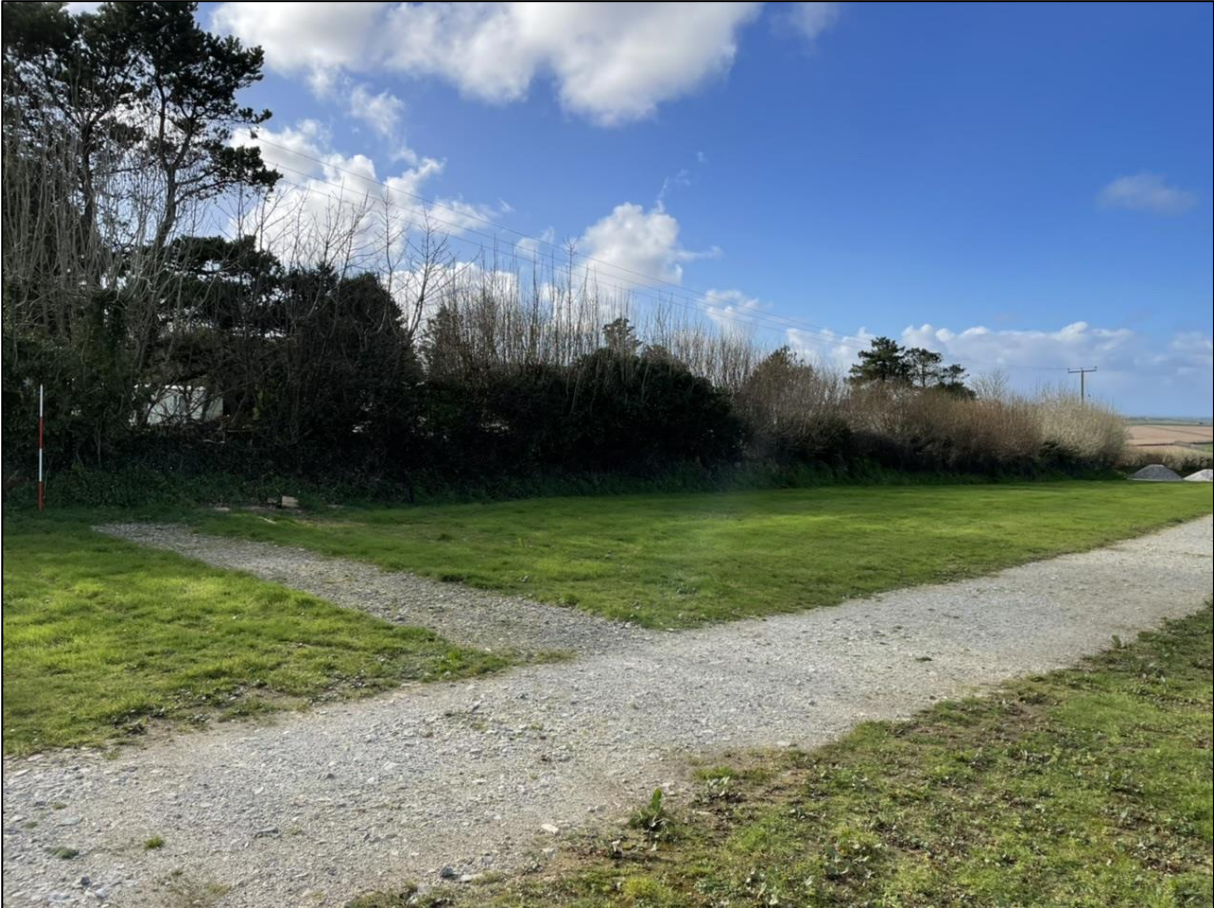
5. THE SOUTHERN EDGE OF THE FIELD; VIEWED FROM THE NORTH-EAST (SCALE 2M).

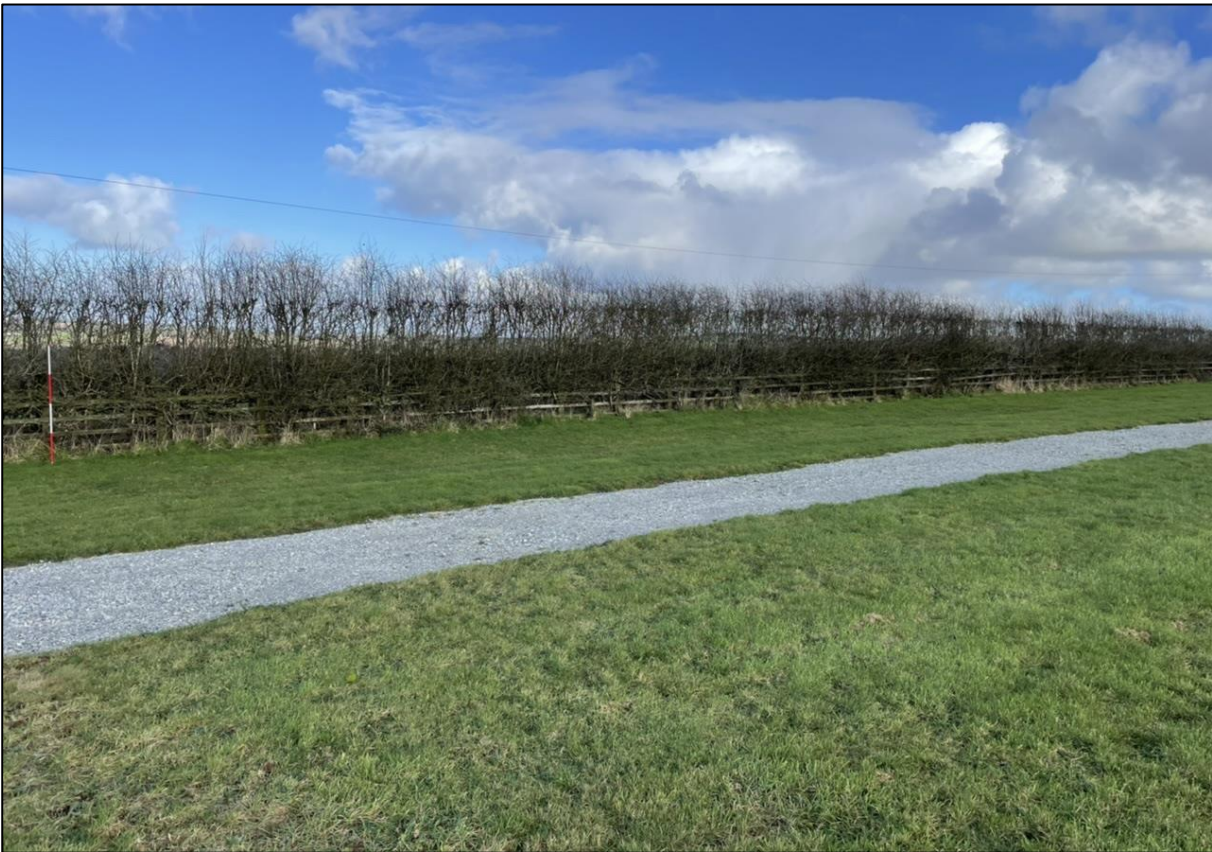
8. THE NORTHERN BOUNDARY OF THE FIELD; VIEWED FROM THE SOUTH-WEST.

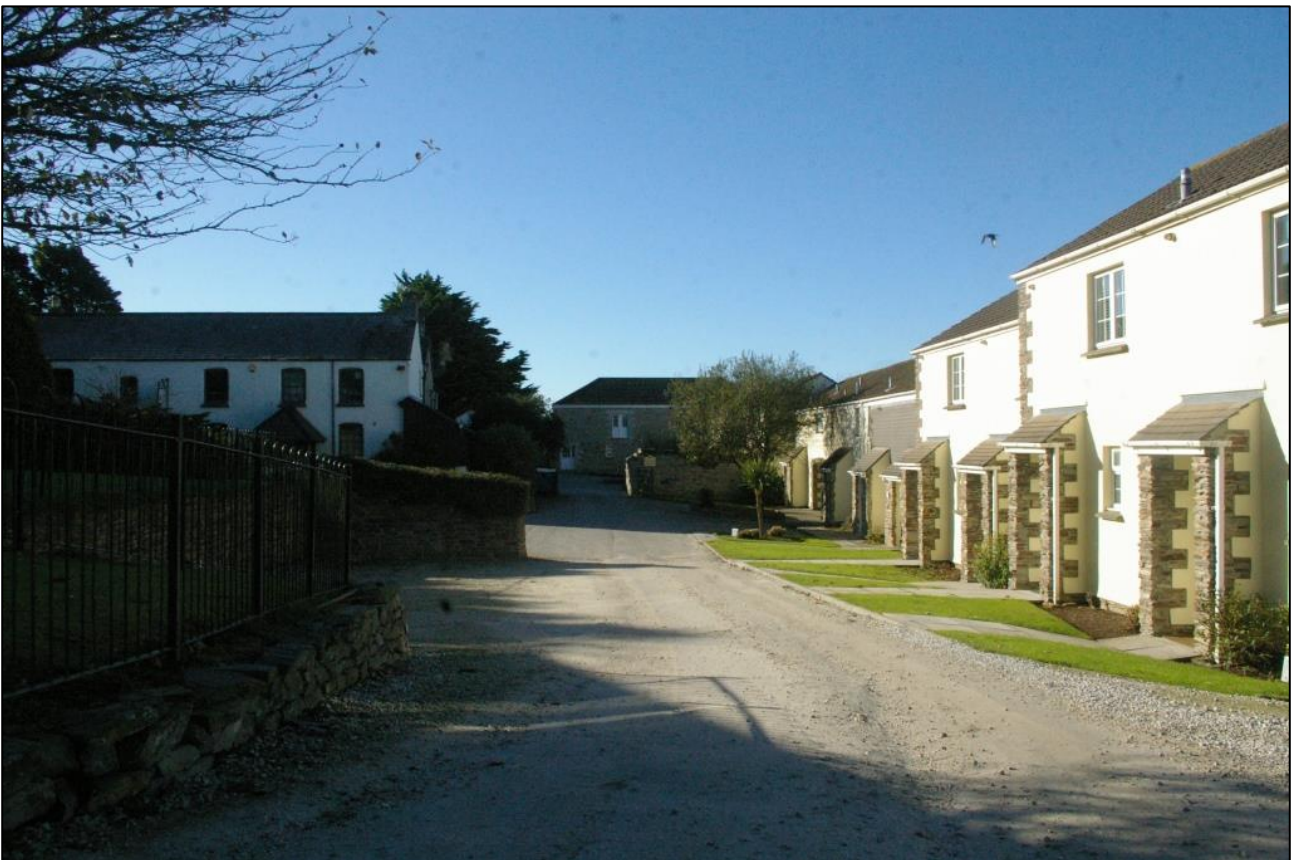
2. VIEW OF THE TERRACED HOLIDAY COTTAGES AND REAR ELEVATION OF THE FORMER FARMHOUSE (LEFT), SHOWING ITS ENCLOSED AND CROWDED SETTING; VIEWED FROM THE NNE.

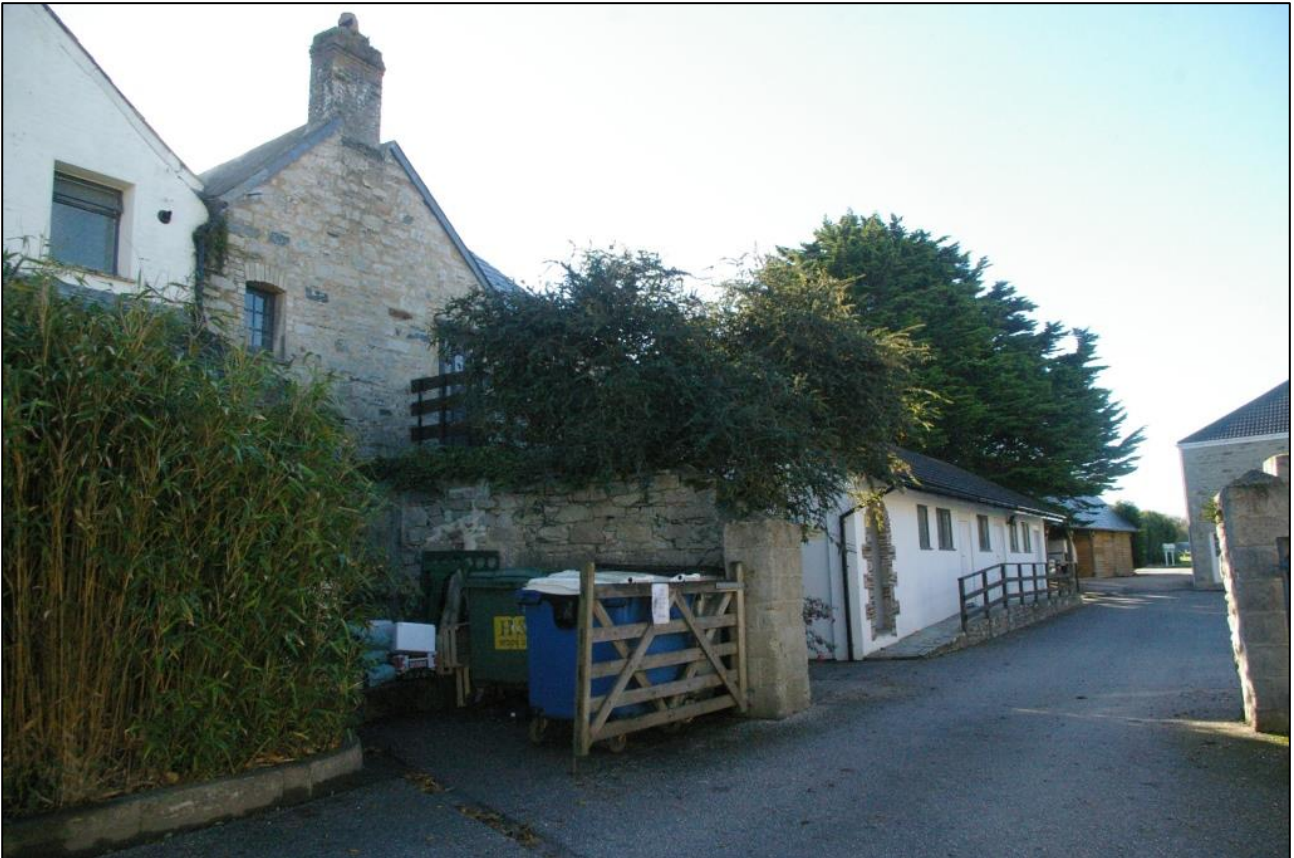
3. VIEW OF THE FORMER FARMHOUSE AND ADJACENT SERVICE BUILDINGS, INCLUDING LAUNDRIES; VIEWED FROM THE NORTH.

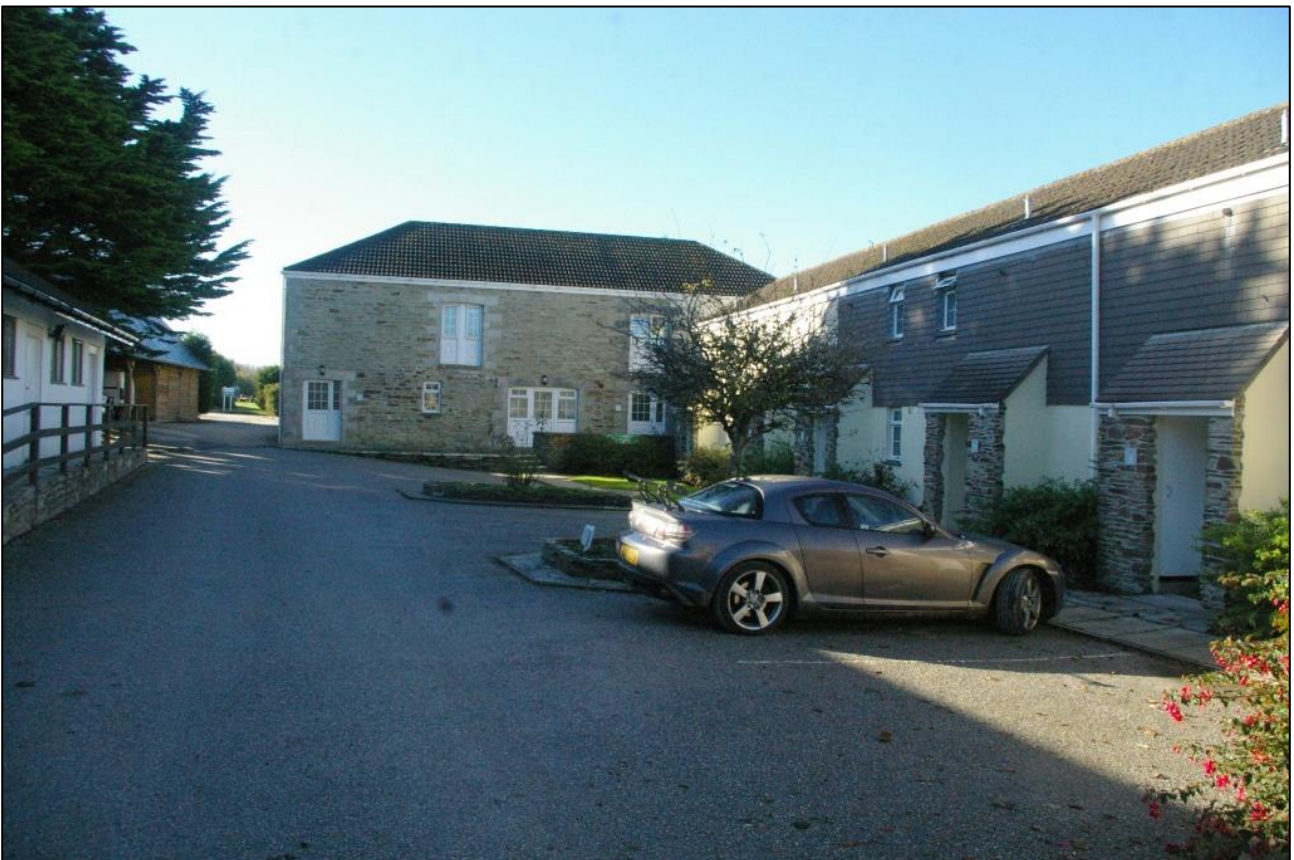
4. VIEW OF THE LARGE CONVERTED CHALL BARN, IMMEDIATELY SOUTH-WEST OF THE FORMER FARMHOUSE; VIEWED FROM THE NNE.

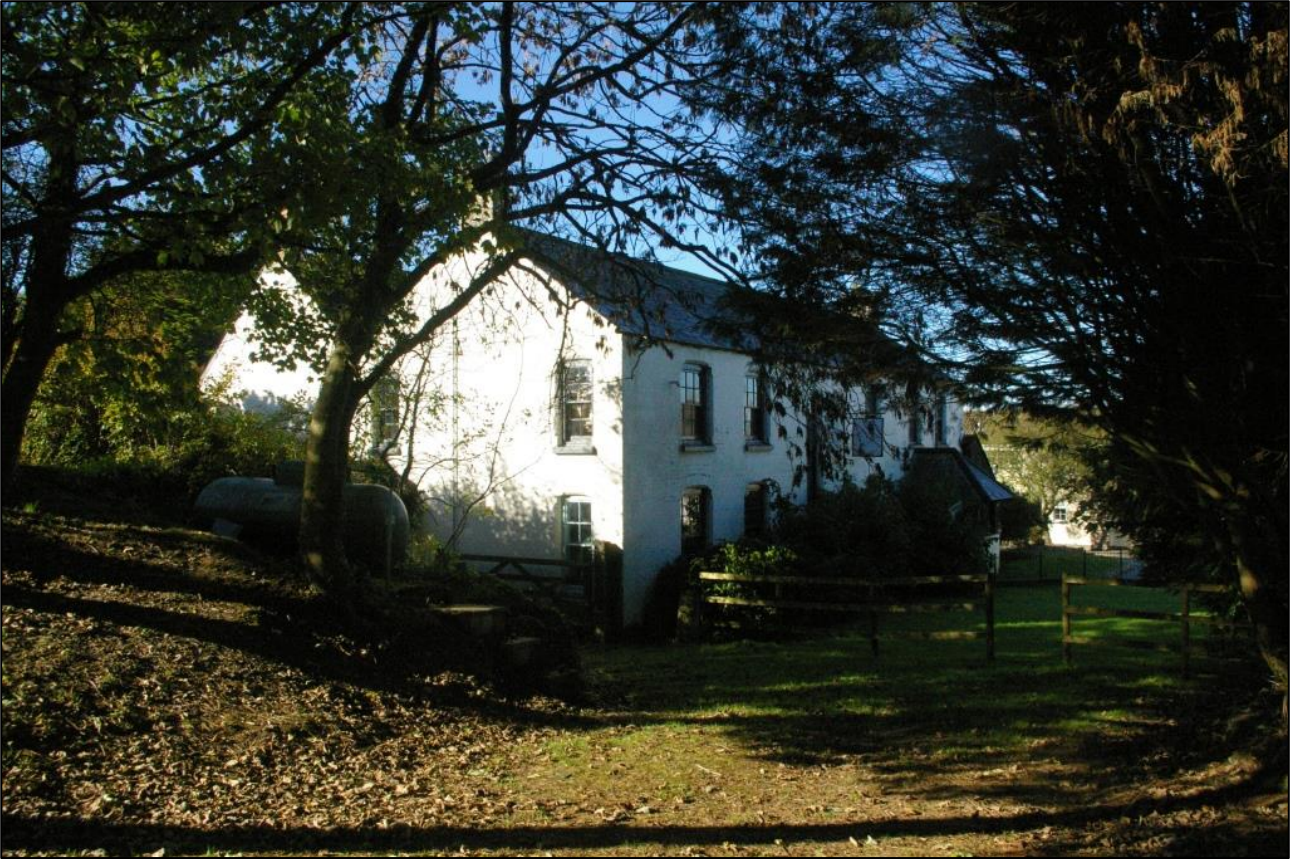
5. THE REAR OF THE FORMER FARMHOUSE WITHIN ITS ENCLOSED GARDEN SETTING, WITH BY OIL TANK, IRON RAILINGS AND VARIOUS SECTIONS OF FENCING DIVIDING OFF AREAS OF THE PUB GARDENS; VIEWED FROM THE EAST.
