Civil Parish & District: Newton St. Loe, Bath & North East Somerset	National Grid Reference ST69359 64076	HER Number: PRN 69325
Subject: Archaeological monitoring and recording of the restoration works of the First Pond on the grounds of Bath Spa University, Newton Park, Bath & North East Somerset		Photo attached? YES
Planning Application no: 22/02065/FUL	Recipient museum: Museum of Somerset	
OASIS ID: southwes1-509260	Museum Accession no: n/a	
Contractor's reference number/code: BSUP22	Dates fieldwork undertaken: 5 th April 2023	
<p>Description of works.</p> <p>Archaeological monitoring and recording was undertaken by South West Archaeology Ltd. (SWARCH) during restoration works of the first pond which required excavations to remove the build-up of silt from the silt trap (Figure 1). This work took place at the request of Bath Spa University (the Client), and was carried out by P. Scrivener on the 5th April 2023 and in accordance with a Written Scheme of Investigation (Boyd 2022) and with best practice and ClfA guidelines.</p> <p>The site lies to the south west of the small parish village of Newton St Loe, and c. 5.5km for the centre of the city of Bath. The area under investigati

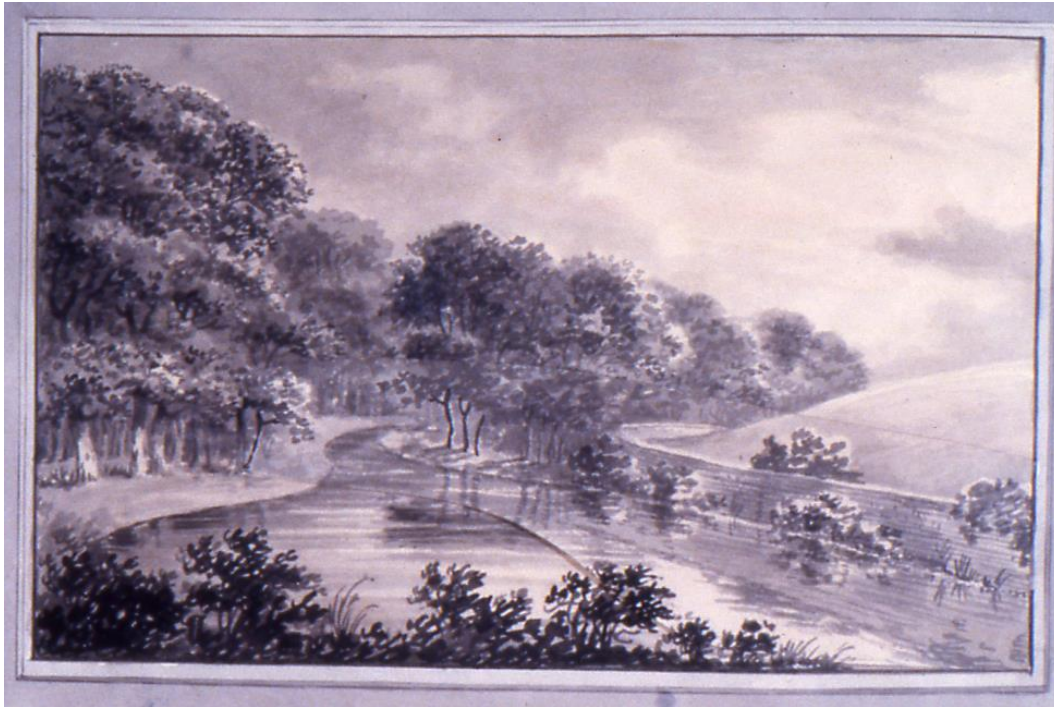
FIGURE 2. VIEW OF THE FIRST POOL (AS EXISTING), NEWTON PARK RED BOOK, HUMPHREY REPTON, 1797.
THE WALLING VISIBLE TO THE RIGHT OF THIS IMAGE WAS LOCATED (FOUNDATION STONES ONLY) AND WAS NOT DAMAGED BY DEVELOPMENTS.

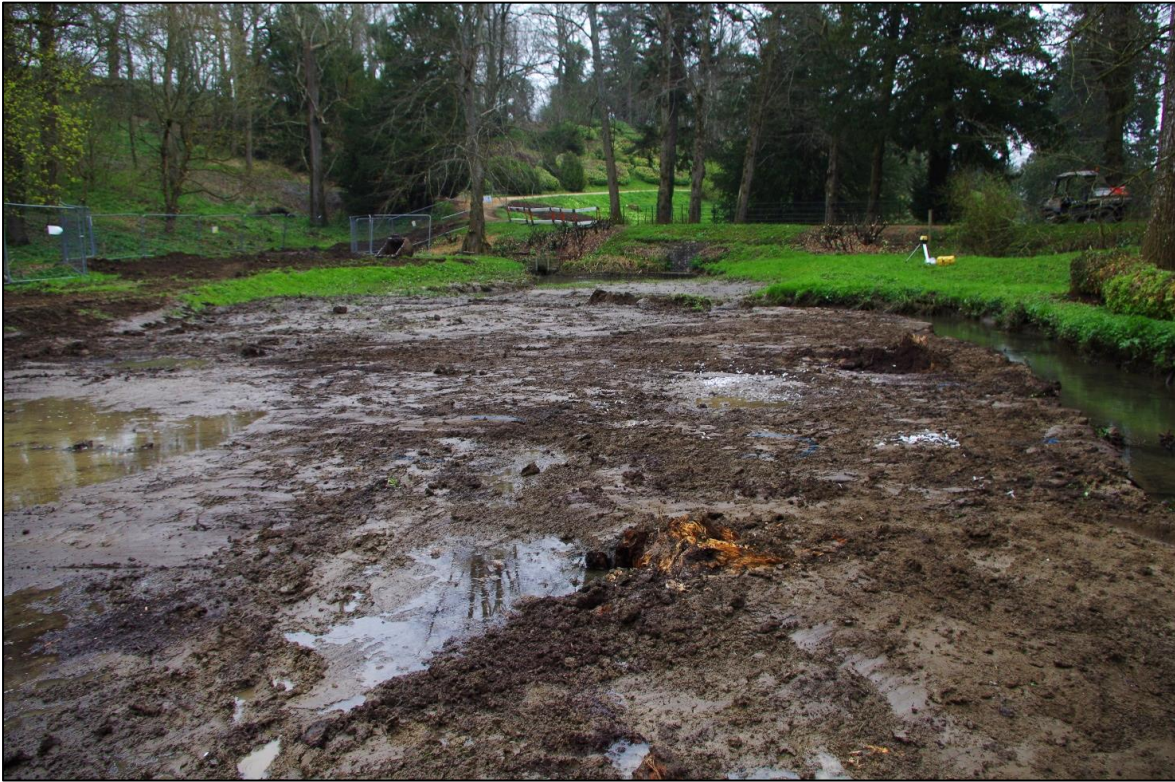
FIGURE 3. PRIOR TO DE-SILTING THE SILT TRAP, WITH TOPSOIL REMOVED. VIEWED FACING NORTH-EAST.

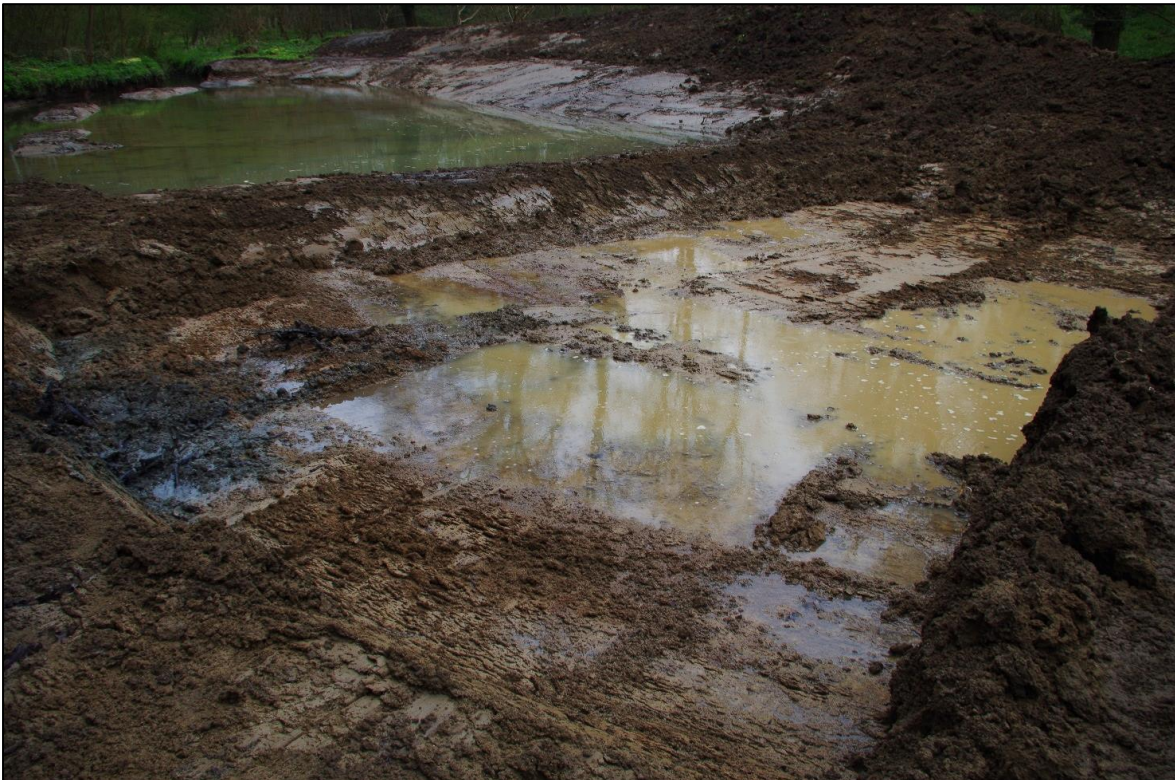
FIGURE 4. MIDWAY THROUGH DE-SILTING: HALF OF THE EXCAVATED AREA HAS ALREADY BEEN FLOODED. THE DARKER AREA TO THE LEFT OF THE IMAGE INDICATES LOCATION OF A PREVIOUS TREE. VIEWED FACING NORTH-WEST.
