BARN AT BRIGHTMANSHAYES

PETROCKSTOWE

Building Recording & Archaeological Monitoring and Recording

South West Archaeology Ltd. report no. 221123

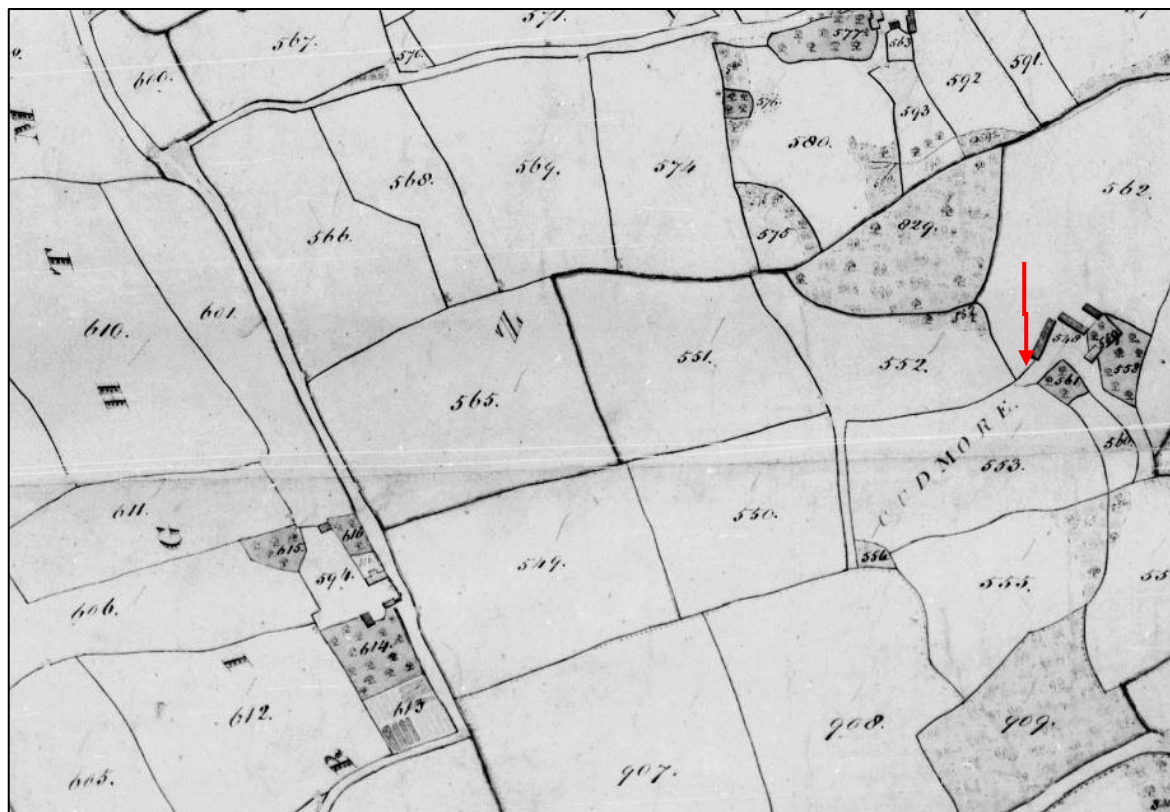
FIGURE 2: EXTRACT OF THE PETROCKSTOWE TITHE MAP OF c.1840 (GENEALOGIST).

The site appears on the Petrockstowe Tithe Map of c1840 as one of a cluster of barns associated with Cudmore farmstead, plot 548, owned by the Right Honourable Lord Clinton and occupied by John Bond. The barn sits on the edge of plot 562, Barn Park, with the same owner and occupier,

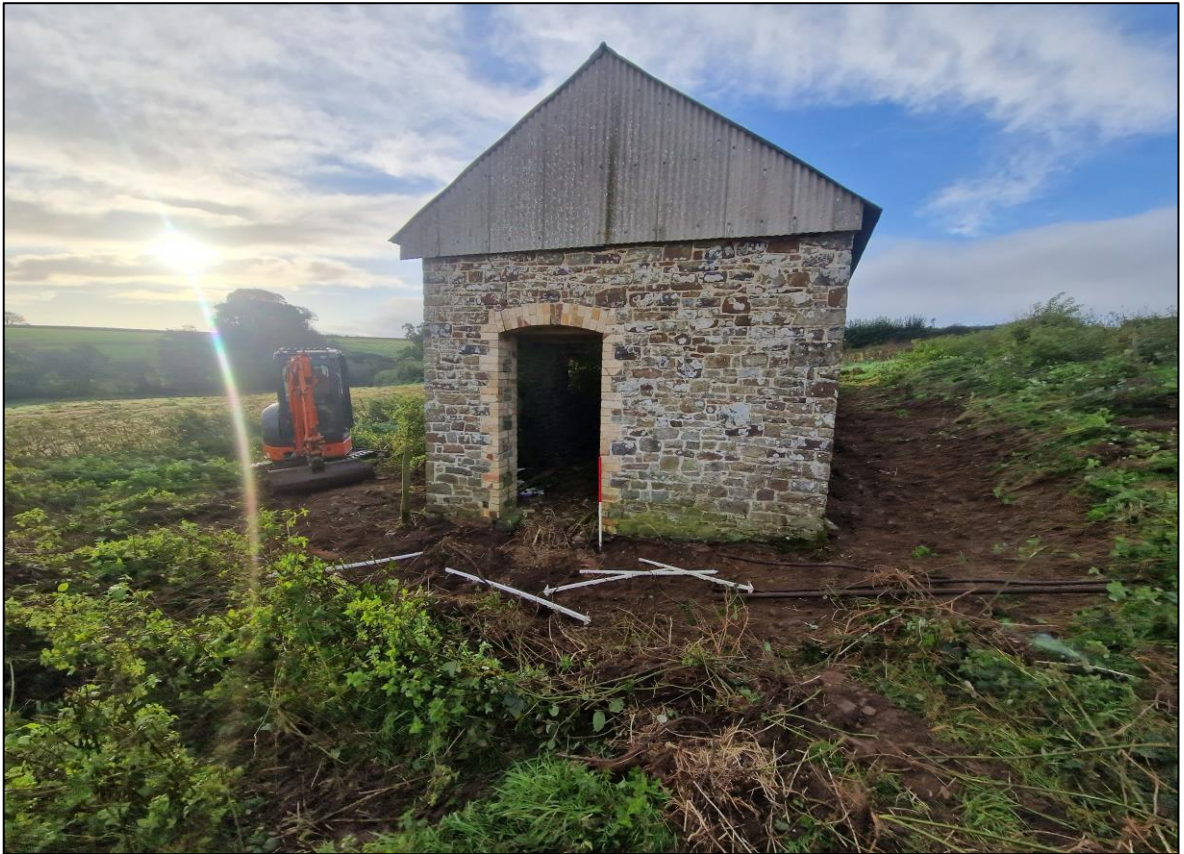
The west wall is blind and survives largely to 1½ height (c.2.3m high). The north gable survives to full height and has a single door opening with Marland brick reveals and damaged stone threshold. The gable was covered with corrugated roofing sheets (see Figure 5). The east elevation has mostly collapsed, with only the northern end upstanding, and this has significant structural cracks which may suggest collapse is likely to occur. There is a single surviving square window with timber lintel to the centre of the surviving portion of this wall. The southern portion of the east elevation has collapsed almost to ground level, but it appears likely that there was a large door opening. Likely to full height or near full-height of the building, to the centre of the elevation. There are a series (five surviving) of small square holes low in the elevation for drainage out of the building, emphasising the building's former use as a cow/livestock shed. The south elevation survived to c.1.3m high and had no surviving evidence of any openings.

FIGURE 5: NORTH ELEVATION FOLLOWING VEGETATION CLEARANCE, FROM THE NORTH (1M SCALE).

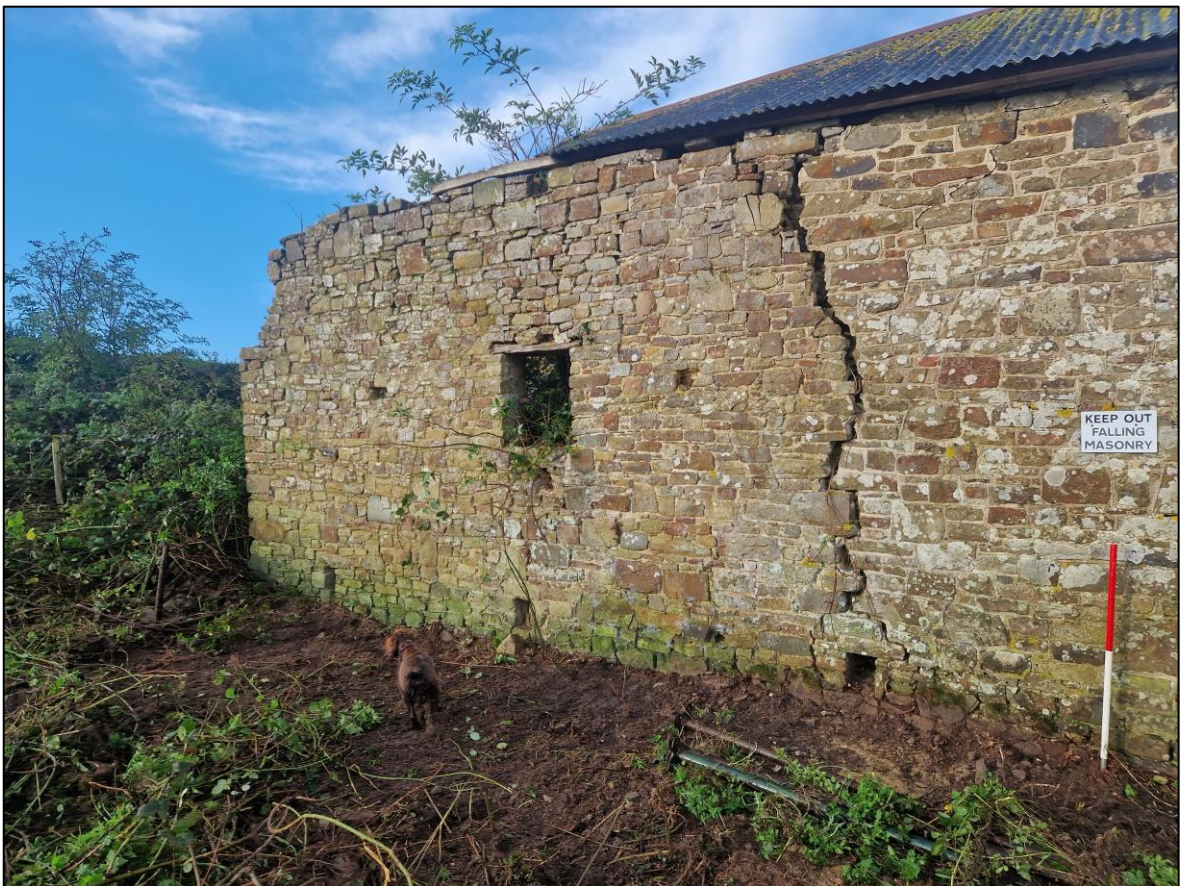
FIGURE 6: EAST ELEVATION FOLLOWING VEGETATION CLEARANCE, SHOWING DRAINS AND SINGLE WINDOW, FROM THE NORTH-EAST (1M SCALE).

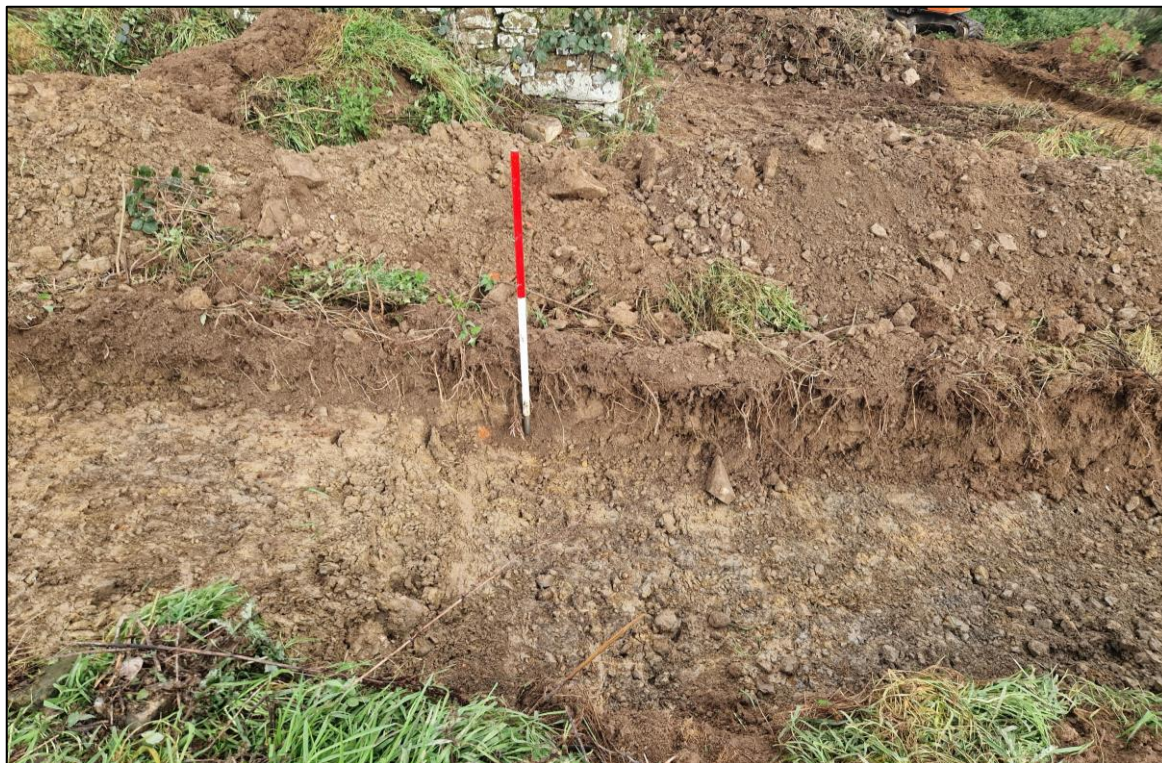
Trench 2 was located to the south of the building and was 11.6m long and 1.4m wide up to 0.4m deep. A 0.2m deep mid yellow-brown silt-clay directly onto natural, except to east end where the topsoil overlay a stoney grey-yellow-grey silt-clay with common sub-angular stones; this deposit contained red-brick fragments. This may represent a terrace, and it would correspond with the location of a boundary on historic maps (see Figure 2-3). It may have been that a track once ran to the east of the boundary. The change in stratigraphy also corresponds with a natural variation, with the clean yellow clay changing to a grey clay to the east end, suggesting that this area was likely once wetter and formerly reedy. The barn was therefore seemingly constructed on the edge of this change of geology.

FIGURE 7: CHANGE IN NATURAL/ POSSIBLE EVIDENCE OF A TERRACE IN TRENCH 2, VIEWED FROM THE SOUTH (1M SCALE).

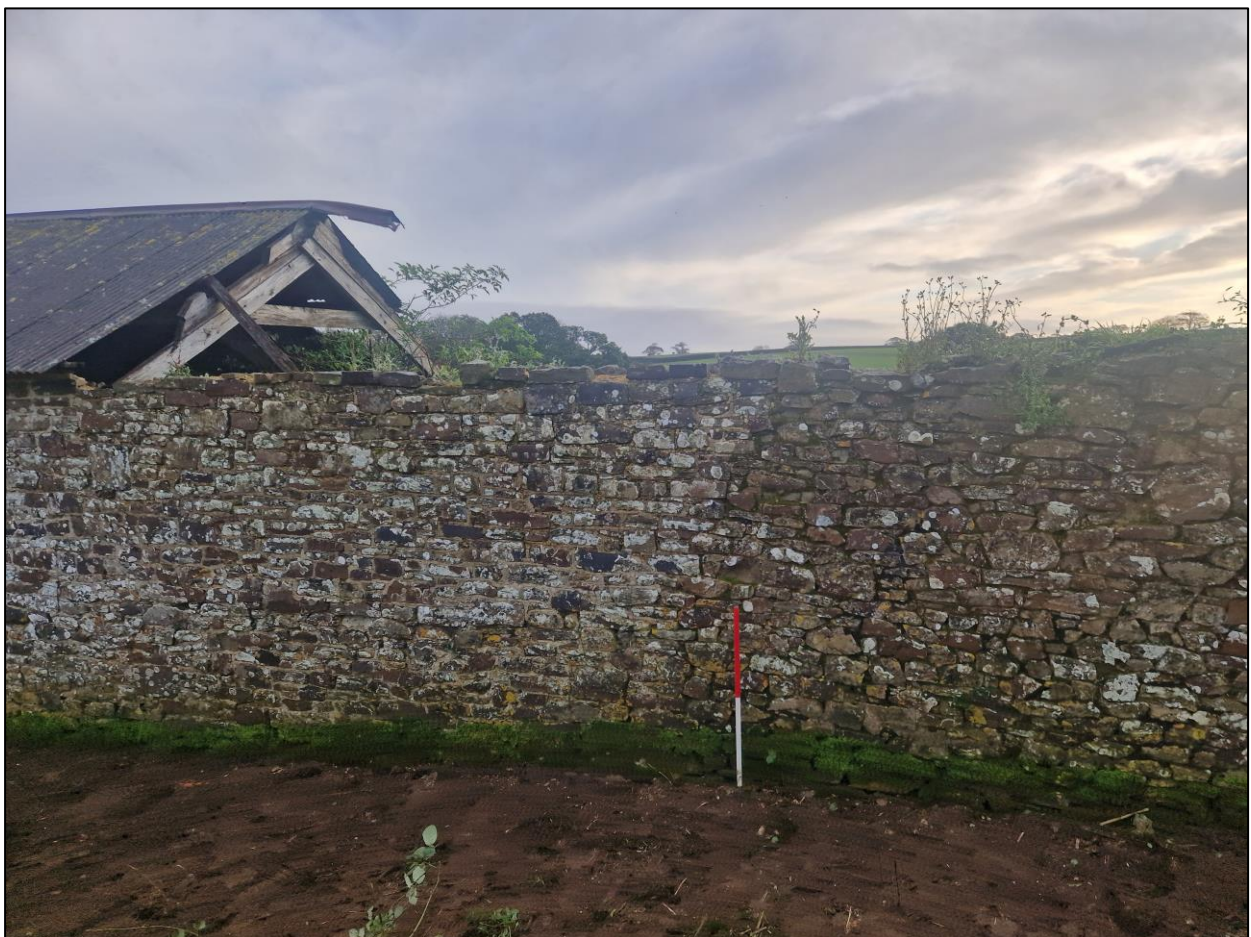
The barn is located in a single large agricultural enclosure, approached via an agricultural track, which approaches the site from the west, before looping around to approach the barn from the south-south-east. The stone building is c.15m long by c.5.4m wide, almost 1½ storeys in height, formerly with a pitched roof of corrugated fibre sheets; only the northern end bay of the roof remains (in part). The walls are of lime/earth bonded stone, between 0.48-0.52m thick. The build is generally of roughly coursed sub angular to sub rounded stone mostly c.0.2m x 0.08m. Some squarer blockier stone (0.2-0.25m x 0.25m) is spread throughout the build and used as the quoins and cornerstones. The walls are bonded with a light yellow-grey earth and lime mortar bond, although there is evidence of re-pointing/rebuilding the northern end of the building with a harder lime with sandy grey-yellow earth with more common small pebble inclusions. There is also some evidence of cement re-pointing, mostly to the west elevation.

northern end of the building and roof appears to have been rebuilt in the late 19th or most likely early 20th century, and the building likely has an early 19th century origin.

FIGURE 9: THE WEST ELEVATION, SHOWING CHANGE IN BUILD; VIEWED FROM THE SOUTH-WEST (1M SCALE).
