TREVOSE HEAD TO ST. MERRYIN CABLE ROUTE

Results of a Geophysical Survey

South West Archaeology Ltd. report no. 230525

By P. Webb & N. Boyd
Report Version: Final
Draft issued: 25th May 2023
Finalised: 31st May 2023

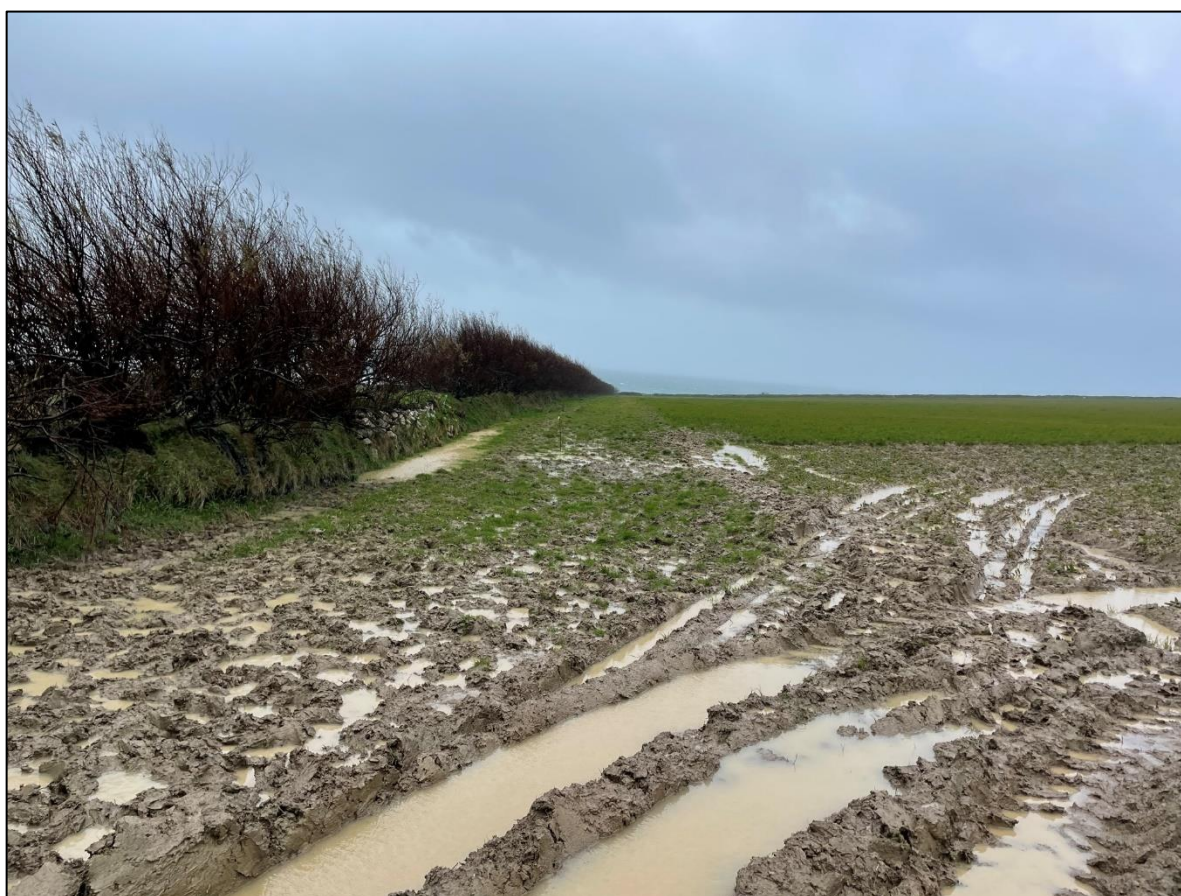
FIGURE 3: PHOTO DEMONSTRATING GROUND CONDITIONS AT THE TIME OF THE SURVEY.

A magnetometry (gradiometer) survey (c.3.5ha surveyed) was undertaken along the proposed route of the cable. The purpose of this survey was to identify and record magnetic anomalies within the proposed site with the intention of identifying the presence and approximate line of field drains – should they be present. While identified anomalies may relate to archaeological deposits and structures the dimensions of recorded anomalies may not correspond directly with any associated features. The following discussion attempts to clarify and characterise the identified anomalies. The survey was undertaken between 28th March and 4th April 2023 by P. Bonvoisin; the survey data was processed by P. Webb. Detailed survey data can be found in Appendix 1; and additional graphic images of the survey data and numbered grid locations can be found in Appendix 2. Weather and ground conditions meant that many of the fields were not subject to survey, with only nine of the twenty-four possible to survey.

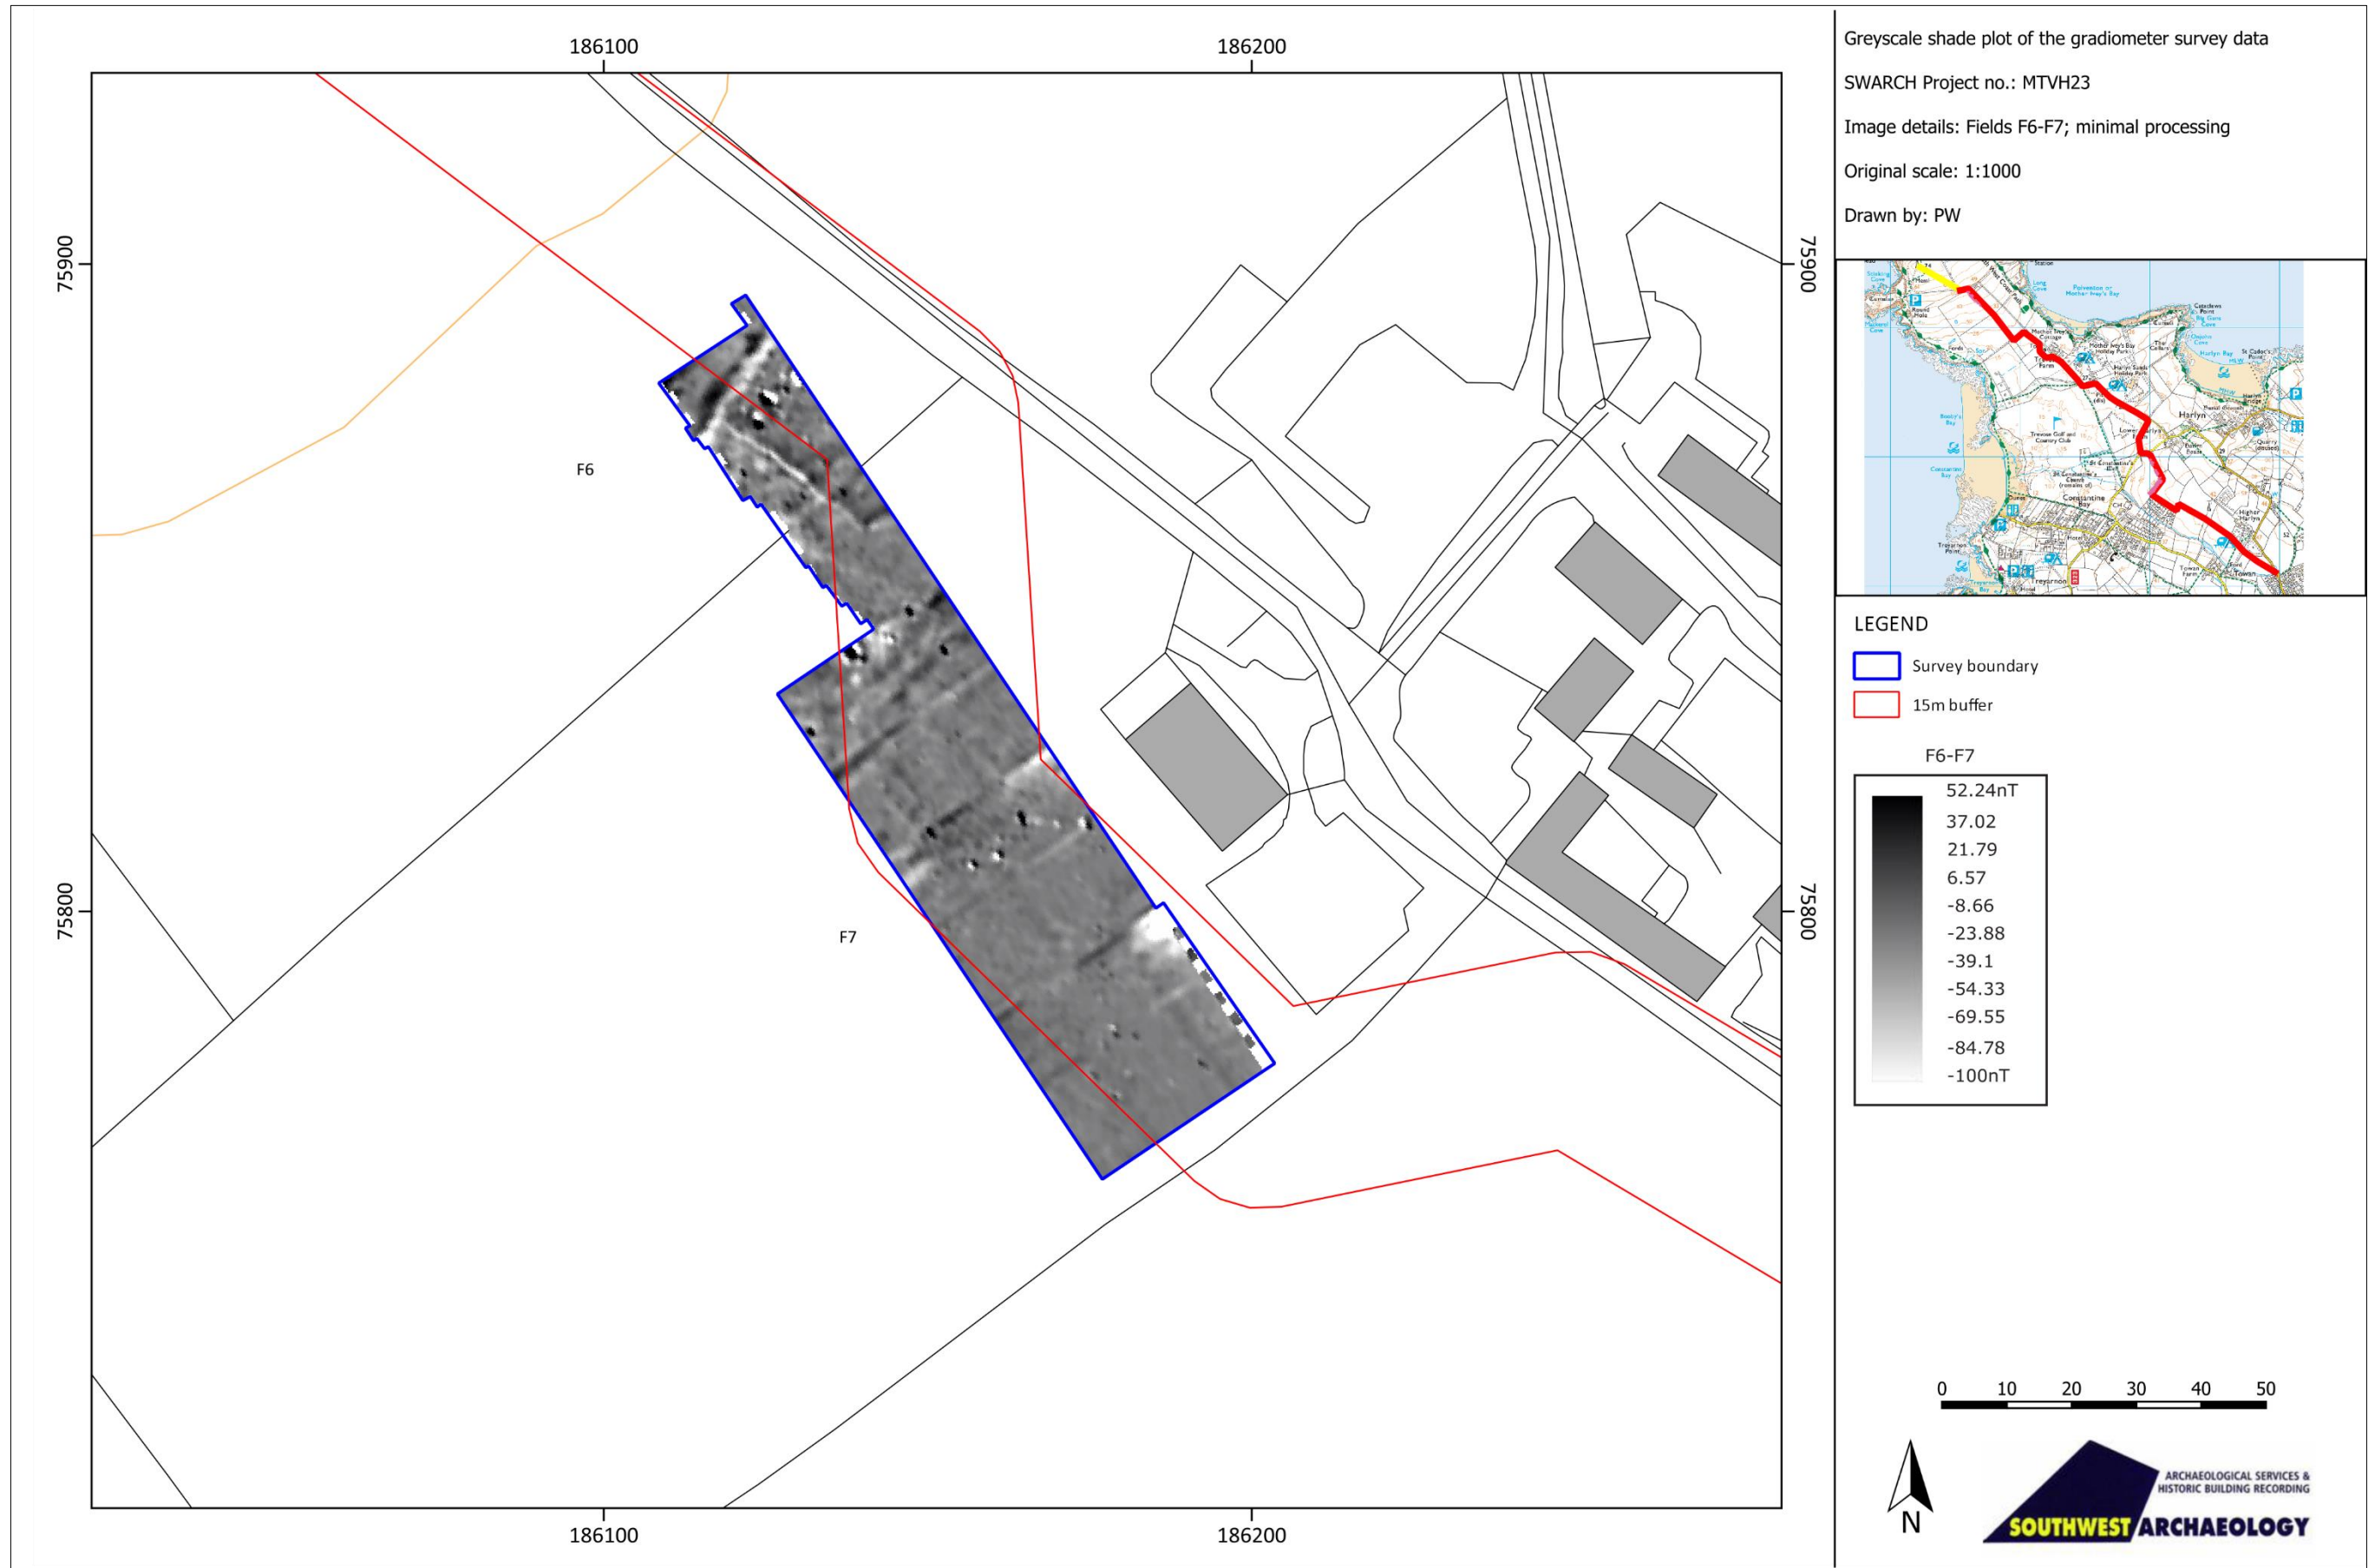
FIGURE 5: GREYSCALE SHADE PLOT OF THE GRADIOMETER SURVEY DATA (FIELDS F6-F7); MINIMAL PROCESSING (CONTAINS ORDNANCE SURVEY DATA © CROWN COPYRIGHT 2023. LICENCE NUMBER 100022432).

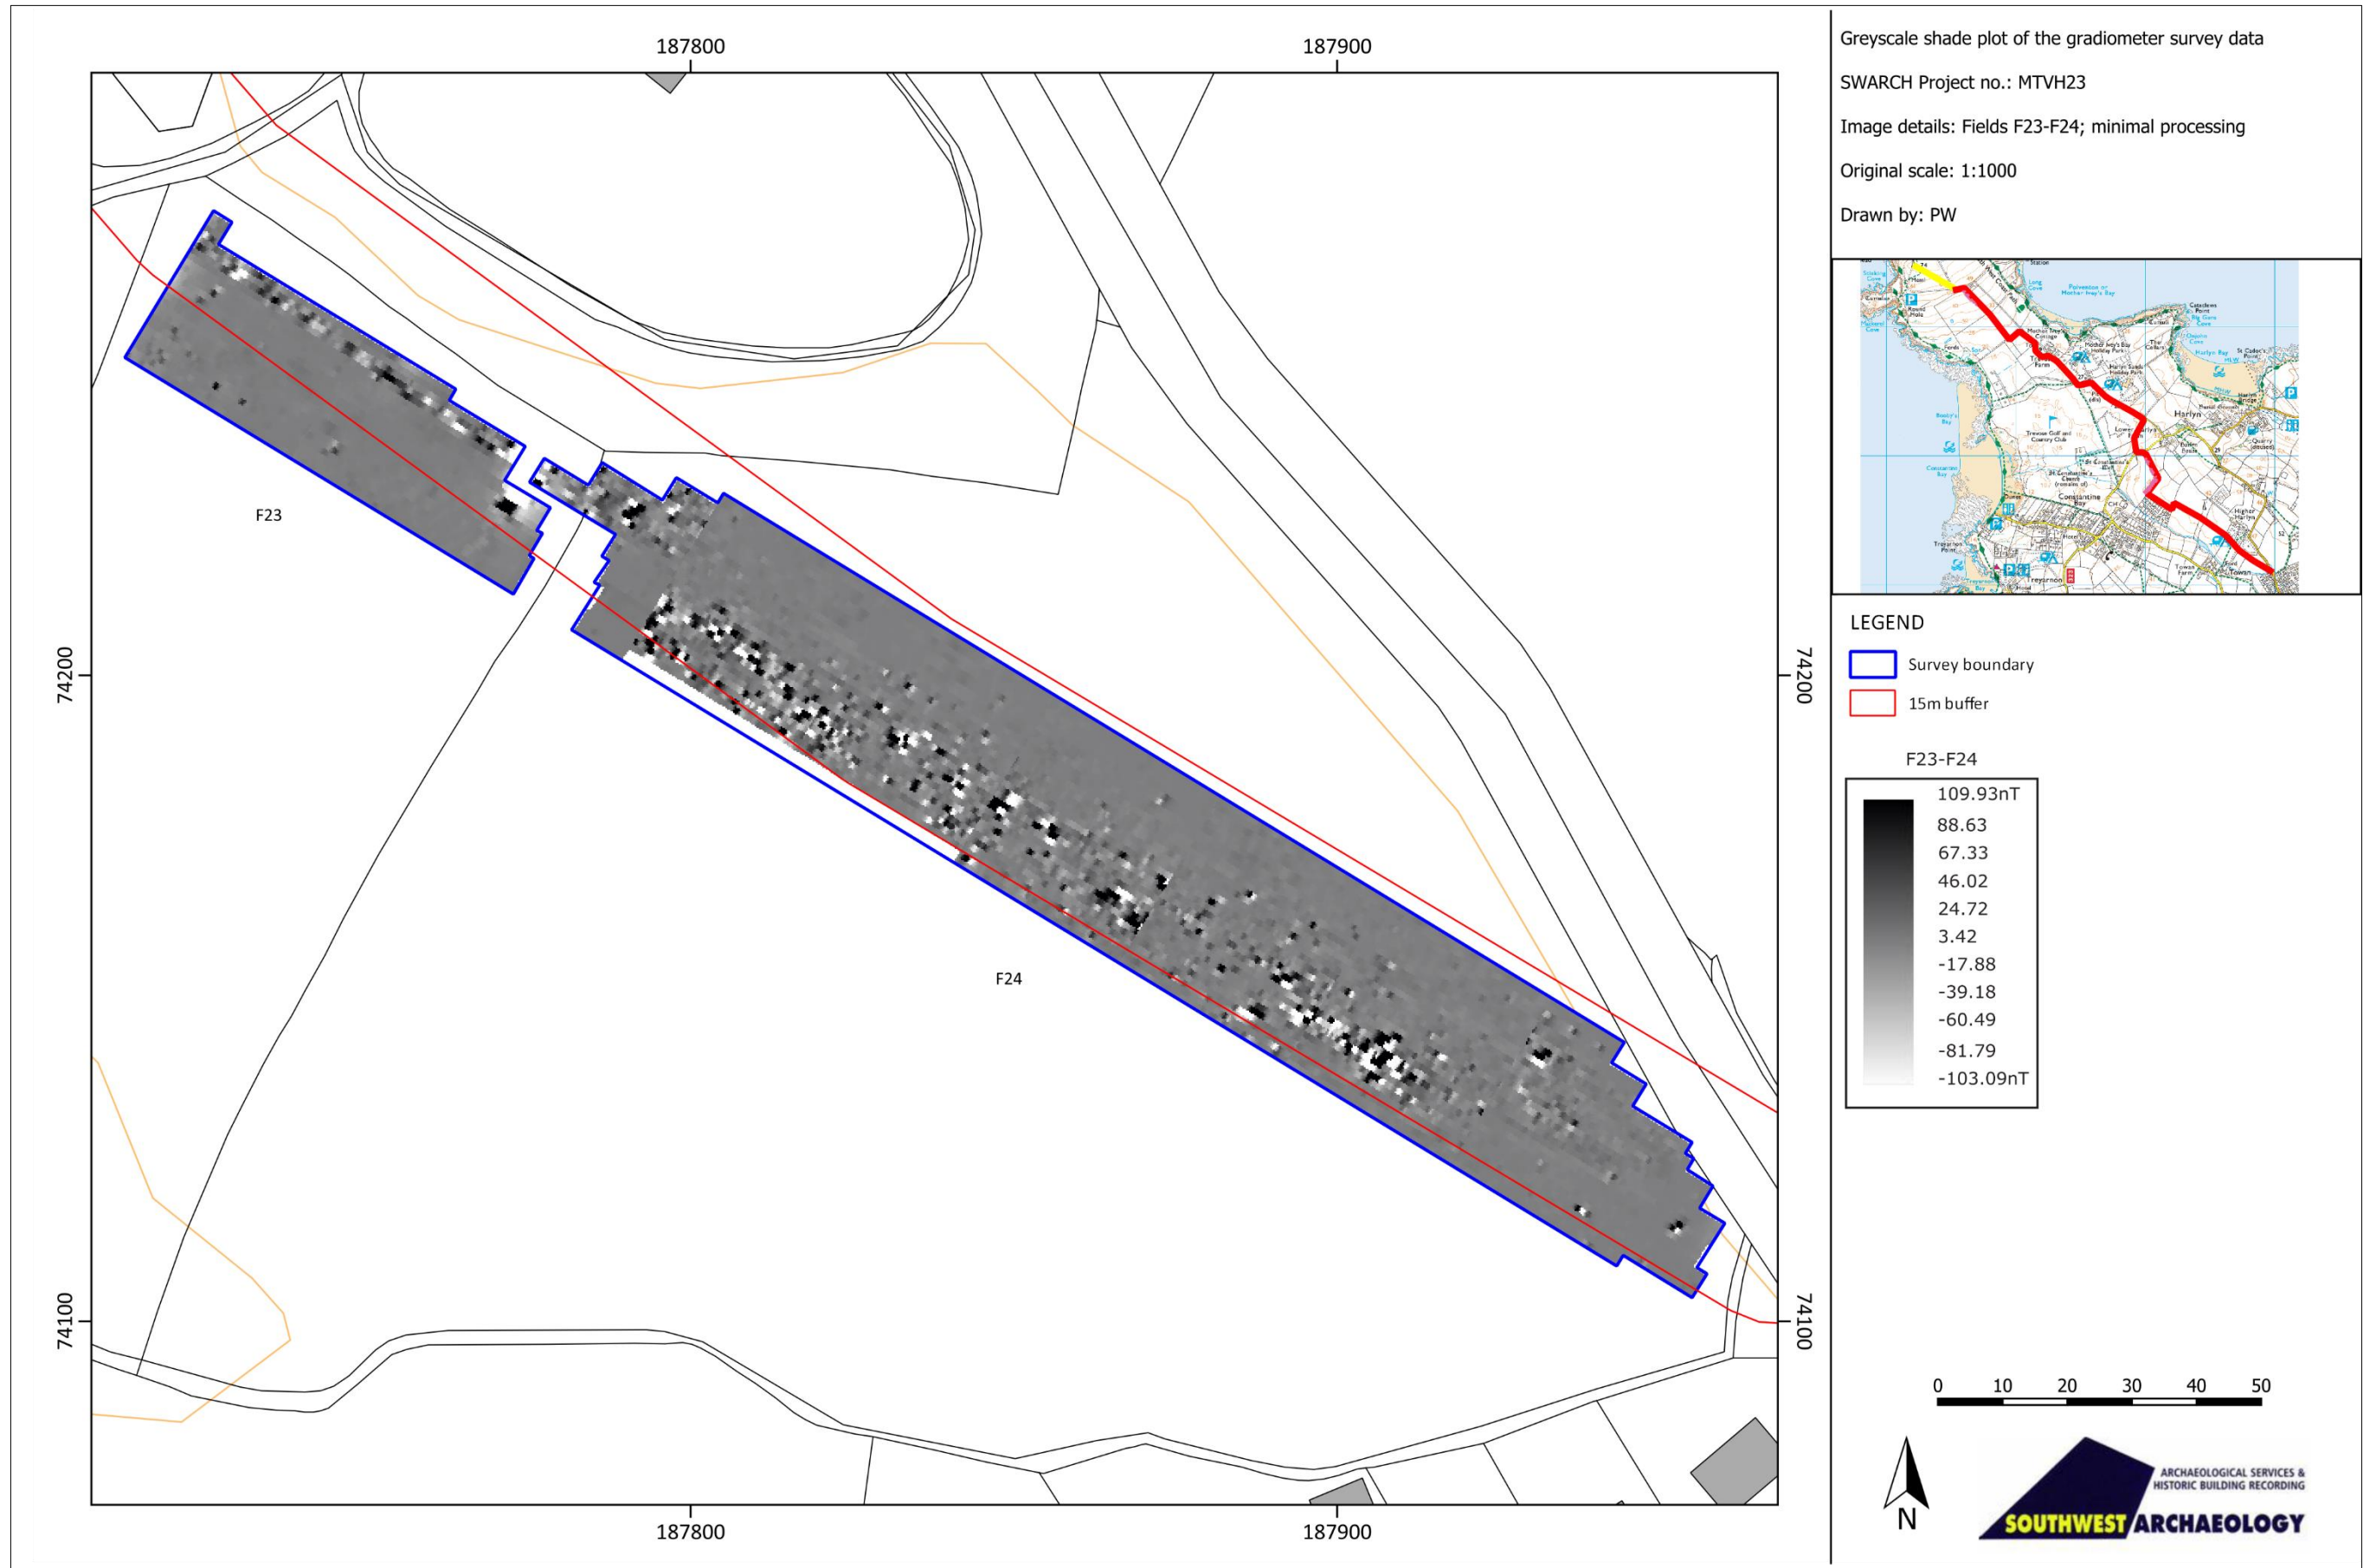
FIGURE 8: GREYSCALE SHADE PLOT OF THE GRADIOMETER SURVEY DATA (FIELDS F23-F24); MINIMAL PROCESSING (CONTAINS ORDNANCE SURVEY DATA © CROWN COPYRIGHT 2023. LICENCE NUMBER 100022432).

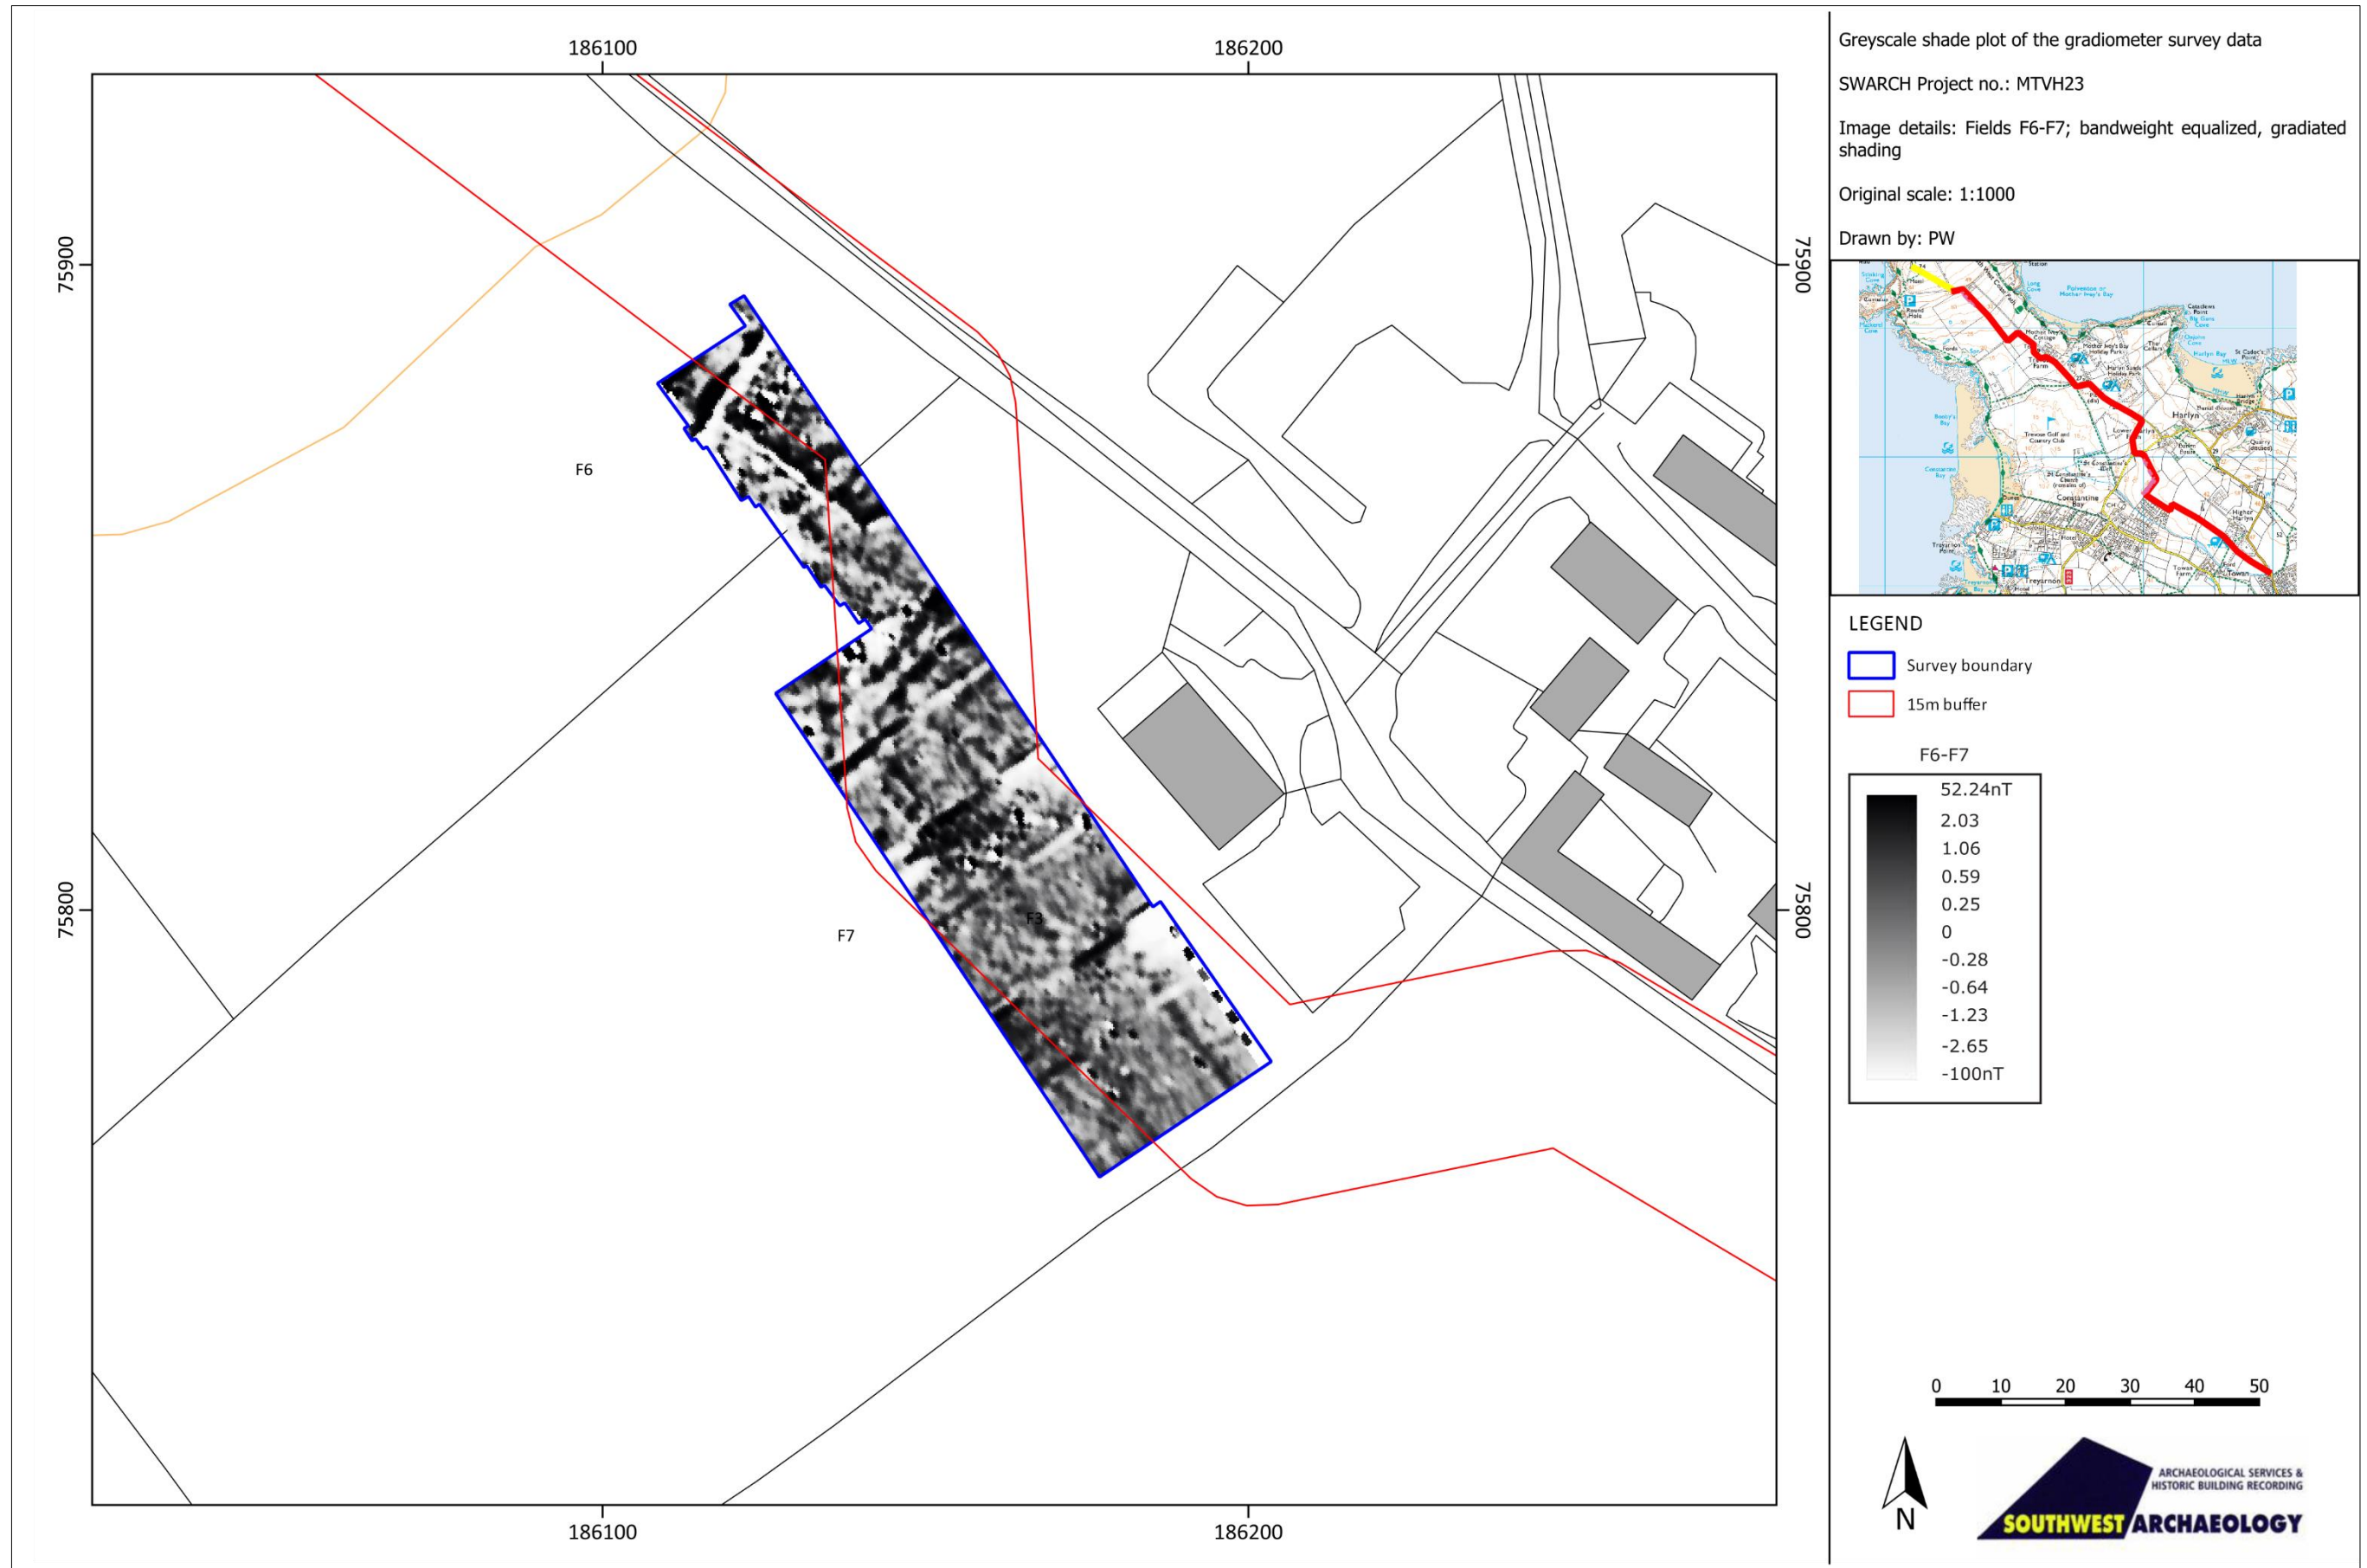
4. GREYSCALE SHADE PLOT OF GRADIOMETER SURVEY DATA (FIELDS F6-F7); BANDWEIGHT EQUALIZED, GRADIATED SHADING (CONTAINS ORDNANCE SURVEY DATA © CROWN COPYRIGHT 2023. LICENCE NUMBER 100022432).

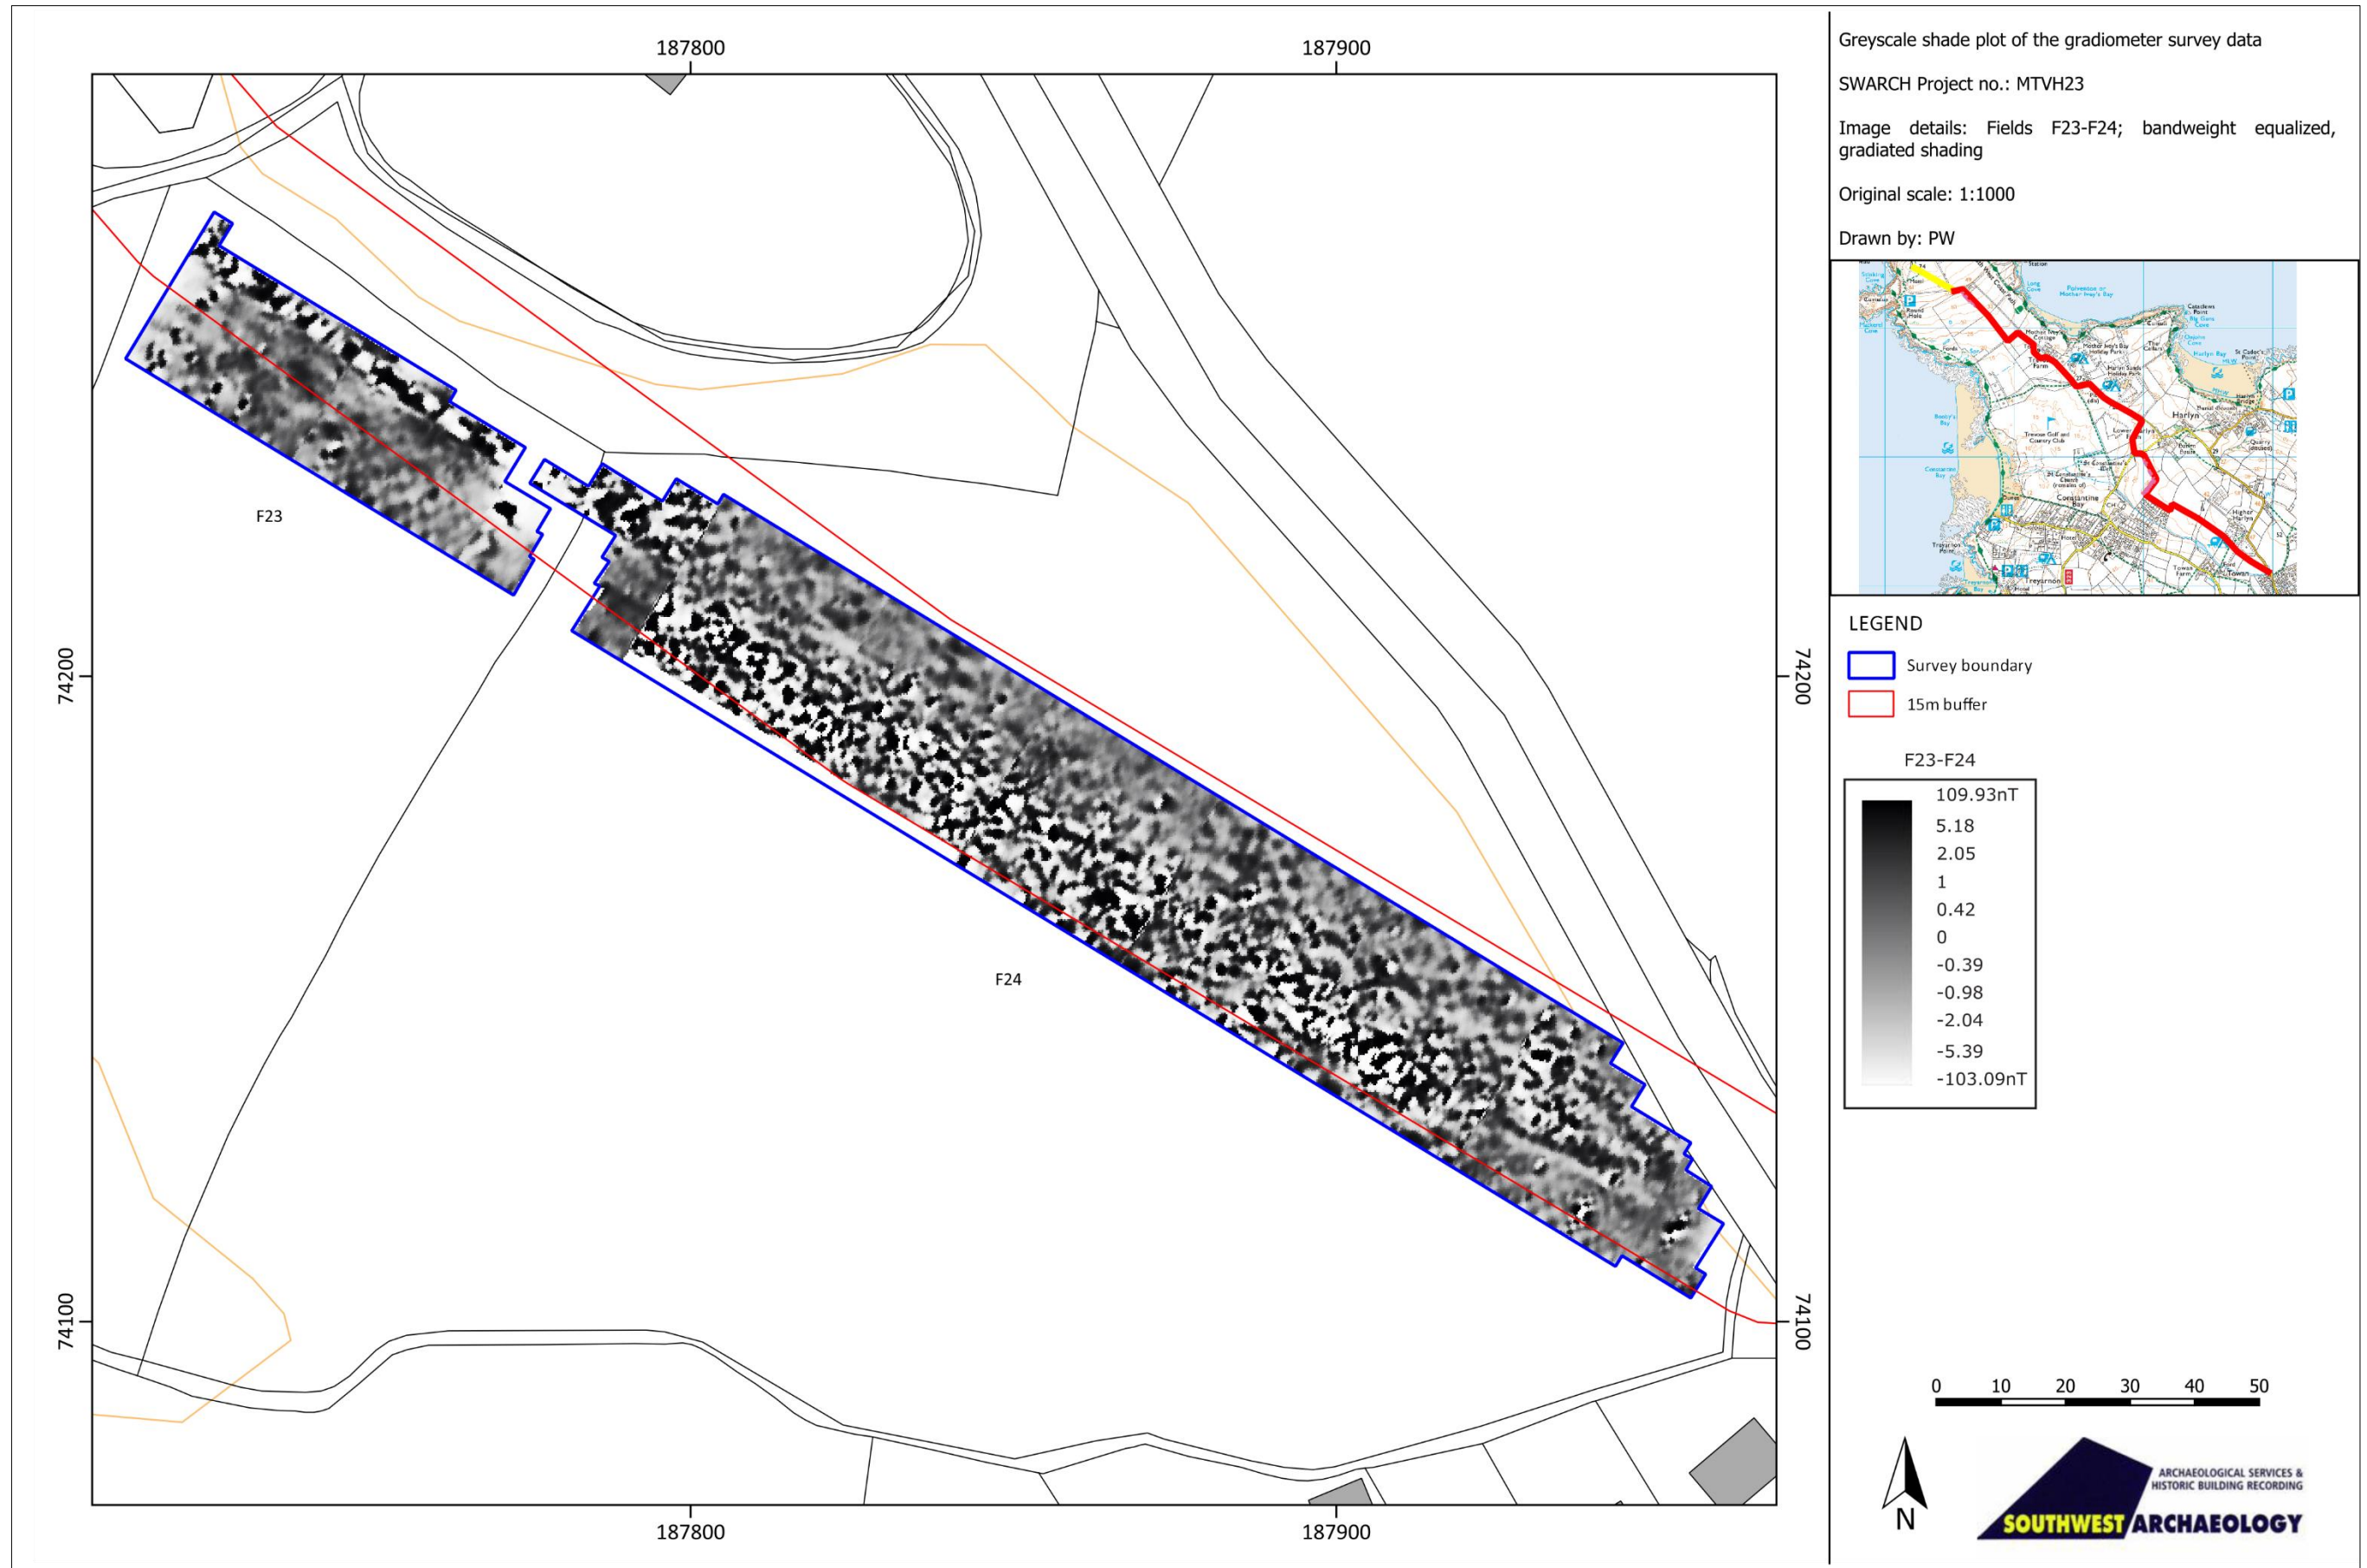
7. GREYSCALE SHADE PLOT OF GRADIOMETER SURVEY DATA (FIELDS F23-F24); BANDWEIGHT EQUALIZED, GRADIATED SHADING (CONTAINS ORDNANCE SURVEY DATA © CROWN COPYRIGHT 2023. LICENCE NUMBER 100022432).
