# Woodlands, Little Torrington, Devon

*Archaeological Monitoring and Recording*

*This report presents the results of a programme of archaeological monitoring and recording undertaken at Woodlands, Little Torrington, as part of conditioned full planning permission: 1/0366/2023/FUL and Listed Building Consent: 1/0367/2023/LBC. This project involved the rebuilding of an adapted 19<sup>th</sup> century extension and the conversion of the fitted kitchen space within the footprint of the medieval building, including the lowering of the floor level, as well as the insertion of associated new services.*

*The building is Grade II Listed (UID: 1326584) as: Farmhouse. Circa second half of the C15 with C17 modifications, extended in C19 and altered in C20.*

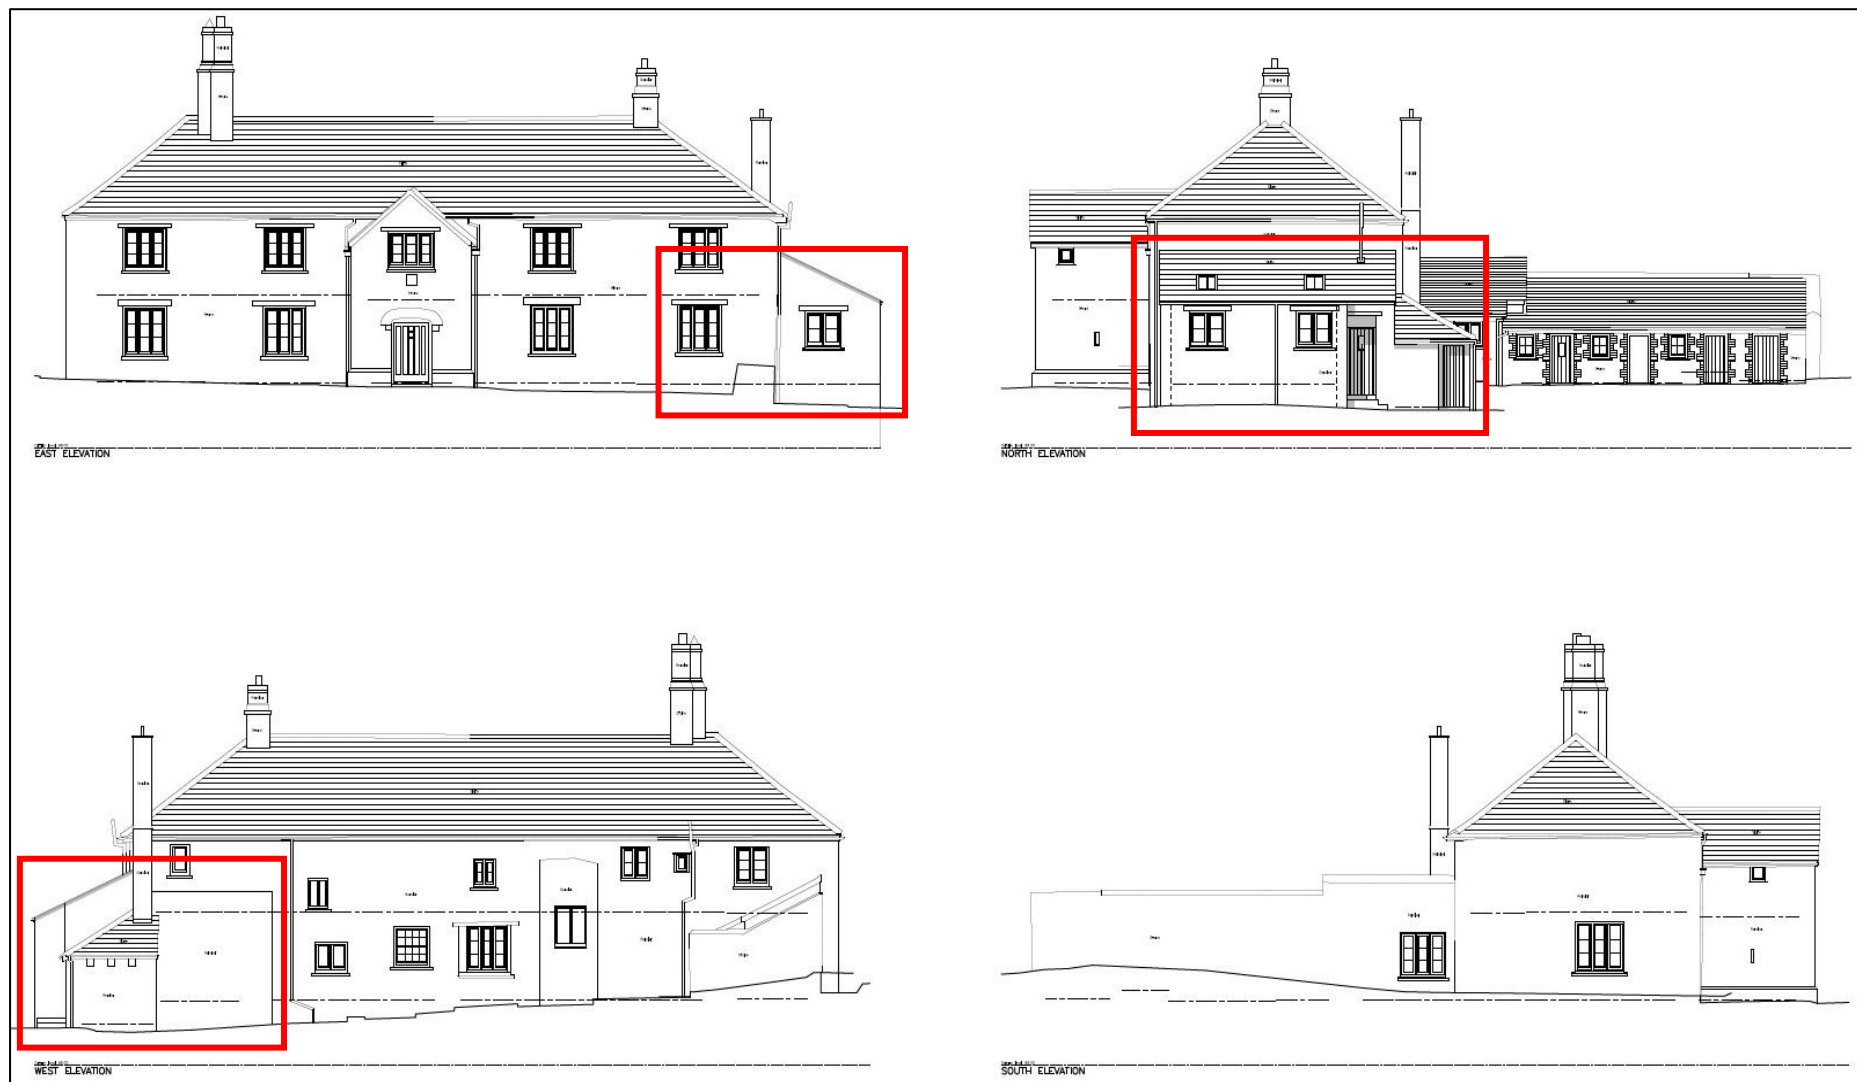
FIGURE 2: EXTRACT OF THE PROPOSED ELEVATIONS DOCUMENT BY AGENT (CADWORKS SOUTH WEST LTD) 2024.

Figures 2 & 3 below are the proposed elevations and ground floor, floor plan for the works as part of the conditioned planning permission. The areas that were focused upon during these works are marked in red boxes on Figures 2 and 3.

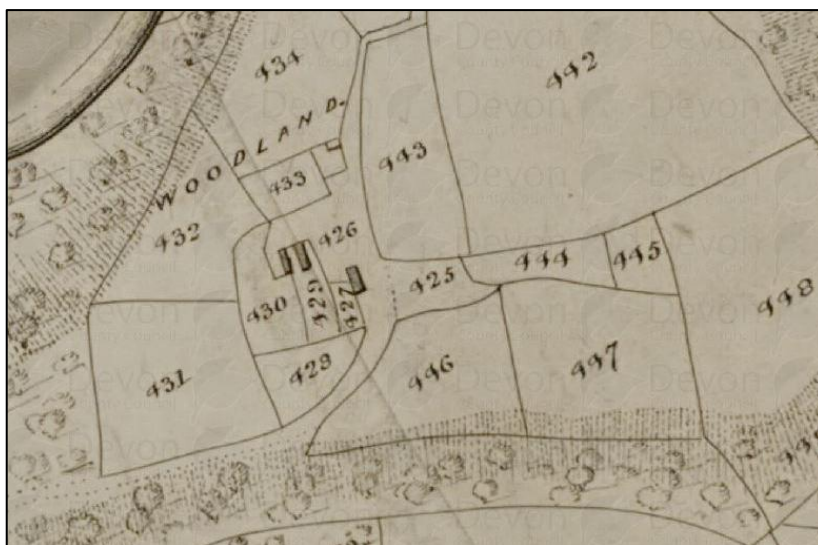
FIGURE 5: EXTRACT OF THE LITTLE TORRINGTON TITHE MAP, c.1840 (DHC).

Three, long, rectangular buildings are depicted on the c.1840 Little Torrington Tithe Map, consistent with the three historic buildings known on the site. The depictions lack detail, however, with elements such as the porch missing on the farmhouse. Looking at other buildings in the surrounding area, all seem to be represented by simple rectangles, so this likely indicates the level of recording as opposed to any structural phases.

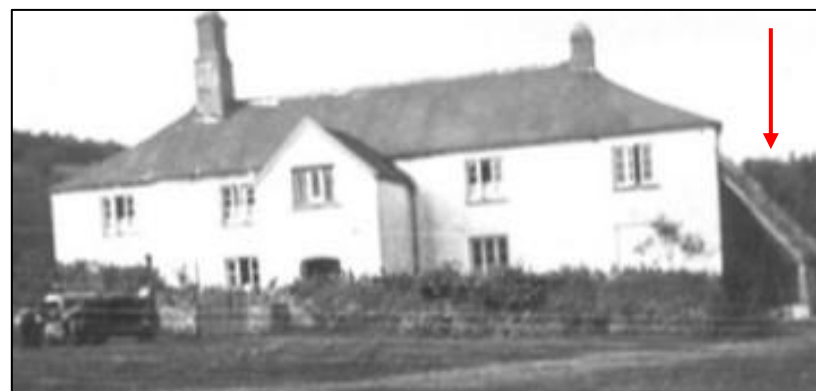
FIGURE 7: PHOTOGRAPH OF WOODLANDS, LIKELY 1900-1940, HELD IN GREAT TORRINGTON HERITAGE MUSEUM ARCHIVE, NOTED MR HUXTABLES HOUSE ON THE BACK.

A historic photograph of the site (see Figure 7 above) is held in Great Torrington Heritage Museum's archive, possibly taken when the building's historic plasterwork was first being recorded by antiquarians – it shows the house with its (correct) lime rendered wall covering, taken from the south-east, with very clearly the original 19<sup>th</sup> century lean-to, to the bottom (right) end of the building (indicated on the photograph with an arrow).

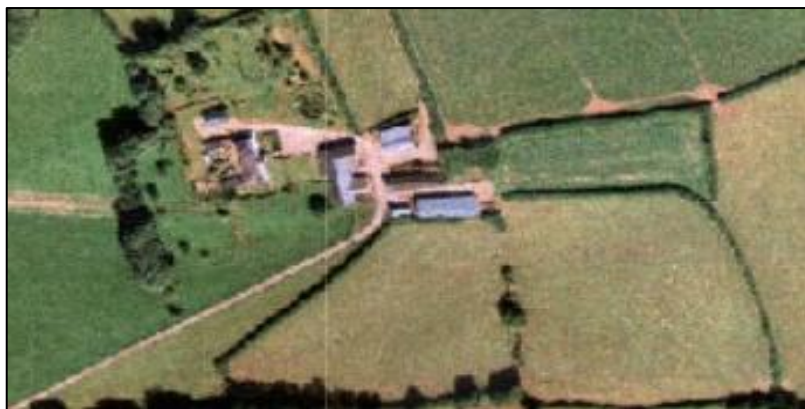
FIGURE 8: ©GET MAPPING MILLENIUM MAP. 1999.

A series of aerial photographs have also been taken of the farm between 1946 and present. The 1946 aerial shot (which is of poor resolution so not reproduced here) shows the large barn has recently been reroofed, likely in tin sheeting. The buildings west of the farmhouse appear to still be roofed. By the 1999 mapping (see Figure 8 above) the larger modern farm buildings have been constructed further east and the space around the barn and farmhouse seems to be more open and cleared away, a domestic character garden setting appears to have been established. There is

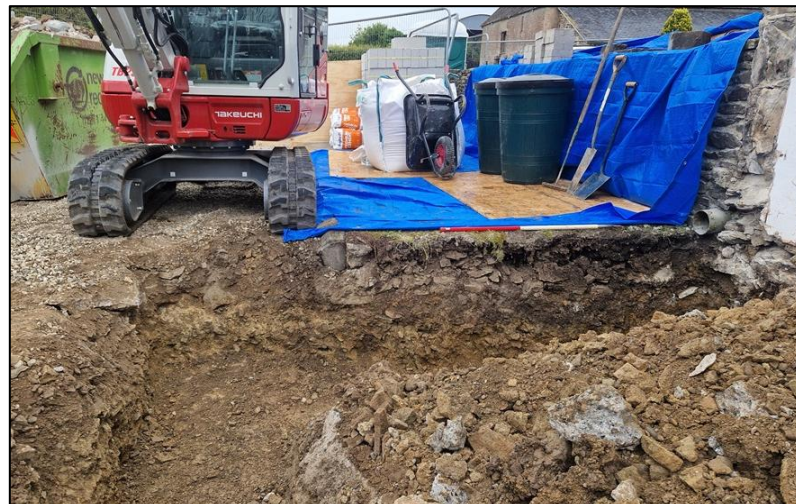
To the east is a 1.9m long single course of a earth bonded stone footing, 0.3m below the grass level this could be edging for a flower bed but has what appears to be three good quoins to the north corner, at this end they are abutted by concrete block, presumably suggesting a return runs away to the west (see Figure 10). This is presently the edge to a lawned/grassed area. This footing stops 0.5m before the garden wall to the south. There is a dark grey-brown 0.2m thick topsoil below this footing, which likely represents the infilled wall cut, as it stops at both ends of the wall.

This truncated wall footing with quoins found just below the footing of the extension didn't have proper foundations and only a shallow wall-cut, it may represent the last of the remnants of the 19<sup>th</sup> century lean-to previously located on this side of the building.

FIGURE 10: VIEW OF EXPOSED FOOTINGS (OF 19<sup>TH</sup> CENTURY LEAN-TO?), FROM THE WEST (1M SCALE).

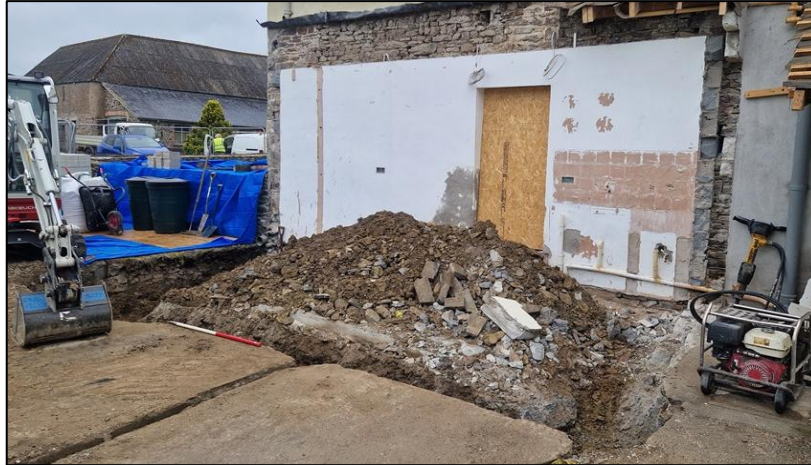
The present footing to the north end of Woodlands House was exposed by this work and recorded. It comprised a single course of large, squared stones, the bottom two quoins on the north-east corner had been removed previously, presumably for the former extension.

FIGURE 11: WORKING SHOT OF THE SITE OF THE DEMOLISHED EXTENSION AND EXCAVATED FOOTINGS, WITH CONCRETE APRON, FROM THE NORTH (1M SCALE).

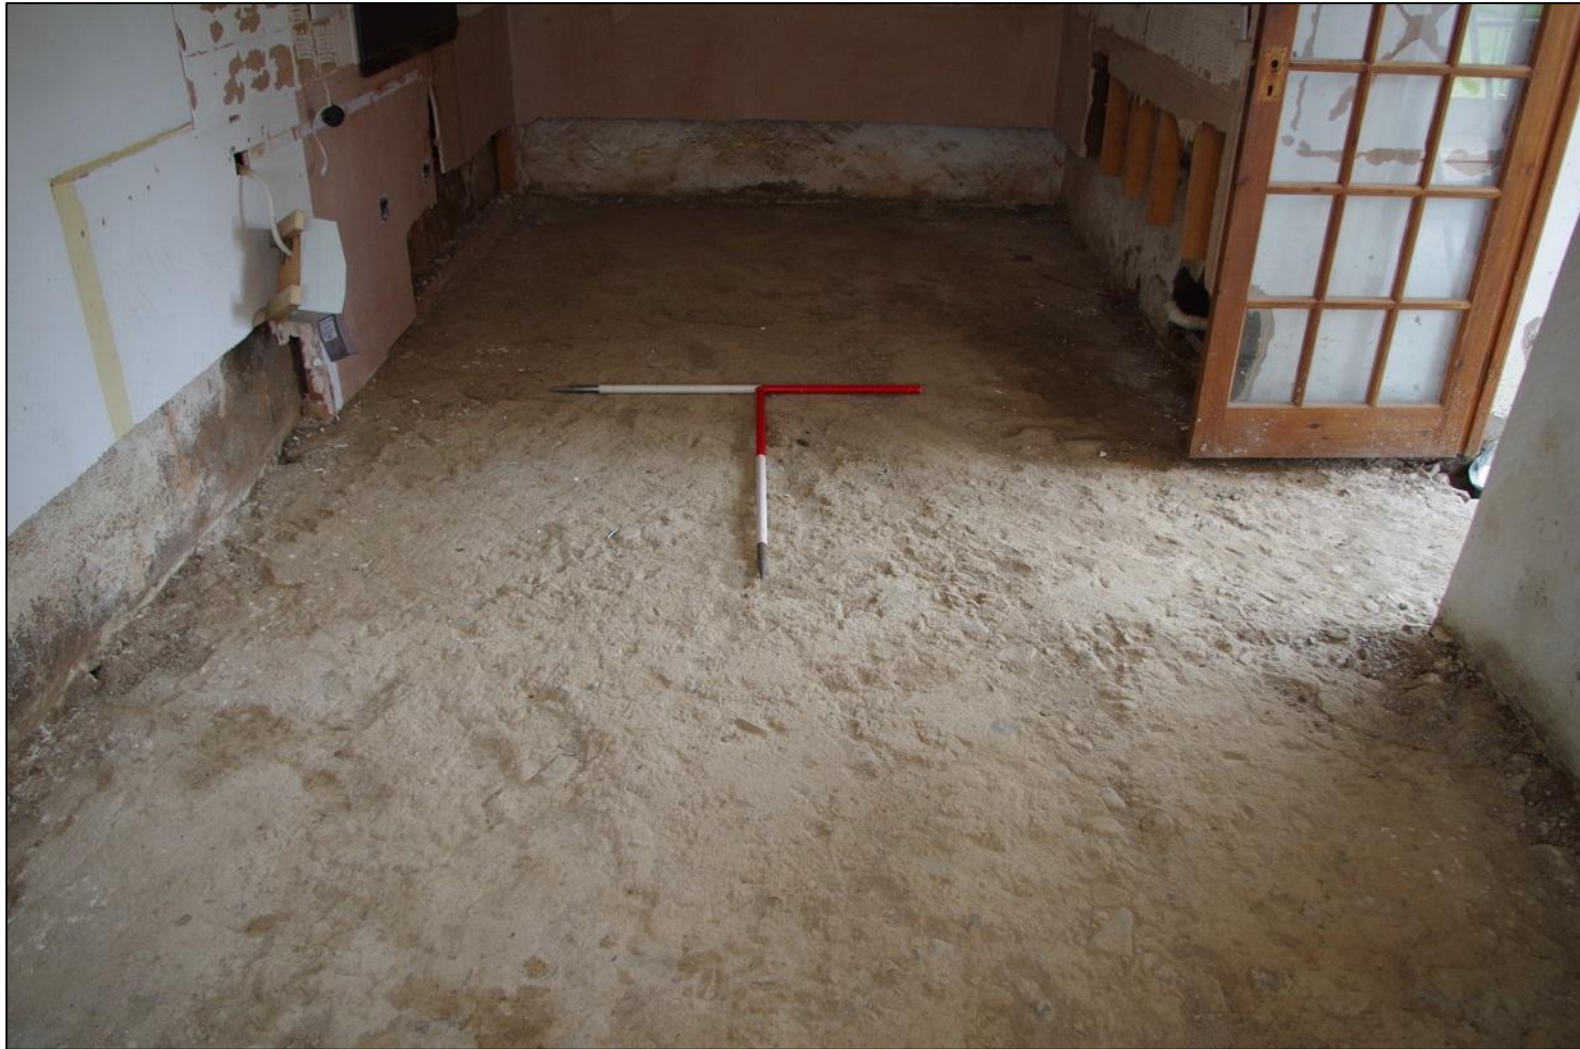
The modern fitted kitchen, lino covering and thin skim of 20<sup>th</sup> century concrete had already been removed prior to attendance. This had exposed a limecrete historic floor (101) which was cleaned and photographed. This floor surface was a hard-packed grey-white, gritty layer, approximately 10cm deep and included some loose river pebble cobbles. The limecrete floor at the south end contained an embedded timber 2.2m long, which appeared to be a base rail for a narrow, lath partition. Beyond this partition the lime

FIGURE 13: THE LIMECRETE FLOOR (101) BEFORE SECTIONING AND EVENTUAL EXCAVATION; FROM THE SOUTH (2 x 1M SCALES).

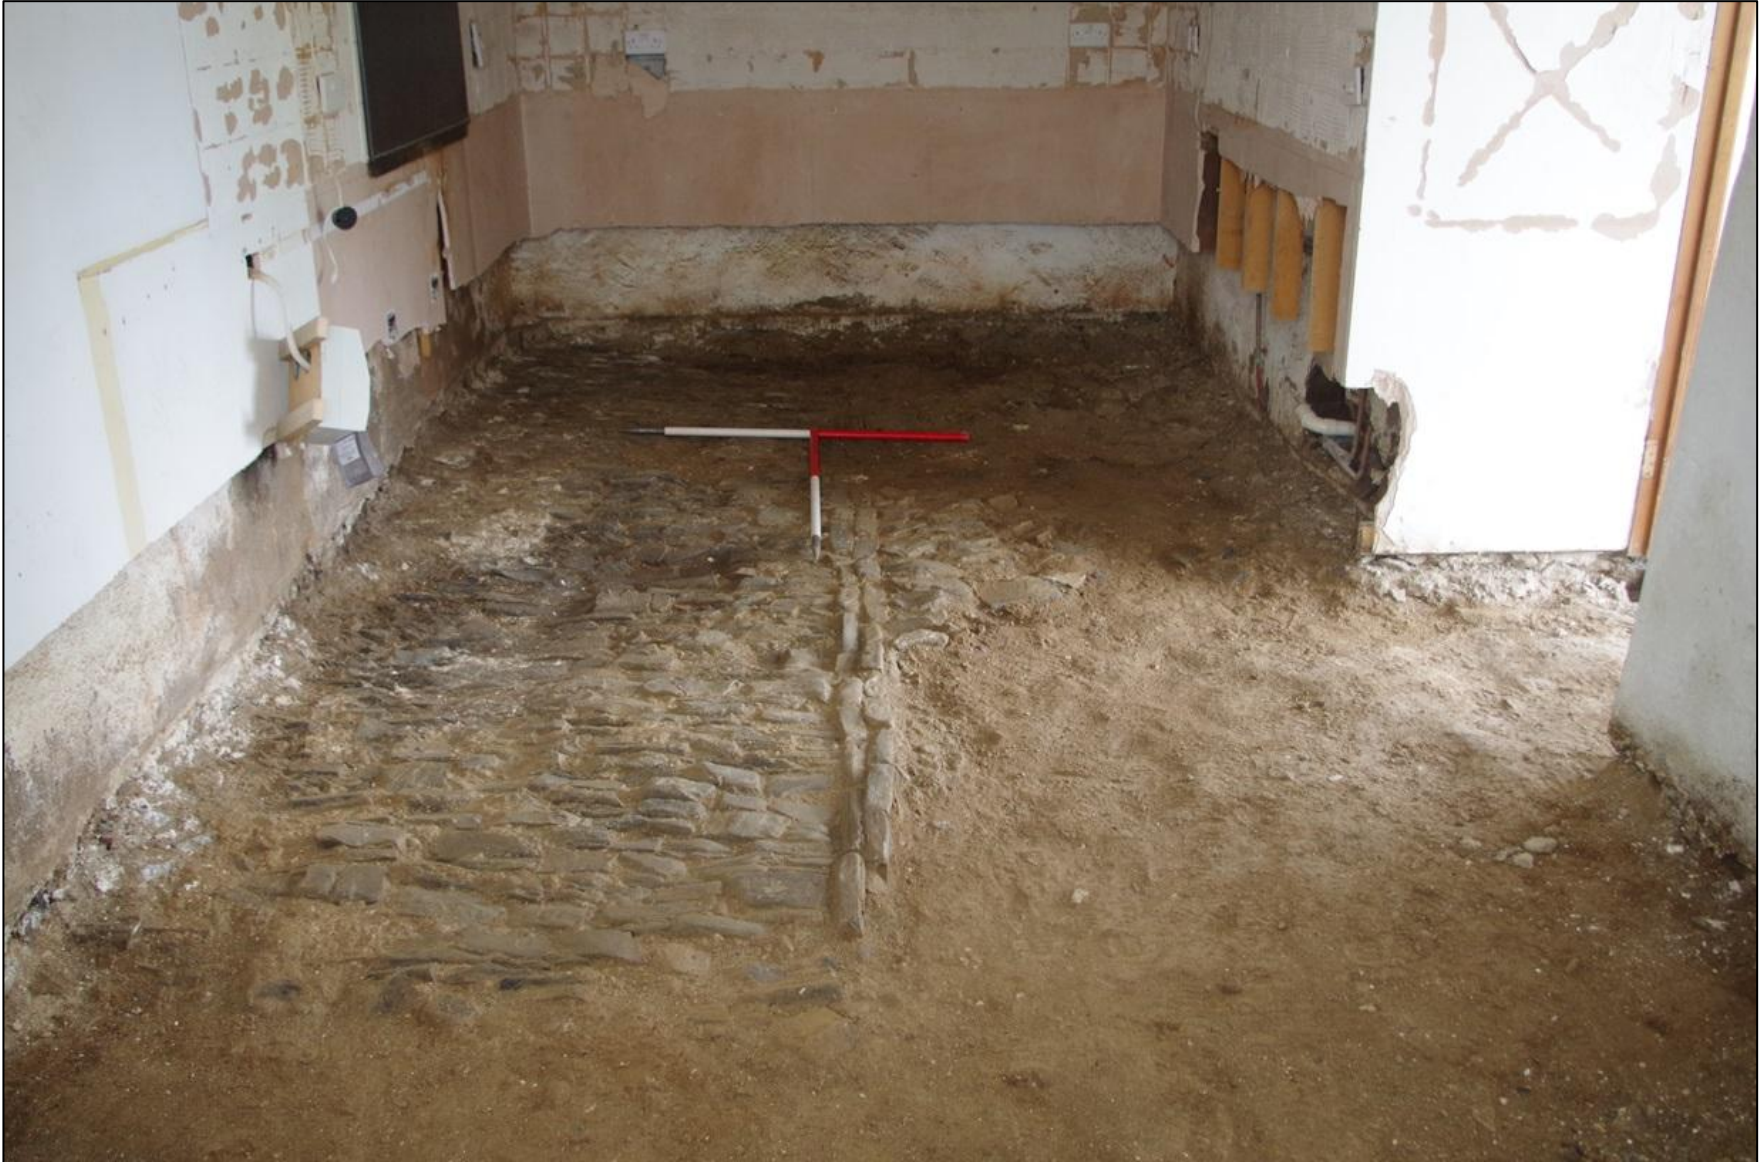
This cobbled floor (107) also had a central cobbled drain running east-west and was 10-20cm deep on average. This floor was deemed archaeologically significant and the limecrete floor was therefore wholly removed to expose the cobbles and the floor was drawn to scale. In several areas the floor had slumped down into the made-ground below, and these sunken areas had been packed with an earlier lime-mix and packed with slates (105). To the north-west corner another area of damage had received remedial packing mixing loose cobbles and possibly demolition rubble in a lime and earth mix, with artefacts like nails, some window glass and pottery – this levelled the ground and provided support to the central drain – this packing and repair was also buried by the limecrete floor – suggesting at least two phases of damage and alteration in this space, before the limecrete floor was installed.

FIGURE 14: THE COBBLED FLOOR (107) AFTER CLEANING; FROM THE SOUTH (2 X 1M SCALES).

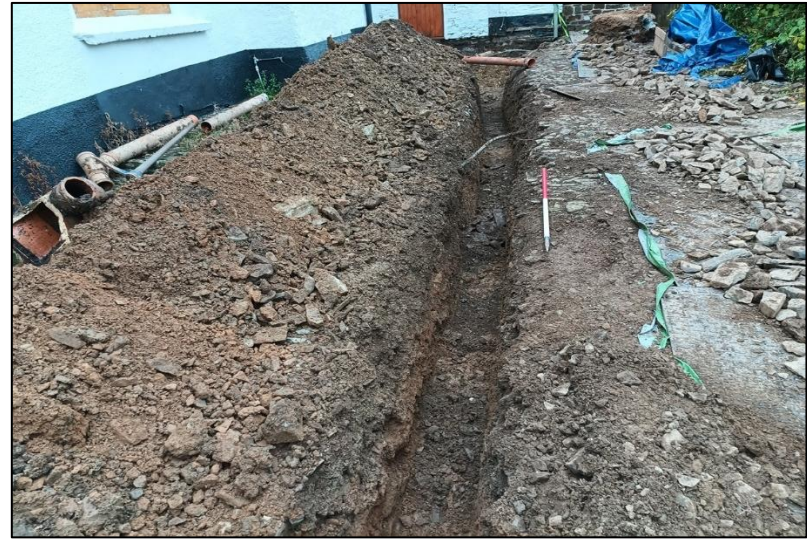
The stratigraphy was of a cobbled surface (111), overlying a layer of light-coloured sand (112), c.0.05m thick; which overlay a buried topsoil (113), a dark grey-brown friable silt, c.0.20m thick; overlying natural (114) a mid-yellow-grey silt-clay.

The cobbled surface of the yard is likely post medieval, c.1700-1900 in date, clearly built around the remains of the earlier medieval buildings. It is much patched and altered, with differences in packing and size and type of stones used, between small pebbles and larger split slates. The various cuts in the subsoil represent phases of modern services.

FIGURE 15: THE SERVICE TRENCH, AS VIEWED FROM THE NORTH (1M SCALE).

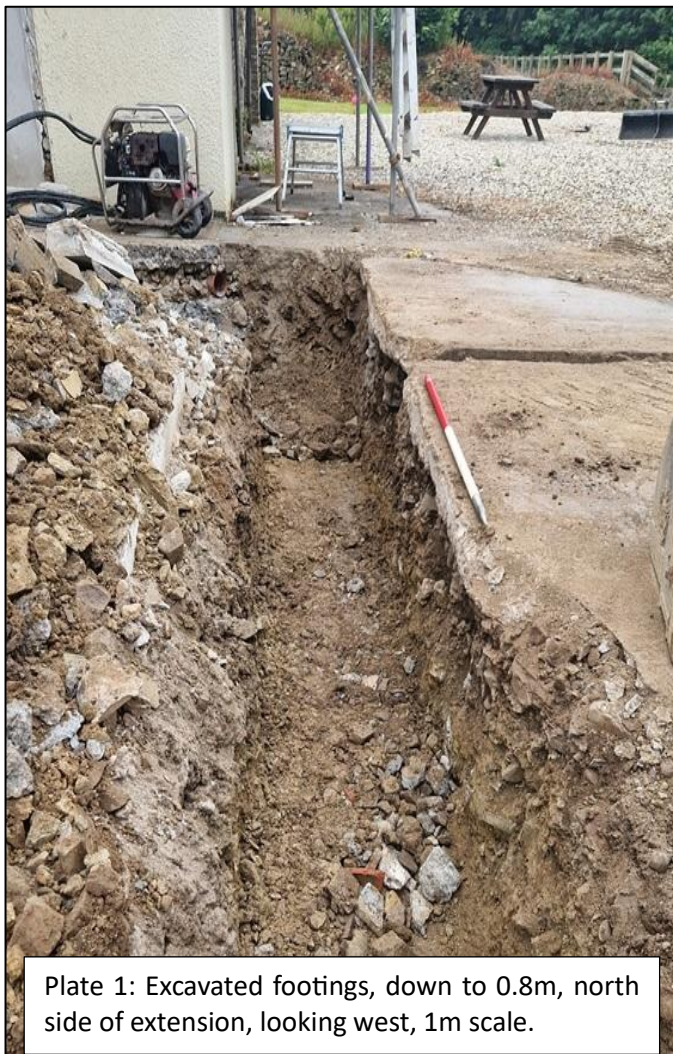
Plate 1: Excavated footings, down to 0.8m, north side of extension, looking west, 1m scale.

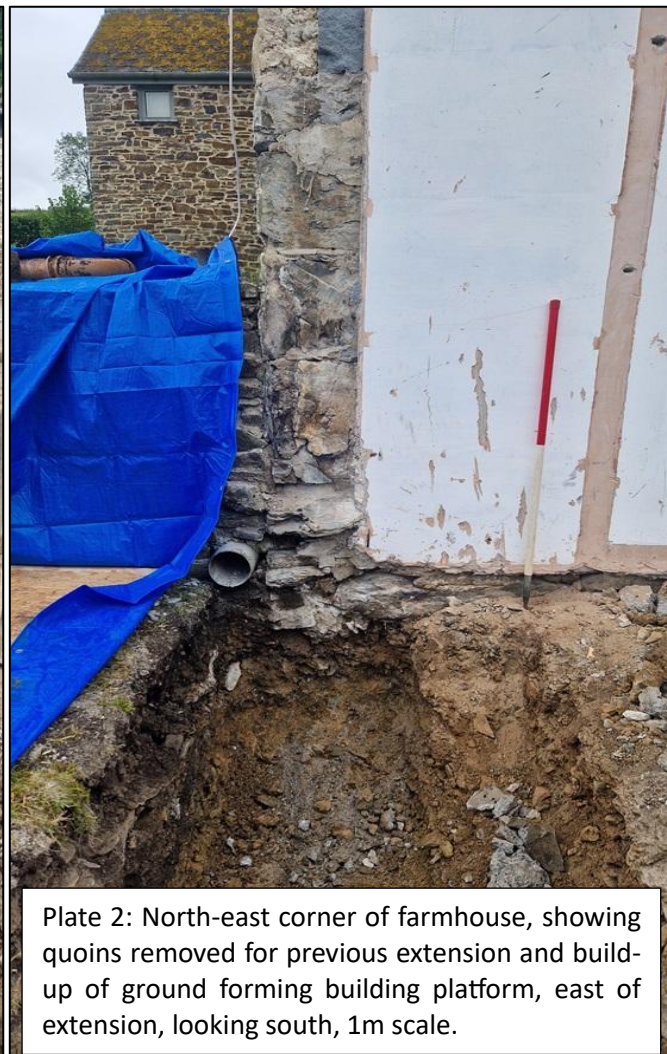
Plate 2: North-east corner of farmhouse, showing quoins removed for previous extension and build-up of ground forming building platform, east of extension, looking south, 1m scale.

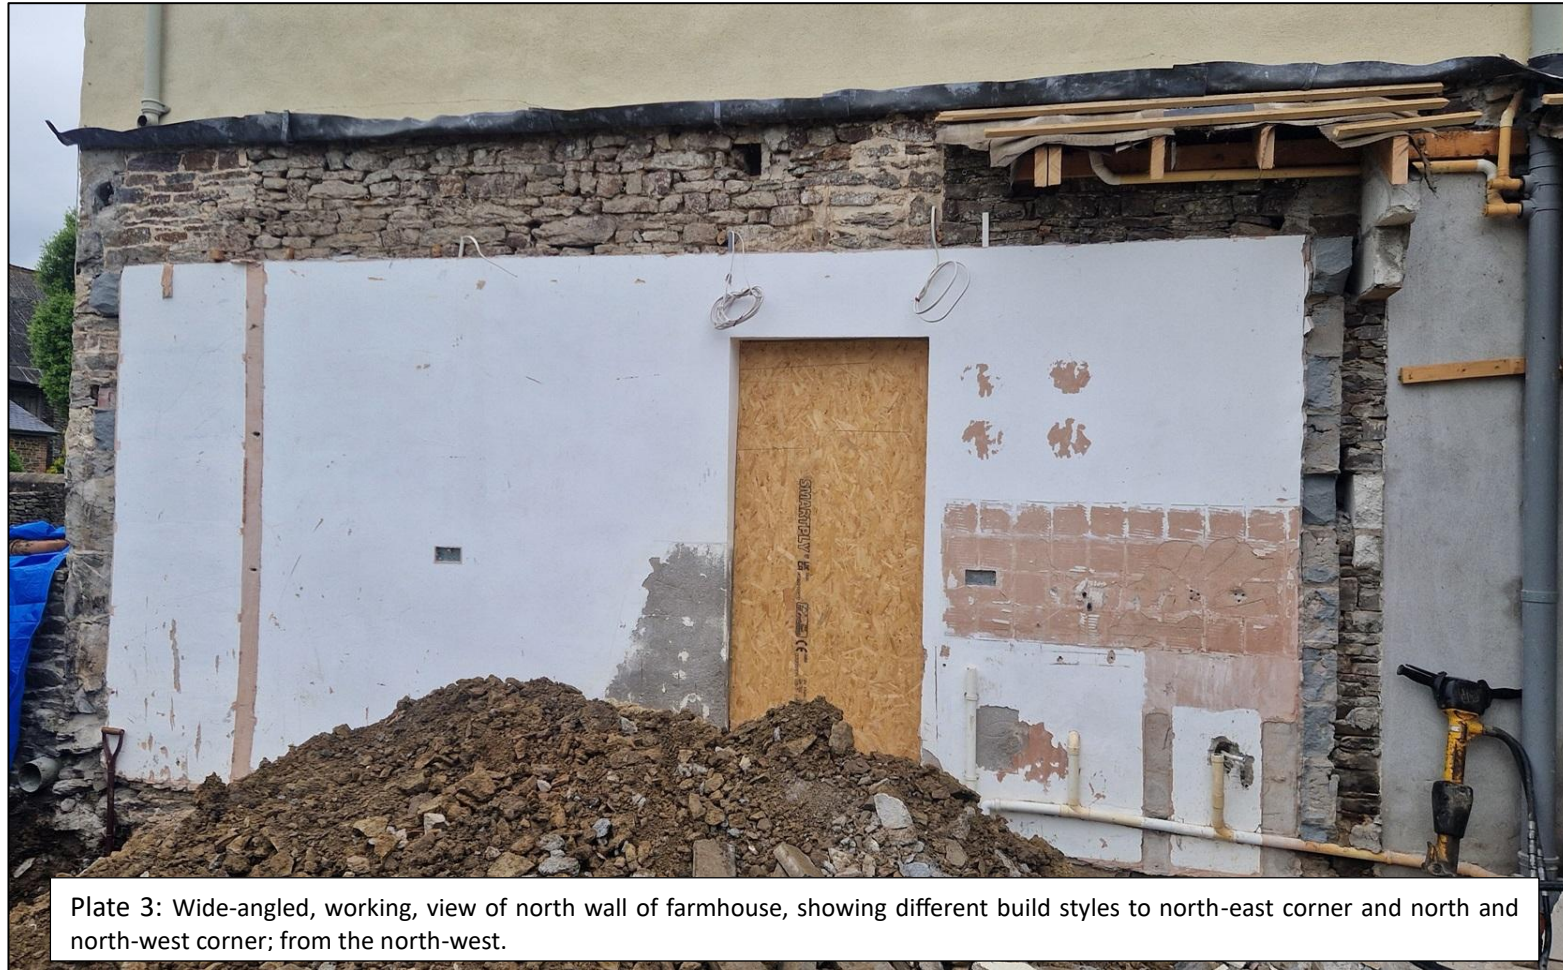
The north elevation of Woodlands was mostly rendered, but where stonework was exposed by the demolition of the modern extension it had largely been previously repointed in cement and or the pointing had been entirely washed out. The build to the 'west' side is of well-coursed blocky sub-angular build, with close joints and minimal earth bond. This is of a fine quality known colloquially in this region as 'freestone'. One possible straight build line may suggest structural phasing, directly above the ground floor door into the current kitchen. Beyond this straight build line, to the 'east' side the stonework is of a more typical rubble build, with closely packed unshaped stones and slabs, in a lime mortar.

Plate 3: Wide-angled, working, view of north wall of farmhouse, showing different build styles to north-east corner and north and north-west corner; from the north-west.

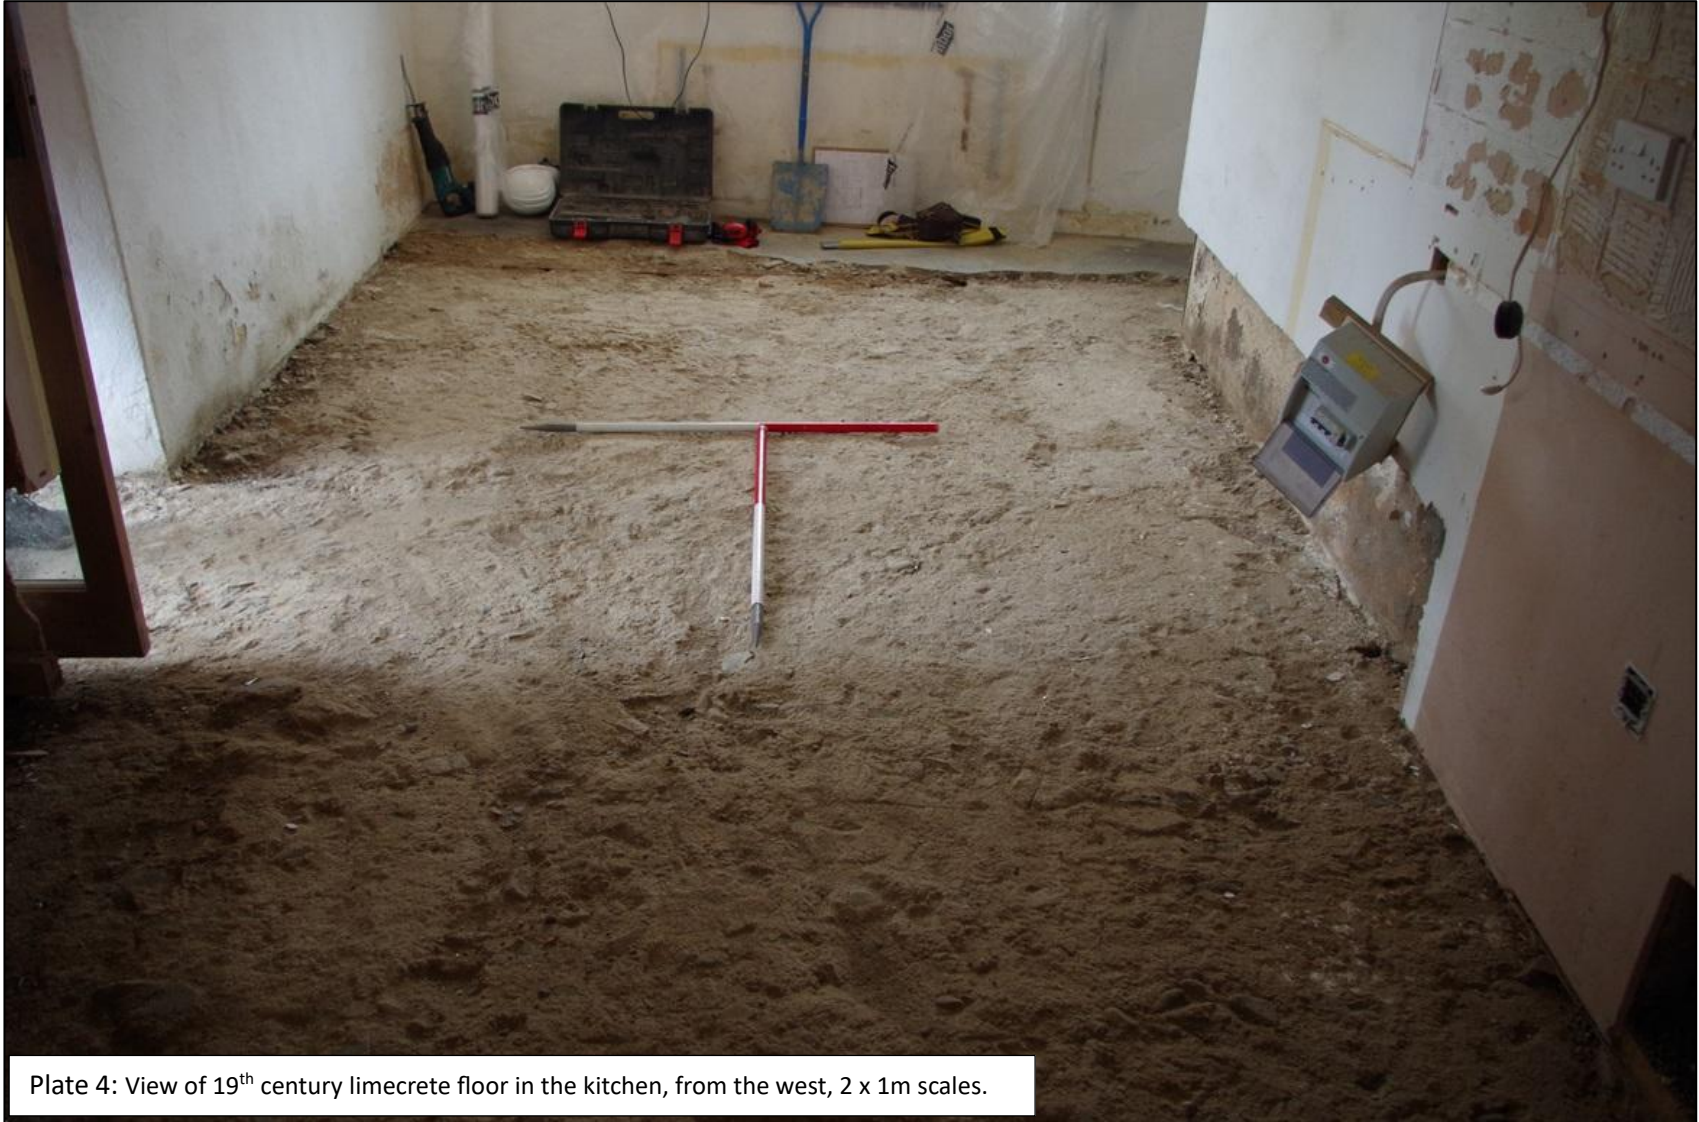
Plate 4: View of 19<sup>th</sup> century limecrete floor in the kitchen, from the west, 2 x 1m scales.

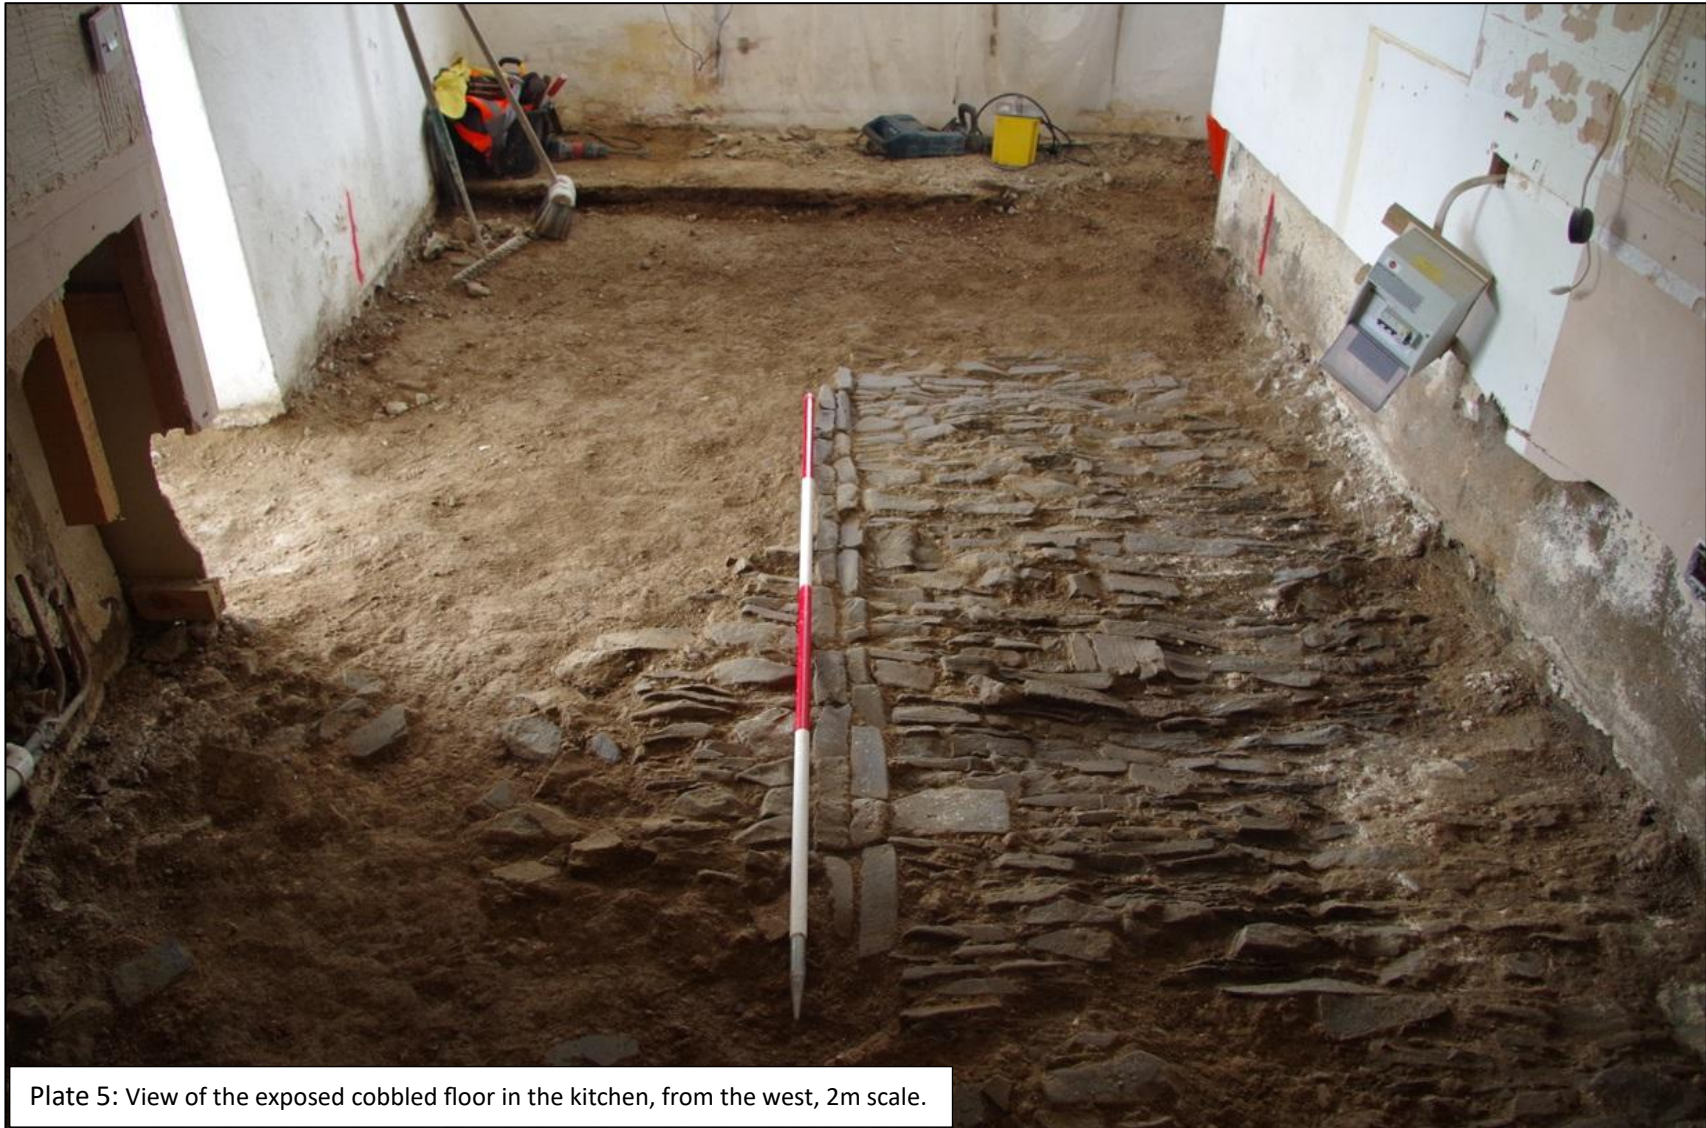
Plate 5: View of the exposed cobbled floor in the kitchen, from the west, 2m scale.

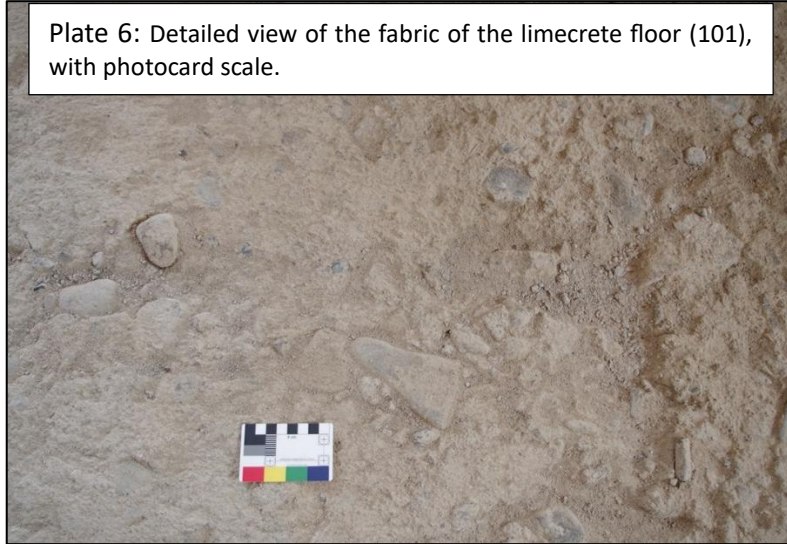
Plate 6: Detailed view of the fabric of the limecrete floor (101), with photocard scale.

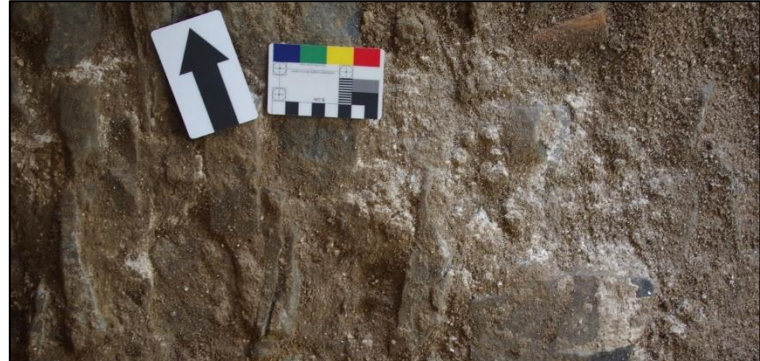
Plate 8: Detailed view of the lime and earth mixed fabric (105), with slates, which packs the sunken areas of the limecrete floor (107), with photocard scale.

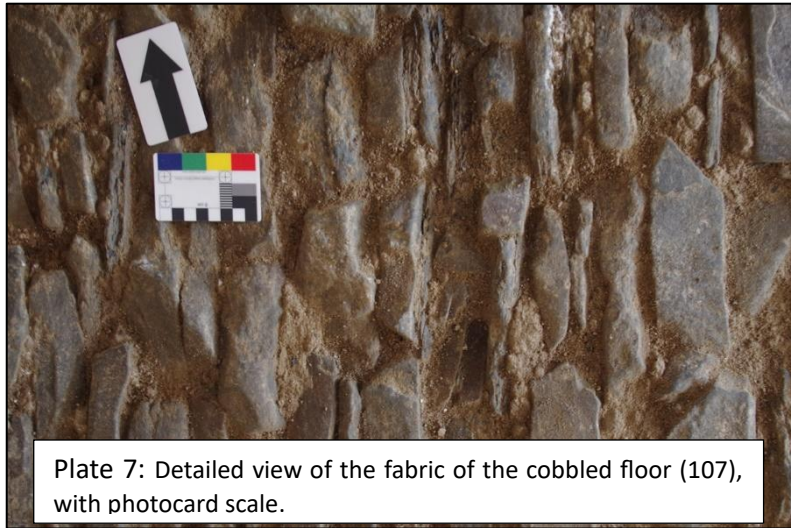
Plate 7: Detailed view of the fabric of the cobbled floor (107), with photocard scale.

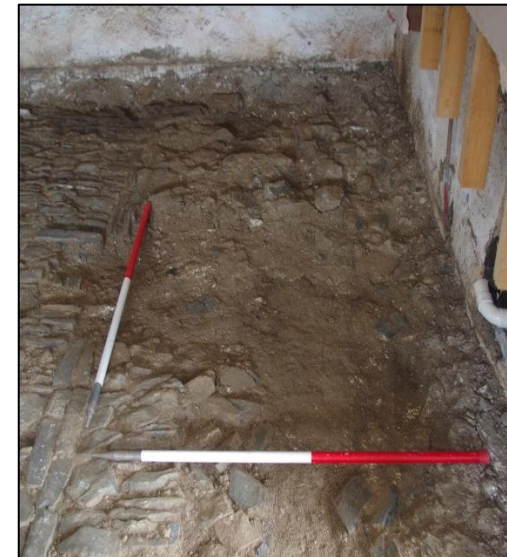
Plate 9: Detailed view of the earlier phase of packing and remedial works to the cobbled floor where the north-east corner had been damaged, viewed from the east, 2 x 1m scales.

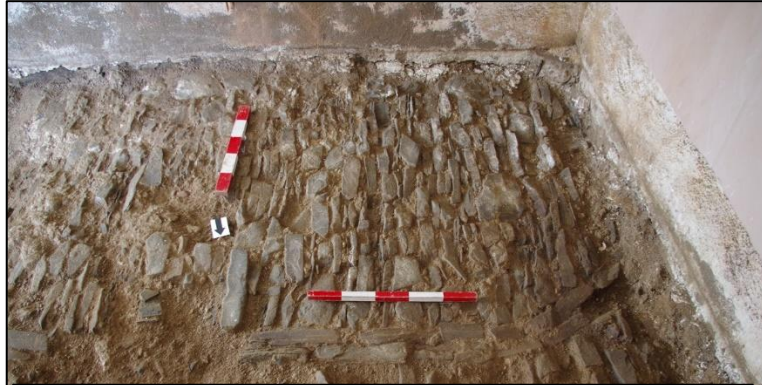
Plate 10: Detailed view of west end of cobbled floor, where the drain curves back to pass through a drain hole in the west wall, now blocked. 0.5m scale. from the north-north-west.

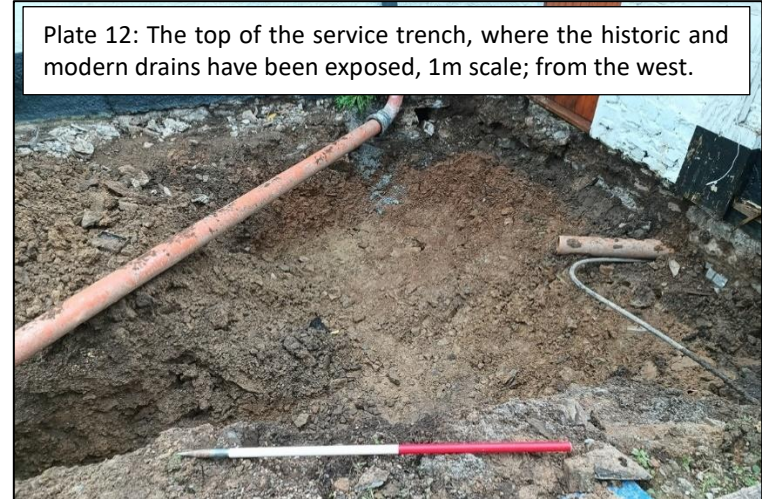
Plate 12: The top of the service trench, where the historic and modern drains have been exposed, 1m scale; from the west.

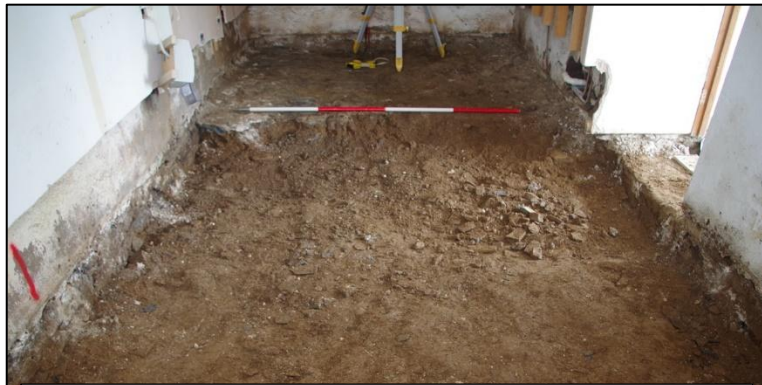
Plate 11: View of almost fully excavated and removed cobbled floor, showing depth of made ground packing beneath that and above the natural yellow-grey clay, 2m scale, from the east.

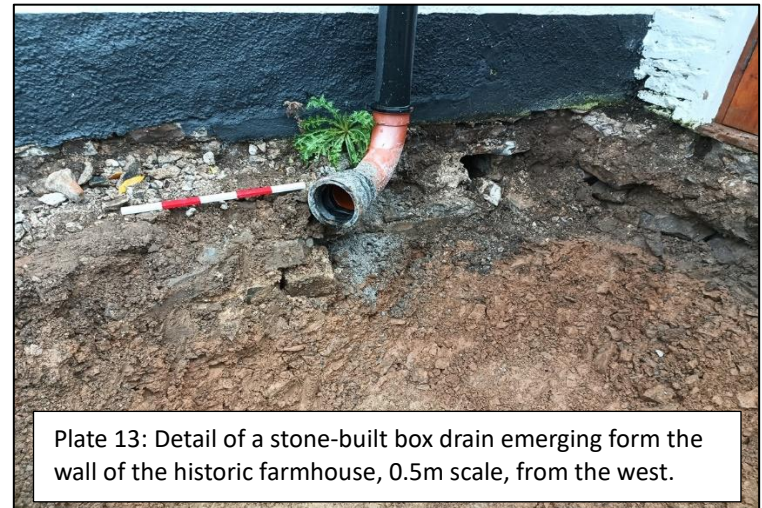
Plate 13: Detail of a stone-built box drain emerging from the wall of the historic farmhouse, 0.5m scale, from the west.
