**No. 34 (FORMER LONDON INN)  
FORE STREET  
REDRUTH  
CORNWALL**

Historic Building Recording

South West Archaeology Ltd. report no. 230904

Draft issued: 29<sup>th</sup> September 2023

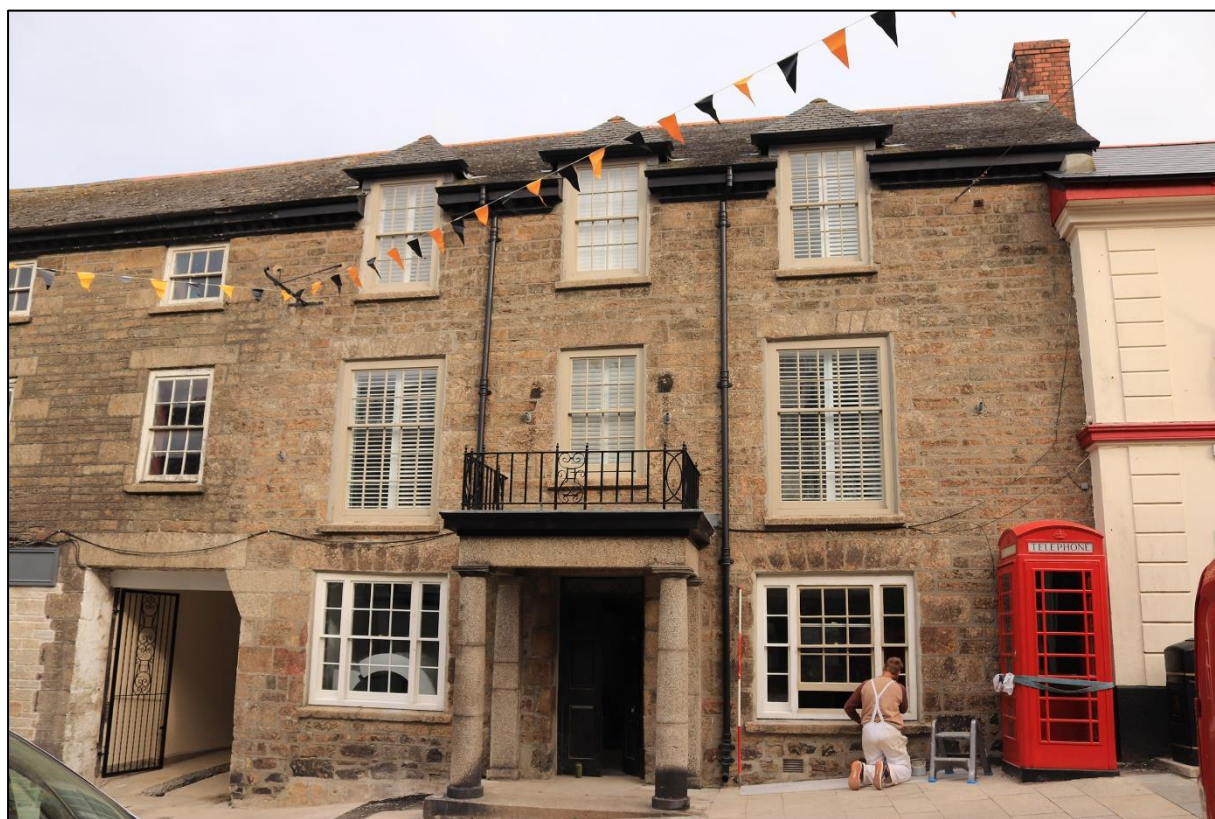
FIGURE 7: THE SOUTH FAÇADE FRONTING FORE STREET, NEIGHBOURING NO.33 STILL COMPLETE WITH SOME ORIGINAL WINDOWS.

works have made the site look very different; the windows have been reinstated with heritage sash replacements including the ground floor tri-partite sashes, and the carriage passage has a new ornate iron gate which matches a new railing lining the central portico.

Access to the public house was through a central door under the projecting portico. The door had been revealed post-conversion (boarded over pre-conversion), and consisted of two slim, paneled doors with integral leaded light pane above – likely an original feature. The entrance has been heavily repointed in cement which unfortunately obscures the detailed granite masonry including quoins, flat arches, voussoirs, and lintels. The portico has been reroofed and relined with new railings above. Earlier photographs of the portico imply this projection is a later addition, although it and the two pillars are shown on the 1877 town plan, with railing added in the mid-20<sup>th</sup> century.

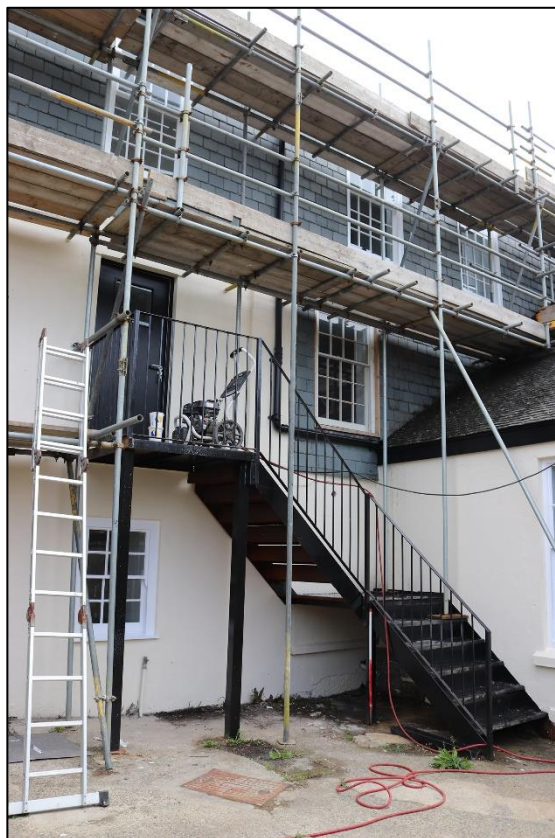
FIGURE 8: SLATE HANGING CONTINUES TO THE FF (MODERN) THE STAIRS HAVE BEEN RECYCLED FROM THOSE WHICH EXISTED INTERNALLY. TAKEN FROM THE NORTH-WEST WITH 1M SCALES.

A lot of work has been undertaken to the external elevations, including fresh paintwork and replacement sash windows. A metal, heavy-duty staircase, that had been utilised inside the property, has been reused at the southern end of the building (client pers. comm. ), creating separate access for the new first-floor flats to this end. New basic timber doors have been replaced to the ground-floor openings, and the rear concrete block extension remains to the far northern end (access not obtained during site visit). The rear of the property now acts as a site compound, and it had been cleared of overgrown vegetation and lined with a rubble mix, this had exposed stone rubble walling to the far north, including surviving wall running along the west boundary, ending by the carriage passage to the south. These boundary walls are likely the historic boundaries as seen to earlier mapping, including the tithe map of 1841. This wall, particularly to the west side, appeared precarious in form with several bulges/ fallouts noted. It largely consists of regularised, heavy granite rubble, coped to the top with rounded cement (north end). The far rear north wall was built up higher and showed evidence of blocked openings but had been heavily repointed in places with cement; beyond this was waste land that was covered with shrubbery and several large, mature trees.

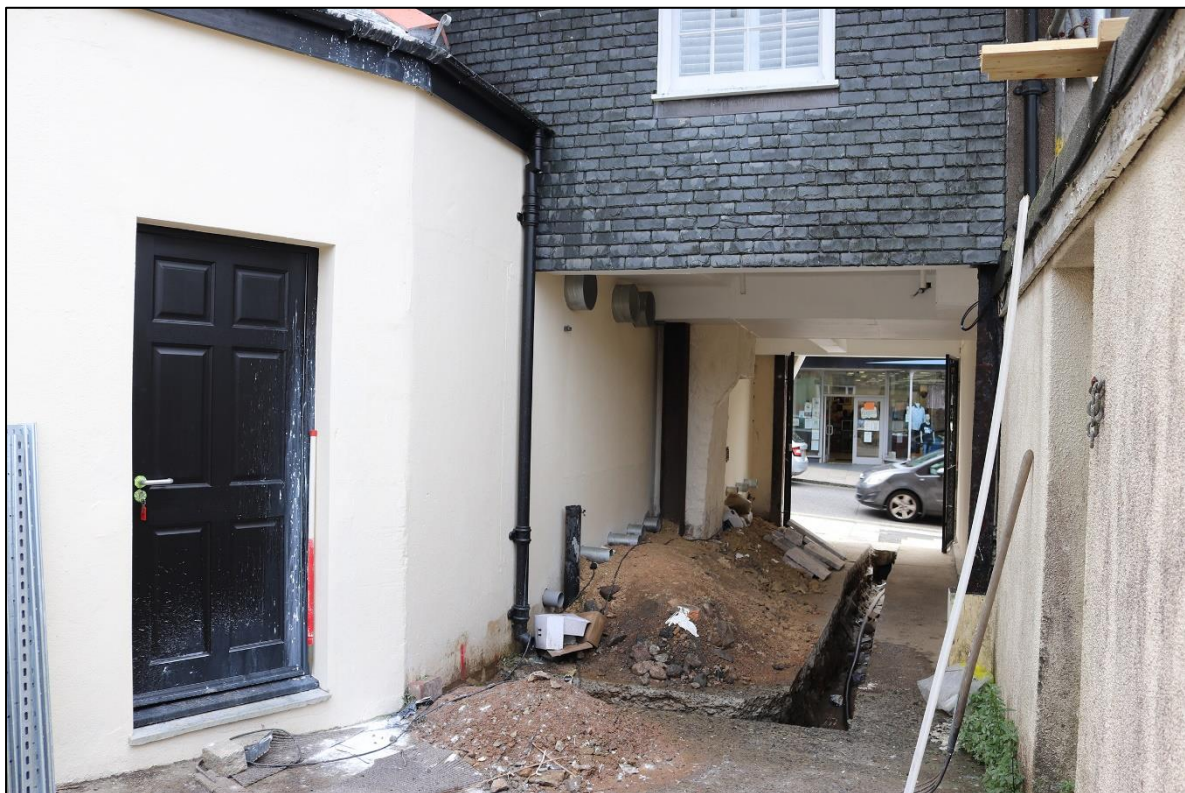
FIGURE 9: THE NORTH FACING REAR OF CARRIAGE PASSAGE WITH (MODERN) SLATE HANGING. TAKEN FROM THE NORTH WITH 1M SCALES.

Pre-conversion the carriage passage, located to the west side of No.34, had been fenced off, though alterations could be identified to its surviving form. Several phases of widening could be seen from

During conversion works, services had been dug into the ground-floor of the passage, following the line of earlier services entering at the north-east corner – this was brick-lined at this end with 20<sup>th</sup> century rusted pipework exposed. This was done without archaeological monitoring and the trench had been open for longer than 3 months; this exposure had obscured any archaeological deposits (if present). However, it could be identified that the floor had been lined with a 0.3-4m layer of concrete and had likely been subject to heavy disturbance from previous 20<sup>th</sup> century alteration works. New gates had been added to the south entrance, with new sockets forced either side. The original width of the passage can still be seen through the length of the surviving lintel to the frontage, which has been later underbuilt with a pier to support the widening works, though the presence of this important feature has been unfavourably dominated by the recent masonry replacing the ground-floor shop frontage to No.33 which is considered not in-keeping with the rest of the façade compromising both buildings narrative and significance as designated heritage assets.

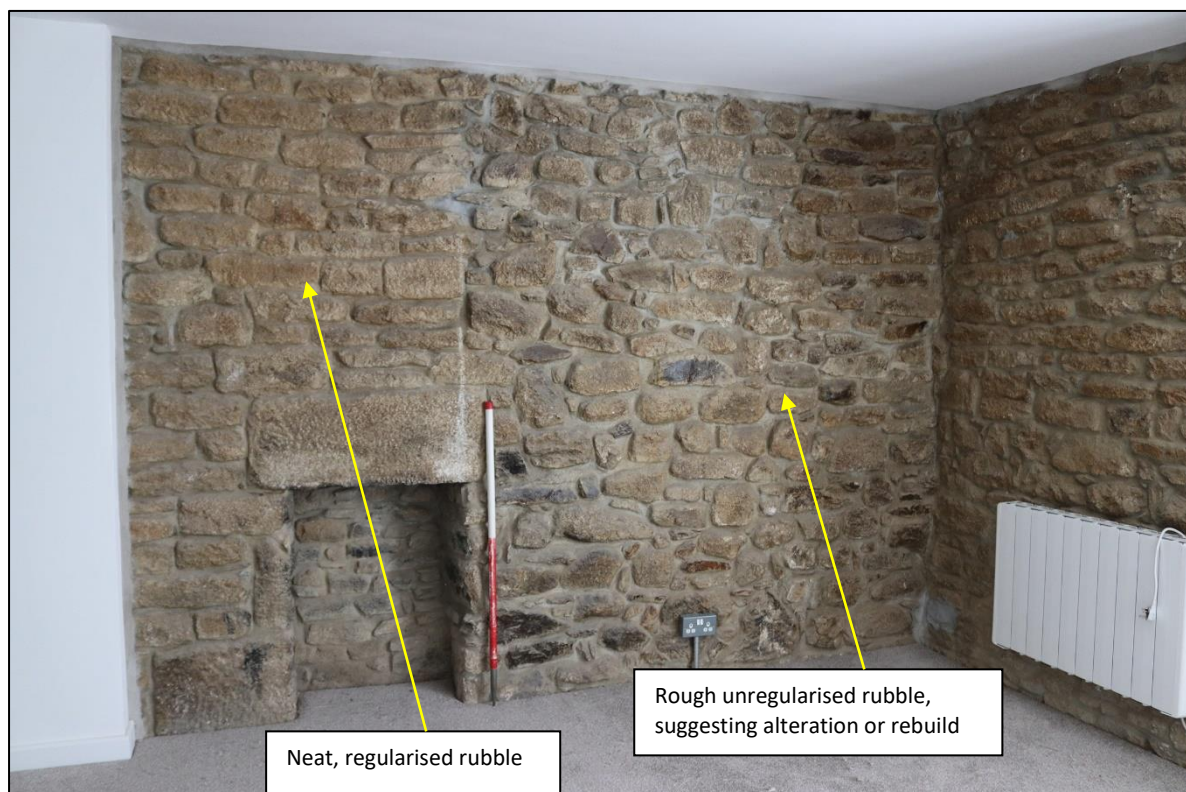
FIGURE 10: EXPOSED FIREPLACE TO FF FLAT TO EAST WITH AREA OF DISTURBANCE TO PARTY WALL, RELATED TO MASONRY ON GF. TAKEN FROM THE WEST WITH 1M SCALE.

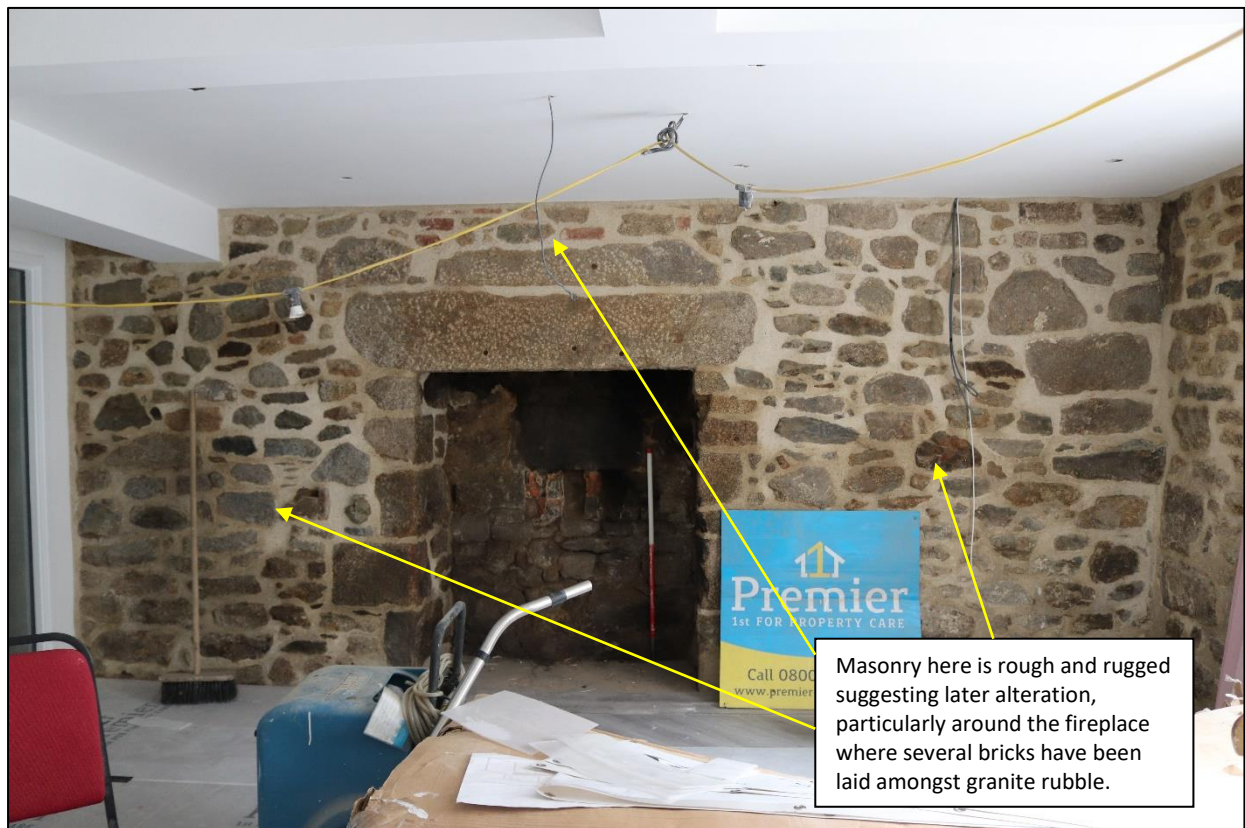
FIGURE 11: THE SURVIVING, DOMINATING GF FIREPLACE TO THE NEW COMMERCIAL UNIT. THE SURROUNDING MASONRY IS ROUGH, IN COMPARISON WITH THAT SEEN FURTHER NORTH IN THE WALL (SEE FIGURE 12), IMPLYING POSSIBLE ALTERATION/ REMODEL, PARTICULARLY OF THE FIREPLACE. TAKEN FROM THE WEST WITH 1M SCALES.

The ground-floor will be operating as a commercial space, predominantly as a beauty/ tanning studio, with several cubicle partitions along the west and north walls. The main entrance lobby is currently a large space that includes the dominant, exposed 18<sup>th</sup> century fireplace to the east wall – this initially strikes as quite unusual in appearance, providing a more domestic character to this space. It is evident from the stonework surrounding it that it has had several alterations, in an area of very rugged rubble – this build form is very different to that exposed to the north end of the same wall, now separated by a commercial cubicle. The lintels are reused pieces of granite with socket holes, their alignment could be associated with an earlier surround. Each jamb is decorated roughly with quoins; however, these appear very makeshift in comparison to other quoin detailing seen to the front façade – again suggesting significant rebuild/alteration to this particular location. The rubble above this includes several small, possible handmade bricks, suggesting a later rebuild/ significant repair to this section of wall – as it is not consistent with that seen further north. The floor of the fireplace has been cemented and sealed, the flue has also been blocked. Internally to the north side a heavy iron pintle has been

forced into a granite block. Against its back several rubble alterations, and the possibility of a fitted stove in this location where the rubble in the upper half is blackened, and rubble areas altered for fittings.

Also striking on this east wall is the notable change in masonry between the north section and southern section (see Figures 11 & 12). Further north along the west wall is another much smaller blocked fireplace (as identified by architect). This had been blocked already with concrete block and has now been skimmed with a yellow, sandy render (consistent with the repointing works across the floors). North of this was another large section of exposed wall. As mentioned above, this masonry was completely different in form – regularised granite rubble, very neat in appearance, possibly implying this is the earliest surviving fabric in the building.

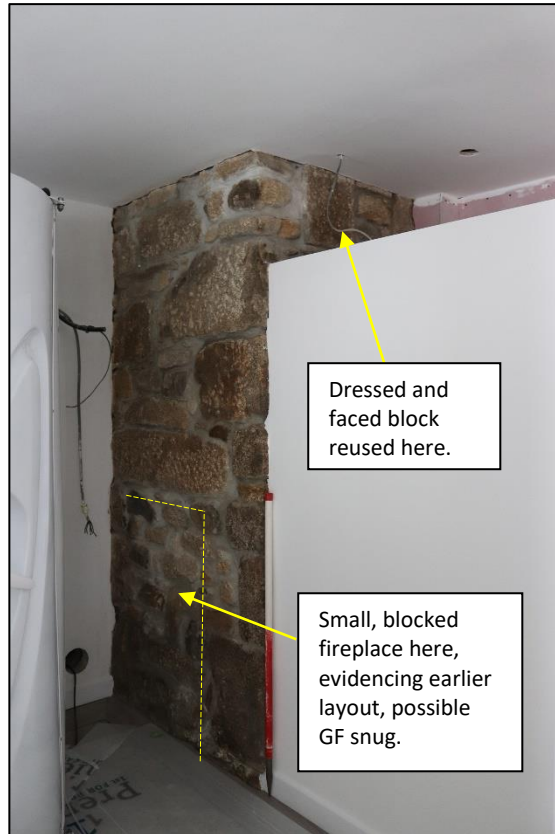
FIGURE 13: SMALL BLOCKED FIREPLACE TO THE WEST WALL WITHIN NEW CUBICLES, MATCHING LOCATION TO THE SMALL BLOCKED FIREPLACE TO WEST FLAT ABOVE, INCLUDING REUSED DRESSED AND FACED GRANITE BLOCK. TAKEN FROM THE SOUTH-WEST, WITH 1M SCALES.

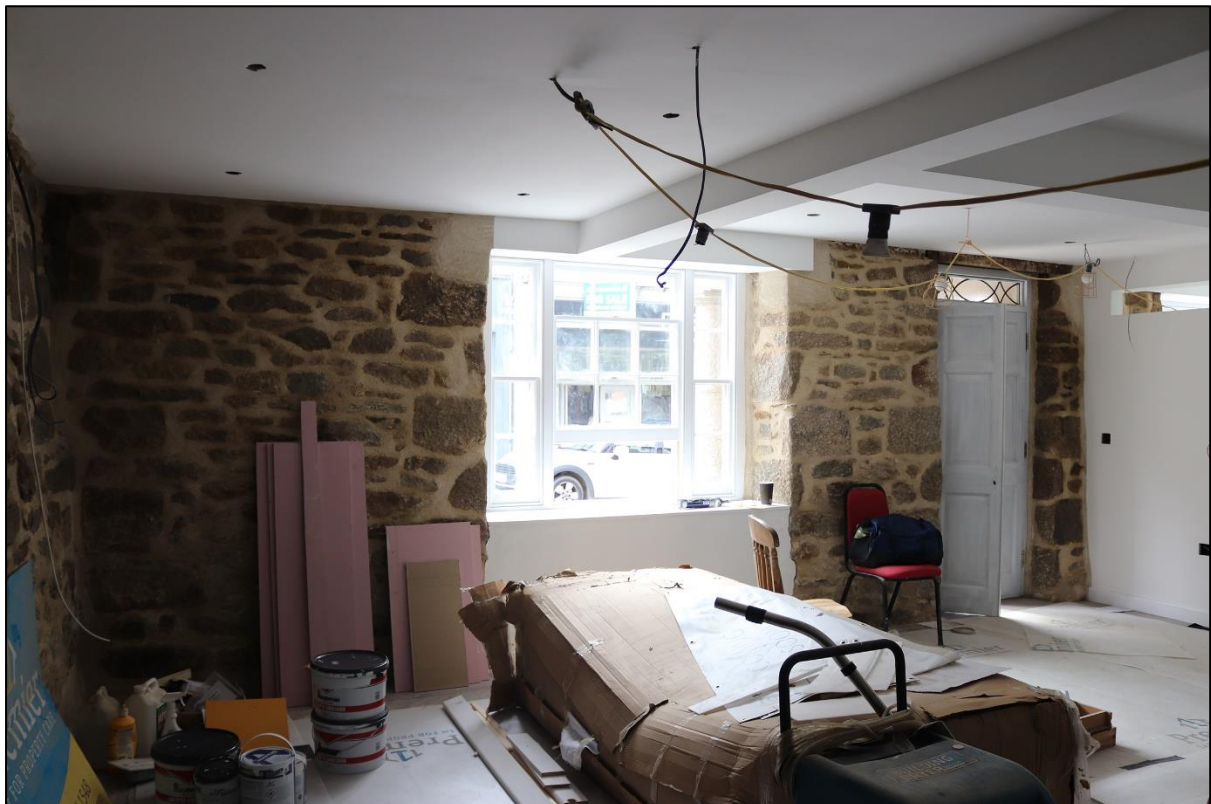
FIGURE 14: THE EXPOSED SOUTH WALL. TAKEN FROM THE NORTH-EAST.

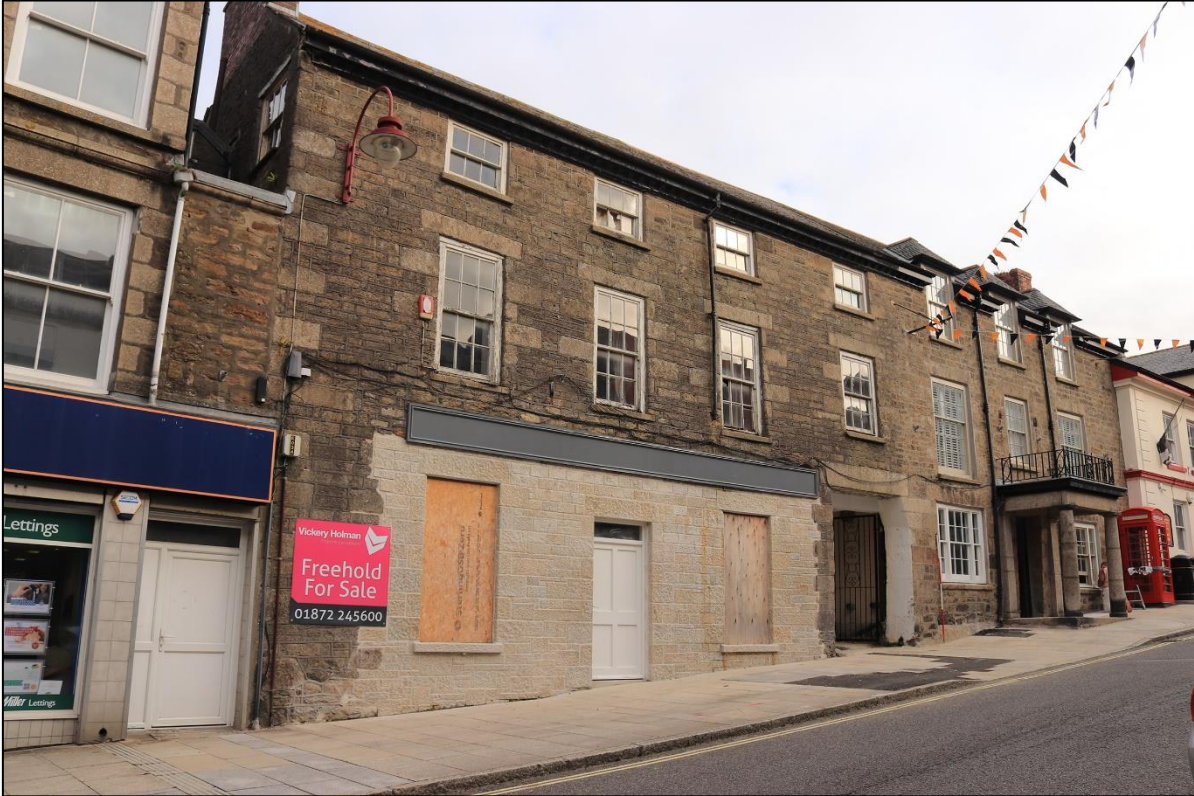
1. THE FRONTAGE OF BOTH NO.33 & 34, INCLUDING TELEPHONE BOX. NO.33 HAD RECENTLY HAD ITS FRONTAGE CONVERTED FROM SHOP PREMISES, THE MASONRY DETRACTING FROM THE EARLIER 18<sup>TH</sup> CENTURY FRONTAGE. TAKEN FROM THE SOUTH-WESTST WITH 2M SCALE.

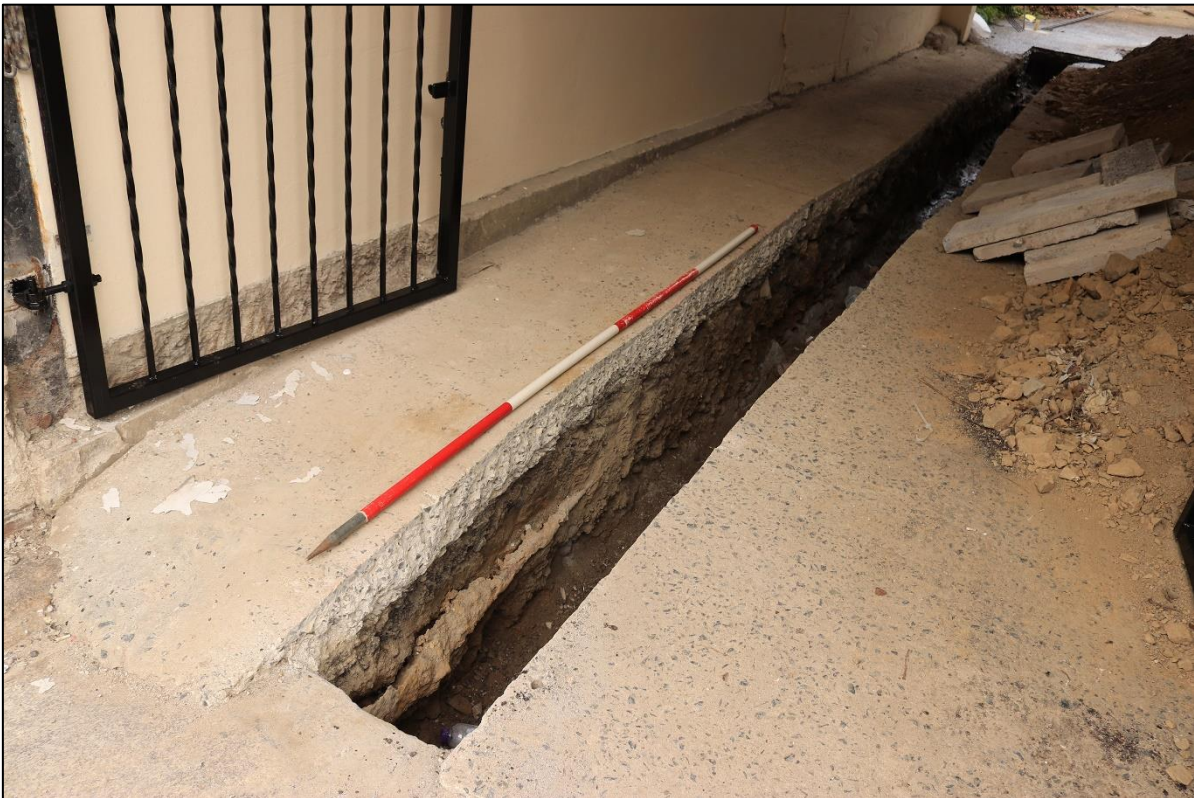
2. UNMONITORED GROUNDWORKS TO THE CARRIAGE PASSAGE SHOWING LATER DISTURBANCE AND RELAYING. TAKEN FROM THE SOUTH-EAST WITH 2M SCALE.

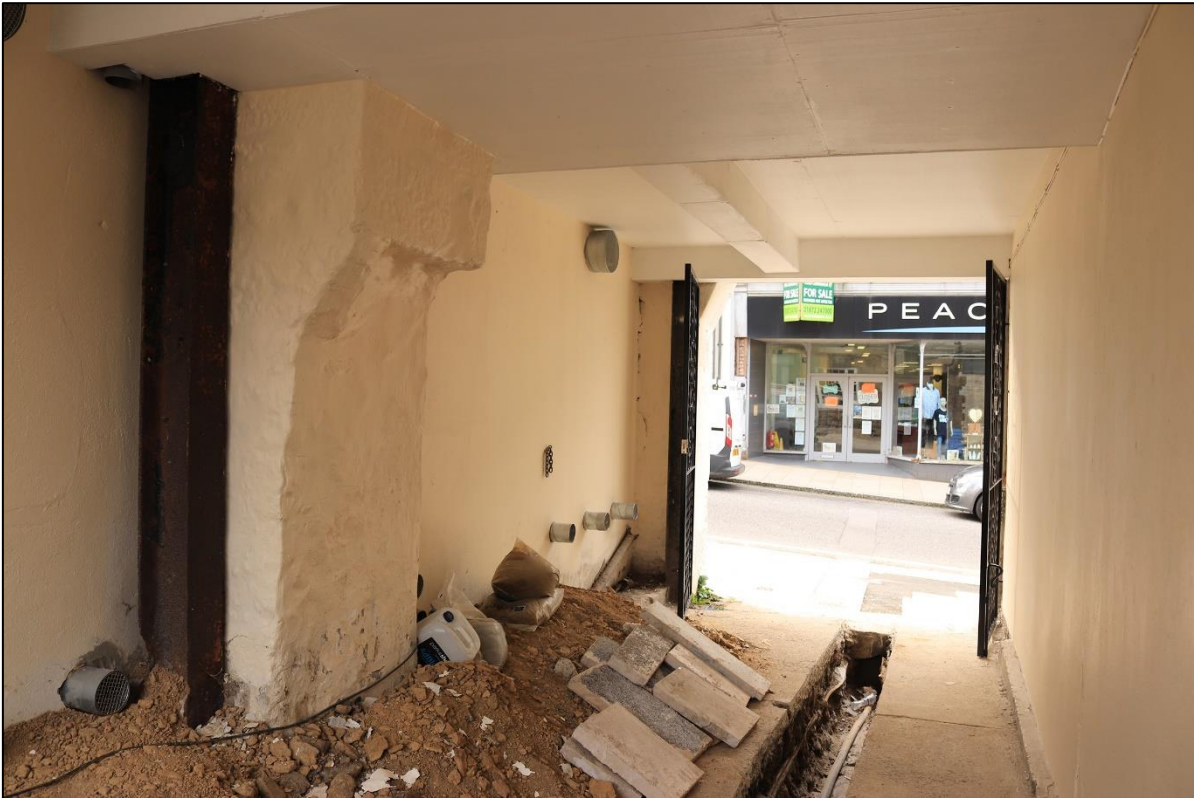
3. THE CARRIAGE PASSAGE FROM THE NORTH LOOKING BACK TO FORE STREET, SHOWING POTENTIAL CUT STACK WITH GRANITE DRESSINGS UNDER PAINTWORK; FROM THE NORTH.

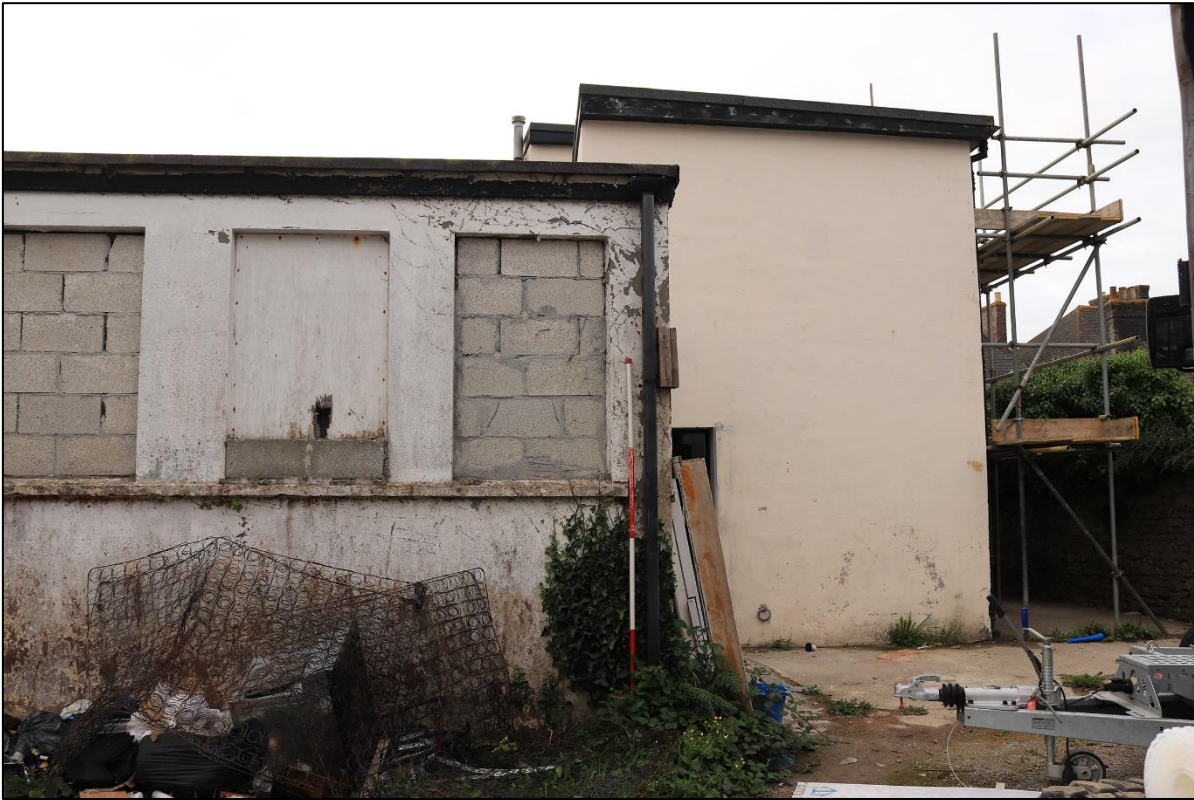
5. RELATIONSHIP BETWEEN 20<sup>TH</sup> CENTURY STORAGE AND REAR OF 19<sup>TH</sup>C BLOCK EXTENSION. TAKEN FROM THE NORTH WITH 2M SCALES.

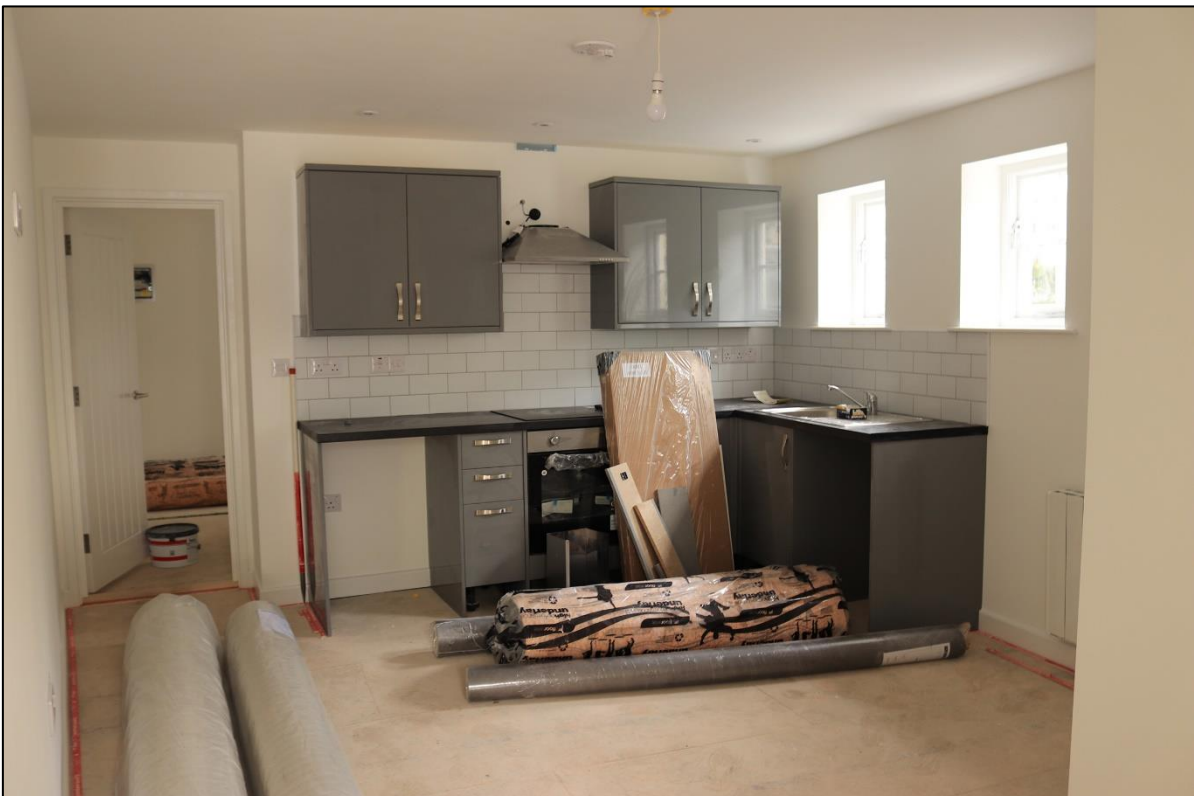
6. REAR CONVERTED GF FLAT; NO HISTORICAL FEATURES EXPOSED/ SURVIVE. TAKEN FROM THE NORTH WITH 1M SCALE.

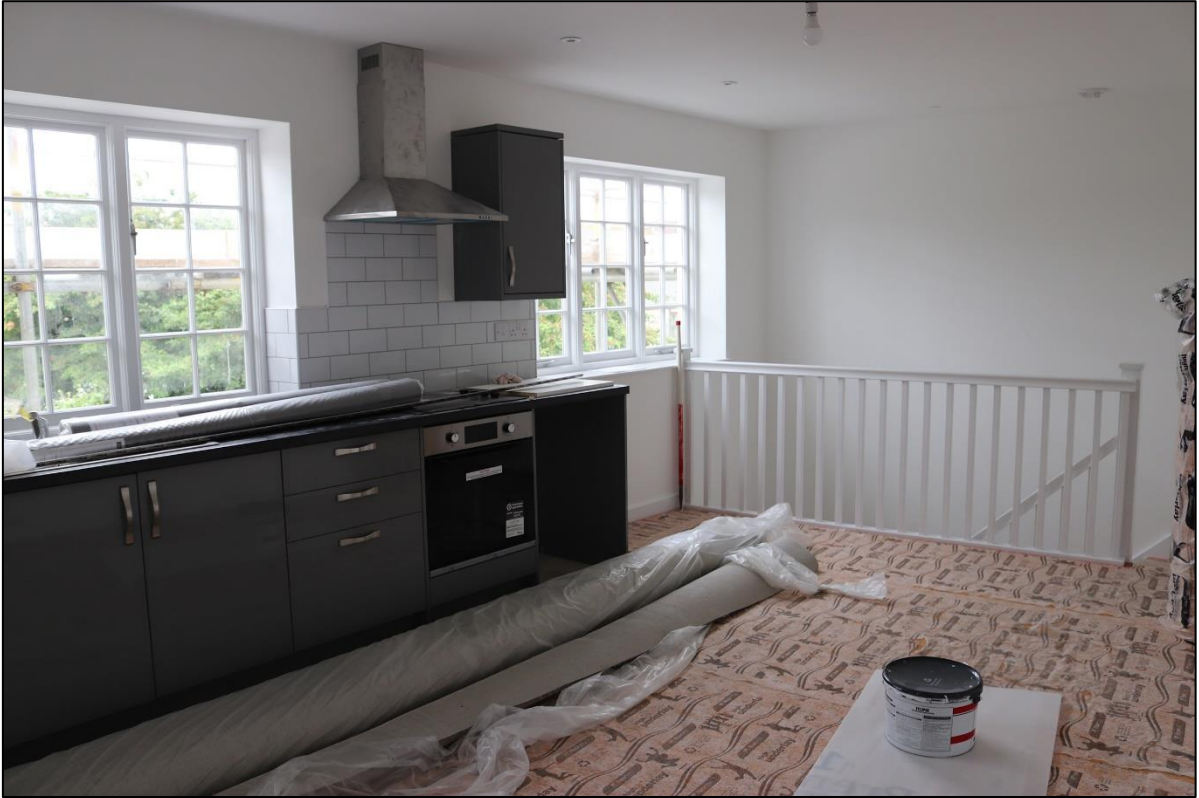
7. REAR FF FLAT; NO HISTORICAL FEATURES SURVIVE. TAKEN FROM THE SOUTH-EAST WITH 1M SCALES.

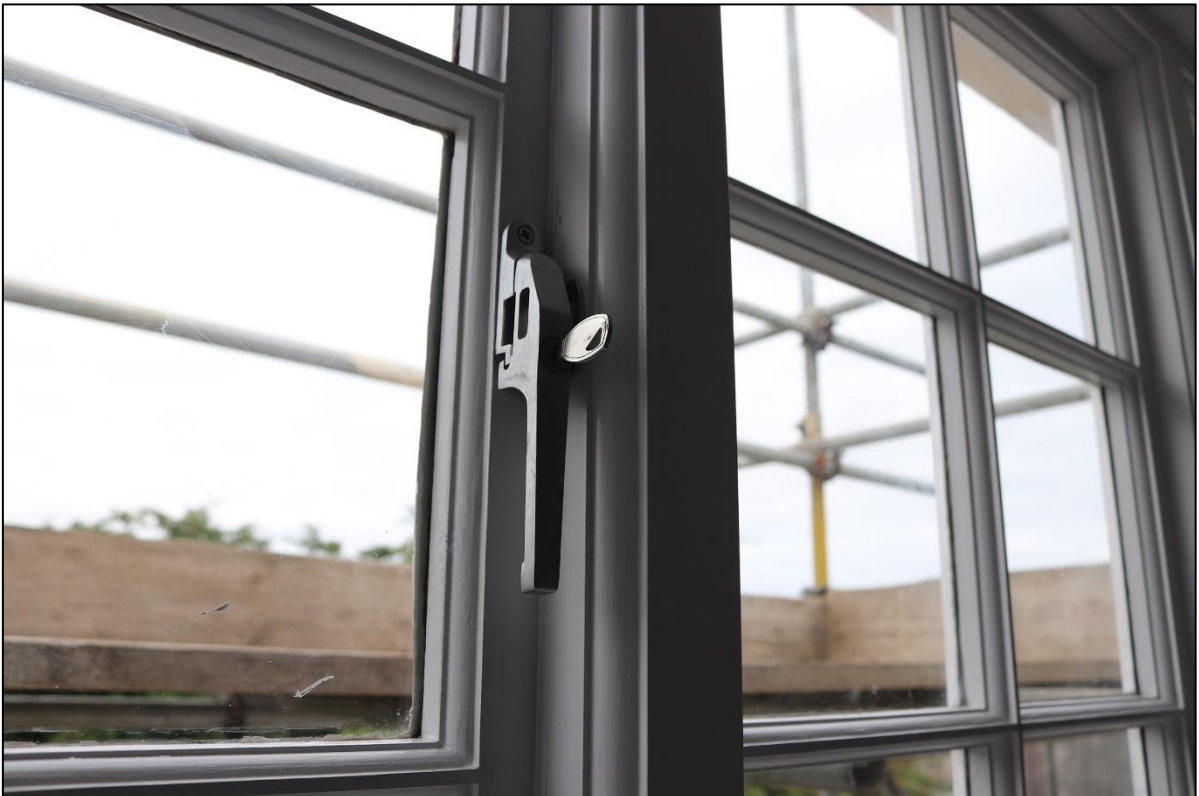
8. ALL WINDOWS WERE FULL REPLACEMENTS.

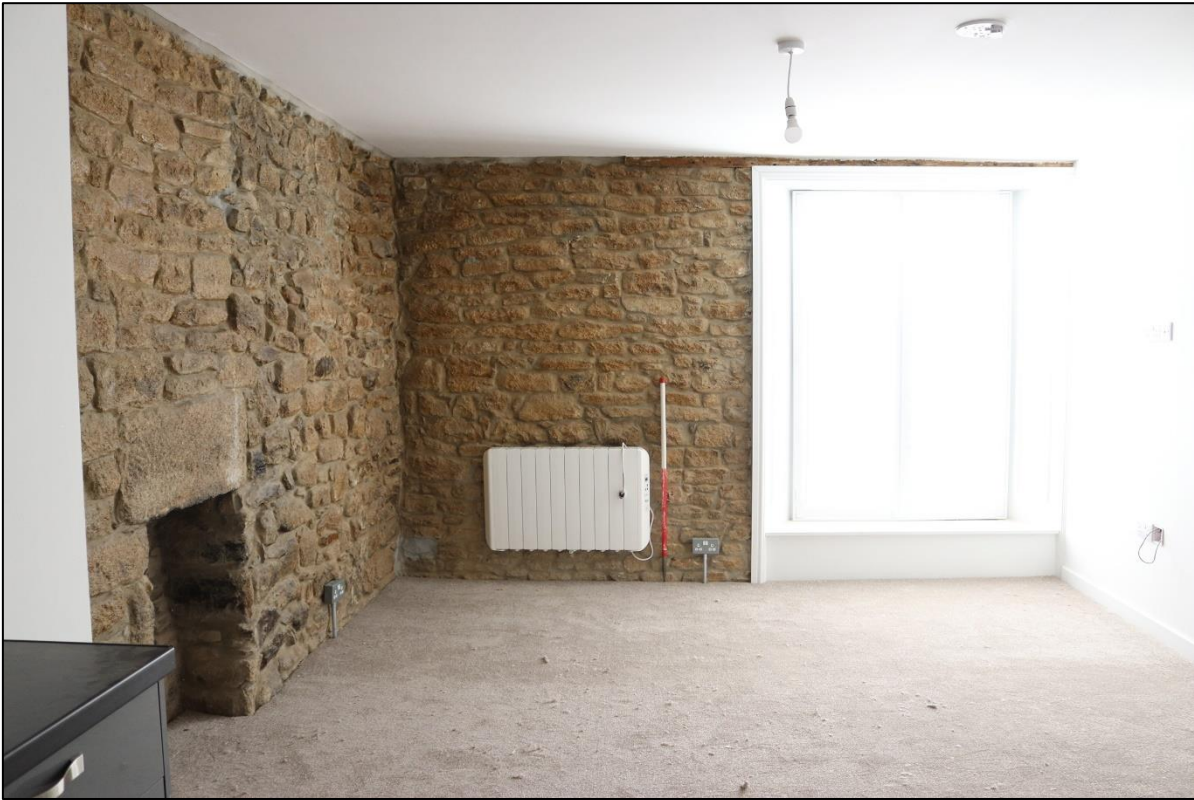
11. THE FF EAST FLAT, WITH EXPOSED FP AND MARKED DIFFERENCES IN MASONRY; FROM THE NORTH WITH 1M SCALE.

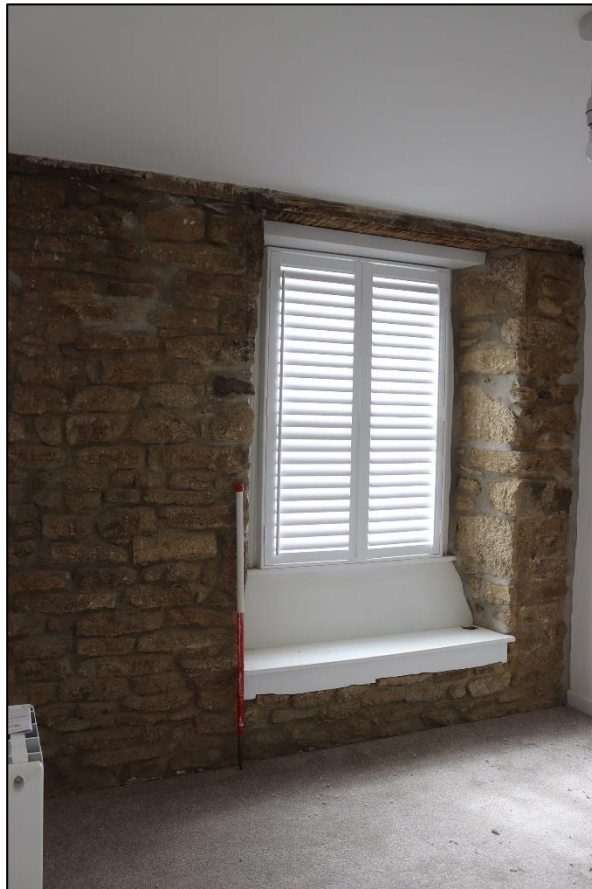
12. EXPOSED WALLING IN NEIGHBOURING BEDROOM ON THE 18<sup>TH</sup> CENTURY FRONTAGE; FROM THE NORTH-WEST WITH 1M SCALE.

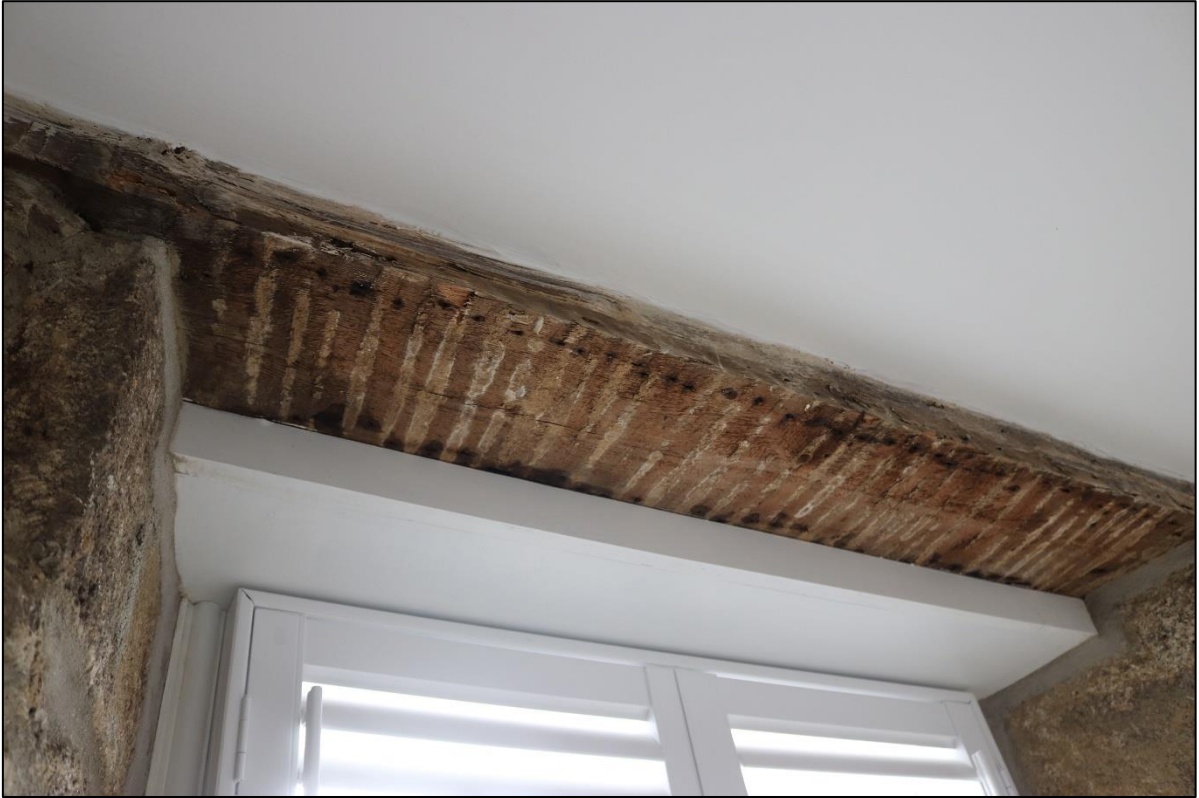
13. THE SURVIVING TIMBER LINTELS TO THE FF FRONTAGE SHOWING SCARRING FOR FORMER LATHE AND PLASTERWORK, WINDOWS REPLACED.

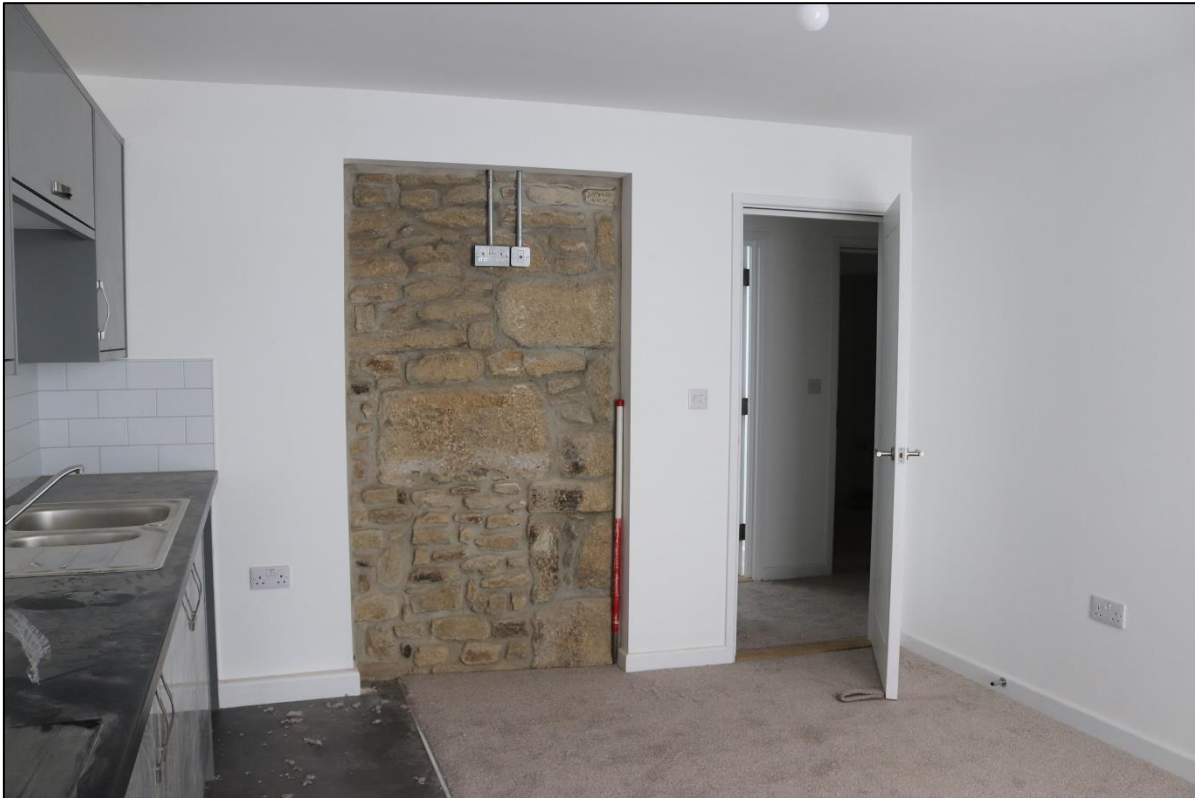
15. REFLECTING EXPOSED STONEMWORK IN THE FF WEST FLAT, WITH SMALL BLOCKED FIREPLACE; FROM THE SOUTH WITH 1M SCALE.

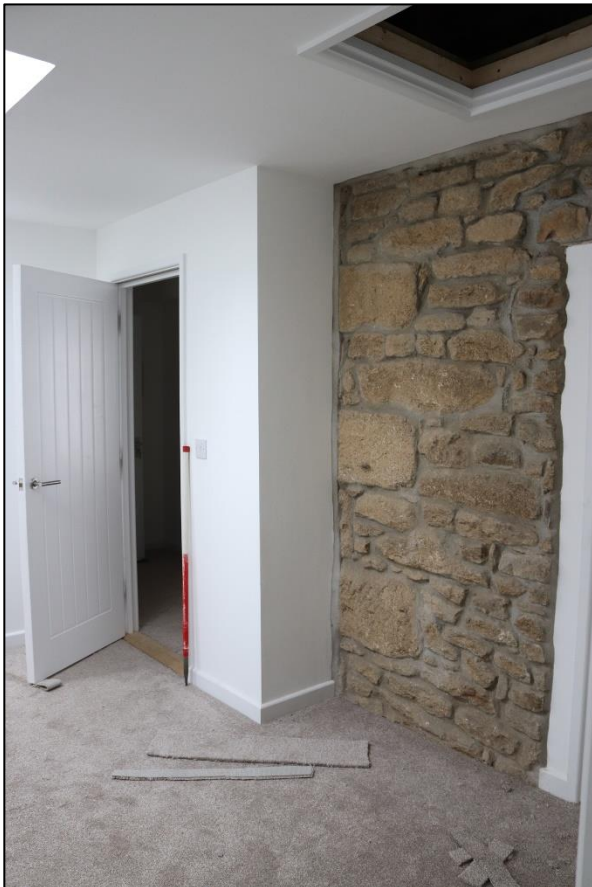
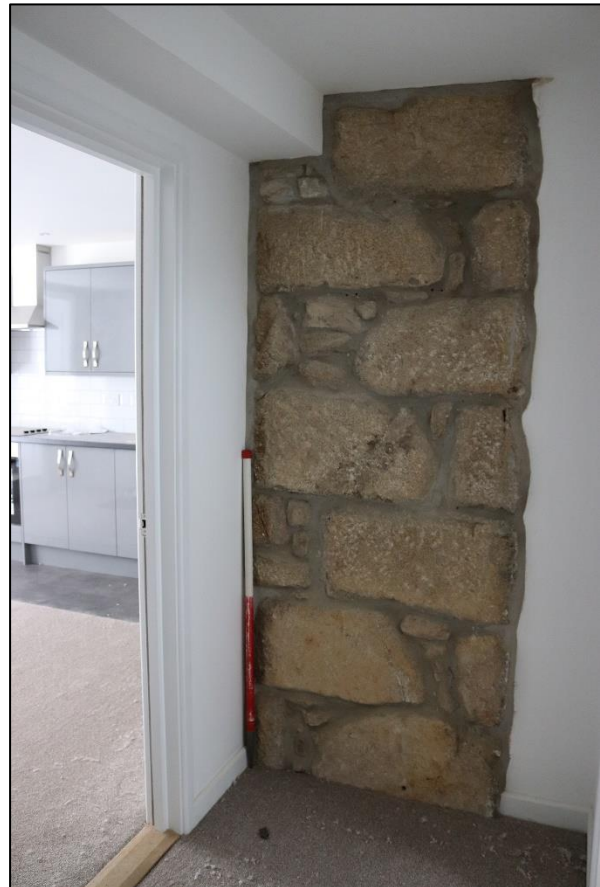
16. LEFT: SMALL BEDROOM TO REAR FF WEST FLAT SHOWING EXPOSED SECTION WITH QUOIN DRESSINGS. RIGHT: INCLUDING SIMILAR FABRIC SEEN ON ENTRANCE TO FLAT FROM THE WEST. BOTH WITH 1M SCALES.

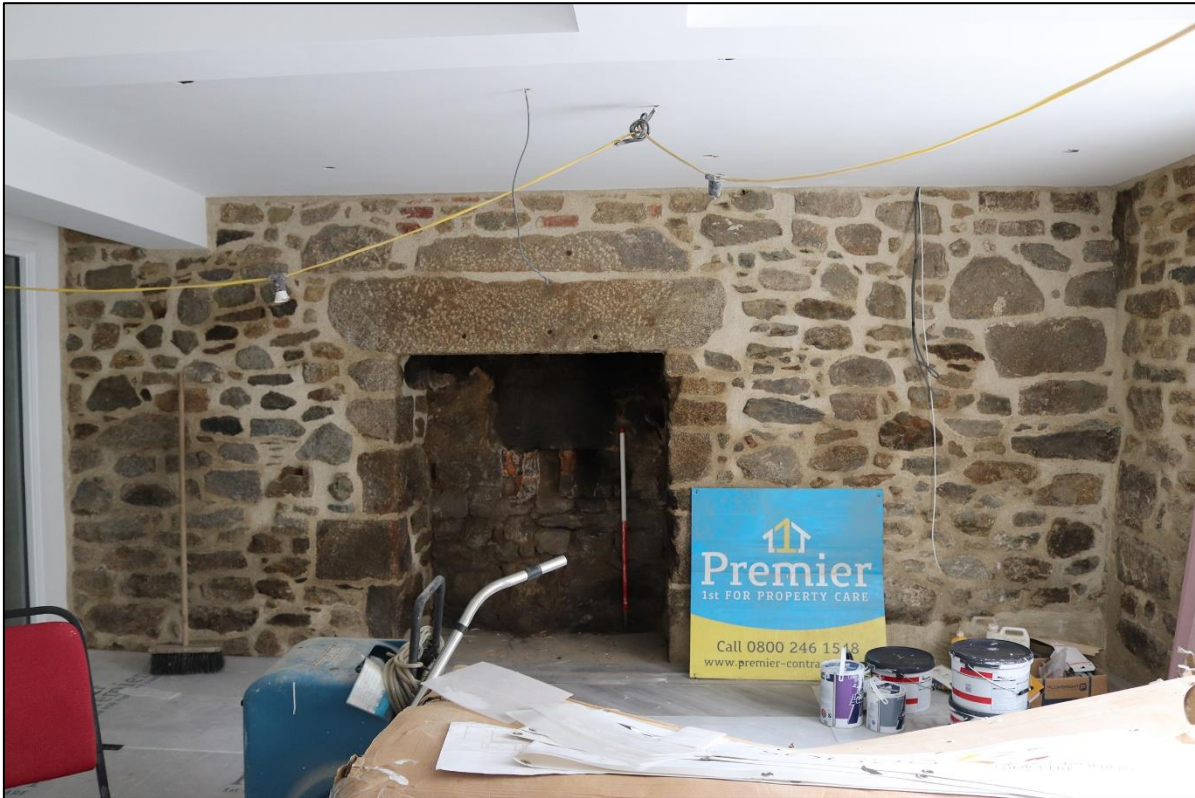
19. THE DOMESTIC CHARACTER FIREPLACE IN GF EAST WALL; FROM THE WEST WITH 1M SCALES.

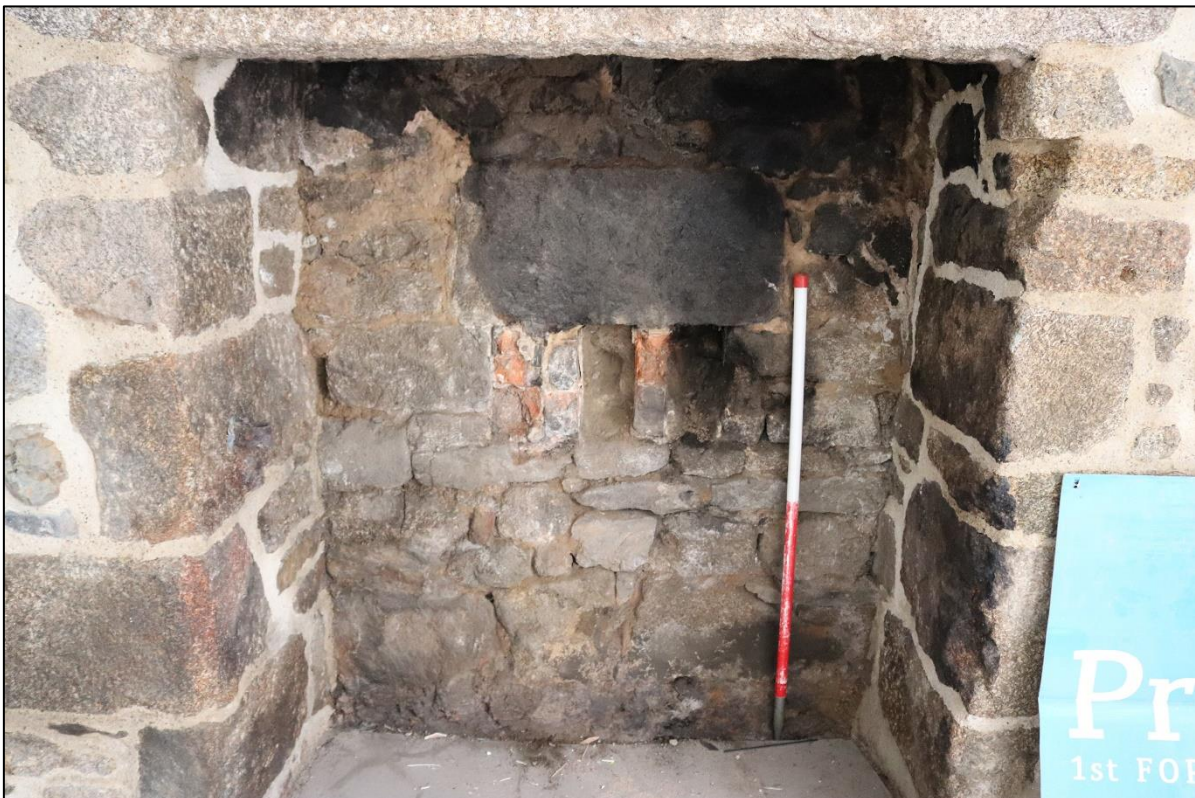
20. THE BACK PLATE OF STACK SHOWING DISTURBANCE FOR LATER STOVE FITTINGS; FROM THE WEST WITH 1M SCALES.

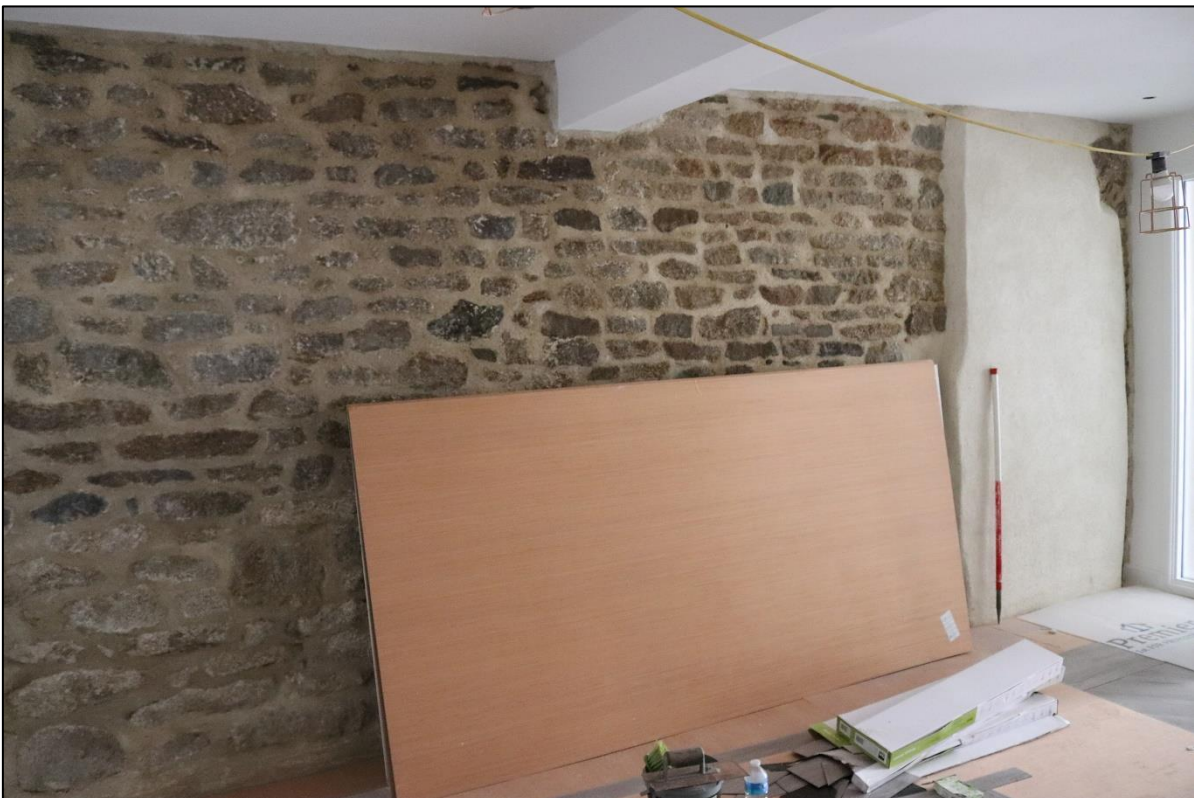
22. THE NOTABLY DIFFERENT MASONRY TO THE REAR GF COMMERCIAL SPACE, WHICH MAY REPRESENT EARLIER FABRIC, INCLUDING BLOCKED FIREPLACE NOW RENDERED; FROM THE WEST WITH 1M SCALES.
