**No. 34 (FORMER LONDON INN)  
FORE STREET  
REDRUTH  
CORNWALL**

Historic Building Recording

South West Archaeology Ltd. report no. 230904

Draft issued: 29<sup>th</sup> September 2023

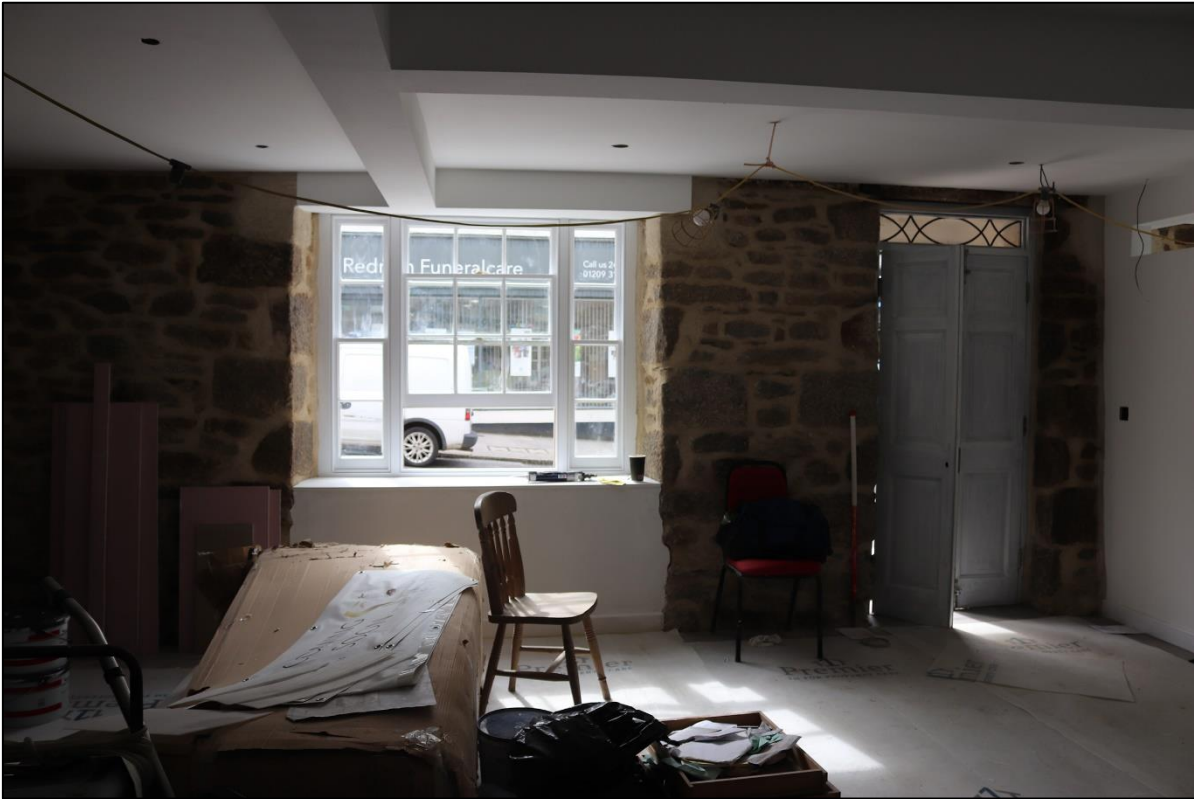
23. GF FRONT, REPLACEMENT TRI-PARTITE. FROM THE NORTH WITH 1M SCALES.

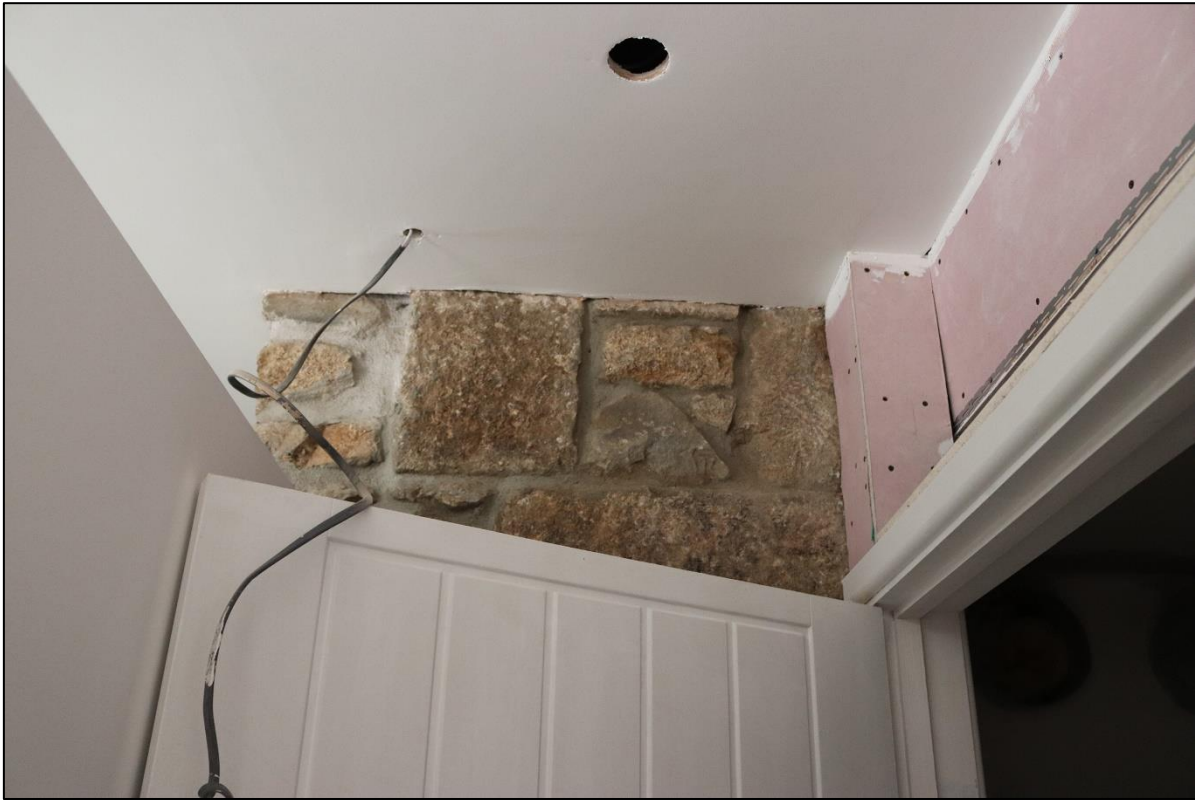
25. REUSED DRESSED GRANITE BLOCKS SEEN TO THE WEST WALL.

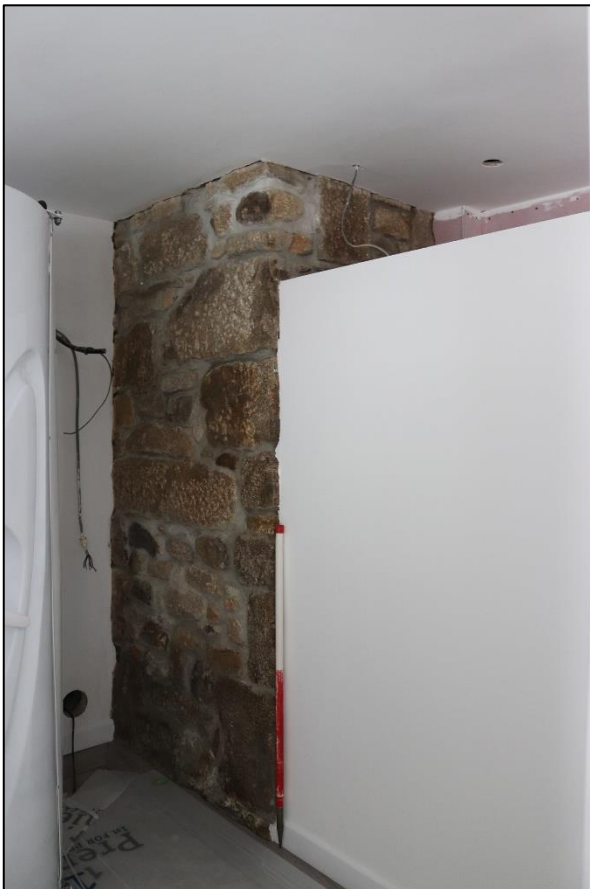
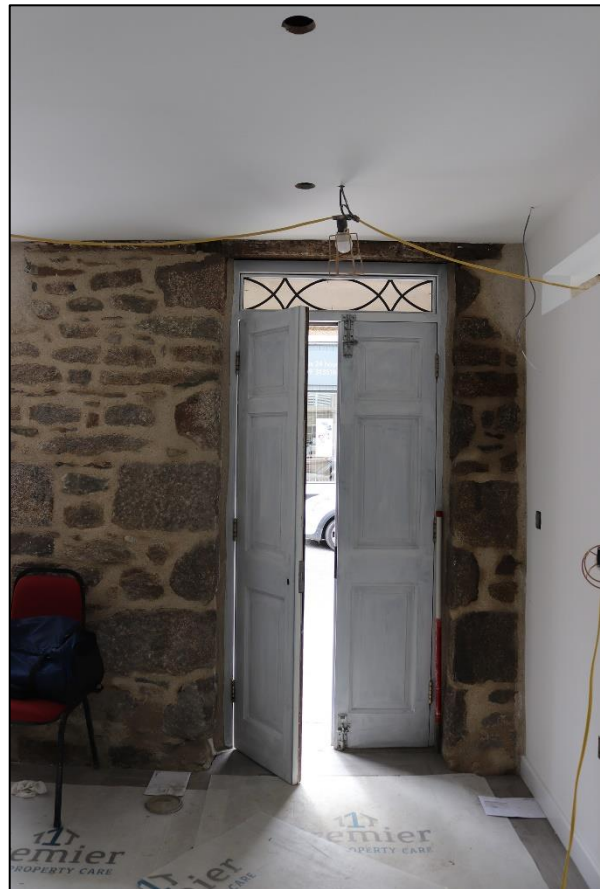
26. LEFT: BLOCKED FIREPLACE TO WEST WALL WITH 1M SCALES, FROM THE SOUTH-EAST. RIGHT: INTERNAL DETAIL OF DOORWAY FROM THE NORTH WITH 1M SCALE.

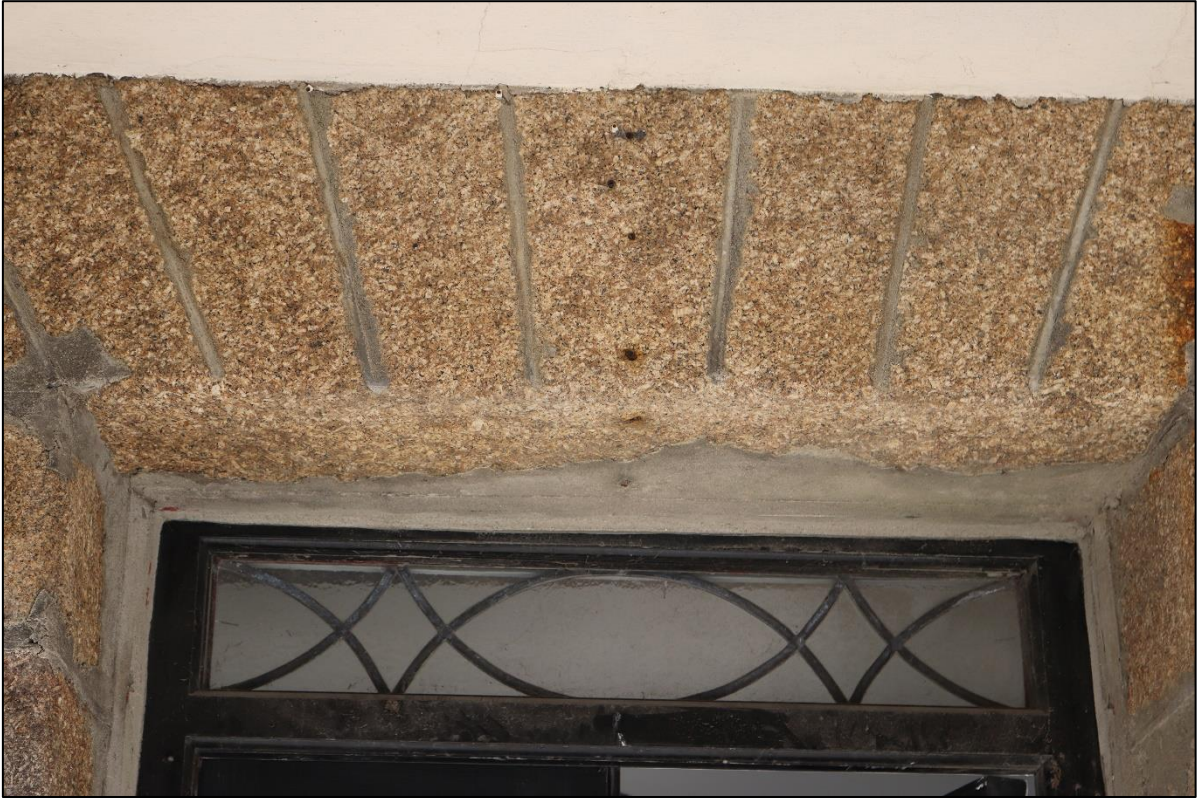
27. LINTEL DETAIL TO THE EXTERNAL FACE OF CENTRAL DOORWAY WITH SIGNIFICANT CEMENT REPAIR.

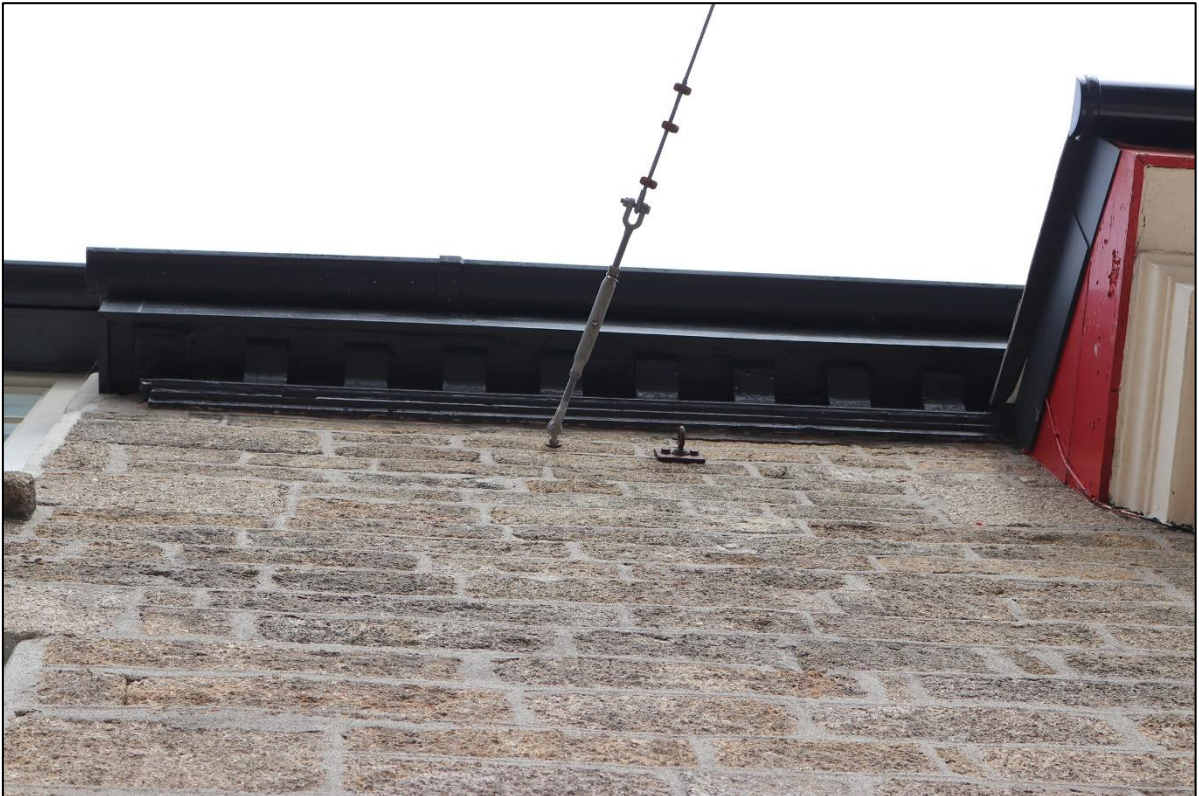
28. DENTIL CORNICE DETAILING JOINING TO THE NEIGHBOURING RED LION.

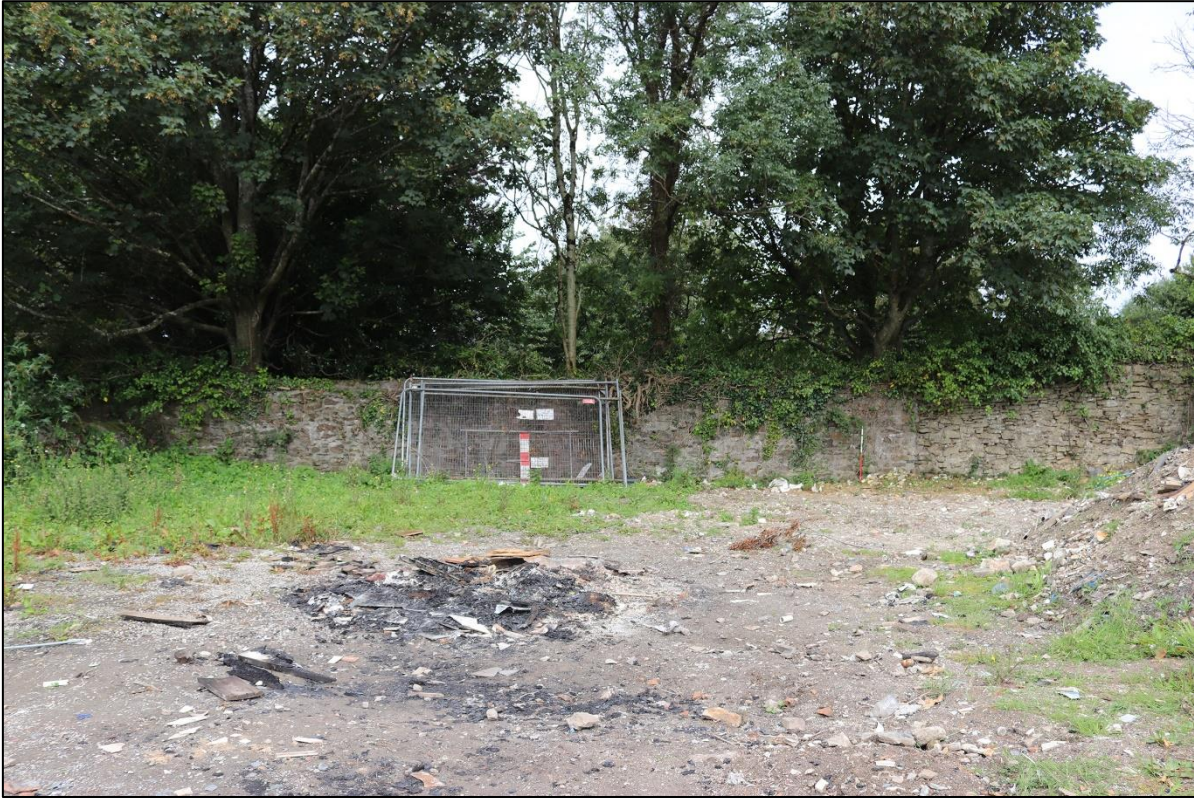
31. THE REAR NORTH COMPOUND WALL WITH BLOCKED OPENINGS; FROM THE SOUTH WITH 1M SCALE.

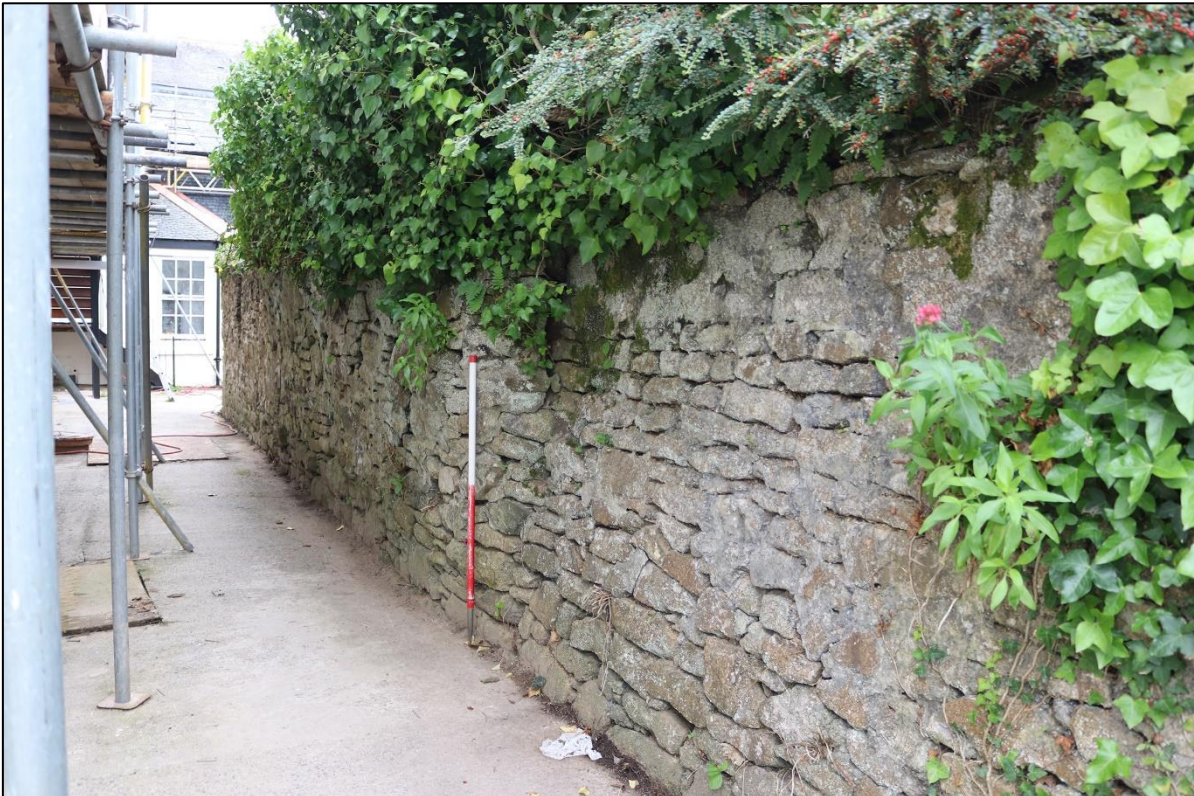
32. THE SURVIVING SECTION OF RUBBLE WALL TO THE EAST SIDE FROM THE NORTH WITH 1M SCALE.
