Negative Watching Brief: Historic Environment Record

Civil Parish & District: Chiselborough, South Somerset	National Grid Reference ST 46749 14873		Number: 48633	
Subject: Archaeological monitoring and recording of groundworks associated with the installation of a toilet at Church of St. Peter and St. Paul, Chiselborough, SomersetPhoto attached? Yes				
Planning Application no: n/a		Recipient museum: Museum of Somerset		
OASIS ID: southwes1-519515		Museum Accession no: N/A		
Contractor's reference number/code: CCL23		Dates fieldwork undertaken: 7 th November 2023

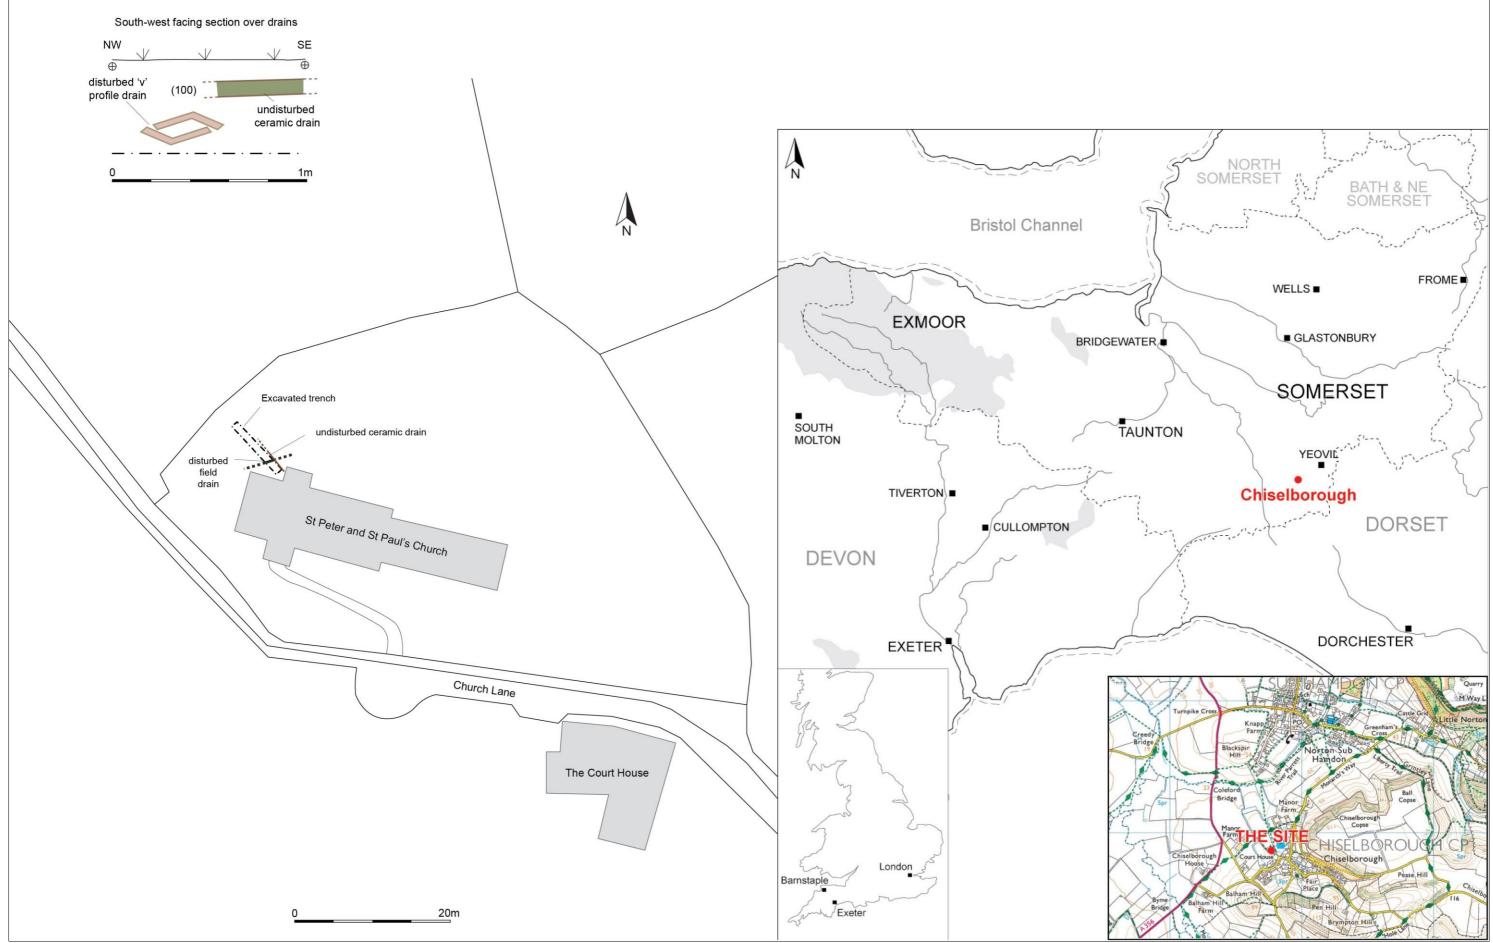
Figure 1: Site location, site plan and section.

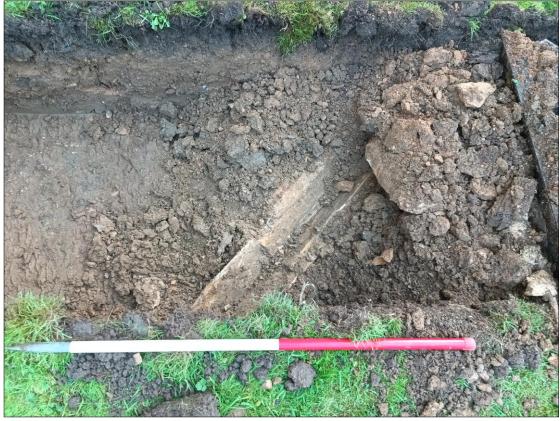
Within the trench were two drains, a ceramic pipe appearing to be in current use, running from a downpipe in the exterior corner of the building and narrowly missing the trench, appearing in section at *c*.0.15m deep, and most likely running north-north-west (Figures 1 and 3). The second was a probable earlier drain, disturbed by the excavator, and running approximately west-south-west to east-north-east through the trench, lying at *c*.0.45m deep. It too was ceramic but of a denser material than that of the 'live' pipe, with a top and lower half, each having a 'v'-shaped profiles, laid in sections (Figures 1 and 2).

Figure 2: Lower half of earlier drain, in situ; viewed from the north-east (1m scale).

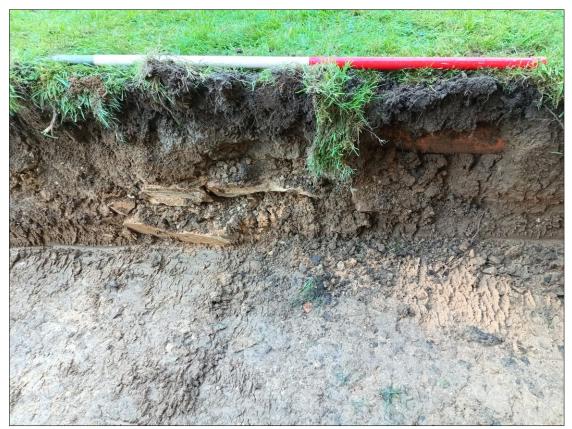
Figure 3: South-west facing section of the trench and drains; viewed from the south-west (1m scale).

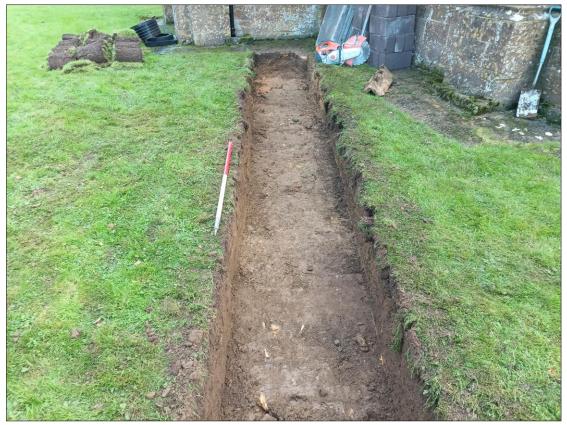
A single trench measuring 1m wide x *c*.7m long was excavated by machine and under archaeological supervision, running from the north-west corner of the church to the north-west, to a maximum depth of *c*.0.50m. The observed stratigraphy consisted of an homogenous mid-brown soft silt-clay topsoil (100), which was more than *c*.0.50m thick.

Figure 4: Trench plan post-excavation; viewed from the north-west (1m scale).
