# CHURCH OF ST. JOHN THE BAPTIST, MESHAW, DEVON,

## *Archaeological Monitoring and Recording*

Work undertaken by SWARCH for a private client  
NGR: SS 75860 19685  
OASIS reference: SOUTHWES1-520494  
South West Archaeology Ltd. report no. 250211

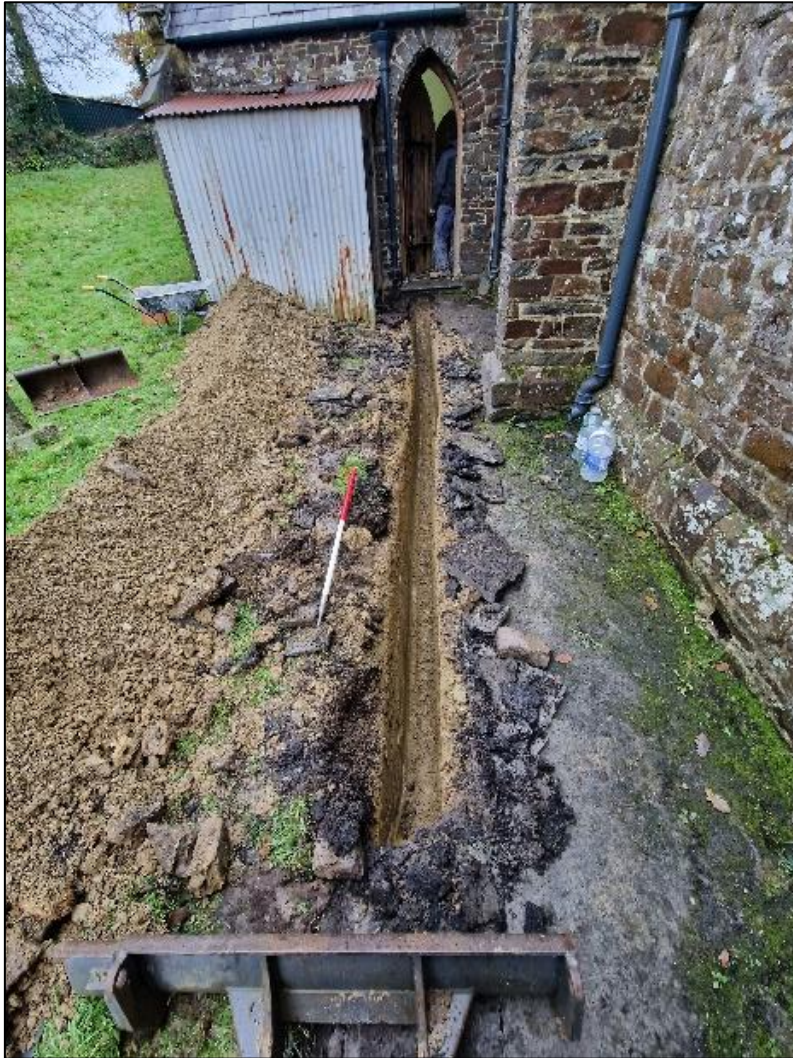
FIGURE 3: FIRST PHASE OF TRENCHING FROM THE VESTRY, VIEWED FROM THE WEST (SCALE 1M).

A trench measuring c. 55m was cut leading from the vestry and followed along the main pathway around the church. The trench was cut in two phases, the first measuring 0.3m wide and covering a small stretch from the vestry door to the manhole located near the northwest corner of the tower. The second stretch of trenching measured 0.4m wide and 0.8m deep and continued from the manhole south, round the tower and along the path leading from the church.

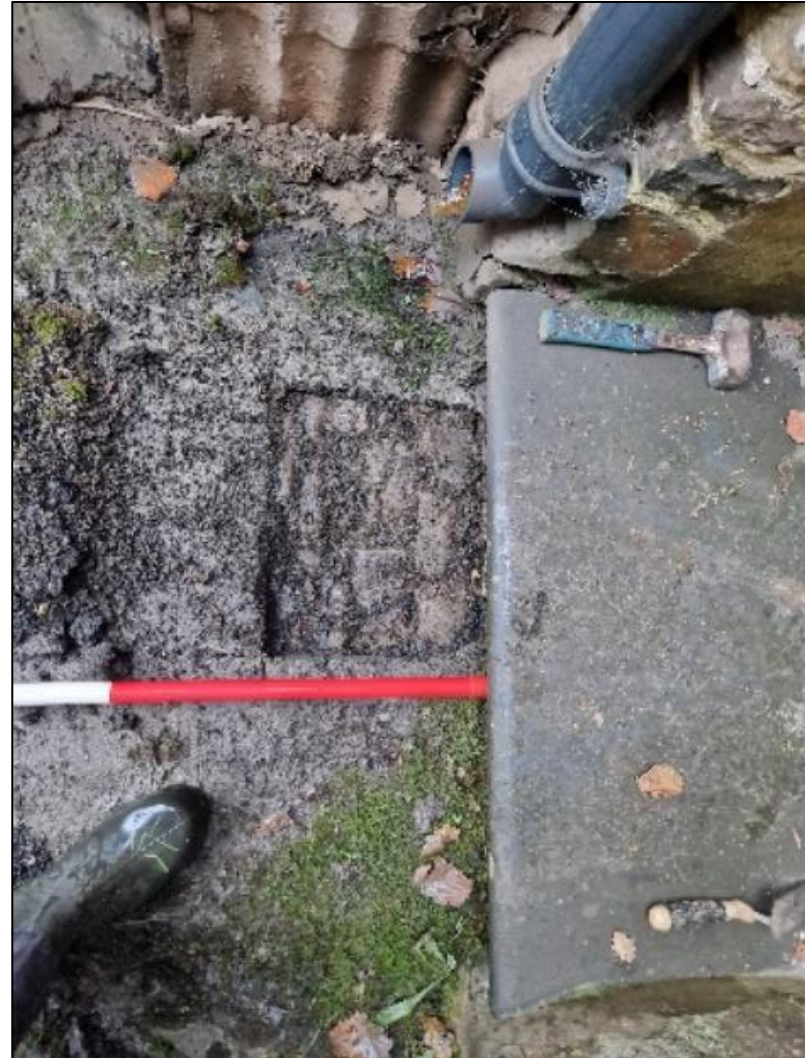
The first stretch of trench was cut through the path, a layer of modern tarmac (100) measuring 0.06m thick. This was overlying (101) a cobbled surface of large sub-angular to sub-rounded stones measuring c.0.15m x 0.1m x 0.07m. Towards the west of the trench (101) began to thin and the stones became smaller. Cobbles were bedded on edge in a matrix of grey-yellow brown silt-clay up to 0.18m thick. (101) was laid directly on top of the natural (102) a firm yellow clay with shillet.

FIGURE 4: COBBLED SURFACE (101) UNDER TARMAC (100) AT VESTRY THRESHOLD (SCALE 1M).

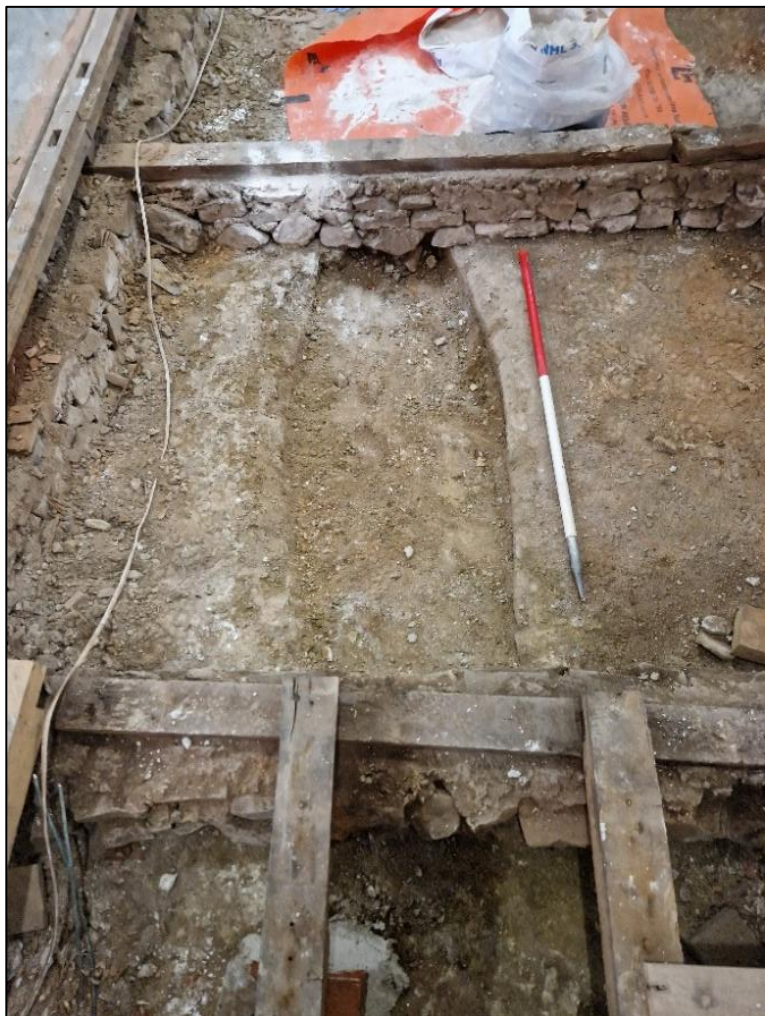
Removing the timber exposed a stone lined tomb [115] coffin shaped with a slightly sunken fill (116). The cut of the tomb measured 1.67m in length with a width varying from 0.44m at the head, 0.68m in the middle and 0.4m to the foot. Both the feet and the head extended under the low dwarf walls and were partially covered by these. The tomb itself was covered with dust and loose rubble from Victorian floor works, including one fragment of roof slate.

FIGURE 5: EXCAVATION INSIDE THE CHURCH SHOWING TOMB [115], FROM THE EAST (SCALE 1M).

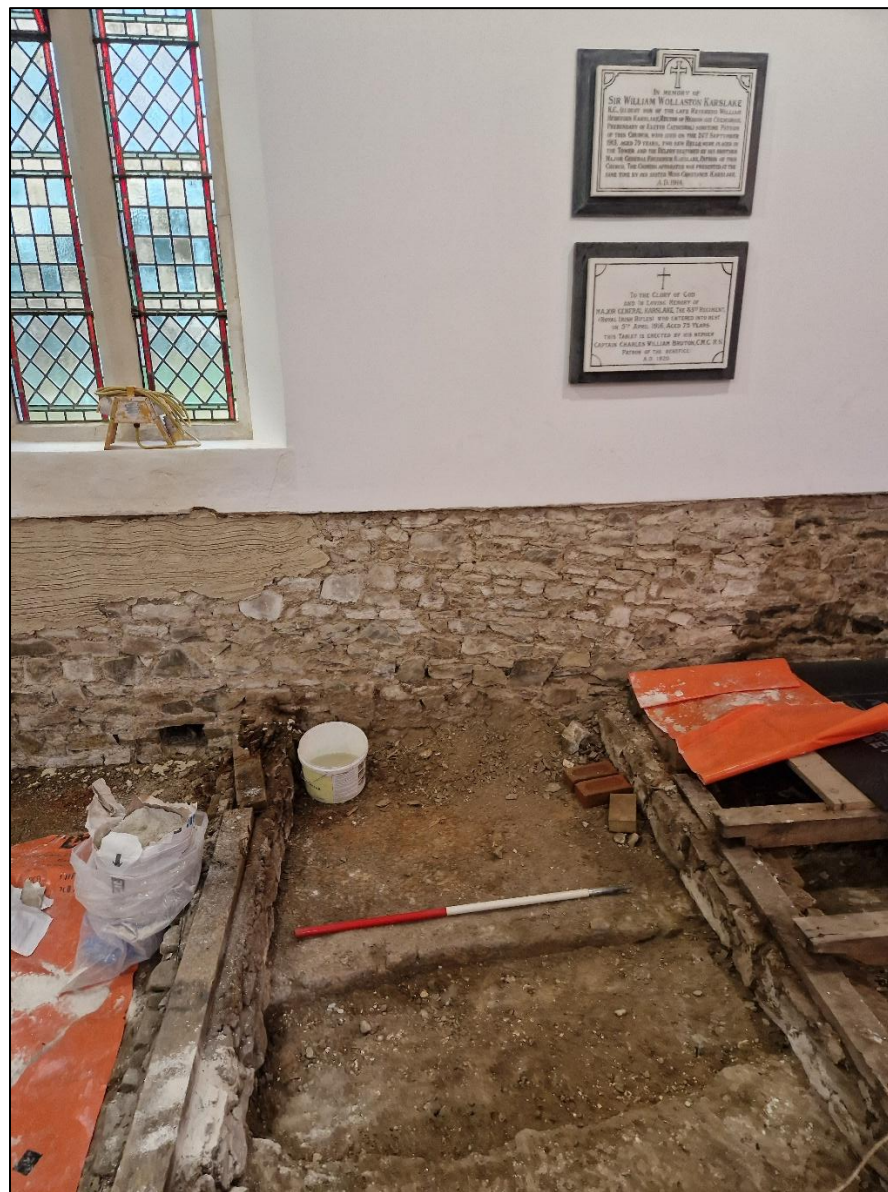
FIGURE 6: TOMB [115], FROM THE SOUTH (SCALE 1M).

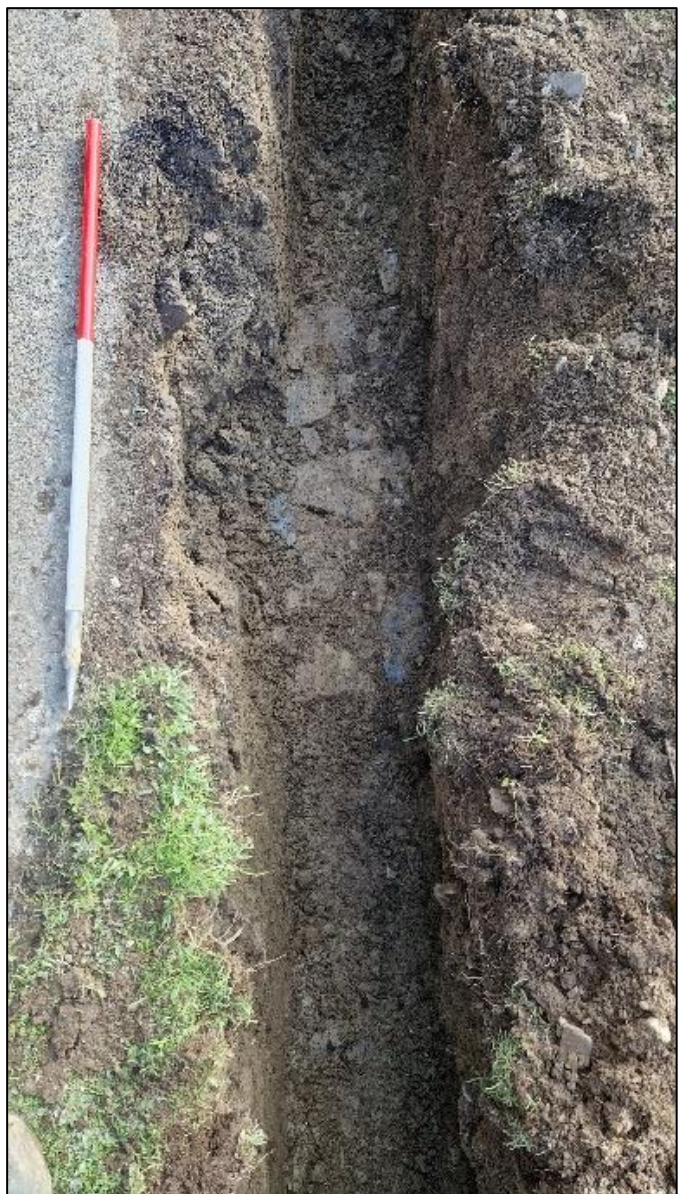
To the west of the tower, under the tarmac path (100) and cobble surface (101) two stone wall footings were uncovered. These were in line with the walls of the tower. The most northernmost wall footing {103} was rubble built and measured 1.15m wide and was the better surviving of the two footings. The footing was built of good sub-rectangular blocky stone, typically measuring 0.6m x 0.2m x 0.18m. The footing was exposed from a depth of 0.4m below the present ground level and extended beyond the base of the excavation, 0.3m(+) deep.

FIGURE 7: (LEFT) SHOT OF WALL FOOTINGS {103} VIEWED FROM NORTH (SCALE 1M).

The two wall footings are interesting as they are aligned with the church tower, and whilst not dated they presumably relate to an earlier church layout, which must predate the 1691 replacement tower, and suggest that the church was formerly longer.

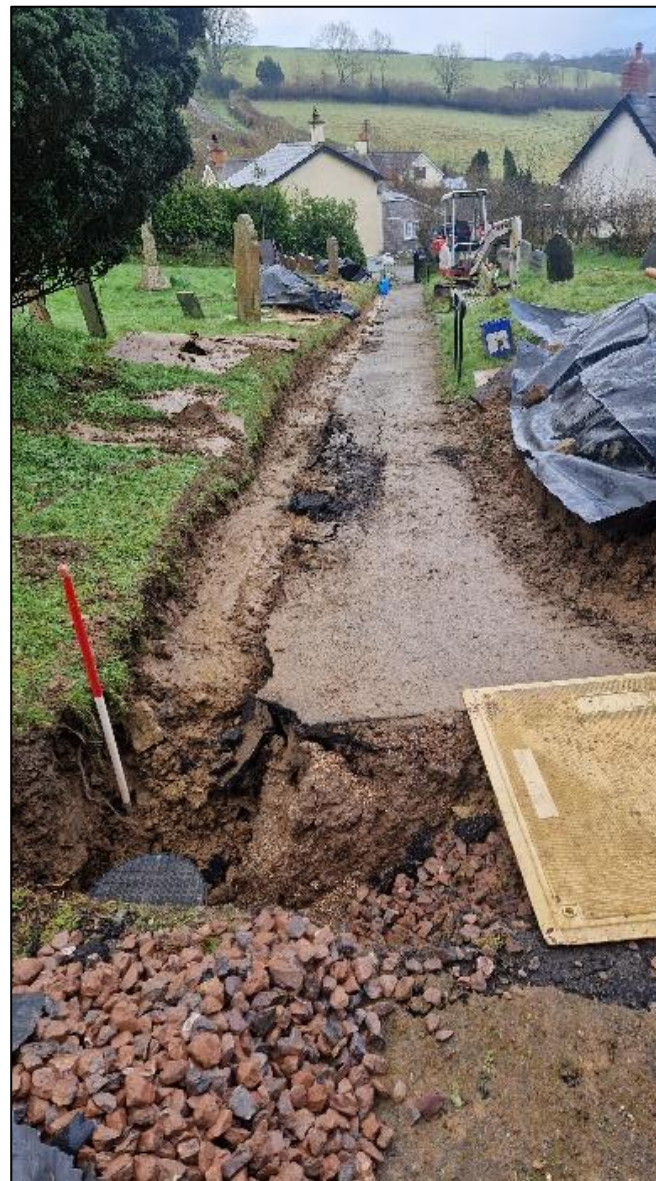
FIGURE 8: TRENCH RUNNING ALONG PATHWAY, VIEWED FROM NORTH (SCALE 1M).

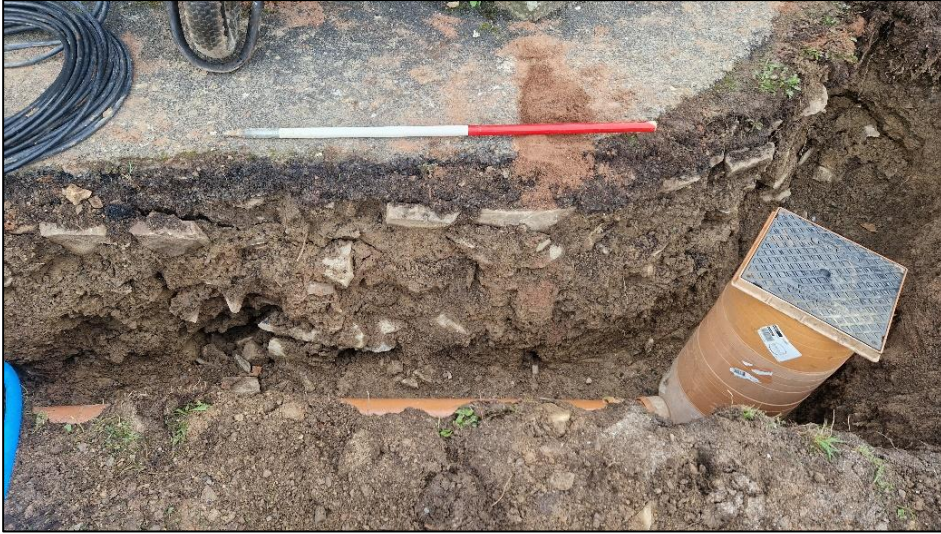
The stratigraphy of tarmac path (100) onto cobble stones (101) continued along the second stretch of trenching around the tower. The cobbles here had good edging stones, sub-rectangular in shape and measuring c. 0.16m x 0.05m x 0.02m thick. The edging stones were exposed in the edge of the trench edge below the layer of tarmac and would be seen curving around the corner of tower (figure 7).

FIGURE 9: EDGING STONES WITHIN (101) CURVING AROUND CORNER OF TOWER UNDER TARMAC (100) (SCALE 1M).

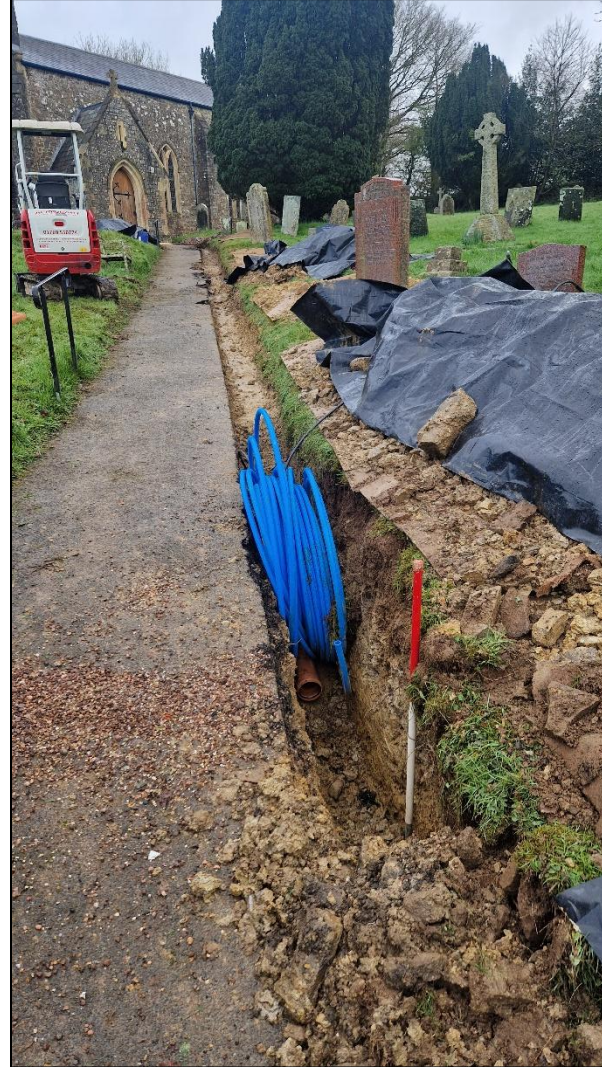
The trench then passed directly along and adjacent to the pathway that leads to the entrance to the church, this part of the route was cut through the topsoil (113) and subsoil (114) to a depth of 0.65m. No further graves or features were noted along this length.

FIGURE 10: SOUTHERN END OF SERVICE TRENCH ALONG CHURCH PATH (SCALE 1M).
