Isolation Hospital (Bicclescombe Nurseries), Ilfracombe, Devon

Historic Building Recording

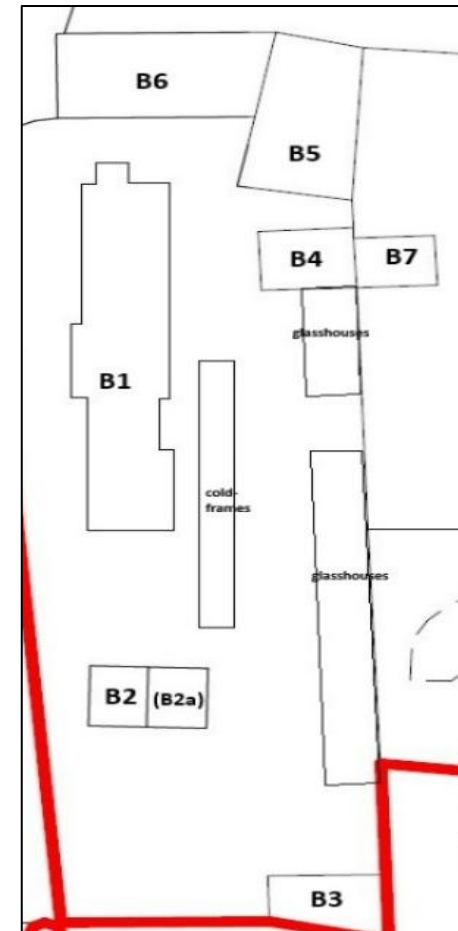
FIGURE 8: SITE PLAN ANNOTATED BY SWARCH BASED ON DRAWING SUPPLIED BY AGENT.

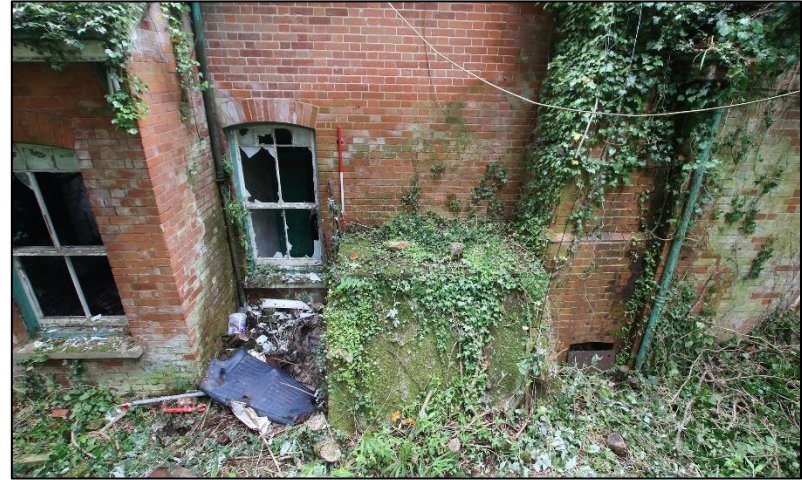
FIGURE 38: THE EXTENSION TO THE INCINERATOR WHICH APPEARS TO HAVE BEEN ADDED ONTO THE CHIMNEY, THE INTERIOR OPENING FOR LAUNDRY BEING BLOCKED, 2M SCALE.

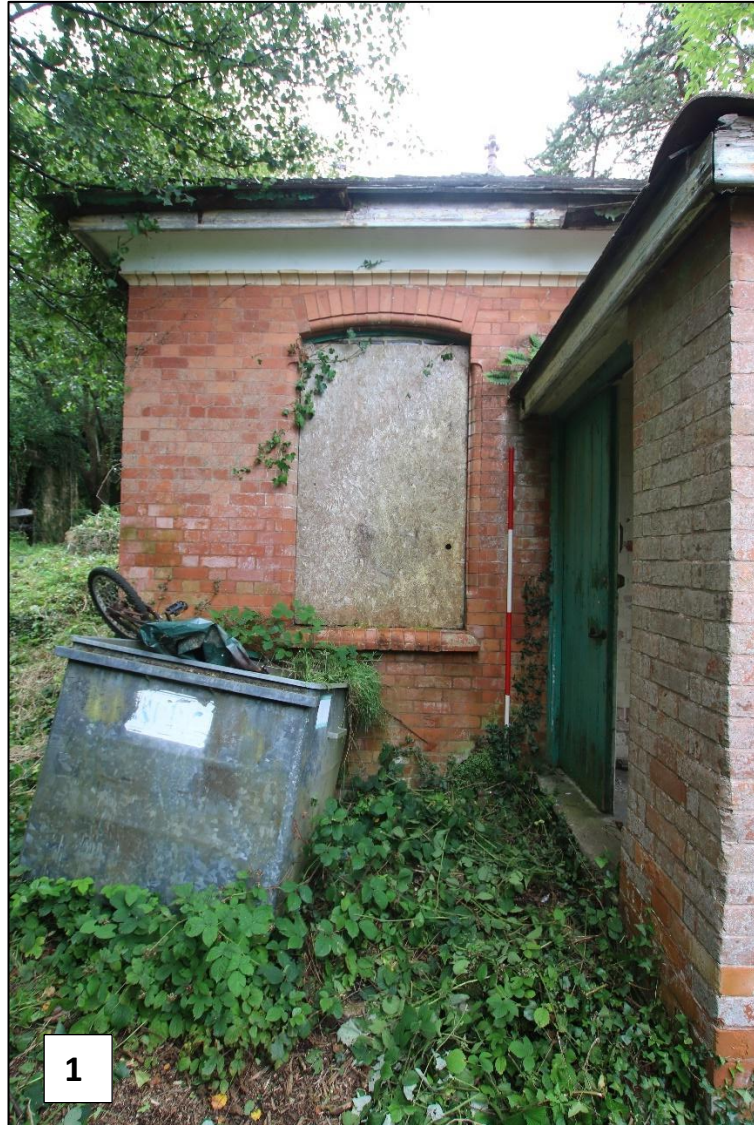
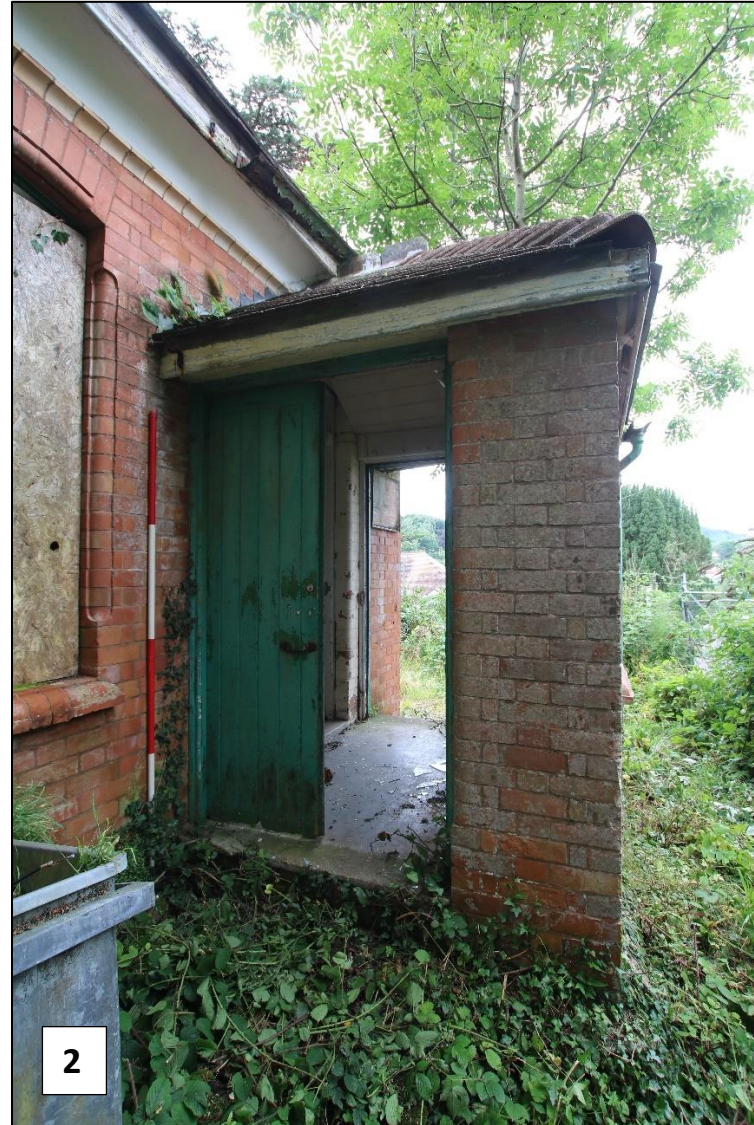
APPENDIX 2 – PHOTOGRAPHIC ‘FULL’ RECORD OF BUILDINGS 1-3
