LAND AT 6 SUTTON ROAD (ST. JOHNS YARD)

ARCHAEOLOGICAL RECORDING OF ARCHITECTURAL FRAGMENTS

LAND AT 6 SUTTON ROAD (ST JOHNS YARD), PLYMOUTH, DEVON: RECORDING OF ARCHITECTURAL FRAGMENTS

South West Archaeology Ltd. report no. 240531

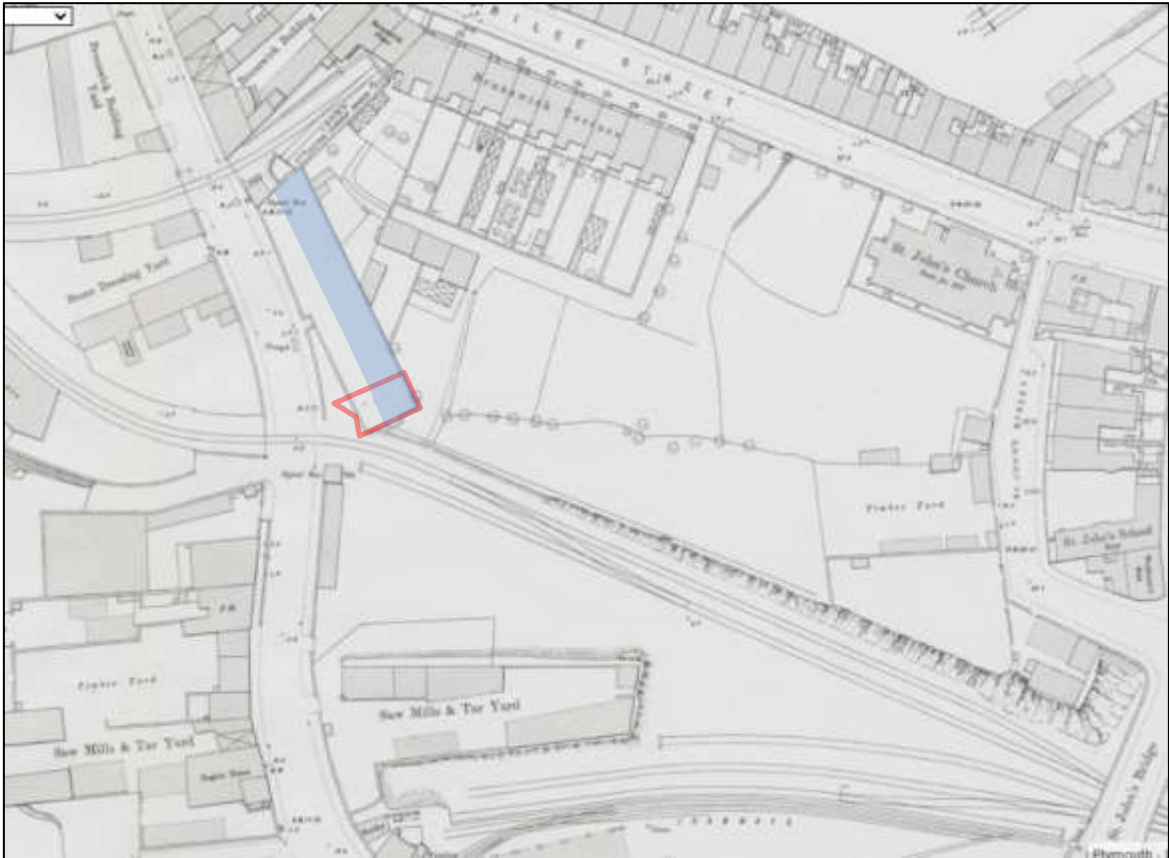
FIGURE 2: 1894 ORDNANCE SURVEY MAP, SHOWING THE YARD, AND POSSIBLE BACK WALL, OF THE FORMER ALMSHOUSES (SHADED BLUE), STILL IN PLACE, THE SITE (IN RED) IS ON THE SOUTHERN END OF THESE FORMER 18TH CENTURY BUILDINGS AND GARDENS.

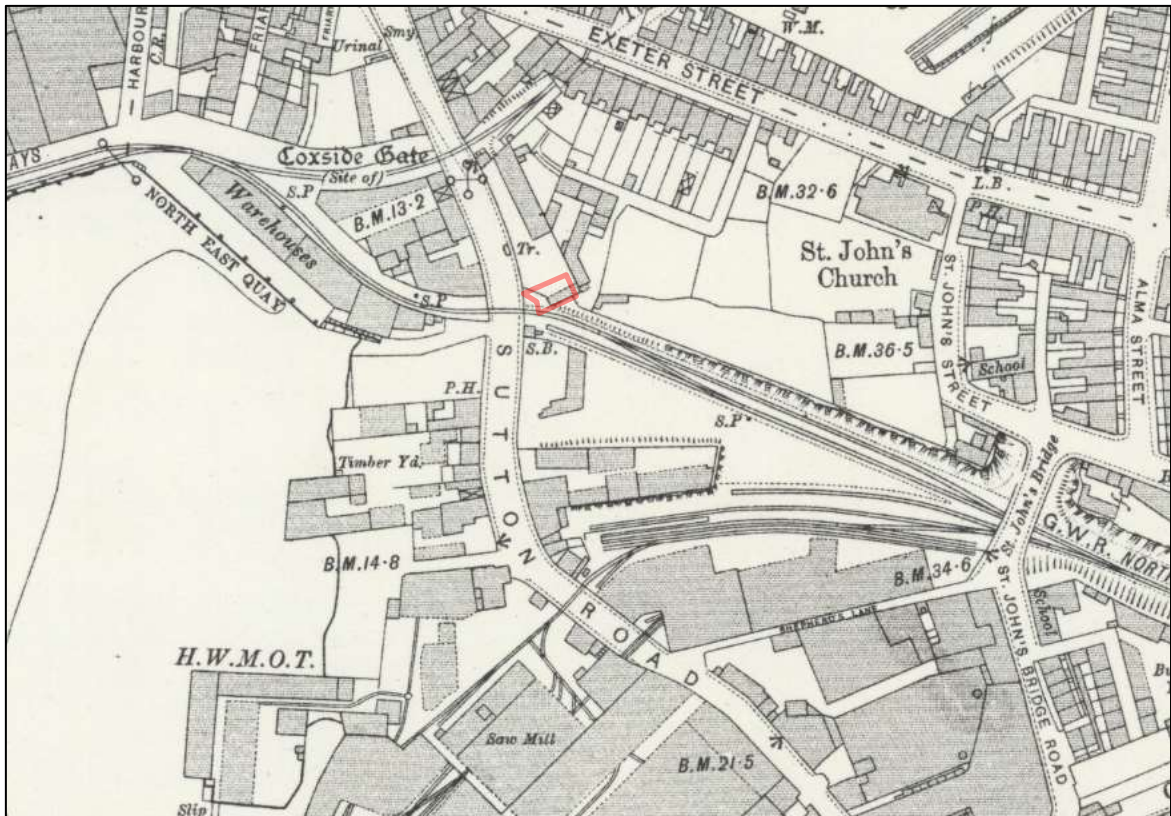
FIGURE 3: EXTRACT OF THE ORDNANCE SURVEY 25 INCH MAP, REVISED 1912, PUBLISHED 1914. SHEET DEVON CXXIII.12 (NLS). THE SITE IS INDICATED IN RED.

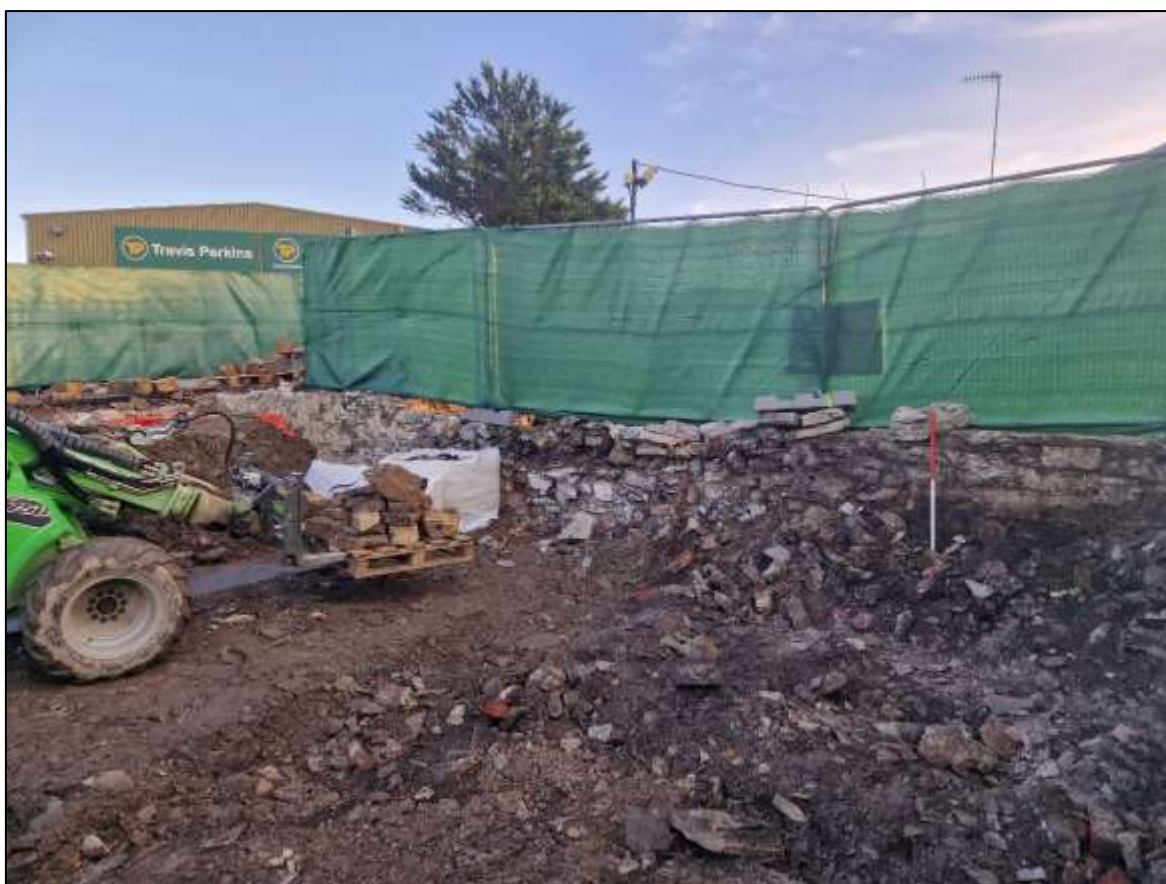
FIGURE 4: SITE DURING WORKS, MASONRY VISIBLE ON PALLET, WITH MASONRY WALL FORMING THE SITE BOUNDARY, VIEWED FROM THE NORTH-WEST (1M SCALE).

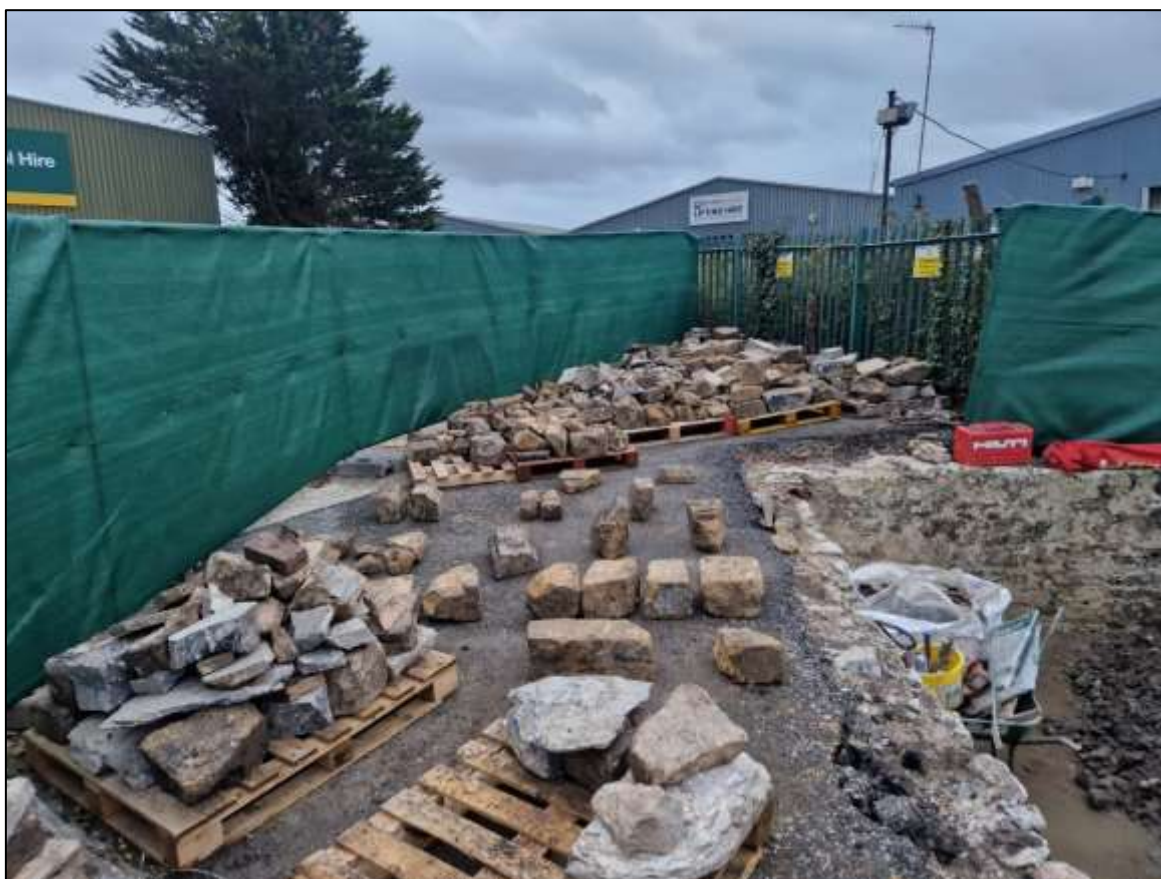
FIGURE 5: SITE DURING WORKS, THE MAJORITY OF THE RECOVERED MASONRY VISIBLE ON PALLETS IN SHOT, THE MASONRY WALLS FORMING THE DEMOLISHED BUILDING ARE TO THE LEFT OF SHOT, VIEWED FROM THE NORTH-WEST (NO SCALE).

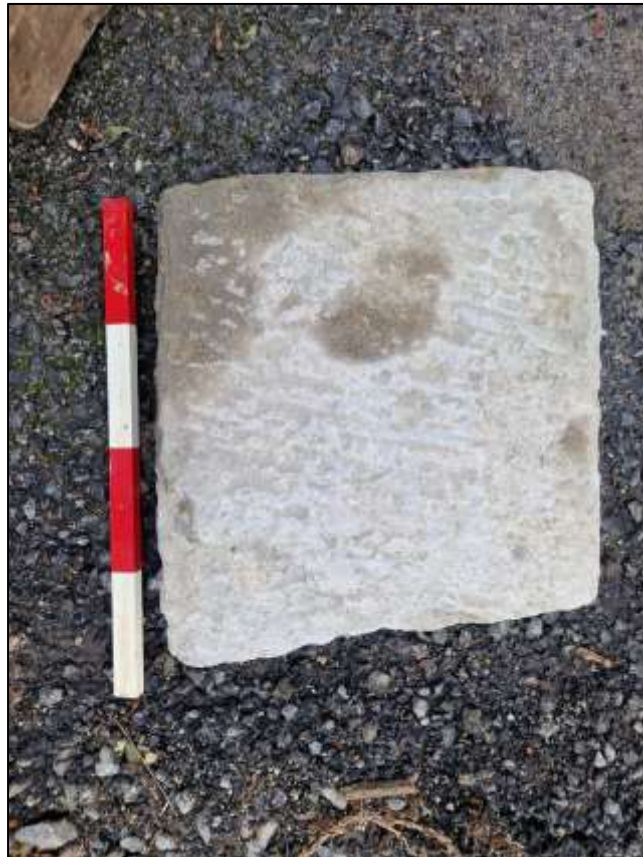
15.

15	Floor slab	slatestone	0.3m x 0.33+ x 0.12m	Light grey slatestone broken rectangular floor slab. Not worn smooth, undressed base.	
16	Floor slab	Yellow/creamy limestone	0.18m x 0.18m x 0.08m	Fragment of possible floor slab. Broken.	
17	Other finds	N/a	Various	Leather shoe, steel fork, silver coated spoon, animal bone, 3x milk bottles, oyster shell, iron ring.	Other objects recovered from amongst the rubble
18	'H' tiles	Ceramic	0.26m x 0.13m x 0.035m	Ceramic tiles, inscribed with the letter H within the bone shaped frog. At least 10 tiles represented by the recovered parts.	Parts of a former floor, likely not church related
19	Air brick imitation?	Limestone	0.27m x 0.22m x 0.07m	Carved creamy limestone, possible floor fragment?	
20	Floor slab or memorial	Slate	0.4m x 0.24m x 0.03m	Polished Slate with groove. Groove runs near 1 edge, possible drain or setting for fitting/fixture?	
21	Floor slab	Slate	0.3m x 0.36m x 0.03m	Slate floor fragment (n.b. one of the better examples found), broken and damaged edges in places, but likely whole.

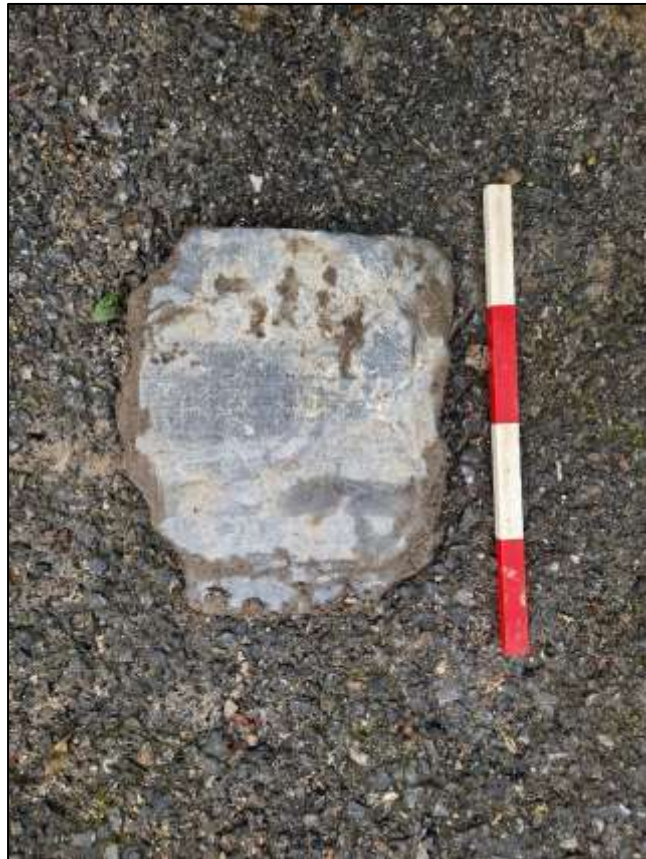
23.

22	Memorial	limestone	0.24m x 0.16m x 0.12m	Memorial stone fragment, creamy limestone. Inscribed ETC/....!...	NO PHOTO
23	Window tracery	Yellow ham stone	0.3m x 0.24m x 0.18m.	Broken central head with two rebates creating a central raised v-shape. Unbroken.	
24	window sill or jamb	Yellow ham stone	0.45m x 0.26m x 0.2m	Groove for window with traces of lead, c.0.08m from edge.	
25	Wall fabric?	limestone	0.4m x 0.26m x 0.15m	Dressed stone, creamy limestone. Rolled tops with rebate/lip. Near complete block.	
26	Foot to memorial?	limestone	0.48m x 0.2m x 0.2m	Dressed grey limestone with decoration. Has lost its top, above decoration. Tapered non-symmetrical profile. One side straight with V-shaped groove to top just below decoration. Other side curves slightly outwards with slight step in at same level as groove. Likely one of two feet to a decorative memorial.	
27	Tile	ceramic/concrete	0.18m x 0.25m x 0.04m	'Siesta' tile. Light pink ceramic/concrete tile	Probably not from the church

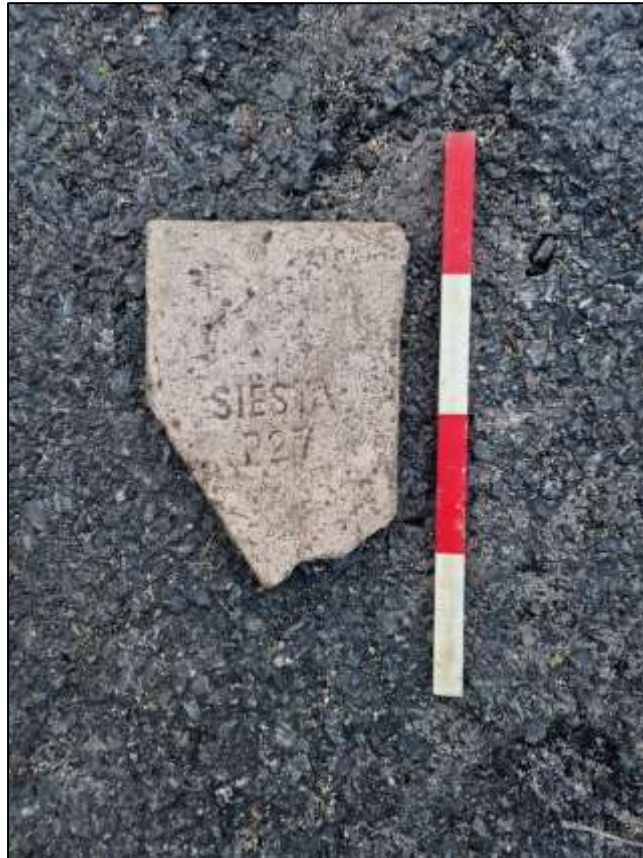
28.

28	Window tracery	Yellow ham stone	0.24m x 0.24m x 0.2m	Window quatrefoil tracery fragment, very broken. Rebate for glass is 0.08m, curve for quatrefoil glass detail	
29	Window surround	Yellow ham stone	0.3m x 0.3m x 0.12m	Part of Arched lintel? Sub-rectangular, one side sloped, very slightly curved. Longest edge is chamfered with a 0.06m depth.

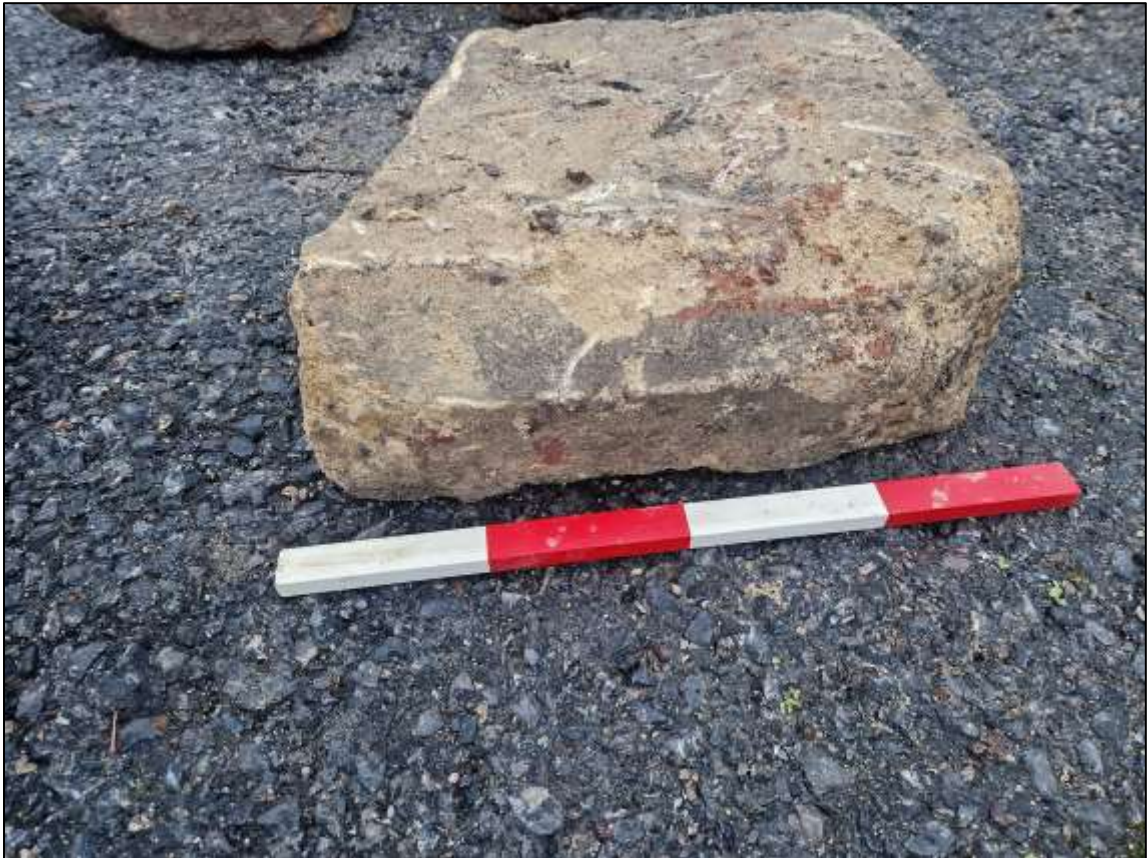
30.

30	Window fragments	Yellow ham stone	0.2m x 0.3m x 0.19m 0.13m x 0.1m x 0.09m	1x part of edge/frame, two shaped faces, but broken 1x small fragment of probably window tracery, very irregular	
31	Window surround	Yellow ham stone	0.28m x 0.2m x 0.13m	Whole block. Sub-rectangular, slightly trapezoidal. Two ridges/rebates extend half-way onto the block, then is just sloped. 0.08m wide and 0.06m deep step.	
32	Window surround	Yellow ham stone	0.28m x 0.19m-0.1m x 0.18m	Part of arch, whole block. One tapered edge.	
33	Window surround	Yellow ham stone	0.42m x 0.28m x 0.22m	Almost whole, part of hood moulding. 0.08m is groove/join of two blocks. Sloped 0.08m x 0.08m face with 0.05m x 0.06m deep roll top and then sloped face.	
34	Window surround	Yellow ham stone	0.31m x 0.3m x 0.22m	Near complete corner, sub-square, one curved corner. 0.16m x 0.16m deep rebate with curved end extends into block with sloped 0.08m face. 0.1m x 0.08m deep curve ended and sloped cut also to opposite edge.

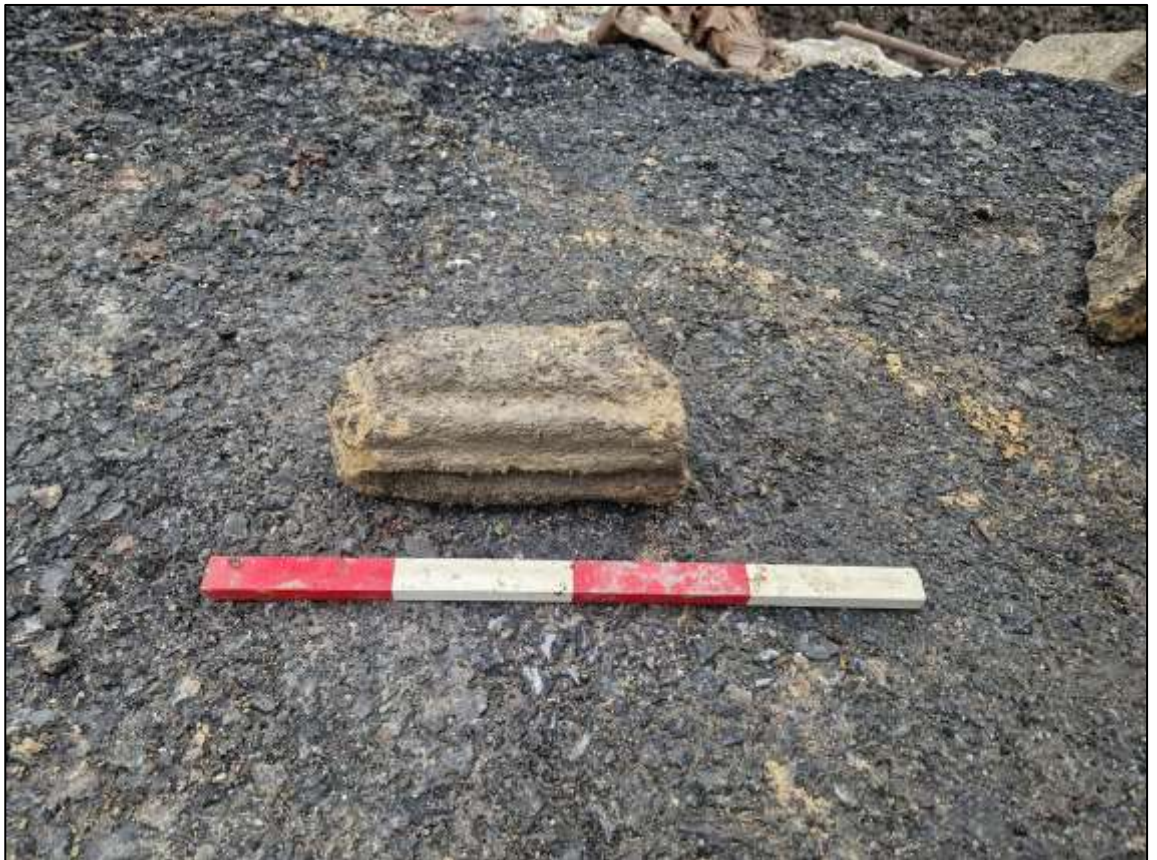
114.

wider and deeper, lower. To the side is a further recess which could be for glass; iron staining from pin.	
114	Window fragment (sill?)	Yellow ham stone	0.22m x 0.2m x 0.1m	Part of window sill/lintel, with square socket for glazing bar to end. Likely different profiles to sills each side, but damage makes less clear. 1 wide concaved, other is shallower concave and step.	Similar to 140
115	Window tracery	Yellow ham stone	0.18m x 0.14m x 0.14m	Window tracery, Part (corner) of a decorative niche as seen elsewhere.	Same as No.79
116	Window surround	Yellow ham stone	0.24m x 0.2m x 0.14m	Window surround, large sub-rectangular block with deep and wide concaved profile to one long edge.	
117	Window tracery	Yellow ham stone	0.23m x 0.17m x 0.17m	Window tracery fragment, sub-rectangular block with central square socket hole 0.032m at one end, filled with cement/stone infill.	
118	Window fragments	Yellow ham stone	-	5x window tracery fragments, small sub-angular to sub-rounded. One with recess for window and significant lead adhering. May suggest heating from fire.

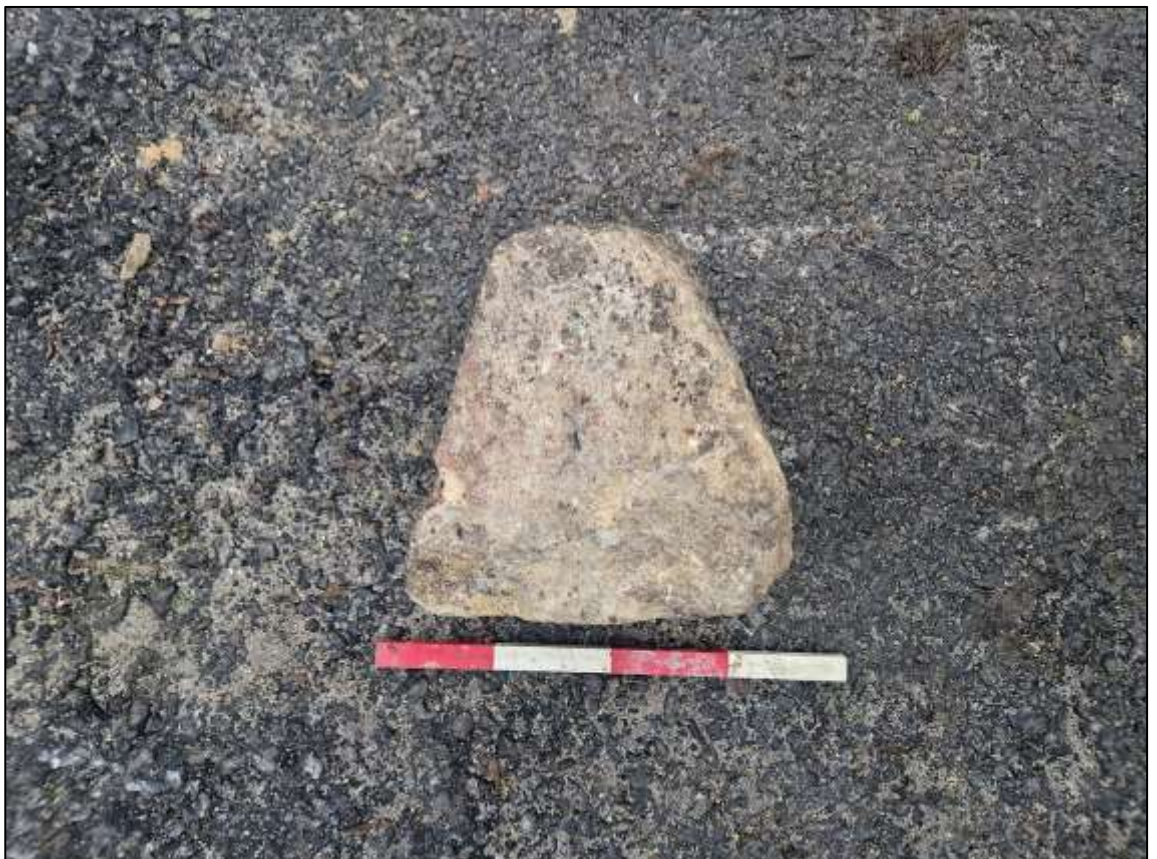
120.

119	Window surround (arch)	Yellow ham stone	0.24m x 0.25-0.14m x 0.2m	Window tracery fragment, Large trapezoidal shaped block, part of arch?	
120	Window fragments	Yellow ham stone	x 0.08-0.16m	6x window tracery fragments, medium, two 0.08m thick (i.e. thinner blocks) with central gully, likely for joining.	Same as no.133
121	Window surround	Yellow ham stone	0.28m x 0.16m x 0.15m	Window tracery, sub-rectangular block, broken. Single deep sloping triangular cut-out. Dressed face sloped out as cut-out gets wider/deeper.	
122	Memorial tablet fragment	Polished grey limestone	0.3m x 0.14- 0.09m x 0.14m	Polished dark grey limestone, likely part of the horse head. Wedge shaped, lost projecting detail at top of narrower end.	
123	Window fragments	Yellow ham stone	0.25m x 0.17m x 0.14m	Window tracery fragment, Decorative sub-rectangular block of top. Two broken but matching 0.05m wide, 0.13m long and 0.03m deep half-circle/round headed triangulated recesses.

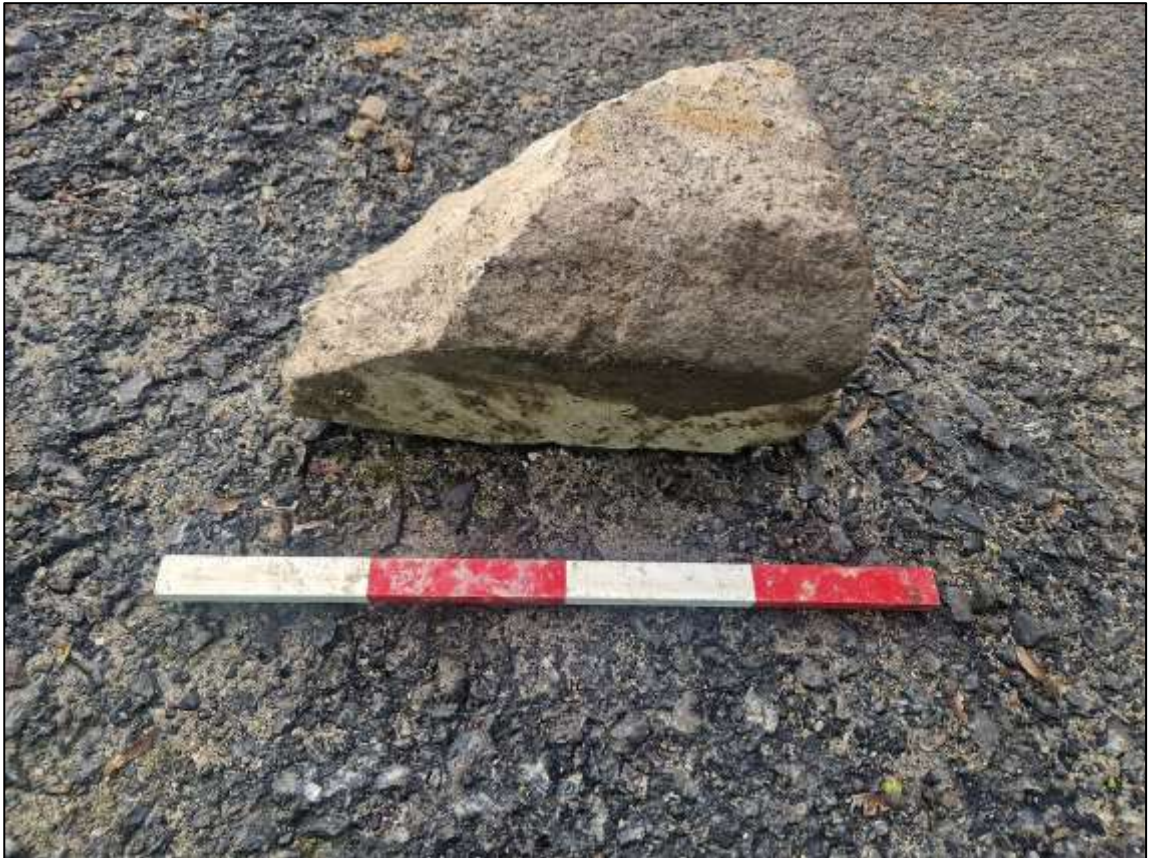
124.

124	Shaped block	Light grey limestone	0.3m x 0.18m x 0.16m	Limestone block, sub-rectangular fragment, with a sloped face to long edge.	
125	Floor fragment	Slate	0.17m x 0.13m x 0.03m	Notched slate. Likely a floor slate?	
126	Window fragments	Yellow ham stone	-	4x window tracery fragments, large sub-angular fragments. 1x likely wedge shaped, one with a sloped long edge. 1x with slate and lime bond adhering.	
127	Memorial fragment?	Light grey/cream limestone	0.24m x 0.2m x 0.17m	Creamy limestone block, broken, with curved edge to flat face panel, to a sloped edge.

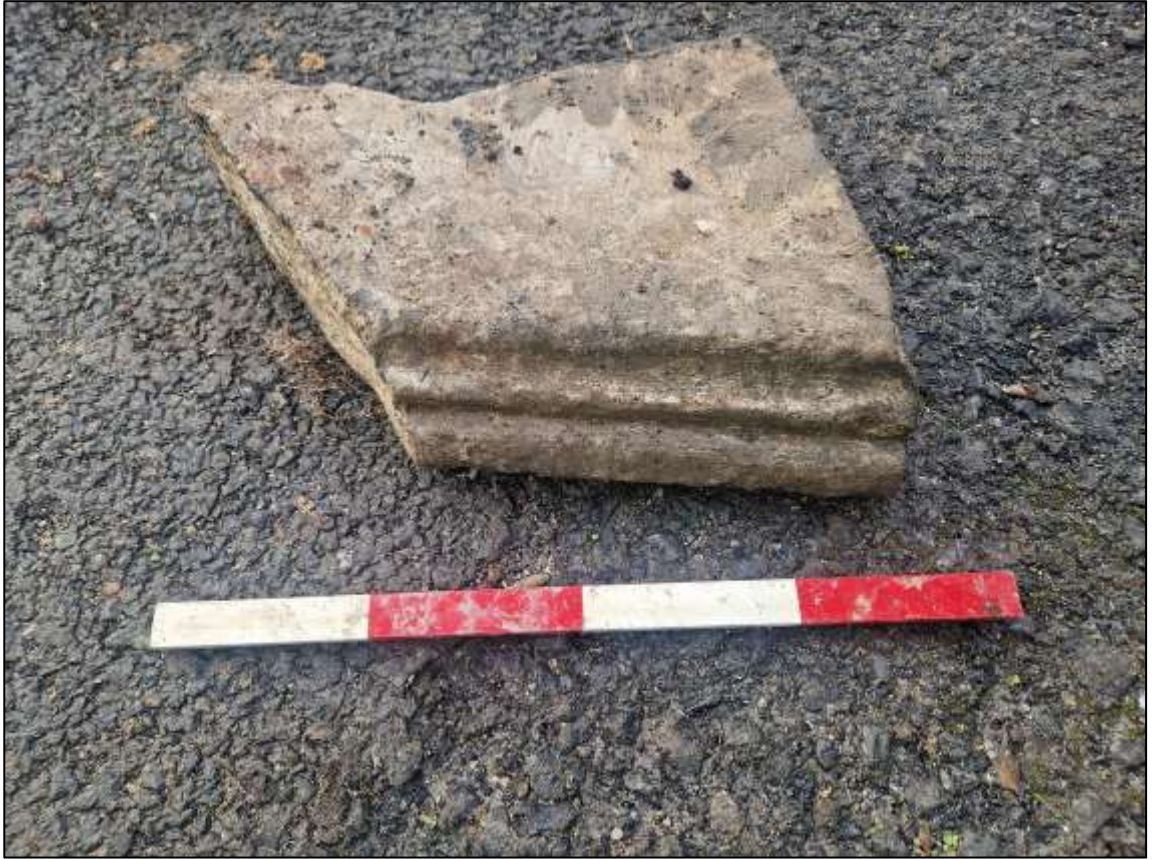
128.

128	Memorial fragment?	Light grey/cream limestone	0.35m x 0.22m x 0.09m	Creamy limestone block, broken sub-angular, with double stepped beaded edge.	
129	Window fragments	Yellow ham stone	-	10x window tracery small sub-angular to sub-rounded fragments, some faced edges. 1x with wide concaved profile. 1x with central square hole with remains of concrete joint.	
130	Window surround	Yellow ham stone	0.24m x 0.24m x 0.2m	Window surround, large square block, with c 45° angle, rebate for joining to stonework. Concrete joint and some lime mortar adhering to side.	
131	Window surround	Yellow ham stone	0.34m x 0.15m x 0.2m (complete)	2x window tracery fragments, both wide slightly concaved wide steps, 1x broken, 1x near complete	
132	Kerb (?)	Limestone	0.45 x 0.13m x 0.19m	Creamy limestone roll-top edging, angled roll-top. Two levels of concrete/mortar scar adhering to inside of bend.	Same as no.14 and 151

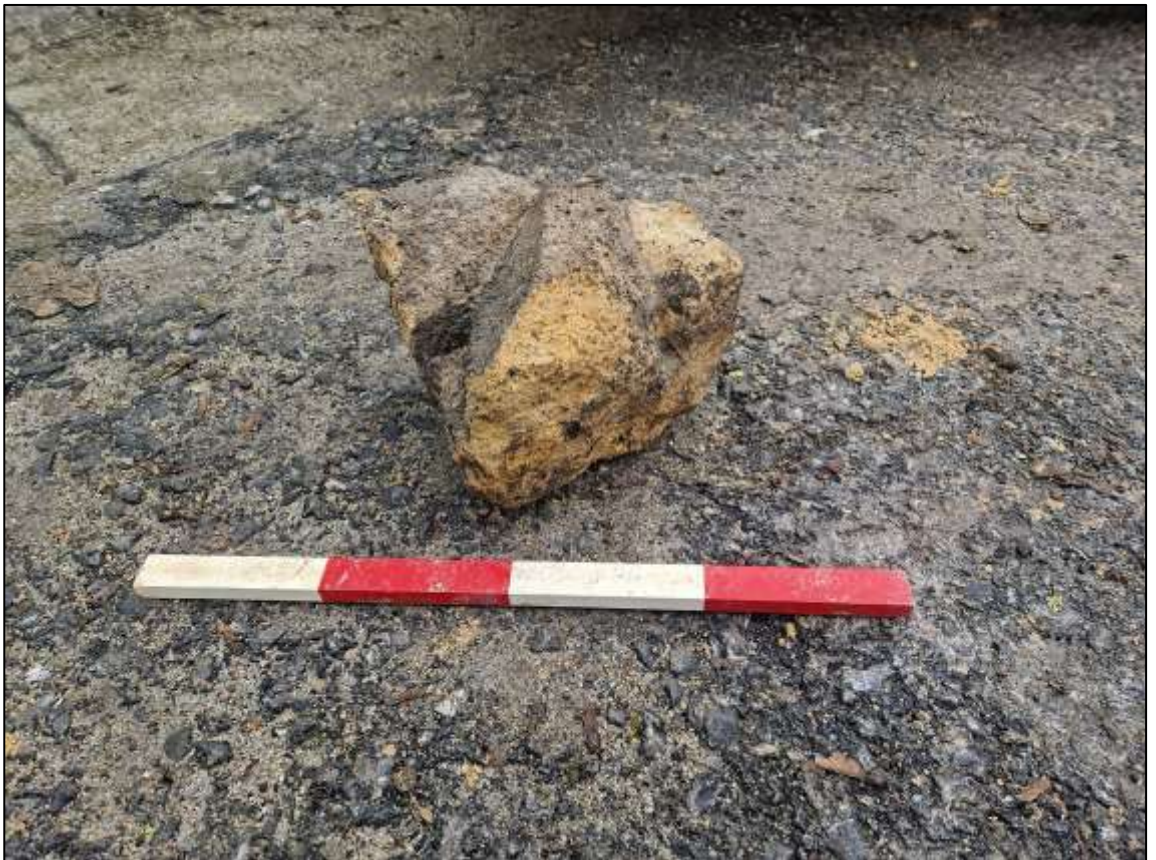
133.

133	Window tracery	Yellow ham stone	0.15m x 0.22m x 0.15m	Window tracery, decorative fragment, likely part of square block, with two sunken round-headed triangles recesses, as block 120.	Same as no.120
134	Window surround	Yellow ham stone	0.25m x 0.2m x 0.12m	Window tracery, broken sub-angular block, with two steps, small concave lower and wide and deep upper. Coated with a yellow-brown paint, very straight edge to this, just before the break (internal vs external).	
135	Drain cover/floor slab	Grey limestone	0.45m x 0.18m x 0.06m	Broken, grey limestone floor slab with central square hole with lipped recess (e.g. for drain) 0.2m x 0.05m+	
136	Window surround	Yellow ham stone	-	5 x window fragments, large to medium sized sub-rectangular blocks. 1x with 1 sloped long edge. 1x largest block has a sloped scar, slight recess, perhaps for join into other stonework?	
137	Window surround	Yellow ham stone	0.18-0.32m x c.0.22m x c.0.15m	3x window tracery fragments with wide sloped to very slightly concaved edges along surviving long edges. 2 then square, 1x has trace of second sloped step, but broken.

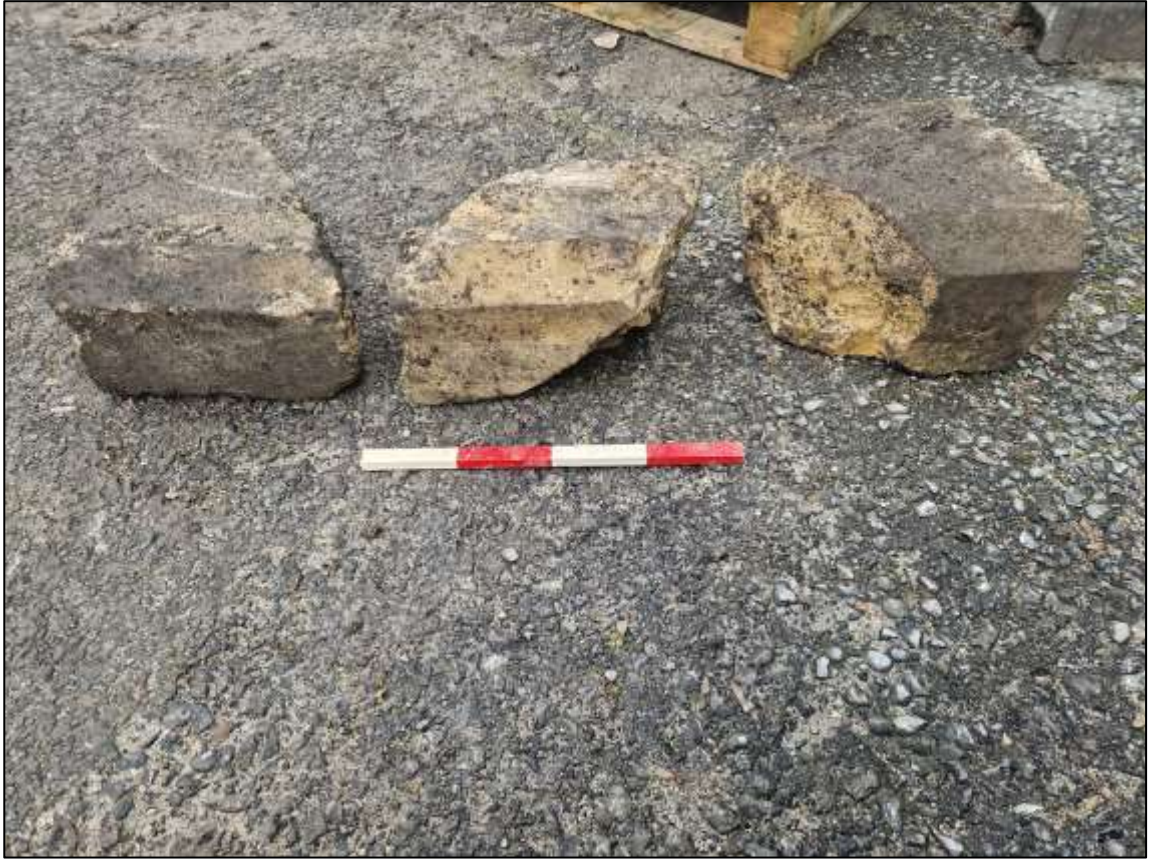
138.

138	Window surround	Yellow ham stone	0.32-0.35m x c.0.3m x c.0.18m	3x window tracery fragments, large parts of sub-rectangular blocks with a single small sloped edge along one long side.	
139	Window tracery	Yellow ham stone	0.28m x 0.3m x 0.12m	Window tracery, broken square block, decorative with recessed middle to sides (for joining?) Single broken decorative recess, two conjoined semi-circles?	
140	Window surround (sill)	Yellow ham stone	0.34m x 0.24 x 0.14m	Window tracery fragment of base, sub-rectangular, broken. Recess for glass to middle, different profile each side as seen previously. Single square socket for glazing bar or join!	Similar to No.114

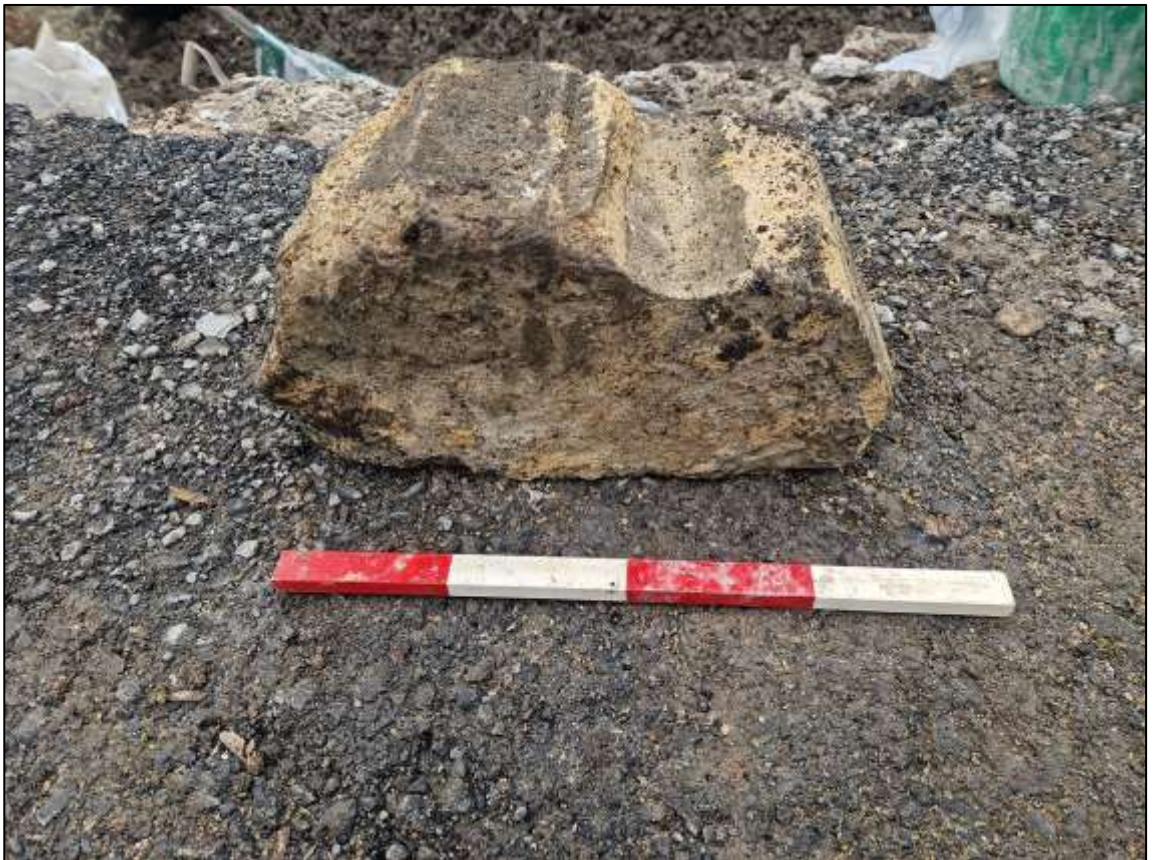
141.

141	Window surround (sill/lintel)	Yellow ham stone	0.28m x 0.15m x 0.2m	Window tracery, top or base. Probably a central recess with single square socket hole adjacent. Different profiles to each side, 2 x wide concave steps one side. Deep and wide concaved lower and small square top step to the other side.	Similar to No. 107
142	Window surround	Yellow ham stone	0.32m x 0.25m x 0.16m	Window tracery, large sub-rectangular block, shaped with rough step to key in neatly to one face, two smooth faces. 3x broken. Roll top and start of triangular cuts x 2 with roll top between.	
143	Window tracery	Yellow ham stone	0.2m x 0.22m x 0.12m	Window tracery, sub-angular to sub-rounded fragment. Possible start of join between two windows, slight lip between two concaved scallops, small square step to edge beyond scallops.	
144	Window fragments	Yellow ham stone	-	18x irregular Window fragments, sub-angular to sub-rounded, small to medium fragments, mostly no details, 1x with sloped edge to long axis. 1x square step with slope leading to it.

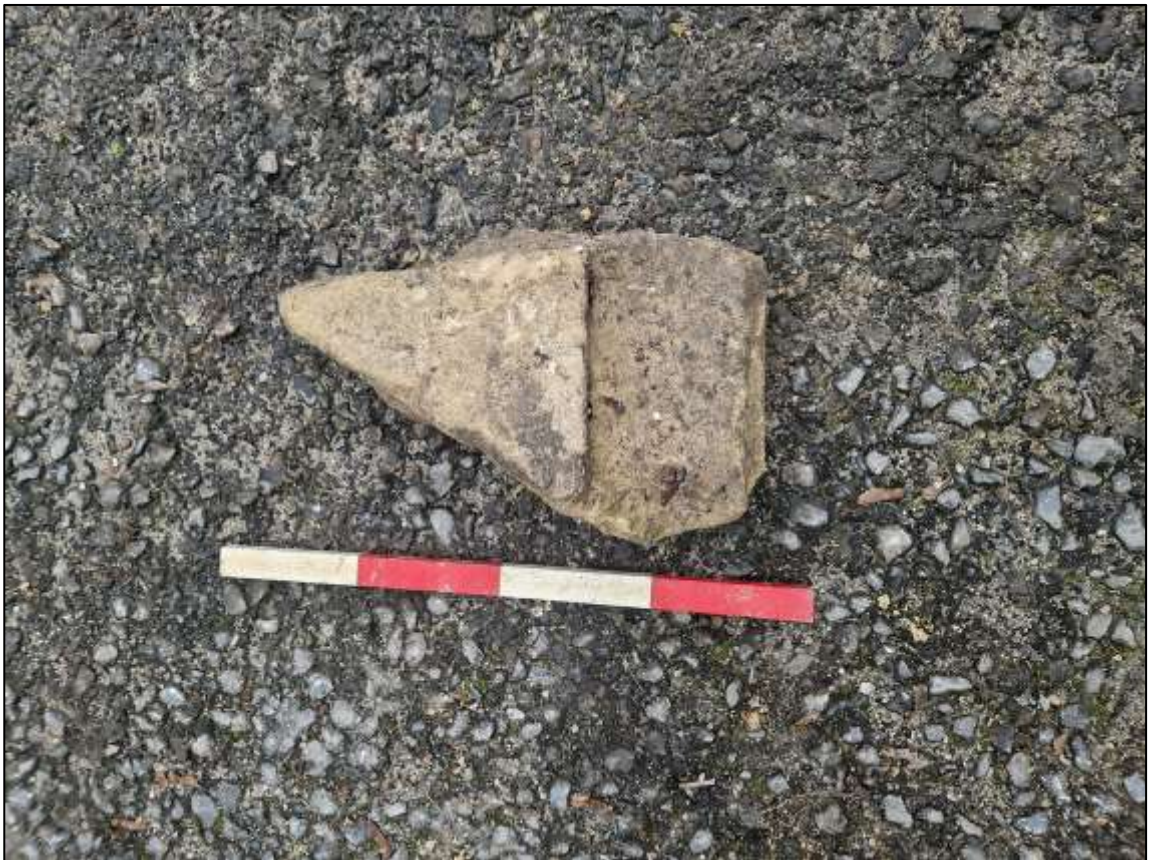
145.

145	Window surround	Yellow ham stone	0.29m x 0.18m x 0.12m	Window fragment, broken, now triangular block, one deep and wide concaved edge off a vertical step.	
146	Window surround (sill?)	Yellow ham stone	0.2-0.25m x 0.2-0.22m x 0.16m	2x window fragments, parts of rectangular blocks, central glazing, 1 with socket (glazing bar?) and lead in-situ. Different profiles each side.	
147	Window surround (sill/lintel?)	Yellow ham stone	0.21-0.32m x 0.24m x 0.18m	2x window tracery fragments, parts of sub-rectangular block. Parts of a sill/ridge? One flat topped, the other flat and raising to a ridge with lead/bond adhering in square area to one face.	
148	Window surround (sill/lintel?)	Yellow ham stone	0.22m x 0.24m x 0.18m	Window tracery fragment, sub-angular. Two flat faces, others rough or broken. Single flat based 0.03m wide and 0.015m deep gully with square socket hole.	
149	Decorative pillar?	Grey limestone	0.28m x 0.28m x 0.2m	Grey limestone, shaped square block, part of a column base. Has a rectangular socket 0.05m x 0.06m to the corner of the quarter circle.

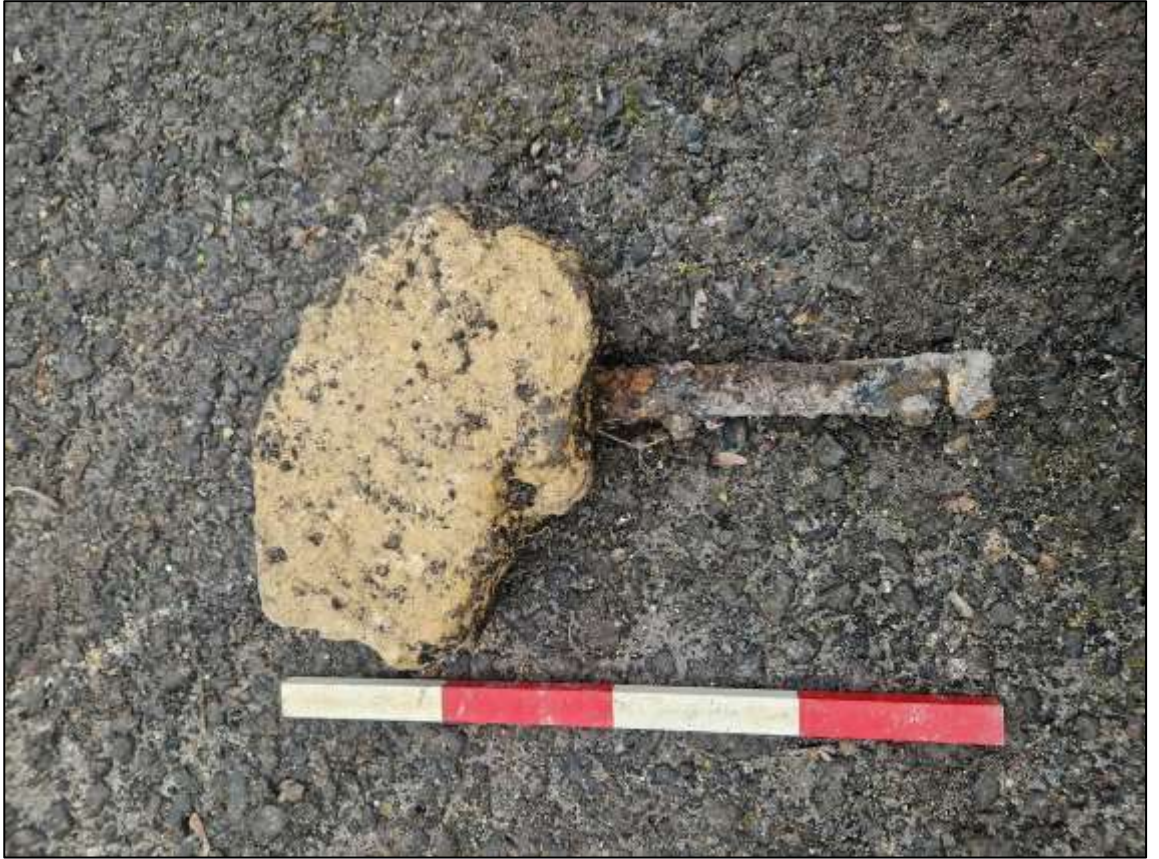
150.

150	Window surround?	Yellow ham stone and Iron	0.16m x 0.22m x 0.08m	Window tracery with iron strap attached, bedded in stone and covered with yellow mortar so not visible. One steep angled corner. Strap is 0.25m x 0.026m and snapped at end but appears to have started to turn.	
151	Kerb?	Limestone	0.28m x 0.12m x 0.1m	Light grey to cream limestone kerb, broken, some drips of molten lead adhering (from fire?)	Same as no.14 and 132

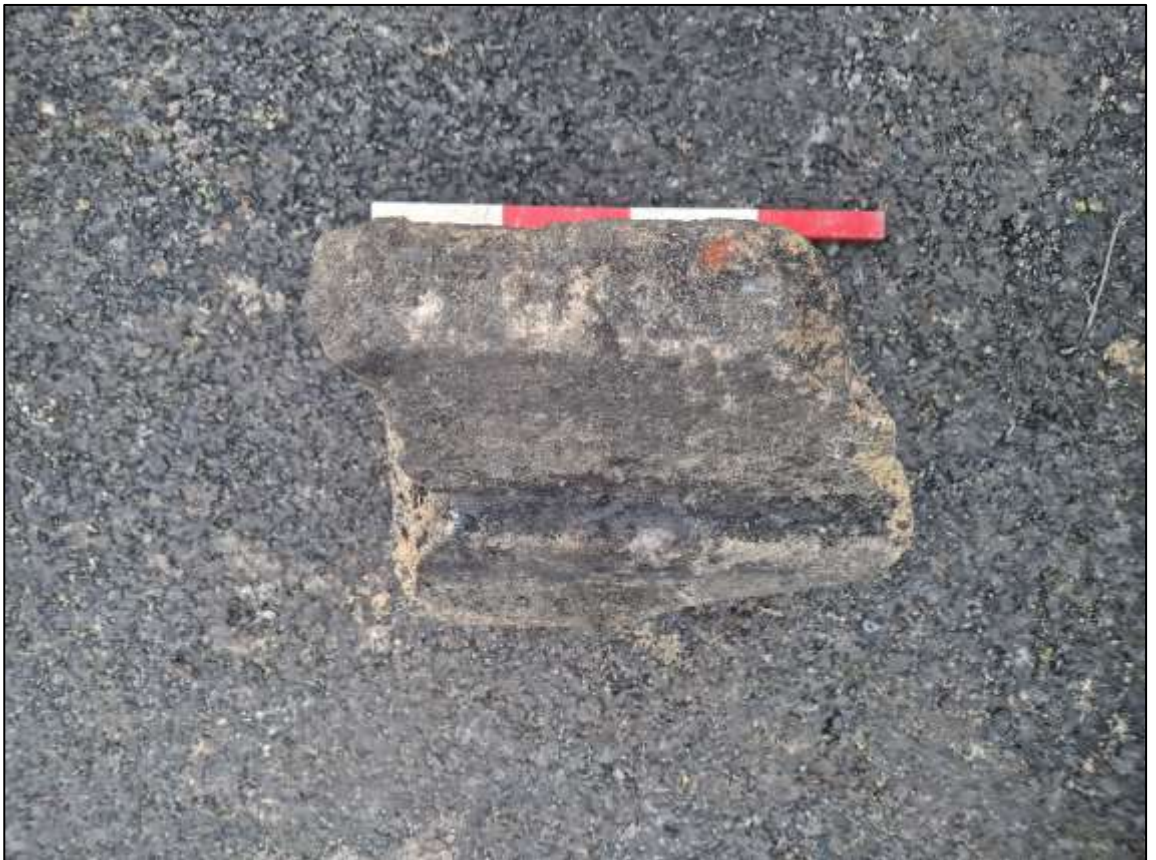
157.

157	Window surround (sill/lintel?)	Yellow ham stone	0.3m x 0.34m x 0.24m	Window surround. Part of sill or lintel? Flat top to steep slope to shallow slightly sloped step to steep slope.	
158	Faced block (wall)	Grey limestone	0.44m x 0.26m x 0.14m	Large, light grey limestone block, one stepped edge (for bonding/setting), other long axis is sloped and this may widen, i.e. surround to door or dressed quoin? but damage makes this unclear.	
159	Window fragments	Yellow ham stone	-	7x window fragments, mixed sub-angular to sub-rounded. 1x from decorative recessed panel, a broken triangle. 1x a grey render/paint to one face.	
160	Window surround (sill/lintel?)	Yellow ham stone	0.2-0.32m x 0.29m x 0.18m	2x large sub-rectangular (but broken blocks). Both with one shaped long axis, sloping with stop-end to both.	
161	Window surround	Yellow ham stone	c.0.3m x 0.3m x 0.18m	4x window surround, sub-rectangular blocks, probably (originally), 1x slightly trapezoidal, with a slight angle to one (long) axis.

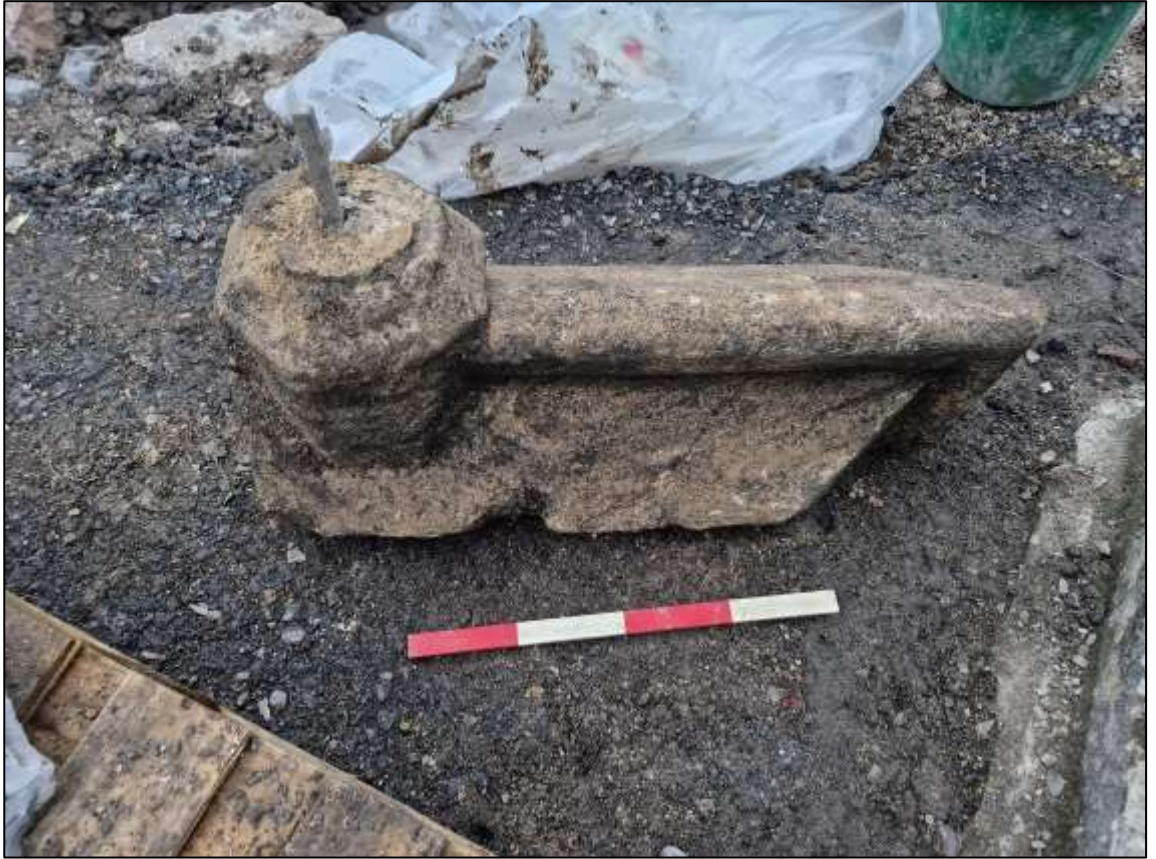
164.

Also, amongst the various likely window tracery fragments were clear decoration mullions (e.g. No. 106). There were also multiple very rounded and un-diagnostic smaller fragments, most of which presumably formed parts of the window mullions (e.g. No. 66). Some of the pieces were more diagnostic, for example, as the external outer mullions (e.g. No.71) or No.117 with its central socket. More diagnostic again were also several parts of quatrefoils, most notably No.11, which contained a remnant of green window glass and lead work. Some parts of hood moulds were also identified, including a very large piece with fitting for a grotesque (no.164).

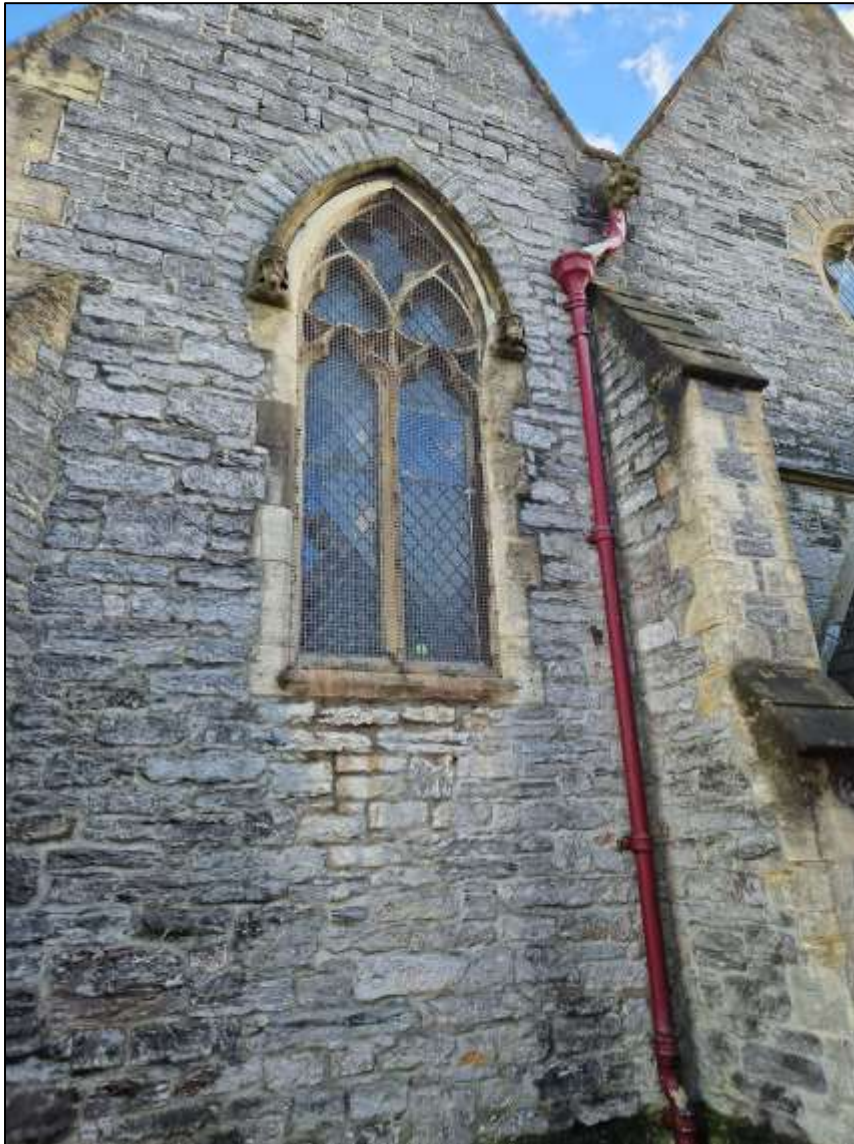
2. WINDOW WITH GROTESQUES TO WEST ELEVATION OF CHURCH.
