LAND AT 6 SUTTON ROAD (ST. JOHNS YARD)

ARCHAEOLOGICAL RECORDING OF ARCHITECTURAL FRAGMENTS

LAND AT 6 SUTTON ROAD (ST JOHNS YARD), PLYMOUTH, DEVON: RECORDING OF ARCHITECTURAL FRAGMENTS

South West Archaeology Ltd. report no. 240531

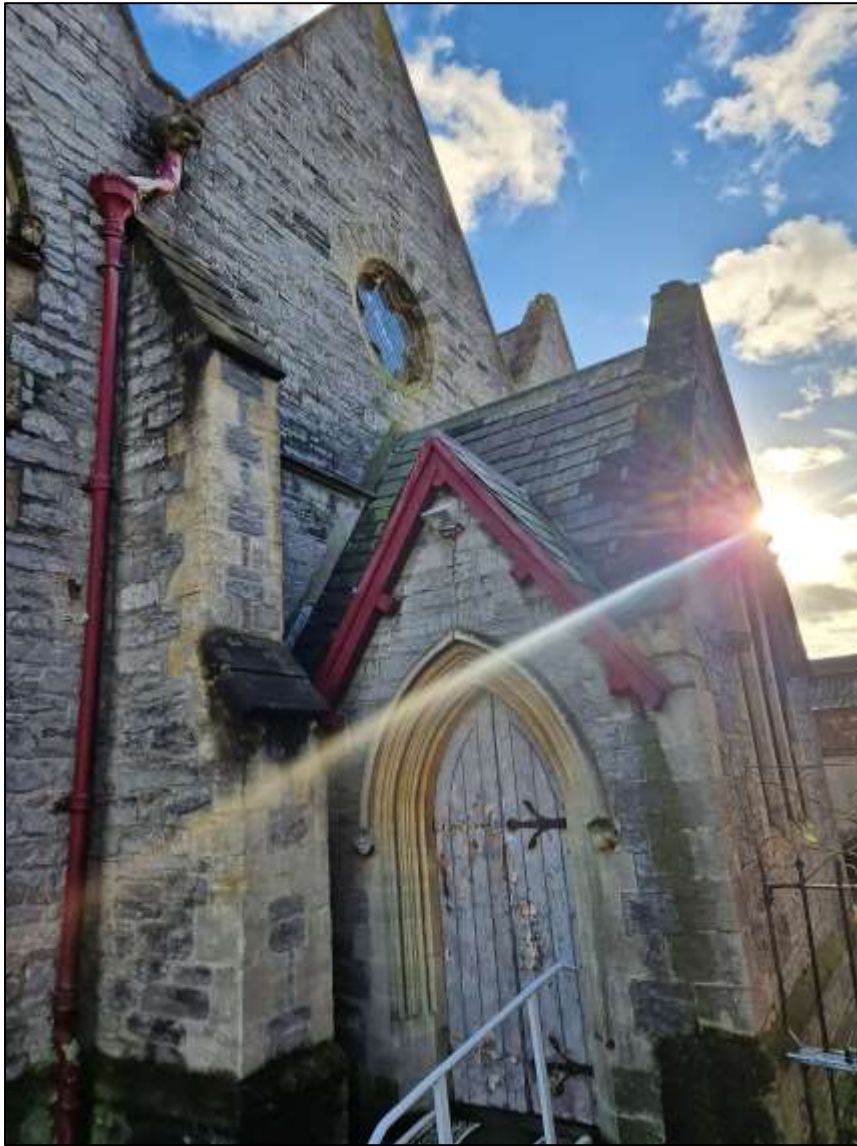
3. PORCH TO WEST OF CHURCH, WITH ROSE WINDOW ABOVE.

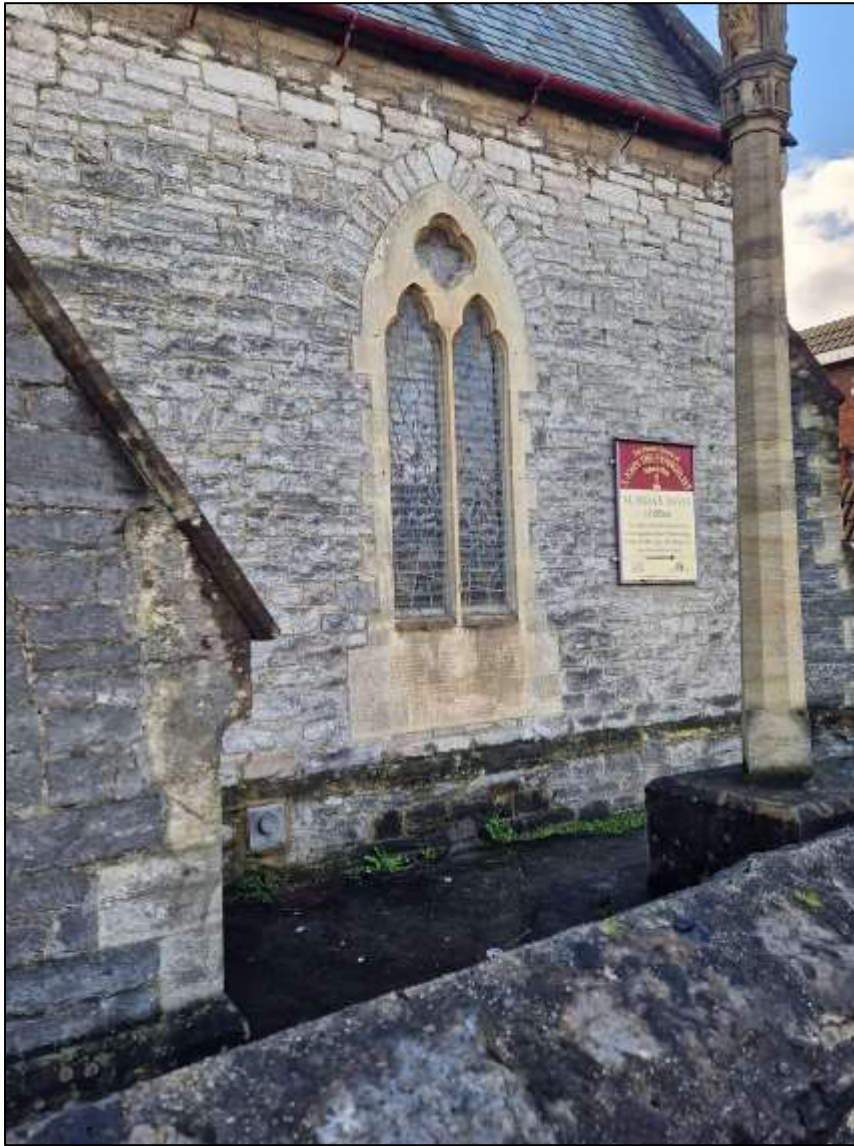
4. WAR MEMORIAL WINDOW OF C.1920 IN NORTH ELEVATION.

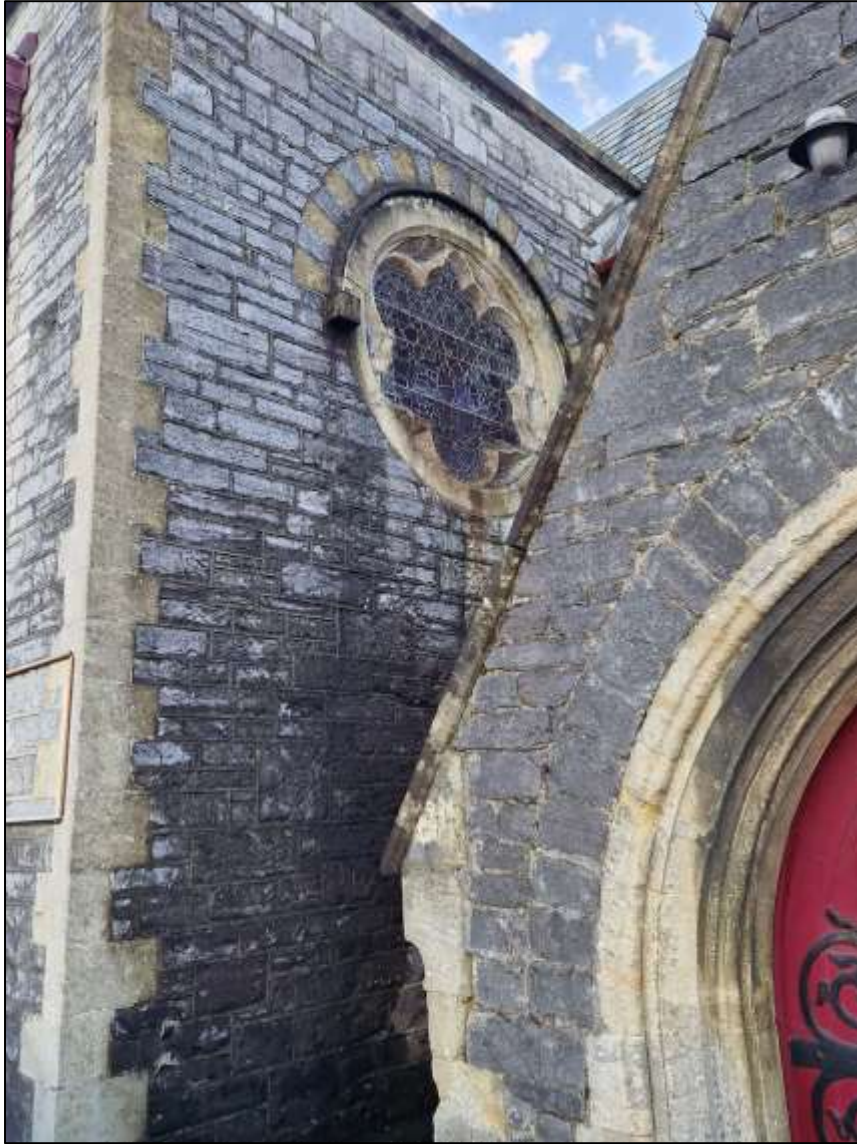
5. ROSE WINDOW TO REBUILT LADY CHAPEL.

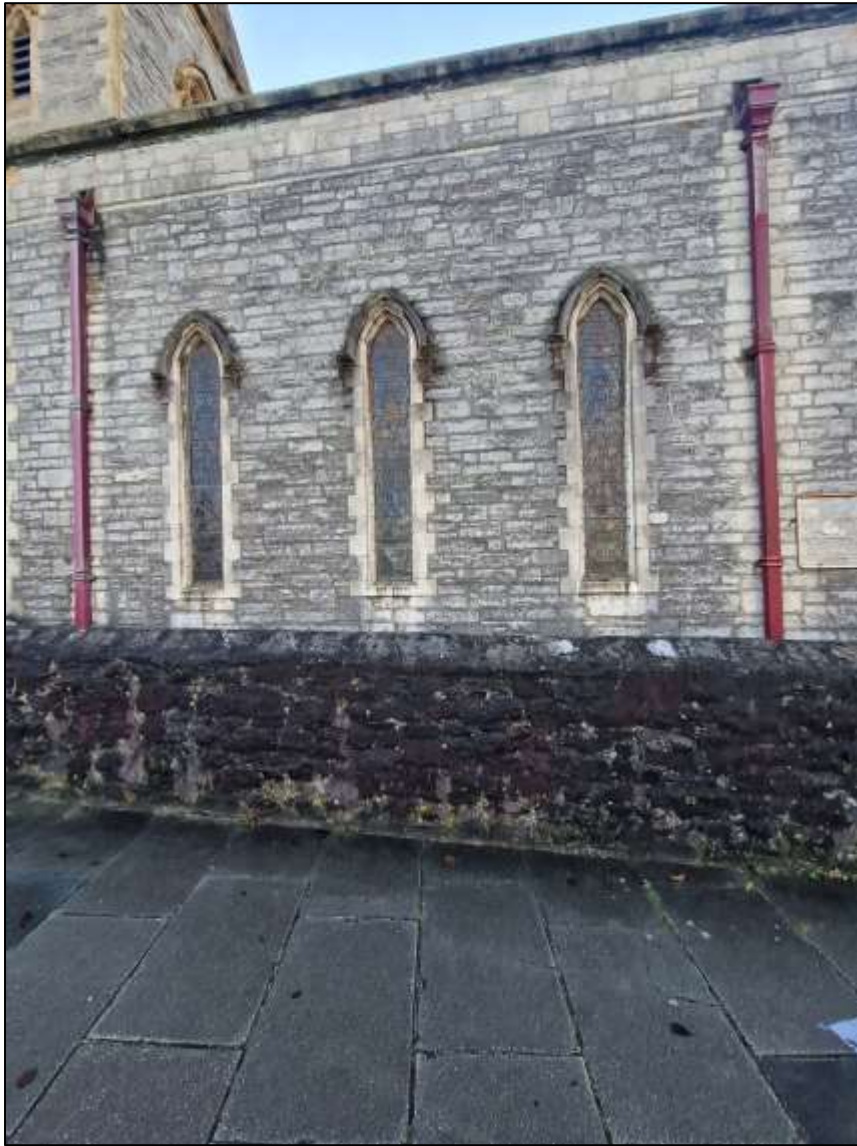
6. REPLACEMENT LANCET WINDOWS TO LADY CHAPEL, FROM THE NORTH.

unrefined, clearly reading as a late extension, and, while the forms are in ham stone, they lack the intricacies of the older windows and feature such as grotesques (see Appendix 3).
