The Barn, Netherdowns Farm, Weare Giffard, Devon

Heritage Assessment

Historic Building Recording

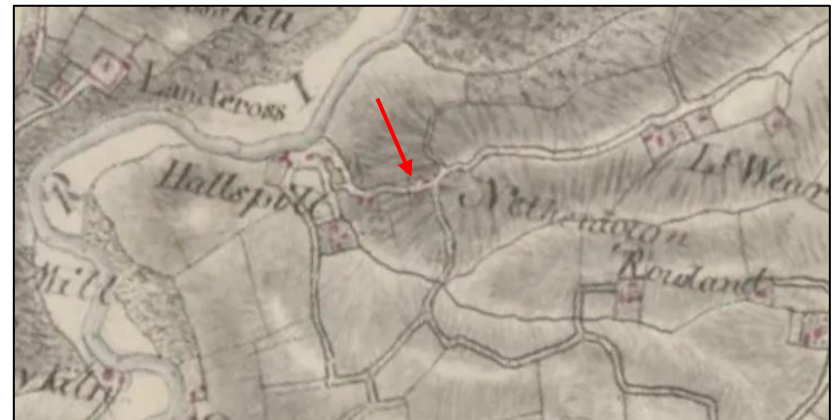
FIGURE 2: 1804 HARTLAND OS SURVEYORS DRAFT , THE FARMSTEAD IS INDICATED (BL).

The site is first recorded on the 1804 Hartland OS surveyors draft map, this identifies a small settlement at Netherdown and indicates at least three separate enclosures, both west and east of the main road, with multiple buildings set around staggered cross-roads. A small block, coloured red is located next to the road in the broad location of the barn.

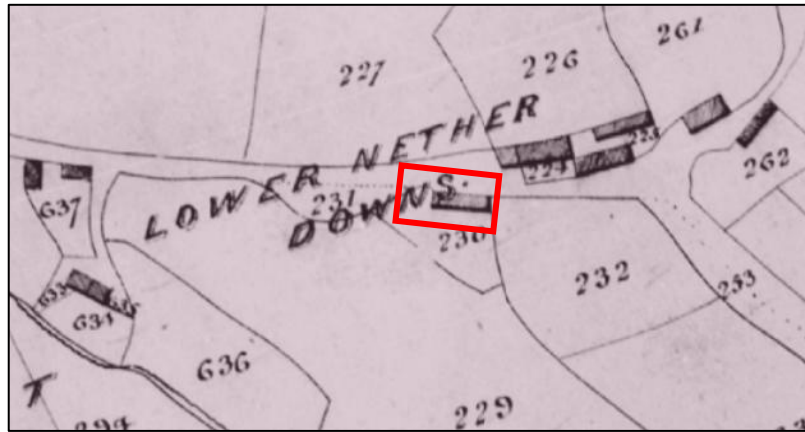
FIGURE 3: 1839 TITHE MAP, CROPPED TO SHOW BUILDINGS OF THE FARMYARD, IN DETAIL (TNA).

The 1839 Weare Giffard tithe map provides more detail on individual buildings. It shows an approximately east-west oriented linear building south of the road. The 1837 tithe apportionment shows that the current farm was formed from two historic farmsteads *Higher Netherdown* and *Lower Netherdown*. Higher Netherdown was part of the Rolle estates, Lower Netherdown part of the Fortescue estates. Each farm was also subdivided into several tenancies.

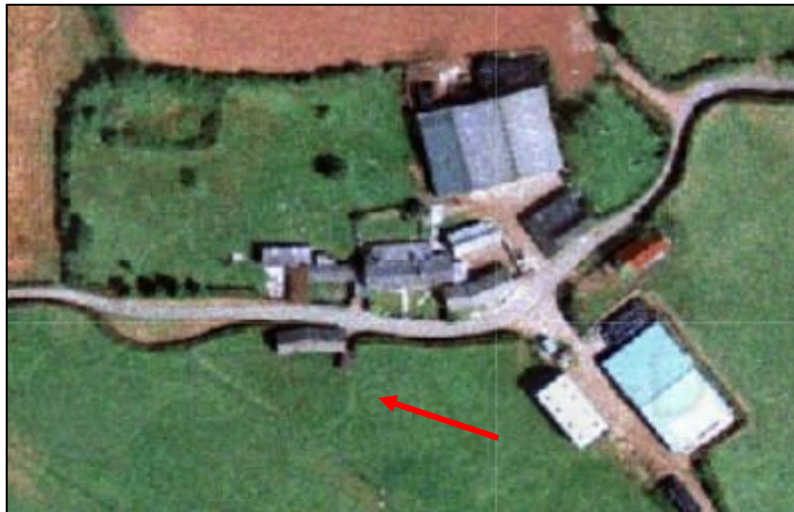
FIGURE 7: 1999 AERIAL PHOTOGRAPH (GET MAPPING: MILLENNIAL MAPPING).

The garden depicted on the title apportionment survived into the 20th century and was extant on mid 20th century aerial images (not illustrated). The wedge-shaped domestic character garden, enclosed by hedge-banks can be seen to survive until the late 1970s on other aerial photographs held by the family. On the 1999 aerial photographs, the bank can still be seen even though the hedge has been removed (Figure 7), and the garden reverted to pasture – the site is now largely levelled and ploughed out – opened-up to the field.

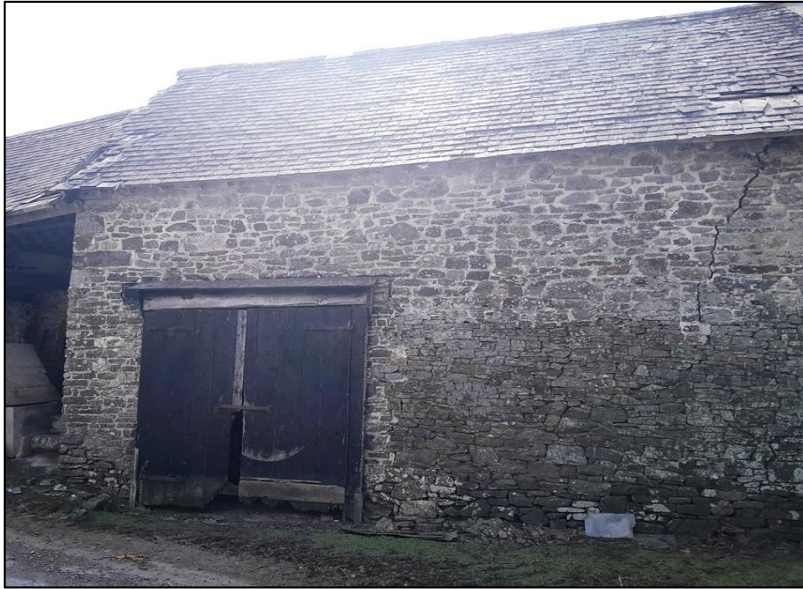
The north wall is of two phases of stone rubble, the lower build to the west is a heavier, denser packed build, shaped slabs, semi-coursed, in an earth and lime mortar, with a slight batter to the profile. The base of the wall is thicker than the raise above, forming the impression of a slight ledge, this lower level is also slightly battered to the north-west corner.

The lower stonework has remnants of limewash or whitewash. The stonework above is of a looser, platey build, in a whiter, lime-dominant mortar. This ‘newer’ build frames the forced double cart door in the north wall. There is a straight line at first floor suggestive of an altered opening within this build as well.

There is a large structural crack on the north-west corner, which is reflected in cracking in the roof and slipped slates. The roof is of graded slates, with terracotta ridge tiles.

FIGURE 9: THE NORTH WALL OF B1; FROM THE NORTH-WEST.

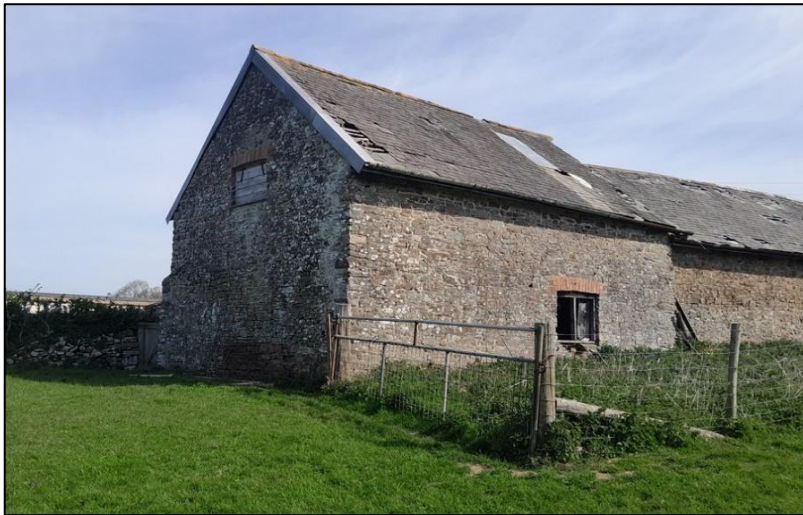
FIGURE 10: THE WEST AND SOUTH ELEVATION OF B1; FROM THE SOUTH-WEST.

The west elevation is again of heavier build, this elevation even more pronounced than on the north elevation, with definite battered profile, bracing onto the slope. The older semi-coursed build is the same wrapping around from the north – representing earlier fabric, in an earth bond, with lime pointing. Once again this is raised in looser stone rubble, in a whiter lime mortar, later repointed in cement.

The earlier ground floor stonework has two straight lines and therefore maybe a rebuilt/infilled opening, on the first floor there is a later window, with brick reveals and segmental lintel, which is low and wide and is clearly altered from a larger window, with loose repairs above. The south-west corner has a large crack which has fairly recently been stitched-repaired. The eaves have been replaced with folded tin to waterproof the first floor. The upper part of the gable is repointed in cement mortar.

The south elevation retains some older fabric to the ground floor west end, but more of this elevation has been rebuilt in the newer style of stonework. Within the newer stonework there is a small window with brick reveals and segmental brick lintel, at ground floor, at the east end. The slate roof is patched here with corrugated sheets, repairing several holes. The south-east corner has ragged toothed stones which suggests the wall of B2 beyond is a rebuild of a linear range.

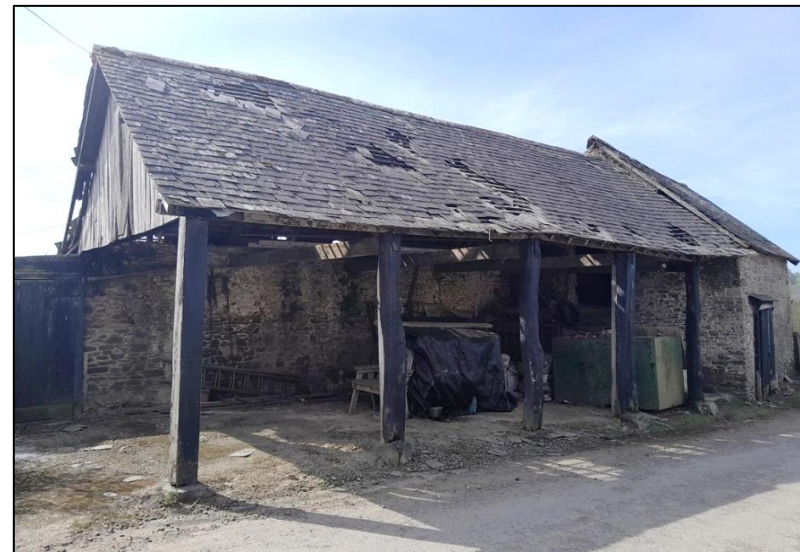
A single storey, open-fronted cart shed, with heavy, vernacular, adze shaped timber posts alongside the road which sit on shaped stone peds, with heavy plank wall-plate above. The first, third and fourth posts are particularly authentic, hand-shaped and may again have been recycled from elsewhere on the farm, the second and fifth posts are machine sawn, planed smooth and with chamfered

edges. Rag slate roof, with terracotta ridge tiles, carried on A-frame trusses, of slight scantling with bolted joints. The rear wall is of loose, platey stone, a mix of sandstones and shales-mudstones, in a lime-dominant mortar. This is of two clear phases of build but both about the south elevation of B1 and B2 appears to be a rebuild of the east end of the original range.

To the west B2 abuts B1, enclosing the granary steps, to the east, the gable is enclosed above by elm plank boarding, of replacement 20th century date.

FIGURE 11: B2, THE OPEN-FRONTED CART SHED; FROM THE NORTH-EAST.

The posts in **B2** are of good vernacular form, sat on large sandstone pads, the first, third and fourth posts are likely original. The second and fifth posts are obviously machine-sawn, so are likely later replacements, but still sit on the historic stone pads. The carpentry of B2 is treated with traditional agricultural bitumen-tar for waterproofing, being next to the road, which is a good aesthetic element. There are no features of interest to be found in **B3**.

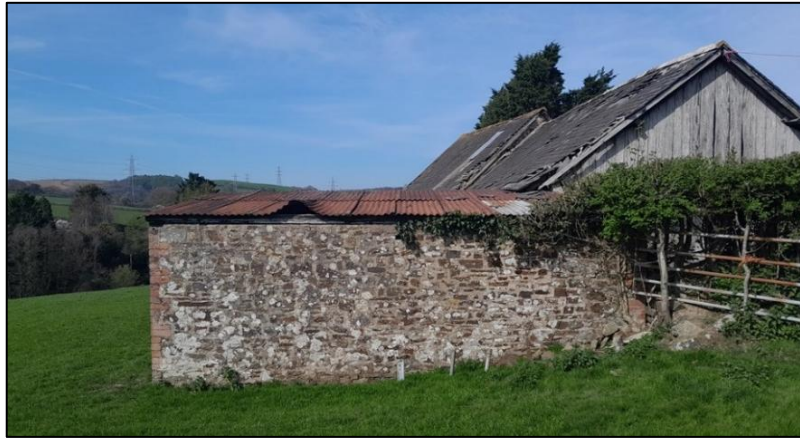
Stone rubble, single storey garage, with shallow sloping mono-pitch roof. Timber plank boarded pair of doors to front. Concrete floor. Window in rear wall recycled a two light 19th century window frame. Very loose, haphazard build, thick lime and cement mix mortar, brick quoins to south-east and south-west corners.

FIGURE 12: B3, THE LONG EAST WALL, SHOWING BRICK QUINS AND CORRUGATED TIN SHEETING FOR ROOF; FROM THE EAST.

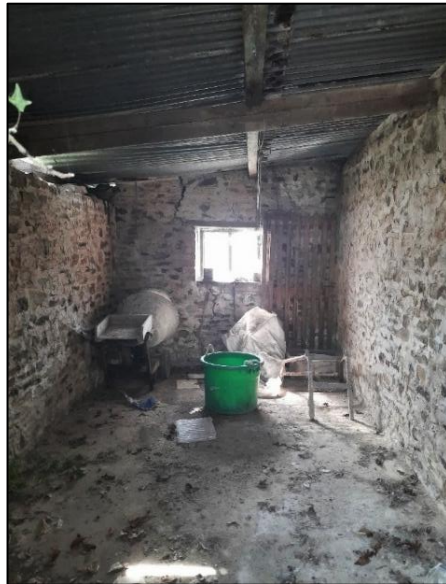
FIGURE 13: THE INTERIOR OF THE GARAGE, B3; FROM THE NORTH.
