Trevanion House, Trevanion Road, Wadebridge, Cornwall

Heritage Assessment

Trevanion House, Wadebridge, Cornwall

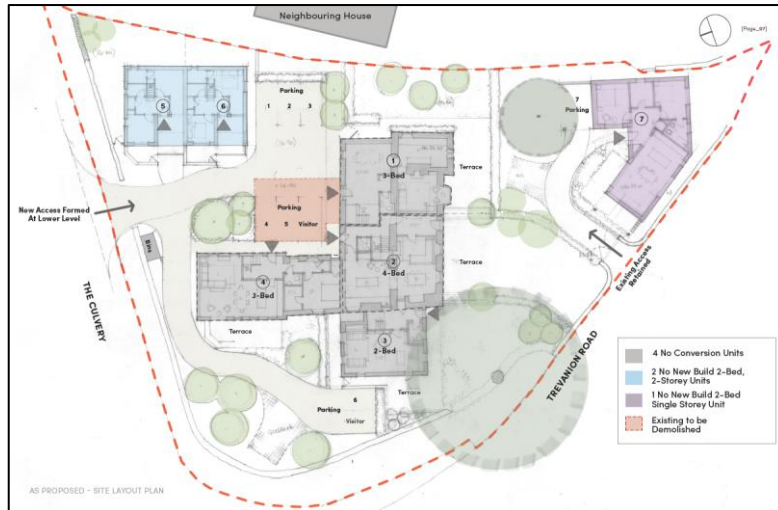
FIGURE 2: INITIAL INDICATIVE MASTERPLAN (HARRISON SUTTON 2025).

The proposals for the Trevanion House site are currently at masterplan stage; initial plans indicate the division of the main house and construction of additional dwellings on its grounds. As part of an iterative design process following production of a draft of this report, the proposed dwelling to the front (south) of the house has been reconsidered from a rectilinear building to a circular structure, with the intention of reflecting the form of the nearby designated Culvery and single storey in design, with the aim of reducing the impact on the significance of Trevanion House as a result of placing a structure in this location.

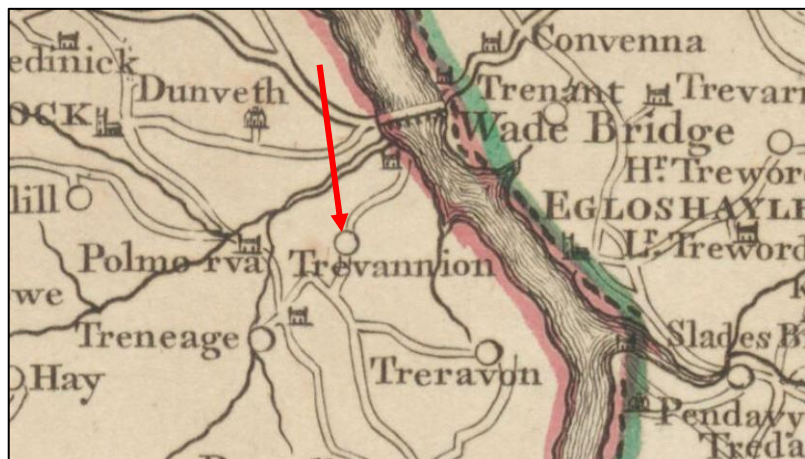
The earliest map available to this study to show the area in which the site is located is the 1748 Martyn Map. *Trevannion* is indicated as a village or small settlement on this map. There is a large house depicted between Treneage and Trevannion but this is more likely to represent Treneague House.

FIGURE 4: EXTRACT FROM THE MARTYN MAP OF 1748 (HARVARD LIBRARY MAP COLLECTION).

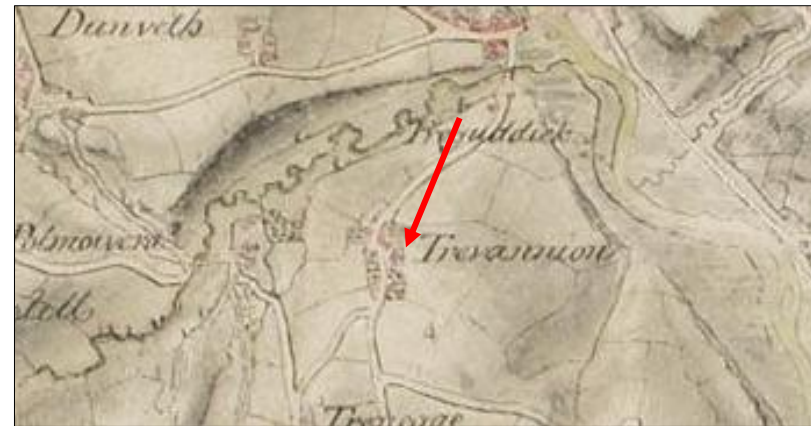
The next cartographic source to show the site is the Ordnance Survey draft map of 1805, which shows the surrounding landscape, although field boundary depictions are indicative rather than accurate. It also appears that the roads are not entirely accurately depicted as they seem to vary from earlier and later mapping. There are a cluster of buildings at Trevannion but it is not clear which, if any, relate to Trevannion House.

FIGURE 5: EXTRACT FROM THE ORDNANCE SURVEY SURVEYOR'S DRAFT MAP OF 1805 (BL). THE APPROXIMATE SITE IS INDICATED.

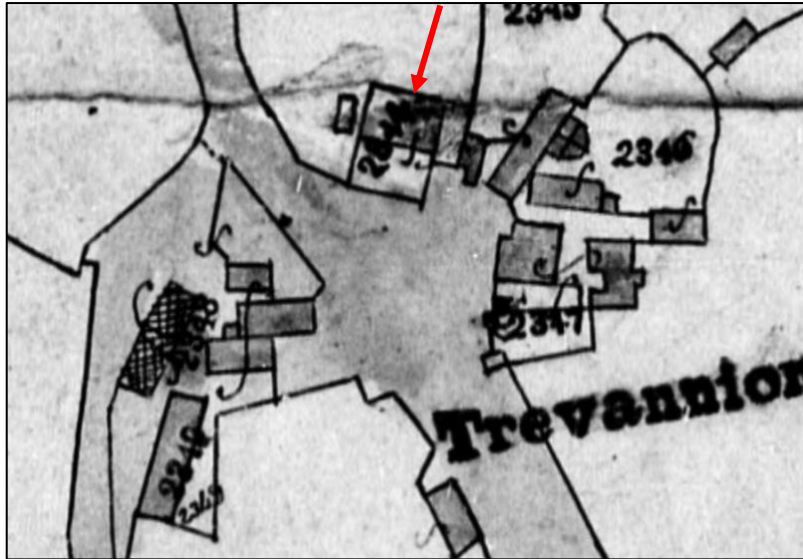
The 1842 St Breock Tithe Map shows a substantial building complex at 'Trevannion', seemingly arranged around a large open area, bisected by the parish road. On the tithe map, the settlement is clearly distinct from Wadebridge, surrounded by a field pattern based upon Medieval strip-fields. At the time of the Tithe Apportionment, the site was owned and occupied by Thomas Werry. The holding is noted as of over 181 acres, a significant holding for the period. A further smallholding of just over two acres is included within Trevannion on the apportionment, owned by Thomas Werry but occupied by John Brewer and others. This land is set away to the north at the end of the long track which leads to the farm, by the bridge over the Polmorla river and comprised a house and orchards. Thomas Werry also owned the holdings of Lower Treneague Farm and land and houses at Trevanson, at which he held c.17 acres 'in-hand', noted as the occupier but appeared to reside at Trevannion. Werry also owned five houses in Wadebridge, the King's Arms and multiple holdings at Matthew's Burlorne Eglos. The Werry family were significant landowners in the area; a Mary Werry owned Treneague Farm and Nanscow Farm.

FIGURE 7: CLOSER VIEW OF THE BUILDINGS DEPICTED ON THE TITHE MAP. TREVANION HOUSE IS INDICATED.

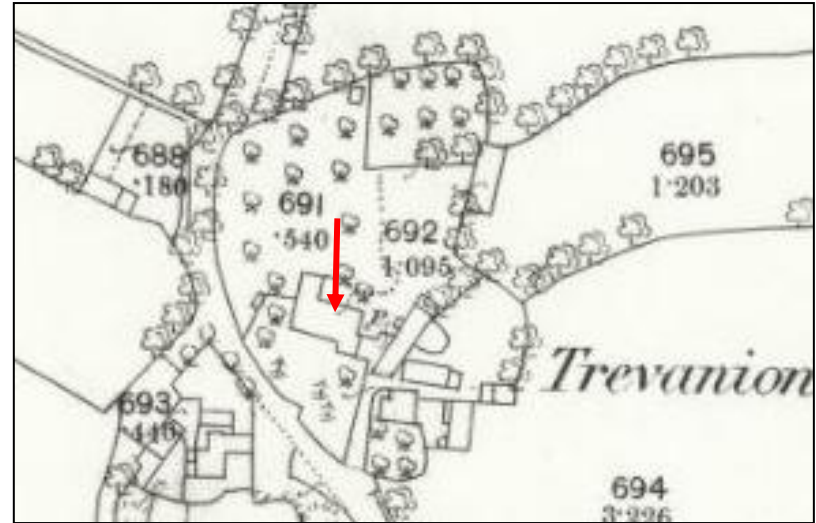
The 1881 First Edition Ordnance Survey Map (Figure 7) shows Trevanion House of similar shape and alignment to the present day. There appear to be a few smaller outbuildings and enclosures around the farmhouse and some of the larger barns shown on the Tithe Map survive but there had been considerable shrinkage of the site, as supported by the census information (below). The fields immediately surrounding the farmhouse appear to be orchards.

FIGURE 8: FIRST EDITION OS MAP, 25", PUBLISHED 1881 (NLS). THE SITE IS INDICATED

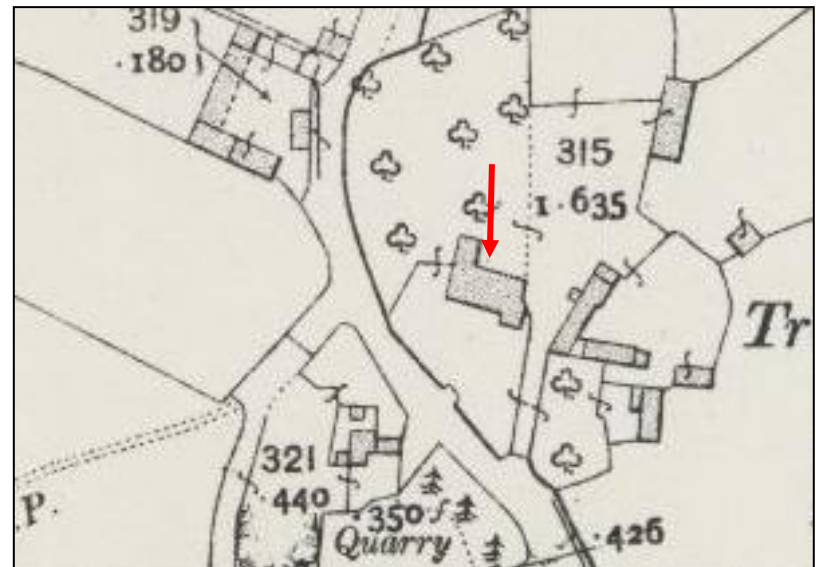
FIGURE 9: SECOND EDITION OS MAP, 25", PUBLISHED 1907 (NLS). THE SITE IS INDICATED.

The Ordnance Survey Second Edition map (Figure 8) shows little alteration to the property. The horse engine had been removed from the barn to the east by this date and there had been significant further reduction in the number of buildings at Trevanion indicating further shrinkage of the holding, the exception being to the north-west where new barns appear to have been added to create a courtyard, possibly indicative of a shift in agricultural practice.

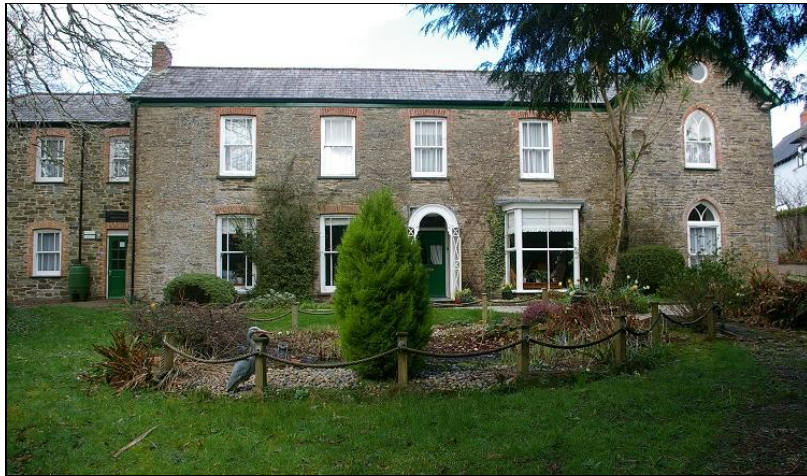
FIGURE 10: TREVANION HOUSE, WITHIN THE GARDEN SETTING; FROM THE SOUTH-SOUTH-WEST.

The front elevation of the house faces south-south-west, framed by a low-walled garden, which has some fine veteran trees and a modern pond; the Medieval ruins noted on the Cornwall HER are no longer evident in this garden setting. The main range is complex from this viewpoint; the central element representing a core four-window range, with offset front door served by a small fretwork canopy porch. The window openings have clearly been altered, blocked and raised, or cut down and elongated, with brick quoins to the later additions, with horned 3x3 pane sashes. To the 'east' end is a tall gabled cross wing, with gothic arched windows, to the 'west' is a small modern extension, of two window range, set back from the main building line, of imitation stone and brick style and heritage style sashes. The central elements display an offset position to the front door, within an elevation otherwise attempting to project symmetry which suggests the re-fronting of a typical vernacular three cell cross passage house, with one or two rooms to the left and single cell to the right. The east cross wing has brick detailing which suggests it, and the window alterations and raising of the walls all occurred in a similar, if not the same phase of aggrandisement.

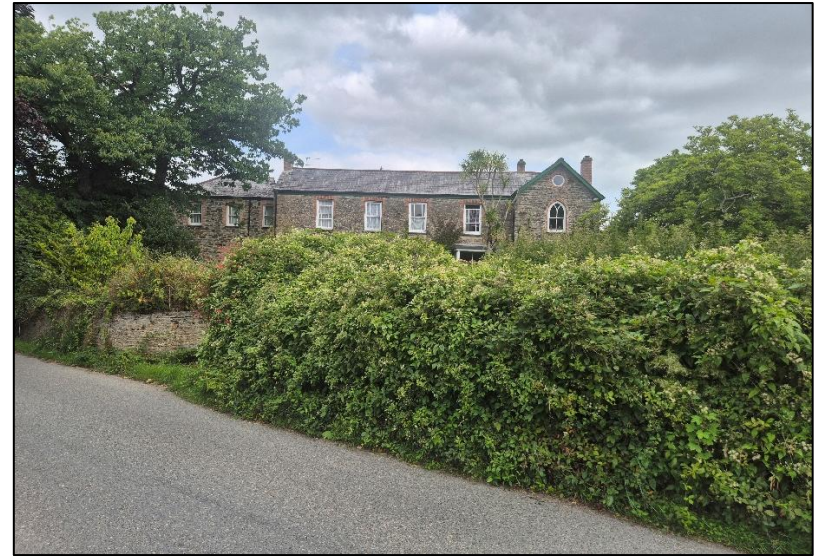
FIGURE 11: VIEW TOWARDS TREVANION HOUSE, ACROSS THE FRONT GARDEN PROPOSED FOR DEVELOPMENT.

It is recommended that in order to avoid harm to the significance of the Listed Building, the front garden area is retained as any structure constructed in front of Trevanion House would lie within the more sensitive part of the buildings setting and is likely to have an impact on the ability to appreciate the significance of the designated heritage asset. The proposals are currently at masterplan stage; initial plans indicate the division of the main house and construction of additional dwellings on its grounds. Feedback has been provided through earlier drafts of this report as part of an iterative design process and the proposed dwelling to the front (south) of the house has been reconsidered from a rectilinear building to a circular structure, with the intention of reflecting the form of the nearby designated Culvery and single storey in design, with the aim of reducing the impact on the significance of Trevanion House as a result of placing a structure in this location. A heritage impact assessment should be undertaken once detailed plans for the proposed buildings are developed.

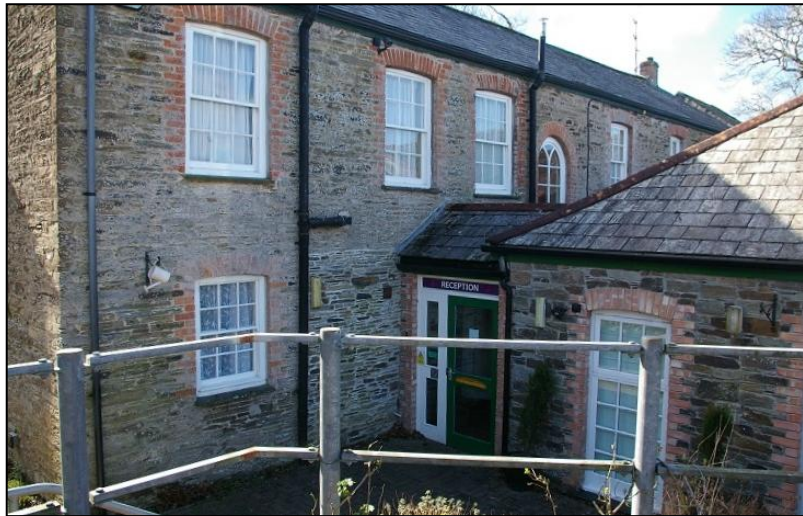
Of the modern extensions to the house; to the rear, east end there is a modern single storey square building set away from the historic house; with, a small linking flat-roofed corridor connecting it back to the main building. This extension has local stonework with brick dressings, a pitched steep slate roof topped with a timber louvred

cupola; this building is of historic pastiche style, with long sash style windows and imitates a garden room or similar structure but is of awkward massing and scale in comparison to the main building. To the west there is a historic extension, a small blocky building, attached to the kitchens, perpendicular to the main building, with steep pitched roof. This structure is 'historic' in style, using a mix of stone and brick dressings, but of modern date. The older outshut is encapsulated within the longer modern building, its footprint obscured externally.

FIGURE 13: THE REAR ELEVATION OF THE PARALLEL RANGE, ABUTTED BY A NUMBER OF EXTENSIONS; FROM THE NORTH-EAST.

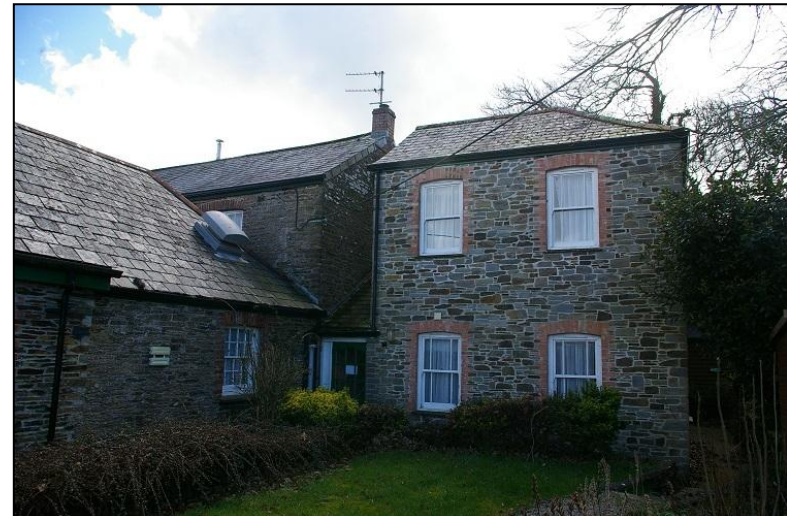
The modern west block is completely separate at the west end of the main range and linked to the main house via a covered fire escape stair; of local stone with brick dressings, again historic pastiche, designed to blend with the extant structure. This obscures the west gable of the main range; however despite restricted views, it can still be seen that the north-west corner of the original west gable end of

the main building represents a different phase to the centre and south-west corner and that there are conflicting styles of build, as well as it being abutted by the parallel range; evidence of a complex developmental phasing history. There is a substantial gable end stack here, the upper shaft rebuilt in brick, of squarer profile. The eaves of the gable are slated. All of the various roofs of the main, parallel ranges and extensions are of slate, with black glazed and red terracotta ridge tiles and there is a mix of white and black plastic guttering, on green painted barge boards.

FIGURE 14: THE WEST MODERN BLOCK; FROM THE NORTH-WEST.

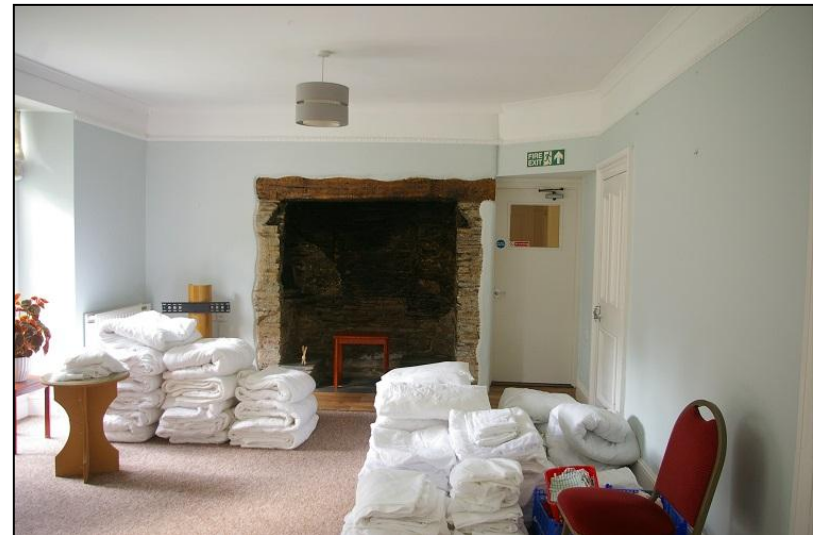
Leading off the dining room, R3 through a doorway forced into the north-west corner, in the gable, one enters the modern western block; this has a hallway (R10a) with door back to the modern commercial kitchen and another to the garden, with an accessible toilet (R10b); off this are two ground floor bedrooms and ensuite bathrooms (Rs11a, 11b, 12a & 12b). Nothing within this block is of historic interest and there is significant flexibility for change and adaption here.

FIGURE 15: THE MAIN FORMAL LIVING SPACE IN THE MAIN RANGE, R3, WITH HISTORIC FIREPLACE; FROM THE EAST.

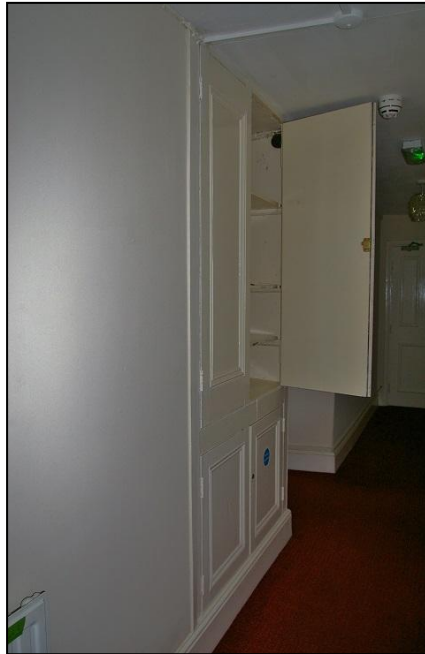
Returning to the entrance vestibule, one enters the parallel rear range under the open archway, opening into a long narrow east-west corridor (R4) which runs along the rear wall of the main range. To the right of the archway is a good surviving panelled cupboard set into a

blocked opening with convex moulded panelled doors and internal shelves, within a simple beaded frame. The corridor has been narrowed and enclosed by modern partitions on the north side which form fire-safety lobbies to the stairs. No other historic features survive and the layout of the rooms accessed off this corridor have been completely transformed, making an assessment of function only broadly possible.

FIGURE 16: THE PANELLED CUPBOARD WITHIN THE REAR CORRIDOR IN THE PARALLEL RANGE; FROM THE EAST-NORTH-EAST.

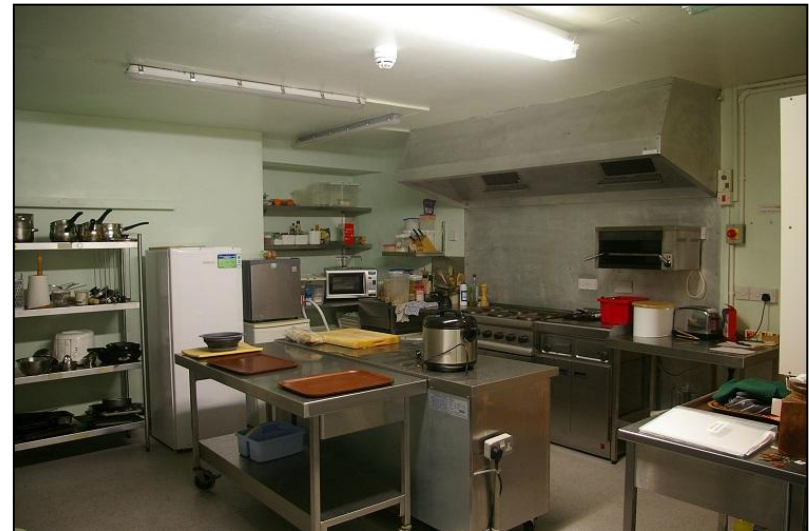
To the west end is a large former historic kitchen (R5). This large room is now divided into several modern spaces - store rooms and boiler rooms; the kitchen has a large, blocked window on the north-west corner and a full height blocked opening in the north wall, a lower blocked doorway enters a former lobby and former servant's stairs to the east of this space. A blocked window in the rear wall of the earlier main range is preserved as an alcove. This room is now a

Leading off the kitchen, to the north, through a forced door is another small historic extension with steeply pitched roof, which has in turn been extended with a modern block. Within the footprint of the historic service range here there is a side access corridor (R14), with two rooms formed by modern partitions, a second kitchen (R15) and an office (R16). The current owners discovered meat hooks and domestic features in this area when it was converted. Beyond the thick forced wall to the north of the corridor is a lobby with stair and several bedrooms and bathrooms (Rs17a-21b). There are no historic features left within this rear range but several of the historic walls survive, indicating its rough footprint; there significant potential to focus a lot of change and adaption in these areas of the building.

FIGURE 17: THE COMMERCIAL KITCHEN, R5, WITH VISIBLE BLOCKED WINDOW TO THE NORTH-WEST CORNER; FROM THE SOUTH-EAST.

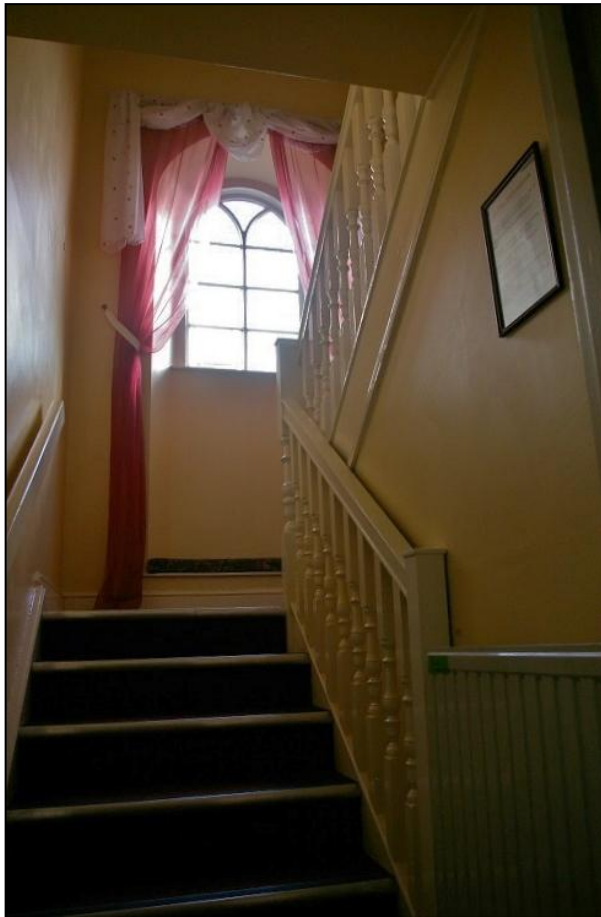
Next to the kitchen and former servant's stair, within the parallel rear range is the former grand stair hall (R6), now closed by fire-break partitions, with a small accessible toilet inserted underneath. The stairs required complete rebuilding when the building was taken over by the current owners as they were in poor condition. The stair window is now a fixed round-headed window with gothic glazing bar details; the base of the frame shows it was once a sash box.

FIGURE 18: THE STAIRS, R6; FROM THE SOUTH-WEST.

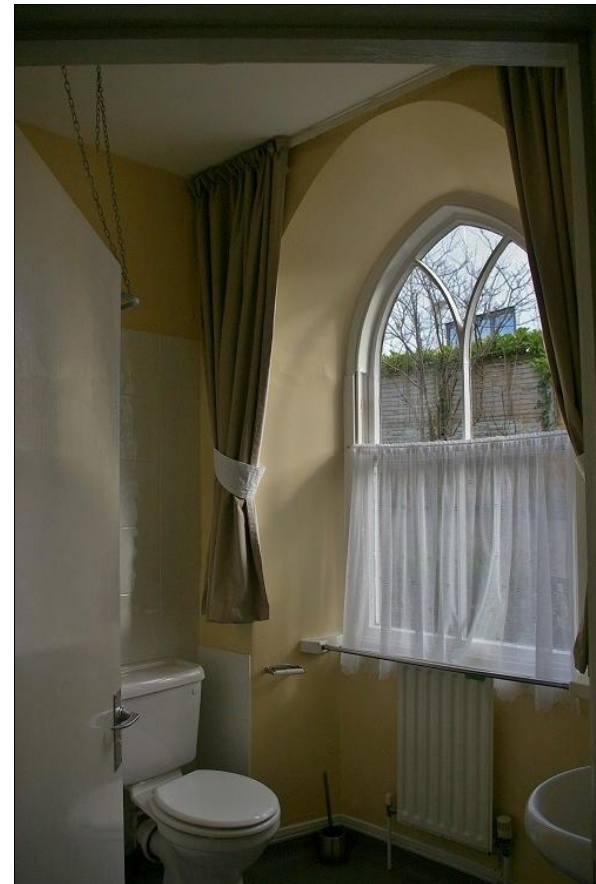
Further to the east end of the long rear corridor (R4) are a series of lobbies (R7) and small bedroom and ensuite bathroom (R8a, 8b) formed from further service areas, with a rear exterior door now blocked and new openings forced linking to the modern extensions. A door at the south-east corner also links into the cross wing, formerly a secondary reception room, now a bedroom (R9a) and ensuite bathroom (R9b). This room has gothic arched windows and a shallow stack, with blocked fireplace to the east wall.

FIGURE 19: THE GOTHIC WINDOWS IN THE CROSS-WING; FROM THE SOUTH-WEST.

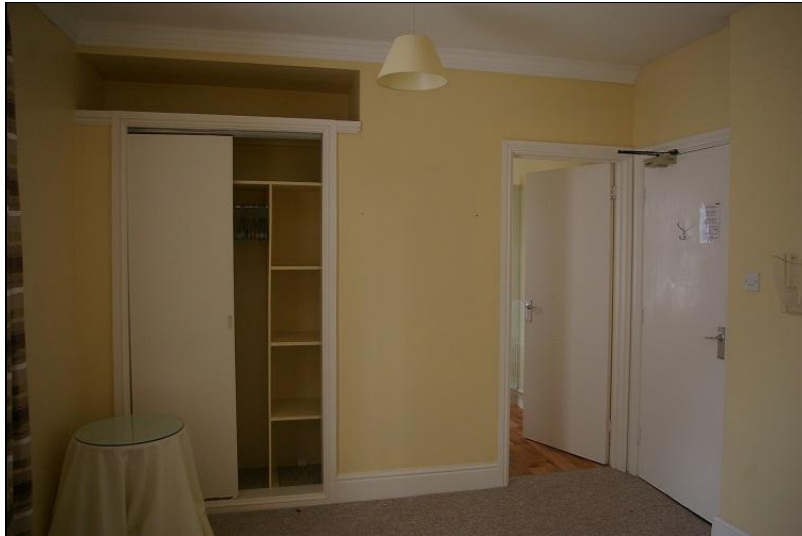
At the end of the long corridor a door opens into a corridor and lobby which connects to the fire escape stair; this stair is modern and in-fills between the modern block and parallel range, the building of this stair meant the window in the kitchen needed to be blocked. Two bedrooms and ensuite bathrooms within the first floor of the modern west block (R36-38b). This area has no historic value and therefore there is great potential for significant change and adaption, or removal if required.

FIGURE 20: BEDROOM 32A, WITH SOME SURVIVING SKIRTING BOARDS AND PLASTER CORNICE, AS WELL AS REMAINS OF TRUNCATED WEST GABLE END STACK; FROM THE SOUTH-EAST.

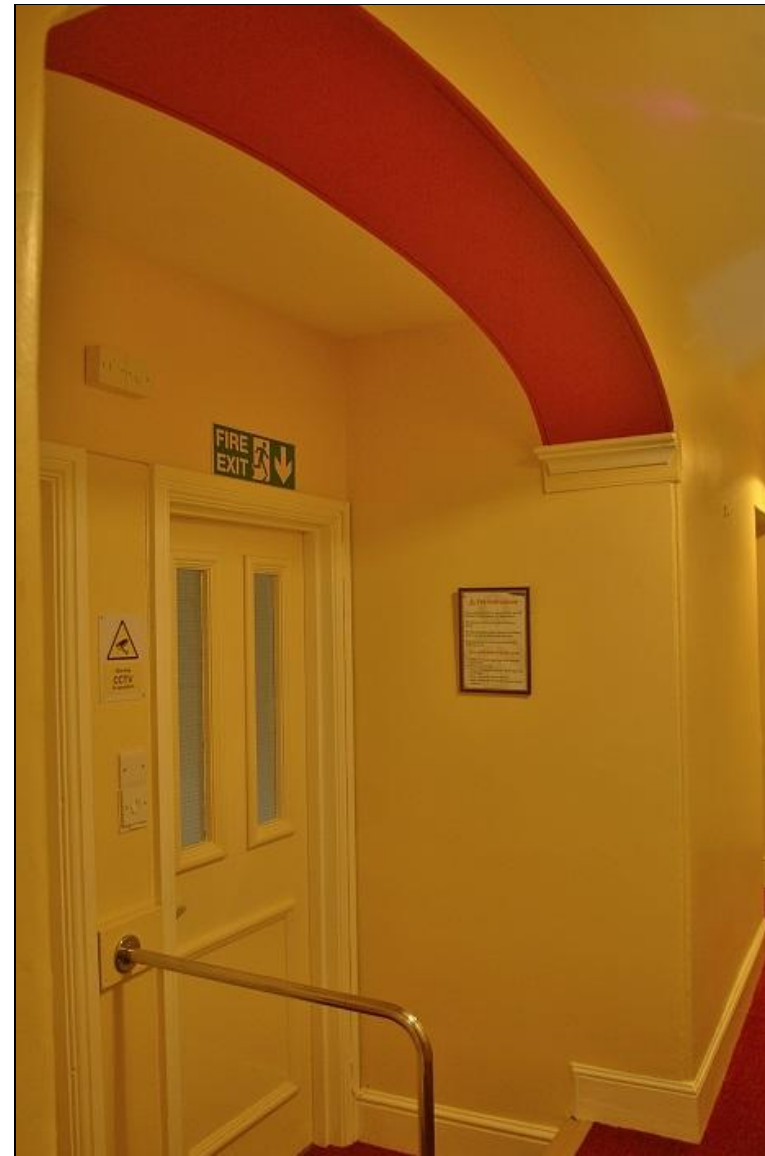
Returning to the corridor and rising up the stairs, modern partitions again close the space for fire-safety. Beyond is a landing (R25a) with wide basket-arched opening forced in the spine wall with the main range, with moulded springers, which match those on the ground floor. There is a shallow step up into the main range through this opening, with ceiling heights being higher in the main range than in the parallel range. A long corridor (R25b) has been formed here, within the main range, with lath and plaster partitions forming bedrooms along the south side of the building.

FIGURE 23: THE ARCHWAY AT THE TOP OF THE STAIRS, R25A & R25B, BETWEEN THE MAIN AND PARALLEL RANGES; FROM THE SOUTH-WEST.

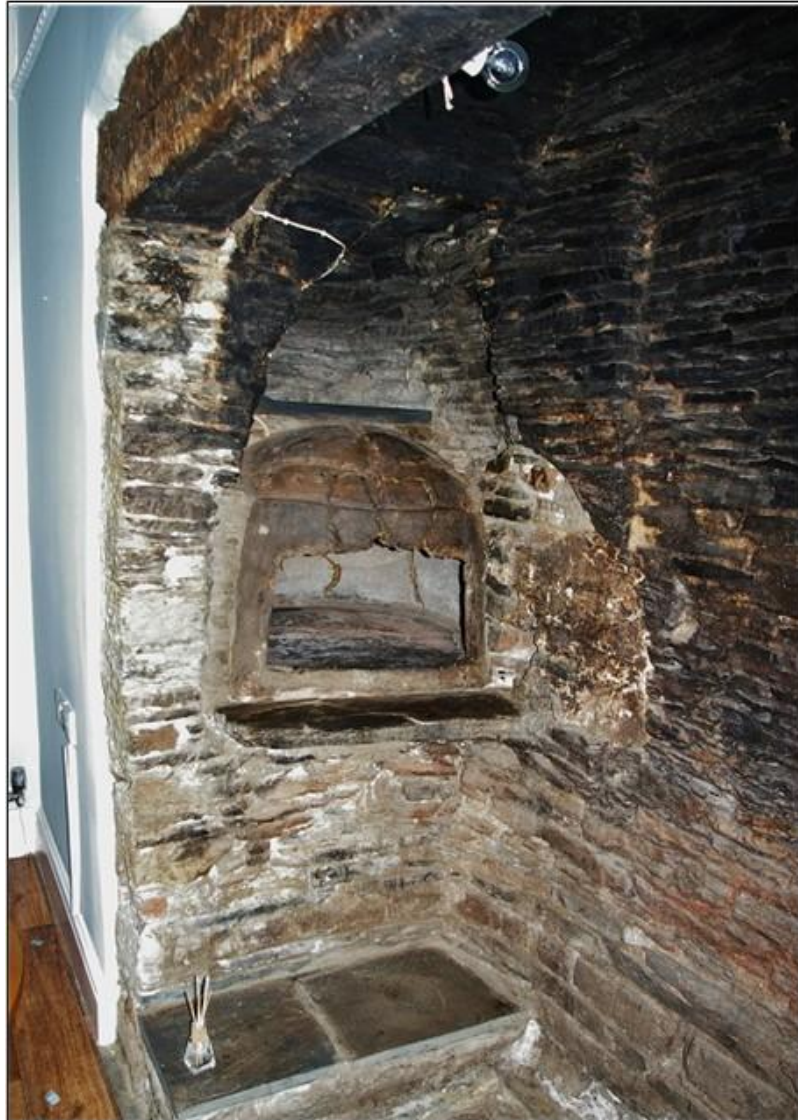
FIGURE 24: THE VICTORIAN CLOAM OVEN THAT HAS BEEN FORCED INTO THE SIDE OF THE 17TH CENTURY STACK, REPLACING AN EARLIER OVEN; FROM THE NORTH-NORTH-EAST.

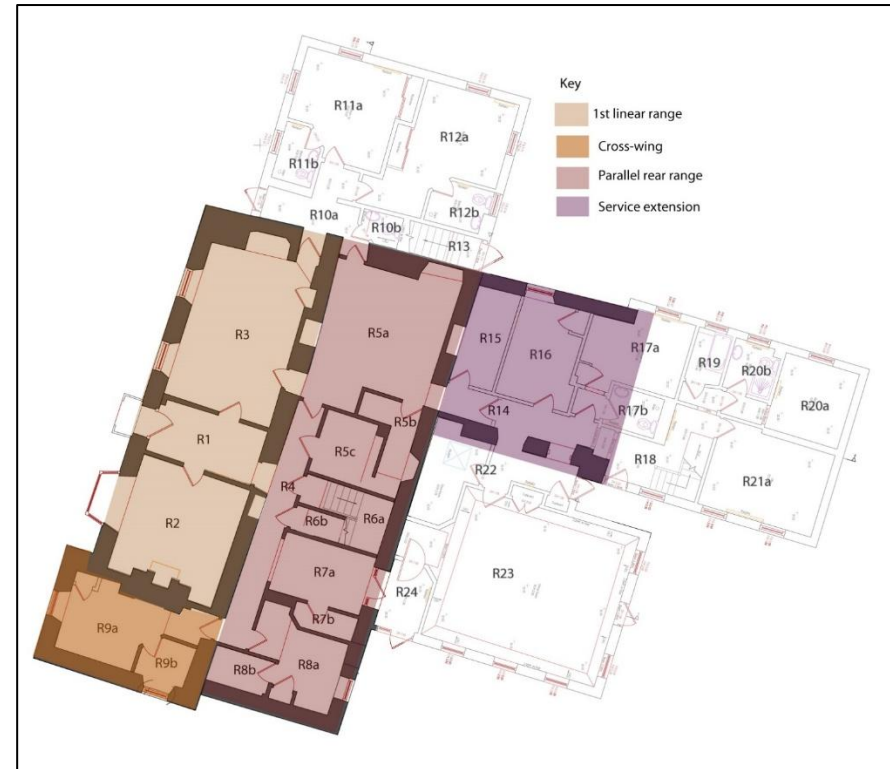
FIGURE 25: PHASED PLAN OF GROUND FLOOR OF TREVANION HOUSE (PLANS SUPPLIED BY AGENT)

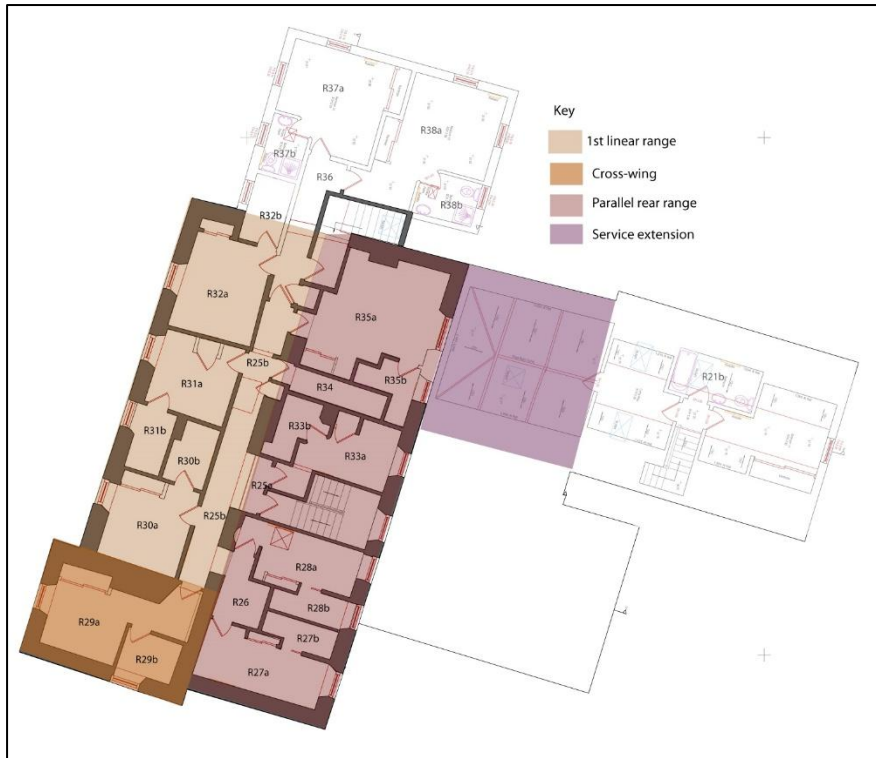
FIGURE 26: PHASED PLAN OF FIRST FLOOR OF TREVANION HOUSE (PLANS SUPPLIED BY AGENT).

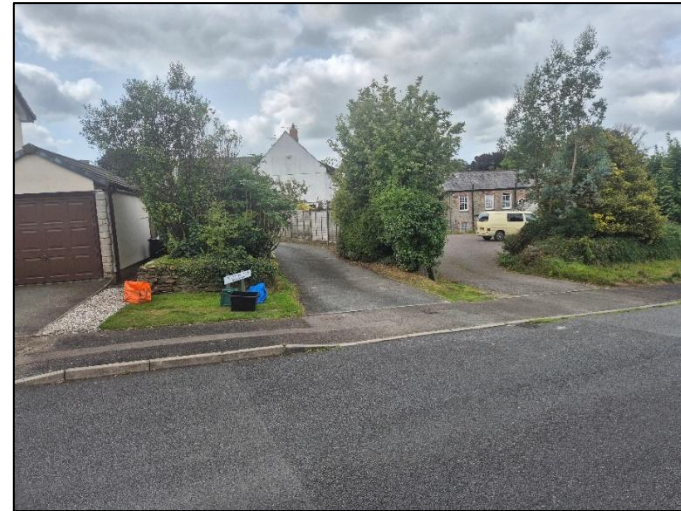
11. VIEW OF THE REAR OF TREVANION HOUSE, ADJACENT TO MODERN DEVELOPMENTS; FROM THE NORTH-EAST.

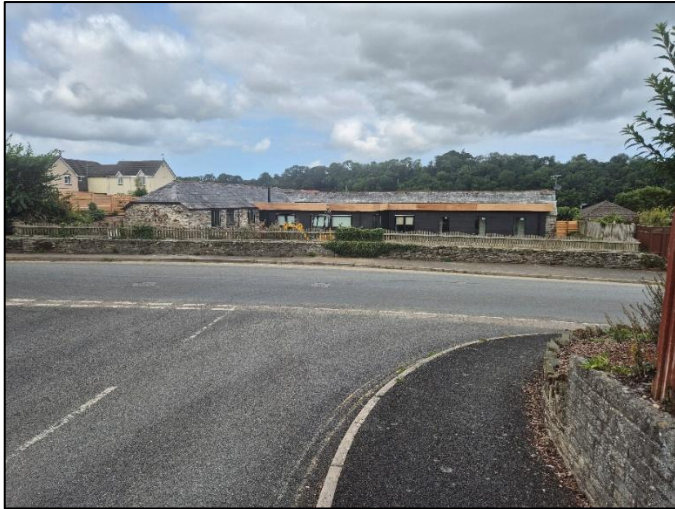
17. TREVANION BARTON, SHOWING MODERN EXTENSIONS OBSCURING THE HISTORIC BUILDING; FROM THE EAST.
