The Former Sawmills, Stevenstone Estate, St Giles in the Wood, Devon

Historic Building Recording

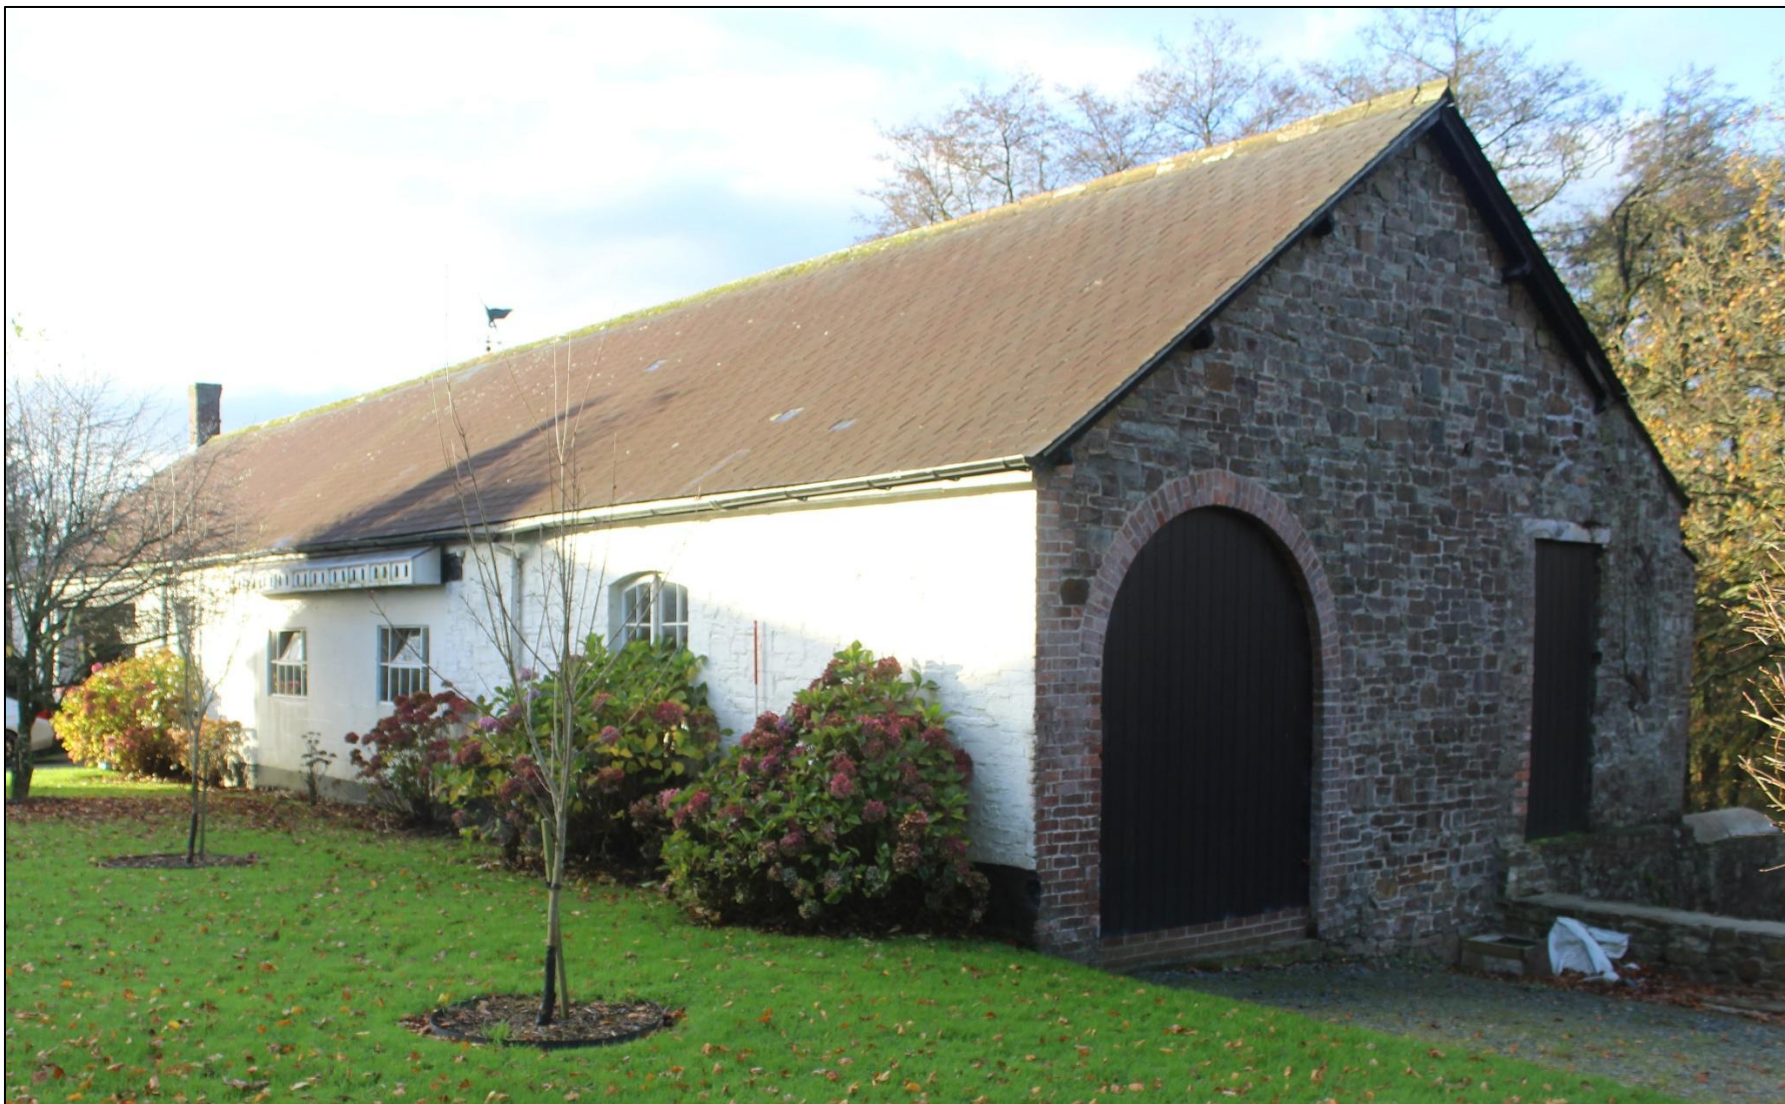
FIGURE 5: THE EAST AND NORTH ELEVATIONS OF THE BUILDING; FROM THE NORTH-EAST (2M SCALE).

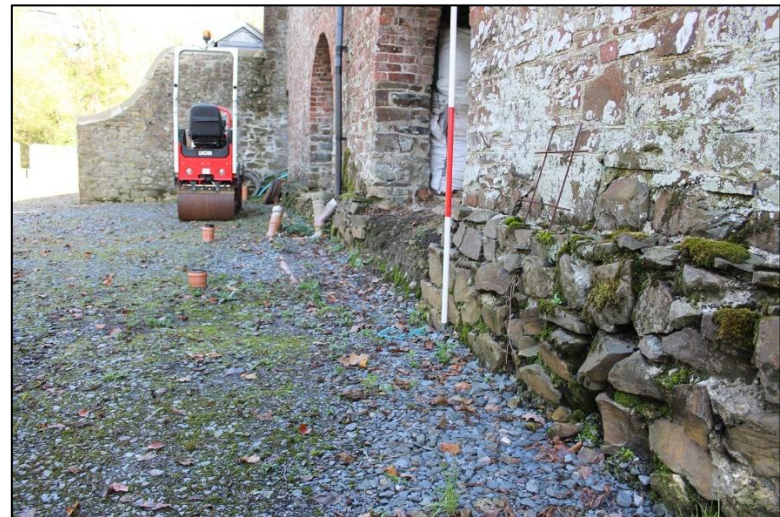
FIGURE 15: THE EXPOSED ROUGH FOUNDATIONS OF THE BUILDING (1M SCALE); FROM THE SOUTH-WEST.

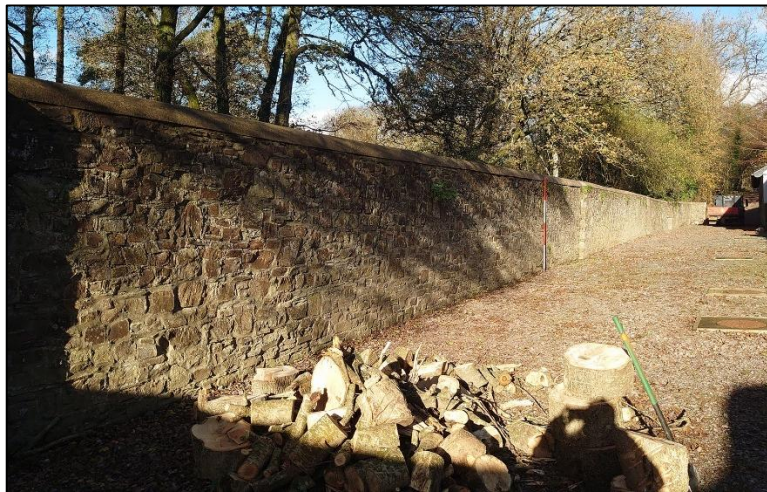
FIGURE 16: THE COURTYARD WALL WHICH ENCLOSES THE BUILDING (2M SCALE).

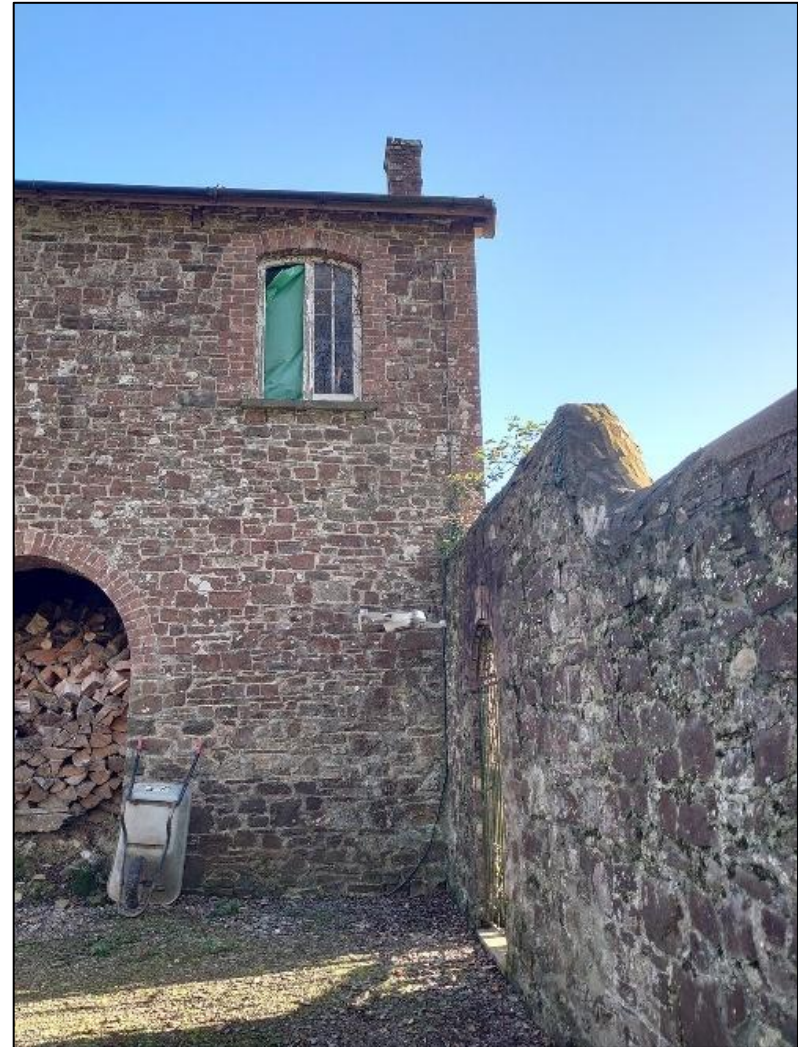
FIGURE 17: THE COURTYARD WALL AND SOUTH END OF THE BUILDING.

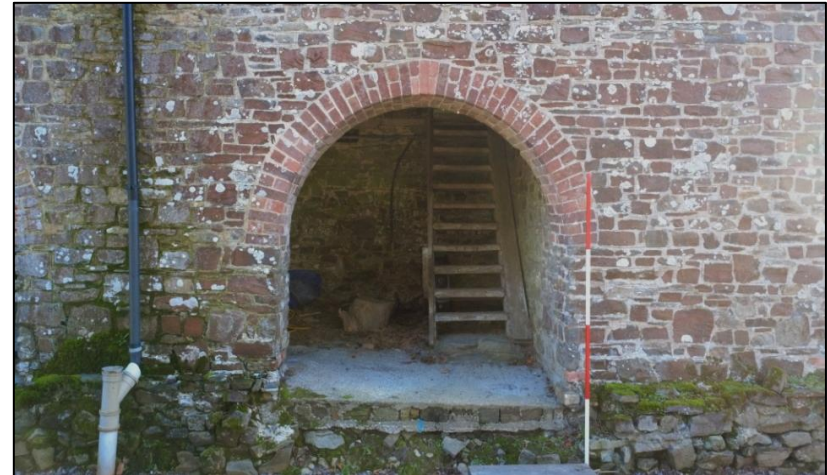
FIGURE 18: DETAILED PHOTOGRAPH OF ONE OF THE ROUND-HEADED ARCHES WHICH DEFINES THE WEST ELEVATION (2M SCALE); FROM THE WEST.

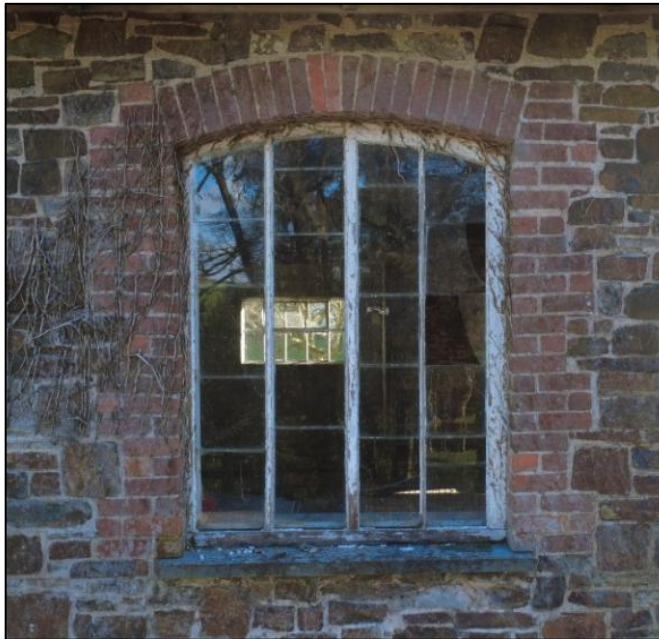
FIGURE 19: ONE OF THE WINDOWS IN THE WEST ELEVATION OF THE SAWMILLS BUILDING, A STYLE COMMON IN THE 19TH CENTURY, ALTHOUGH THESE WINDOWS APPEAR TO BE 20TH CENTURY COPIES.

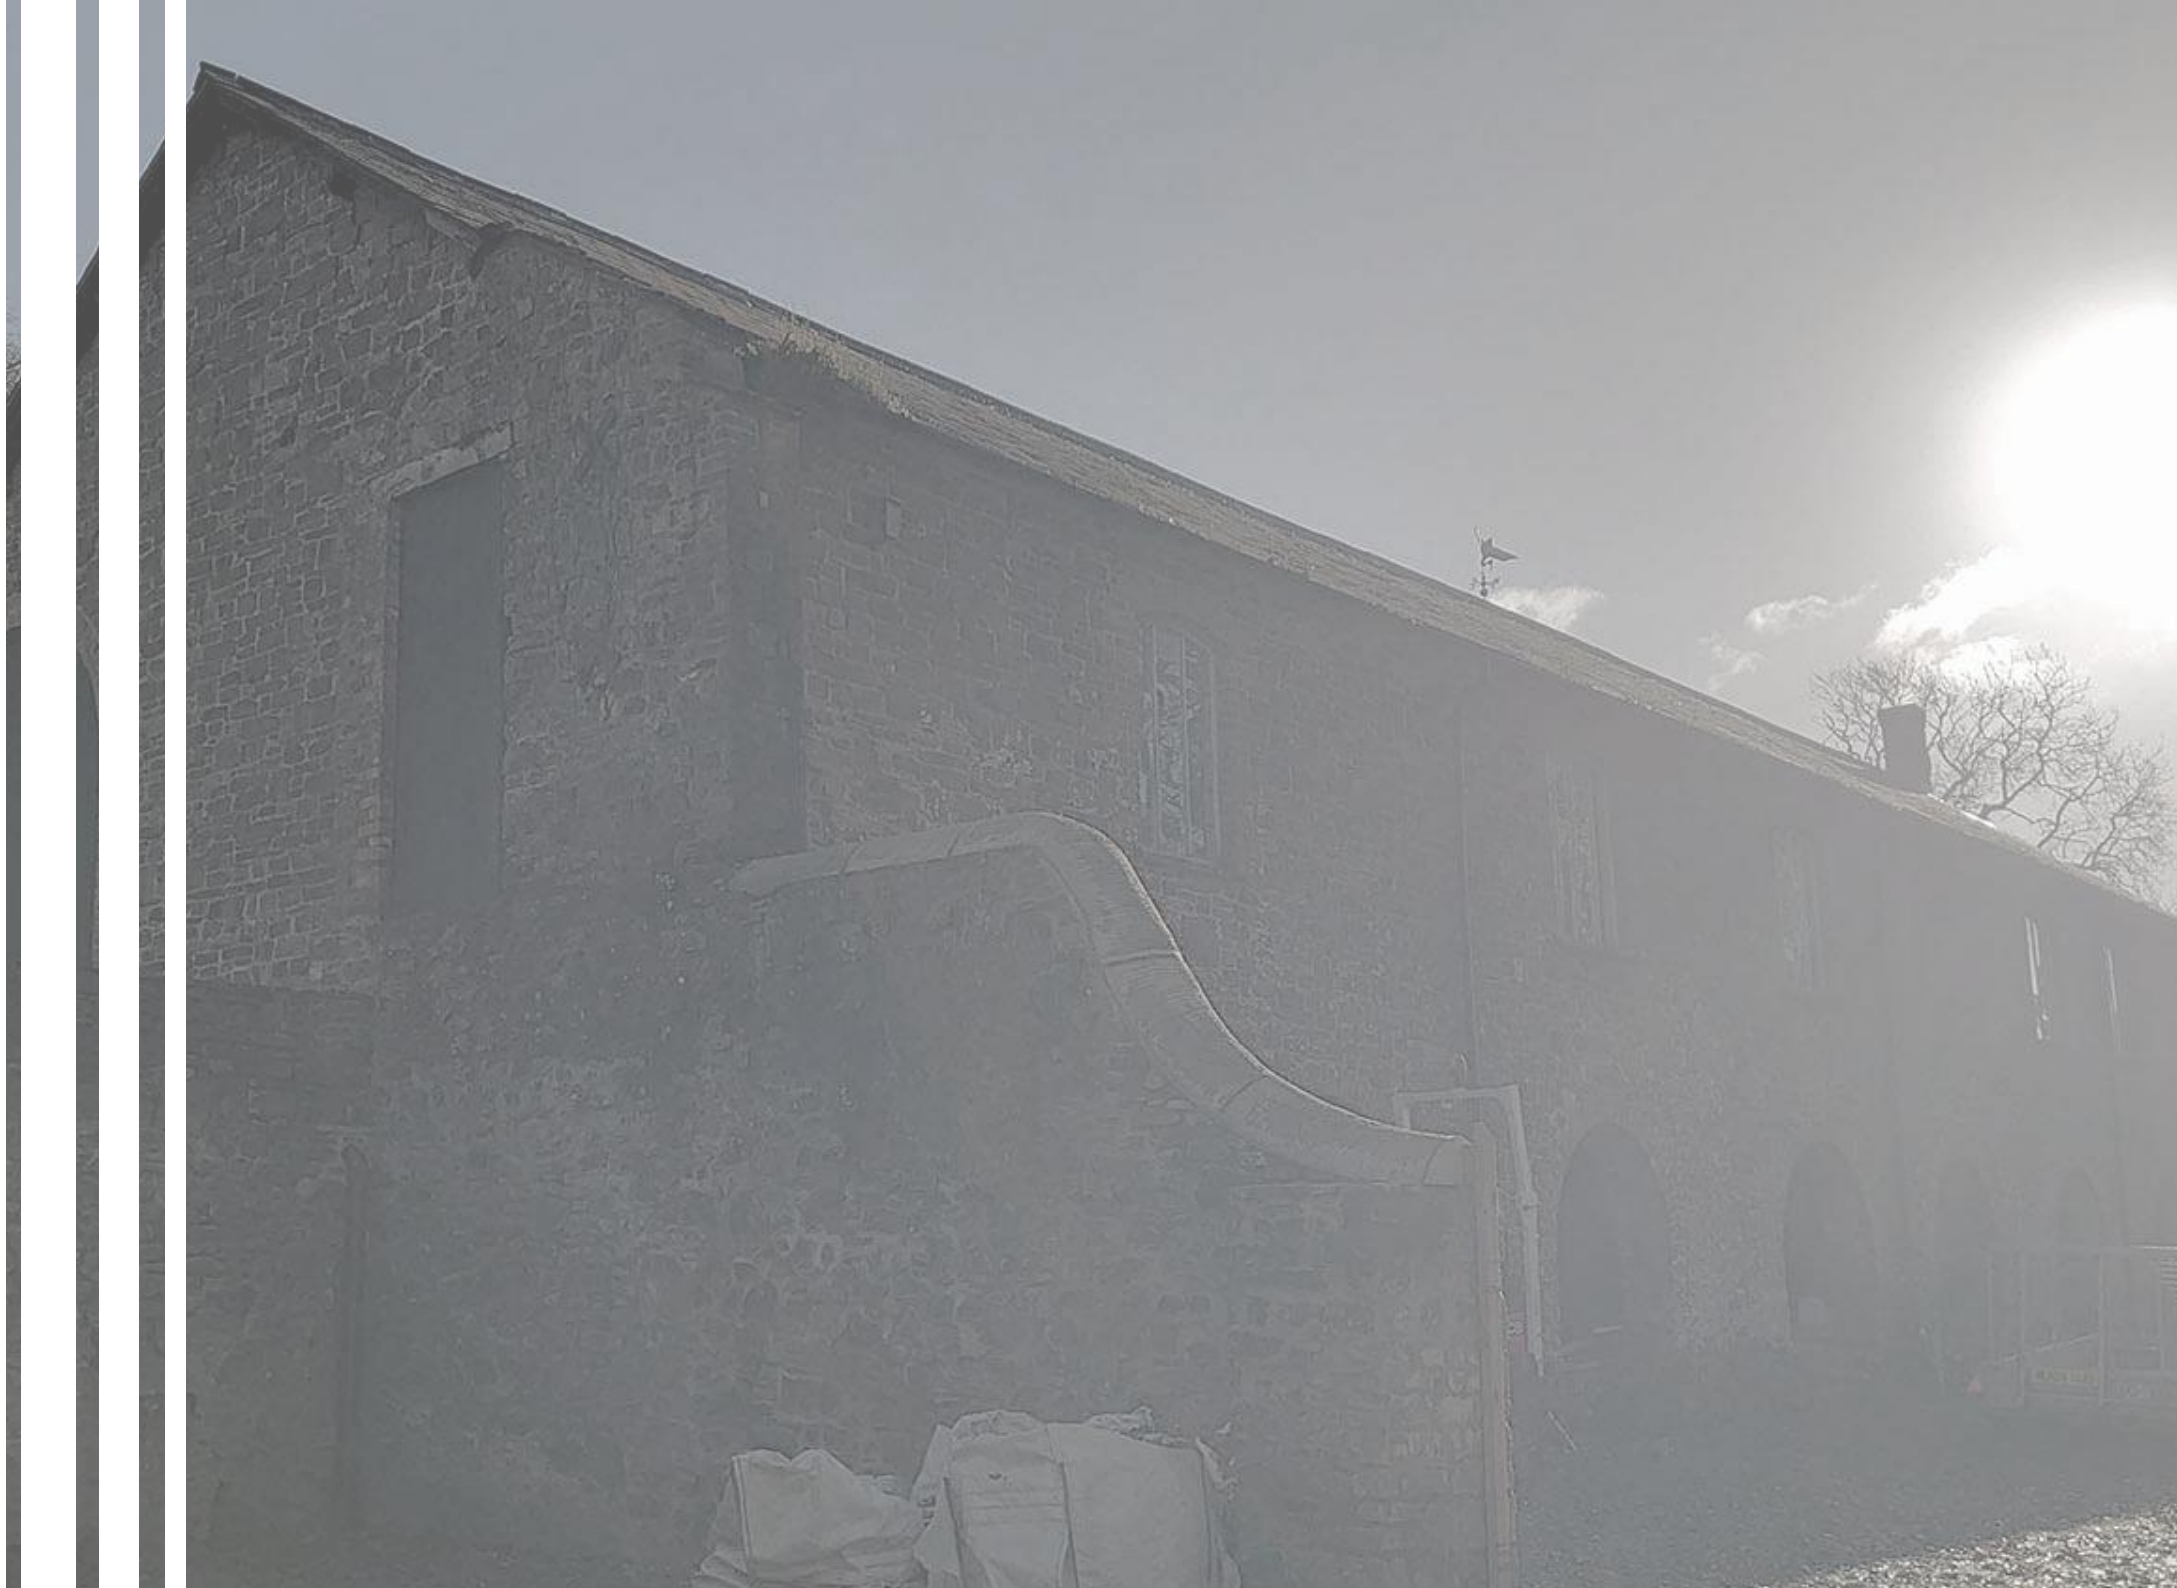
Walls:		Rationalised rubble build, lime mortars, patched and repaired in cement mortars.
Floor:		The yard area has already been excavated, lowered c.1m, as the foundations of the west elevation are exposed.
Doors:		Opening in the wall to the north leading to adjacent courtyard area serving the other building, opening to the south to the garden, opening to the south-west to the woodland.
Significant Details:		Cement coping to the top, where it appears the walls have likely been reduced in height and rationalised.
Dating Evidence:		Form, build and plan, alterations to fabric, and historic mapping.
