FARM BUILDINGS AT KNOWLE FARM COPPLESTONE DEVON

Results of a Desk-Based Assessment
and
Historic Building Survey

Report No.: 090606
Authors: T. Green
C. Humphreys
Date: 18.12.2009

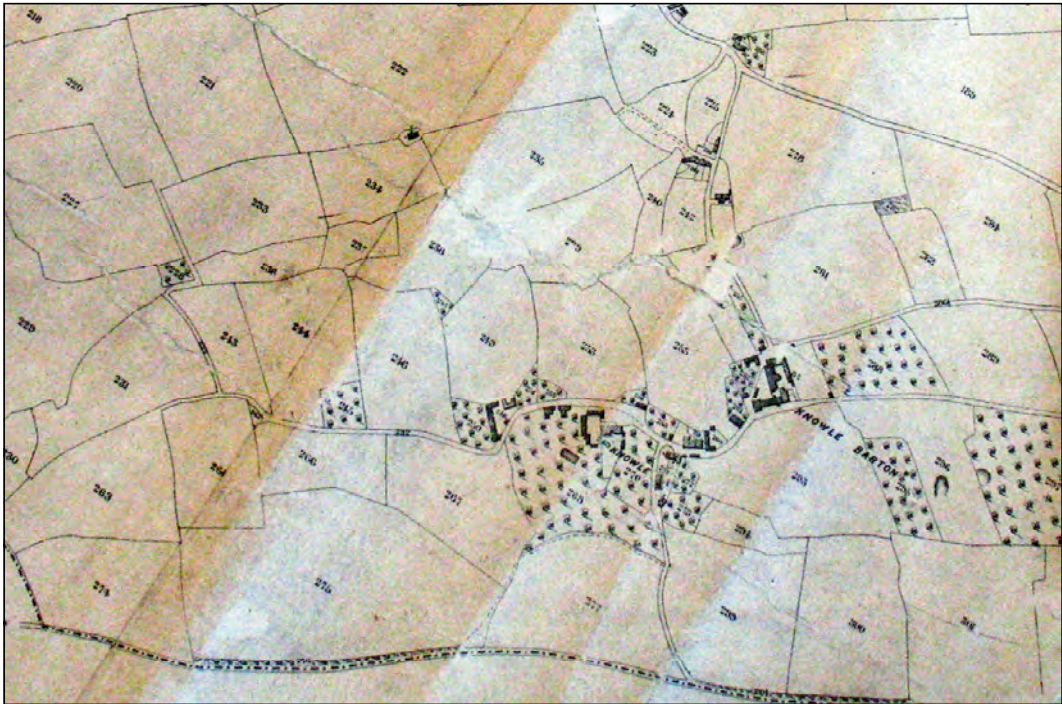
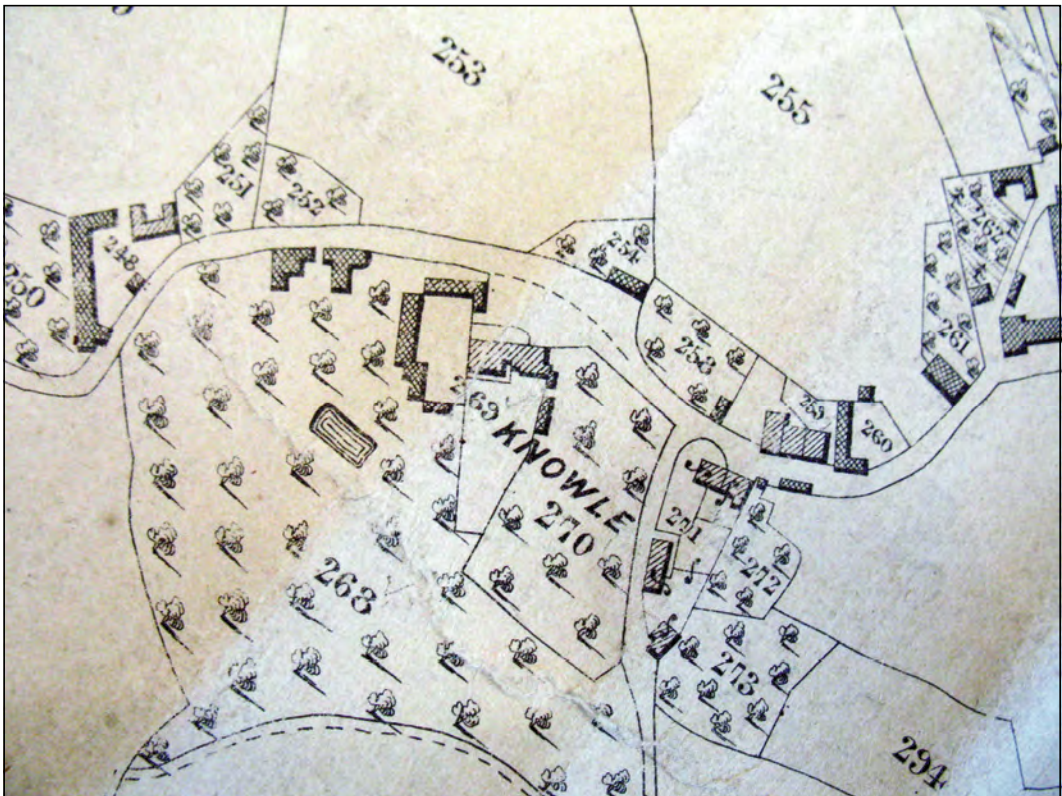
Fig. 5a: Extract from the Crediton tithe map of 1841 showing Knowle Farm (named here simply 'Knowle') within the contemporary landscape. (DRO)

Fig. 5b: Detail from the Crediton tithe map of 1841.

This map provides the earliest detailed record. Fig. 5a shows Knowle Farm within its immediate landscape context with, to its north, field boundaries which have been interpreted as representing the fossilised remnants of a medieval strip field system (see the results of the Devon Historic Landscape Characterisation project). Fig. 5b provides a detailed view of the complex of buildings at Knowle Farm at this date. In the tithe apportionment (1839) numbers 268 and 270 are described as ‘orchard’. Number 269 is ‘house, courtlage, etc.’ the layout of which comprises the dwelling (diagonal hatching) on an east-west axis to the east and a yard enclosed on three sides by outbuildings (criss-cross hatching) to the west. Beyond these to the north-west are two further detached buildings lying adjacent to Knowle Lane.

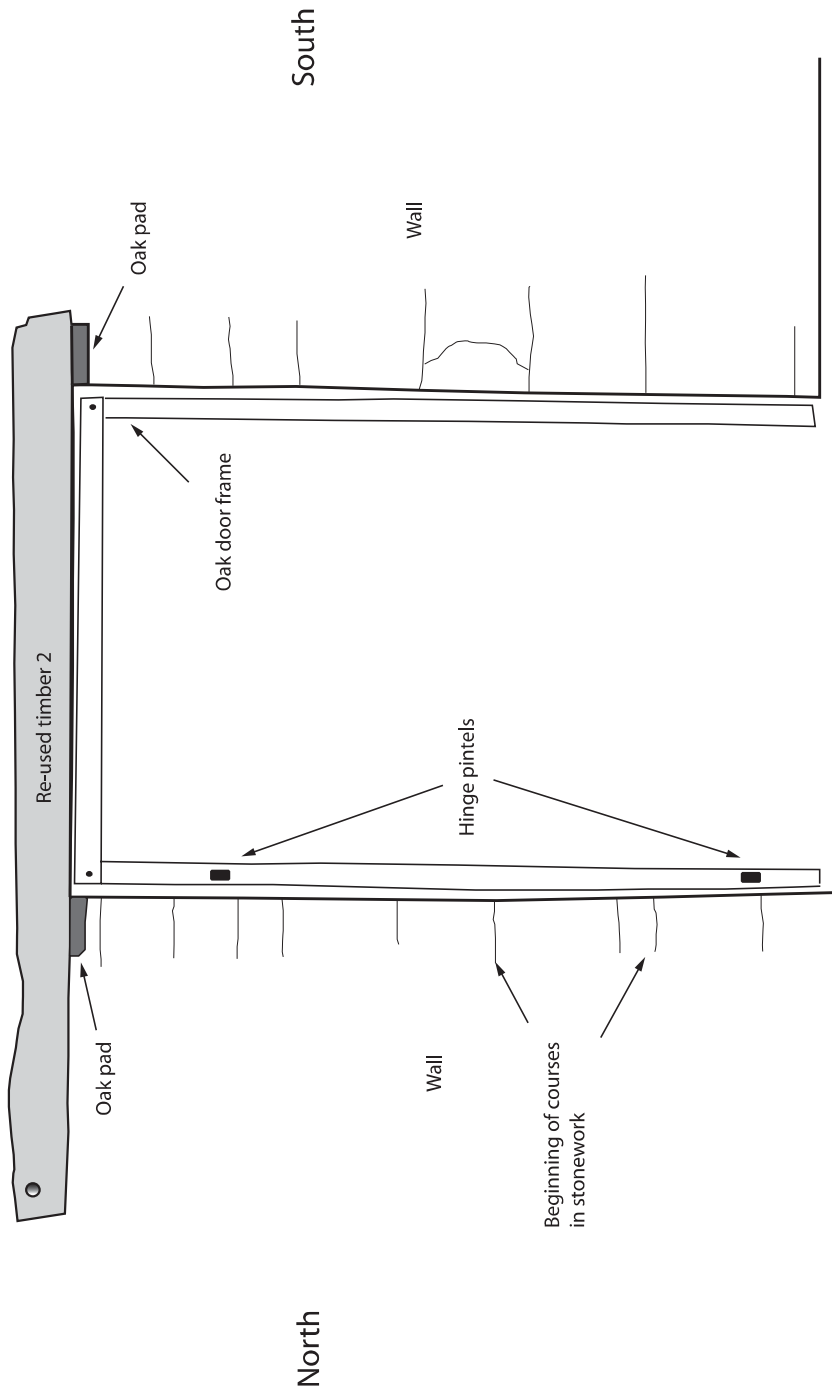
Fig. 12a: Knowle Farm, the re-used timbers over the linhay doorway (D6).

View of re-used timber 1 over the doorway (D6) in the west wall of the linhay
Viewed from the west.

Doors: All in the west wall. D4 at ground floor level is a later 19th century door forced through in the centre bay, with machine-made brick jambs and an oak lintel. This was blocked in the 20th century. D5 in the 1st bay south of centre, with a plank door with four planks and three battens in elm, with a traditional oak finger latch and oak lintel and in a plain pegged oak frame. This is original to the building. D6 in the 4th bay from the south is as D5 above with spear-ended strap hinges, in a pegged oak frame and with recycled oak lintels; see Appendix 5 and Figs 12a & 12b.

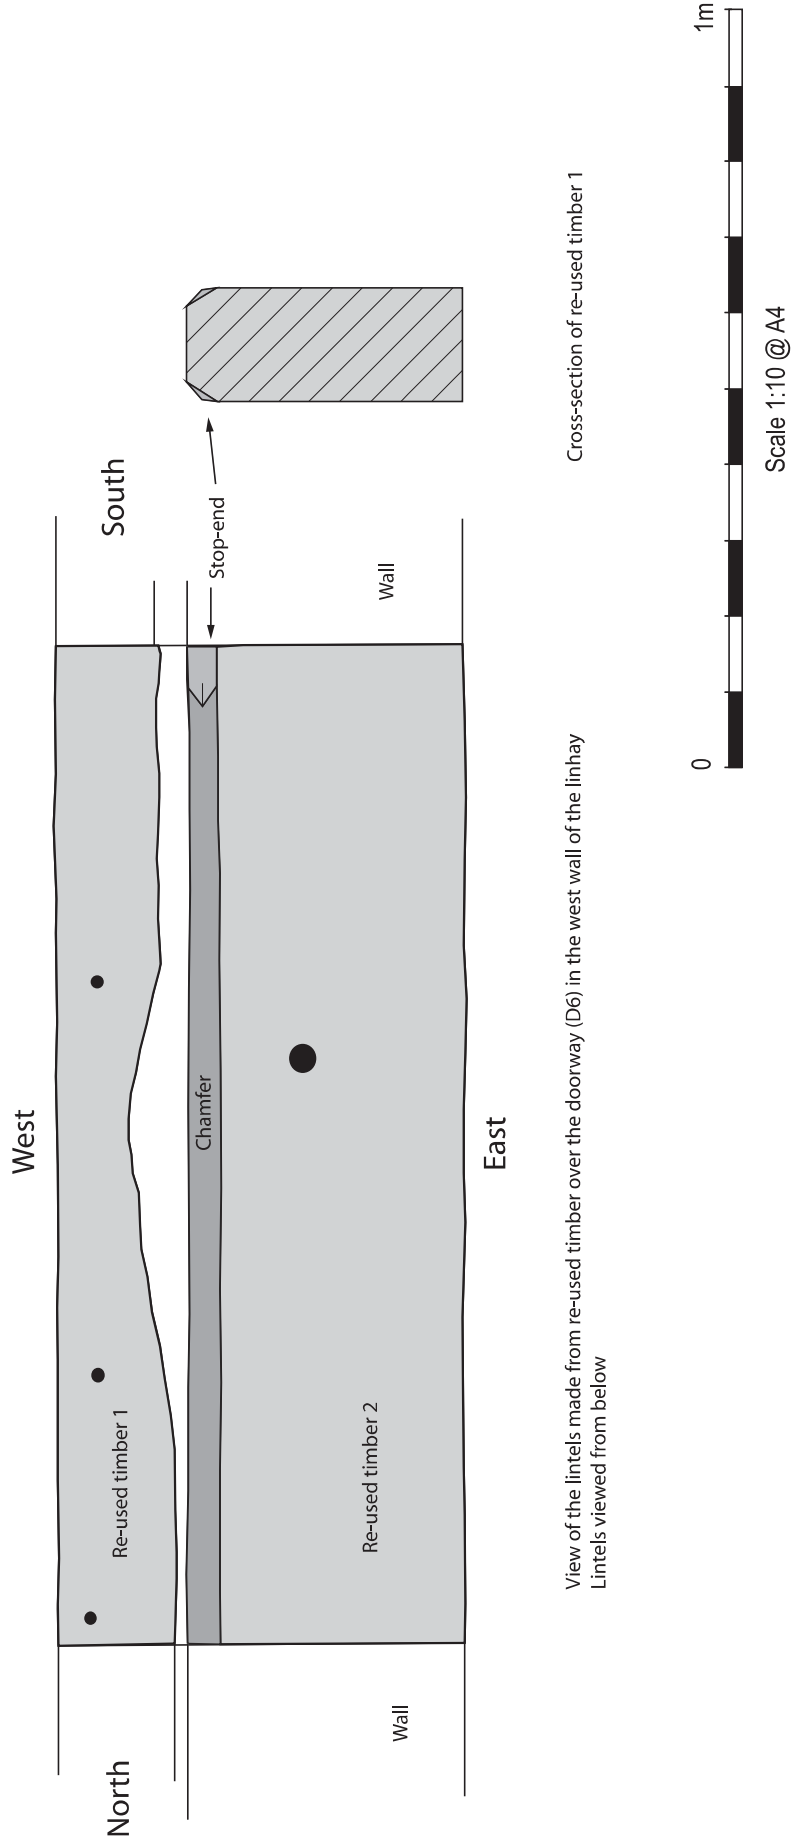
Fig. 12b: Knowle Farm, the re-used timbers over the linhay doorway (D6).

View of the lintels made from re-used timber over the doorway (D6) in the west wall of the linhay
 Lintels viewed from below

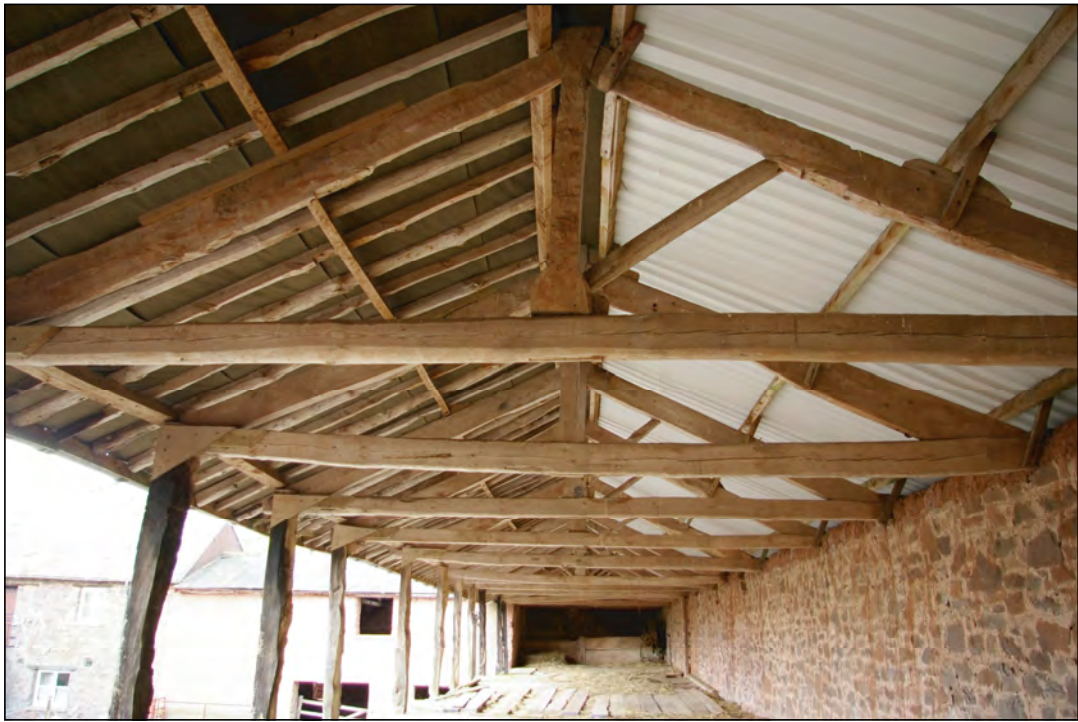
Plate 5: The first floor and roof structure of the Linhay, viewed from the north.

Roof: Sixteen tie-beam and king-post trusses (as the Pound House) but many of the tie-beams are of pine and some blades are re-used from an earlier 45 degree roof, with trenched purlins and face-pegged collars. The tie-beams are slotted into trenches in the tops of the eastern wall posts and set into a small amount of cob on top of the western stone rubble wall.

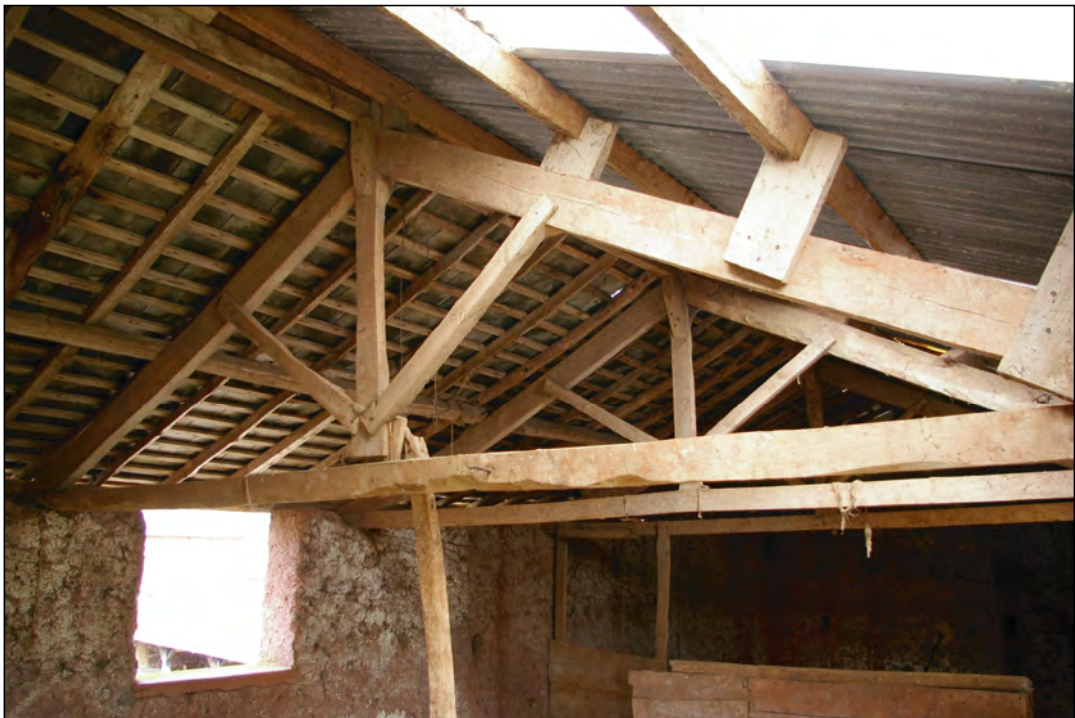
Plate 6: The roof structure of the Pound House, viewed from the south west.

Roof: Welsh slate with a red ridge-tiles on tie-beam and king-post trusses, mitred into the Lincay roof. The structure has three elm tie-beam and king-post trusses, with a square-set ridge-pole supported on nailed corbels. The king-post foot is jowled with two halved and nailed struts, morticed and tenoned into the tie-beam. Both end walls stop at eaves level and have short posts supporting the purlins. There are five purlins per side, which are mostly modern but with some older elm purlins remaining. The light common rafters and battens have mostly been replaced on the north pitch, and have gone on the south. The trusses are notched into the top of the cob walls.
