THE WATER TANK
to the rear of
CHURCH PARK COTTAGES
KINGSWEAR
DEVON

Results of an archaeological building survey

Report No.: 090717
Authors: C. Humphreys
R. Waterhouse

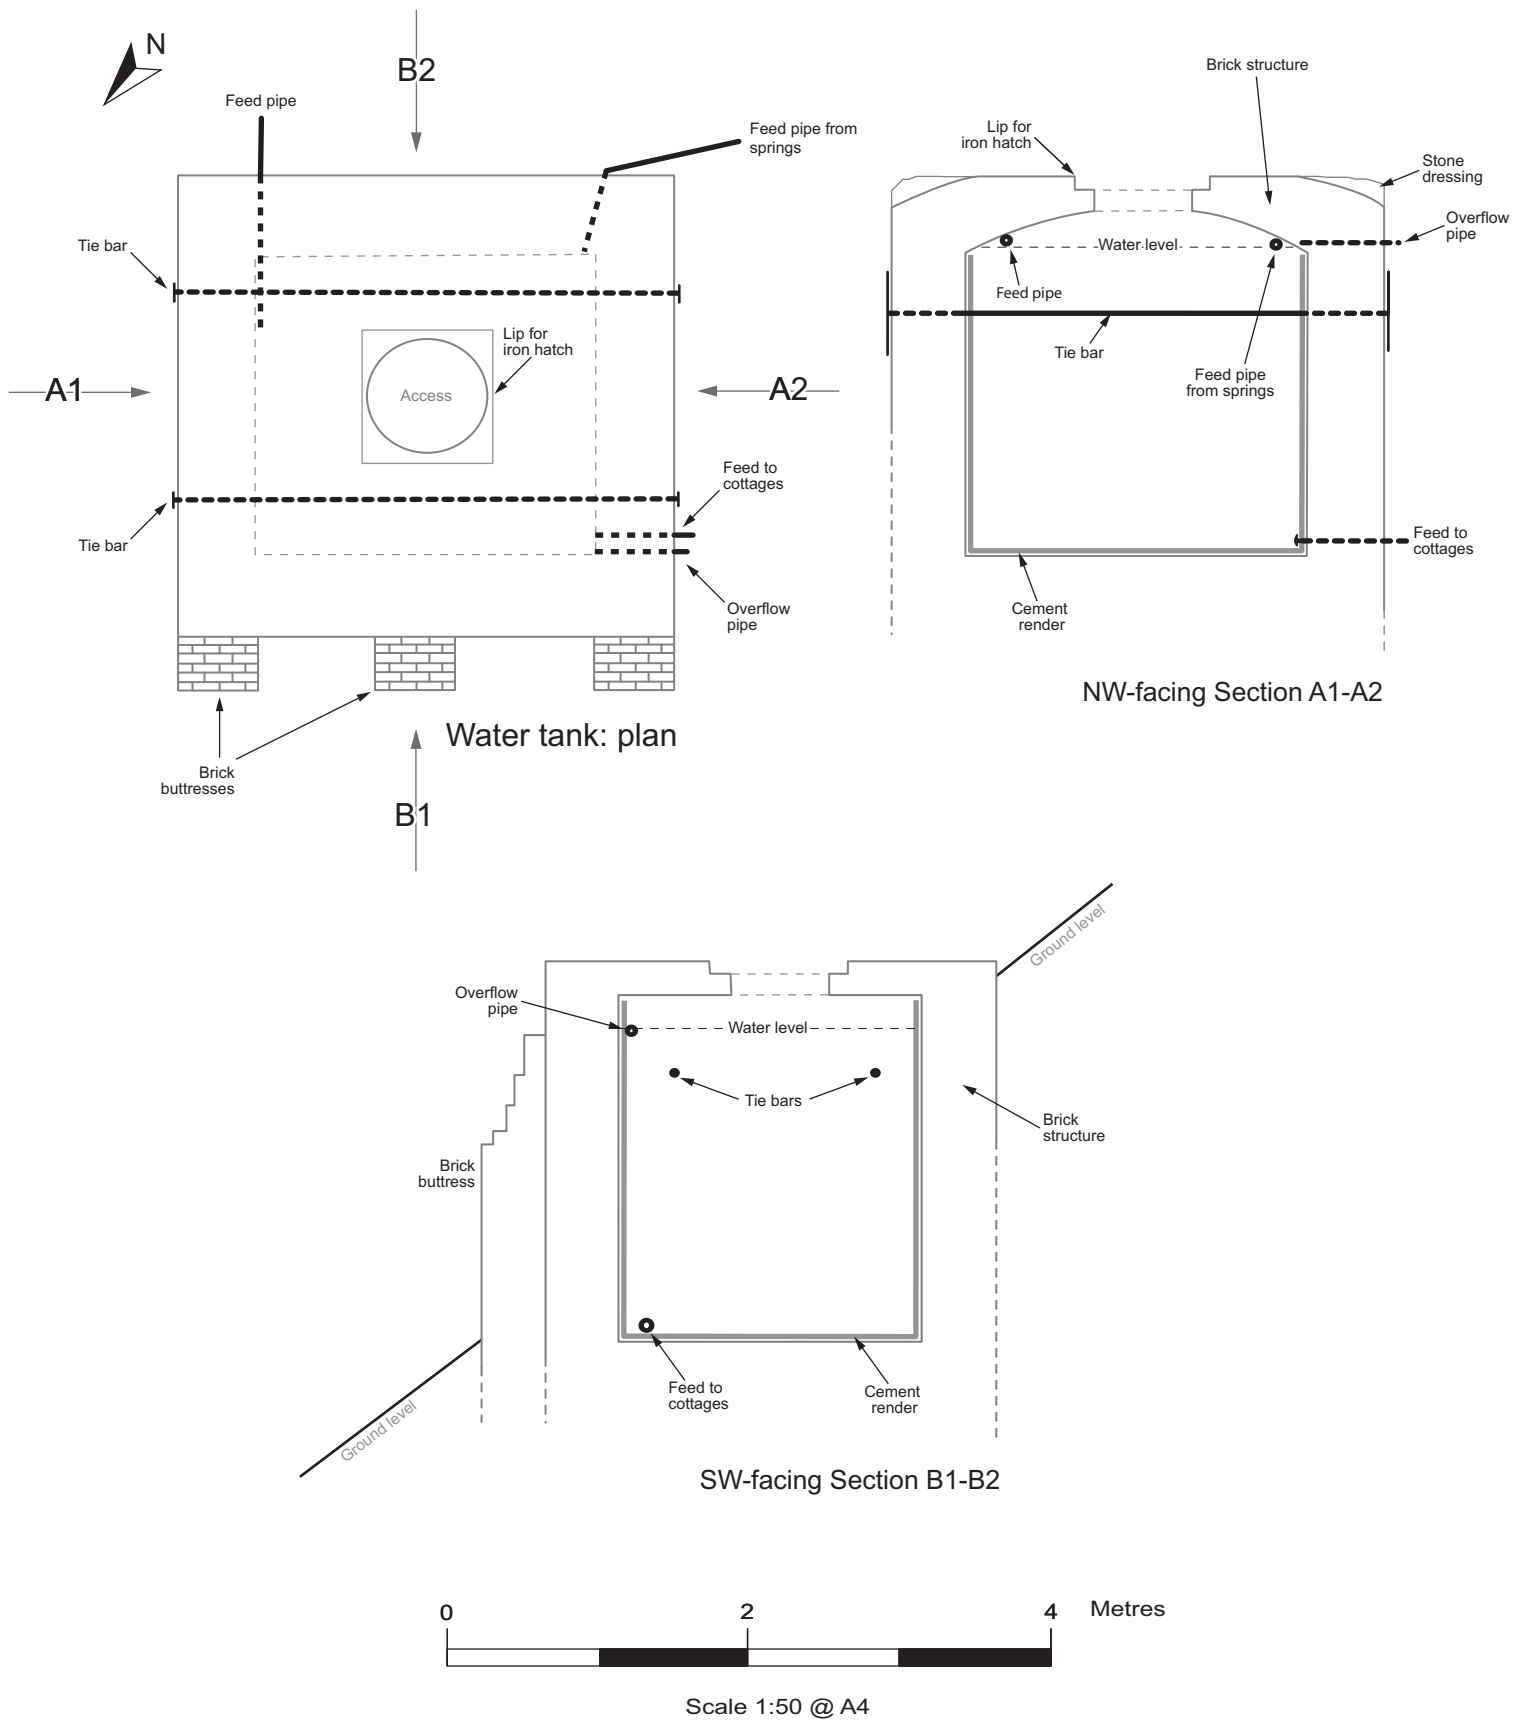
Fig. 4: Plan and cross-sections of the water tank at Church Park Cottages, Kingswear.

The interior of the tank comprises a sub-square chamber circa 2.5m square, cement rendered to make it watertight, *c.*2.35m high internally with the water level when full approximately 2m.

The water feed arrives via a 2" OD/1½"ID iron pipe that projects from the wall in the south west corner, and exits via a 2¾"OD/2"ID cast-iron pipe set at a slightly lower level at the northern end of the west wall. This curves as if to go vertically down the wall and was probably fed downslope to the cottages.

The roof of the chamber is a segmental arched vault aligned north-south with a springer east-west. Two wrought-iron/steel tie-rods pass through the structure east-west with square nuts and wrought strip plates on the outside of the structure.

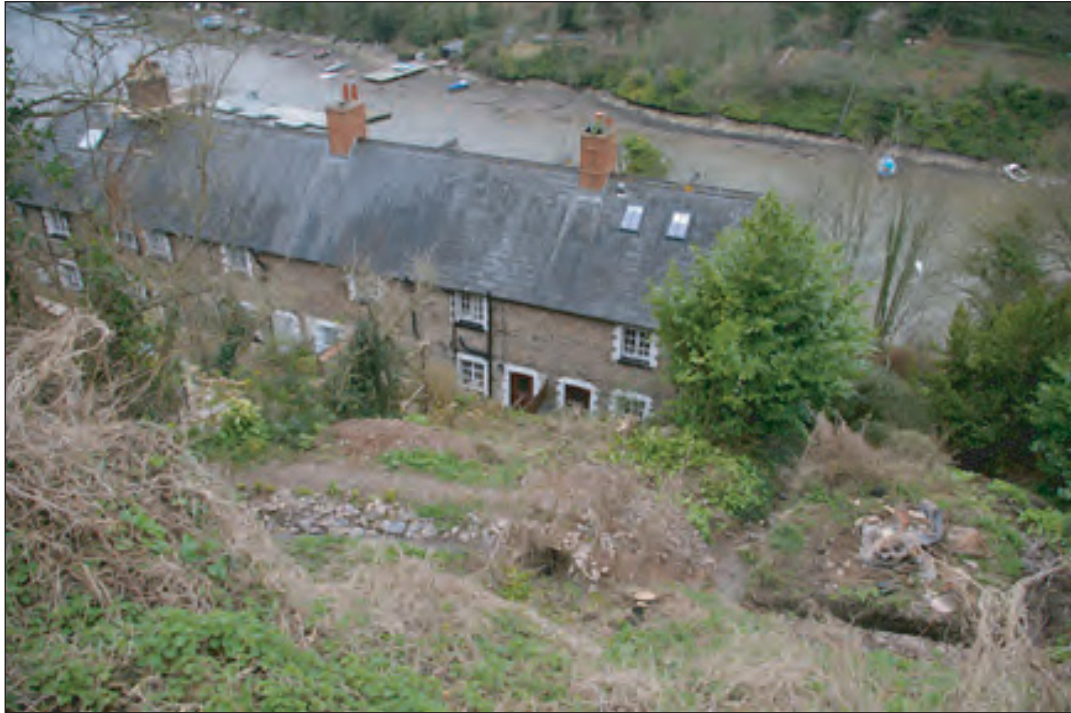
Plate 1: Looking down on Church Park Cottages from Lower Contour Road to the south.
The water tank is in the foreground on the right of the image.

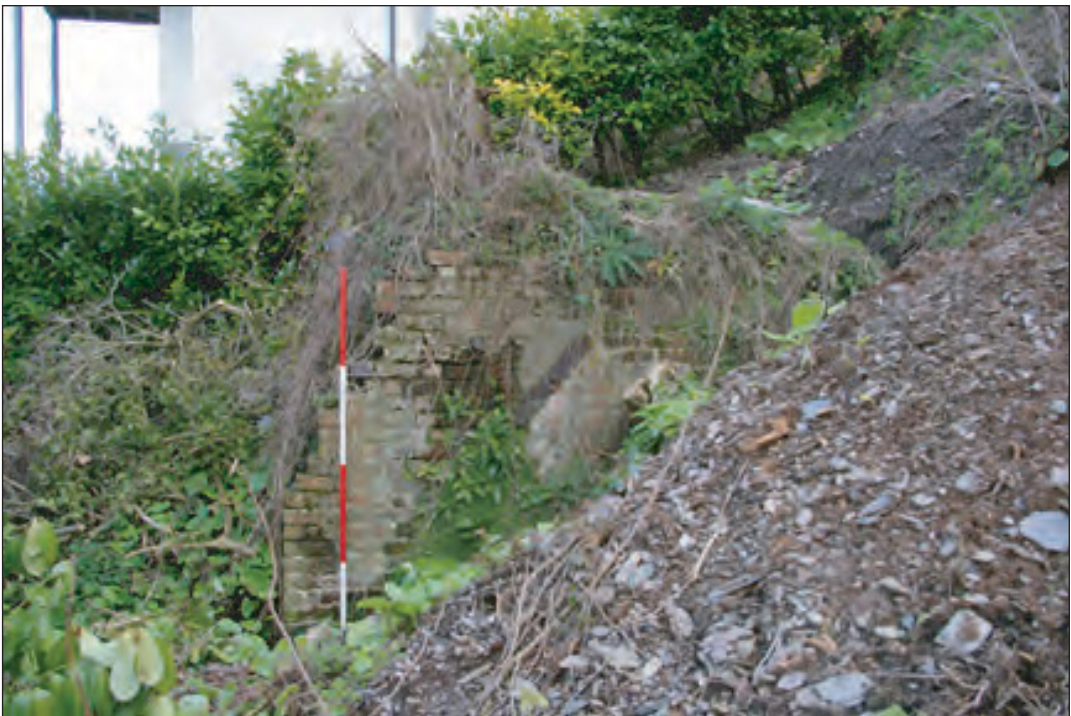
Plate 2: The water tank prior to work commencing, viewed from the west.

The water tank is of lime-bonded coursed red brick construction, of late hand-made or early machine-made brick with a generally smooth surface but not perfectly so. The east, west and south exterior walls are plain but the north wall (on the downslope side) has three shallow buttresses with the tops stepped back to the wall face. The top of the tank has a centrally placed square brick and cement lip with a wrought-iron frame and hinged lid. This feature may be later as it sits directly onto a circular hole formed in the barrel-vault of the tank. Originally the top of the water tank may therefore have been profiled to the shape of the vault.

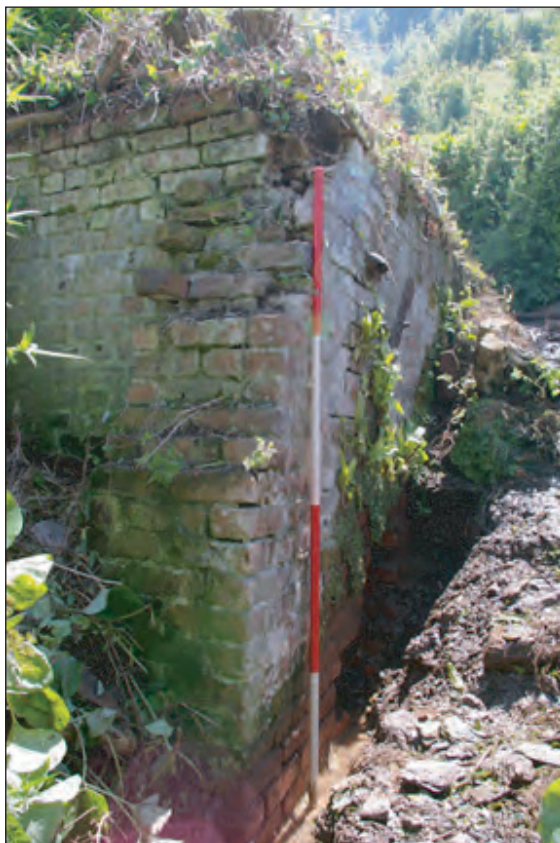
Plate 3: The west wall of the water tank during demolition, viewed from the north.

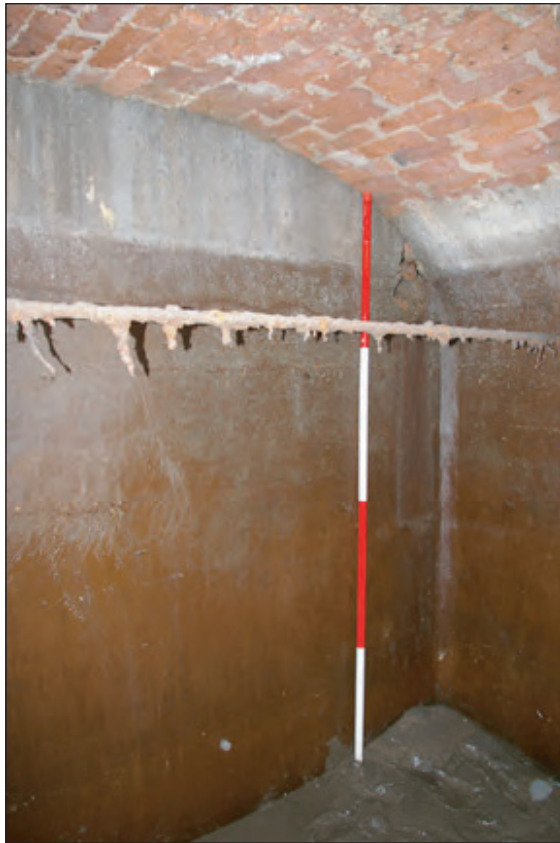
Plate 4: Inside the water tank, the south west corner. A red and white measuring pole is visible in the corner.
