HIGHER LANGAGE FARM SPARKWELL DEVON

Results of a Desk-Based Assessment,
Historic Building Recording & Archaeological Evaluation

Report No.: 110105
Date: 05.01.2011
Authors: T. Green
C. Humphreys
B. Morris
S. Walls

SWARCH project reference: HLF09
National Grid Reference: SX 57295630
Plymouth Museum Accession Number: AR.2007.9
Devon County Historic Environment Service Reference: n/a
Devon County Council Planning Reference: 49/1020/98/1
OASIS reference: southwes1-60436
Project Director: Colin Humphreys
Desk-Based Assessment: Terry Green
Building Recording: Colin Humphreys; Robert Waterhouse; Deb Laing-Trengove
Fieldwork Managers: Bryn Morris
Project Officer: Bryn Morris
Fieldwork Supervisor: Bryn Morris
Fieldwork: Bryn Morris; Martin Tingle; Deb Laing-Trengove
Post-Excavation Co-ordinator: Bryn Morris
Report: Terry Green; Colin Humphreys; Samuel Walls
Report Editing: Lee Bray; Bryn Morris; Deb Laing-Trengove
Research: Terry Green; Bryn Morris
Graphics: Colin Humphreys; Bryn Morris; Samuel Walls

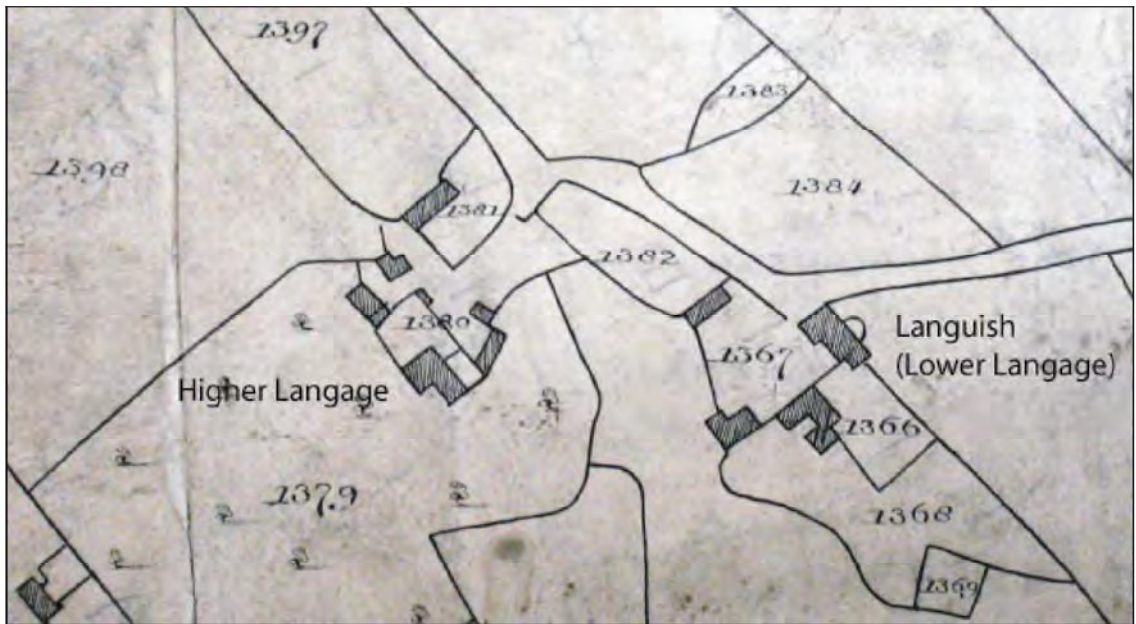
Figure 6: Extract from the Plympton St Mary Tithe Map of 1841 (DRO).

The Tithe Apportionment identifies number 1380 as the "House, Buildings and Court" of Higher Language; number 1367 is identified as the "House, Buildings and Court" of Languish (later named Lower Language). Higher Language comprised 69 acres plus 24 acres designated as Prior Parks.

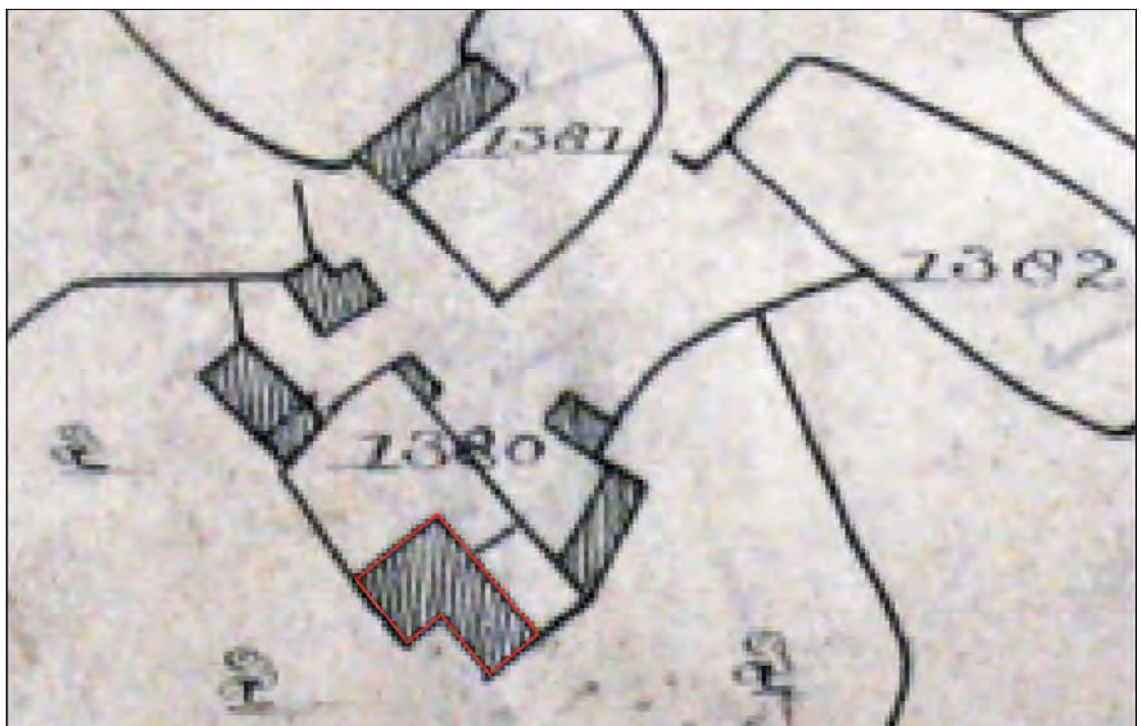
Figure 7: Detail from Tithe map of 1841. Higher Language farmhouse is outlined in red.

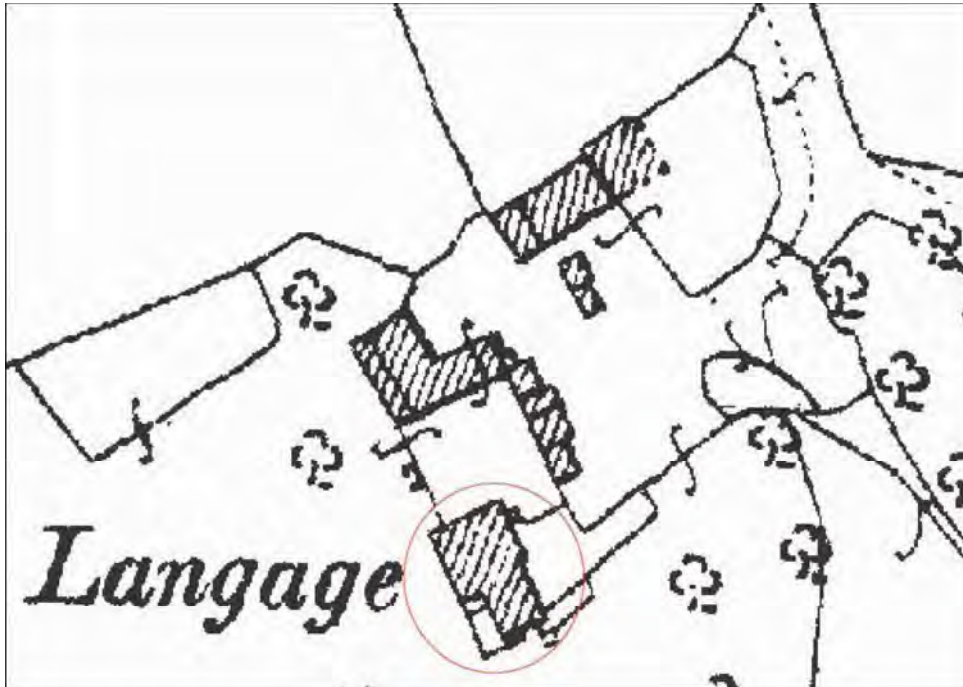
Figure 8: Extract from the Ordnance Survey First Edition map of 1889, showing Higher Langage with the farmhouse circled in red.

There are only some minor changes discernable since 1841, primarily amongst the outbuildings.

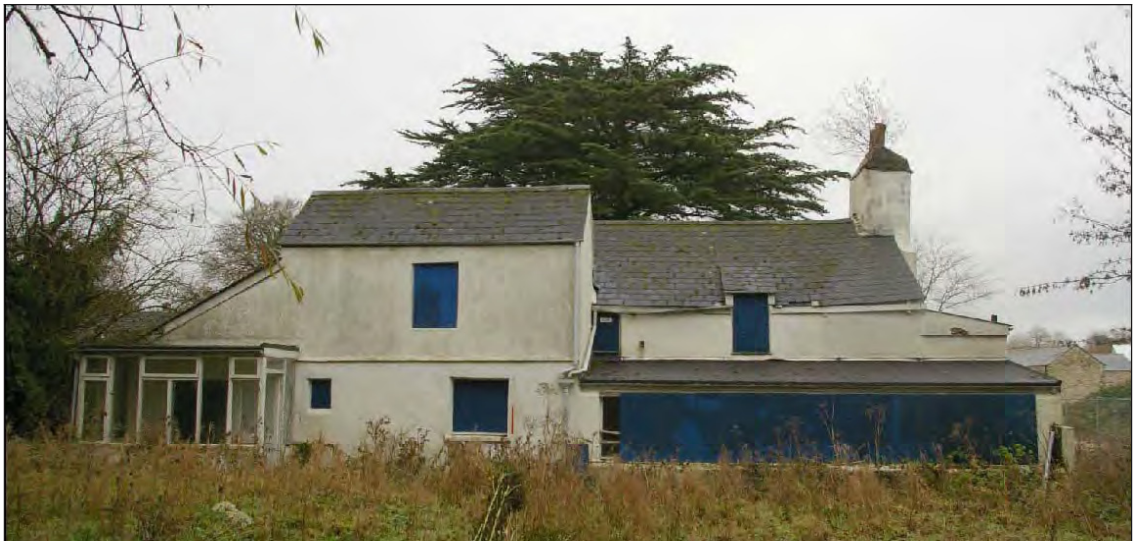
Figure 10: Higher Langage farmhouse, viewed from the west.

East facing 1½ storey farmhouse with projecting lateral chimneystack and hall window on the east elevation, and a more modern chimneystack in the south gable (Figure 11). The building has been truncated at the southern end (here a fireplace is located on the external wall). The northern end of the building may also have been truncated in the position of the extant mono-pitch single storey extension. To the west (rear) of the building there is a two-storey and a modern single-storey extension (Figure 10). All walls are rendered with a modern cement mortar over a mix of stone rubble and cob. The roof to the main range, quarter hipped to the north, is covered with composite slates, while the extension roof to the north is of corrugated asbestos sheet.

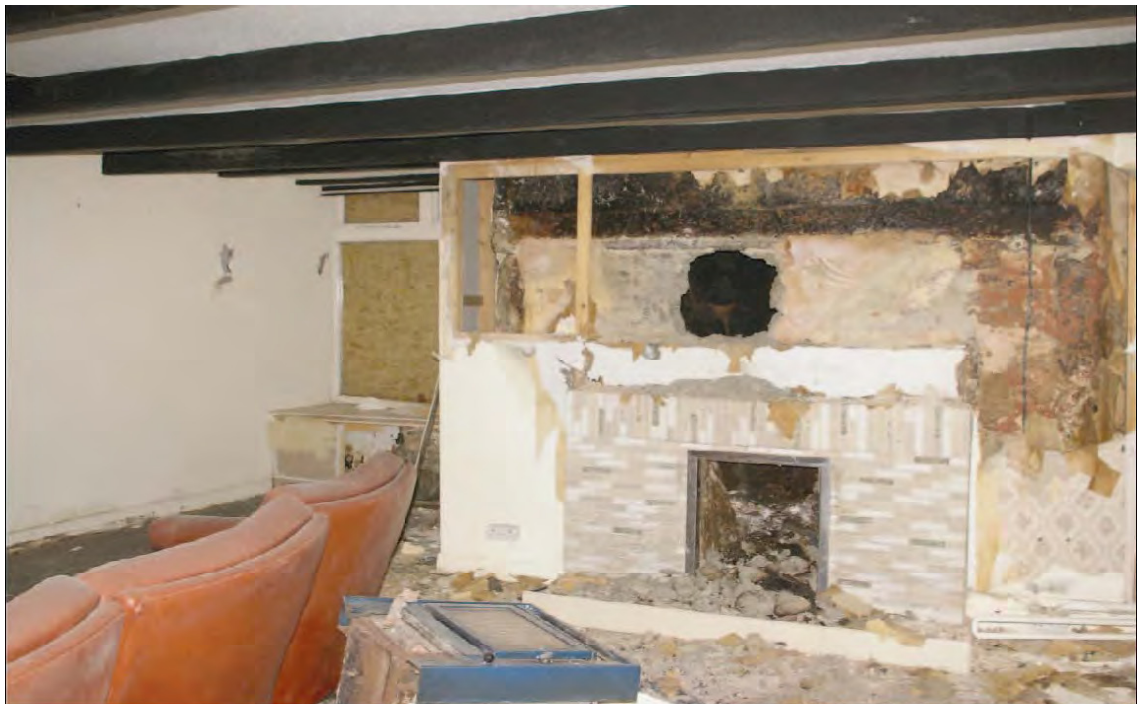
Figure 13: Room 3 viewed from the west showing, the fireplace and hall window.

Access to the hall (3) is from room (4). This room has been modernised, with modern exposed rafters and a modern open stair inserted in the north-west corner. The large fireplace in the east wall has been blocked with a modern grate and surround. The adjacent window is modern as is the door in the west wall giving access to a sub-divided part of the extension, latterly used as a utility room (7). In the south-west corner of the hall a doorway with a mid-19th century door leads to a lobby with an understair cupboard and access to room (8). There is a bathroom in the northern end of the modern extension.

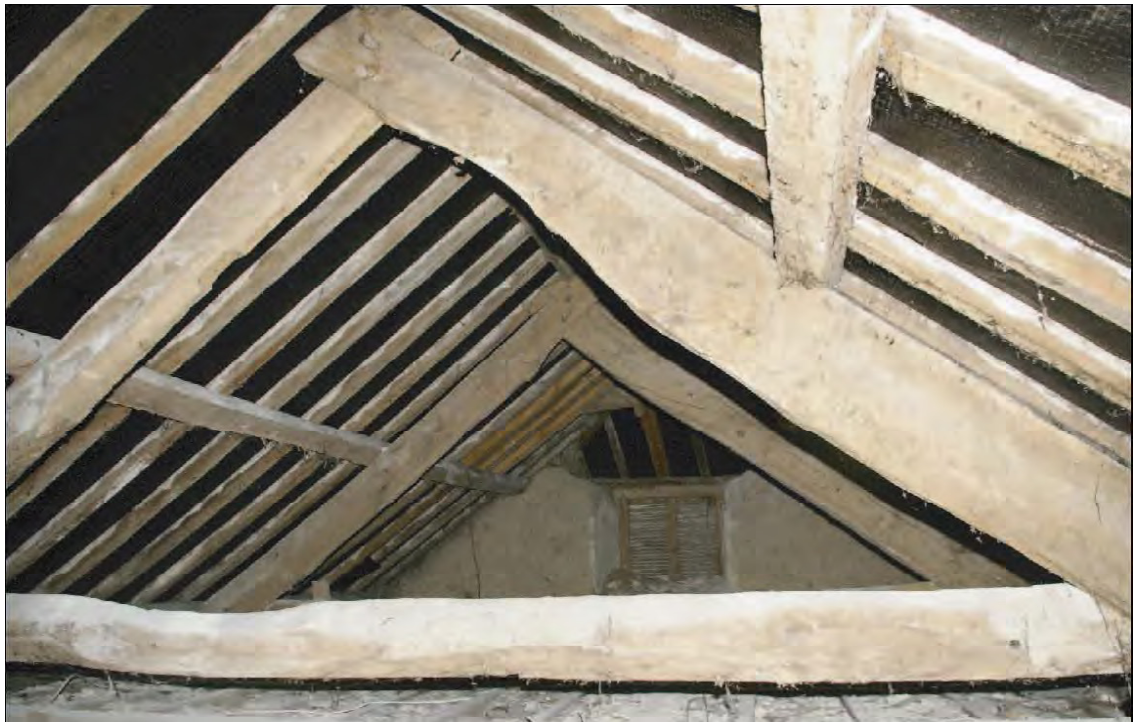
Figure 14: The roof structure over the main range, showing a blocked window in the north wall. Viewed from the south.

The earliest roof structure is that over the main range (a late 18th century replacement for an earlier structure) and consists of 5 roof trusses each with straight blades resting on the wall tops with a half-lapped and pegged apex and a collar set low on the blade which is spiked and pegged. Each pitch has a single set of purlins set on the back of the blades. A diamond set ridge pole sits in the apex of each truss (Figure 14).

The roof is quarter hipped to the north with a crude two-light wooden window frame set just below the hip. The roof structure over the rear extension is slightly later with a notched, half-lapped, spiked and pegged apex with the blades sitting on a tie beam that in turn sits on the wall tops. A ridge board is supported by a wooden saddle nailed to each truss. Each pitch has a single set of purlins set on the back of the blades.

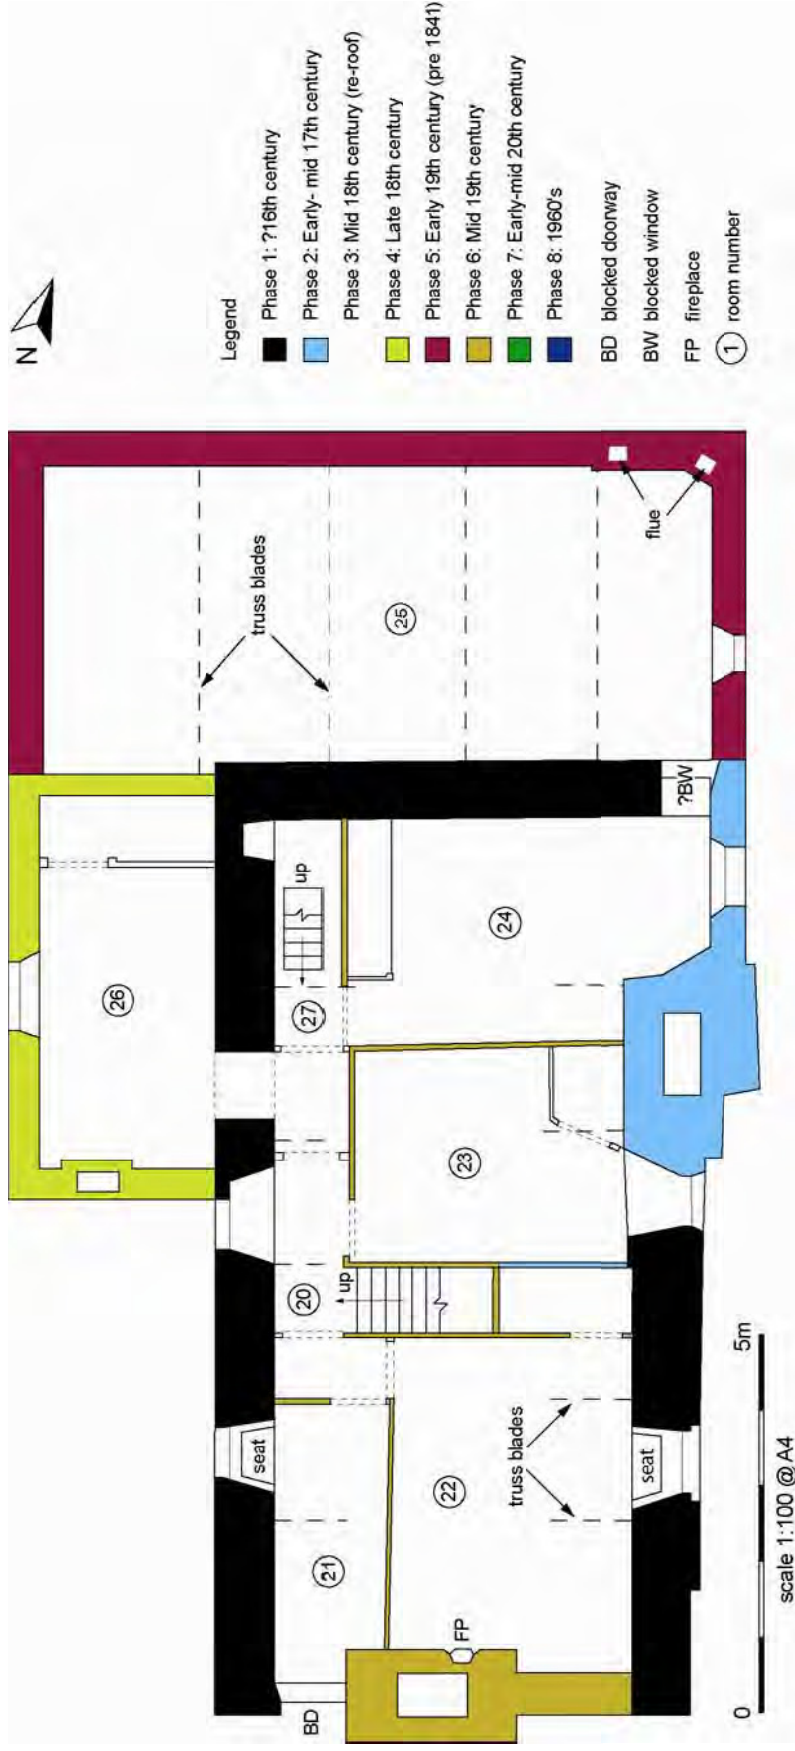
Figure 15: First floor plan of Higher Langlege Farmhouse, with phasing.

The partitions, the doors and the fireplace in the west wall of room (22) all suggest a mid 19th century redesign of the layout. The only feature that may be earlier is the panelling between the cupboard over the cross-passage in room (22) and room (23). This may be the upper part of a cross-passage screen possibly of the date when the first floor over the hall was inserted. All other features, including the windows, are modern.

The numbers in brackets refer to the rooms shown on the building plans (Figure 12 and Figure 15).

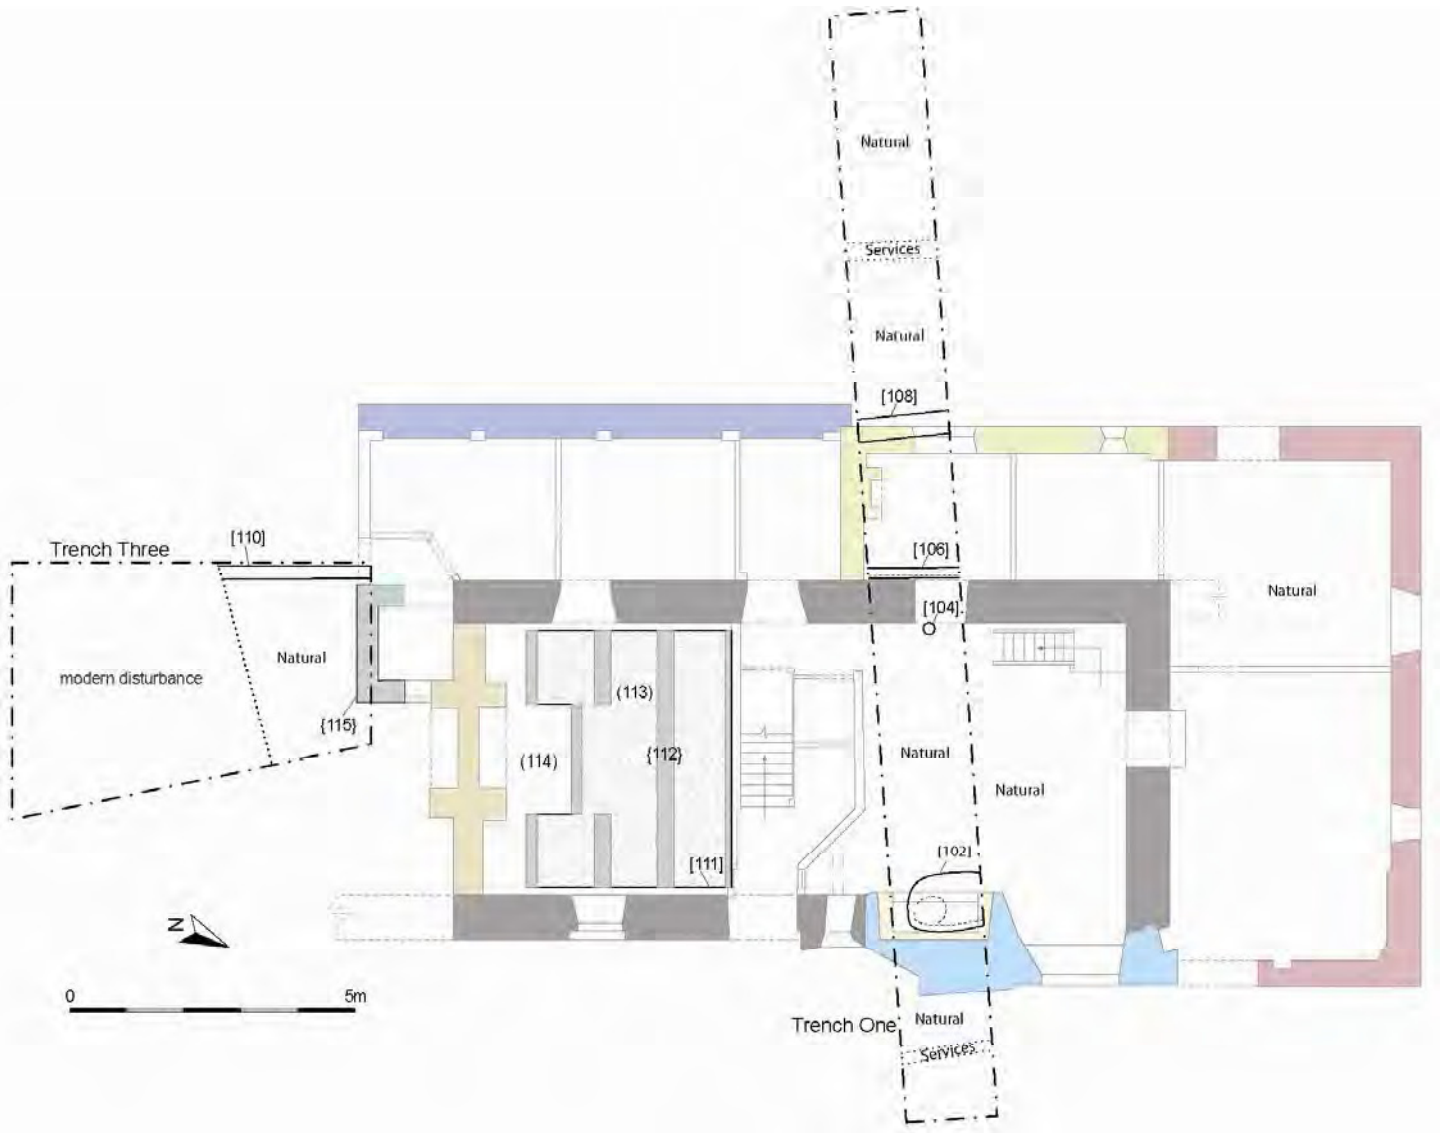
Figure 16: Plan of the evaluation trenches and floor layers in Room 1.

Trench One demonstrated that no earlier floors or hearths survived beneath the modern floors of the structure. The house platform had been cut into the slope and the floors in the northern half of the building had been laid straight onto the bedrock. Indeed, the bedrock survived at a higher level beneath the walls, clearly indicating that internal floor levels had been reduced since the structure was built.

A number of features were observed to cut into the natural, but with few exceptions they proved to be of relatively recent date. For example, the shallow oval pit [102] located beneath the fireplace in the former hall (Room 3) even contained the remains of wood-chip wallpaper.

Pit [102] was 1.04×1.34m in extent and 0.22m deep, with a steep or nearly vertical eastern side and a shallow sloping western side. It was filled by (101), a firm dark greyish-brown clayey-silt containing abundant shale inclusions, common flecks of charcoal and occasional fragments of mortar. It also contained a few sherds of white refined earthenware (post 1720). This feature lay directly beneath the main fireplace in the eastern wall of the building.

A narrow gully [106] crossed the trench just to the west of the original core of the building, and probably formed a drainage or 'drip' gully. It was 0.2m wide and 0.06-0.09m deep, with a steep or nearly vertical eastern side and a shallow sloping western side. The fill of this feature (105) was a soft greyish-brown silty clay that contained abundant shale inclusions and a single sherd of post-medieval pottery.

A second gully [108] crossed Trench One 2m to the west of [106]. This gully was 0.4m wide and contained a soft wet brown mud with common angular stone inclusions, running with water. This was interpreted as a stone drain, but it was later observed to closely correspond with the outer wall of the farmhouse, and thus could represent the footings for that wall. It produced a single sherd of blue shell-edged plate (post-1810).

The base of a possible post-hole [104] was also observed in Trench One. This lay inside the building and was 0.2m in diameter but only 0.04m deep. The remaining fill (103) was a dark reddish-grey silty clay containing abundant shale inclusions and some quartz fragments.

Trench Three was opened to investigate the southern end of the farmhouse. No buried structural evidence relating to the farmhouse was uncovered, though the white, mortar-bonded walls {115} of the former toilet (Room 12) were encountered which were associated with 19th century pottery.

A single linear gully [110] was identified running north-west-south-east, parallel to the original walls of the farmhouse and probably forming a southern extension of feature [106] from Trench One. It was 0.25m wide, up to 0.15m deep and contained a loose, light brown silty-clay containing abundant shale inclusions. Two sherds of white refined earthenware (post 1720) were recovered from this context.
