CABLE COTTAGE NORTH SANDS SALCOMBE DEVON

Results of a Desk-Based Study
and
Archaeological Building Survey

Report No.: 091201
Authors: C. Humphreys
D. Laing-Trengove
B. Morris

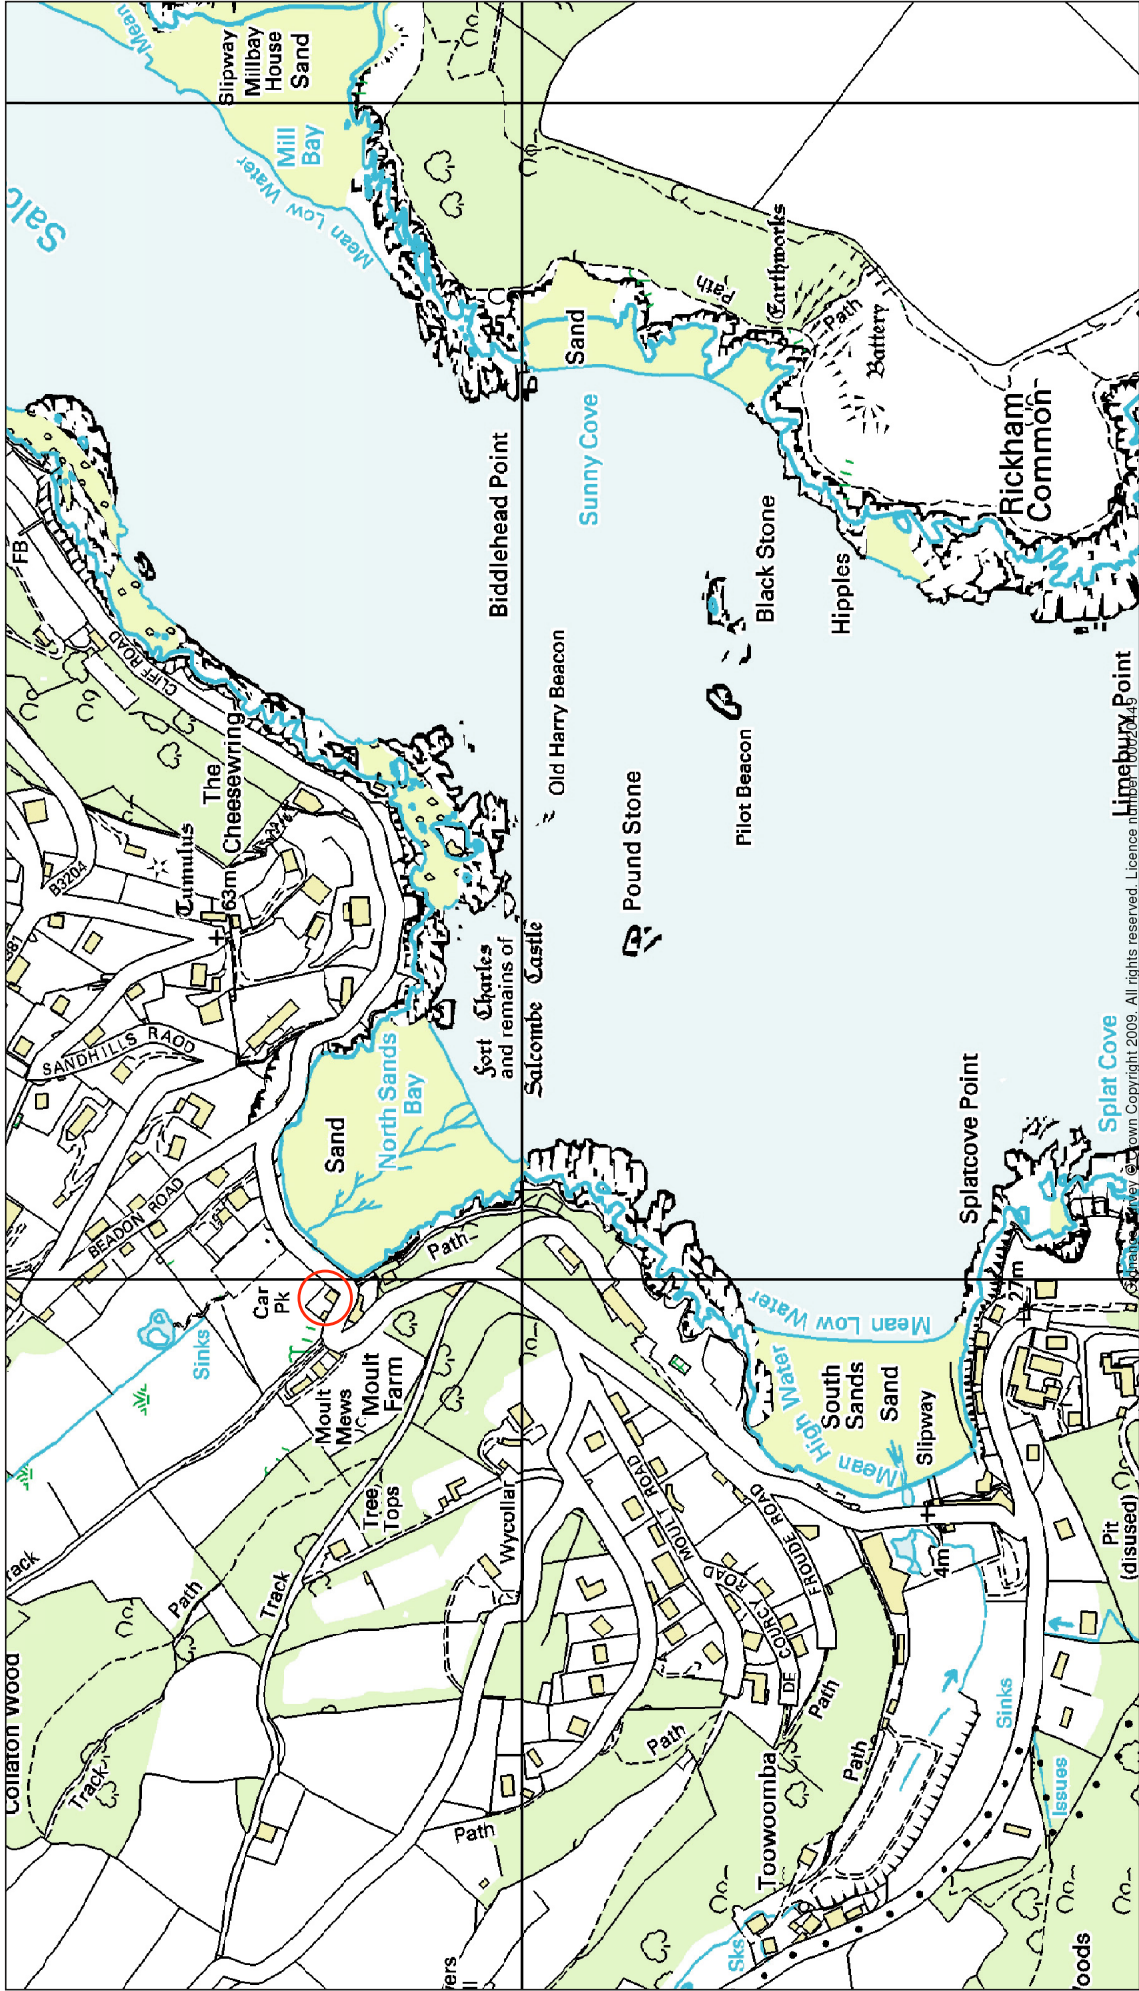
Fig 1b: Site location, with Cable Cottage circled in red.

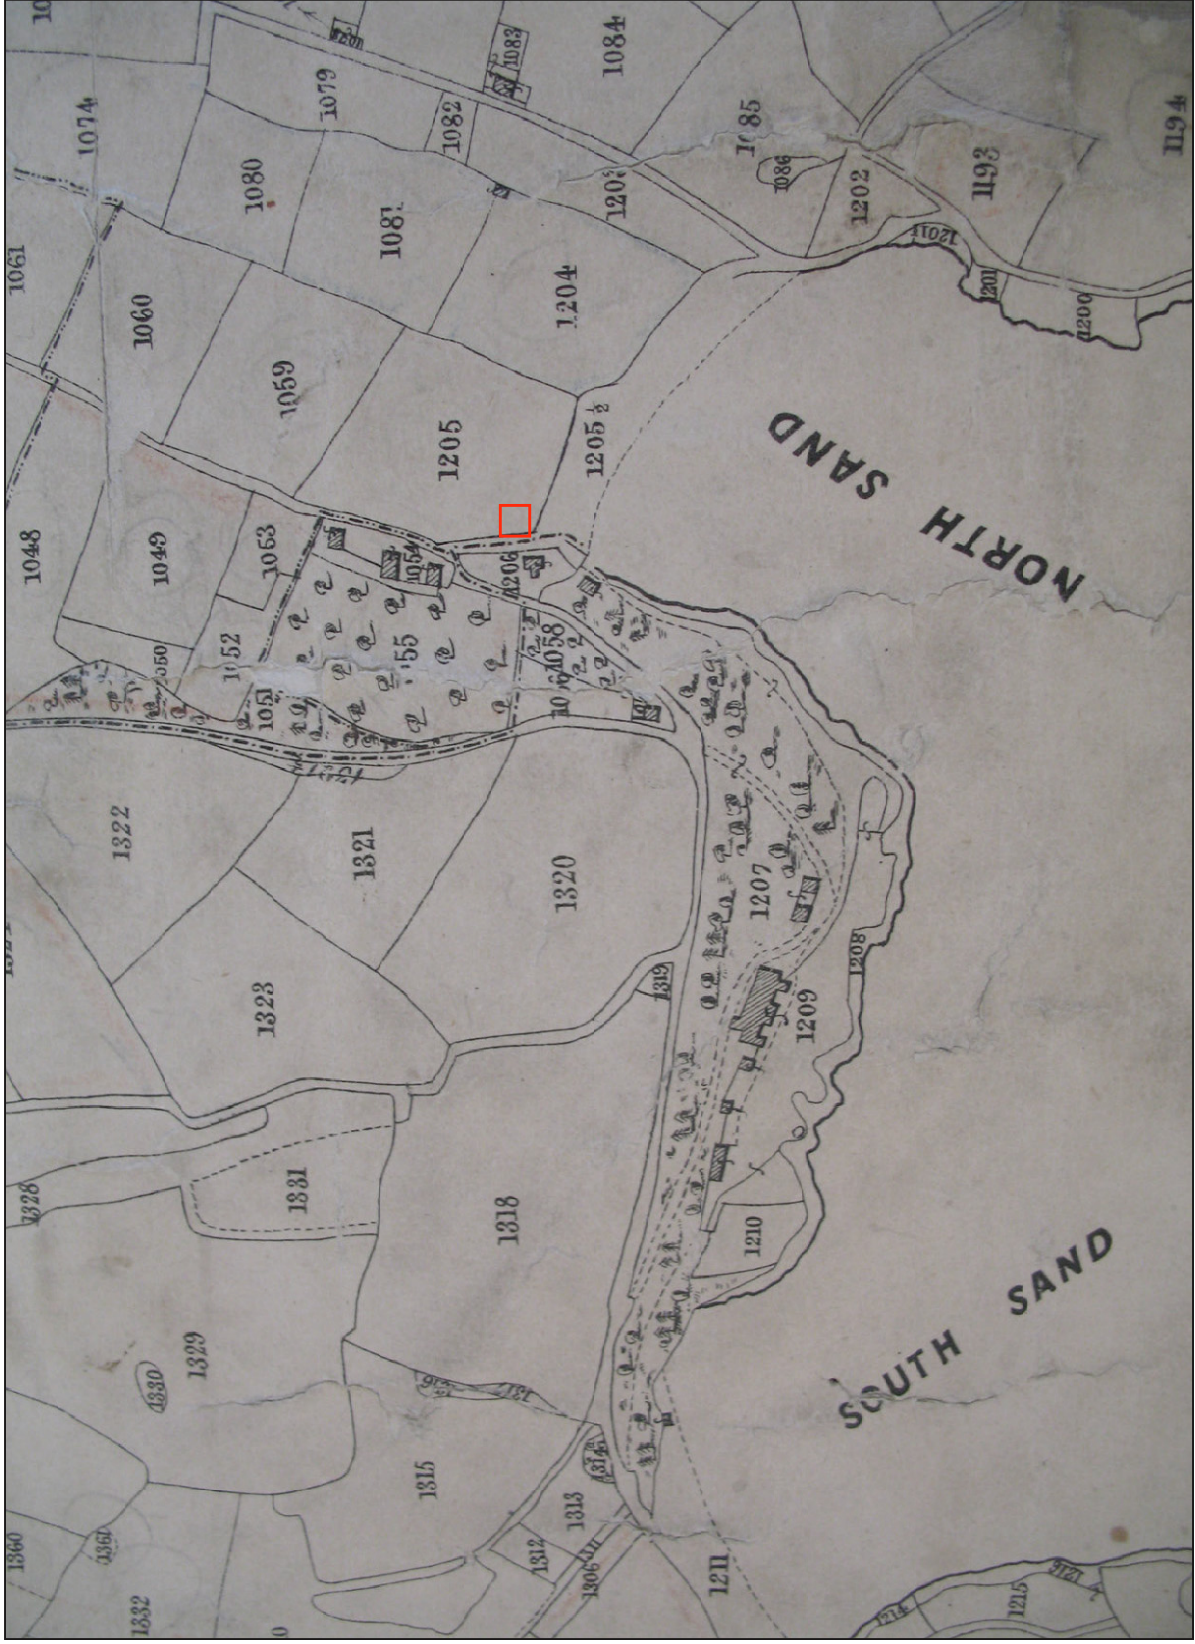
Fig. 2: Extract from the Salcombe tithe map of 1840. The red square represents the position of Cable Cottage.

The land for the cable hut at North Sands – ‘North Sands Meadow’ – was acquired from William Reginald Earl of Devon and was originally a parcel of the manor of Collaton. The Salcombe tithe map of 1840 (Fig. 2) shows the field (no. 1205) where the cable hut was to be built. The hut is first shown on the First Edition 6" Ordnance Survey map, surveyed and published c.1885 (Fig. 3) At this date the footprint of the building appears to be the same as the extant building (without the modern extensions), as it does on subsequent mapping (see Fig. 4). Photographic records and postcards from the late 19th – early 20th centuries (Plate 3-6) also appear to show the same building.

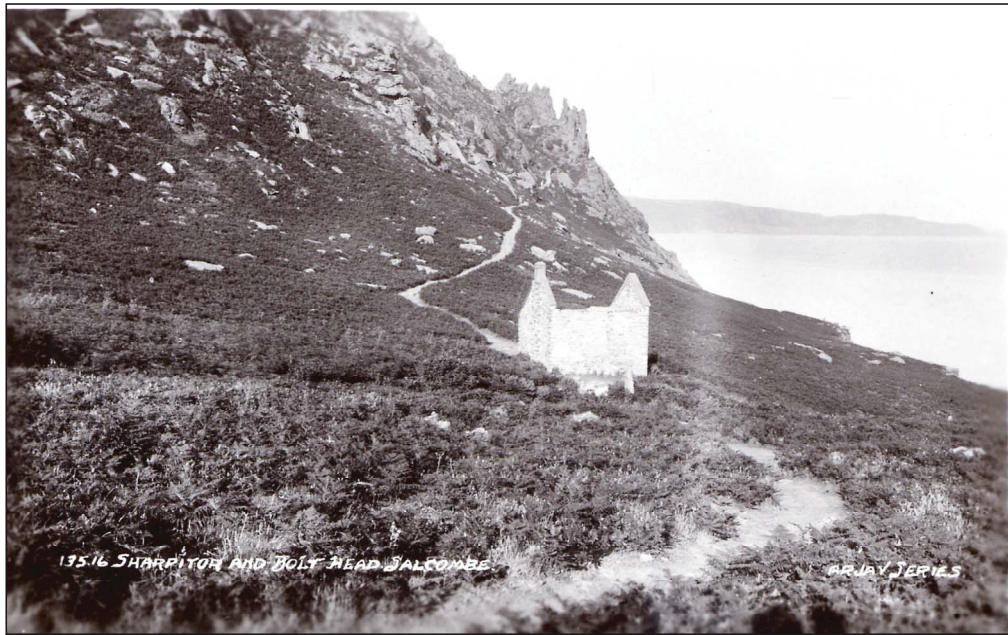
Plate 1: The Old Cable House at Starehole Bay, Bolt Head, looking to the north. Built in 1869 for the connection to the French-American telegraph cable. (Arjay Series; P0105 - Cookworthy Museum)

The building at Starehole that is said to be the former cable hut can be seen in a photograph of the period (Plate 1). At this point the building is without a roof and appears to be a single storey, single cell structure with a chimney built into the west gable. As noted above (2.3) the received opinion of others who have studied the subject is that only a box containing the connection between the marine and land cable would have been needed within a purpose built building, with, in some cases, test equipment also installed inside. If it is the case that the Starehole building was built specifically for the cable connection then it may be that the building at North Sands would have been of a similar original design. During the demolition of Cable Cottage the remains of a wall were uncovered (shown in light blue Fig. 5) which may be part of the remains of an earlier building. It could therefore be suggested that the western, Dining Room (2) part of the cottage was built on the footprint of an earlier structure which in proportion would be similar to that at Starehole.

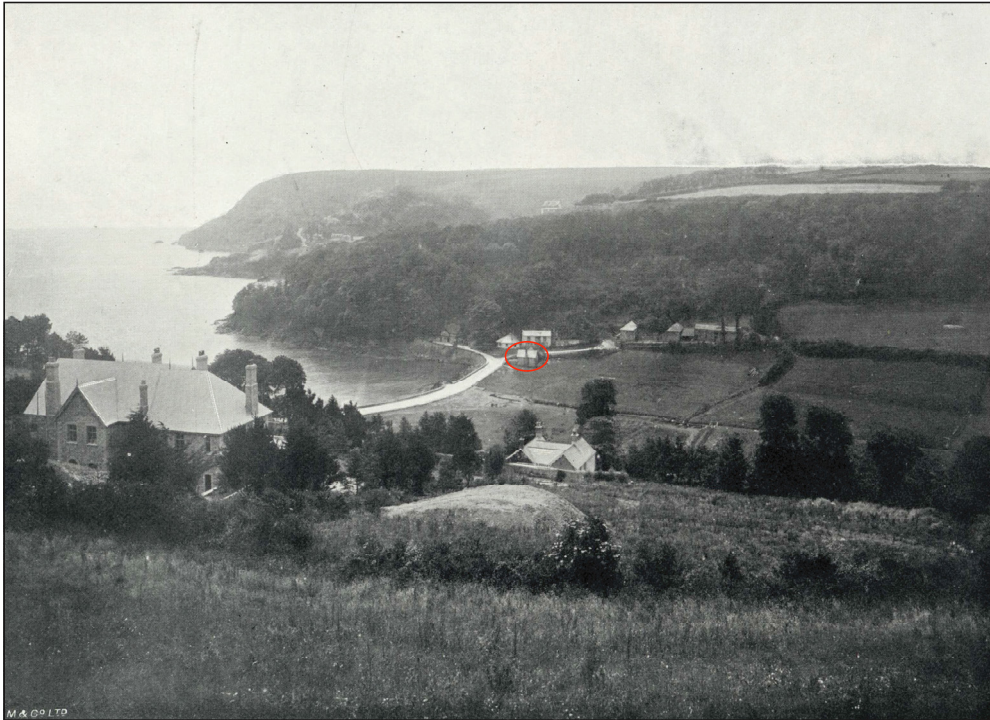
Plate 2: Salcombe, Bolt Head and North Sands bay (undated). Cable Cottage is circled in red. (P4116bd - Cookworthy Museum).

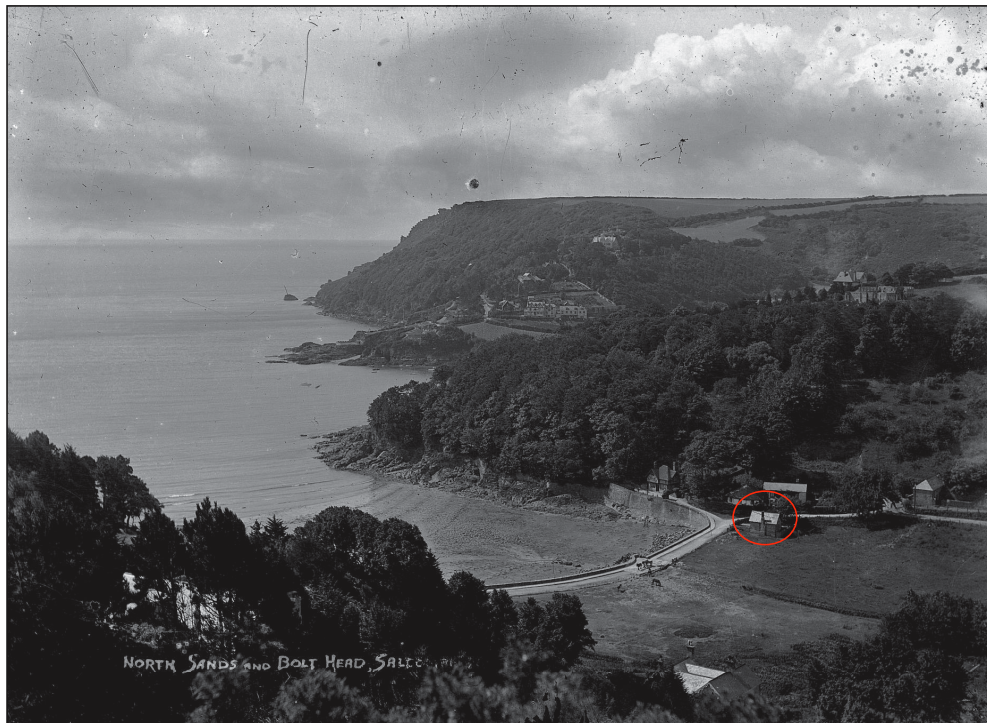
Plate 3: View of Bolt Head, North Sands and The Moults at Salcombe from the north, circa 1900. Cable Cottage can be seen in the centre of the image. (P1108.13 - Cookworthy Museum)

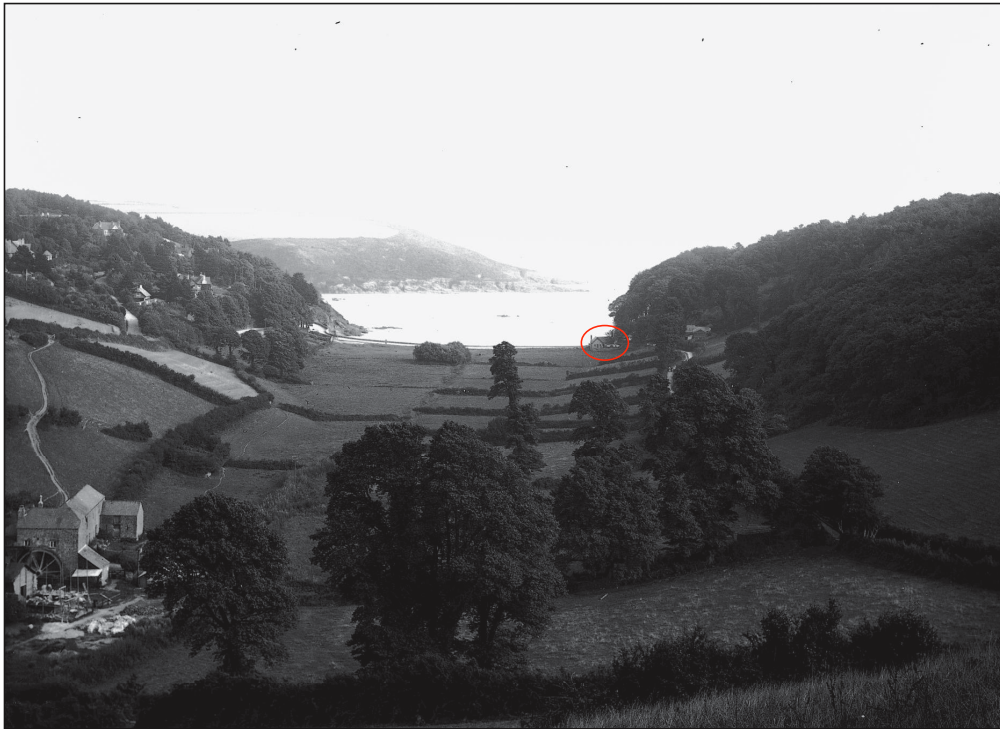
Plate 4: Postcard captioned 'North Sands and Bolt Head, Salcombe'. View from Sandhills Road, looking down to the beach, 1910-1930. Cable Cottage is circled in red. (P1400.8.16 (P2172a) - Cookworthy Museum)

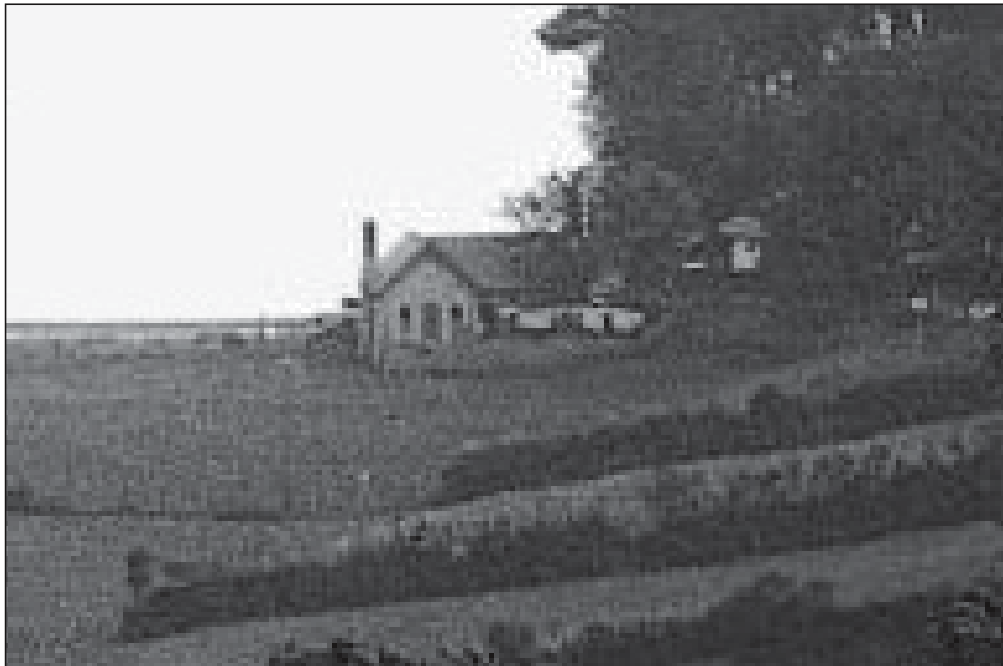
Plate 5: Postcard captioned 'Salcombe - North Sands Valley'. No. 197. Looking down the valley towards the sea , with Hanger Mill in the foreground, with the waterwheel visible and building work going on. 1910-1930. Cable Cottage is circled in red. (P1400.8.11 (P2167a) - Cookworthy Museum).
