# THE CHAPEL LOWER ALSWORTHY FARM BRADWORTHY DEVON

Results of a Desk-Based Assessment  
&  
Archaeological Building Recording

Report No.: 100803  
Date: 03.08.2010  
Authors: T. Green  
C. Humphreys

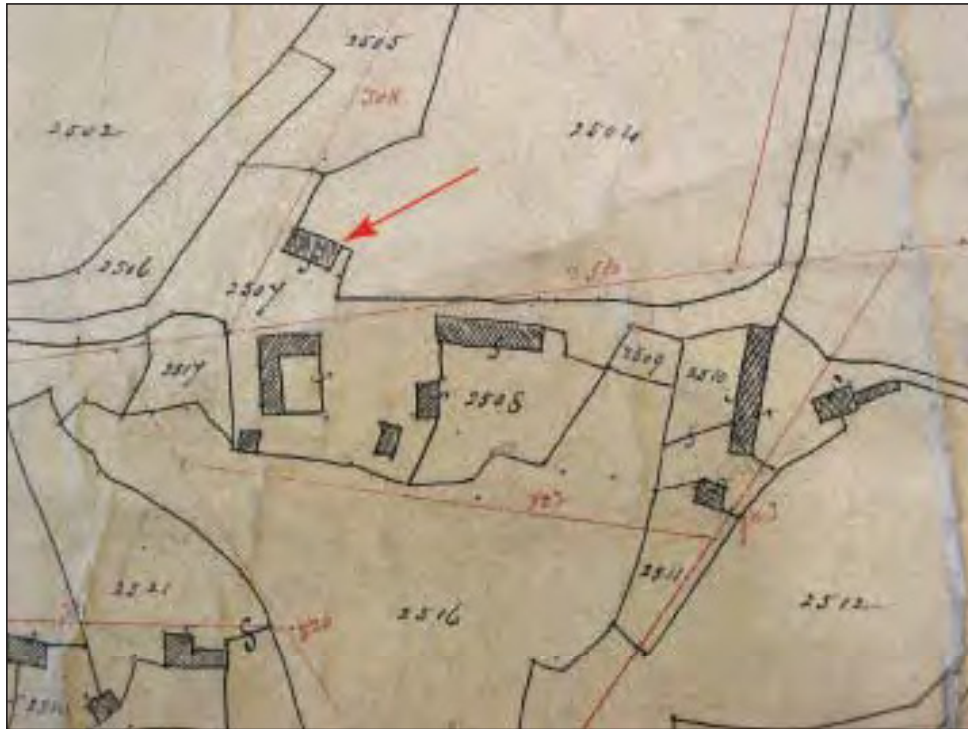
Fig. 2: Extract from the Bradworthy Tithe map of 1843 (DRO). The chapel is indicated.

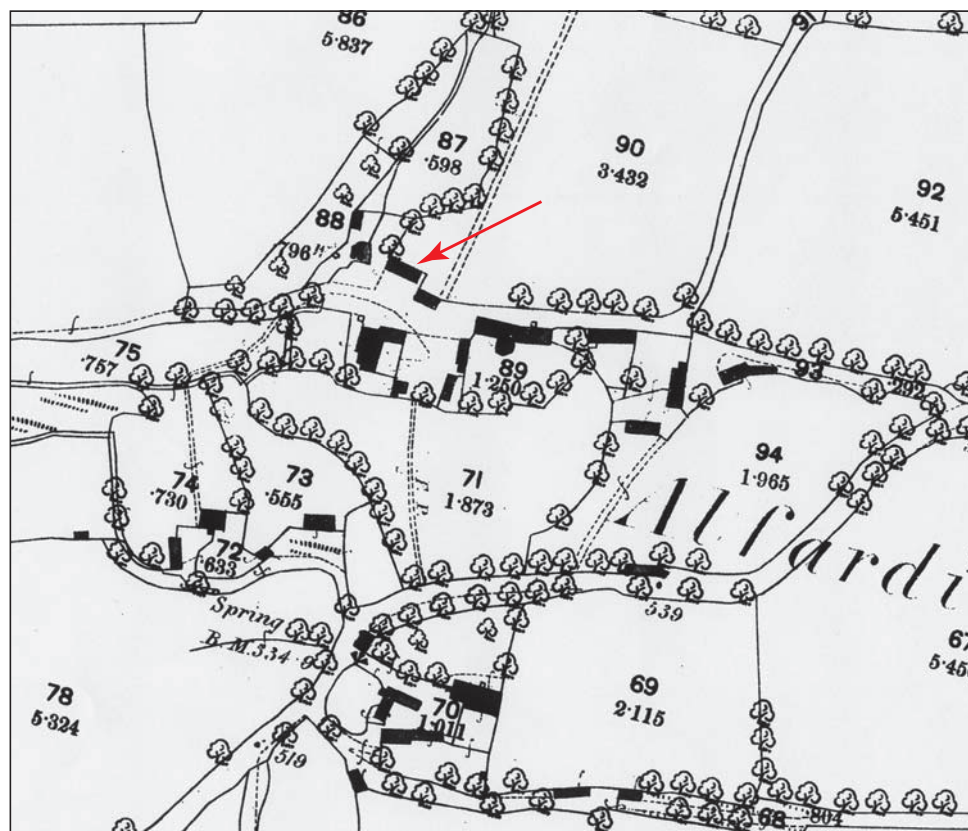
Fig. 3: Extract from the Ordnance Survey First Edition map at a scale of 25 inches to one mile, published 1891 (courtesy West Country Studies Library).

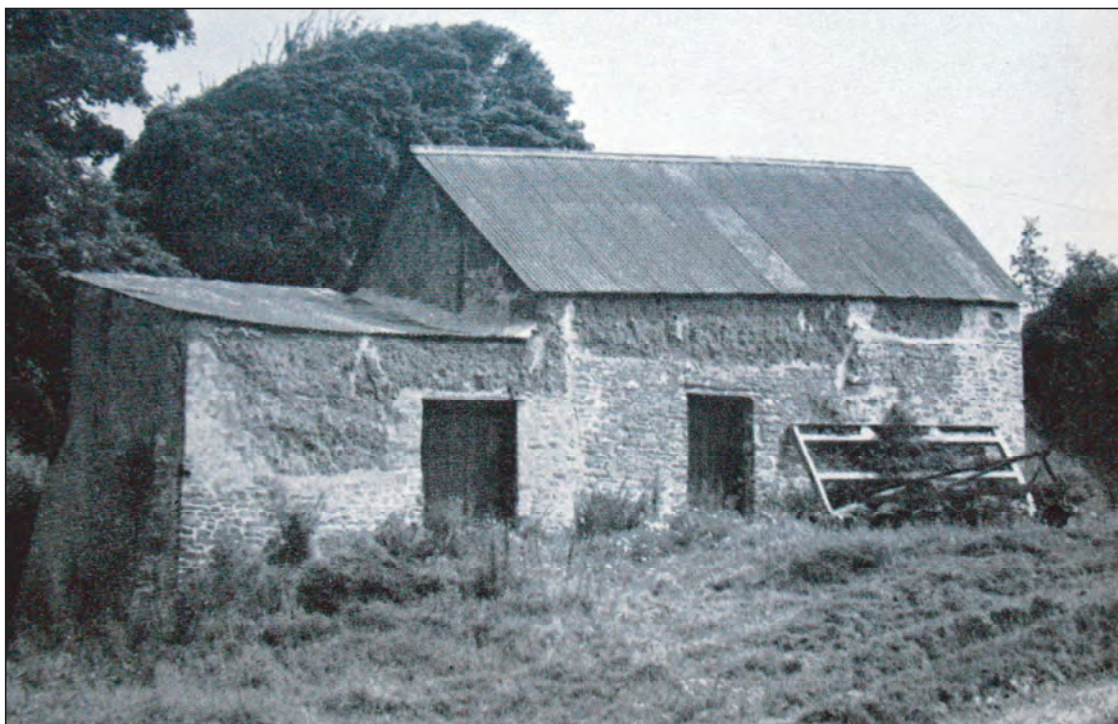
Plate 1: The chapel in the 1970's with the possible priest's dwelling still in place.  
(From Seymour 1977, Photo by M.Leach.)

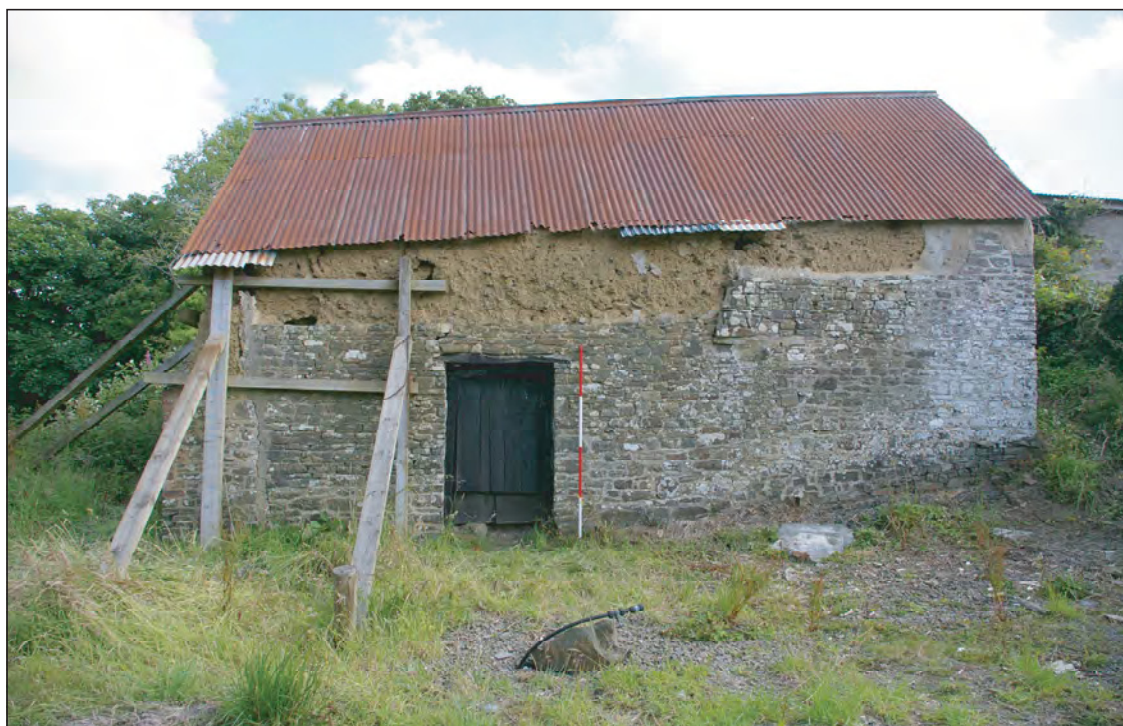
Plate 2: The chapel before conservation, viewed from the south.
