# THE OLD GAOL SOUTH MOLTON DEVON

Results of a Desk-Based Study  
and  
Historic Building Survey

Report No.: 100128  
Date: 16.02.2010  
Authors: T. Green  
C. Humphreys  
D. Laing-Trengove

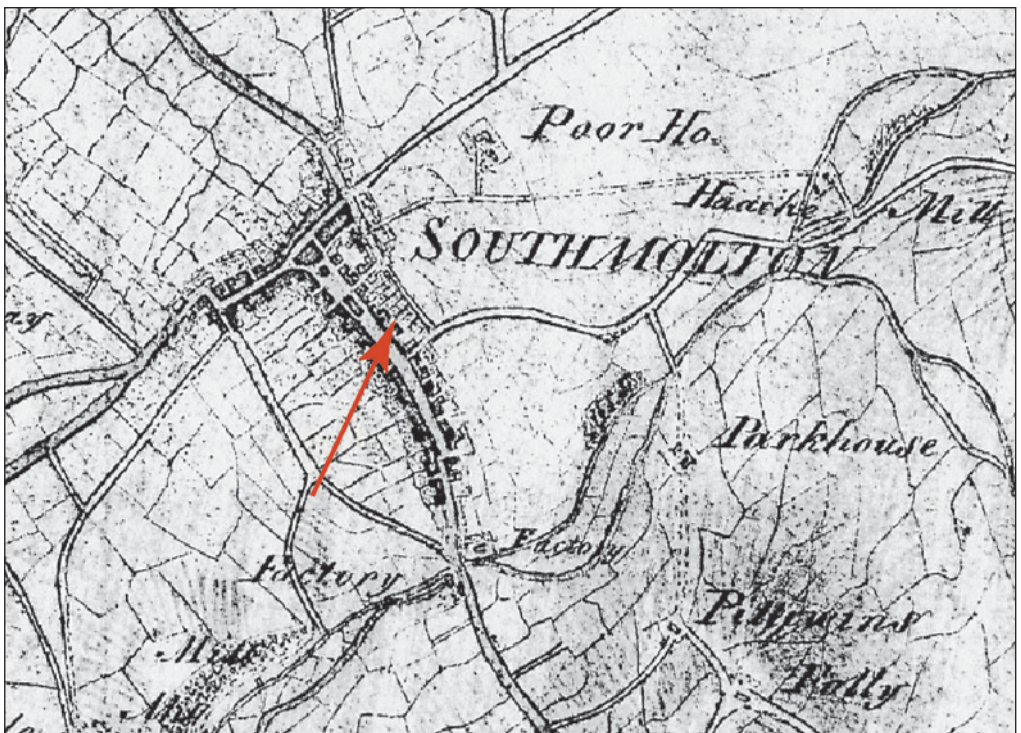
The earliest mapping that provides any detail is the Ordnance Survey Surveyor’s draft map of 1802 (Fig. 3). This appears to show the long burgage plots between East Street and North Street with what appears to be a fairly substantial building on the corner of East Street and what is now Station Road. Normally the tithe map of *circa* 1840 provides the earliest useful cartographic detail. Unfortunately in this case the South Molton tithe map of 1844(?) (Fig. 4) which ought to show the gaol, is lacking in detail, all the buildings on East Street being bundled together as “Part of the Town” (number 2235 on the tithe map). Not until the production of the Ordnance Survey First Edition 1:2500 map of 1889 (Fig. 5), do we clearly see the shape of developments in this part of the town. The gaol is visible as a long building with an E-W axis to the rear of the houses on East Street. To the north of the gaol is apparently a garden. The Ordnance Survey Second Edition 1:2500 map published 1904 (Fig. 6) shows essentially the same.

Fig. 3: Extract from the Ordnance Survey Surveyor's Draft of 1802. The (future) location of the gaol is indicated. (WCSL)

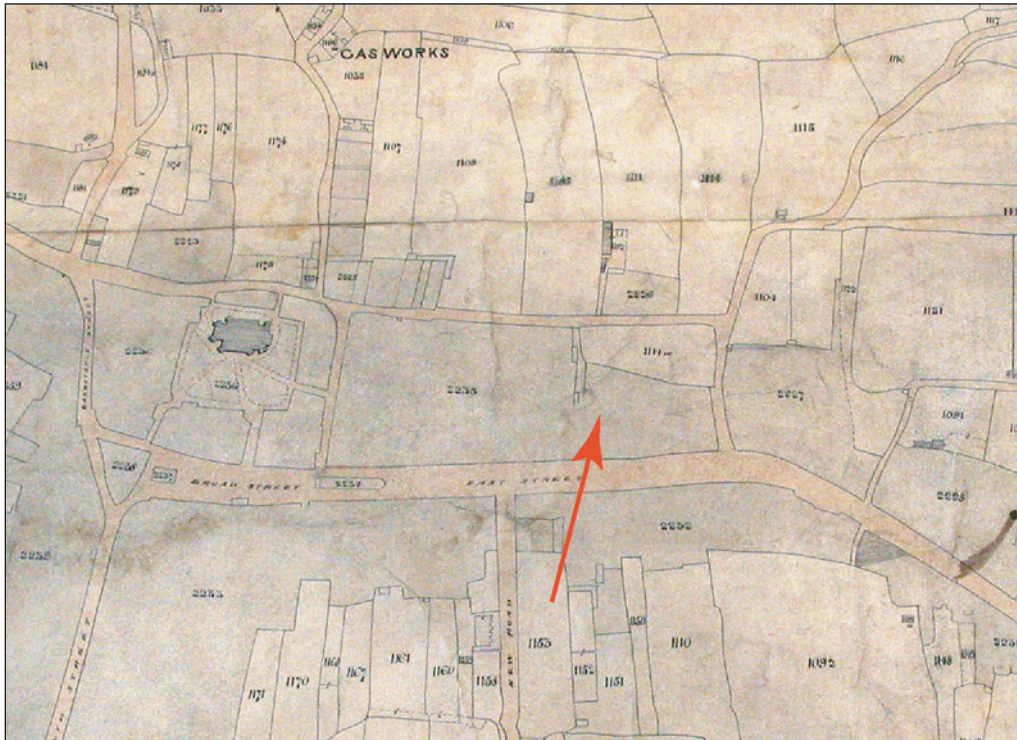
Fig. 4: Extract from the South Molton tithe map of 1844(?). The location of the gaol is indicated. (DRO)

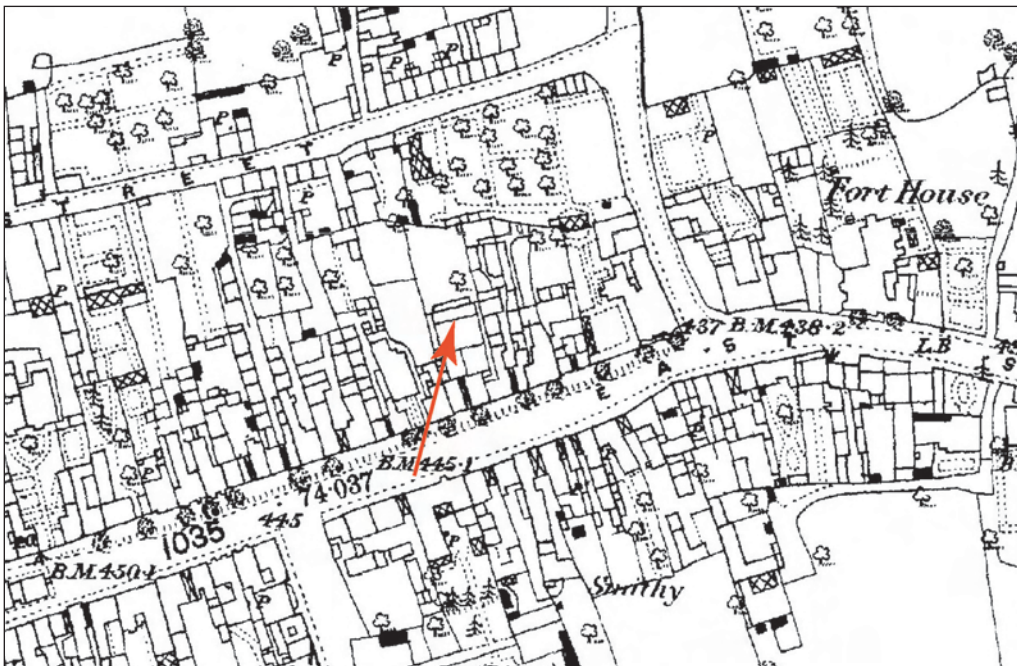
Fig. 5: Extract from the Ordnance Survey First Edition map at 1:2500 published 1889. The location of the gaol is indicated.

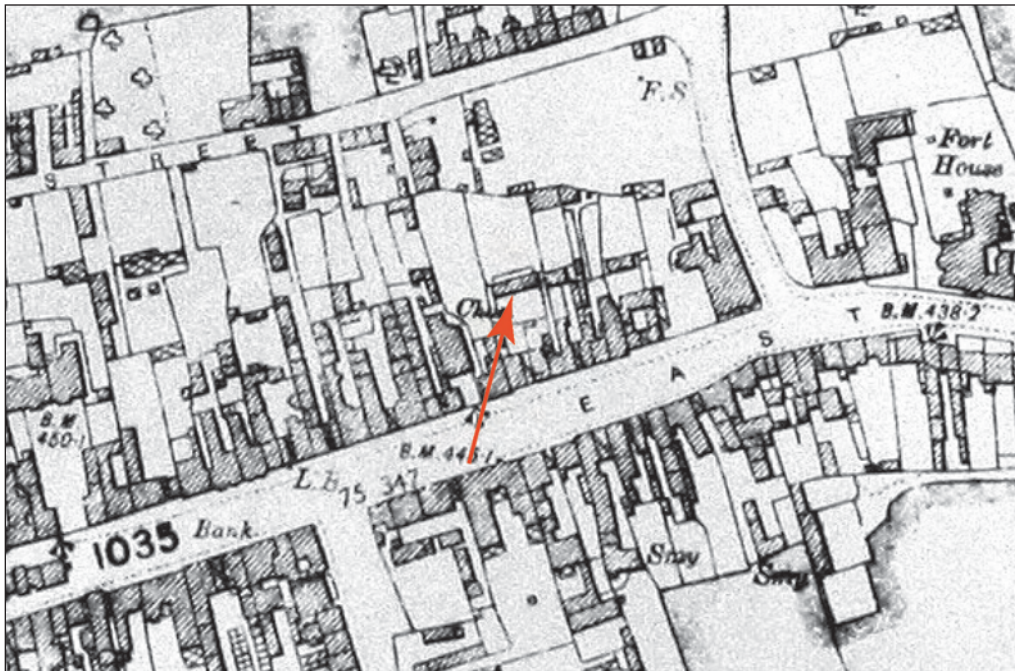
Fig. 6: Extract from the Ordnance Survey Second Edition map at 1:2500 published 1904. The location of the gaol is indicated. (WCSL)

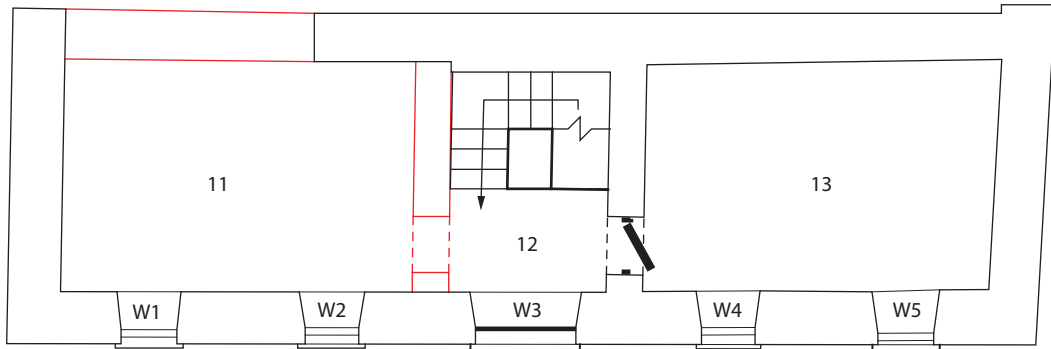
Fig. 7: The ground and first floor plans of the Gaol (prior to recent building works).

The room numbering system is not sequential. Ground floor rooms are numbered 1-6, first floor rooms are numbered 11-13.

Walls in red removed prior to recent conversion work

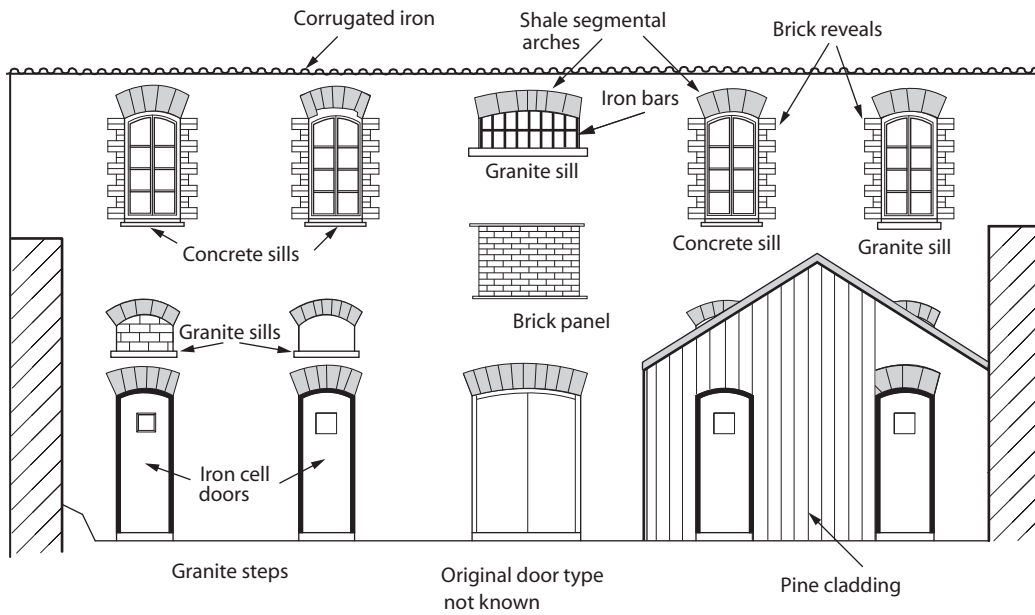
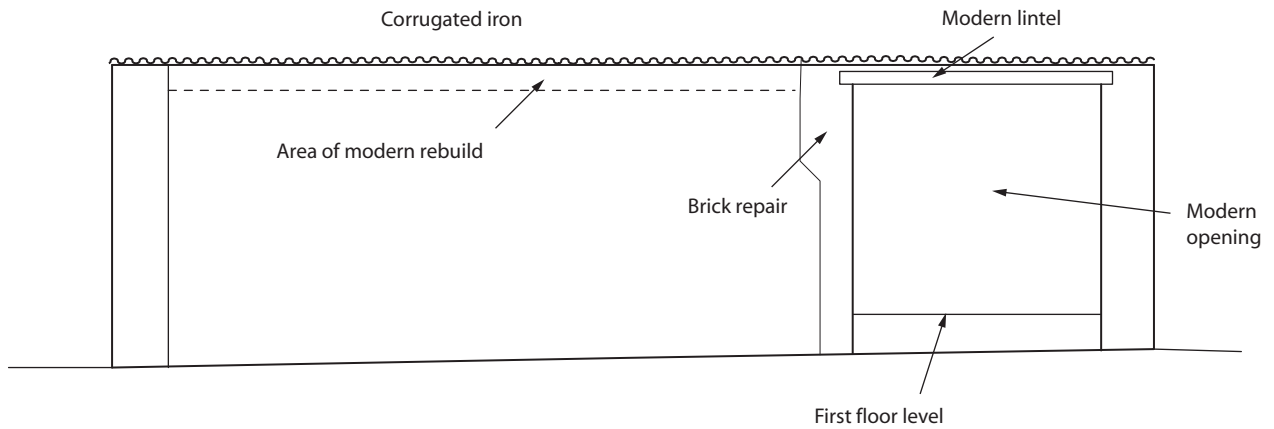
Fig. 8: The north and south elevations of the Gaol (prior to recent building works).

Only the south front elevation is fenestrated, with symmetrically placed openings to ground and first floor. With a large central door opening and two evenly spaced cell doors with window openings above to east and west at ground floor level and five windows at first floor level. All openings have shale segmental arches and the first floor windows have machine made brick quoins, timber lacing is visible to top and bottom of the ground floor door jambs. All cell doors are original but the larger central opening has a modern door and frame. Above the central door is a rectangular section of brickwork, set flush to the wall face and apparently set between slim slate lintels, which was possibly formerly a recess to hold a name and/or date plaque. Each door opening appears to have formerly had two granite steps, with the upper forming the threshold. To the west D1 has the former sill of a first floor window reused here as the lower step (see 3.3.2. below). The central (W3) and easternmost (W5) windows being the only openings at first floor level still retaining the original sills in situ. All original sills and steps are of granite. There is an open fronted timber summerhouse, possibly a reading room added in the later 19<sup>th</sup> century, now with a pitched modern corrugated sheet metal and plastic roof, abutting the east end of the south elevation and closing the cell windows at this end. Here the building has been clad in pine planking to the interior of the summerhouse (described below).

The first floor north elevation has been partially rebuilt in concrete block and refaced with stone rubble on the exterior face at the west end where an opening had formerly been forced through with brick quoins to the east and rebuilt stone rubble to the west (see Fig. 8). At the east end there is a blocky stone buttress.

A south facing, two storey, purpose built goal set in a walled courtyard (Fig. 1c yard 3) to the rear (north) of 22-23 East Street and built into the slope to the north to first floor level. Access to the existing courtyard and gaol was formerly from either of the two still extant yards (Fig. 1c. yards 1 & 2) set between the gaol and 22-23 East Street to the south (The yards were not subject to survey). The opening from the eastern yard (2) is now blocked with hand-made bricks and stone rubble. Yard (1) has a number of small outbuildings located on it's western side which may have provided ancillary accommodation or facilities such as water for the inmates. The Old Gaol building has recently undergone some renovation and conversion works but the ground floor has been largely unaffected by these works. Photographic evidence dating from before the current works show that the building was extremely overgrown to the south and had suffered some damage to the north at first floor level where a large opening had been forced through. The building was also roofed with a single pitch corrugated iron roof (as illustrated in Fig. 8).

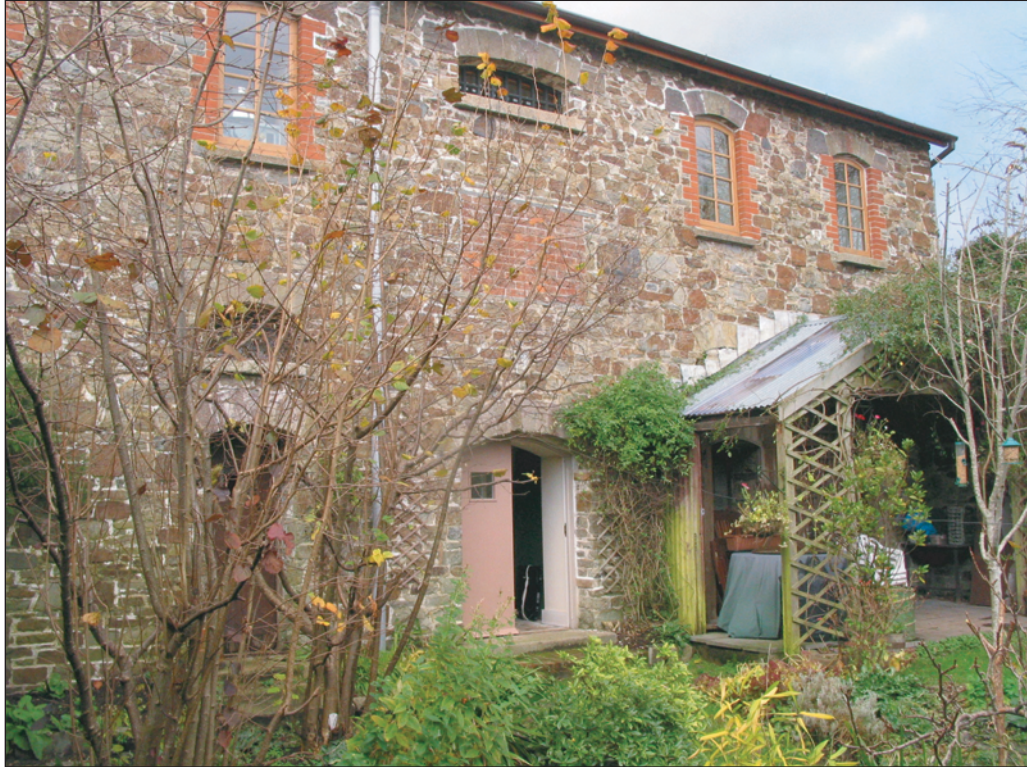
A rectangular two storey building of semi-coursed blocky mixed (sandstone and shale) stone rubble with creamy lime pointing and with a recently added modern pitched slate roof and modern windows at first floor level.

Plate 1: The east end of the south front of the Gaol viewed from the south.

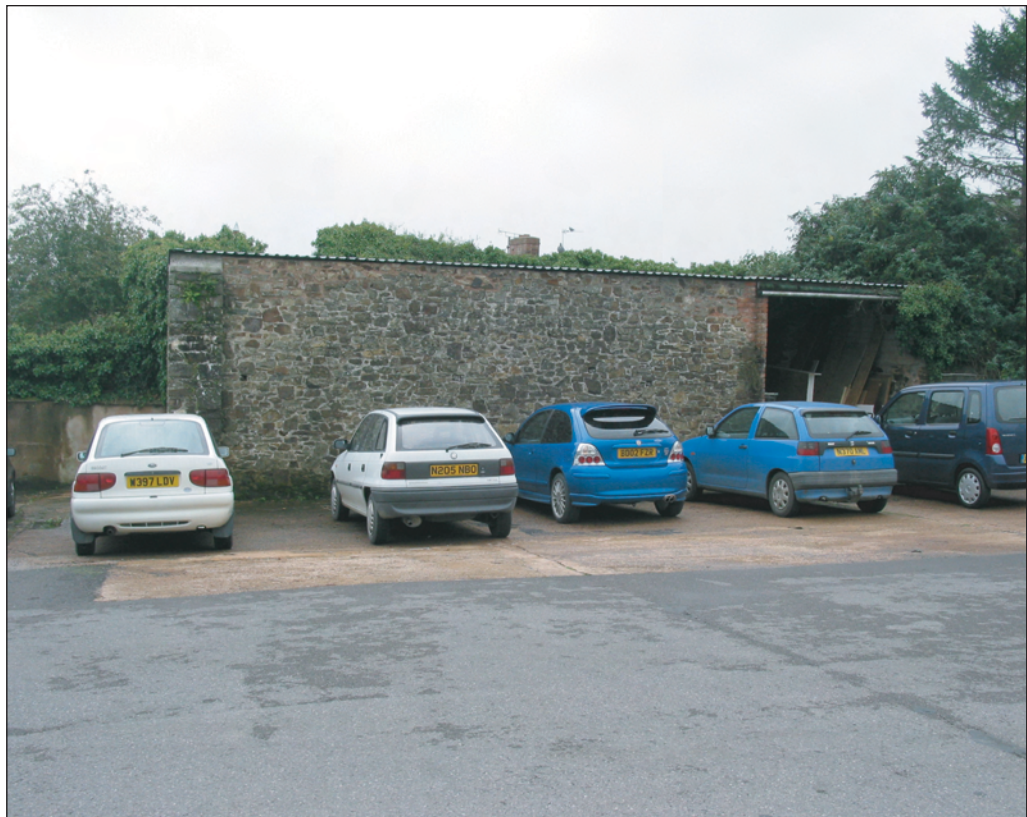
Photographic evidence from before the start of the most recent works show the south front of the building almost completely obscured by a thick, potentially damaging cover of ivy. This has now been completely removed.

Plate 2: The Gaol viewed from the north east, prior to recent building work.

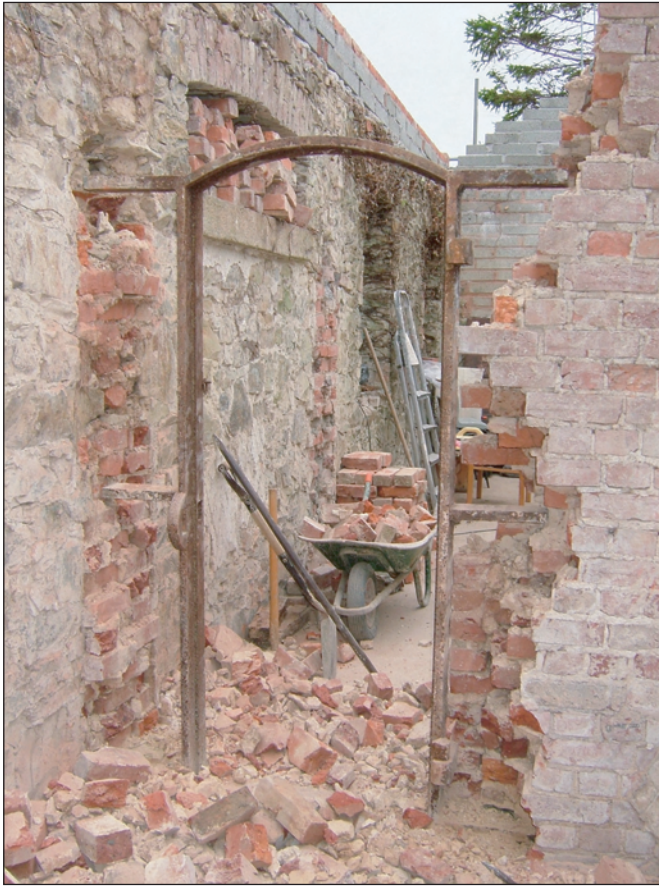
**Door:** Modern. Formerly (from photographic evidence - see Plate 3) the door was set in an arched heavy iron frame to the south end of the west wall, and was as the cell doors below on the ground floor, heavy and reinforced. A door, probably formerly opening onto a first floor room but now removed and stored in the summerhouse, has the lock and handle to the exterior but no opening or mesh. This has the word 'armoury' with some illegible text below (possibly VBDR) painted on the centre of the upper portion and probably relates to a later use of the building (Plate 4).

Plate 3: The removal of the secure doorway to room (13) viewed from the east.

In recent decades much of the first floor had been destroyed by the operations of Mole Valley Farmers. One of the internal walls and a section of the rear north wall had been removed and the central staircase filled with rubble. The north wall has now been rebuilt and the staircase cleared with the rail and ballisters restored and reset. Although the refurbishment has meant the removal of the strong door from the first floor room (13), the door and the frame have been retained.

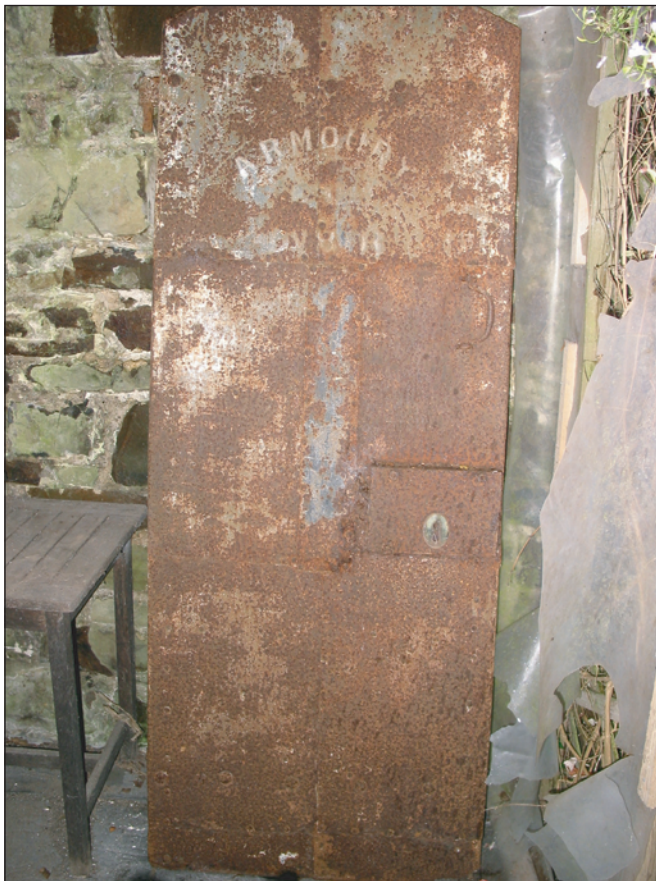
Plate 4: The door removed from room (13).

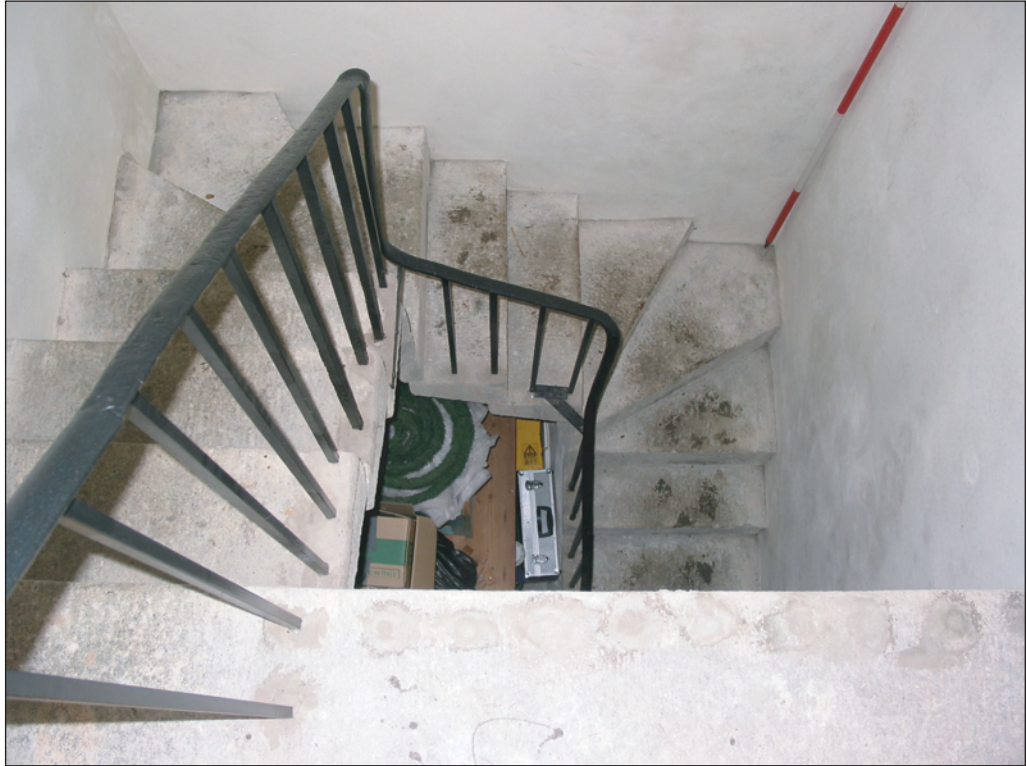
**Stair:** A dogleg stair, with granite steps set into the wall with flat treads, cut obliquely to the underside. With a wrought iron rail to the stair with squared ballisters and volute set into the bullnose lower step. The stairs were formerly whitewashed to the underside.

**Floor:** The top of the stair rests on the west end of a large granite lintel set at the former floor height. To the east of the stair is a row of scars where the ballisters were formerly inset into the lintel. These are now set into the modern pine floor which is raised above the former floor level.

Plate 5: The stairs viewed from above. (Note the scars along the edge of the granite lintel).

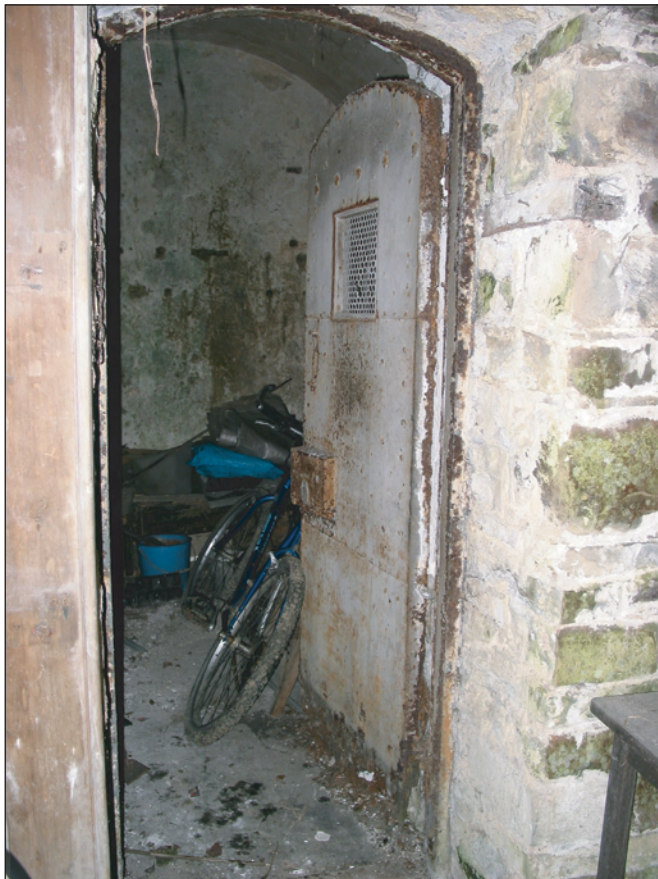
**Doors:** The doors to the cells are set back in the arched openings almost flush with the interior walls. The doors are all roughly the same, with that to the far west differing slightly (see below). The doors to the cells to the east (D4 & D5) are better preserved; less corroded and still hold a covering of grey paint (see Plate 6), having been protected from the weather by the addition of the summerhouse at this end of the building. All doors are constructed of wood, possibly oak, encased in riveted iron sheets with a central opening in the upper portion with a slim bead frame and a perforated zinc mesh. The doors sit in heavy iron frames built into the rubble stone jambs, and hang on long, heavy strap hinges fixed to the inside width of the door to top and bottom, with a heavy lock and metal pull handle to the exterior. The cell door to the west (D1) differs in that the central opening is smaller and contains a simple wooden door rather than mesh, the lock is also fixed to the inside of this door rather than the exterior, but scars to the exterior suggest it has been moved.

Plate 6: The doorway to cell (5) viewed from the south west.
