FISHLEIGH HOUSE HATHERLEIGH DEVON

Results of a Desk-Based Assessment,
Historic Building Recording & Archaeological Monitoring

Report No.: 101111
Date: 11.11.10
Authors: L. Bray
C. Humphreys
B. Morris

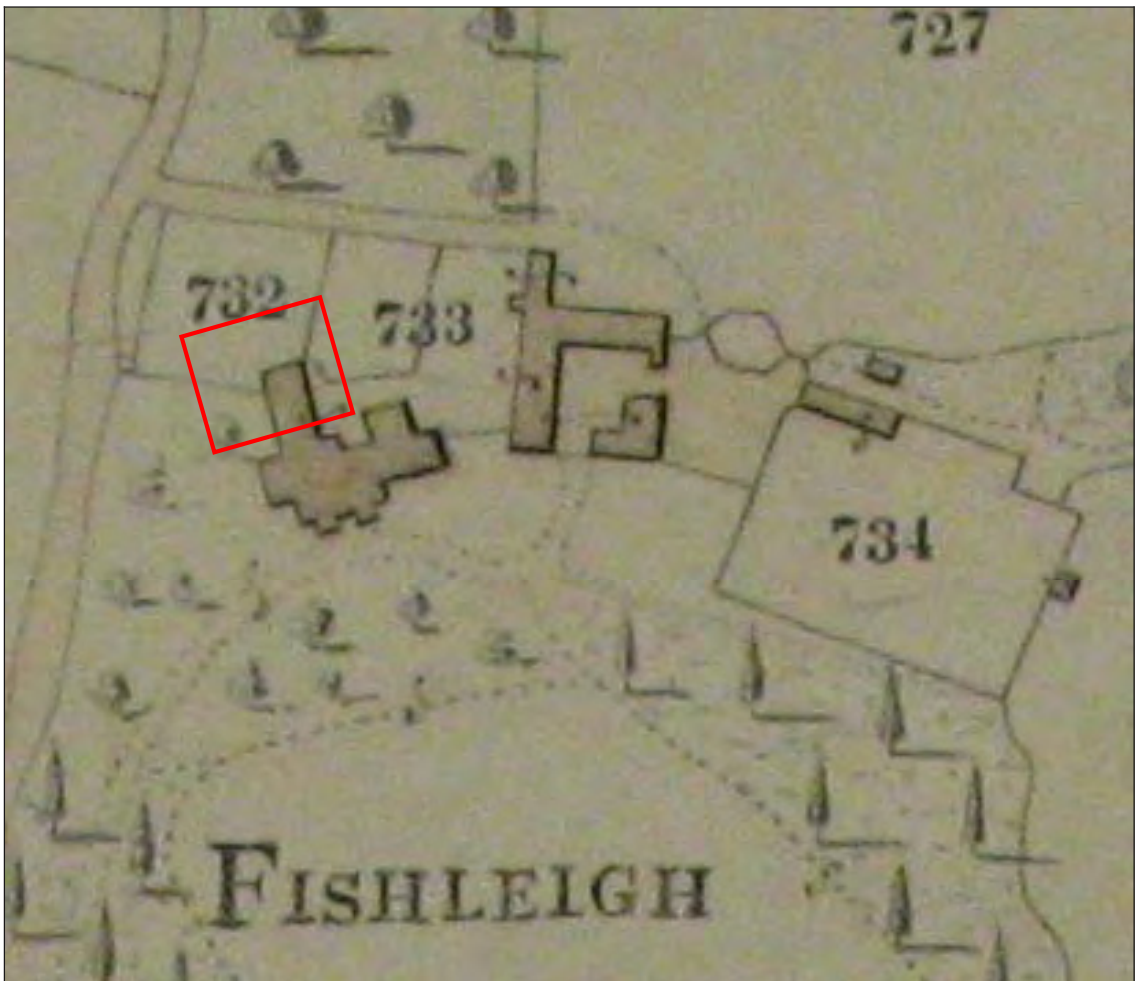
Figure 4: Detail from the Hatherleigh tithe map, showing the area of the development and the wing to be demolished (DRO).

The Hatherleigh tithe map of 1839 (see Figure 3 & Figure 4) shows a familiar suite of domestic and non-domestic buildings. The wing to be demolished is clearly shown as one build with the house, although the Hatherleigh map is not colour-coded as Devon tithe maps often were (with domestic buildings in red/pink and non-domestic buildings in grey).

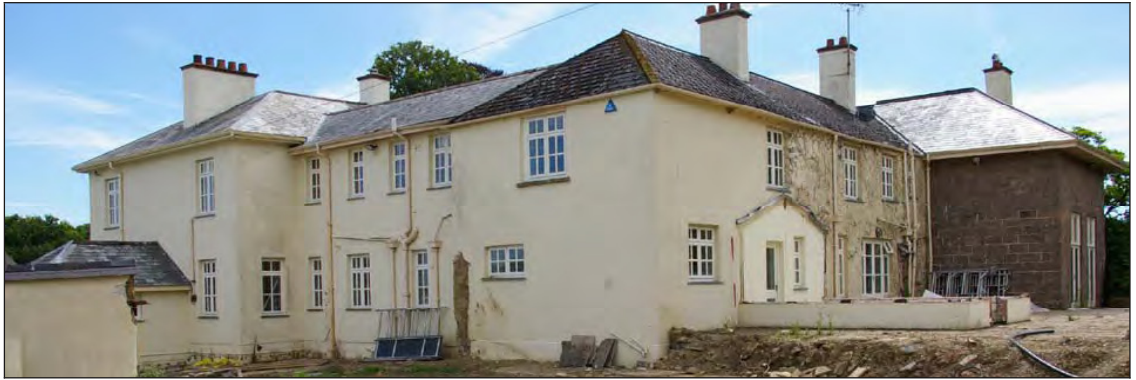
Figure 8: Fishleigh House, the north-west elevation.

This building survey is limited to the wing of the house subject to demolition (Figure 7 & Figure 8). The rest of the house is heavily modified but appears to be largely 18th century in date, although the nearby DoE Listed barn (Appendix 3) contains heavily chamfered and stopped beams that may have come from an earlier building on the site.

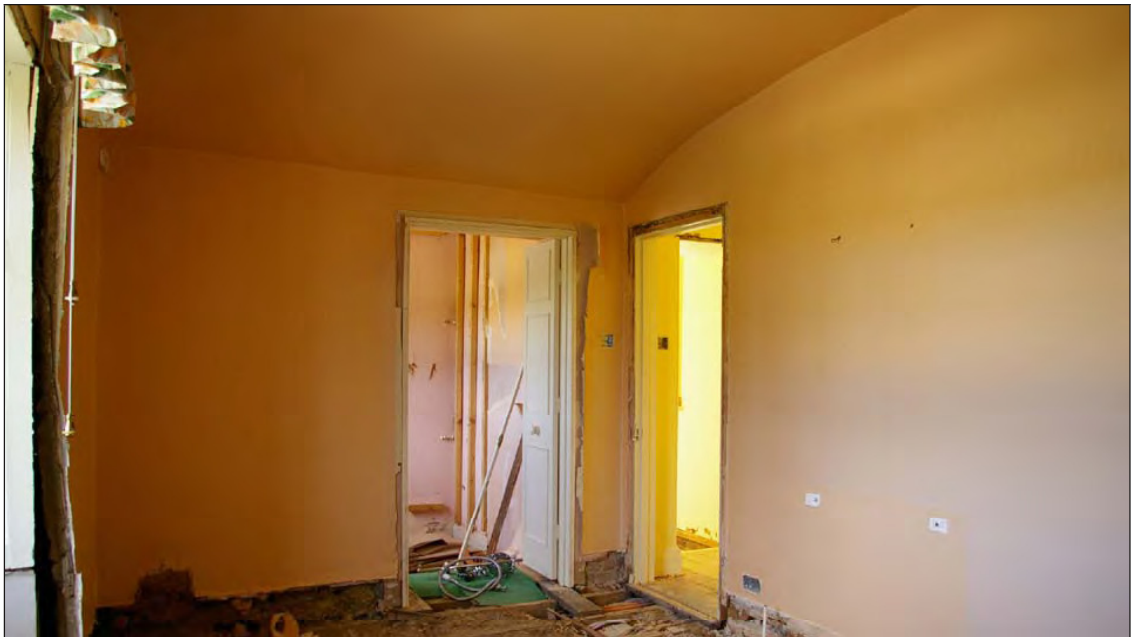
Figure 9: Room 5, viewed from the north-west. Note the curving ceiling.

3.3 First Floor (Figure 7 and Figure 9)

A corridor gives access to two bedrooms (Rooms 4 & 5) and the modern extension to the north-east. The hallway and both bedrooms have been created through the subdivision of a single larger chamber with a lath-and-plaster ceiling that curves downwards to the south-east, south-west, north-west and north-east. The partition walls of this area are all modern.

The windows and doors are all modern. A cupboard in Room 4 has a panelled door with 2 plain panels below and a single plain panel above, and is probably mid 19th century in date. The splayed window that faces onto the courtyard – formerly fitted with shutters – has panels with stepped ogee moulding; two to the shutter door, one below shutter, one large panel below the window and one closing the soffit.

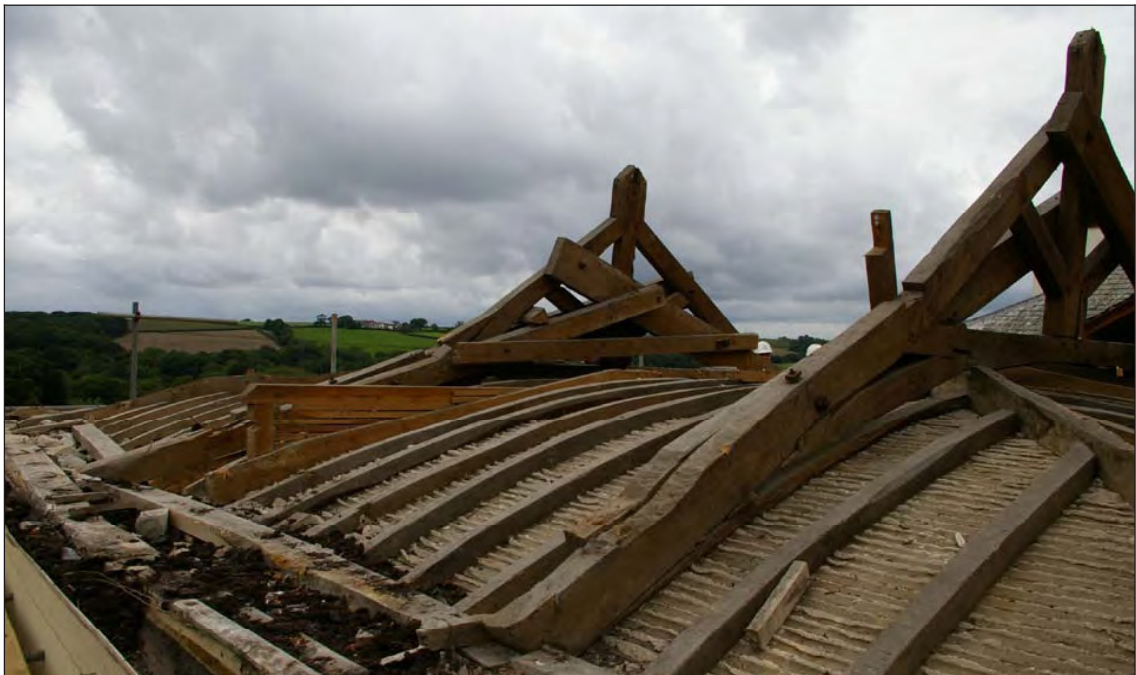
Figure 10: The ceiling and roof structure above Rooms 4 and 5, viewed from the south-west.

3.4 Roof Structure (Figure 10, Figure 11 & Figure 12)

Pine kingpost trusses with mortice and tenon pegged joints sit over the 20th century extension. In the earlier wing, are a pair of early 19th oak kingpost trusses, pegged and bolted, with indications that the north-eastern end of the roof was hipped. These trusses have failed and sagged, pushing out the wallplate on the western side. Subsequently repaired and strengthened with bolted pine additions, the roof line has been raised, probably when the 20th century extension was built.

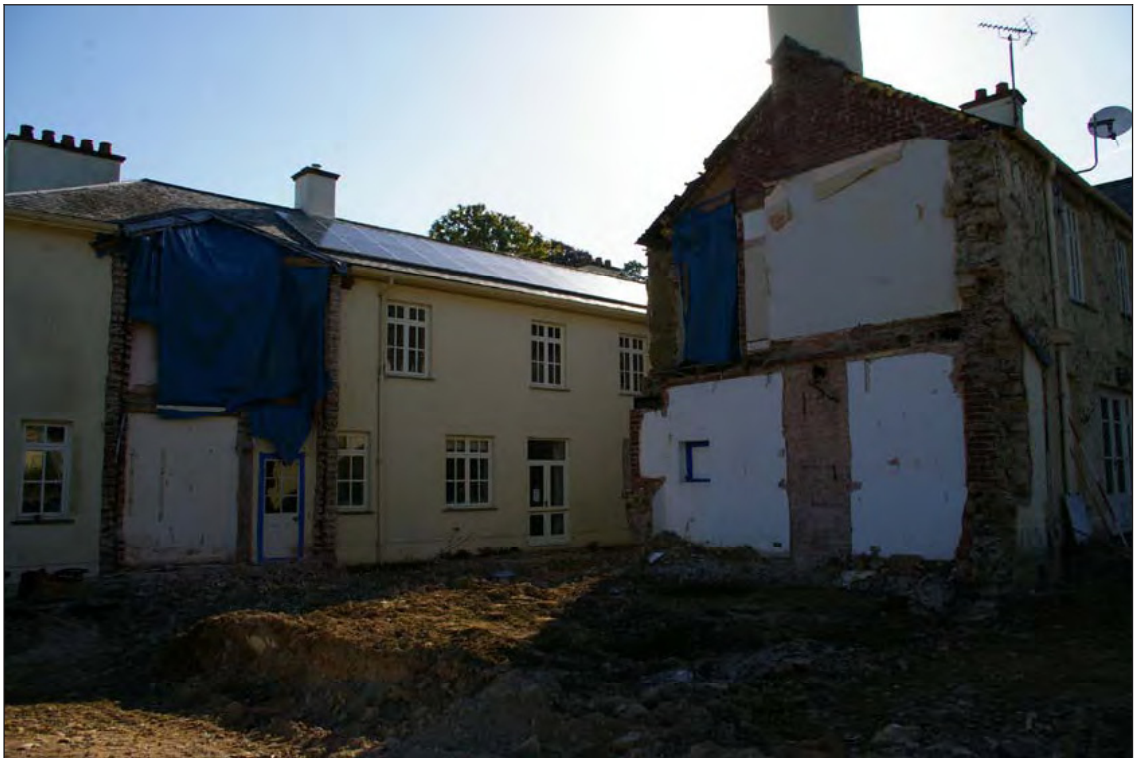
Figure 14: Fishleigh House, following the demolition of the wing and 20th century extension, viewed from the north-west.

Based on the archaeological evidence, the demolished section of the wing at Fishleigh House was probably built in the mid-late 18th century. It formed part of a larger space (Room 1+) with an integral service room (Rooms 2/3) and entrance to the north. This structure may or may not have been domestic in character. At some later date – and perhaps contemporary with the early 19th century curving ceiling and the kingpost roof-trusses – the wing was raised and was incorporated into the domestic house.
