# HIGHER PATCHOLE FARM KENTISBURY DEVON

Results of a  
Desk-based Assessment  
and Historic Building Survey

Report No.: 100416  
Date: 15.6.2010  
Author: T. Green  
C. Humphreys

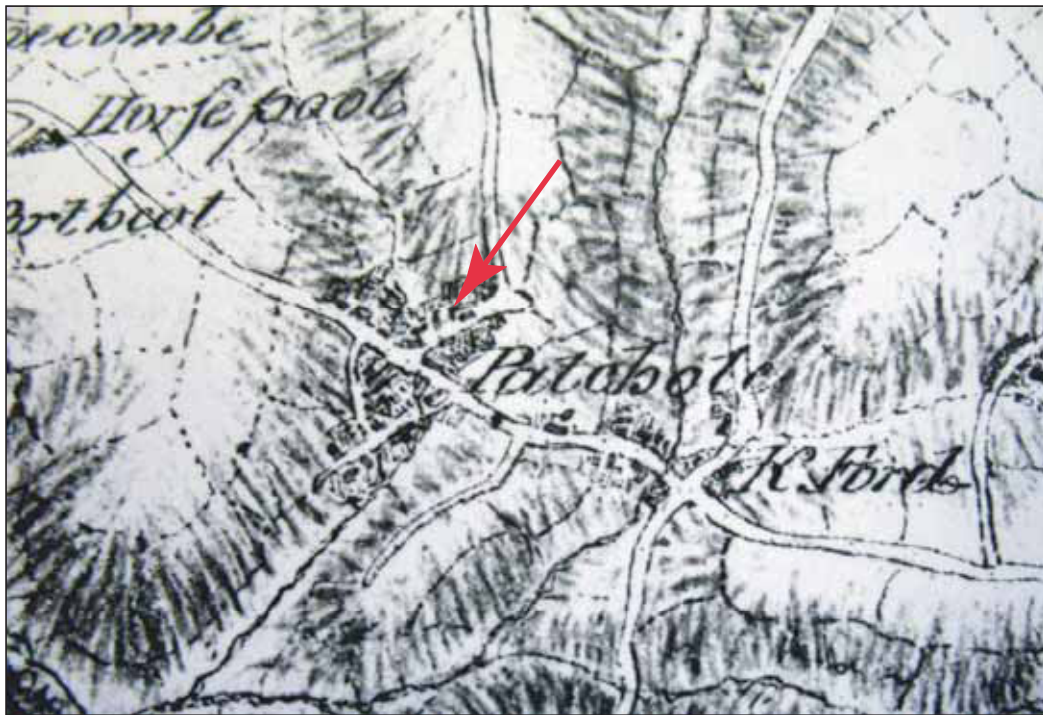
Fig. 2: Extract from the Ordnance Survey surveyor's draft c.1805. Higher Patchole is arrowed. (WCSL)

This is the earliest available cartographic record of Patchole. Here the hamlet is sketched in, giving a rough idea of the lay-out at that date, but it is not clear enough to provide any evidence of the configuration of the buildings.

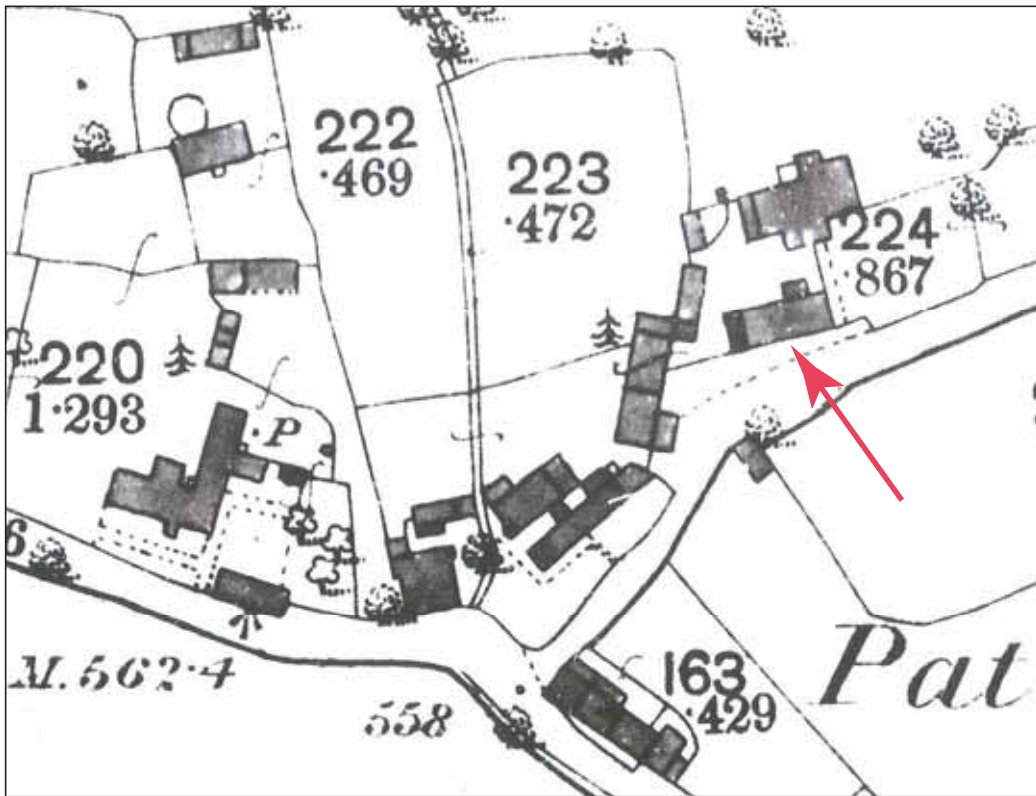
Fig. 4: Extract from the Ordnance Survey First Edition map at 1:2500 (Devonshire sheet 6.9), surveyed 1886, published 1889. Higher Patchole threshing barn is arrowed. (WCSL)

This provides evidence of change during the mid-19<sup>th</sup> century. The symmetrical plan of the house has been considerably altered, having been extended westwards, gaining what appears to be a second porch, an outshut to the rear and a separate element at its west end. The outbuilding to the south has possibly been extended and now has a projecting bay on the north side. On the west side of the yard it appears that the original long range has been demolished or reduced. In its place is a shorter and narrower rectangular building with an internal division at its southern end. In the north west corner of the yard there is now a small rectangular building. On the east side of this building the cartographer has drawn a line demarcating a quadrant which *may* indicate the presence of a horse engine.

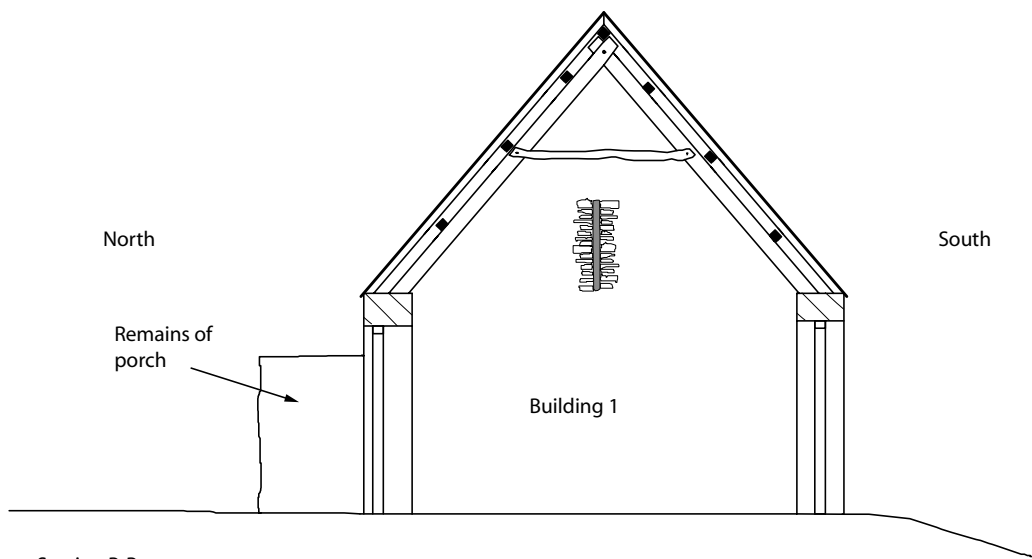
Fig.10: The Threshing Barn and attached buildings (Buildings 1,2 &3), cross-sections.

**Roof:** Five A-frame trusses of semi-squared round wood, with the truss blades and collars slightly waney and each apex clasped and pegged with a single square peg projecting from the faces. The blade ends project slightly beyond the joint to clasp the diamond set ridge pole, which is scarfed at the joints. The collars are spiked to the blades, with two sets of purlins per side, staggered on the backs of the blades. The waney common rafters are reset, as they do not match the peg-holes in the purlins. With short stemmed straw thatch, spiked and tied to waney split oak battens, with some split round wood battens, possibly of ash.

The truss blades sit on short timber pads in the wall tops, set on top of stone walls with cob surrounding the common rafter ends. This means that the cob belongs with this roof structure, which could be later than the stone walls. Some purlins have formerly scarfed ends and they and some common rafters have peg holes which do not relate to the present structure.

The small quarter hip structures are contemporary with the common rafters of the roof. The western hip is larger with a central principal blade nailed to the angled end of the ridgepole, with two angled sub-blades, nailed to the sides of the principal near the top. With wide split oak battens nailed on the backs, the common rafters of the main roof are nailed to the backs of the sub-blades. All three blades are set in cob on the wall top. The eastern hip structure is smaller, the design as above, but all three blades clasp the down-turning end of the waney round wood ridgepole. All truss feet have had short horizontal stiffeners added, passing through cob wall tops. The second truss from the west has a lower tie beam, bolted to the east face of the blade, with two posts, coach-bolted to the west face, down to the floor. The purlins appear to be elm, as possibly is the rest of the roof. The purlins and the cob date from around 1650-1700 and the trusses etc probably from c.1750 – 1800.

**Walls:** The walls are of clay-bonded slate rubble, founded onto the natural bedrock (exposed on the outside at the west end where the yard surface has eroded). The interior faces are flush pointed with lime mortar. At the tops, the cob has traces of smooth plaster, sloped away from the wall face. The west wall is not white washed, except at the top, where the plastered cob survives as on the side walls. The east end wall is flush pointed in lime, but only up to the eaves, with bare masonry above. The north and south walls east of the threshing floor are flush pointed with lime mortar. The north and south walls of the area west of the threshing floor are smooth rendered in lime plaster, with straw in the mix, and whitewashed. (The plaster on the cob wall above appears to be secondary here). These two wall surfaces are broken into by the flush pointing of the west end wall which projects a short distance into the side walls. This change does not show on the outside, due to the flush pointing (probably of the same date) all round the west end and the north and south side walls.

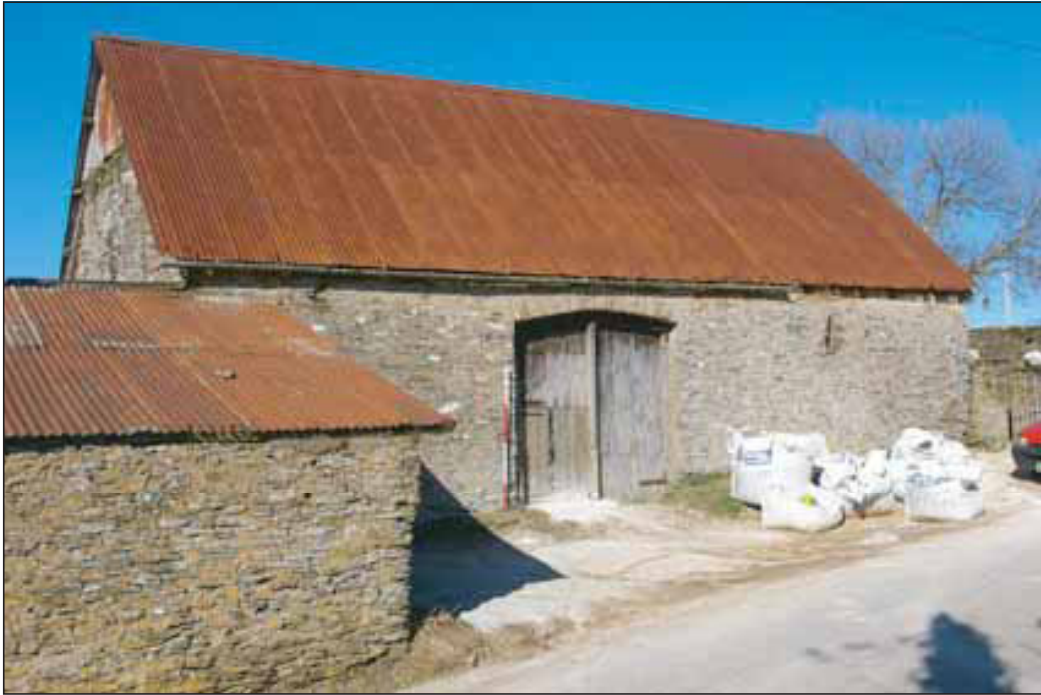
Plate 3: The Threshing Barn (1) viewed from the south.

With single large, arched doorways to north and south of the threshing floor and with single slit windows facing north and south lighting the barn to the east of the threshing floor. A similar tall slit window is set higher in the east gable, with a shorter, possibly later, window in the west gable. The west gable has a corrugated iron triangle filling the top, indicating the position of a former quarter hip, with the same at the east end.

The walls of the barn are of clay-bonded, with semi-coursed small slate rubble with some lime pointing. The last 30-40cm at the tops of the walls and rising up the roof slopes at the gables is in cob, typically patched with stone. Short lengths of timber lacing at the eaves support the rafters.

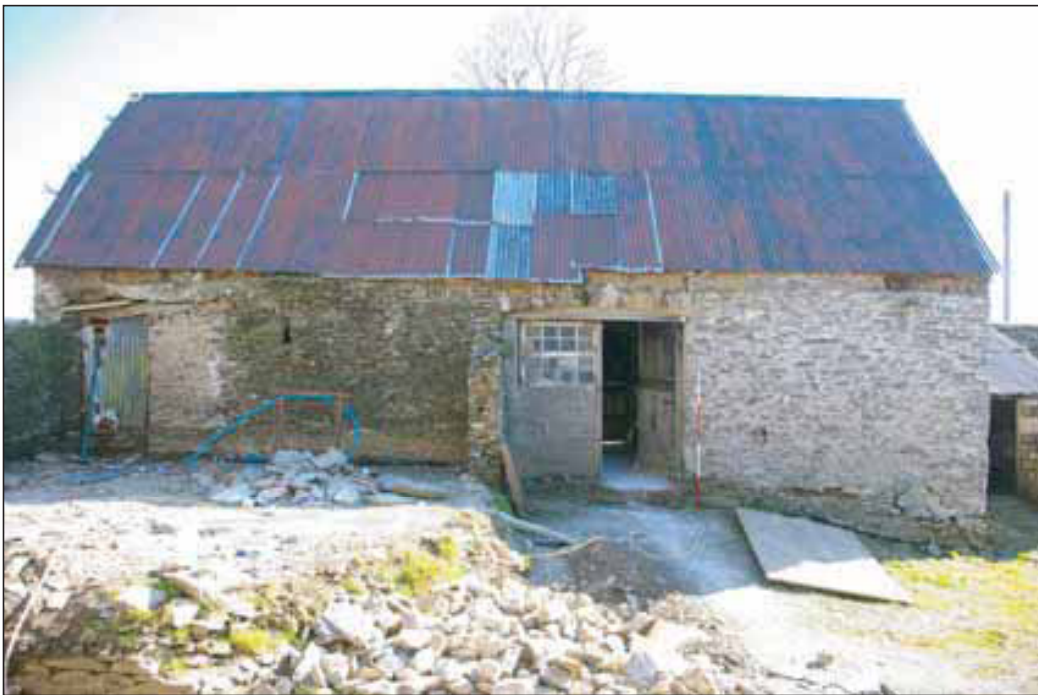
Plate 4: The Threshing Barn (1) viewed from the north.

A rectangular single storey barn with the threshing floor slightly west of centre, with relatively high eaves and gabled to east and west. The truncated remains of a substantial horse engine house on the north side projects into the yard immediately east of the north door. This abuts the north wall of the barn and appears to have abutted the garden wall to the east. The majority of the horse engine survives only as a low plinth with angled corners to the north. The horse engine base abuts the remains of the cheek wall of the north porch of the barn, which in turn abuts the north wall of the barn.

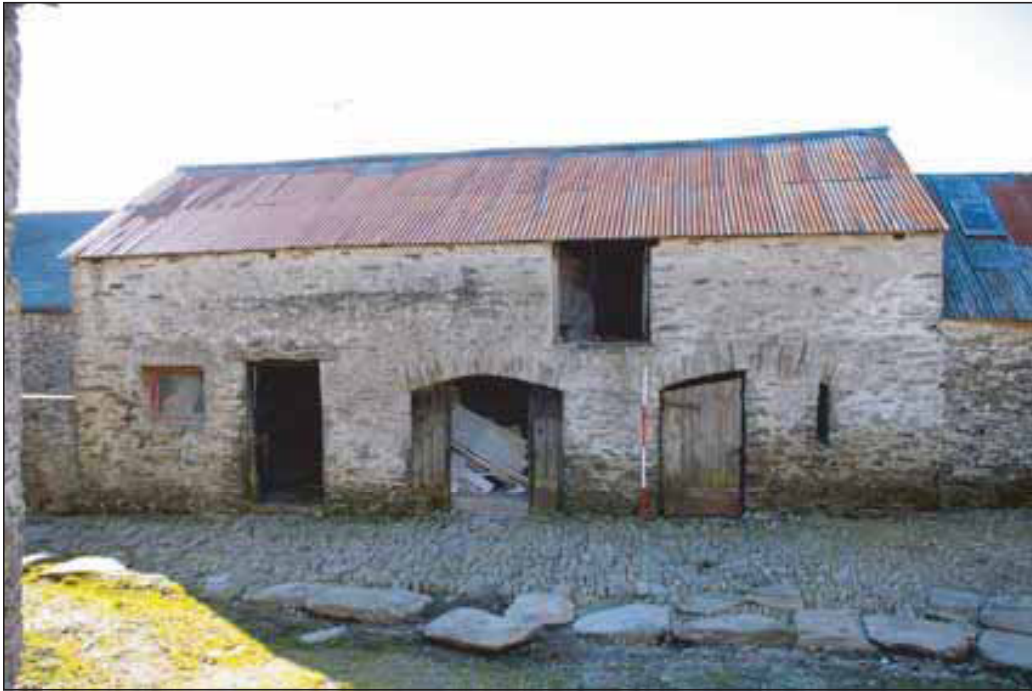
Plate 5: The Shippon (5) viewed from the west.

Of three bays and one and a half storeys, aligned north east to south west. With a shallow pitched ridged roof gabled to north and south, of mortared flush pointed slate rubble construction with a corrugated iron roof. The east elevation onto the yard originally had three symmetrically placed segmental arched openings, allowing animals free access between the building and yard. Rough slate voussoirs form slightly cracked arches; the centre arch only survives intact, that to north being semi-infilled and that to south destroyed by the insertion of numerous doors and windows when converted to a stable. A horizontal line c.800mm below the eaves shows where the building was raised to form a hayloft over at a later date; with a loading door inserted off centre to the north at this time. The south gable shows evidence of this infill with a steeper pitch profile beneath more recent masonry. The rear wall to the field is featureless other than a single small upper floor window in the centre.
