BARNs AT HIGHER LEY FARM NORTH MOLTON DEVON

Results of a Desk-Based Assessment
&
Historic Building Recording

Report No.: 110113
Date: 13.01.11
Authors: T. Green
C. Humphreys
E. Wapshott

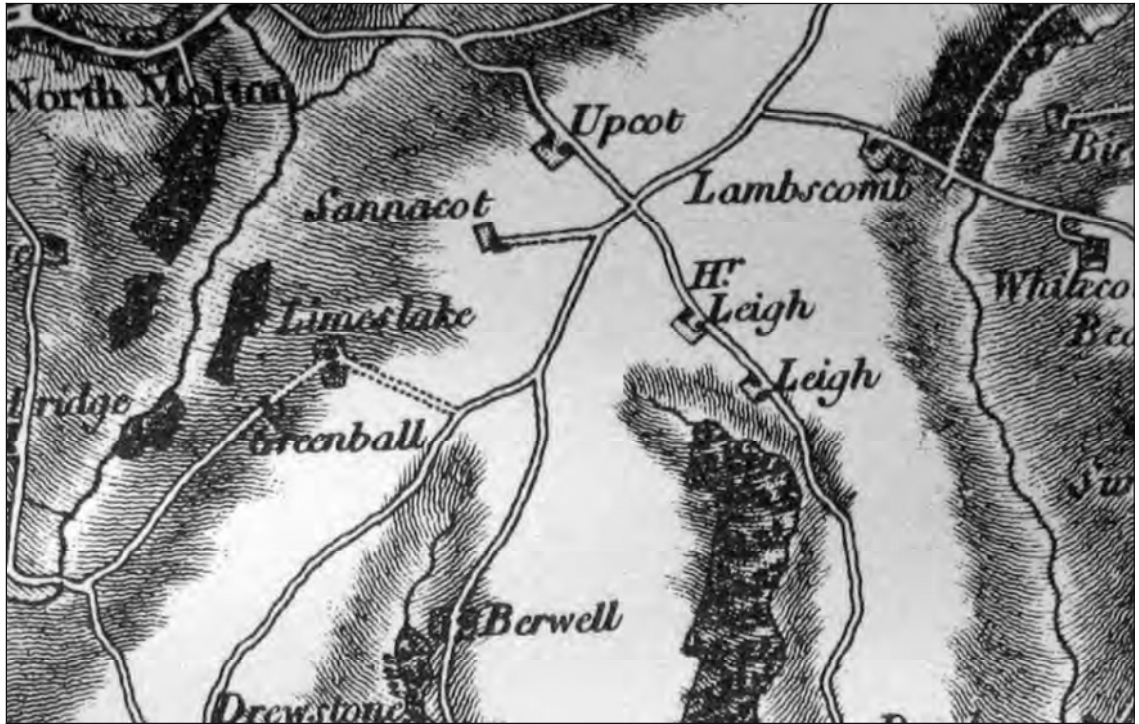
Figure 3: Extract from the Ordnance Survey 'Old Series' one inch map, published 1809. (WCSL)

This is the earliest map to provide any detail of the site. This map record does not meet the standards of later mapping, but taking it at face value appears to represent Higher Ley (spelt Leigh) as two buildings and a yard.

The historic mapping evidence appears to show on the Ordnance Survey ‘Old Series’ one inch map, published in 1809 (Fig. 3), a building to the north of the yard, in the position of the farmhouse, with a parallel range to the south-east, roughly in the position of Shippon no.2. Although we cannot rely on the accurate representation of buildings in these early maps, this appears to be supported by the 1827 Greenwood map of Devon (Fig. 4) and the 1840 North Molton tithe map (Fig. 5) which again show two main buildings, although the tithe map indicates that these are located at right angles to the north and east of a central farmyard.

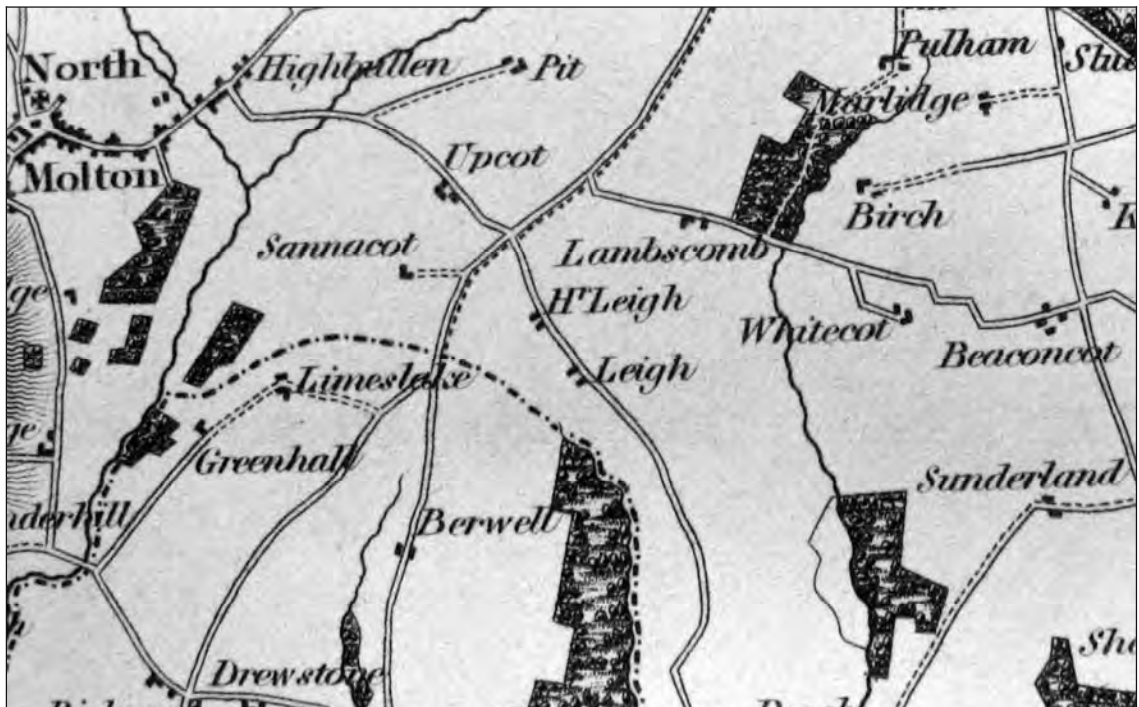
Figure 4: Extract from the Brothers Greenwood map of Devon, 1827. (WCSL)

This map indicates something similar to the above.

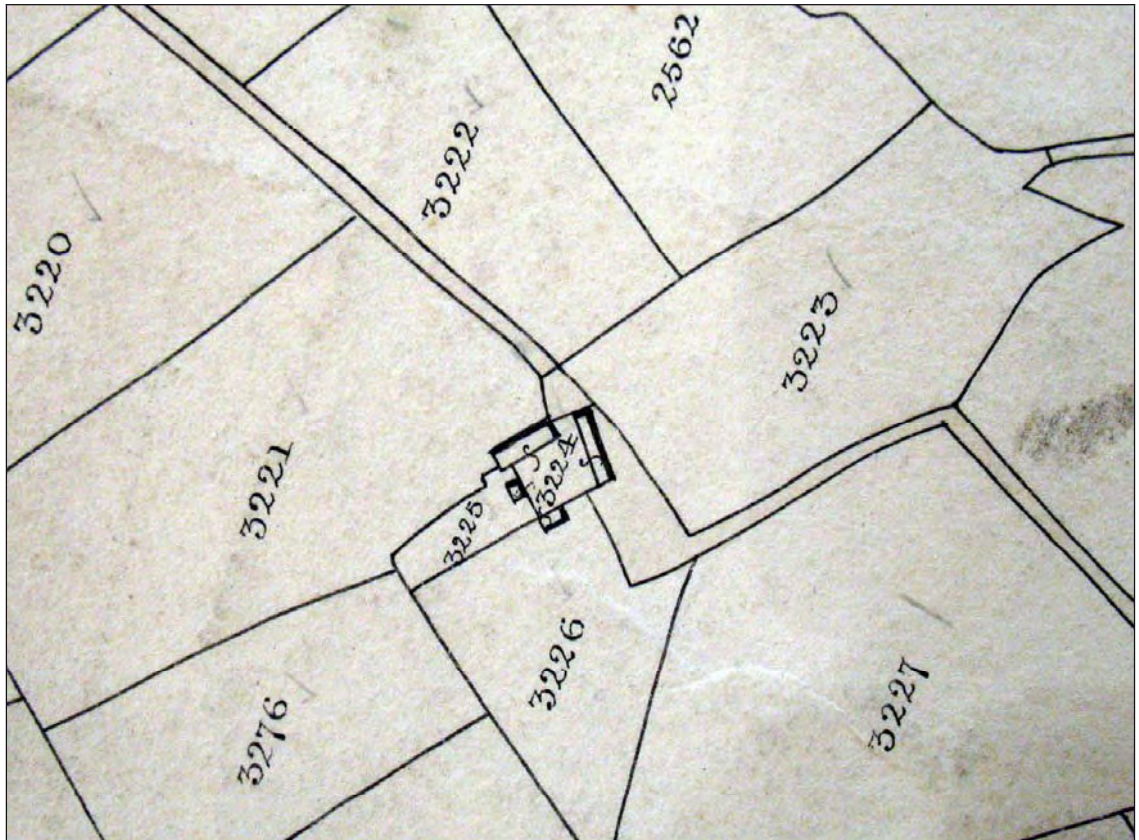
Figure 5: Extract from the North Molton tithe map, 1840. (DRO)

This is the earliest fully detailed map at a large scale. From this it can be seen that in 1840 there were two principal buildings, a yard, and two small ancillary buildings. The cartographer has not colour coded the buildings to distinguish domestic from non-domestic, but the building on the north side of the yard must be the farmhouse. To the east of the house was a long building on a N-S axis which stood well out into the road.

The tithe apportionment of 1840 indicates that at that date Higher Ley was owned by Lord Poltimore, leased to John Tamlyn and was occupied by John Snell. The farm buildings (3224 on the map) are described as House, Barton, etc.

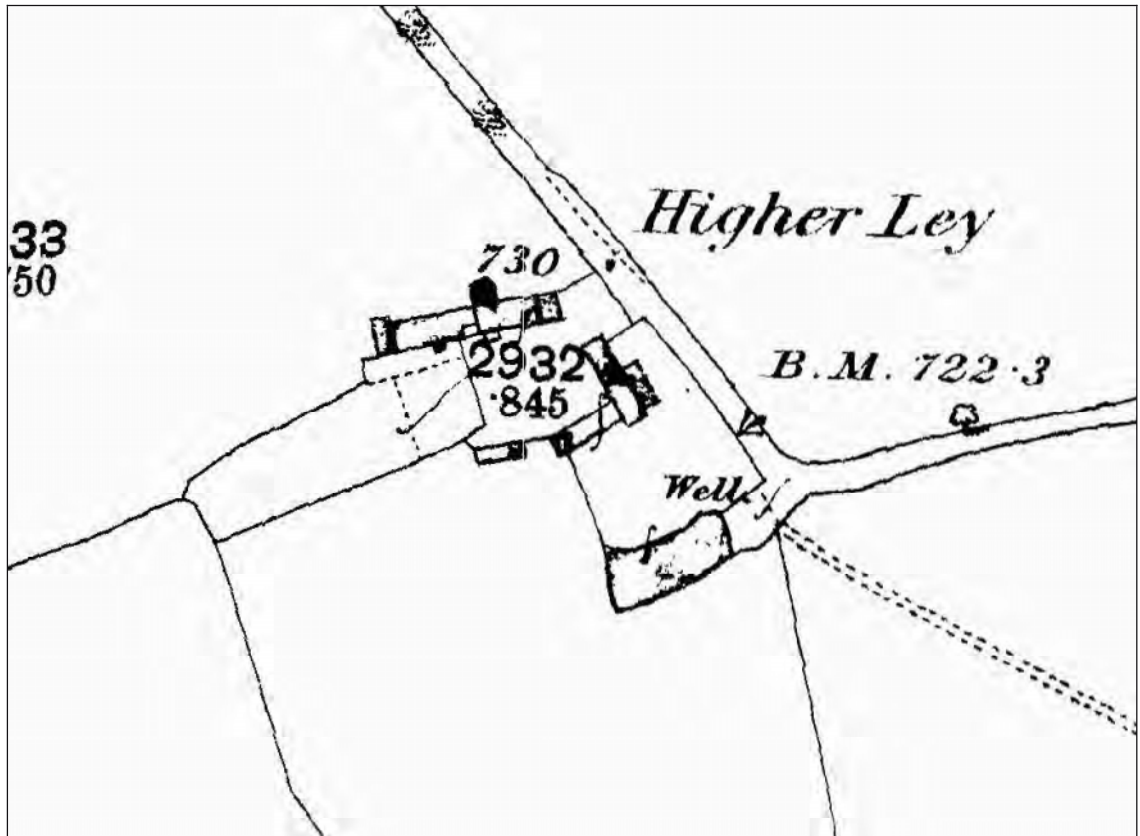
Figure 6: Extract from the Ordnance Survey First Edition map at 1:2500, published 1889. (County Series, Devonshire sheet 15.15)

This represents considerable change during the mid- to later 19th century. After a possible re-alignment of the road, a building appears to have been added at the east end of the farmhouse with possibly an engine house on its north side. A small addition has also been made to the west end of the farmhouse. The long building which previously stood out into the road appears to have been replaced by a building of the same alignment but located somewhat farther to the south (alternatively the existing building may have been truncated at its northern end, though this would have also involved some sort of re-alignment). This new building has a small outshut on its eastern side, while a further new building has been added at right angles at its southern end. To the west of this extension is a further building on an east-west axis. A small square building which previously stood against the western boundary of the yard has been removed. Boundaries have been altered most notably to the south-east where what was previously a widening of the road has been taken in with a well towards the south-east corner.

The biggest period of change to the configuration of the buildings at Higher Ley Farm occurred during the middle of the 19th century. By the time the Ordnance Survey First Edition map was published in 1889, Shippon no.1 had been built to the east of the Threshing Barn and a horse engine appears to have been constructed to the rear of the earlier structure, presumably to drive new mechanical threshing equipment. We can therefore assign a mid 19th century date to Shippon no.1 (1840-1889). The building most probably started its life as a stables, built to house the horses who worked the horse-engine, with a small hay-loft above. The economic outlay to build a horse engine house was substantial and the horses would have been prized stock and well looked after, evidenced by the specially constructed hay feed-chute alcoves to the rear (north) wall. Later, the barn appears to have had its roof raised, as we can see the original roof line in the purlin sockets still visible in the cob of the western gable and just below the eaves on the north elevation. The front wall was not extended and may have been partly dismantled during the raising of the roof, to form an open-fronted linhay. The stables were subsequently converted to a cattle byre, which has remained its use until recent times and this is no doubt when the further openings were forced through the south wall.

Shippon no.2, appears in its current form, on the 1889 map, a shorter, wider structure with a new building abutting its eastern side. The structure's coarser, cheaper build dates to the 1840-1889 period, with an earlier structure being truncated to the north and rebuilt on a slightly different axis. The two openings with brick segmental arches on the west elevation date to this period, the form of the arches is technically sophisticated but they are of poor quality using cheap bricks with no attempt to hide the makers stamps. A floor was then introduced to the probably former single-storey open barn, evidenced by the forcing of tie-beams into the east wall of the barn to support a tallet, this was built in stone. This barn seems to undergo a further raising of the roof height at some point in the late 19th or early 20th centuries, (using only cob, which was faced in stone on the west front) with two tallet loading doors forced in the south and west elevations and a window forced into the east elevation. The 1905 Ordnance Survey Second Edition map shows Shippon no.2, with an open fronted extension built on its southern end, which is when the large ground floor opening, now blocked, was probably forced into the south elevation. The roof displays a mixed use of joint fixings which may indicate re-use of timbers from the earlier building.

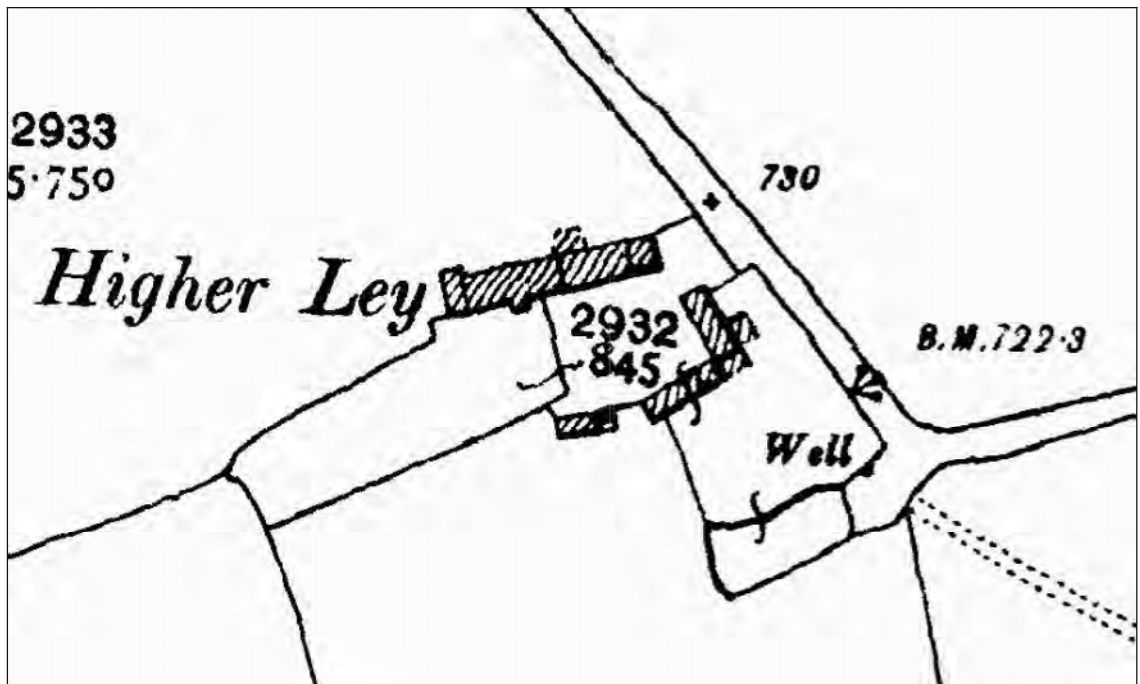
Figure 7: Extract from the Ordnance Survey Second Edition map at 1:2500, published 1905. (County Series, Devonshire sheet 15.15)

This indicates no further change.

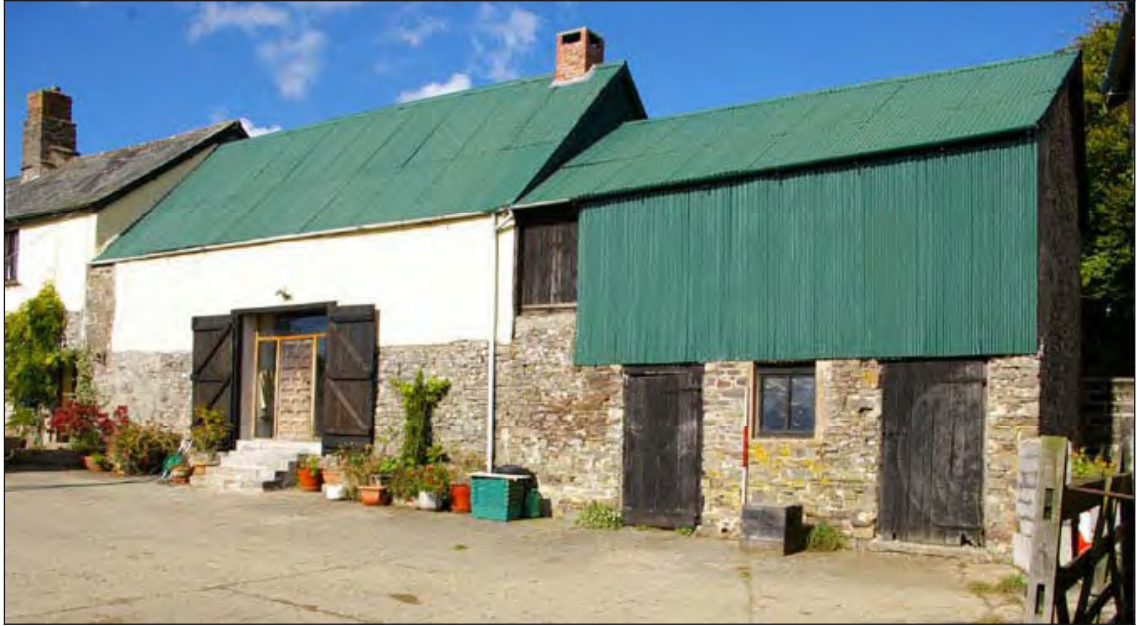
Figure 8: The south elevation of the parallel range; Threshing Barn and Shippon No. 1, viewed from the south-east (2m scale).

A three bay former Threshing Barn to the north of the farmyard, now converted for domestic use is attached to the farmhouse to the west and Shippon no.1 to the east (Fig. 8). Constructed of rubble slate stone to below first floor level, with part cob upper elevations under a corrugated iron roof and with plastic guttering. A small brick built chimney stack is situated on the eastern gable-end.

The rubble stones are platey, coursed and closely packed, and have surviving lime mortar in places, but are predominately repointed with cement; on the south elevation a concrete 'pebble-dash' layer has been applied over the upper cob portion of the elevation. The south elevation has two openings, a blocked opening on the ground floor to the west and a short flight of concrete block steps leading up from the farmyard to the raised central threshing door with a pair of modern ledged and braced boarded double doors, which are no longer in use. This opening is now blocked by a modern timber frame inset with glass panels and with a reclaimed framed and blocked continental period door. The north elevation is roughly coursed rubble stone, partly obscured by the bank to the rear (north) and with a rendered upper. This elevation also has two openings; a large partly blocked opening, with a large three pane casement window and a large single glass panel set into a tall narrow opening at the west end adjacent to the join with the farmhouse.

A three bay former stable, with internal stalls, now an enclosed linhay, is attached to the east end of the Threshing Barn, at the end of the parallel range (Fig. 8). Rubble slate stone and part cob elevations, with concrete block repairs under a corrugated iron roof, with plastic guttering. The stonework is platey, but only roughly coursed and has been largely re-pointed in cement mortar; the south elevation facing the yard has corrugated iron cladding to the upper section of the wall, over a timber frame with concrete block pillars supporting the roof trusses. The east and north walls are roughly coursed rubble stone with no openings, although the east elevation has concrete block repairs to the upper south portion. The north elevation in contrast has been raised using several courses of cob, now rendered, and a straight join in the masonry between it and the Threshing Barn is clear. The south elevation has four openings; an upper tallet loading door to the west; two ground floor boarded doors of seven plank width, ledged and braced to the west, ledged and half-braced to the east, with strap hinges; and a two-light window in between the lower doors. The door to the west and the window appear to have been forced, the door jambs and window reveals are ragged and contain bricks and cement patching. The eastern door appears to have stone jambs and be contemporary with the build of the wall.

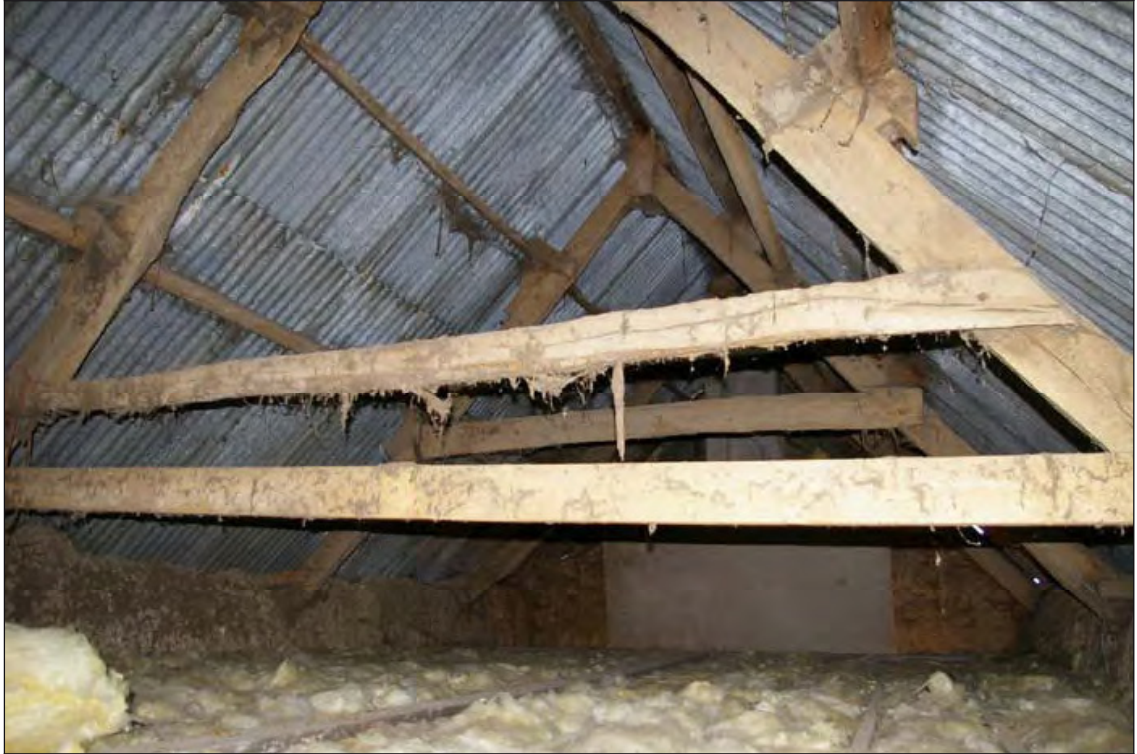
Figure 9: The roof structure of the threshing barn , viewed from the south-west.

The loft is one open space, with three crude (probably elm) timber A-frame roof trusses, each with a spiked collar and apex (Fig. 9). Two sets of purlins to each pitch are set on the backs of the truss blades with modern purlins set above the earlier purlins on blocks fixed onto the tops and sides of the truss blades. The earlier purlins and collars are spiked with the later elements bolted to the central A-frame. There appears to be light chamfering to the earlier A-frames and collars. The east gable is cob to north and south but now with a central inserted modern concrete block and cement chimney. The west end of the Threshing Barn abuts the eastern gable-end of the house, which is also of cob construction.

domestic use of the Threshing Barn, many of the original identifiable and dateable features, such as internal structures and in-situ timbers, have been removed. The roof trusses remain however and the assembly of the timbers, using spiked and not bolted joints, supports a late 18th century date.

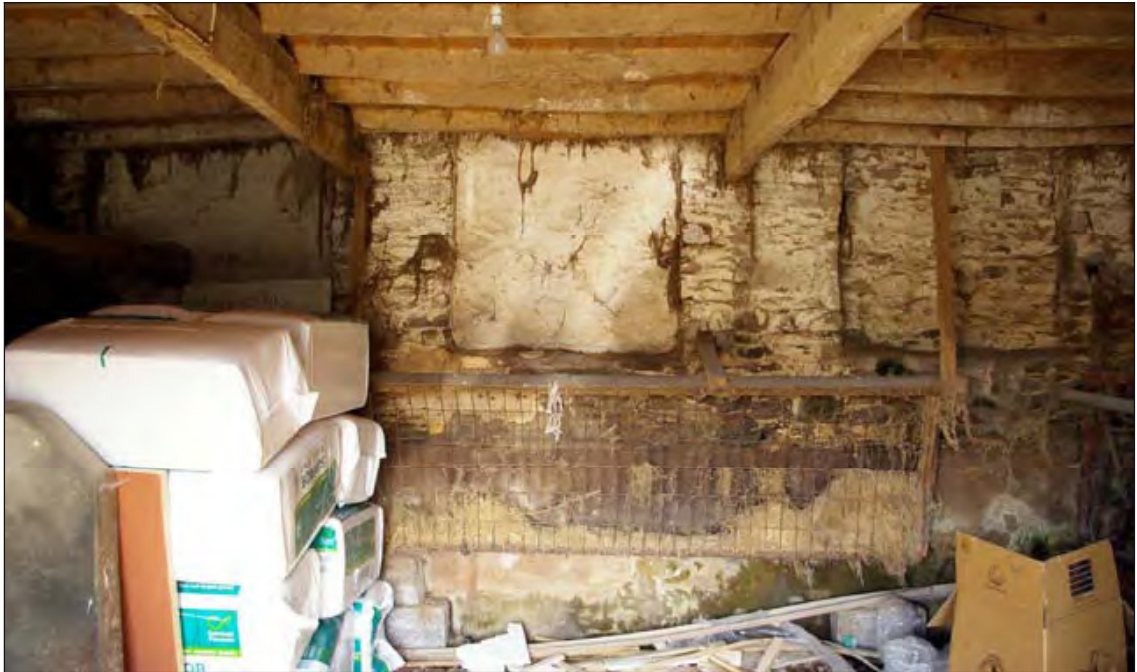
Figure 10: The interior north wall of Shippon no.1 with recessed alcoves for feeding access.

Entered from the yard through the western door. The ceiling is timber with a central beam, with a lightly chamfered rough profile to the east face and a narrow beam inserted to the west. Even width floor boards sit above, resting on floor joists which lie on top of the beams. The walls are stone, with whitewashed uppers and the north, south and west walls are part rendered to the feeding; the curve of these bays has been created within the width of the wall and they extend up into the tallet above, the floor did not originally extend into these bays which were open to the roof. There is a further bay to the left of the western door, underneath the tallet loading

door, which partially blocks it. The floor has been lowered and is now concrete with a central drainage channel, with a terracotta pipe, draining into the farmyard through the south wall. The doorway of the western door has a stone step and potentially some surviving cobbles. There are concrete cattle bays to the west wall with hayricks over, and a large hay feeder to the north wall. There is also an iron and wooden planking feed channel attached to the east wall. A large single beam provides a lintel to the three ground floor openings. The south wall of the tallet is open to the corrugated iron sheeting, with concrete block pillars supporting the roof trusses. The north wall has three recessed alcoves above the render lining, with timber lintels visible in the upper floor (Fig. 10).

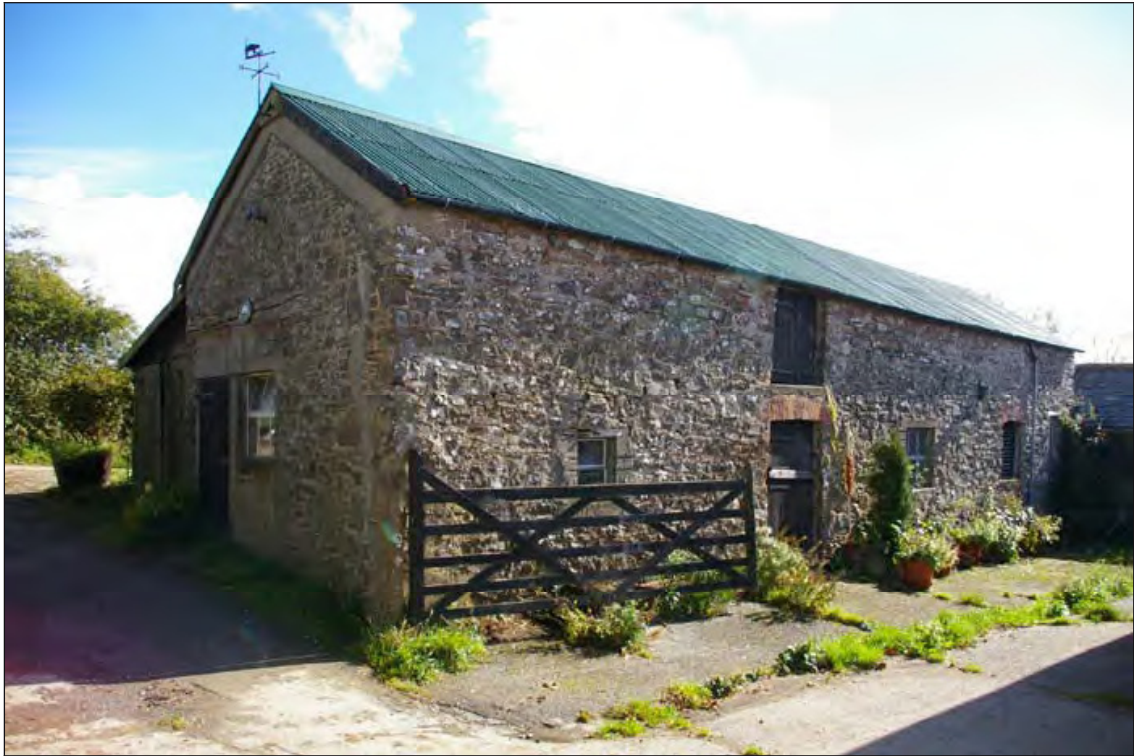
Figure 11: The north and west elevations of Shippon no.2, viewed from the north-west (2m scale).

A former shippon, forming the east side of the farmyard and attached to the single-storey stone stable block at the south-west corner (Fig. 11). Constructed of un-coursed rubble slate stone and part cob, under a corrugated iron roof, with plastic guttering.

The stones used in the construction of this barn are larger and blockier and are more widely spaced and uncoursed than the other surveyed buildings. The barn has surviving lime mortar on the east elevation, while the west elevation has largely been repaired with cement mortar and pointing. The south elevation has a mixture of cement and lime mortar render, and the northern elevation has cement mortar and pointing. Each elevation of this barn exhibits some form of cob upper; this is most clearly seen on the east elevation. The western elevation, which is the presentation face of the barn, fronting onto the courtyard, has a cob upper faced in stone. The tie-beams supporting the first floor appear to have been forced through the east elevation leaving large ragged holes, some partly re-blocked with debris. There is a wood-framed and corrugated iron clad lean-to attached to the north end of the east elevation.

The south gable-end elevation has two openings; a large upper loading door to the tallet, with a timber lintel, this has ragged sides, due to the removal of the door and frame; below this to the east is a large doorway with a timber lintel now blocked with concrete blocks. The east elevation has one opening; a wooden hopper casement window, with a timber lintel and concrete sill. The north elevation also has a single opening; with a formerly large opening with a substantial timber lintel, now partly blocked with concrete blocks and brickwork to create a doorway, with a modern planked door, and a window to the west, with a metal casement.

The west (front) elevation has seven openings. A small modern window to the north with a timber lintel and concrete sill appears to have been forced into the wall and is surrounded by concrete block repairs. To the right of this is the upper loading door to the tallet, with a boarded timber door with strap hinges and an iron latch. Below this is a doorway with a segmental brick arch of crude construction (bricks are stamped with the word 'oven') with a boarded stable door, both leaves with strap hinges and an iron latch. To the south of the stable door there is a modern metal casement window with cement lintel, which also appears to have been forced into the wall, with concrete block repairs to the left reveals. At the south end of the elevation there are two openings; a large former window which has a brick segmental arch and stone reveals and is now blocked with timber louvres; and to the right of this there is a further narrow

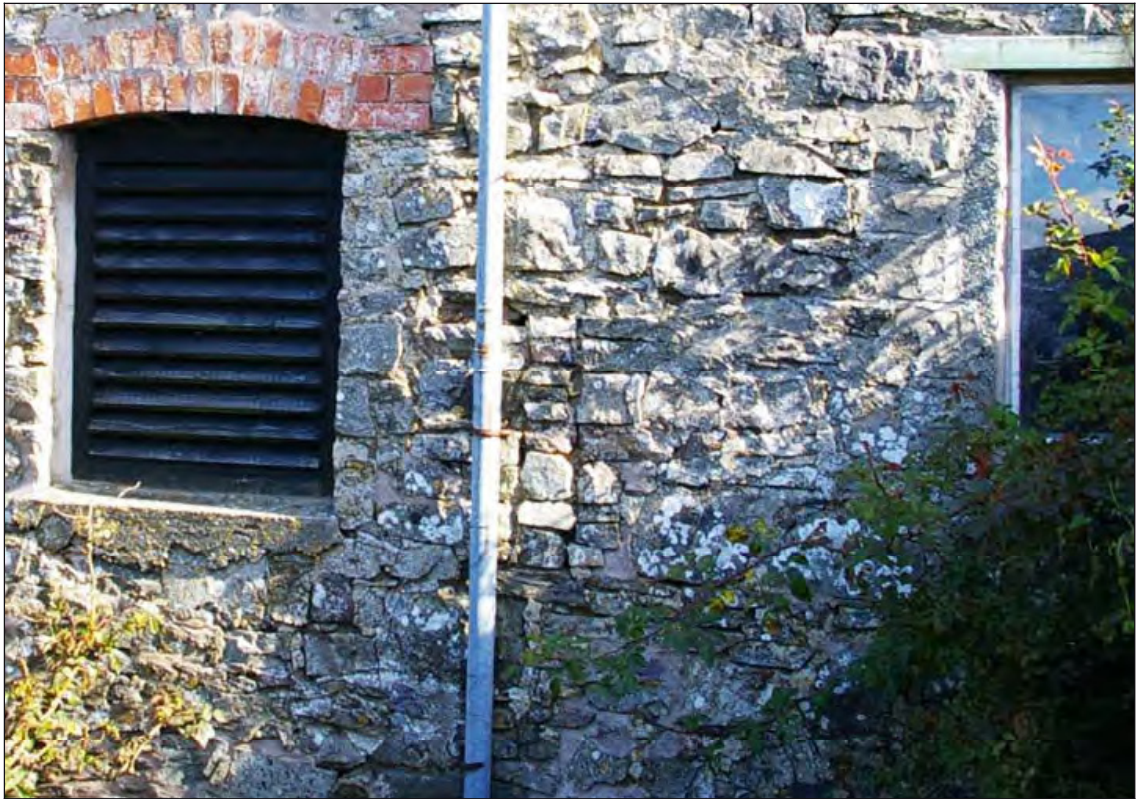
Figure 12: Detail of the slit air-vent in the west elevation of Shippon no. 2, viewed from the west.

opening with a timber lintel and concrete block reveals which again appears forced into the wall. Between these two existing openings is a blocked slit air-vent with a slate stone slab lintel, sill and stone reveals (Fig. 12).
