WEST WITHEVEN FARM BARN CANWORTHY WATER CORNWALL

Results of a Historic Building Survey
and Photographic Recording

Report No.: 122121
Date: 03.09.2010
Authors: E. Wapshott
N. Berry
C. Humphreys
L. Bray

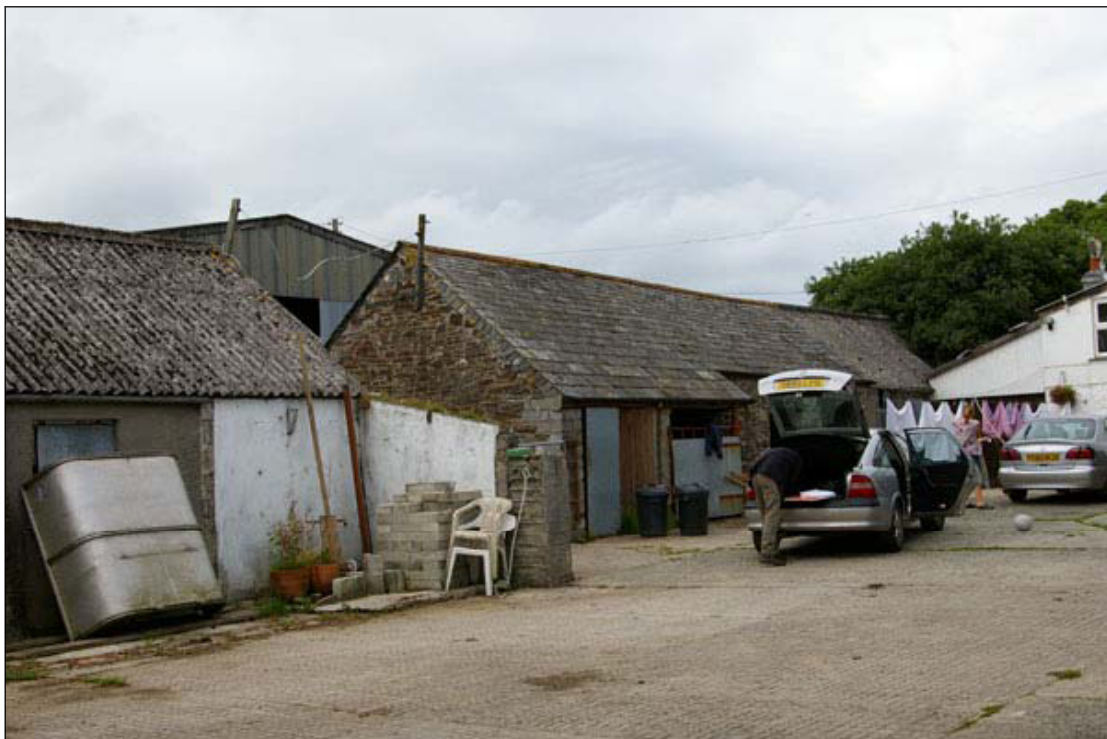
Figure 2: The farmyard, with the single-storey barns and farmhouse, viewed from the south-east.

The barn is set on an east-west axis and is situated to the north of a small concreted yard adjacent to the lane and to the south of the main farmyard (Fig. 2) that is enclosed by the farmhouse to the north and a range of single-storey buildings to the west. Attached to the west end of the barn are modern agricultural buildings (Fig. 3).

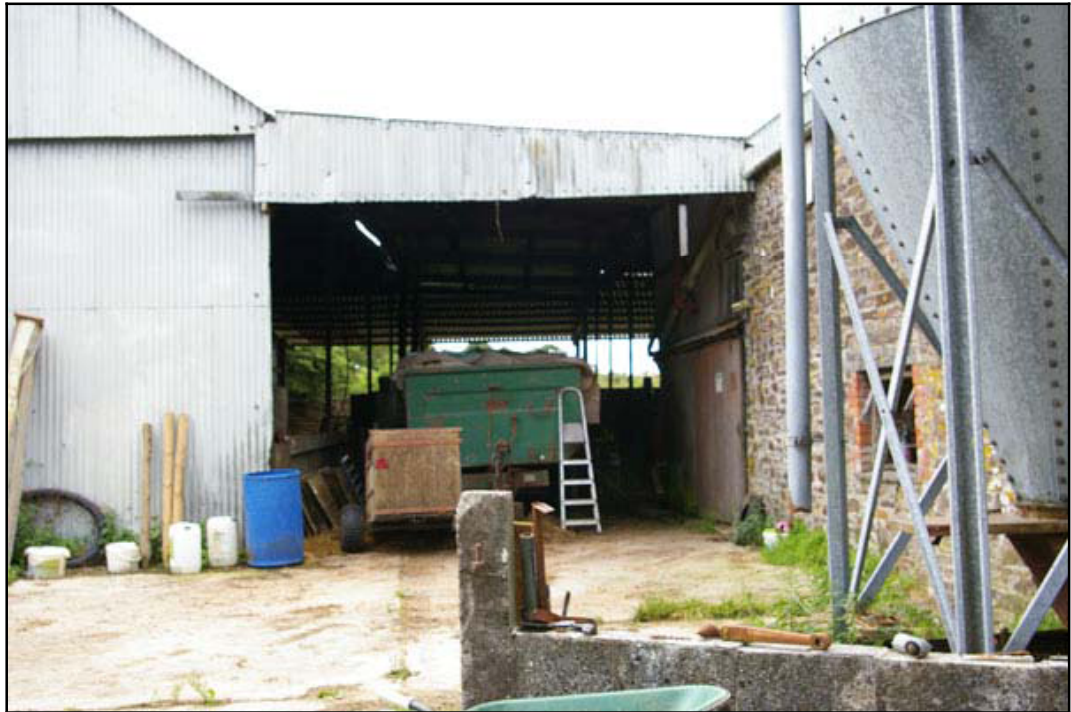
Figure 3: The modern farm buildings wrapping around the west end of the barn, viewed from the east.

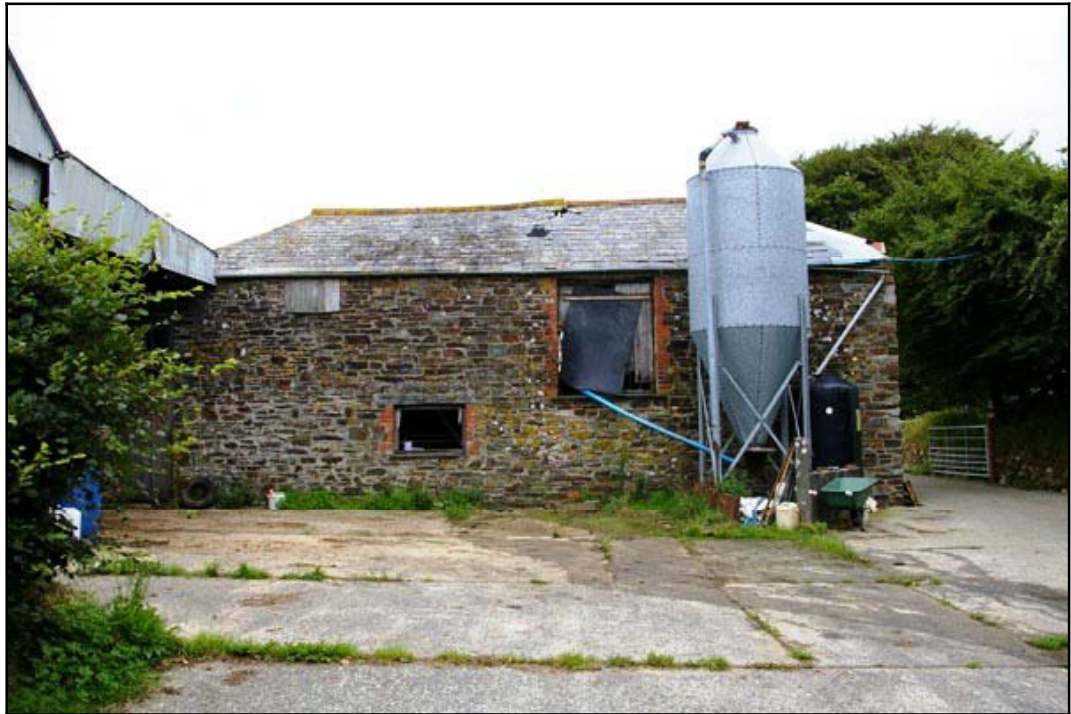
Figure 4: The south elevation of the barn.

The south elevation of the barn (Fig. 4) measures 12.3m long and is of semi-coursed rubble construction bonded with a mix of original lime mortar (yellow or white-grey in colour) and cement with some re-pointing apparent in places. Faced stone quoins are present at both ends, with the eastern end being part of the 20th century rebuild (see below). In detail, three different styles of stonework are apparent. At its western end this elevation is of semi-coursed, rubble construction composed predominantly of closely spaced slabs of local slate with occasional granite blocks. It is bonded with lime mortar with modern cement pointing repairs in places. This style of stonework also occurs towards the eastern end of the elevation in vertical section up to 2m wide that is pierced by a cross-brace. The second style of construction is recent, associated with the re-construction of the eastern elevation of the barn (see below) and is present at the eastern end of the elevation in a vertical strip around 1m wide. The final style dominates the central part of the elevation and again is of semi-coursed rubble construction, bonded with a lime mortar and composed mostly of local stone. However, the slate used in this style is larger, more blocky and less closely packed than those of the first.

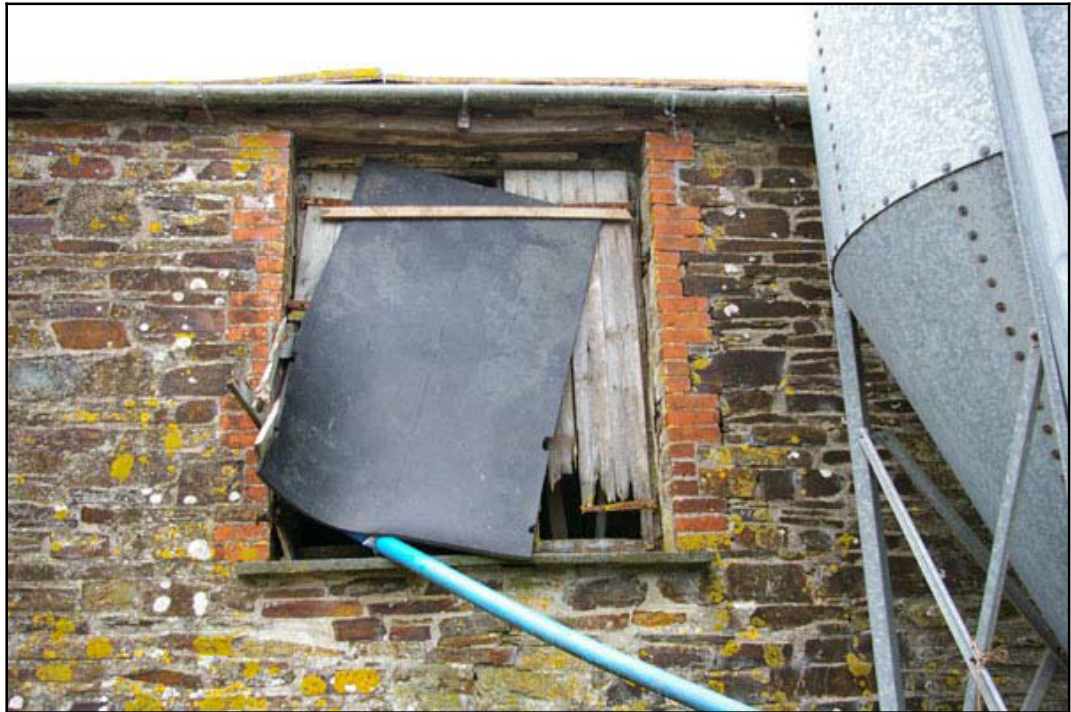
Figure 5: The eastern first-floor opening in the southern elevation.

There are three openings in the southern elevation. The easternmost (Fig. 5) and central of the two have bright orange-red machine-made brick reveals with slate sills, while the bricks of the western opening reveal are brownish-orange in colour, similar to those used in the openings of the northern elevation and may be handmade. Both first floor openings have wooden lintels while that of the lower is formed of two large slate slabs, above which is a large granite lintel (Fig. 6). Disturbed stonework is also apparent below this opening. The first-floor threshing door to the east, has wooden double doors, formerly of four-plank construction with iron hinges. However, these have partially rotted away and a large square section of plastic has been fixed to them to protect the barn interior. A cross-brace has recently been fixed into the elevation, possibly following the rebuilding to the east, to counteract the bowing of the north elevation.

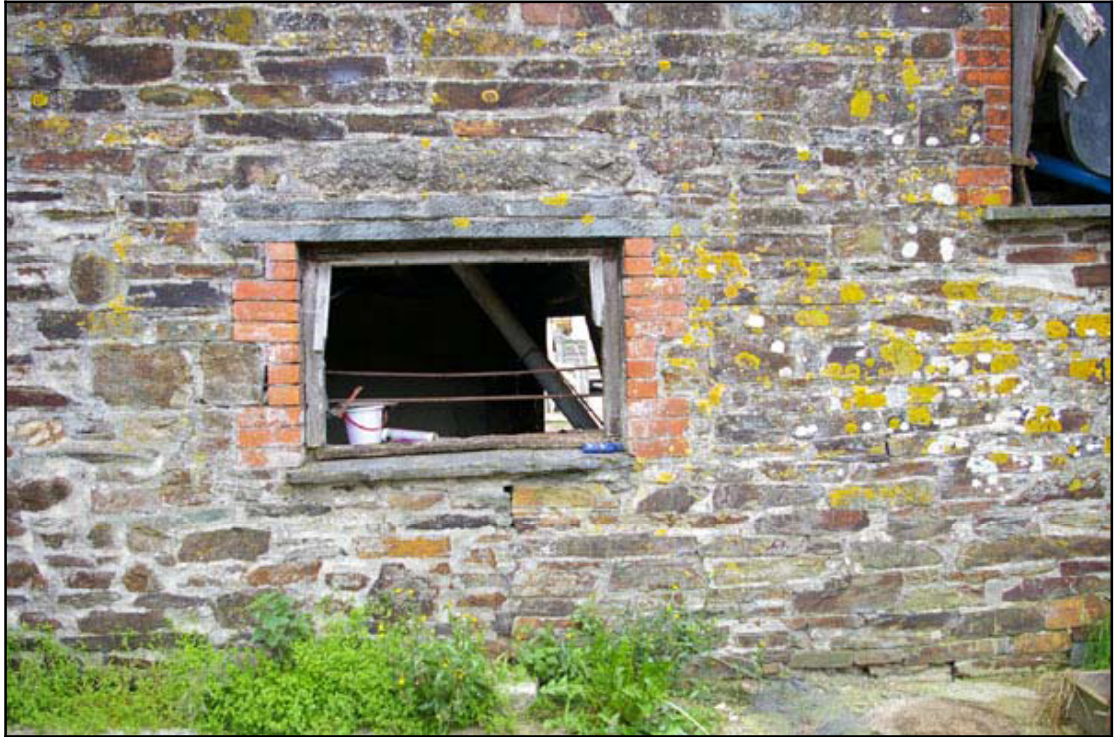
Figure 6: Ground-floor opening to the west of the south elevation, with a double slate slab lintel.

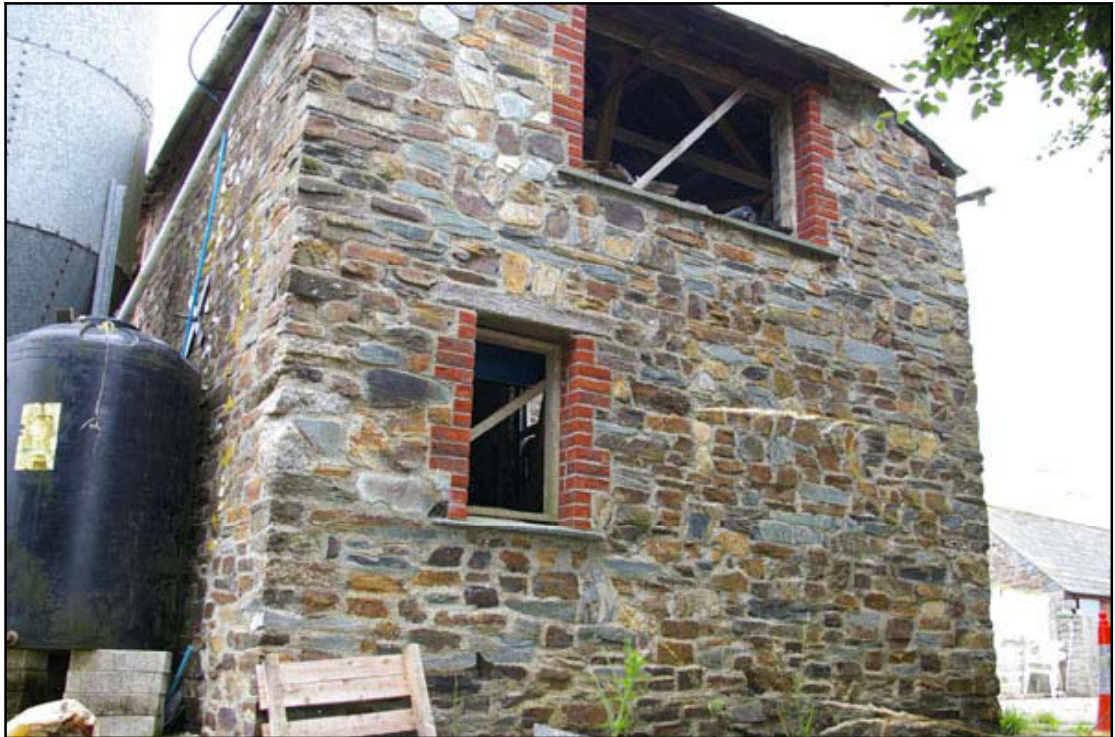
This has been completely rebuilt using semi-coursed rubble construction and slate and granite quoins in keeping with the remainder of the building (Fig. 7). Ground and first floor openings are present, probably in the locations of the originals, although there is no evidence for this, with dark brick-red brick reveals. The gable end of the roof is hipped with corrugated iron sheeting repairs at eaves height, but multiple holes remain in the surviving slate section towards the apex of the hip.

Figure 7: East elevation of the barn viewed from the south east.

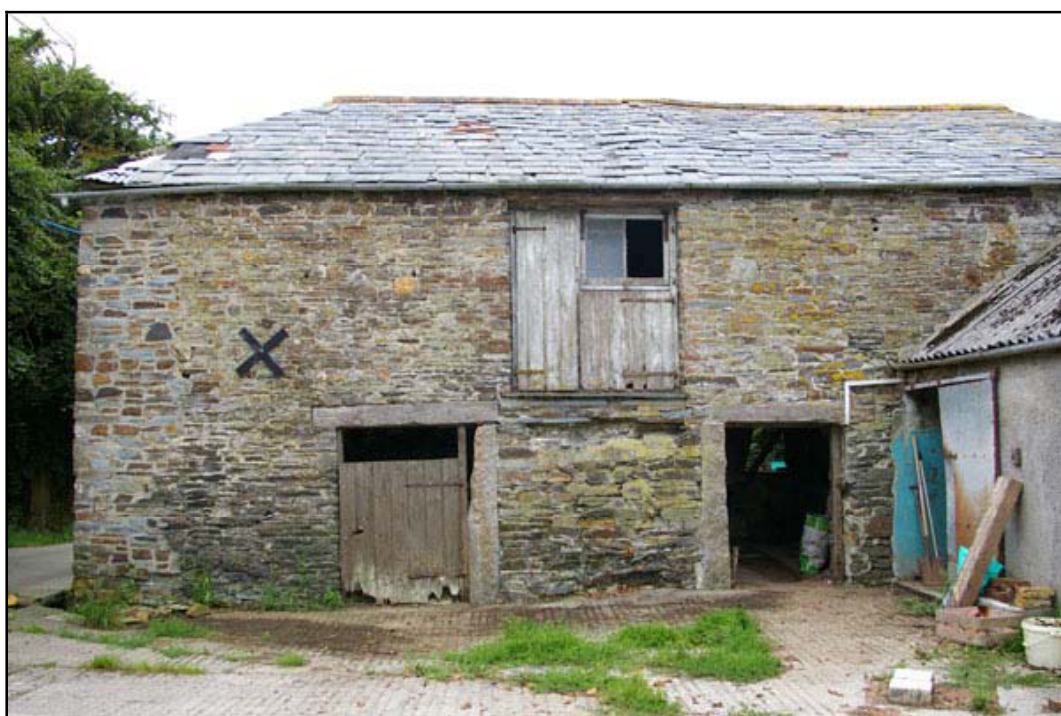
The adjoining mid-20th century milking parlour abuts this elevation at its western end with a concrete farmyard adjacent to the north (Fig. 8).

The east end of the elevation has been rebuilt with granite and slate quoins, as part of the replacement of the east elevation (see above). To the west of this the cross brace is present, reinforcing a bowing section of wall.

This elevation is pierced by three openings, two at ground level and a third on the first floor. The ground level openings have oak lintels and a single door jamb each formed from granite posts (Fig. 9). The latter are mostly undressed except on the face adjoining the stone work. The door frame is also built out from this post to hold the seven-plank, oak stable door the fitments of which are possibly handmade. It is obvious that the current doorways are later insertions while the walling between is blocking the original doorway.

Figure 8: North elevation of the barn.

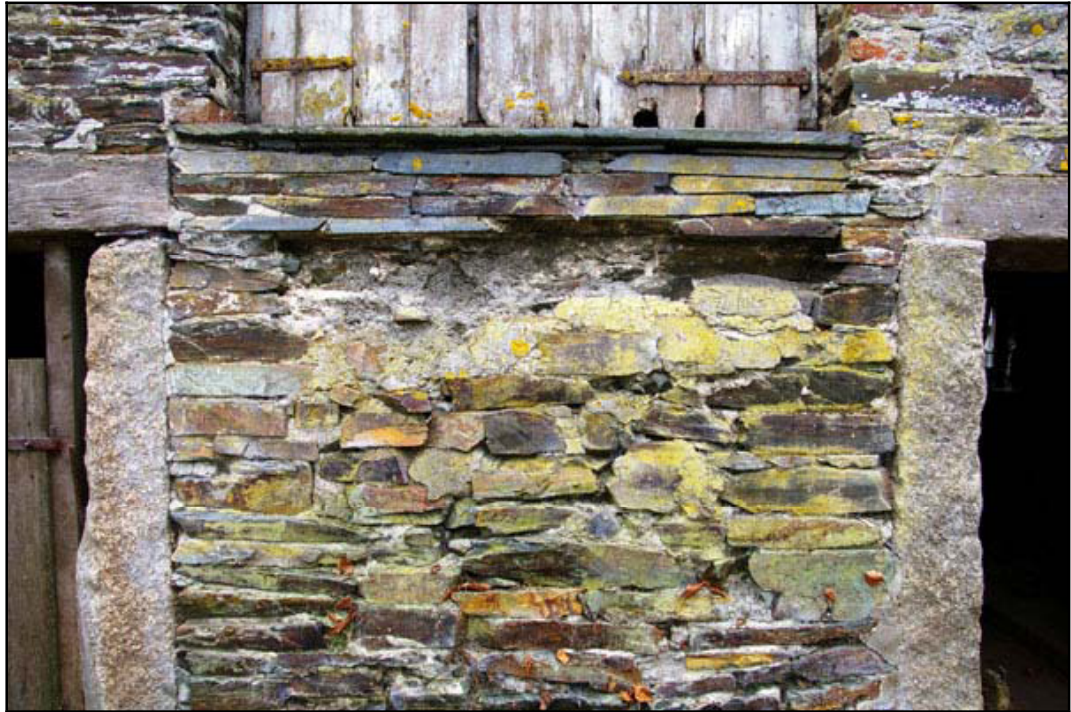
Figure 9: Granite posts flanking the ground floor openings in the north elevation.

In addition to the recent rebuild of the eastern part of the northern elevation several different styles of stonework are apparent (e.g. fig. 9). To the east of the eastern ground floor and first floor openings the wall is of semi-coursed construction bonded with lime mortar and consists of thin slabs of slate with occasional granite blocks. A similar style of stonework is visible at the western end of the elevation adjacent to the milking parlour. The original ground floor opening has been blocked with a rough wall of semi-coursed rubble construction composed of slate blocks originally bonded with lime mortar (fig. 9). However, its central section is bonded with cement and, according to a scratched inscription, is a later repair dating to 1984. Immediately above this, below the first floor opening are four courses of regular, coursed stonework. To the west of the upper opening, the wall is of semi-coursed rubble in a different style again composed of slate blocks bonded with lime mortar. Associated with this below the eaves are two distinct courses of regular stonework, bonded with lime mortar.

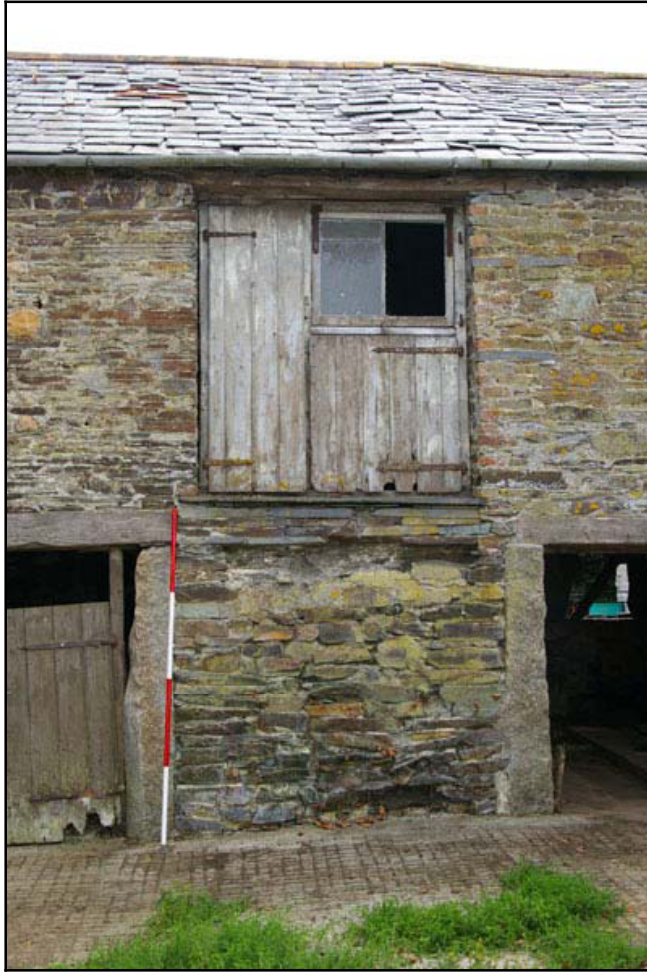
The first floor opening (fig. 10) has a reveal composed of possibly hand-made bricks on its western side while, on the east, there is no formal reveal and the stonework is somewhat ragged suggesting the opening has been inserted into the wall. This opening has an oak lintel and a fine, though broken, slate slab sill. The door frame is of oak with four-plank full height door to the east and a stable door to the west. The ironwork on this door is also possibly handmade.

Figure 10: The central section of the north elevation (scale 2m).

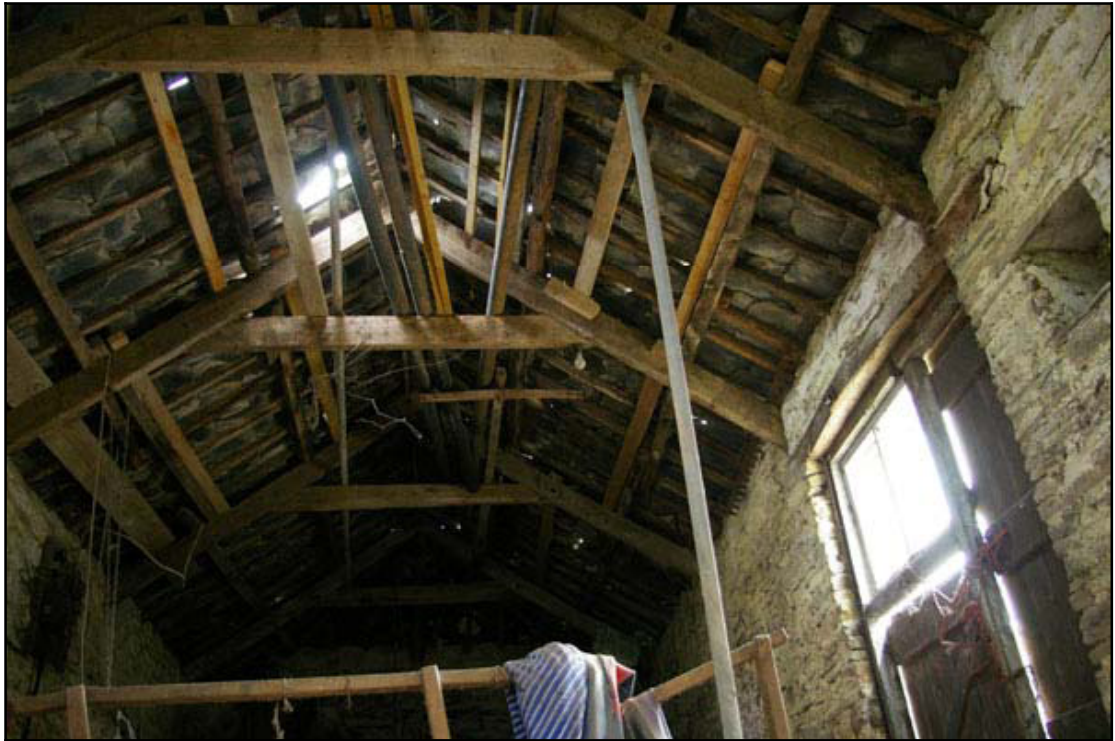
The roof (Fig. 11 & 13) of the barn is in poor condition at its eastern end above the recently rebuilt eastern elevation. In this area there are multiple missing slates with noticeable damage due to water ingress and rotting to the roof trusses and purlins beneath. Large, wooden beams are temporarily in place to provide additional support. Further damage is evident approximately half way along the roof where the roof structure has failed. Here the ridge tiles are raised up and numbers of slates have slipped. The roof is constructed with trusses spaced at approximately 2m intervals and most of its elements display machine-cut squared profiles and are fixed with iron bolts. The exceptions to this are the central beams of the eastern and western gables which are roughly hewn with rounded profiles, suggesting hand-shaping. The roof slates are attached directly to the rafters.

Figure 11: Roof structure, viewed from the east.

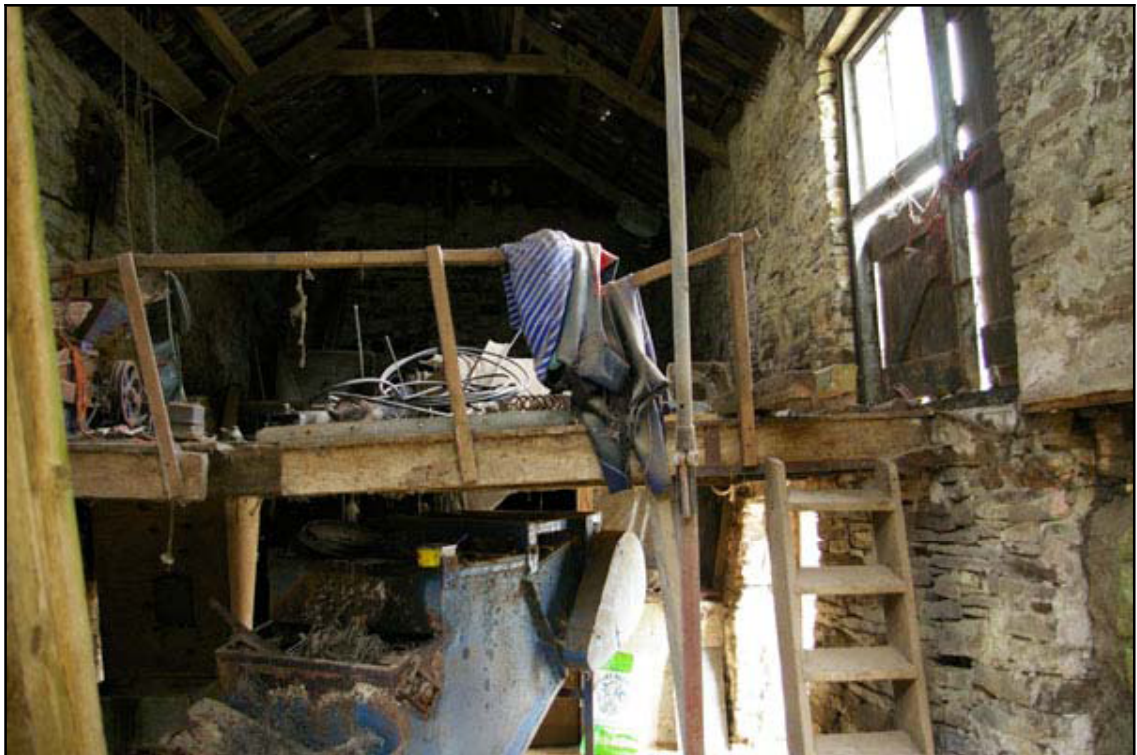
Figure 12: Internal view of barn from the east showing the floor and *in situ* machinery.

A floor (Fig. 12 & 13), inserted at a height of 1.5-1.7m., covers two thirds of the interior of the barn and is constructed of oak joists and floor boards with oak railings and posts on the open, eastern end. The oak lintel of the eastern opening in the northern elevation has a number of slots for joists cut into it, suggesting that originally the floor may have extended for the whole length of the building. Access to the floor is currently provided by a five rung, oak loft ladder on the northern side. A number of hatches have been cut through the floor which relate to farm machinery, some of which remains *in situ*. The floor is fixed together with iron bolts and hand-made nails.
